ACTIVITIES OF THE CROATIAN CONSERVATION INSTITUTE
ON THE PROJECT OF THE RESTORATION OF THE FAÇADE OF
THE CHURCH OF ST BLAISE AT DUBROVNIK

DJELATNOST HRVATSKOG RESTAURATORSKOG ZAVODA NA PROJEKTU OBNOVE PROČELJA CRKVE SV. VLAHA U DUBROVNIKU

OBNOVA PROČELJA CRKVE SV. VLAHA U
DUBROVNIKU / RESTORATION OF THE
FAÇADE OF THE CHURCH OF ST BLAISE AT
DUBROVNIK

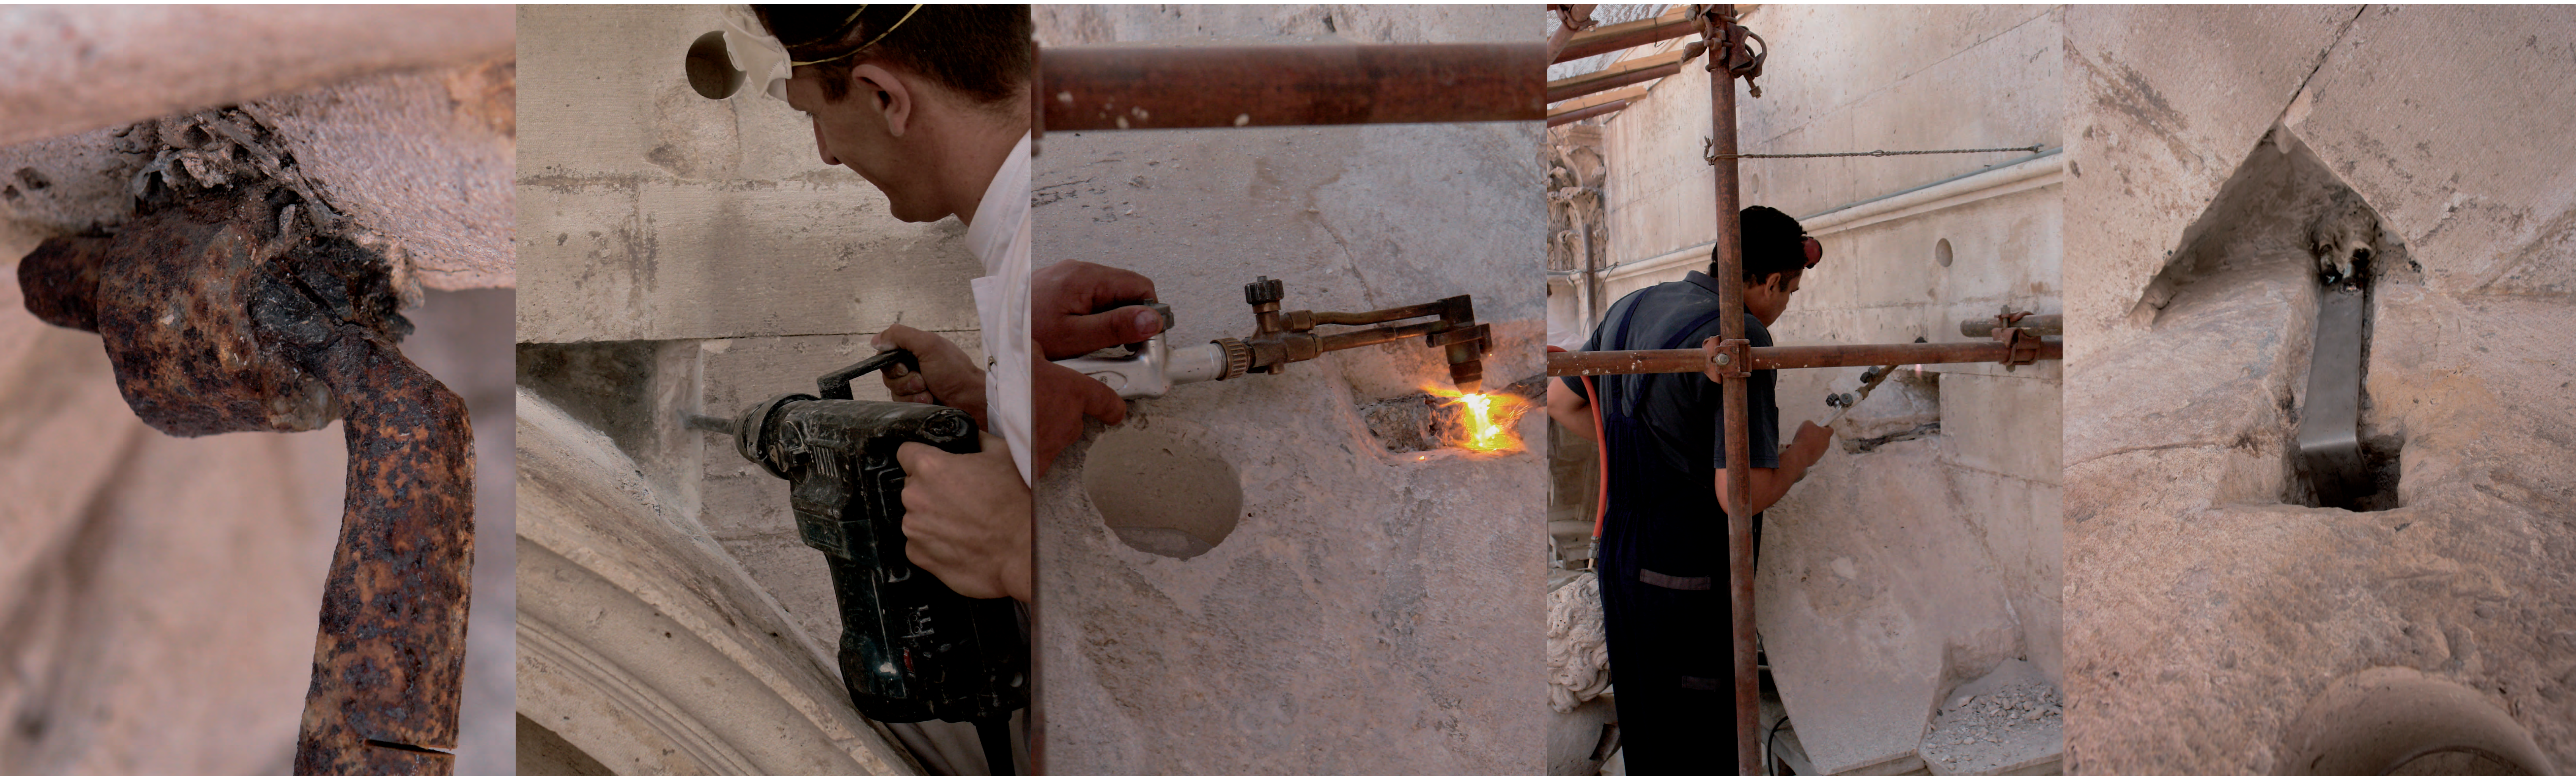
REPLACING OF THE
METAL PARTS

parts caused damage to the stone and this in turn created the possibility of further damage. In most cases, the damage lead to the expansion of the corroded fixing cramps which increased their volume and destroyed the stone core. By-products of the chemical reaction were transported through the action of the elements onto the stone surface and created a layer of dirt. That is why it was decided to replace all metal parts with the new ones made of non-corrosive metal.

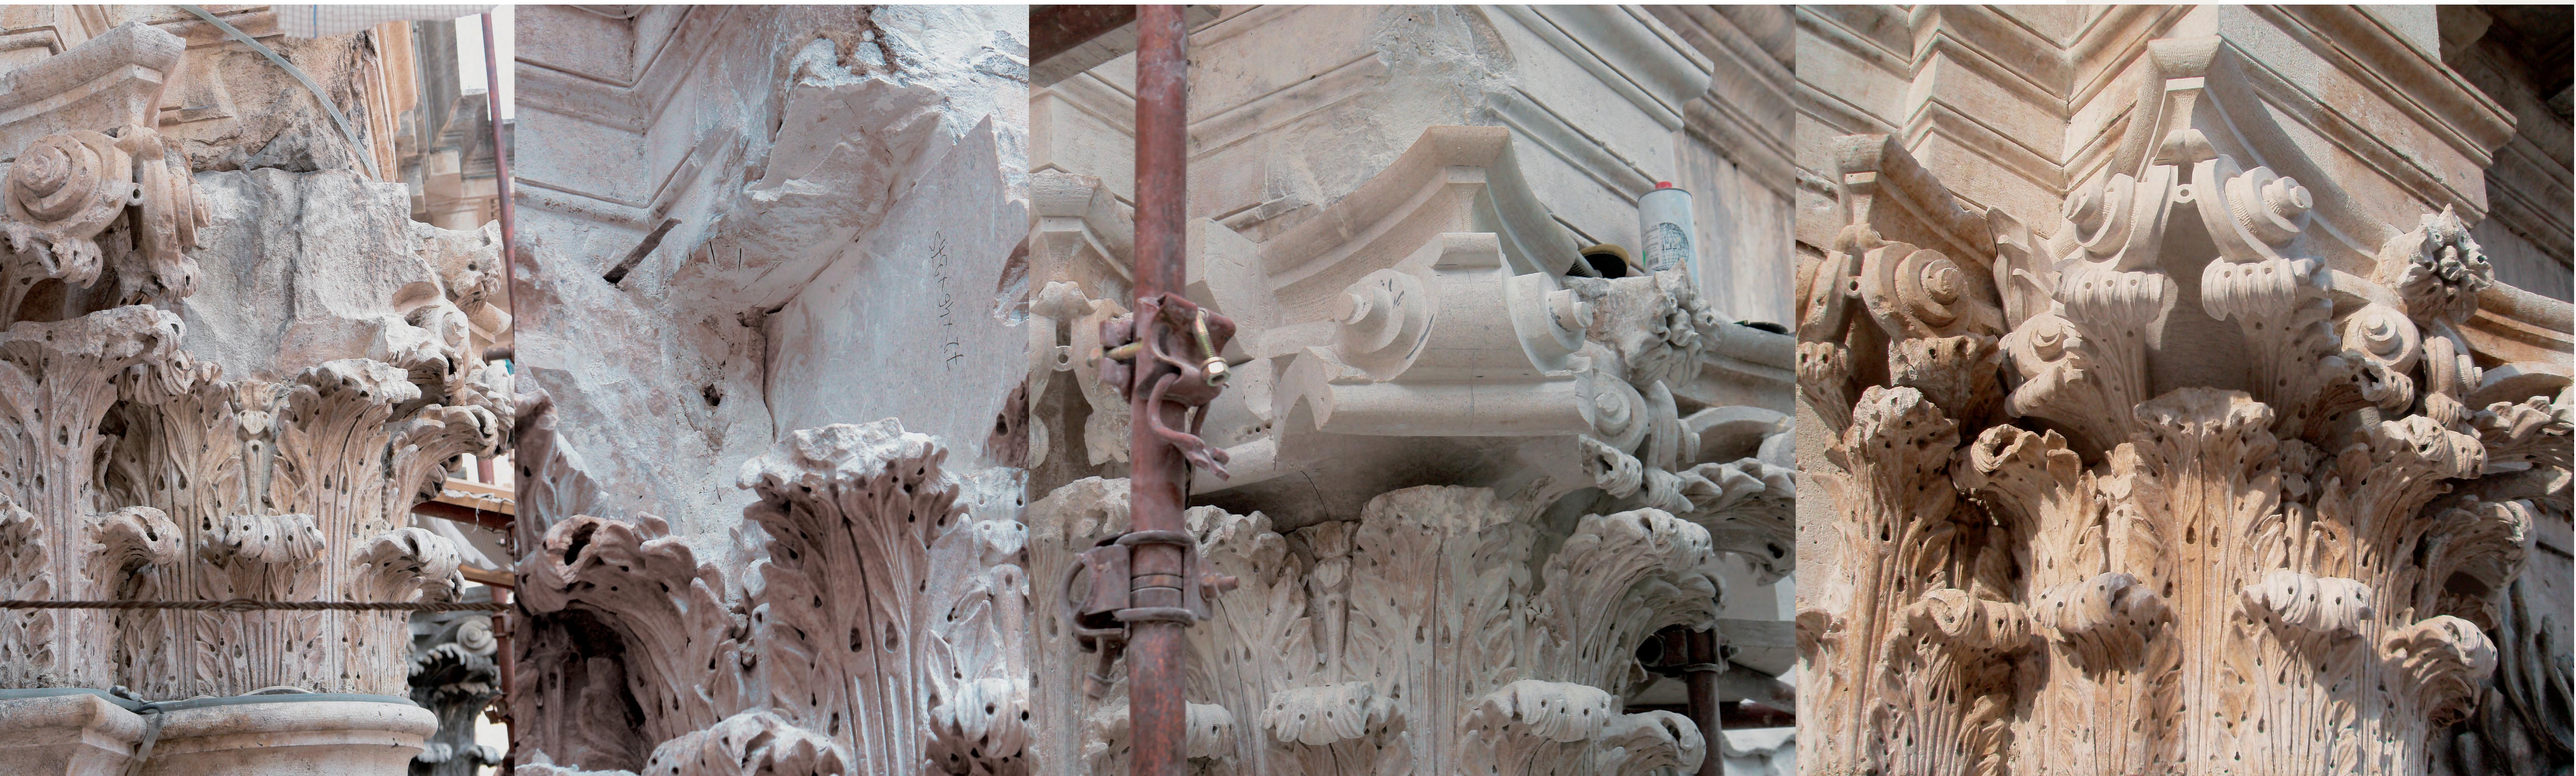
REPLACEMENT OF
STONE BLOCKS

izravnim spojevima originalnih i tašeliranih dijelova upotrijebljeno je dvokomponentno ljepilo za kamen. Površinska obrada zamjenskih elemenata kamene plastike također je prilagođena obradi originalnih blokova. In the places where the masonry structure was severely damaged and where the crumbling and splitting of stone blocks appeared causing some of them to break off and fall, new blocks of the same stone had to be inserted. These blocks, which had been previously treated with the rough carving technique, were fixed into the

bedding plane of the masonry. The joints between them were filled with lime mortar mixed with cement mortar. When it was necessary to embed the stone implant, the rod that was used was made of stainless steel and provided with a screw, while the mortar was the same as the one used for the joints. Where the original and the inserted blocks were joined directly, the dual-component glue for stone was applied. The surface of the replacement carved stones was also treated to match the workmanship of the original blocks.
