## ZATEČENO STANJE

## INITIAL CONDITION

HRVATSKI  
RESTAURATORSKI  
ZAVOD

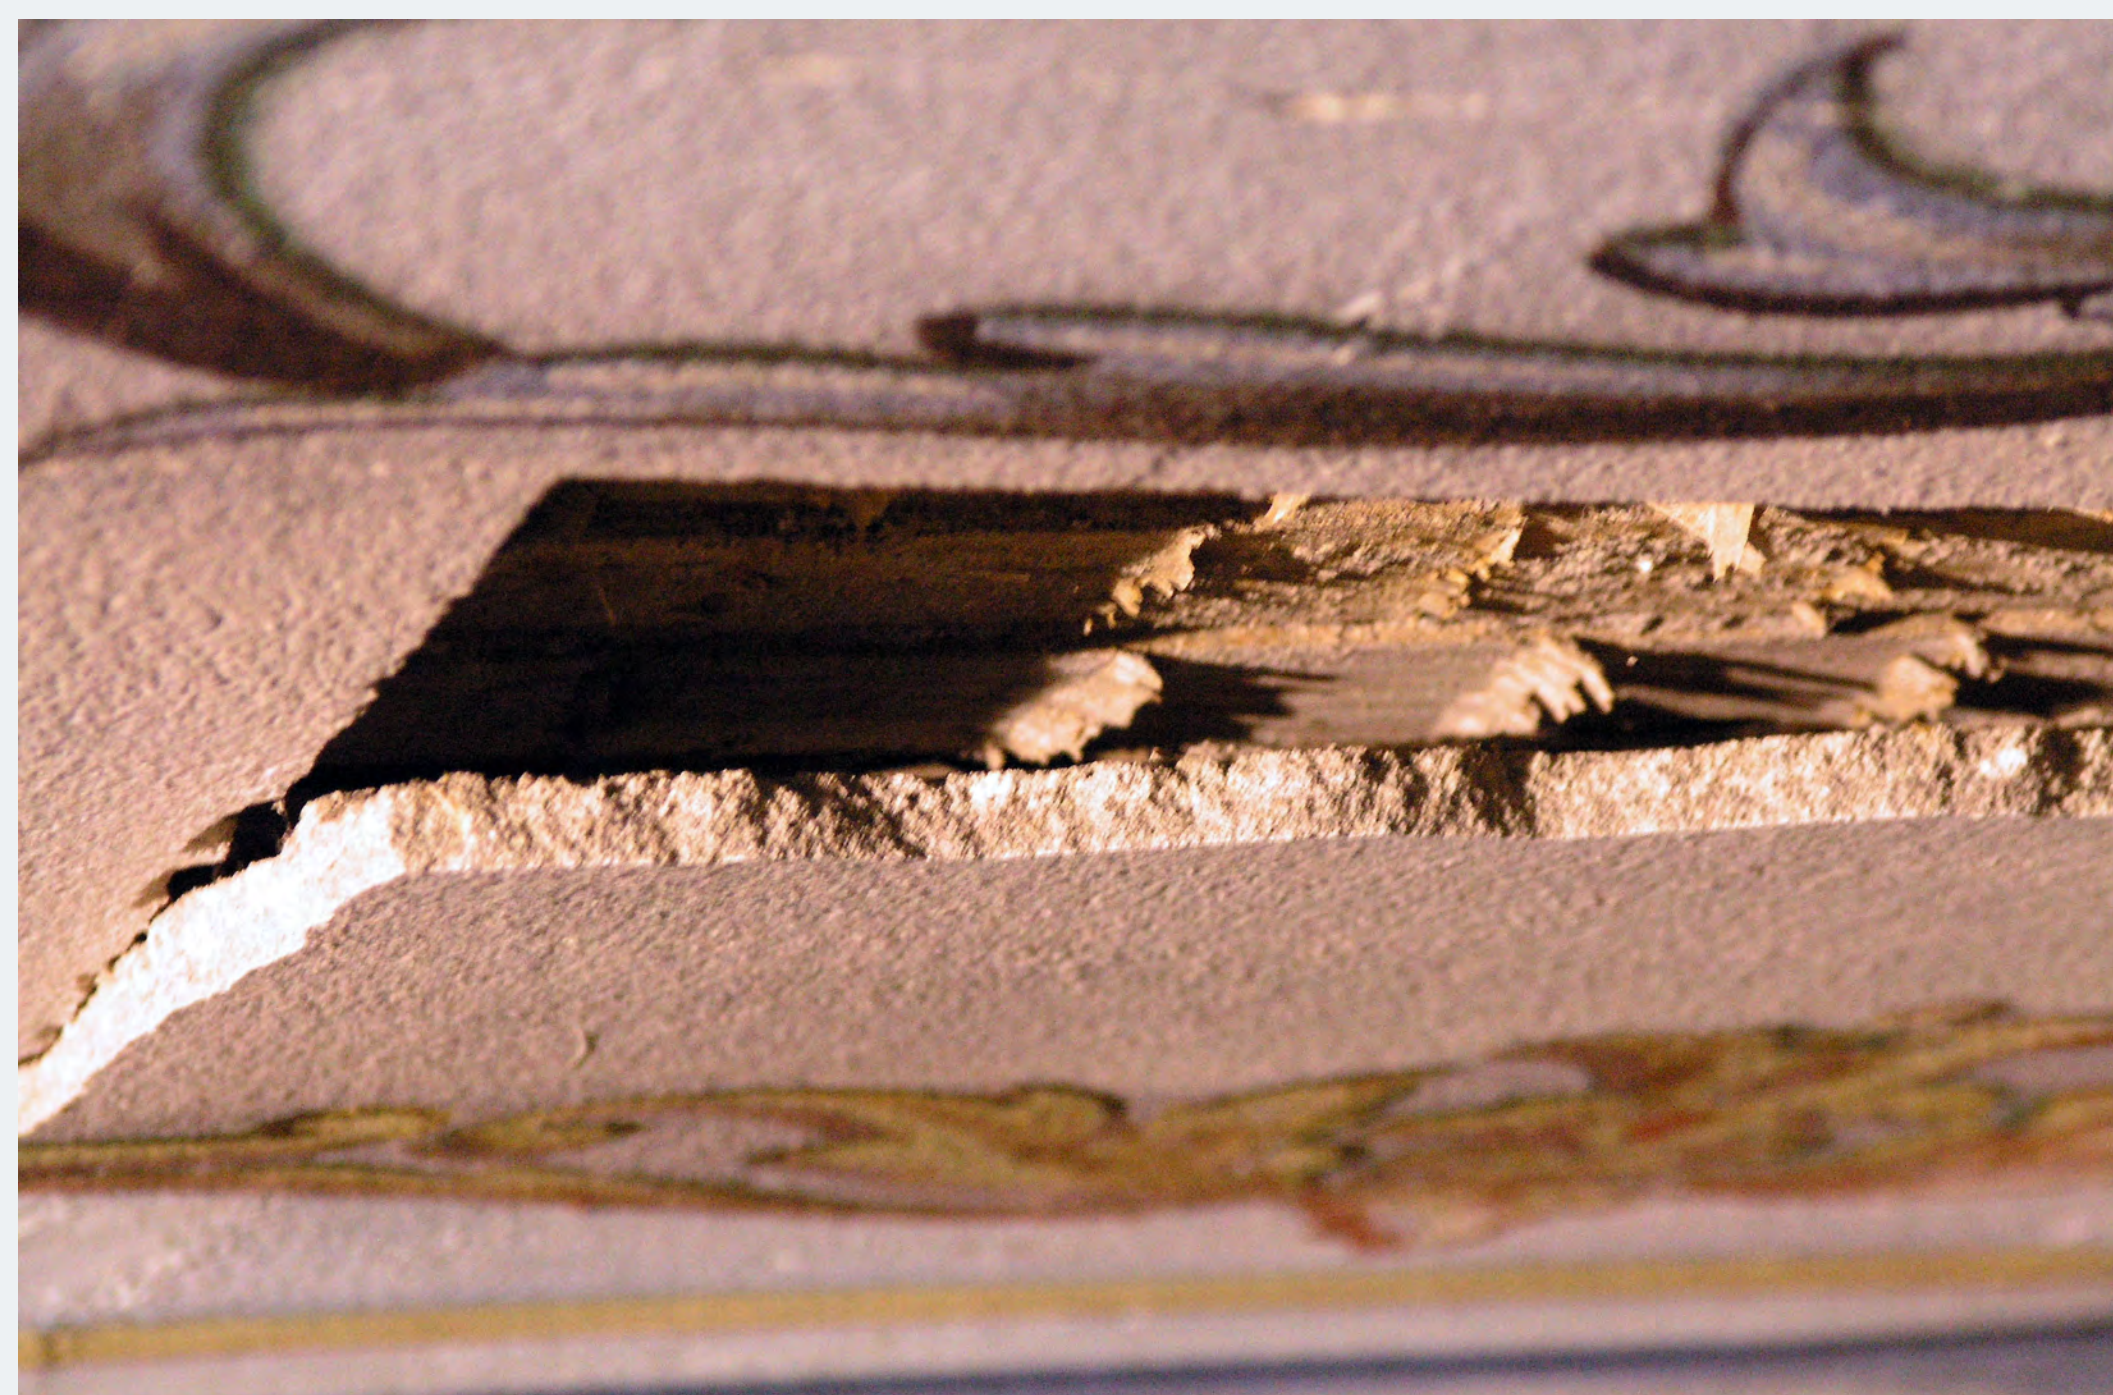
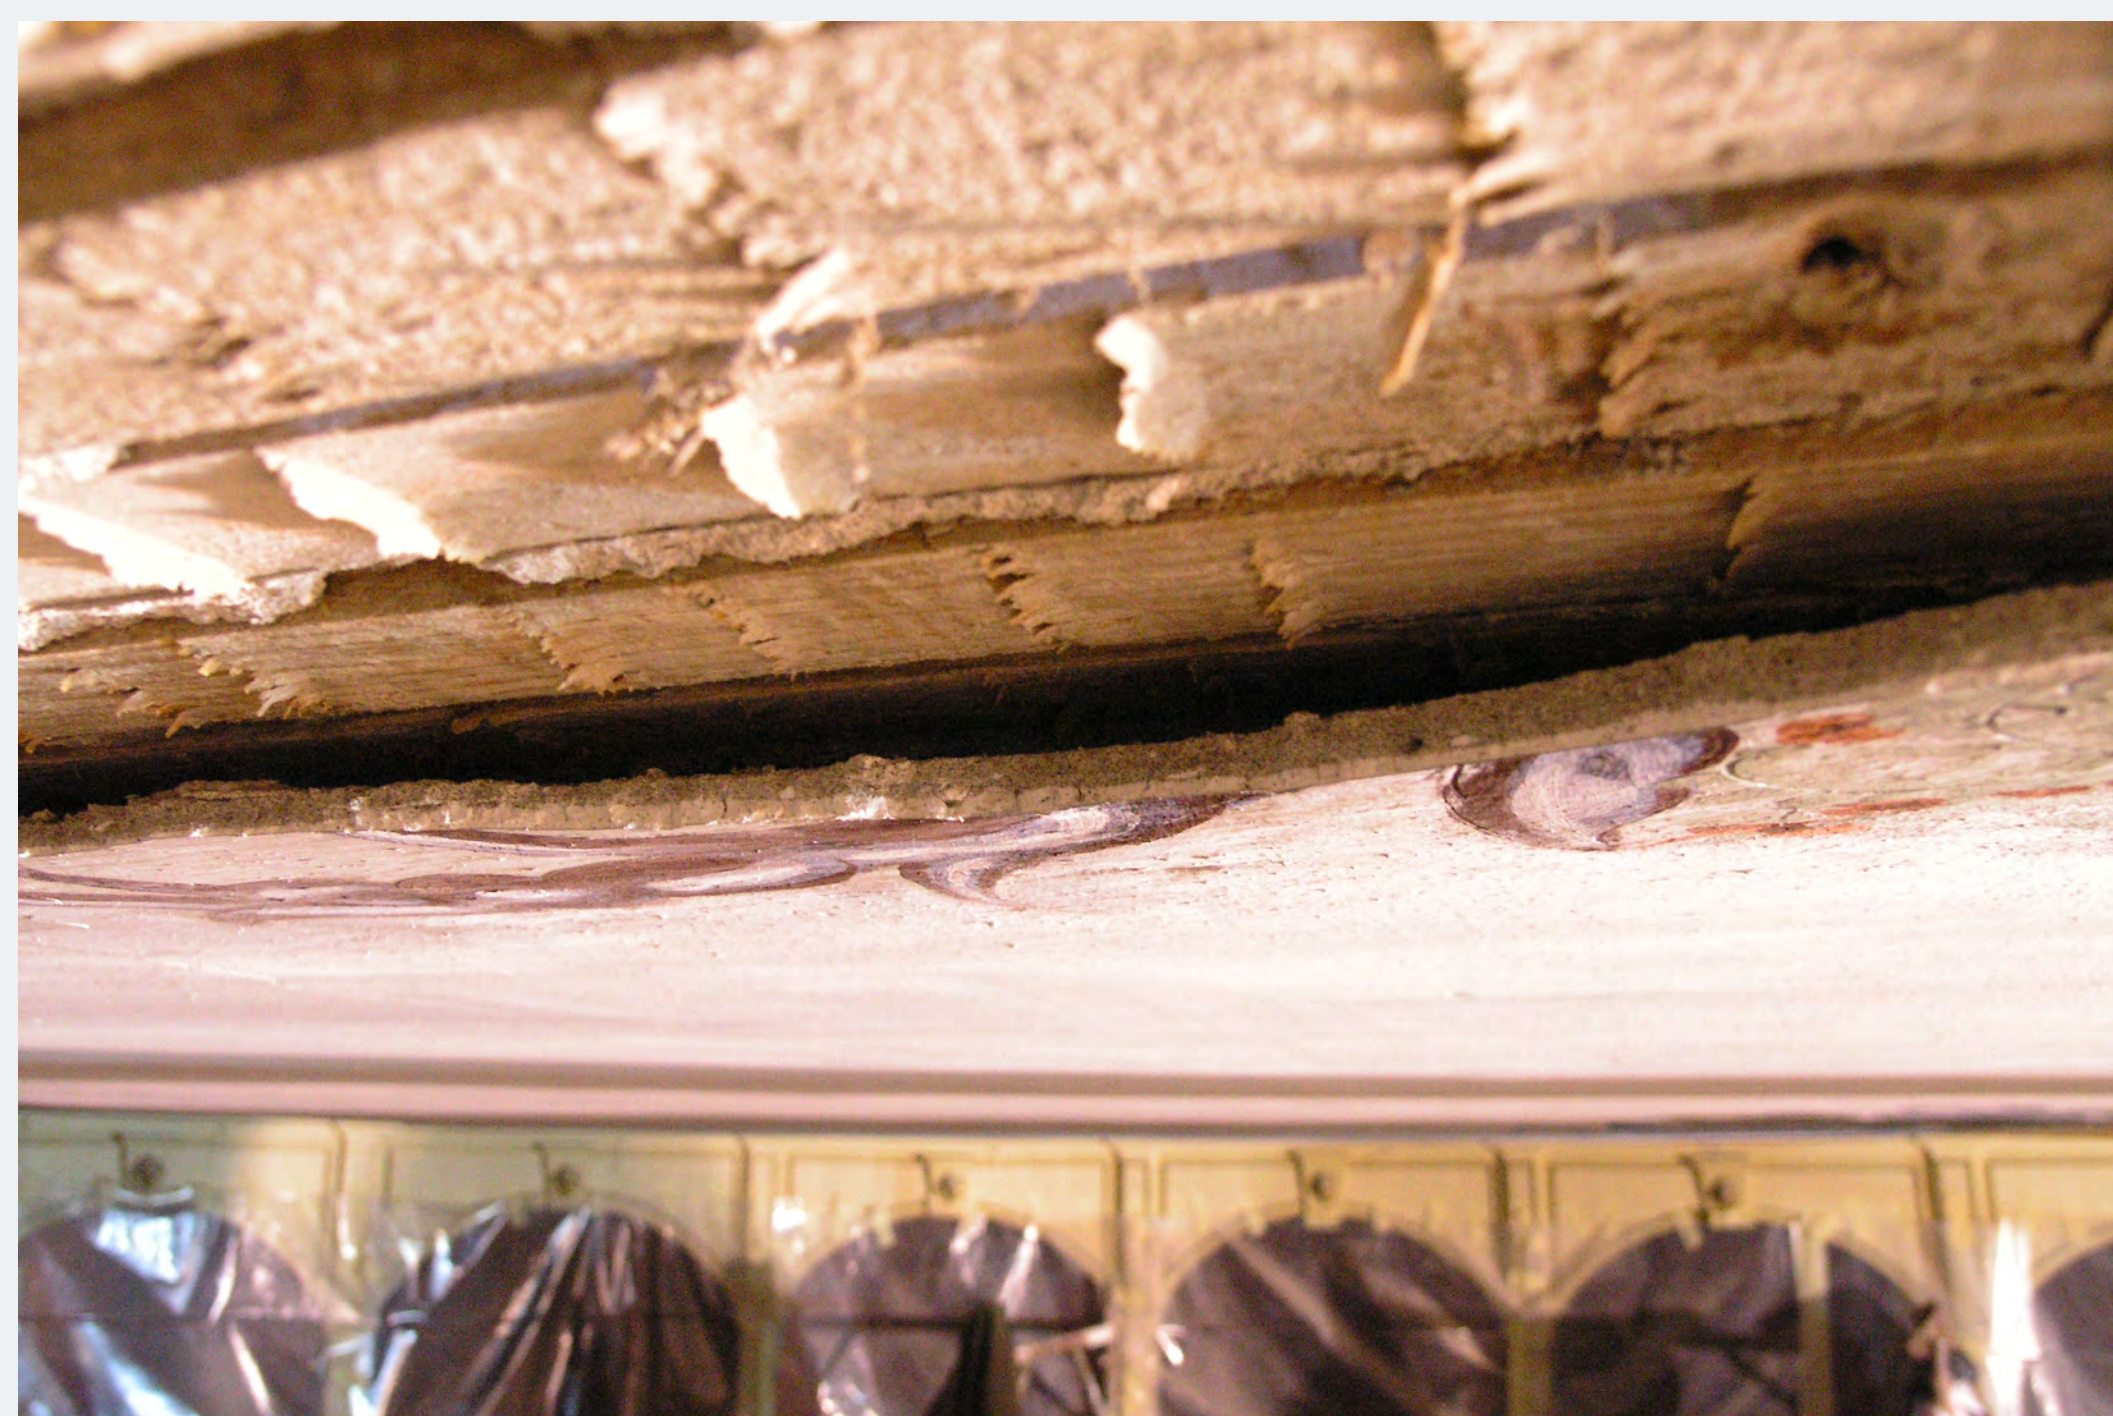
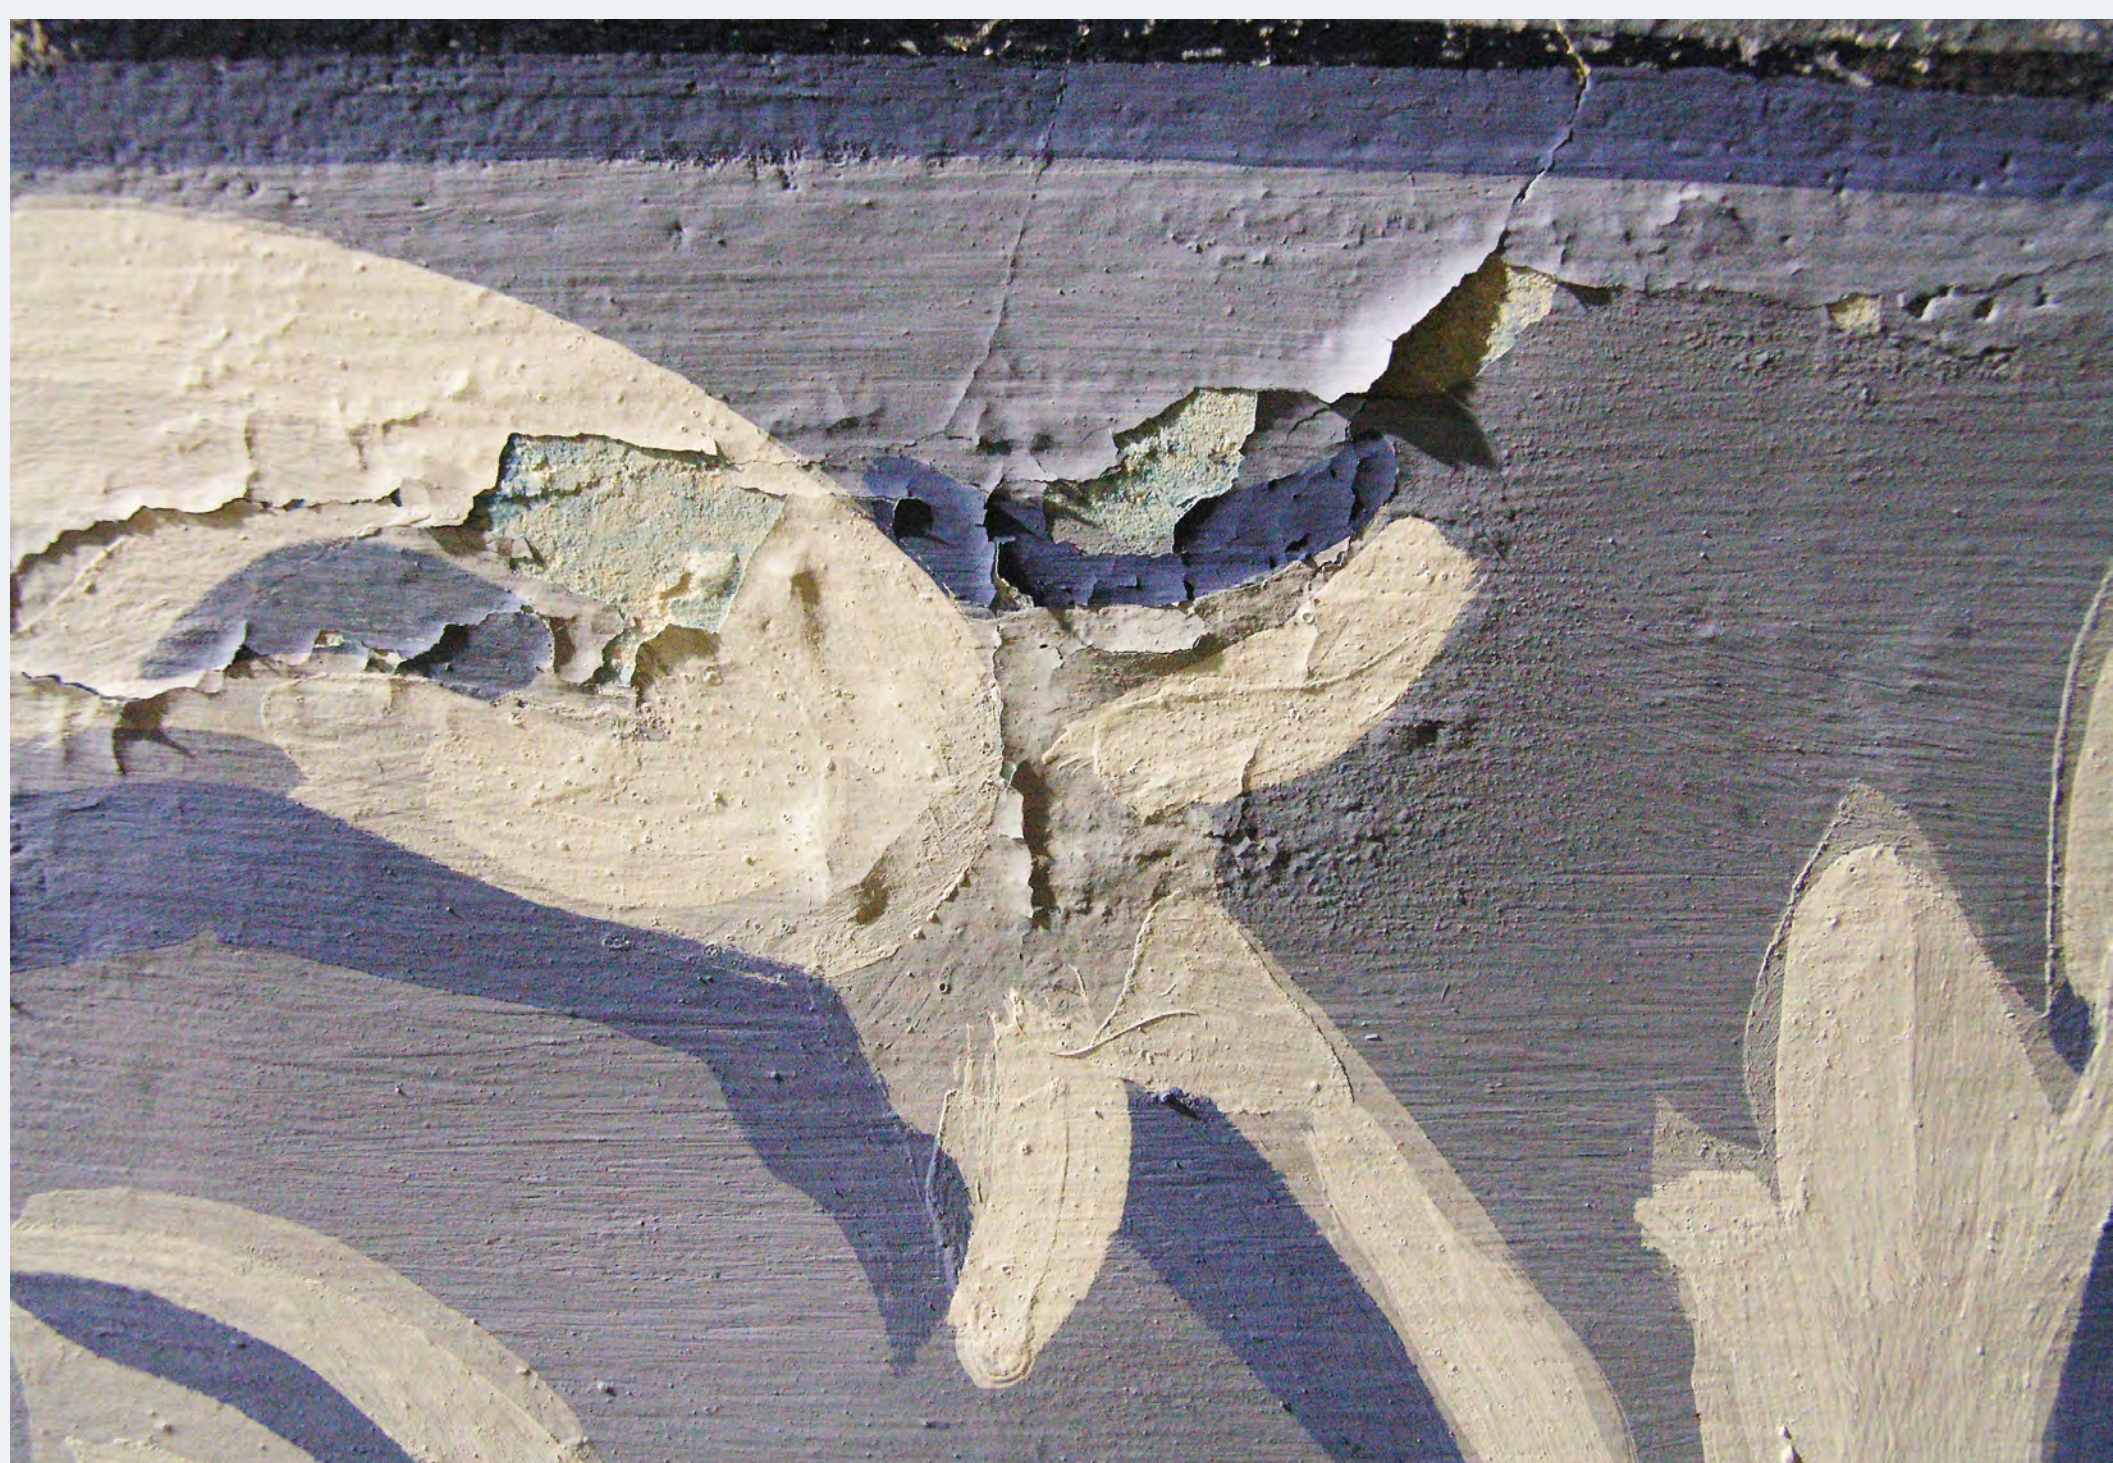
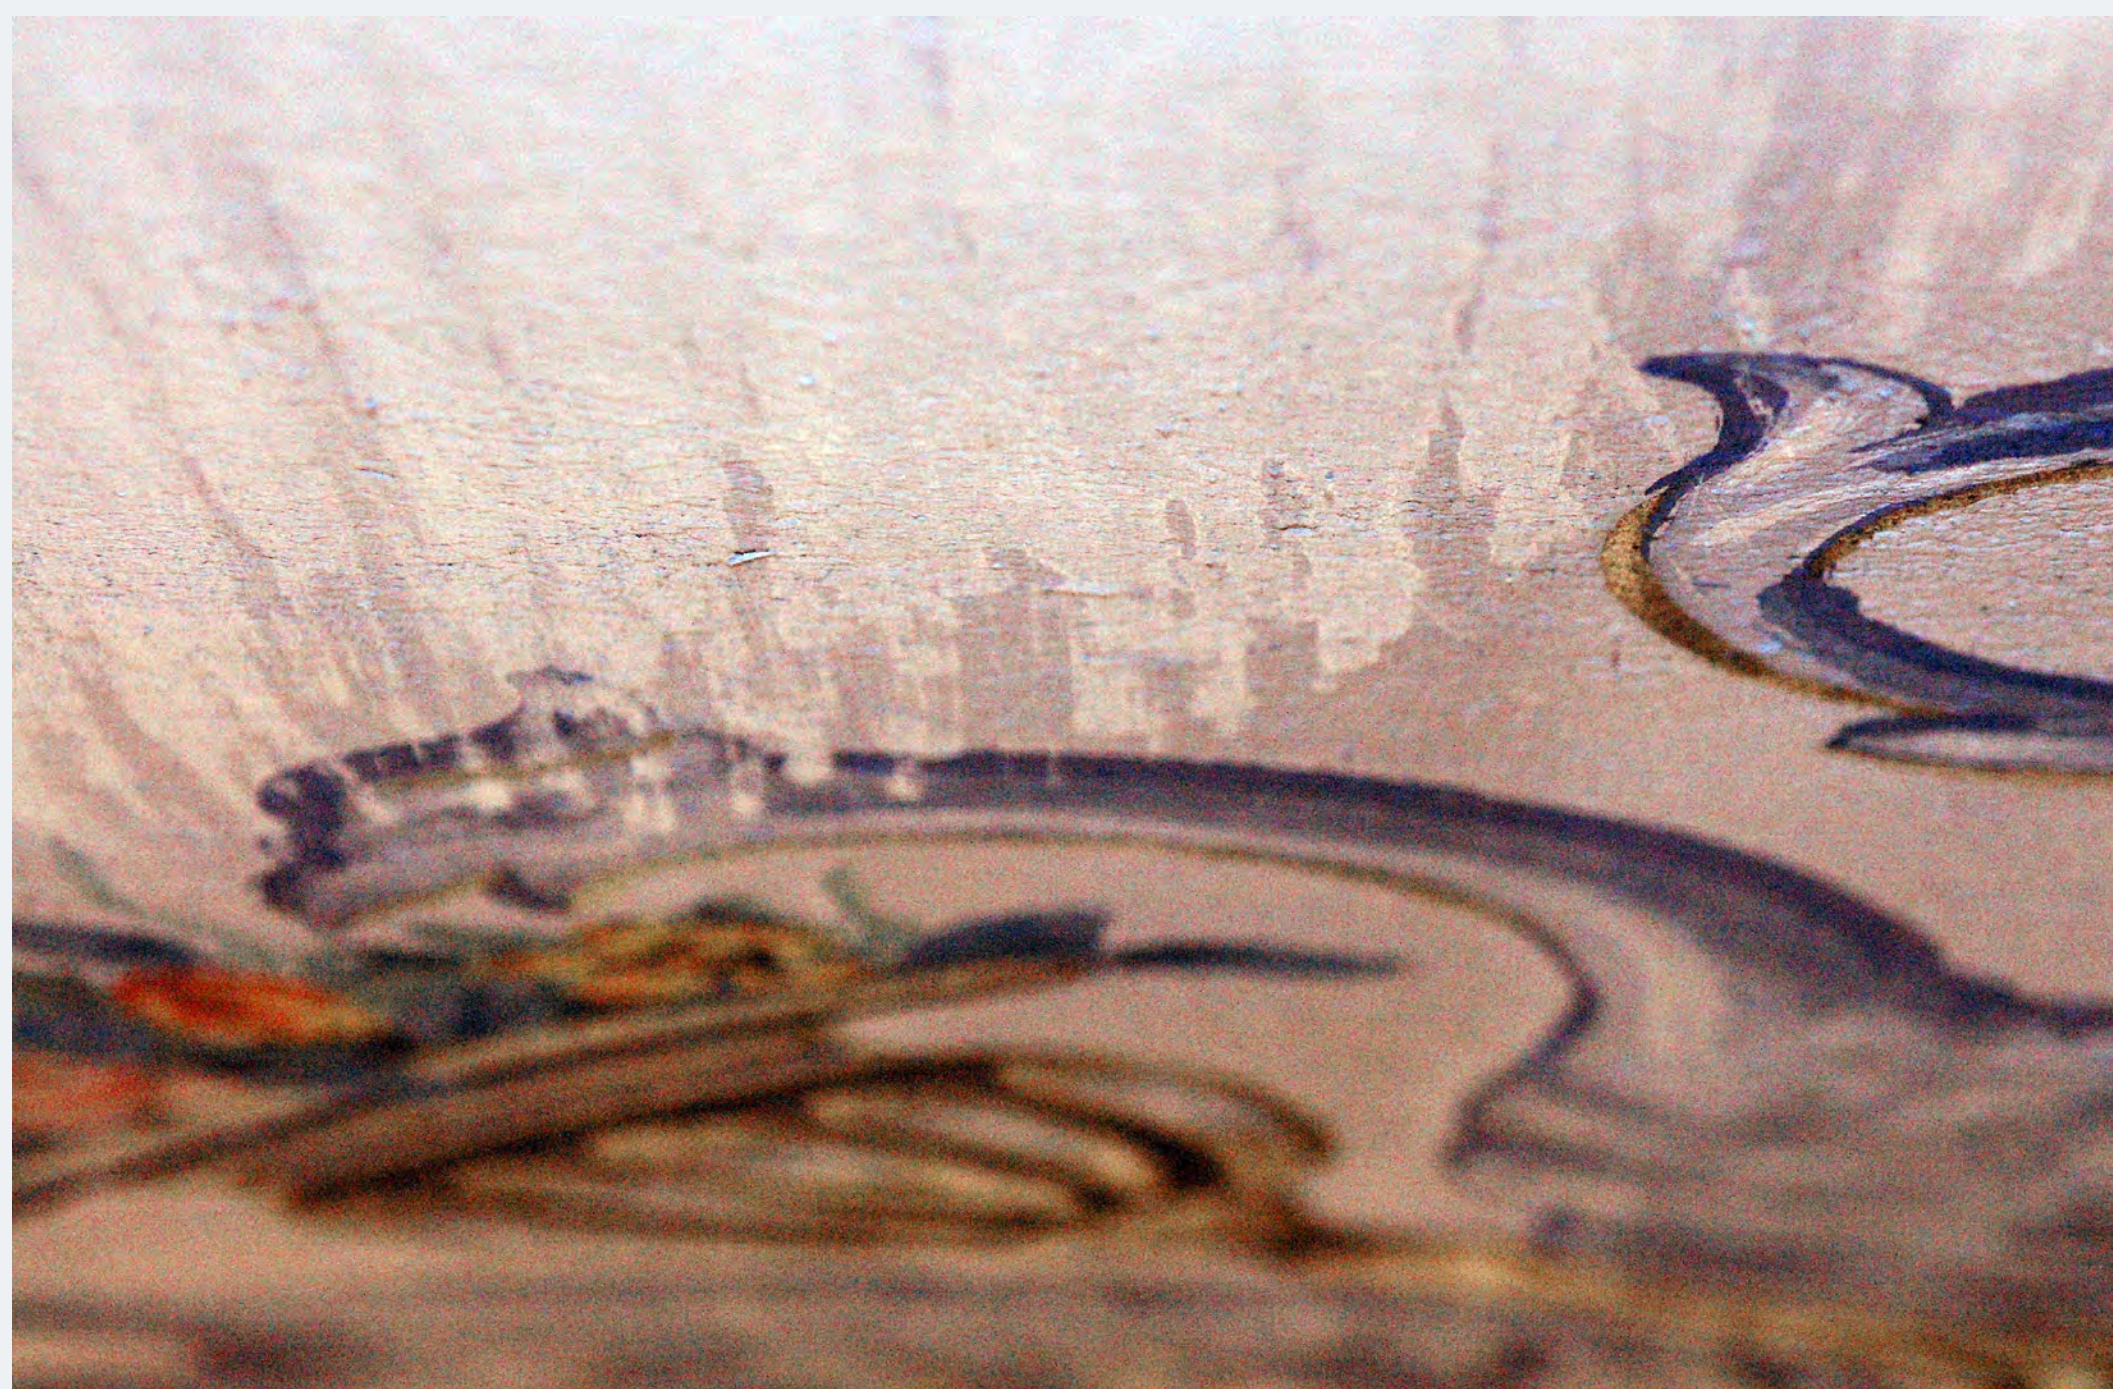
Zidna slika na stropu iznad gledališta hvarskog Kazališta izvedena je u tehnici tempera i rasprostire se na približno 70 četvornih metara. Nosilac slikanog sloja je vapnena žbuka nanescena u dva sloja, od kojih je podložni sloj utisnut među letvice drvene stropne konstrukcije koja je učvršćena za poprečne grede. Dugotrajno djelovanje statičkih i dinamičkih opterećenja uzrokovalo je brojna i raznovrsna oštećenja koja su zamijećena i zabilježena u početku radova 2007. godine. Najsloženiji restauratorski problem bila je nestabilnost stropa izazvana slabljenjem vezivnih spona žbuke i drvene stropne konstrukcije, što je uzrokovalo otpadanje 1,5 četvornih metara slikarije na sjevernom središnjem dijelu stropa. Zidna slika već je pretrpjela otpadanje dijela stropa na južnoj strani koji je obnovljen rekonstruktivnim zahvatom. Vjerojatno je, u istom vremenu, prebojen i središnji podložni svijetloplavi ton kao i rubne dekorativne trake. Dugotrajno djelovanje mehaničkih sila i prirodno „starenje“ materijala uzrokovalo je brojne pukotine i naprsnuća žbuke te denivelaciju (poremećaj razine) stropne površine, što je izazvalo nepoželjne promjene slikanog sloja.

The painting on the ceiling above the audience of the Hvar Theatre is executed in tempera, and it covers a surface of approximately 70 square metres. The painted layer is applied against a ground consisting of lime plaster applied in two coats, with the bottom coat pressed in between the lattices of the wooden ceiling construction, fixed to cross-beams. The many years of static and dynamic pressure have caused extensive and varied damage, which was noticed and recorded at the beginning of the work in 2007. The most demanding problem, from the point of view of conservation, was the instability of the ceiling, caused by the weakened binding between the plaster and the wooden ceiling construction, which resulted in the falling-away of 1.5 square metres of the painting on the northern side of the central part of the painting. A piece of the wall painting had also fallen off earlier and been reconstructed in the meantime. The light blue colour of the background in the central part and the decorative ribbons along the edges were probably applied on that occasion.
