## ZATEČENO STANJE

## INITIAL CONDITION

HRVATSKI  
RESTAURATORSKI  
ZAVOD

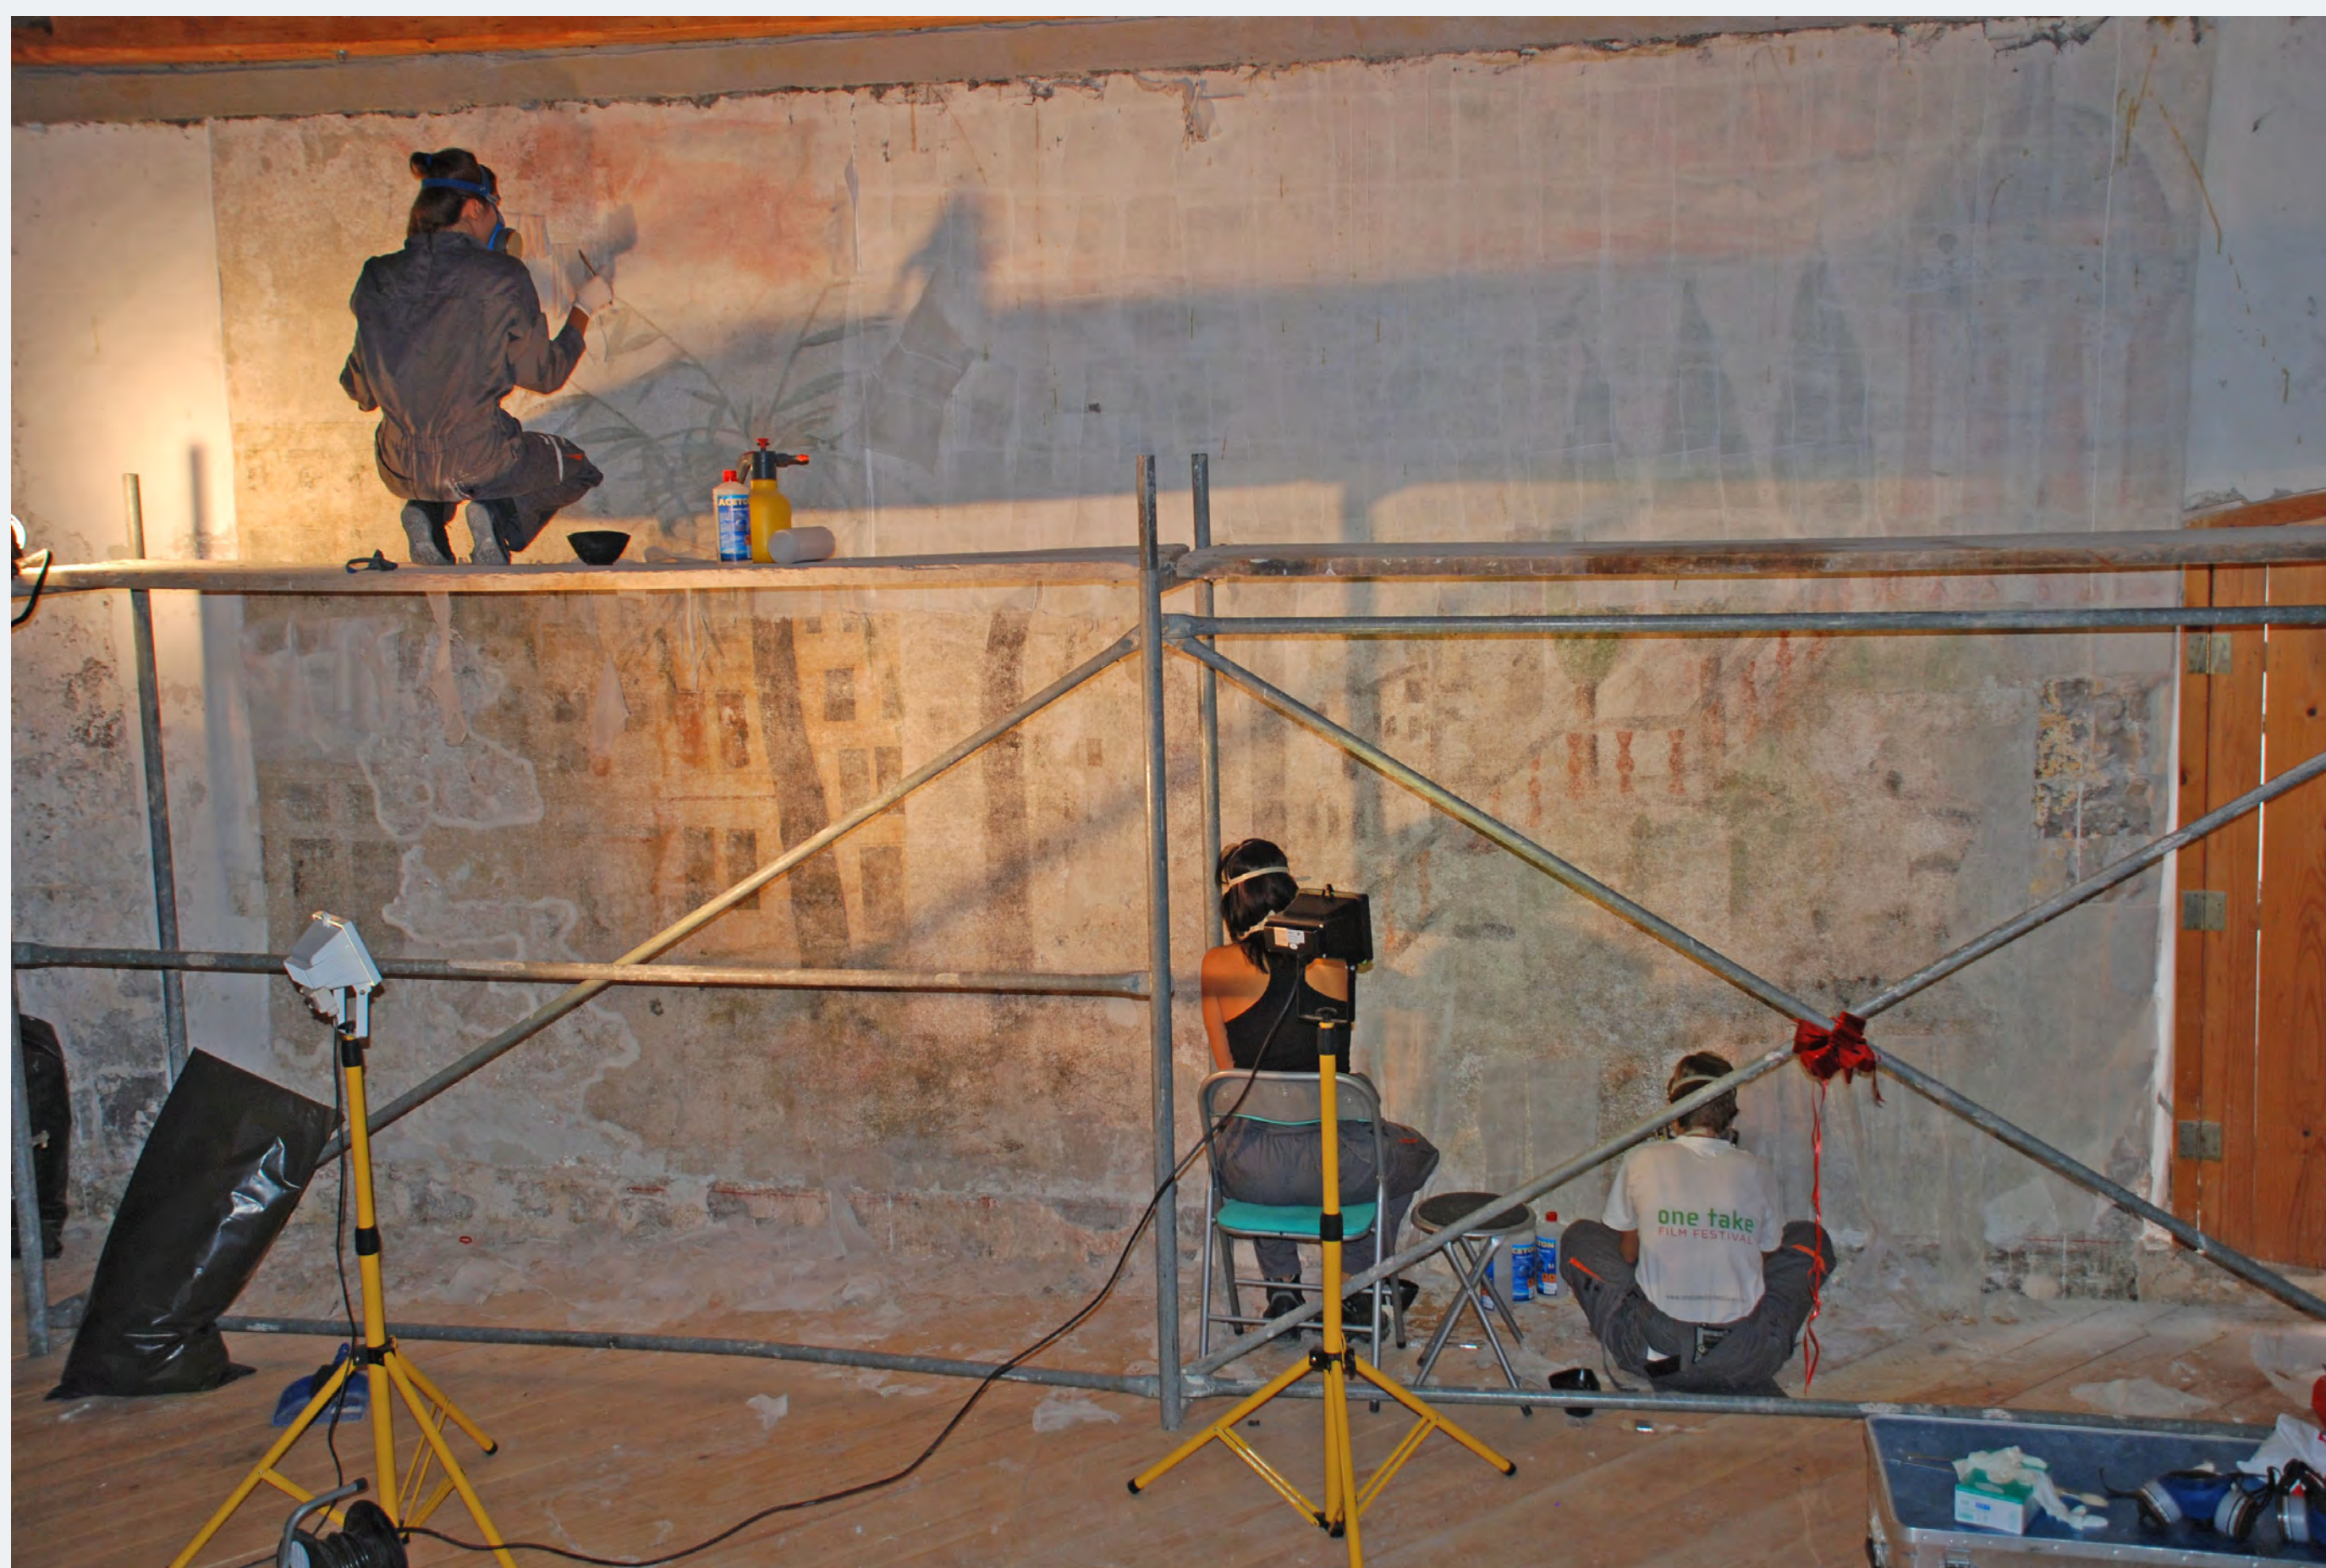
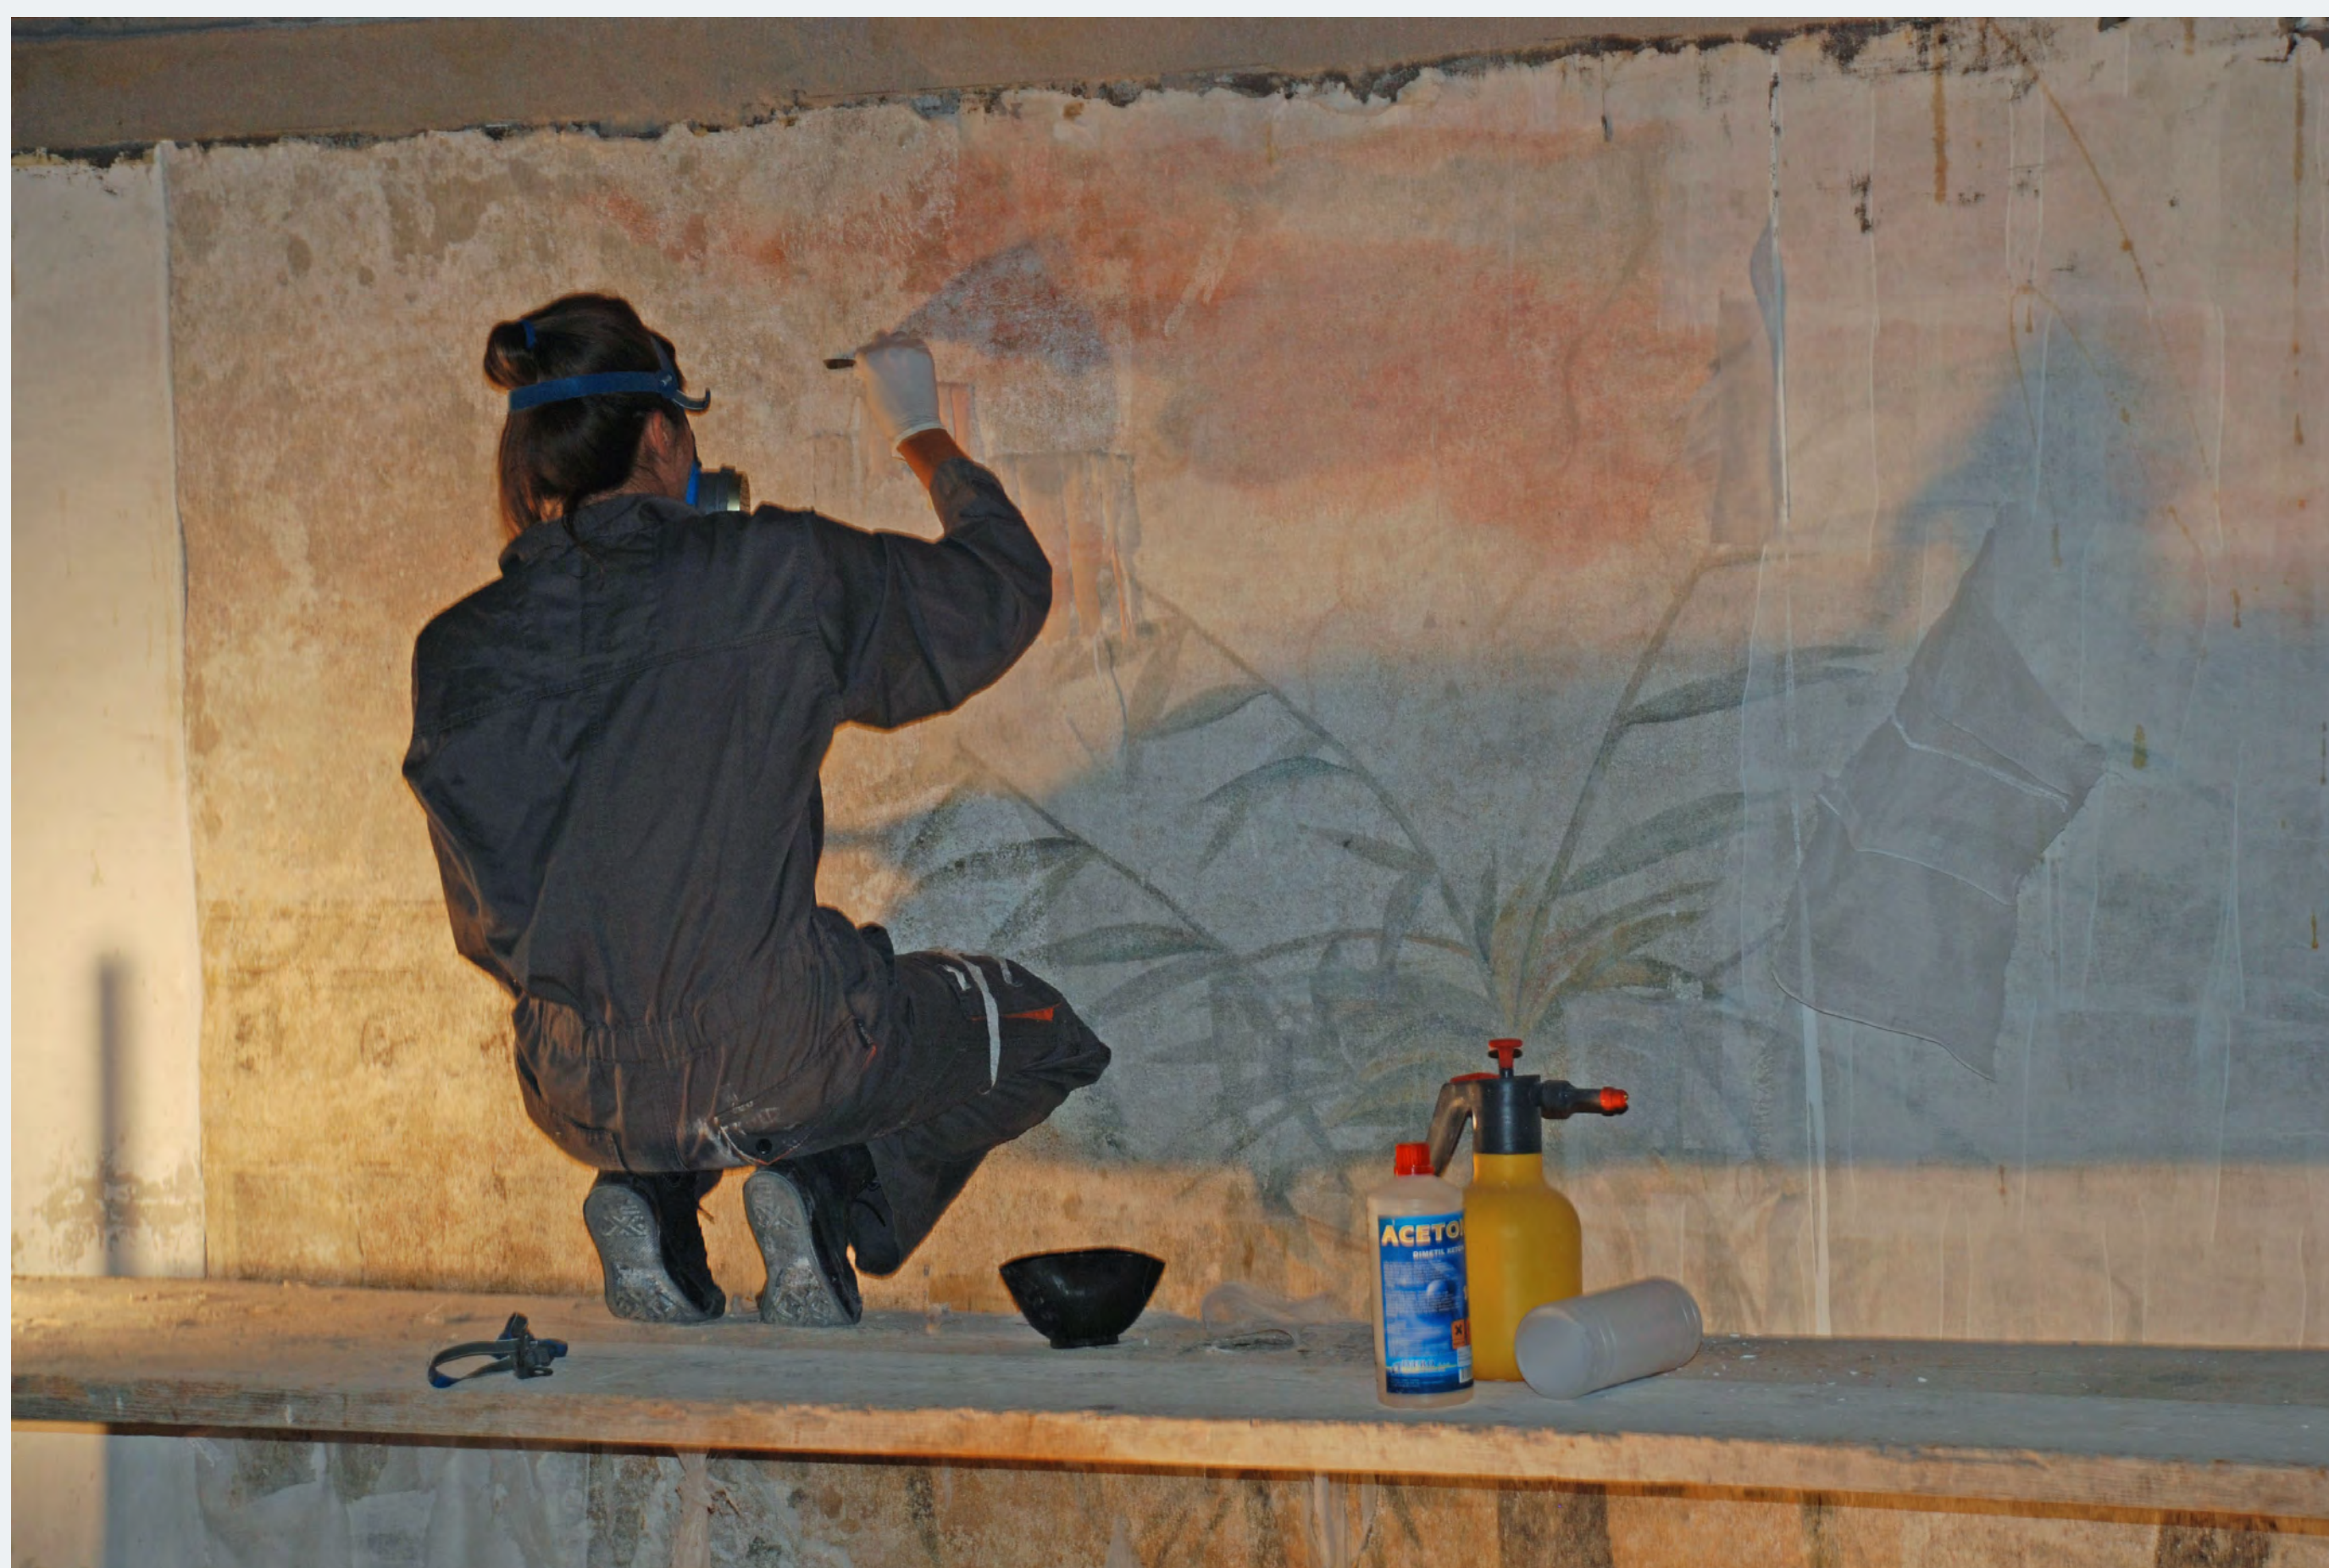
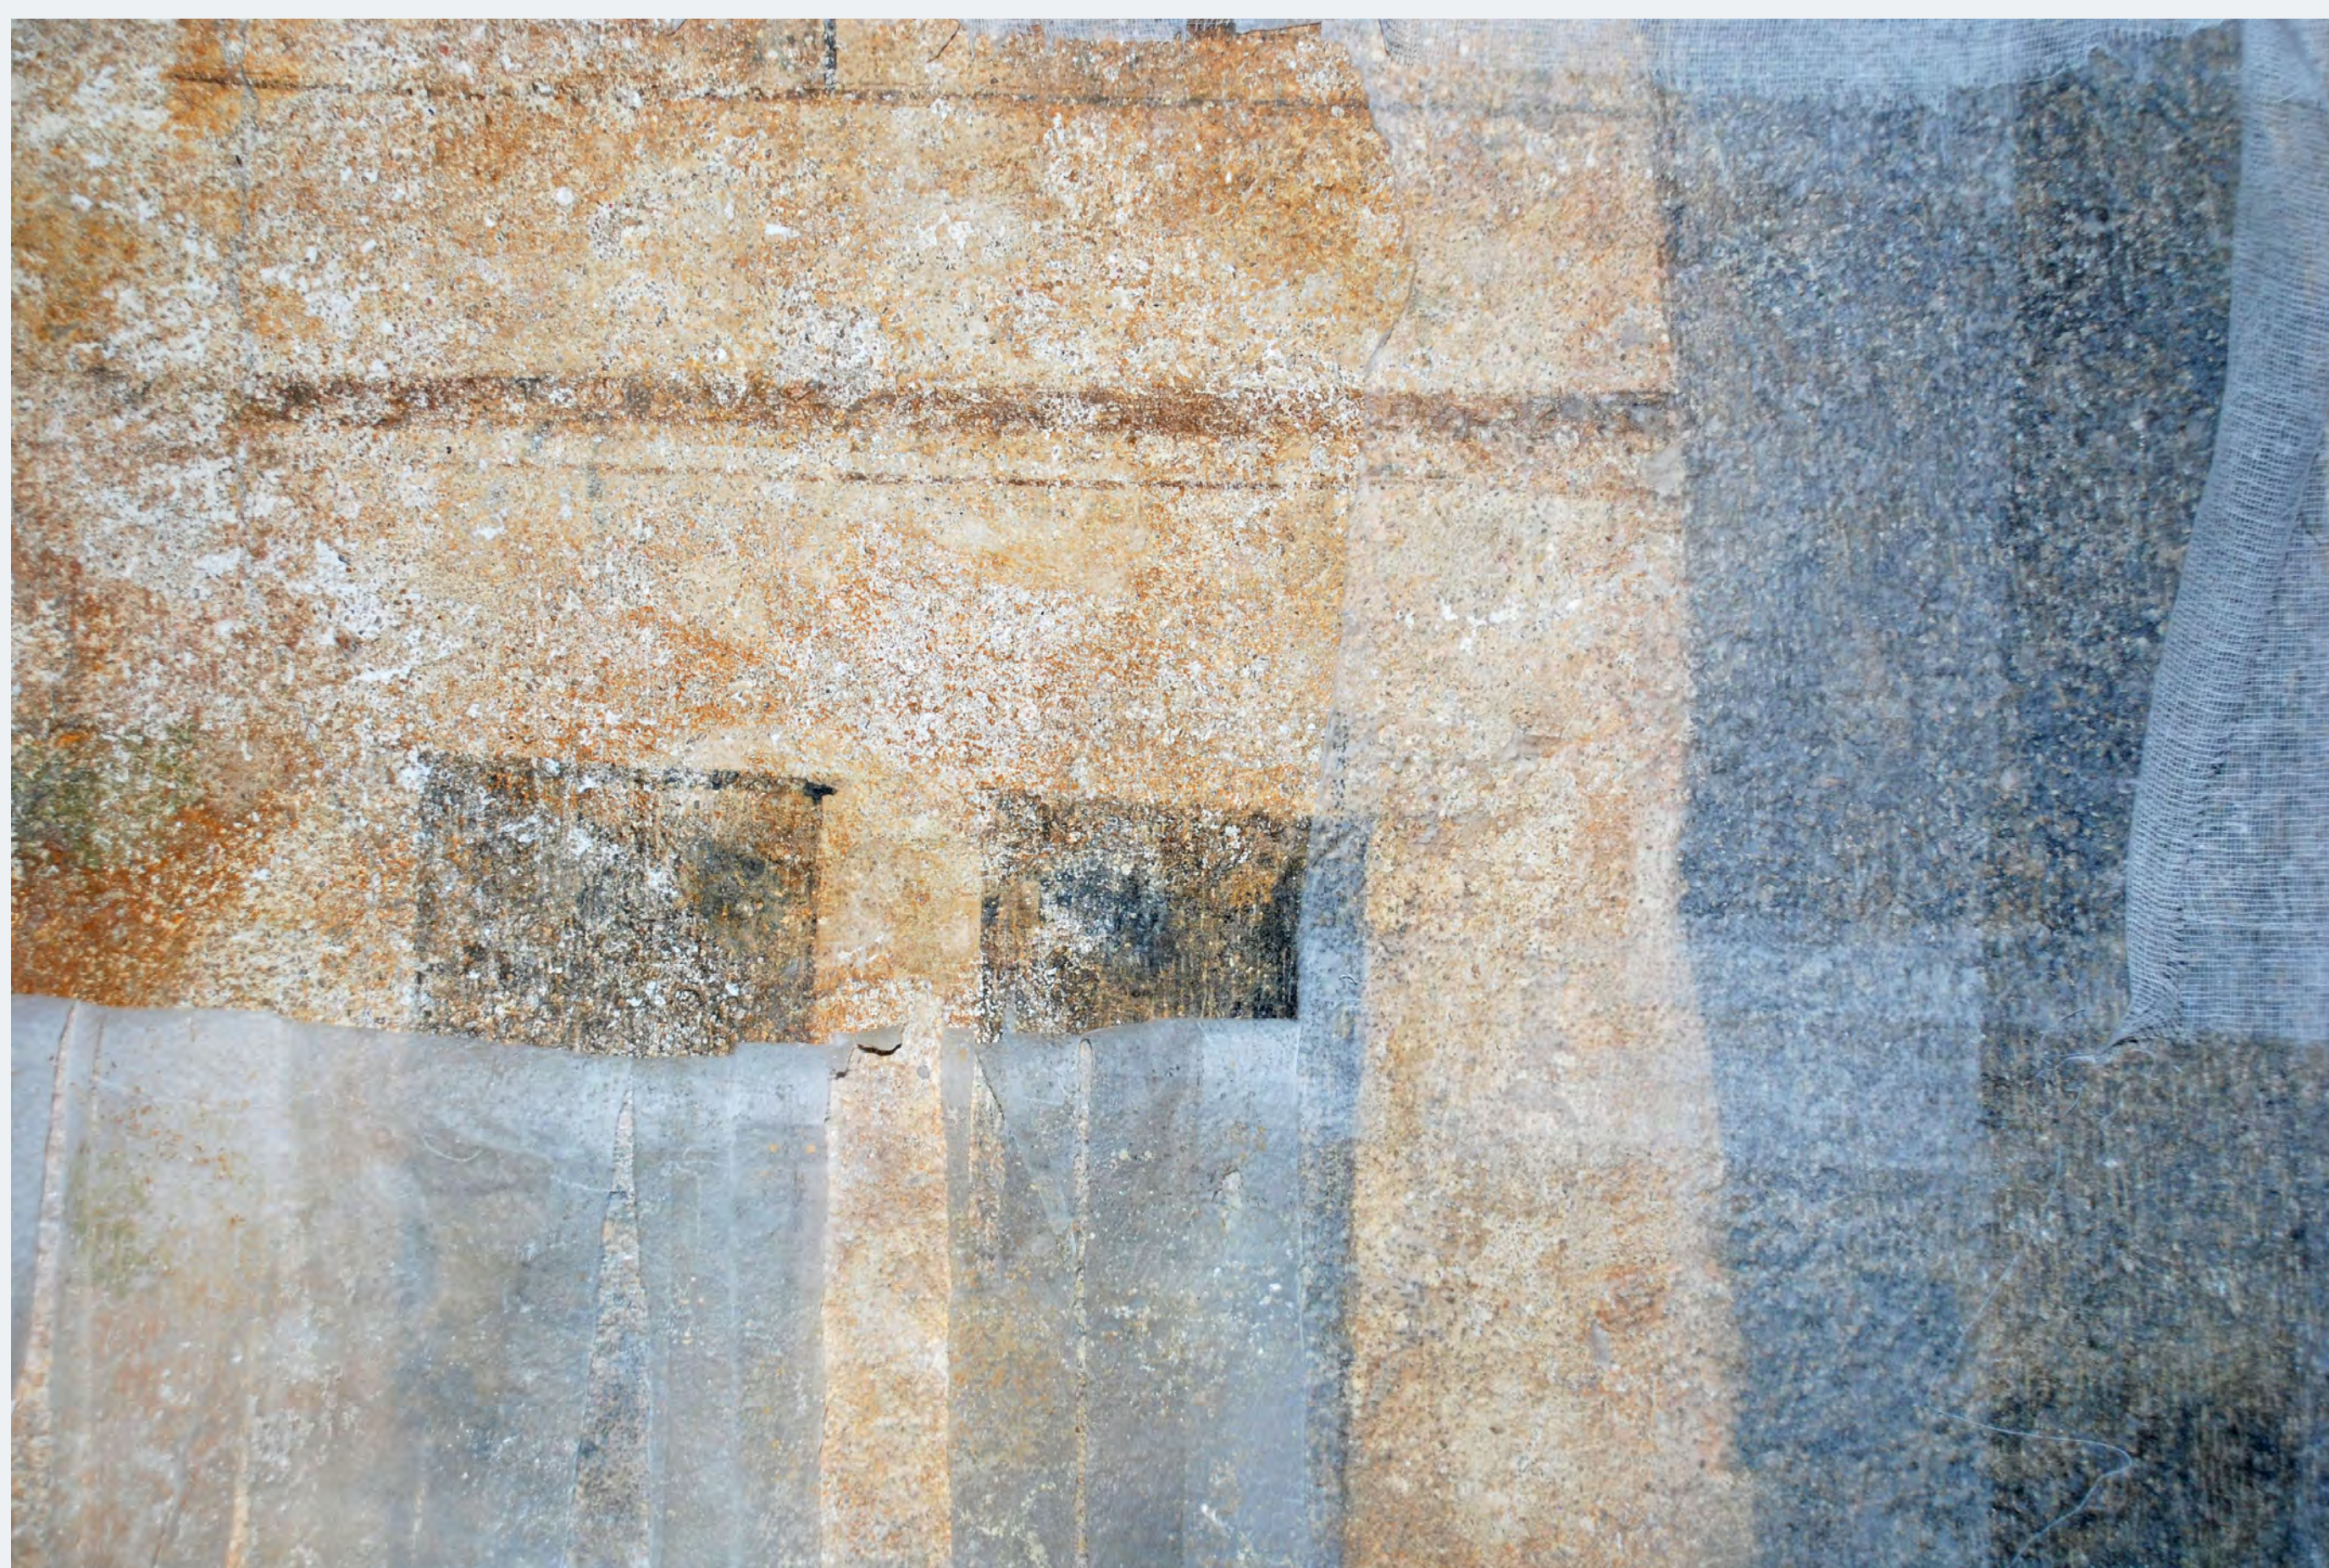
Mjestimično zamijećen gubitak adhezije i kohezije unutar izvorne žbuke rezultat je djelovanja zaostalih soli u zidovima, no na temelju provedene građevinske sanacije i činjenice da tijekom rada nije zamijećeno prodiranje vlage koja bi ponovno pokrenula procese migracije soli, zaključujemo da su daljnja oštećenja takve vrste svedena na minimum.

It was noticed that in some places the original plaster had lost its adhesion and cohesion, which was a result of the action of salts that had remained in the walls. However, the building was structurally rehabilitated, and during our work no moisture was observed which could restart the salt migration, so our conclusion is that further damage of this kind had been reduced to a minimum.

Prema prethodno provedenim istraživanjima, zaštitni sloj uklonjen je acetonom, otapalom koje je slabilo čvrstoću ljepila te je na taj način omogućilo jednostavno odvajanje armaturnog materijala s lica slikarije. Aceton je zbog velike hlapljivosti zahtijevao hitrost u radu, a samo odvajanje trebalo je izvesti s najvećom pažnjom, kako uklanjanje armaturnog materijala ne bi izazvalo spontano odvajanje slikanog sloja od žbuko-podloge.

In line with prior testing, the facing was removed using acetone – a solvent which reduced the strength of the glue and thus allowed the reinforcing material to be removed easily from the face of the painting. Due to its high volatility, acetone called for quick work, while at the same time the separation of the facing had to be done extremely carefully in order not to cause spontaneous detachment of the painted layer from its plaster ground. In parallel with the removal of the facing, the face of the painting was additionally cleaned with mechanical and chemical methods. The remaining dirt, glue and facing material were removed using special detergents and solvents.

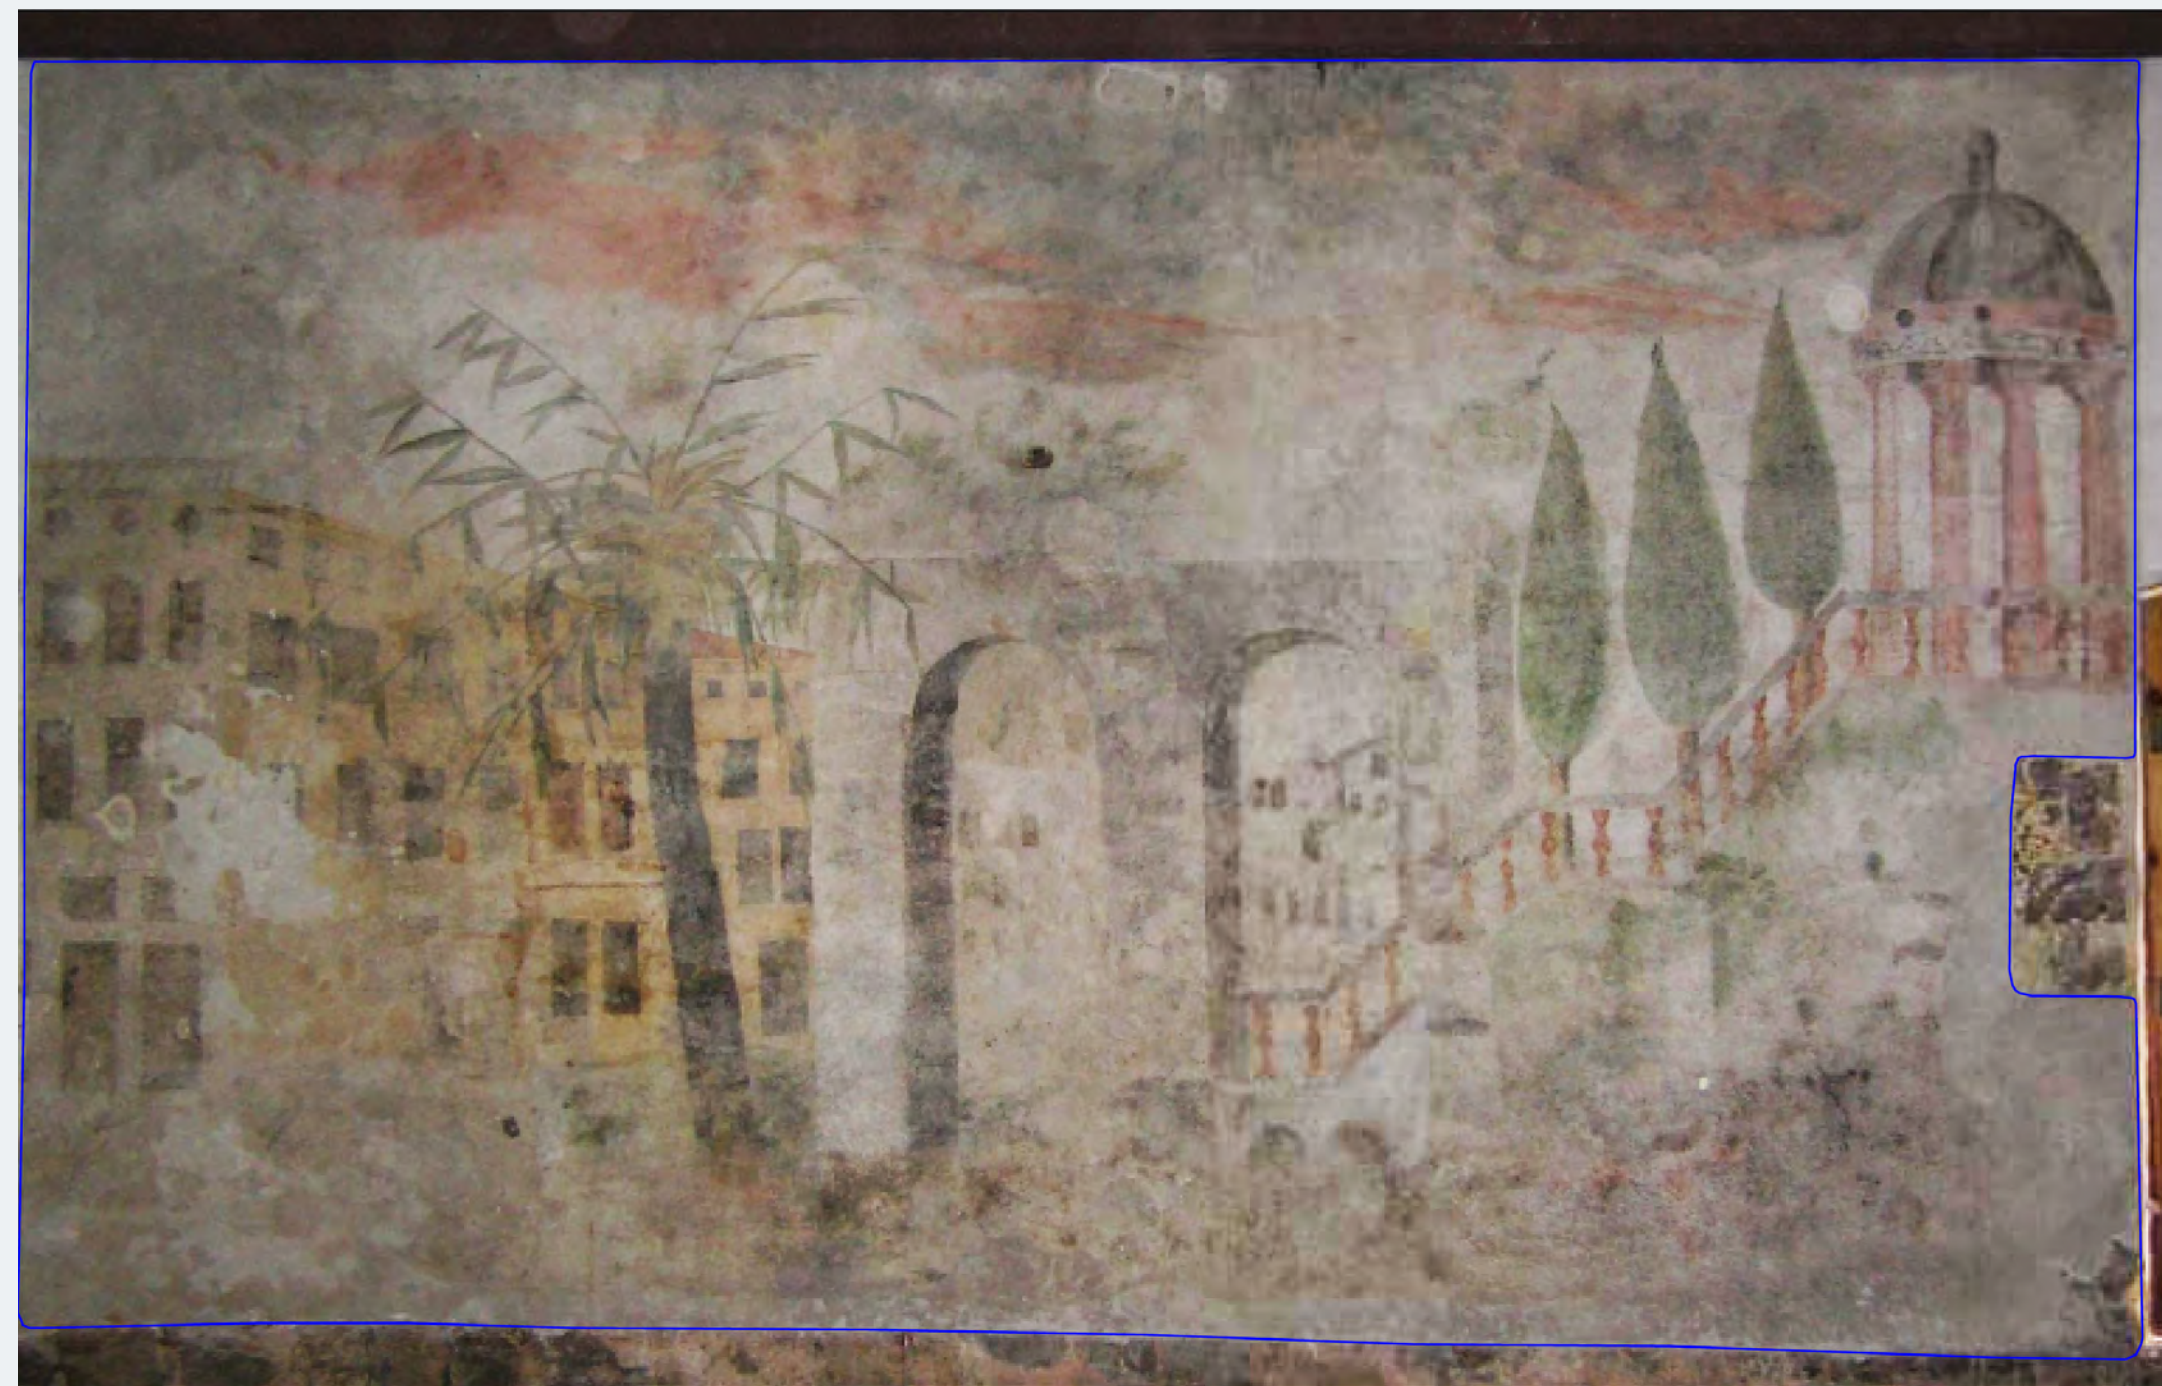
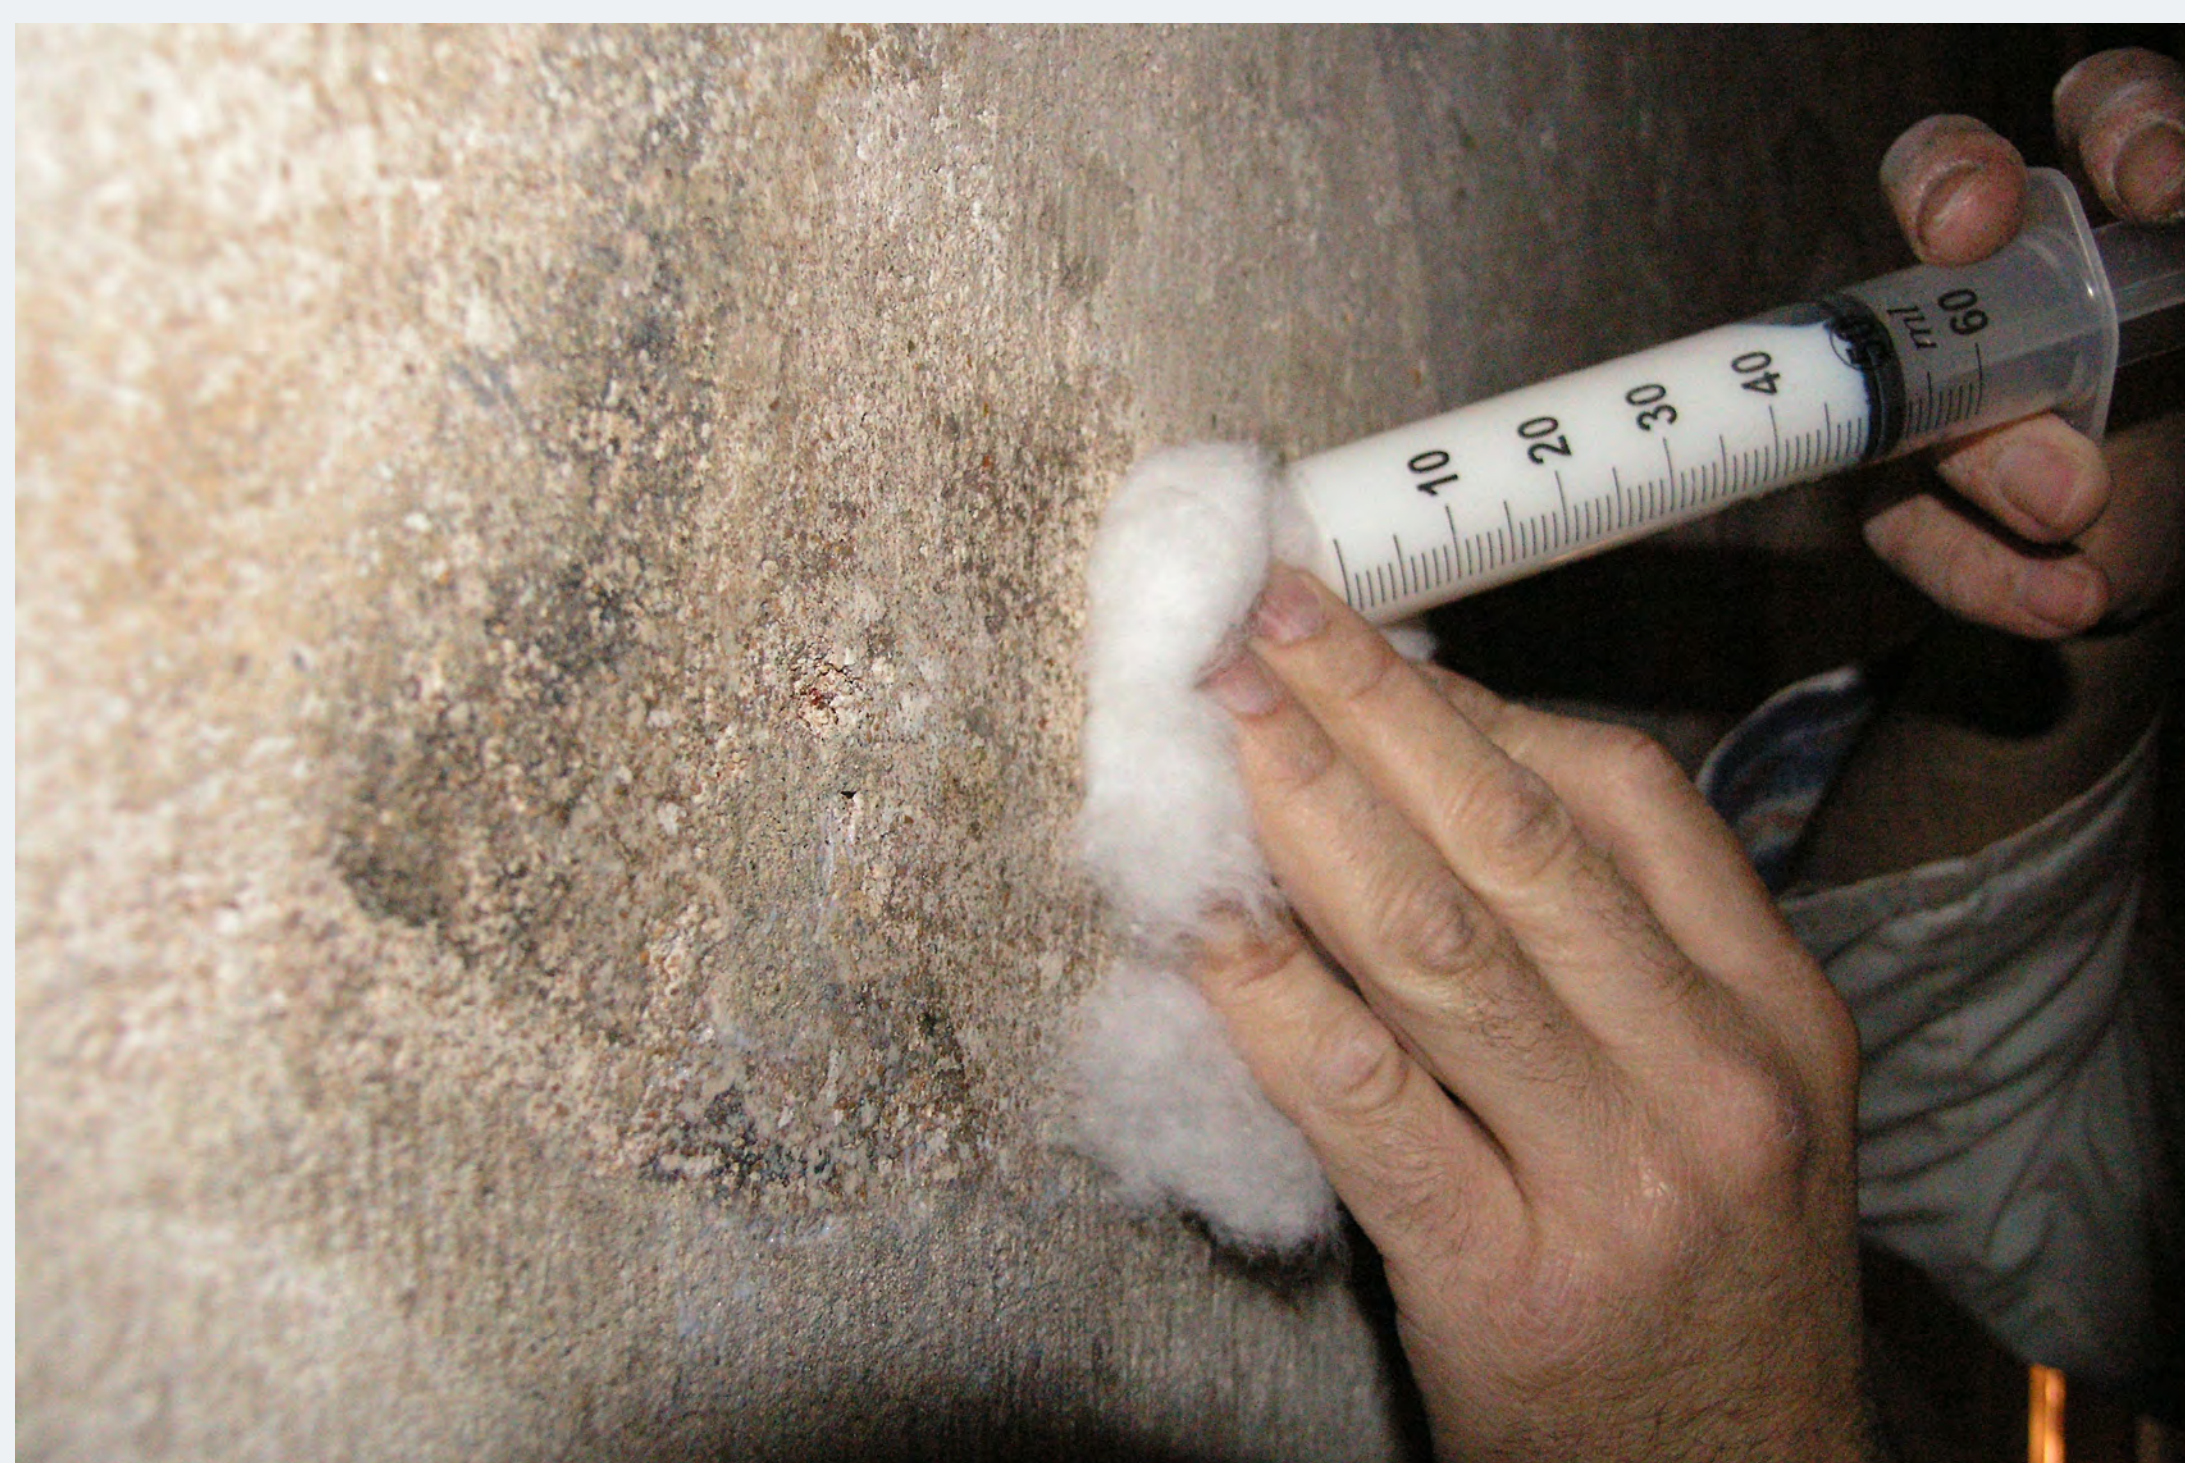
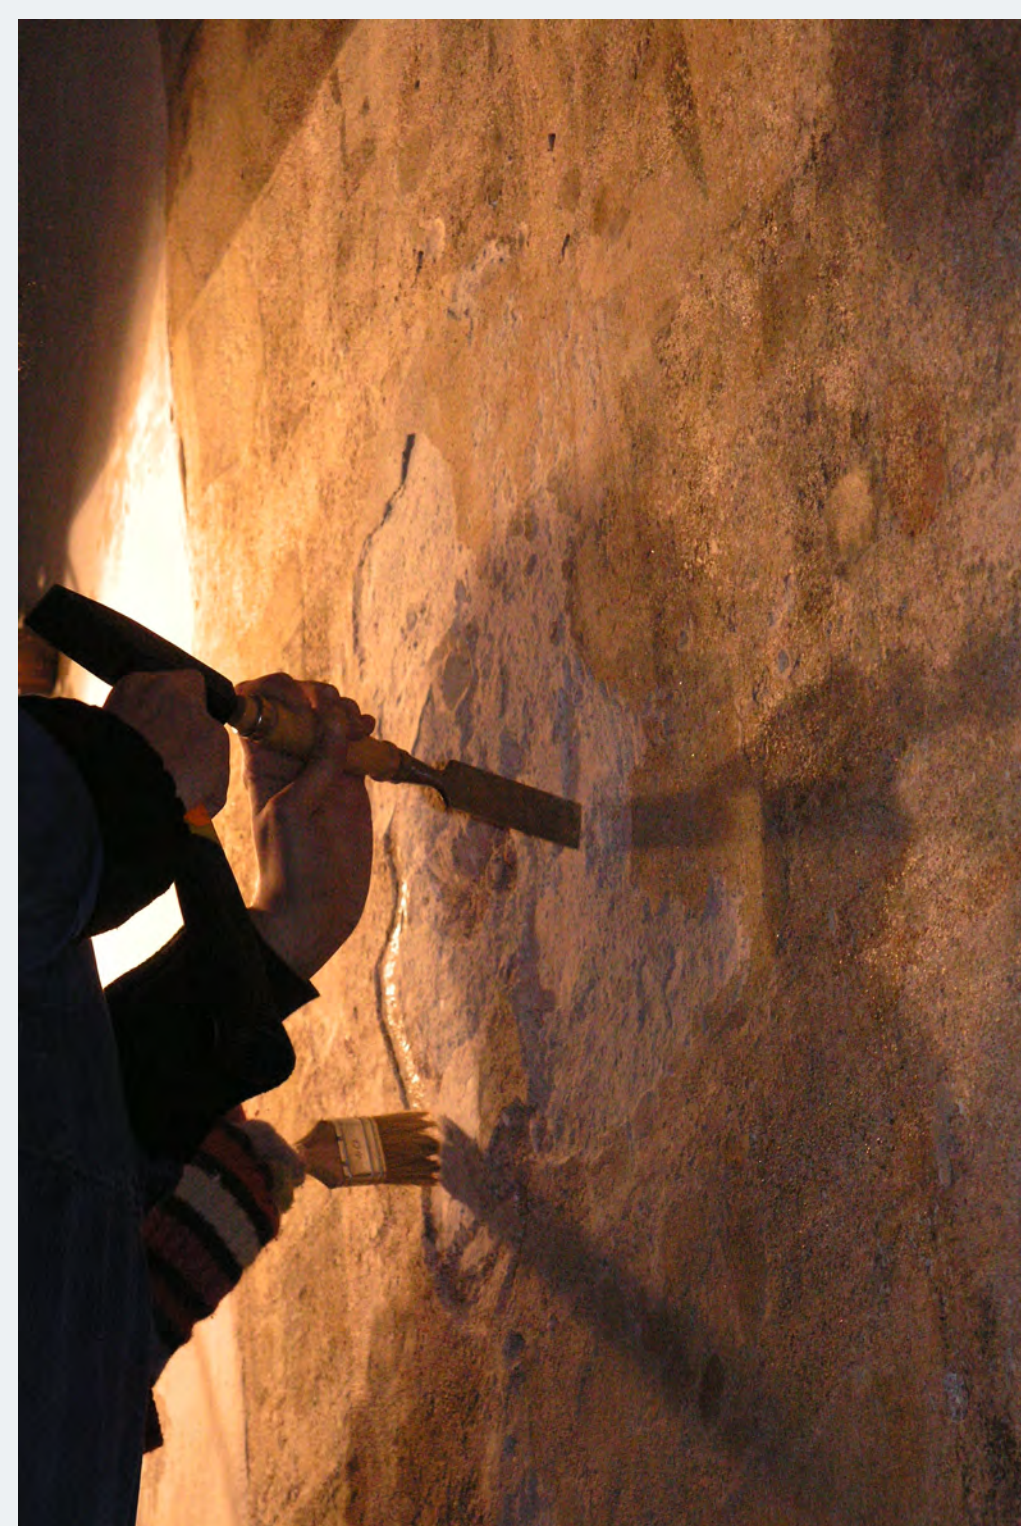
Zidna slika smještena na istočnom zidu hvarskog Kazališta kao scenska dekoracija pozornice ima površinu od približno 15 četvornih metara. Oslíkana je i položena u tanjem sloju koji tek mjestimično na sljubnicama zida pokazuje debljinu od 15 milimetara. Zamijećena oštećenja u obliku pulverizacije slikanog sloja i brojnih potklobučenja, rezultat su gubitka adhezije i kohezije unutar materijala, što je uzrokovano djelovanjem lako topivih soli koje preko vlage migriraju unutar materijala. Prodor vlage kroz istočni zid Kazališta najizraženiji je bio na mjestu zazidanog sjevernog prozora. Konzervatorsko-restauratorskim zahvatom koji je proveden 1989. godine sanirana su oštećenja te je izvedeno dožbukavanje i retuš, no intenzivno djelovanje vlage uzrokovalo je nova oštećenja.

Pulverizacija slikanog sloja, potklobučenja, pukotine, naprsnuća, brojne lakune te potreba za građevinskom sanacijom cijelog Kazališta zahtijevali su daljnje zaštitne zahvate.

The wall painting on the eastern wall of the Hvar theatre, which functions as a stage decoration, covers approximately 15 square metres. It is painted in a thin layer which, only in certain places, along the wall joints, reaches a thickness of 15 mm. The damage noticed, in the form of pulverization of the painted layer and numerous air pockets, resulted from loss of adhesion and cohesion within the materials, caused by the action of readily soluble salts which migrated to the materials, assisted by moisture. The most extensive penetration of moisture through the eastern wall of the theatre occurred at the location of the walled-in northern window. In the 1989 conservation and restoration intervention, the damage was repaired, additional plaster applied, and the surface retouched, but the intensive moisture caused new damage. Further protective treatment was necessitated by pulverization of the painted layer, air pockets, cracks, fractures, numerous lacunae and the need for the structural rehabilitation of the entire theatre.

Mehanički su uklonjene velike žbuko-zakrpe postavljene u prijašnjim zahvatima (1989. godine) na donjem sjevernom dijelu slikarije čija je struktura zbog djelovanja vlage oslabjela, što je uzrokovalo osipanje i listanje. Rubovi slikarije na oštećenim su dijelovima ojačani nanošenjem obruba prikladnom žbukom. S obzirom na to da je zvučno detektiran velik broj potklobučenja, provedeno je injektiranje veziva da bi se žbuci vratila kompaktnost i stabilnost. Kao mjesta za injektiranje iskorištena su već postojeća oštećenja slikarije, čime se spriječilo njezino dodatno oštećenje. Navedenim zahvatima konsolidacije žbuke oštećenja su sanirana, čime se spriječilo njezino daljnje propadanje, ali i zaštita od mogućih oštećenja tijekom građevinske sanacije Kazališta.

The large plaster patches made during earlier interventions (in 1989) were mechanically removed from the lower northern part of the painting. The painting's structure had been weakened by moisture, causing dropping and flaking. In the damaged segments, the painting's edges were strengthened by the application of appropriate plaster. Due to the fact that a substantial number of air pockets were detected by sound, a binding substance was injected in an attempt to restore the plaster's compactness and stability. Existing locations of damage were used as points of injection, thus preventing any additional damage. These procedures led to consolidation of the plaster and repair of damage to it, thus preventing its further deterioration, and protecting it from possible damage caused by the structural rehabilitation of the theatre.
