## ZATEČENO STANJE

## INITIAL CONDITION

HRVATSKI  
RESTAURATORSKI  
ZAVOD

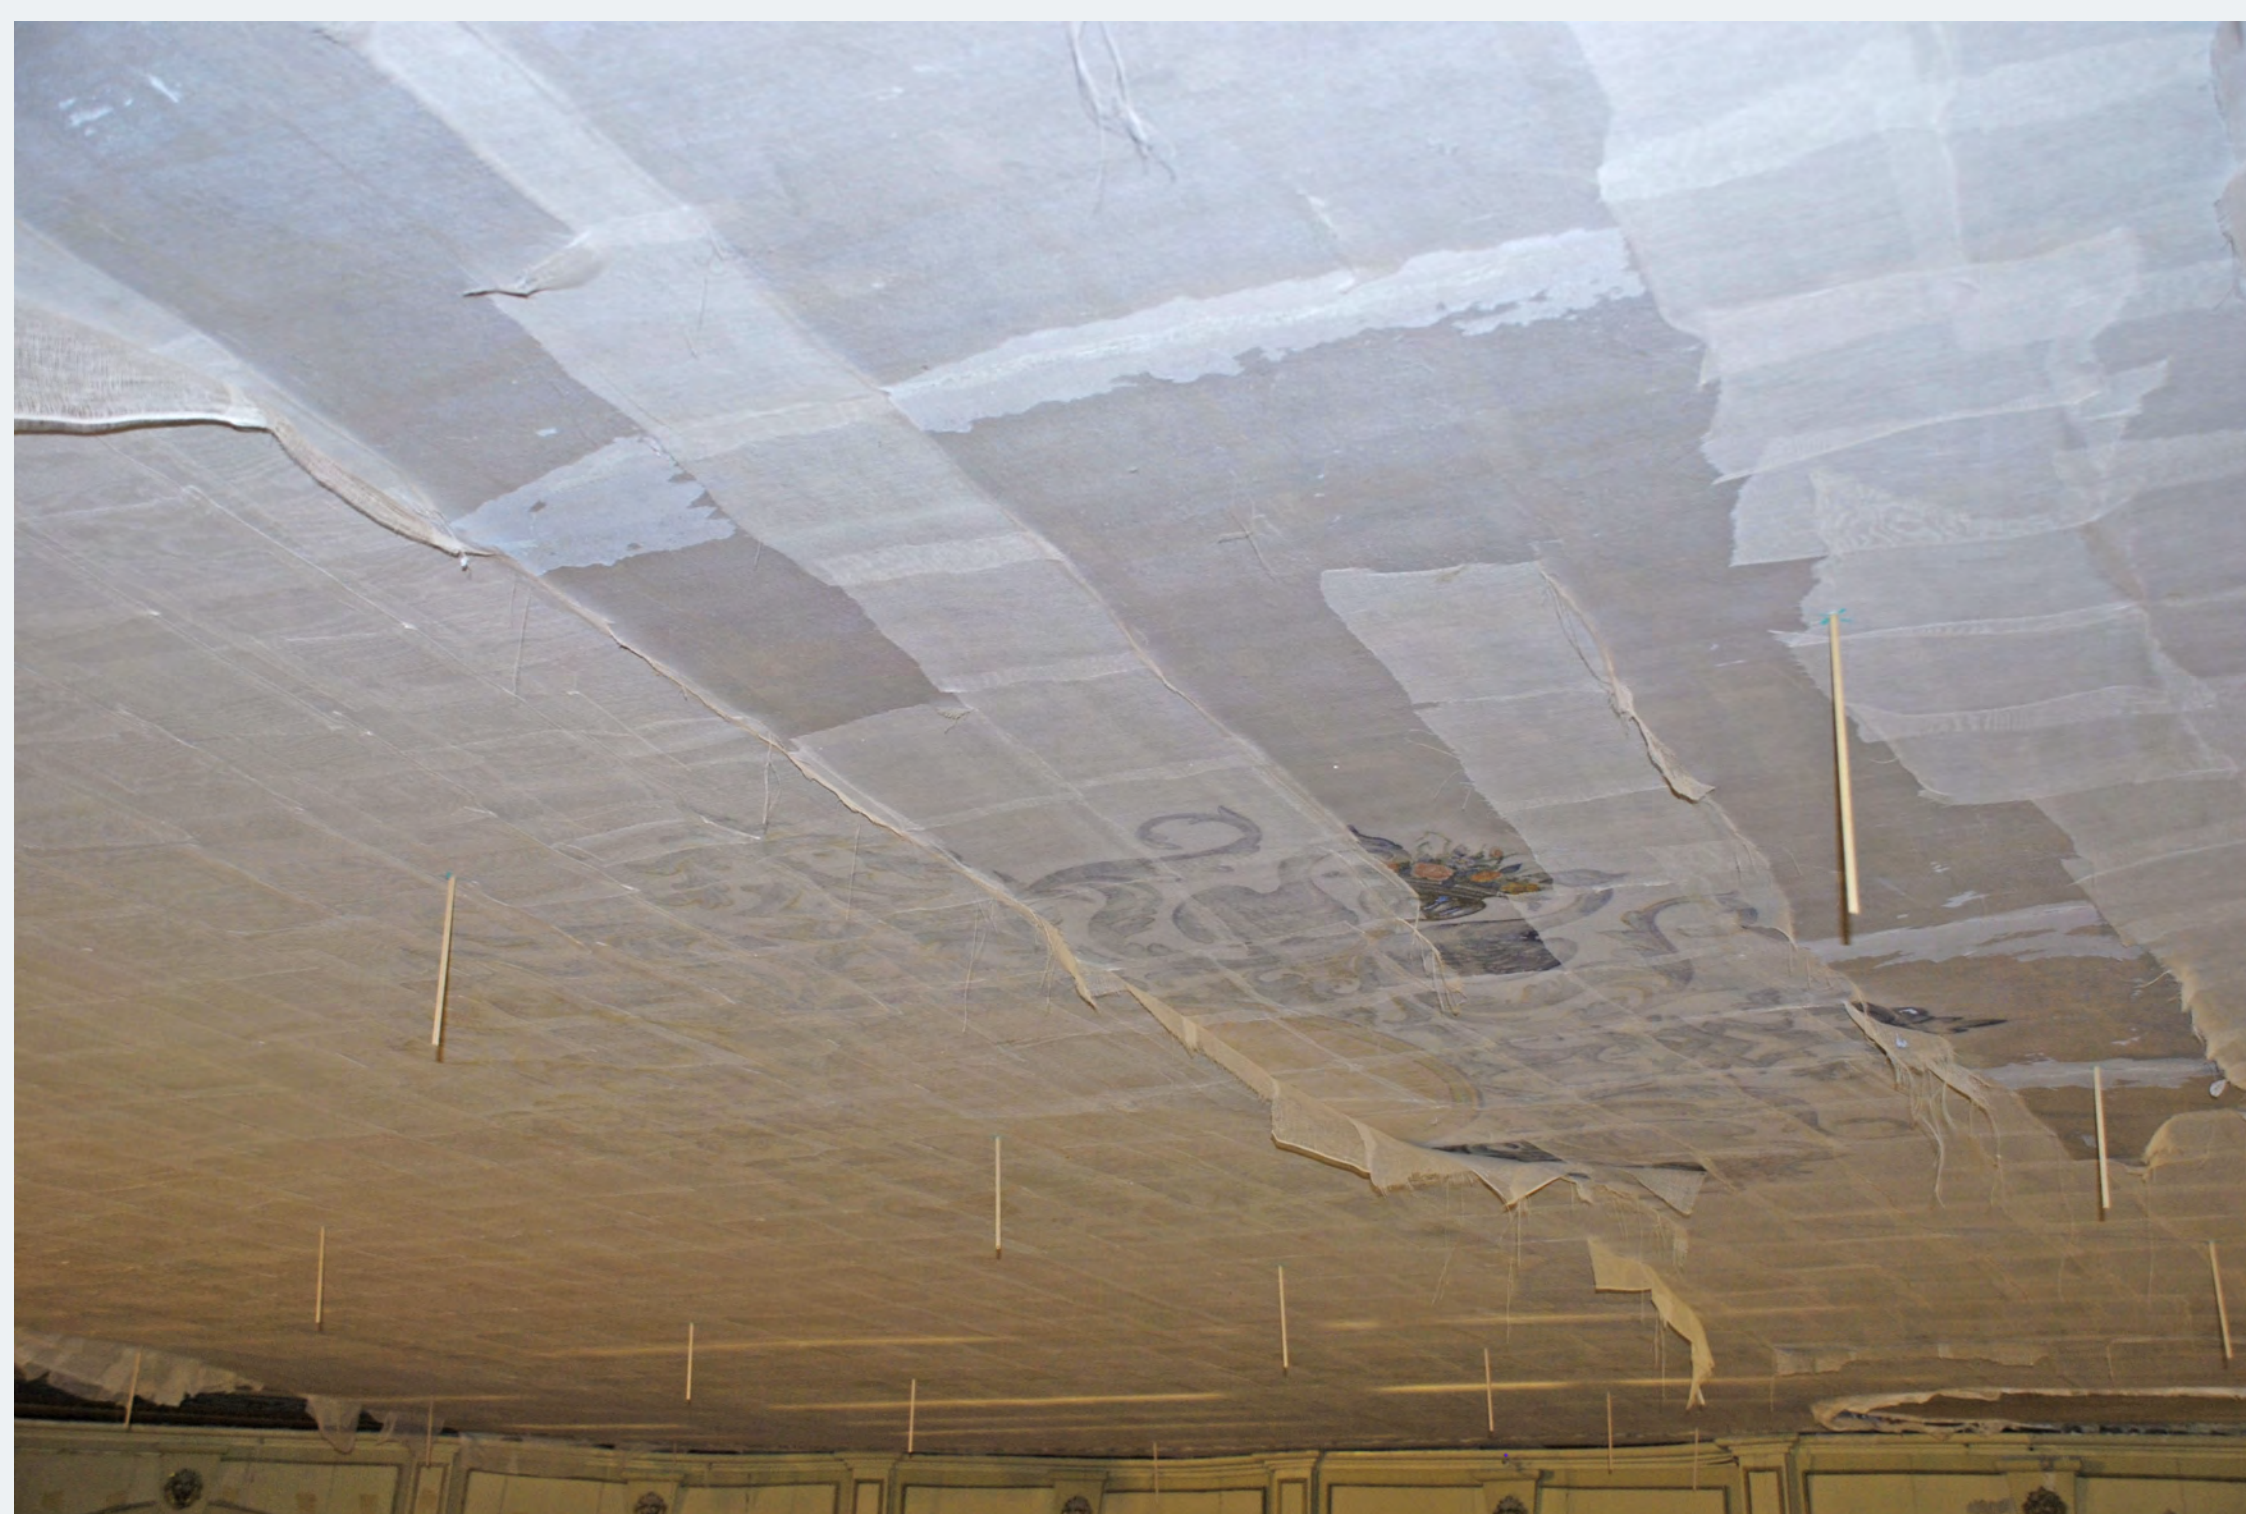
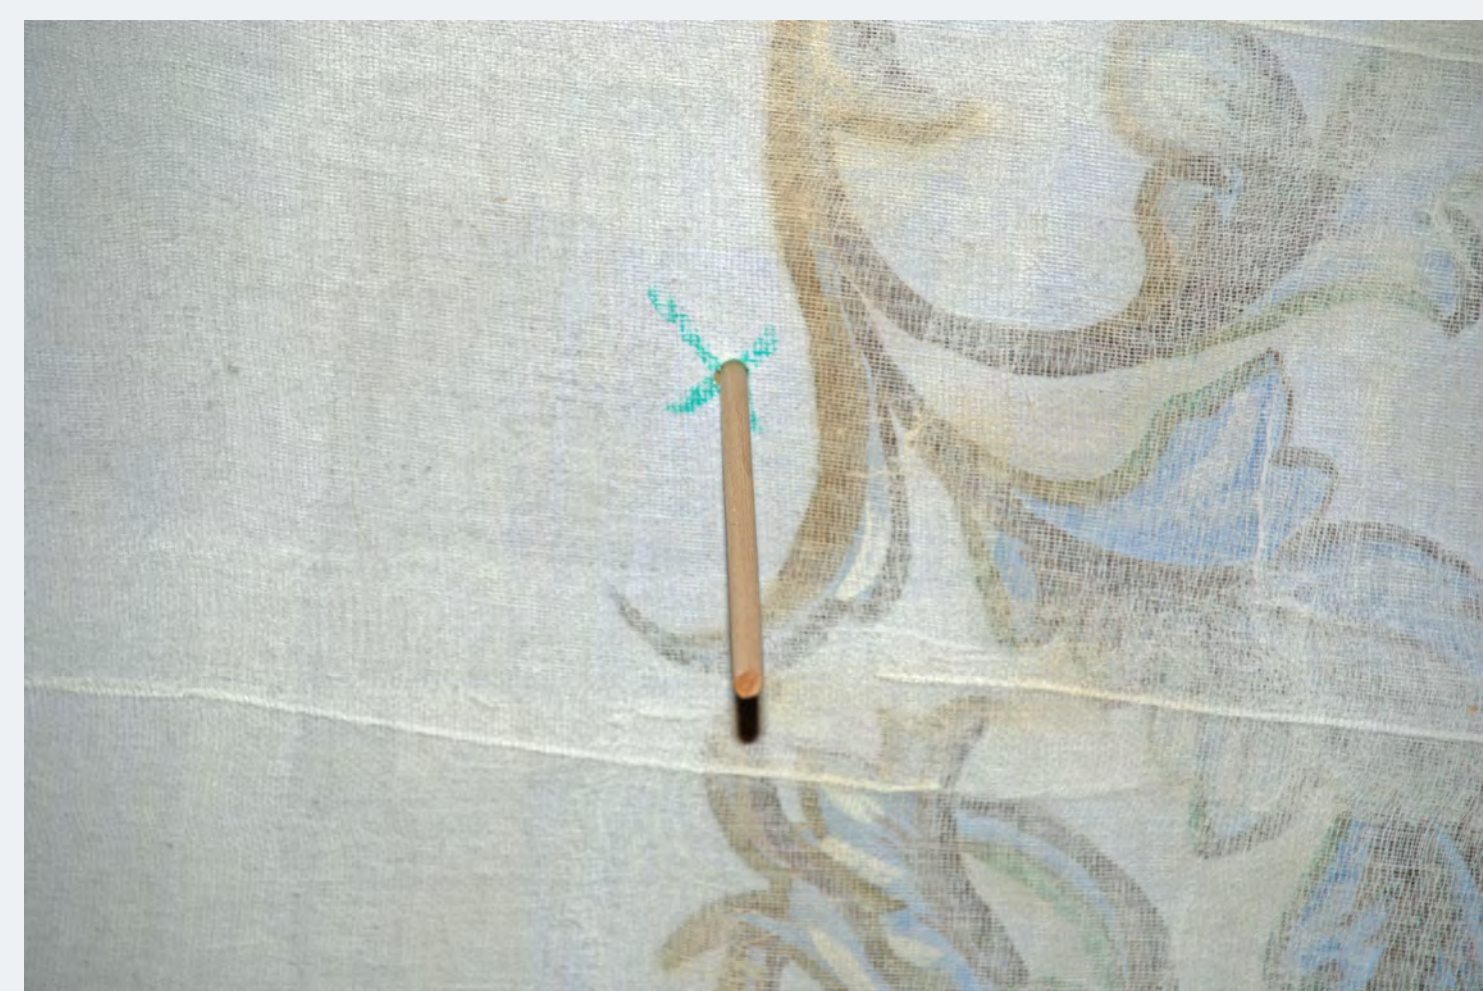
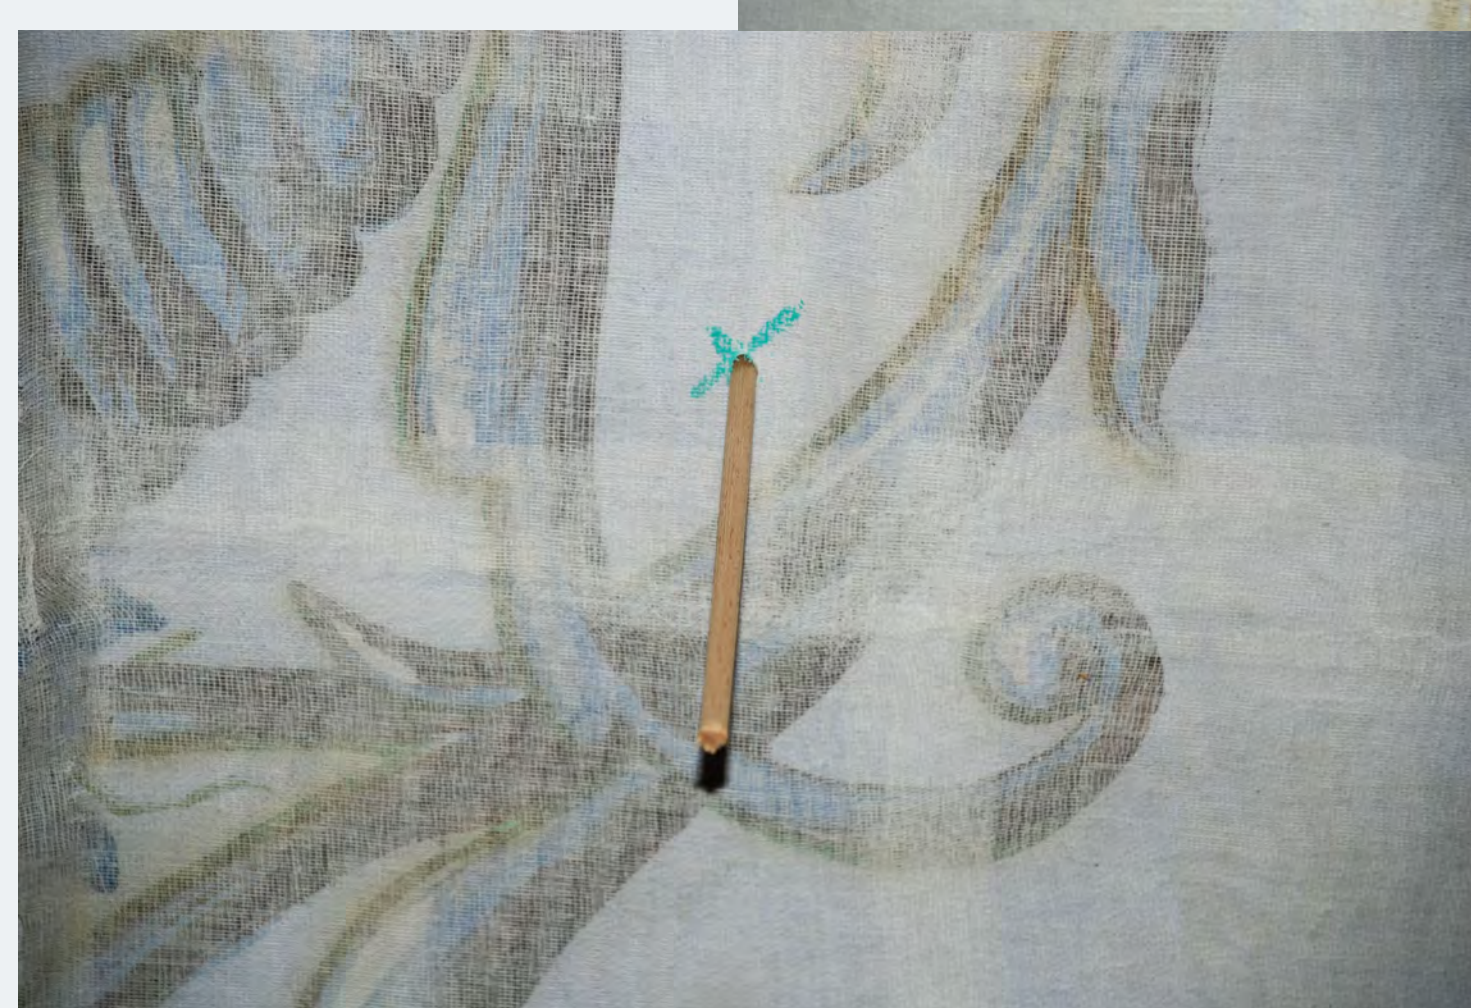
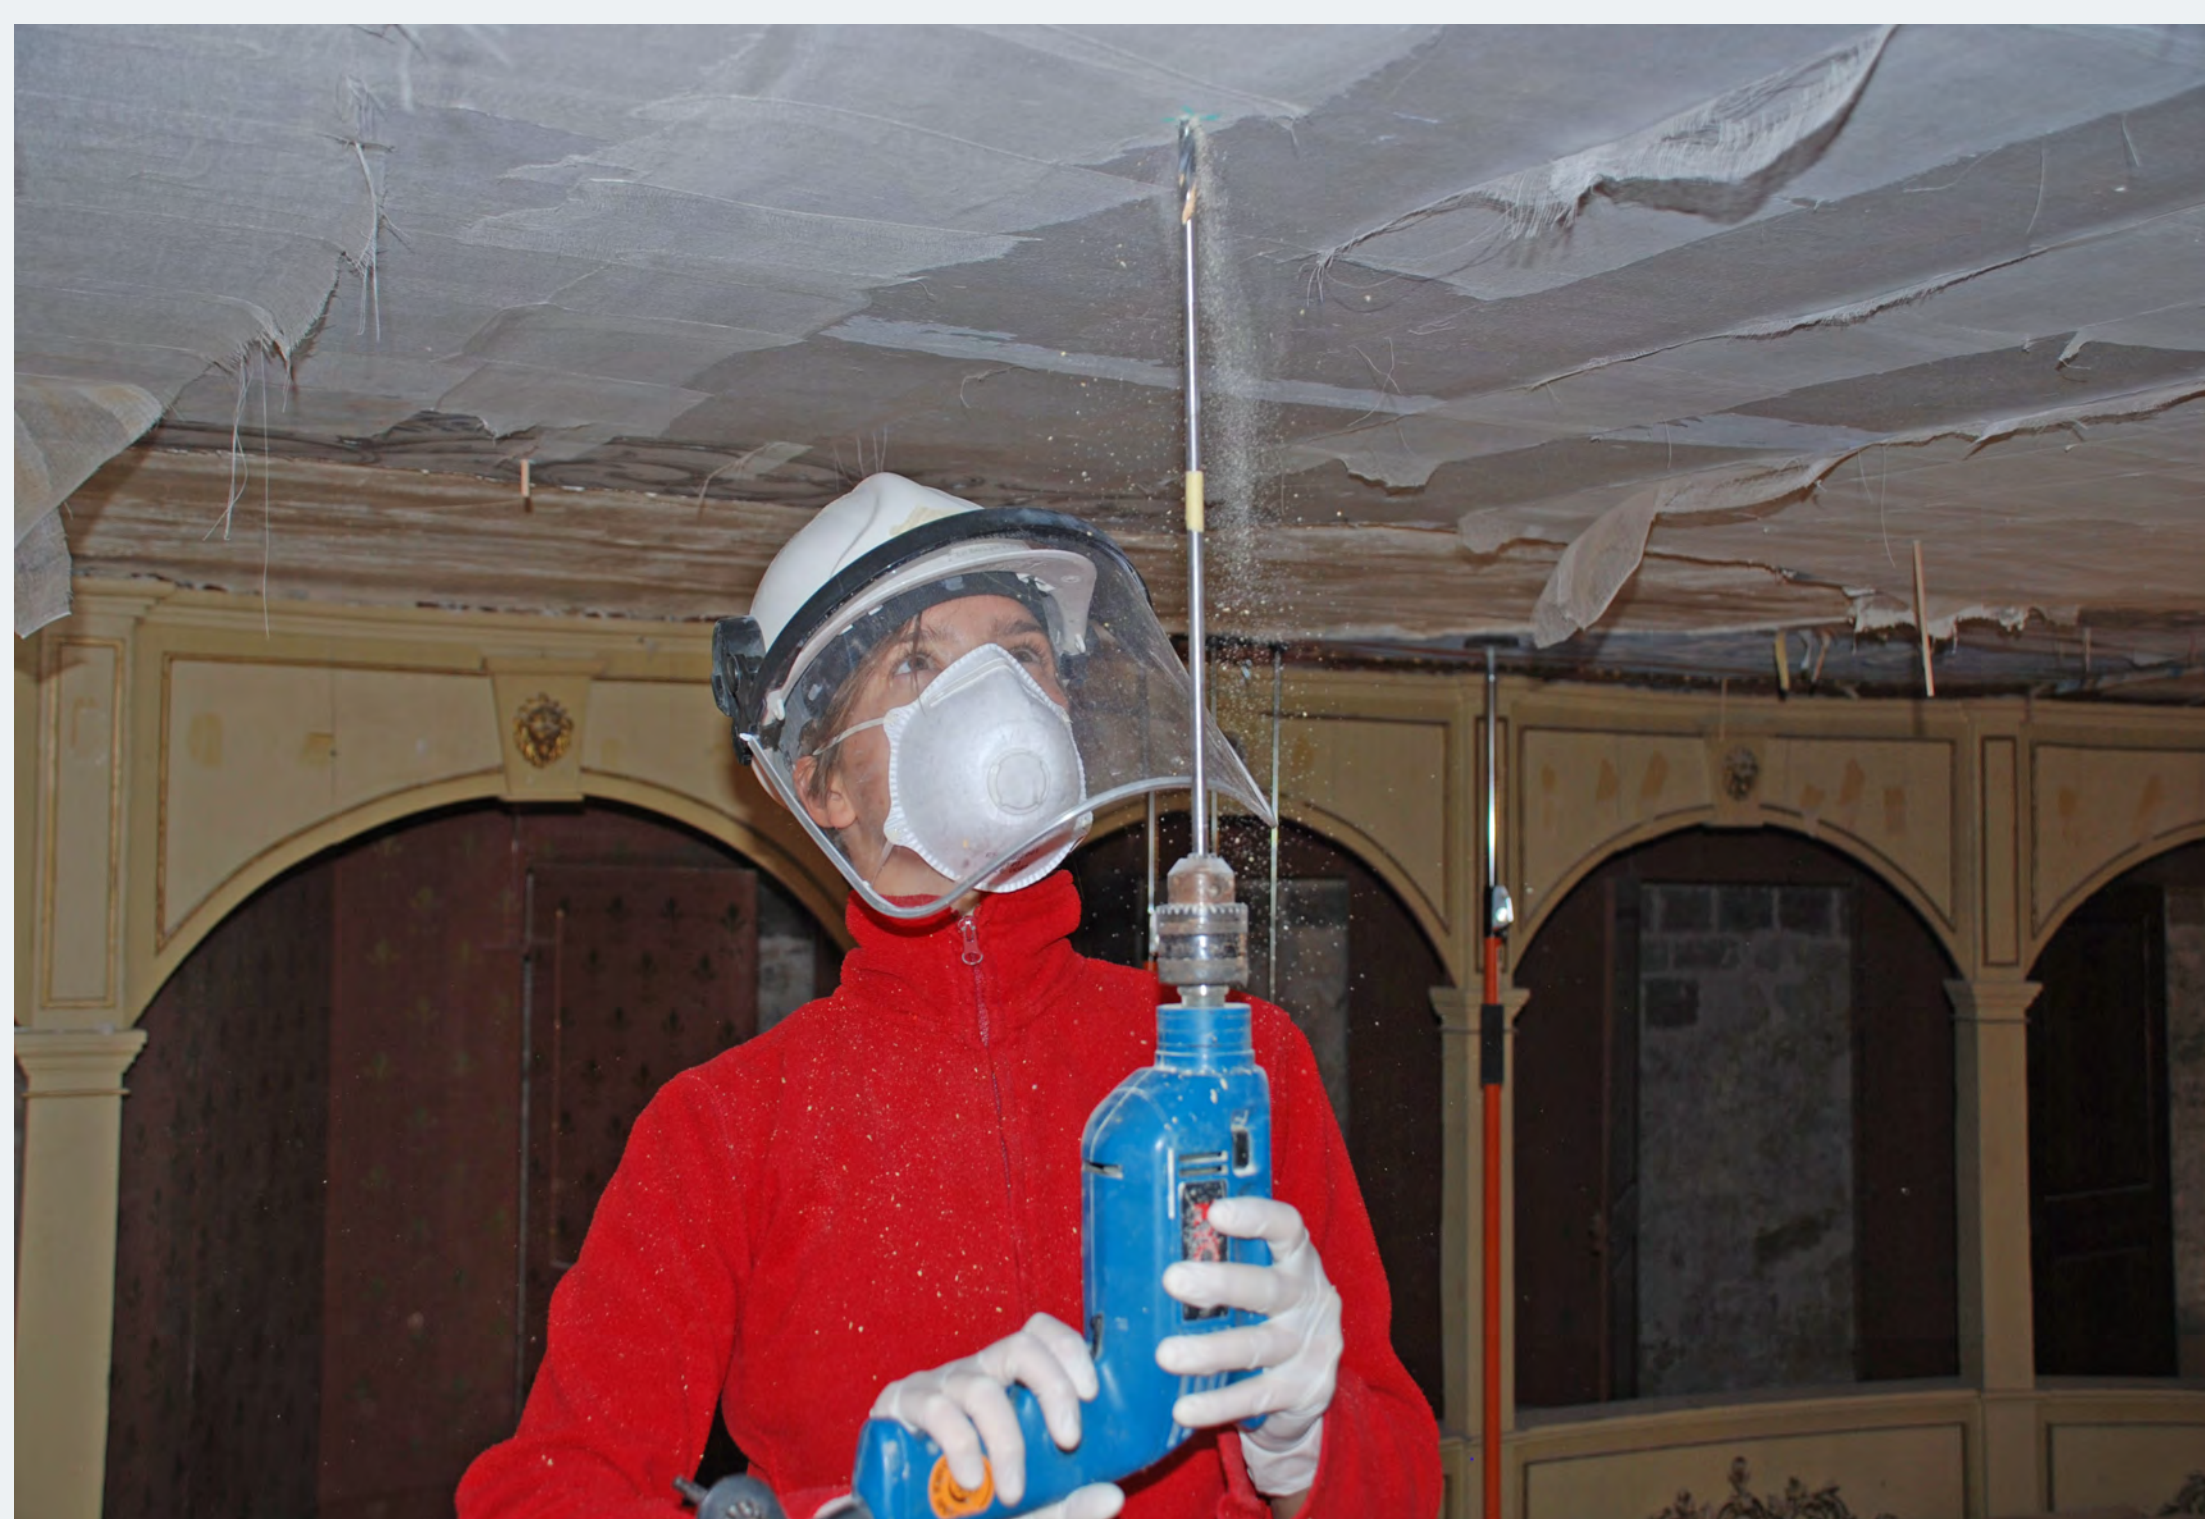
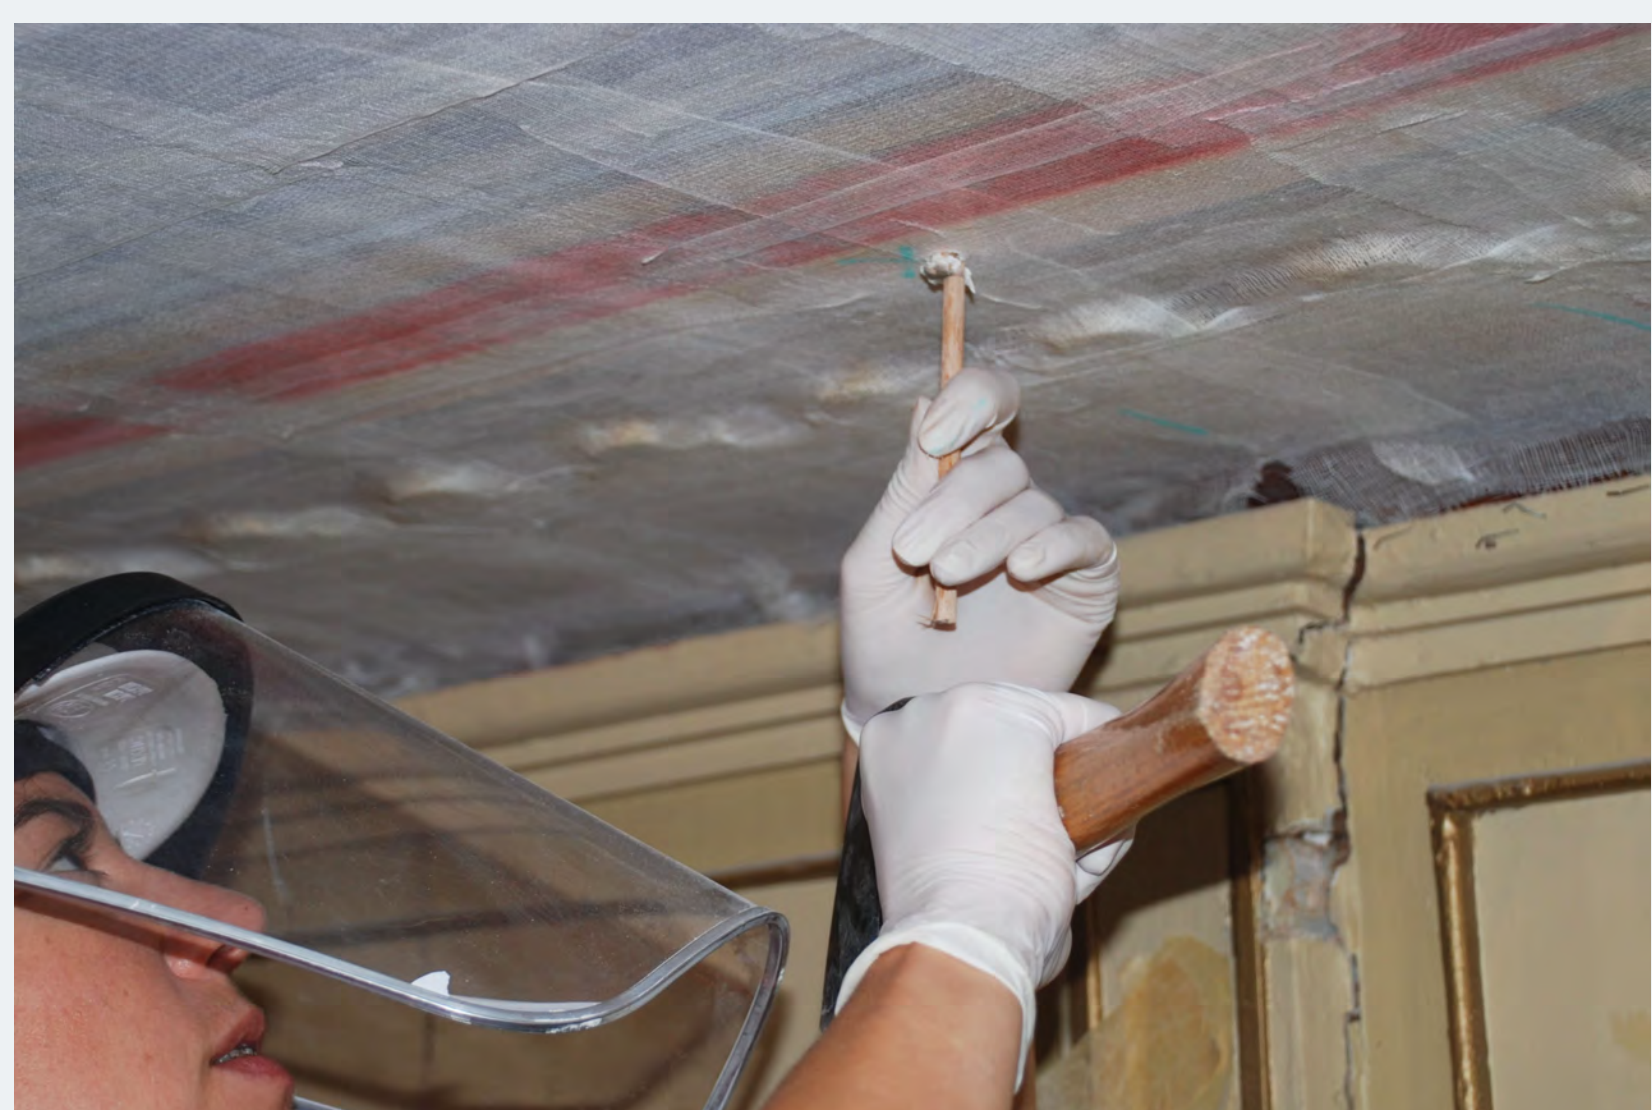
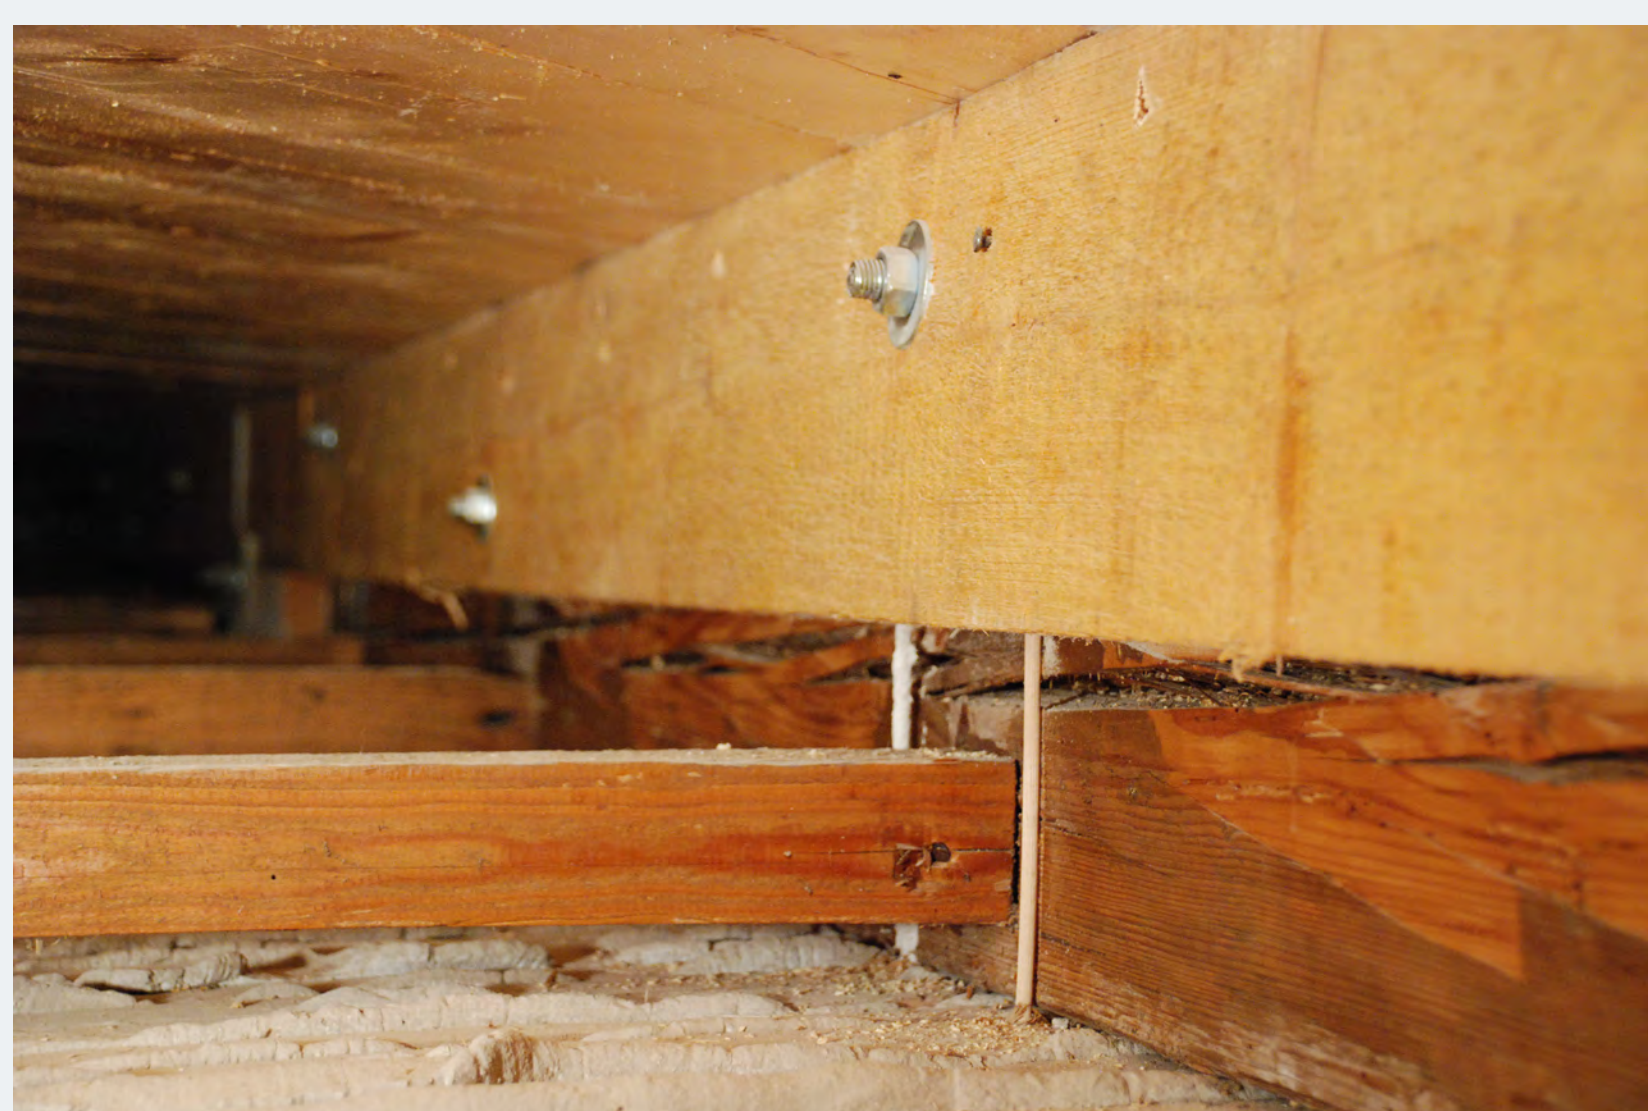
Stabilnost stropne slikarije hvarskog Kazališta bila je ugrožena djelovanjem štetnih mehaničkih oštećenja, prije svega onih koje je uzrokovao čovjek, ali i prirodnim propadanjem materijala (starenjem), što je uzrokovalo njezino mjestimično odvajanje od drvene stropne konstrukcije. Da bi se odvajanje spriječilo i da bi se neutralizirali štetni utjecaji vremena, slikariju je potrebno učvrstiti i ponovno uspostaviti narušenu homogenost žbuke-nosioca slikanog sloja i drvene konstrukcije- nosioca zidne slike. Učvršćenje nestabilnih područja žbuke provedeno je umetanjem drvenih štapića koji služe kao poveznica tih dvaju sustava. Drvenim štapićima odgovarajuće veličine slikarija se „sidrila“ za novopostavljene poprečne grede. Smještaj štapića odgovara rasporedu novih greda, a štapići se ritmično nižu u razmaku od oko 1 četvornog metra, ovisno o smještaju figuralnih i ornamentalnih elemenata oslikane kompozicije koji se pritom nastoje izbjeći. Najprije su učvršćena mjesta uz velike lakune, zatim pukotine i na kraju cijela površina stropa. Mjesta sidrenja zabilježena su na dokumentacijskom crtežu, tako da se u svakom trenutku mogu jednostavno odrediti.

The stability of the ceiling painting in the Hvar theatre was impaired by harmful mechanical influences, primarily those caused by man, but also by natural deterioration (ageing) of the materials, which had caused its sporadic separation from the wooden ceiling construction. In order to prevent further separation and neutralize the damaging impact of time, the painting had to be reinforced, and the disturbed homogeneity of the plaster (carrier of the painted layer) and the wooden construction (carrier of the wall painting) had to be restored.

The unstable segments of the plaster were reinforced by inserted wooden sticks, used to bind together the two systems. The appropriately-sized wooden sticks were inserted to 'anchor' the painting to the newly-placed cross beams. The position of the sticks corresponded to the position of the new beams, and they were distributed regularly with a separation of approximately 1 square metre, depending on the position of figural and ornamental elements of the painted composition, which we tried to avoid. The places next to large lacunae were reinforced first, followed by cracks, and finally the entire ceiling surface was reinforced. The anchors were recorded in a documentation drawing, so that they can always easily be found.
