## ZATEČENO STANJE

## INITIAL CONDITION

HRVATSKI  
RESTAURATORSKI  
ZAVOD

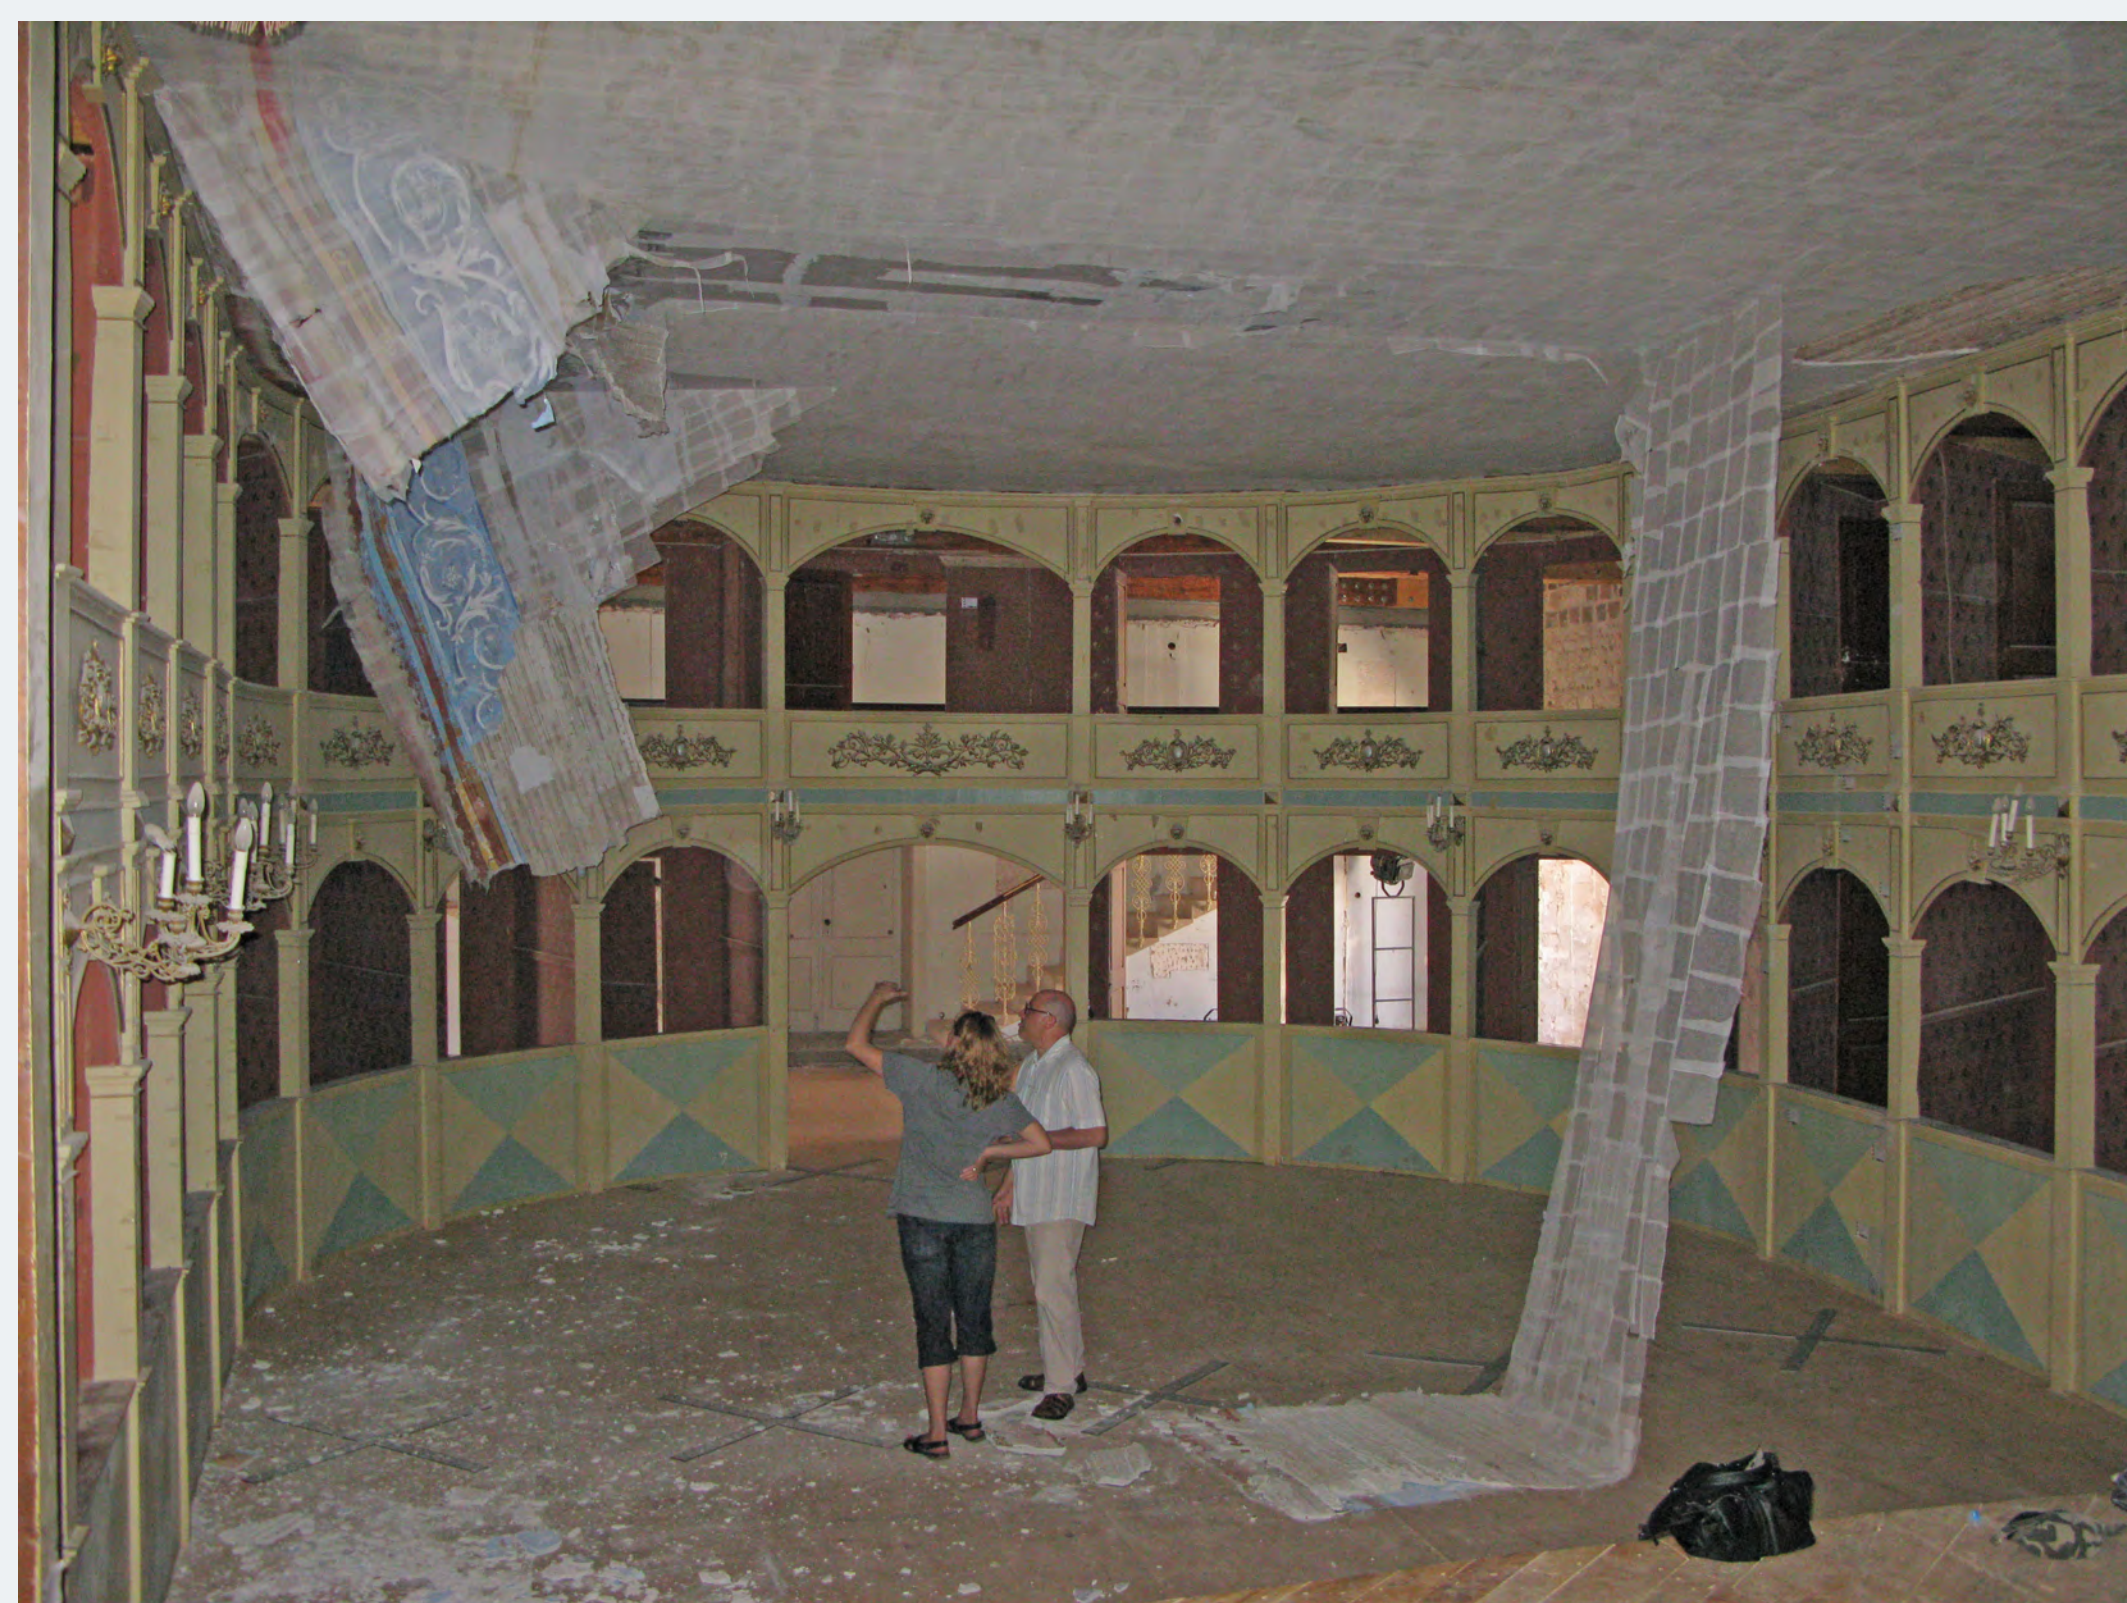
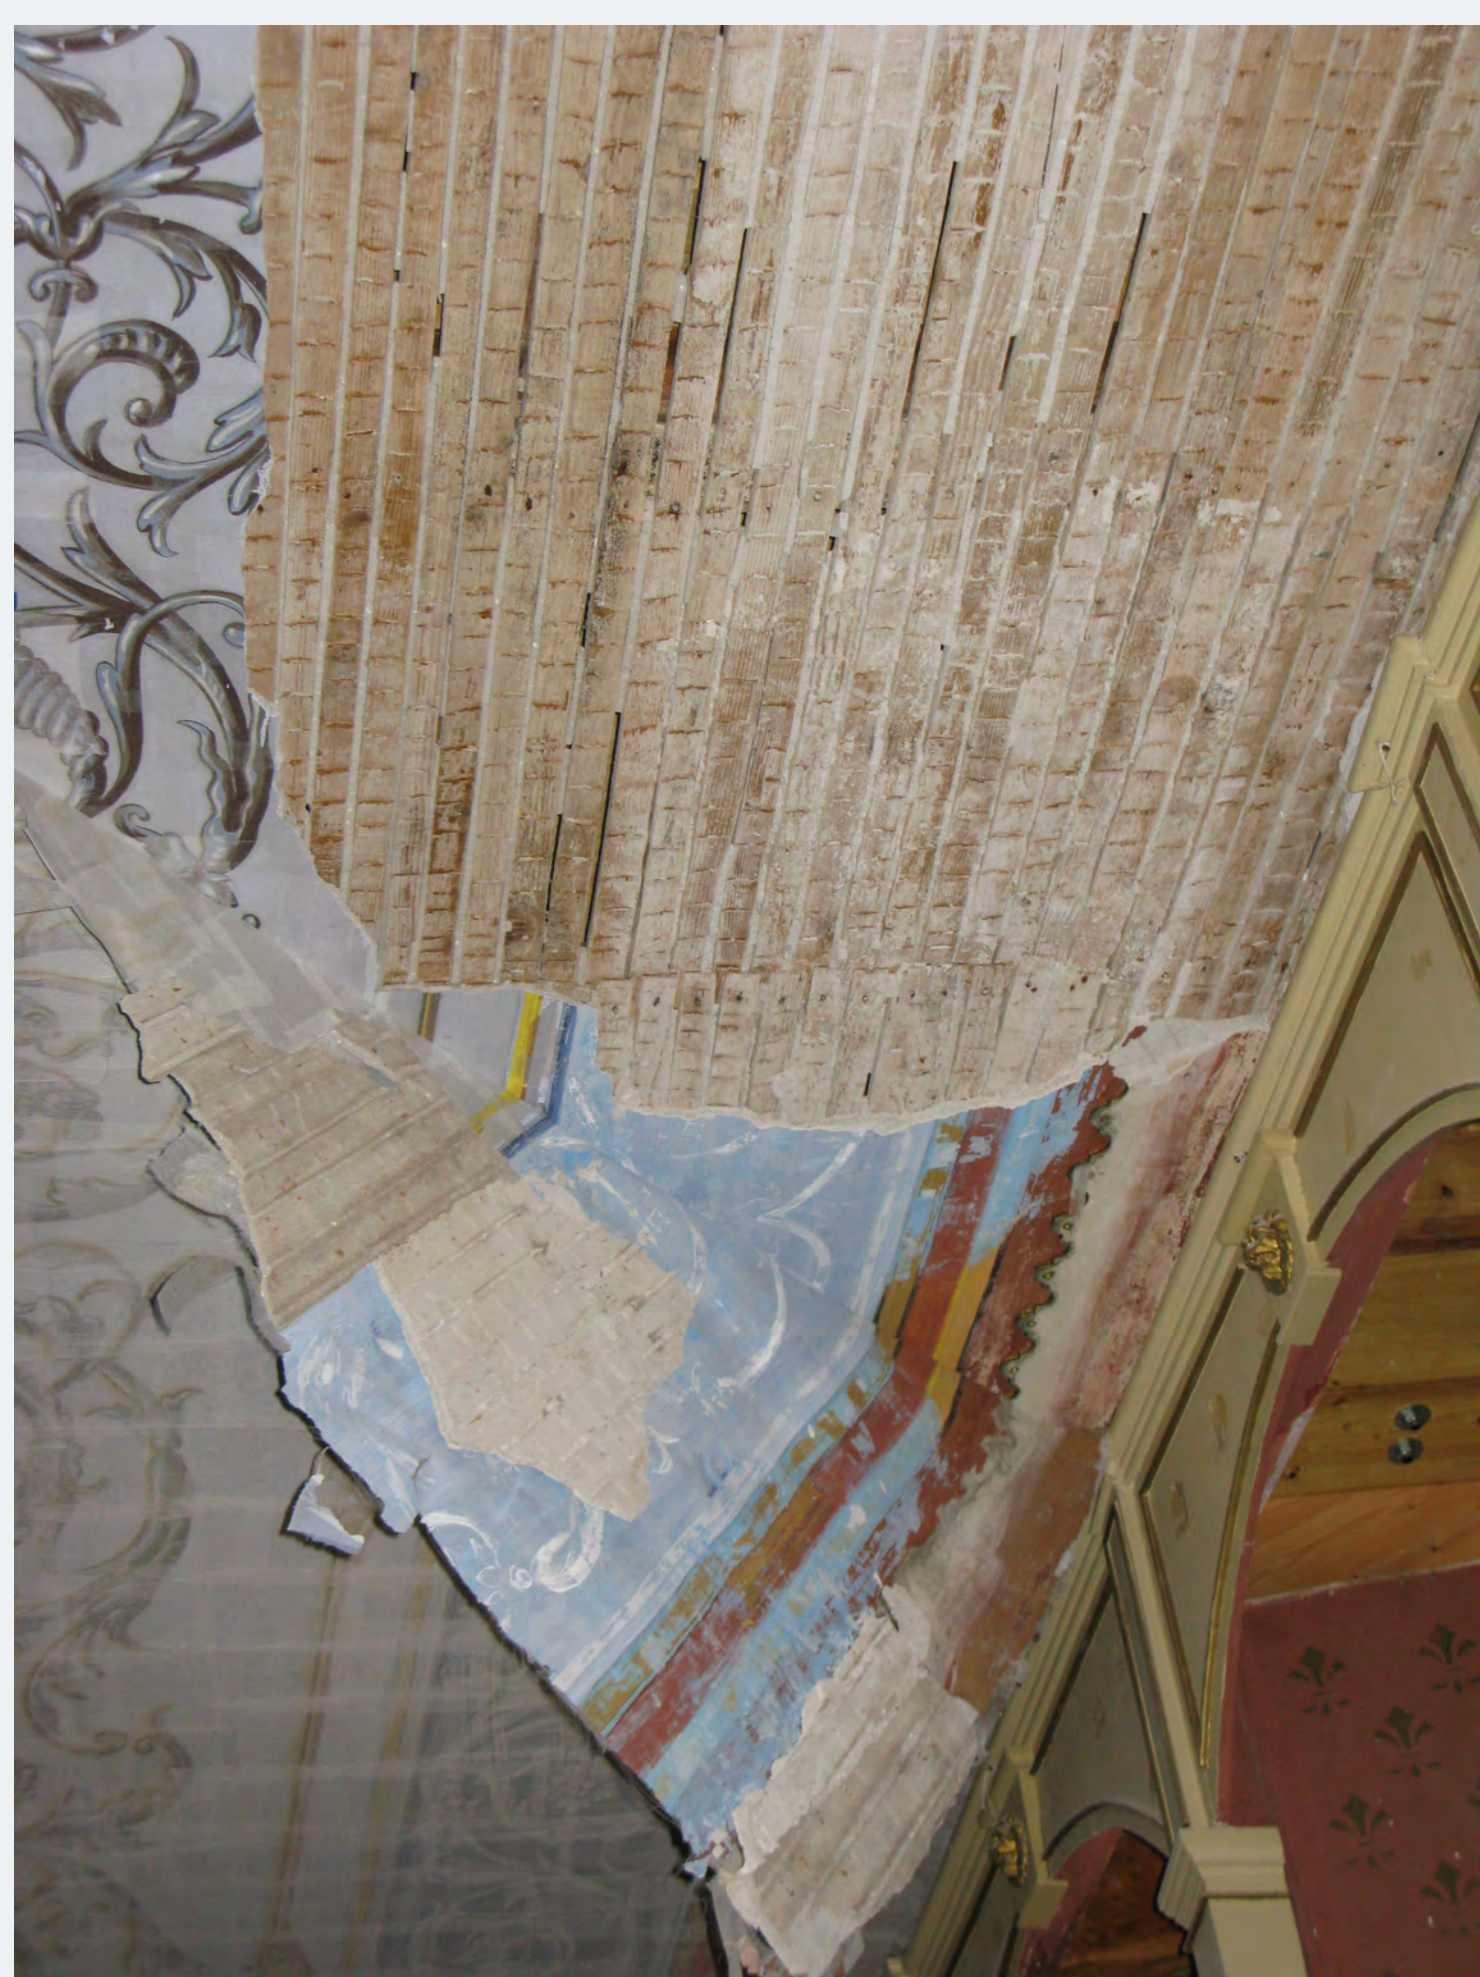
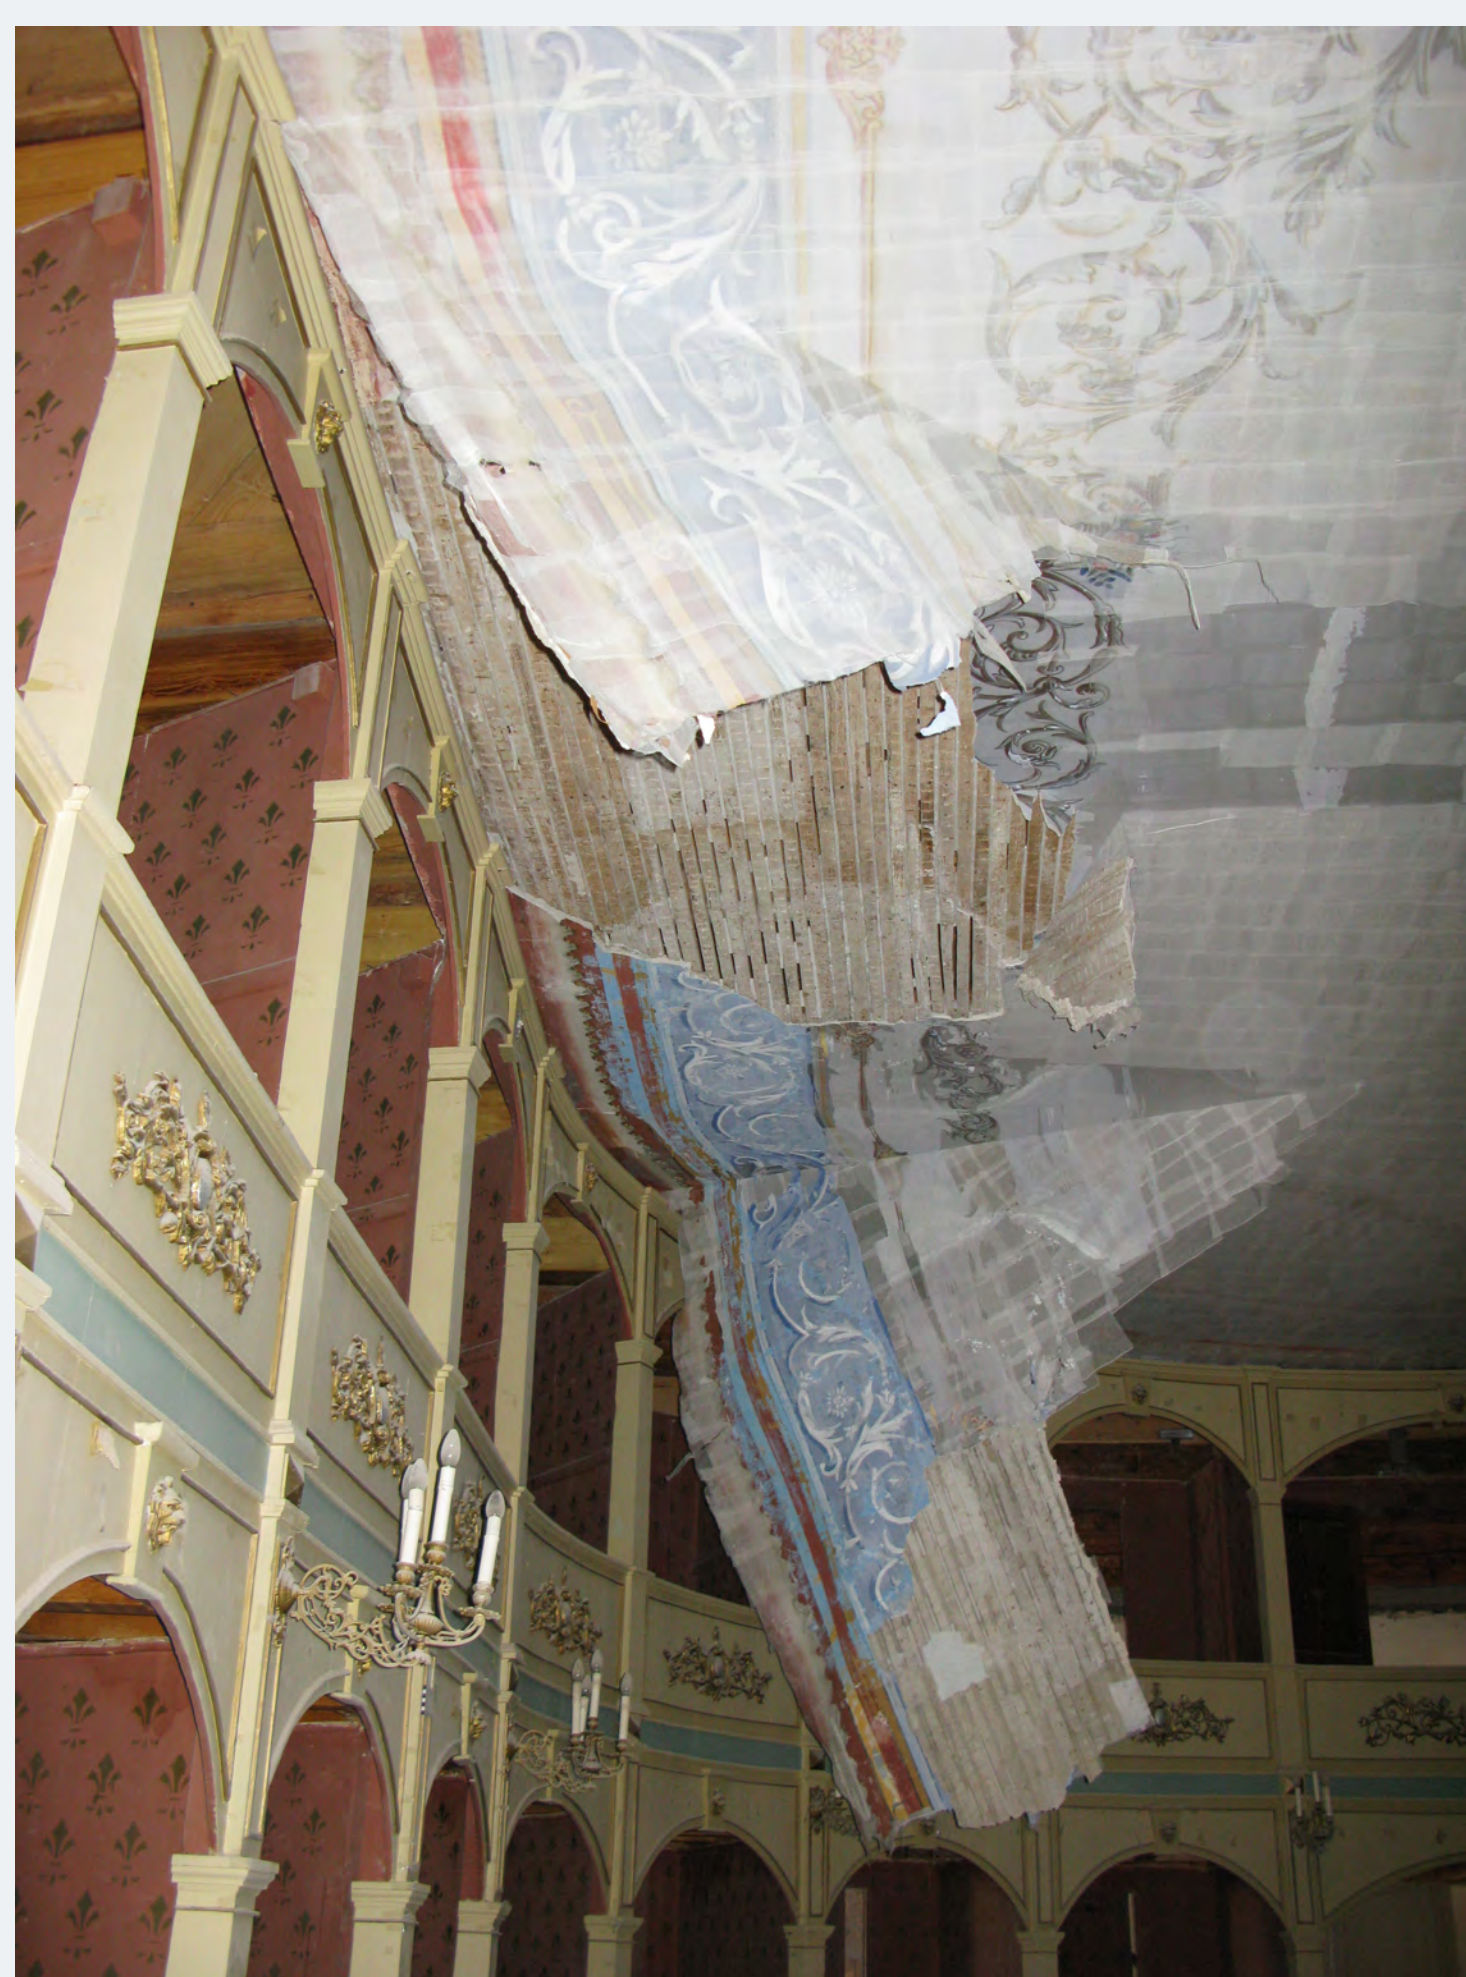
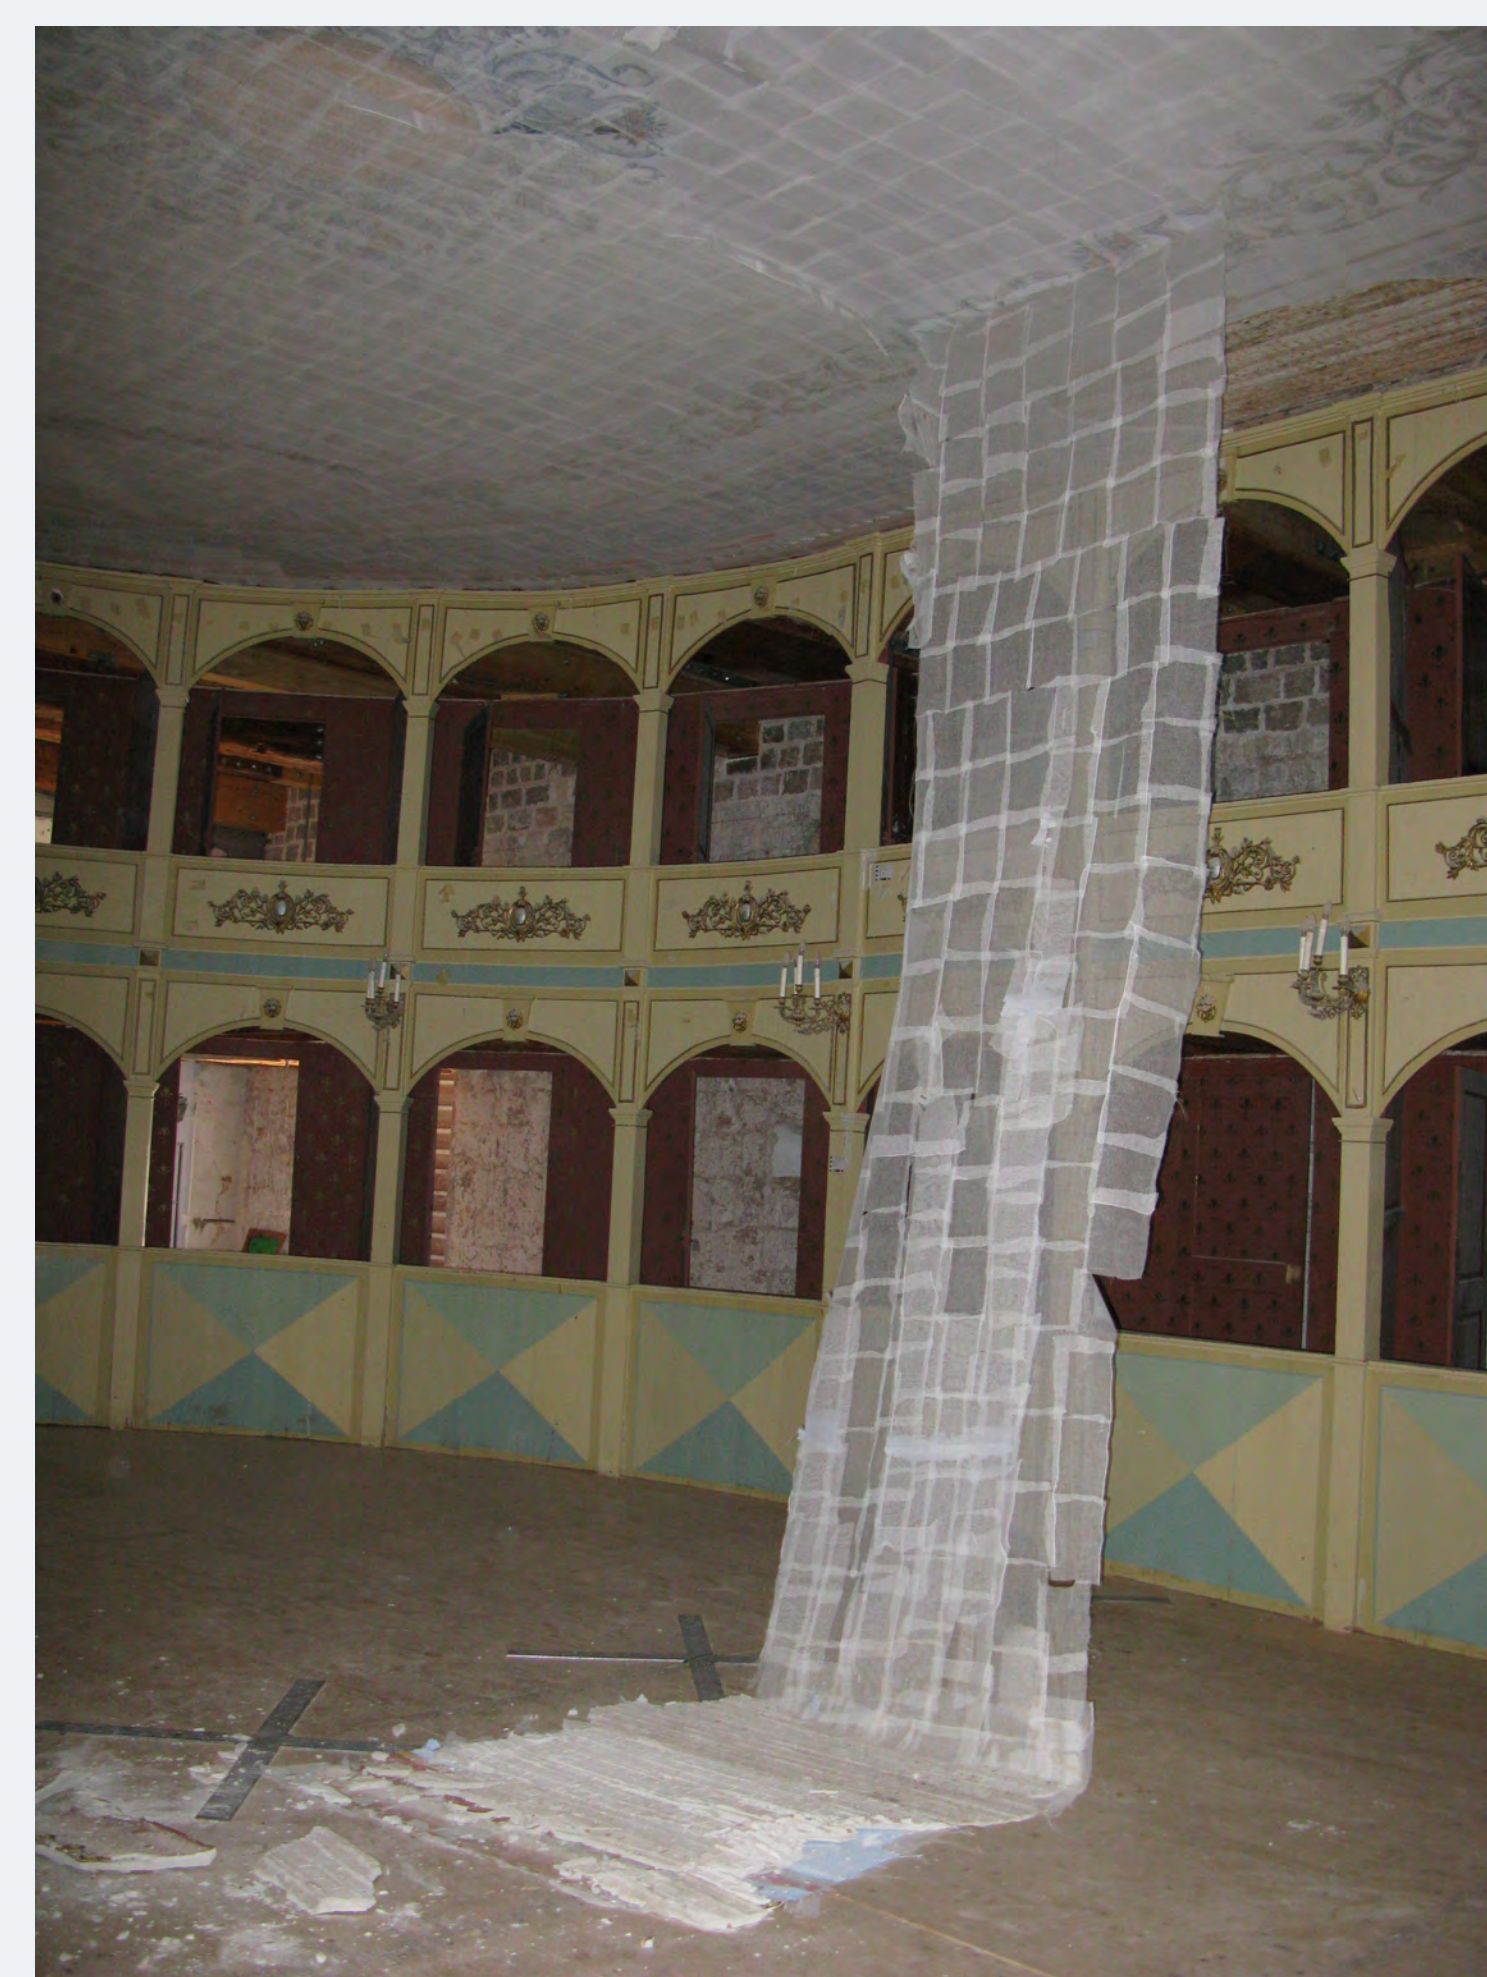
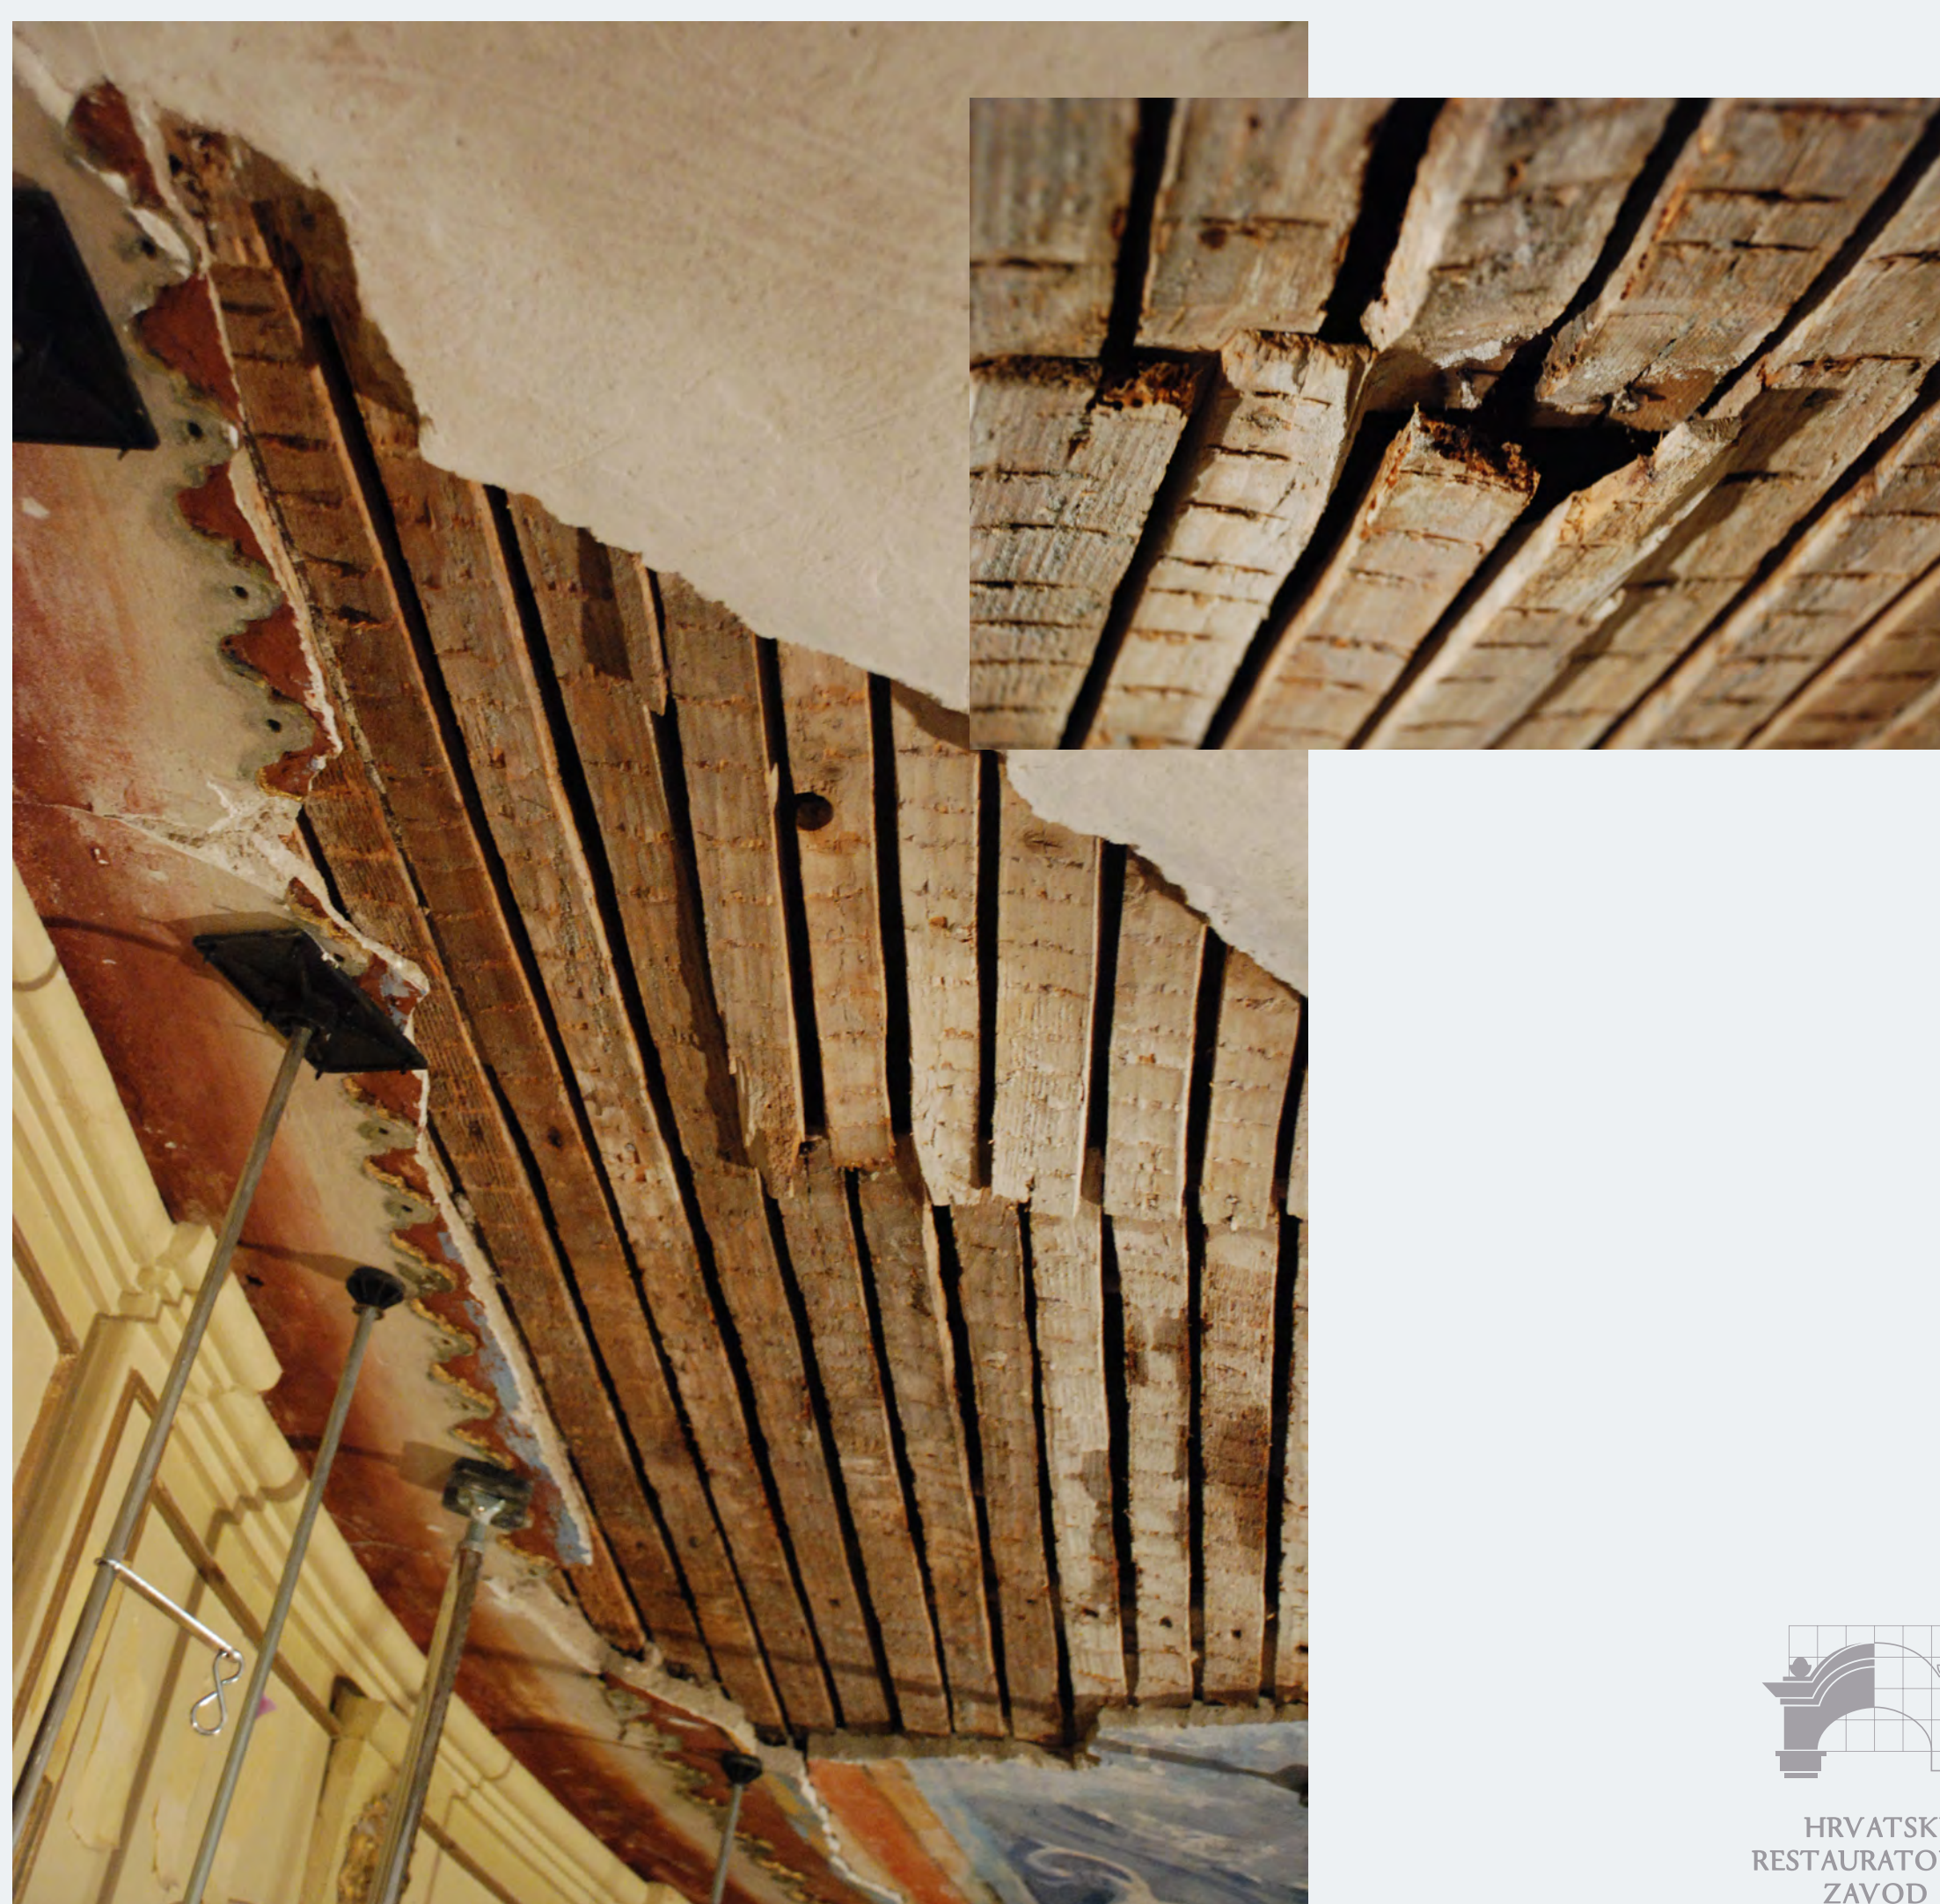
Tijekom 2007. godine Odsjek za zidno slikarstvo, mozaike i štuko proveo je preventivne zaštitne zahvate da bi se zaštitio oslikani strop i umanjile se potencijalne opasnosti u provođenju građevinske sanacije. Druga faza radova koja je pretpostavljala provođenje cjelokupnog konzervatorsko-restauratorskog zahvata trebala se što skorije realizirati kako bi se izbjegli rizici dugotrajnog utjecaja različitih mehaničkih opterećenja na oslikani strop. Postavljeni zaštitni sloj te djelomično sidrenje površine stropa nisu mogli spriječiti dugotrajna opterećenja izazvana izlaganjem vibracijama različitih strojeva i alata te izravnim pritiscima na oslikani strop odozgo. S vremenom su vezivne sponje u spojevima stropne žbuke i letvica popustile, što je rezultiralo potpunim odvajanjem dijela oslikanog sloja sa žbukom. Odvajanje se dogodilo na mjestu već repariranog stropa u južnom središnjem dijelu, ali nasreću izvorni oslik nije pretrpio znatnija oštećenja.

In 2007, the Section for Conservation and Restoration of Wall Paintings, Mosaics and Stucco carried out protective treatment, with the goal of protecting the painted ceiling and reducing possible threats caused by the construction rehabilitation works. The second phase of the treatment, encompassing an overall conservation and restoration intervention, needed to be implemented soon afterwards, in order to avoid the risks posed by the long-term influence of various mechanical burdens on the painted ceiling. The placed facing and the partial anchoring of the ceiling could not prevent long-term damage caused by exposure to the vibrations of various machines and tools, as well as by direct pressure applied against the painted layer from above. With time, the binding in the connections between the ceiling plaster and the lattices became weaker, resulting in a complete separation of one section of the painted layer, together with the plaster. The separation occurred in a place that had already been repaired, on the southern side of the central part of the painting, but, luckily, the original painting coat had not suffered significant damage.
