## ZATEČENO STANJE

## INITIAL CONDITION

HRVATSKI  
RESTAURATORSKI  
ZAVOD

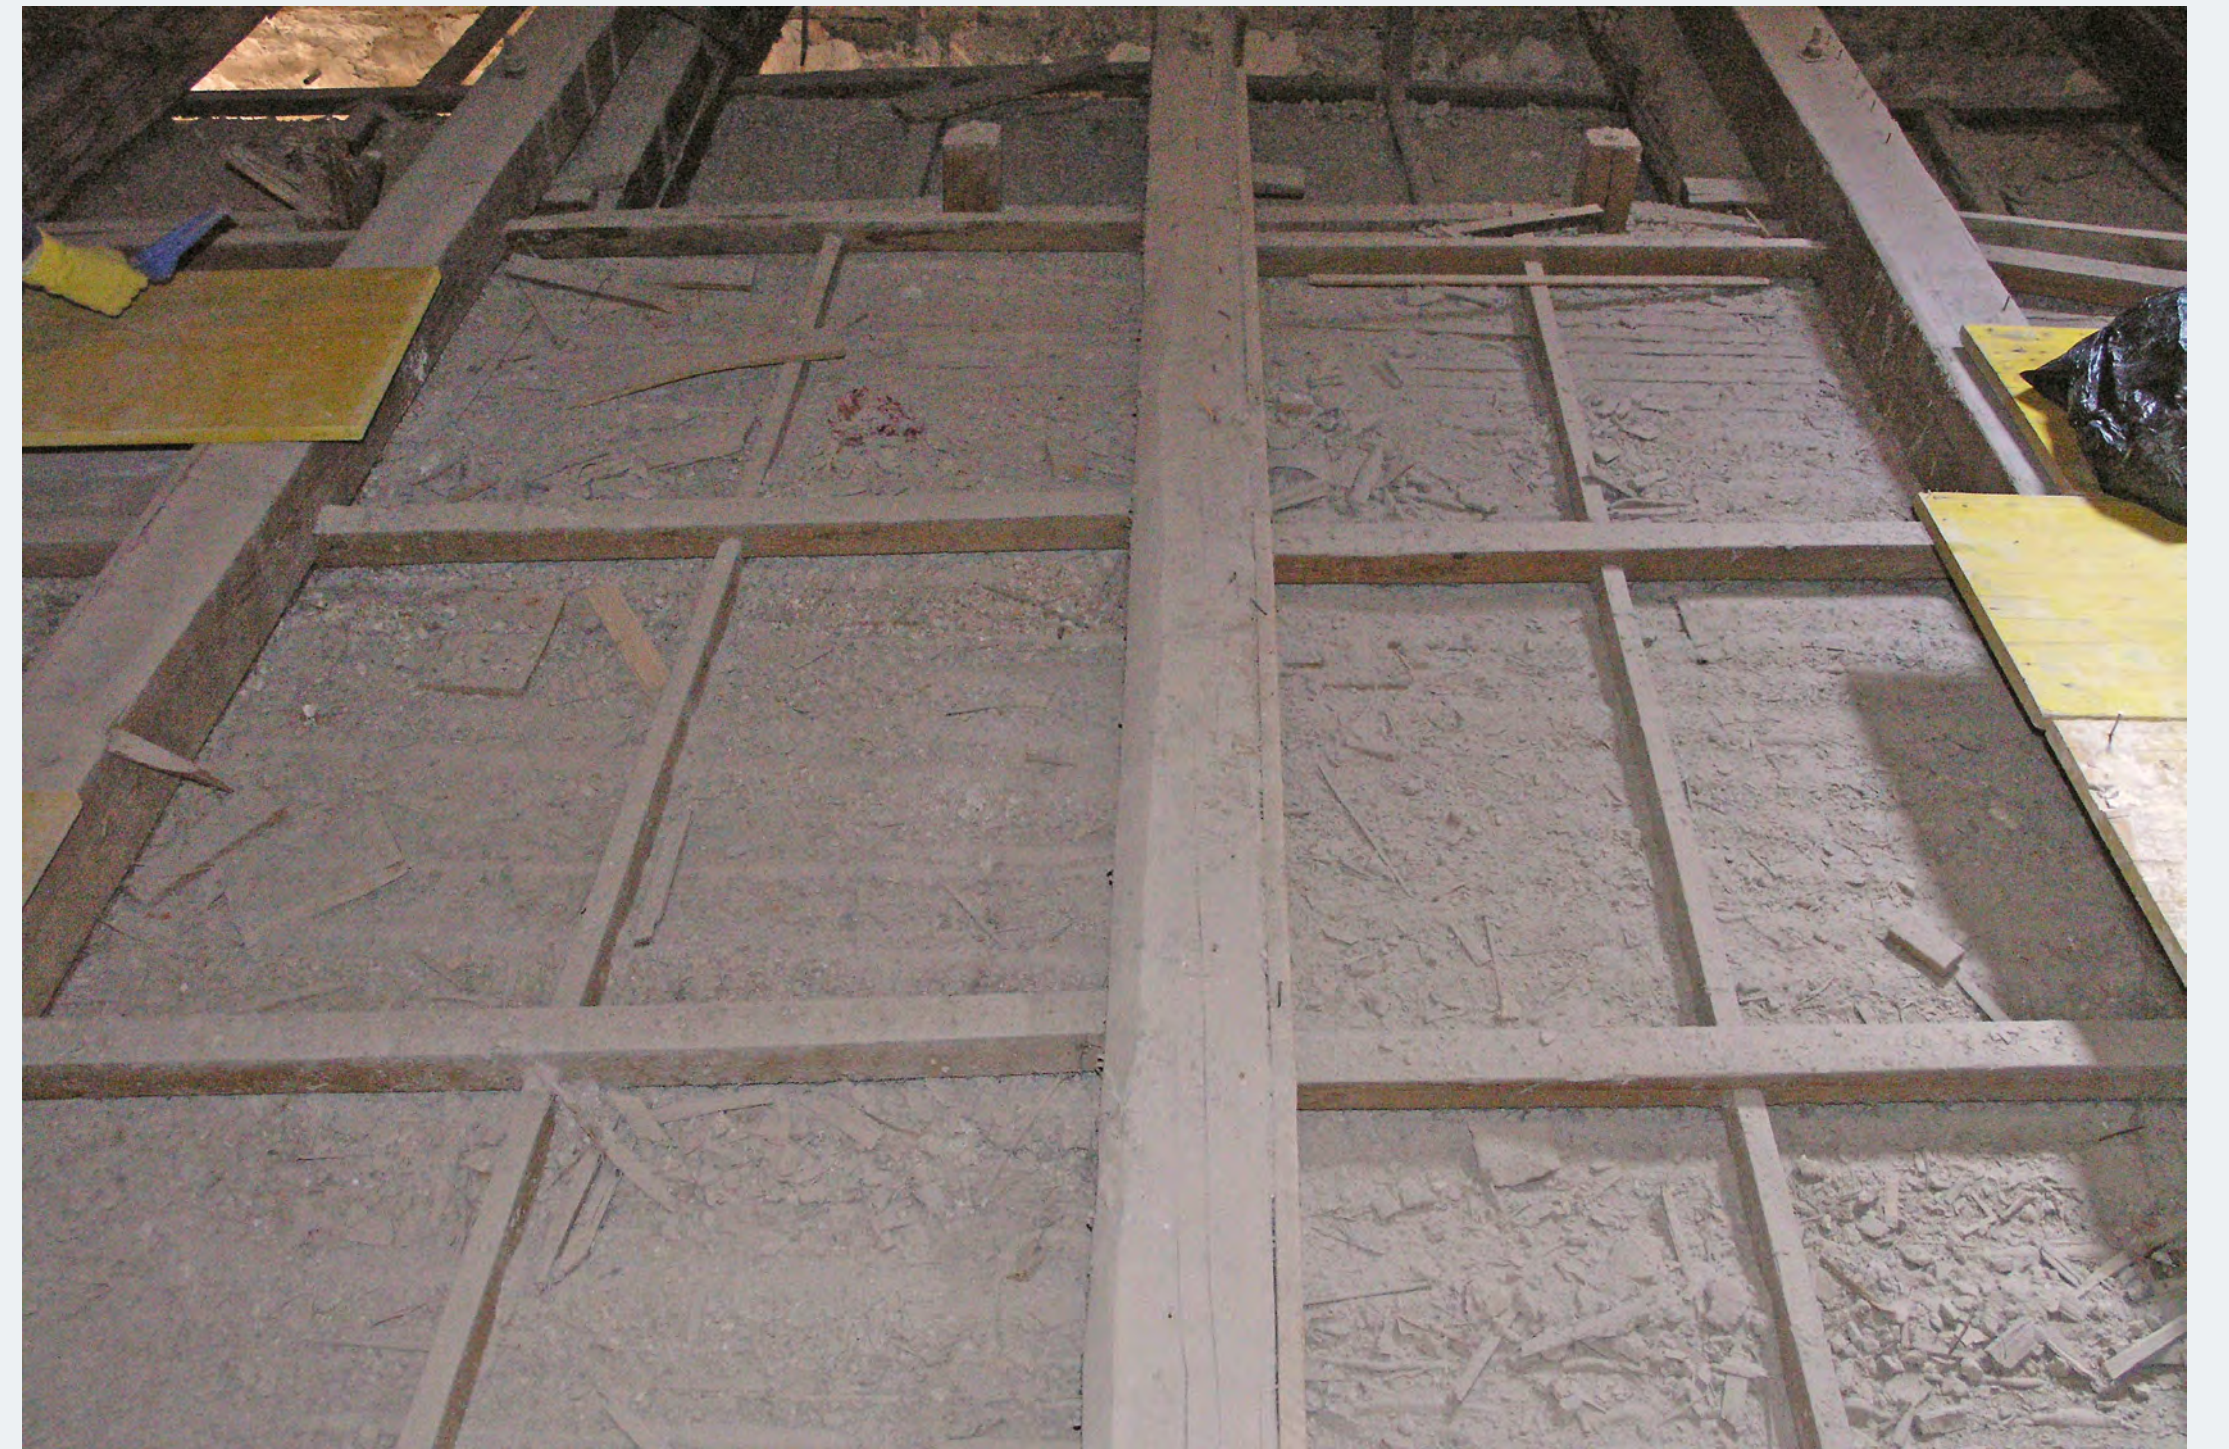
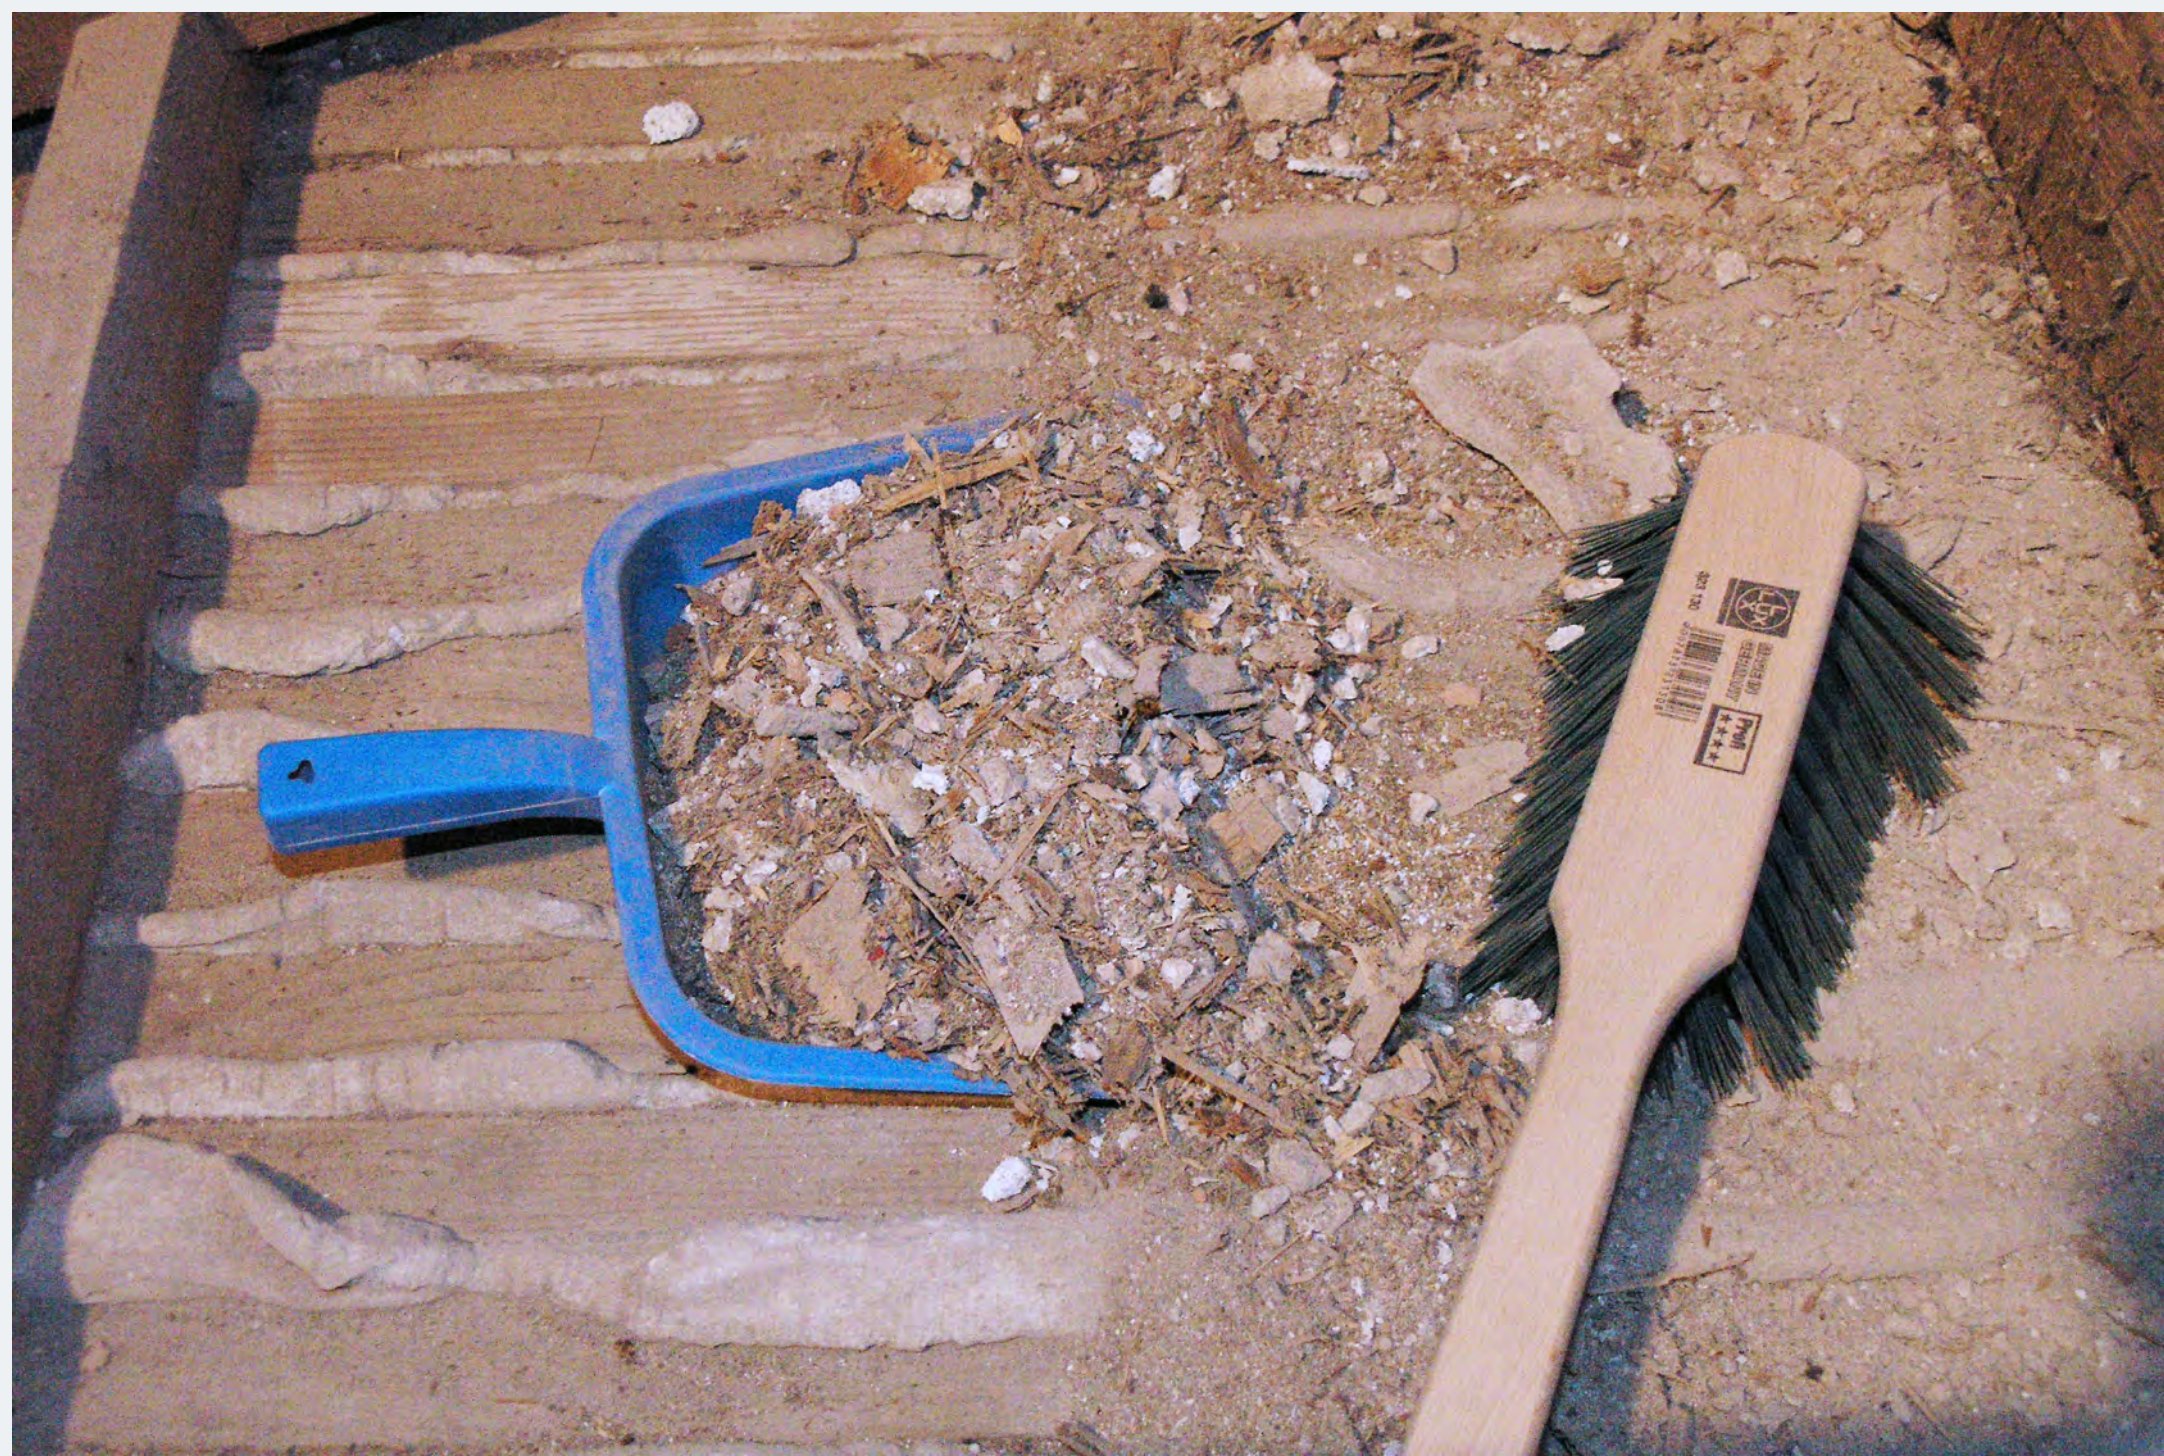
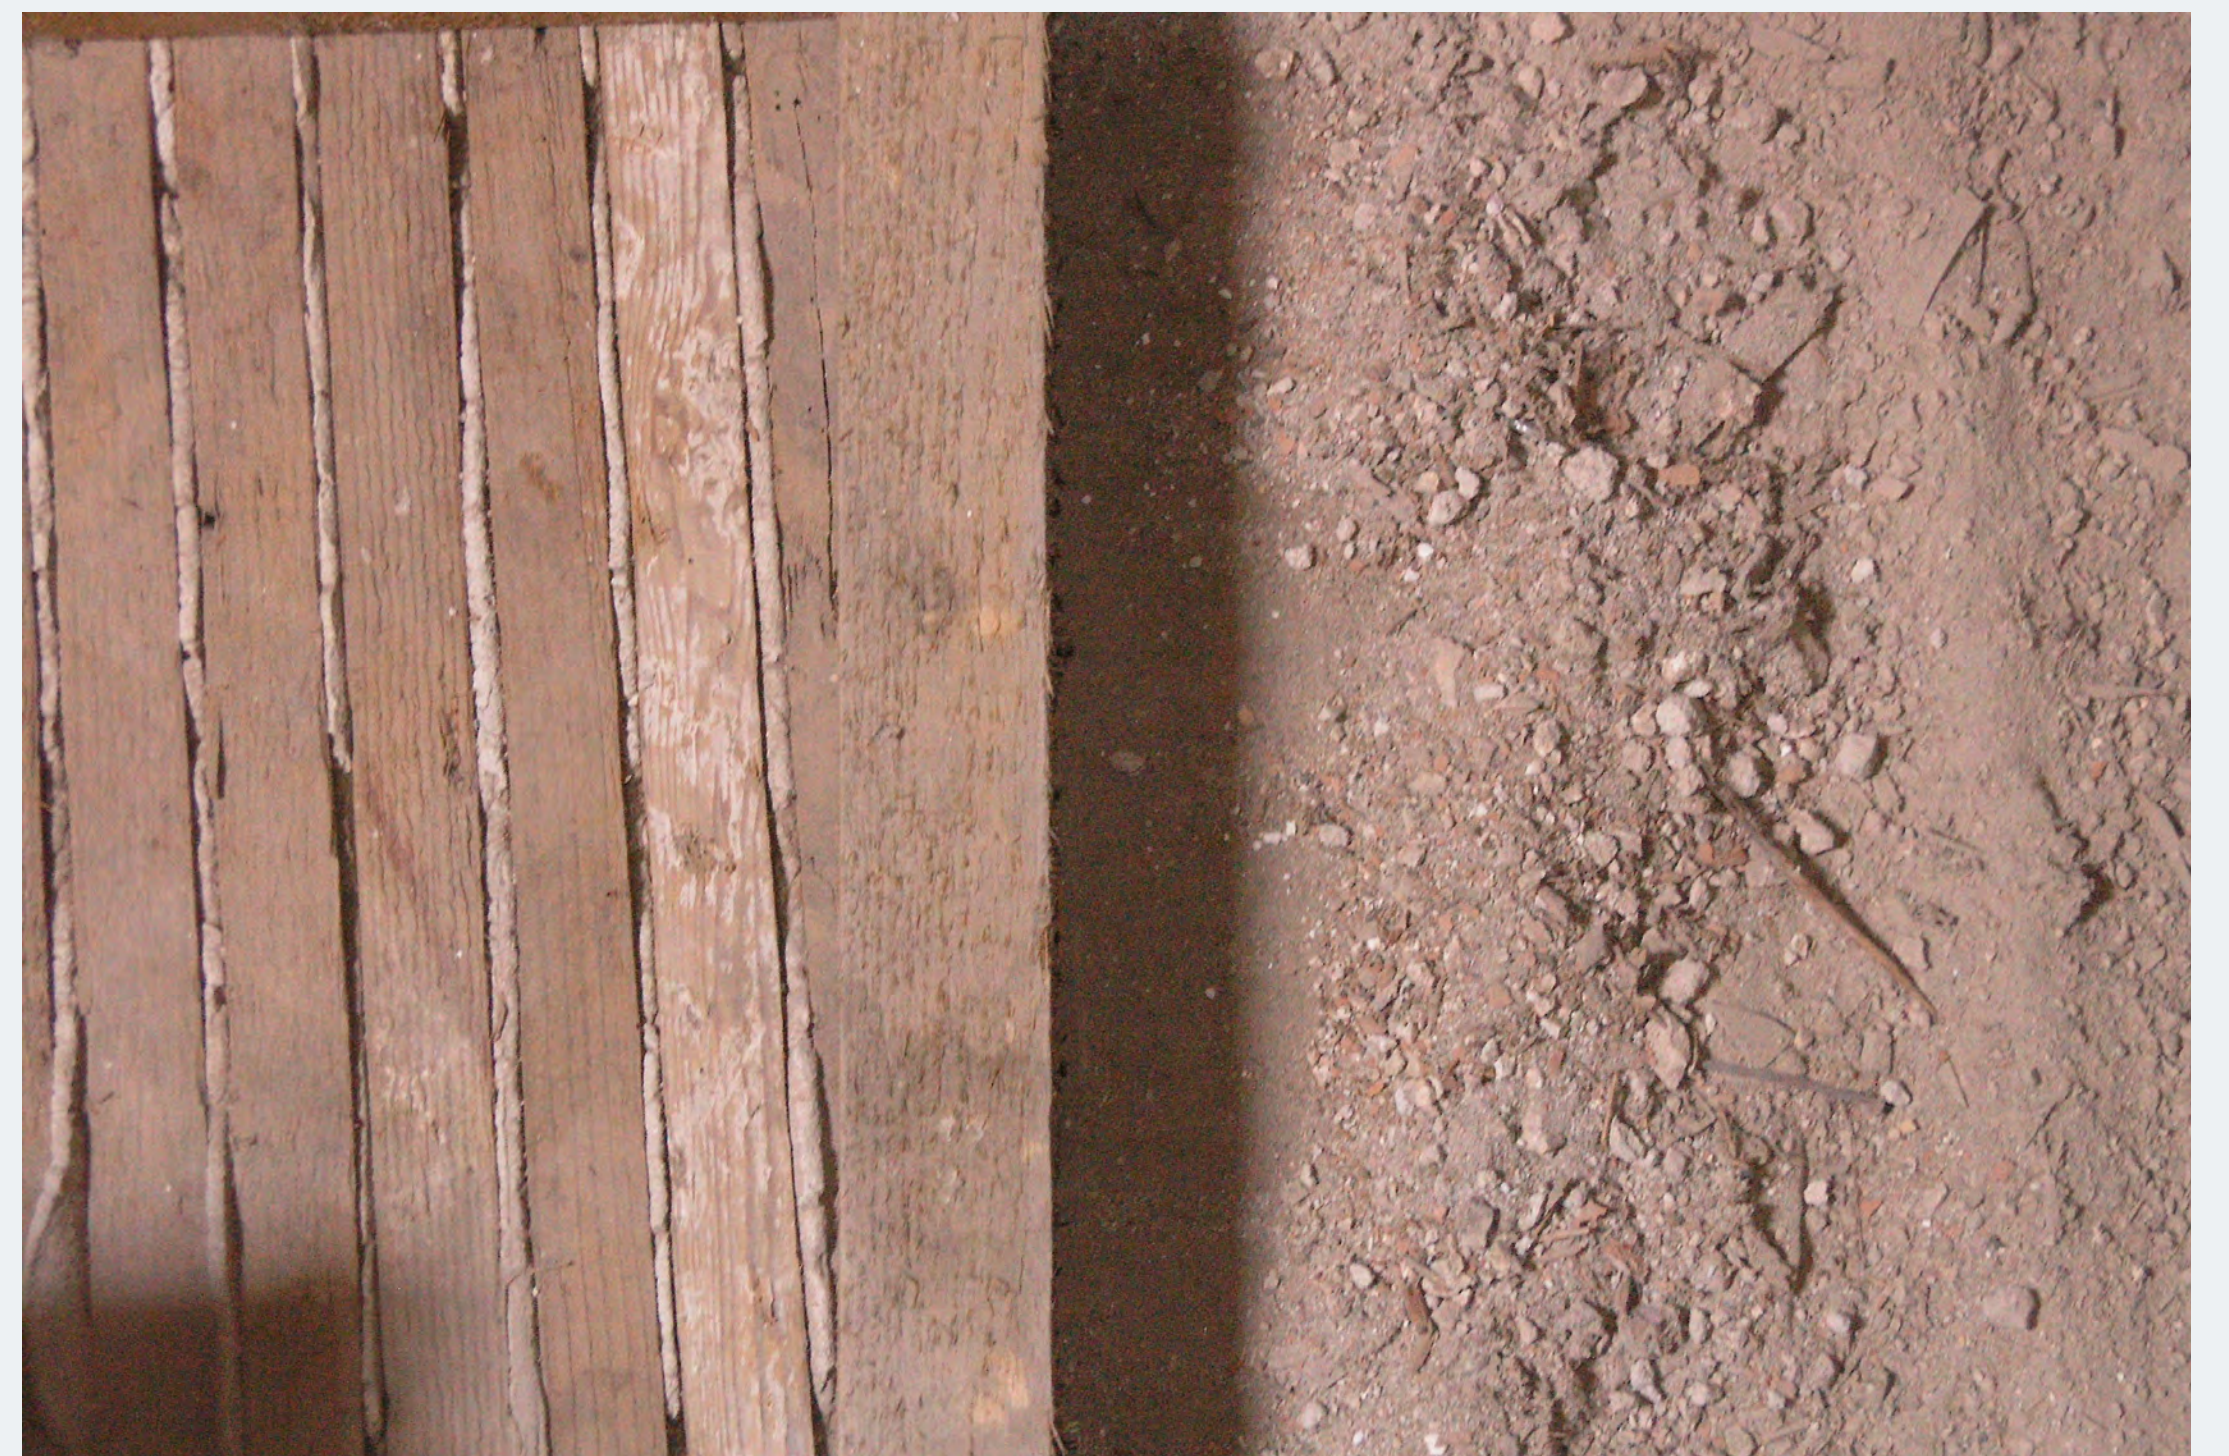
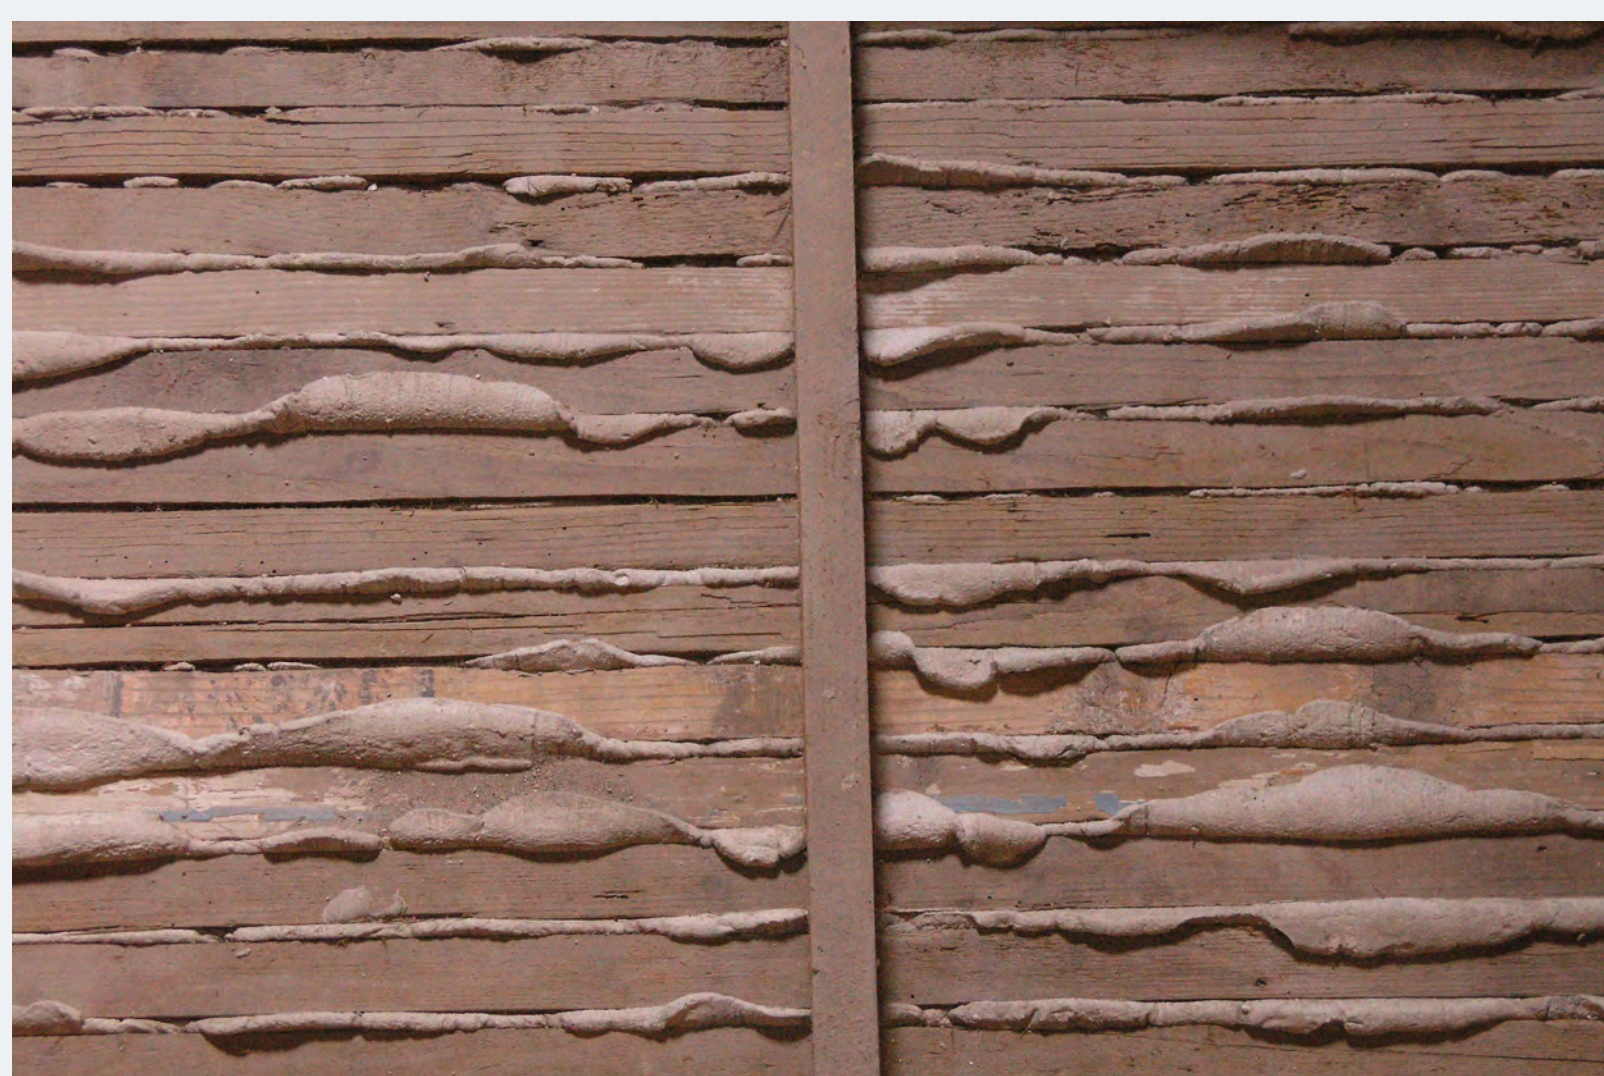
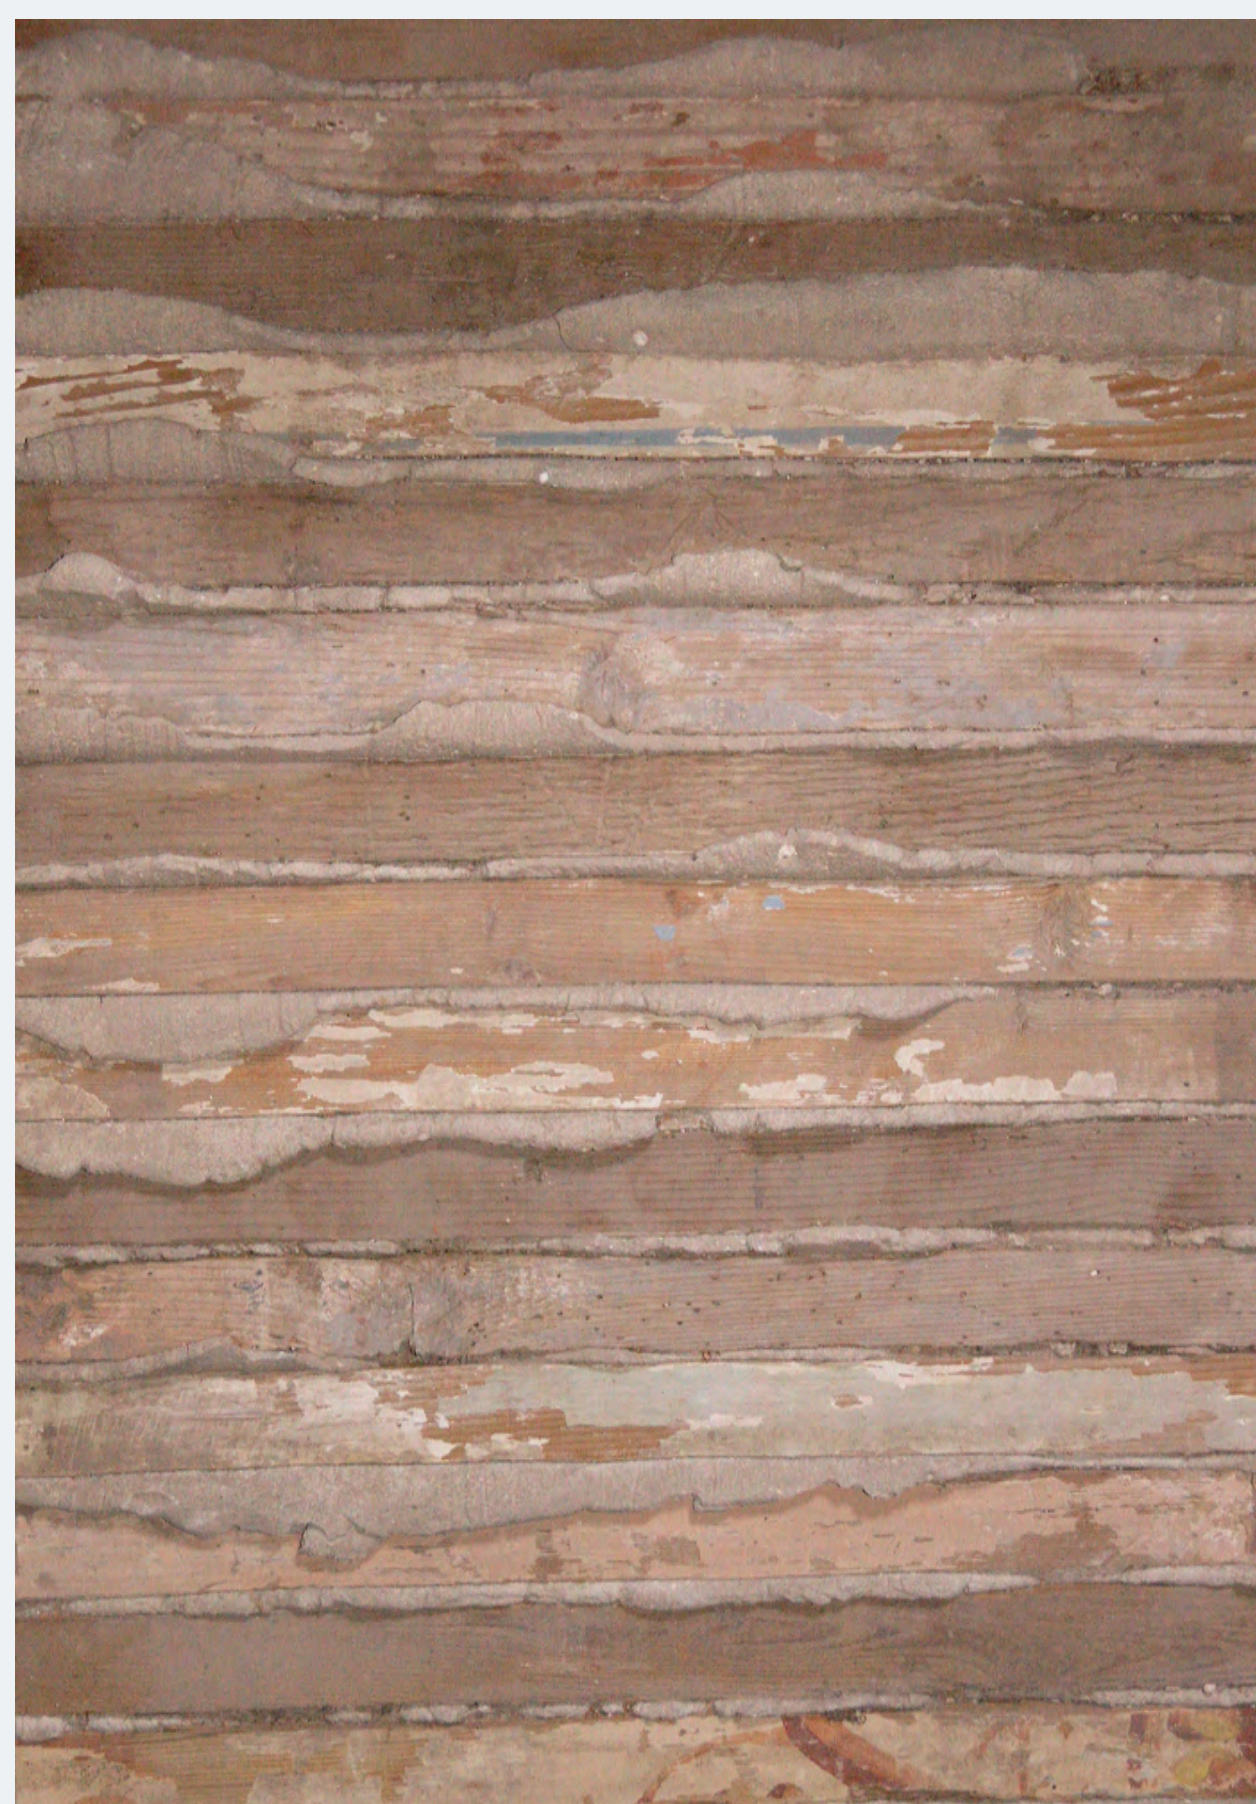
Poledinu drvene stropne konstrukcije svojom je težinom opterećivao 5 cm deo sloj prašine te različitog krupnijeg i sitnijeg otpada koji se je taložio desetljećima. Pri čišćenju prljavštine i otpada s poledine drvenih letvica uočeni su ostaci slikanog sloja. Prema nasumičnom smještaju letvica s oslikom, pretpostavlja se da su prije ugradnje u strop te letvice korištene kao dekoracija nekog drugog sklopa. Nakon čišćenja svi su drveni elementi stropa zaštićeni od daljnjeg propadanja nanošenjem specijalnog insekticidnog i fungicidnog sredstva, a na poledini je provedena impregnacija žbuke radi boljeg prijanjanja uz stropnu konstrukciju.

The back of the wooden ceiling construction was additionally burdened with a 5-cm-thick layer of dust and a variety of coarse and fine debris which had deposited over the decades. When cleaning the dust and debris from the back of the wooden lattices, the remains of a painted layer were noticed. Given the random distribution of the lattices that contained the painted coat, it was assumed that, prior to their insertion into the ceiling, they were used as decoration for another composition.

Once they were cleaned, all wooden elements of the ceiling were protected from further decay with special insecticide and fungicide, and the plaster on the back was impregnated to improve its adhesion to the ceiling construction.
