## ZATEČENO STANJE

## INITIAL CONDITION

HRVATSKI  
RESTAURATORSKI  
ZAVOD

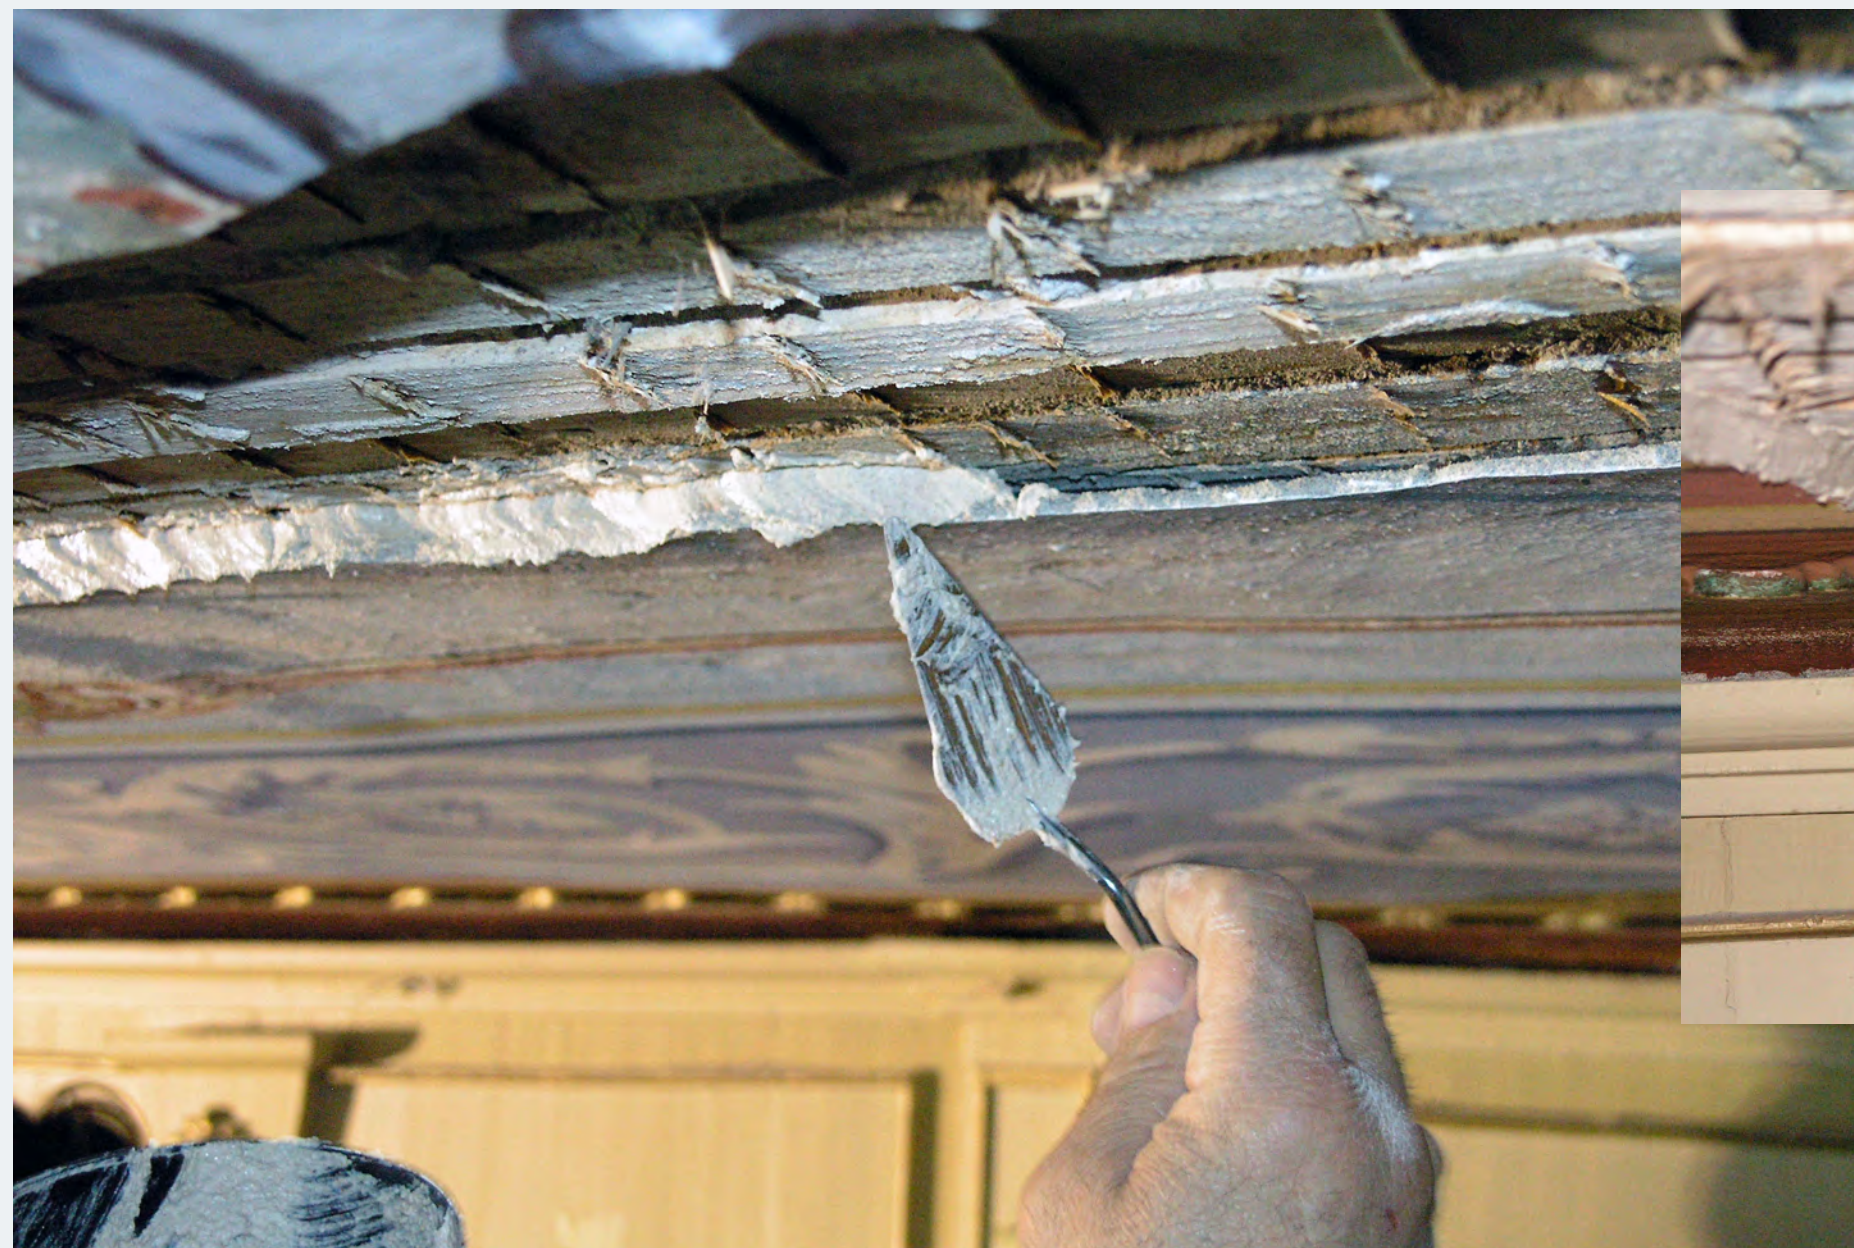
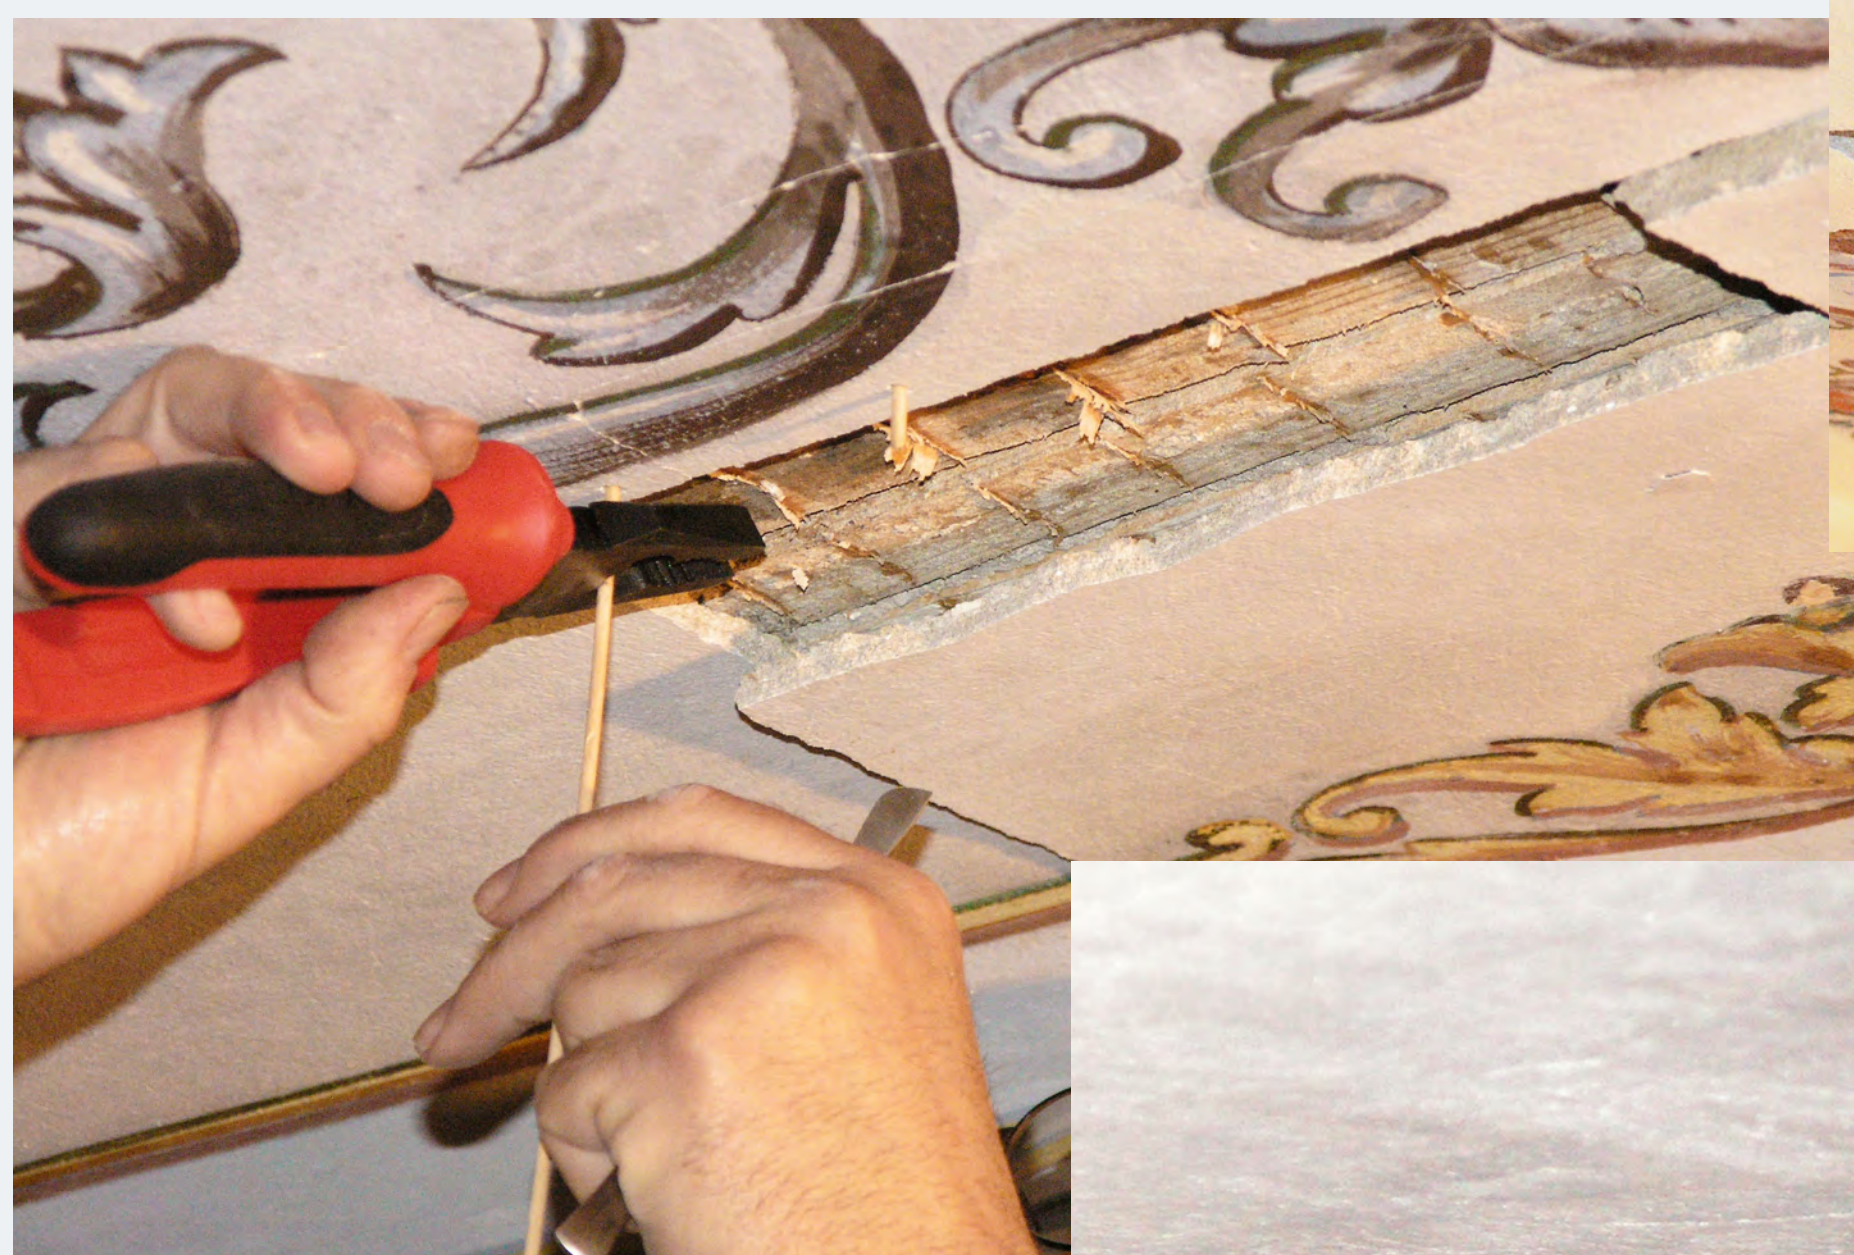
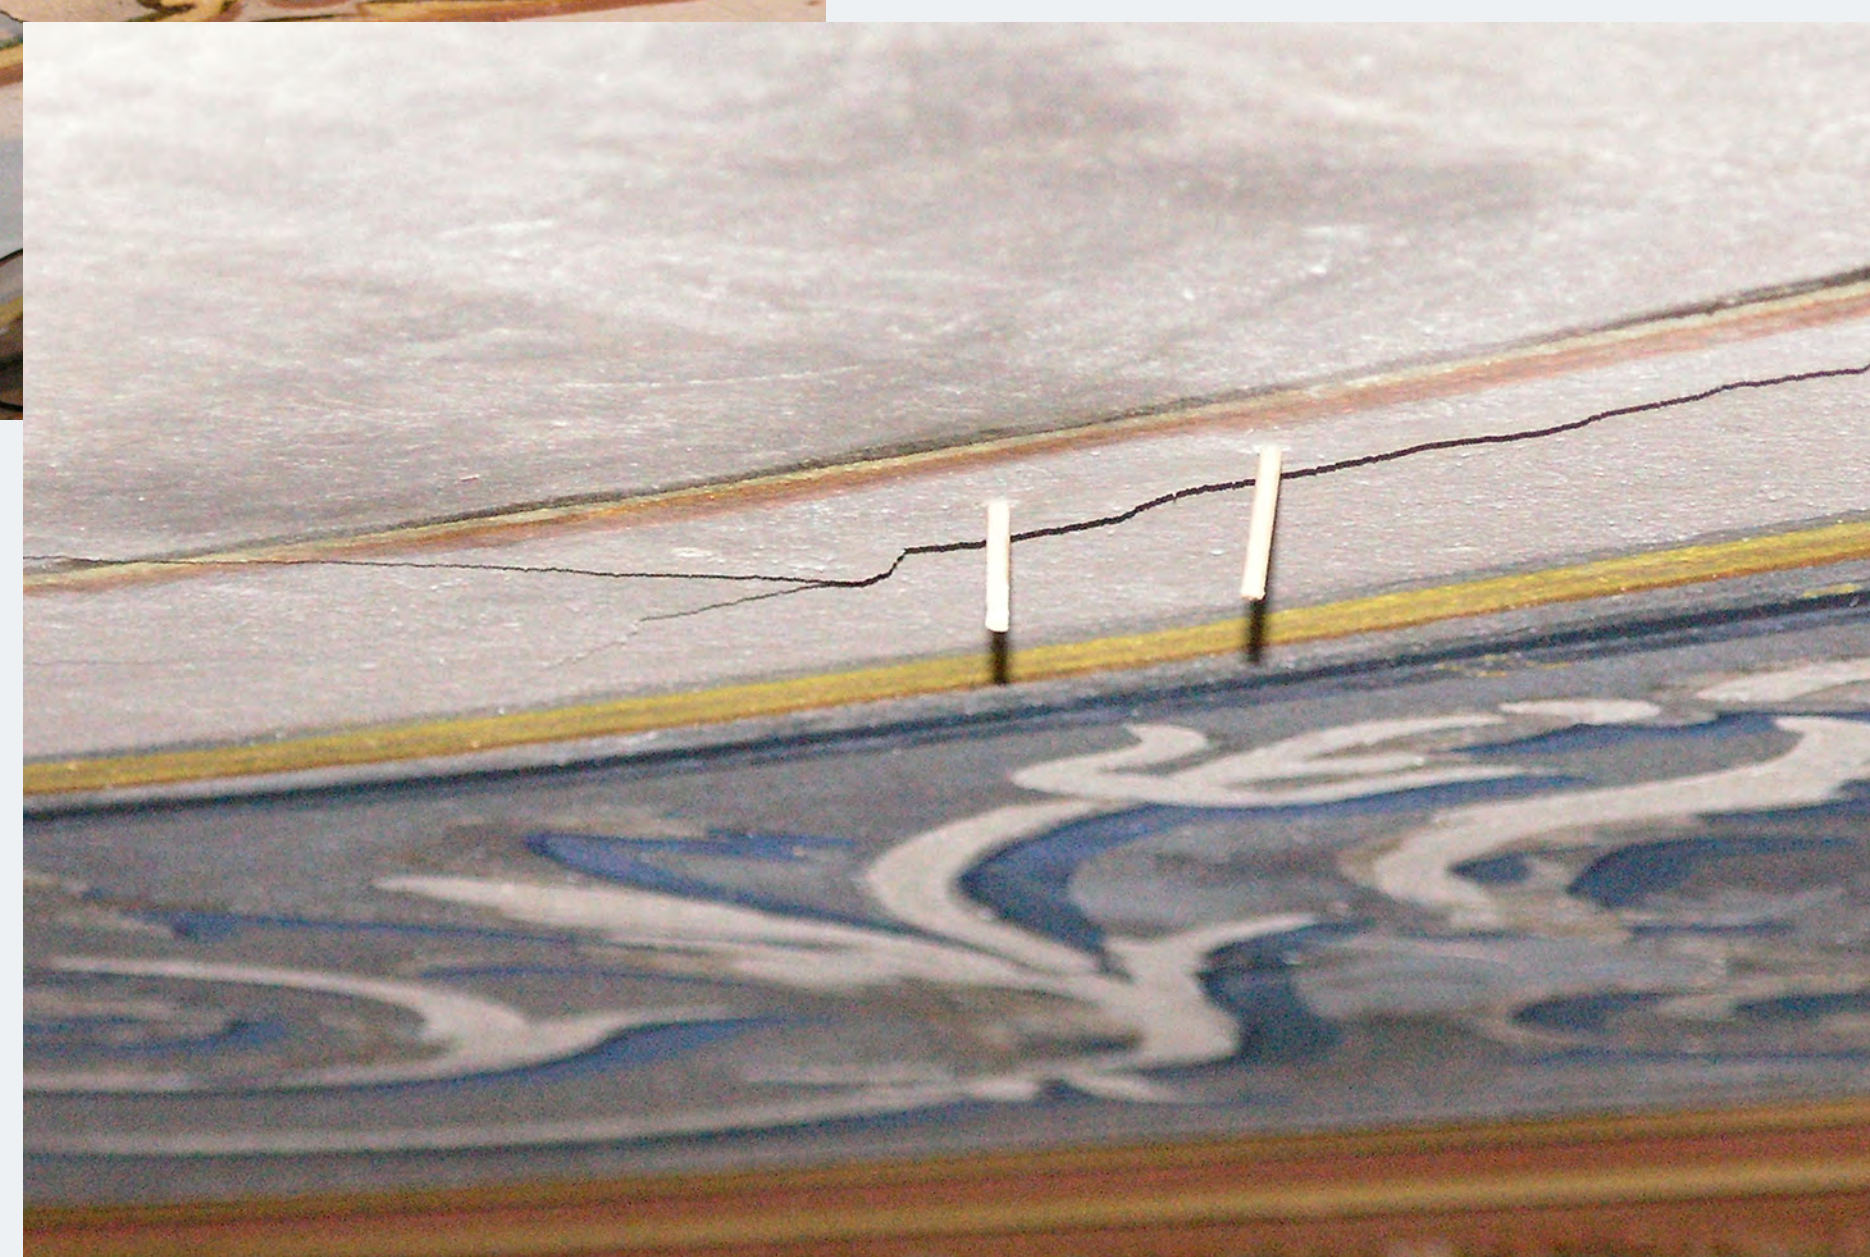
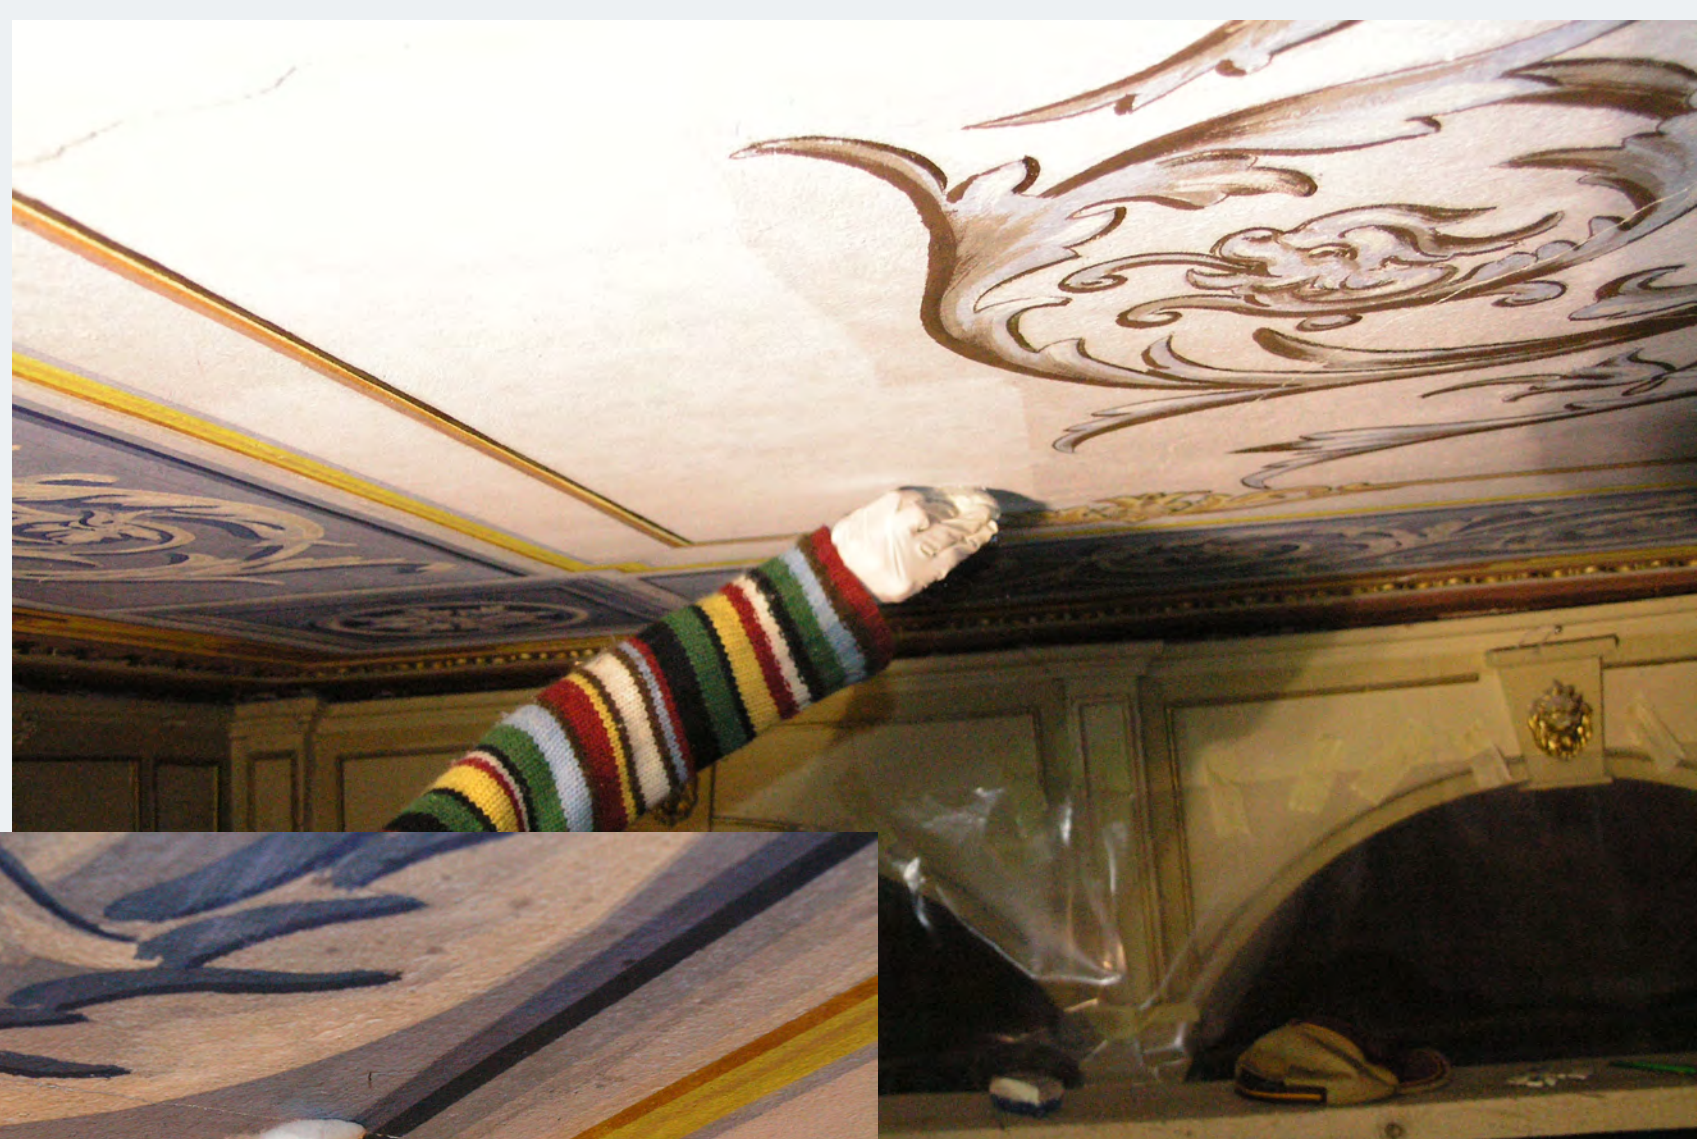
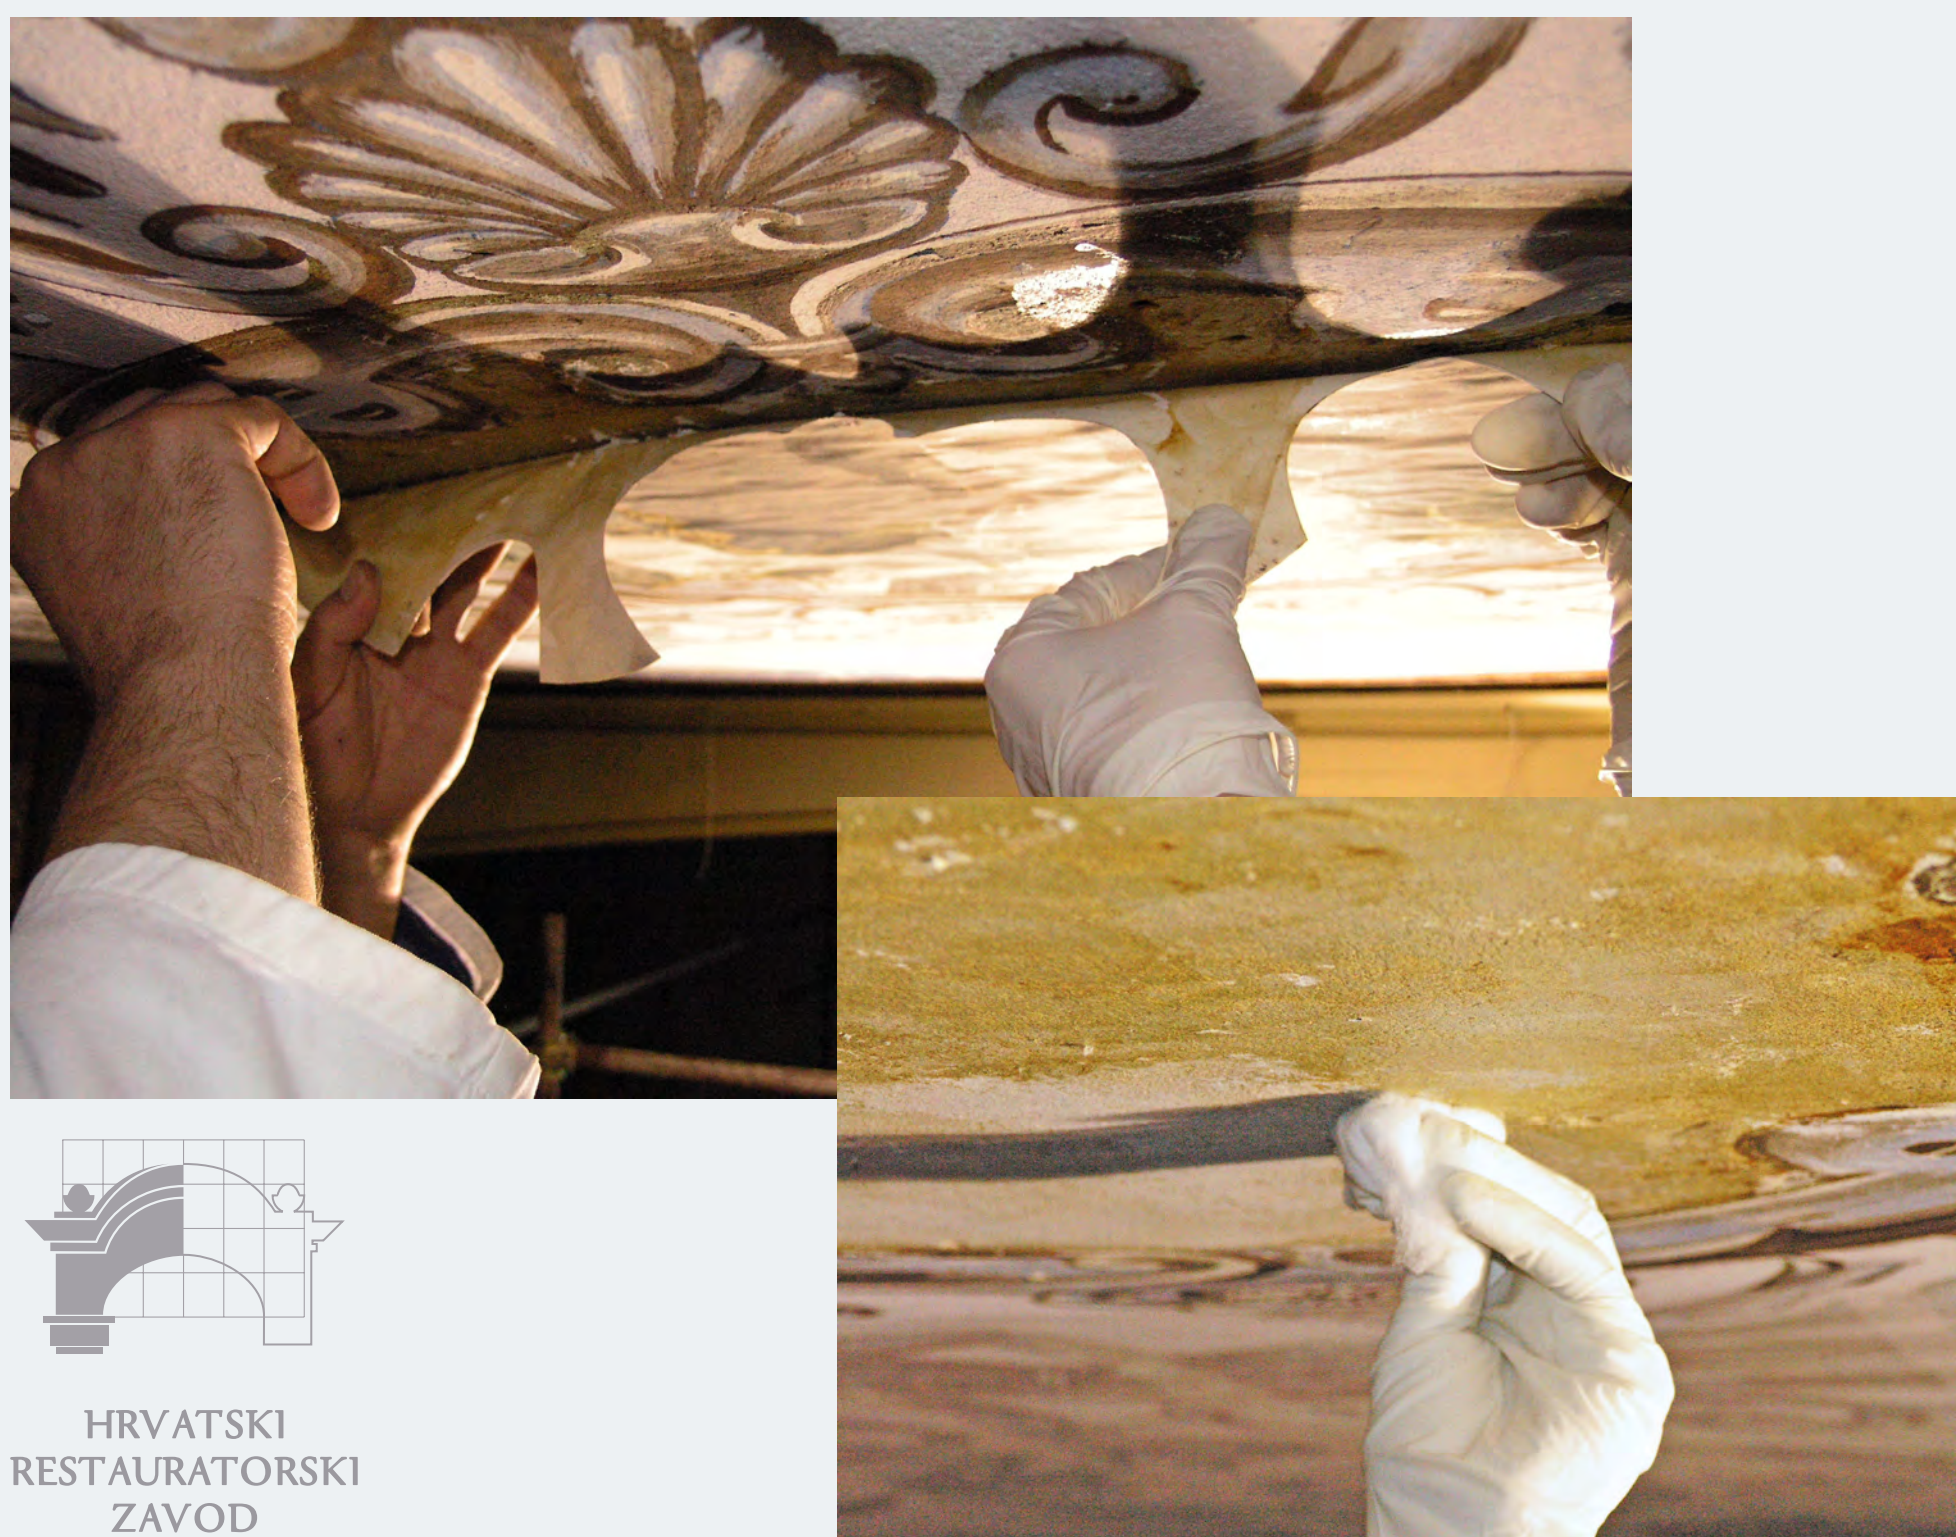
Ljepilo koje je držalo sliku s vremenom je oslabjelo te je slika mjestimično bila potpuno odvojena od stropa, a zbog djelovanja vlage njezina površina namreškana, što je dovoljan razlog za njezino skidanje i prosljeđivanje na restauraciju uspecijaliziranu radionicu.

The adhesive that held the painting had weakened with time, and in some places the painting had completely separated from the ceiling. Due to moisture, its surface was wrinkled, providing us with sufficient reason to pull the painting down and forward it to a specialized workshop for restoration.

Konsolidaciju čini niz složenih restauratorskih postupaka kojima se tretira žbuka i slikani sloj da bi se ponovno uspostavila njihova izgubljena izvorna svojstva i u najvećoj mogućoj mjeri uklonili i zaustavili uznapredovali procesi propadanja na njima. S tim ciljem sve nestabilne dijelove žbuke i slikanog sloja potrebno je učvrstiti i ojačati da bi se spriječilo njihovo daljnje oštećivanje te se omogućilo nesmetano provođenje ostalih restauratorskih zahvata na umjetnini. Područja na kojima je zamijećeno odvajanje žbuke od drvenih letvica stropne konstrukcije stabilizirana su umetanjem drvenih štapića kao poveznice žbuke i stropne konstrukcije. Rubovi lakuna i velikih dijelova bez žbuke koji su skloniji habanju i fragmentarnom otpadanju obrubljeni su da bi se učvrstili i osigurali. Površinska prljavština s lica slikarije očišćena je kombinacijom kemijskih i mehaničkih metoda čišćenja koje su odabrane na temelju rezultata probi metoda i materijala čišćenja na destabiliziranim dijelovima pojedinih skupina pigmentata.

Consolidation consists of a range of complex conservation procedures that the plaster and painted layer are exposed to with the goal of regaining their lost original features, and removing and stopping, as much as possible, the advanced decaying processes within them. For this reason, all unstable sections of plaster and painted layer need to be strengthened and consolidated, to prevent any further damage and ensure unhindered execution of other conservation and restoration interventions on the artefact. The sections in which the plaster was separated from the wooden lattices of the ceiling construction were stabilized with inserted wooden sticks, which served as a link between the plaster and the ceiling construction. The edges of the lacunae and of the large segments that were left without plaster, which are prone to wear and to falling away in fragments, were reinforced and secured.
