KONZERVATORSKO-RESTAURATORSKI RADOVI NA TREĆEM KATU PALAČE SKOČIBUČIĆ-LUKARIS

CONSERVATION-RESTORATION WORKS ON THE THIRD FLOOR OF THE SKOČIBUČIĆ-LUKARIS

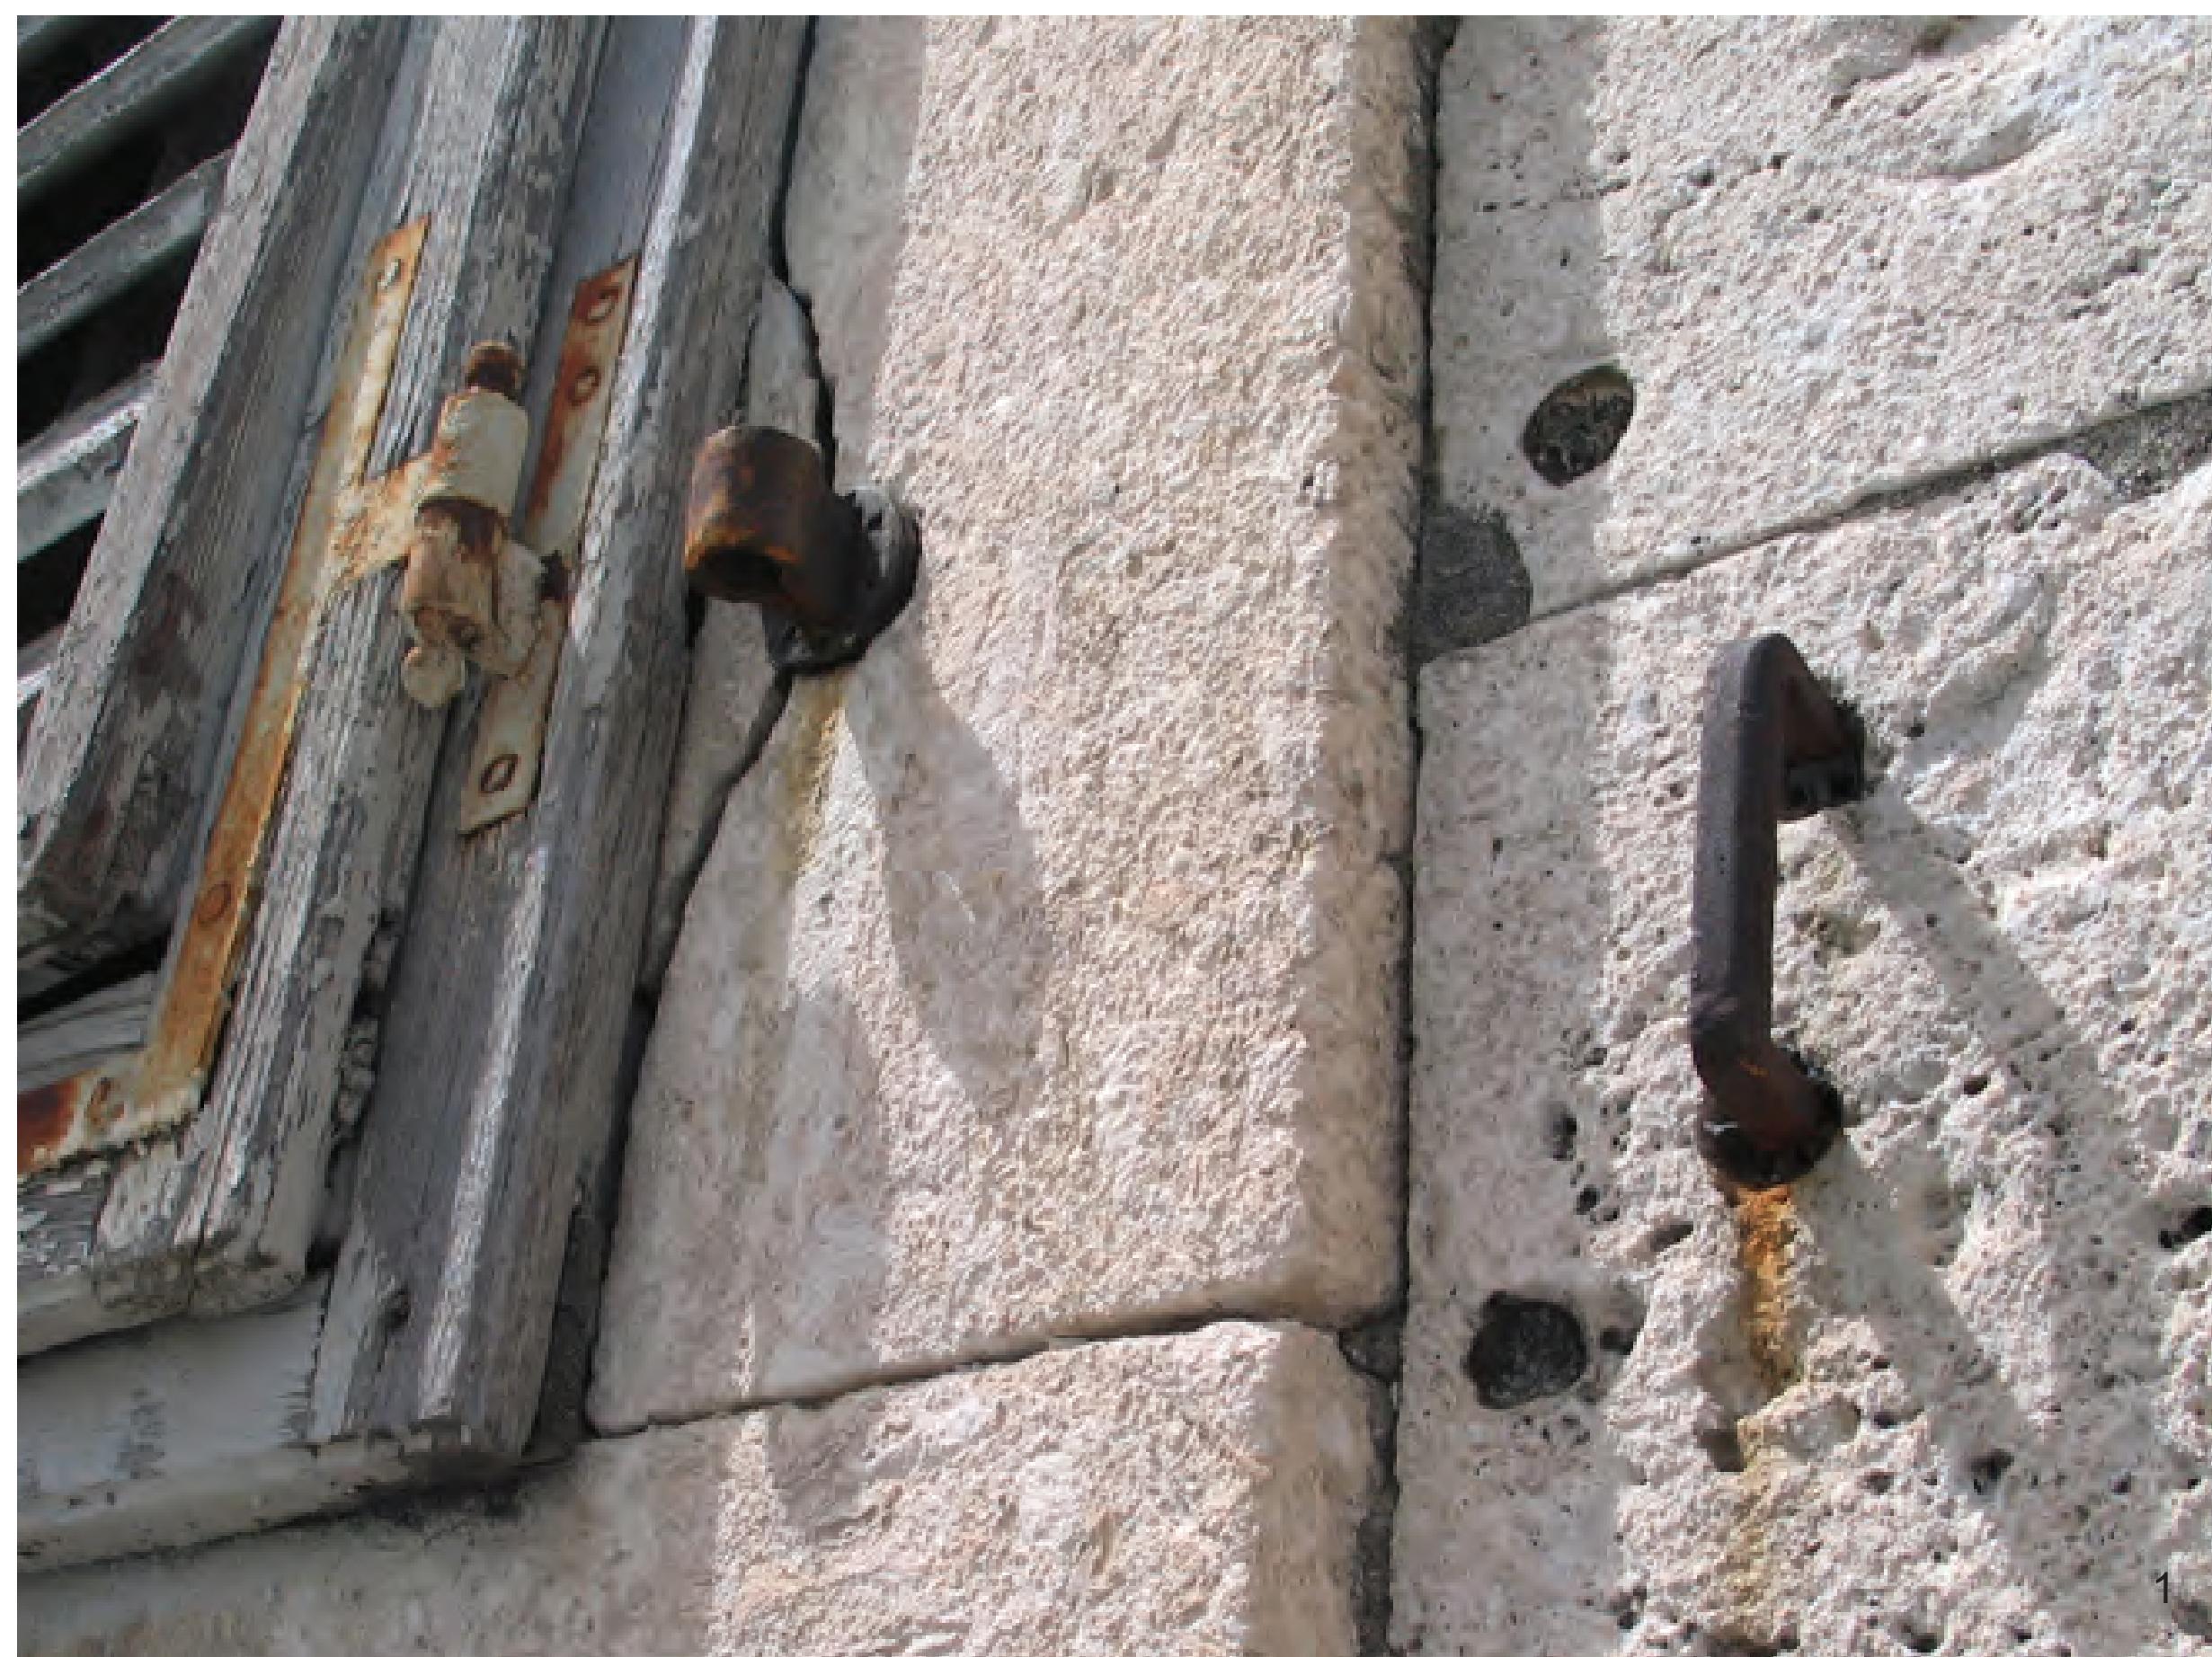
The iron shutter mountings had been anchored into the stone with the traditional technique with molten lead, the role of which was to buffer the dimensional changes of iron brought about by corrosion. The corrosion, however, had in fact led to the stone cracking and breaking off (**Fig. 1**). The iron mountings were taken out, and the unstable parts of the stone were consolidated with the injection of epoxy resin and consolidated.
