# KONZERVATORSKO-RESTAURATORSKI RADOVI NA GORNJEM DIJELU KOLONADE I LUKOVIMA

## CONSERVATION-RESTORATION WORKS ON THE UPPER PART OF THE COLONNADE AND THE ARCHES

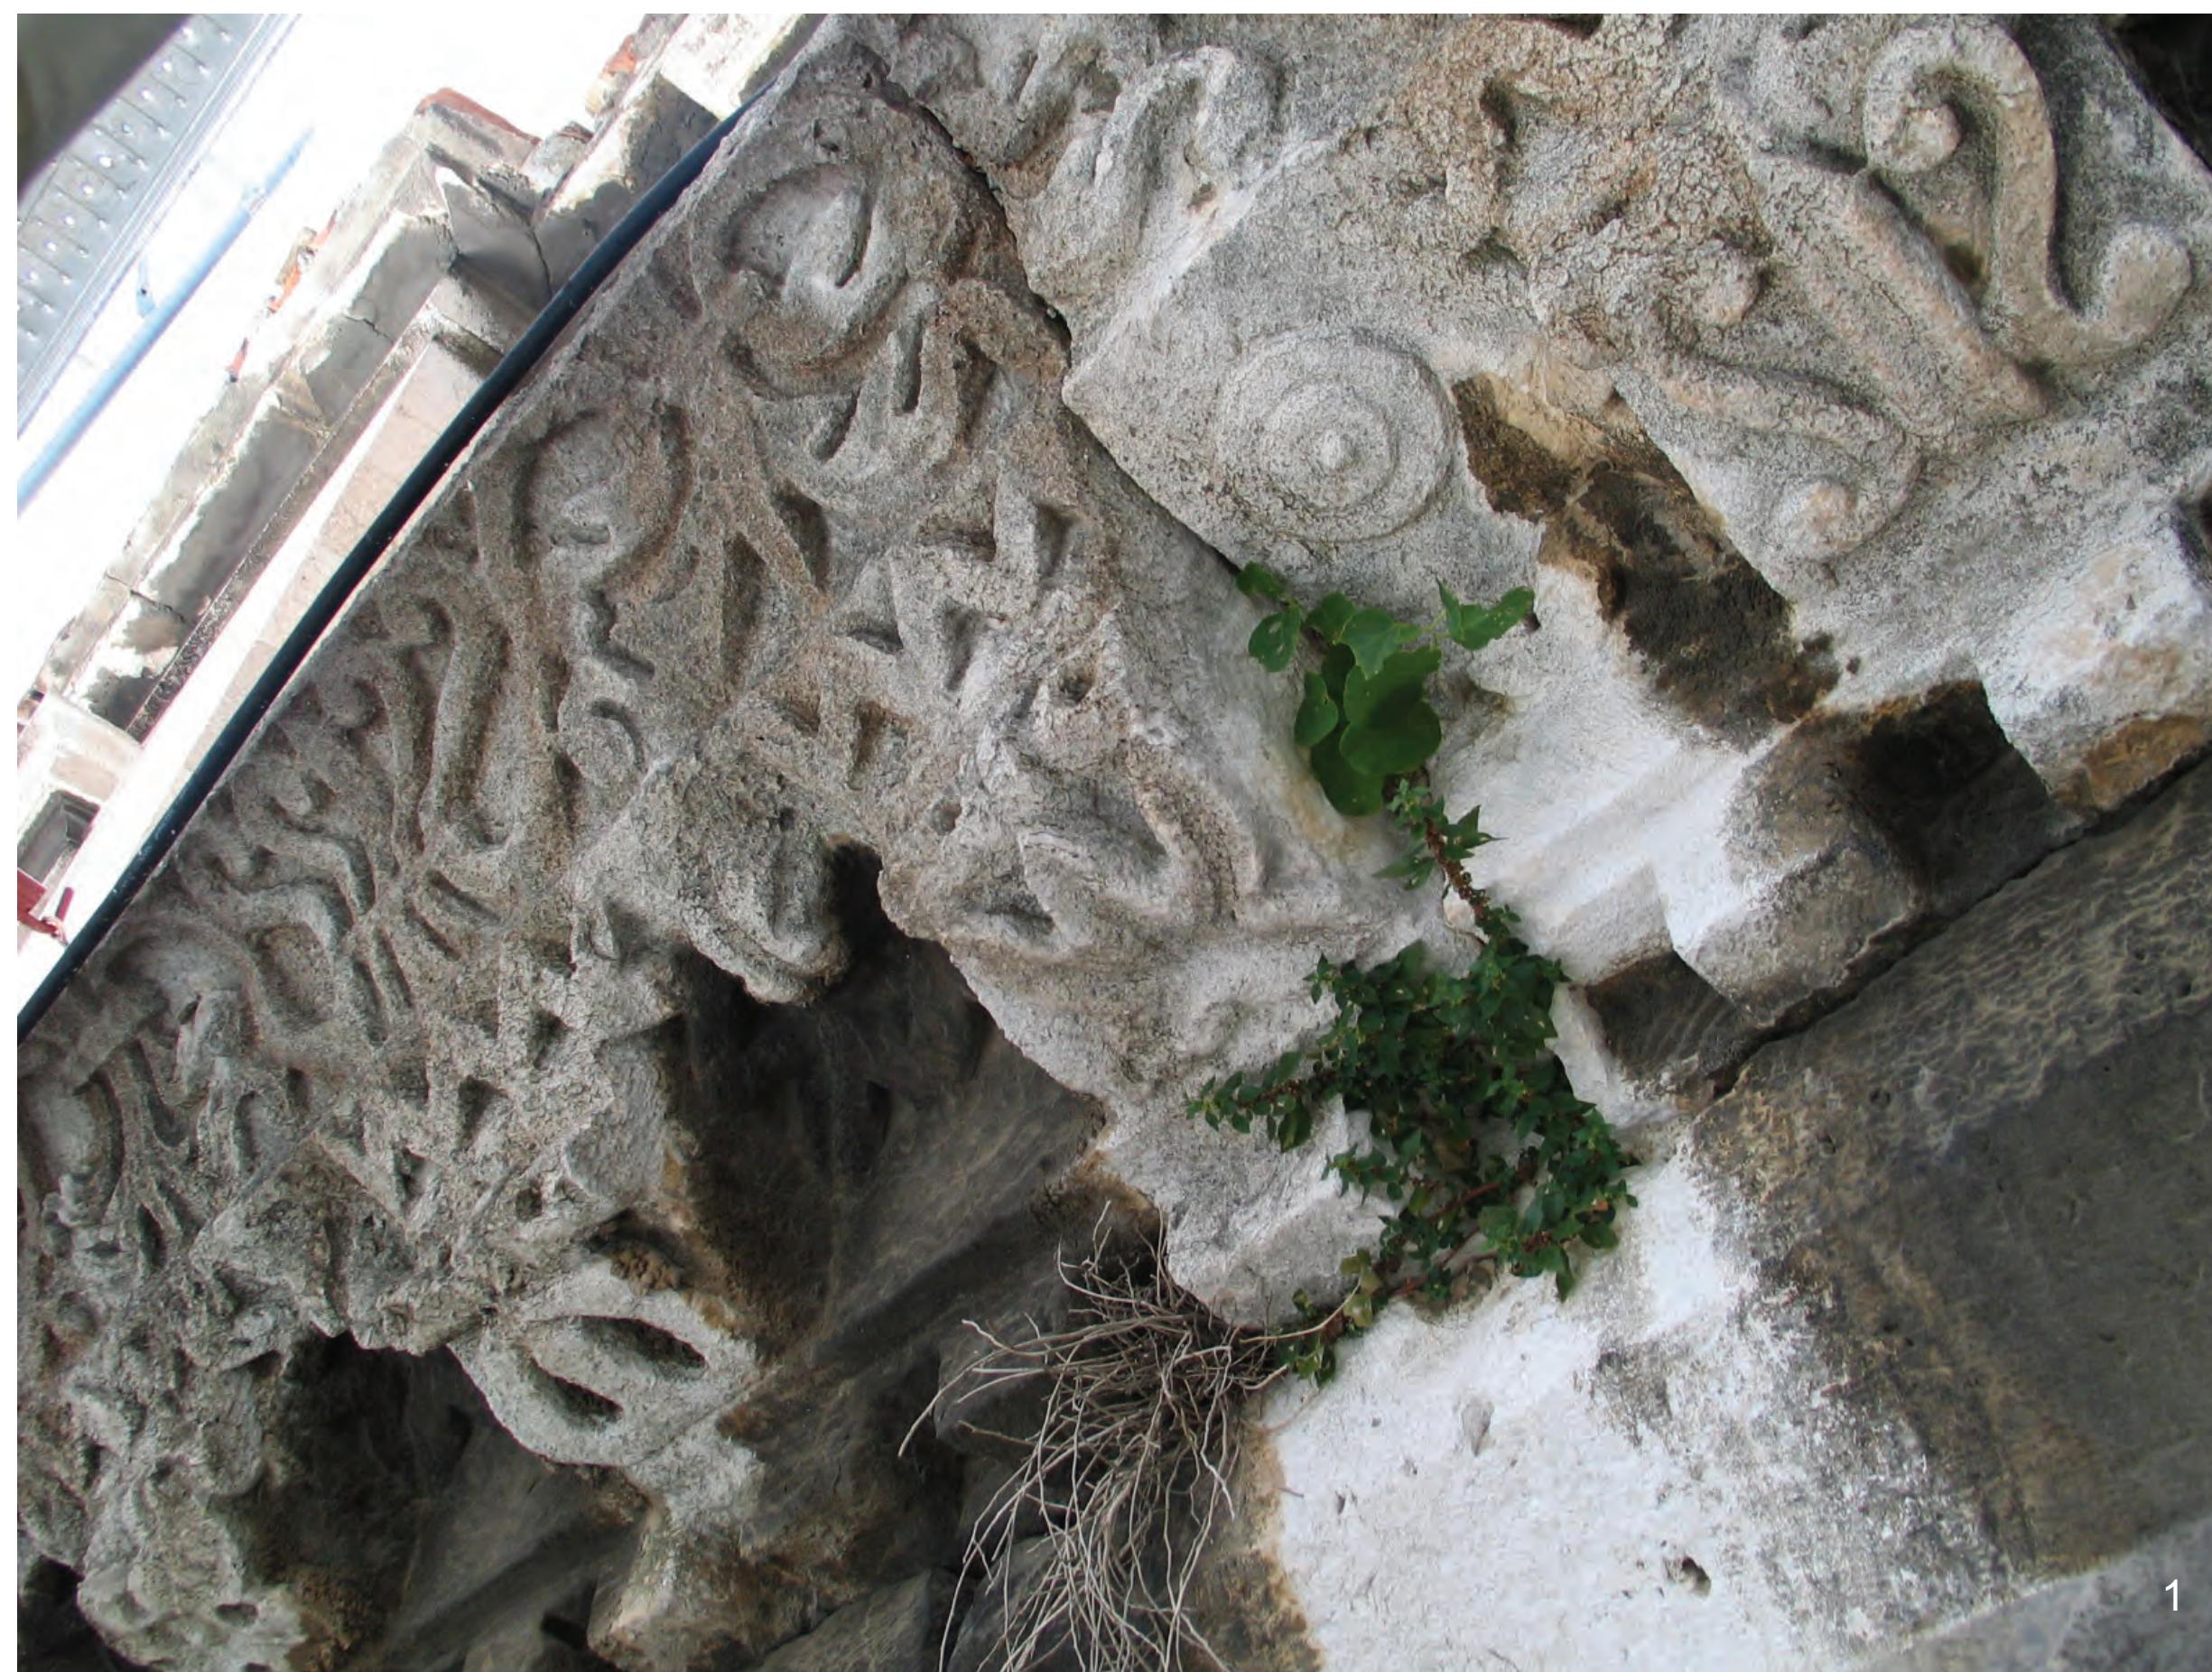
Zbog izloženosti kiši, kamene površine istaknutih dijelova vijenca su erodirane, a fini detalji klesarske obrade potpuno izgubljeni. U sljubnicama između kamenih blokova stanište su pronašle više biljke. Na površinama koje su izložene kiši razvile su se kolonije mikroorganizama, a na onima koje su od kiše zaklonjene formirale su se debele crne kore (SI. 1).

Because of exposure to rain, the stone areas of the protruding parts of the cornice had been eroded, and the fine details of the carving had been totally lost. In the joints between the ashlar, several plants had found habitats. On surfaces exposed to rain, colonies of microorganisms had developed, and on those that were protected from the rain thick black crusts had formed (Fig. 1).
