KONZERVATORSKO-RESTAURATORSKI RADOVI NA BALKONU NA DRUGOM KATU PALAČE

CONSERVATION-RESTORATION WORKS ON THE BALCONY ON THE SECOND FLOOR OF THE PALACE

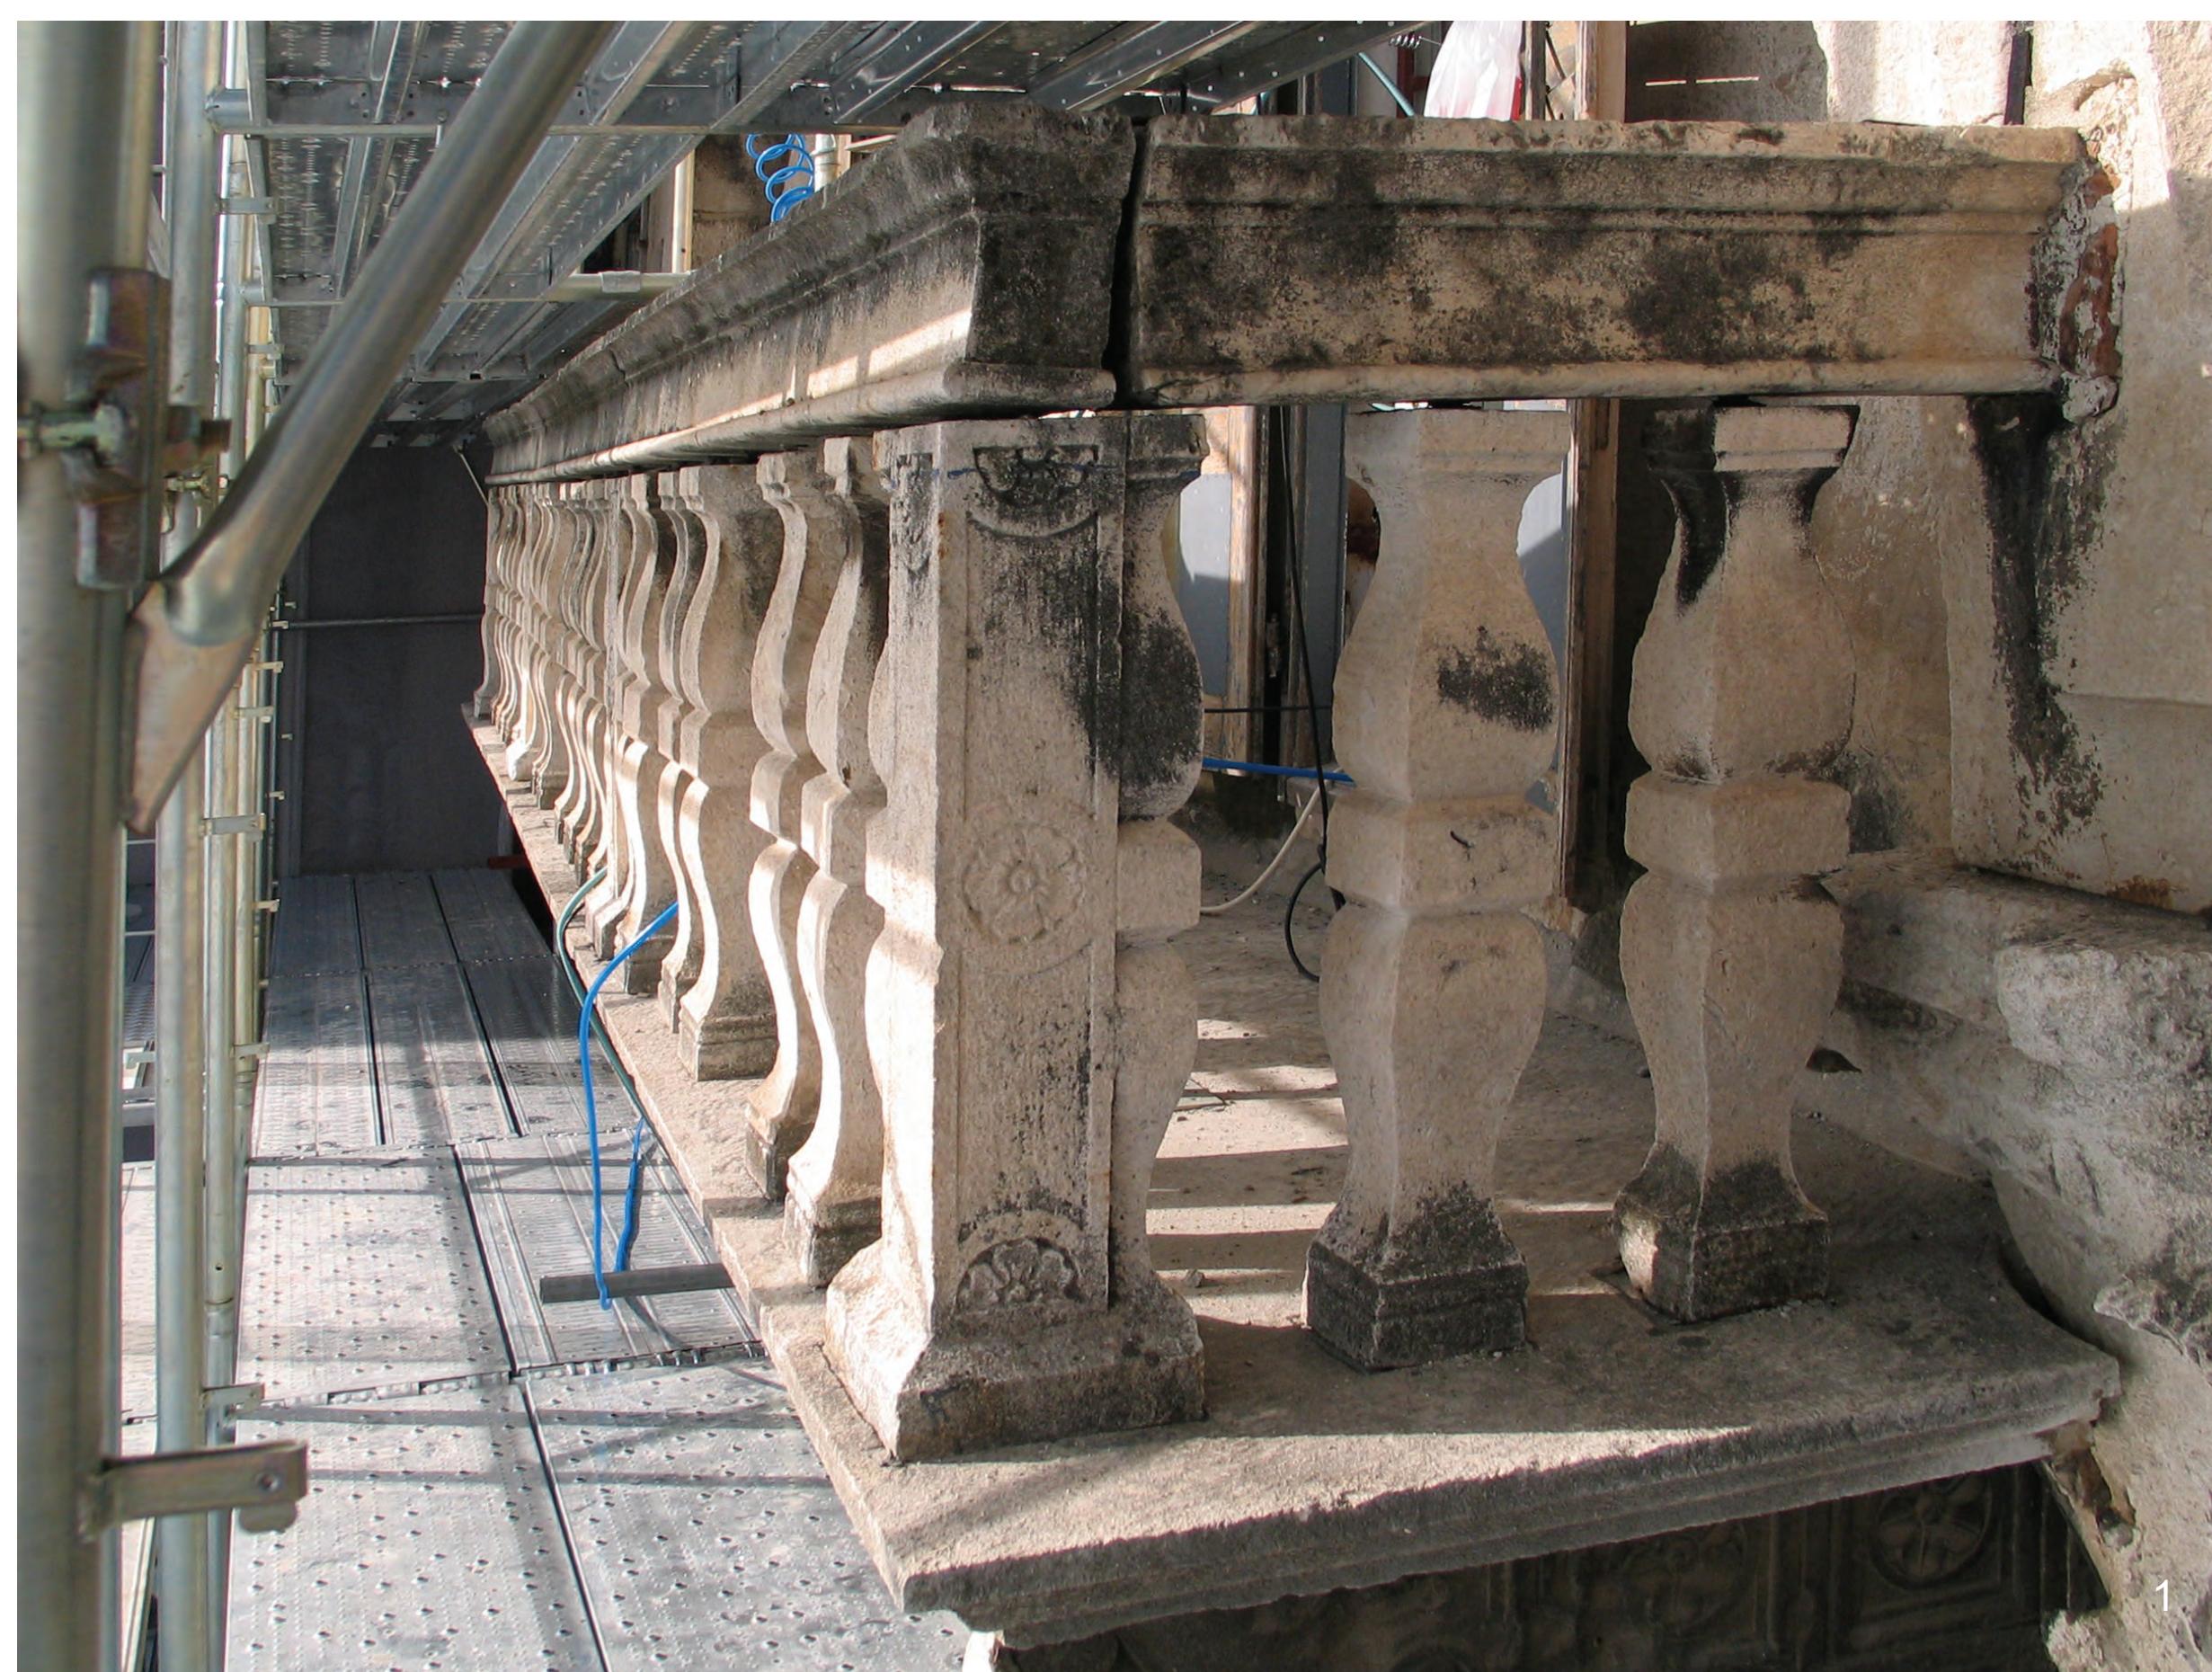
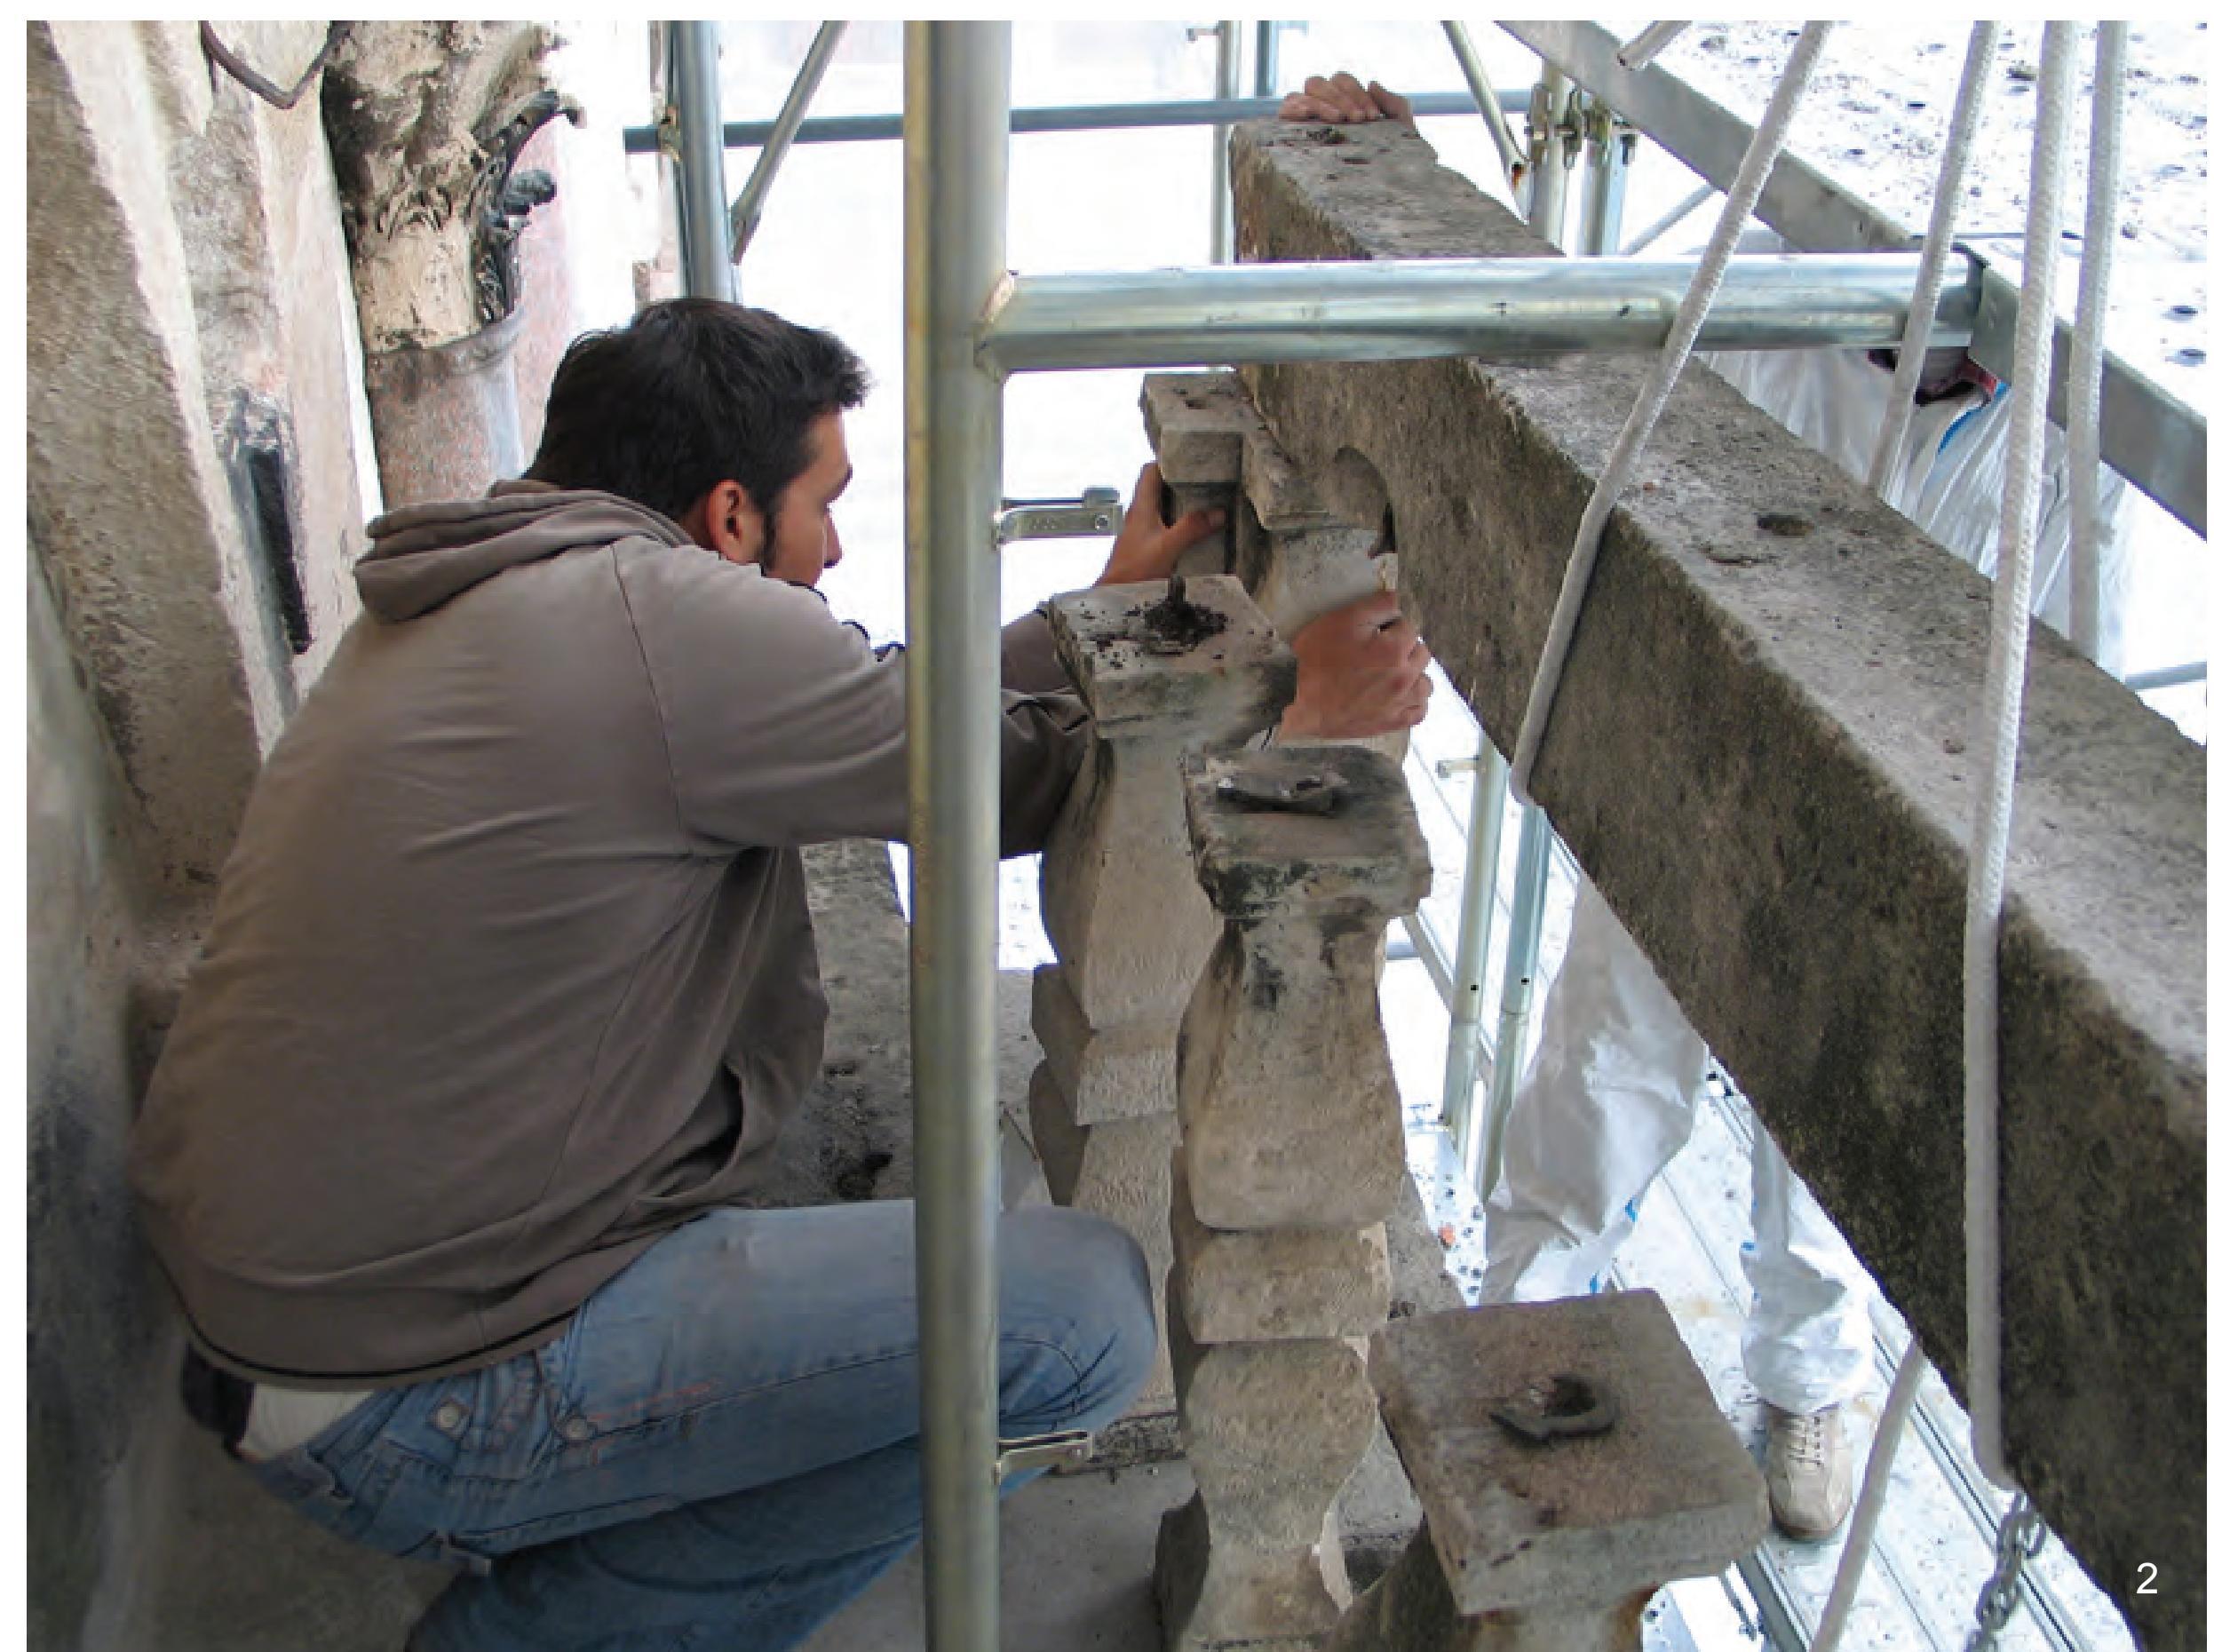
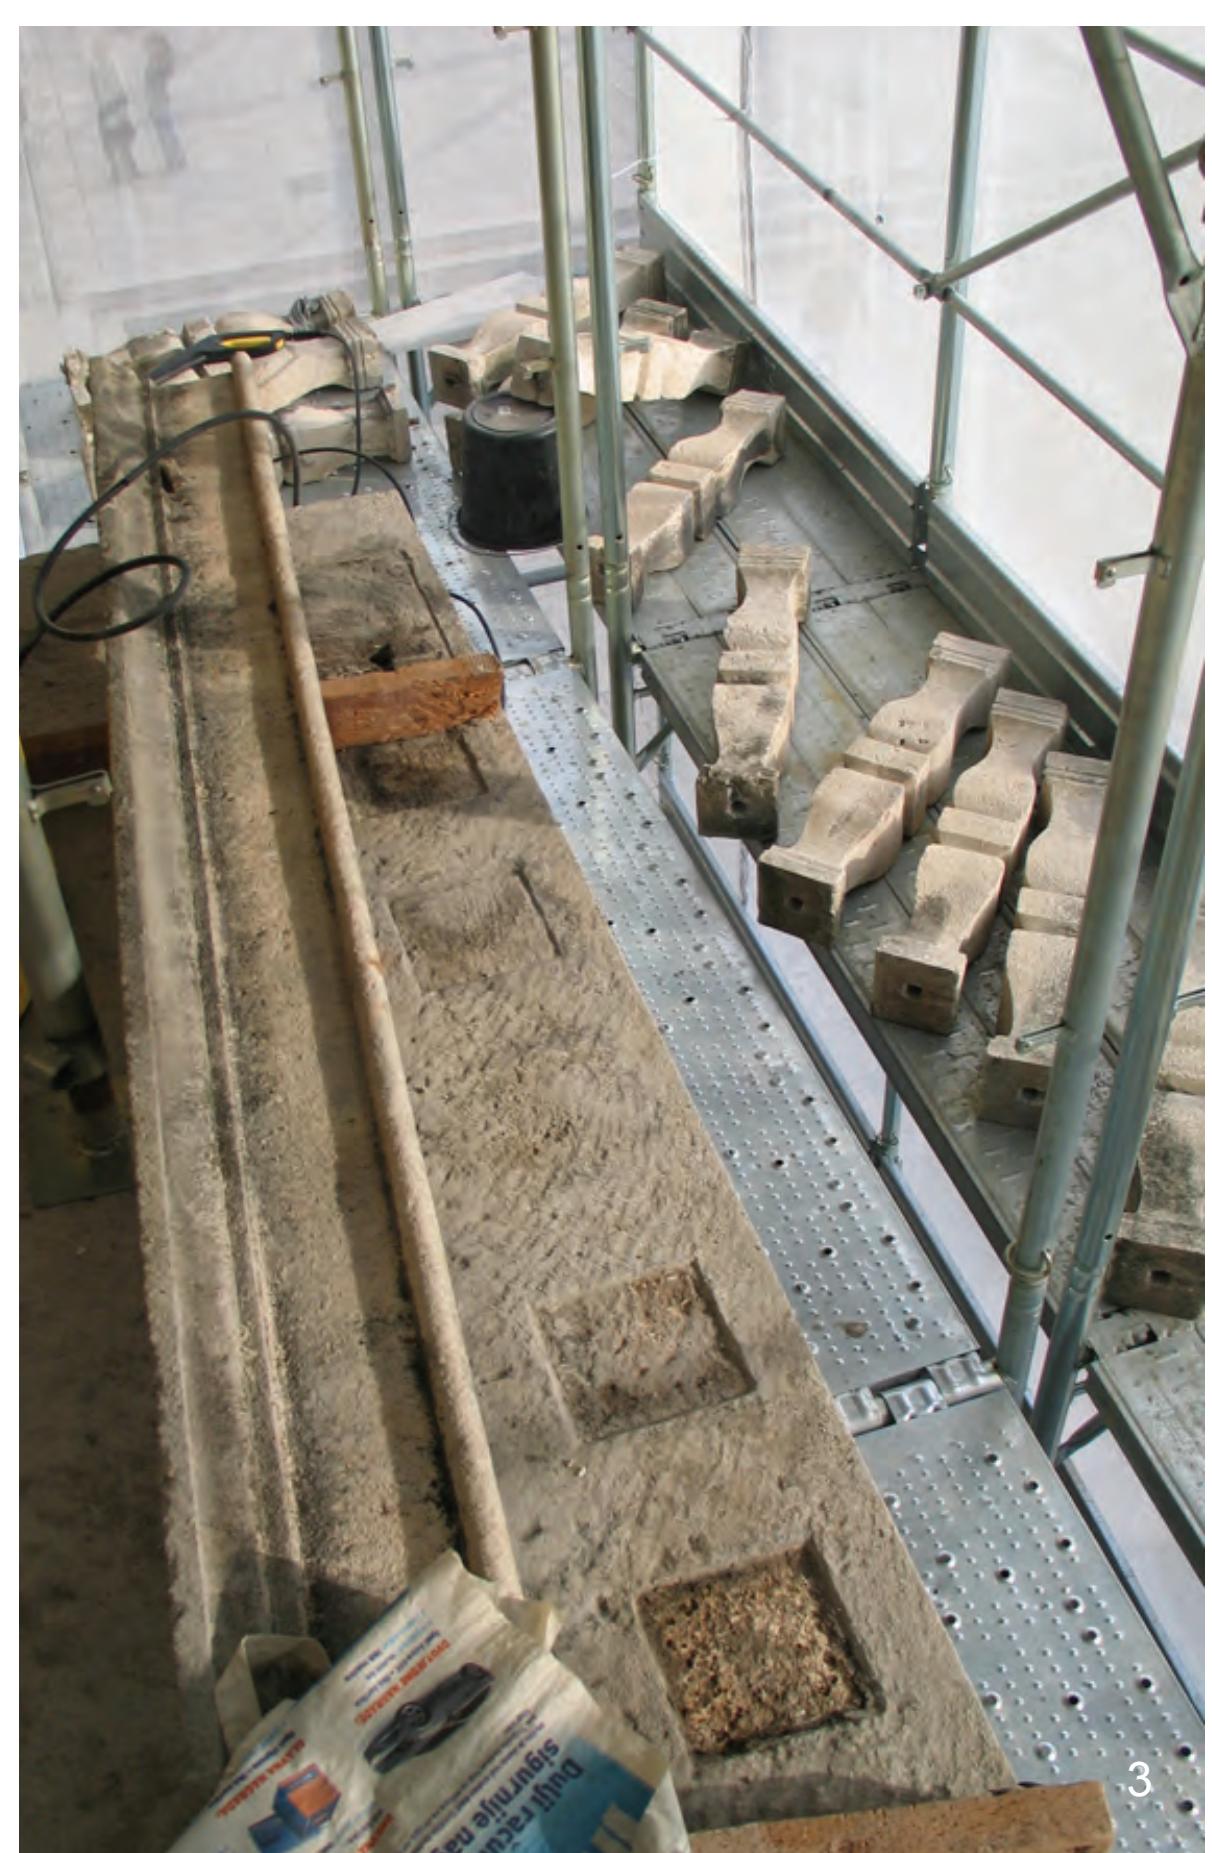
Zbog narušene stabilnosti, većinom zbog djelovanja korozije željeznih kopči i trnova, ograda balkona na drugom katu palače demontirana je i zatim ponovno montirana, što je bio jedan od najsloženijih zahvata ove faze projekta (Sl. 1-3).

Because of the impaired stability, mostly resulting from the corrosion of the iron clamps and bars, the railing of the balcony on the second floor of the palace was disassembled and then assembled again, which was one of the more complex operations of this phase of the project (Fig. 1-3).
