KONZERVATORSKO-RESTAURATORSKI RADOVI NA BALKONU NA DRUGOM KATU PALAČE

CONSERVATION-RESTORATION WORKS ON THE BALCONY ON THE SECOND FLOOR OF THE PALACE

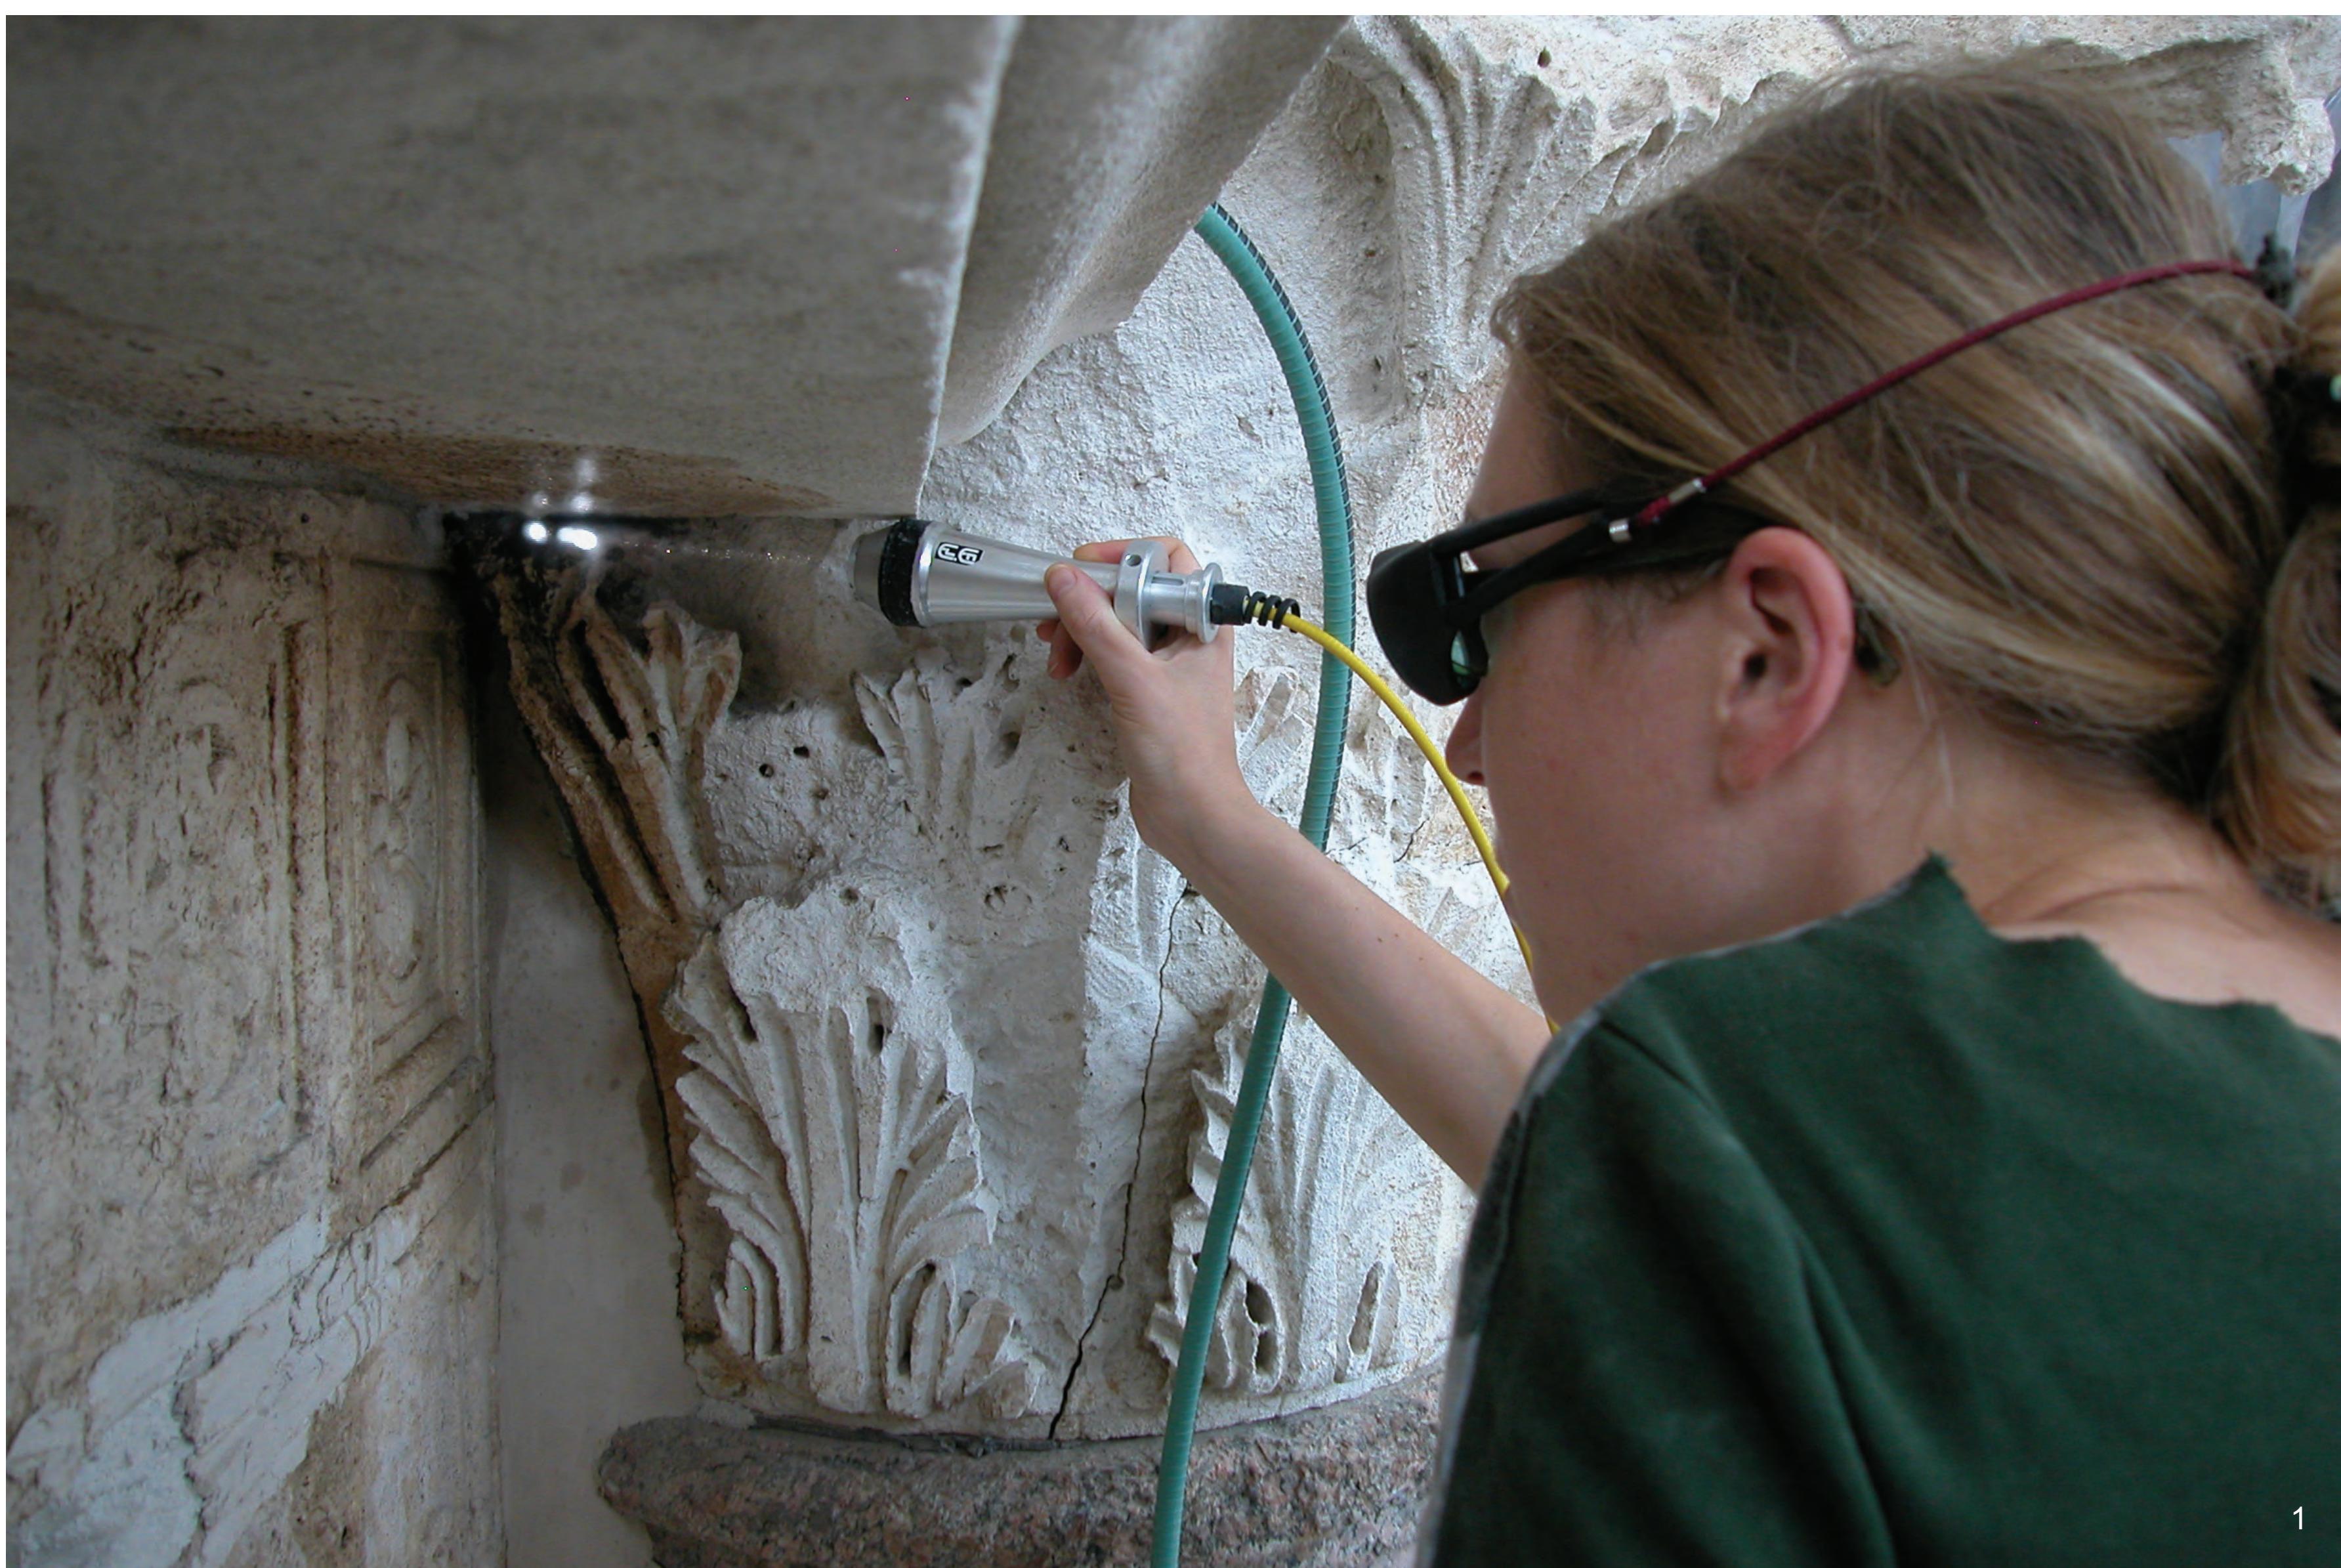
Usporedo s ovim zahvatom, metodom laserskog čišćenja su odstranjene crne kore i druge tamne presvlake sa četiriju konzola i donje strane podnice balkona (Sl. 1-5). Zbog razvedenosti površine kamenih elemenata i velike debljine kora, lasersko je čišćenje ponovno bilo jedan od najzahtjevnijih i najdugotrajnijih zahvata. Naime, promjer laserske zrake iznosi svega 1,5 mm, a kod debljih je onečišćenja redovito potrebno više udaraca zrake za odstranjivanje nepoželjnih slojeva.

At the same time as this operation, laser cleaning was removing the dark crusts and other dark coatings from the four corbels and the lower side of the floor of the balcony (Fig. 1-5). Because of the highly indented surface of the stone elements and the great thickness of crust, laser cleaning was once again one of the most demanding and time-consuming operations. The diameter of a laser beam is no more than 1.5 mm, and in the case of thicker soiling several blasts of the beam would regularly be needed to dislodge the unwanted layers.
