KONZERVATORSKO-RESTAURATORSKI RADOVI NA PRVOM KATU PALAČE I ŽBUKAMA

CONSERVATION-RESTORATION WORKS ON THE FIRST FLOOR OF THE PALACE AND ON THE PLASTER

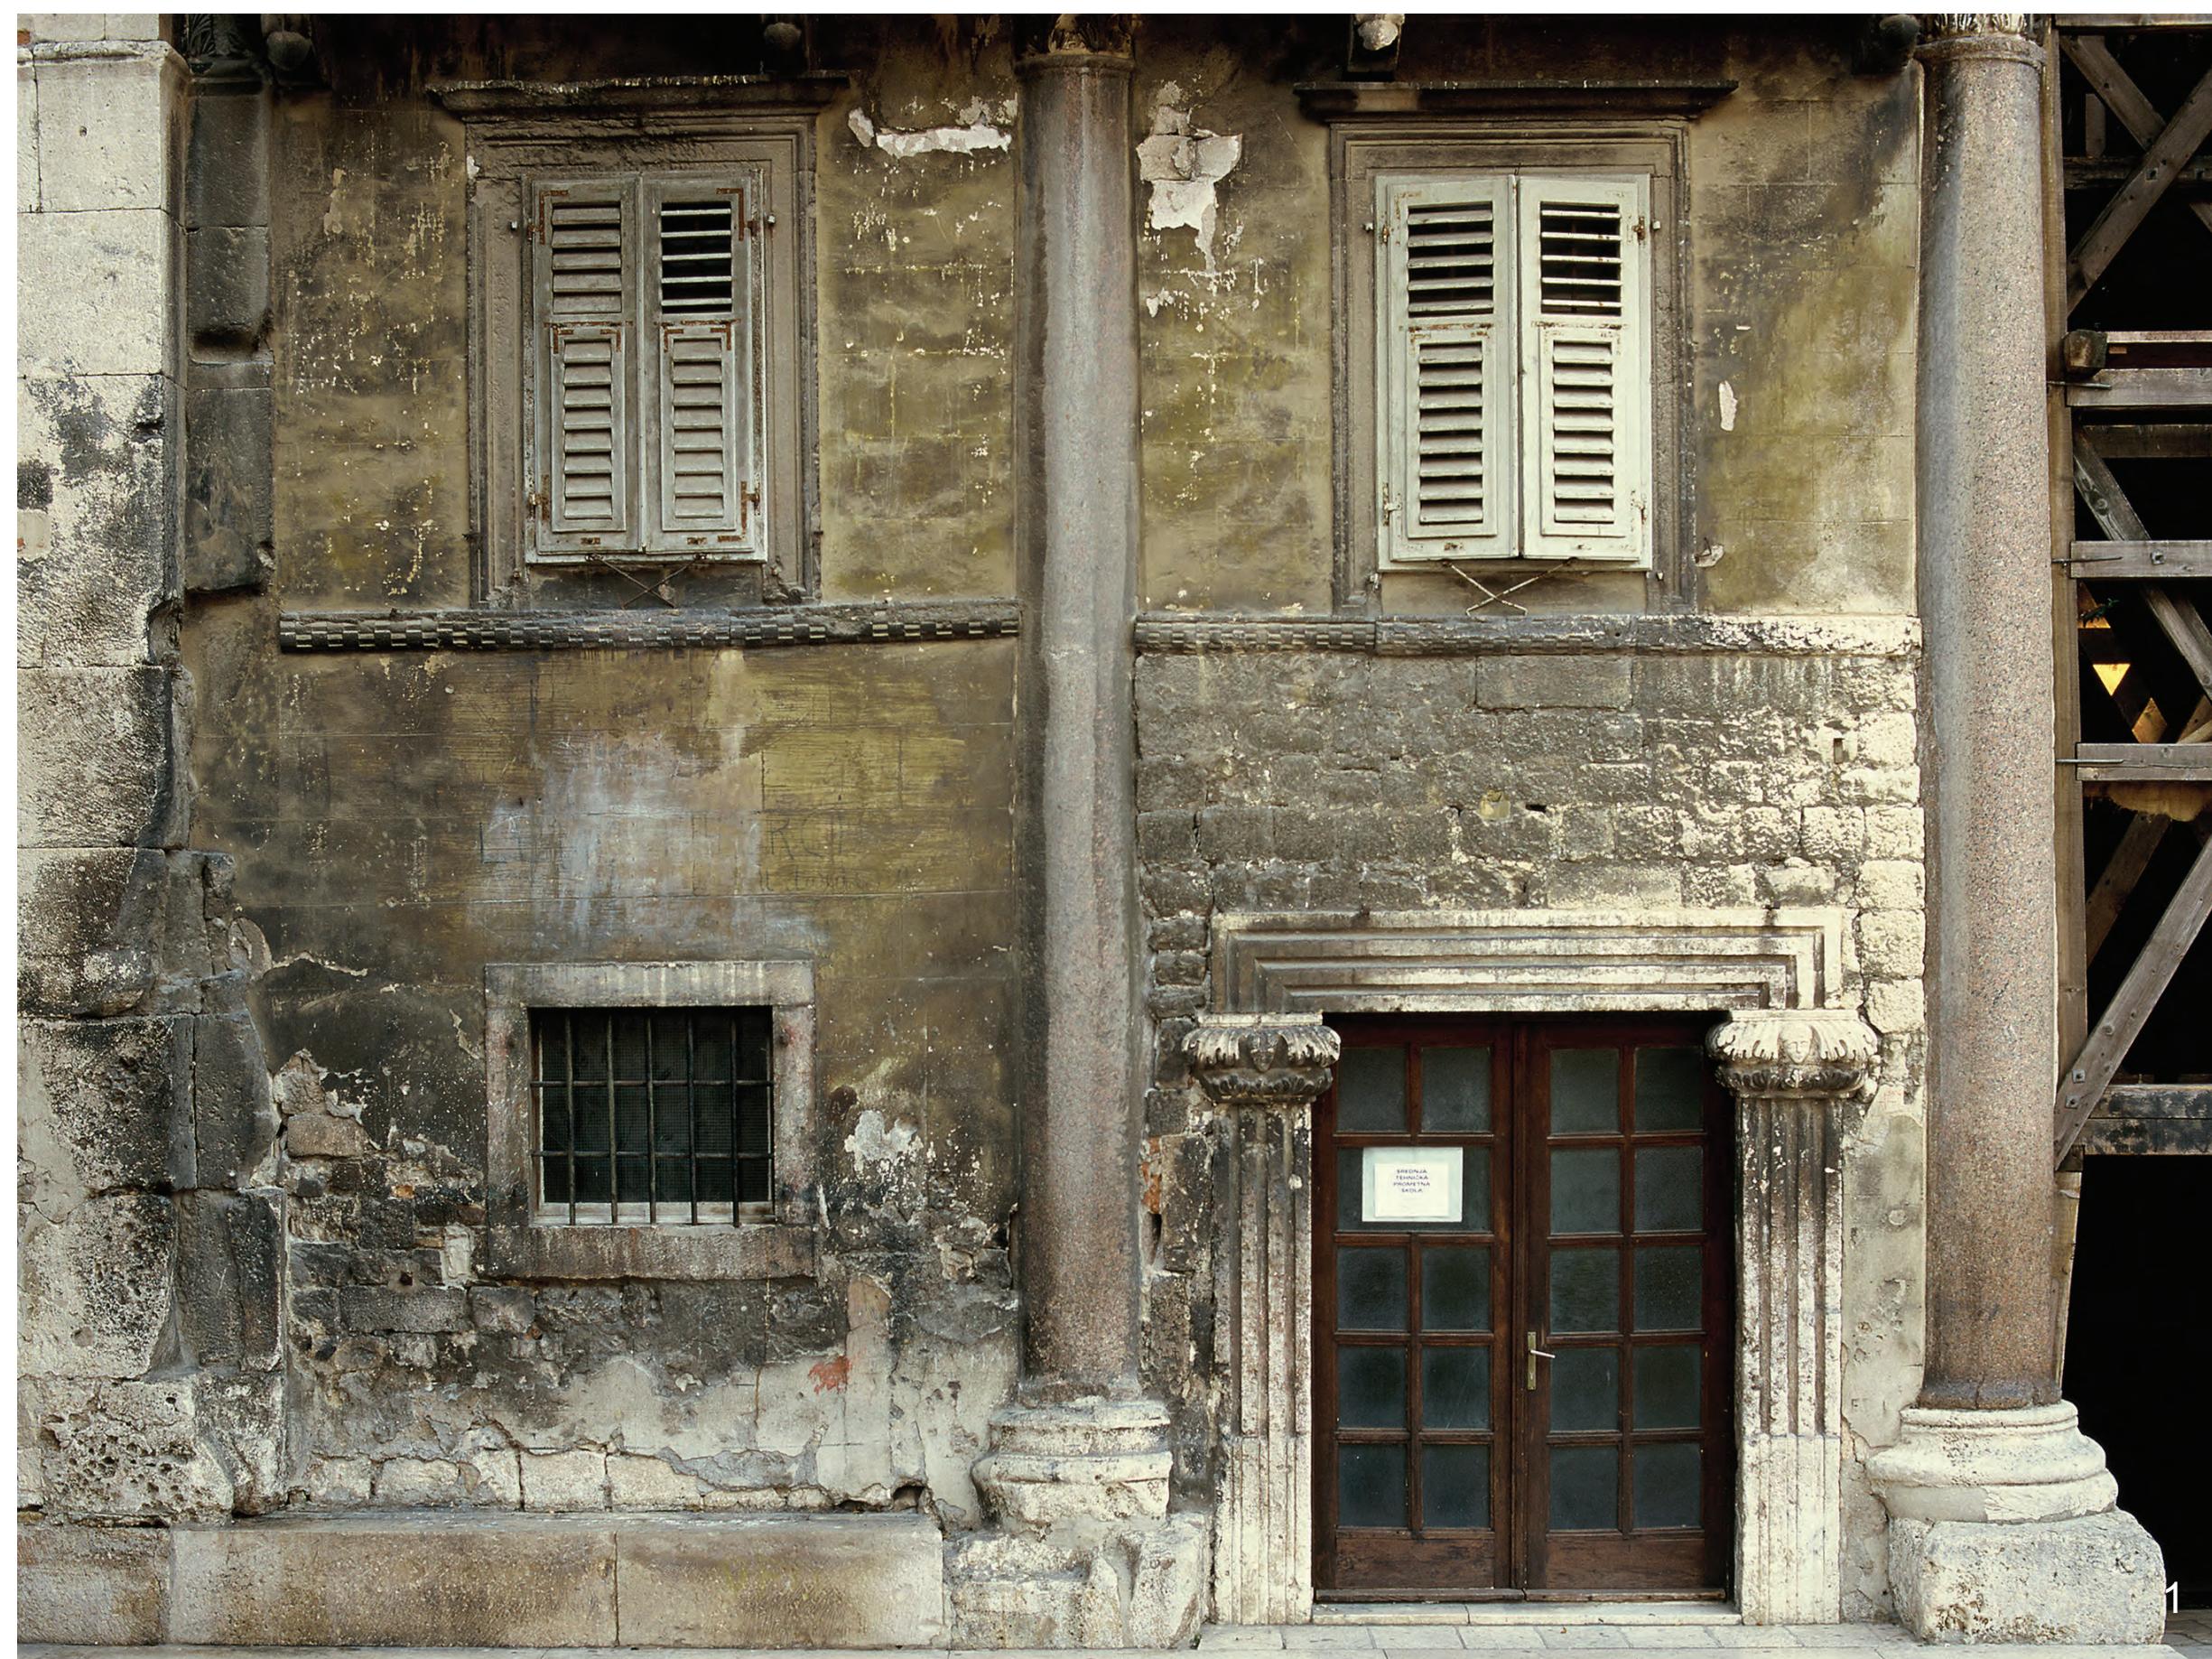
Na prvom katu palače dominiraju dva velika kvadratna prozora, smještena pod balkonom (Sl. 1). Prozorski su okviri bili prekriveni debelim crnim korama koje su prikrivale velika strukturalna oštećenja kamena.

Two large square windows located underneath the balcony dominate the first floor of the palace (Fig. 1). The window frames were covered with thick black crusts that covered up large areas of structural damage to the stone.
