## Na završetku desetljeća obnove Peristila

## At the end of a Decade of the Peristyle Restoration

The conservation and restoration work on the Peristyle of Diocletian's Palace has been in many ways the most important project in recent period within the scope of renovation of the historical core of the town of Split. The Peristyle is the centre and the most impressive part of the imperial palace, and also the heart of the town which has grown around it. The square, which reflects historical layers of the creation and development of the town, has become its symbol and its main tourist attraction. It serves as the most attractive backdrop for cultural events, and a stage at which public life evolves.

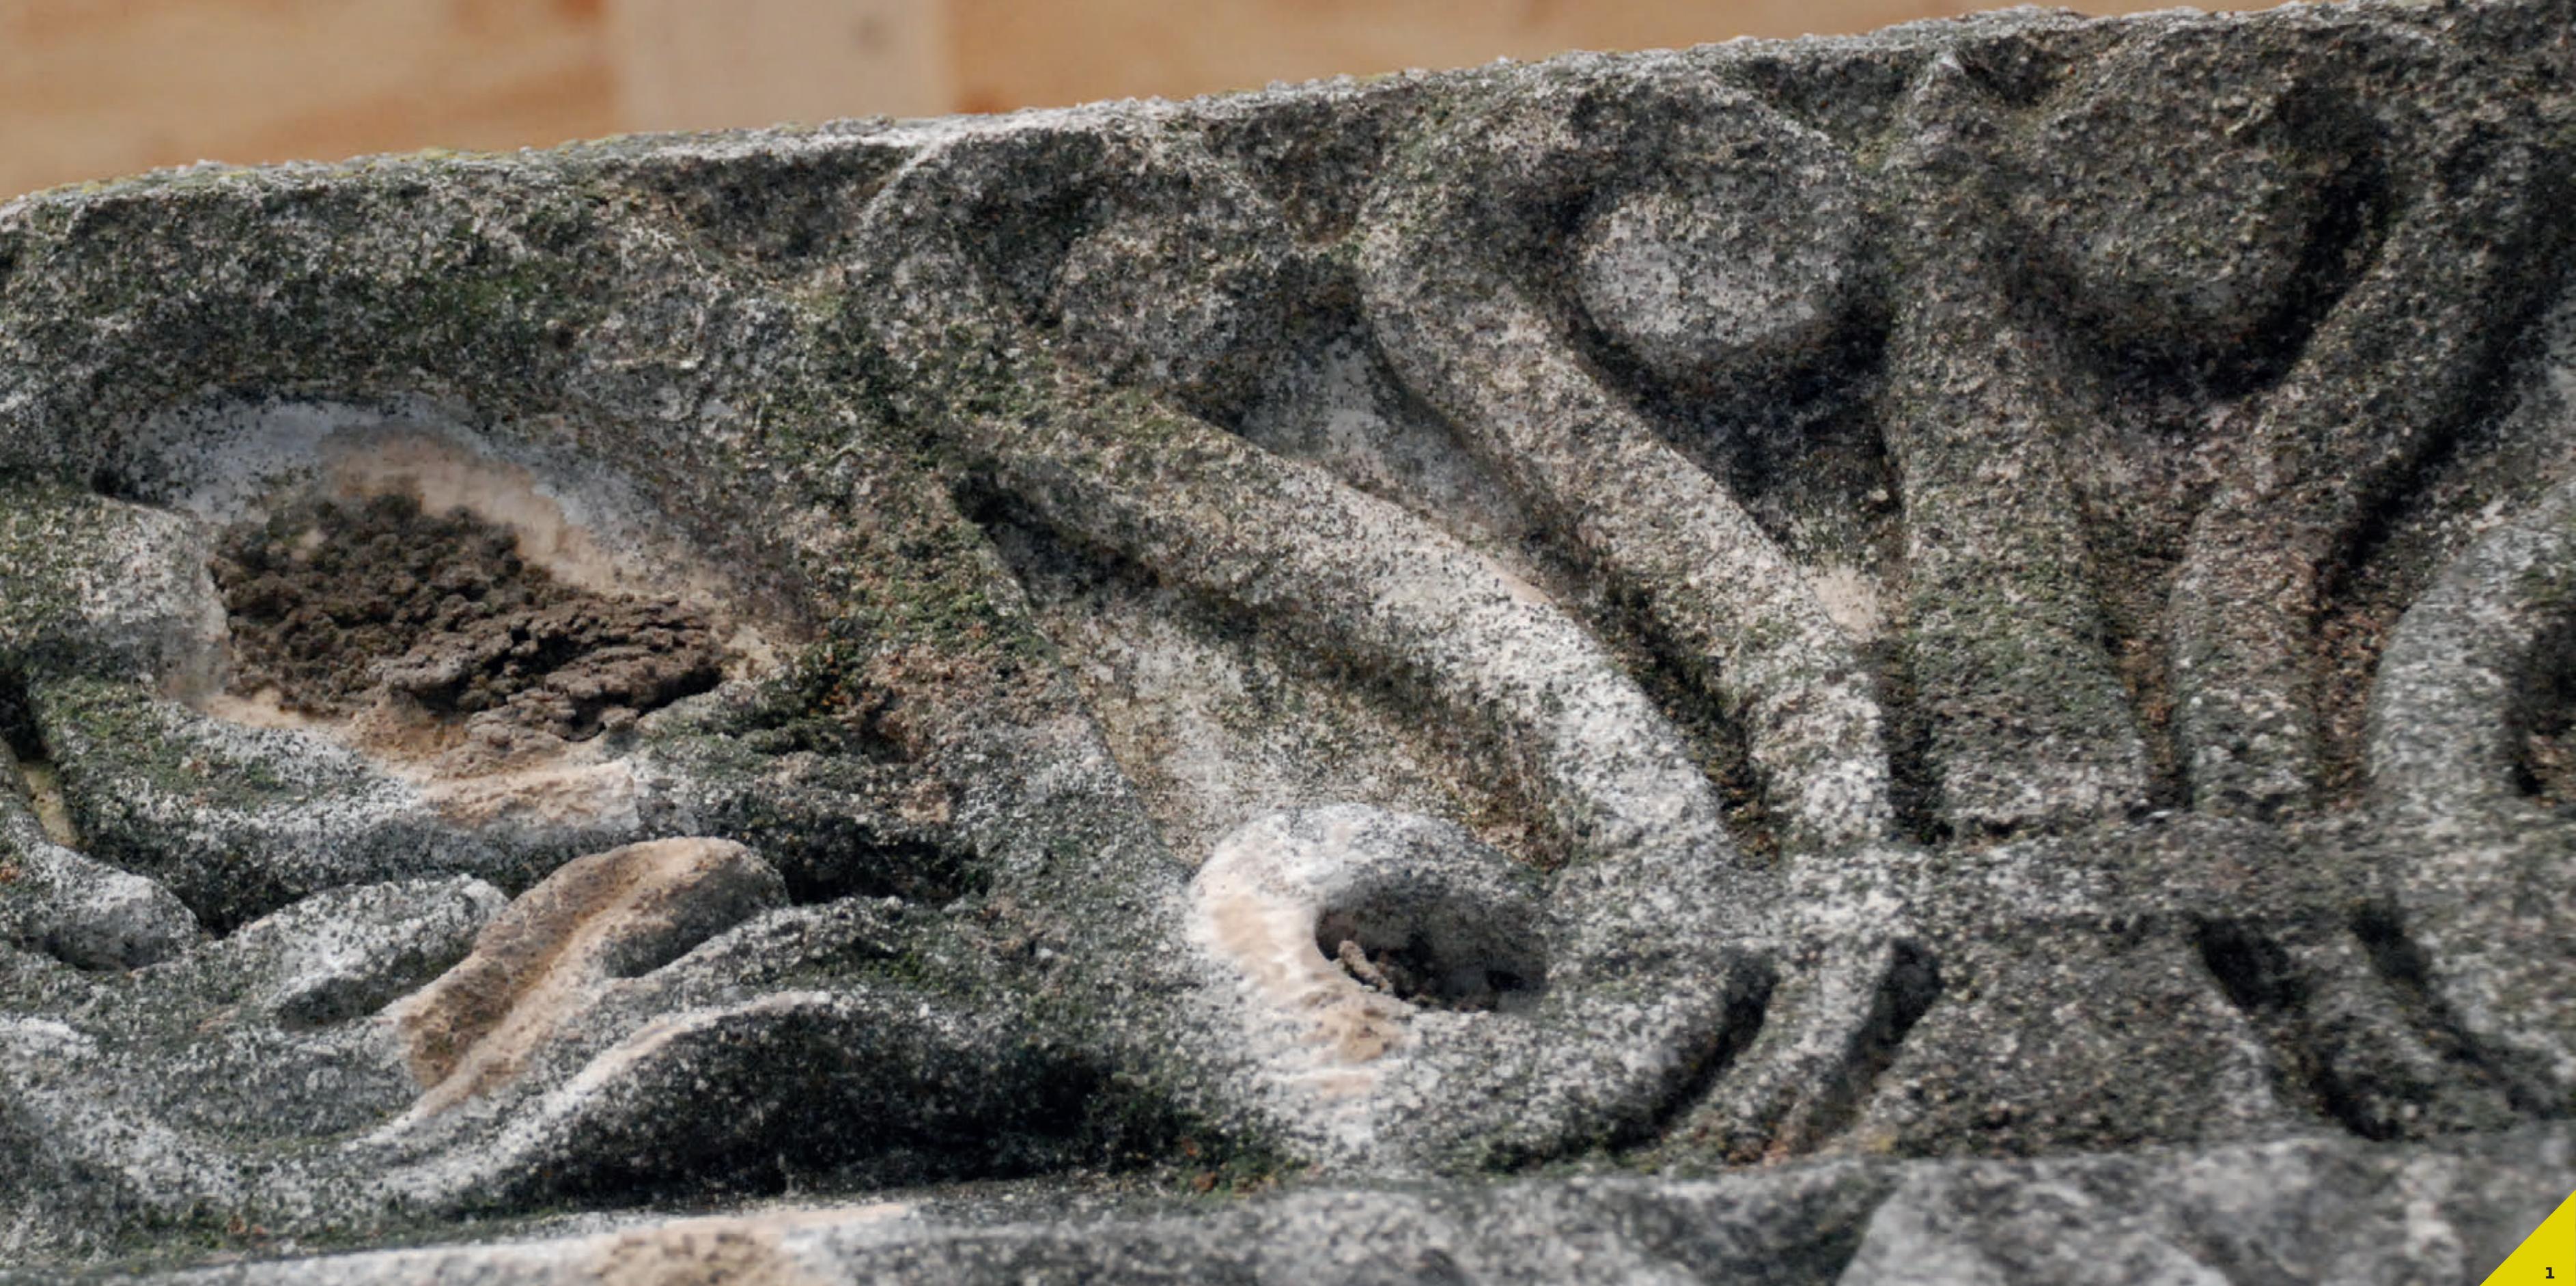
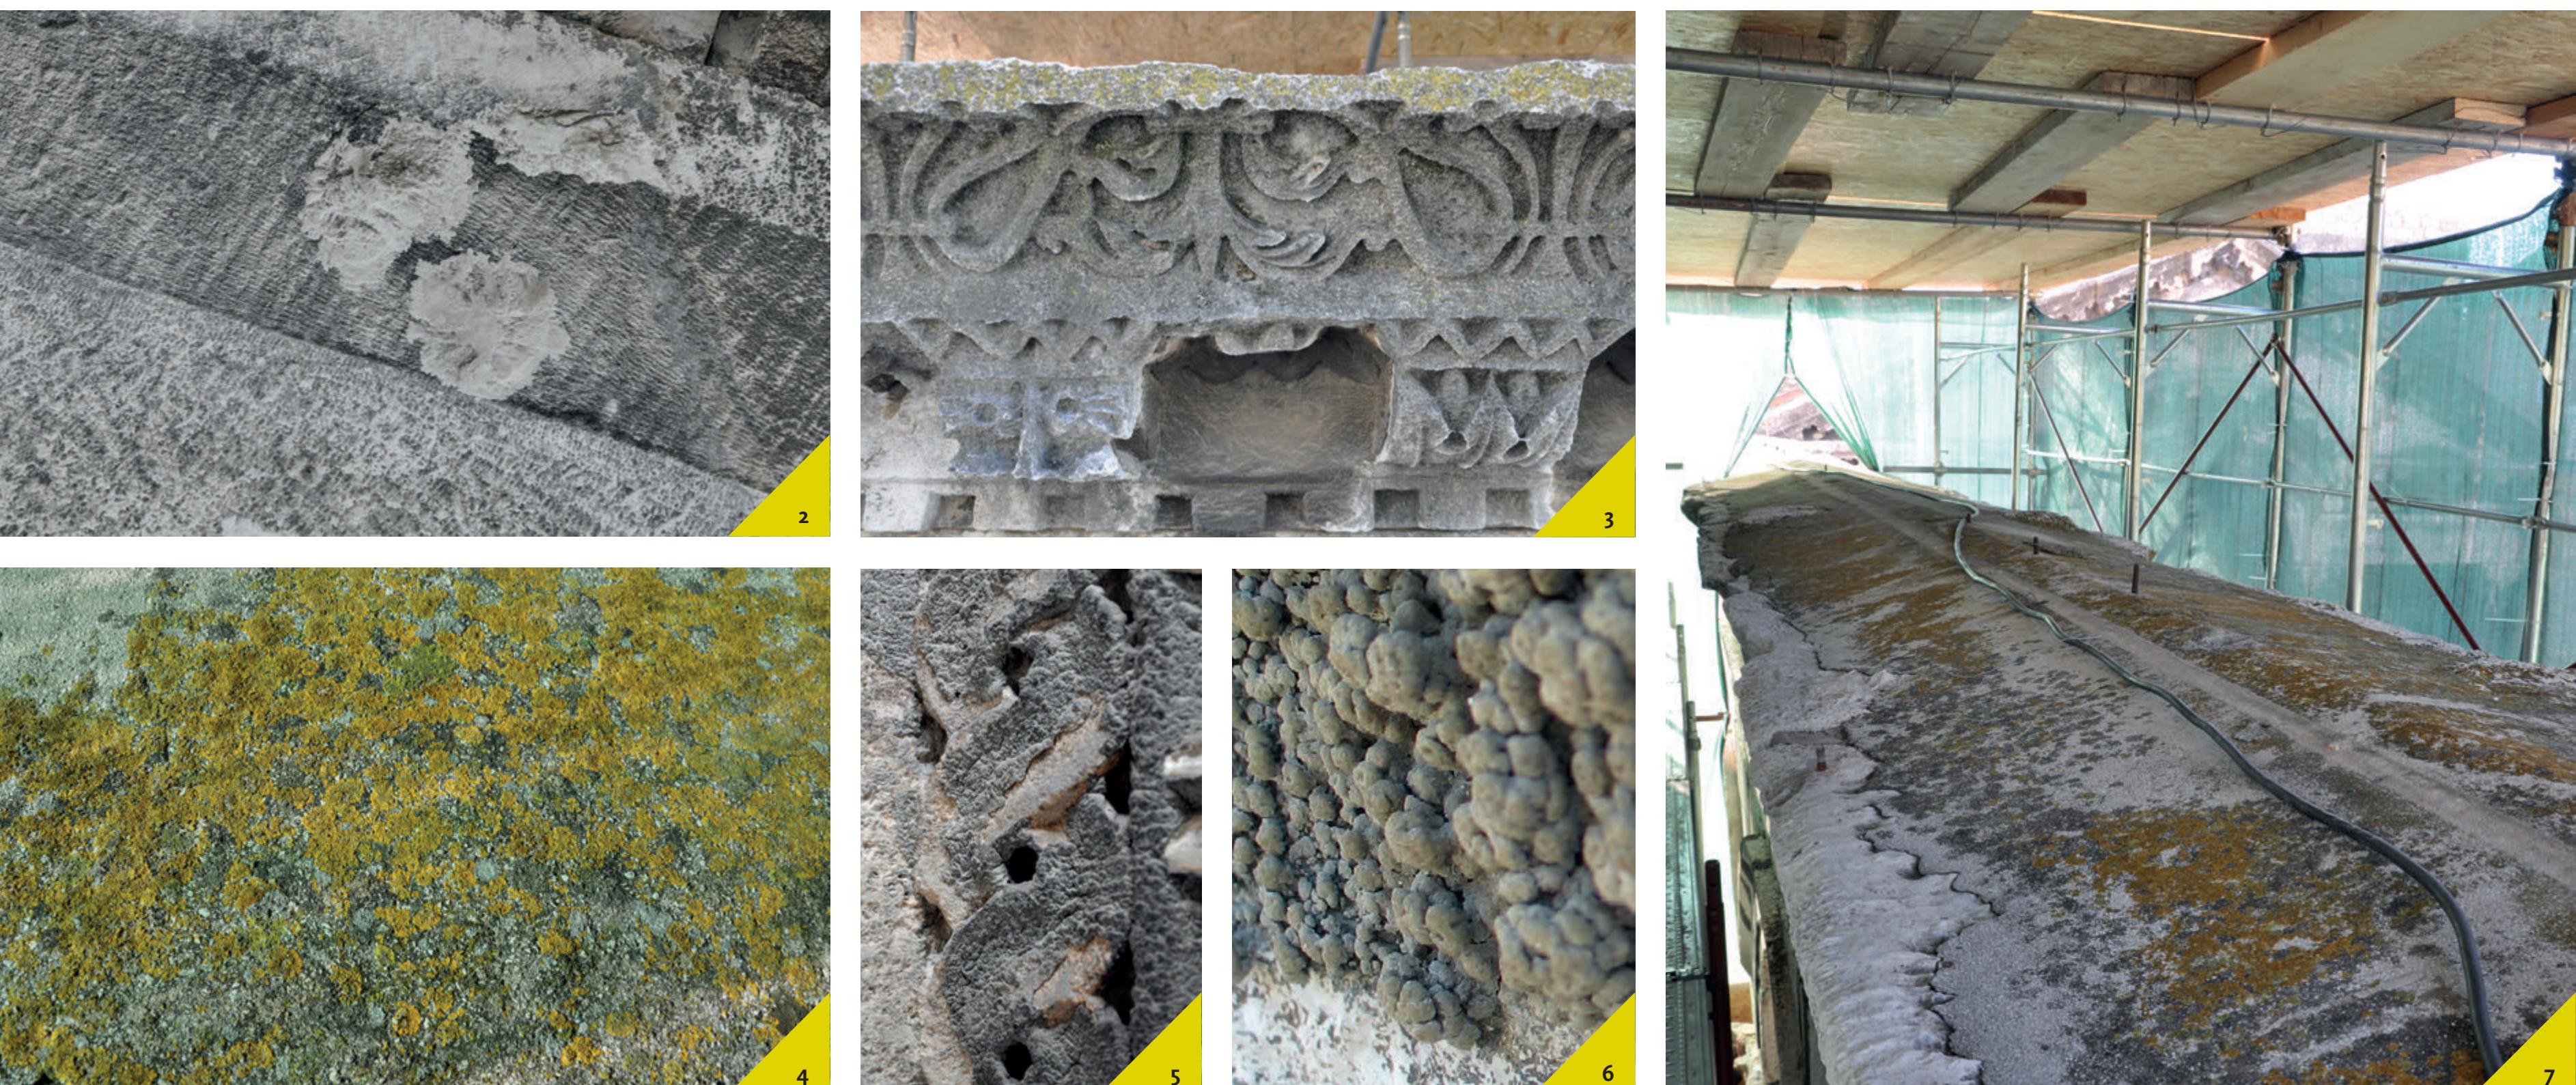
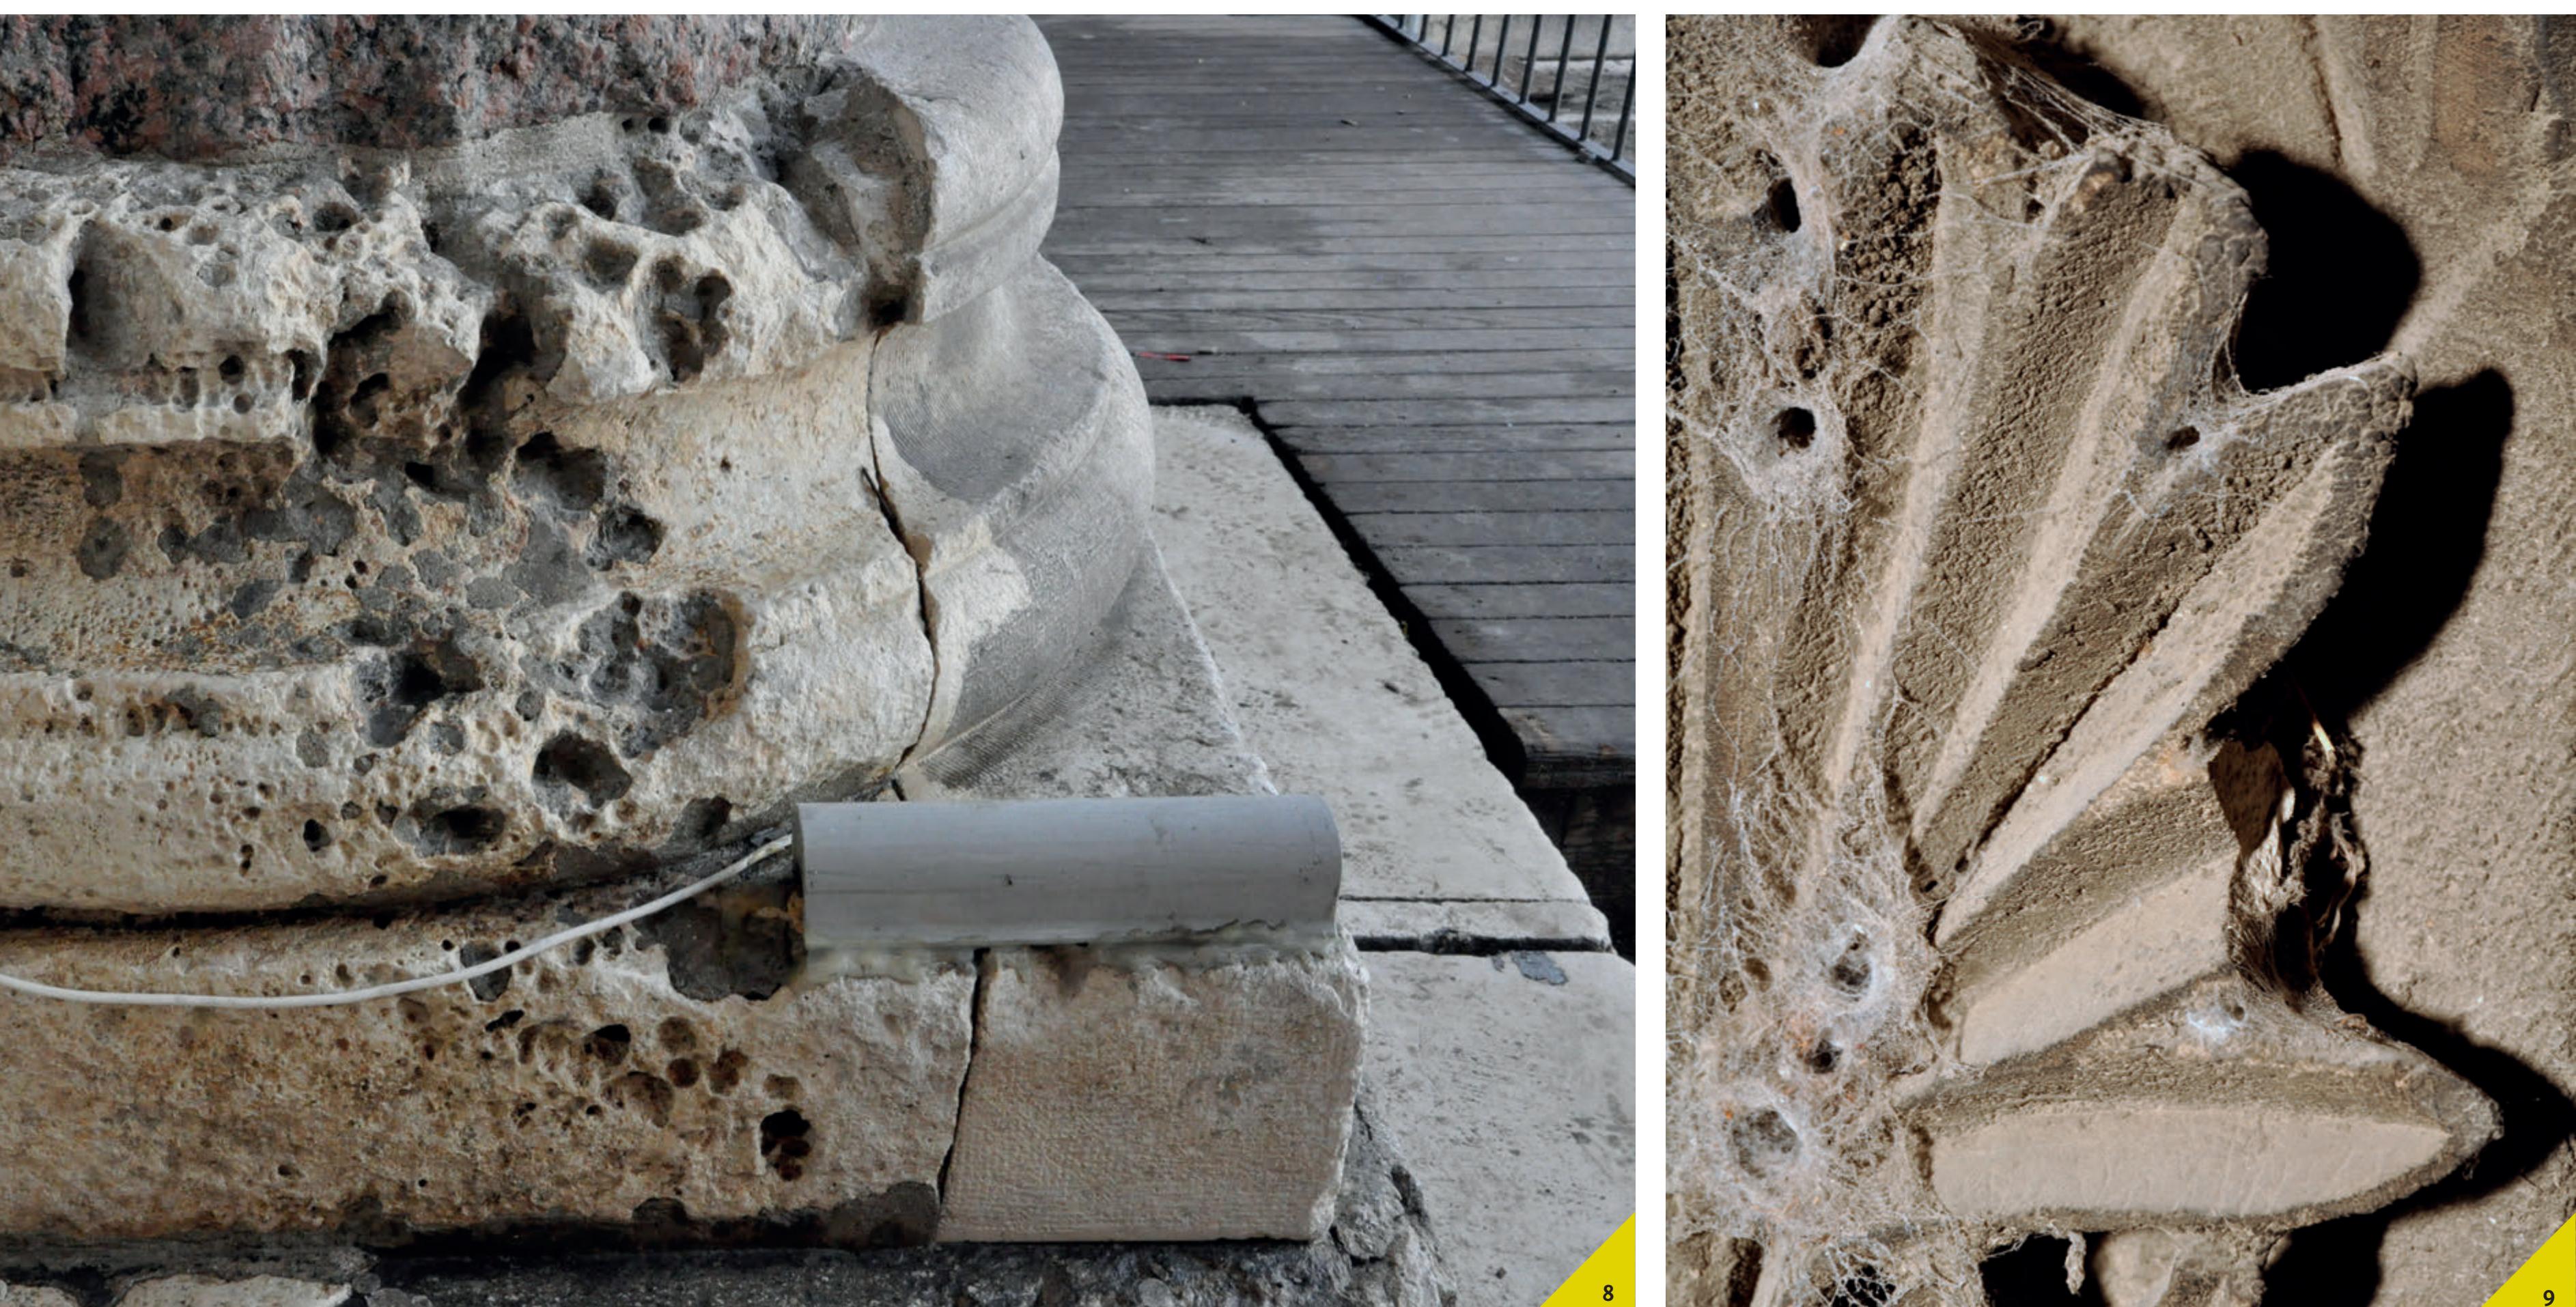
Several main types of damages and soiling were observed on stone used in Peristyle: biological soiling, surface deposits, harmful salts, weathered areas and structural damages.

Dark sediments (crusts) appear on surfaces that were not exposed to rain, and their colour derives from the soot particles. Carbon particles found in black crusts on stone in Peristyle derive from the soot created by burning of coal in households and industry. Cement industry located in the vicinity of Split has over the 125 years also contributed to the creation of black cement crusts on stone. The problem of harmful soluble salts present in crusts should also be considered. Splitting and flaking of stone covered in crust is the result of crystal growth in the salts just beneath the surface. When crystallization pressure becomes higher than stone density, salts start destroying the structure. Recently, damages of stone sculptures in Peristyle have been repaired with cement mortar that releases salts into stone.

Rain influences stone in two ways: raindrops mechanically damage loosened particles of stone surface and lower its relief and since rain is usually mildly acidic, it chemically destroys stone as well. Its surface becomes ribbed and characteristic cavities are created from the decay of fossils.

Mechanical damages of stone in Peristyle are caused by various factors: damages caused by reconstructions, shifts in construction, II World War bombardment. Numerous damages were created by the expansion of rust of iron elements inserted in stone.

1, 3, 4. BIOLOŠKI OBRAŠTAJ; 2. POGOTCI GELERA; 5. DETALJ S PORTALA VESTIBULA - SKRAMA NA Površini KAMENA; 6. MACROFOTOGRAFIJA SKRAMA; 7. BIOLoŠKI OBRAŠTAJ NA ISTOČNOJ KOLONADI; 8. ŠUPLJINE U STRUKTURI KAMENA UZROKOVANA PROPADANJEM FOSILNIH ORGANIZAMA; 9. DETALJ KAPITELA - SKRAMA I PAUKOVE MREŽE; 10. PROPADANJE KAMENA UZROKOVANO KOROZIJOM METALA; 11. SKRAMA NA Površini KAPITELA; 12. EROZIJA PovršINE KAMENA UZROKOVANA KİŞOM

1, 3, 4. BIOLOGICAL SOILING; 2. SHRAPNEL HITS; 5. DETAIL FROM VESTIBULUM PORTAL - BLACK CRUST ON THE SURFACE OF STONE; 6. MACROPHOTO OF BLACK CRUST; 7. BIOLOGICAL SOILING ON THE EAST COLONNADE; 8. CAVITIES CREATED FROM THE DECAY OF FOSSILS; 9. DETAIL OF CAPITAL - CRUST AND SPIDER WEB; 10. DAMAGE CREATED BY THE EXPANSION OF RUST OF IRON ELEMENTS; 11. BLACK CRUST ON THE SURFACE OF THE CAPITAL; 12. EROSION OF STONE SURFACE CAUSED BY RAIN

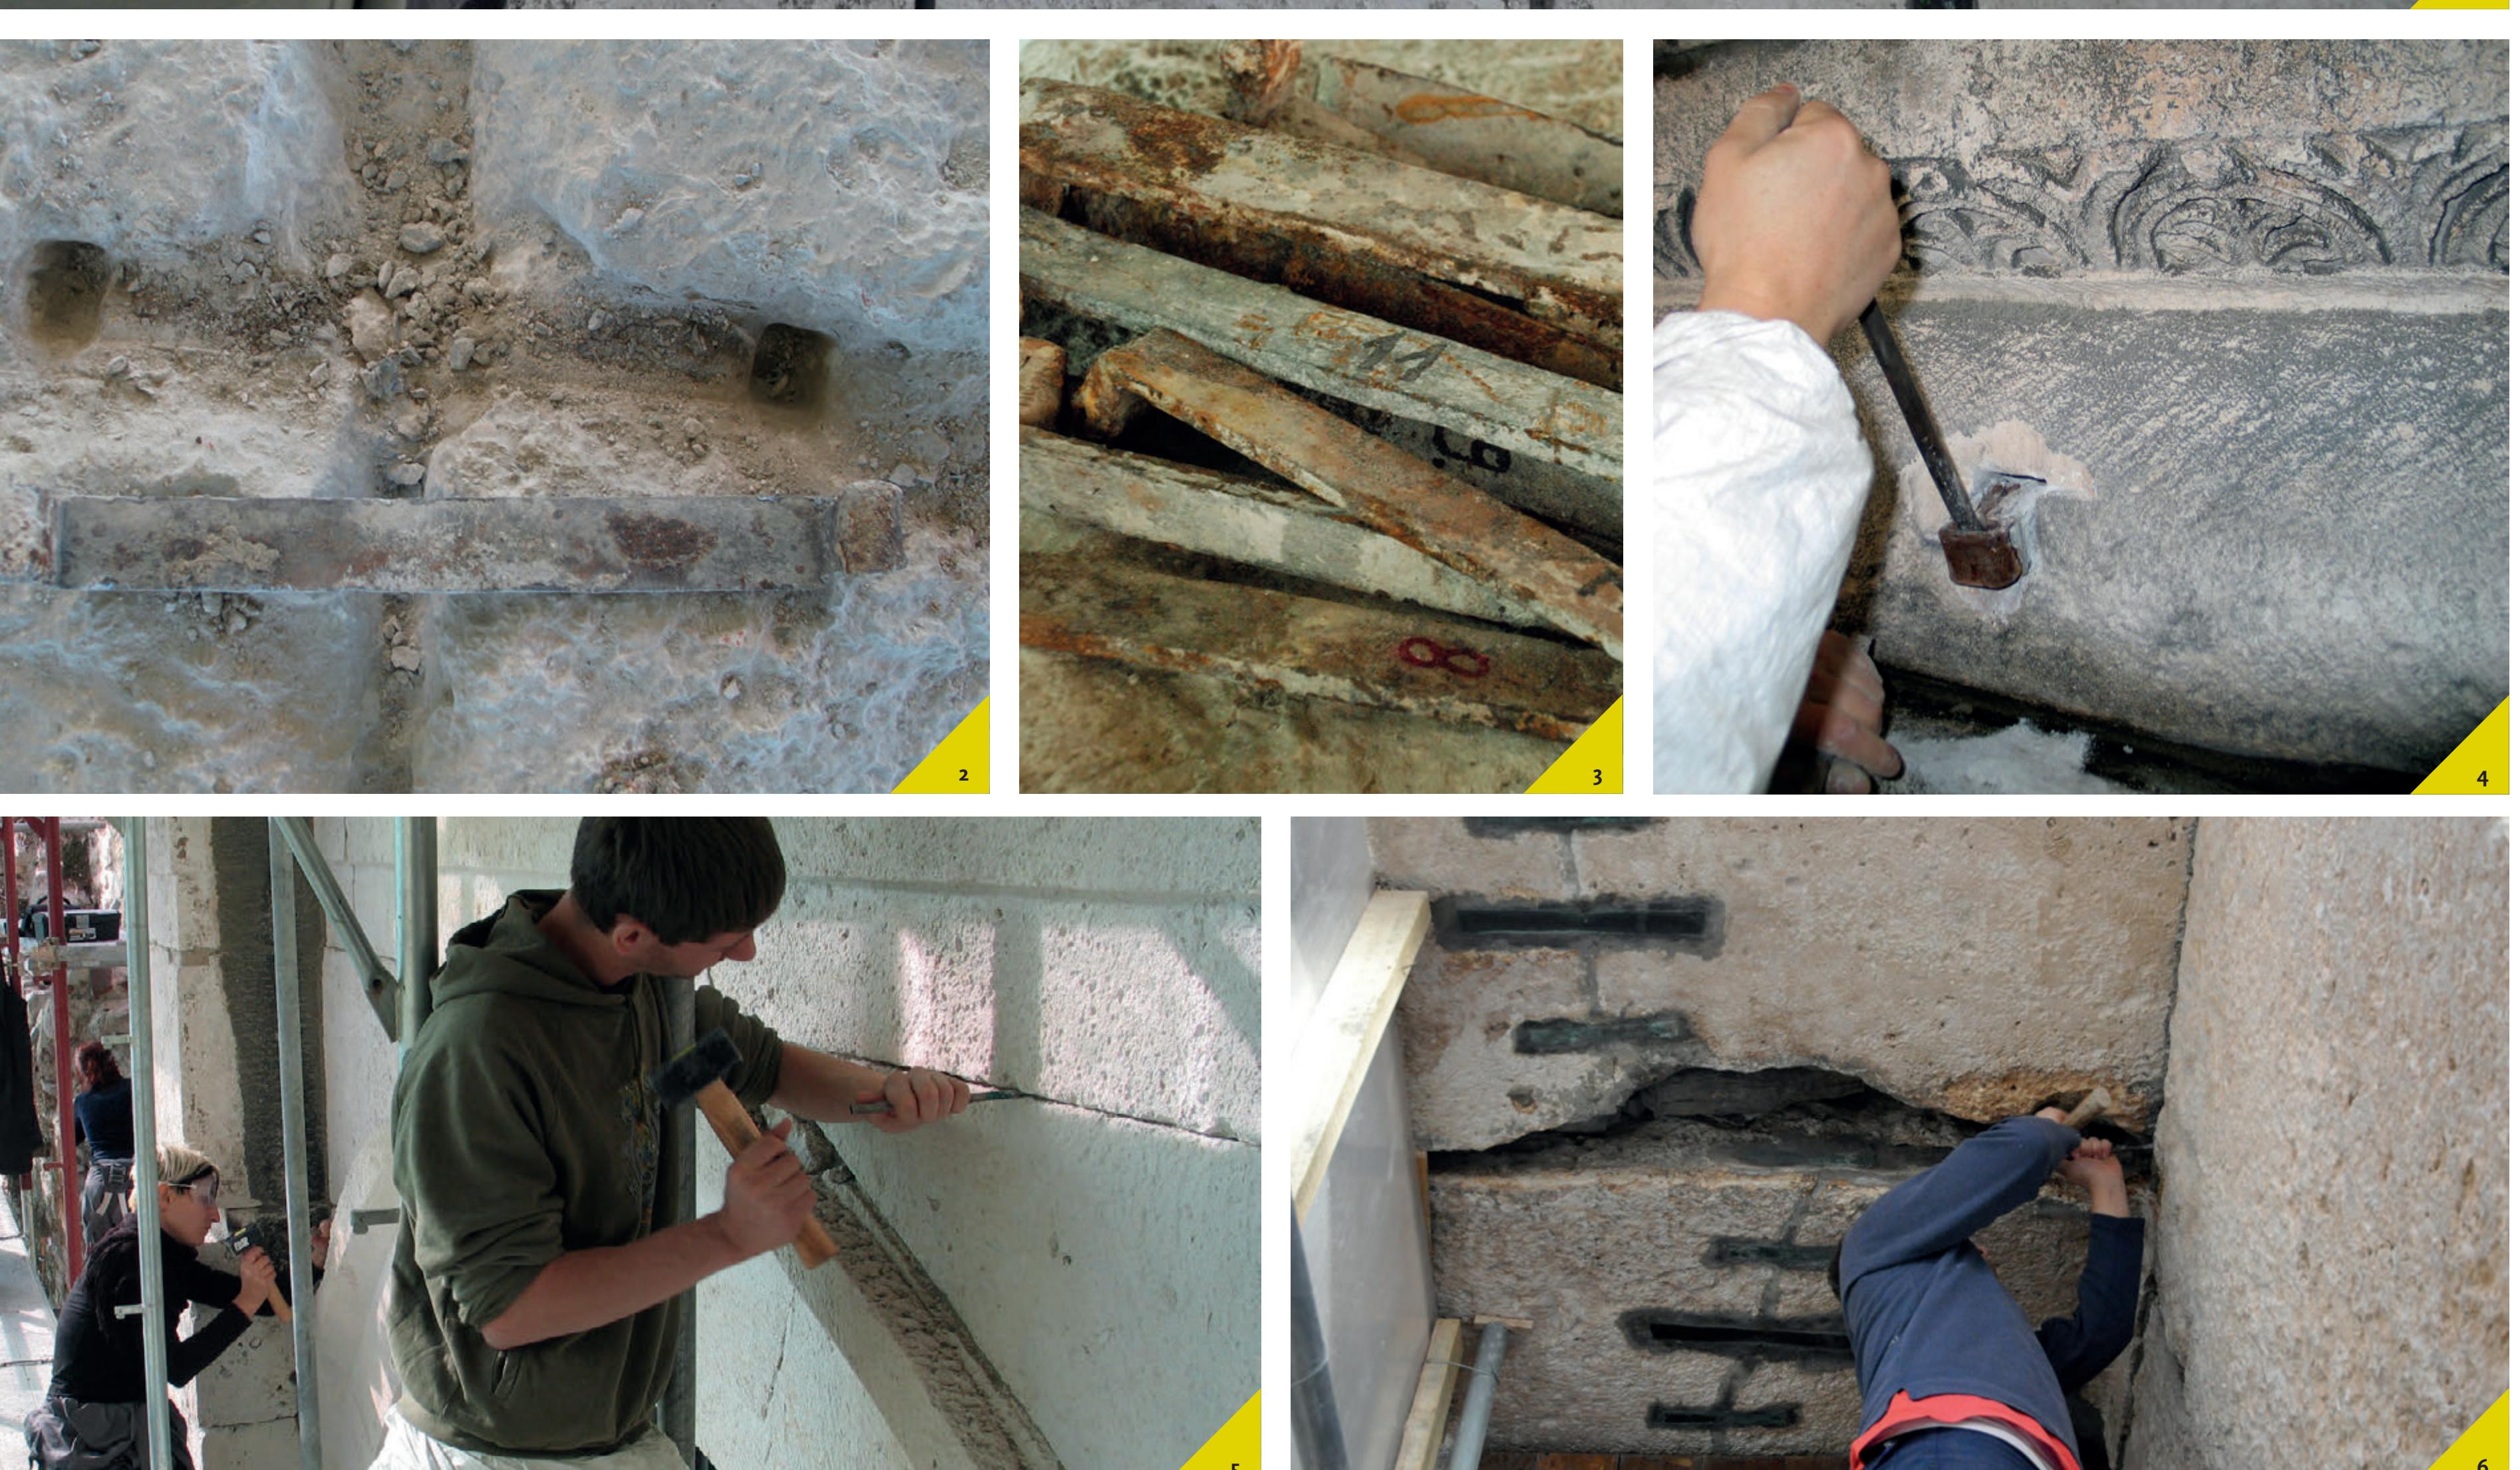
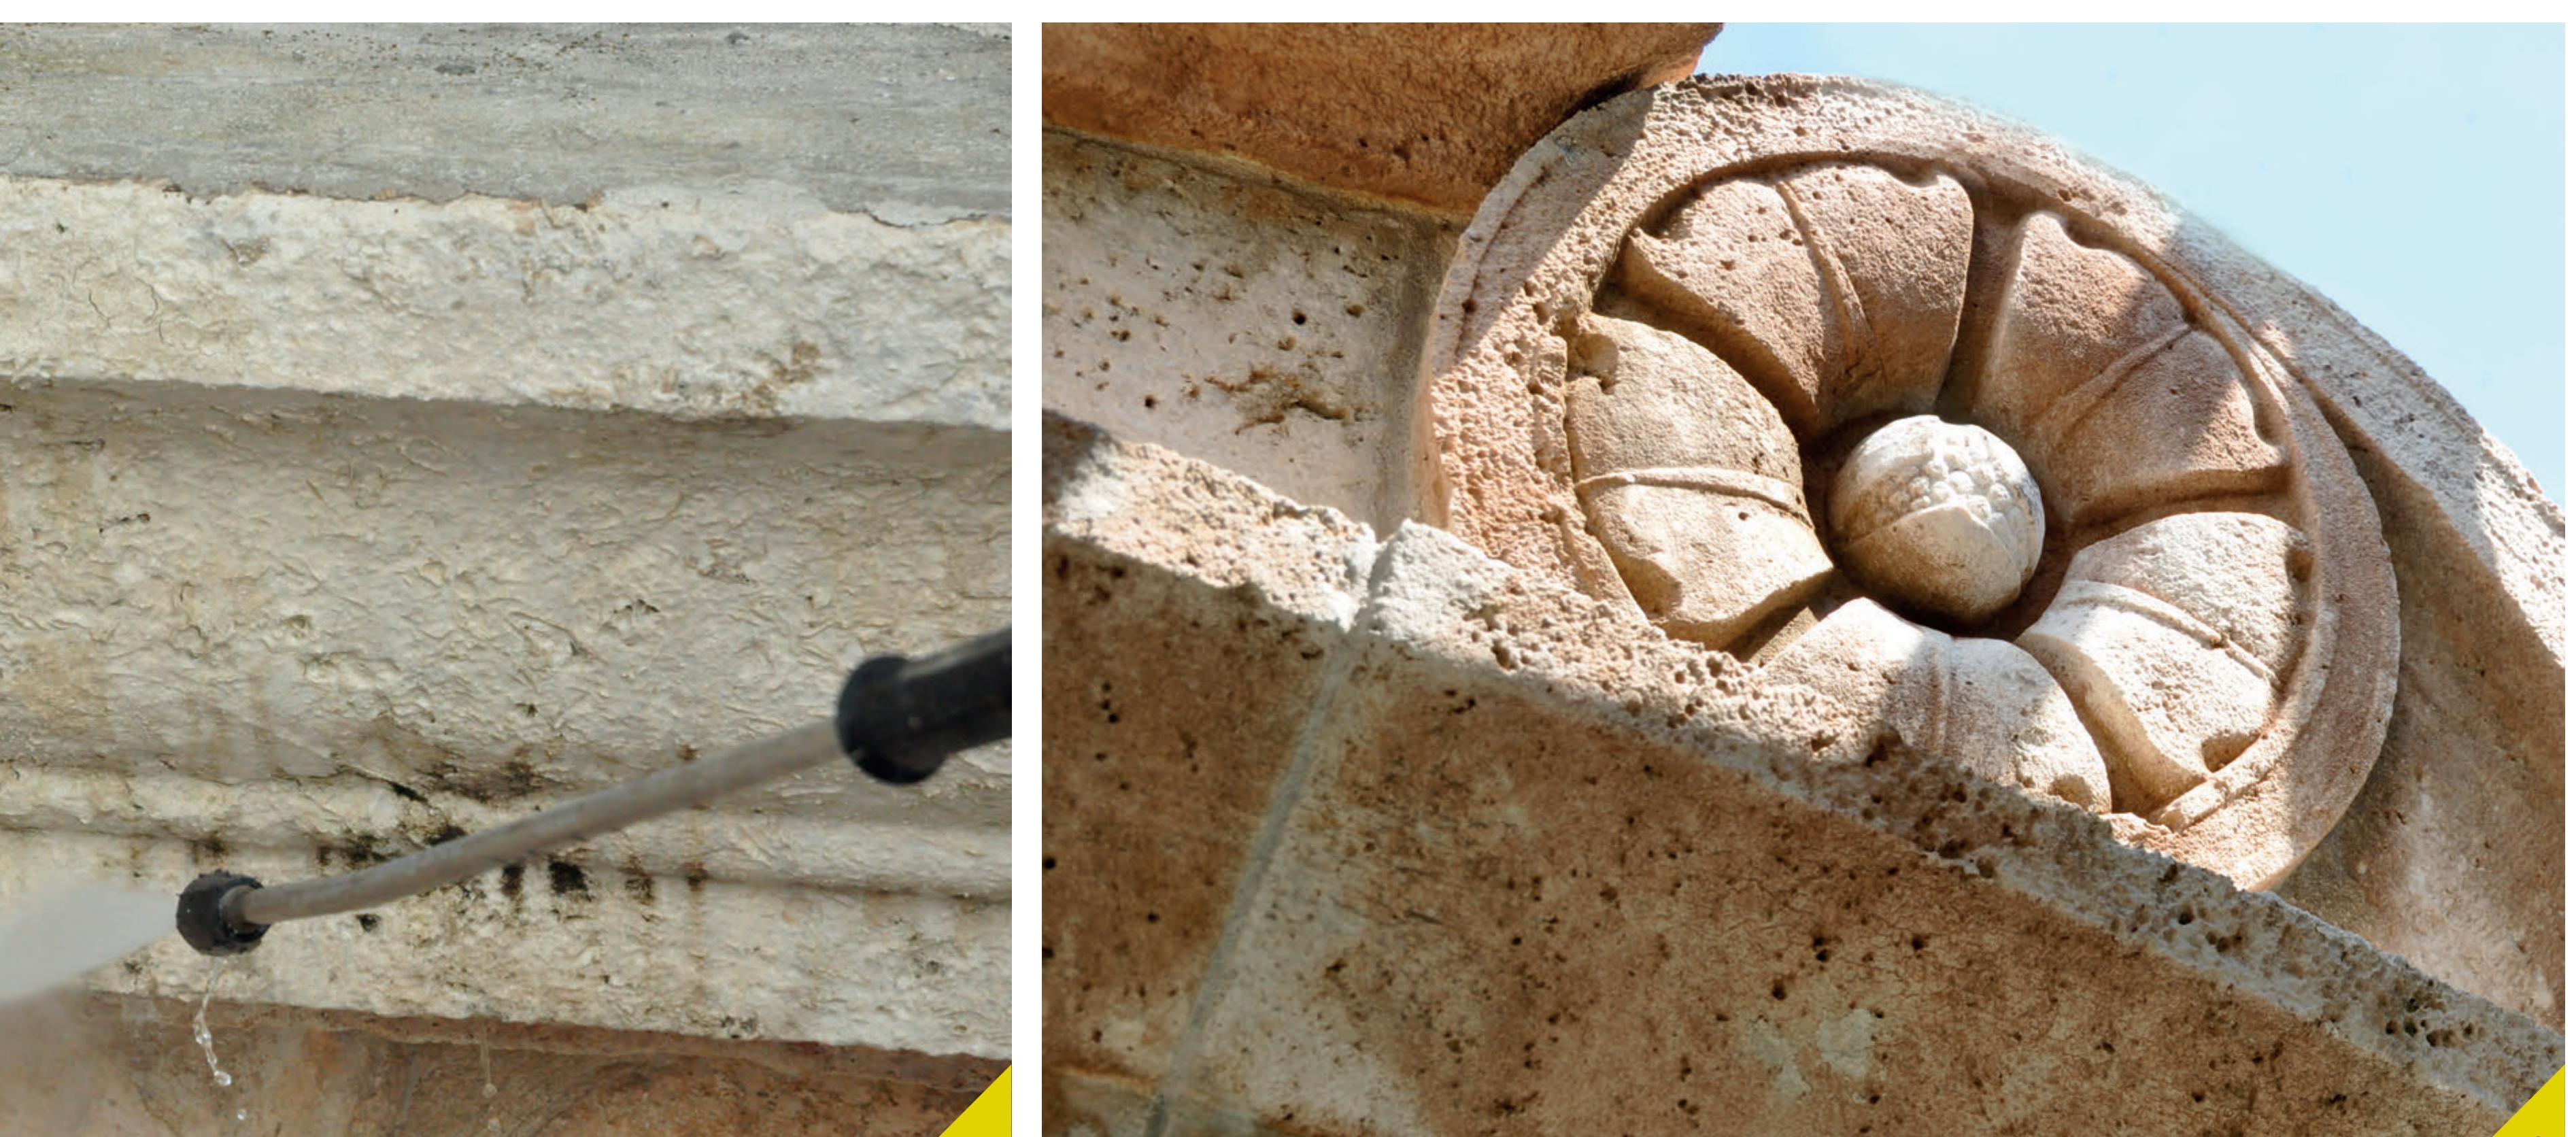
1, 2, 3. UKLANJANJE KORODIRANIH ŽELJEZNIH KOPČI SA ZABATA PROTIRONA; 4. POSLJEDICE EKSPANDIRANJA KORODIRANE ŽELJEZNE KOPČE; 5. UKLANJANJE CEMENTA IZ KAMENIH SLJUBNICA; 6. ODSTRANJIVANJE CEMENTNIH REKONSTRUKCIJA IZ PORTALA VESTIBULE

1, 2, 3. REMOVAL OF CORRODED IRON CLAMPS FROM THE GABLE OF THE PROTHYRON; 4. RESULTS OF EXPANSION OF CORRODED IRON CLAMP; 5. REMOVAL OF THE CEMENT MORTAR POINTING; 6. REMOVAL OF THE CEMENT MORTAR PATCHES FROM THE PORTAL OF THE VESTIBULE; 7. HOT STEAM STONE CLEANING; 8. STONE AFTER APPLYING CHEMICAL AGENT TO ELIMINATE BIOLOGICAL OVERGROWTH

Površine kamena tijekom povijesti su oštećivane sidrenjem metalnih elemenata (kopče, klinovi, vijci, nosači električnih instalacija). Oni su uklonjeni finim klesarskim alatima pažći da se ne ošteći struktura kamena. Dotrajali željezni elementi koji se nisu mogli ukloniti bez oštećivanja kamena (poput elemenata između kapitela i tijela stupu) injektirani su inhibitorima korozije. Bakreni klamfe, obruči i svornjaci, postavljeni u prethodnim restauracijama, koji ne uzrokuju oštećenja kamena, nisu uklanjeni jer još uvijek obavljaju svoju funkciju. Izvorne antičke korodirane željezne spojnice između kamenih blokova izvadene su i zamijenjene novima od nehrđajućeg metalra, zaliivenima olovom poput izvornih.

Organic dirt (biological colonization and bird droppings) was removed with a combination of mechanical and chemical methods. With this intervention, the stone surface was cleaned, disinfected and prepared for further work.
