## Na završetku desetljeća obnove Peristila

## At the end of a Decade of the Peristyle Restoration

The conservation and restoration work on the Peristyle of Diocletian's Palace has been in many ways the most important project in recent period within the scope of renovation of the historical core of the town of Split. The Peristyle is the centre and the most impressive part of the imperial palace, and also the heart of the town which has grown around it. The square, which reflects historical layers of the creation and development of the town, has become its symbol and its main tourist attraction. It serves as the most attractive backdrop for cultural events, and a stage at which public life evolves.

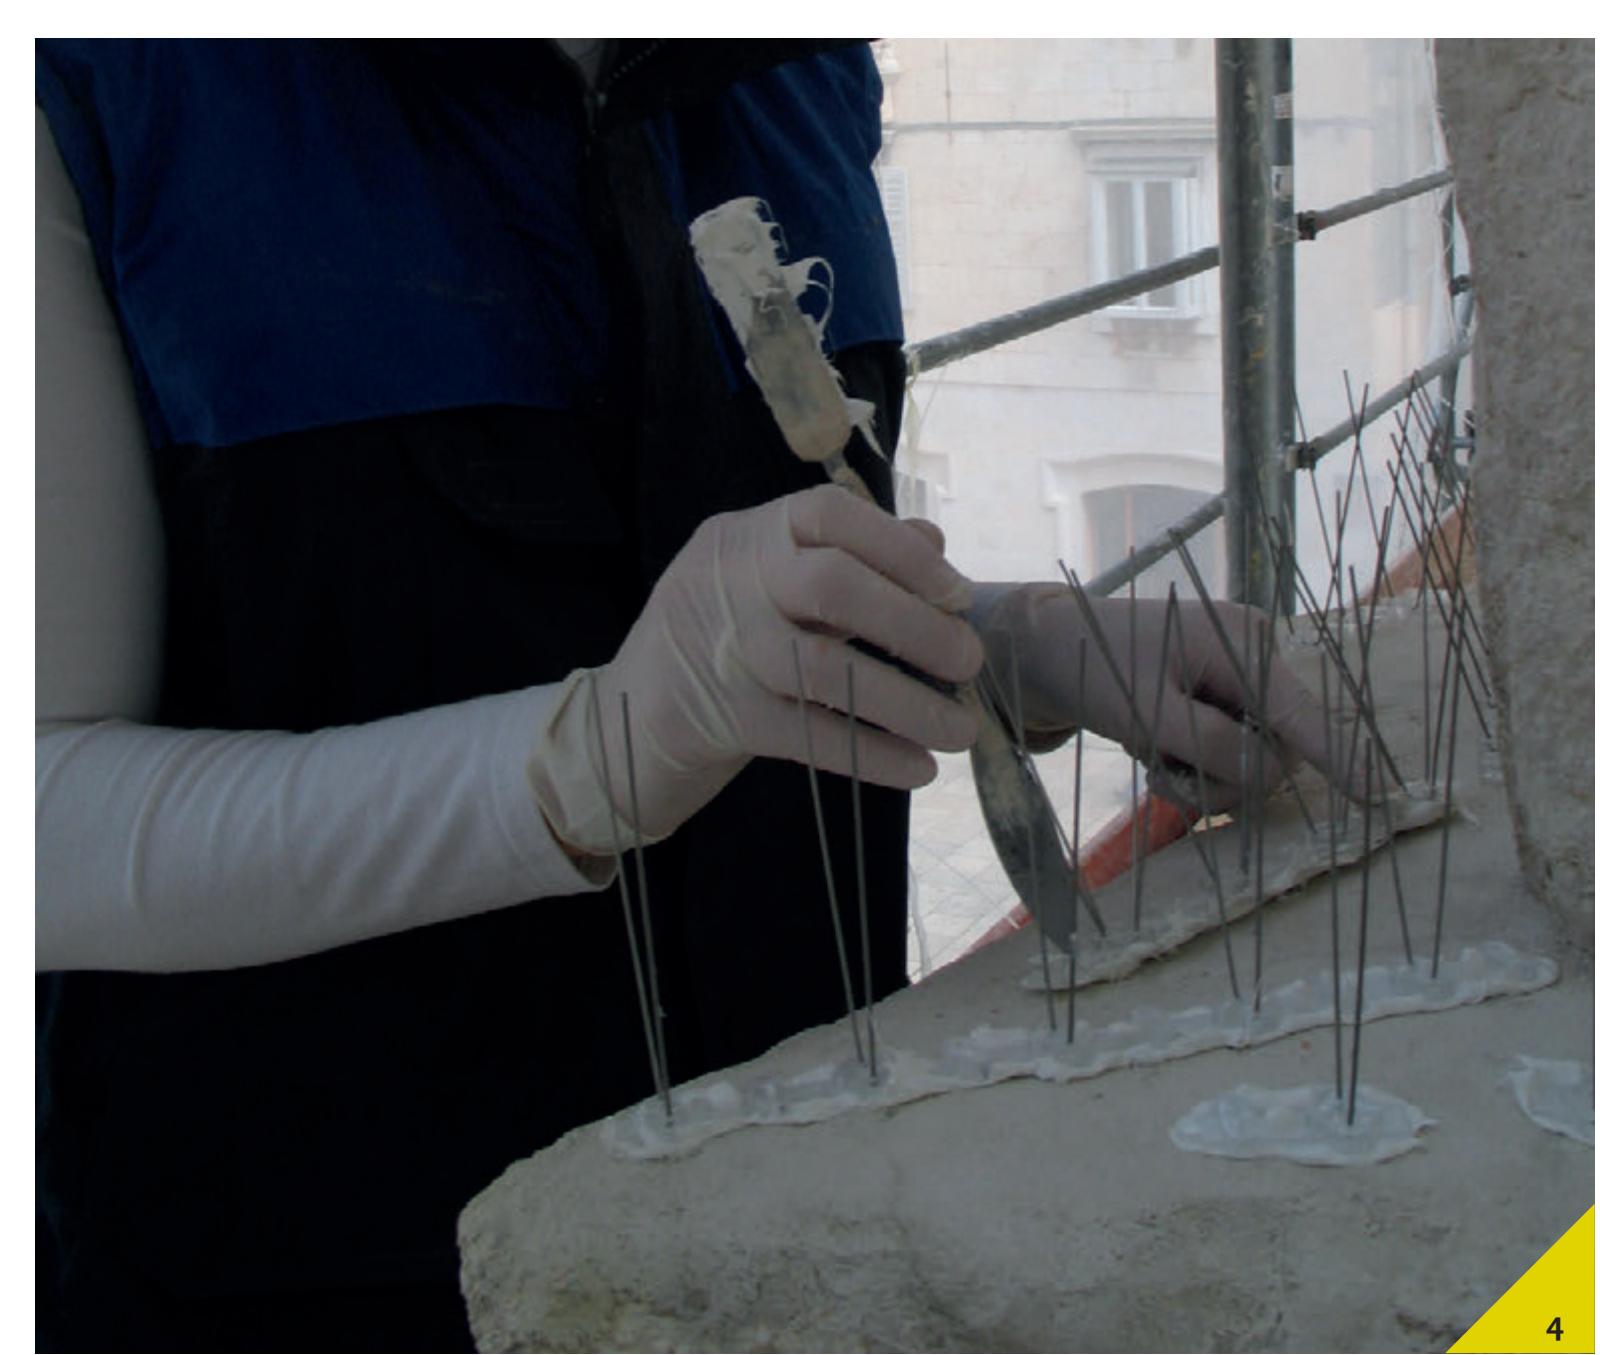
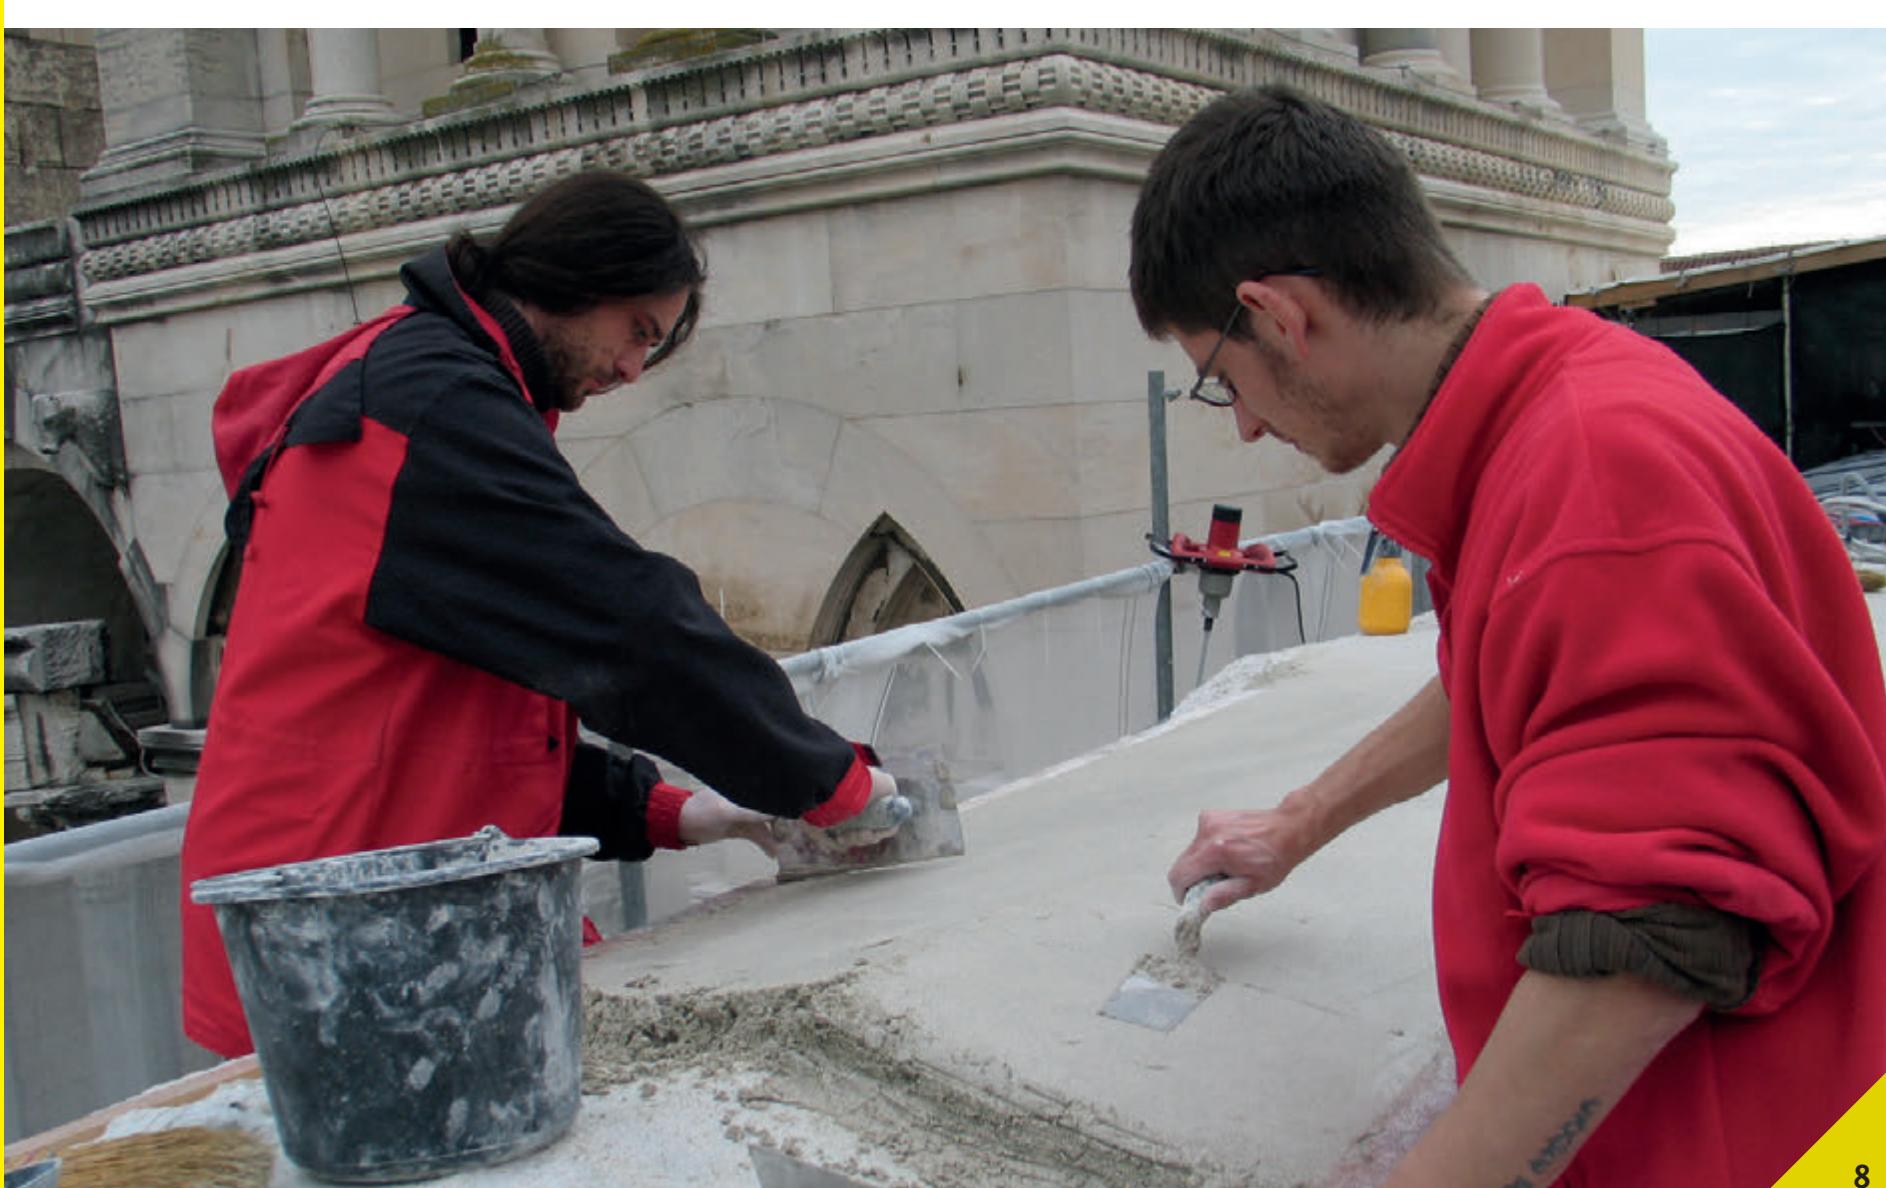
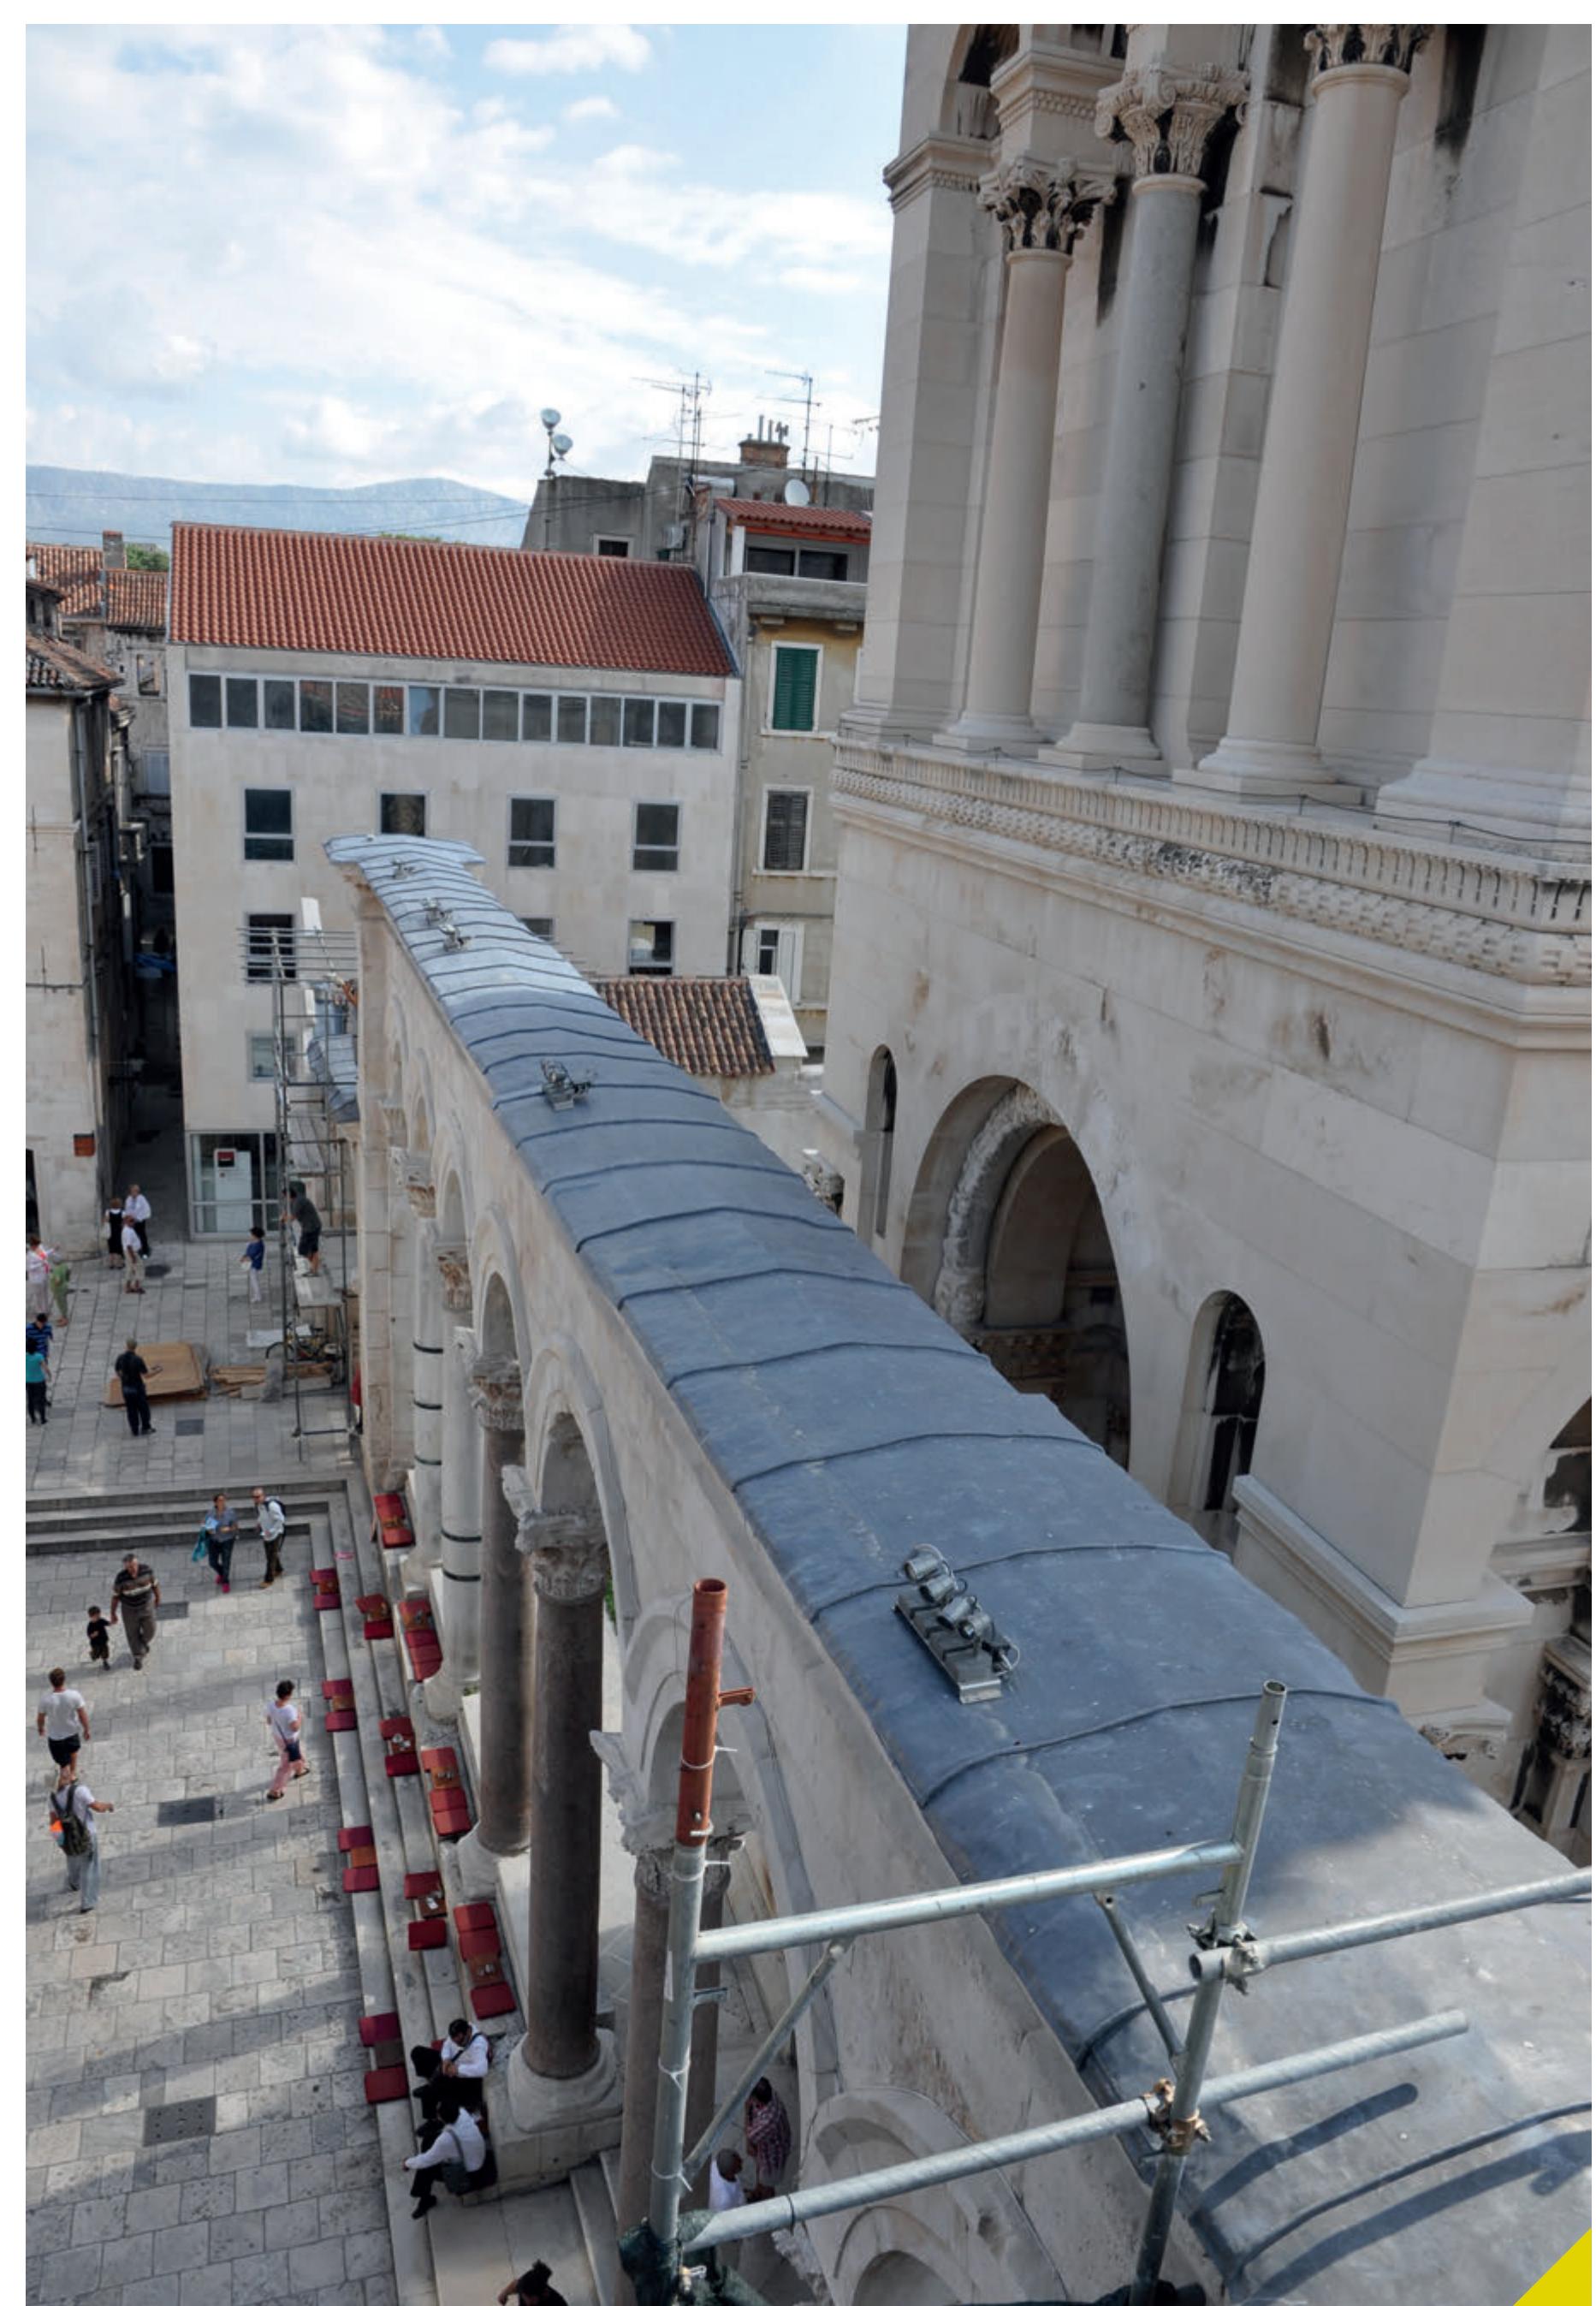
1. ŽBUKANJE GORNJIH DIJELOVA LUKOVA KOLONADE; 2. NOVA SLJUBNICA IZMEĐU PORTALA I ZIDA VESTIBULA; 3. ŽBUKANJE GORNJIH DIJELOVA KAPITELA, 4. POSTAVLJANJE IGLIČASTE ZAŠTITE OD PTICA; 5. ZAŠTITA MORTOM RAVNIH PLOHA KOLONADE; 6, 7. IZRADA SLJUBNICA I PUЊENJE LAKUNA AKRILNO-VAPNENIM MORTOM 8, 10. IZRADA ZAŠTITE OD MORTA I POSTAVLJANJE OLOVNIH PLOĆA; 9, 11. ZABAT PROTIRONA I ISTOČNA KOLONADA S POSTAVLJENIM OLOVNIM PLOČAMA

Sljubnice između kamenih blokova fugirane su akrilno-vapnenom žbukom. Kako bi se spriječilo ispiranje kamenih površina kišnicom, na sve veće horizontalne plohe postavljen je nakošeni pokrov od morta, na koji je pričvršćena oplata od olovnog lima s okapnicom koja osigurava zaštitu kamena od oborinskih voda.

Smaller stone sculptures such as projections on capitals and stone cornices were plastered to prevent the corrosion and erosion caused by weathering. Finally, a system of spikes was installed on projecting surfaces to prevent birds from landing.
