## Na završetku desetljeća obnove Peristila

## At the end of a Decade of the Peristyle Restoration

The conservation and restoration work on the Peristyle of Diocletian's Palace has been in many ways the most important project in recent period within the scope of renovation of the historical core of the town of Split. The Peristyle is the centre and the most impressive part of the imperial palace, and also the heart of the town which has grown around it. The square, which reflects historical layers of the creation and development of the town, has become its symbol and its main tourist attraction. It serves as the most attractive backdrop for cultural events, and a stage at which public life evolves.

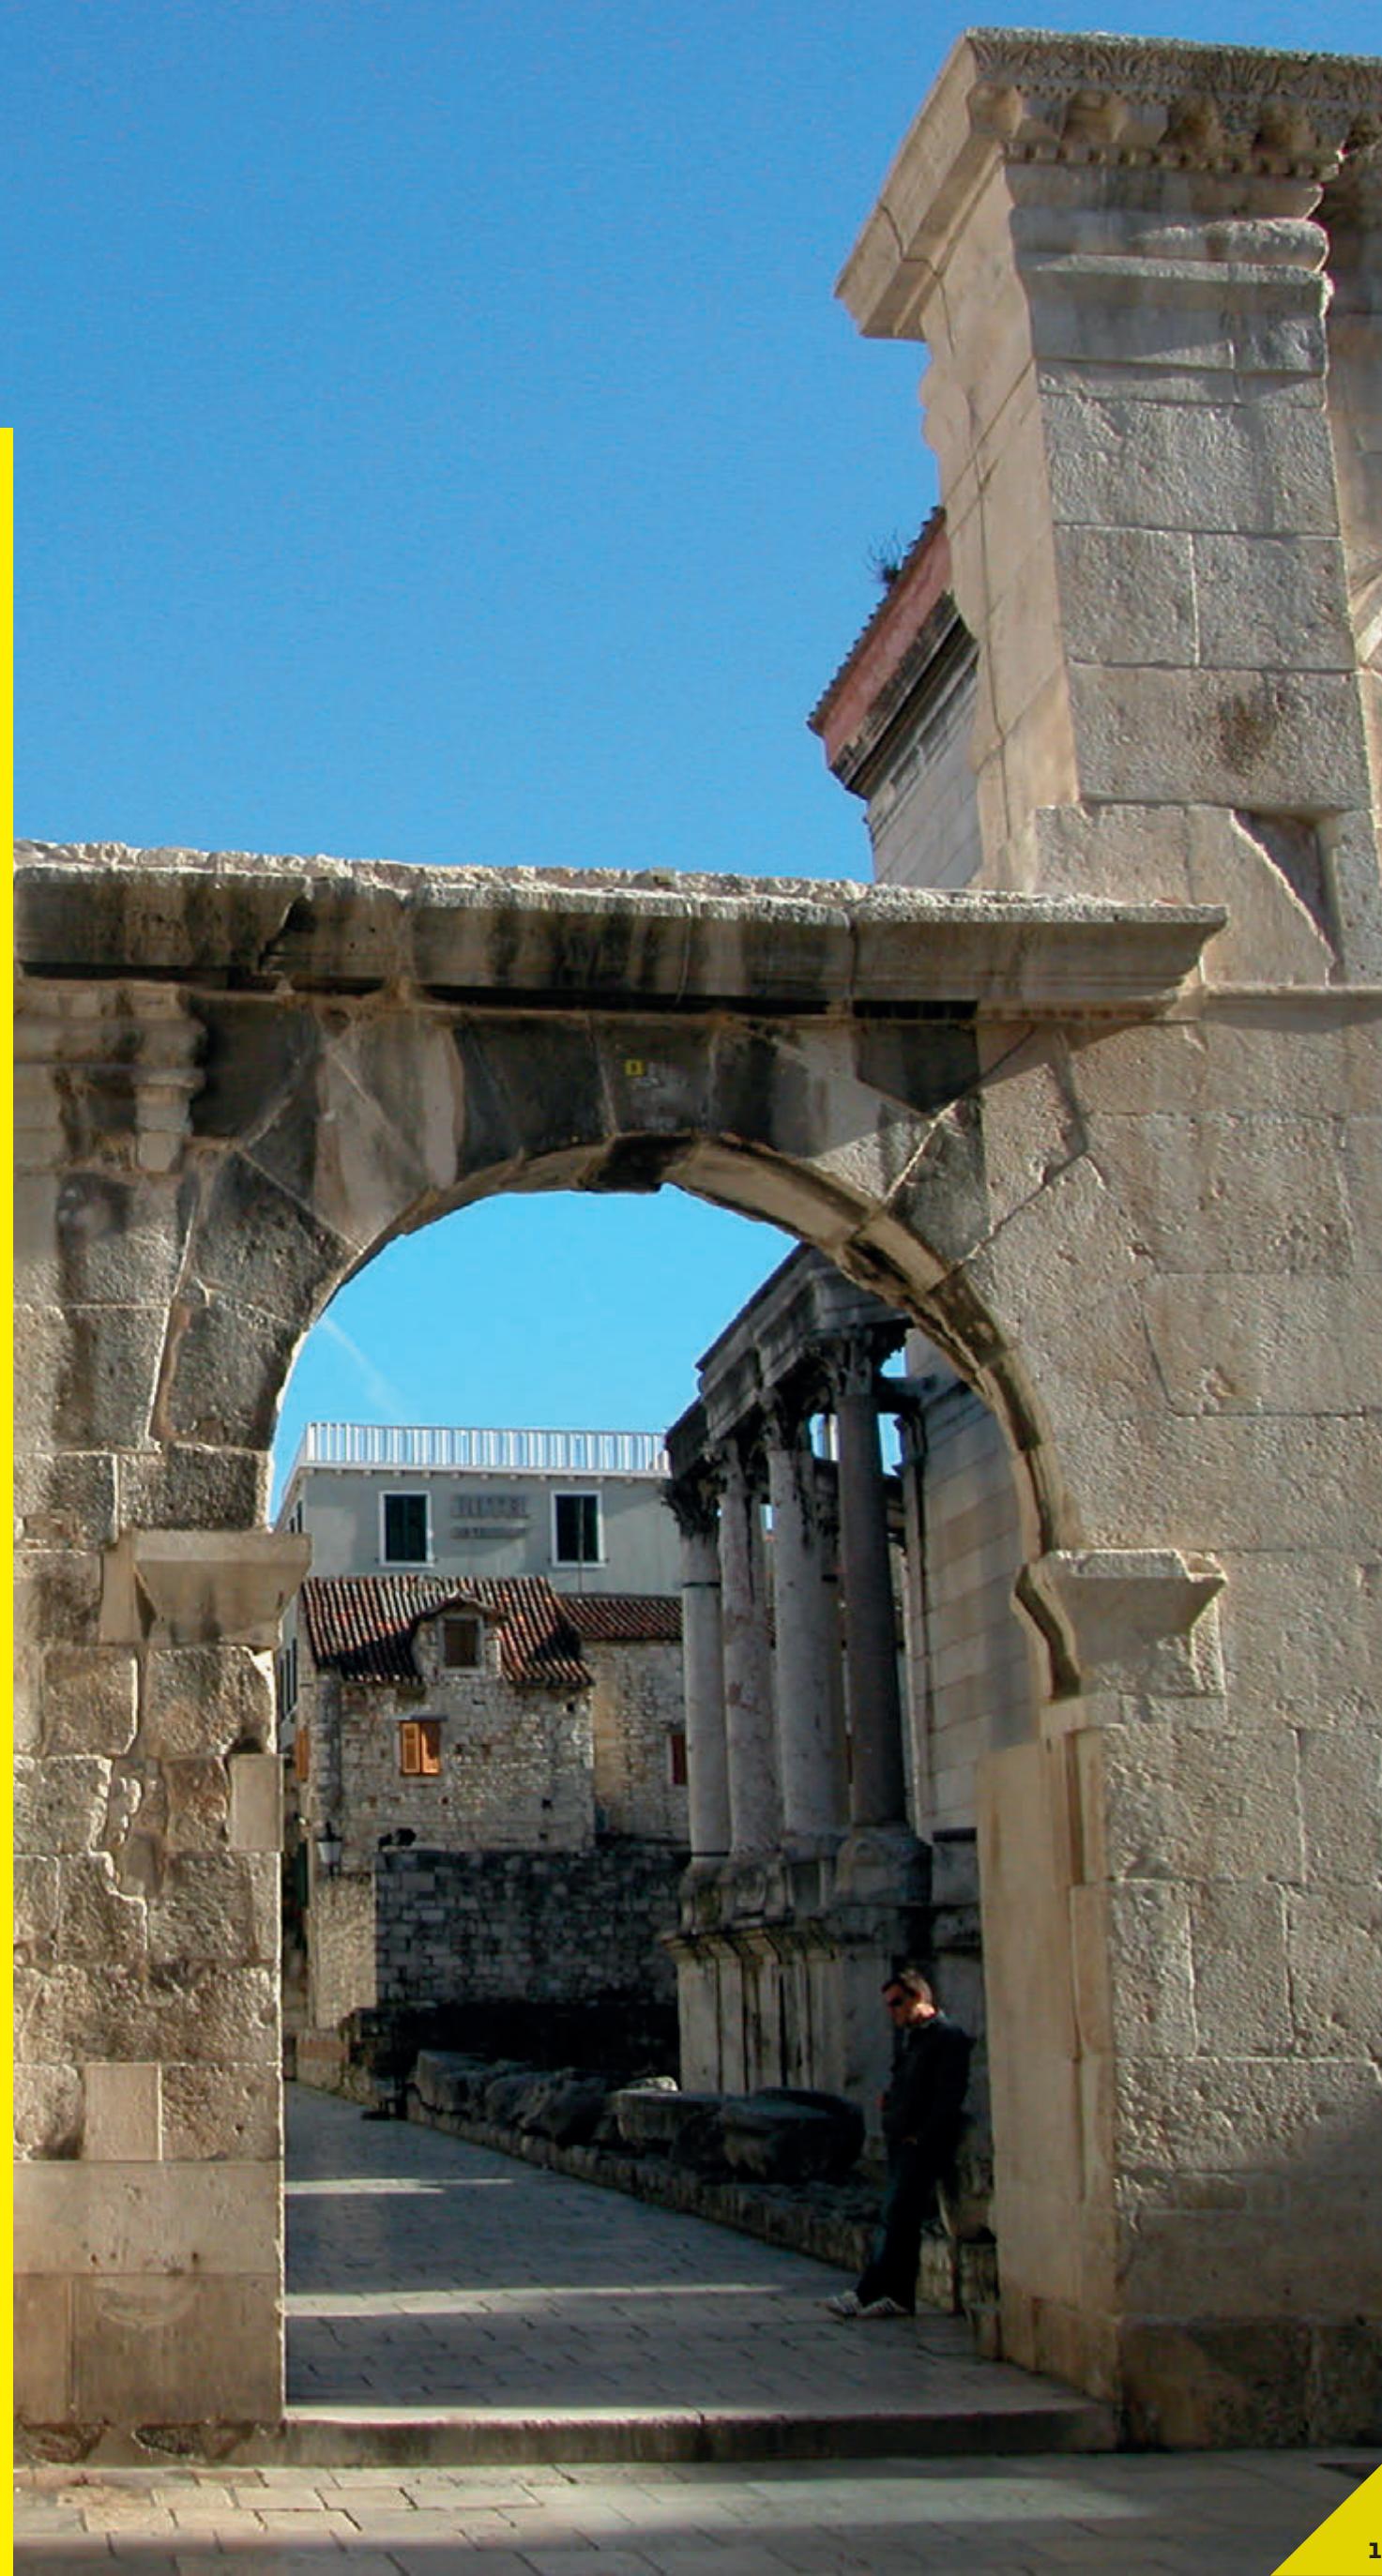
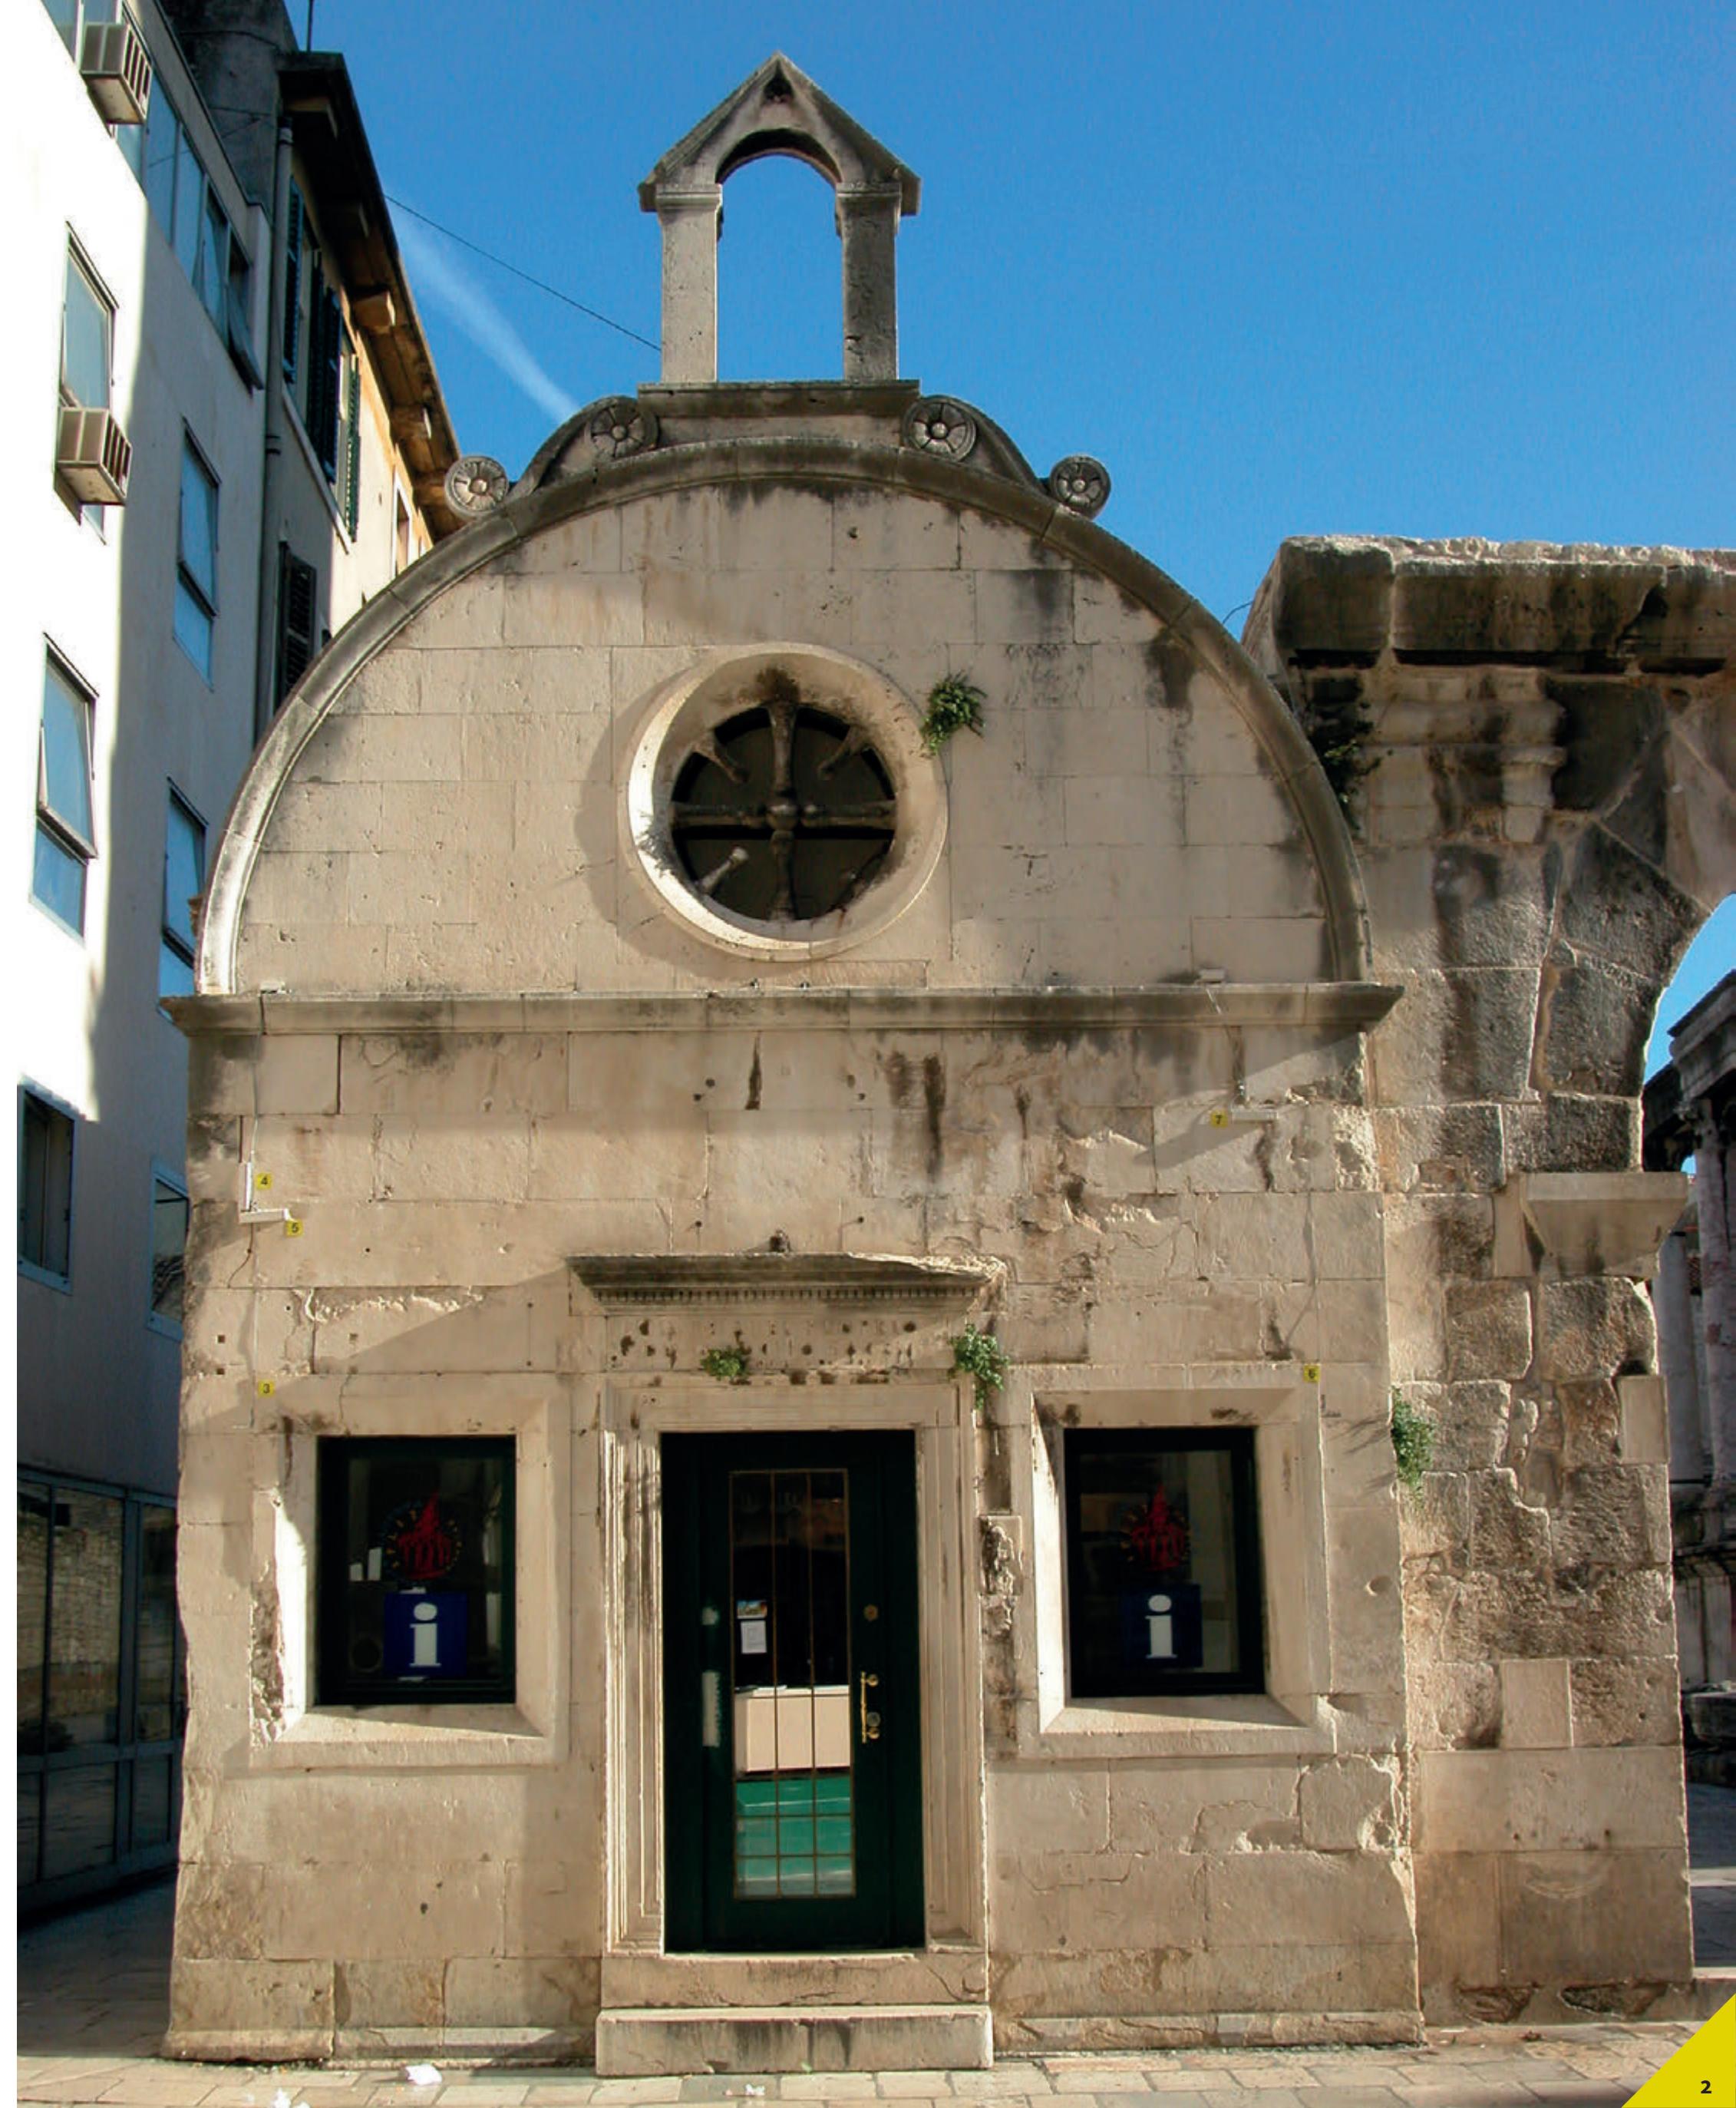
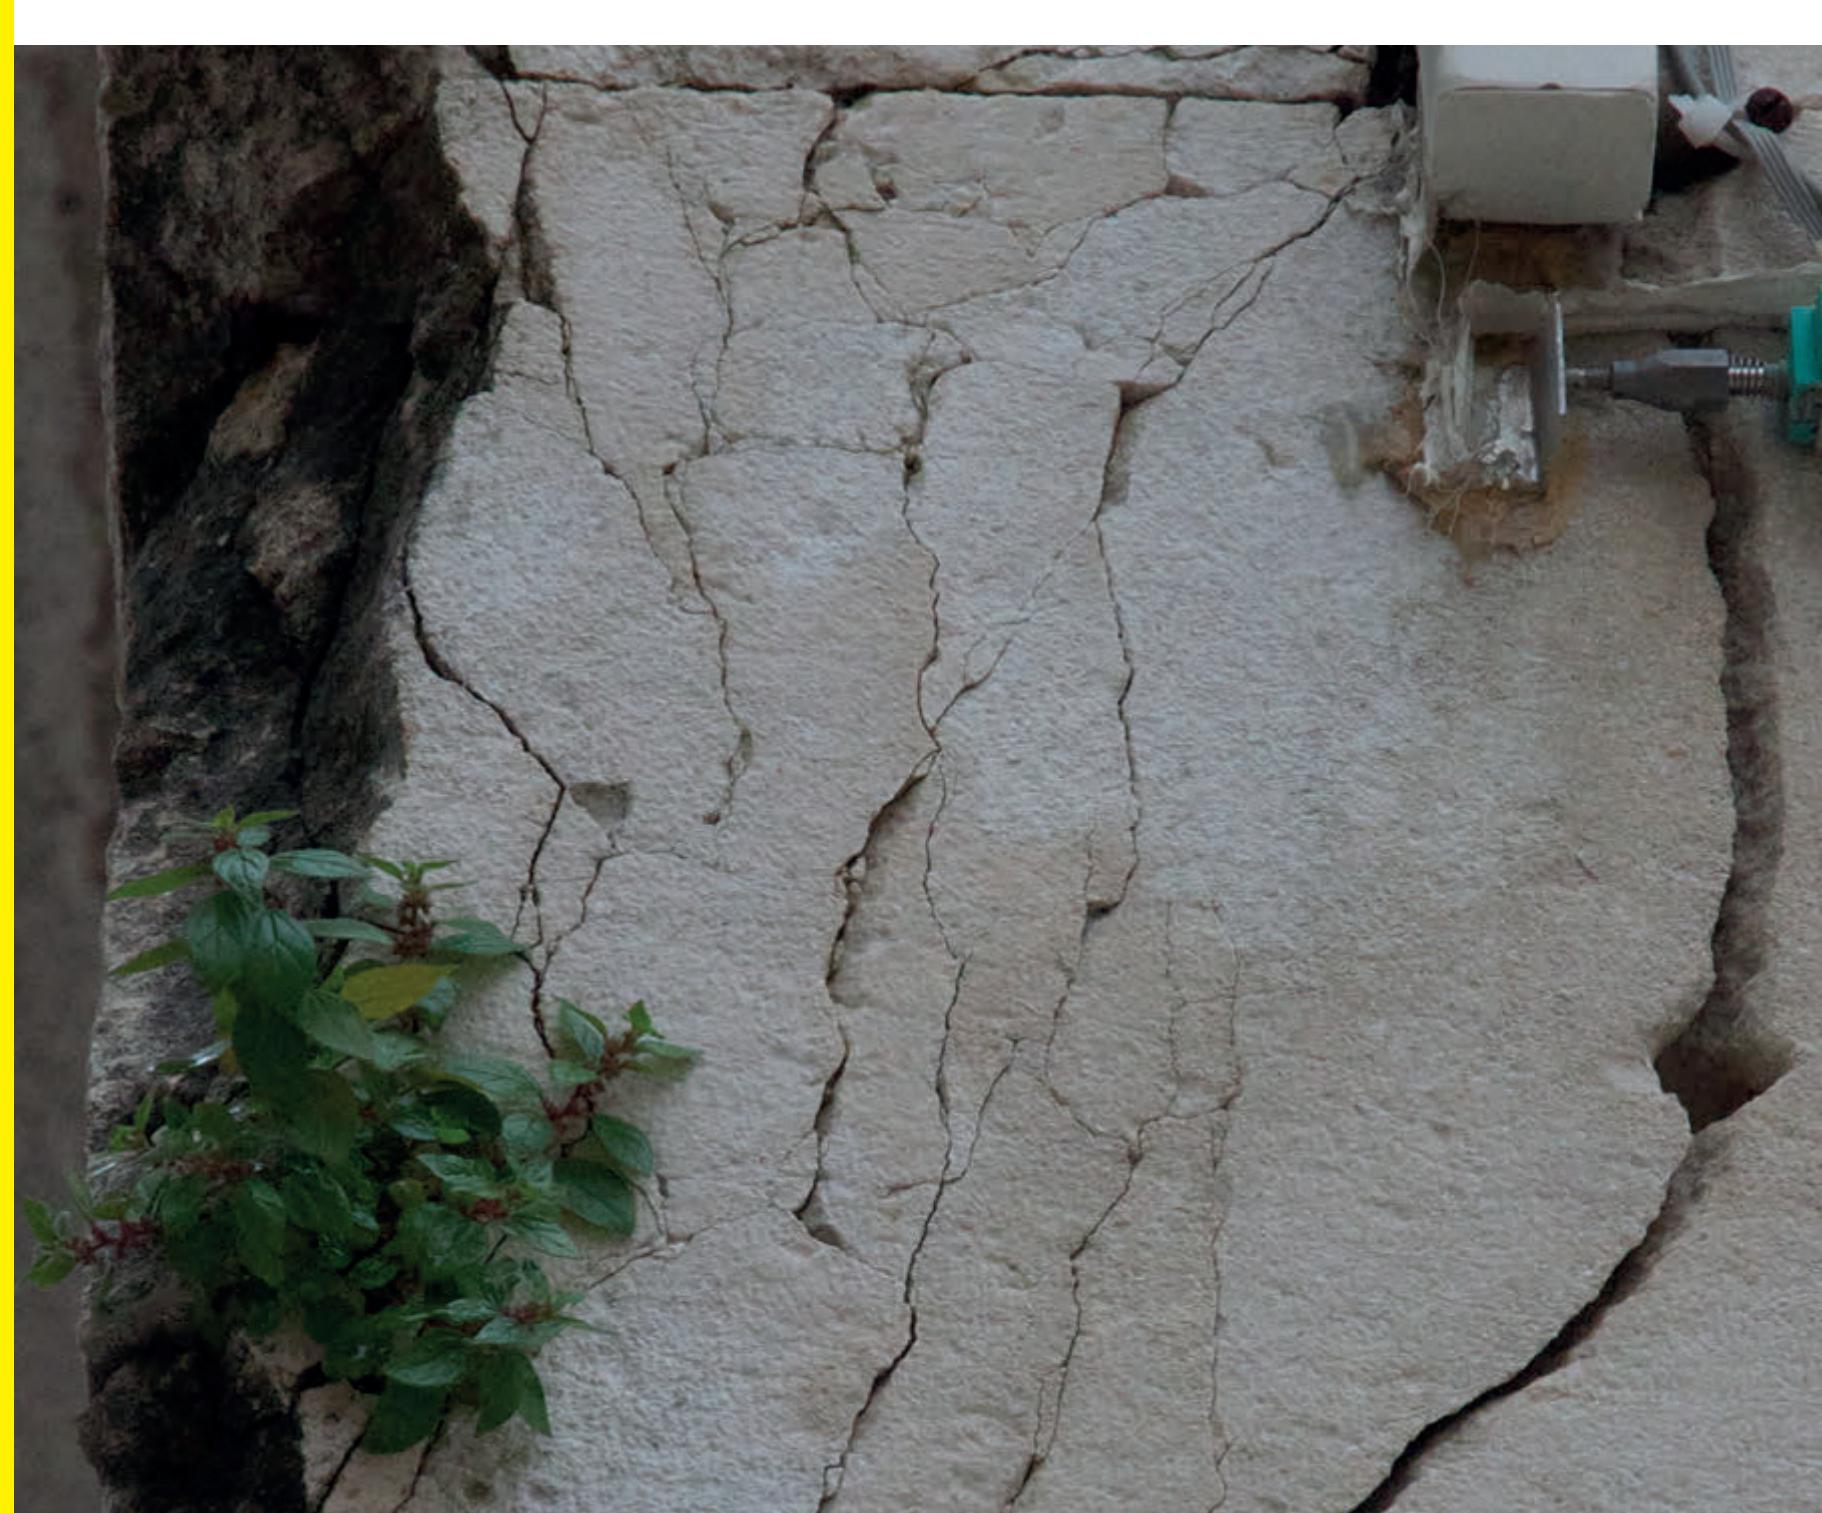
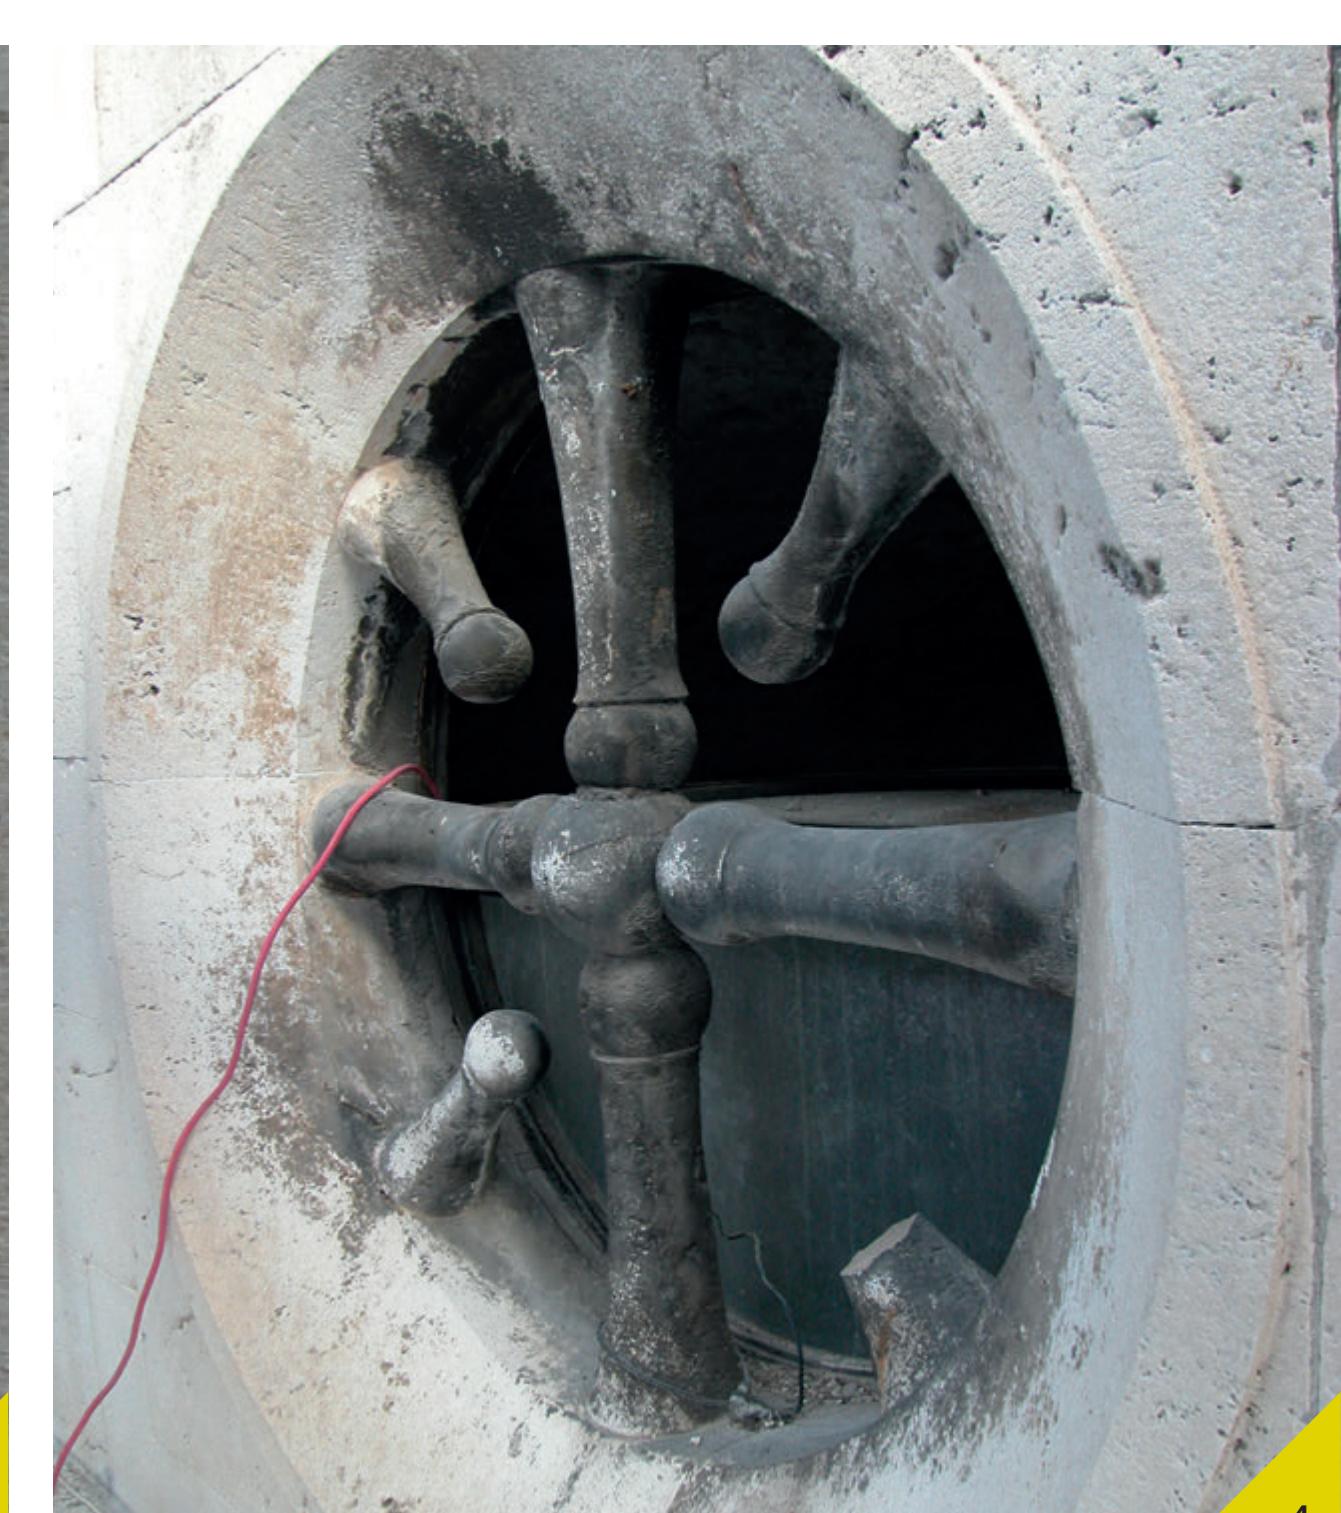
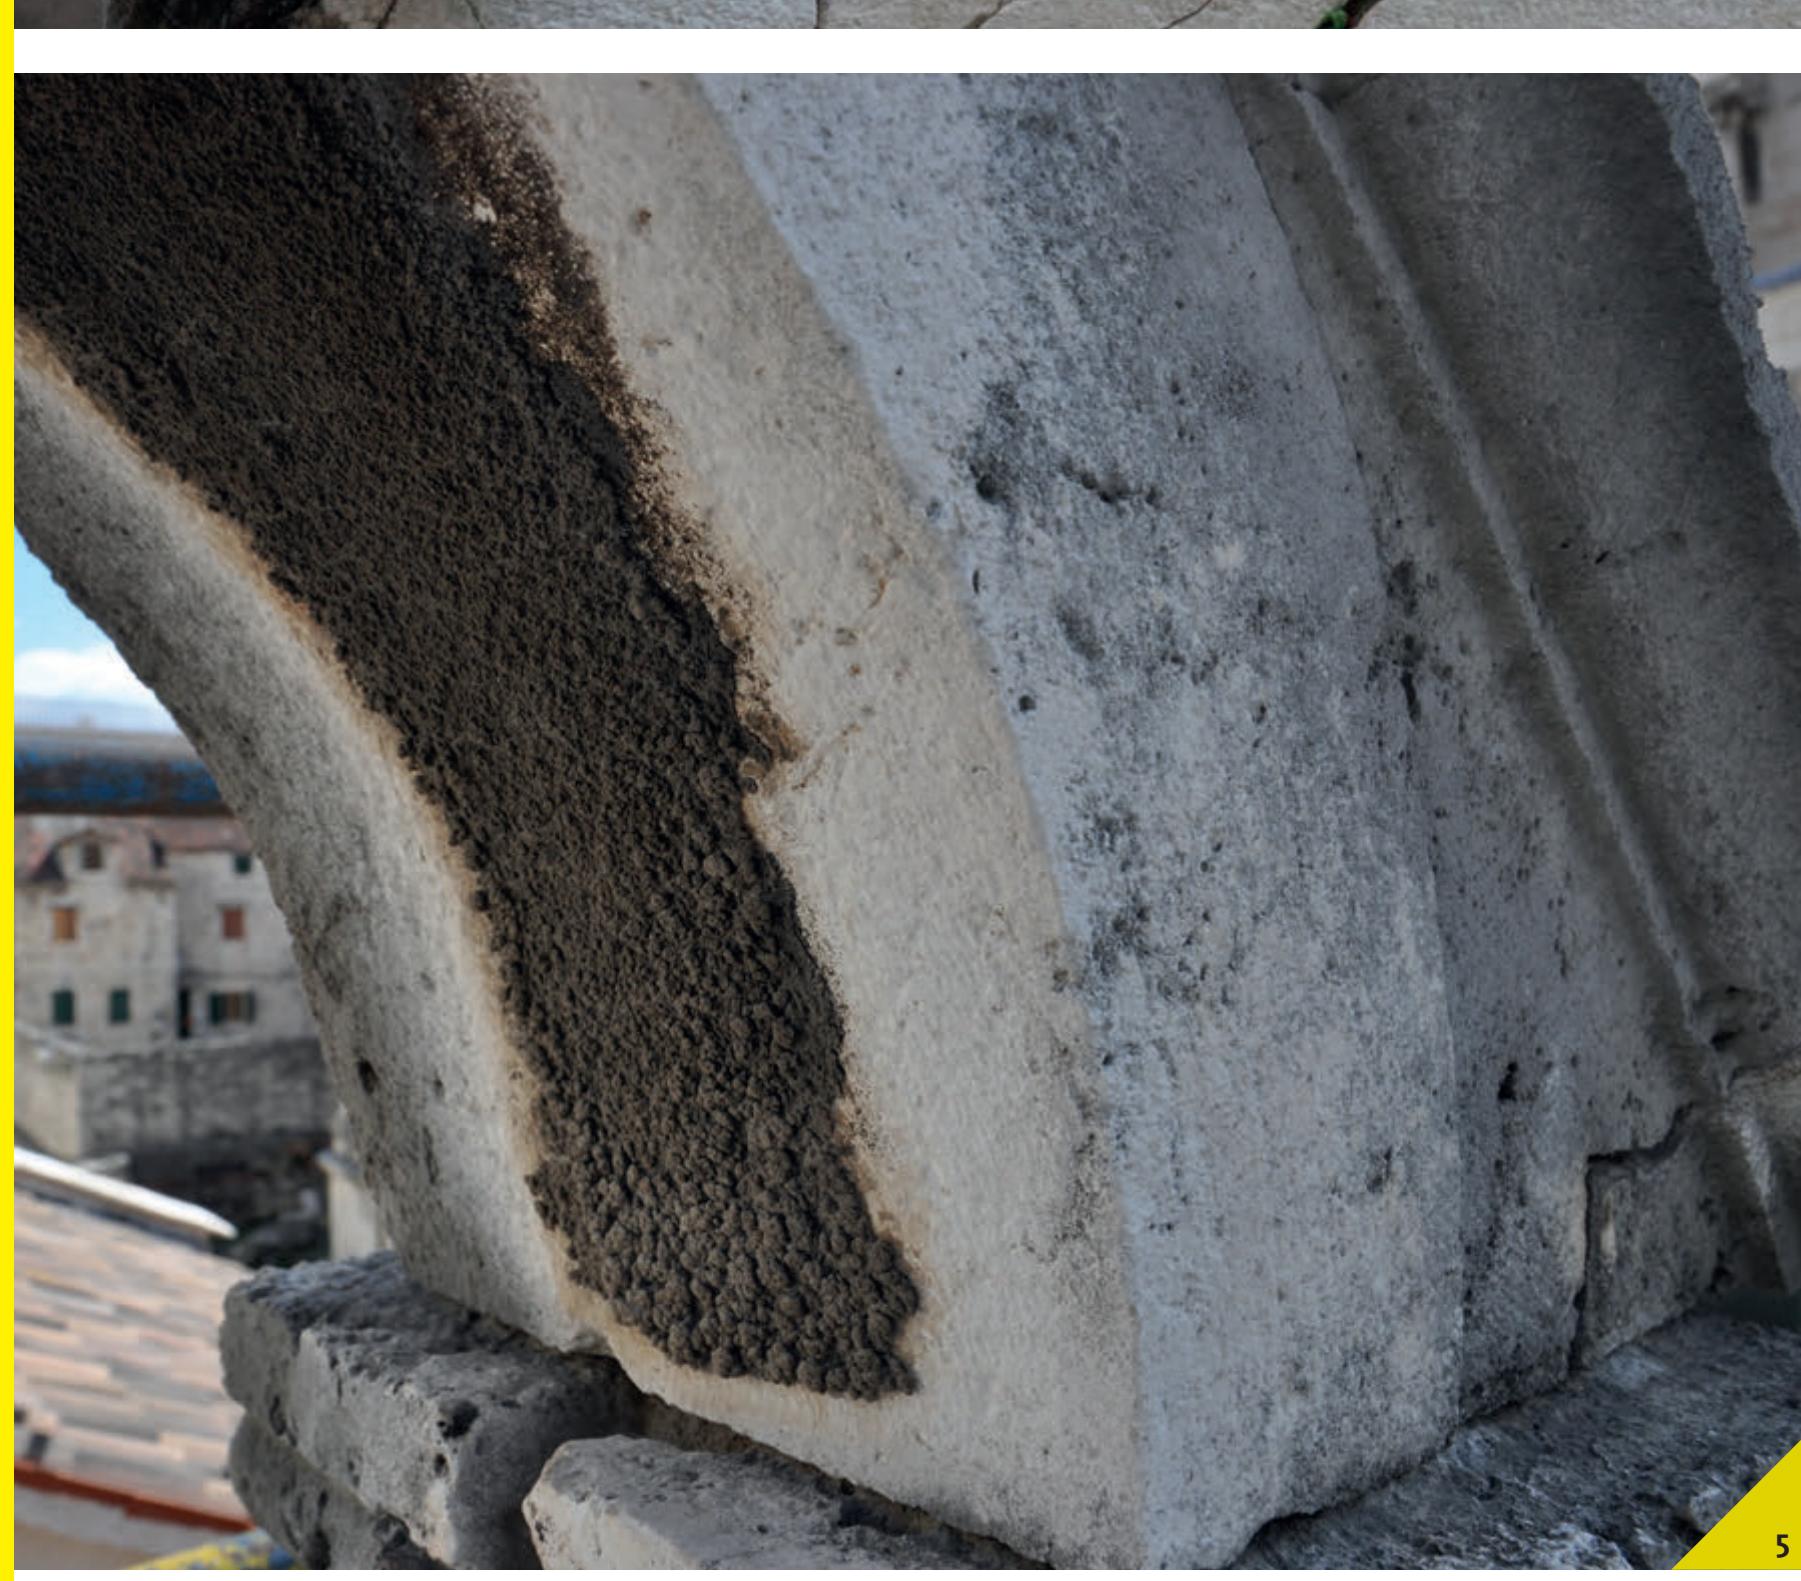
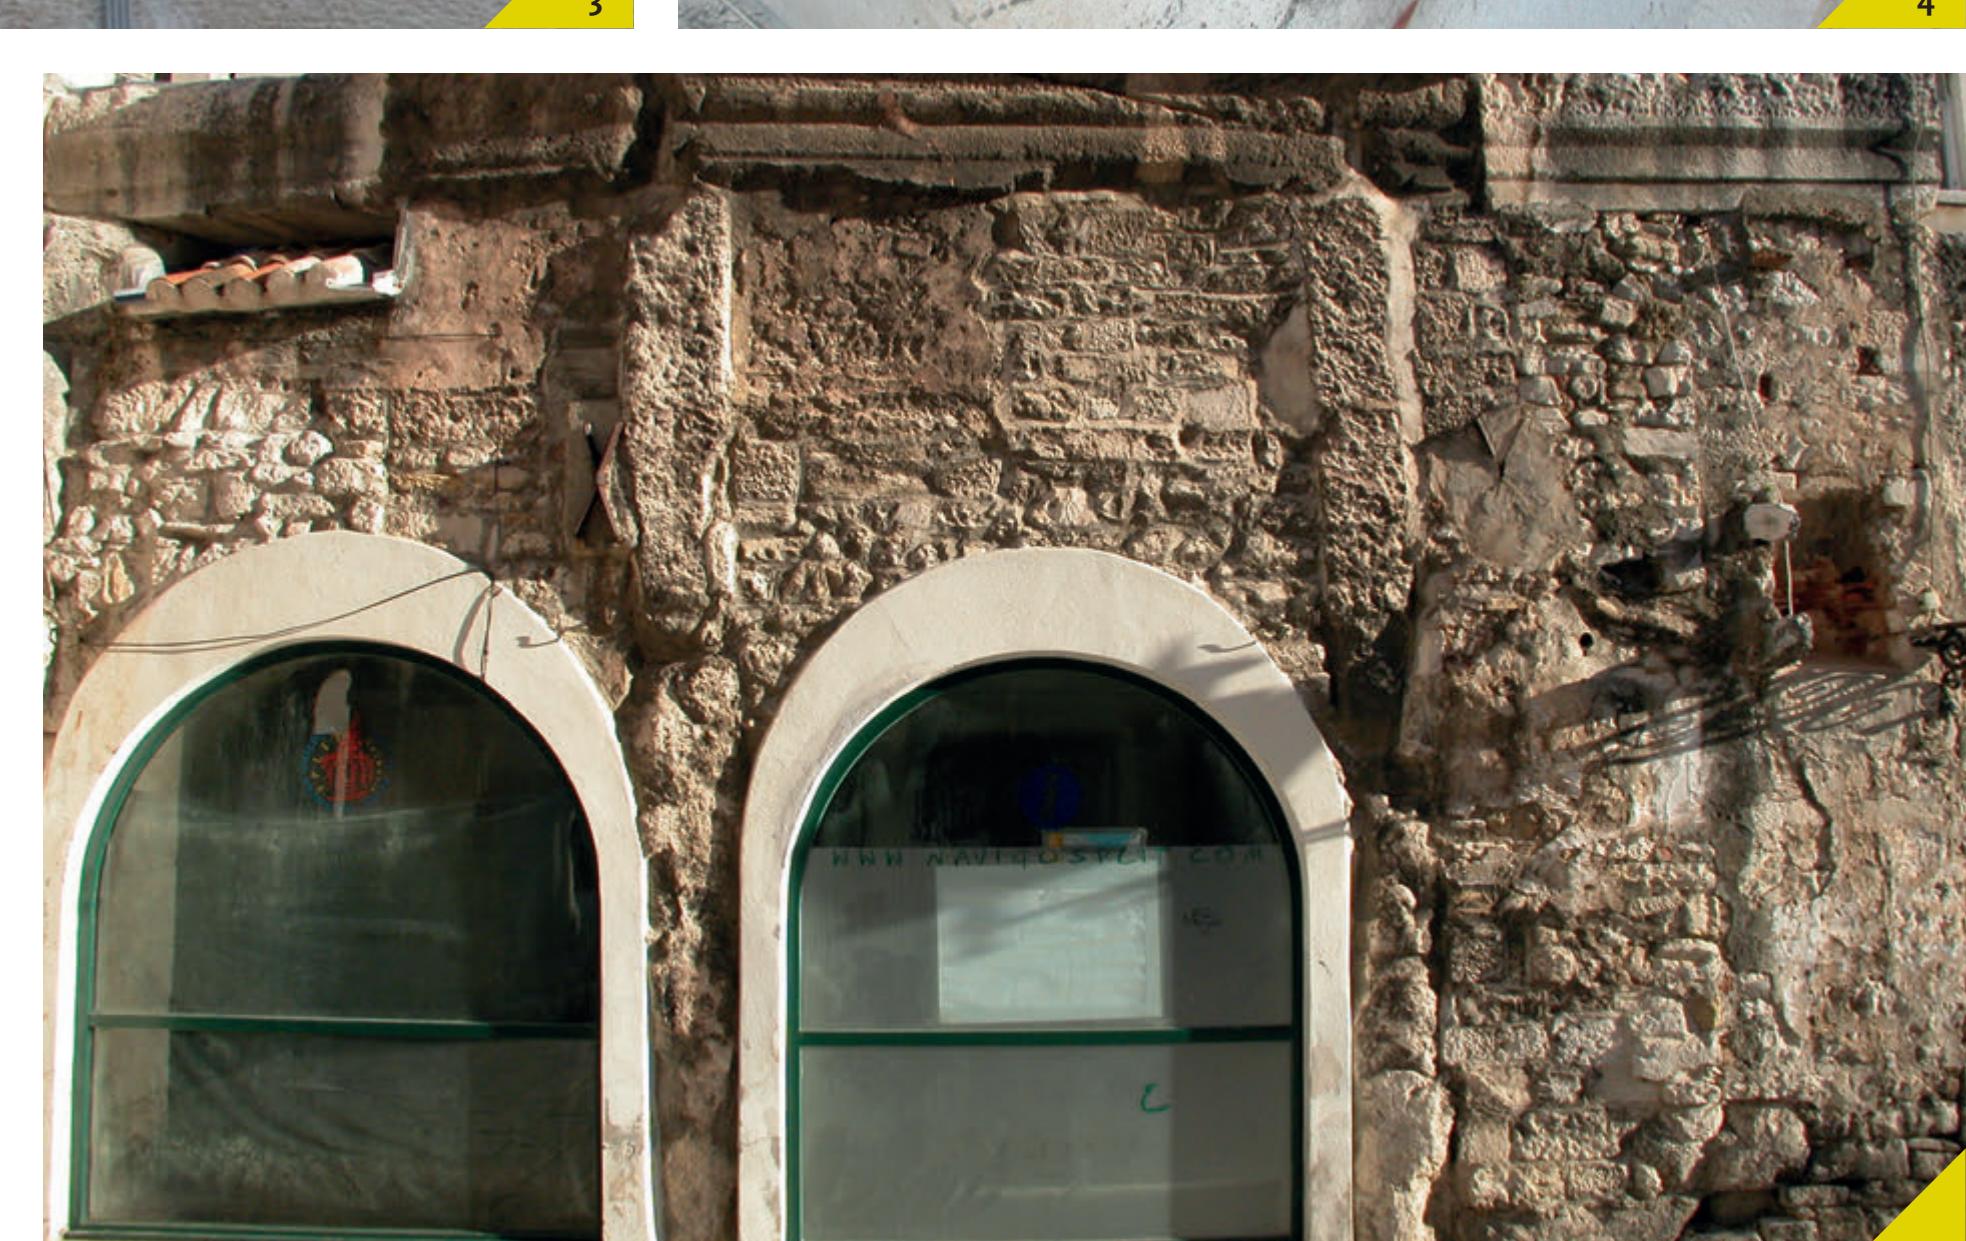
1. THE FIRST ARCH OF THE PORTICO OF THE ANCIENT DECMUMANUS; 2. THE FAÇADE OF THE CHURCH OF ST. ROCH; 3. VERTICAL CRACKING OF STONE ON THE FAÇADE OF THE CHURCH OF ST. ROCH; 4. ROSE WINDOW OF THE CHURCH OF ST. ROCH COVERED WITH BLACK CRUST; 5. DETAIL OF THE CHURCH OF ST. ROCH WITH A BLACK CRUST ON THE PARTS THAT ARE NOT WASHED BY RAIN; 6. THE SOUTH SIDE OF THE CHURCH OF ST. ROCH BEFORE CONSERVATION-RESTORATION WORK; 7. MECHANICAL DAMAGE TO THE PORTAL OF ST. ROCH; 8. TRACES OF ROMANESQUE WINDOWS WERE FOUND ON THE ARHITRAVES OF THE DECMUMANUS PORTICO; 9. FOUNDATIONS AT THE NORTHWEST CORNER OF THE CHURCH OF ST. ROCH
