## Na završetku desetljeća obnove Peristila

## At the end of a Decade of the Peristyle Restoration

The conservation and restoration work on the Peristyle of Diocletian's Palace has been in many ways the most important project in recent period within the scope of renovation of the historical core of the town of Split. The Peristyle is the centre and the most impressive part of the imperial palace, and also the heart of the town which has grown around it. The square, which reflects historical layers of the creation and development of the town, has become its symbol and its main tourist attraction. It serves as the most attractive backdrop for cultural events, and a stage at which public life evolves.

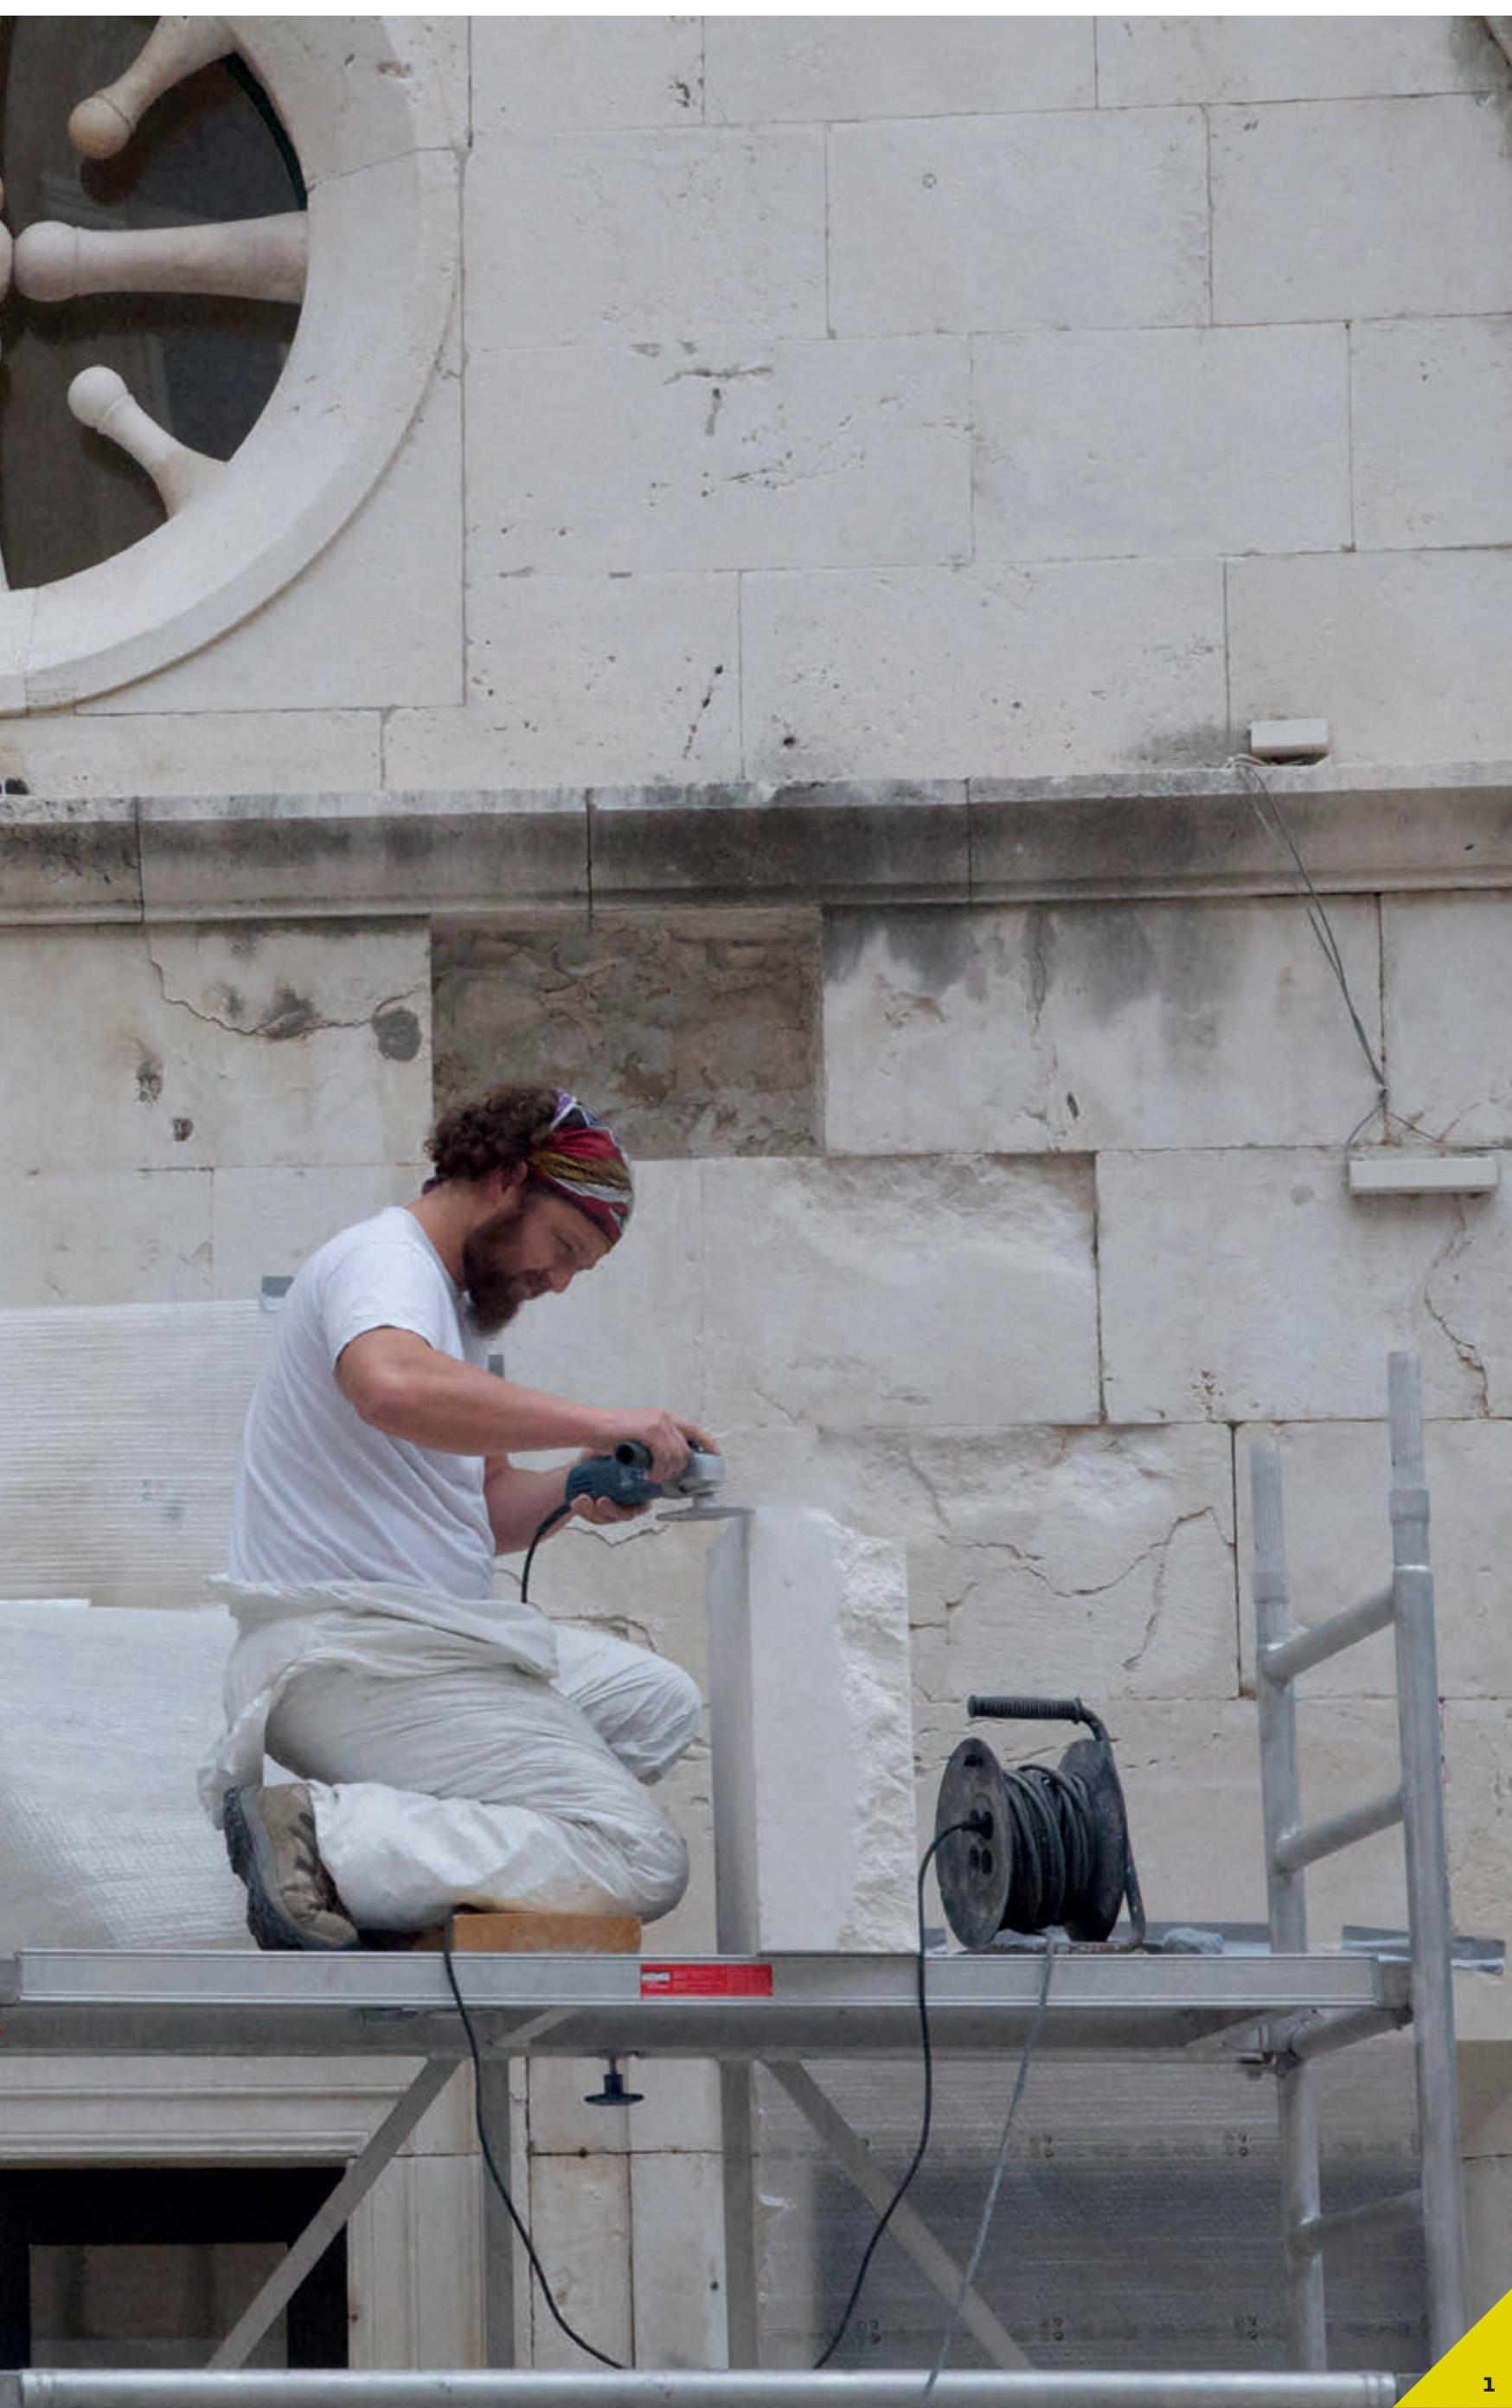
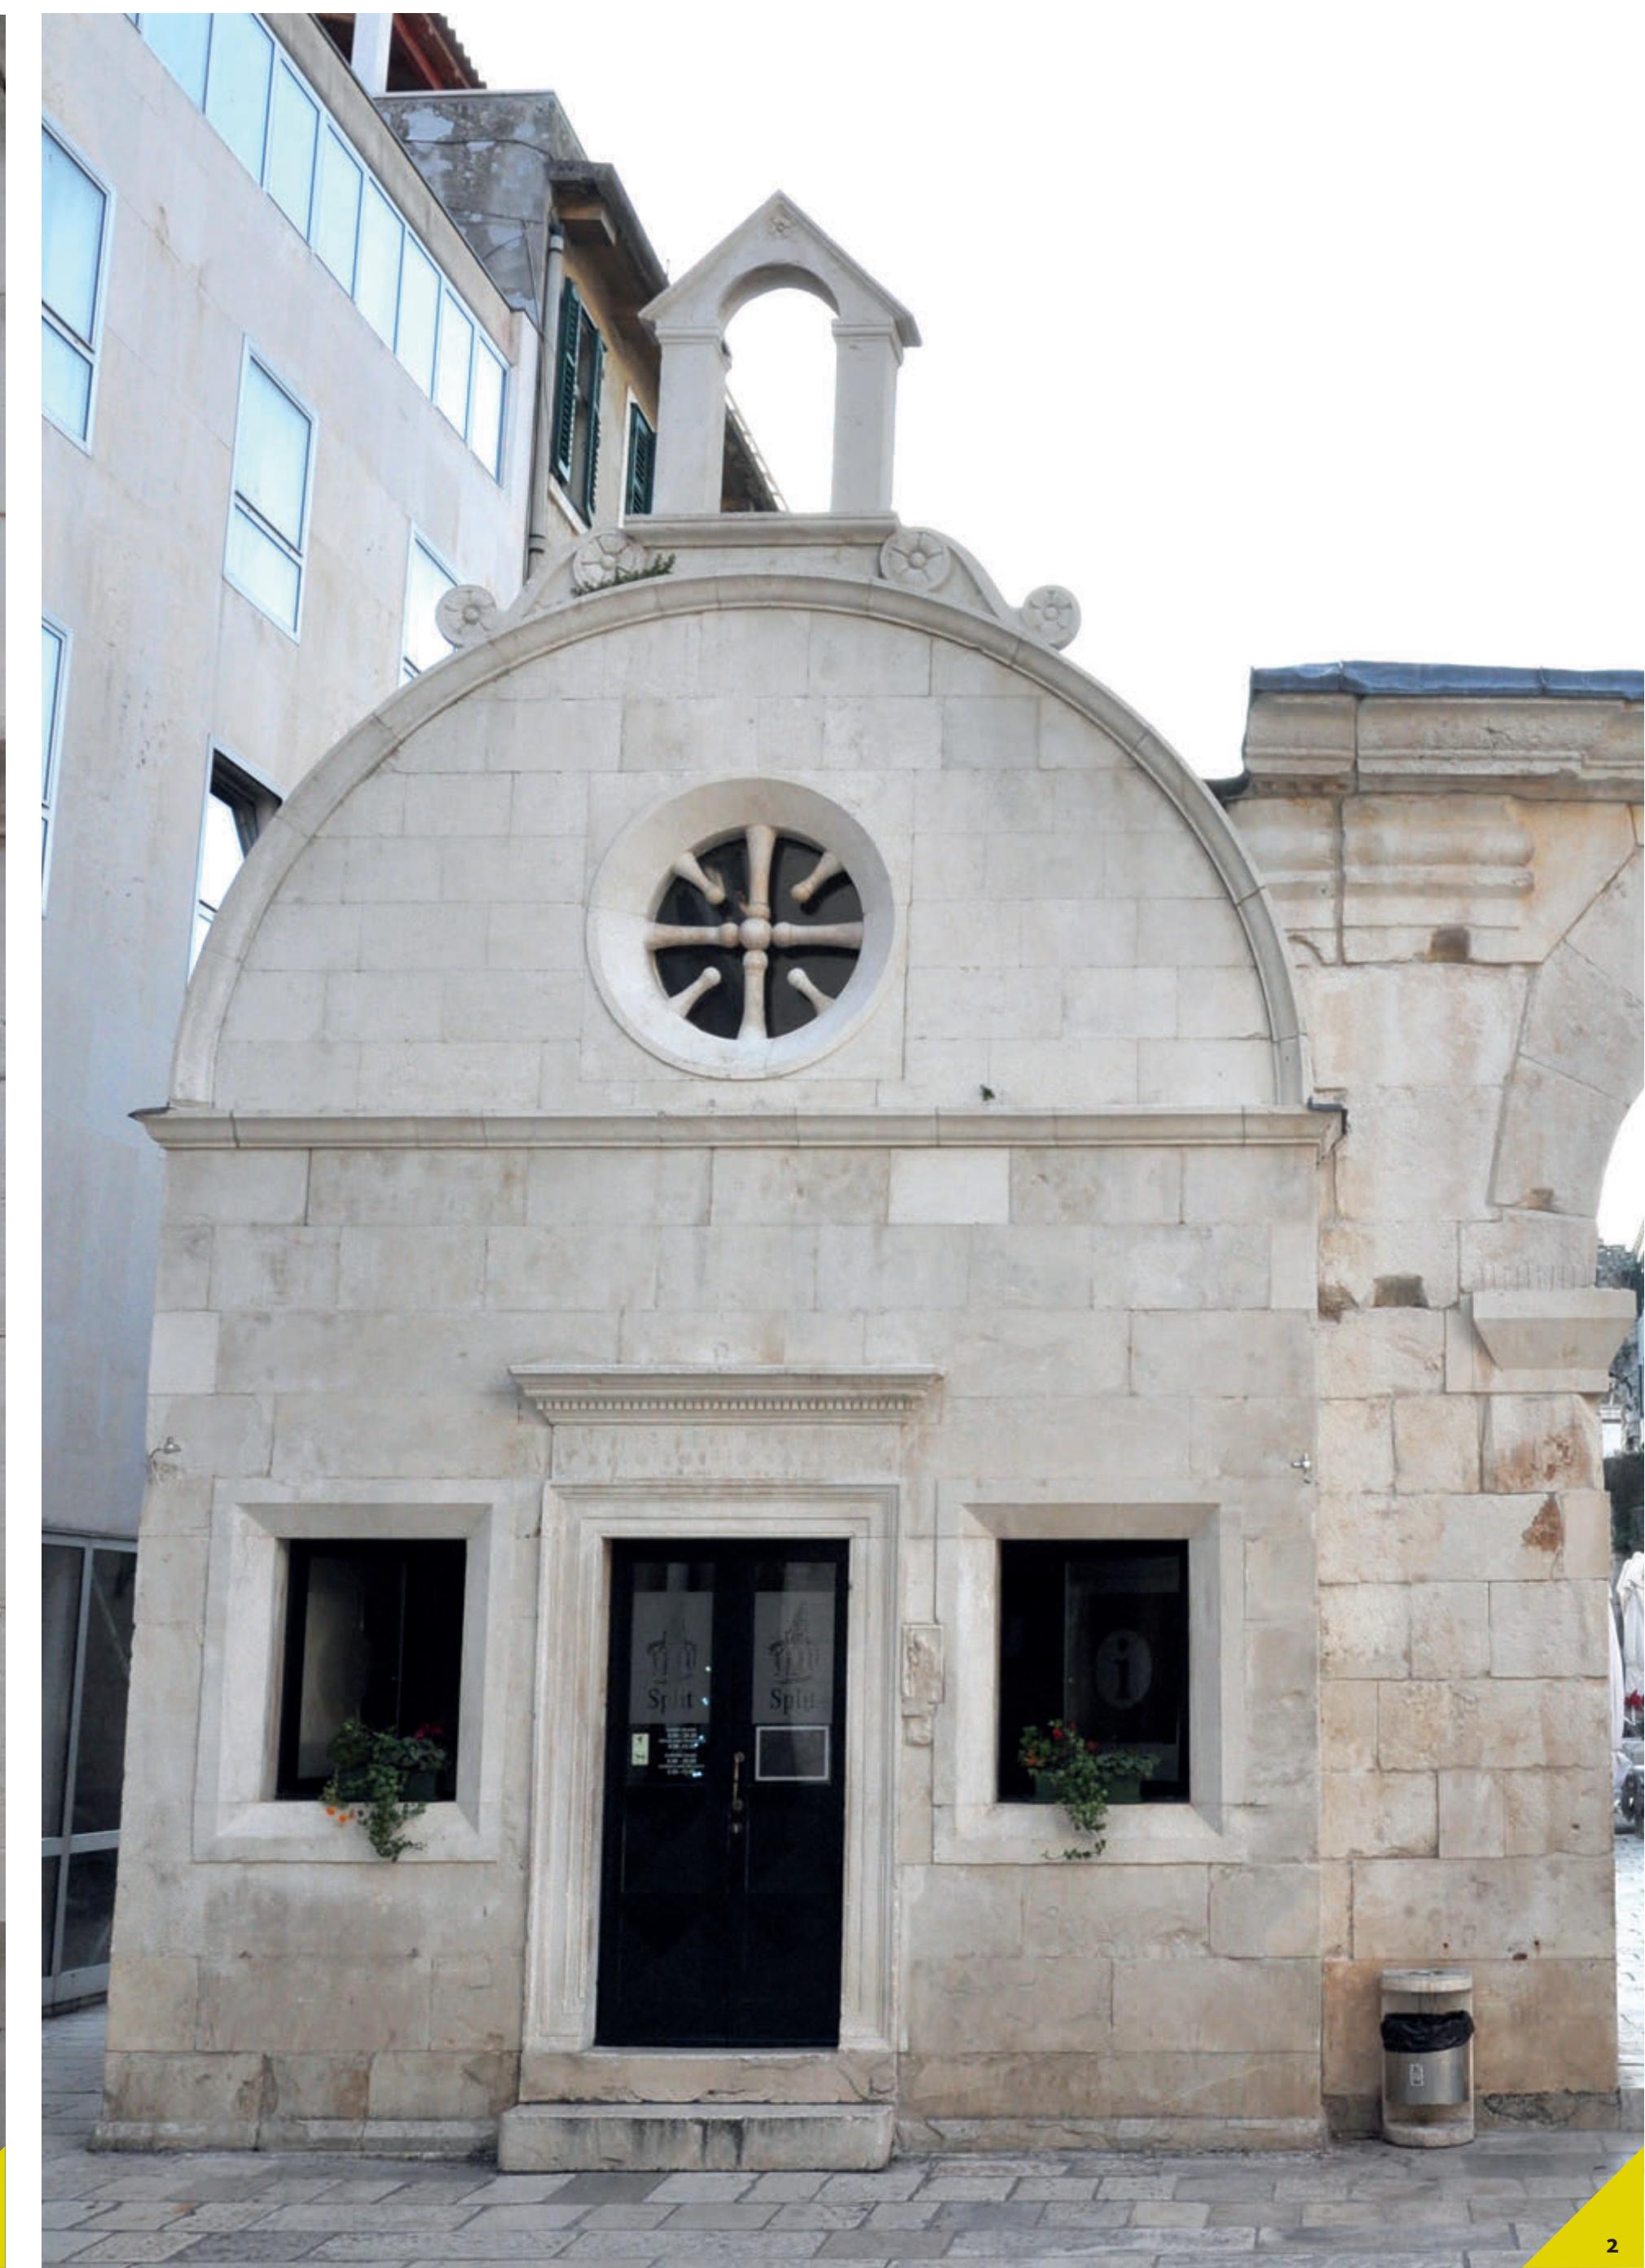
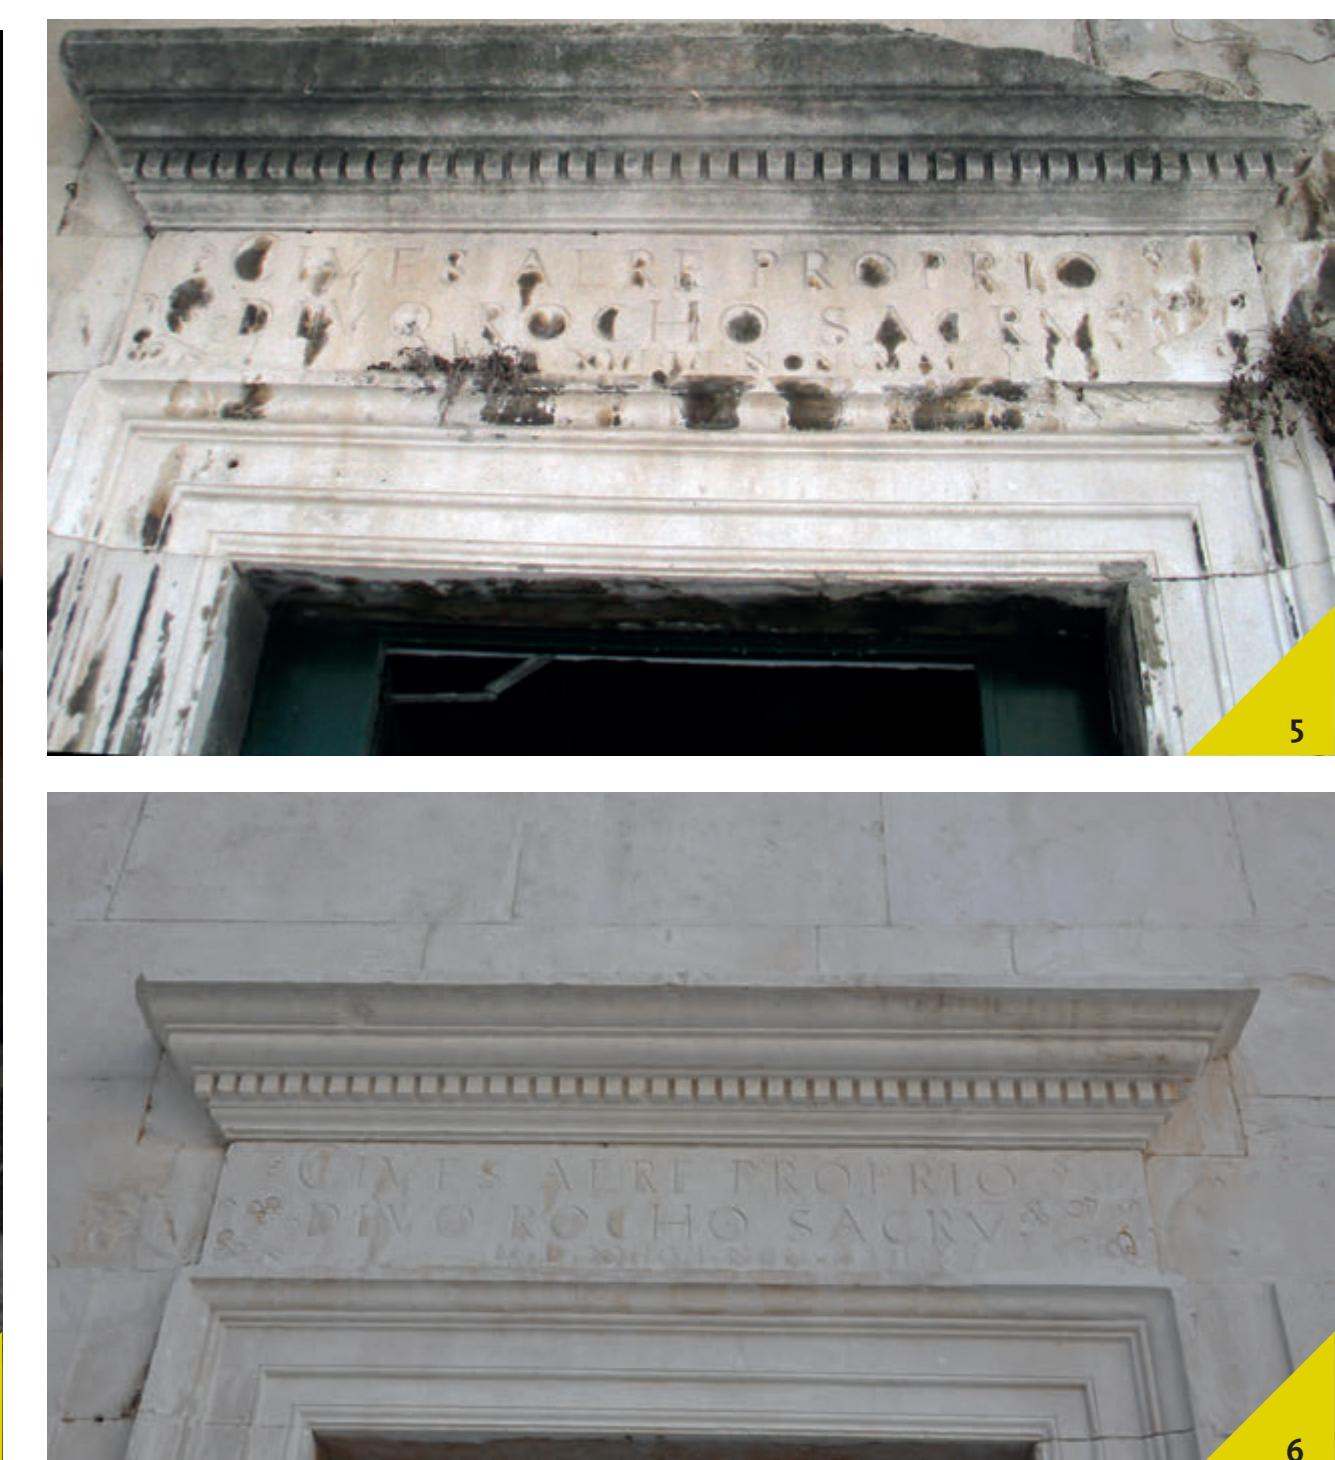
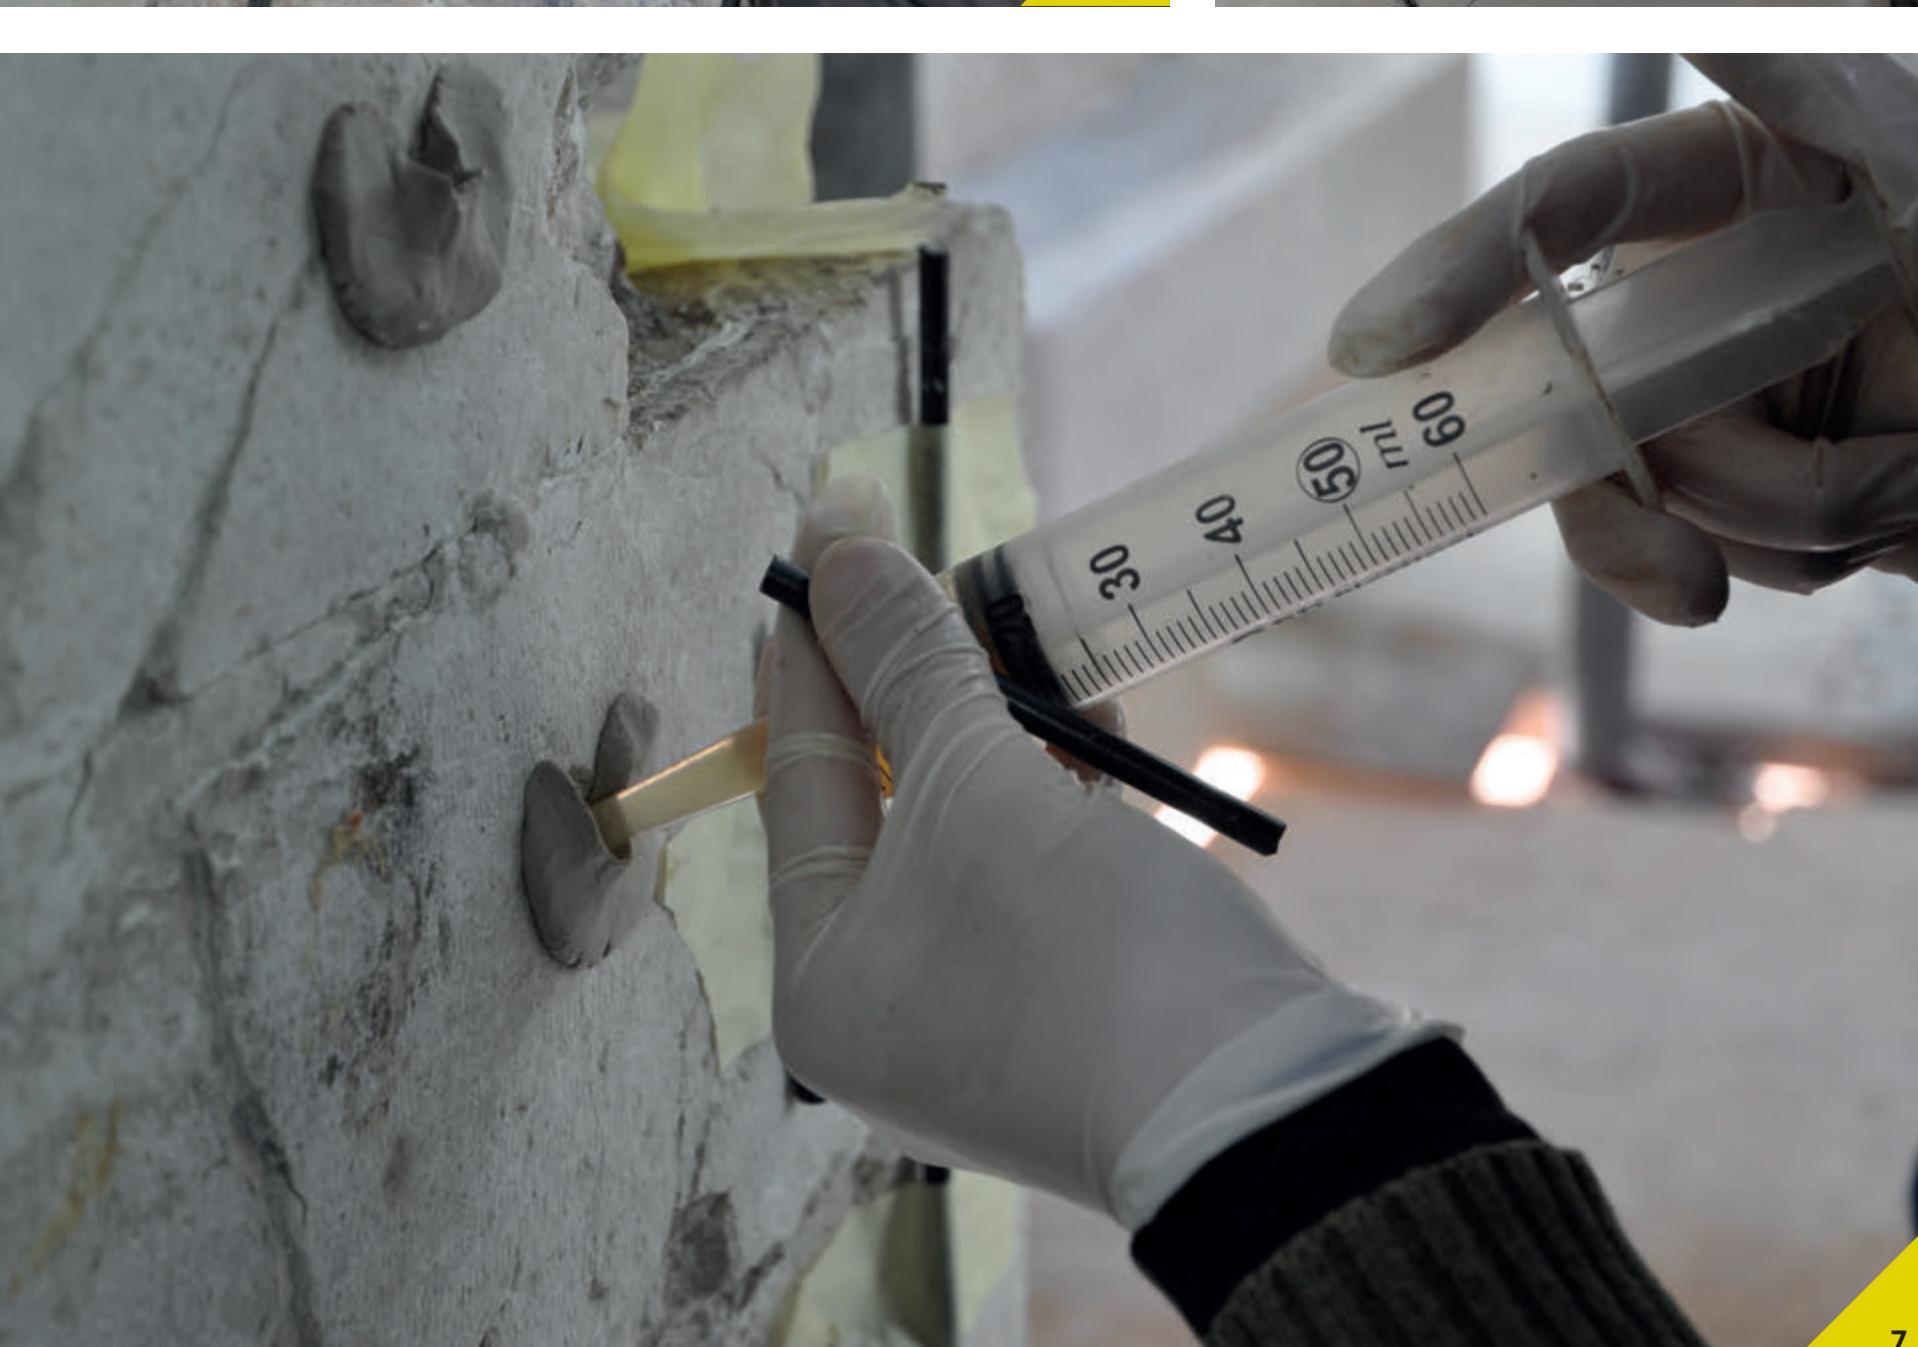
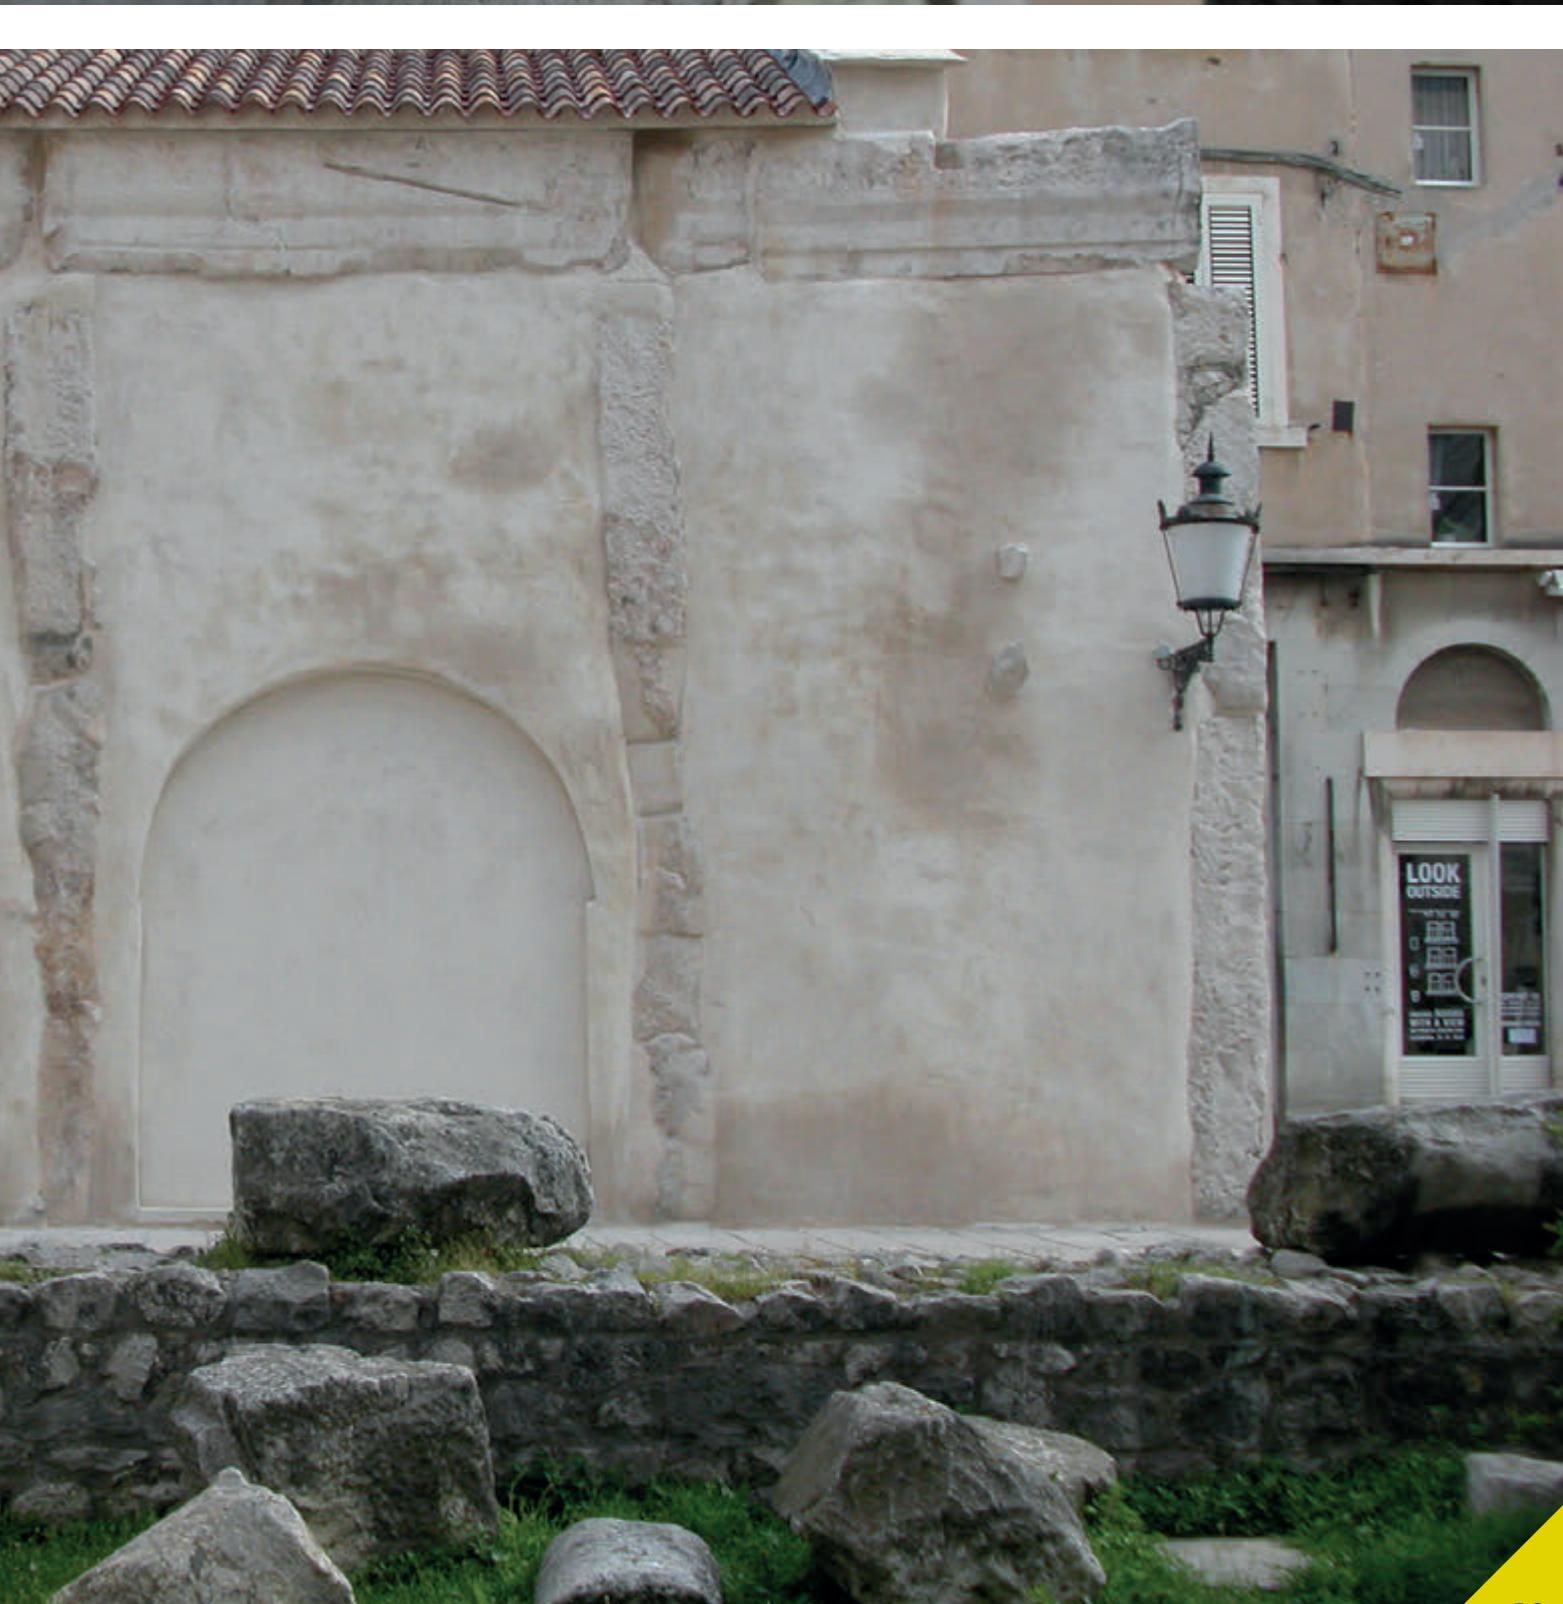
1. OBRAĐA KAMENOG BLOKA ZA UGRADNJU U FASADU CRKVE SV. ROKA; 2. FASADA CRKVE SV. ROKA NAKON KONZERVATORSKO-RESTAURATORSKOG ZAHVATA; 3, 4. TIJEKOM IZRade REKONSTRUKCIJE NA VJENCU PORTALA SV. ROKA; 5, 6. VJENAC PORTALA SV. ROKA PRIJE I NAKON KONZERVATORSKO-RESTAURATORSKOG ZAHVATA; 7. INJEKTIRANJE EPOXIDNE SMOLE I UMETANJE KARBONSKIH TRNOVA U VERTICALNO RASPUCALU STRUKTURU KAMENA U SRVHU UČVRŠĆIVANJA ISTOГ; 8. FASADA CRKVE SV. ROKA TIJEKOM KONSOLIDIRANJA POVRŠINE VAKUM METodom; 9. IZRADA REKONSTRUKCIJE NA FASADI CRKVE SV. ROKA; 10. JUŽNA STRANA CRKVE SV. ROKA NAKON KONZERVATORSKO-RESTAURATORSKOG ZAHVATA; 11, 12. RELIEF SV. ROKA NA FASADI CRKVE PRIJE I NAKON KONZERVATORSKO-RESTAURATORSKOG ZAHVATA

Interior was redecorated in accordance with conservation demands. Tombs found under the recent floor have been conserved and protected with a new stone pavement. Stone imposts and cornices on the walls have been reconstructed, wide arch openings in the south wall have been walled-up and old mortar was replaced with a new acrylic-lime mortar.
