## Na završetku desetljeća obnove Peristila

## At the end of a Decade of the Peristyle Restoration

The conservation and restoration work on the Peristyle of Diocletian's Palace has been in many ways the most important project in recent period within the scope of renovation of the historical core of the town of Split. The Peristyle is the centre and the most impressive part of the imperial palace, and also the heart of the town which has grown around it. The square, which reflects historical layers of the creation and development of the town, has become its symbol and its main tourist attraction. It serves as the most attractive backdrop for cultural events, and a stage at which public life evolves.

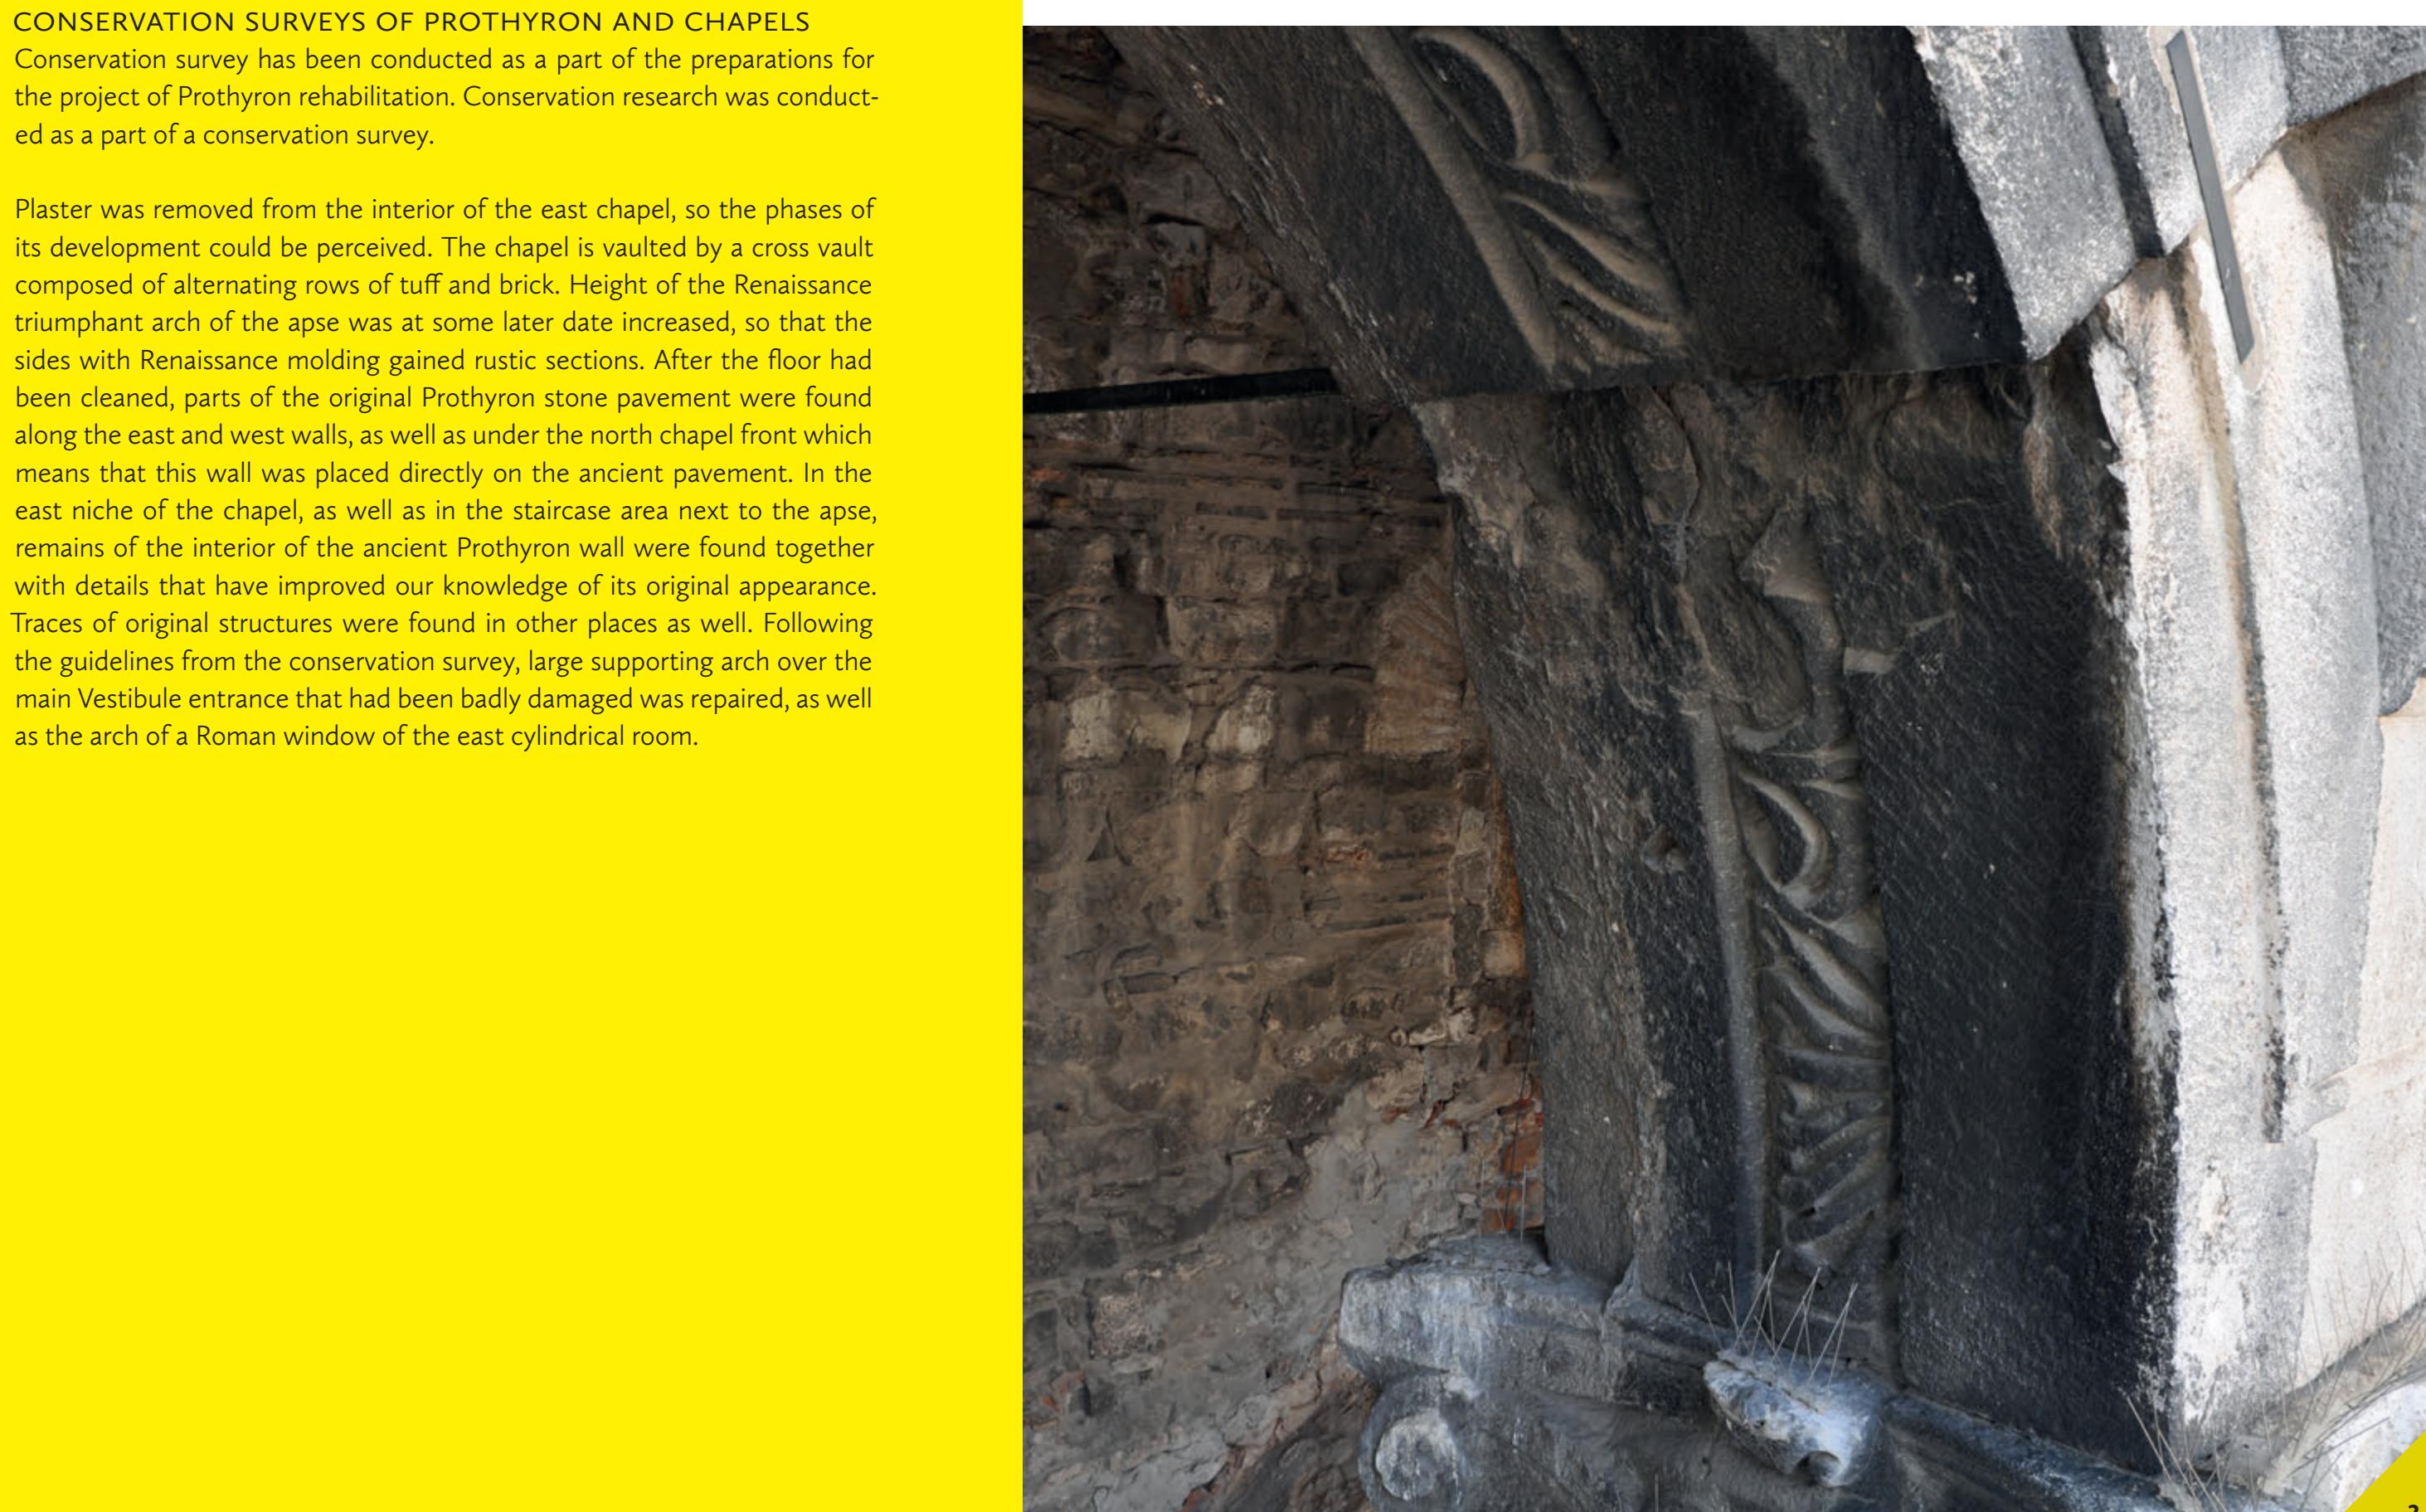
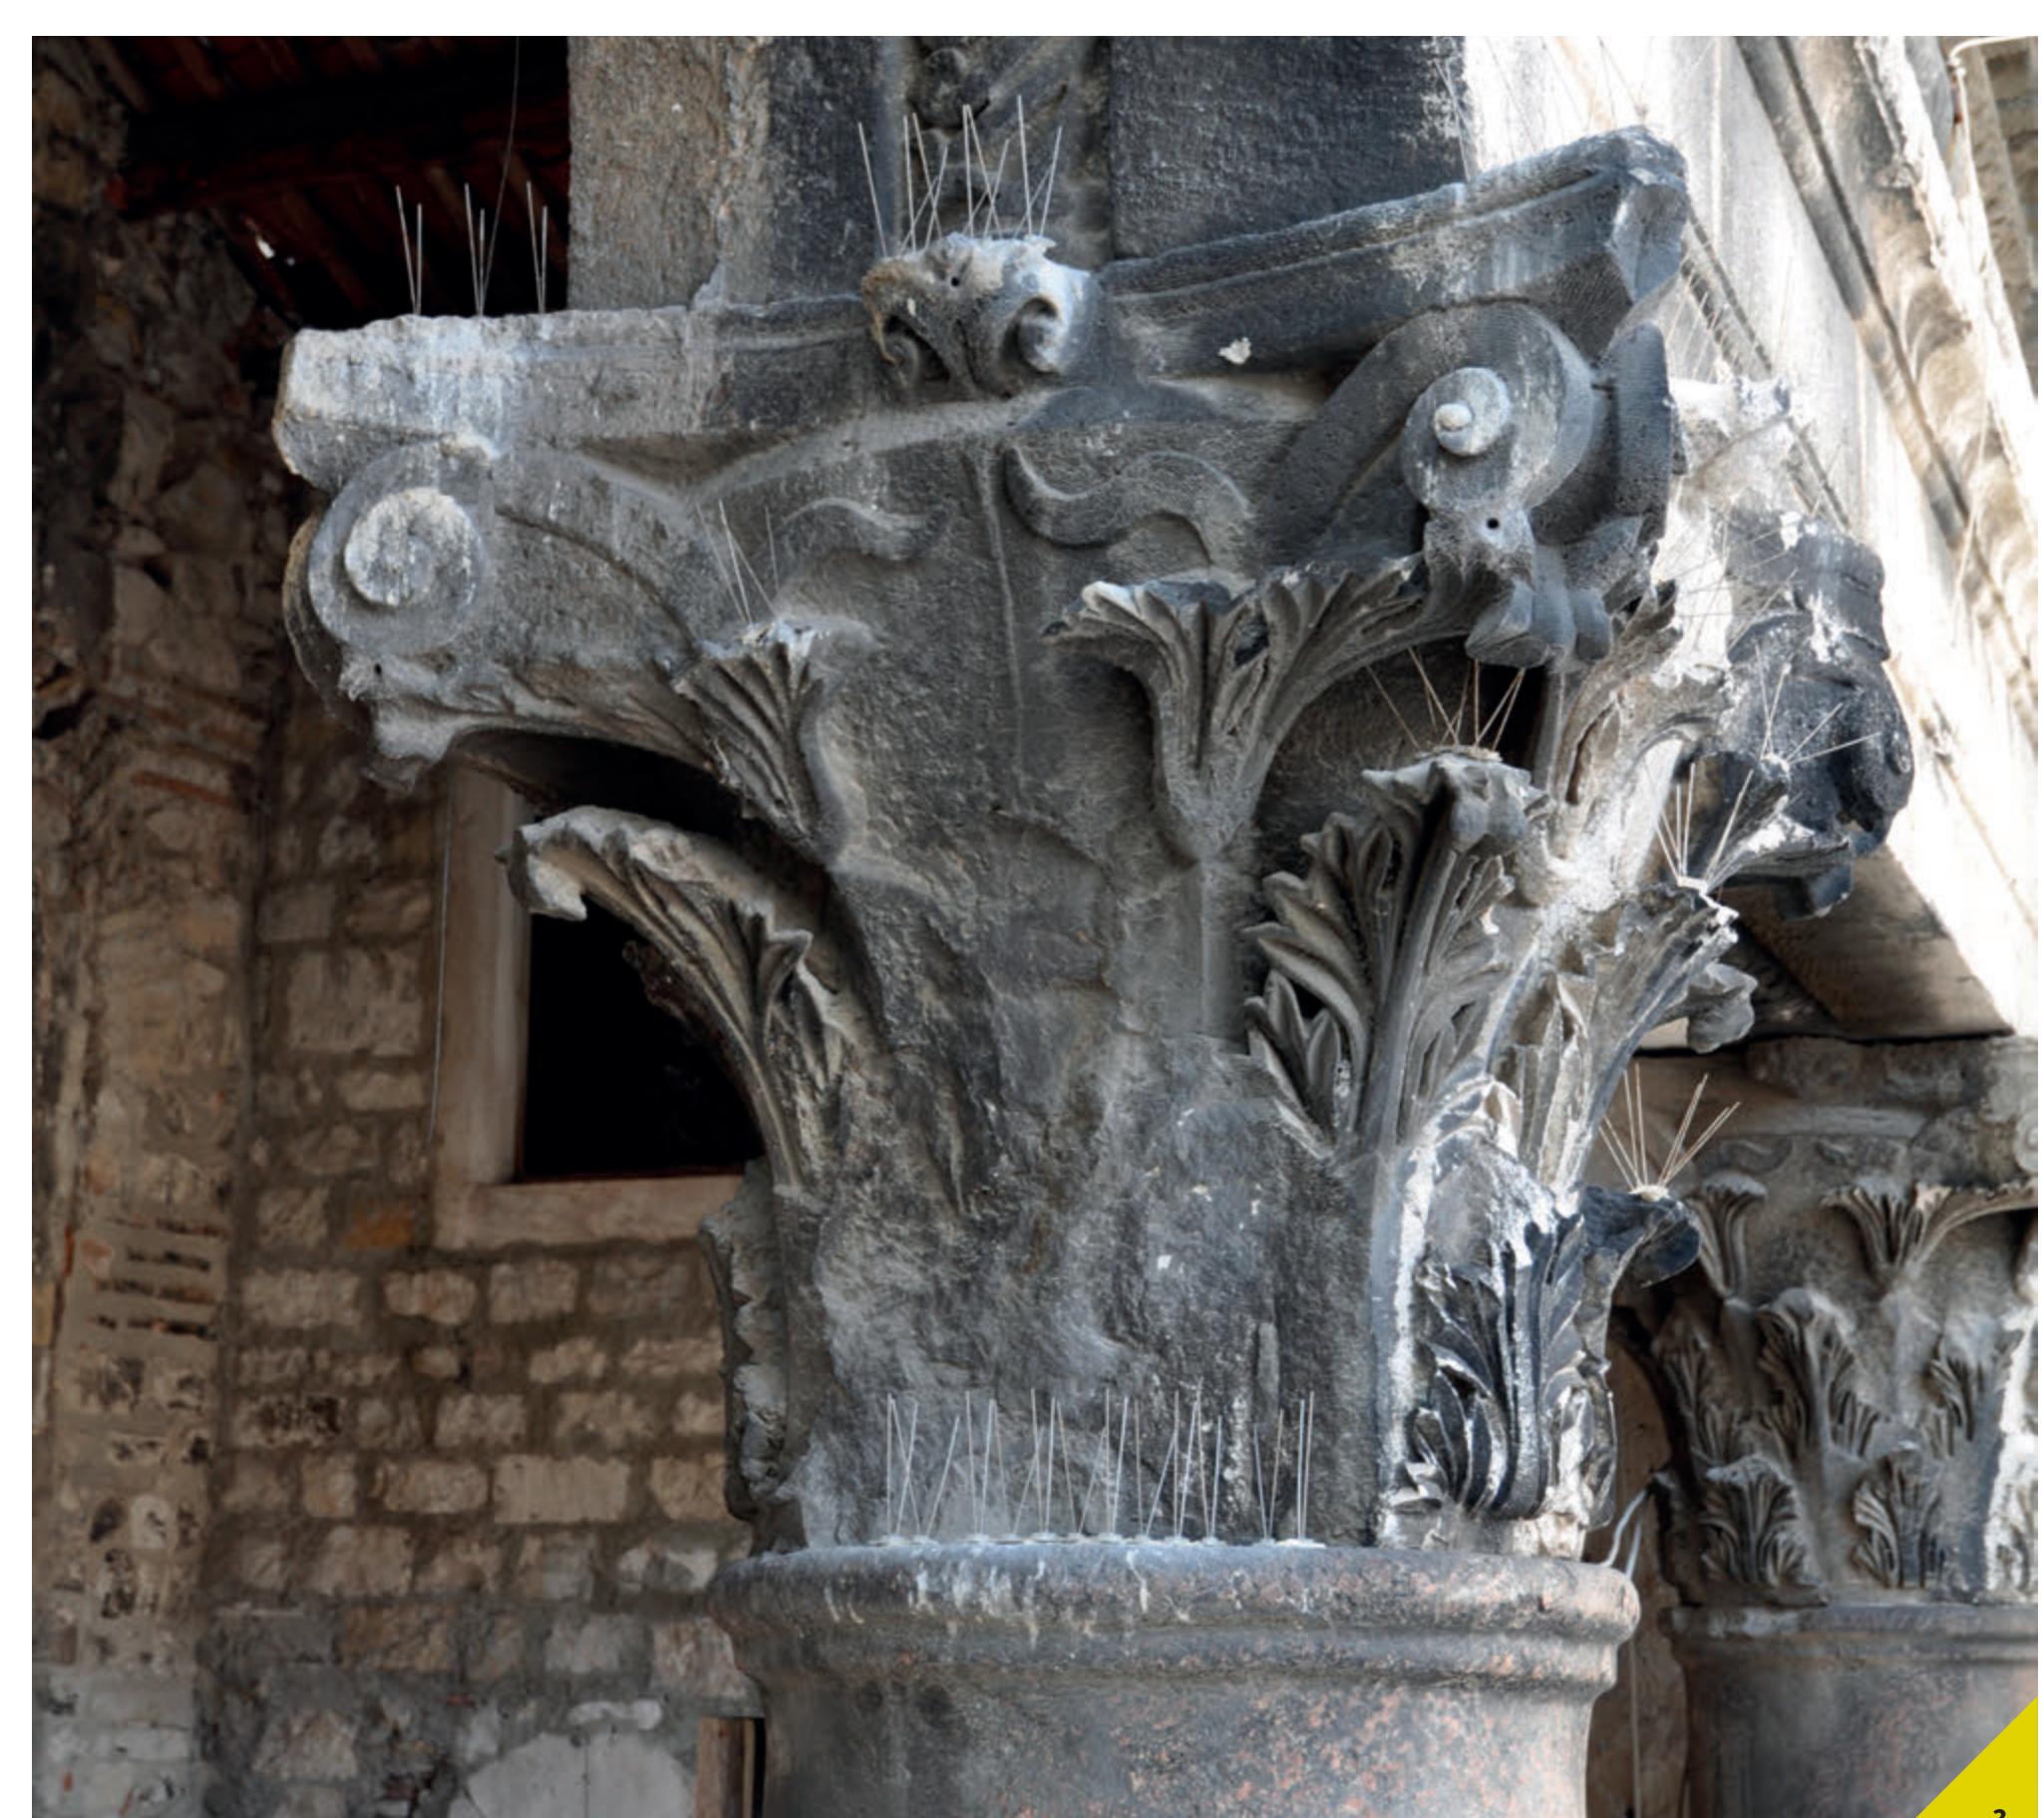
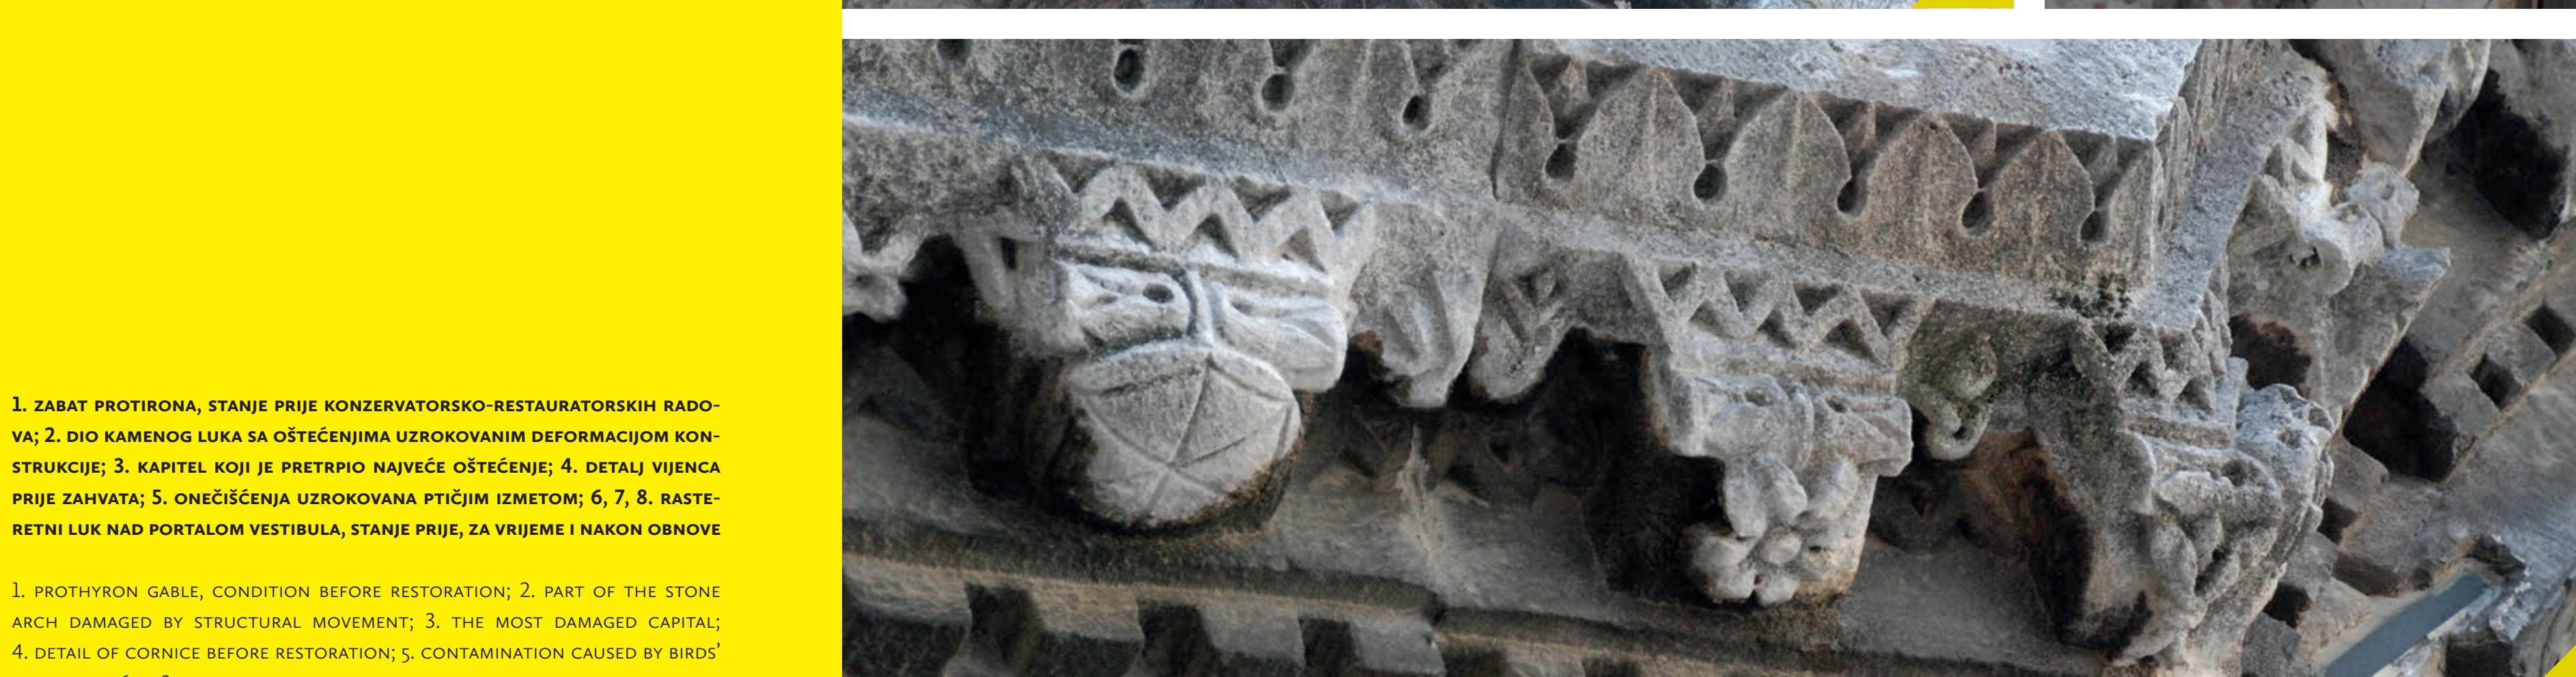
1. PROTHYRON GABLE, CONDITION BEFORE RESTORATION; 2. PART OF THE STONE ARCH DAMAGED BY STRUCTURAL MOVEMENT; 3. THE MOST DAMAGED CAPITAL; 4. DETAIL OF CORNICE BEFORE RESTORATION; 5. CONTAMINATION CAUSED BY BIRDS' DROPPINGS; 6, 7, 8. RELIEVING ARCH ABOVE THE VESTIBULE PORTAL, CONDITION BEFORE, DURING AND AFTER RESTORATION

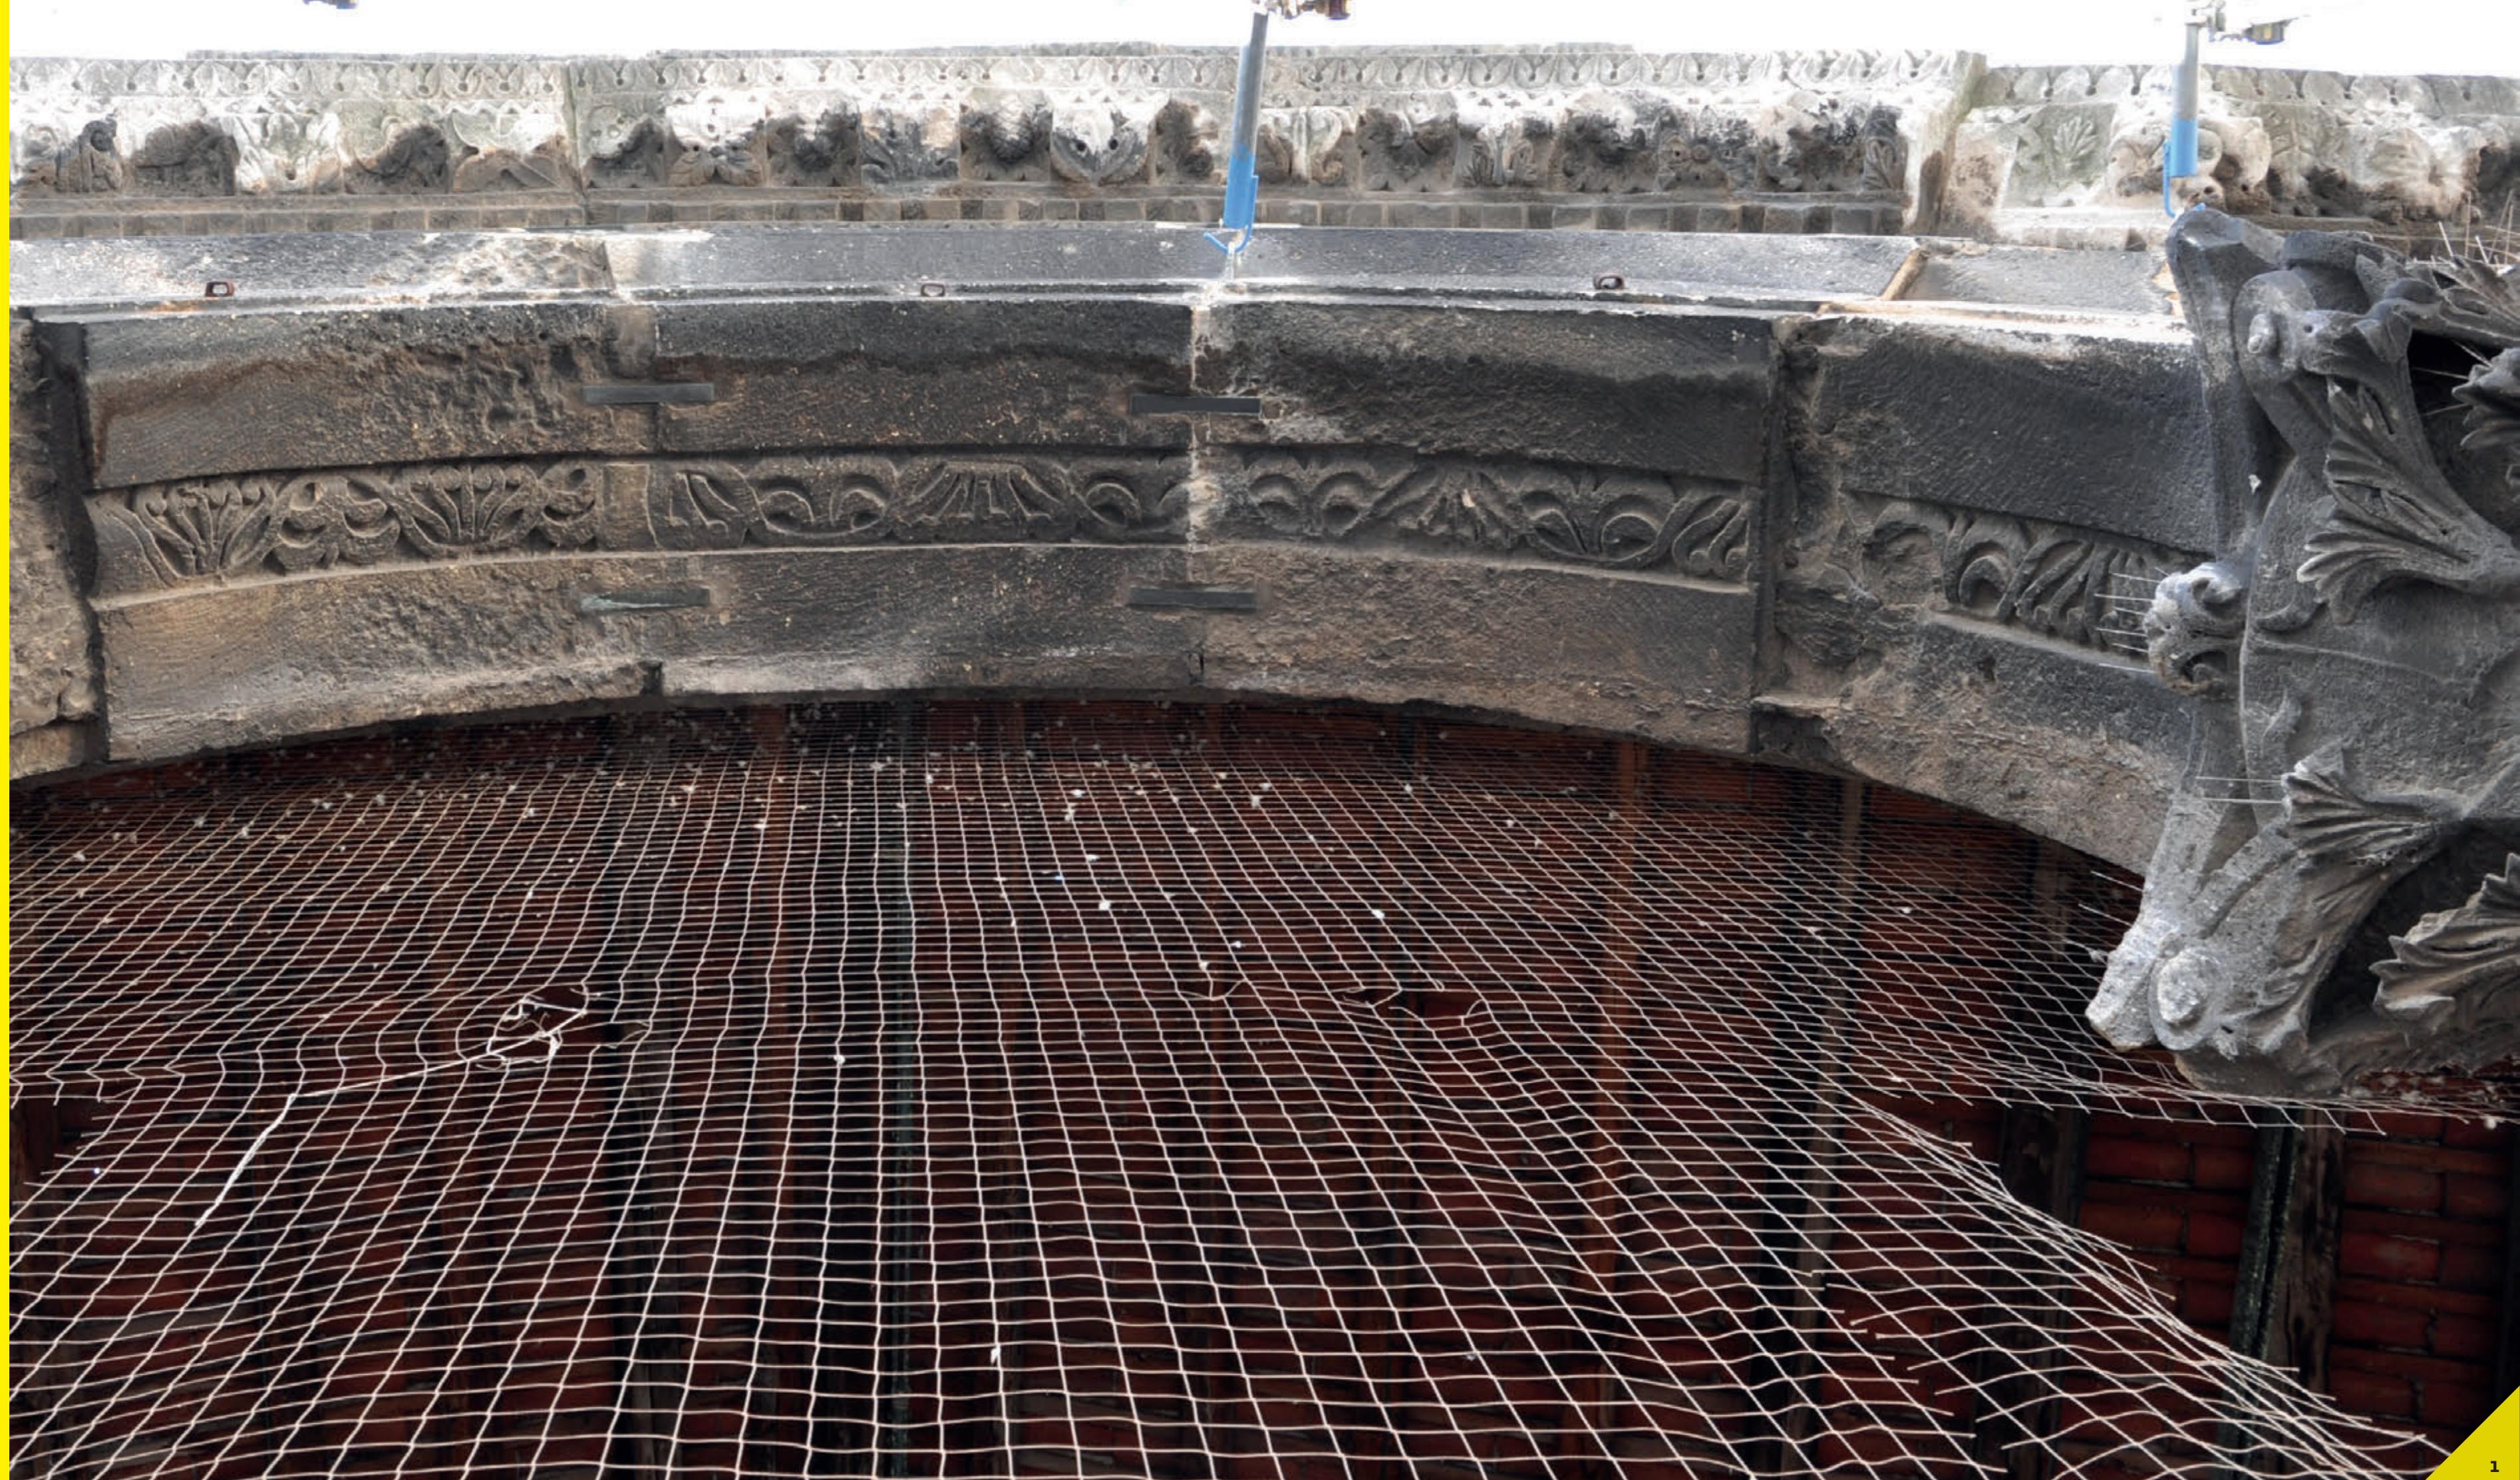
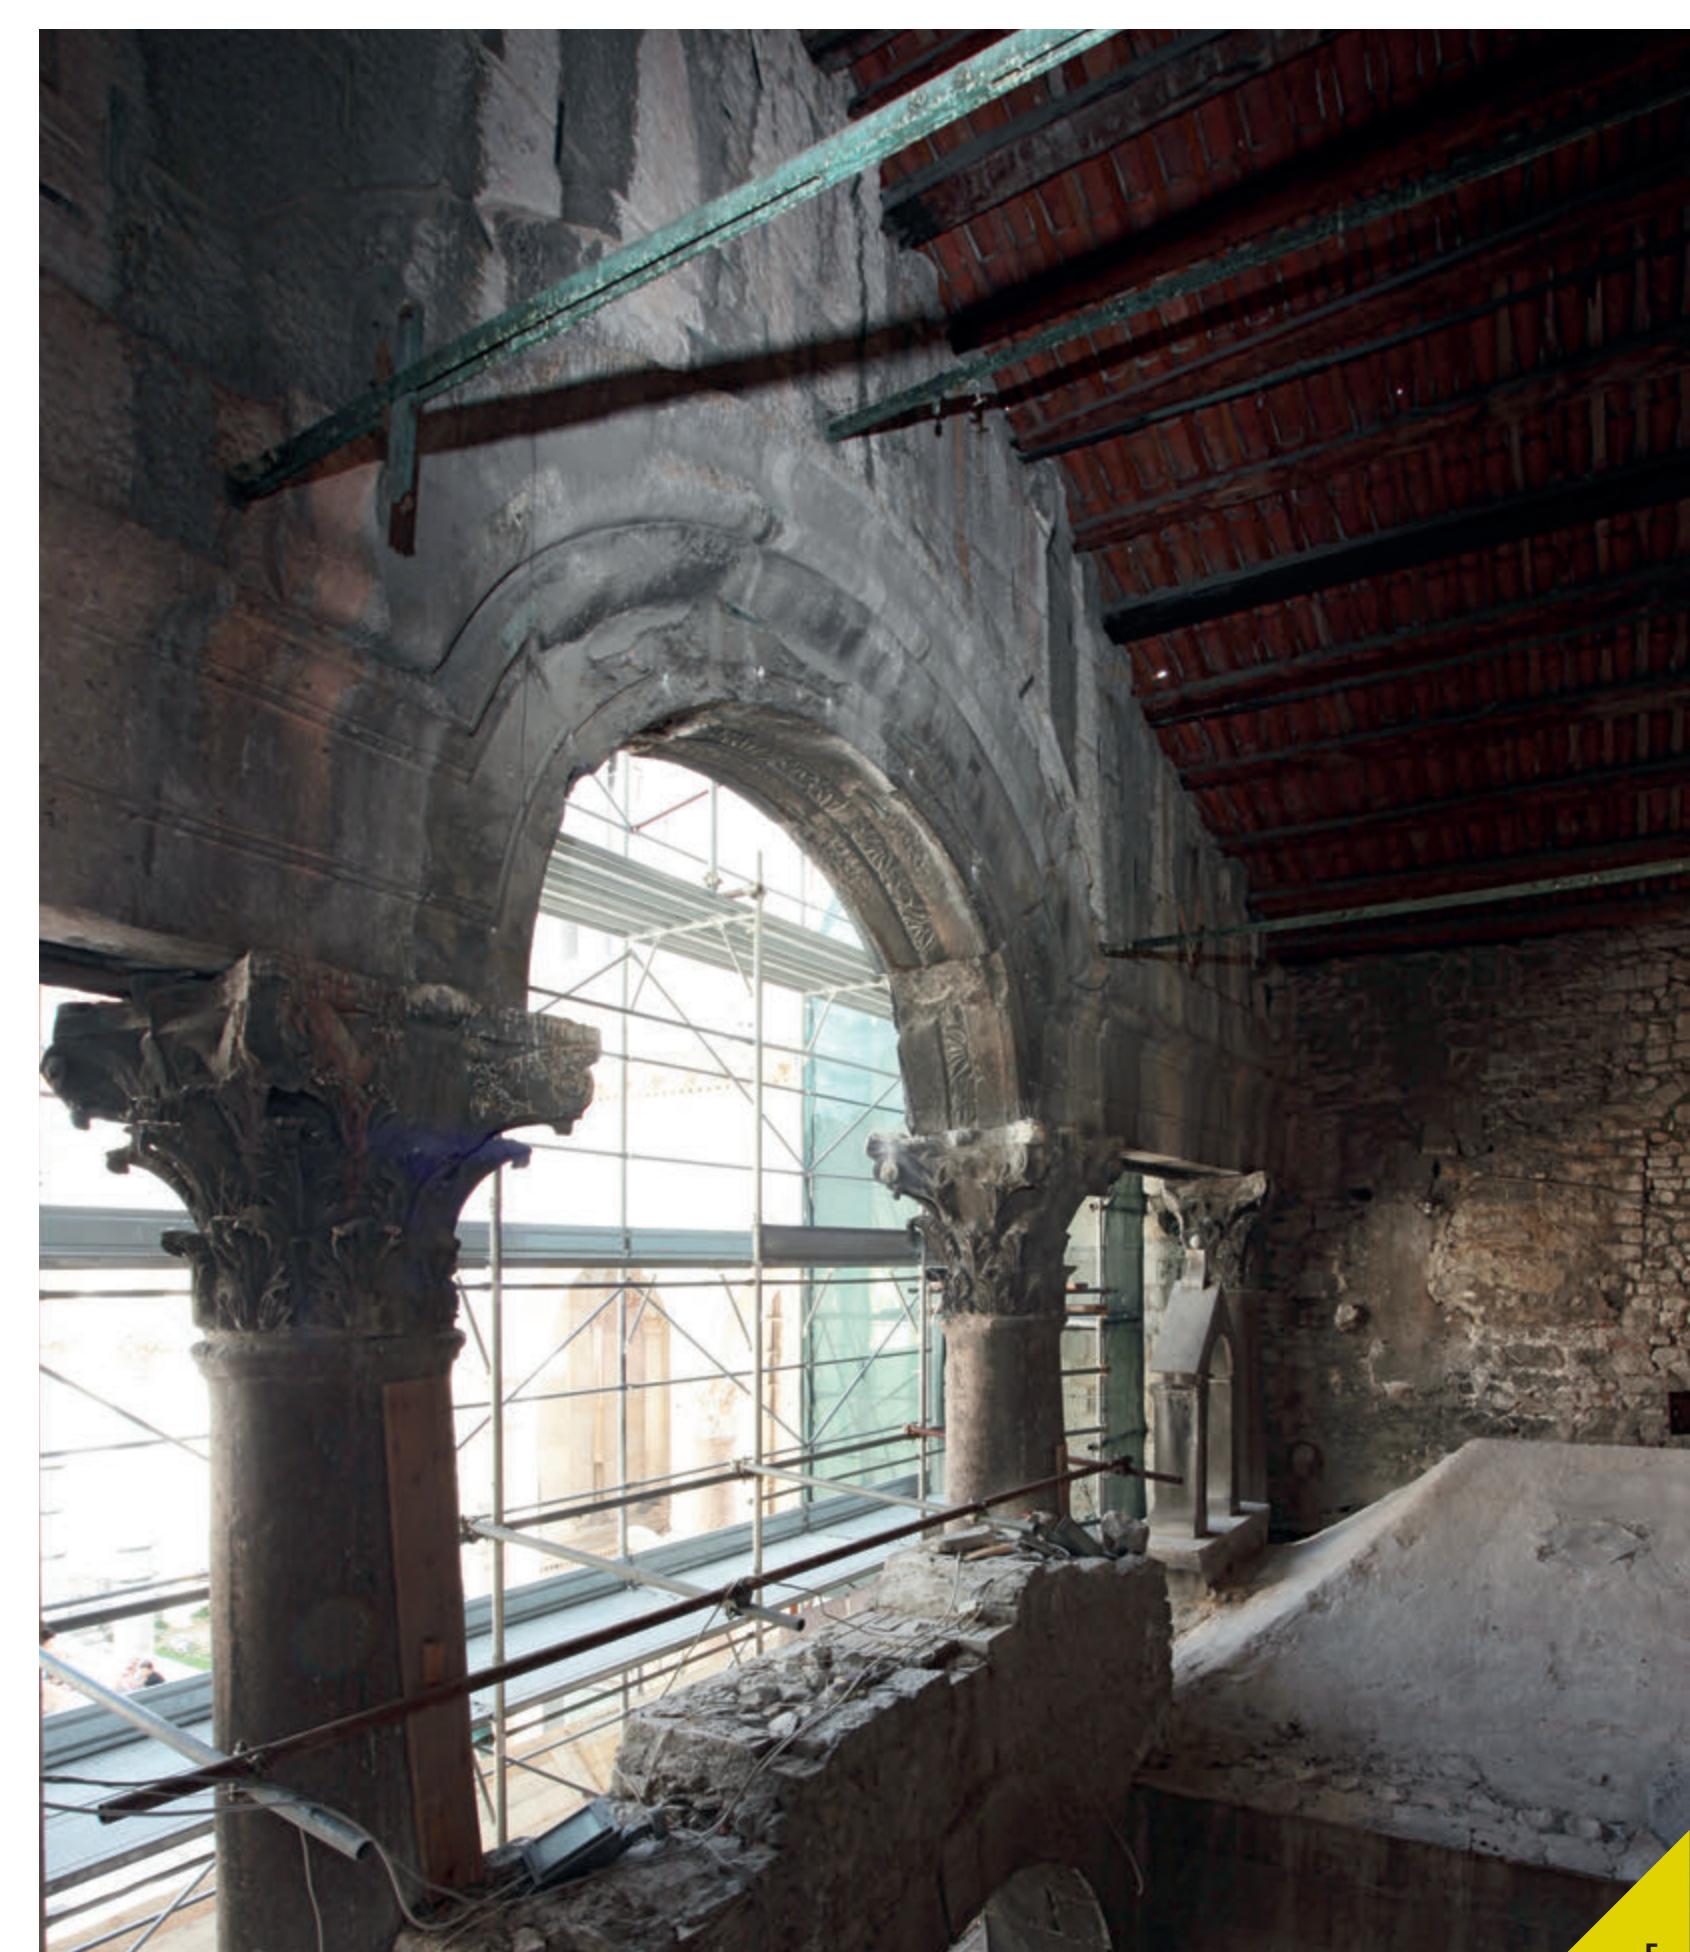
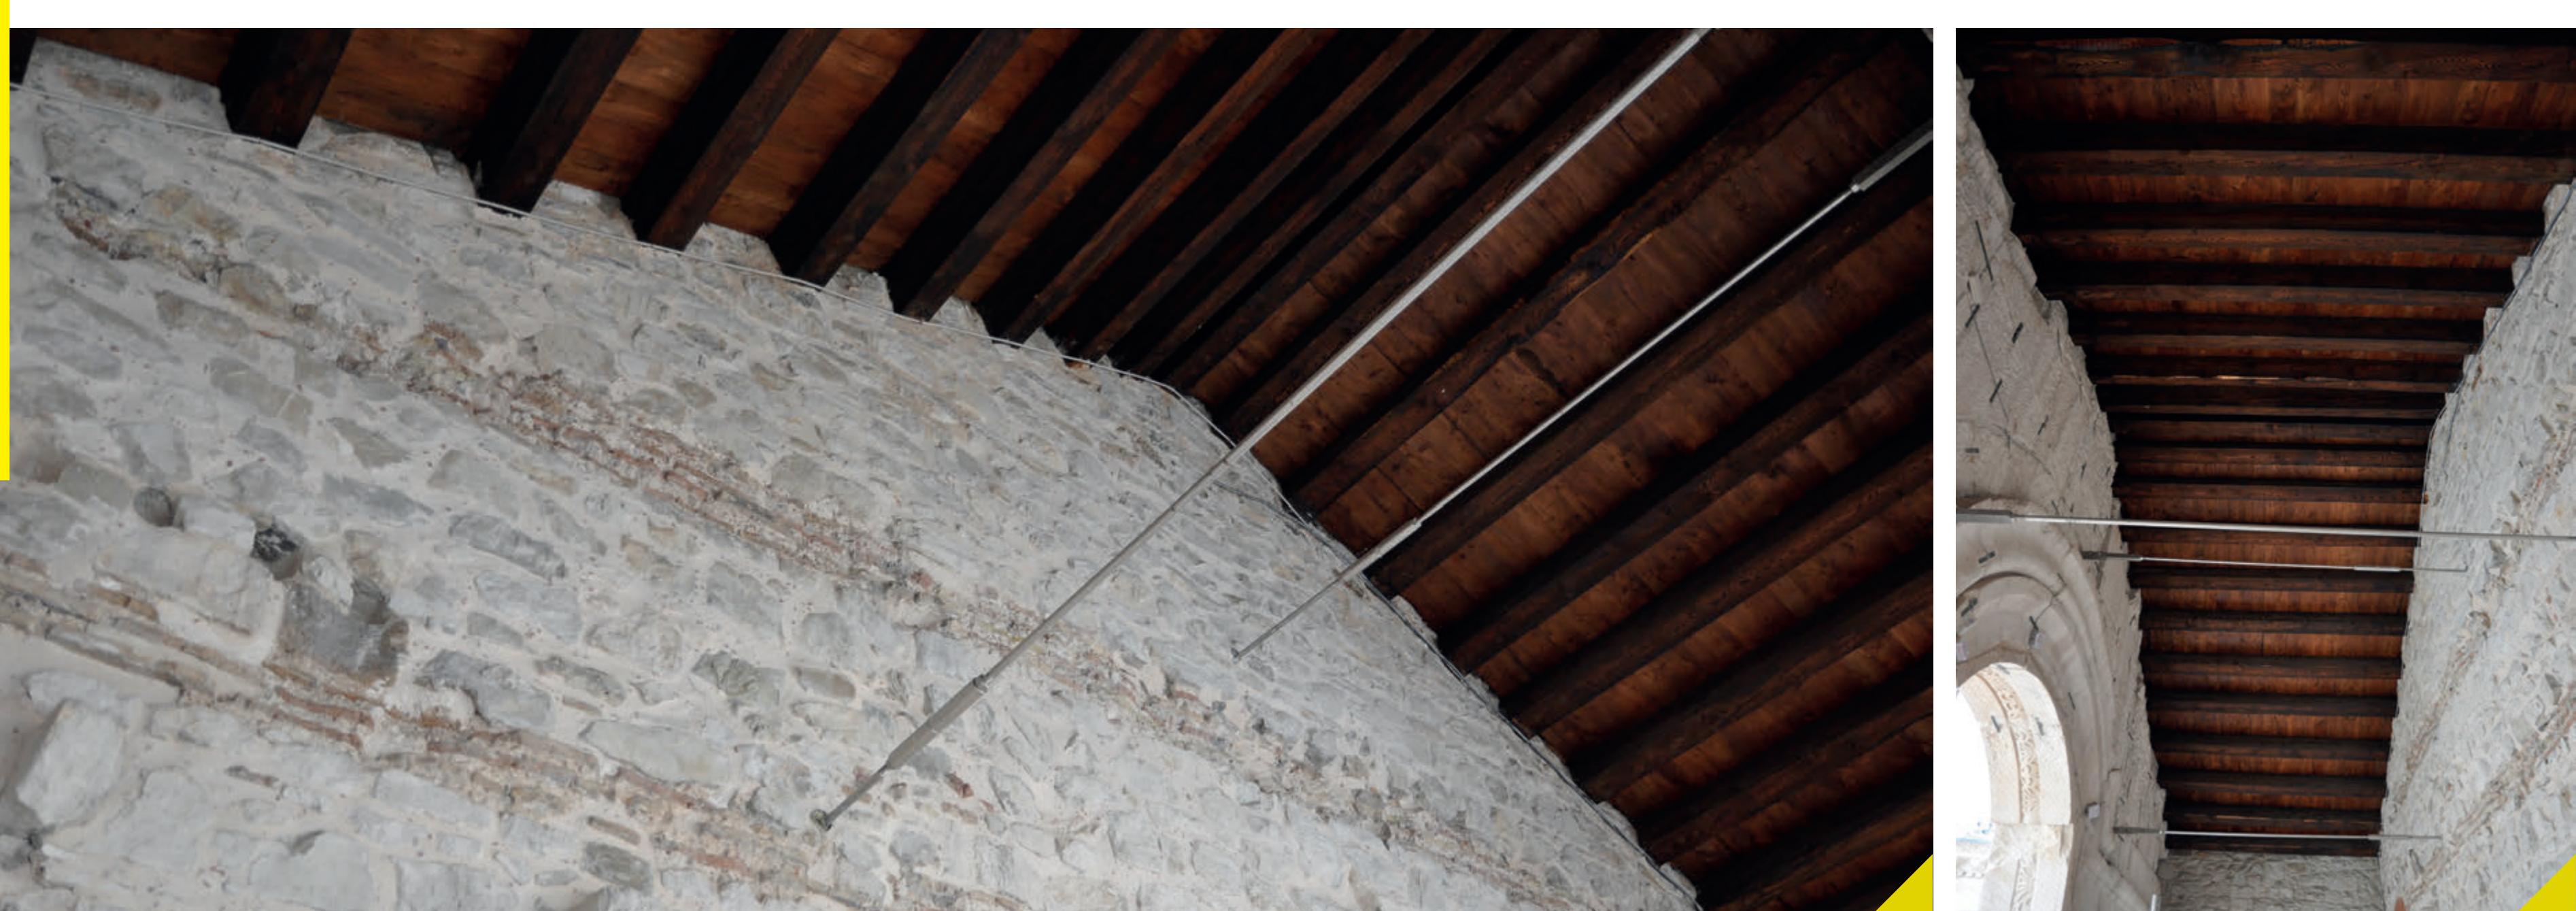
1. PROTHYRON ARCH BEFORE RESTORATION; 2. STONE CRACKS CAUSED BY STRUCTURAL MOVEMENT; 3. COPPER CLAMPS HOLDING STONE ELEMENTS OF THE PROTHYRON TOGETHER; 4. A CAPITAL COVERED WITH BLACK CRUSTS AND BIRD'S DROPPINGS; 5. BACK SIDE OF THE GABLE WITH OLD COPPER TIES; 6. STRUCTURAL STABILIZATION USING ROOF BEAMS; 7, 8. ROOF CONSTRUCTION WORKS; 9. THE NEW STAINLESS STEEL TIE IN THE INTERIOR OF THE PROTHYRON, DETAIL; 10. THE VESTIBULE WALL, TO WHICH THE PROTHYRON GABLE WAS TIED; 11. NEW TIES AND THE NEW ROOF
