## Na završetku desetljeća obnove Peristila

## At the end of a Decade of the Peristyle Restoration

The conservation and restoration work on the Peristyle of Diocletian's Palace has been in many ways the most important project in recent period within the scope of renovation of the historical core of the town of Split. The Peristyle is the centre and the most impressive part of the imperial palace, and also the heart of the town which has grown around it. The square, which reflects historical layers of the creation and development of the town, has become its symbol and its main tourist attraction. It serves as the most attractive backdrop for cultural events, and a stage at which public life evolves.

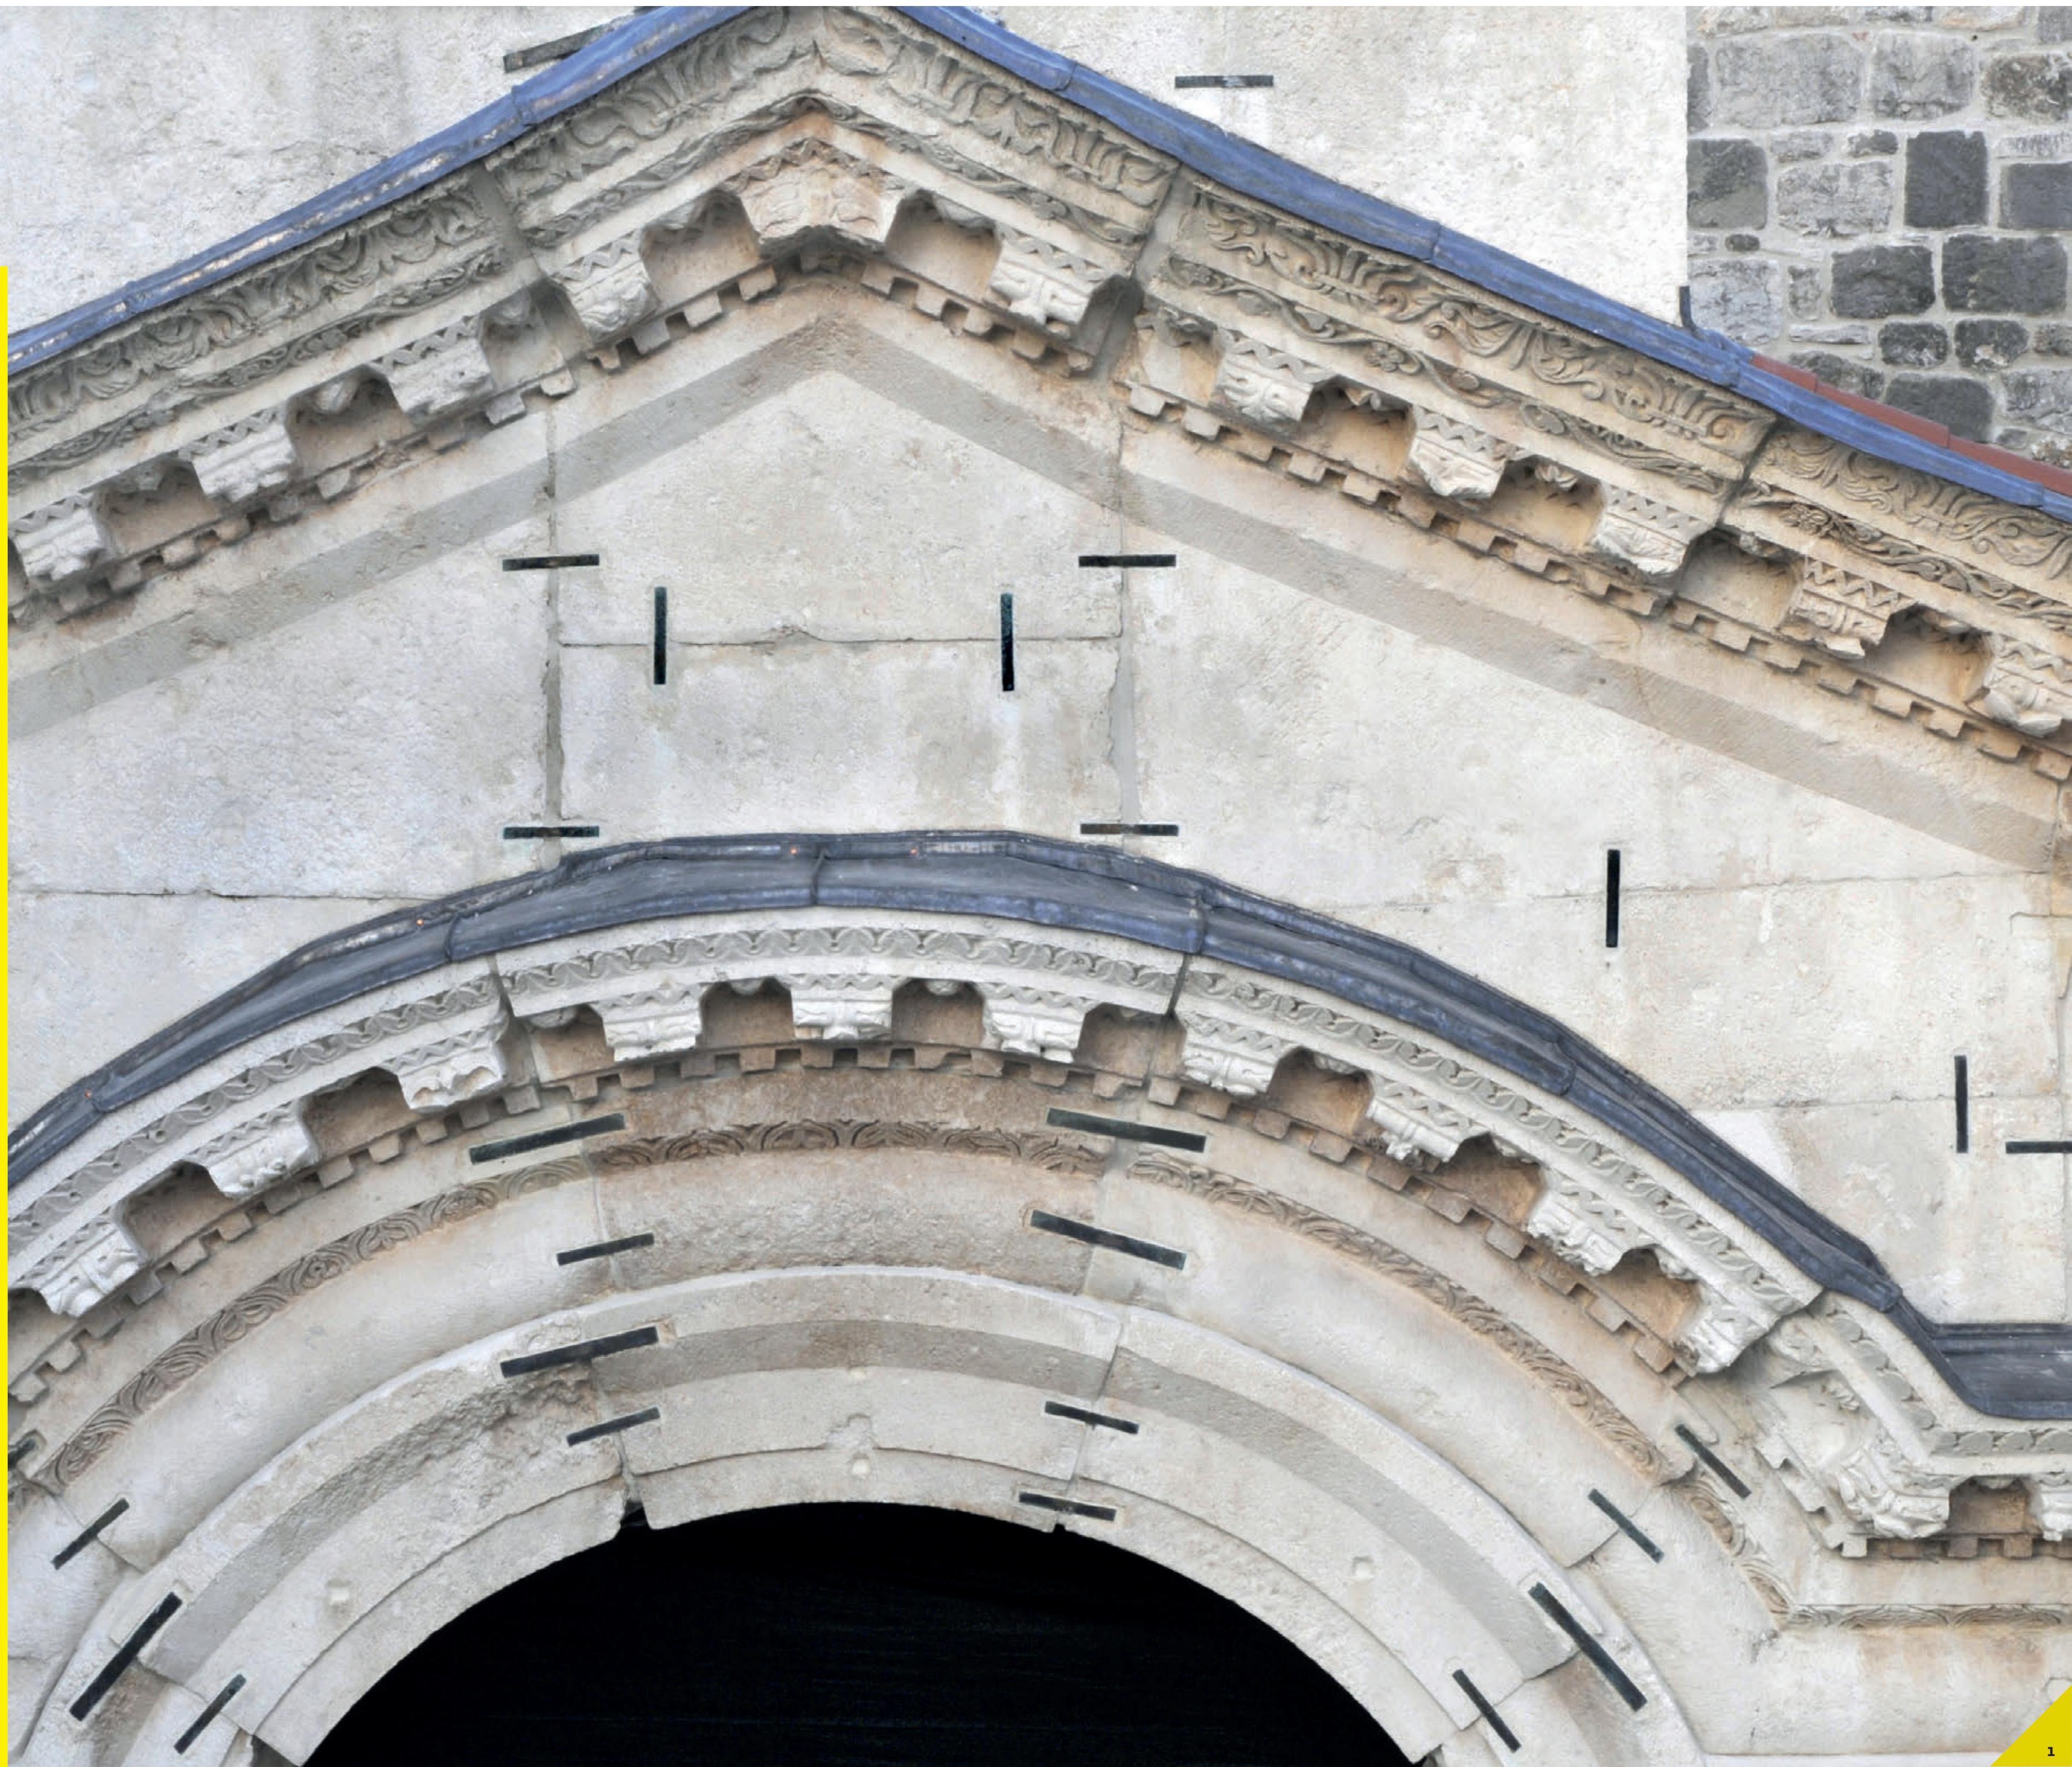
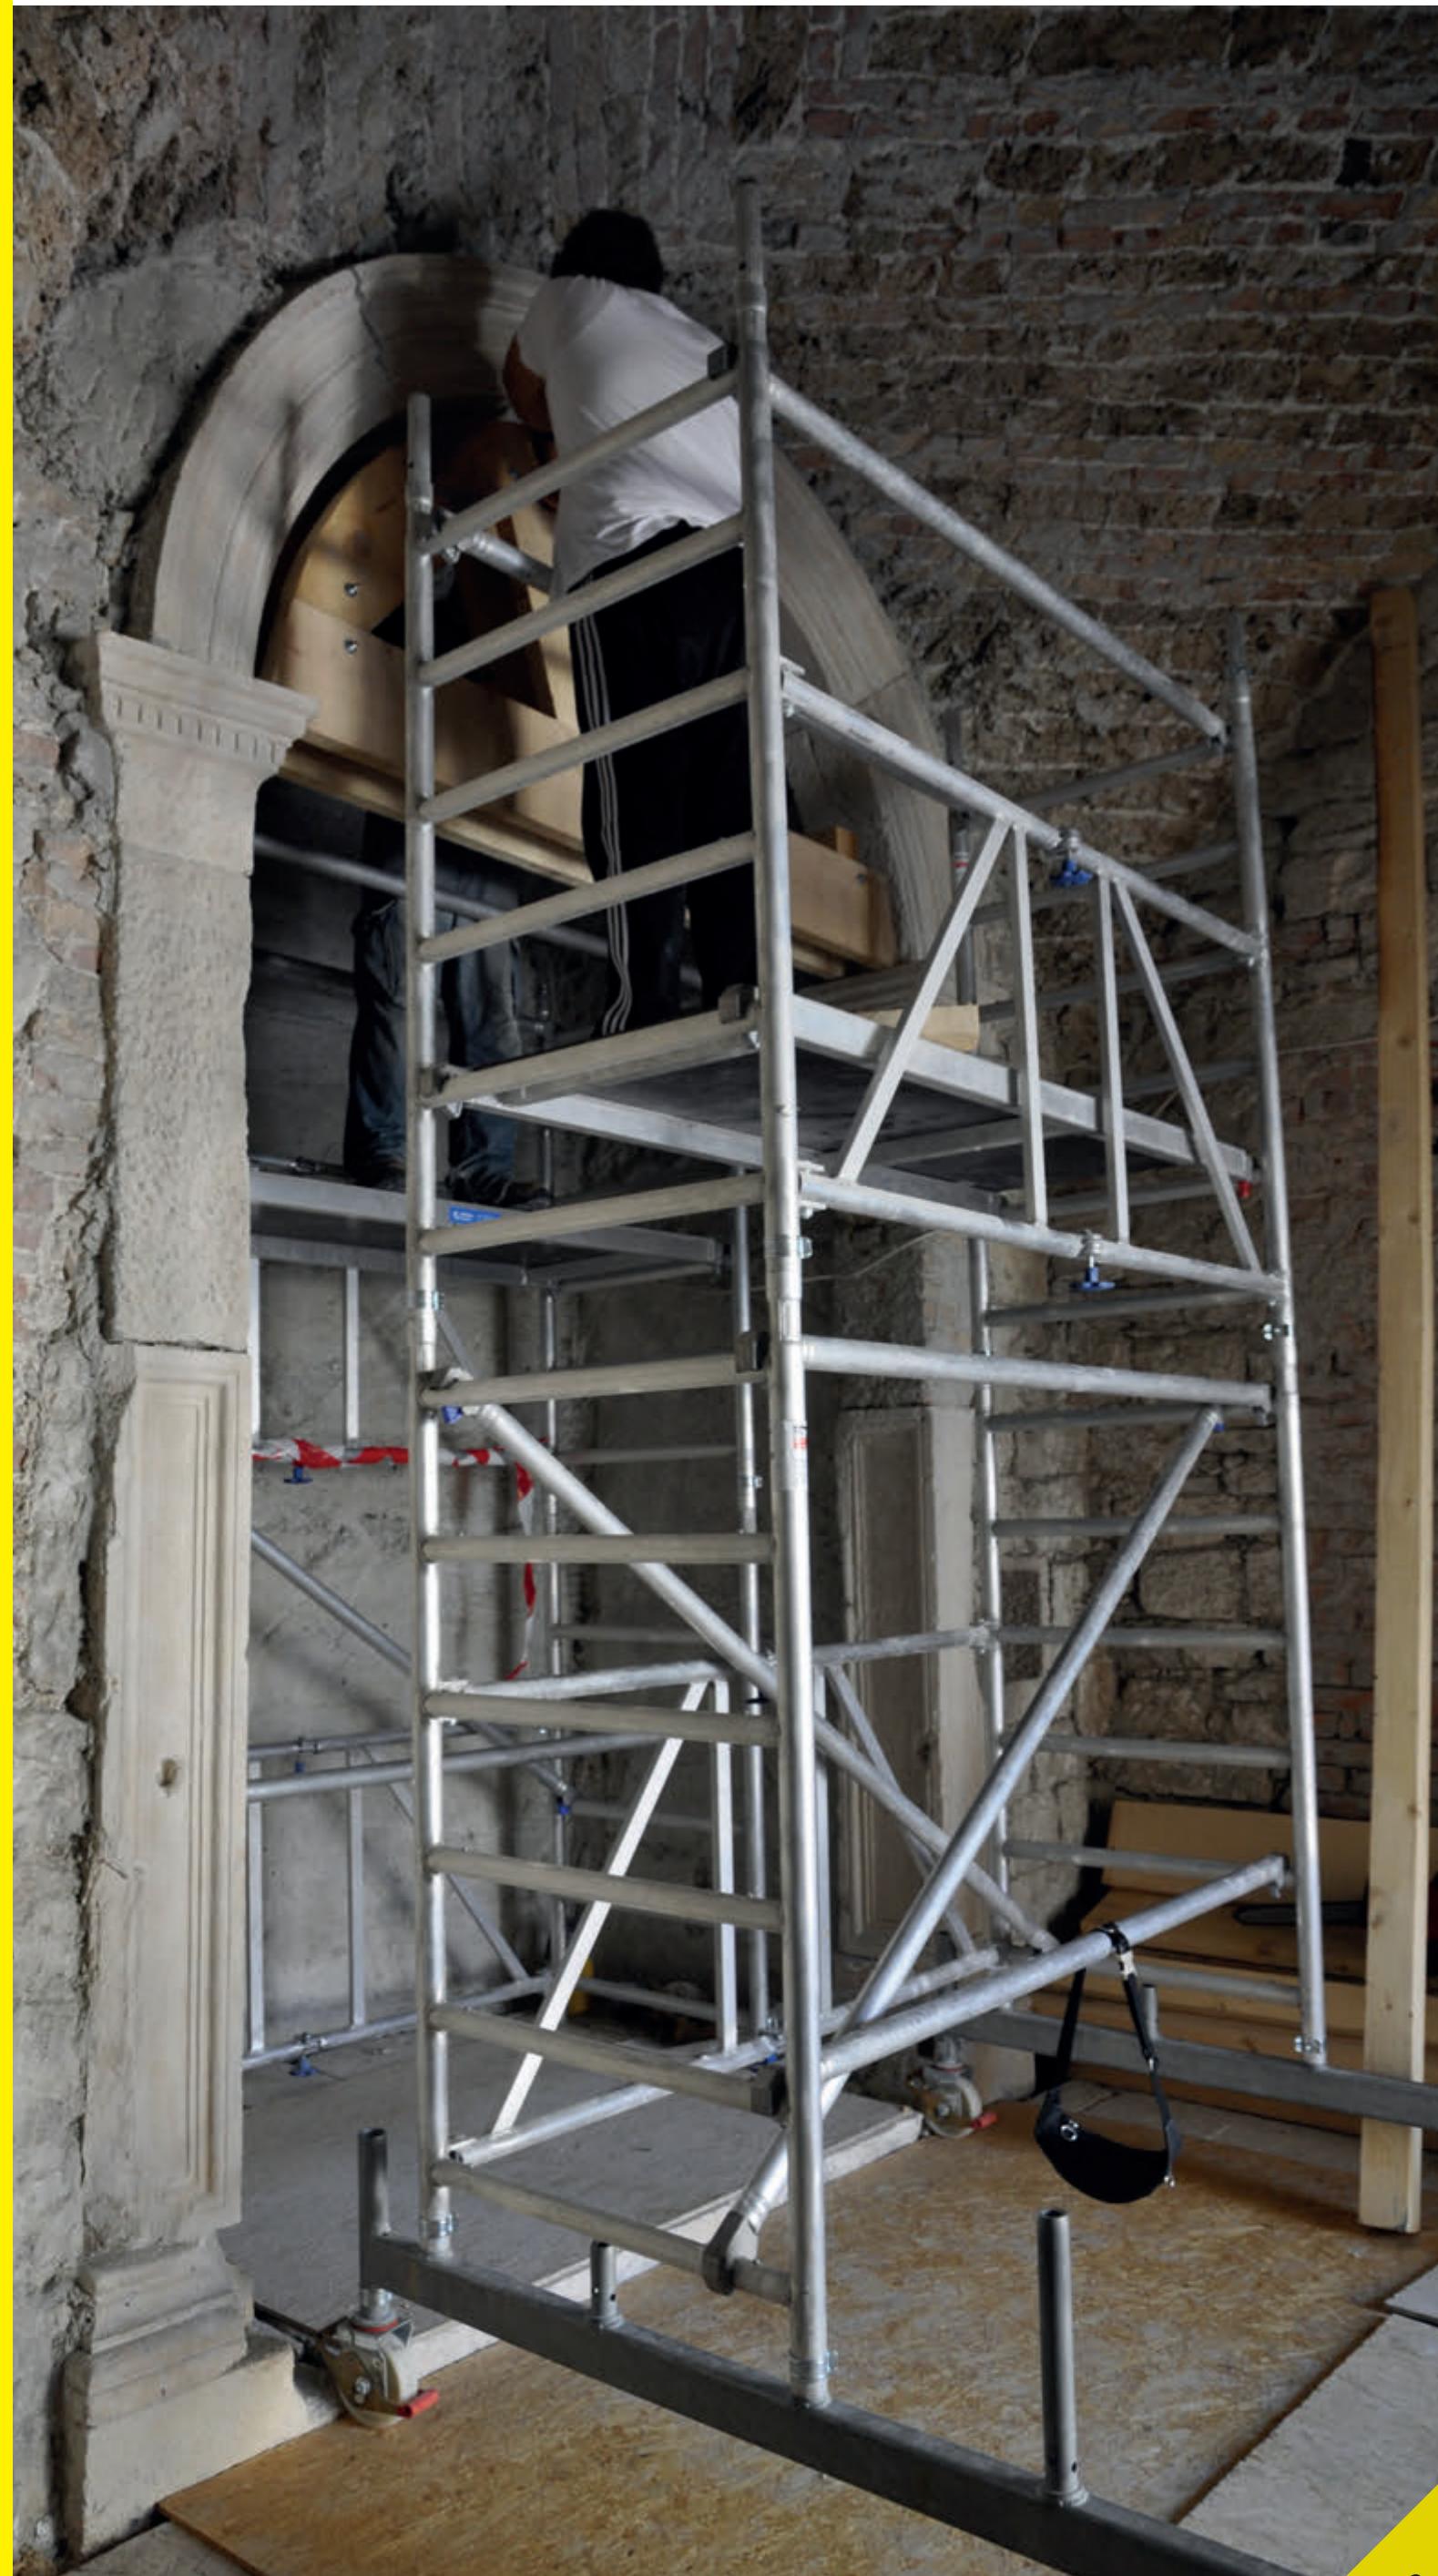
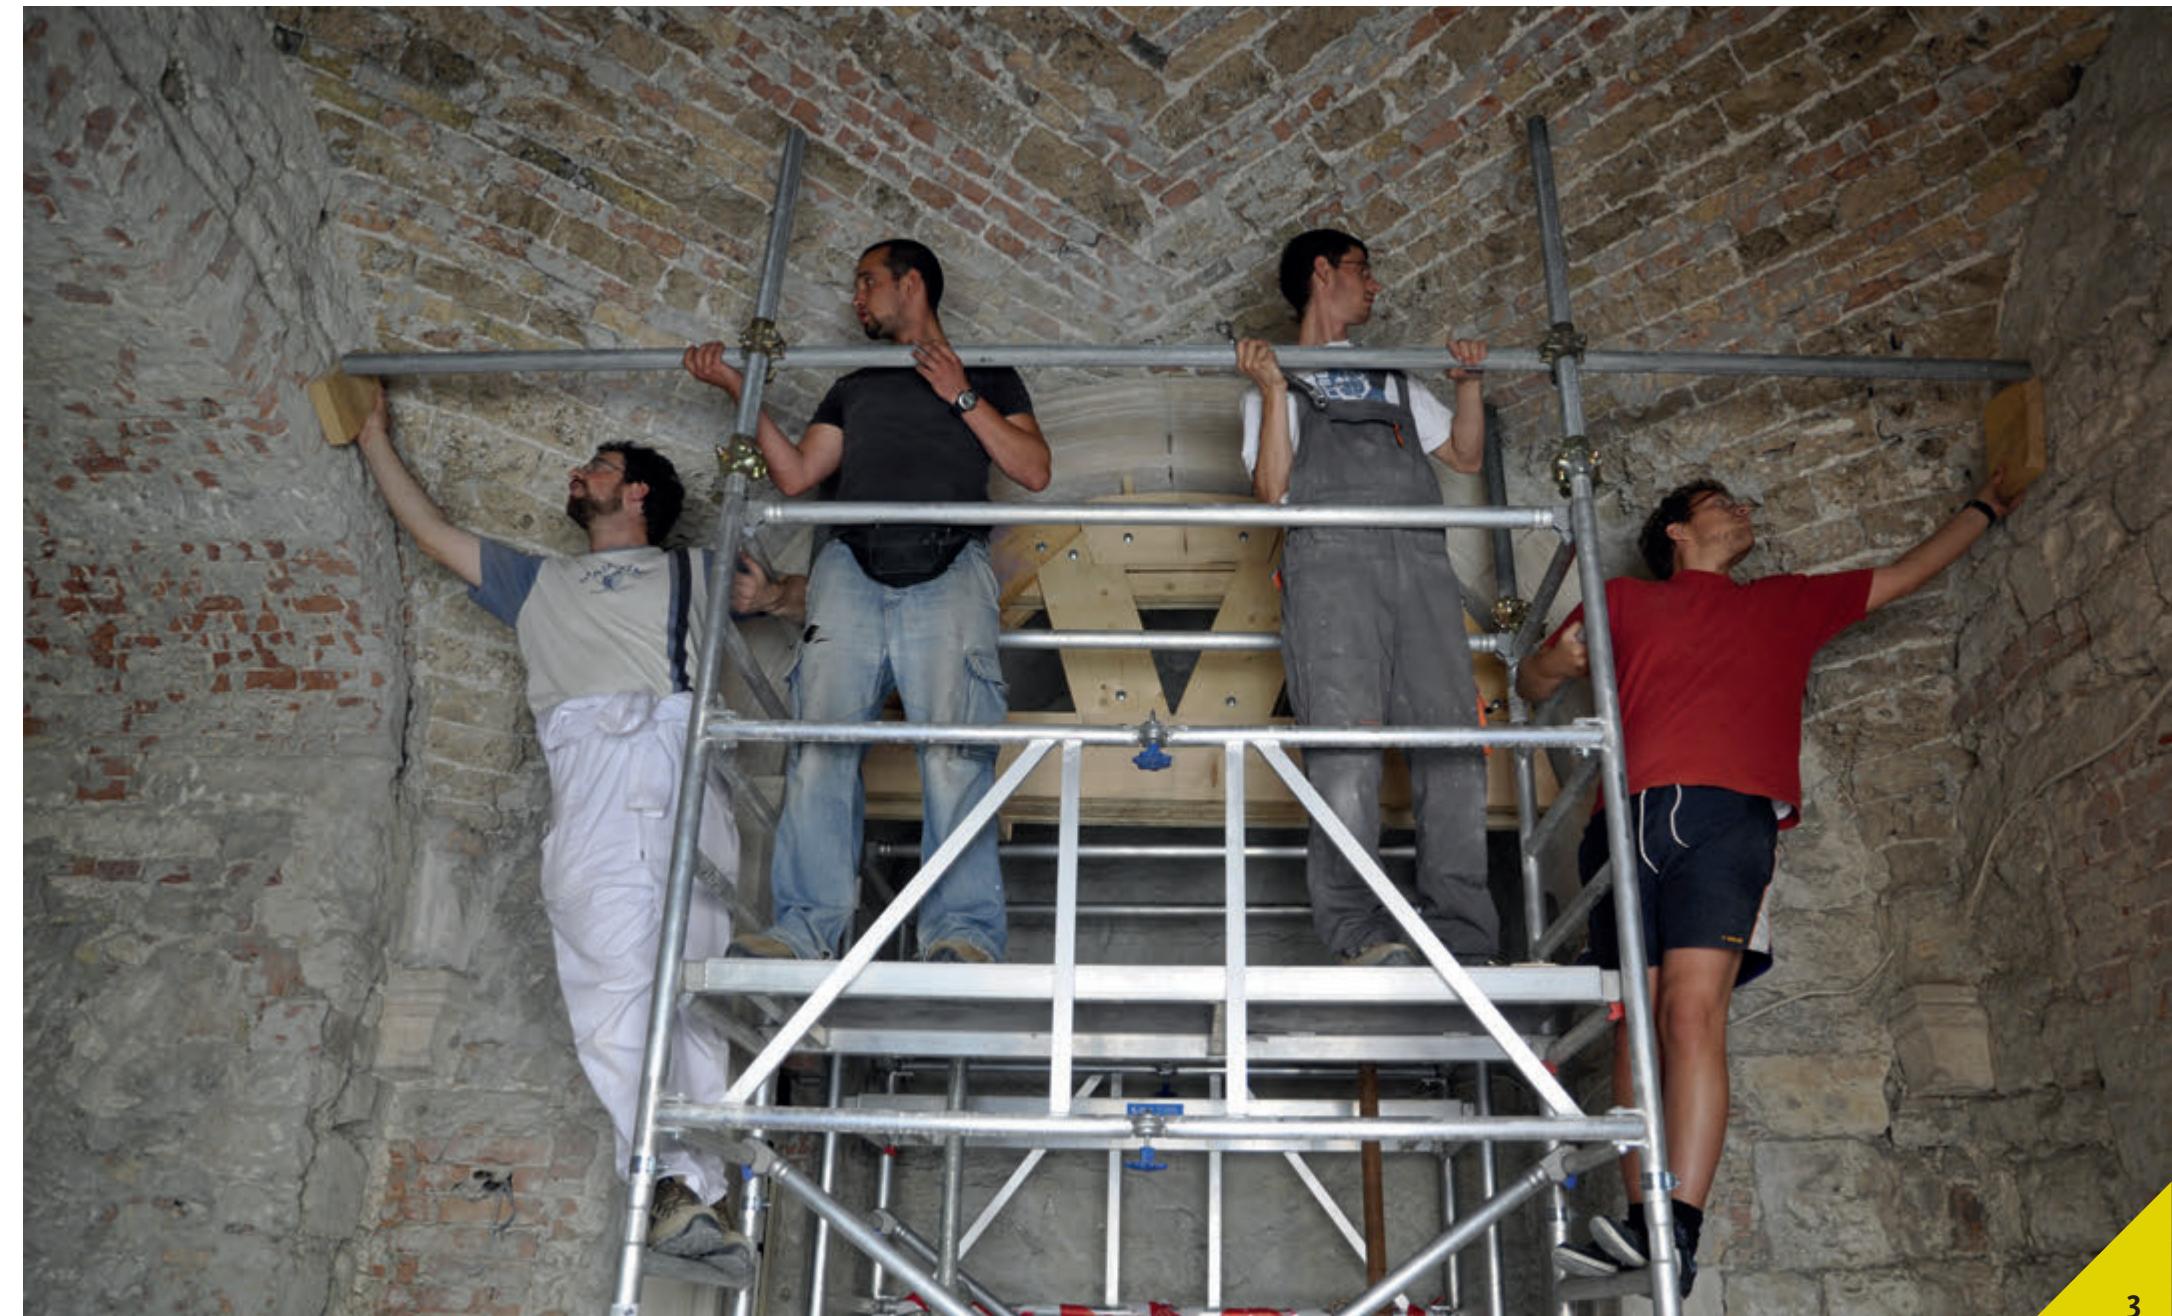
1. PROTHYRON GABLE, CONDITION AFTER RESTORATION; 2, 3, 4, 5, 6. RESTORATION OF THE STONE ARCH IN THE EASTERN CHAPEL; 7, 8, 9. CONSOLIDATION OF THE CRACKED CAPITAL AND ARCH
