# konzervatorsko-restauratorski radovi na pilu sv. trojstva u osijeku

CONSERVATION AND RESTORATION WORK ON THE HOLY TRINITY VOTIVE  
MONUMENT (PIL) IN OSIJEK

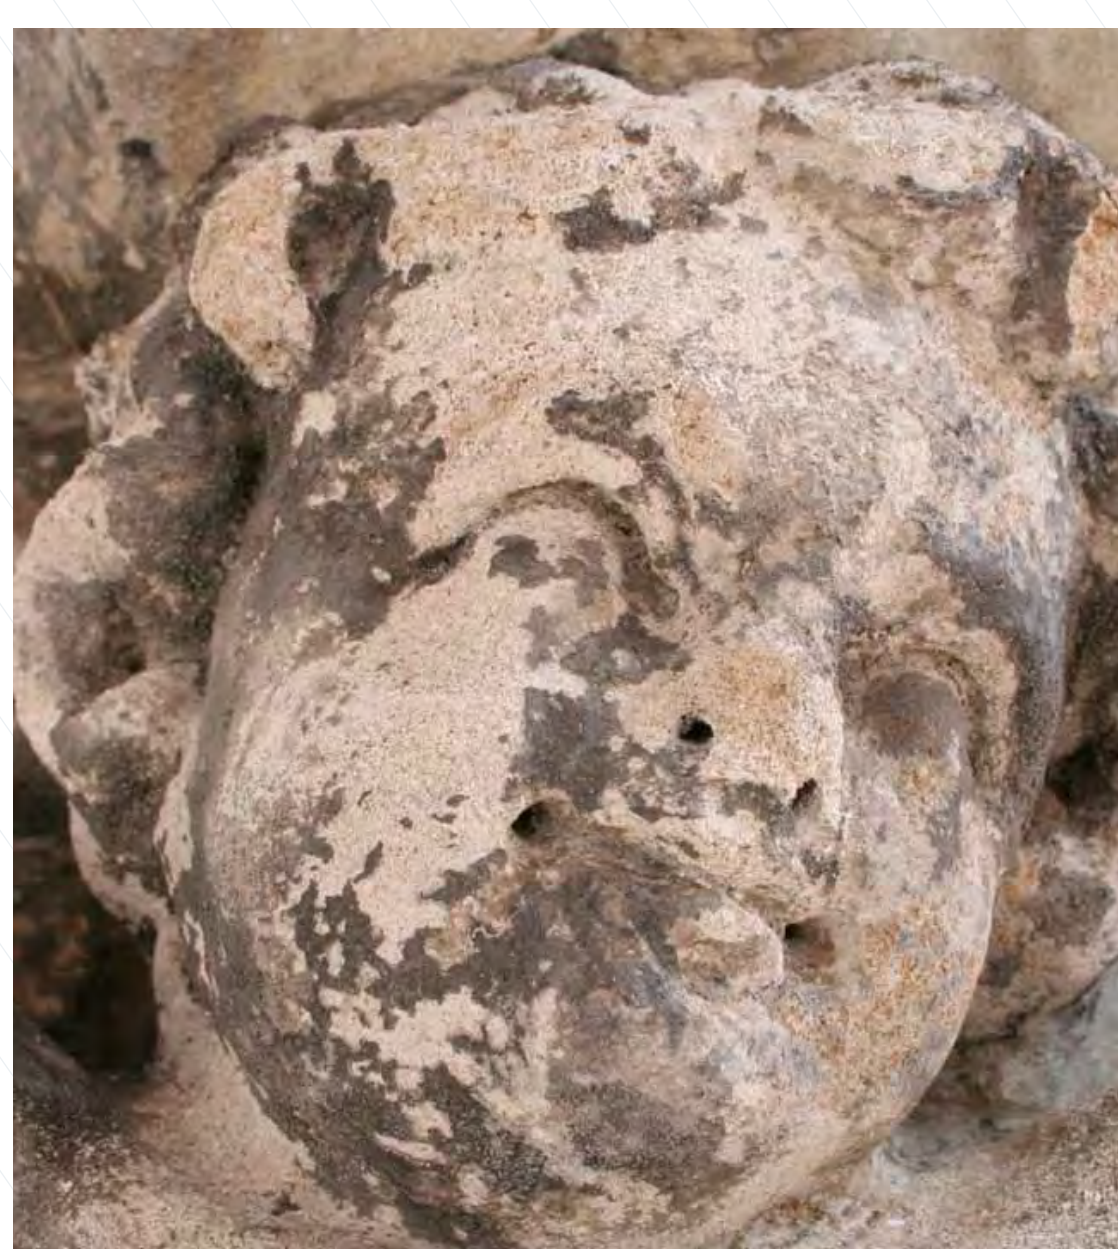
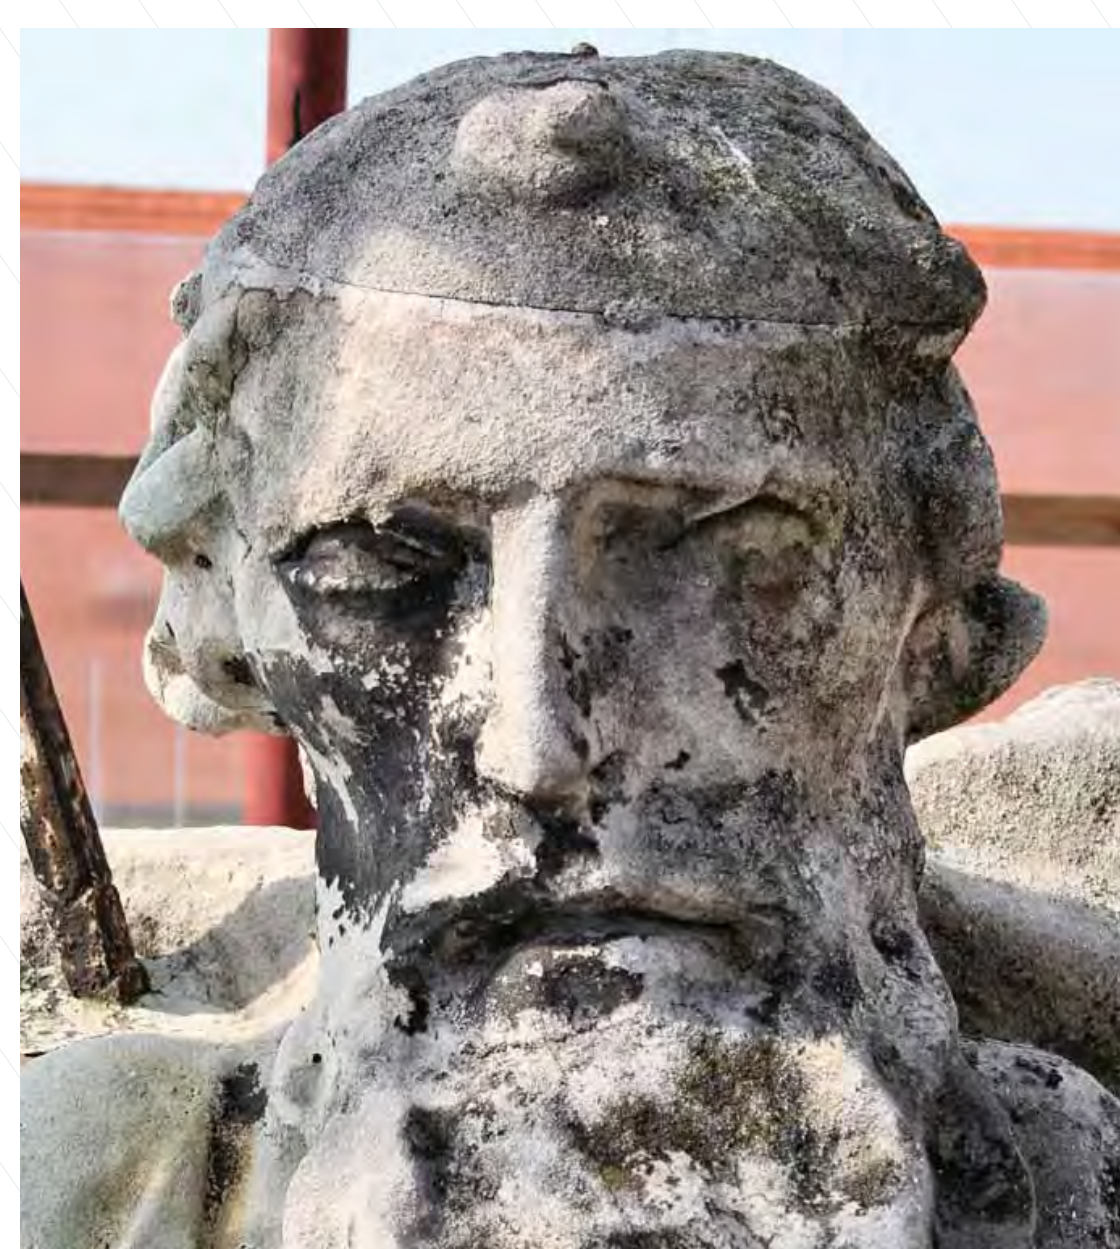
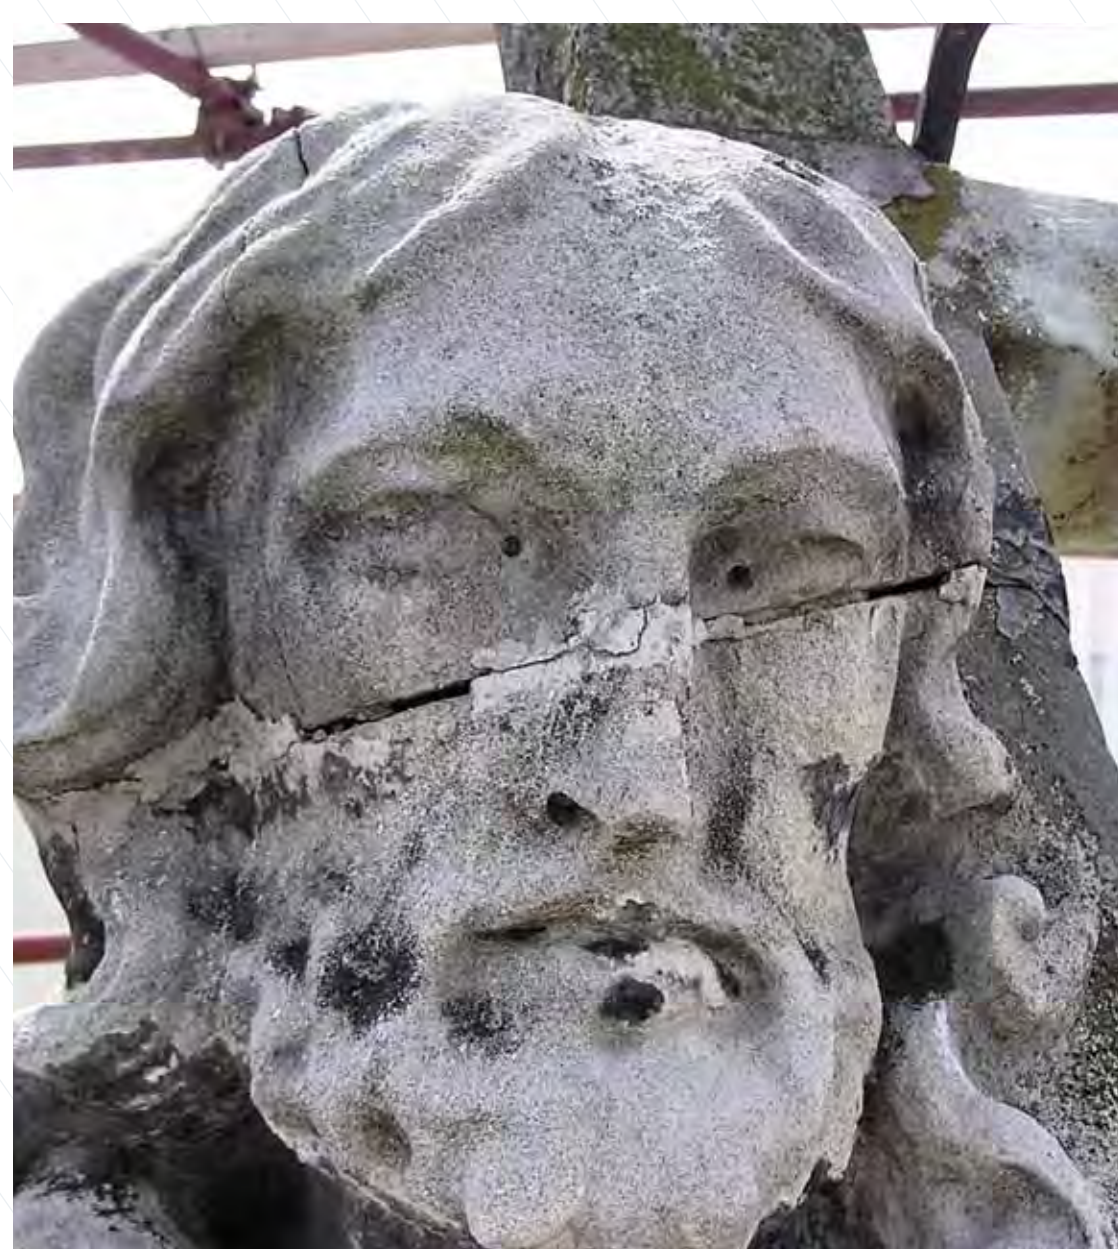
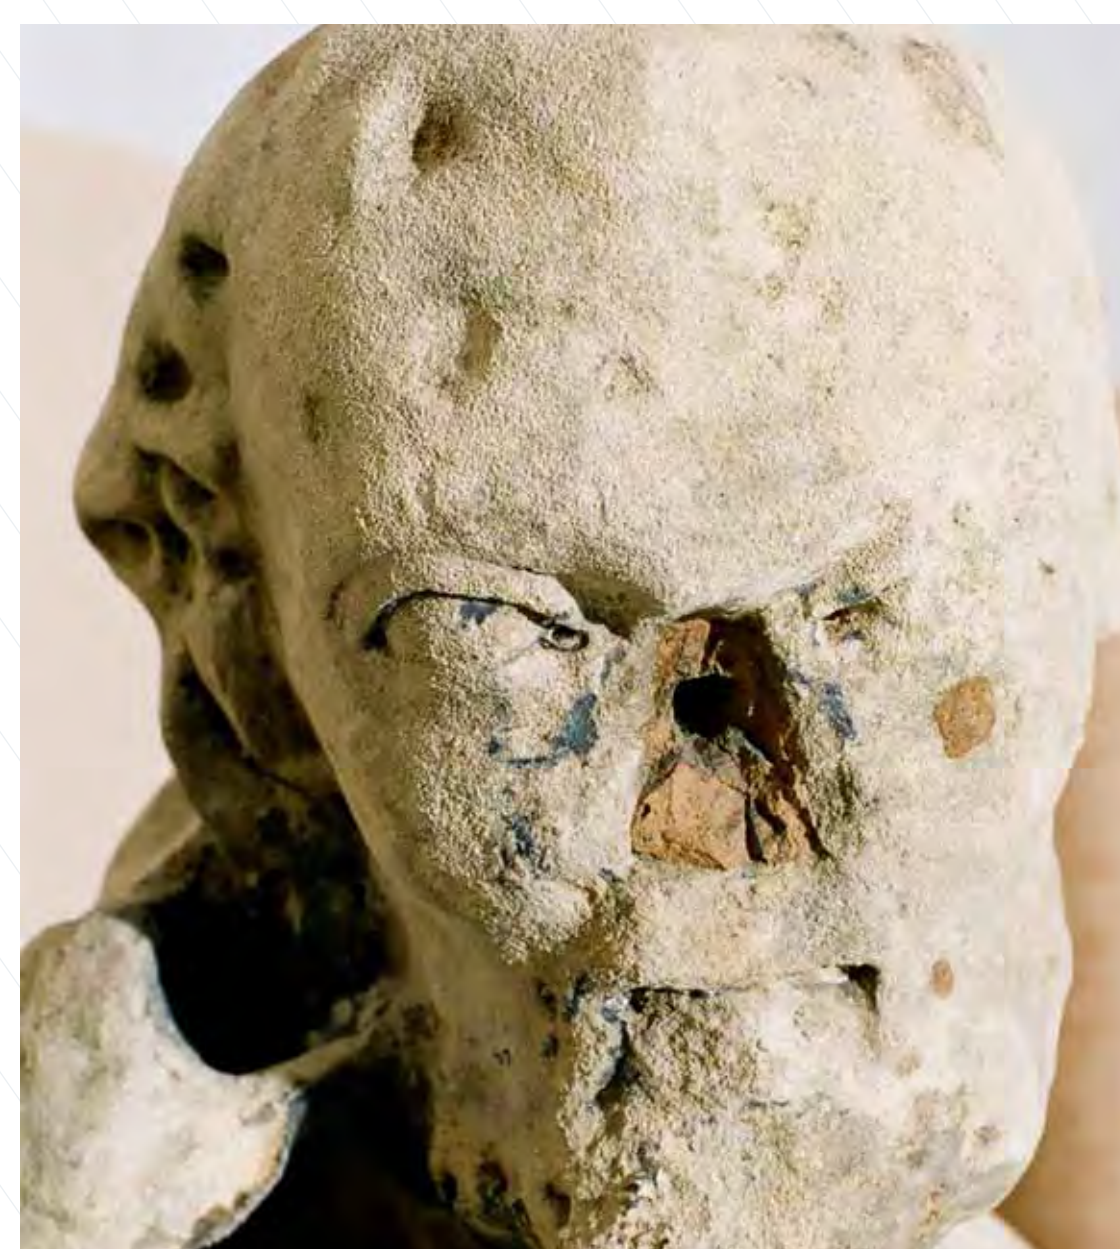
Oštećenja kamena na glavama skulptura: anđela, Boga Oca, Krista i sv. Josipa  
 Damages of stone on the heads of an angel, God the Father, Christ and St. Joseph

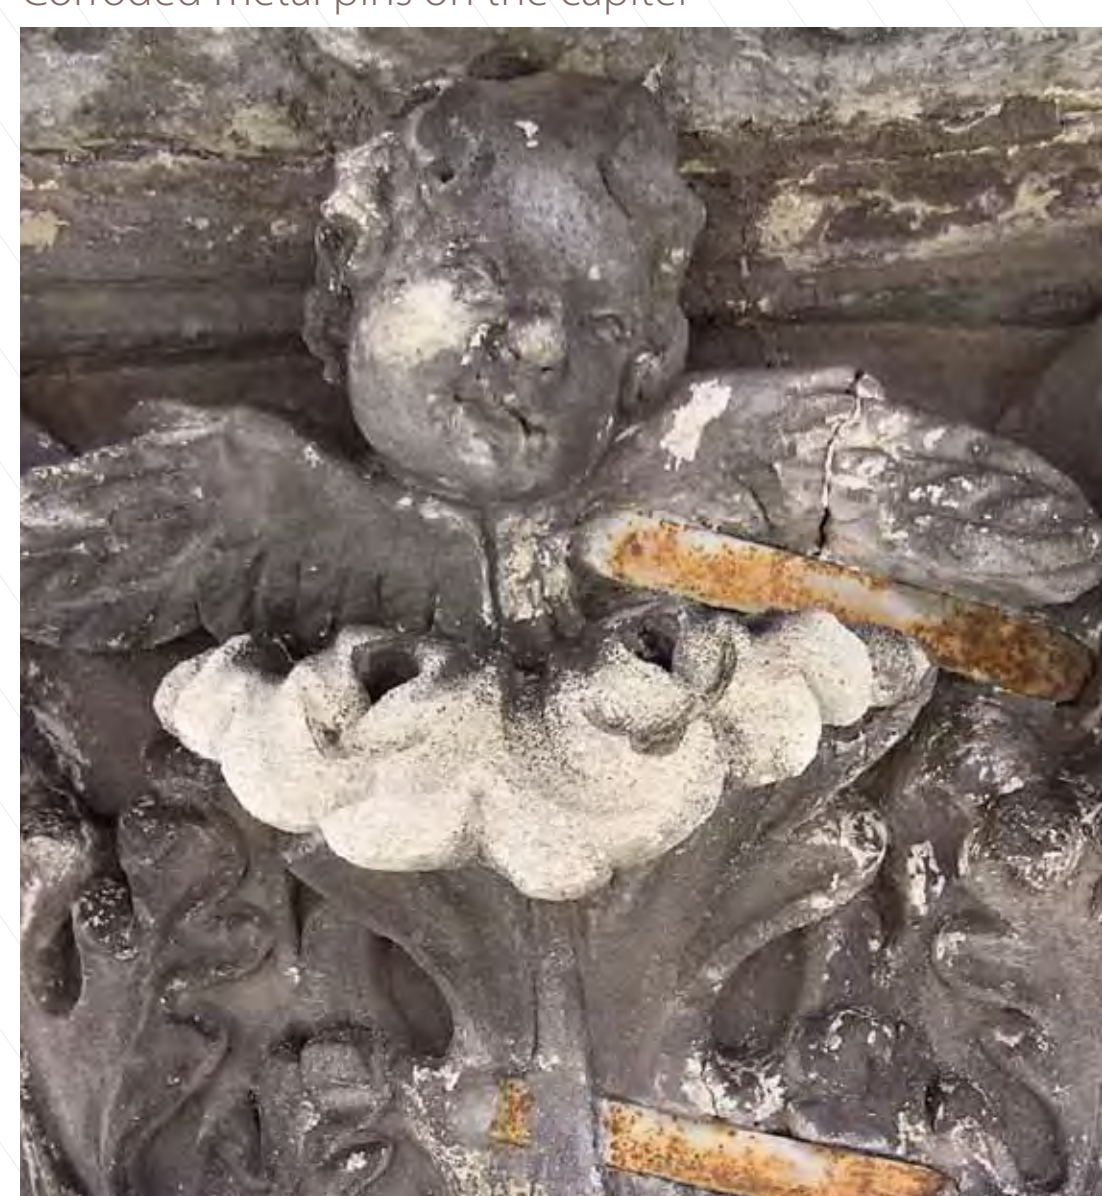
Korodirane željezne klanfe na kapitelu  
 Corroded metal pins on the capitel

iron elements. The corrosion of the iron objects anchored in the stone with its increase in volume caused the rupture of the stone, therefore, their replacement during the conservation and restoration works was necessary with non-corrosive metal parts.

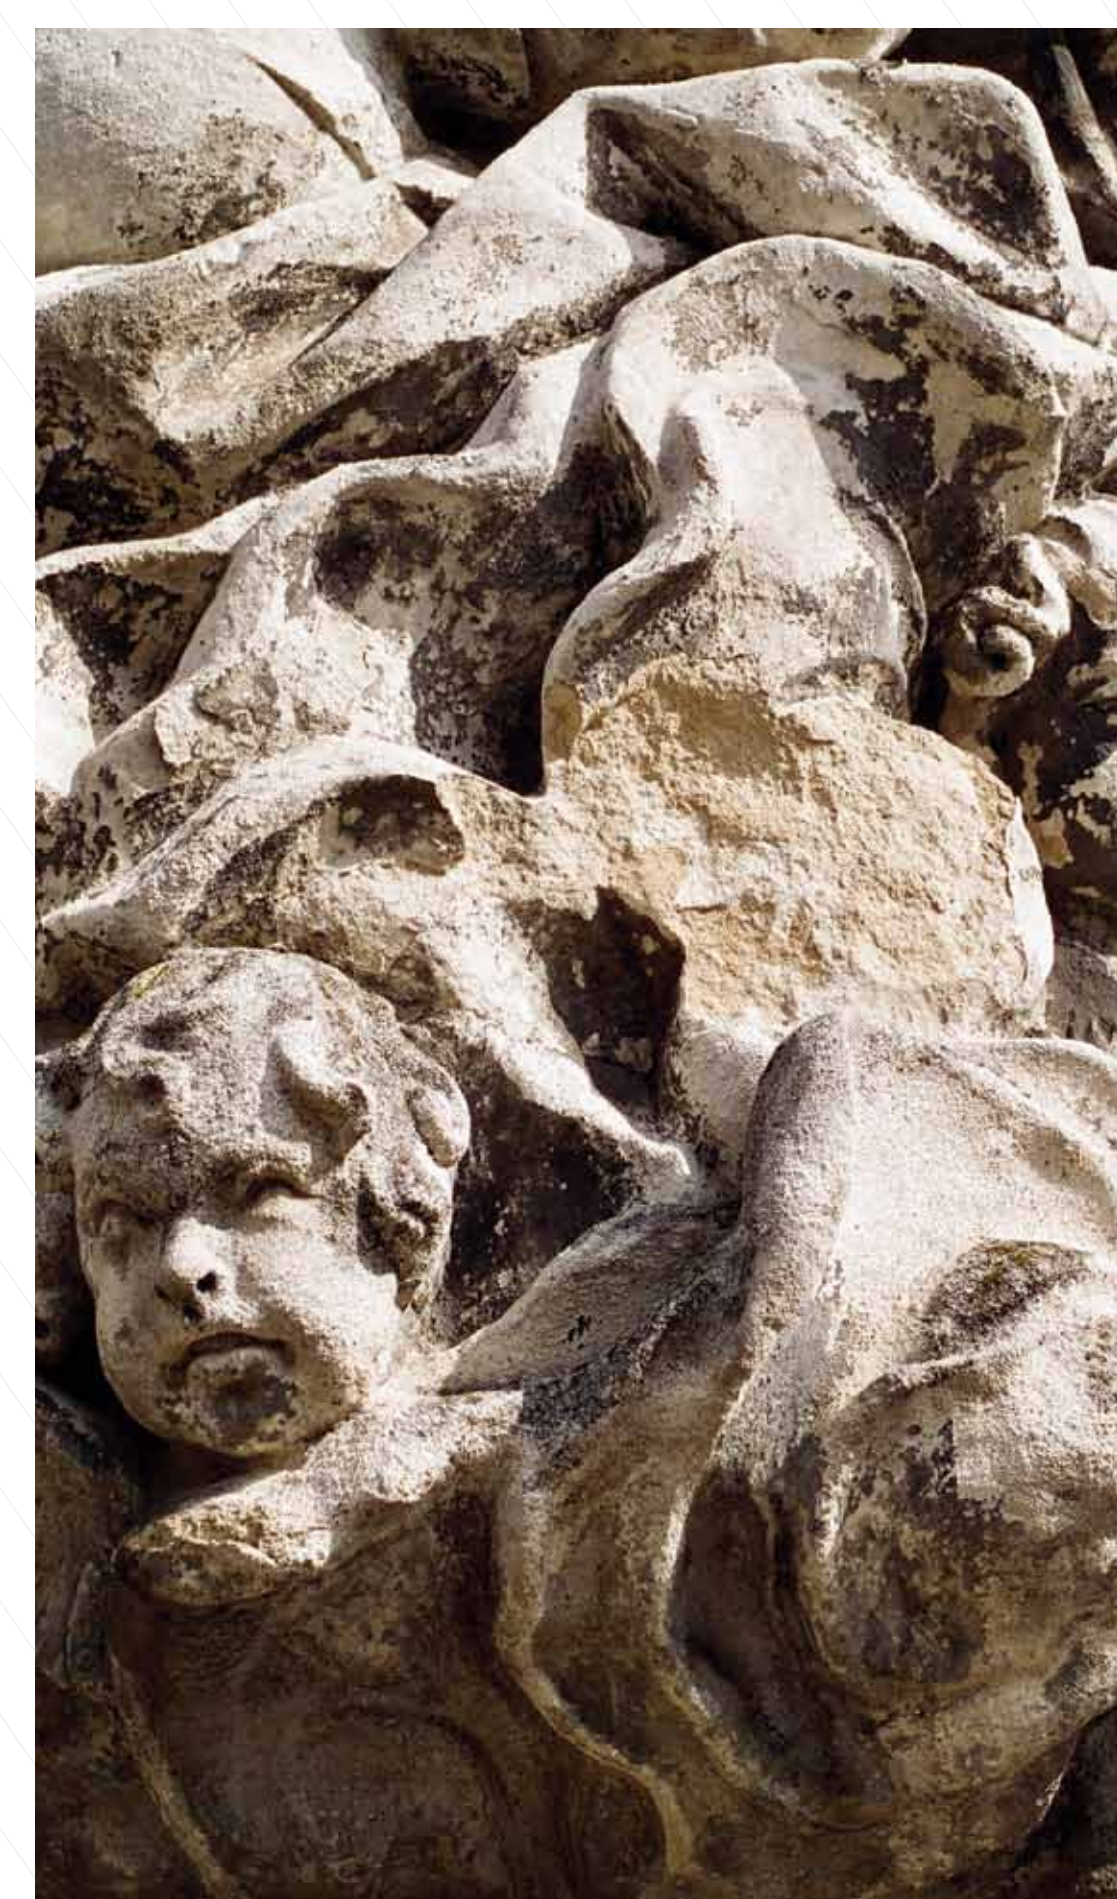
Oštećenja kamenih dijelova na vrhu spomenika  
 Damages of stone at the top of the monument

damage occurred as a result of the shelling during the Homeland War, or was caused by fragments of the missiles which had damaged the architectural elements. Some of the damage was caused by vandalism. Not long before the start of extensive renovation, the statue of St. Catherine was toppled from its base, after which it was transported to a workshop in pieces. Apart from the damage caused by the human factor, the mechanical damage was also caused by the elements. Precipitation had caused erosion of the stone surface on the projecting sections of the monument, dusting and scaling of the stone, which was the reason why the stone statues of the saints had lost the contours of the face, the hair, or parts of the drapery.

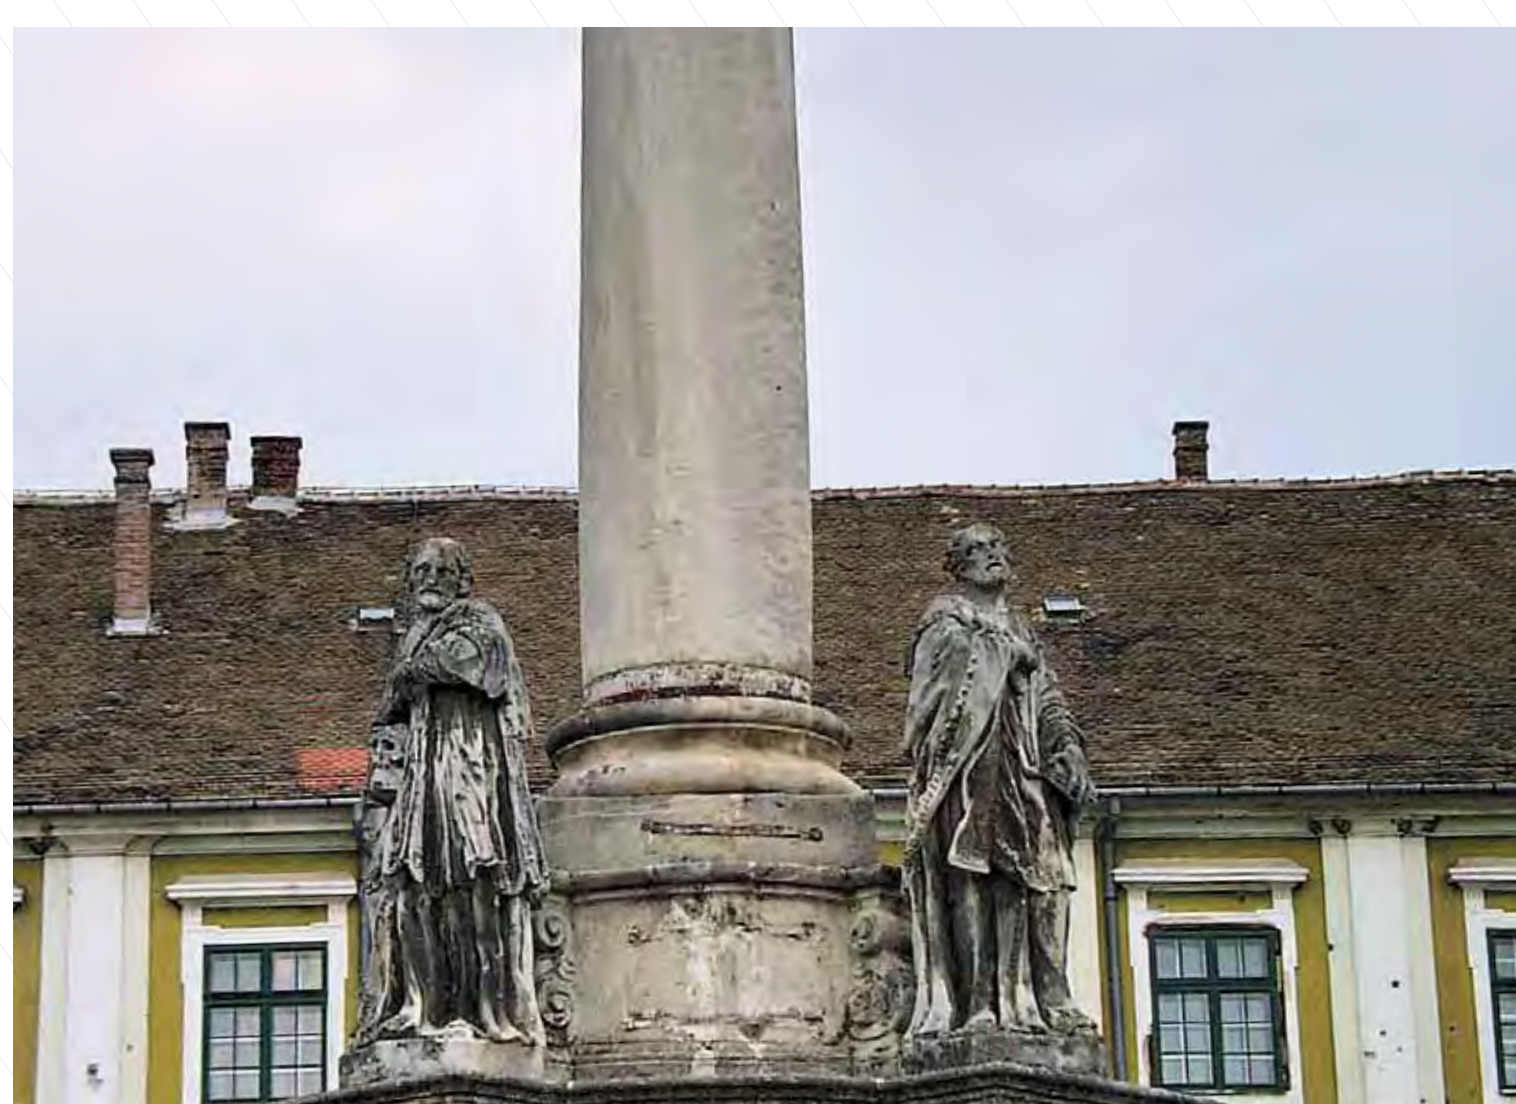
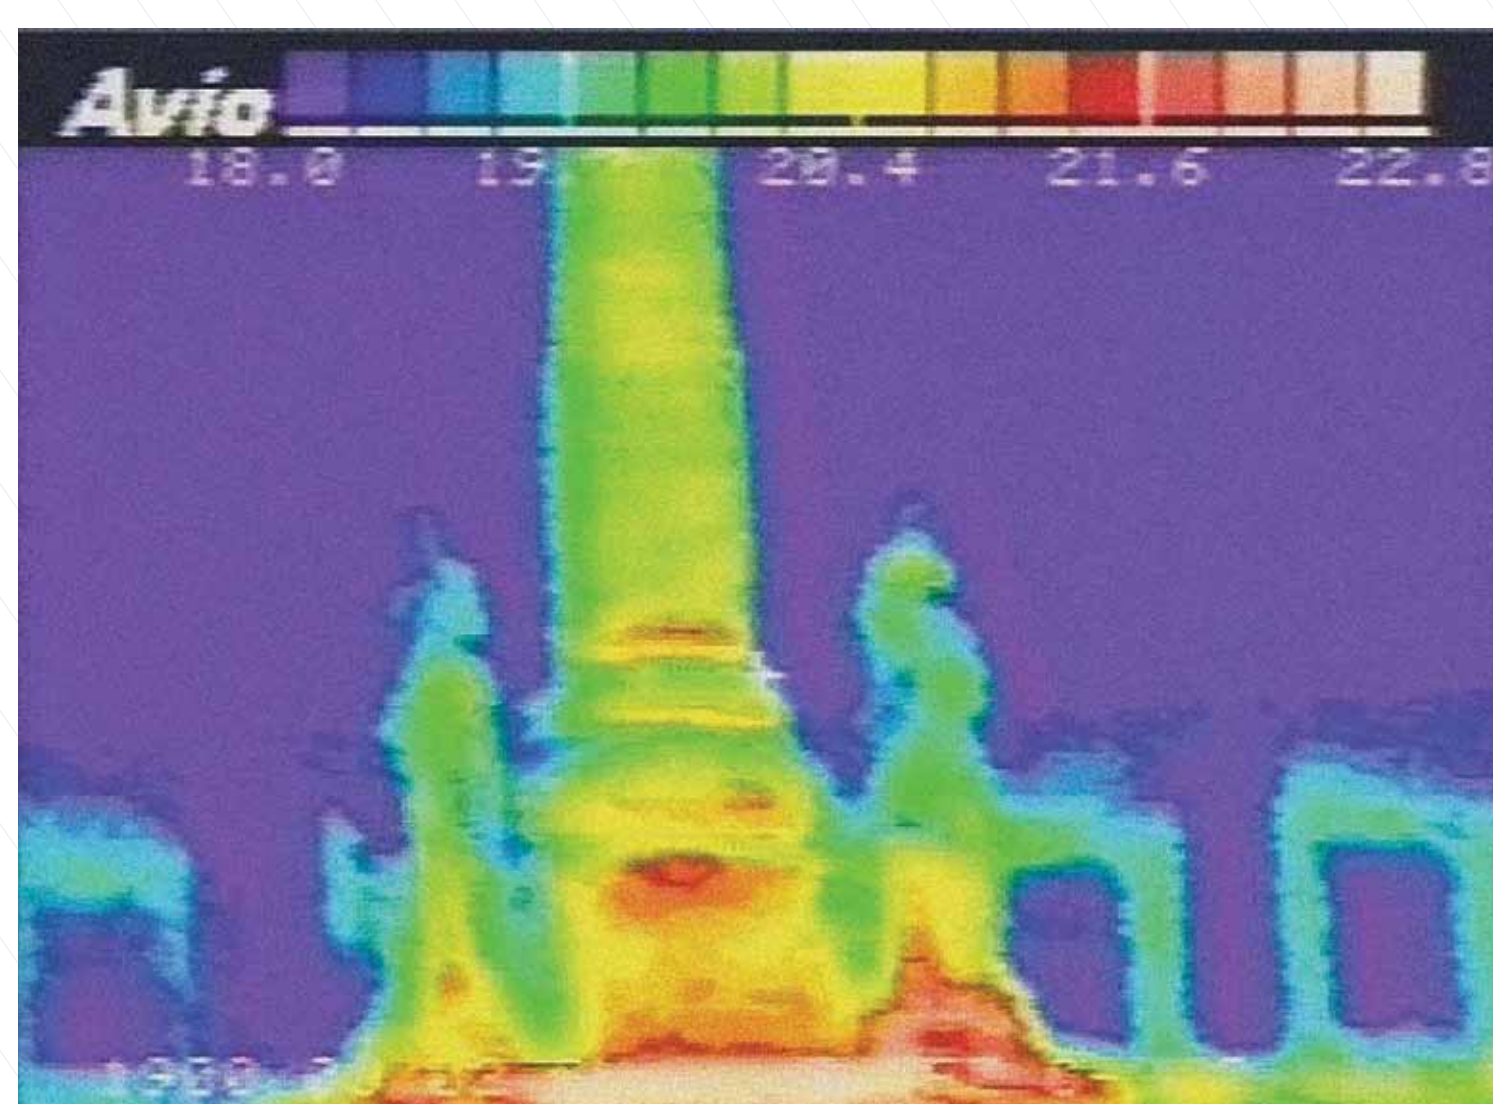
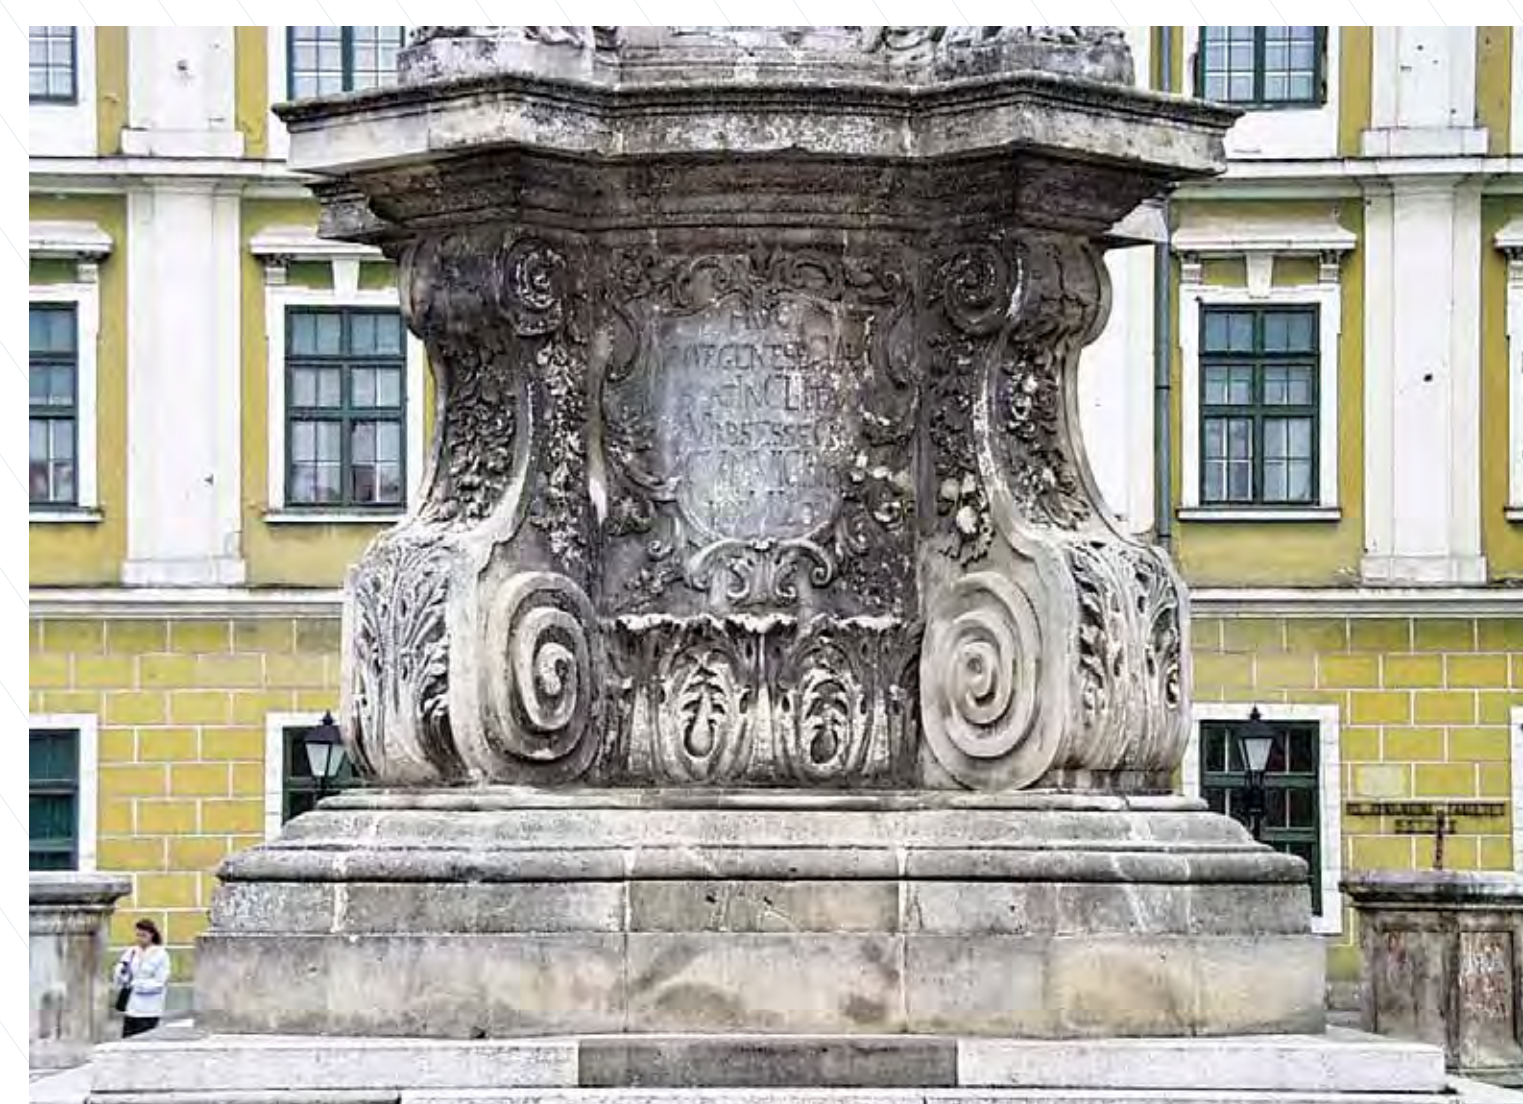
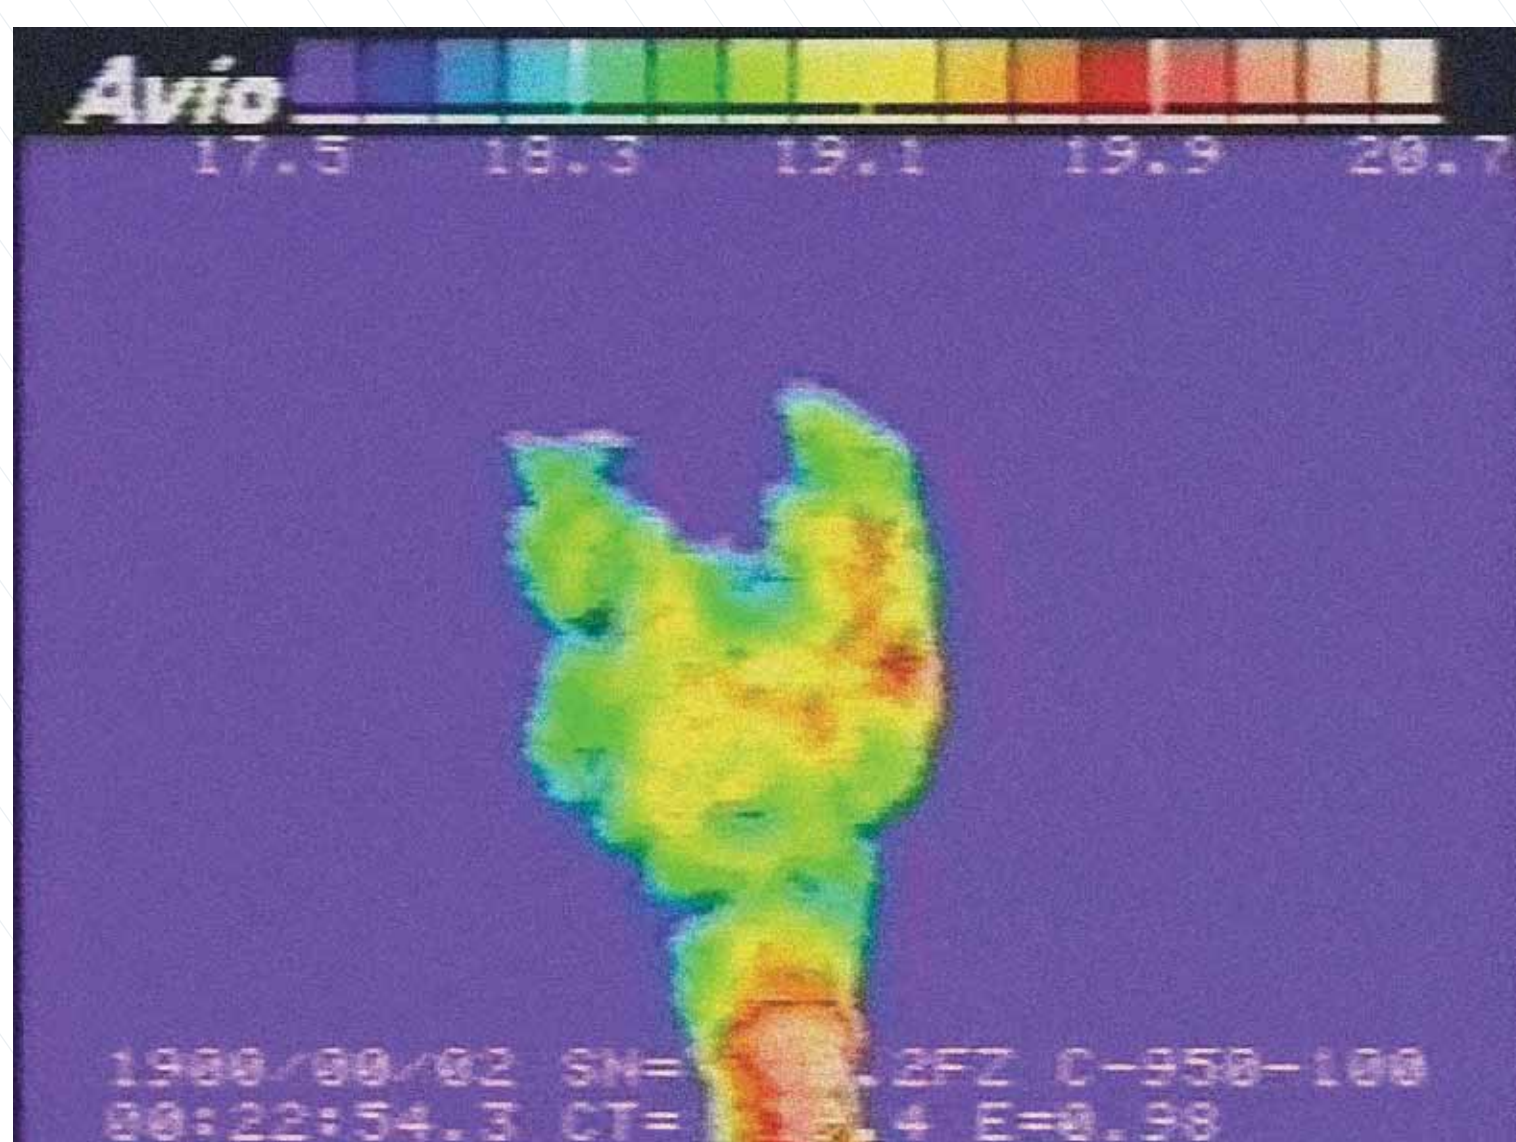
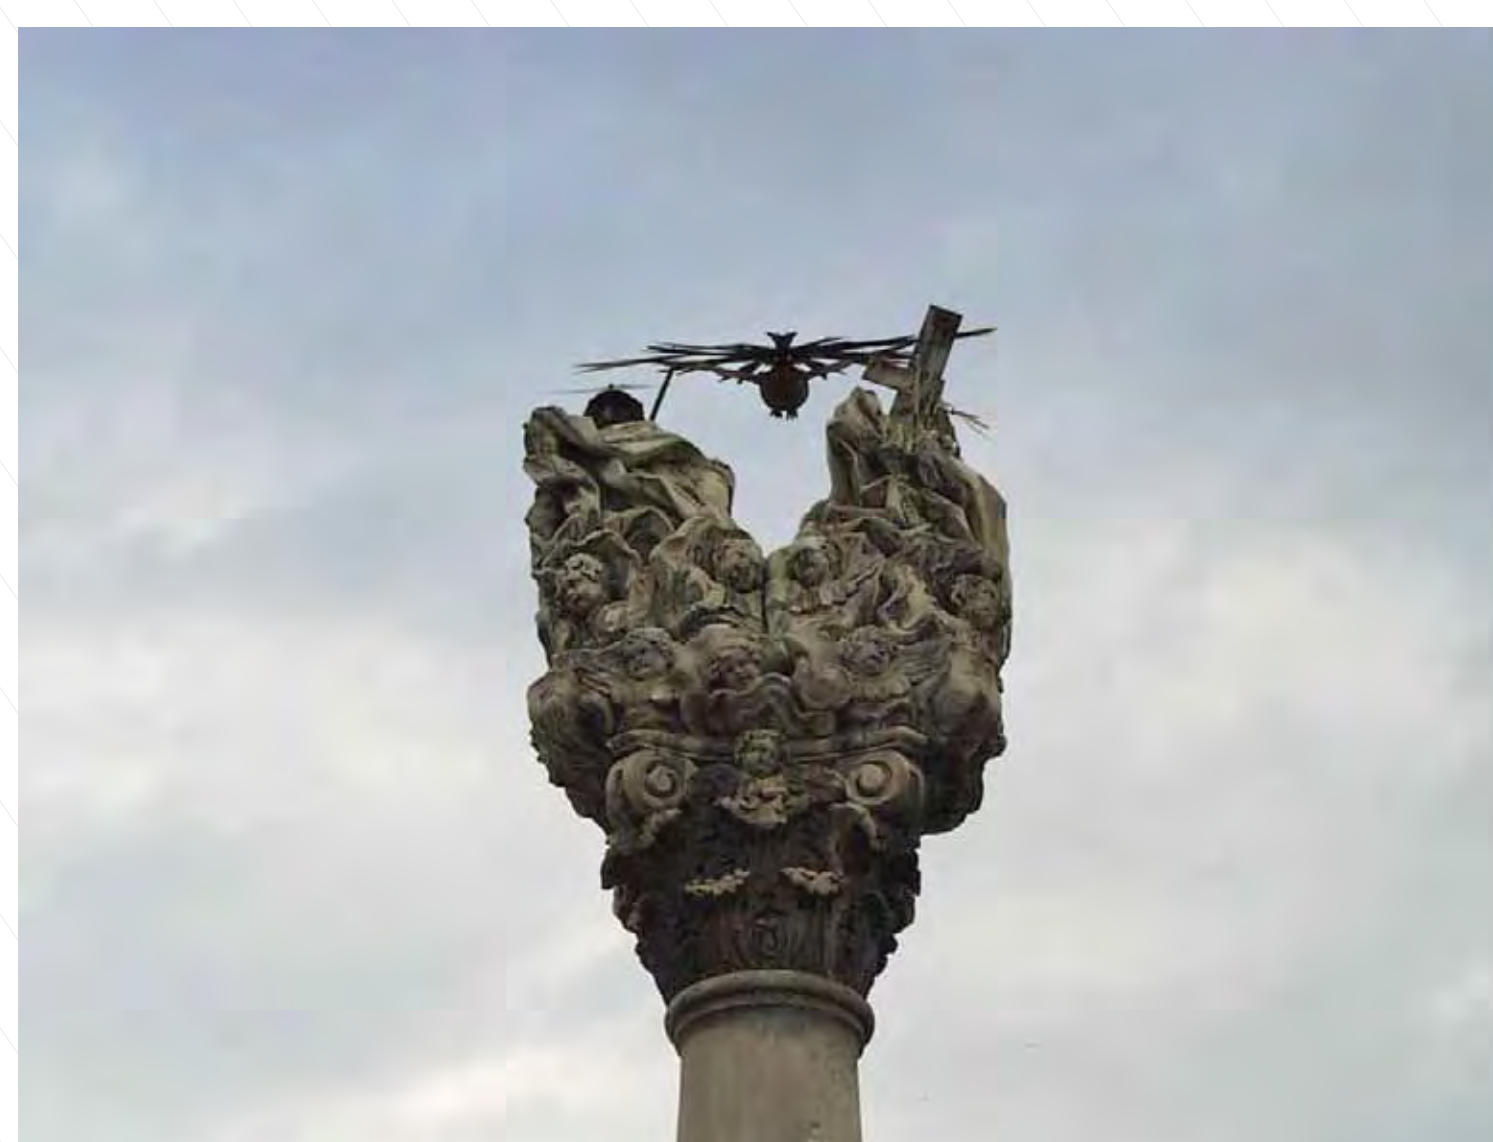
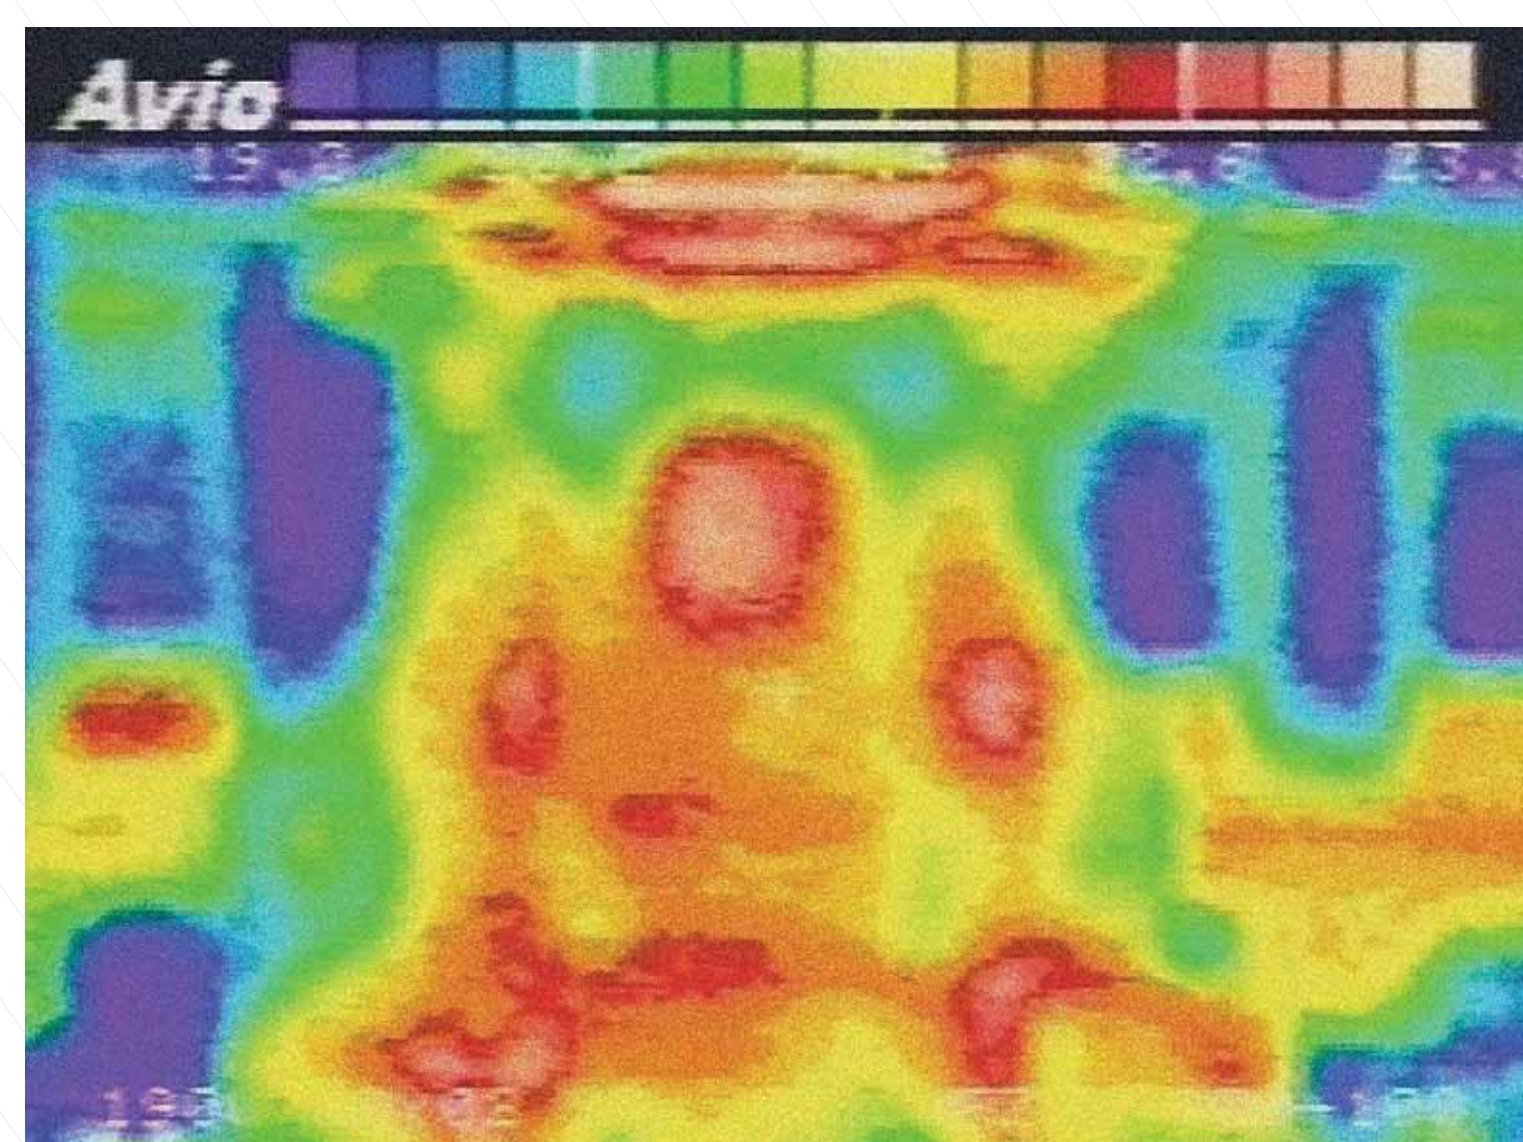
Termografski snimci pokazuju dijelove spomenika na kojima je kamen izrazito porozan (zelene zone), dijelove na kojima se kamen počeo raslojavati i ljuštiti (plave zone) te dijelove spomenika na kojima je kamen kompaktan i zdrav (zone obojane crvenom i drugim toplim tonovima)  
Thermal imaging shows parts of the monument where the stone is extremely porous (green areas), parts where the stone surface begun to erode (blue areas) and parts of the monument where the stone is compact and solid (red, yellow and orange areas)

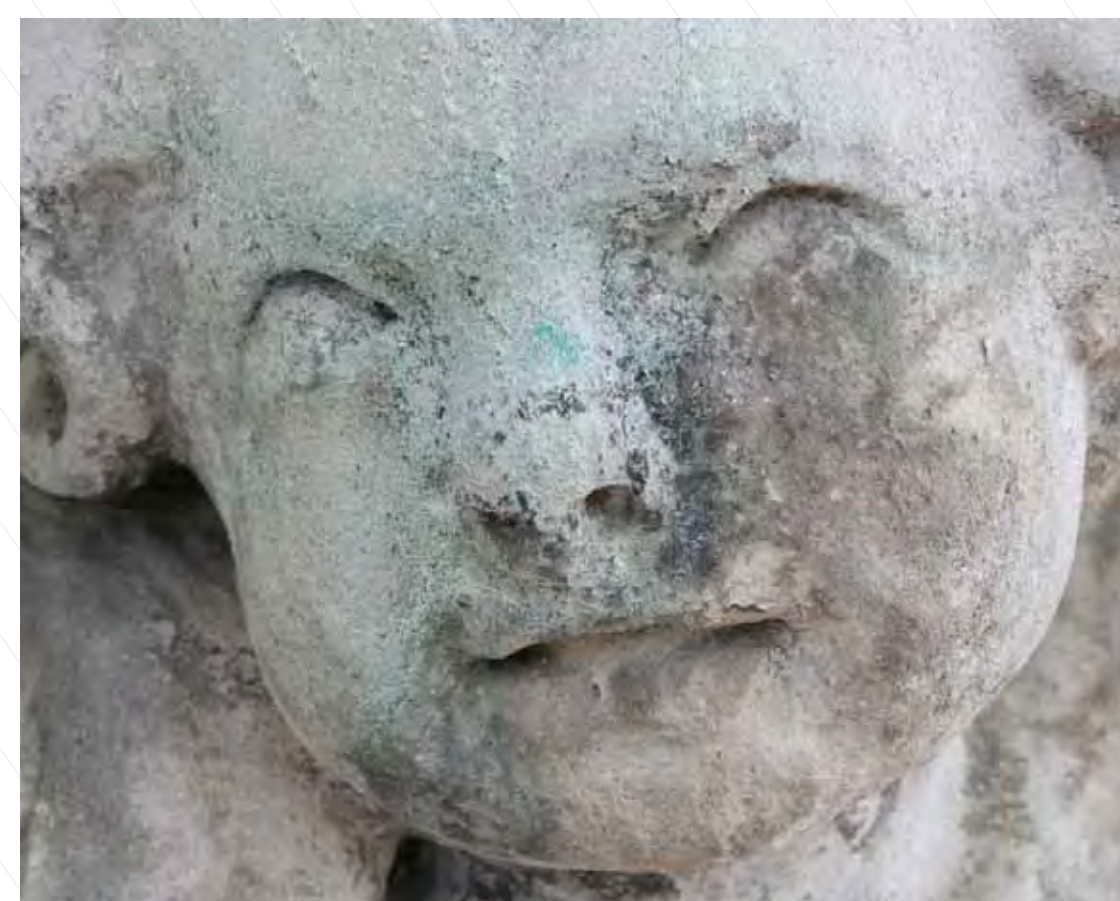
Malahitne mrlje na glavi anđela  
Malachite stains on the head of an angel

Apart from the treatment of the salt in the material structure, also chemically treated were the so called malachite stains, found on the surfaces of the upper sections of the monument, caused by the copper particles from the dove

and other copper parts of the Holy Trinity composition. Copper particles had penetrated the stone structure, creating green staining on the surfaces. The staining was treated with cellulose pulp saturated with ammonia carbonate which dissolves copper. Drying of the pulp draws the dissolved copper to the stone surface and into the actual pulp, where it manifests as blue staining.
