# konzervatorsko-restauratorski radovi na pilu sv. trojstva u osijeku

CONSERVATION AND RESTORATION WORK ON THE HOLY TRINITY VOTIVE  
MONUMENT (PIL) IN OSIJEK

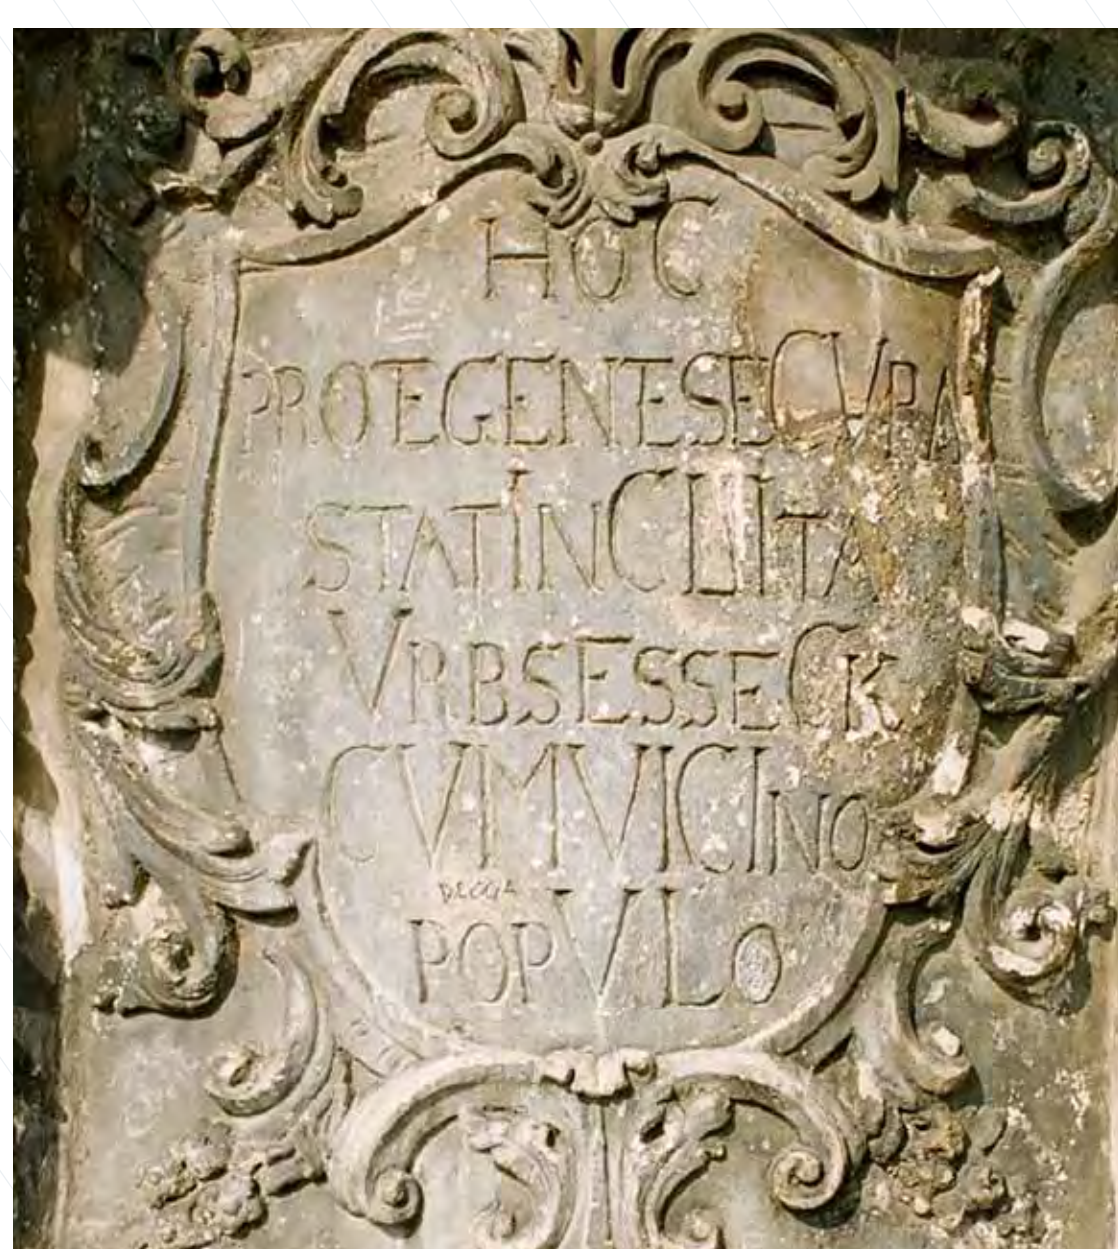
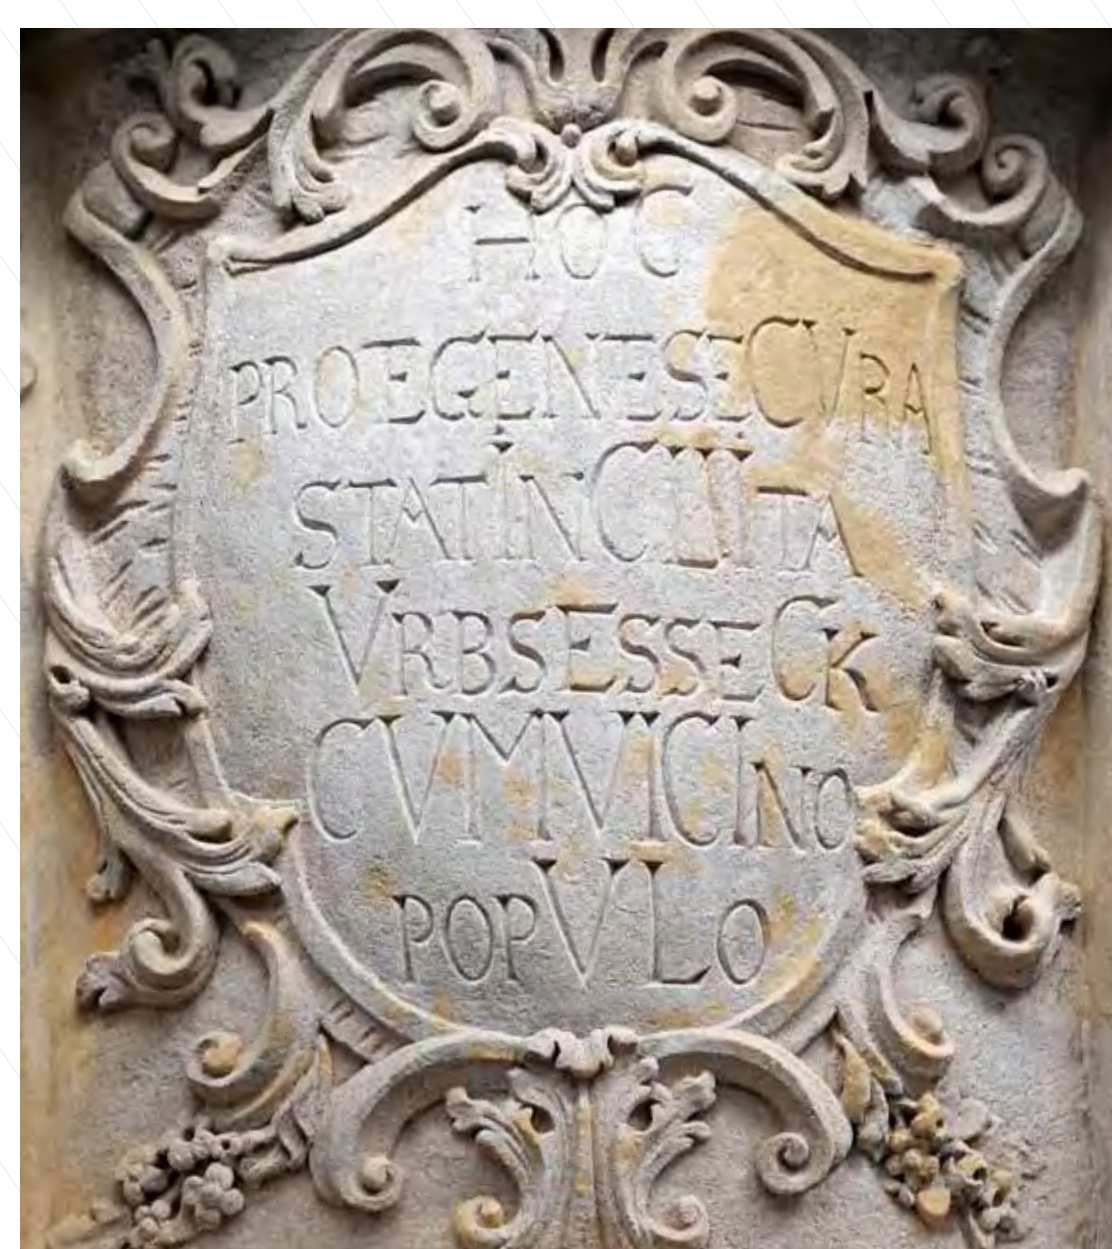
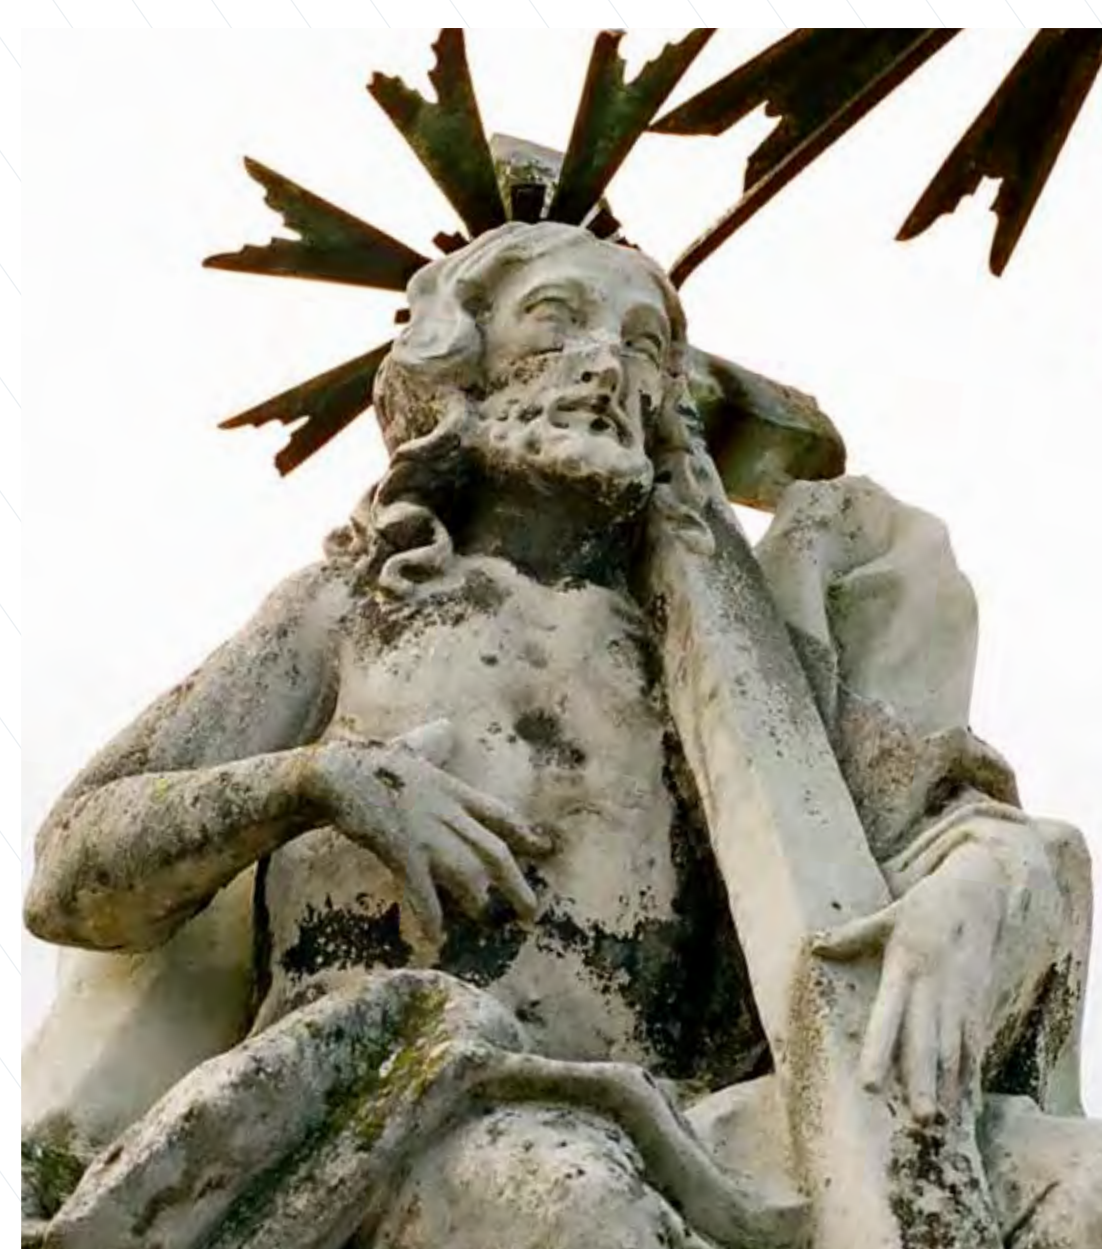
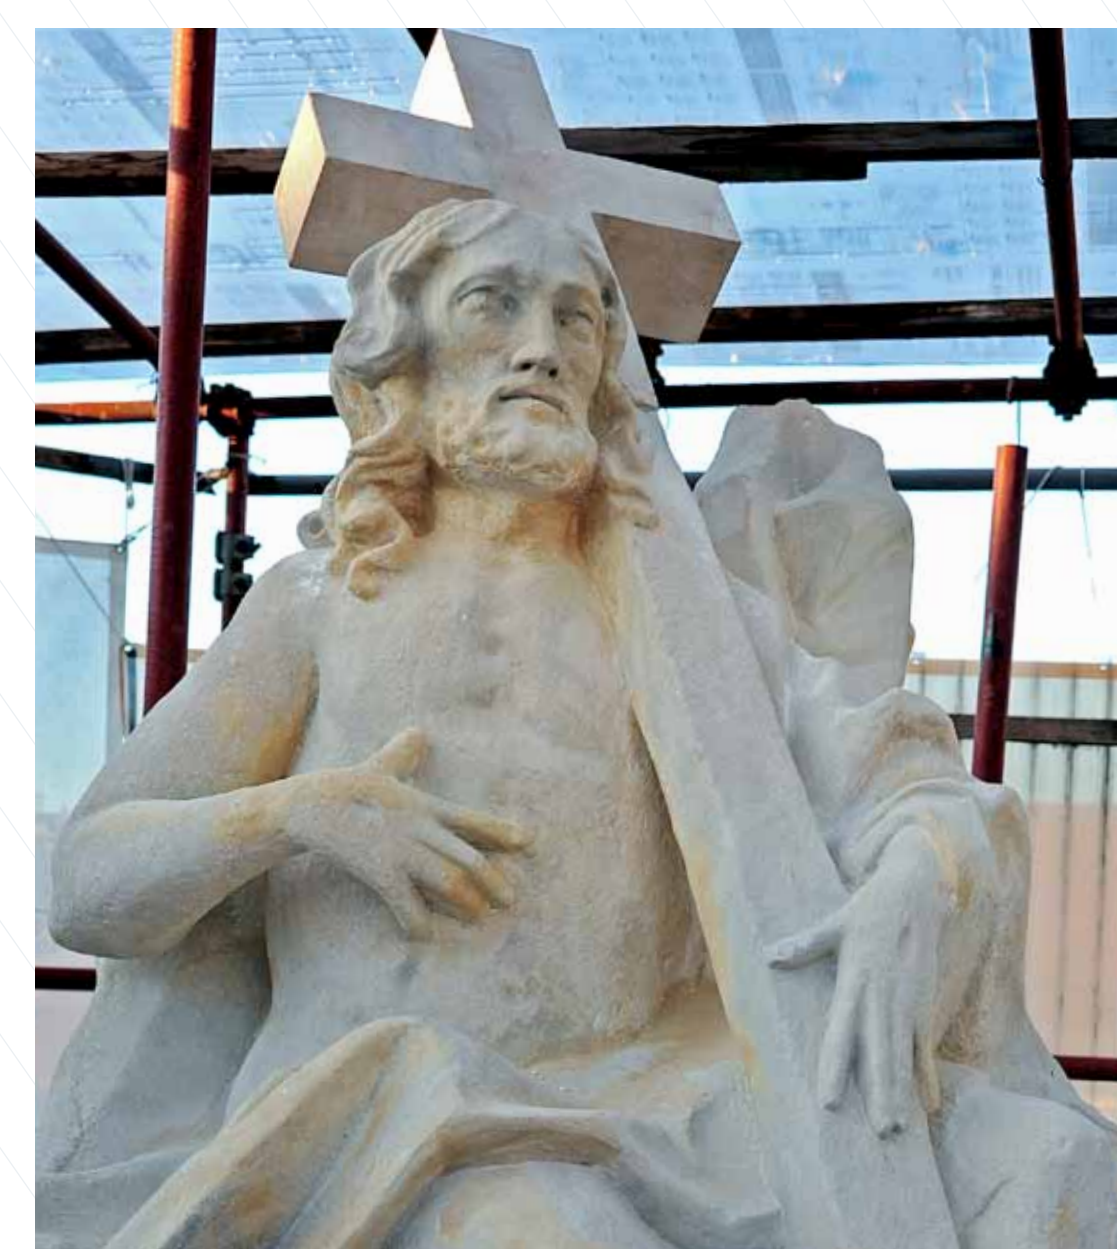
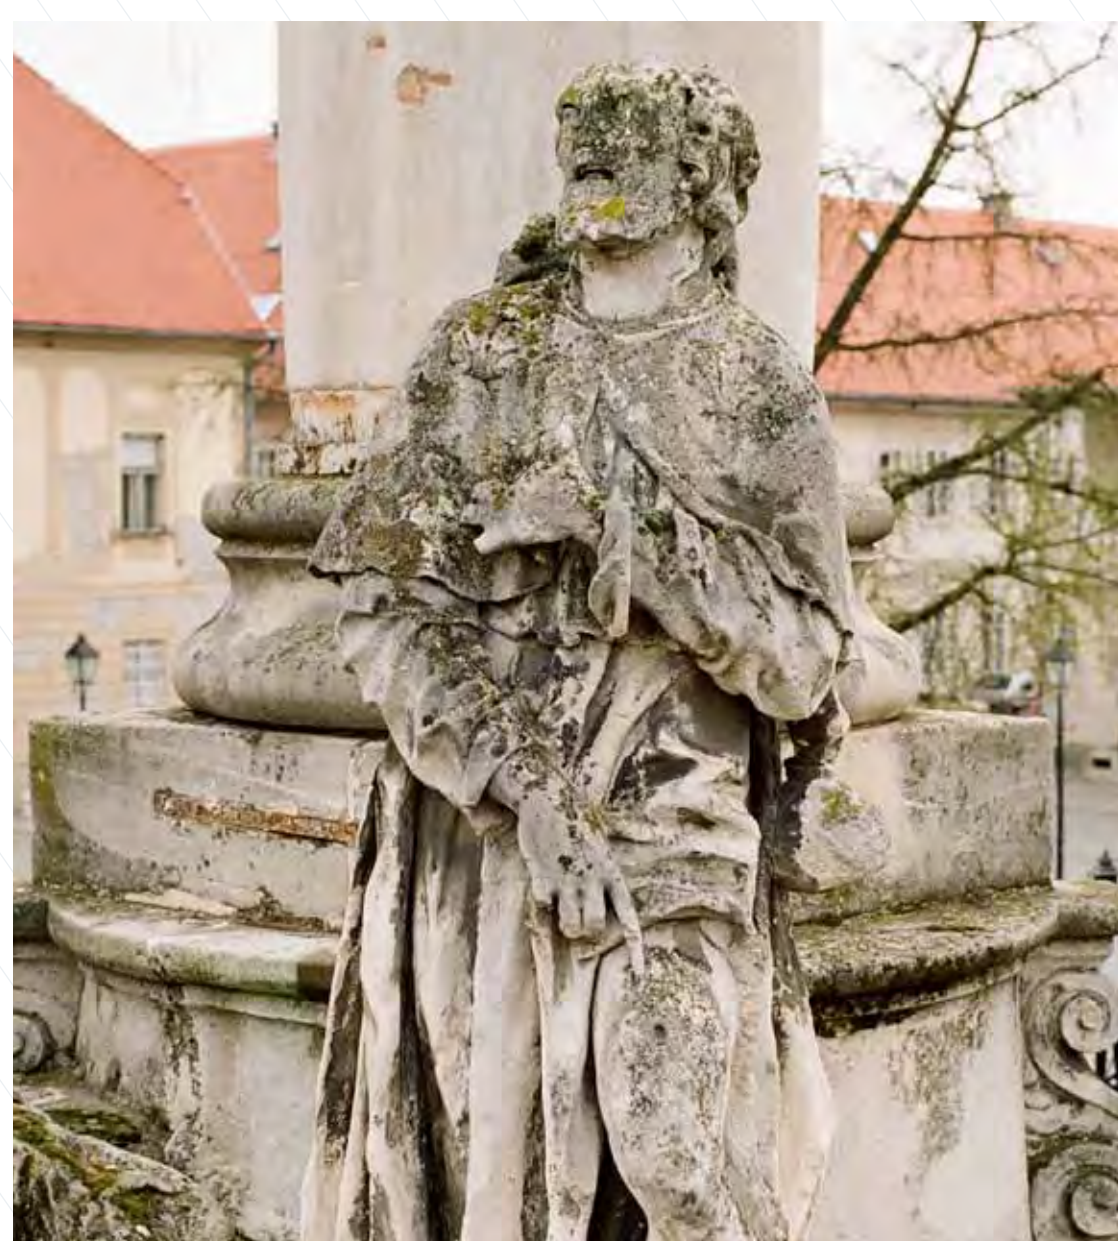
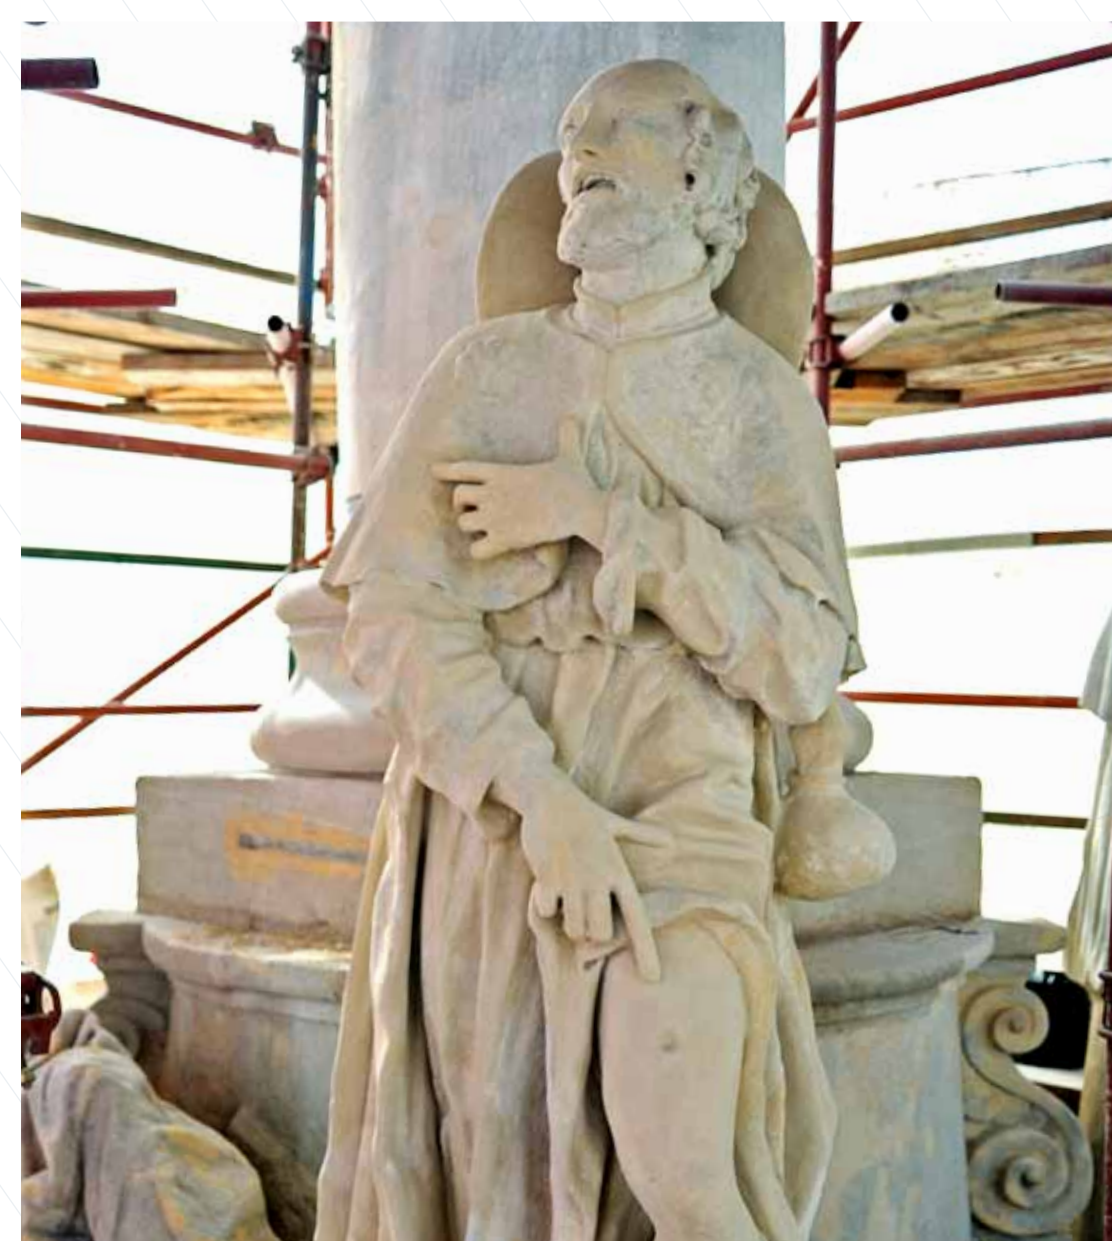
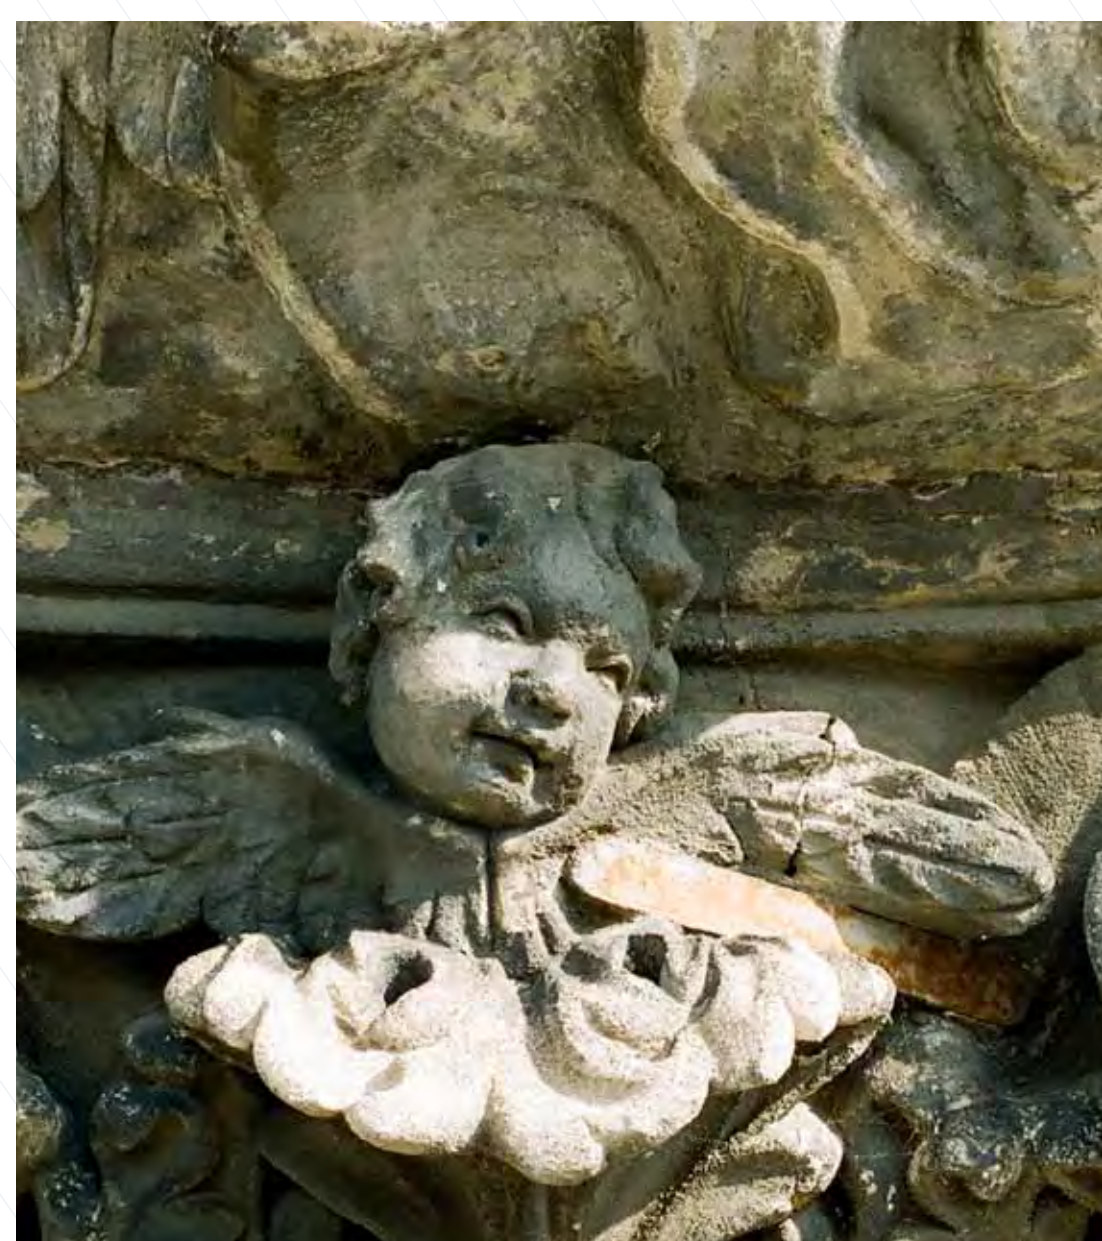
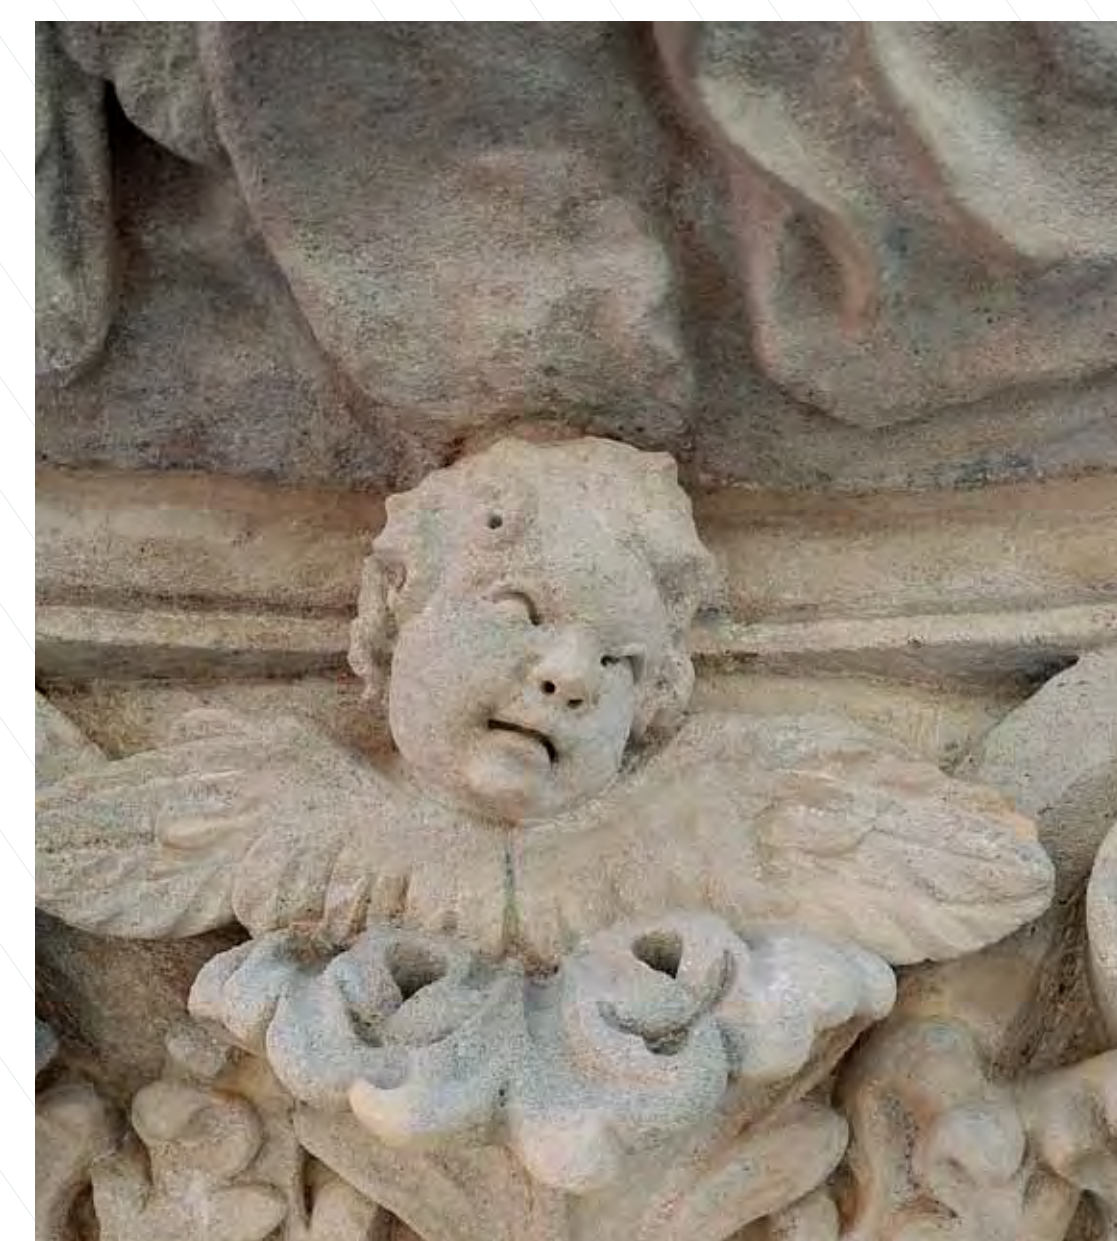
Prije i nakon konzervatorsko-restauratorskih radova: polje s natpisom na podnožju pila, skulptura Krista, skulptura sv. Roka, glava anđela  
 Before and after conservation-restoration work: inscription on a high stand, the statue of Christ, the statue of St. Roch, head of an angel

DEGRADED BY DIFFERENT types of damage, numerous parts of the monument had to be restored. The original stone surface of all the statues was destroyed due to erosion, and the figures of saints had lost the facial features and other details. The eroded stone surfaces, as well as smaller missing details (fingers etc.) were reconstructed using artificial stone, a mix of lime, binder and stone dust. Artificial stone was used to model the missing forms, returning the contours to the figures, with a more extensive reconstruction carried out to replace some of the features of the saints, such as the crucifix in the hands of St. Charles Borromeo. Apart from the modelling in artificial stone, the damaged parts were replaced by insertion of ready made carved pieces of stone in place of the

damaged sections in the previously carved grooves. Using the same method, the crucifix in the hand of Christ was reconstructed. Joints of the stone elements were sealed with a special grout, composed of coarse aggregate with increased water permeability, to prevent water retention on the joints. Individual elements and fissures were reconnected with carbon fibres inserted into the stone structure. The carbon fibres are a type of tension-resistant material, light and non-corrosive, used for the joining of individual parts during the restoration work on stone sculptures and architectural elements. Replacement of the stone step of the base destroyed by shelling during the Homeland War is also considered reconstruction of a stone element. The new step was carved in sandstone.

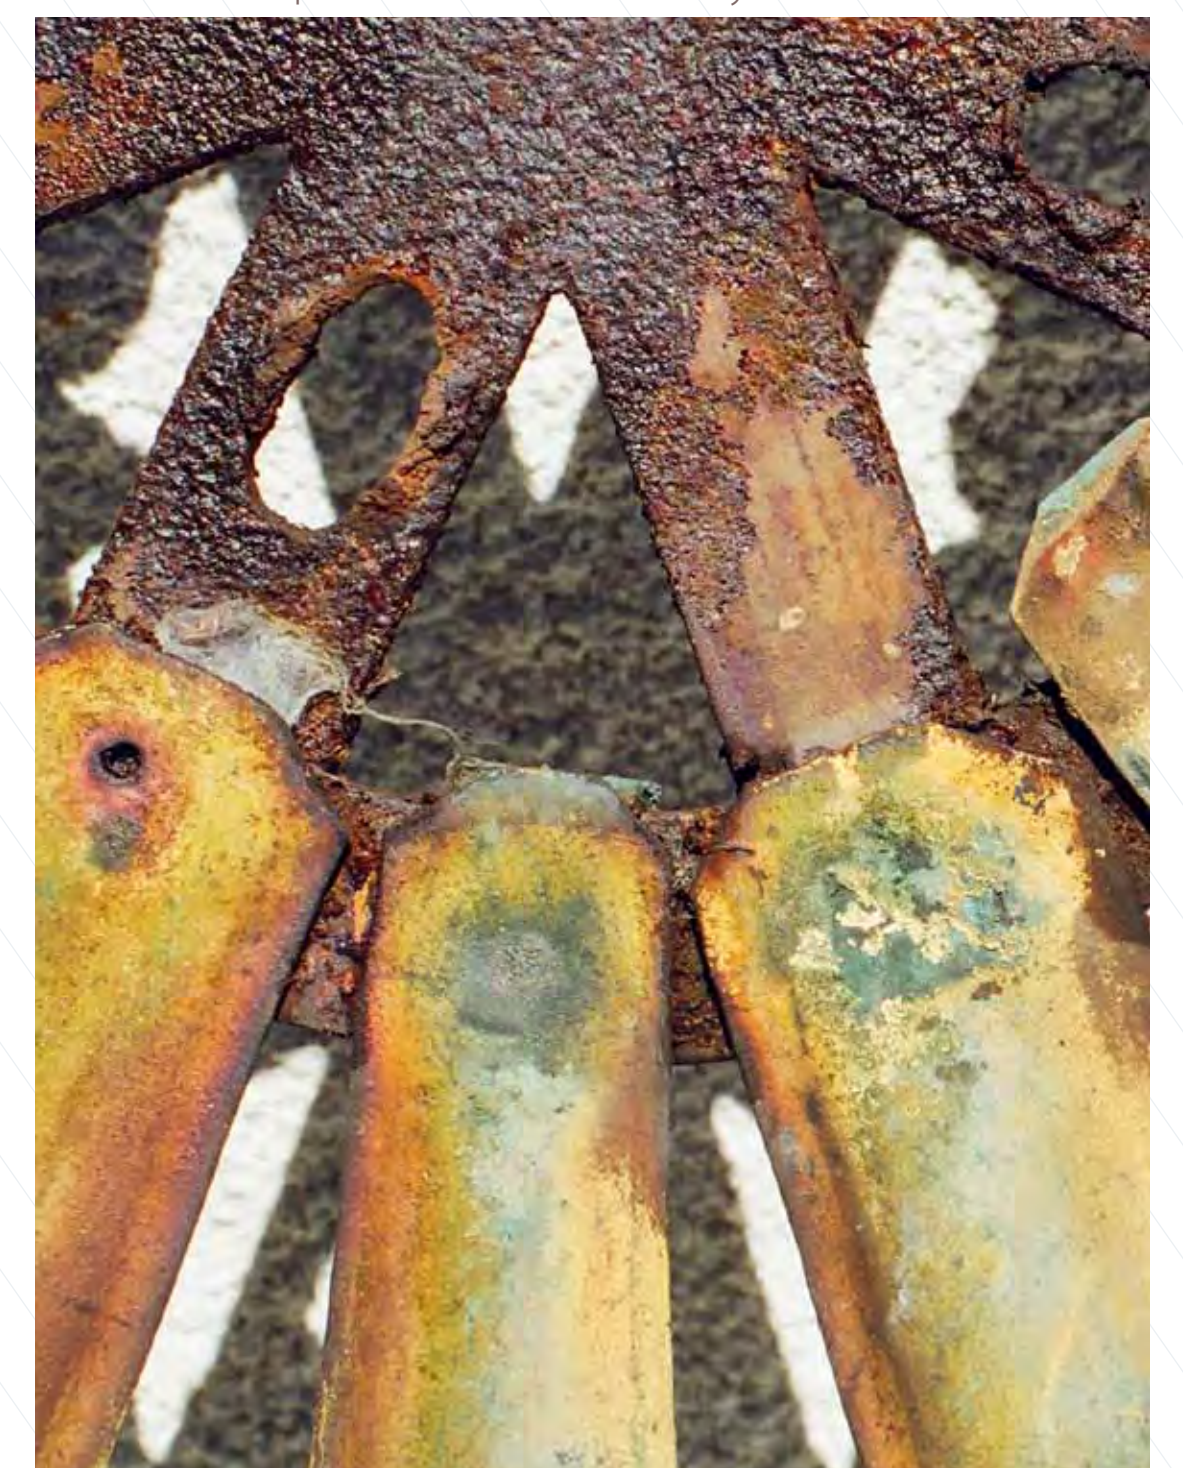
Korozija na dijelu zrakaste aureole  
Corrosion on part of the halo with rays

The copper elements from the top of the monument were cleaned, the material stabilized, partial reconstruction of the missing parts was carried out where necessary, and the elements were coated with a new layer of gold leaf. The preserved parts of the original dove were tightened, conserved and prepared for the museum presentation. The reconstruction of the dove and the restoration work on the copper elements were performed by the metal restoration expert Valentina Ljubić.
