IZLOŽBA O KONZERVATORSKO-
RESTAURATORSKIM RADOVIMA
NA PERISTILU DIOKLECIJANOVE
PALAČE U SPLITU

EXHIBITION OF CONSERVATION-
RESTORATION WORKS AT THE
PERISTYLE OF DIOCLETIAN'S
PALACE IN SPLIT

Split
Svibanj / May
2013

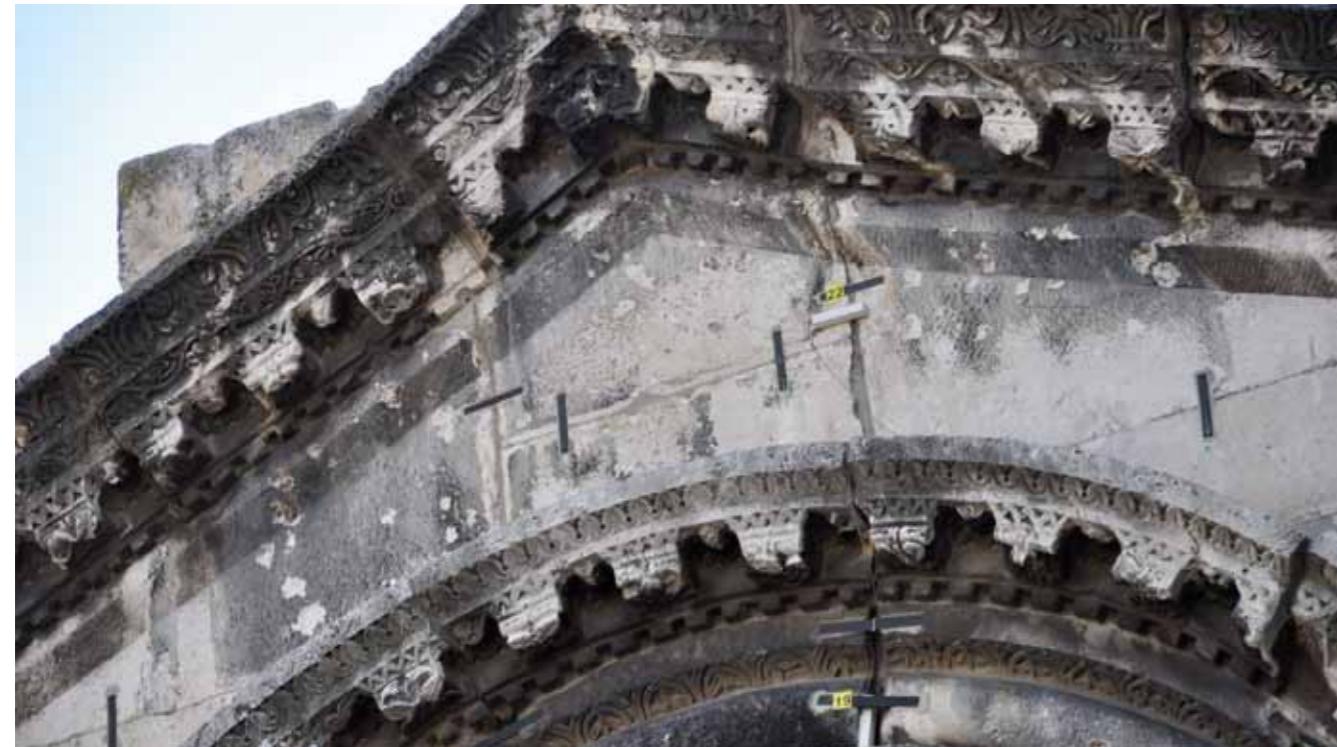
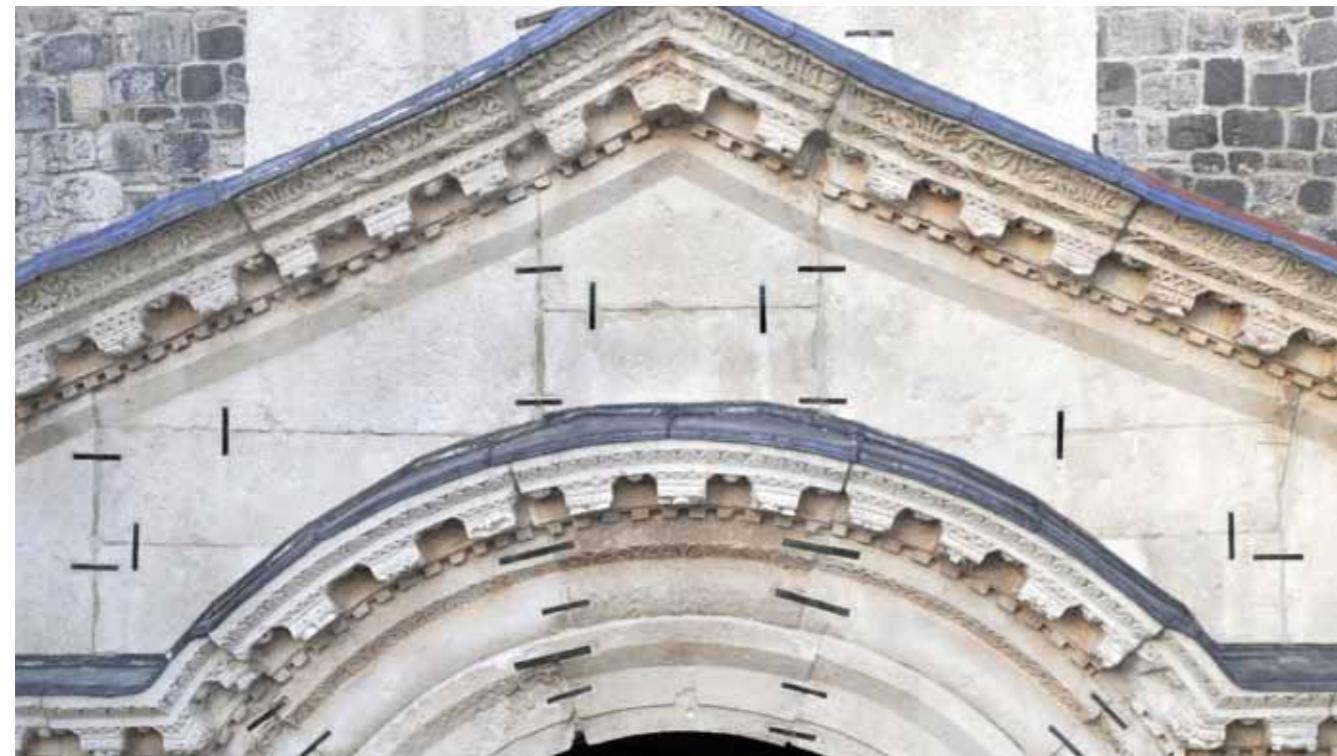
ZABAT PROTIRONA PRIJE I NAKON KONZERVATORSKO-RESTAURATORSKOG ZAHVATA
THE PEDIMENT OF THE PROTHYRON BEFORE AND AFTER RESTORATION

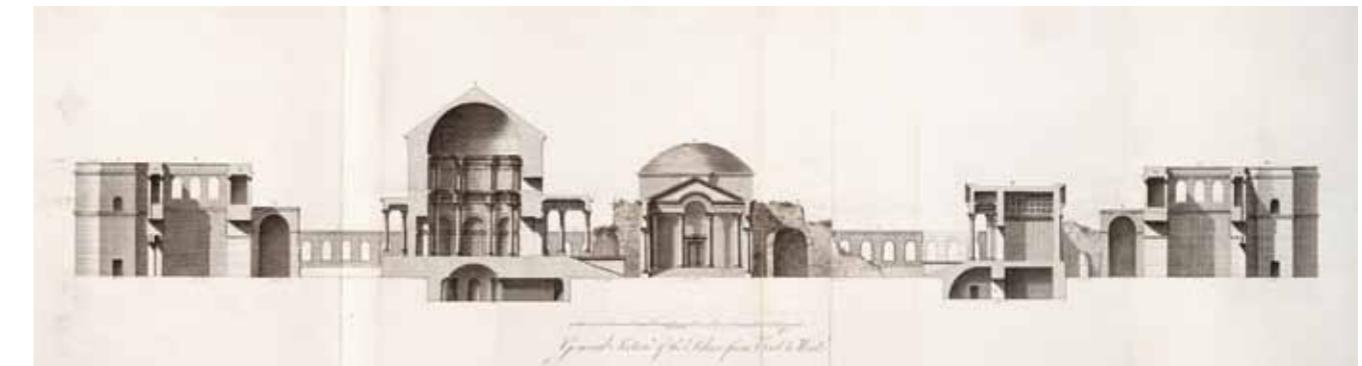
POPREČNI PRESJEK PALAČE, R. ADAM, 1764.

CROSS SECTION OF THE PALACE, R. ADAM, 1764

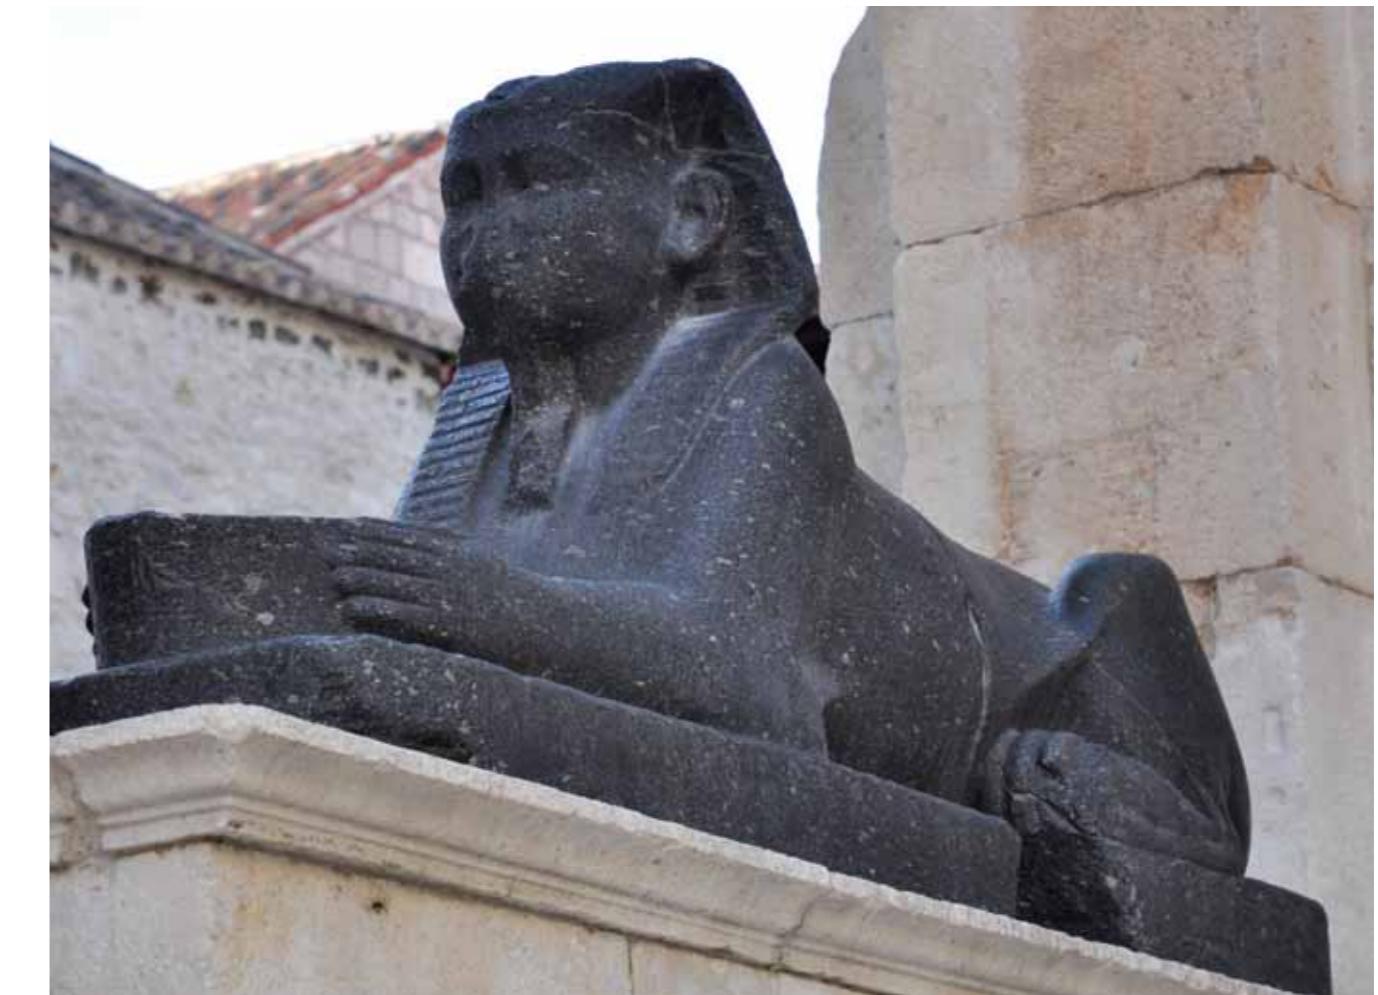
SFINGA NA PERISTILU

THE SPHINX ON THE PERISTYLE

Splita. Nekoliko znatnih oštećenja na glavi i velika pukotina koja je prepolovila tijelo sfinge nastali su davno, prema predaji, padom kamena gornjih katova zvonika prilikom udara groma. Prilikom izrade odjelja peristilske sfinge otkriven je reljef na šrtveniku na kojem piše, kako je to protumačio egiptolog Igor Uranić, Ankh-det ili „vječan život“, što je simbolična poveznica s dugovječnošću skulpture koja je stara više no sam Peristil.

by order of Diocletian for the embellishment of his palace, only twelve sculptures or their parts have been preserved. The greatest and the most beautiful among them is the sphinx from the reign of Tuthmoses III, and is the only one completely preserved. Placed beneath the southern arch of the eastern colonnade, it has become a symbol of the Peristyle and of Split. According to oral tradition, several significant damages on its head and a large fissure that has split its body in half have been created a long time ago by stones that fell from the upper parts of the bell tower as it was struck by lightning. During the casting of the copy of the sphinx, on its front side a relief was discovered with the inscription *Ankh-Tjet* – "eternal life", as it was deciphered by the Egyptologist Igor Uranić. Therefore it is symbolically connected to the longevity of sculpture that is significantly older than the Peristyle.

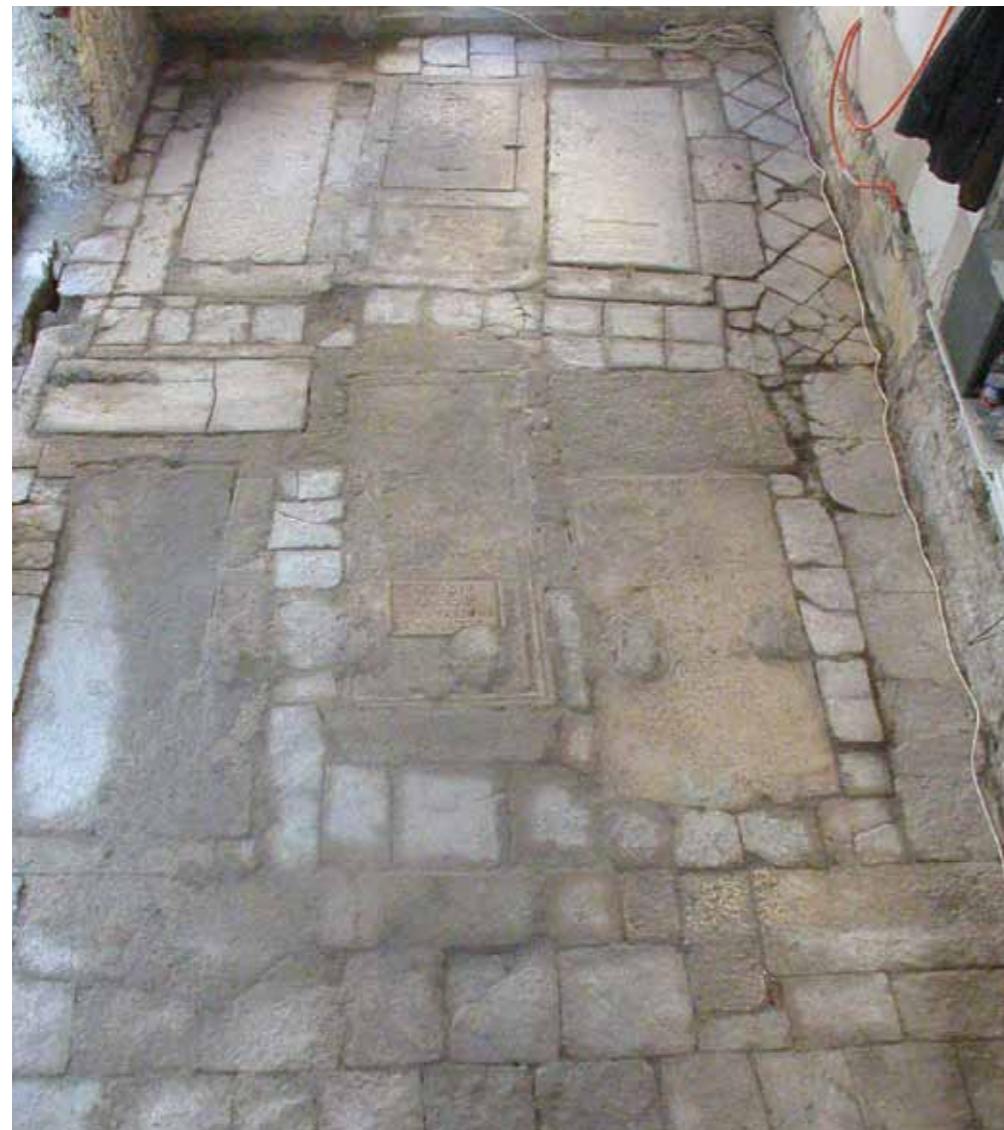
RENESSANSNI PLOČNIK CRKVE SV. ROKA PRONAĐEN PRILIKOM ARHEOLOŠKIH ISTRAŽIVANJA

RENAISSANCE PAVEMENT OF THE CHURCH OF ST. ROCH FOUND DURING ARCHEOLOGICAL RESEARCH

Underneath the recent floor in the church of St. Roch a well preserved Renaissance pavement was found. Eight stone grave slabs were found in the larger, western section of the floor, of which four belonged to sealed interments of plague victims, while the remaining four were burials of brethren of St. Roch with the year 1617 engraved on them.

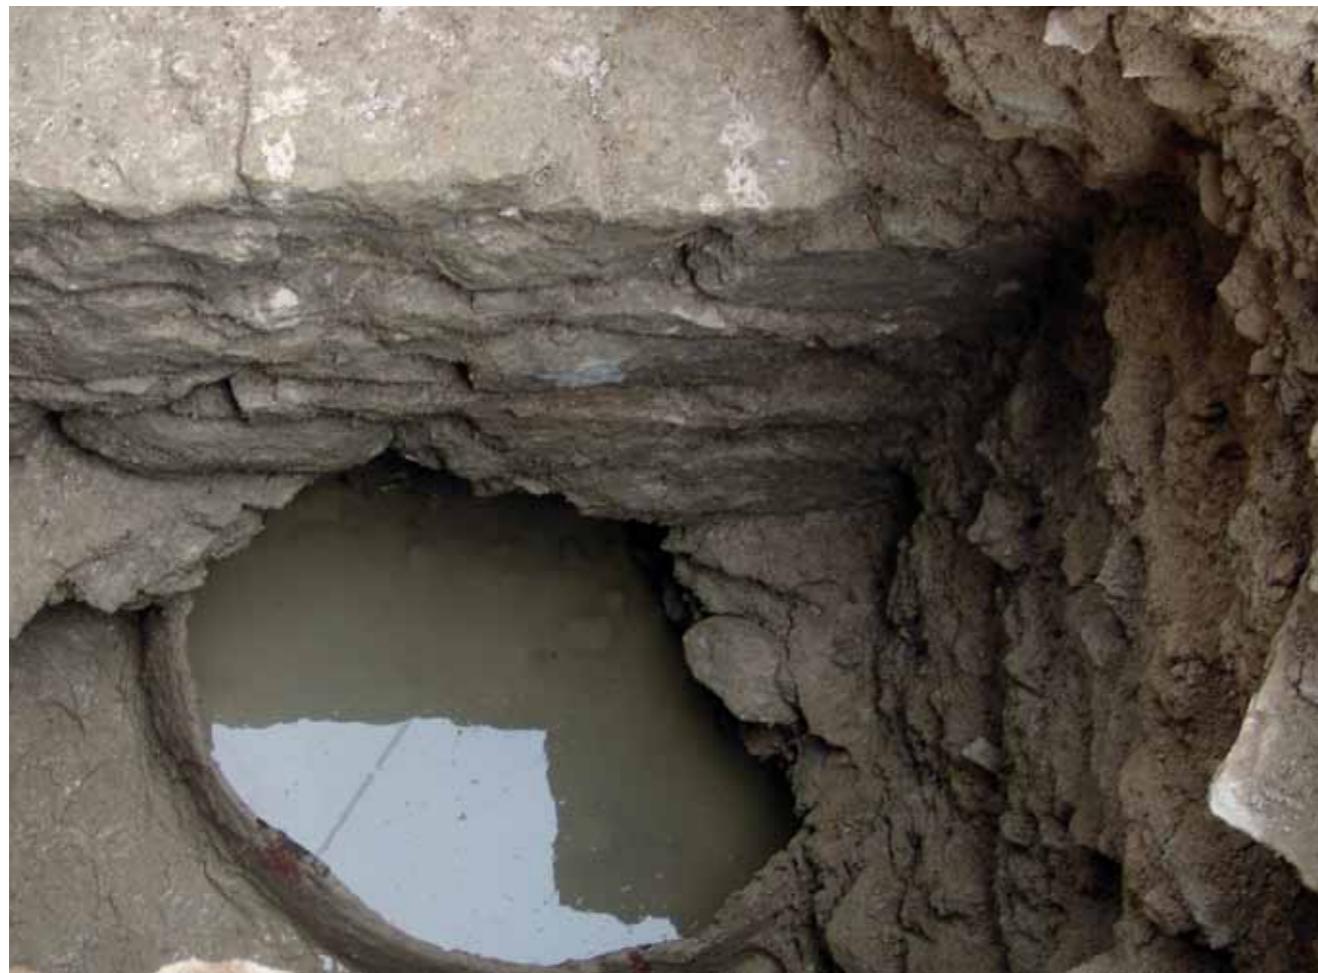
ARHEOLOŠKA SONDA U JUGOISTOČNOM DIJELU PERISTILA S PRONAĐENIM PITHOSOM

ARCHAEOLOGICAL TEST PIT IN THE SOUTHEAST PART OF THE PERISTYLE WITH REMAINS OF A PITHOS

mljiv arheološki sloj čiji je vrh utvrđen ispod razine tankog temeljnog proširenja ispod razine antičkog kanala i temeljnog zida kolonade. U tom sloju otkriven je oštećeni antički *pithos* – velika keramička posuda koja se uglavnom koristila za skladištenje namirnica u antičko doba. Međutim, iz konteksta u kojem je *pithos* pronađen, može se pretpostaviti da je u ovom slučaju korišten za usmjeravanje (kaptazu) vode koja izvire u blizini.

To the west and near the southernmost column of the east colonnade of the Peristyle, the archaeological dig has identified another drainage channel, which extends toward the *temenos*, through the foundation underneath the column. A specially interesting archaeological layer was found in the same test pit, with a damaged ancient *pithos* – a large ceramic vessel, generally used to store foodstuffs in antiquity. However, the context in which the *pithos* was found indicates that in this case it was used to redirect the water that sprang nearby.

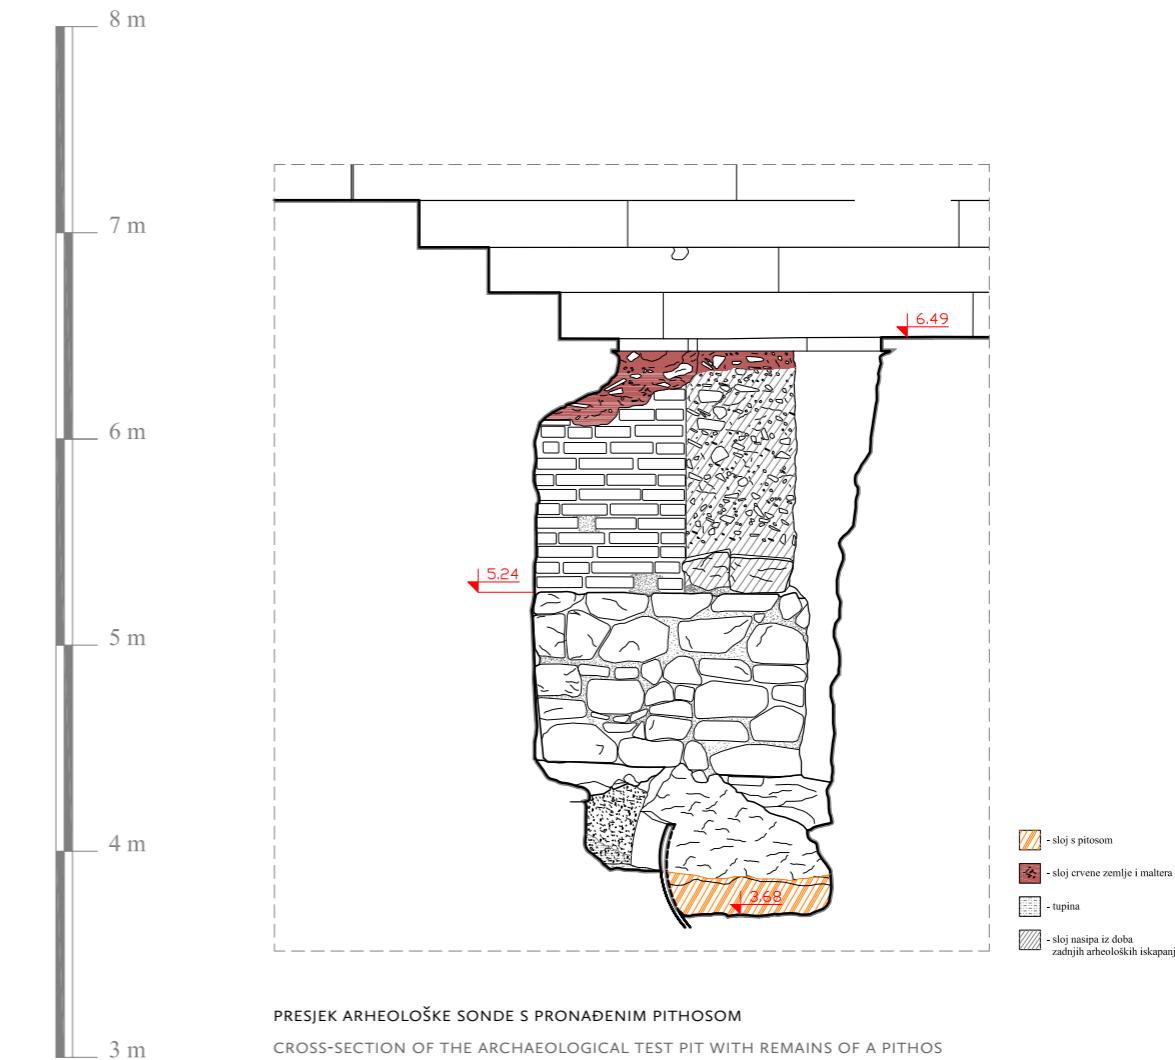
PRESJEK ARHEOLOŠKE SONDE S PRONAĐENIM PITHOSOM

CROSS-SECTION OF THE ARCHAEOLOGICAL TEST PIT WITH REMAINS OF A PITHOS

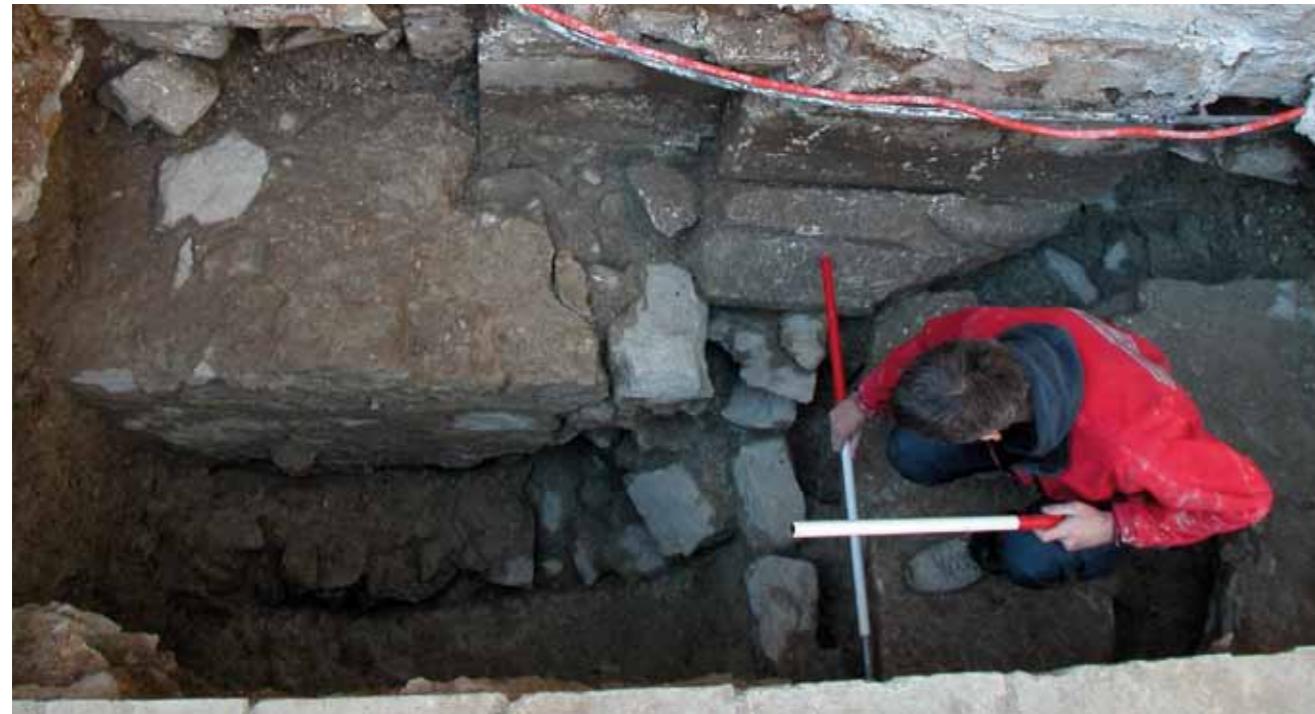
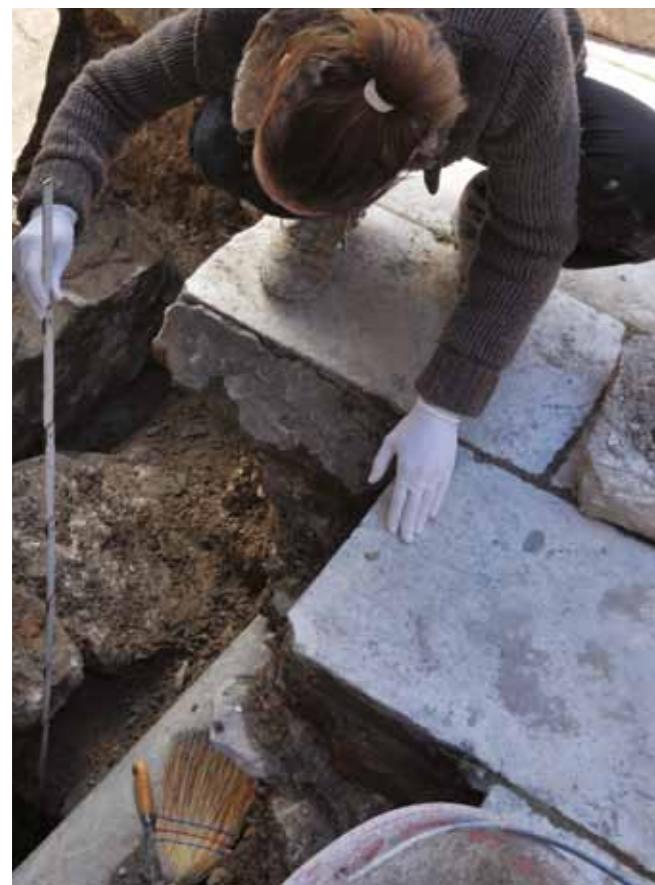
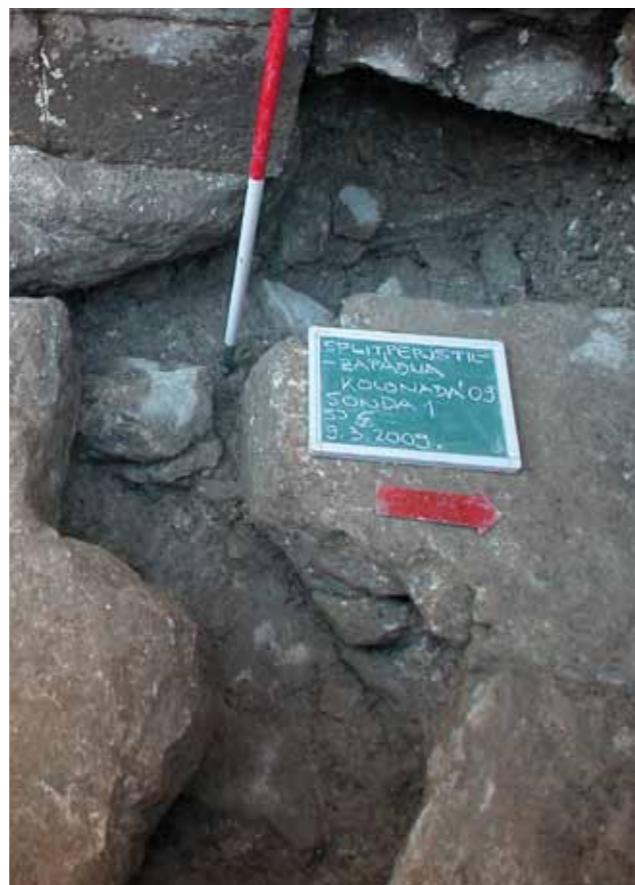
The test pit within the *temenos* of the Mausoleum, to the east of the second column (counting from the north) revealed a manhole of the Roman drainage channel. It is set on the line parallel to the colonnade's *stylobate*, to the north and south of the manhole.

ARHEOLOŠKA ISTRAŽIVANJA NA PERISTILU
ARCHAEOLOGICAL RESEARCH ON THE PERISTYLE

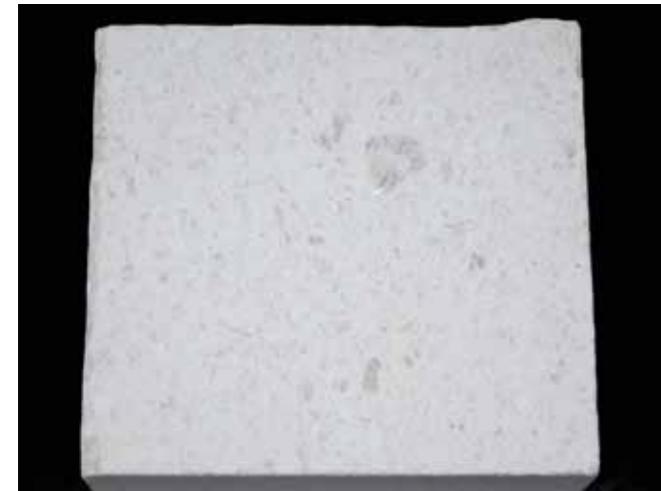
ODREĐIVANJE VRSTE I PORIJEKLA KAMENA
DETERMINING THE TYPE AND ORIGIN OF THE STONE

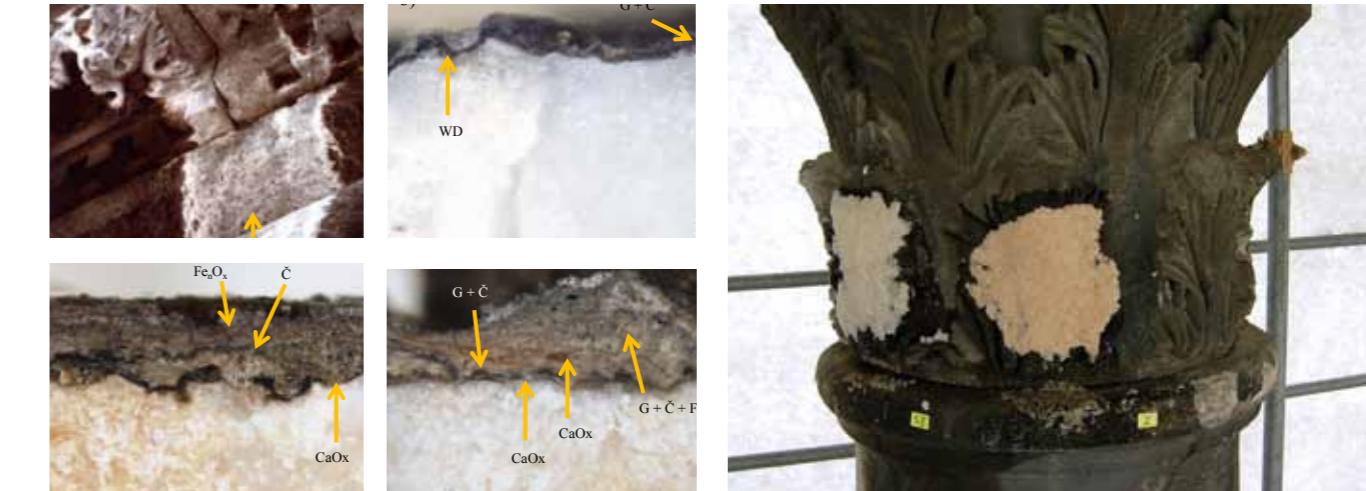
ODREĐIVANJE SASTAVA KORA NEČISTOĆE NA KAMENU
DETERMINATION OF THE COMPOSITION OF DIRT LAYER ON THE STONE

PROBE ODSOLJAVANJA
(AMONIJ/BARIJ – LIJEVO; IONSKI IZMJENJAVAČ – DESNO)
EXPERIMENTAL DESALINATION
(AMMONIUM/BARIUM – LEFT; ION EXCHANGER – RIGHT)

The black crust on the stone, at places up to one centimetre thick, generally consisted of gypsum, soot and iron oxides. Occasionally, there was also calcium oxalate dihydrate (weddellite) in it. The greyish patina was identified as weddellite and, at places, gypsum. The yellowish patina, found in certain places beneath the black crust, consisted of calcium oxalate monohydrate (whewellite) and dihydrate (weddellite). In addition to mineral patinas, the presence of algae and lichen was also ascertained on the surface of the stone.

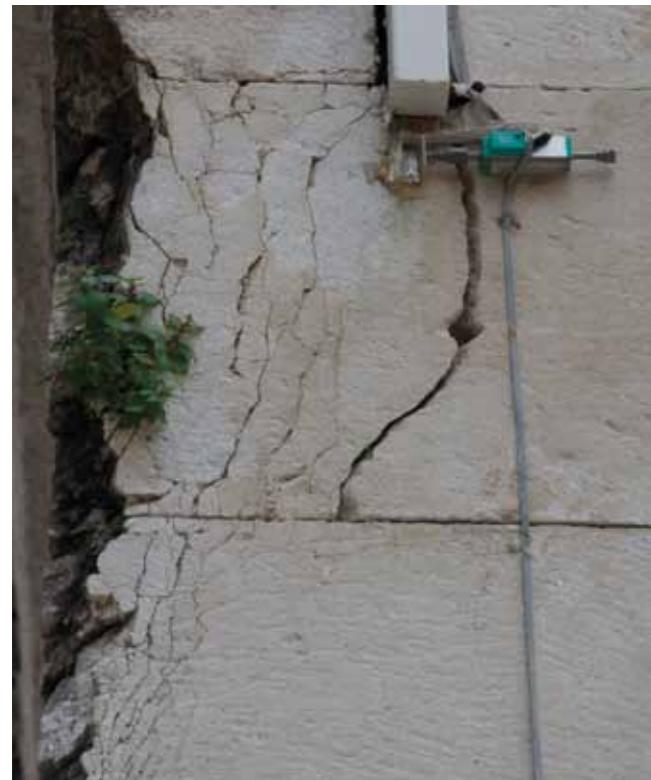
MONITORING VERTIKALNIH PUKOTINA NA CRKVI SV.ROKA

MONITORING THE VERTICAL CRACKING ON THE CHURCH OF ST. ROCH

The problem of construction stability was for the first time fully addressed during the conservation- restoration works at Peristyle. Monitoring was conducted in order to obtain information of the intensity and speed of deformation growth. Changes and resonance of the construction were measured before, during and after the treatment. Resonance of the copper clasps on the Prothyron pediment has shown that they were carrying weight, so a hundred-year-old intervention was still effective. Condition of iron bolts located between the granite columns and their bases was examined endoscopically (by inserting a probe with camera and optic fibres). Foundations and ground beneath them were examined in critical areas with geomechanic and archaeological probes. It was established that the Roman structure was mostly founded on solid ground that is on solid remains of older structures and, to a lesser extent (pillars of the decumanus porch) on an insufficiently stable ground. Most of the walls of the church of St. Roch are founded directly on Roman pavement.

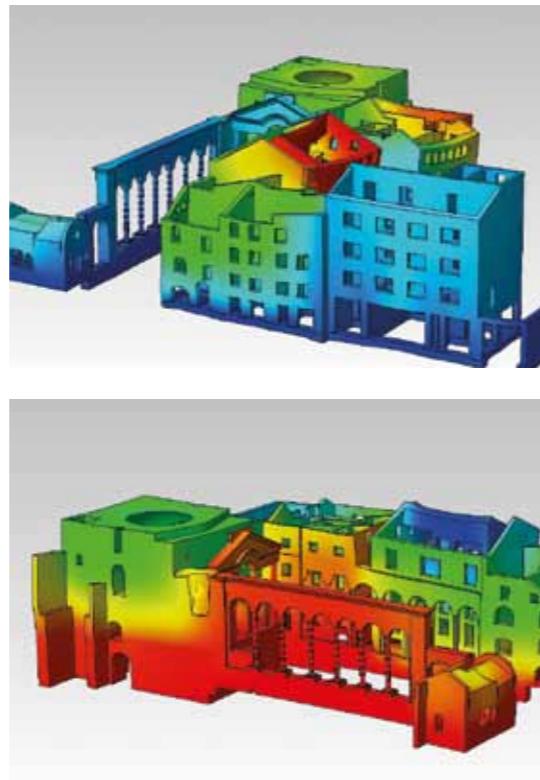
RAČUNALNI MODEL KONSTRUKCIJE PERISTILA

COMPUTER 3D STRUCTURAL MODEL OF THE PERISTYLE

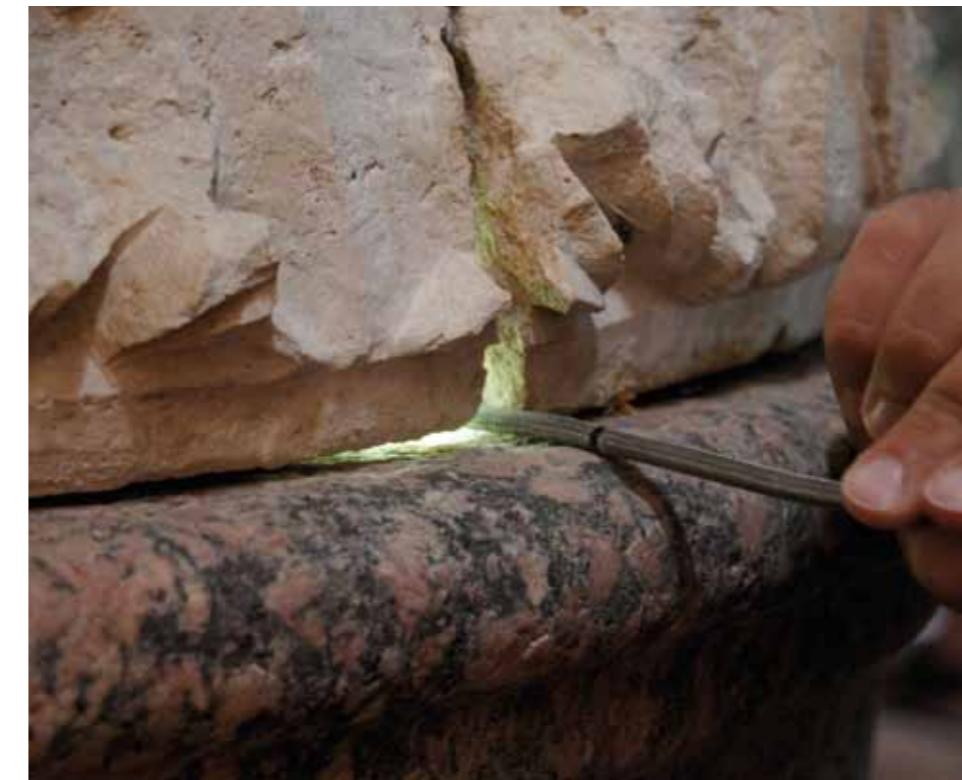
ENDOSKOPSKO ISPITIVANJE ŽELJEZNOG TRNA IZMEĐU GRANITNOG STUPA I KAPITELA NA PROTIRONU

ENDOSCOPIC EXAMINATION OF IRON DOWEL BETWEEN A GRANITE COLUMN AND A CAPITAL ON THE PROTHYRON

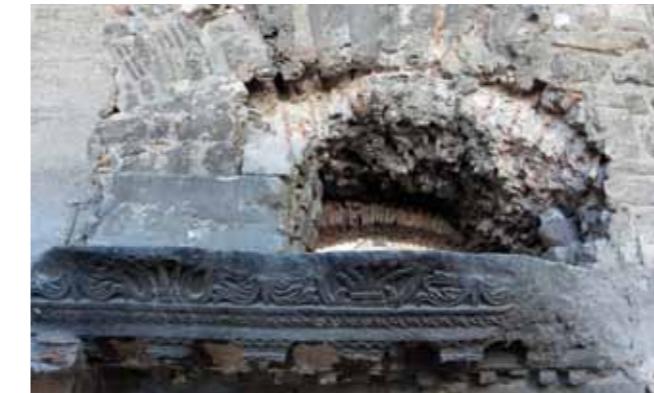
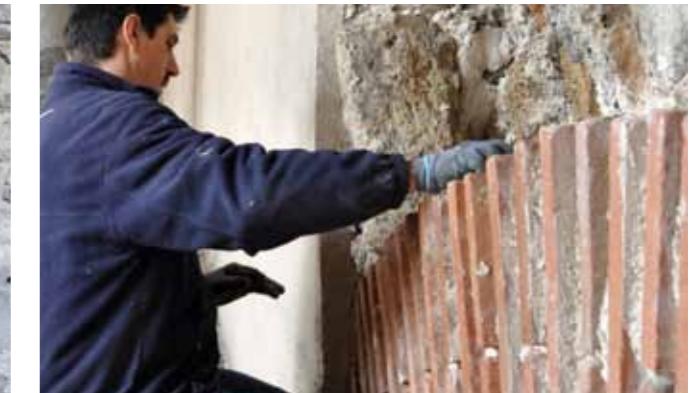
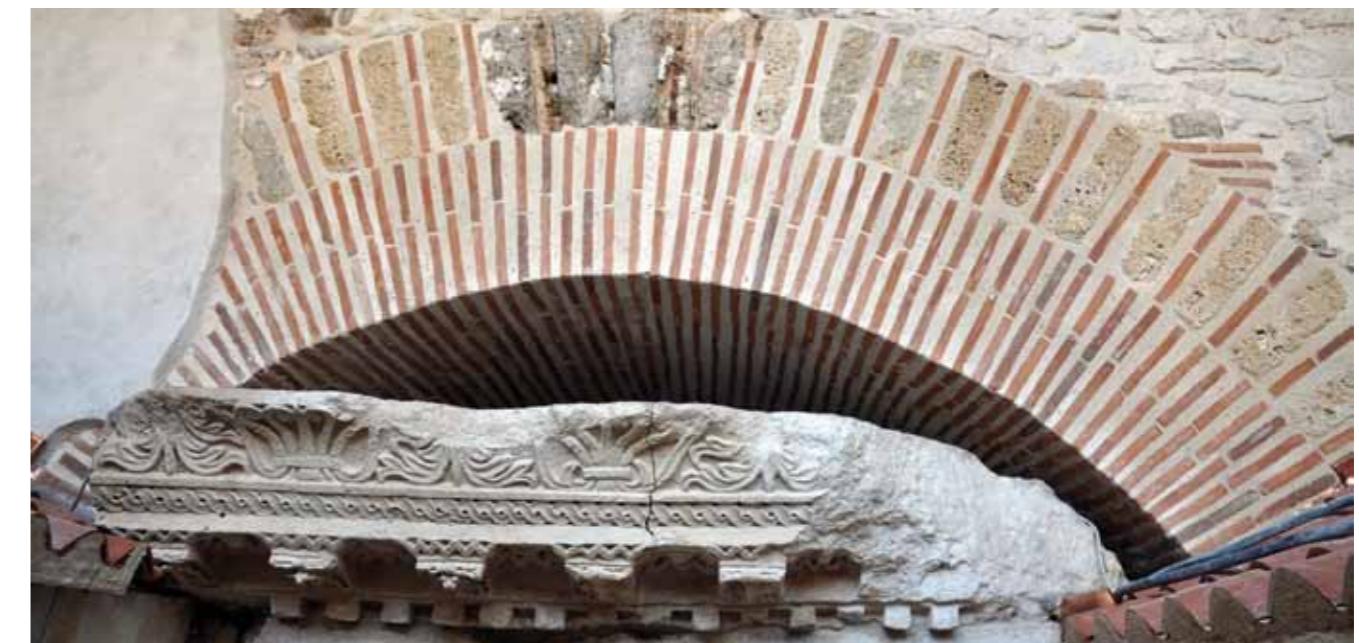
RASTERETNI LUK U STRAŽNJEM ZIDU PROTIRONA PRIJE, TIJEKOM I NAKON KONZERVATORSKO-RESTAURATORSKOG ZAHVATA
RELIEVING ARCH IN THE BACK WALL OF THE PROTHYRON BEFORE, DURING AND AFTER RESTORATION WORK

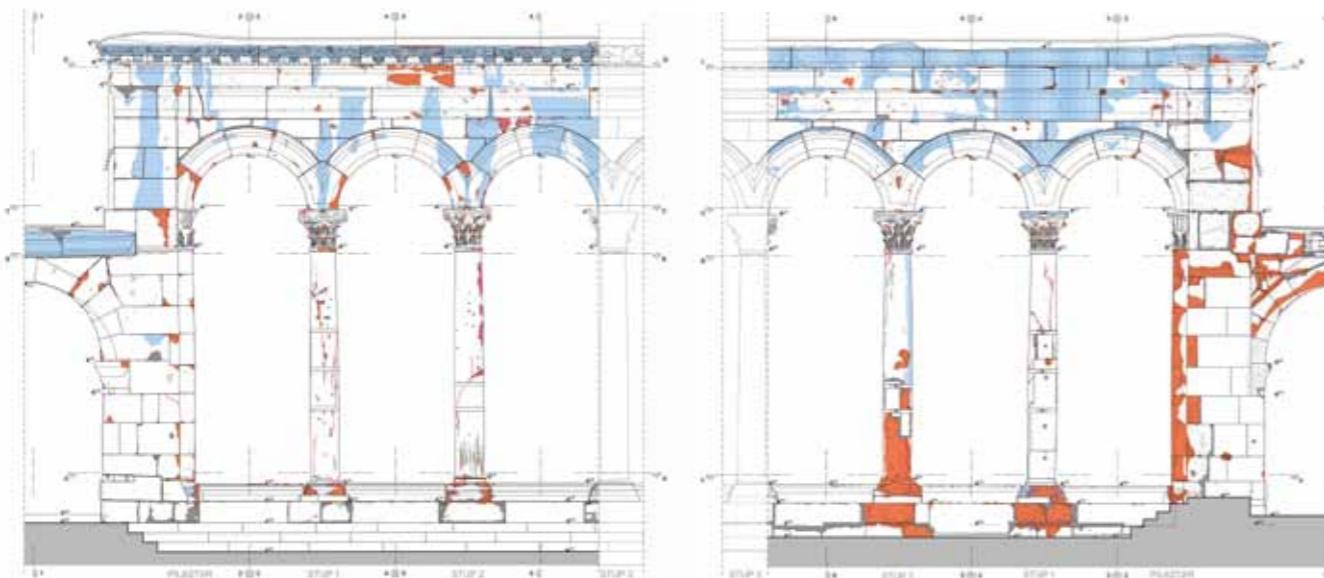
Numerous iron bolts, nails and similar elements were inbuilt in stone over a period of time. Due to weathering they have corroded and rust has damaged the surrounding stone. Such damages were found on capitals and columns in the shapes of large splits and chipped off areas.

NACRTI ISTOČNE KOLONADE SA UCRTANIM OŠTEĆENJIMA | SURVEY OF THE EASTERN COLONNADE WITH MAPPED DAMAGES

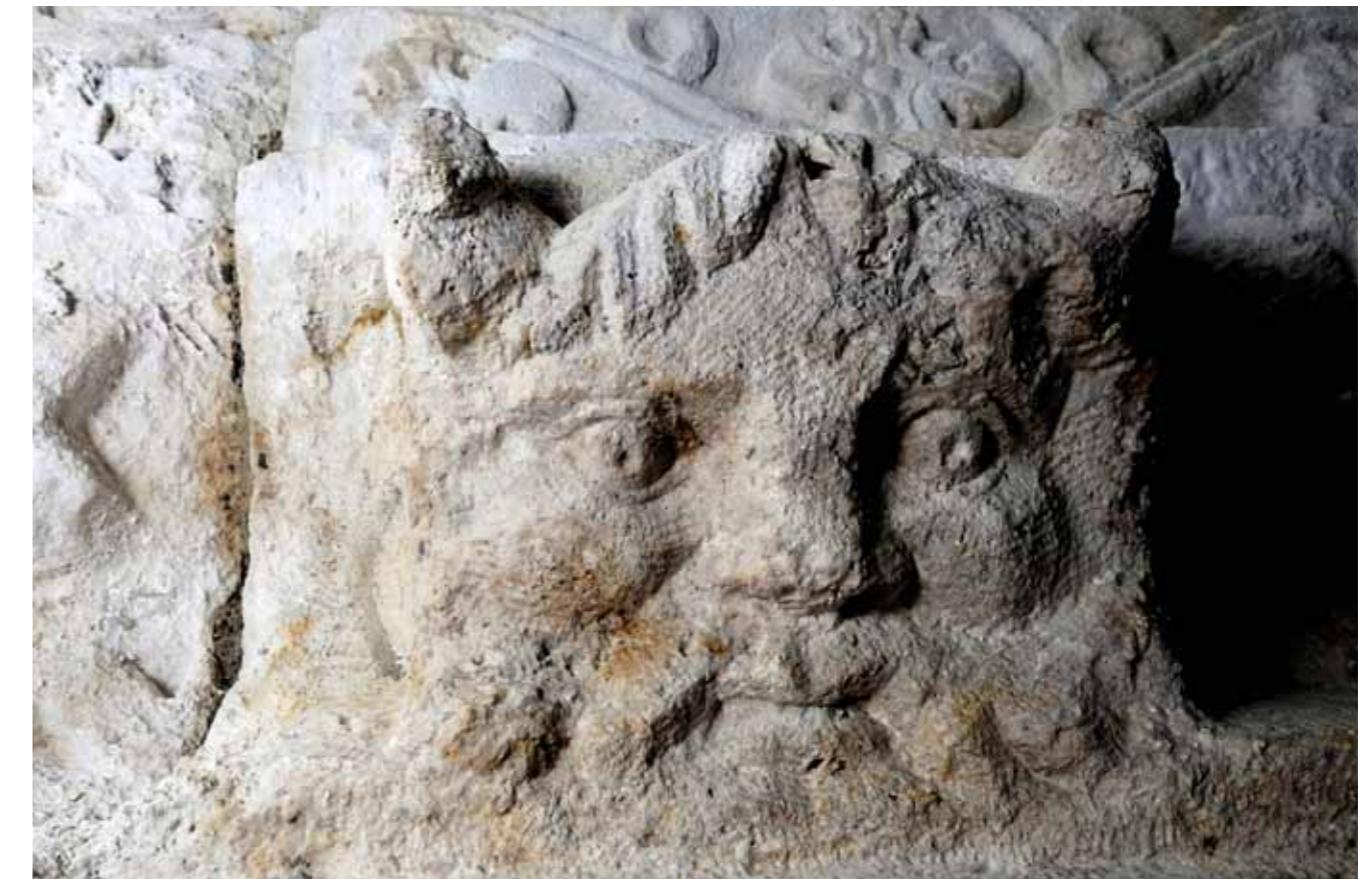
DETALJ SA VIJENCA ZABATA PROTIRONA, GLAVA SA BRADOM I ROGOVIMA

DETAIL FROM THE GABLE CORNICE OF THE PROTHYRON - HEAD WITH BEARD AND HORNS

In this context, noteworthy are the decorative motifs which were fully recognized and documented only after cleaning. The five relief faces in the south-east corner of the Prothron's pediment represent the symbols of Diocletian's reign: two fantastic characters in the form of man-bulls, a possible portrayal of Jupiter Ammon, and two much damaged images which cannot be identified, but which were certainly a component of the iconographic repertoire of imperial propaganda. Laser cleaning facilitated greater insight into the details and plasticity of the relief images, and even some traces of the original stone-carving tools became visible. Desalination and consolidation improved characteristics of the material and increased its resistance to weathering. In addition to enhancing general aesthetic and monumental values, the conservation and restoration interventions also had a wider dimension relating to spatial planning

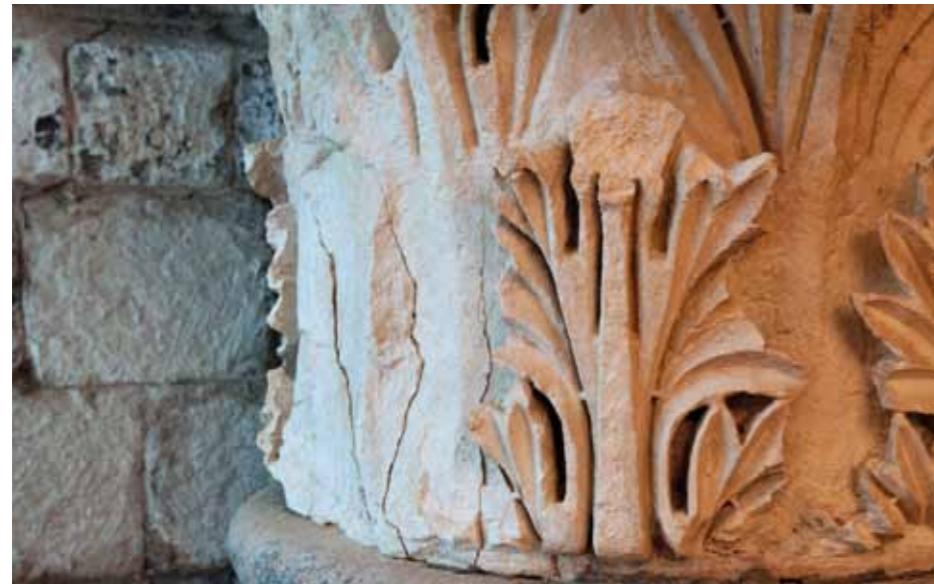
UČVRŠČIVANJE NAPUKLIH DIJELOVA KAPITELA I LUKA SA PROTIRONA

CONSOLIDATION OF CRACKED PARTS OF THE CAPITAL AND ARCH OF THE PROTHYRON

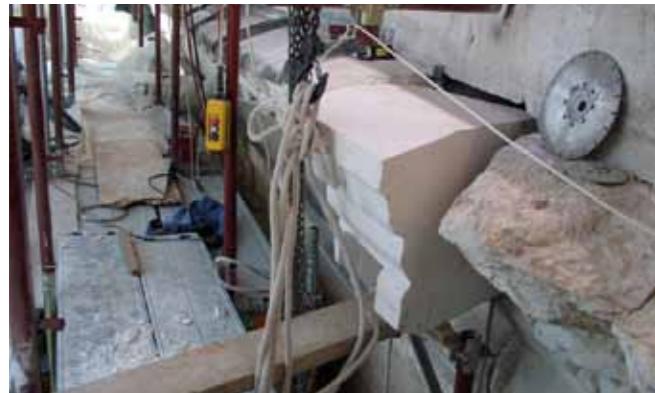
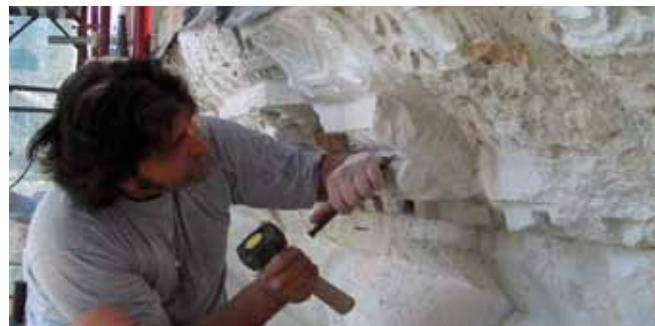
UGRADNJA I OBRADA KAMENOG BLOKA NA VIJENCU ISTOČNE KOLONADE
MOUNTING AND FINISHING OF STONE BLOCK ON THE EASTERN COLONNADE

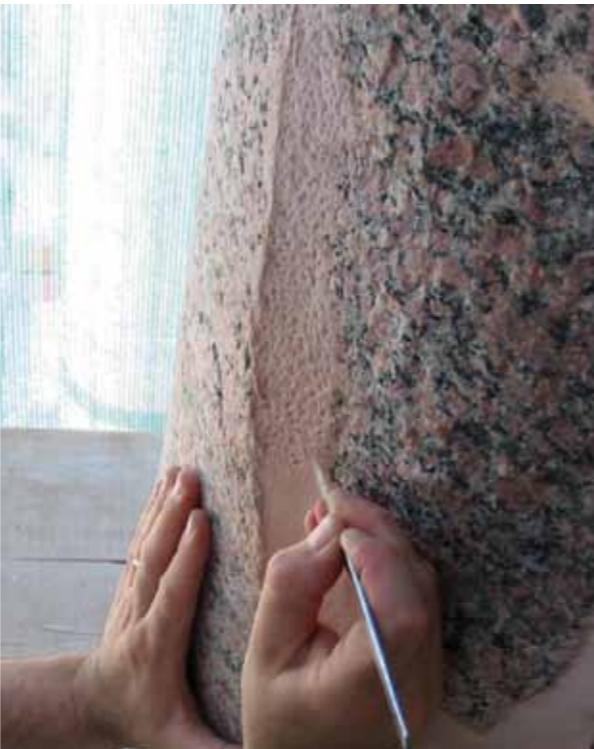
OBRADA I RETUŠ NA REKONSTRUIRANOM DIJELU GRANITNOG STUPA
FINAL RETOUCHING OF THE RECONSTRUCTED PART OF A GRANITE COLUMN

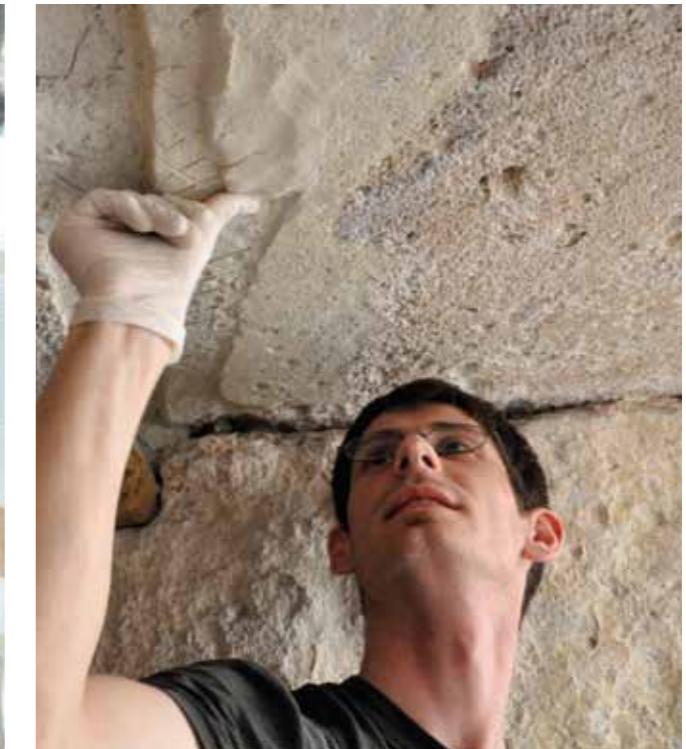
REKONSTRUKTIVNI ZAHVATI NA PORTALU VESTIBULA
RECONSTRUCTION OF MISSING PARTS ON THE VESTIBULE PORTAL

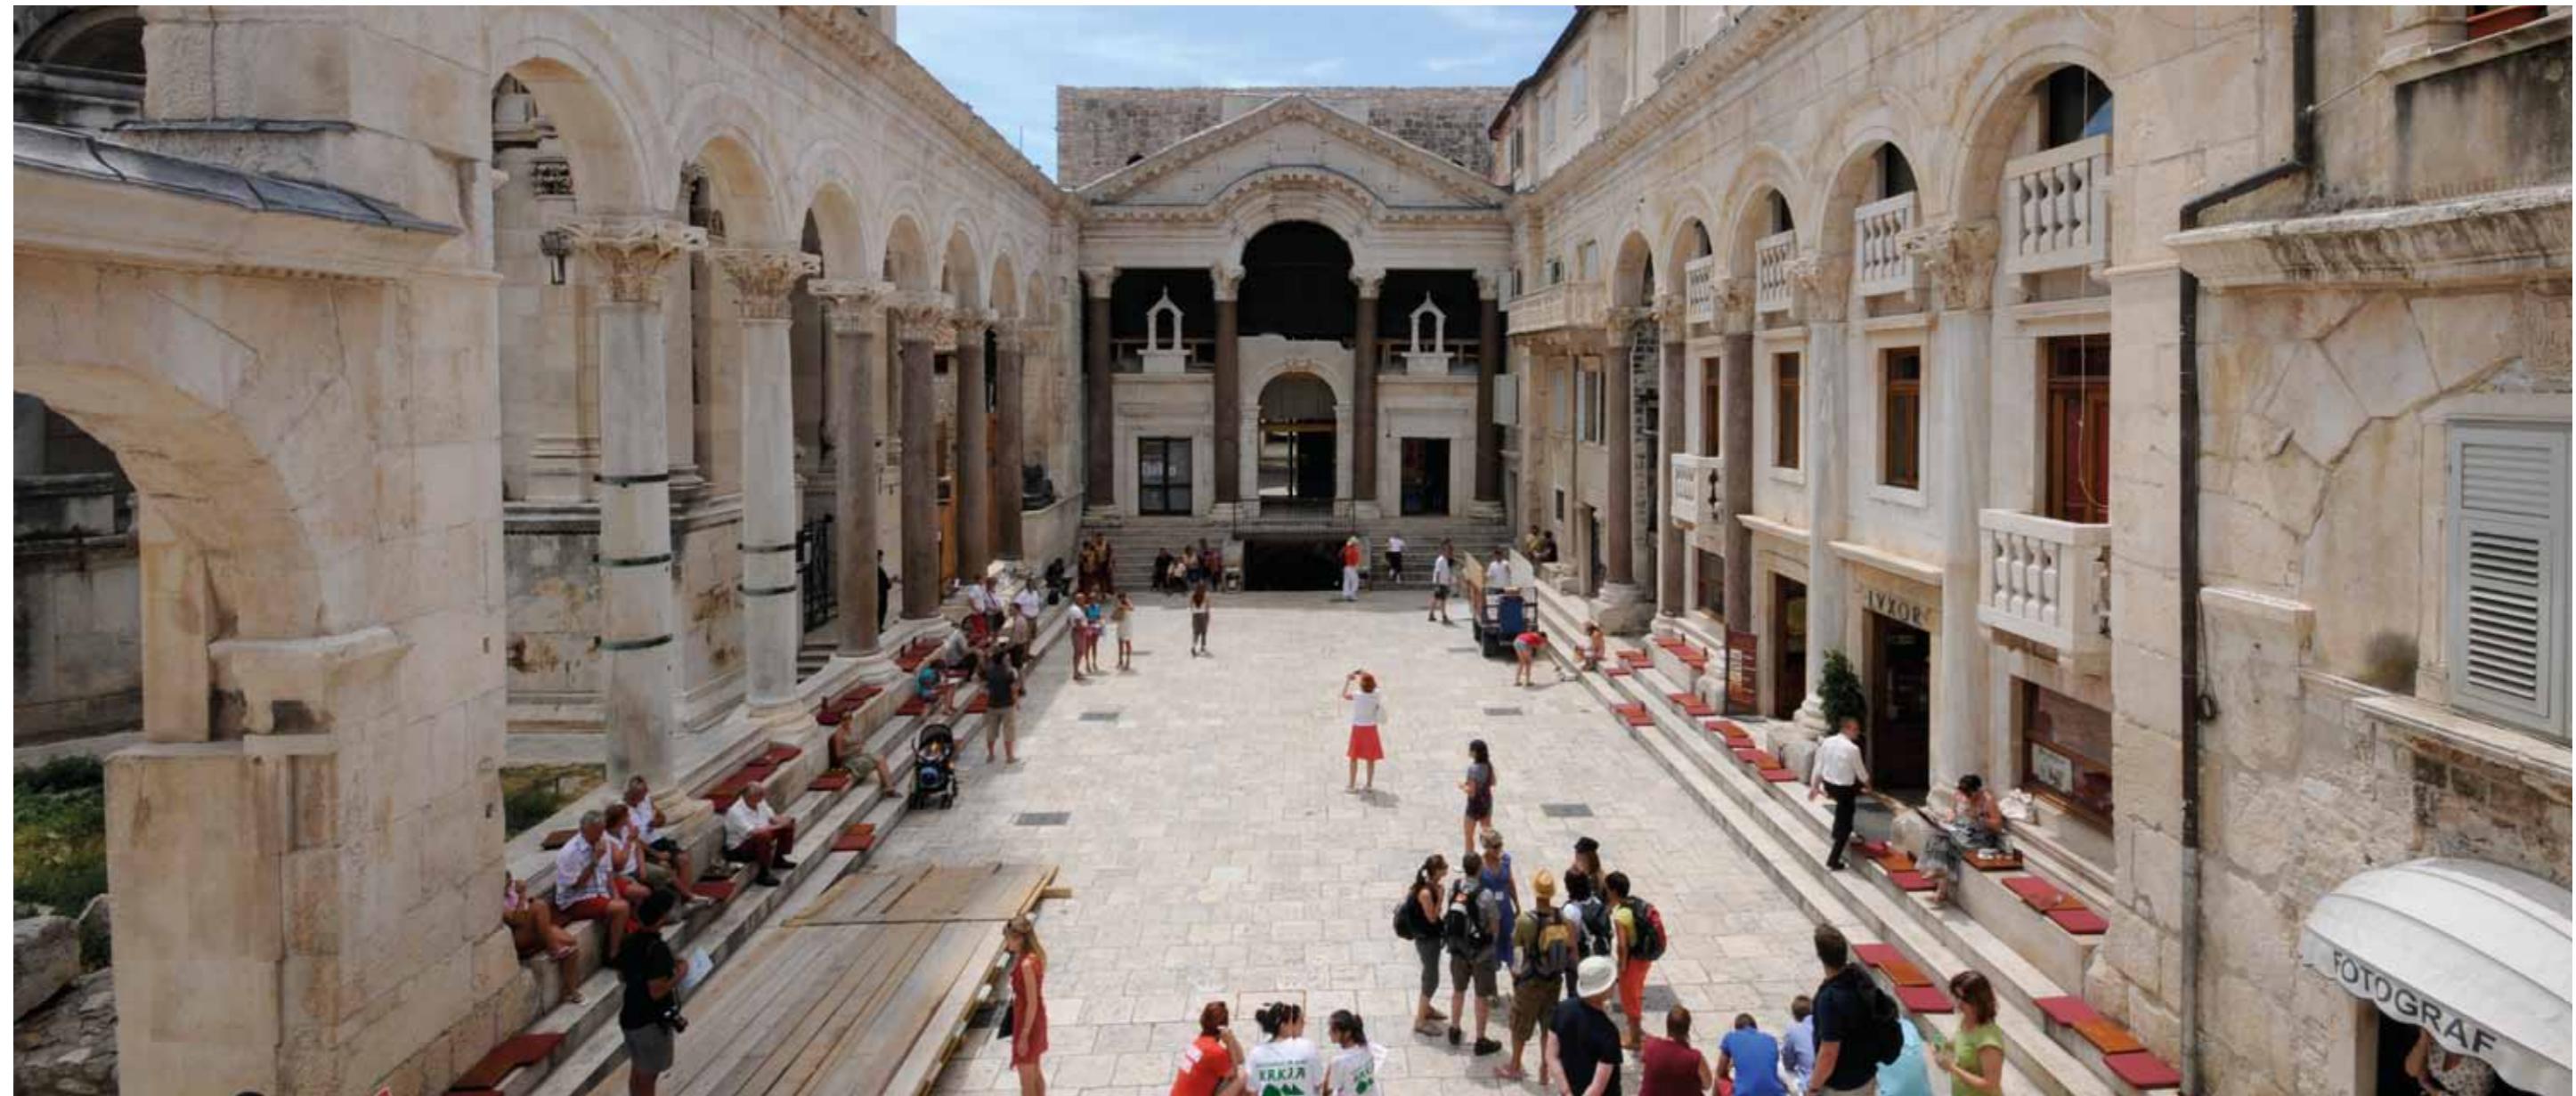
The advanced processes of deterioration of the structure and decomposition of stone and other materials have been slowed through a combination of construction and restoration procedures. The removal of dark layers of impurities has restored the cleanliness of the architecture and decorative elements. The value of the monument has also been increased by the discovery of new facts concerning the original materials and construction history.

PERISTIL 2012, PRI KRAJU KONZERVATORSKO-RESTAURATORSKOG ZAHVATA

PERISTYLE 2012, NEAR THE END OF THE CONSERVATION-RESTORATION TREATMENT
