CONTEMPORARY EXPERIENCES IN CONSERVATION OF WALL PAINTINGS

International scientific
and professional conference
on the conservation
of wall paintings

BOOK OF ABSTRACTS
KNJIGA SAŽETAKA

Draguč, House of Frescoes, 8 – 10 July 2015

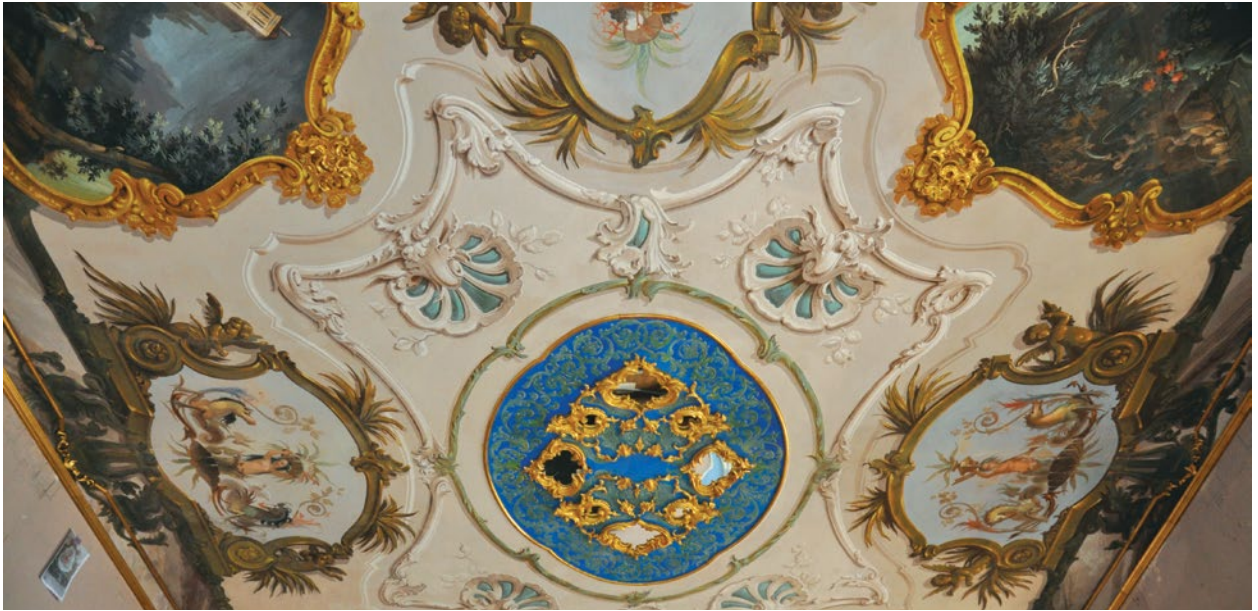
| The southeastern room, ceiling painting after conservation

Jugoistočna prostorija, zidna slika na stropu nakon radova

As a result of reconstructions and the replacement of the wooden floor with a concrete one in the story topping the central portion of the palace, considerable damages were inflicted to the ceiling paintings, so the project of the wall paintings' restoration was initiated in 2004. Given the conditions encountered and a lack of access to the paintings from the upper side, the restoration was carried out in two ways: in the southwestern room the ceiling had to be detached and after the treatment mounted to the newly set-up structure, while in the southeastern room the restoration was performed *in situ*, which offered us the possibility to compare the two approaches. The extent of damages to the ceiling paintings of the southeastern room was not such that it would require detaching them from the ceiling beam structure, and we were able to provide stability to the ceiling by anchoring, embedding wooden joints at certain portions. Ensuring the stability of the ceiling was a prerequisite for the work that ensued.

Usljed građevinskih radova i zamjene drvenog poda betonskim na katu iznad reprezentativnog dijela palače, došlo je do znatnih oštećenja stropnih oslika i projekt restauracije zidnih slika započeo je 2004. godine. S obzirom na zatečene uvjete i nemogućnost pristupa oslicima s gornje strane zahvati su izvođeni na dva načina: u jugozapadnoj prostoriji strop je bilo nužno odvojiti te nakon zahvata montirati na novopostavljenu konstrukciju dok je u jugoistočnoj prostoriji zahvat proveden *in situ*, što pruža mogućnost poredbe dvaju pristupa. Oštećenja zidne slike na stropu jugoistočne prostorije nisu bila takve naravi da bi zahtijevali njeno odvajanje od stropne gredne konstrukcije te je stabilnost stropa bilo moguće ostvariti sidrenjem, mjestimičnim umetanjem drvenih poveznica. Osiguranje stabilnosti stropa bio je preduvjet za radove koji su uslijedili.

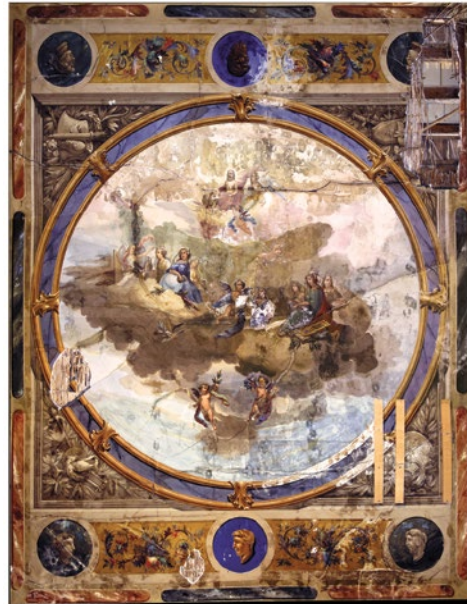
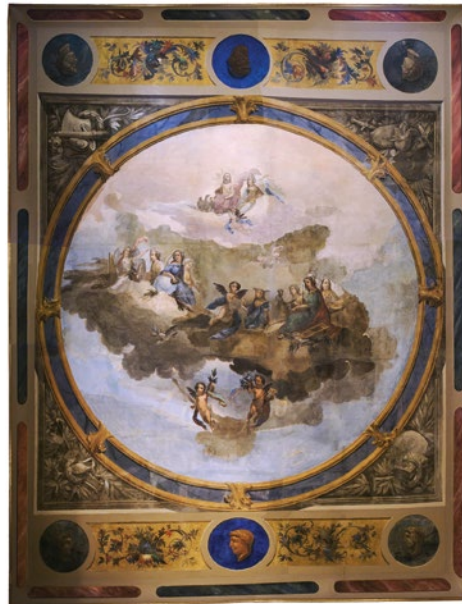
The southwestern room
 Jugozapadna prostorija
 | pre-existing condition of the ceiling paintings
 zatečeno stanje stropnog oslika
 || ceiling paintings after the conservation
 stanje nakon završenih restauratorskih zahvata

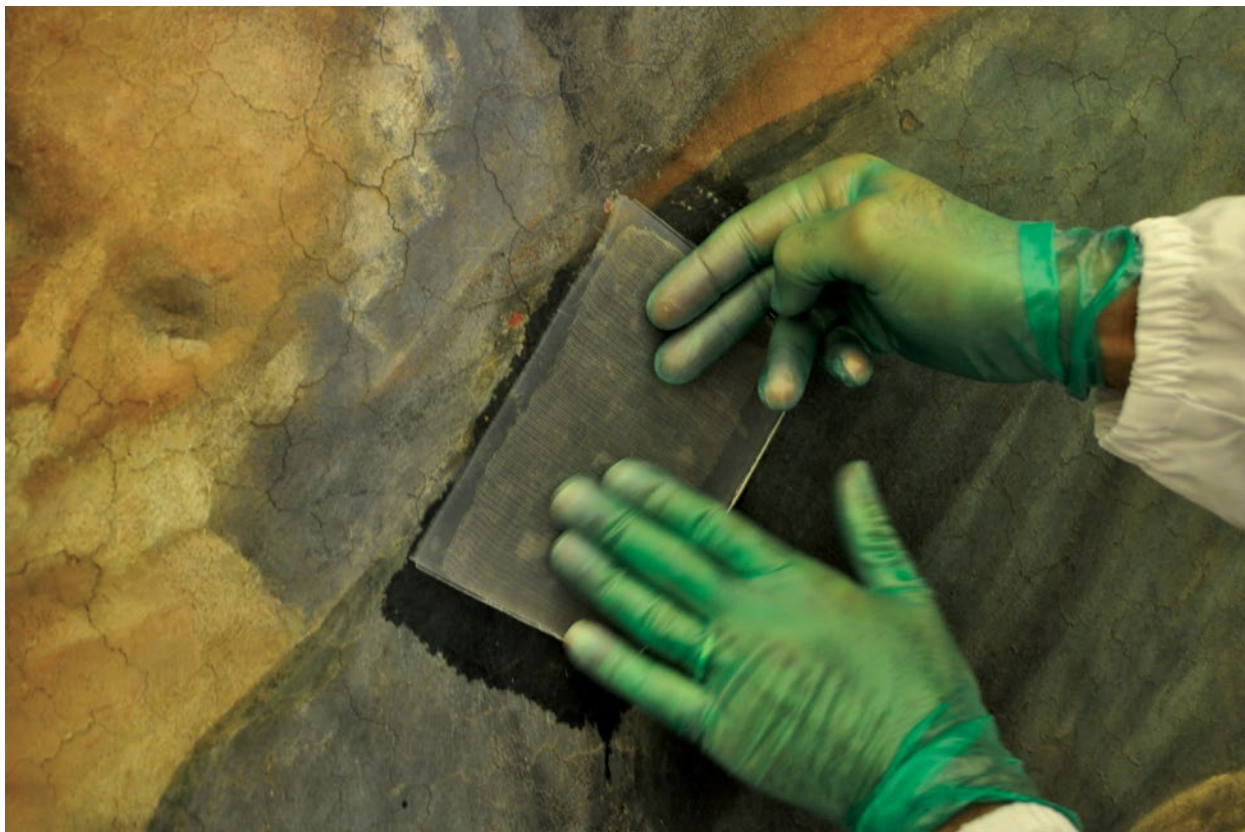
| Application of the microbial biotechnology for cleaning of the wall painting "La Navicella", Vatican Museum

Primjena mikrobne biotehnologije kod čišćenja zidne slike „La Navicella“, Vatikanski muzej

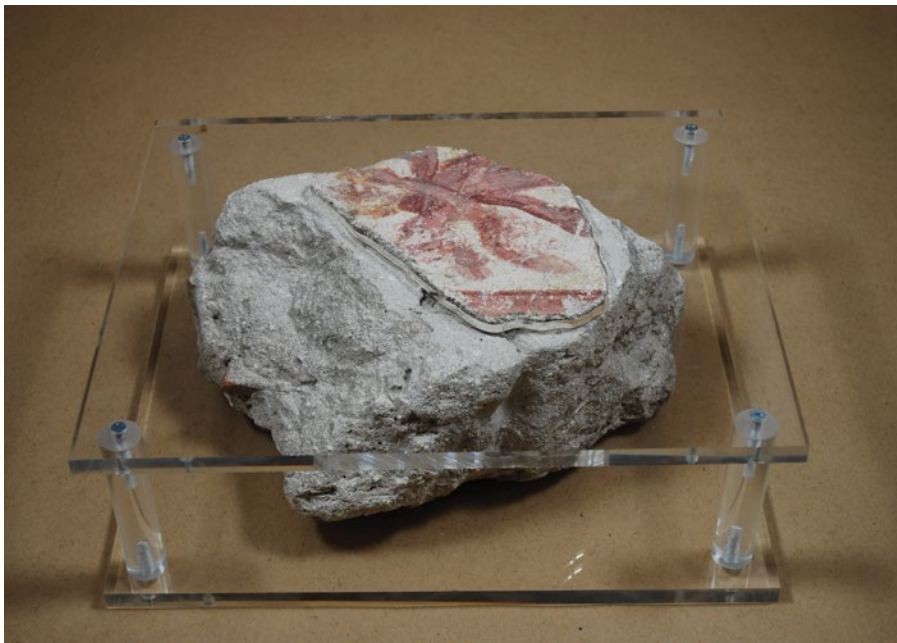
| Fragment with a floral ornament, after conservation

Fragment s cvjetnim ornamentalnim ukrasom, nakon radova

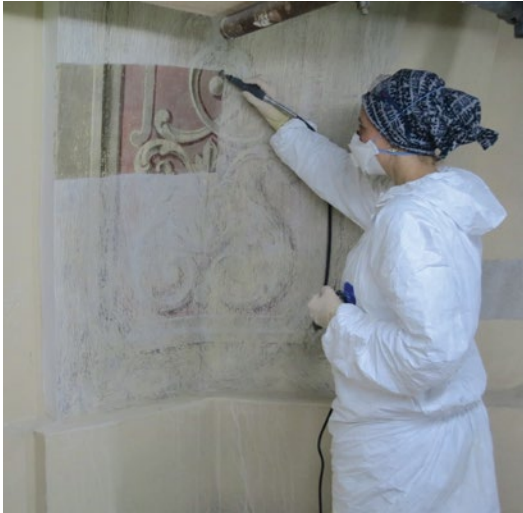
| Removal of lime wash overlayers

Uklanjanje vapnenih premaza

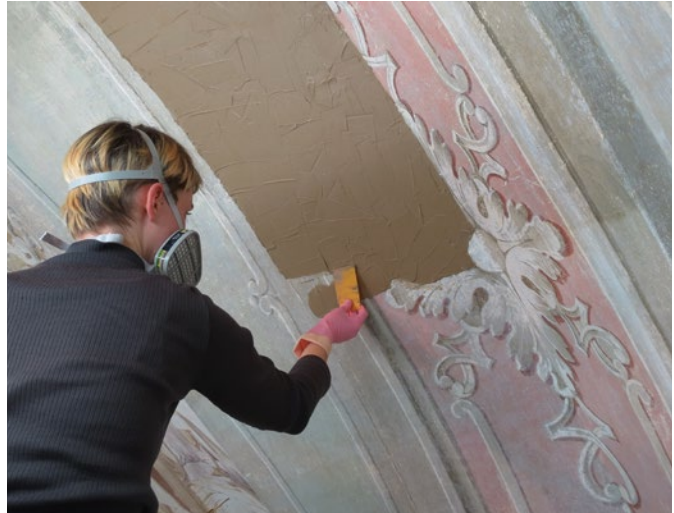
|| Application of sepiolite poultice (of triammonium citrate and EDTA solution)

Nanošenje sepiolitne pulpe (od triamonij citrata i otopine EDTA)

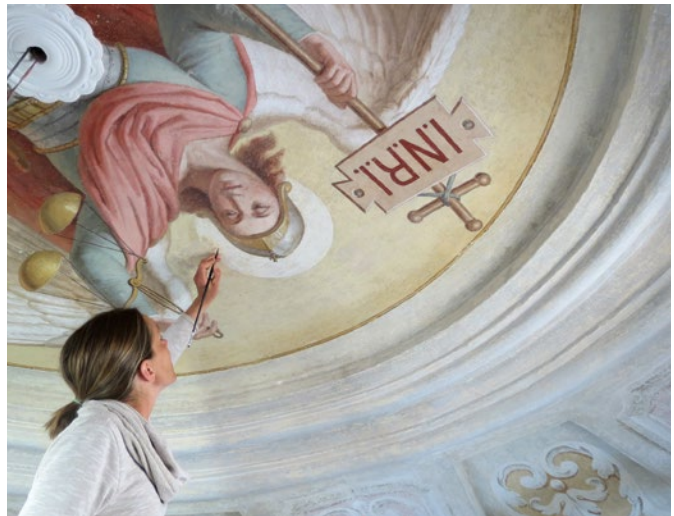
| Retouching

Retuš

After cleaning and removal of the film, the process of consolidation, plaster patching and injecting followed. Retouching and reintegration of the missing parts is still in progress.

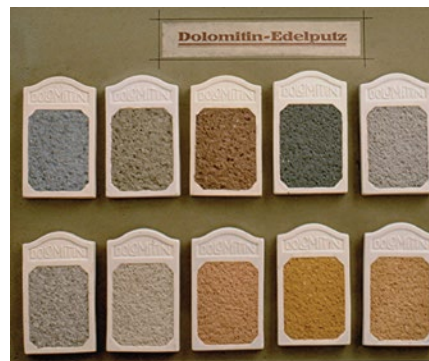
| Advertisement brochure TERRANOVA || Detail of the Pergamon Museum façade || Samples of the DOLOMITIN mortar
| Propagandna brošura TERRANOVA || Dio pročelja Pergamon muzeja || DOLOMITIN uzorci žbuke

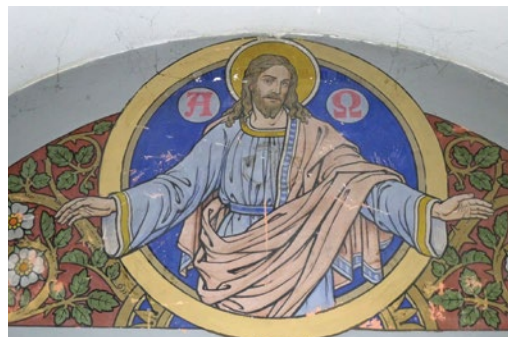
| Zwingli church in Berlin || Conservation work on the façade || Wall painting in the church interior
| Zwingli crkva u Berlinu || Konzervatorski radovi na pročelju || Zidni oslik u unutrašnjosti

U sklopu projekta koji je pratio studij tijekom posljednje semestara obrađena je tema pročelja i zidnog slikarstva ranog 20. stoljeća na crkvi Zwingli u Berlin-Friedrichshain. Uz istraživanja povijesti izgradnje objekta u načelu se radilo o konzerviranju i restauriranju polja timpanona iznad ulaza te o takozvanom „spomeničkom ratnom slikarstvu“ za poginule u Prvom svjetskom ratu u unutrašnjosti crkve. Uz istraživanja i ispitivanja tehnike žbukanja i slikanja, snimku postojećeg stanja i postupan razvoj i ispitivanje materijala primjenjenih za konzerviranje i restauriranje dodane su i opširne diskusije koje su razjasnile obojenja s ciljem ponovnog uspostavljanja vizualnog dojma.

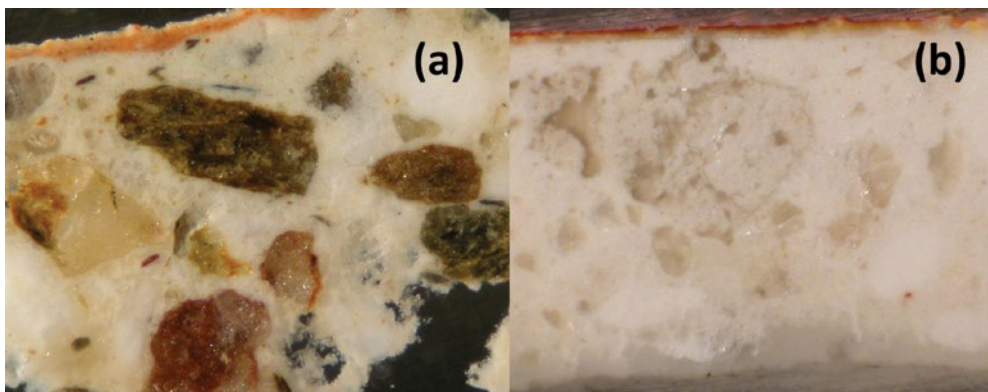
| Differences in mortar composition shown by two cross-sections. (a) made of lime and sand (x50). Bodovlje. (b) made of lime and crushed marble of lime-rock (x25). Veliki Otok near Postojna

Razlike u sastavu žbuke prikazane na dvama poprečnim presjecima. (a) izvedena od vapna i pijeska (x50). Bodovlje. (b) izvedena od vapna i drobljenog mramora vapnenačke stijene (x25). Veliki otok kraj Postojne

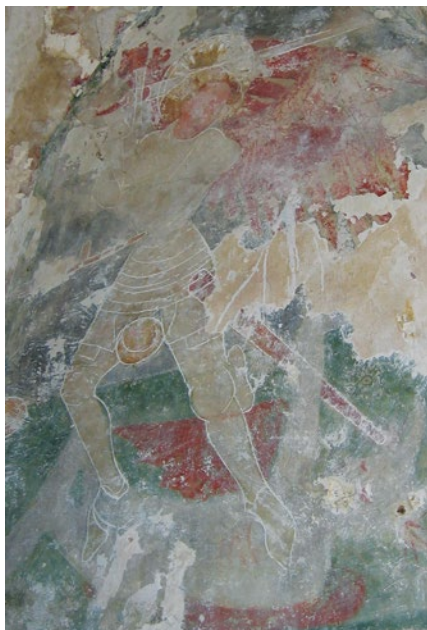
| Incisions made in fresh mortar for St. George's figure. Famlje.

Urezi u svježoj žbuci na prikazu sv. Jurja. Famlje.

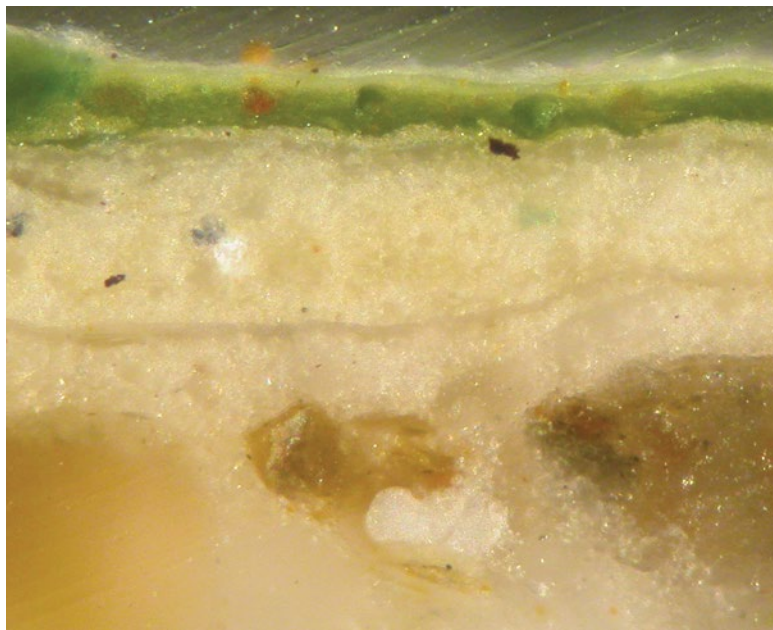
|| Cross-section (x200) showing the use of lime technique: a layer of lime was applied on a dry mortar; a layer of green colour was applied *a fresco* on the lime layer. Bodešče

Poprečni presjek (x200) prikazuje upotrebu vapnene tehnike: sloj vapna nanesen je na suhu žbuku; sloj zelene boje nanesen je *a fresco* preko sloja vapna. Bodešče

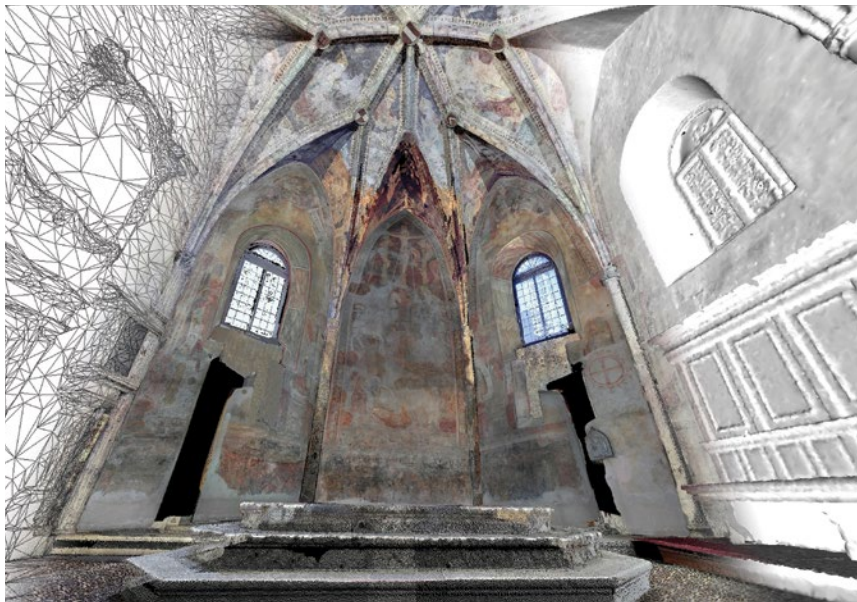
| Church of St. Nicolas in Pazin - Orthophotos of wall paintings integrated in 3D model of the church interior acquired with several 3D scanning techniques (Vektra d.o.o.)

Crkva sv. Nikole u Pazinu - ortofoto zidnih slika integriran u 3D model unutrašnjosti crkve dobiven korištenjem nekoliko tehnologija 3D skeniranja (Vektra d.o.o.)

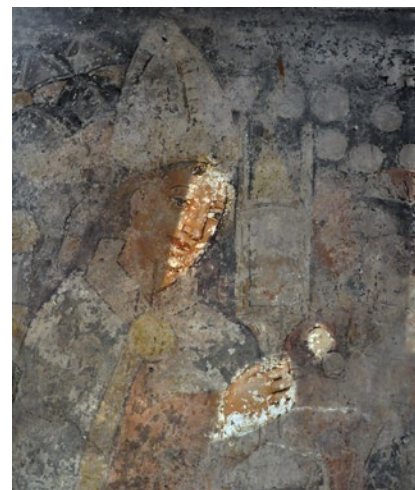
|| Cleaning probe - church of St. George in Lovran

Proba čišćenja - crkva sv. Jurja u Lovranu

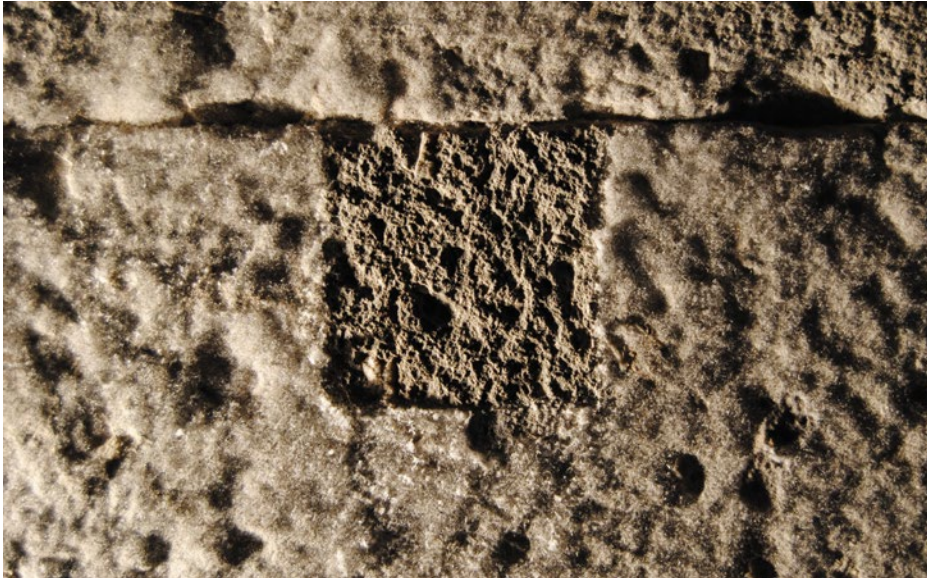
| Defined area (size: 5 cm²) used for monitoring of new salt crystallizations in the Crypt of St. Maria im Kapitol in Cologne, Germany

Ograničena površina (veličine 5 cm²) za praćenje novonastalih kristalizacija soli u kripti crkve sv. Marije na Kapitolu u Kölnu, Njemačka

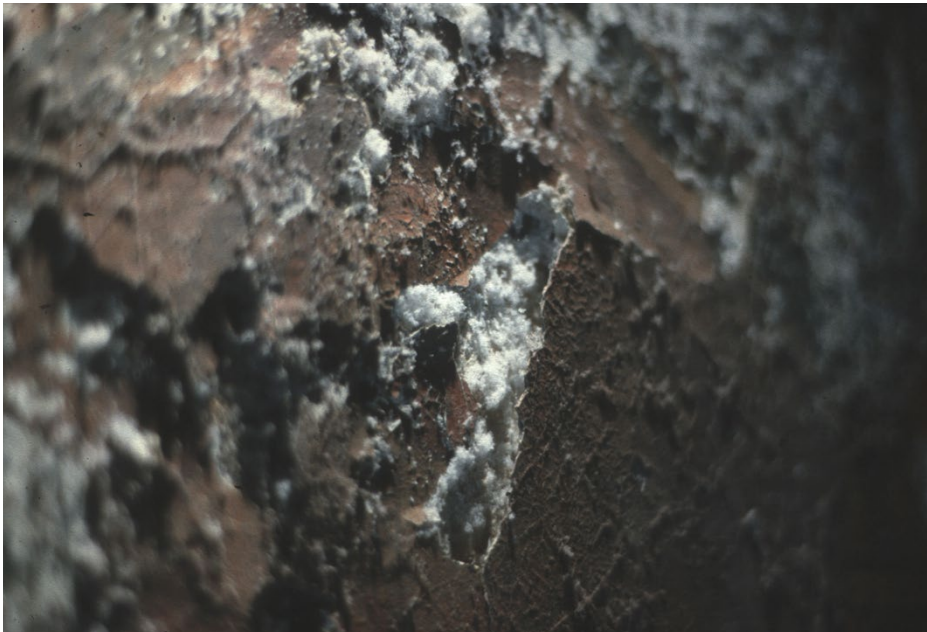
| Climate controlled salt crystallization on wall paintings in Neustadt/Mußbach, Rhineland-Palatinate, Germany

Klimatski kontrolirana kristalizacija soli na zidnim slikama u Neustadtu/Mußbachu, Rhineland-Palatinate, Njemačka

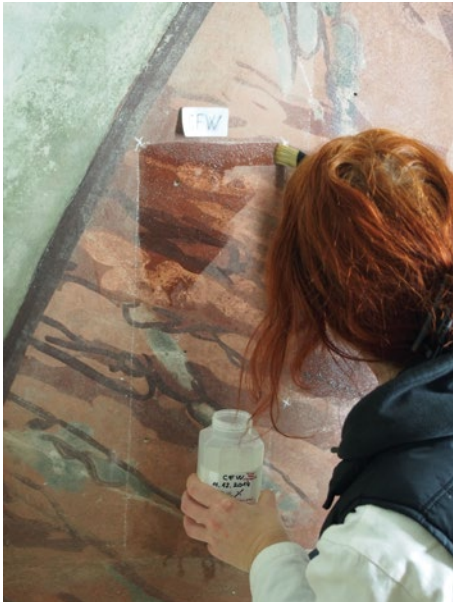
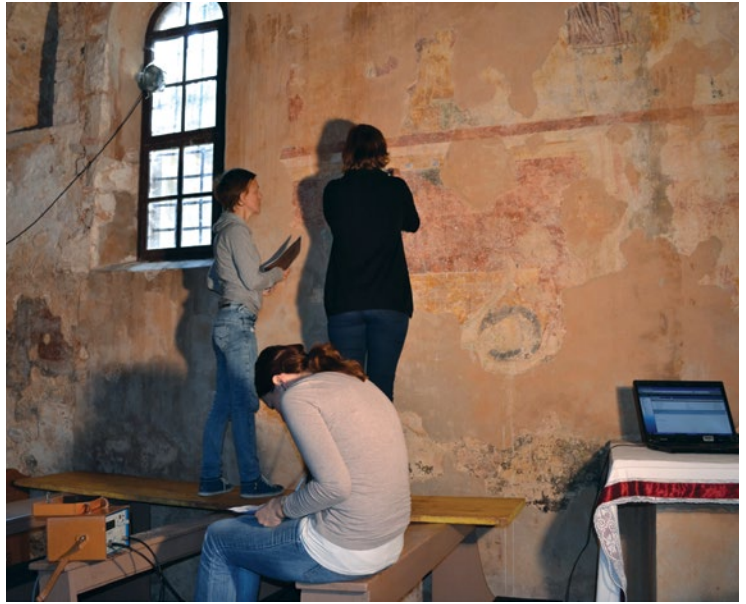
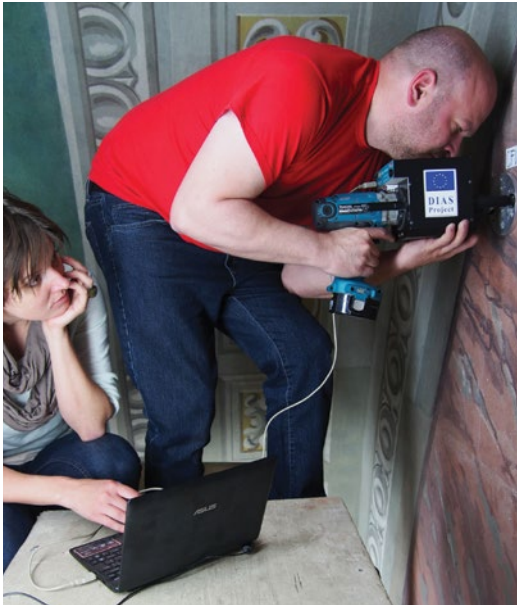
| Application of newly developed consolidant to the test site

Primjena novo razvijenih učvršćivača na probnom području

The main advantage of the new consolidant is deeper consolidation, where re-cohesion between the particles of deteriorated historic materials is established, compatibility with carbonate-based substrates and good appearance with no whitening effect and minimal colour change on the surface of the historic material.

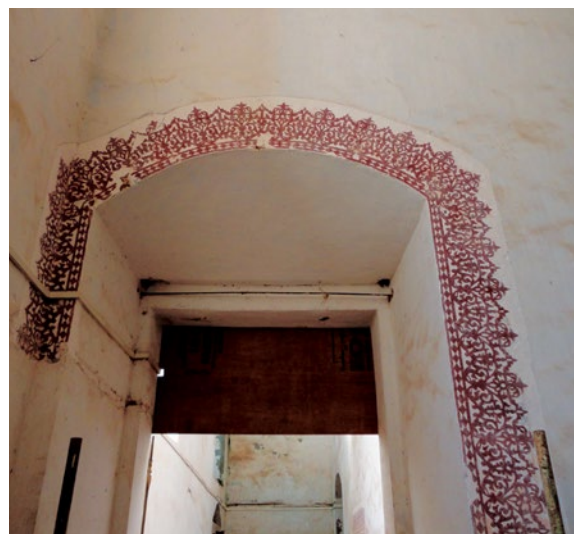
|| Sgraffito in the vestry of Santa Monica Convent, Old Goa, Goa, India (during removal of covering layers of lime), end of 16th or beginning of 17th c.

Sgraffito u sakristiji samostana sv. Monike, Stara Goa, Goa, Indija (tijekom uklanjanja slojeva vapnenih premaza), kraj 16. ili početak 17. st.

Još jedan slučaj žbuke koja se ne temelji na vapnencu nalazimo na zidnim slikama u Goi, najmlađoj od indijskih država, koja je do 1961. godine bila dijelom portugalskog imperija. Ovdje se vapno proizvodi uglavnom iz morskih školjaka i jedina poznata fresko tehnika je kromatski snažan sgraffito (slika 3).

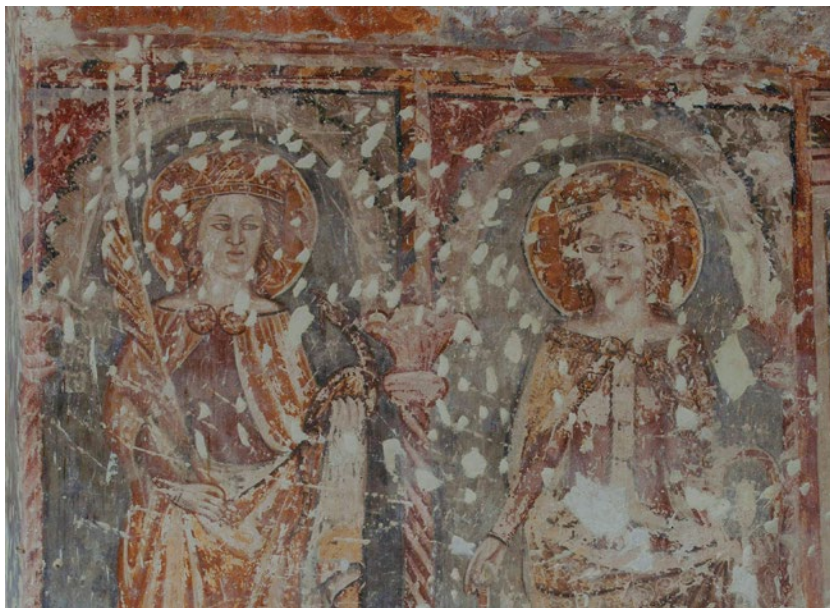
| Požega, crkva sv. Lovre. Sveta Margareta i Sveta Katarina, južni zid glavnoga broda (cca 1380.). Stanje prije i nakon radova Photographed in 2014 (I. Srša)

Požega, crkva sv. Lovre. Sveta Margareta i Sveta Katarina, južni zid glavnoga broda (cca 1380.). Stanje prije i nakon radova. Fotografirano 2014. (I. Srša)

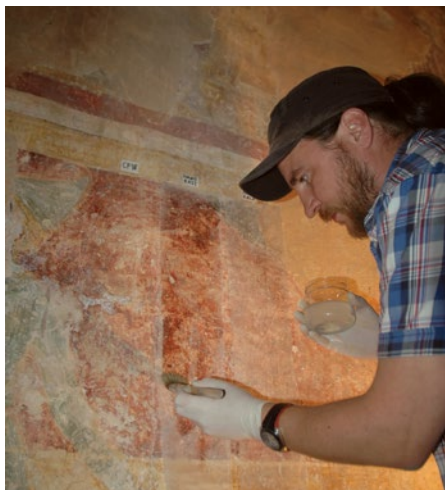
| Applying consolidant based on soluble calcium compounds onto the wall painting

Nanošenje učvršćivača na osnovi topljivih kalcijevih spojeva na zidnu sliku

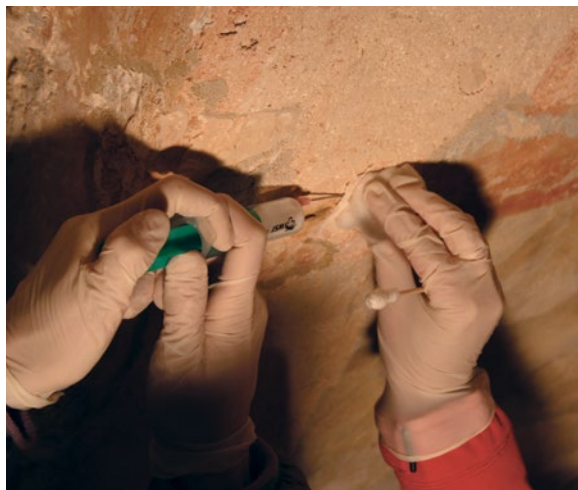
|| Consolidation of swollen plaster

Konsolidacija podbuhle žbuke

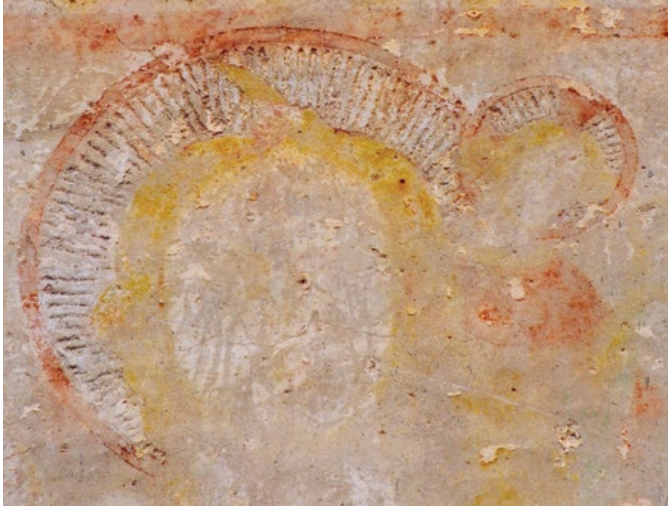
| Pitting decay and colour fading occurring on wall painting on the exterior of St. Thomas's church in Velike Poljane, Slovenia

Jamičasto propadanje i blijedenje boje na zidnim slikama na fasadi crkve sv. Tome u Velikim Poljanama, Slovenija

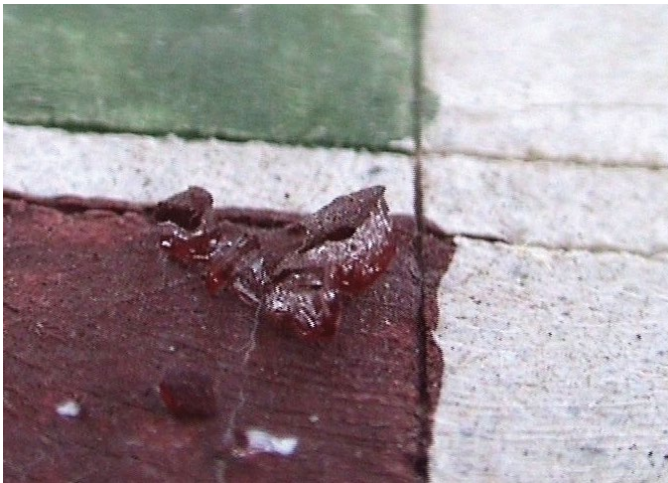
| Active phase of eruption caused by water crystallization on the test sample during freeze-thaw cycle

Aktivna faza erupcije nastala kristalizacijom vode na testnom uzorku tijekom ciklusa smrzavanja i otapanja

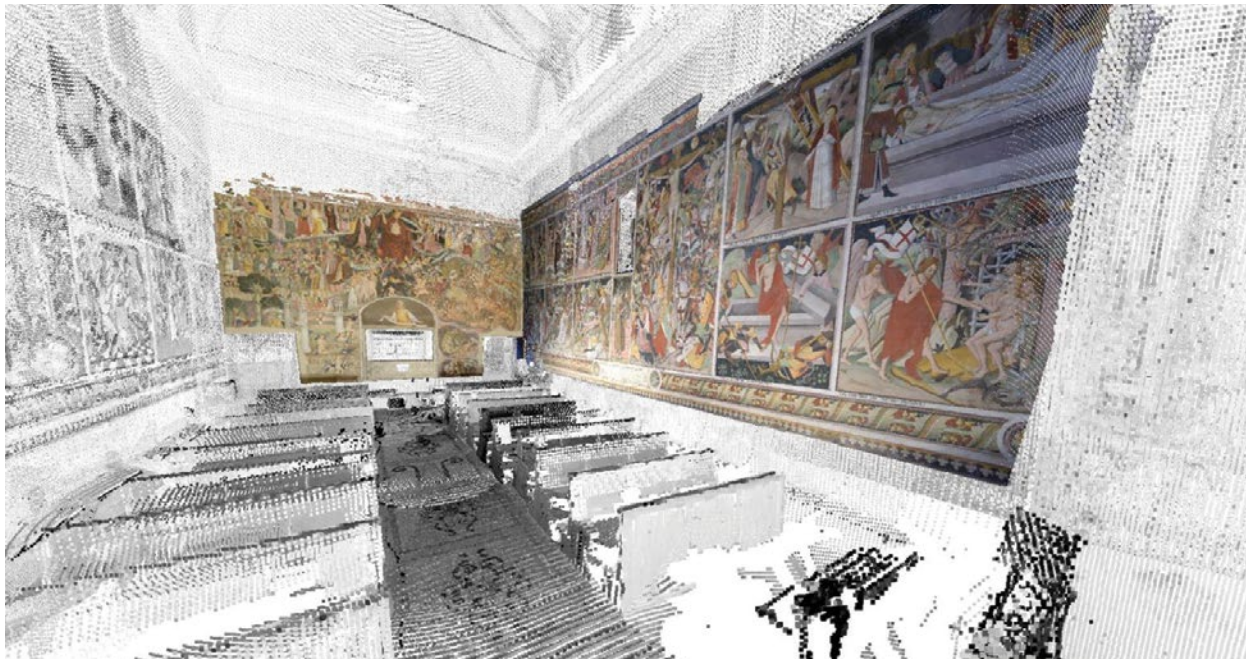
| Merging of points cloud and images; Notre Dame des Fontaines' chapel (La Brigue, 06, France) ; photo credit : MAP-E. Gattet & T. Messaoudi

Spajanje oblaka točaka i slika; kapela Notre Dame des Fontaines (La Brigue, 06, Francuska); fotografija: MAP-E. Gattet i T. Messaoudi

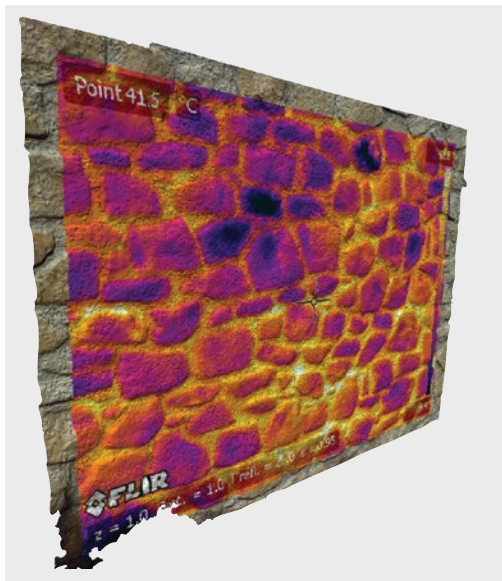
| Merging of IR thermography imaging and photo; photo credit: CICRP-JM. Vallet and MAP-E. Gattet

Spajanje snimka infracrvene termografije i fotografije; fotografija: CICRP-JM. Vallet i MAP-E. Gattet

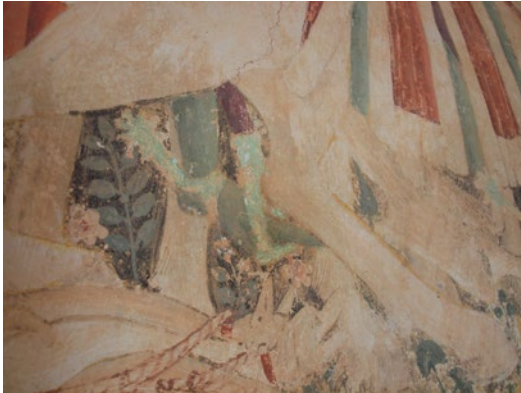
| Detail of the northwestern wall where two green pigments are visible, green earth and a copper-based pigment

Detalj sjeverozapadnog zida s vidljiva dva zelena pigmenta, zelene zemlje i pigmenta na bazi bakra

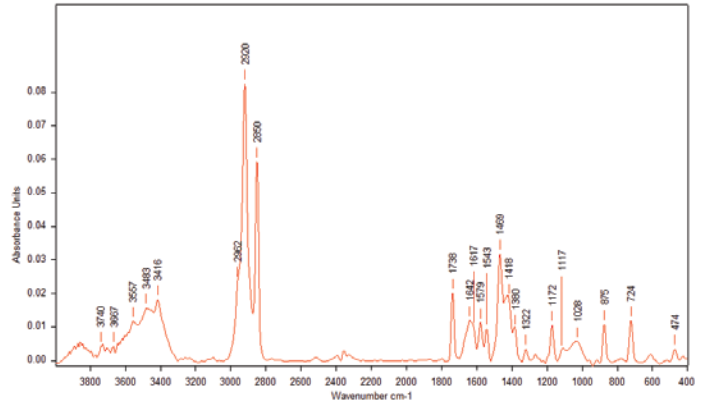
|| FT-IR spectra of a surface coating found on the southwestern wall, probably a past restoration, identified as beeswax.

FT-IR spektri površinskog premaza pronađeni na jugozapadnom zidu, vjerojatno iz ranijeg restauratorskog zahvata, identificirani kao pčelinji vosak

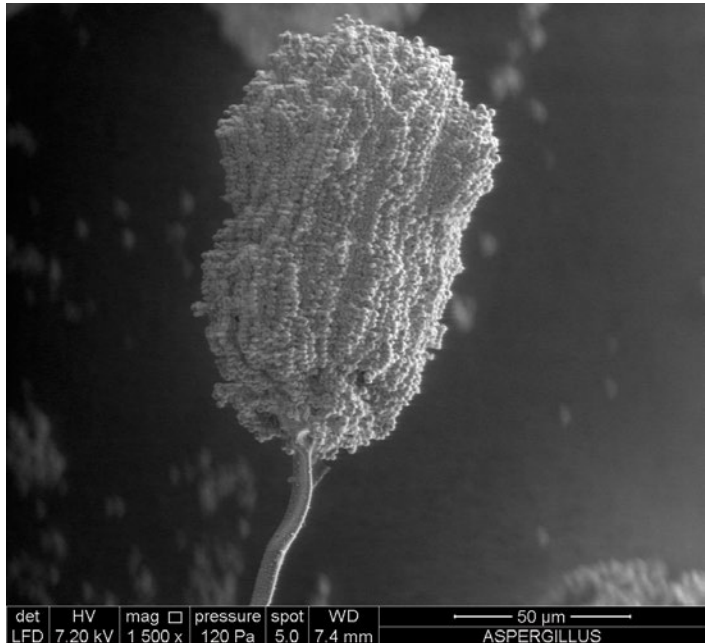
| SEM/SE image of the mycelium of a mold found in the church, recognized as *Aspergillus* sp.
