4th SEE Mosaics Conference IV. Savjetovanje SEE Mosaics

**Presentation of Detached Mosaics
on Movable Supports**

**3rd-6th October 2017
3. - 6. listopada 2017.**

**Pula, Croatia
Pula, Hrvatska**

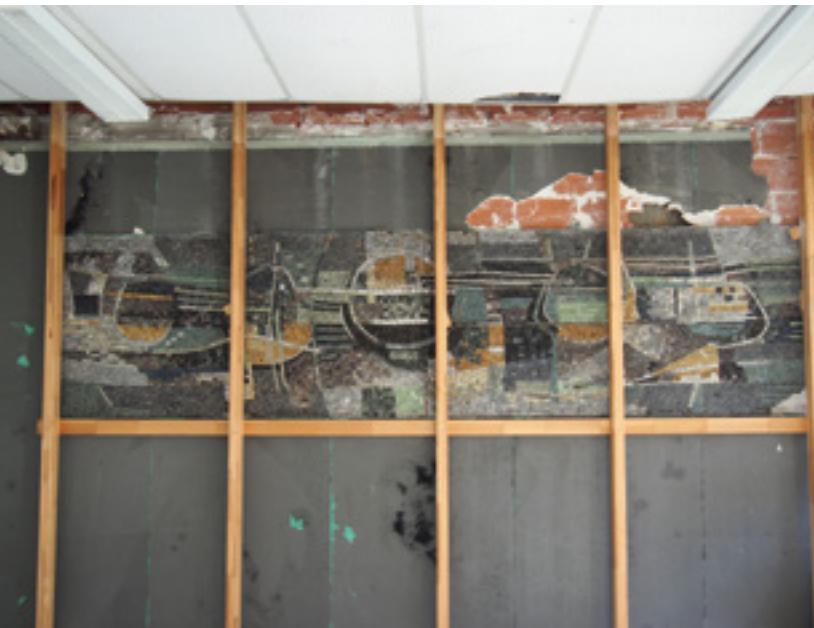
Creutzwald. The green mosaic before protection and removal. (Photo: Astrid Maréchaux)

In time, the classrooms ceased to be used, and the mosaics suffered from dirt, losses, cracks... In 2017, the building is planned to be destroyed. Therefore, the demand was to remove the two mosaics from the old walls, to transfer them to new buildings of the high school, and to “bring them back to light”. However, the previous study of these masterpieces has revealed that the support for the mosaics was made entirely with asbestos, a big problem for their removal. It is impossible and dangerous to scratch, move, touch or break the support. Moreover, the weight of the tesserae is too high not only for this kind of support, but also for the walls. The panels of the mosaics are completely deformed, and the supporting walls are collapsing. To find solutions, a team of conservators, asbestos specialists and metalworking craftsman has been created. How can mosaics, 4 m long, be removed without touching or breaking the asbestos support? What kind of new hanging system can be created to exhibit the mosaic panels in a school? And how can they be restored and protected?

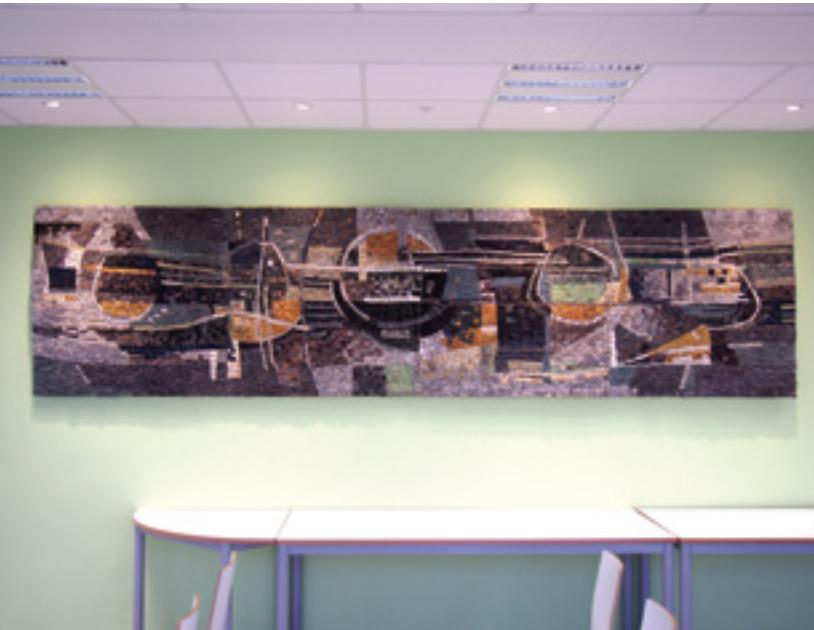
Creutzwald. The green mosaic after restoration, presented in the new school building. (Photo: Astrid Maréchaux)

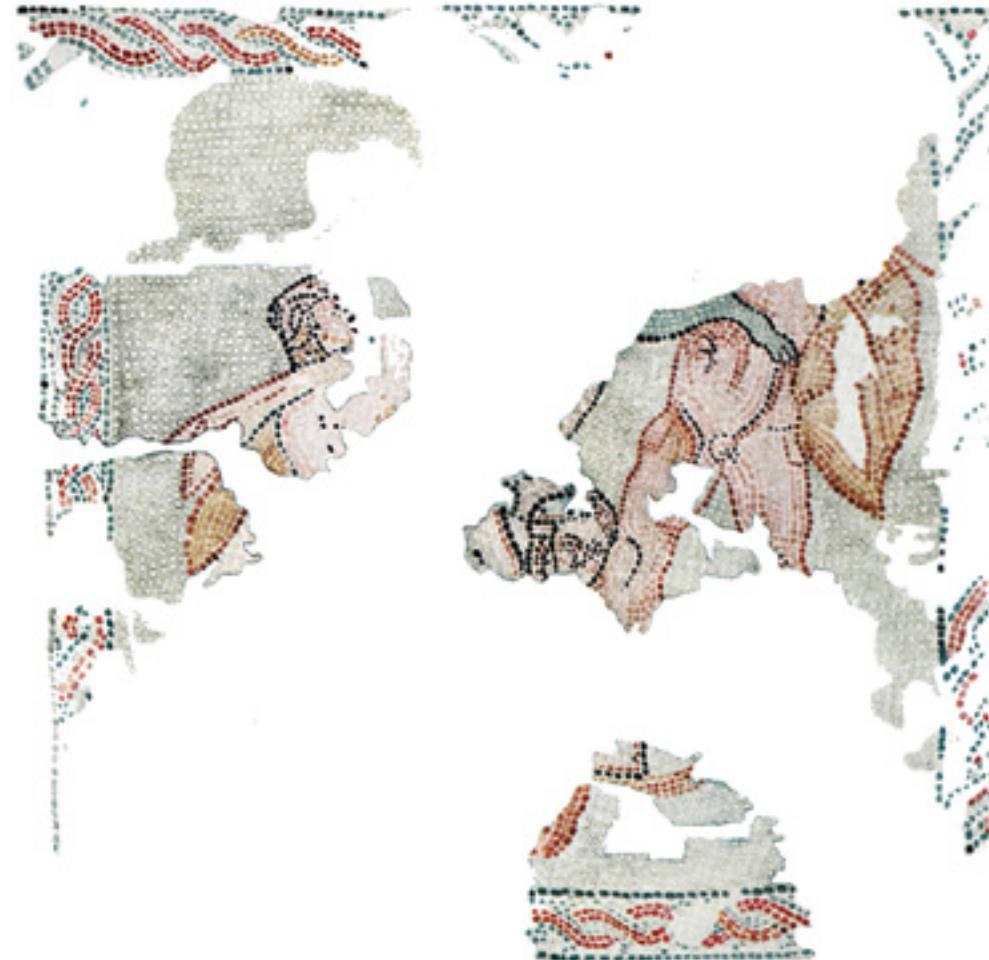
Aquincum. Drawing of the excavated parts of 'The Punishment of Dirce' mosaic emblem from 1943. (Photo: Lajos Nagy: Dirke bűnhődése az aquincumi mozaikon. In: Budapest Régiségei 13, 1943, p. 89, Fig. 10)

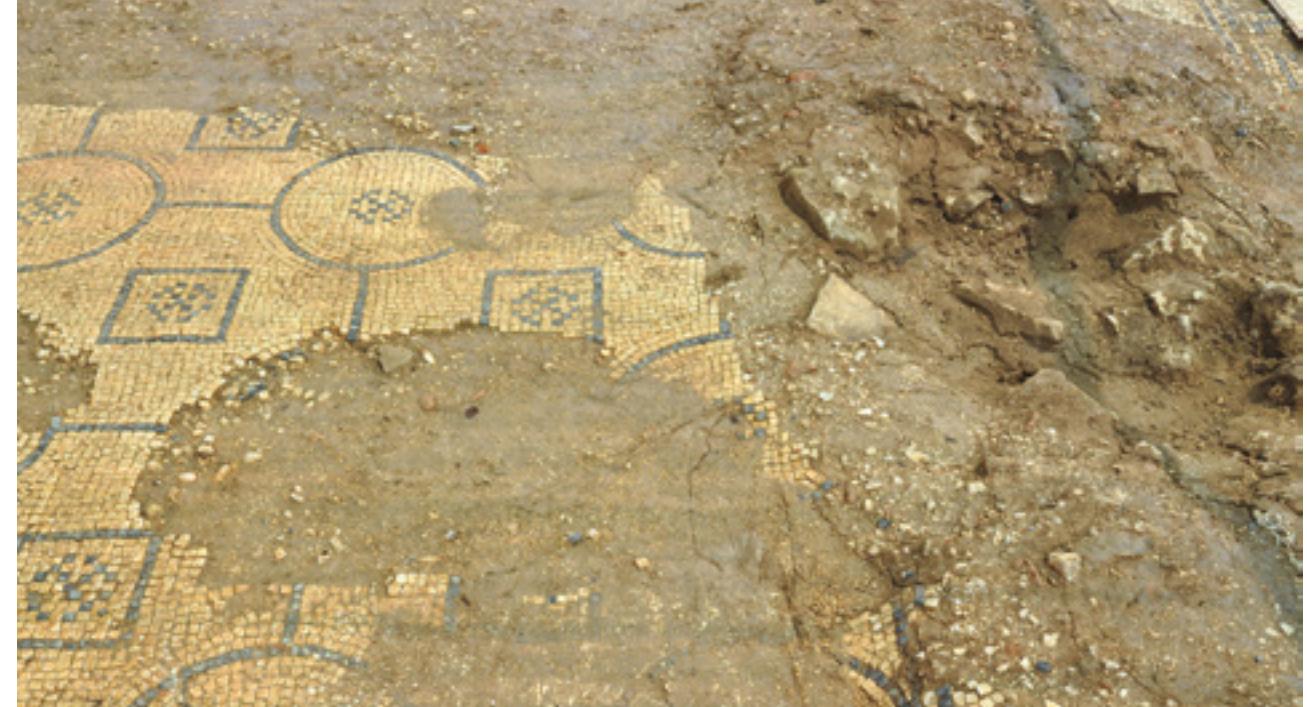
Island of Krk, Baška, 'Podno Miri'. Mosaic after the removal of protective layers of soil and plastic foil. (Photo: Tonči Borovac)

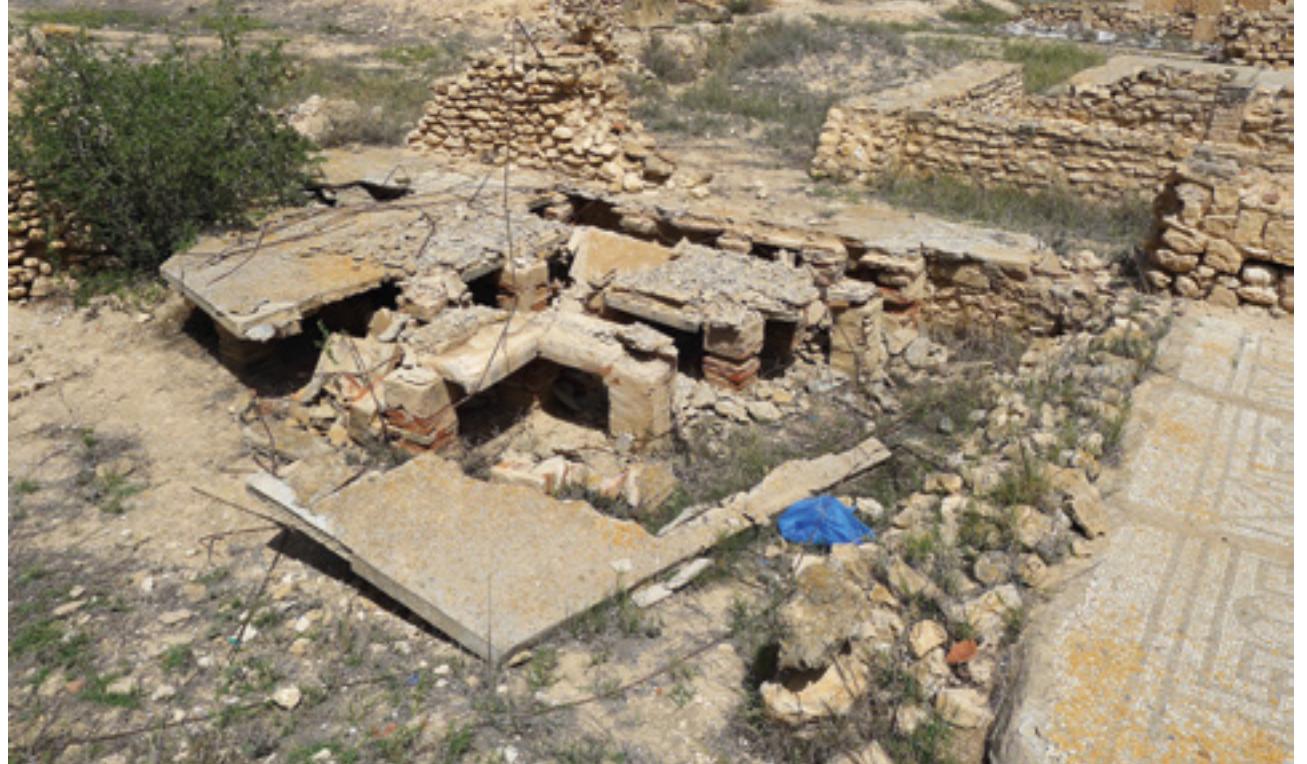
Tunisia, El Jem-Bir Zid, Maison de Lucius Verus.
Lifted and relaid mosaic near total loss.
(Photo: Ermanno Carbonara, 2013)

Using examples from Tunisia, this paper will discuss the advantages and disadvantages of treating and presenting mosaics *in situ* and those of lifting mosaics for storage or display, and will argue that, in most cases, mosaics should be left *in situ* despite the level of condition.

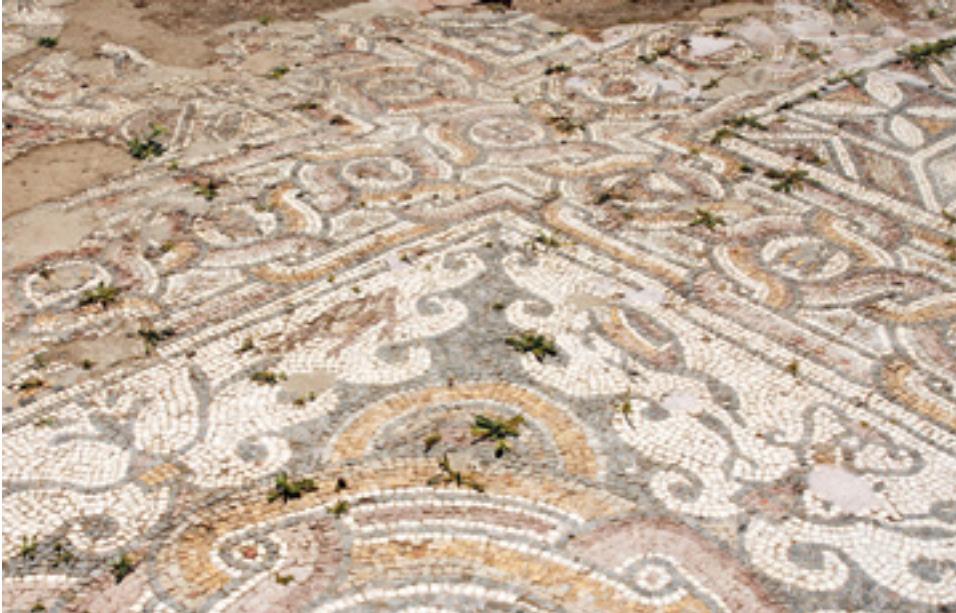
Stobi, narthex of the Episcopal Basilica. Detail of the mosaic surface showing growth of vegetation in 2011. (Photo: Mishko Tutkovski)

The mosaics were opened again in 2011, when we detected a lot of structural damage caused by the absence of maintenance during the previous four decades. Immediately after the opening, we started *in situ* conservation of the mosaics, but unfortunately this was an unsuccessful attempt. Unstoppable and rapid growth of vegetation, which had started right after the opening of the mosaics, was destroying all the mosaic layers, including all our interventions. Thus, we were forced to detach the mosaics and continue the project in other directions. This presentation discusses all the conservation-restoration treatments that were carried out on these mosaics from their detachment, through setting on a movable support and finally placing them back *in situ*, in the narthex of the Episcopal Basilica.

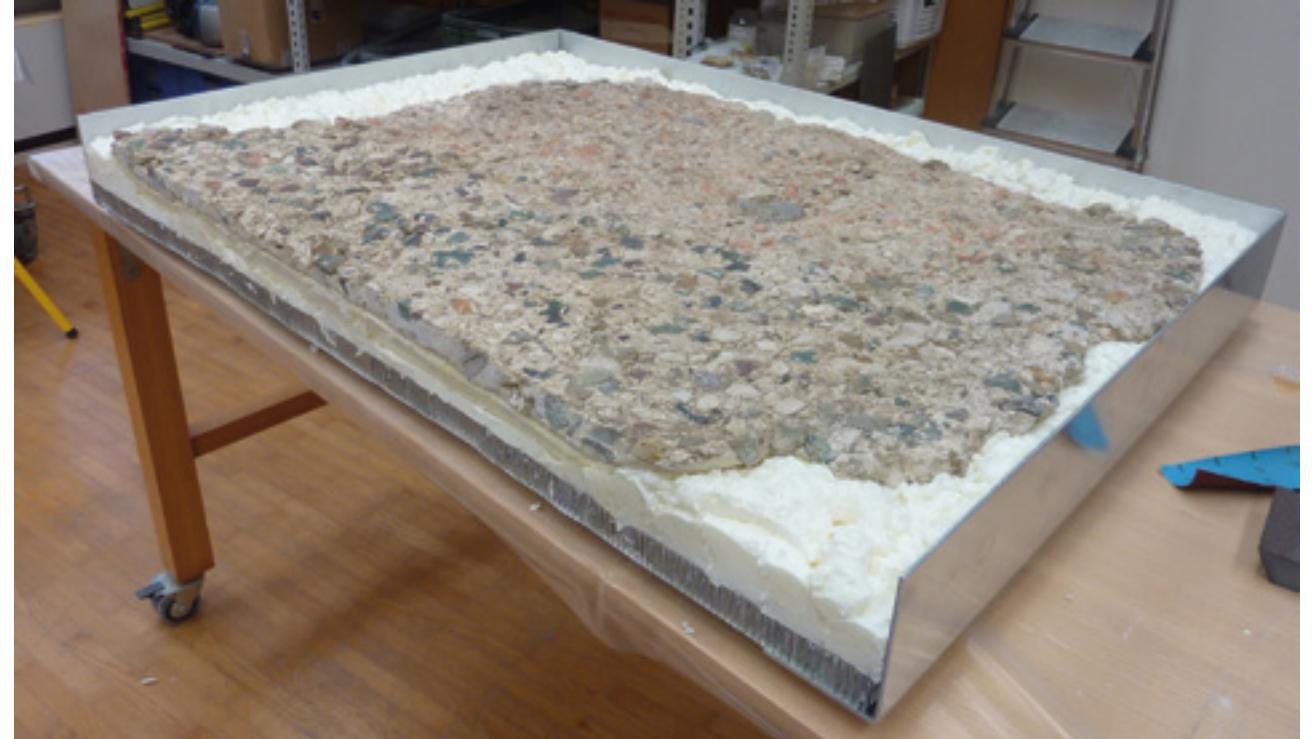
Ljubljana, mosaic from *Insula XIII*. Empty spaces between frame and pavement filled with polyurethane foam. (Photo: Petra Benedik)

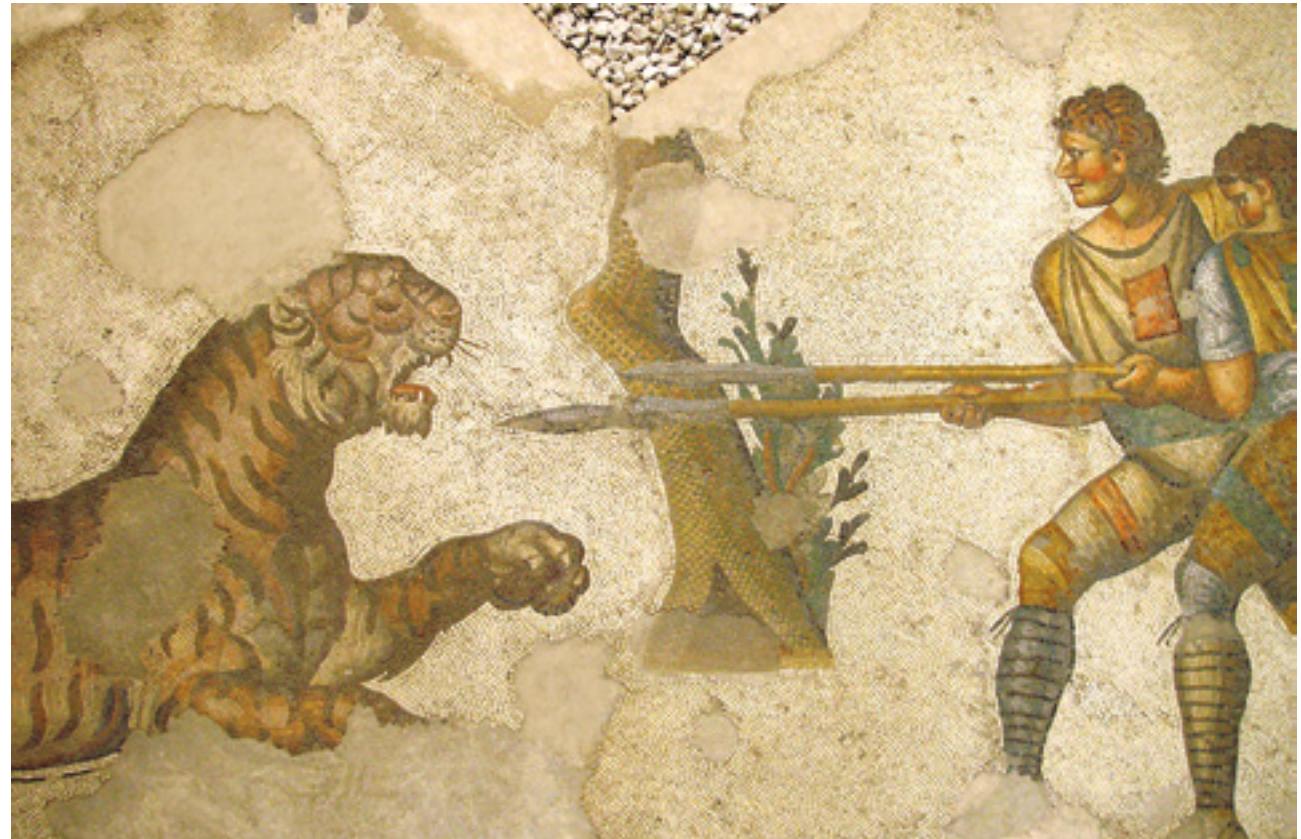
Istanbul, Great Palace. Room A, unfinished – first integrations, 1989.
(Photo: Peter Berzobohaty)

The 'Great Palace Mosaic' conservation project in Istanbul (1983-90), using aluminium-honeycomb supports as backing, will be illuminated critically: the colour found on site is sometimes *sinopia*, but at least in figurative mosaics, there is a polychrome painting underneath the *tesserae*. This fresco painting was totally ignored by the extraction team of 1983-85 (due to incorrect analyses). The fresco on the setting bed should be considered the most artistic layer in the process of making a mosaic. After the later superposition of the tesserae, it is usually forgotten by scientists. Parenthetically, the detachment of modern mosaics from walls is shown. Twofold facing – one flexible, one rigid – is used with a layer of Styrofoam in between, later to be cut through with electric wire, which opens the two facings. Cutting through the wall is performed with diamond cables. A new support (backing) is constructed on an aluminium-honeycomb base. Our team prefers preservations *in situ*, but this method is chosen in buildings from the 1950s or '60s that are at the end of their lifespan. We cut mosaics into sections of 5-10 m².

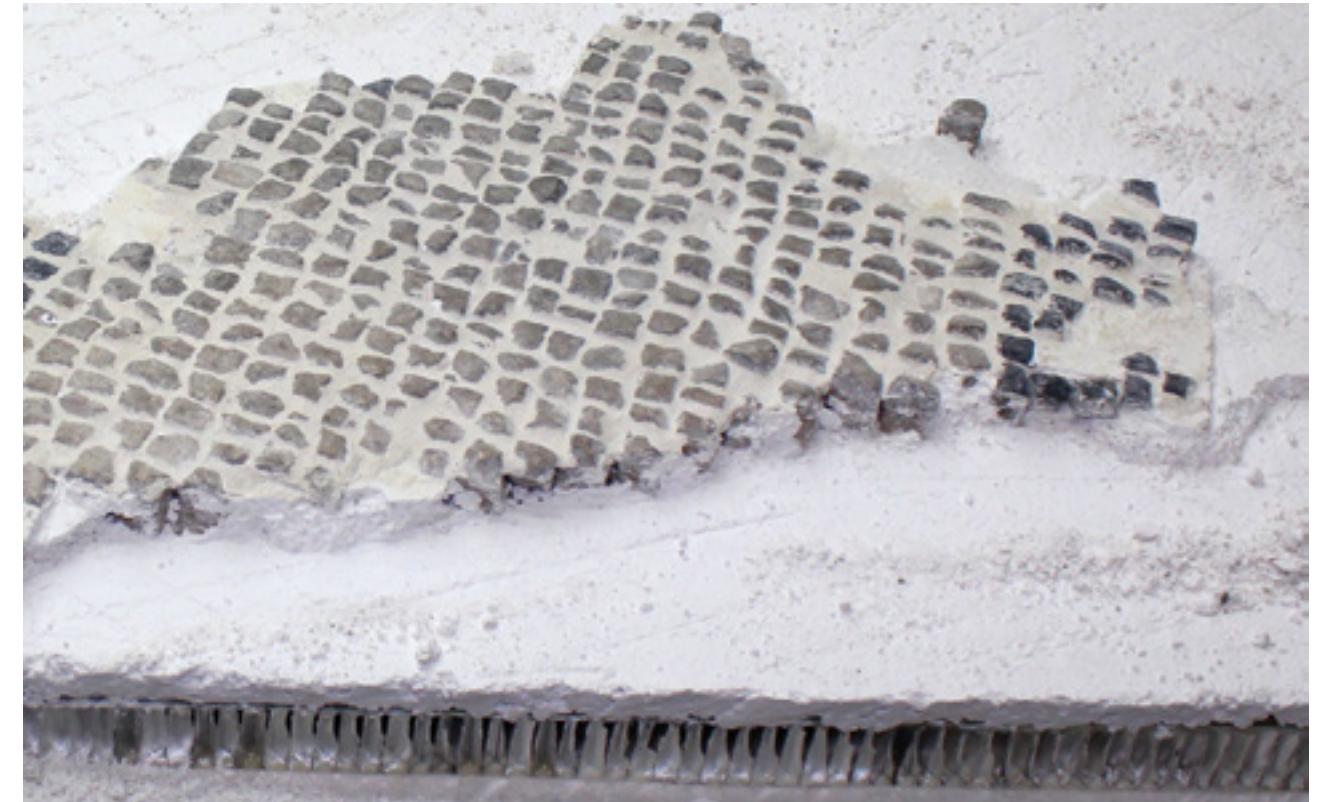
Original Roman mosaic tesserae placed on an aluminium honeycomb panel and layers of new plaster during conservation treatment at the Academy of Fine Arts and Design. (Photo: Blaž Šeme)

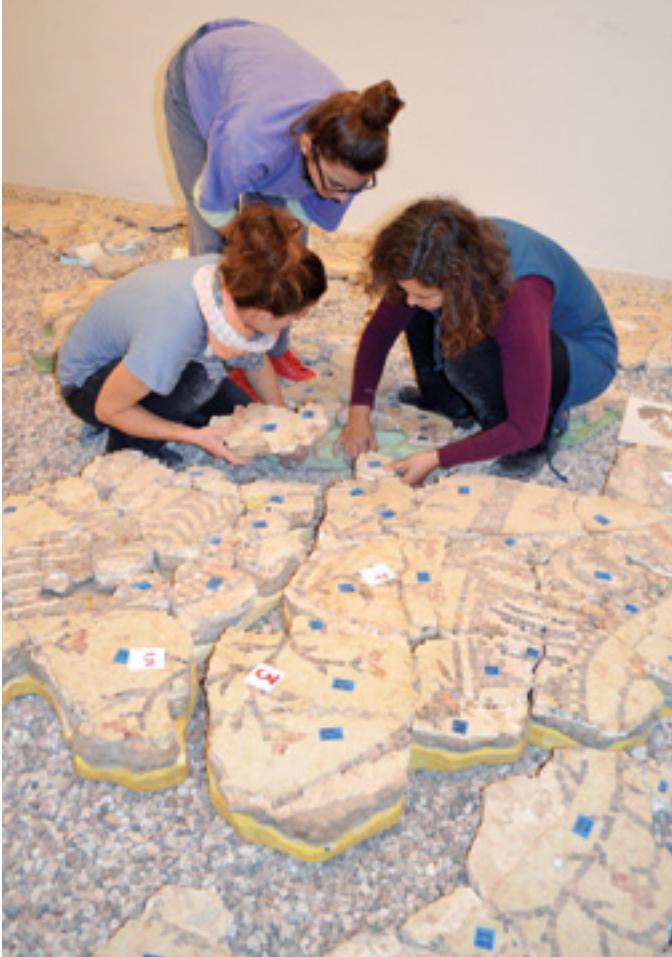
Assembling mosaic sections supported on portable cast mounts. (Photo: Stefania Chlouveraki)
Spajanje dijelova mozaika na prijenosnoj izlivenoj podlozi (foto: Stefania Chlouveraki)

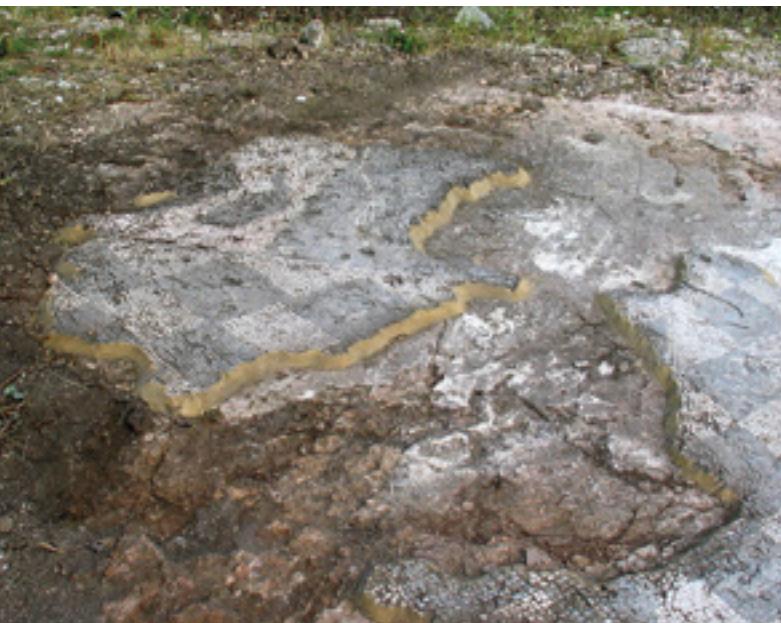
Trilj, Gardun. Partially preserved mosaic floor with the depiction of the bull as a central motif before detachment from its original substrate. (Photo: Branko Matulić, Tonči Borovac)

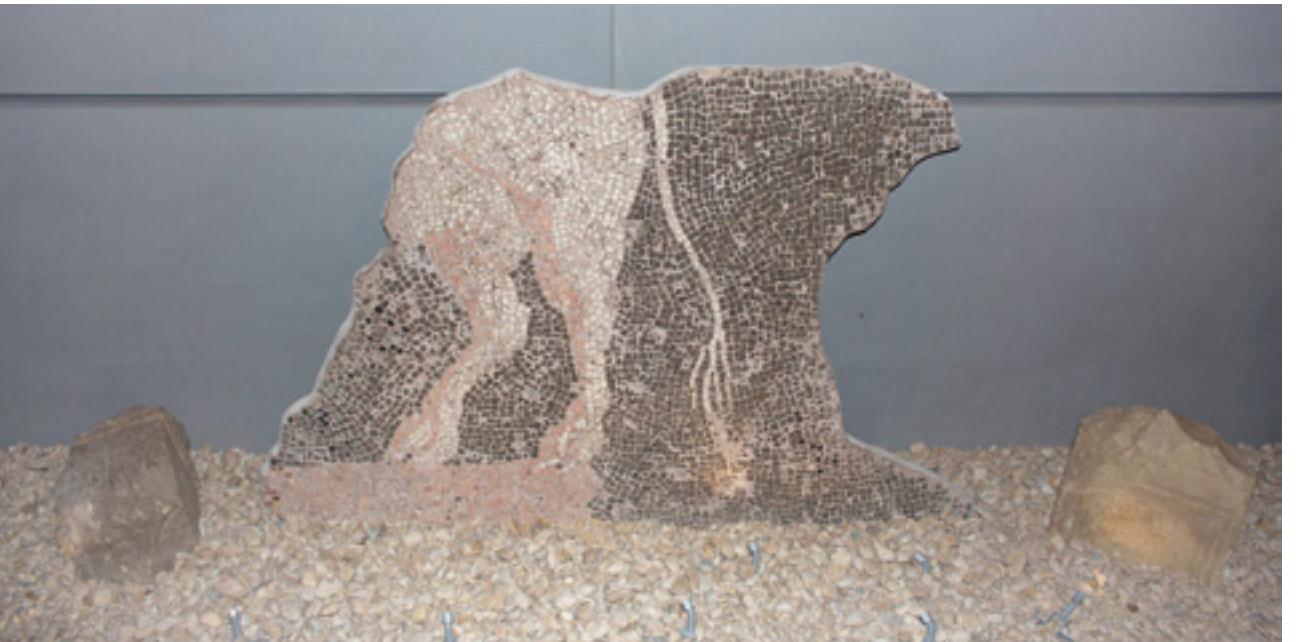
Museum of the Trilj Region. Aerolam panel with the fragment of the mosaic from Gardun with the depiction of the bull. (Photo: Nikola Radošević)

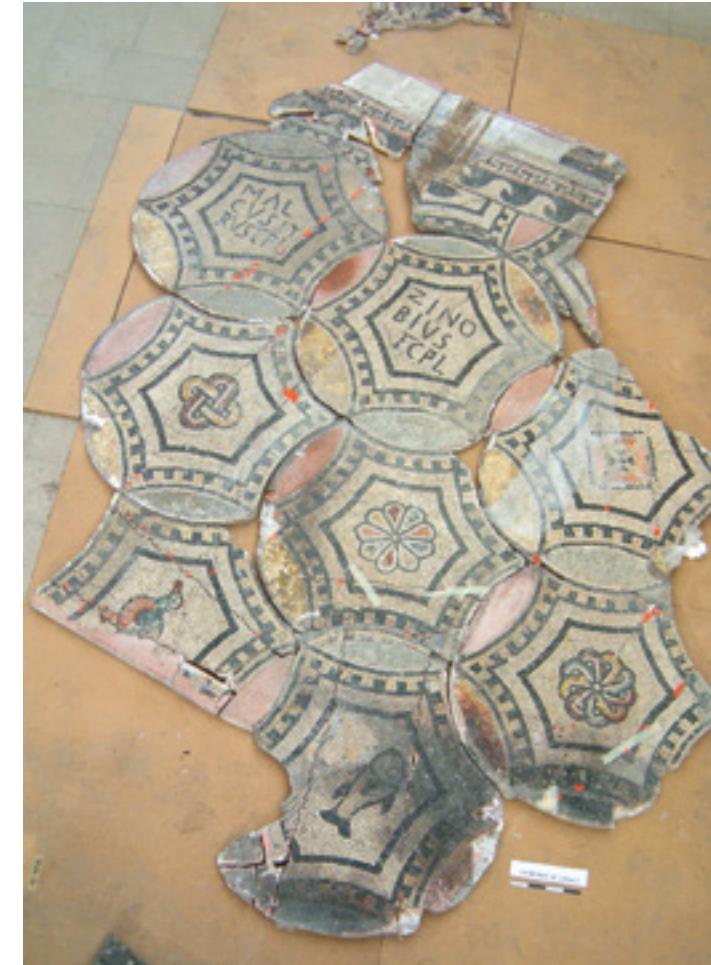
Mosaic carpet with hexagonal fields from the archaeological site of Guberevac (collection of the National Museum in Belgrade) before restoration. (Photo: Dušan Maksimović)

Posterom je predstavljen tretman lakuna vapnenim žbukama u boji koje ističu geometrijsku dekoraciju mozaika. Tim izabranim pristupom omogućeno je razumijevanje geometrijskog crteža mozaika.

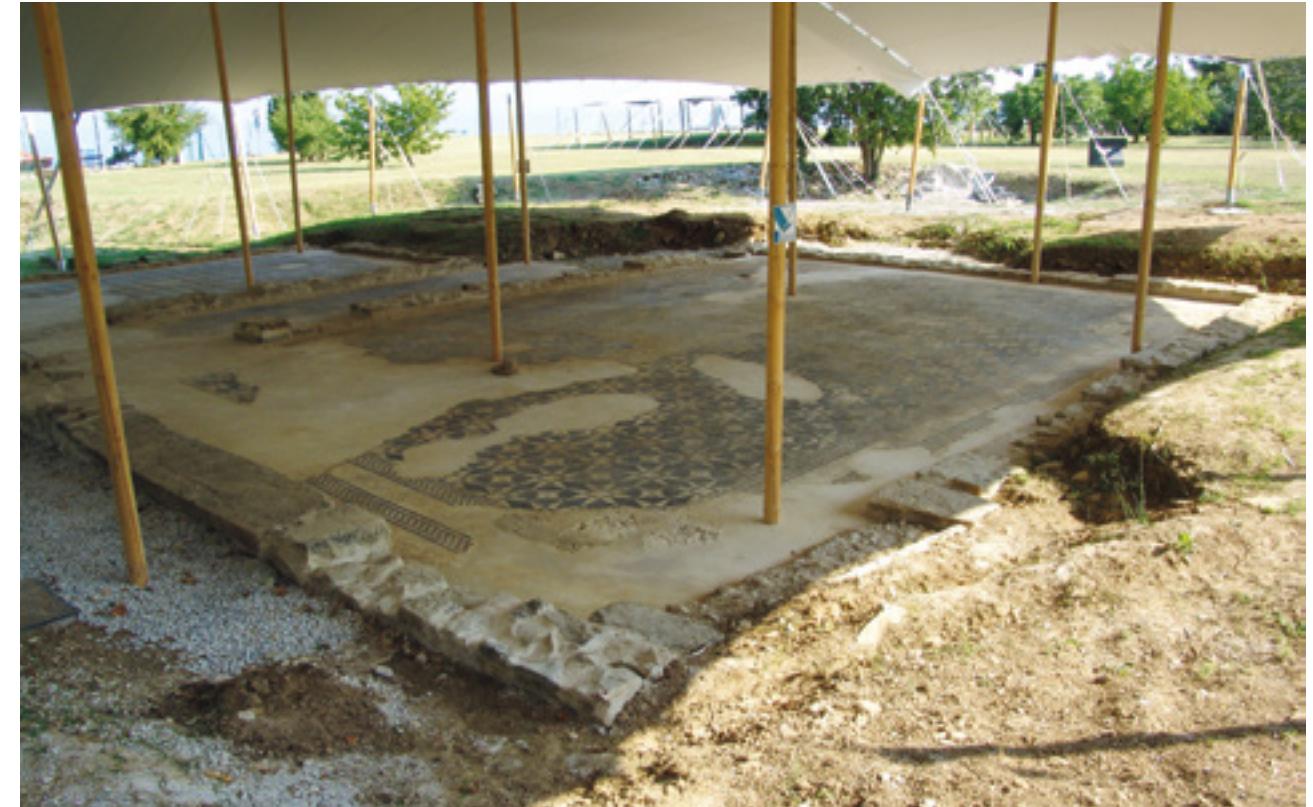
Izola, St. Simon's Bay. The shelter over Area 2 with three returned mosaics. (Photo: Nataša Škrjanec)
