## Sotin, Main Altar of Church of the Blessed Virgin Mary Help of Christians

Sotin, glavni oltar crkve Blažene Djevice Marije Pomoćnice kršćana  
Sotin, Main Altar of Church of the Blessed Virgin Mary Help of Christians

## Sotin, glavni oltar crkve Blažene Djevice Marije Pomoćnice kršćana

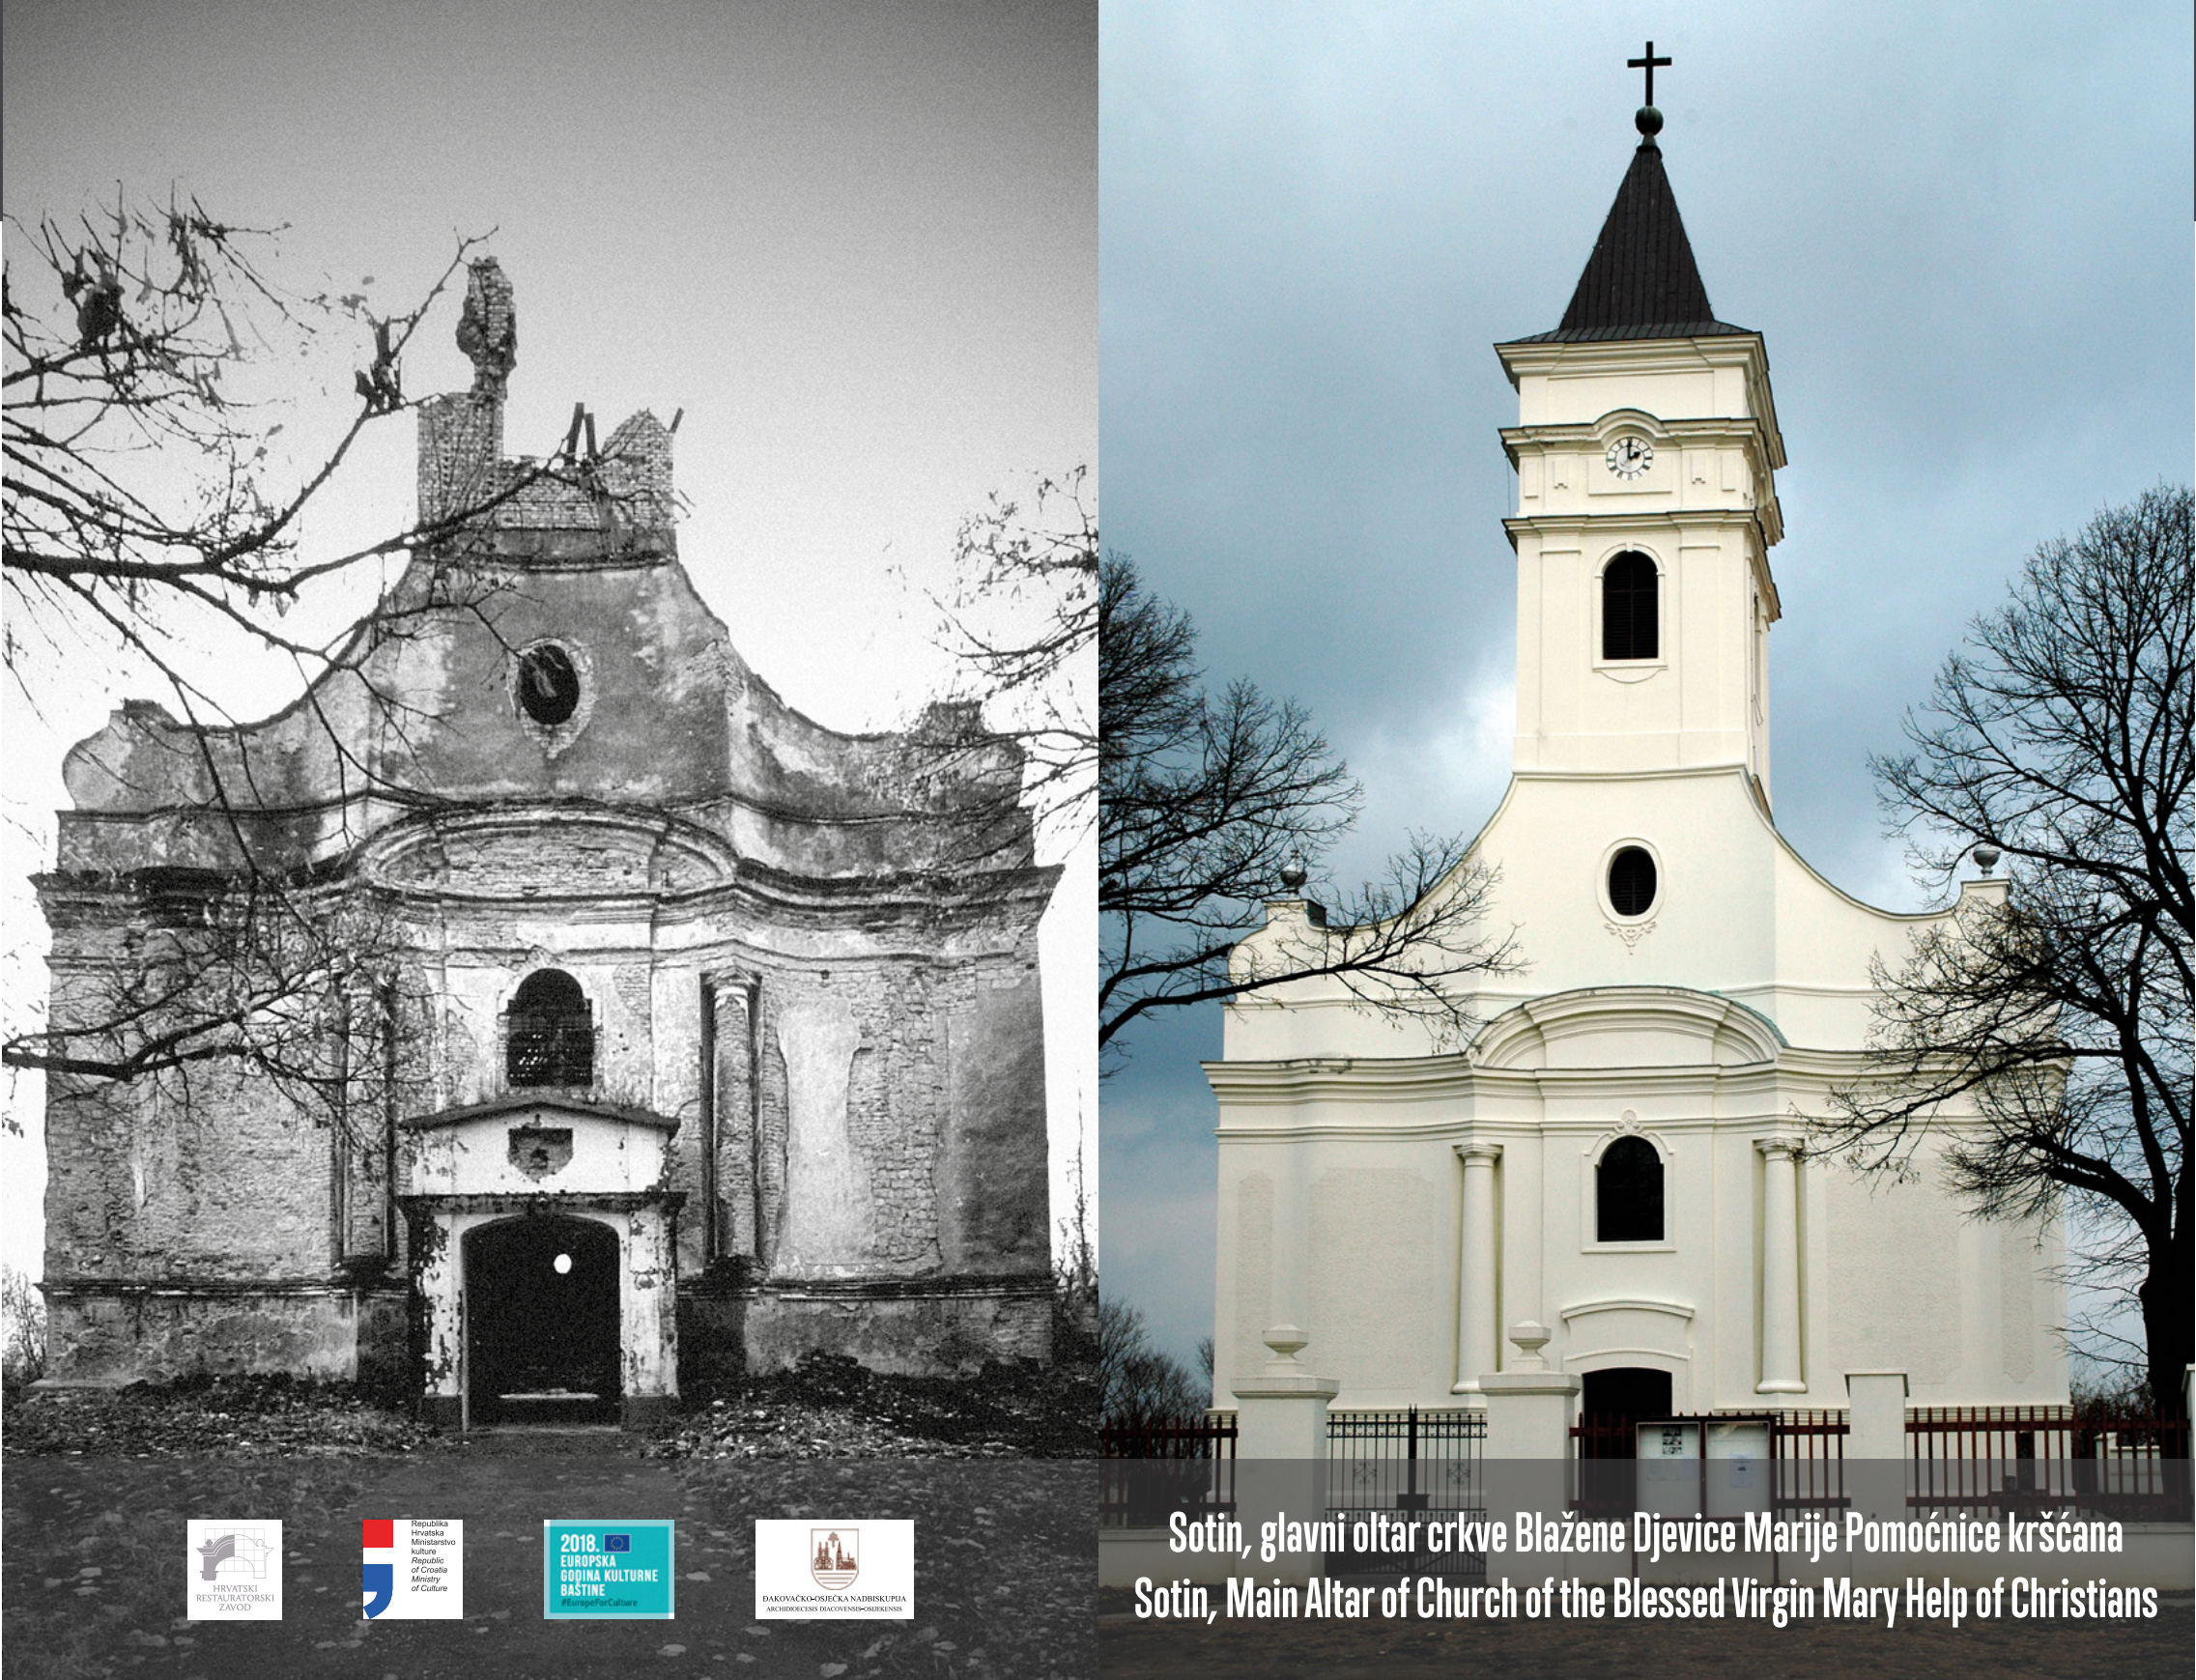
The main altar in Sotin is a single-tiered retable with an attic. Rising above the side pedestals and the altar stone with a typical concave-convex shape is a predella with consoles that carry columns and serve as pedestals for sculptures of St. Joachim

and St. Anne. The central focus of the retable is the oil-on-canvas painting of the Blessed Virgin Mary, one of numerous similar copies based on the template by the German painter Lucas Cranach. During the construction of the altar, special attention was paid to the design of the tabernacle in the form of a small *tempietto*. The altar was constructed using a special technique that combines plaster, various pigments and animal glue to imitate different types of marble.

During the European Year of Cultural Heritage comprehensive conservation of the main altar from the church in Sotin has been completed. The work, carried out from 2007 to 2018, included the construction of the missing wooden structure, rendering of the rough supporting plaster, replacing a layer of stucco marble with different patterns on all elements of the altar architecture, and creating a facsimile of the sculptures. The abovementioned work, as well as all the technical and technological solutions that came from extensive research, were carried out by the staff of the Department for Stucco at the Croatian Conservation Institute. The complexity of the work is evident in the fact that only a handful of Central European workshops specialize in the conservation of art pieces made using this technique.

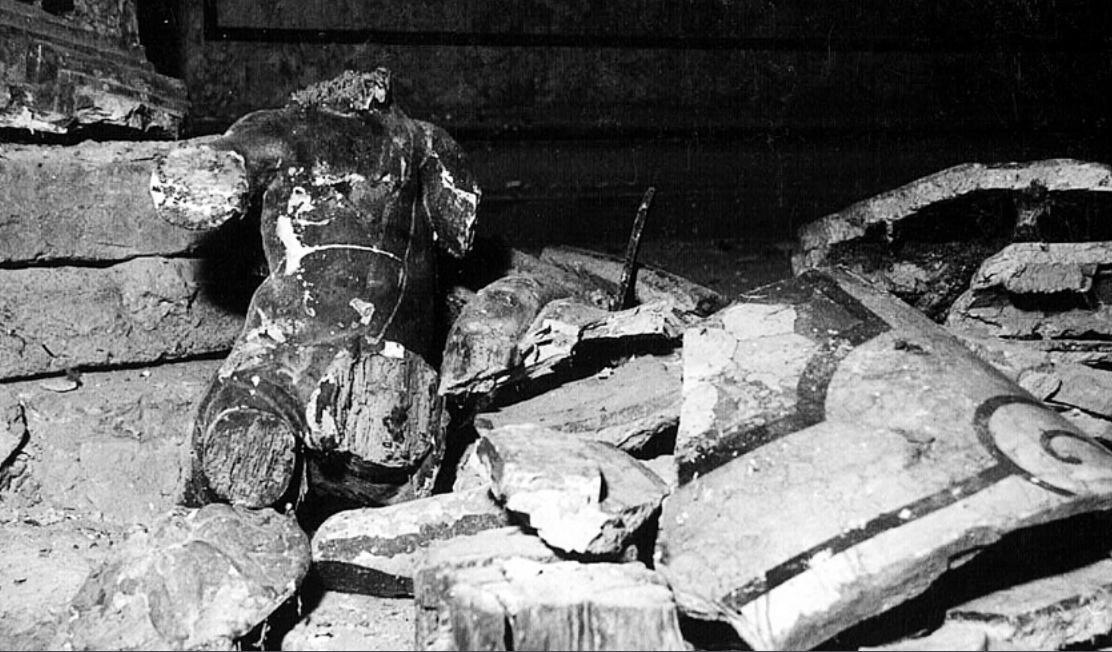
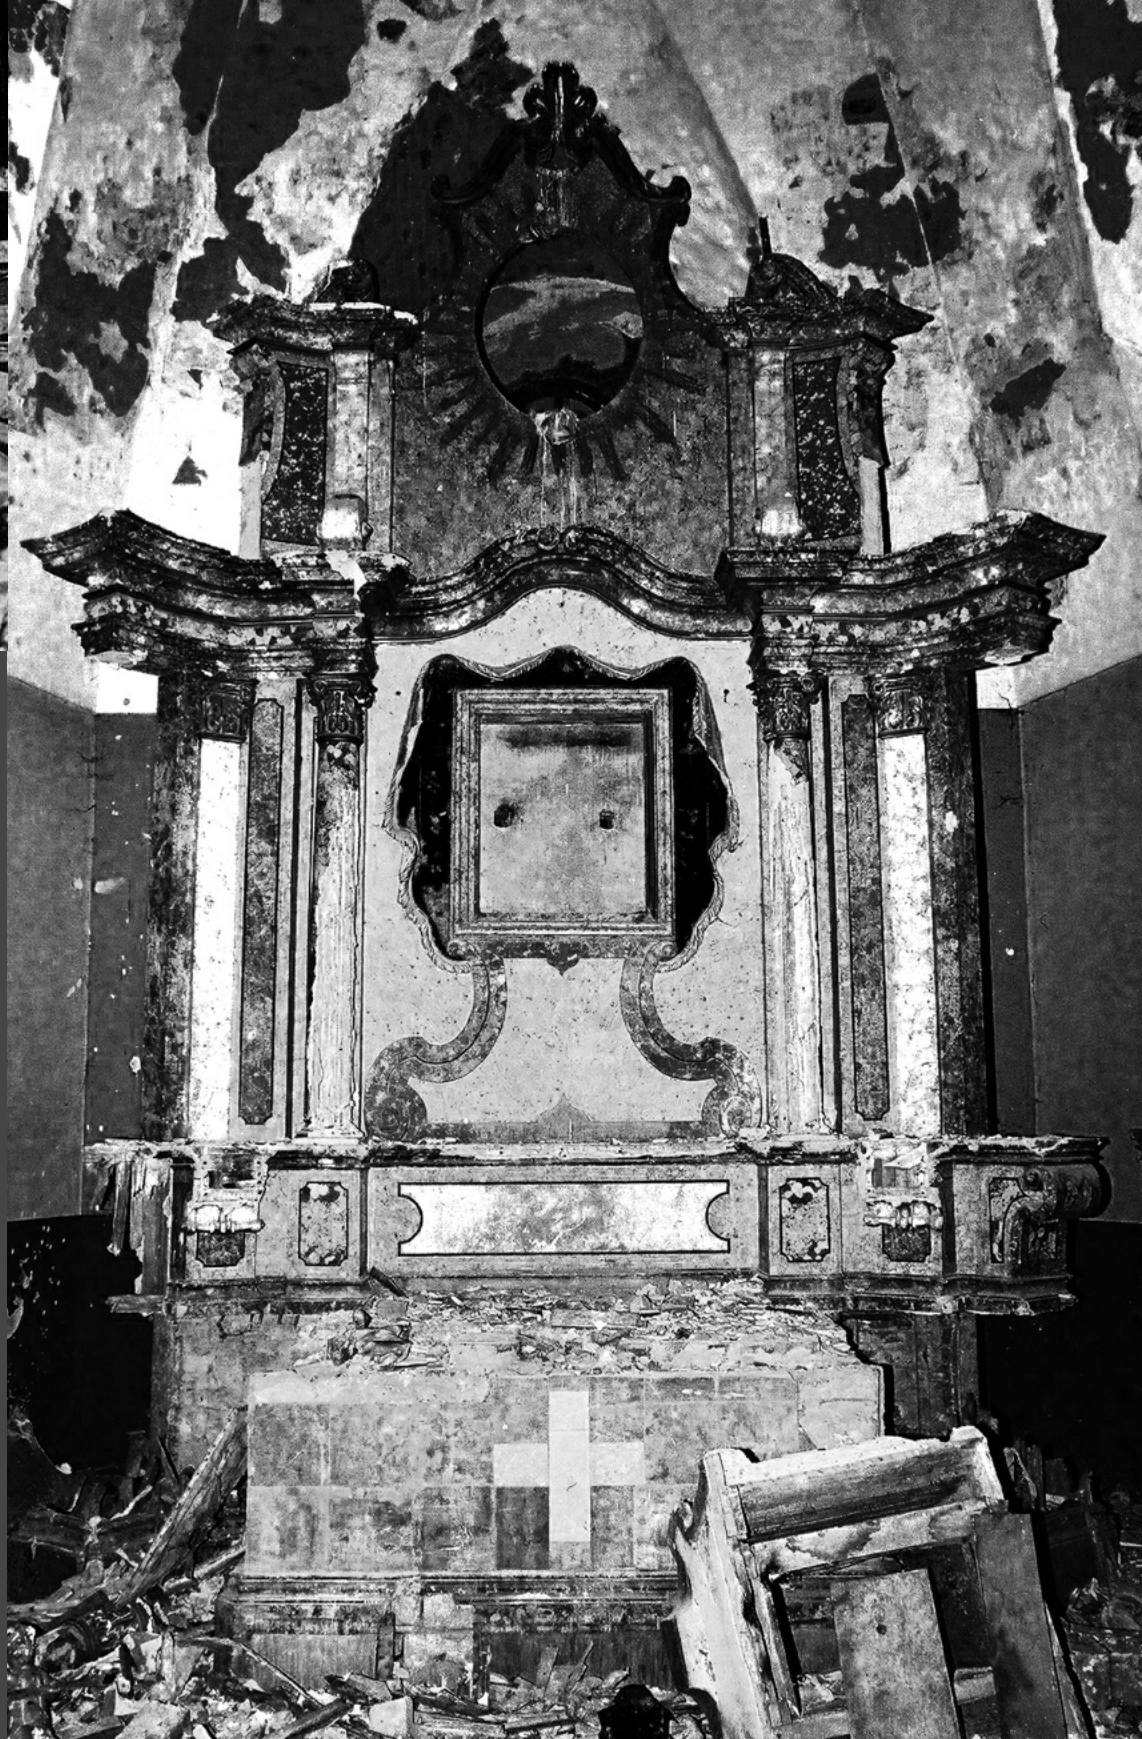
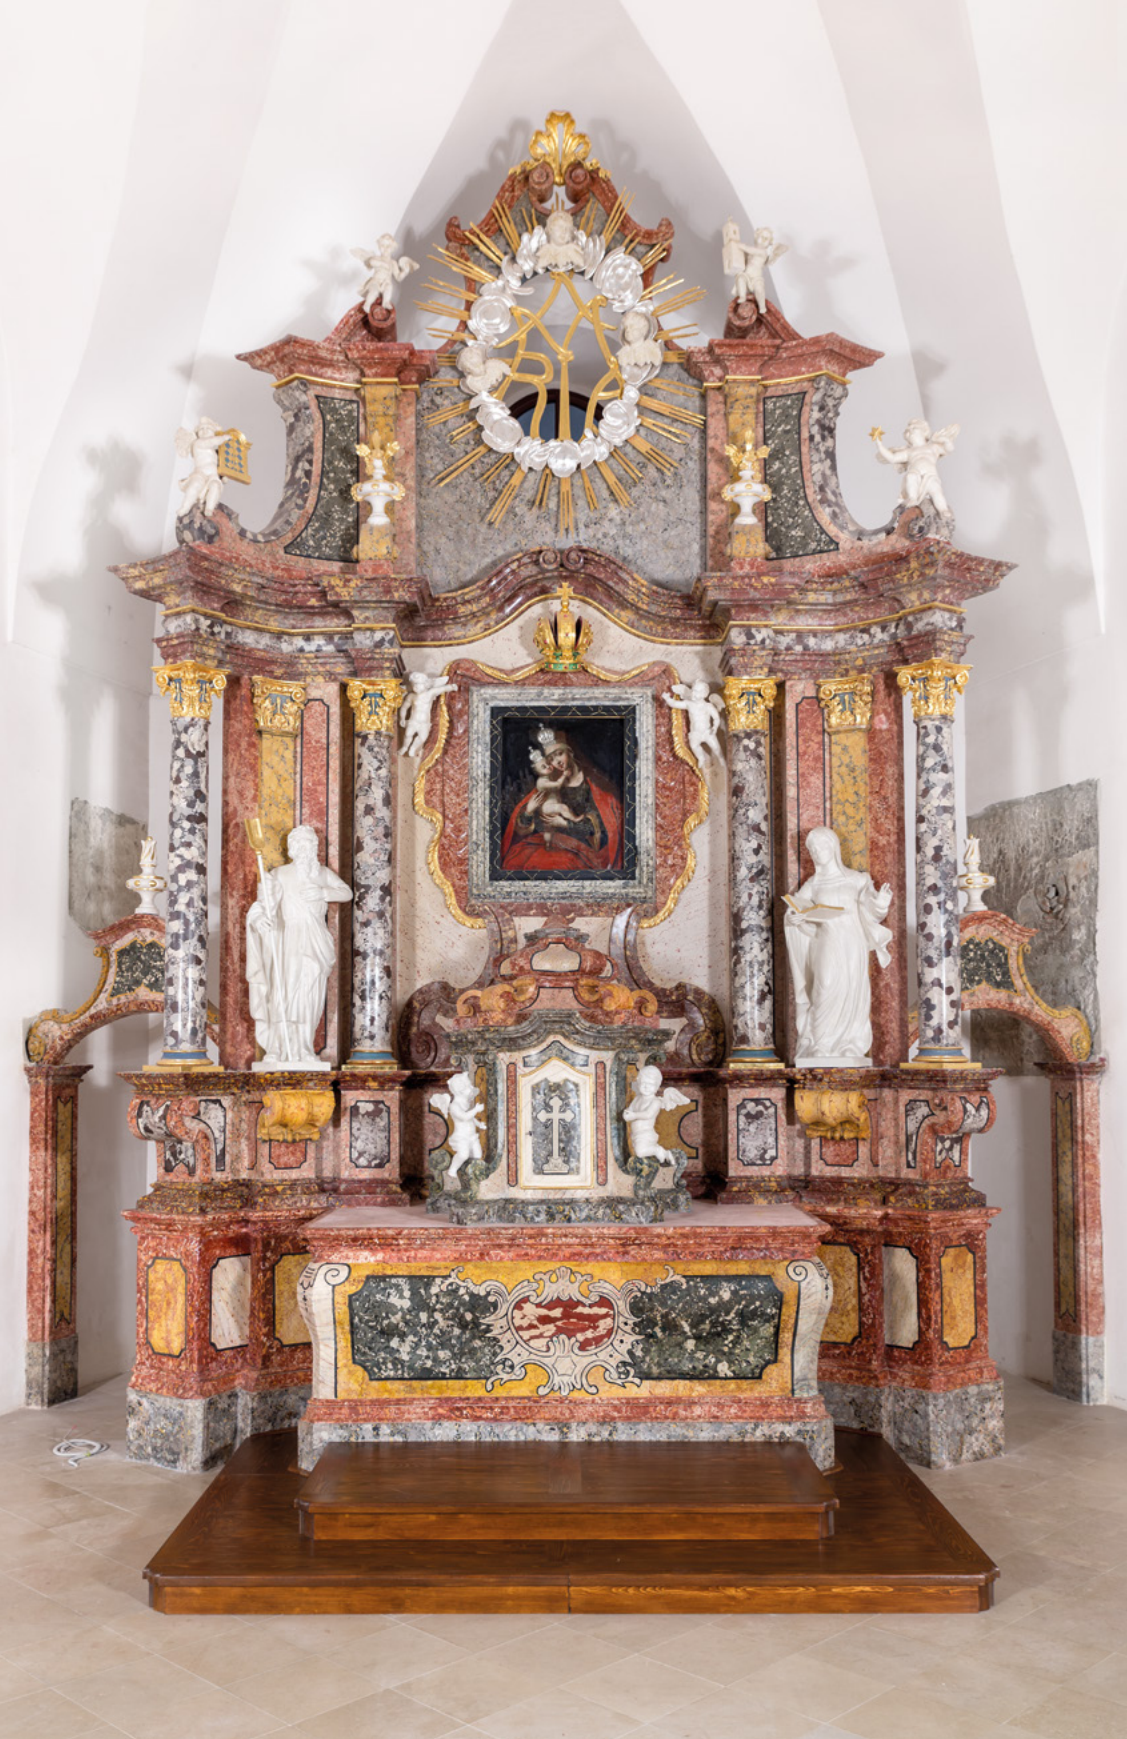
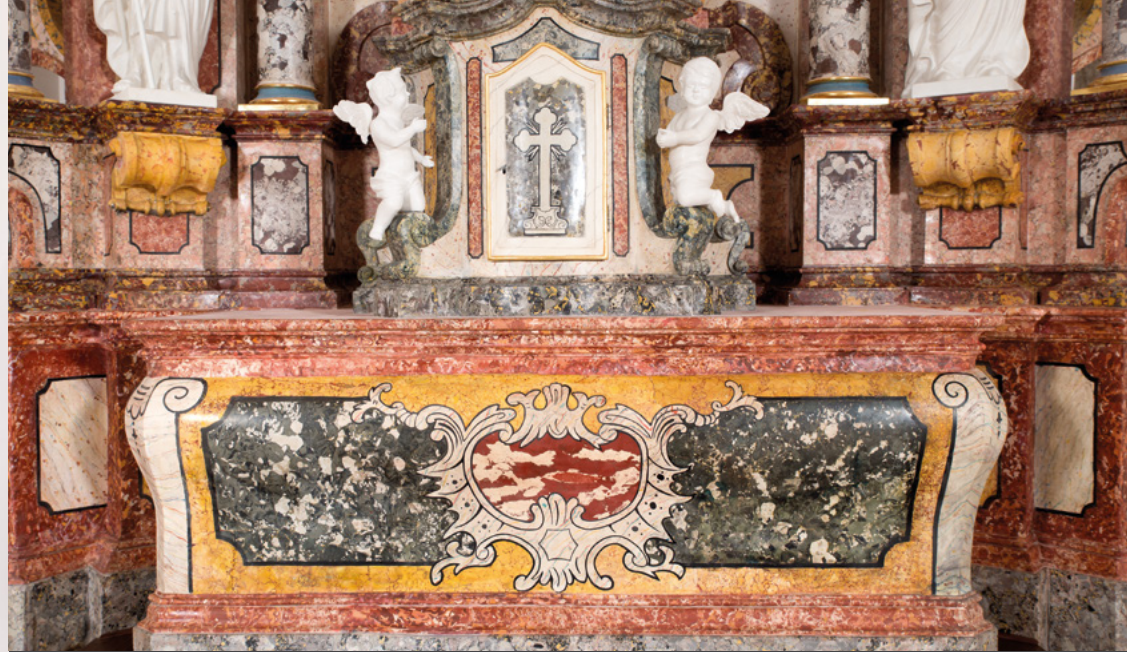
U agresiji na Hrvatsku 1991. godine sotinska je župna crkva teško stradala. Oltar je na više mjesta bio mehanički oštećen, drvena konstrukcija je bila rasušena ili nagorena, sloj podložne žbuke odvajao se od drvene konstrukcije, a sloj štukomramora bio je raspucan, mehanički oštećen ili je u cijelosti nedostajao. Kipovi sv. Joakima i sv. Ane su nestali, a od figura anđela sačuvano je samo nekoliko fragmenata.

U Europskoj godini kulturne baštine dovršeni su konzervatorsko-restauratorski radovi na glavnom oltaru sotinske crkve. Radovima, koji su s prekidima trajali od 2007. do 2018. godine, obuhvaćena je izrada nedostajuće drvene konstrukcije, polaganje podložne žbuke, nadomještanje sloja štukomramora različitih uzoraka na svim elementima oltarne arhitekture te izrada faksimila kipova. Navedene radove, kao i sva primijenjena tehnička i tehnološka rješenja koja su proizašla iz opsežnih istraživanja, proveli su djelatnici Odjela za štuko Hrvatskog restauratorskog zavoda. Na složenost radova upućuje i činjenica da se samo nekoliko srednjoeuropskih radionica bavi konzervatorsko-restauratorskim postupcima na umjetninama izvedenim navedenom tehnikom.

Konzervatorsko-restauratorski zahvat na štukomramoru uključuje radove na drvenoj potkonstrukciji, učvršćivanje postojeće i polaganje nove podložne žbuke te njezino modeliranje i brušenje, polaganje završnog sloja štukomramora te njegovo brušenje i poliranje. Da bi rekonstruirani dio štukomramora oblicima i bojom bio prilagođen izvornom materijalu, potrebne su brojne probe svih faza postupka za svaki uzorak.
