# OLTAR SV. KRIŽA, KAMENSKO, CRKVA BL. DJEVICE MARIJE SNJEŽNE THE ALTAR OF THE ST. CROSS, KAMENSKO, CHURCH OF THE BLESSED VIRGIN MARY OF SNOW

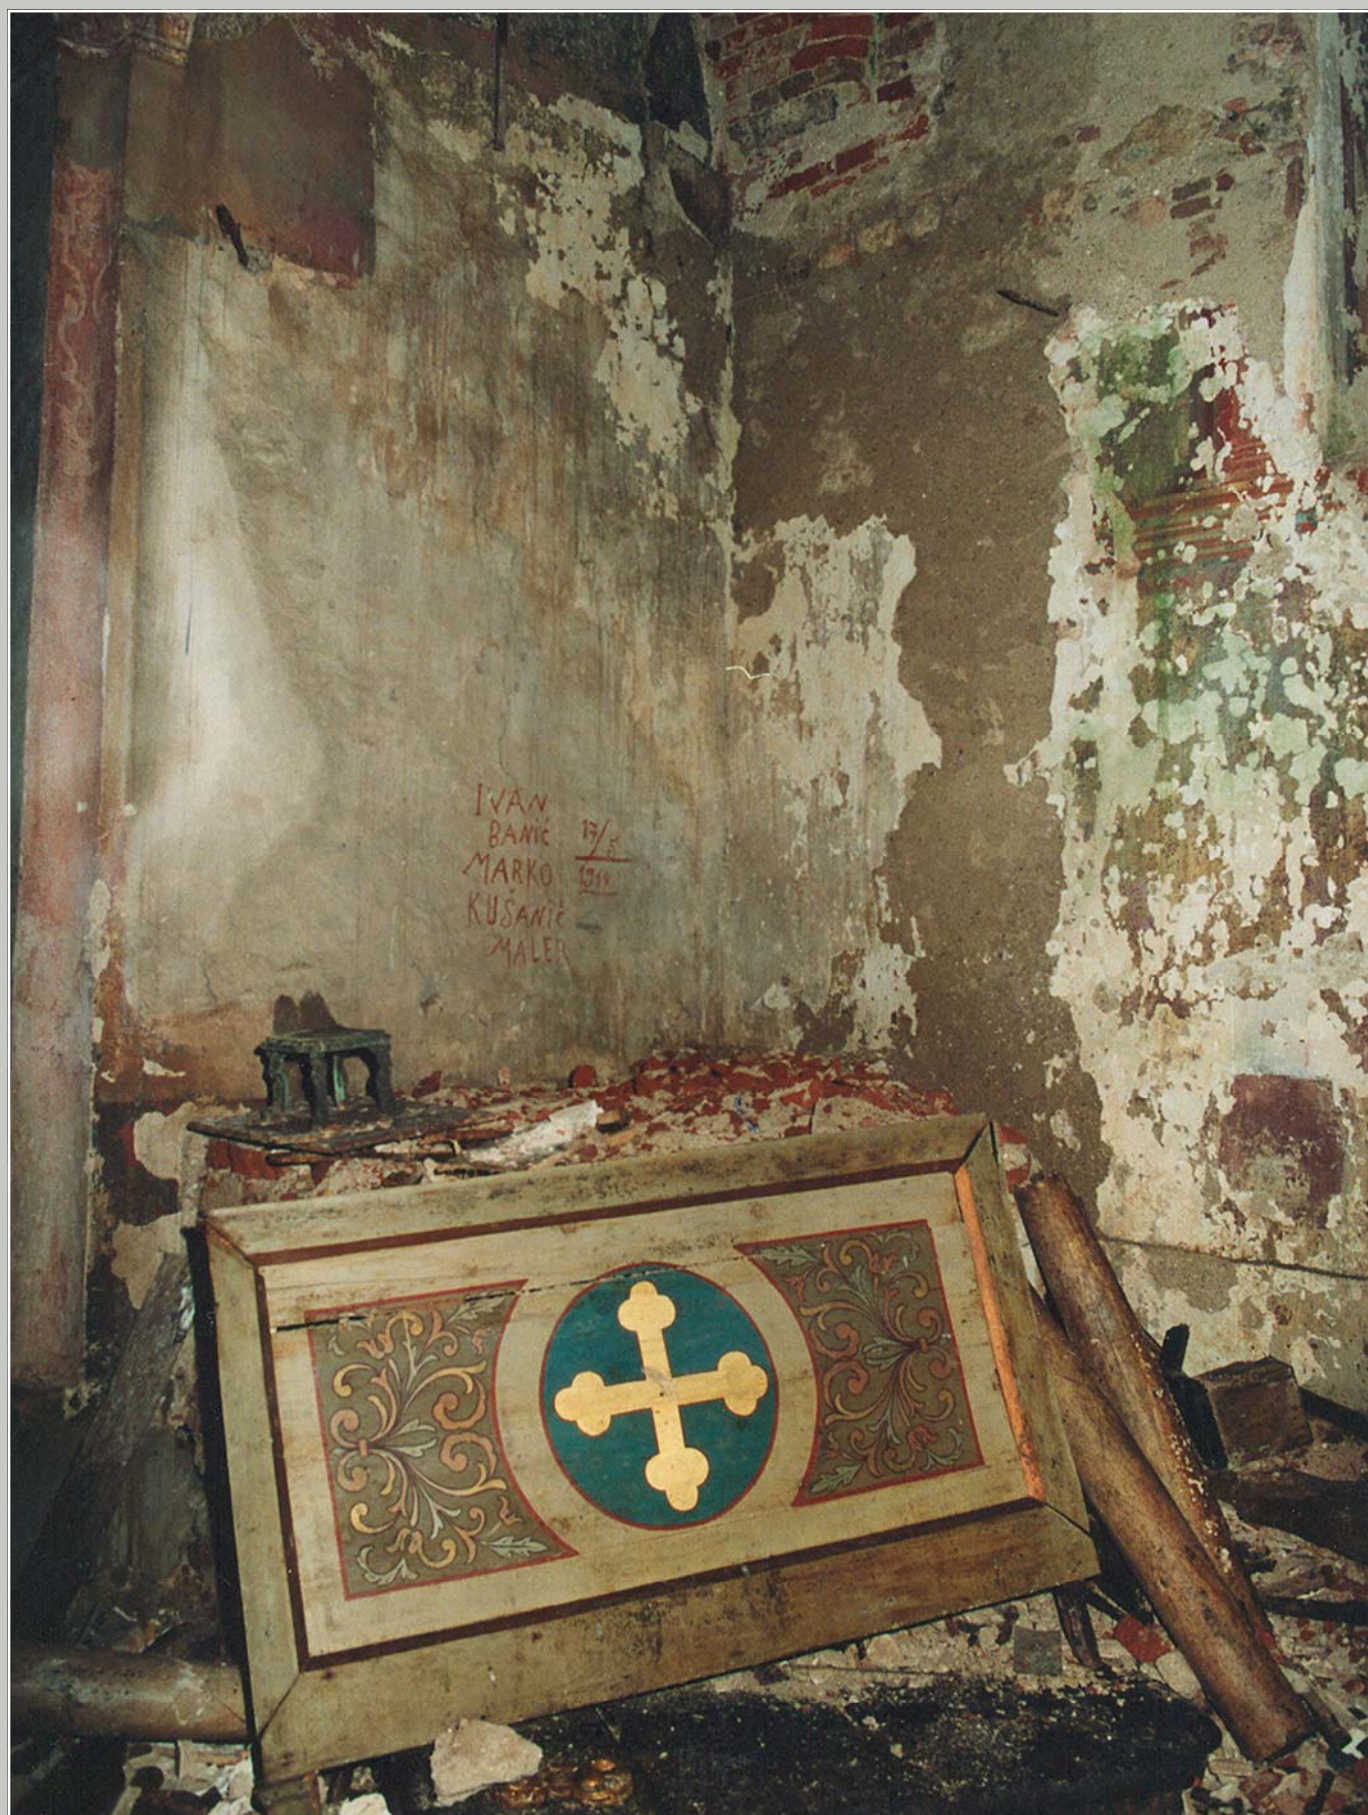
Zatečeno stanje oltara Sv.Križa in situ 1995 godine, nakon završetka oružanog sukoba  
The state of the altar of St.Cross in situ in the year 1995, after armed conflict

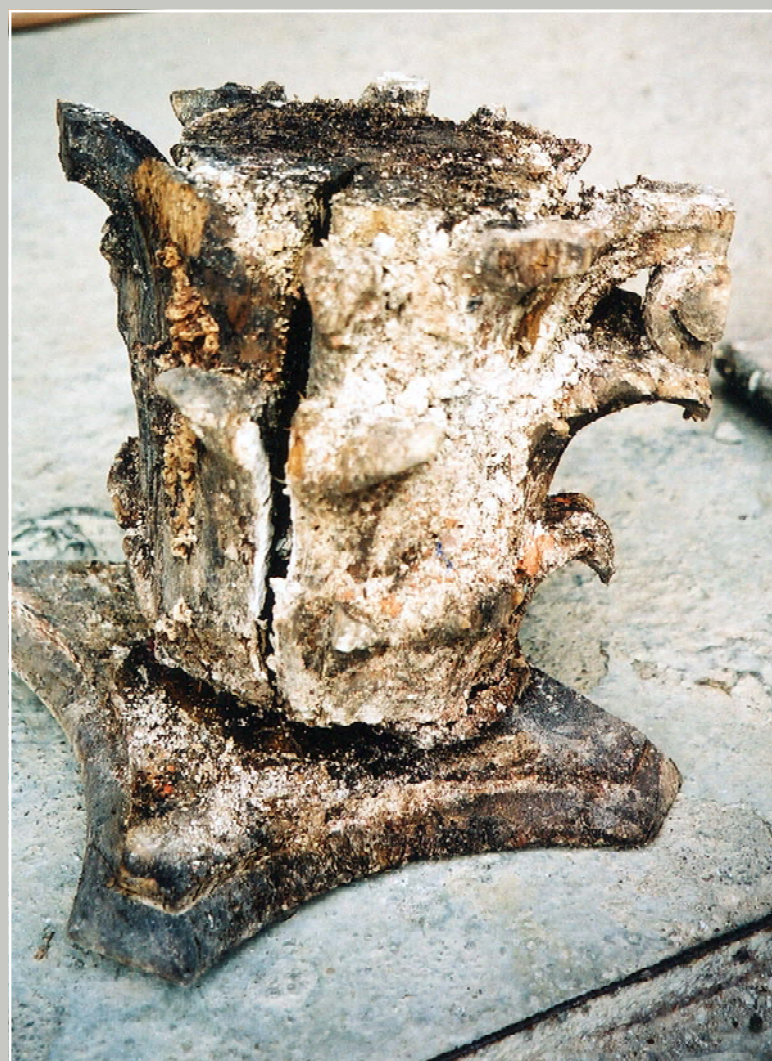
Kapitel sa naslagama mikroorganizama  
Capital with layers of microorganisms

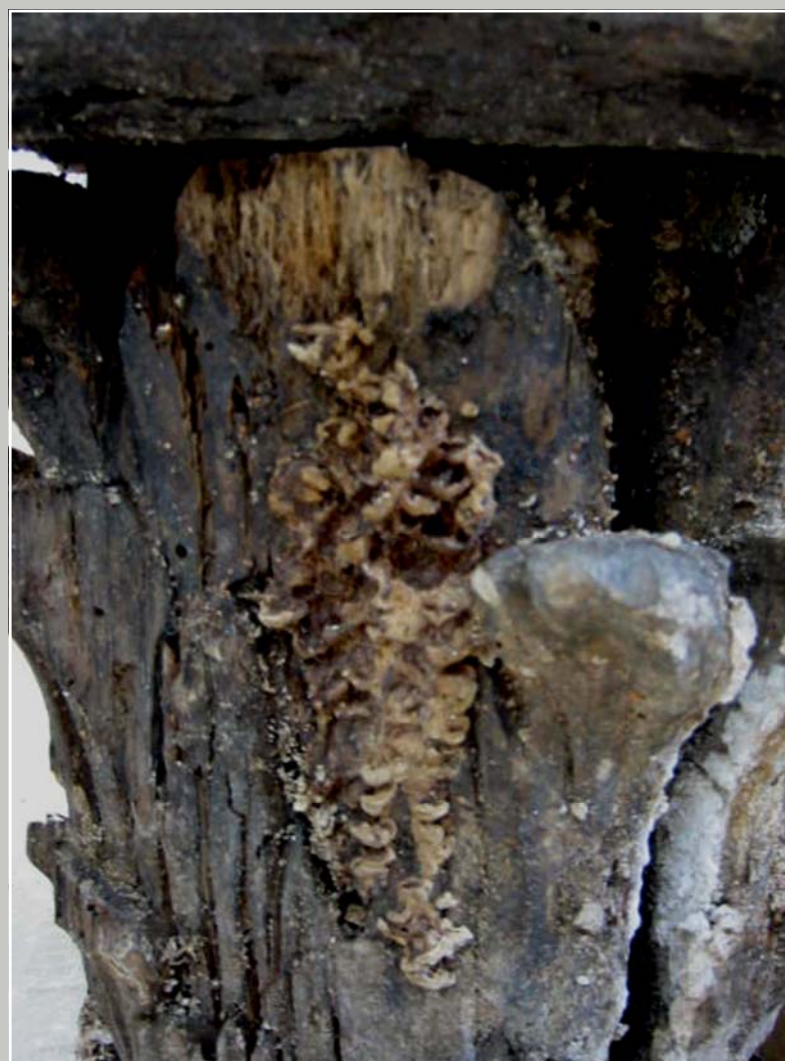
Detalji kapitela sa vidljivo razvijenim naslagama mikrobiološke aktivnosti.  
Detail of the capital with highly developed micro-

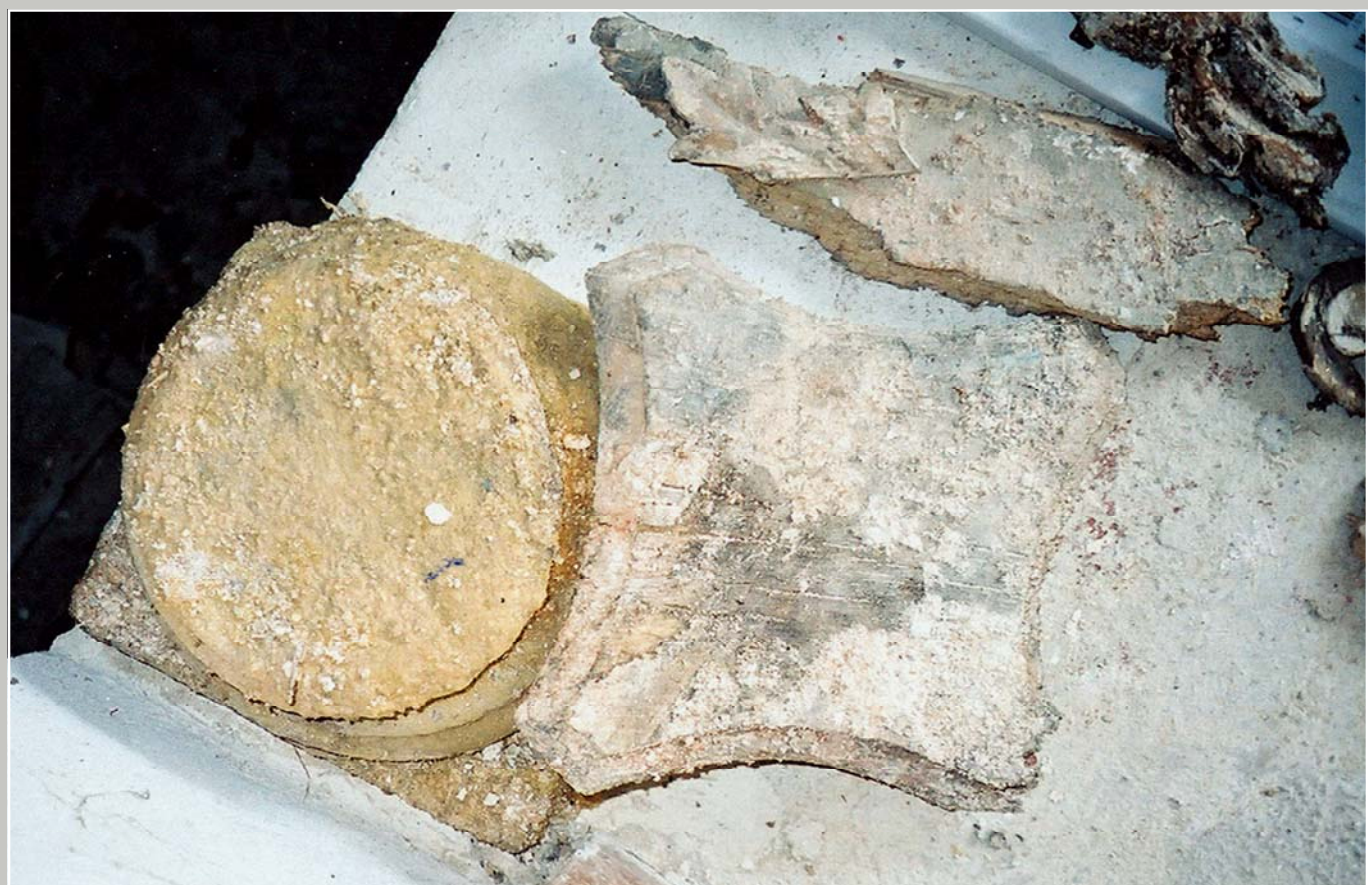
Baze stupova, kapiteli i fragmenti ornamentike oltara s naslagama plijesni  
Bases of columns, capitals and fragments of the altar's ornaments covered by mould and fungi

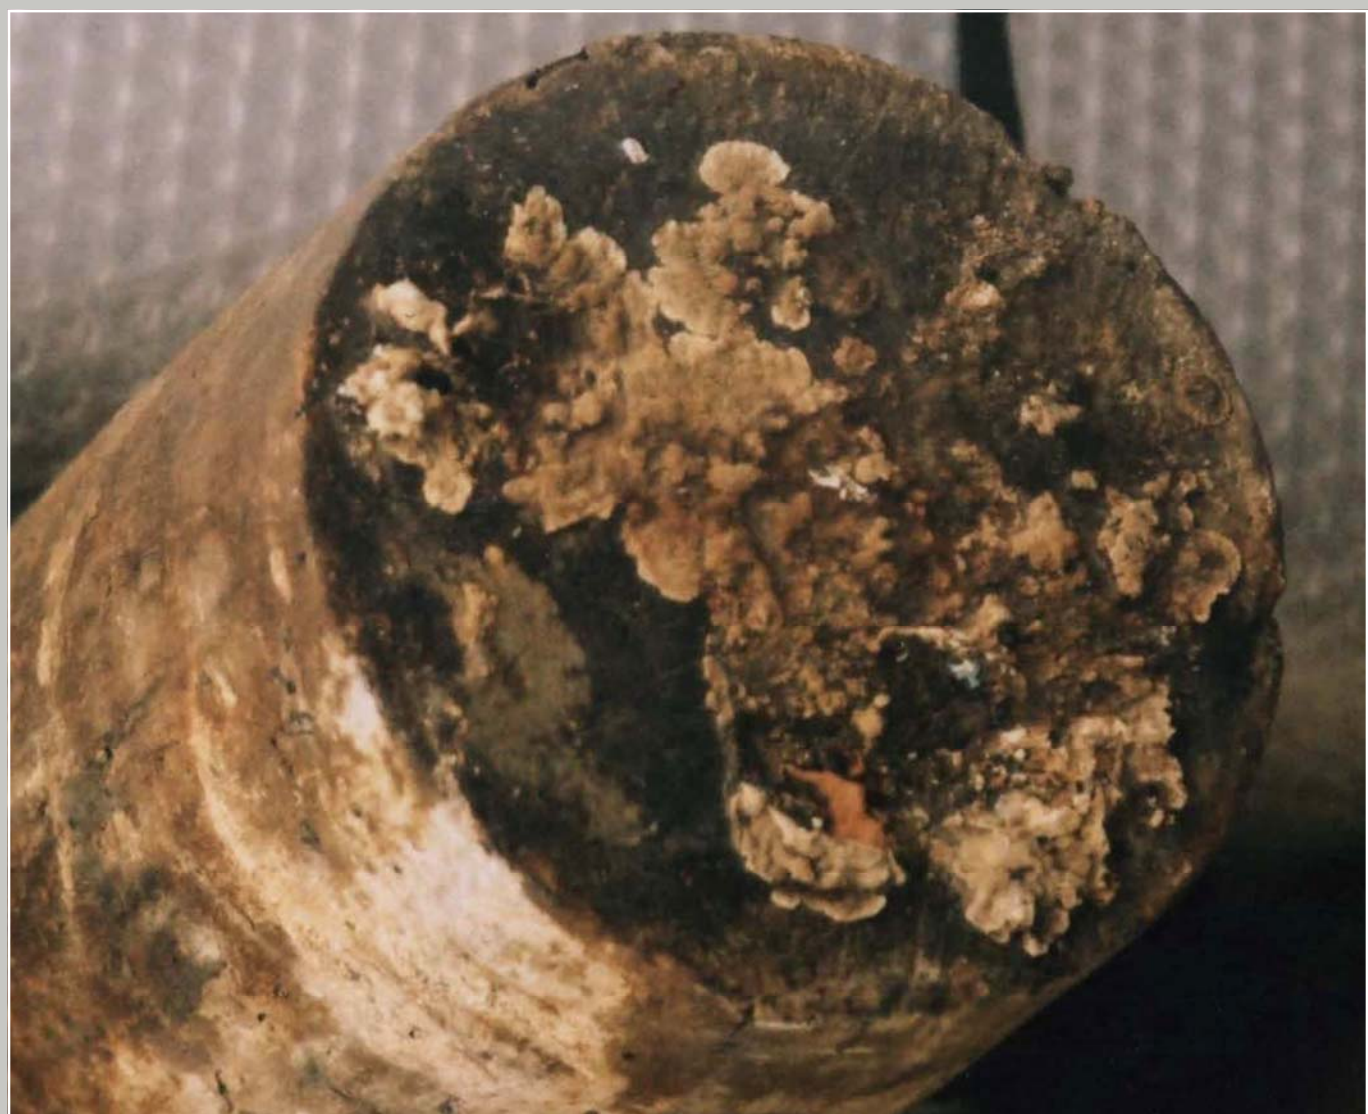
Plijesan i gljivice na dijelu stupa / Mould and fungi on the top of the column

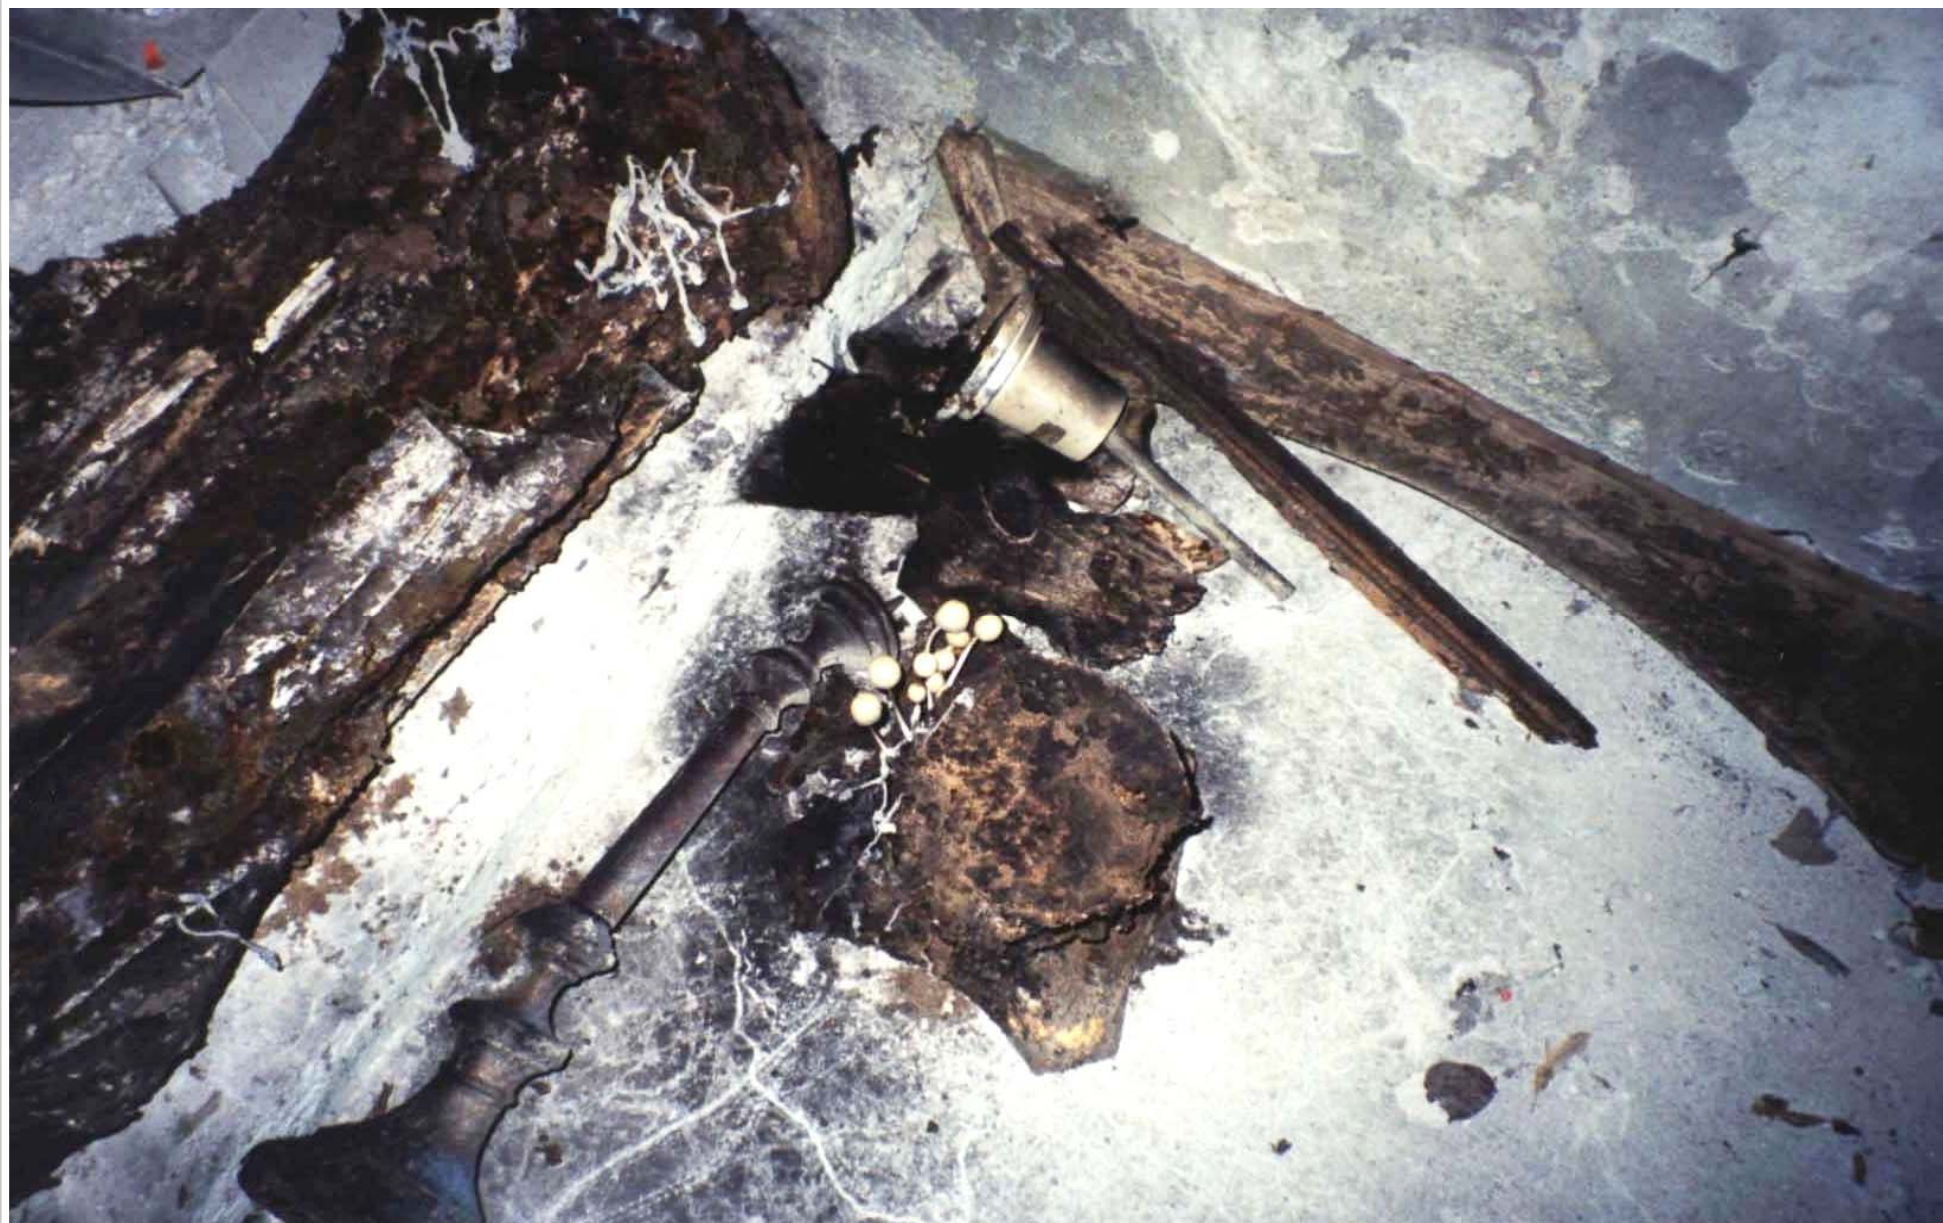
Dijelovi oltara, kapitel i kip nađeni u kripti, na kojima je došlo do jakog razvoja mikrobiološke destruktivne aktivnosti  
Parts of the altar, capitals and a statue which were found in the crypt and the severe microbiological activity on them

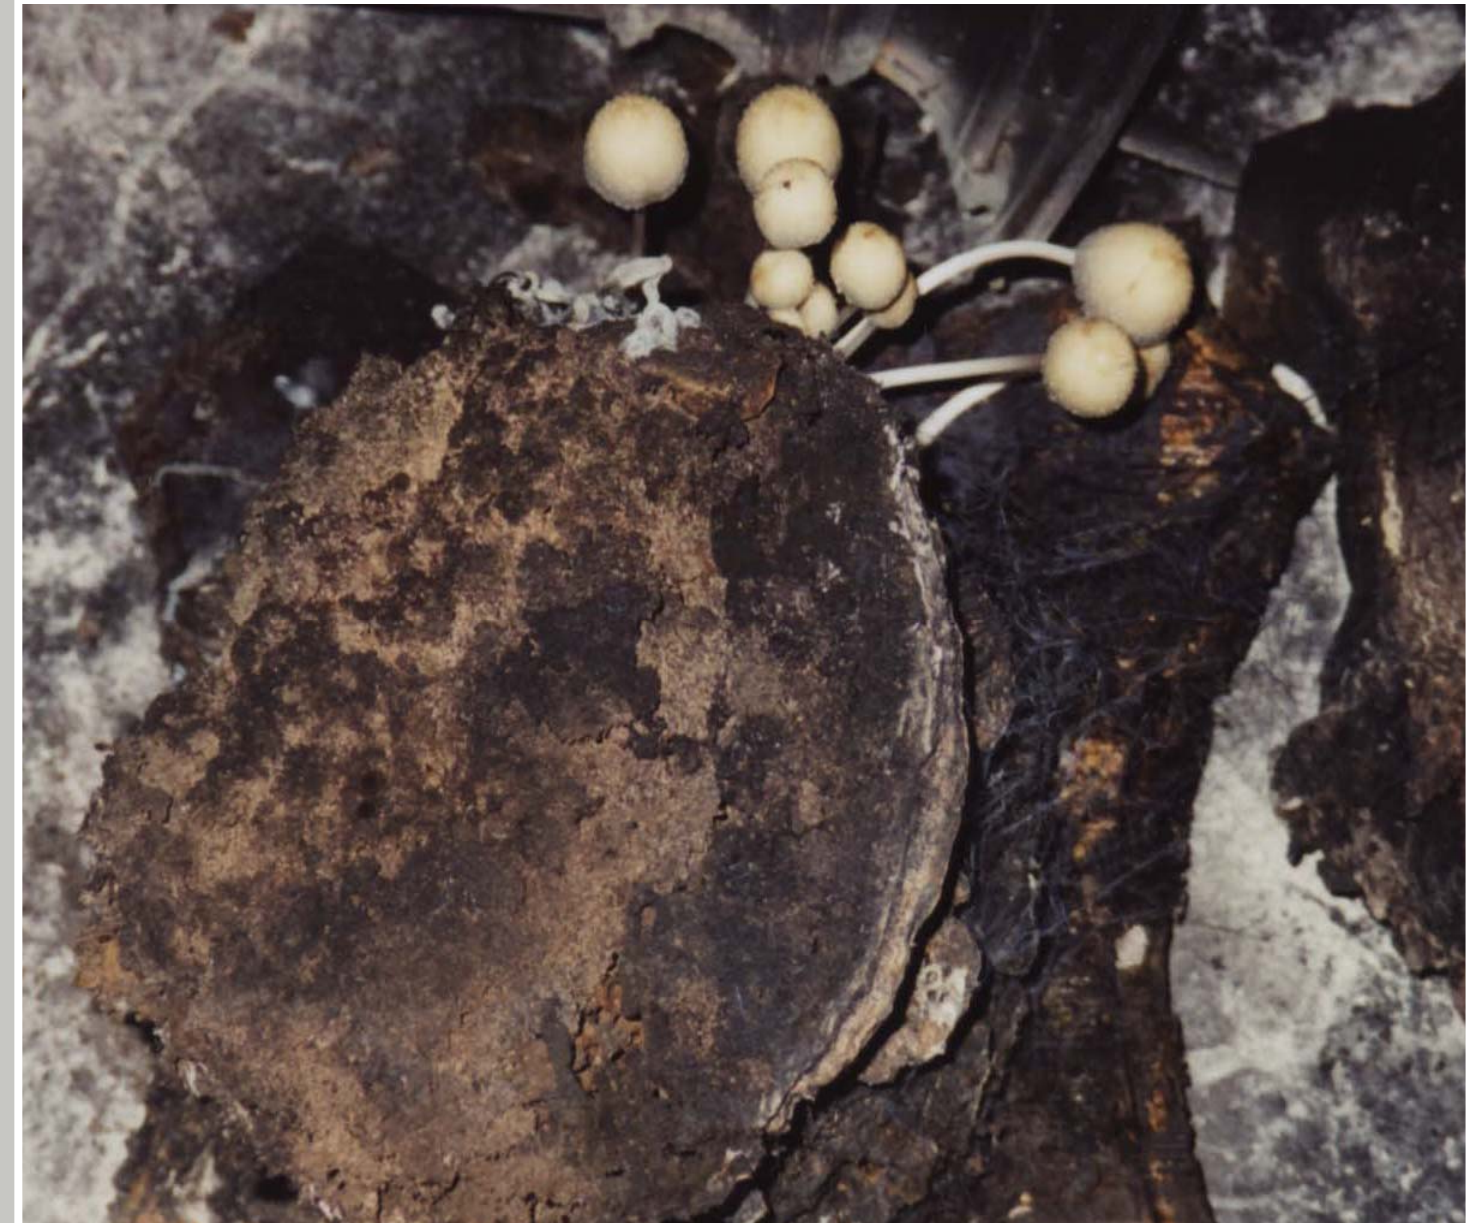
Detalji baze nađene u kripti  
Detail of the base of the column found in a crypt
