## ZATEČENO STANJE

## INITIAL CONDITION

HRVATSKI  
RESTAURATORSKI  
ZAVOD

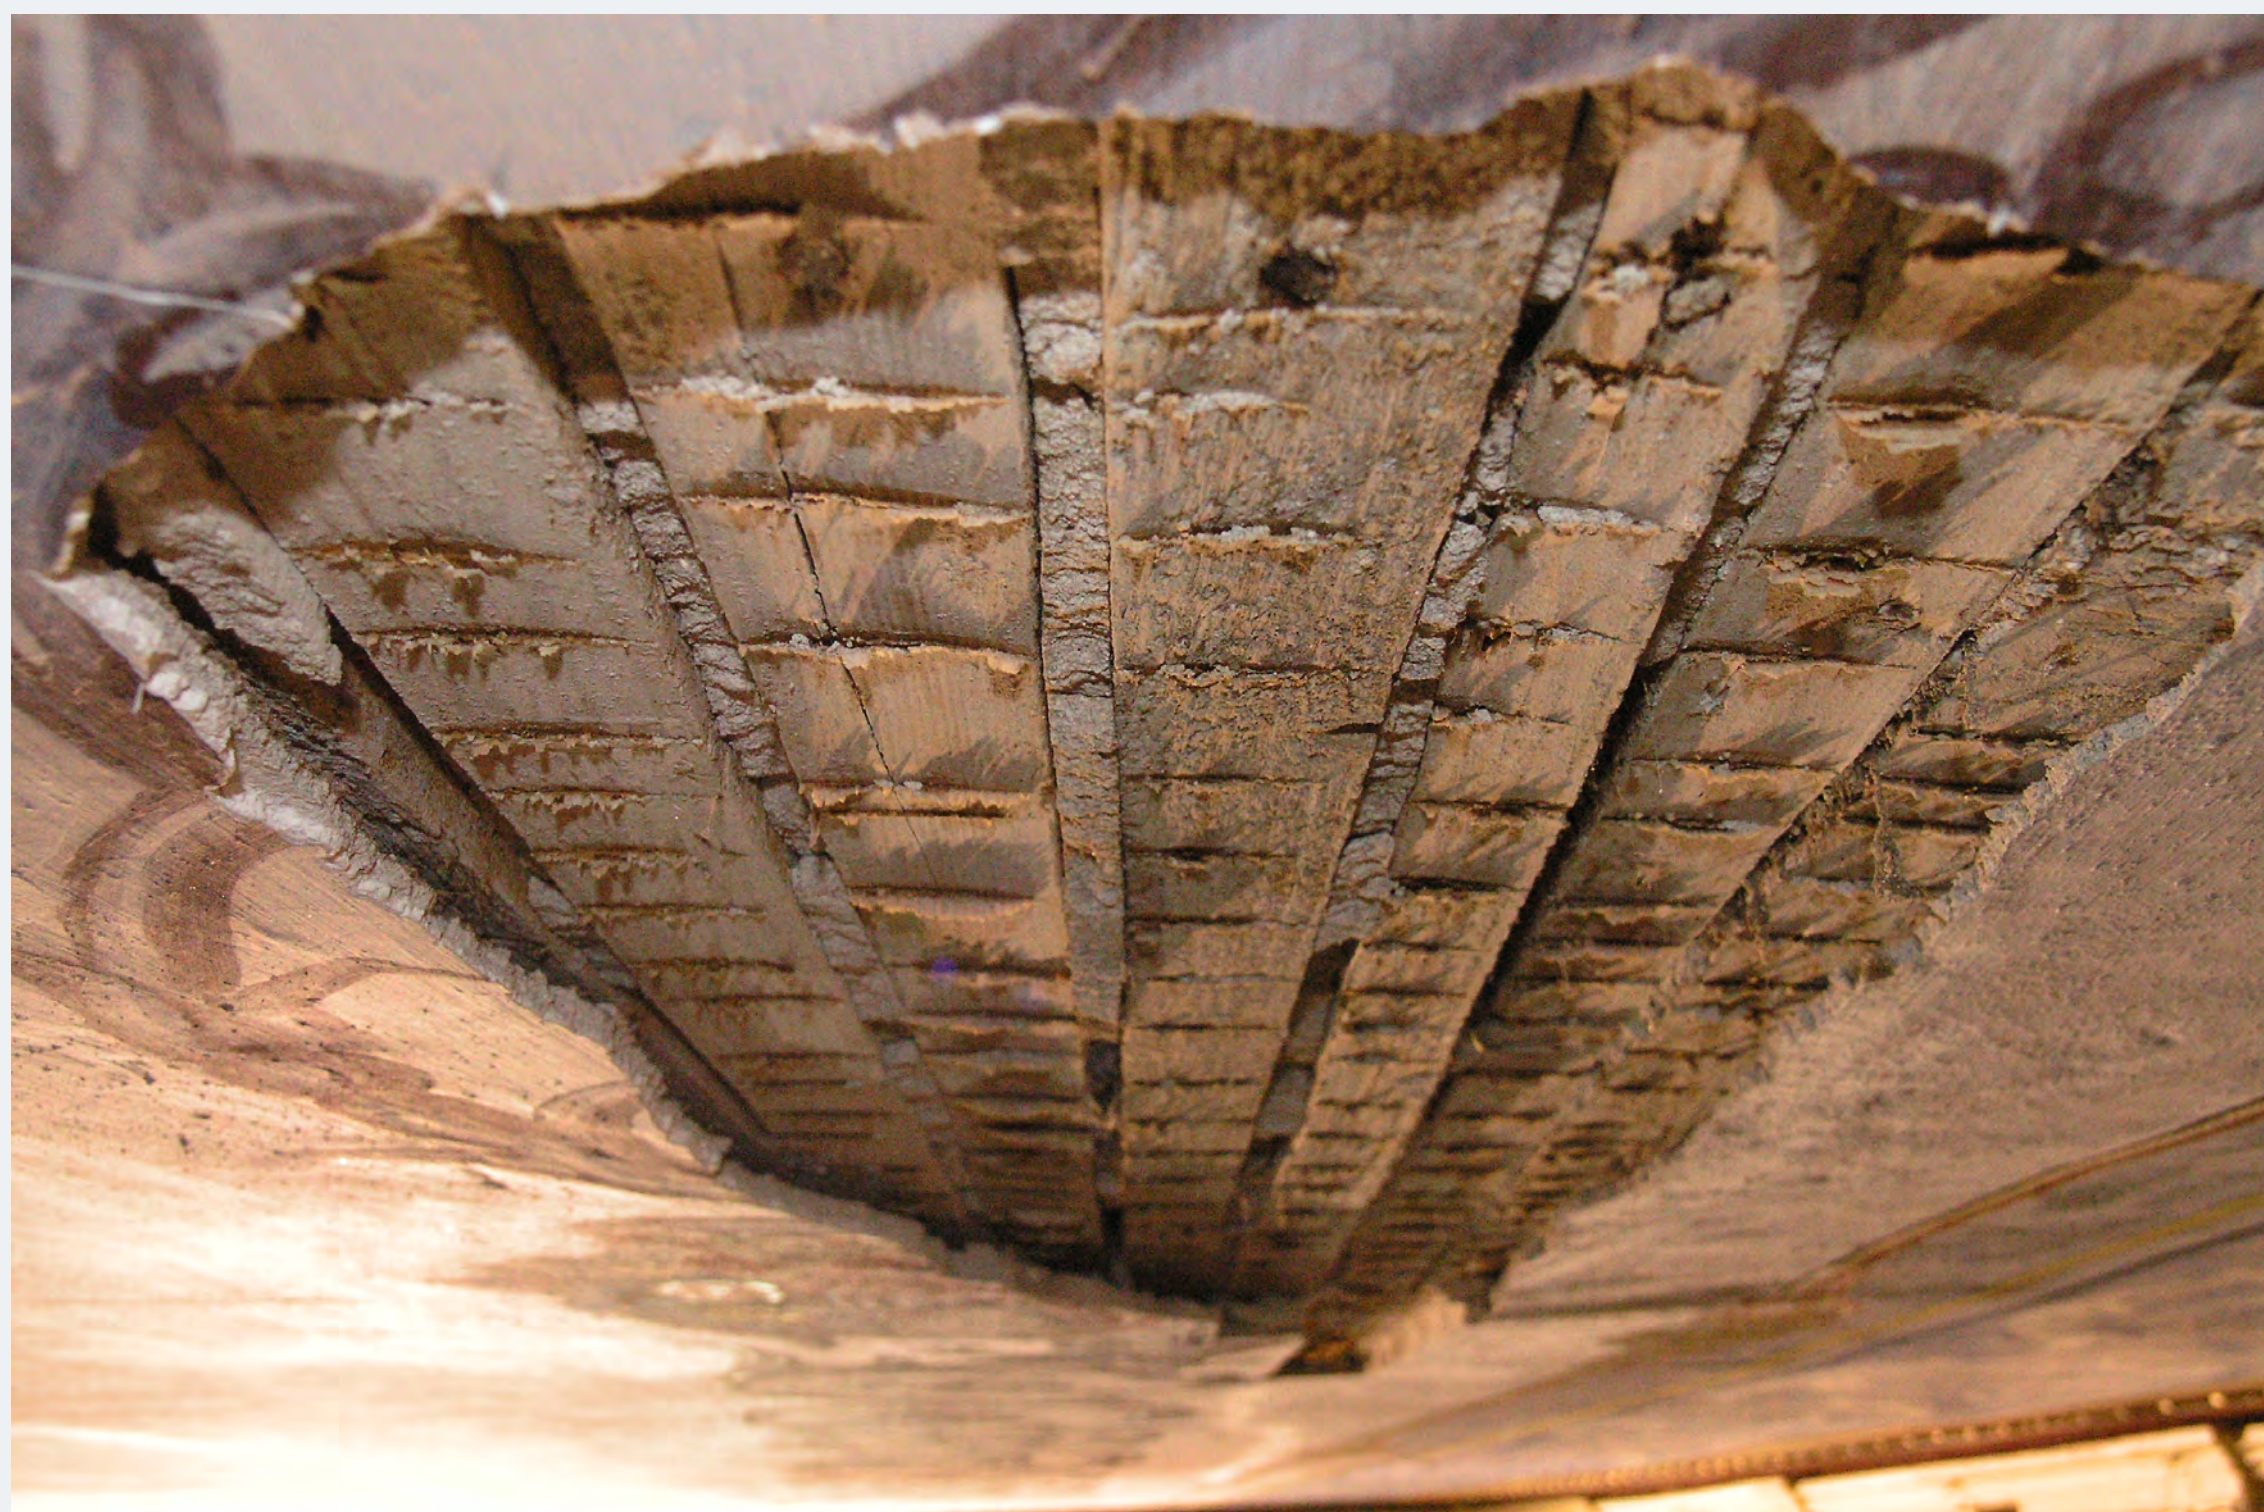
Zidna slika na stropu iznad gledališta hvarskog Kazališta izvedena je u tehnici tempera i rasprostire se na približno 70 četvornih metara. Nosilac slikanog sloja je vapnena žbuka nanescena u dva sloja, od kojih je podložni sloj utisnut među letvice drvene stropne konstrukcije koja je učvršćena za poprečne grede. Dugotrajno djelovanje statičkih i dinamičkih opterećenja uzrokovalo je brojna i raznovrsna oštećenja koja su zamijećena i zabilježena u početku radova 2007. godine. Najsloženiji restauratorski problem bila je nestabilnost stropa izazvana slabljenjem vezivnih spona žbuke i drvene stropne konstrukcije, što je uzrokovalo otpadanje 1,5 četvornih metara slikarije na sjevernom središnjem dijelu stropa. Zidna slika već je pretrpjela otpadanje dijela stropa na južnoj strani koji je obnovljen rekonstruktivnim zahvatom. Vjerojatno je, u istom vremenu, prebojen i središnji podložni svijetloplavi ton kao i rubne dekorativne trake. Dugotrajno djelovanje mehaničkih sila i prirodno „starenje“ materijala uzrokovalo je brojne pukotine i naprsnuća žbuke te denivelaciju (poremećaj razine) stropne površine, što je izazvalo nepoželjne promjene slikanog sloja.

The painting on the ceiling above the audience of the Hvar Theatre is executed in tempera, and it covers a surface of approximately 70 square metres. The painted layer is applied against a ground consisting of lime plaster applied in two coats, with the bottom coat pressed in between the lattices of the wooden ceiling construction, fixed to cross-beams. The many years of static and dynamic pressure have caused extensive and varied damage, which was noticed and recorded at the beginning of the work in 2007. The most demanding problem, from the point of view of conservation, was the instability of the ceiling, caused by the weakened binding between the plaster and the wooden ceiling construction, which resulted in the falling-away of 1.5 square metres of the painting on the northern side of the central part of the painting. A piece of the wall painting had also fallen off earlier and been reconstructed in the meantime. The light blue colour of the background in the central part and the decorative ribbons along the edges were probably applied on that occasion.

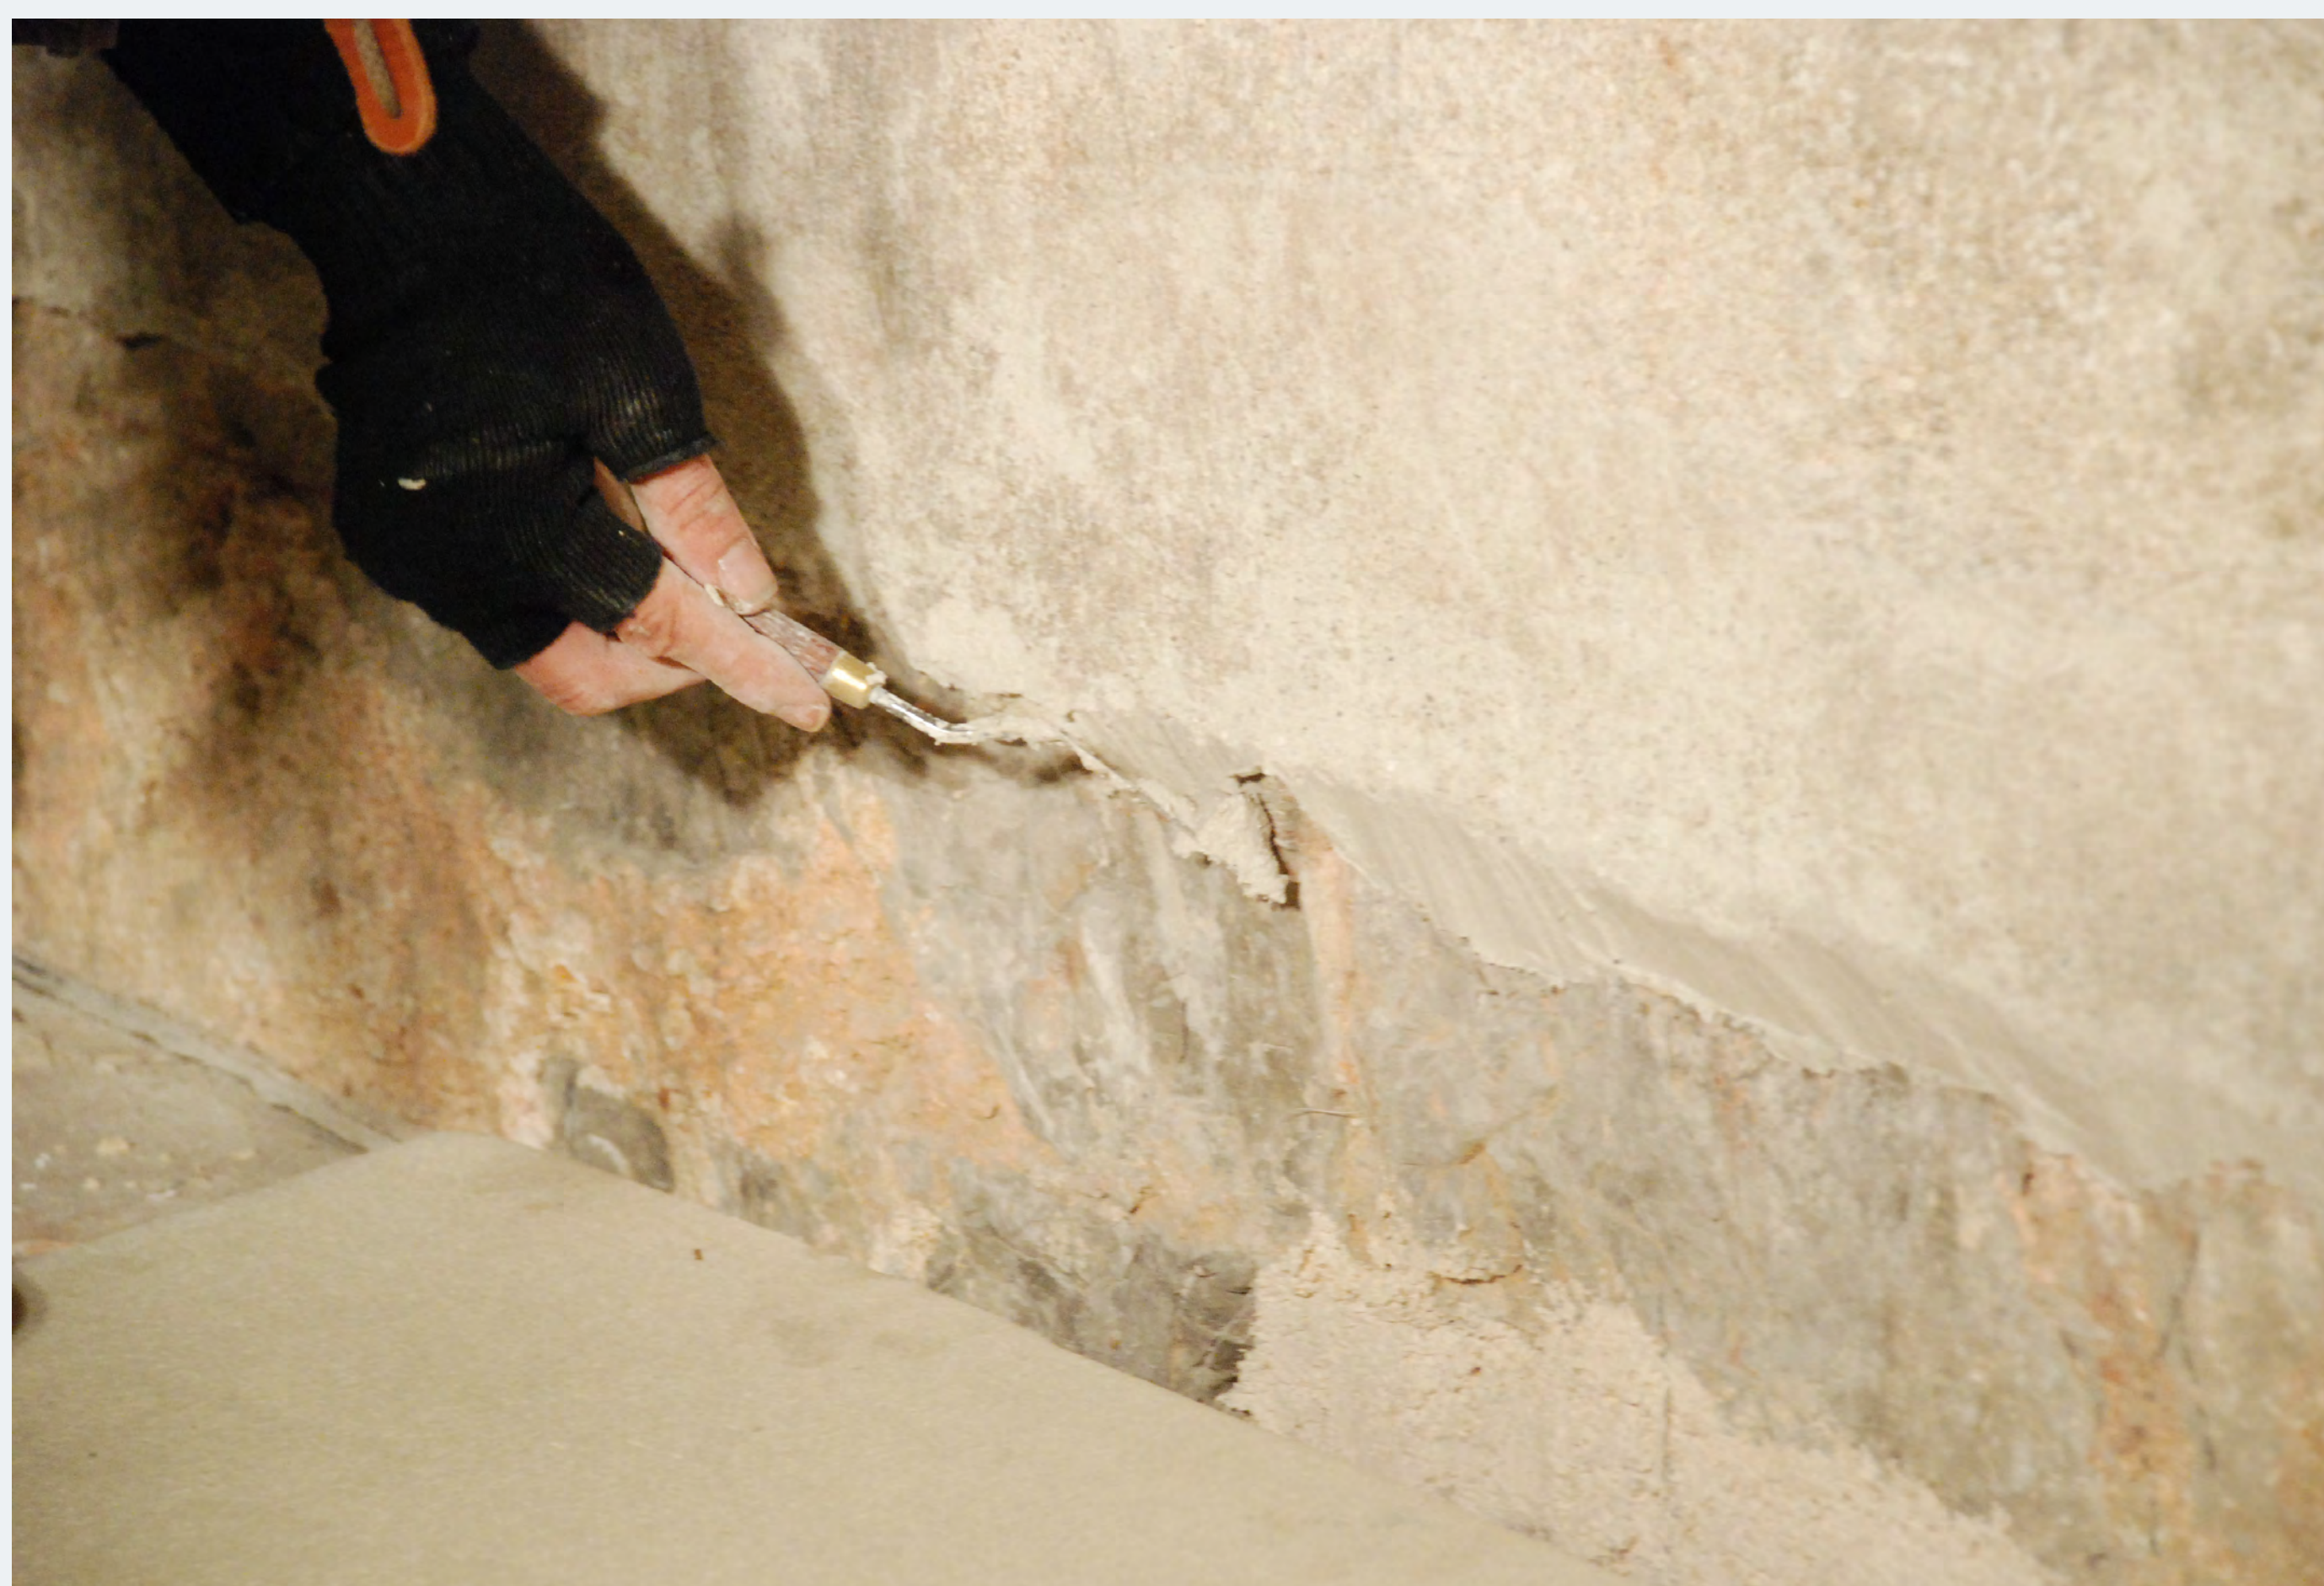
## INITIAL CONDITION 2010

It was noticed that in some places the original plaster had lost its adhesion and cohesion, which was a result of the action of salts that had remained in the walls. However, the building was structurally rehabilitated, and during our work no moisture was observed which could restart the salt migration, so our conclusion is that further damage of this kind had been reduced to a minimum.

In line with prior testing, the facing was removed using acetone – a solvent which reduced the strength of the glue and thus allowed the reinforcing material to be removed easily from the face of the painting. Due to its high volatility, acetone called for quick work, while at the same time the separation of the facing had to be done extremely carefully in order not to cause spontaneous detachment of the painted layer from its plaster ground. In parallel with the removal of the facing, the face of the painting was additionally cleaned with mechanical and chemical methods. The remaining dirt, glue and facing material were removed using special detergents and solvents.

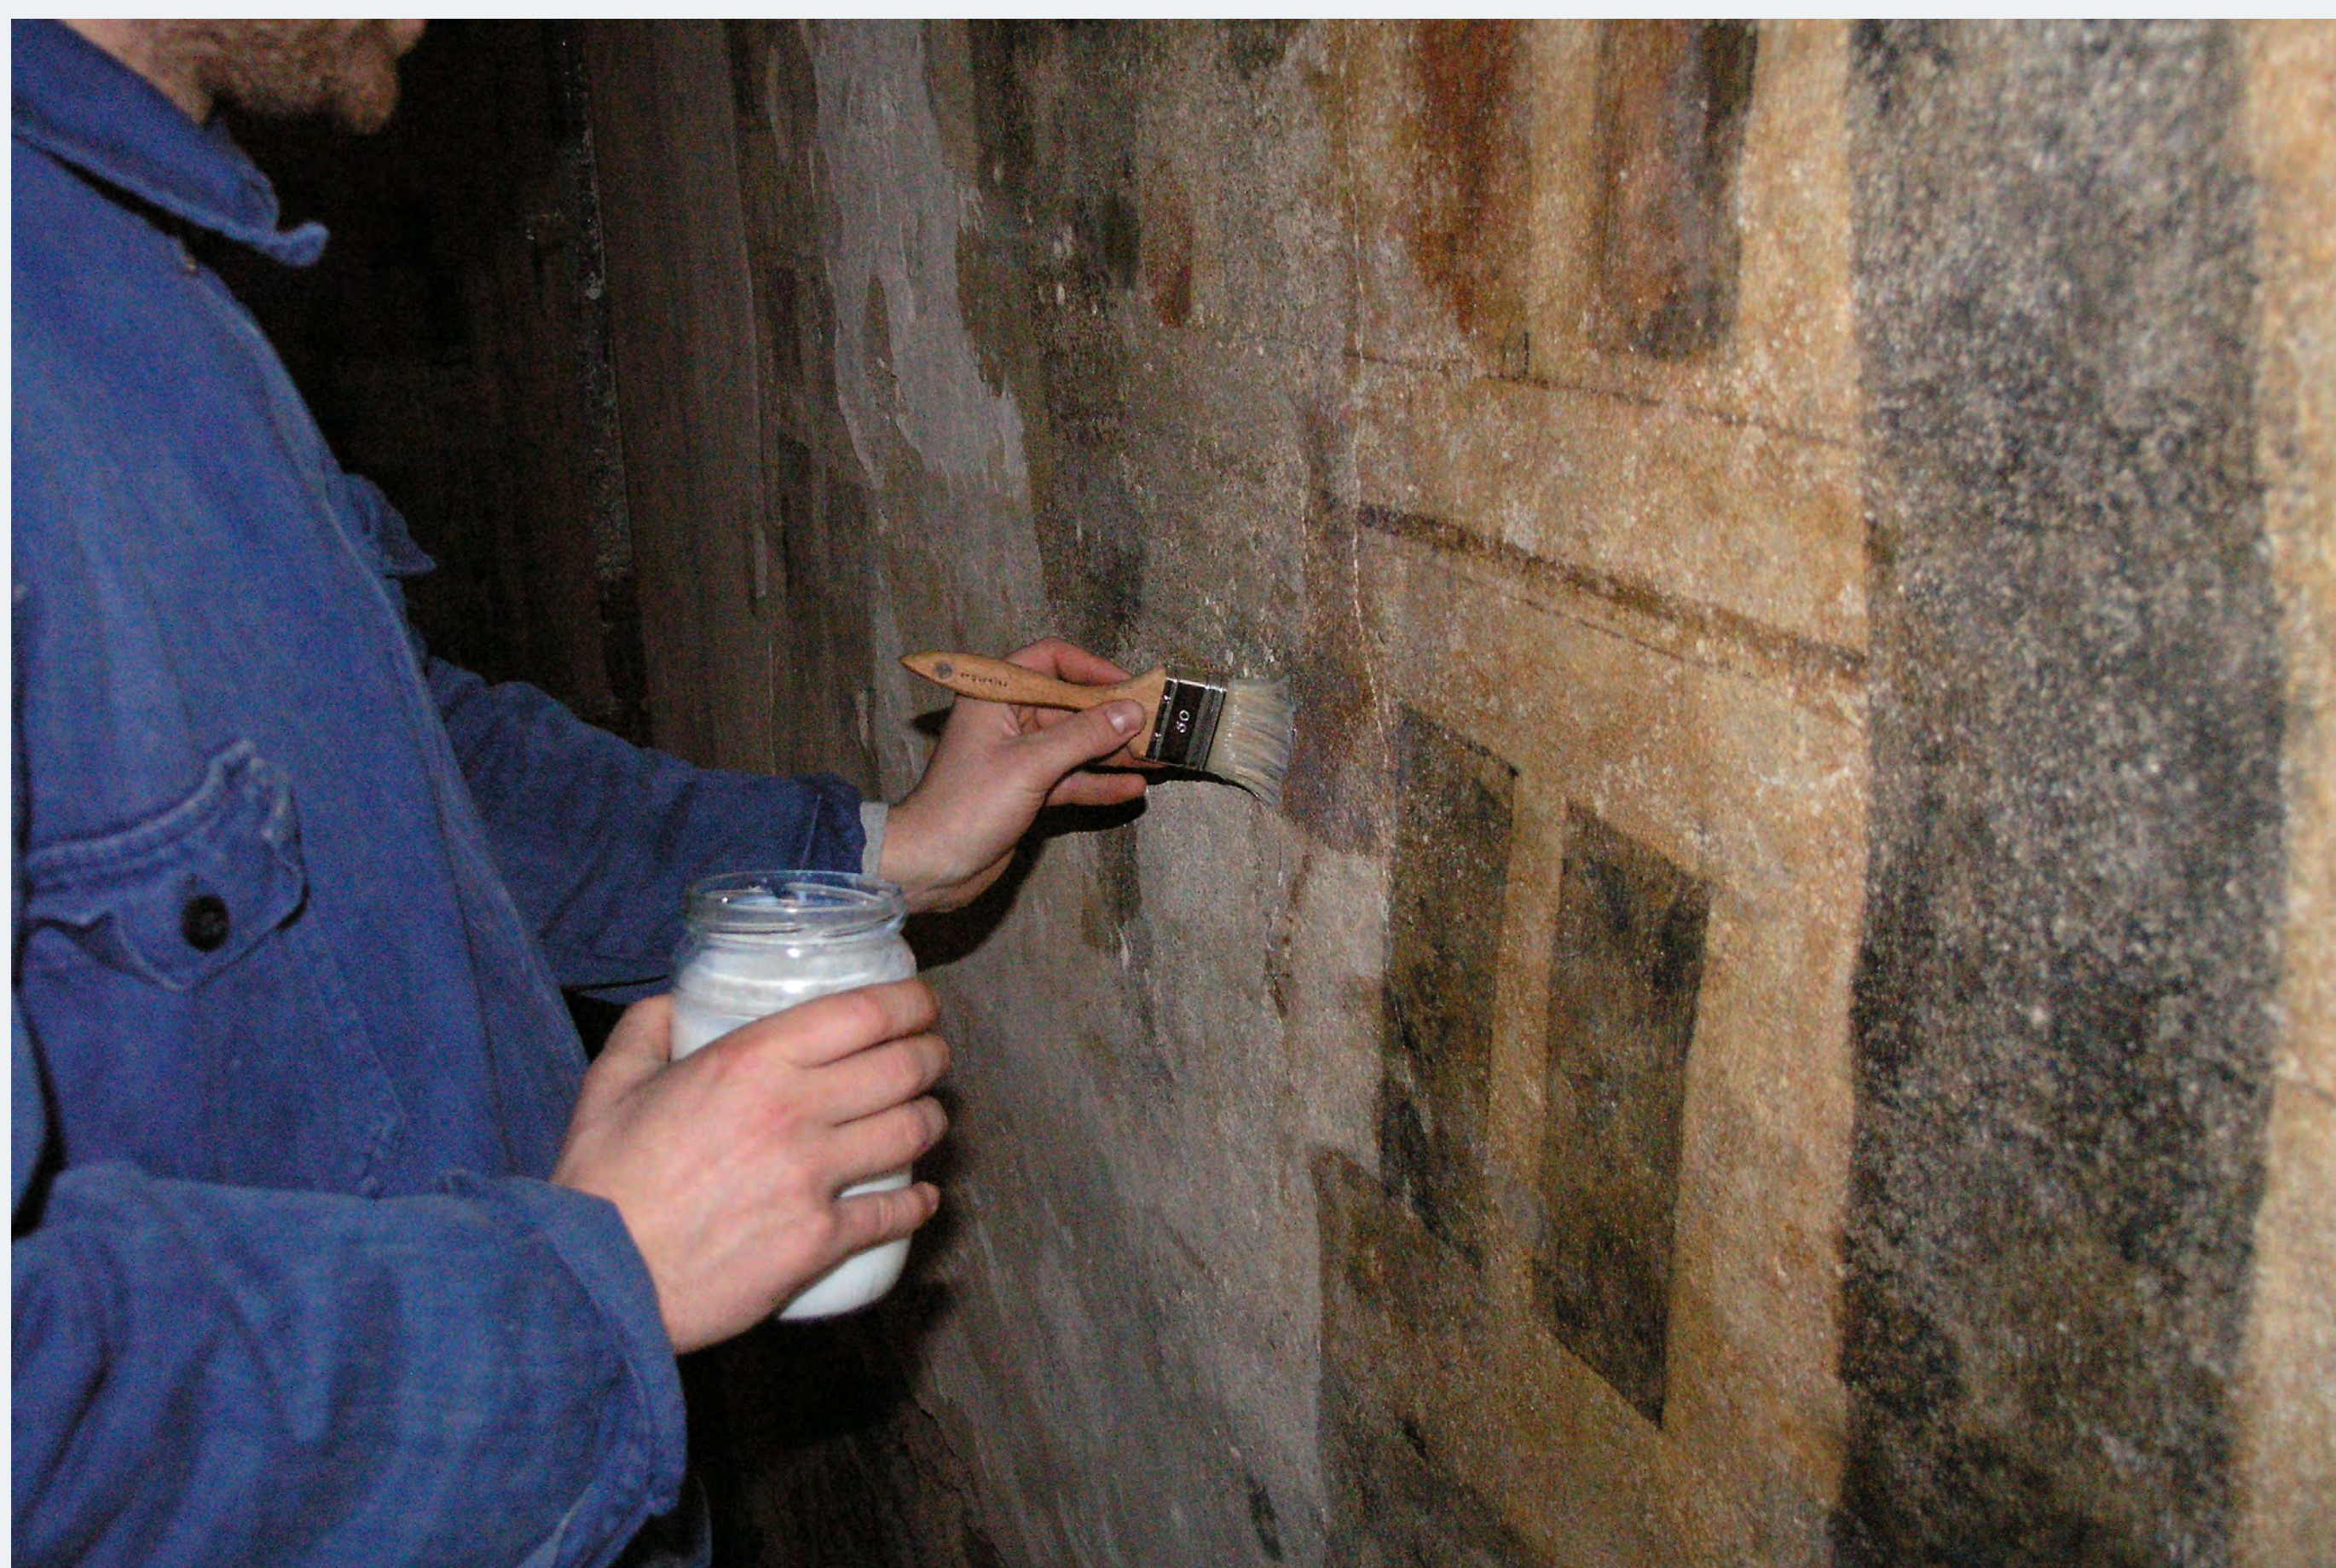
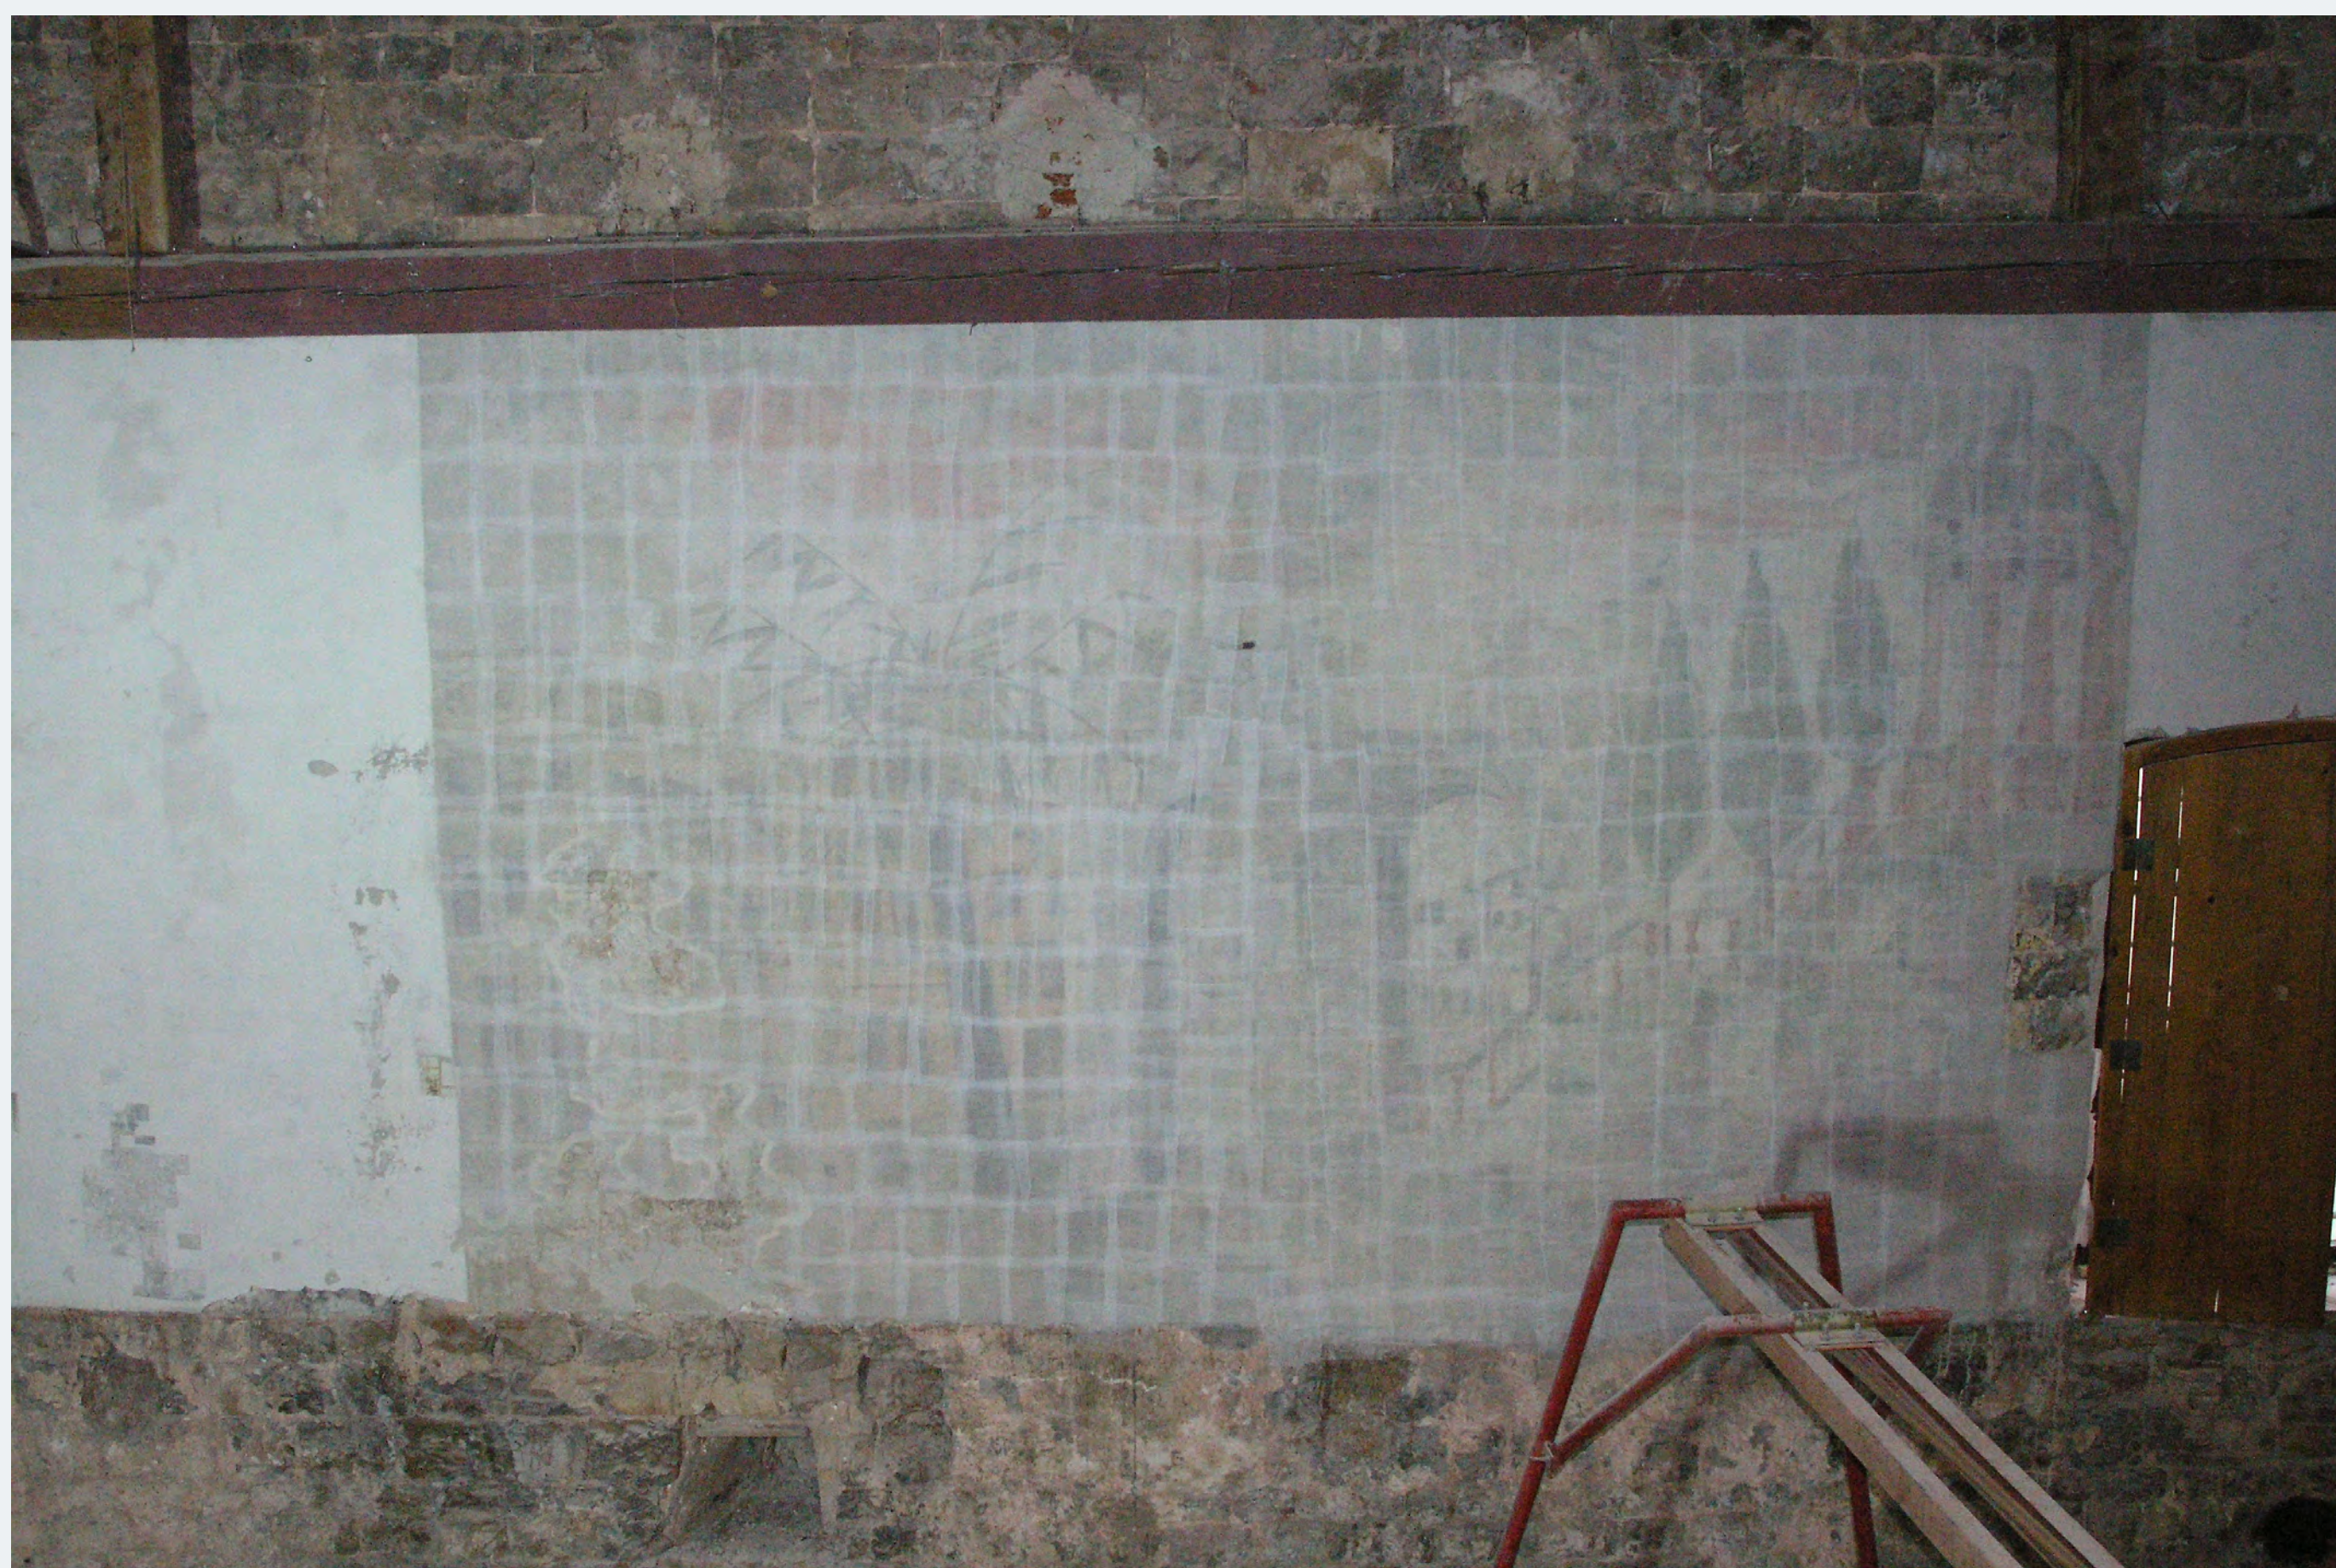
INITIAL CONDITION  
2007

Pulverizacija slikanog sloja, potklobučenja, pukotine, naprsnuća, brojne lakune te potreba za građevinskom sanacijom cijelog Kazališta zahtijevali su daljnje zaštitne zahvate.

The wall painting on the eastern wall of the Hvar theatre, which functions as a stage decoration, covers approximately 15 square metres. It is painted in a thin layer which, only in certain places, along the wall joints, reaches a thickness of 15 mm. The damage noticed, in the form of pulverization of the painted layer and numerous air pockets, resulted from loss of adhesion and cohesion within the materials, caused by the action of readily soluble salts which migrated to the materials, assisted by moisture. The most extensive penetration of moisture through the eastern wall of the theatre occurred at the location of the walled-in northern window. In the 1989 conservation and restoration intervention, the damage was repaired, additional plaster applied, and the surface retouched, but the intensive moisture caused new damage. Further protective treatment was necessitated by pulverization of the painted layer, air pockets, cracks, fractures, numerous lacunae and the need for the structural rehabilitation of the entire theatre.

The large plaster patches made during earlier interventions (in 1989) were mechanically removed from the lower northern part of the painting. The painting's structure had been weakened by moisture, causing dropping and flaking. In the damaged segments, the painting's edges were strengthened by the application of appropriate plaster. Due to the fact that a substantial number of air pockets were detected by sound, a binding substance was injected in an attempt to restore the plaster's compactness and stability. Existing locations of damage were used as points of injection, thus preventing any additional damage. These procedures led to consolidation of the plaster and repair of damage to it, thus preventing its further deterioration, and protecting it from possible damage caused by the structural rehabilitation of the theatre.
