## ZATEČENO STANJE

## INITIAL CONDITION

HRVATSKI  
RESTAURATORSKI  
ZAVOD

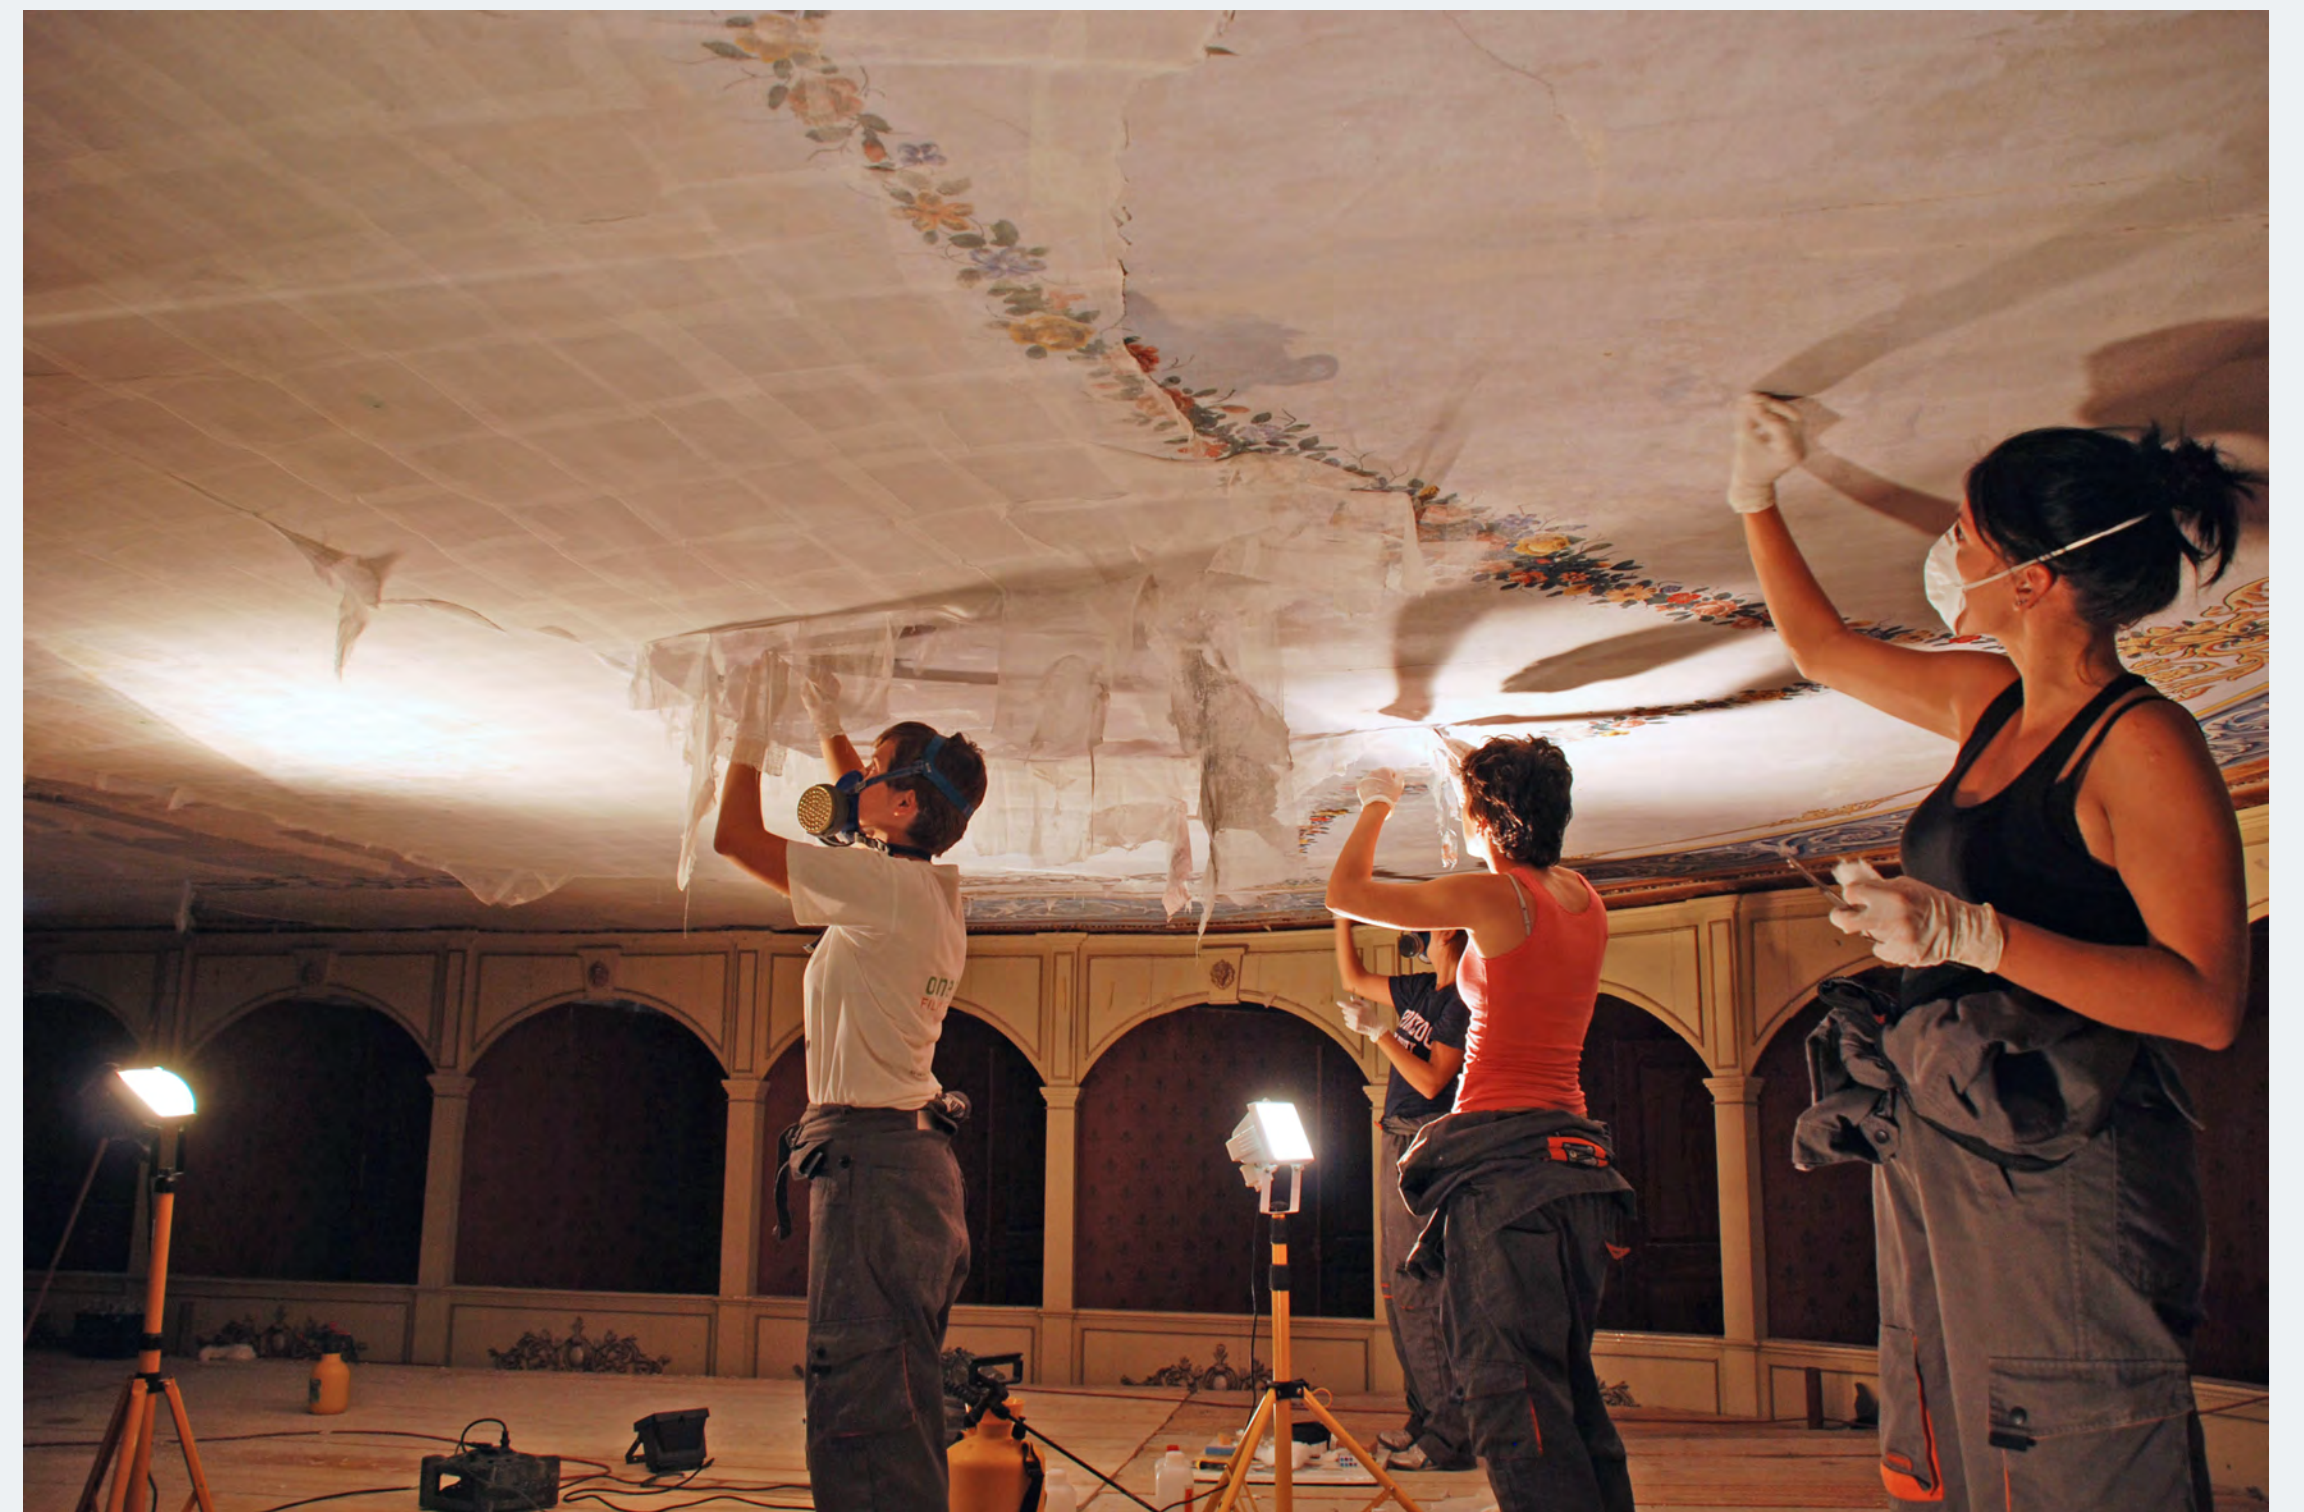
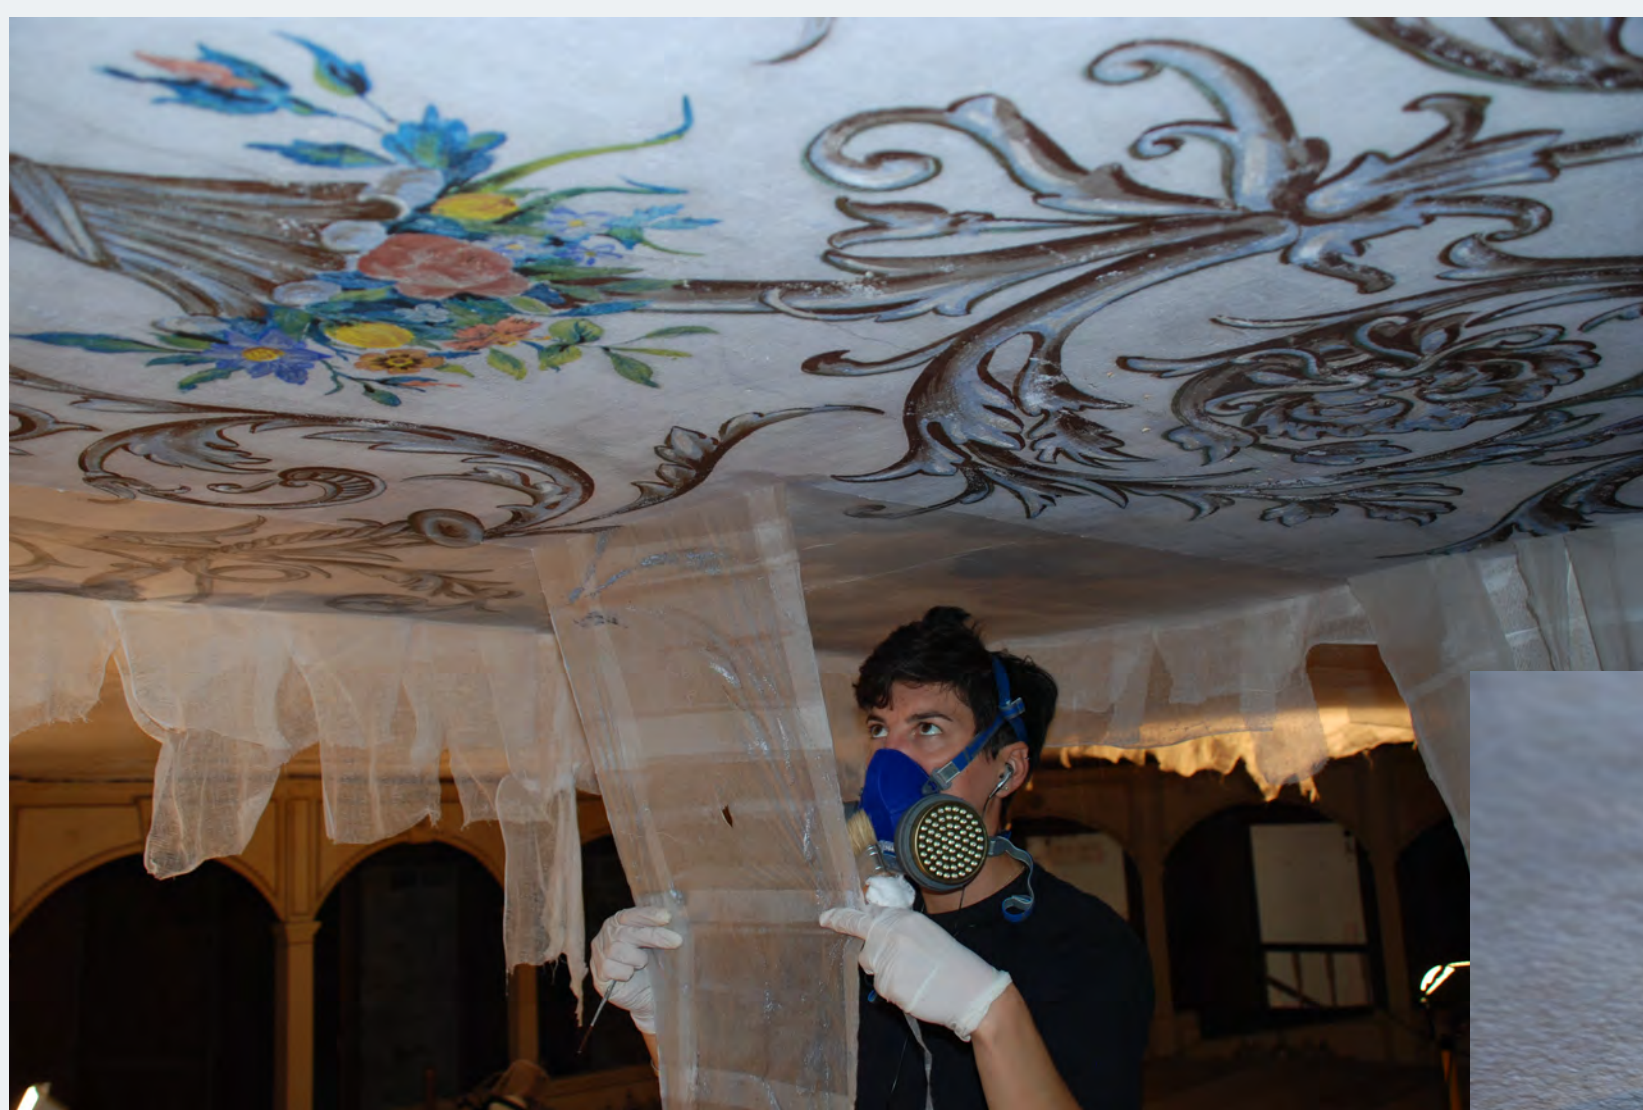
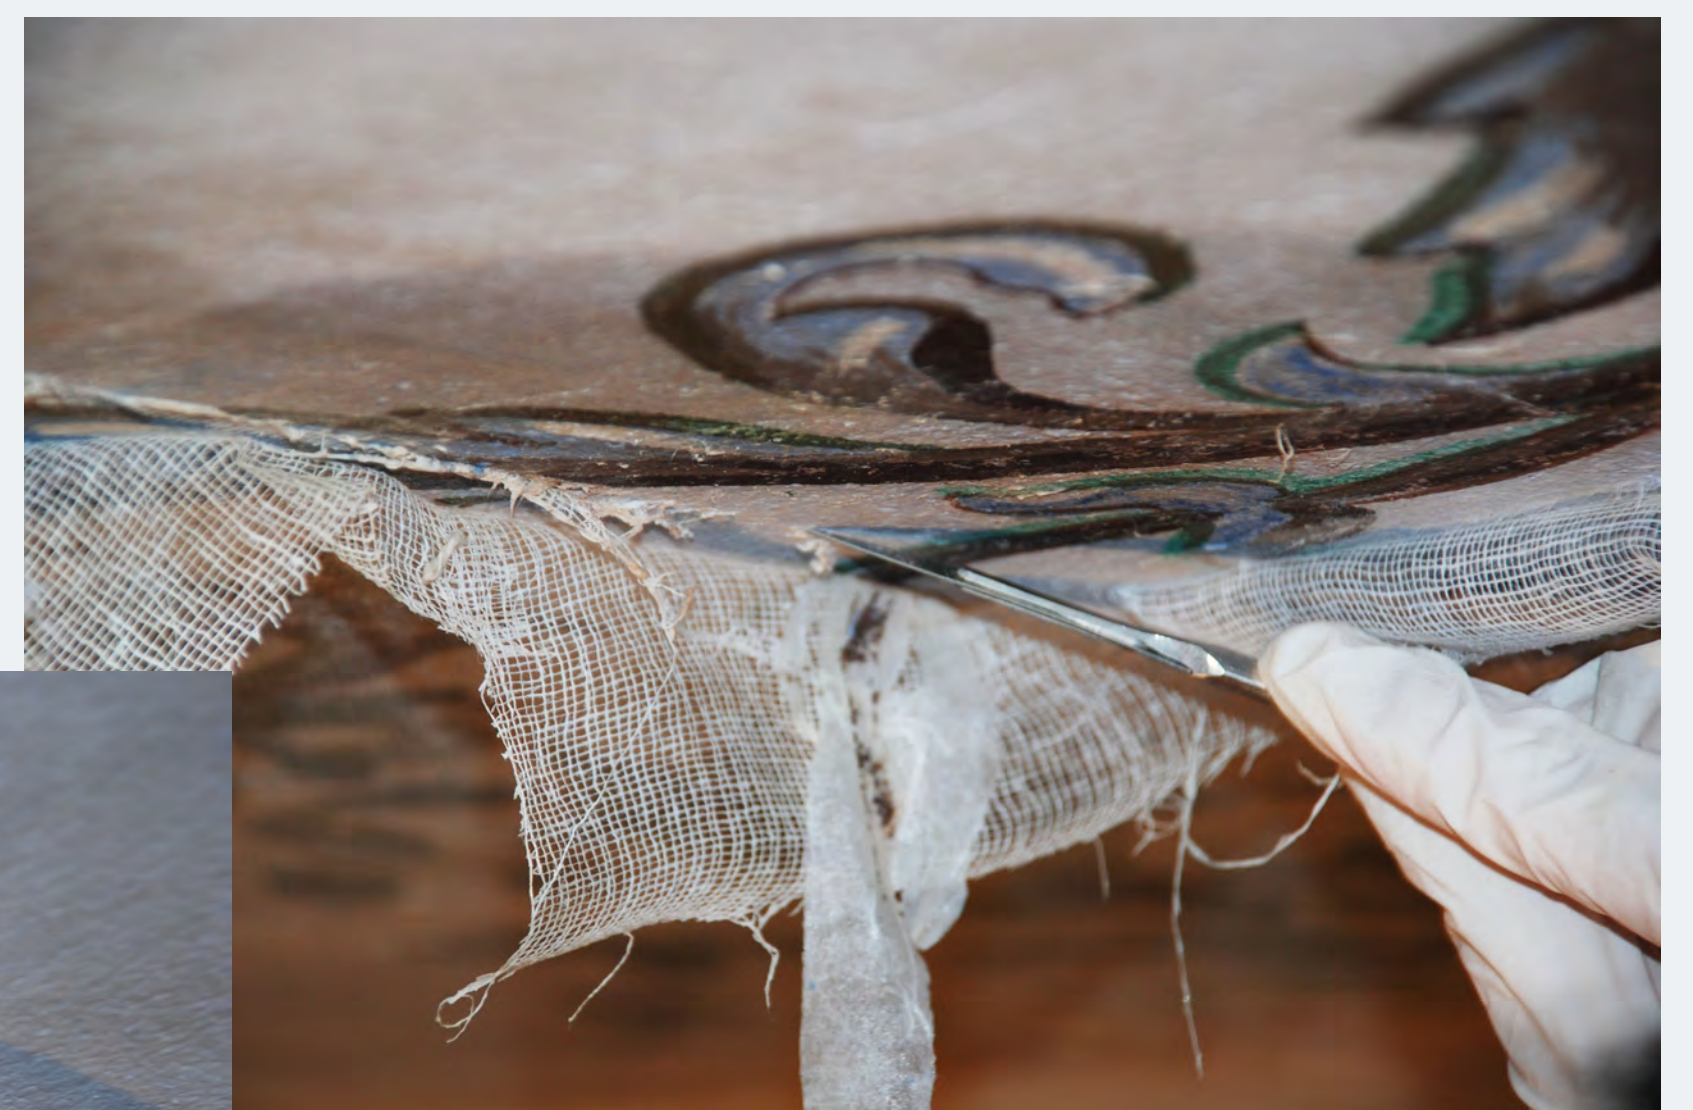
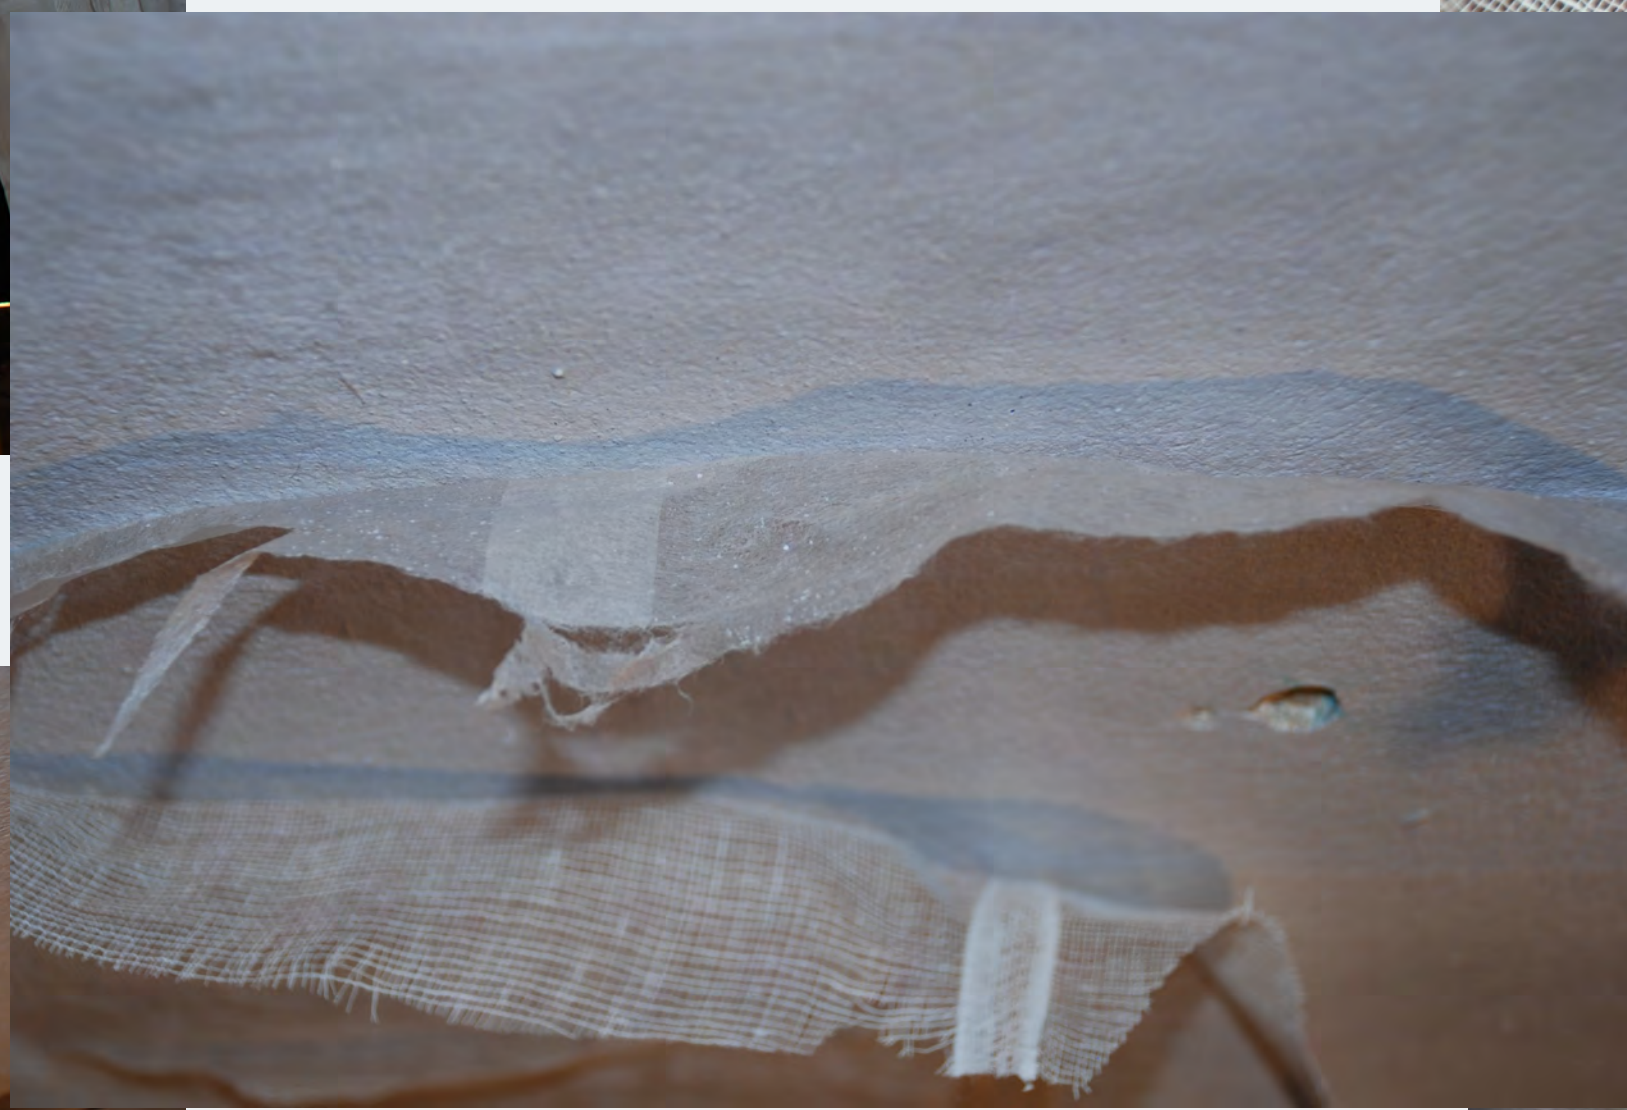
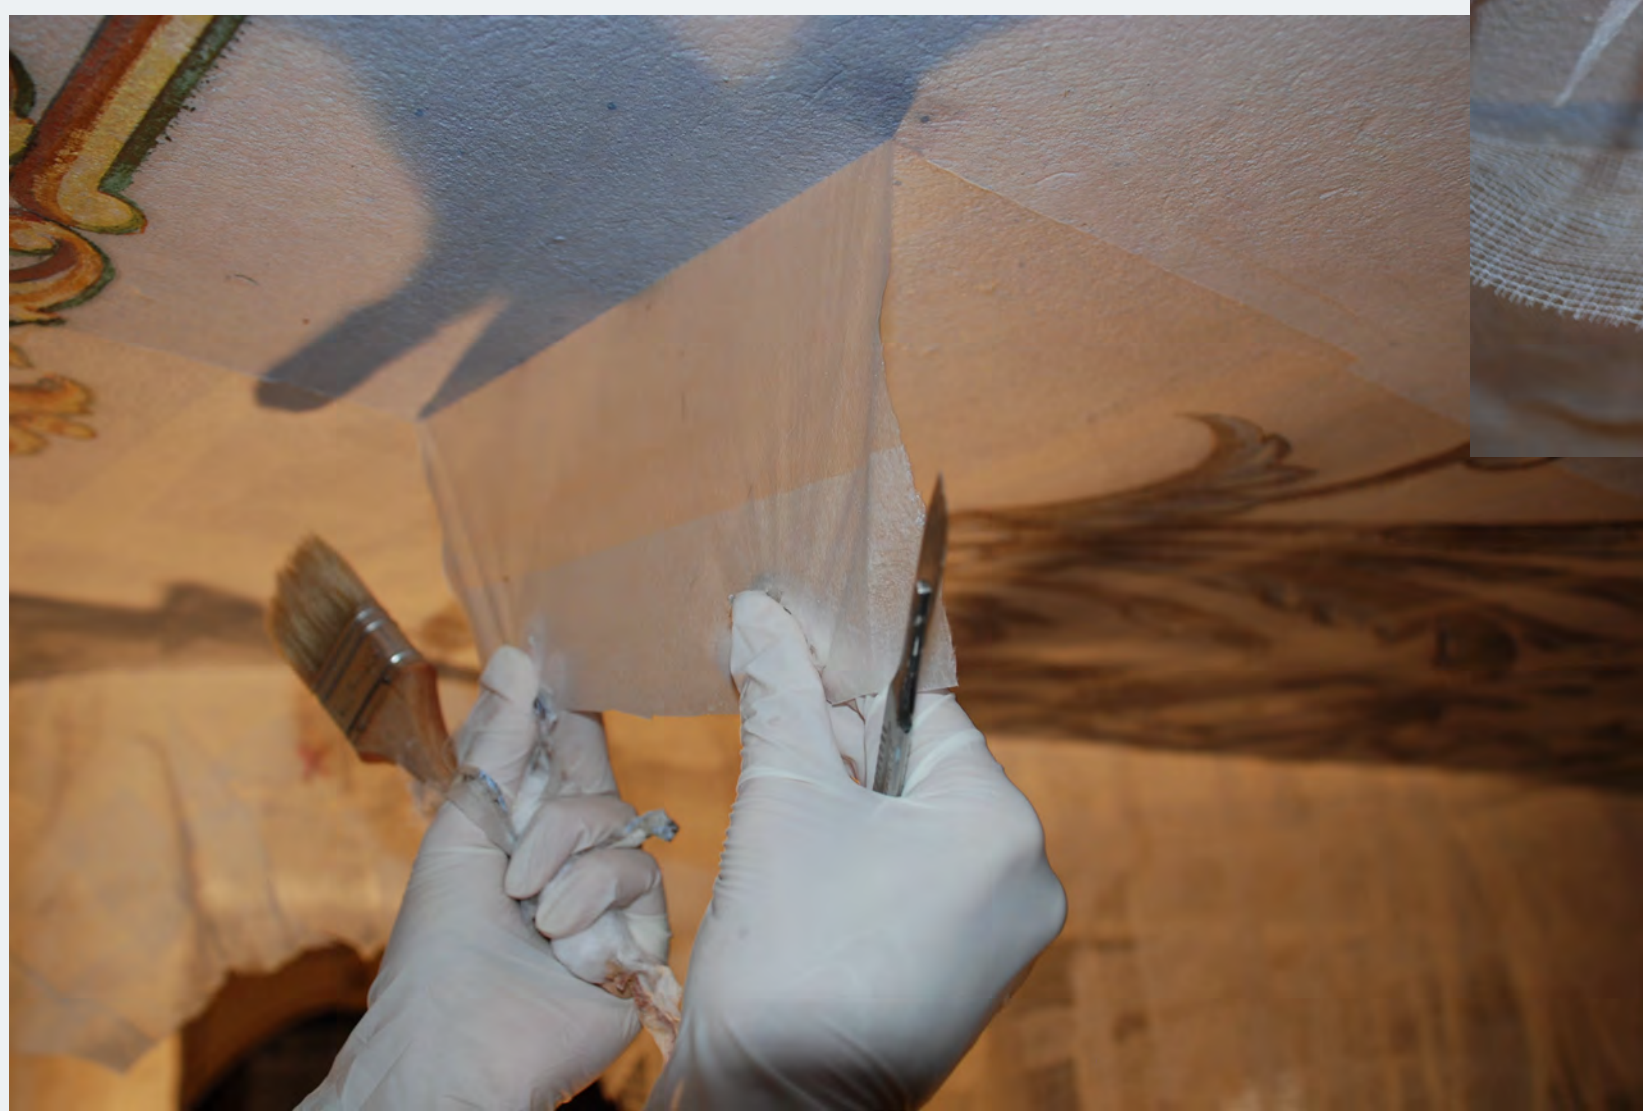
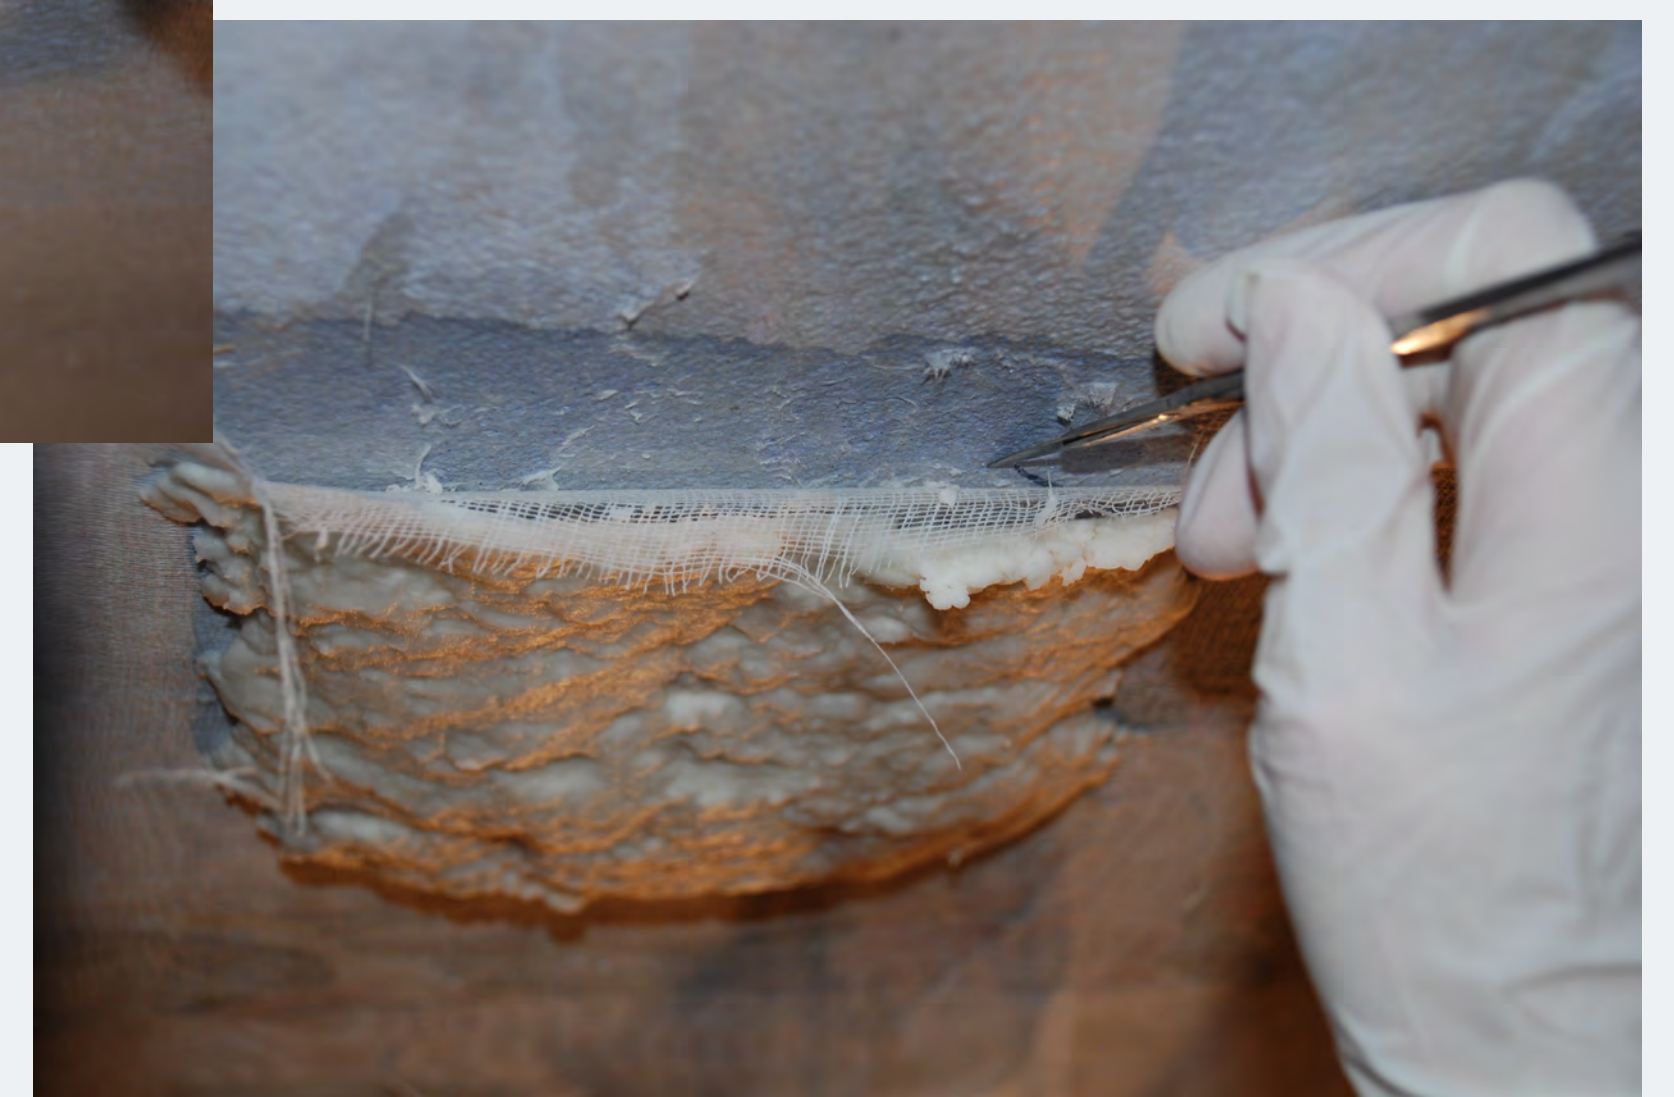
Razdoblje privremene zaštite hvarskih slikarija bilo je dulje od preporučenog, što je uzrokovalo otežano rastvaranje ljepila zaštitnog sloja. Materijali armaturnog sloja uklonjeni su postupnim pojedinačnim odvajanjem slojeva te su se usporedno sa slikane površine uklonili ostaci ljepila i neutralizirala zaštitna opna koja je u prethodnoj fazi zahvata postavljena radi izoliranja intonacca prije postavljanja privremenog zaštitnog sloja.

The period of time that the Hvar paintings had spent under the facing was longer than recommended, causing difficulty in dissolving the glue in the protective layer. The reinforcing layer was removed by gradual separation of individual layers, and at the same time, remains of the glue were removed from the painted surface, and the protective film – placed during an earlier phase of the intervention to isolate the intonacco prior to the placing of the temporary protective layer – was also neutralized.

Uklanjanje privremenog zaštitnog sloja s lica slikarije ponajprije podrazumijeva otapanje ljepila kako bi se armaturni materijal mogao jednostavno ukloniti. Djelovanjem otapala, ljepilo zaštitnog sloja će popustiti te se zaštitni sloj s lica umjetnine uklanja laganim povlačenjem.

The removal of the facing from a painting consists primarily of dissolving the glue, so that the reinforcing material can easily be removed. The solvent weakens the adhesive capacity of the glue in the facing, and the facing can be removed by gentle pulling.

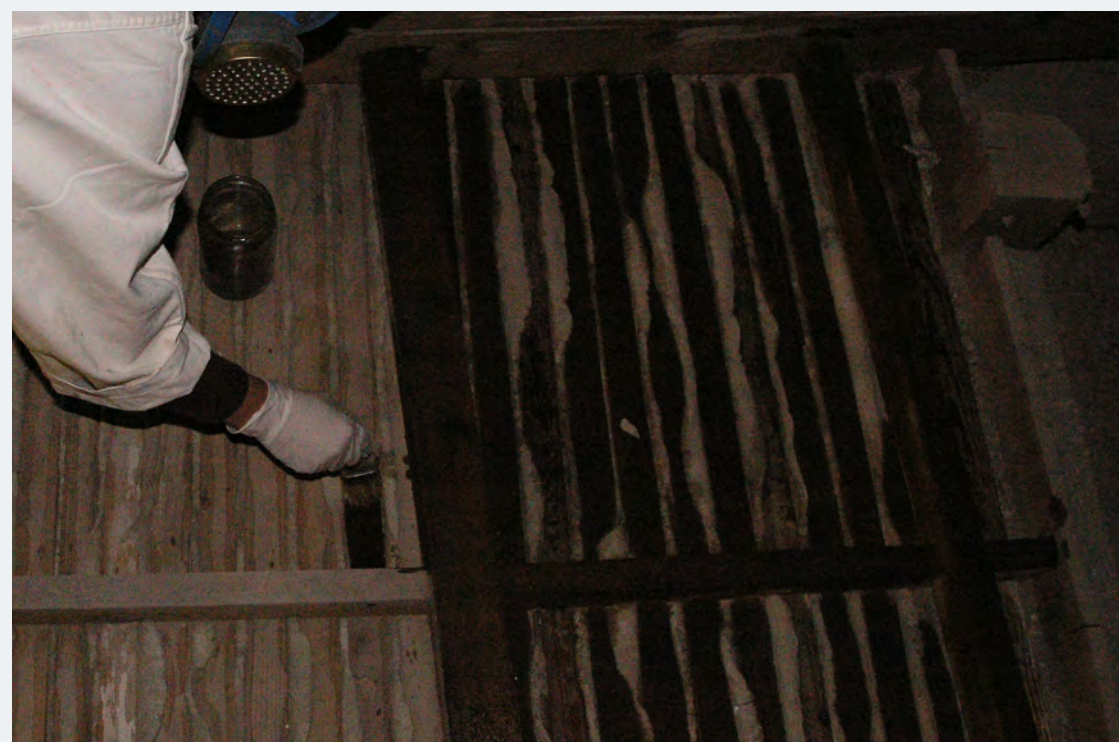
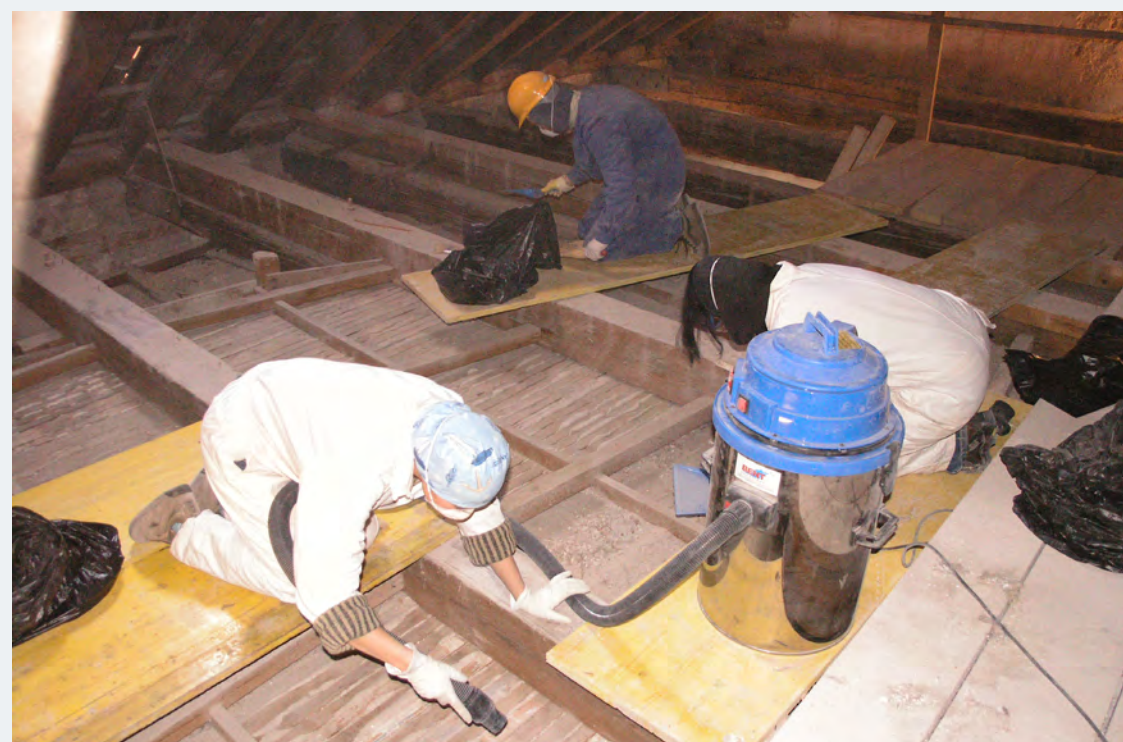
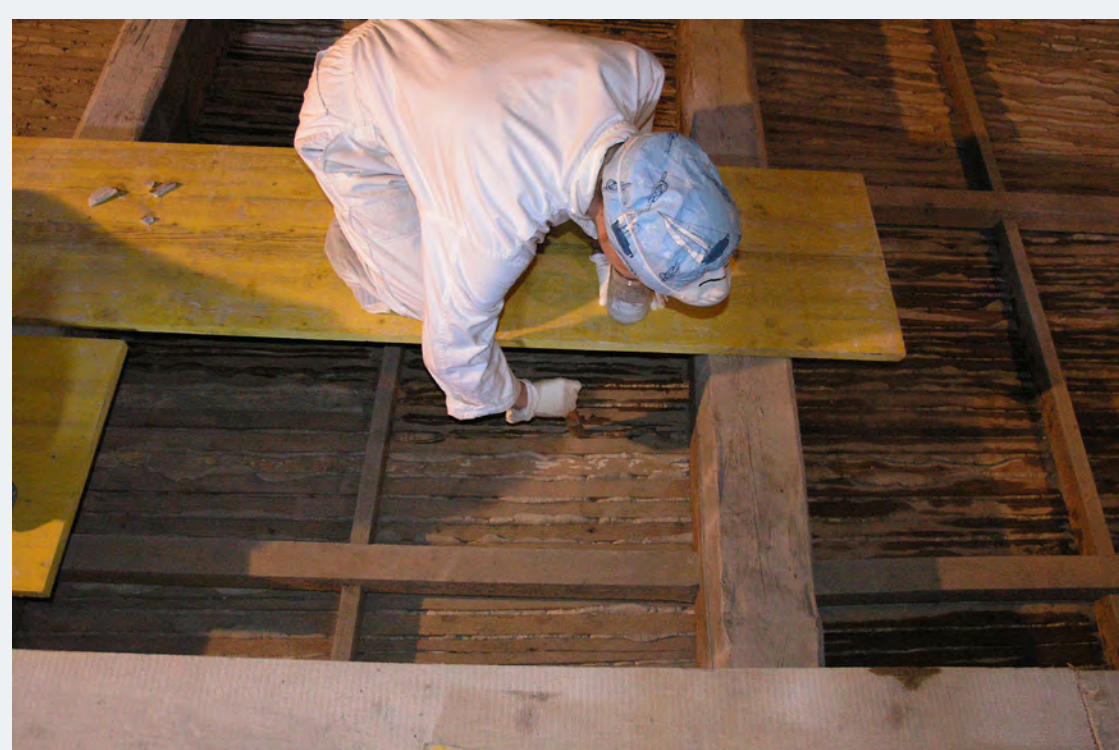
Poledinu drvene stropne konstrukcije svojom je težinom opterećivao 5 cm deo sloj prašine te različitog krupnijeg i sitnijeg otpada koji se je taložio desetljećima. Pri čišćenju prljavštine i otpada s poledine drvenih letvica uočeni su ostaci slikanog sloja. Prema nasumičnom smještaju letvica s oslikom, pretpostavlja se da su prije ugradnje u strop te letvice korištene kao dekoracija nekog drugog sklopa. Nakon čišćenja svi su drveni elementi stropa zaštićeni od daljnjeg propadanja nanošenjem specijalnog insekticidnog i fungicidnog sredstva, a na poledini je provedena impregnacija žbuke radi boljeg prijanjanja uz stropnu konstrukciju.

The back of the wooden ceiling construction was additionally burdened with a 5-cm-thick layer of dust and a variety of coarse and fine debris which had deposited over the decades. When cleaning the dust and debris from the back of the wooden lattices, the remains of a painted layer were noticed. Given the random distribution of the lattices that contained the painted coat, it was assumed that, prior to their insertion into the ceiling, they were used as decoration for another composition.

Once they were cleaned, all wooden elements of the ceiling were protected from further decay with special insecticide and fungicide, and the plaster on the back was impregnated to improve its adhesion to the ceiling construction.

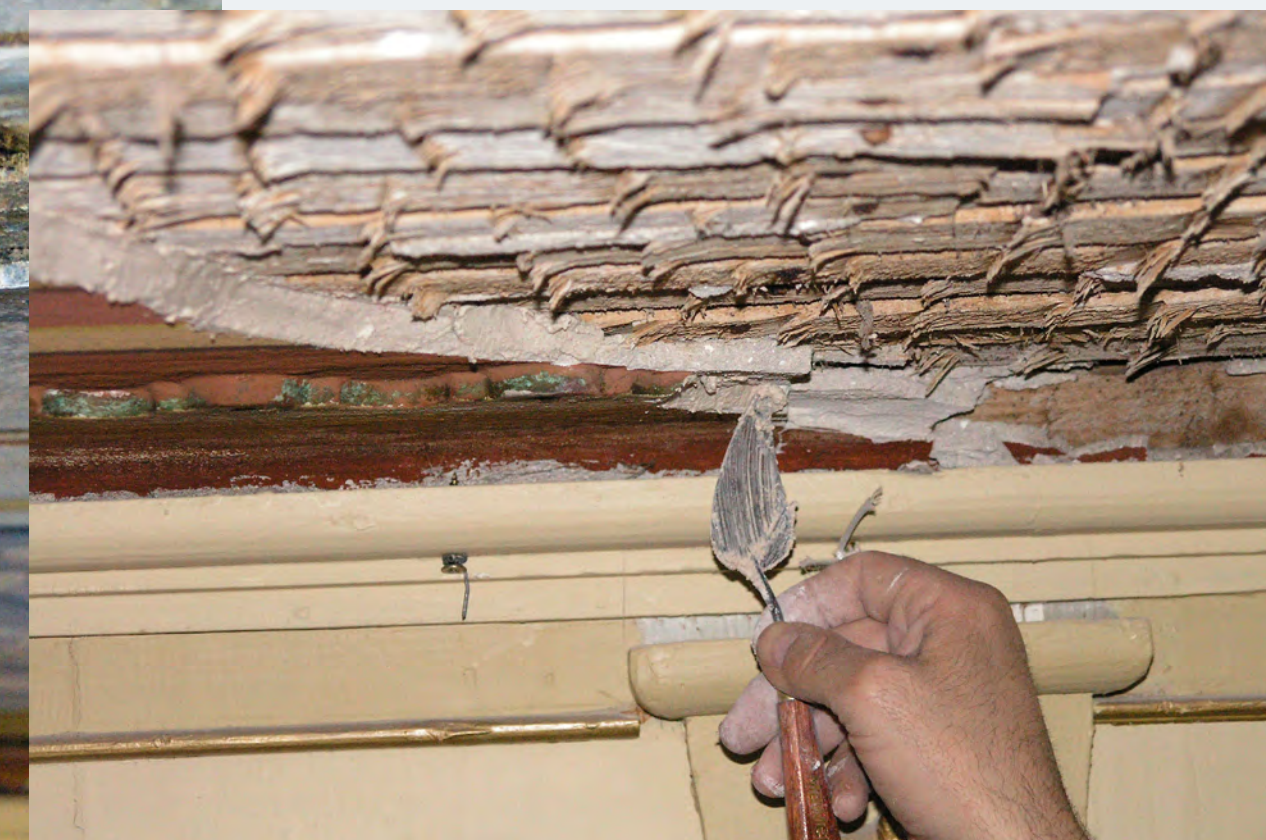
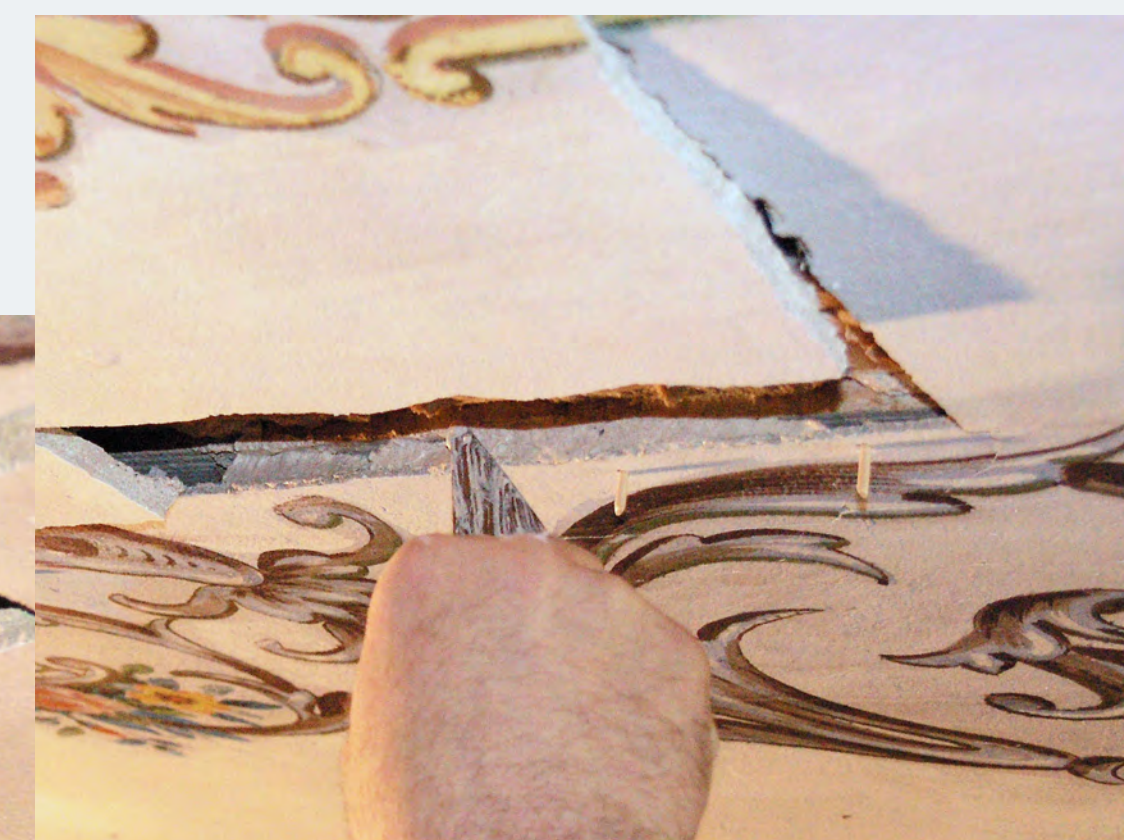
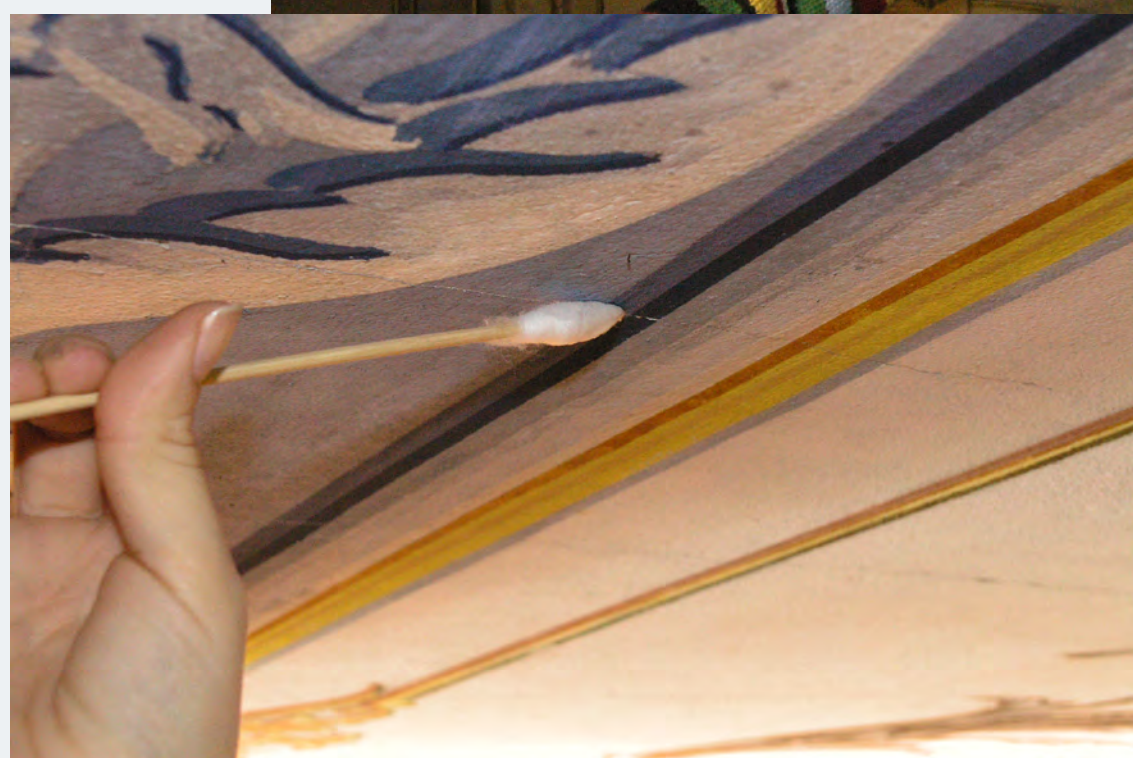
Ljepilo koje je držalo sliku s vremenom je oslabjelo te je slika mjestimično bila potpuno odvojena od stropa, a zbog djelovanja vlage njezina površina namreškana, što je dovoljan razlog za njezino skidanje i prosljeđivanje na restauraciju uspecijaliziranu radionicu.

The adhesive that held the painting had weakened with time, and in some places the painting had completely separated from the ceiling. Due to moisture, its surface was wrinkled, providing us with sufficient reason to pull the painting down and forward it to a specialized workshop for restoration.

Consolidation consists of a range of complex conservation procedures that the plaster and painted layer are exposed to with the goal of regaining their lost original features, and removing and stopping, as much as possible, the advanced decaying processes within them. For this reason, all unstable sections of plaster and painted layer need to be strengthened and consolidated, to prevent any further damage and ensure unhindered execution of other conservation and restoration interventions on the artefact. The sections in which the plaster was separated from the wooden lattices of the ceiling construction were stabilized with inserted wooden sticks, which served as a link between the plaster and the ceiling construction. The edges of the lacunae and of the large segments that were left without plaster, which are prone to wear and to falling away in fragments, were reinforced and secured.

The surface dirt was cleaned off the face of the painting with a combination of chemical and mechanical cleaning methods, selected on the basis of the results of testing out various cleaning methods and materials on destabilized sections of individual groups of pigments.
