KONZERVATORSKO-RESTAURATORSKI RADOVI NA TREĆEM KATU PALAČE SKOČIBUČIĆ-LUKARIS

CONSERVATION-RESTORATION WORKS ON THE THIRD FLOOR OF THE SKOČIBUČIĆ-LUKARIS

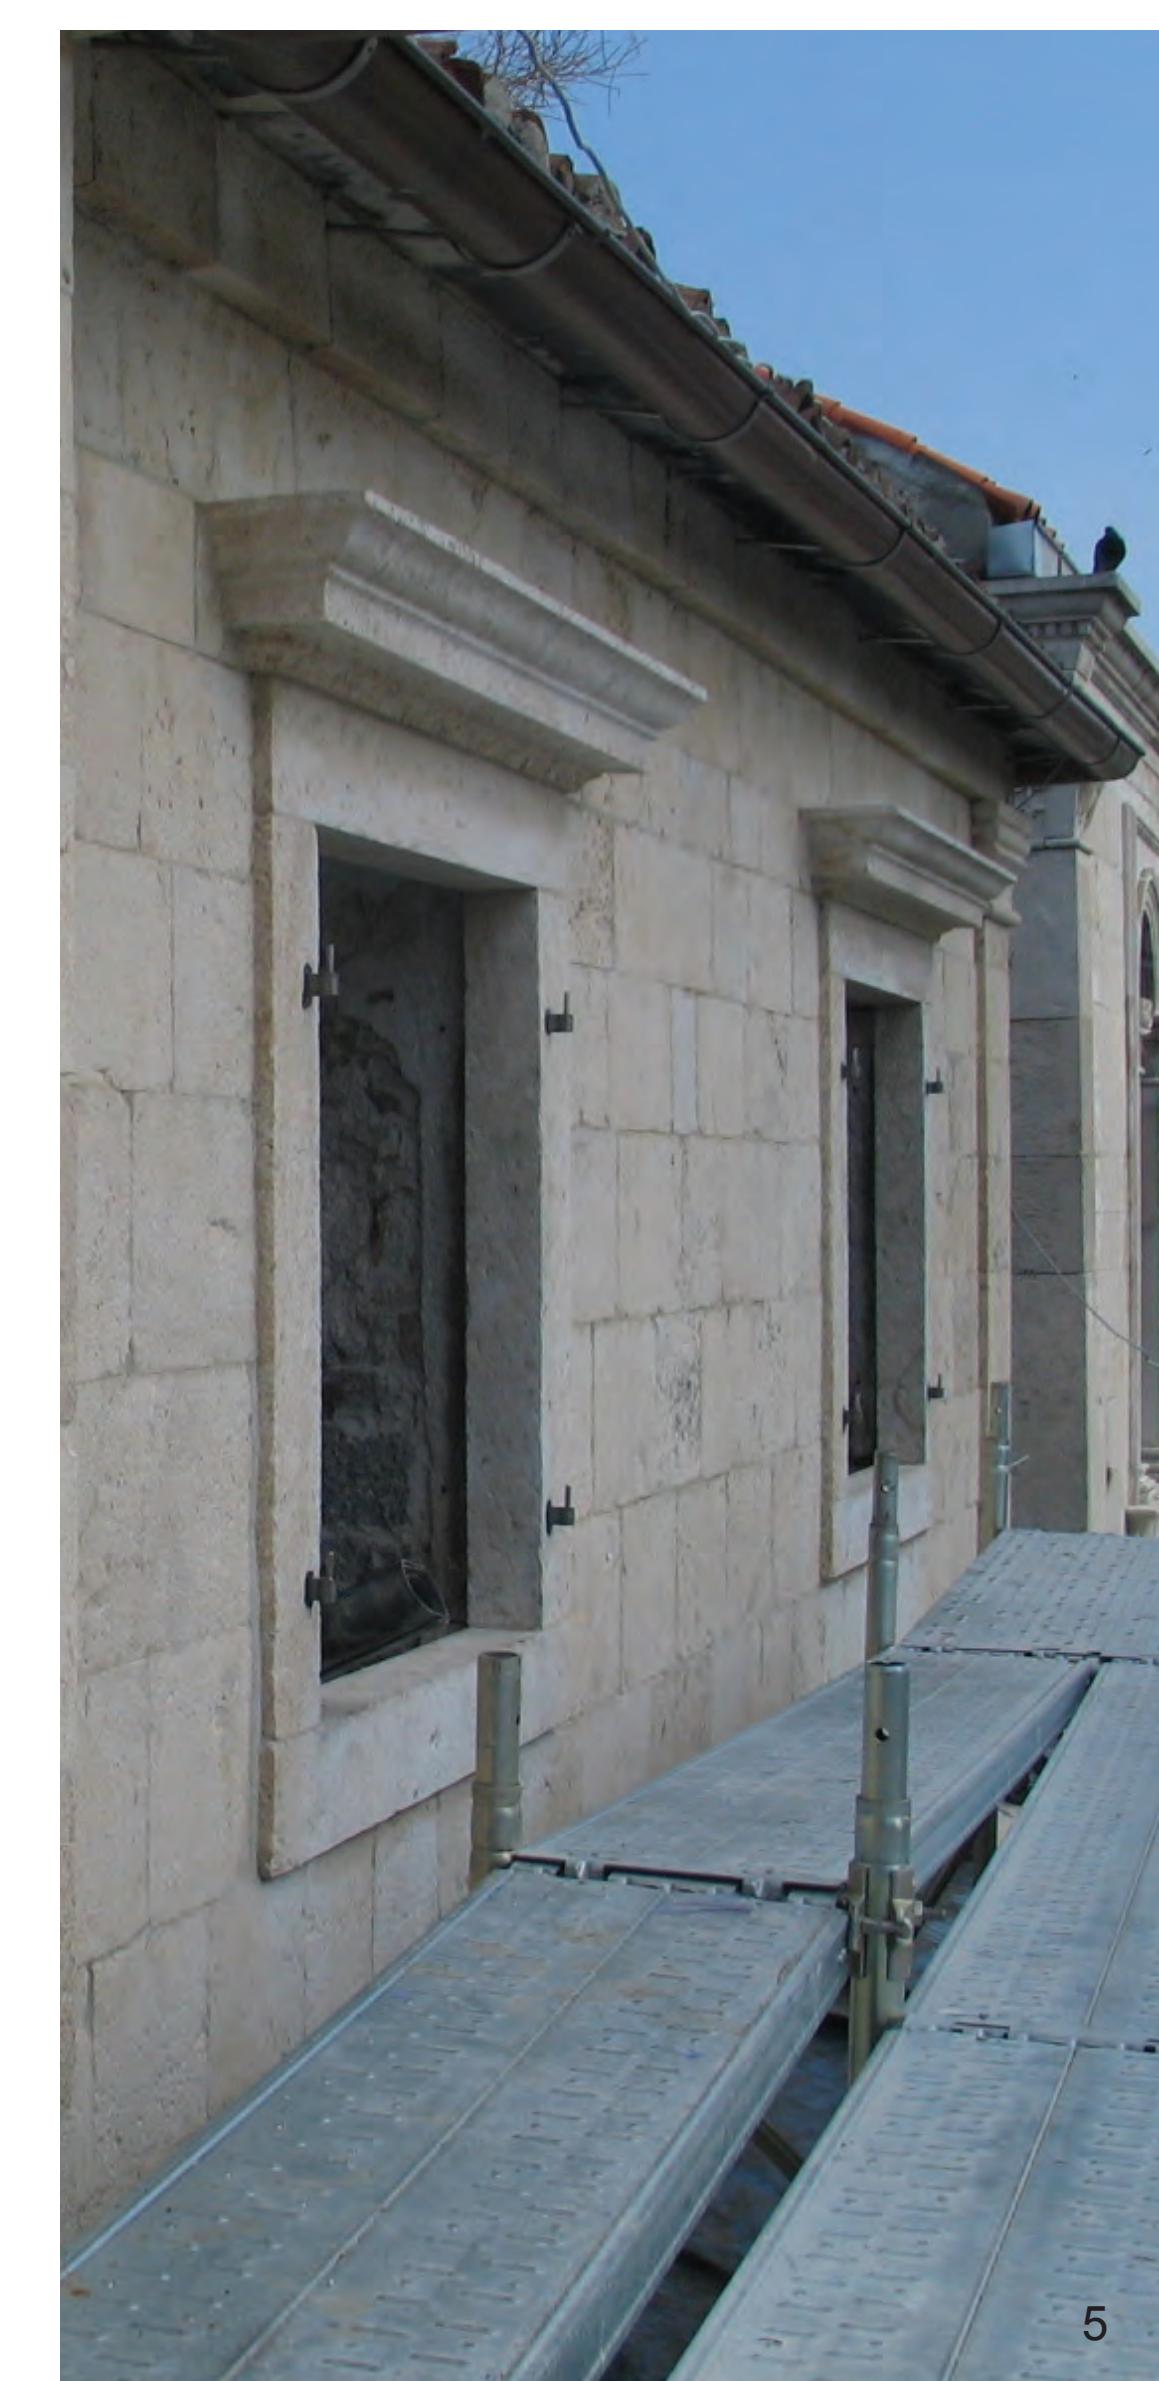
The cement binder was removed from the joints between the ashlar (**Fig. 4**), and the joints were pointed with acrylic-lime mortar. The cement was removed from the upper side of the mouldings and replaced with a layer of artificial stone. Any fairly large sharp-edged voids on the faces of the ashlar were filled with artificial stone in order to prevent water seeping into the wall structure.
