KONZERVATORSKO-RESTAURATORSKI RADOVI NA BALKONU NA DRUGOM KATU PALAČE

CONSERVATION-RESTORATION WORKS ON THE BALCONY ON THE SECOND FLOOR OF THE PALACE

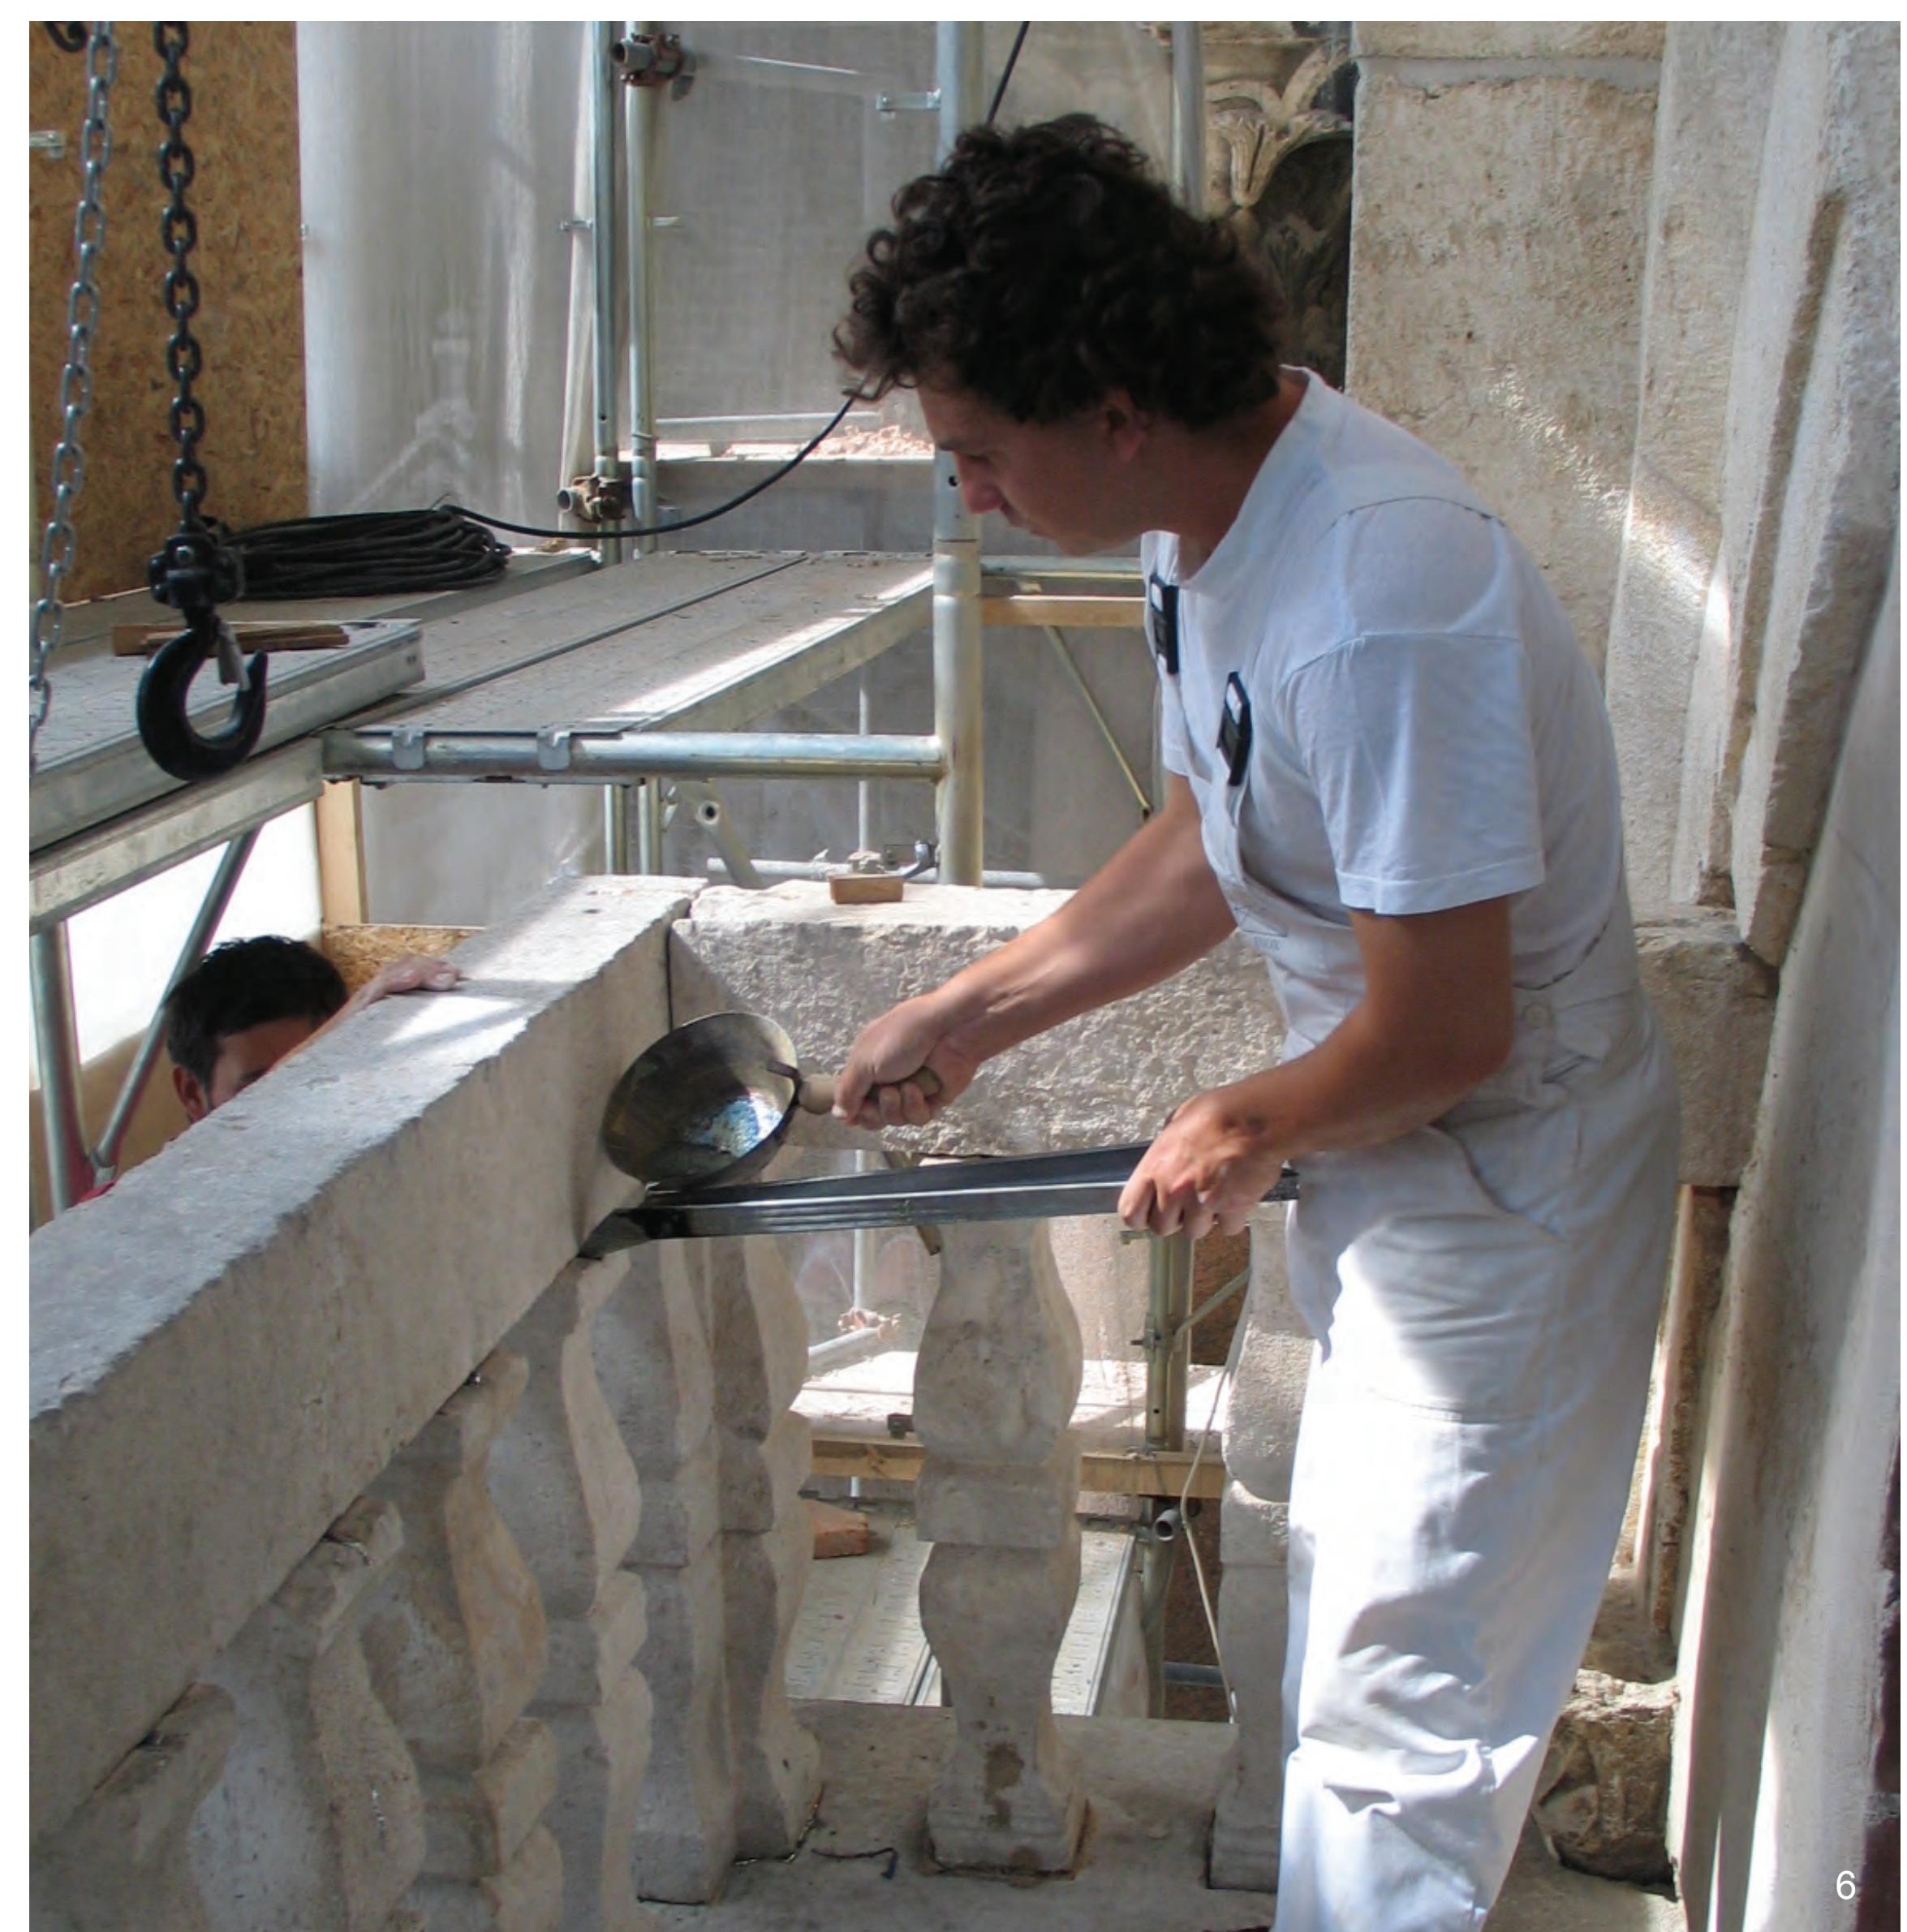
Zbog narušene stabilnosti, većinom zbog djelovanja korozije željeznih kopči i trnova, ograda balkona na drugom katu palače demontirana je i zatim ponovno montirana, što je bio jedan od najsloženijih zahvata ove faze projekta (Sl. 1-3).

Because of the impaired stability, mostly resulting from the corrosion of the iron clamps and bars, the railing of the balcony on the second floor of the palace was disassembled and then assembled again, which was one of the more complex operations of this phase of the project (Fig. 1-3).

The situation as found was documented in drawings, and the pillars and parts of the handrail were numbered. The iron clamps were taken out, and the iron fixings that held them together were sawn through. After disassembly, all the parts were thoroughly cleaned from organic and inorganic soiling. Then came the demanding task of taking out the iron fixings and removing the remains of the lead that had been poured around them in the holes. The baluster that was missing was carved in the same kind of stone from which the balcony was made (Fig. 4).

The procedure of assembling the balcony followed the original building technique. The balusters were arranged in the original order and mortared to the base. Stainless steel bars were used to link the elements again (Fig. 5). When each part of the handrail was put in place, molten lead was poured over the bars (Fig. 6). In the last phase of the operation, new connecting plates were fixed between the separate beams of the handrail and at the joint of the handrail with the facade.
