## Na završetku desetljeća obnove Peristila

## At the end of a Decade of the Peristyle Restoration

The conservation and restoration work on the Peristyle of Diocletian's Palace has been in many ways the most important project in recent period within the scope of renovation of the historical core of the town of Split. The Peristyle is the centre and the most impressive part of the imperial palace, and also the heart of the town which has grown around it. The square, which reflects historical layers of the creation and development of the town, has become its symbol and its main tourist attraction. It serves as the most attractive backdrop for cultural events, and a stage at which public life evolves.

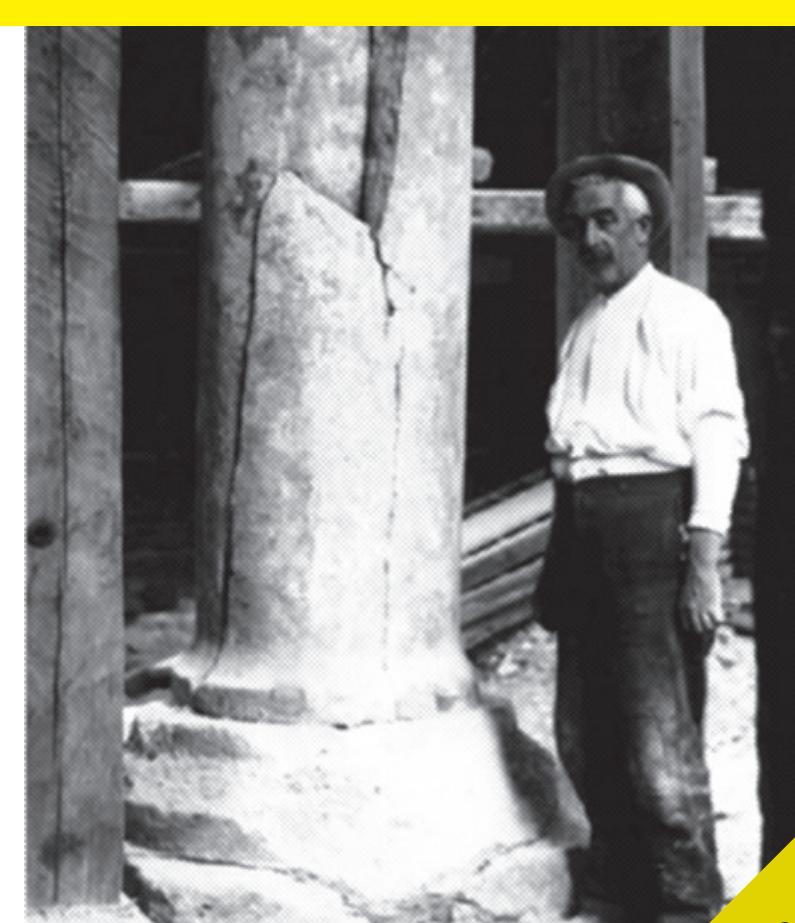
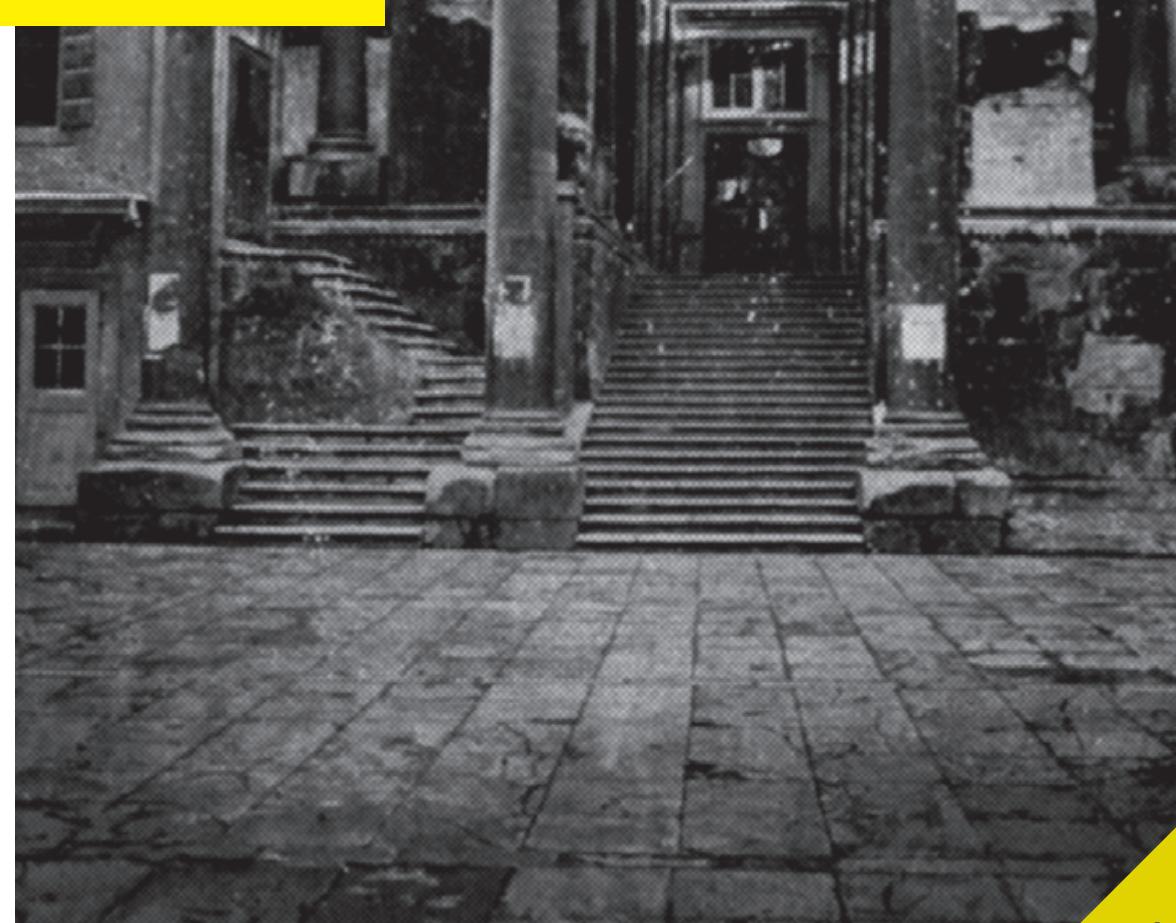
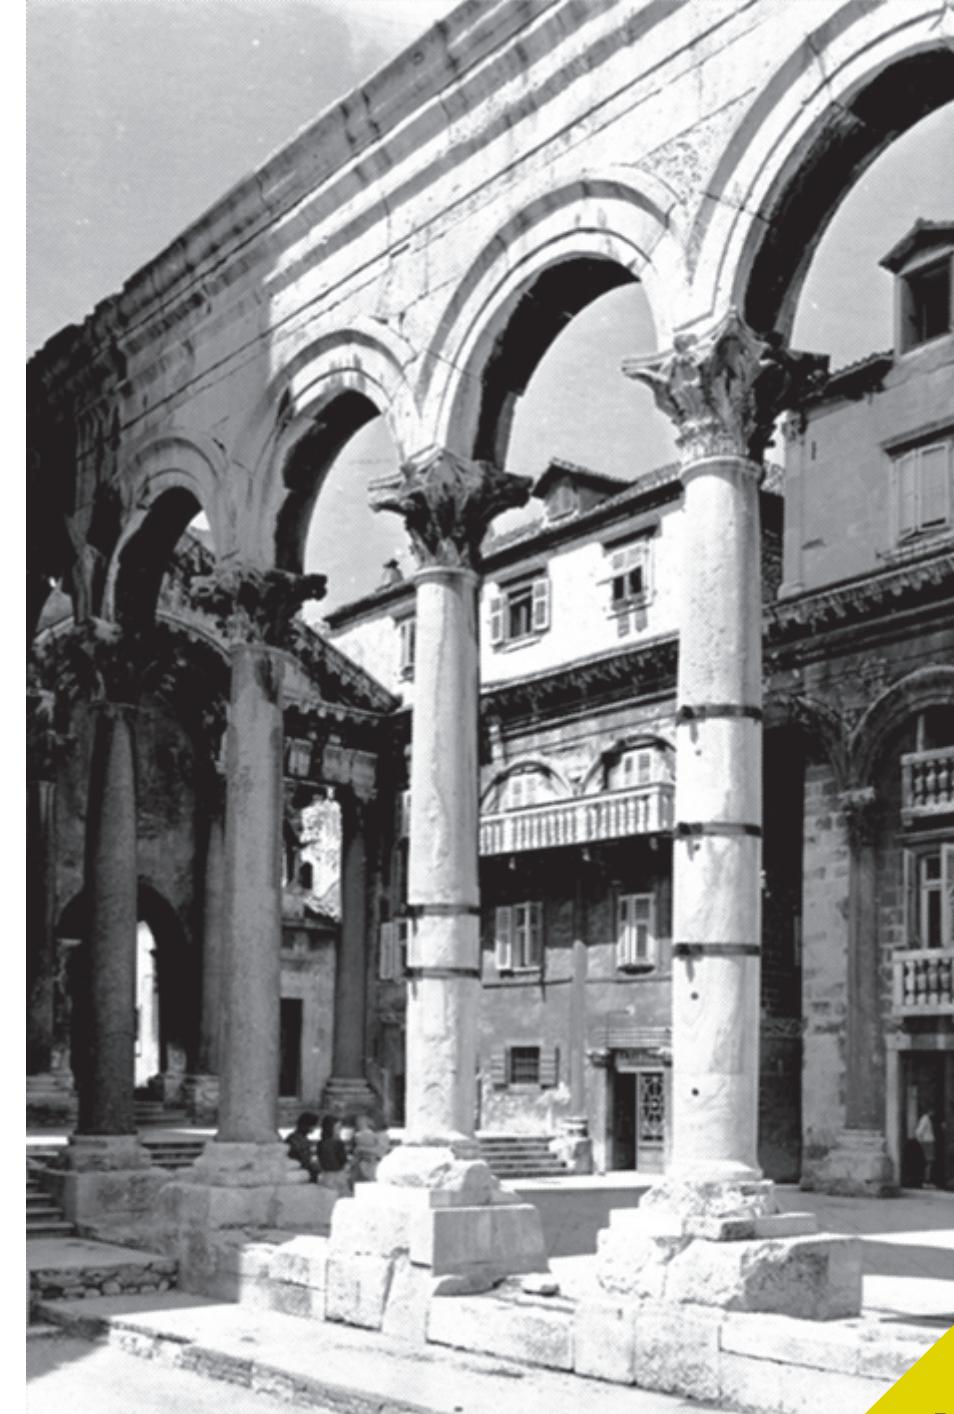
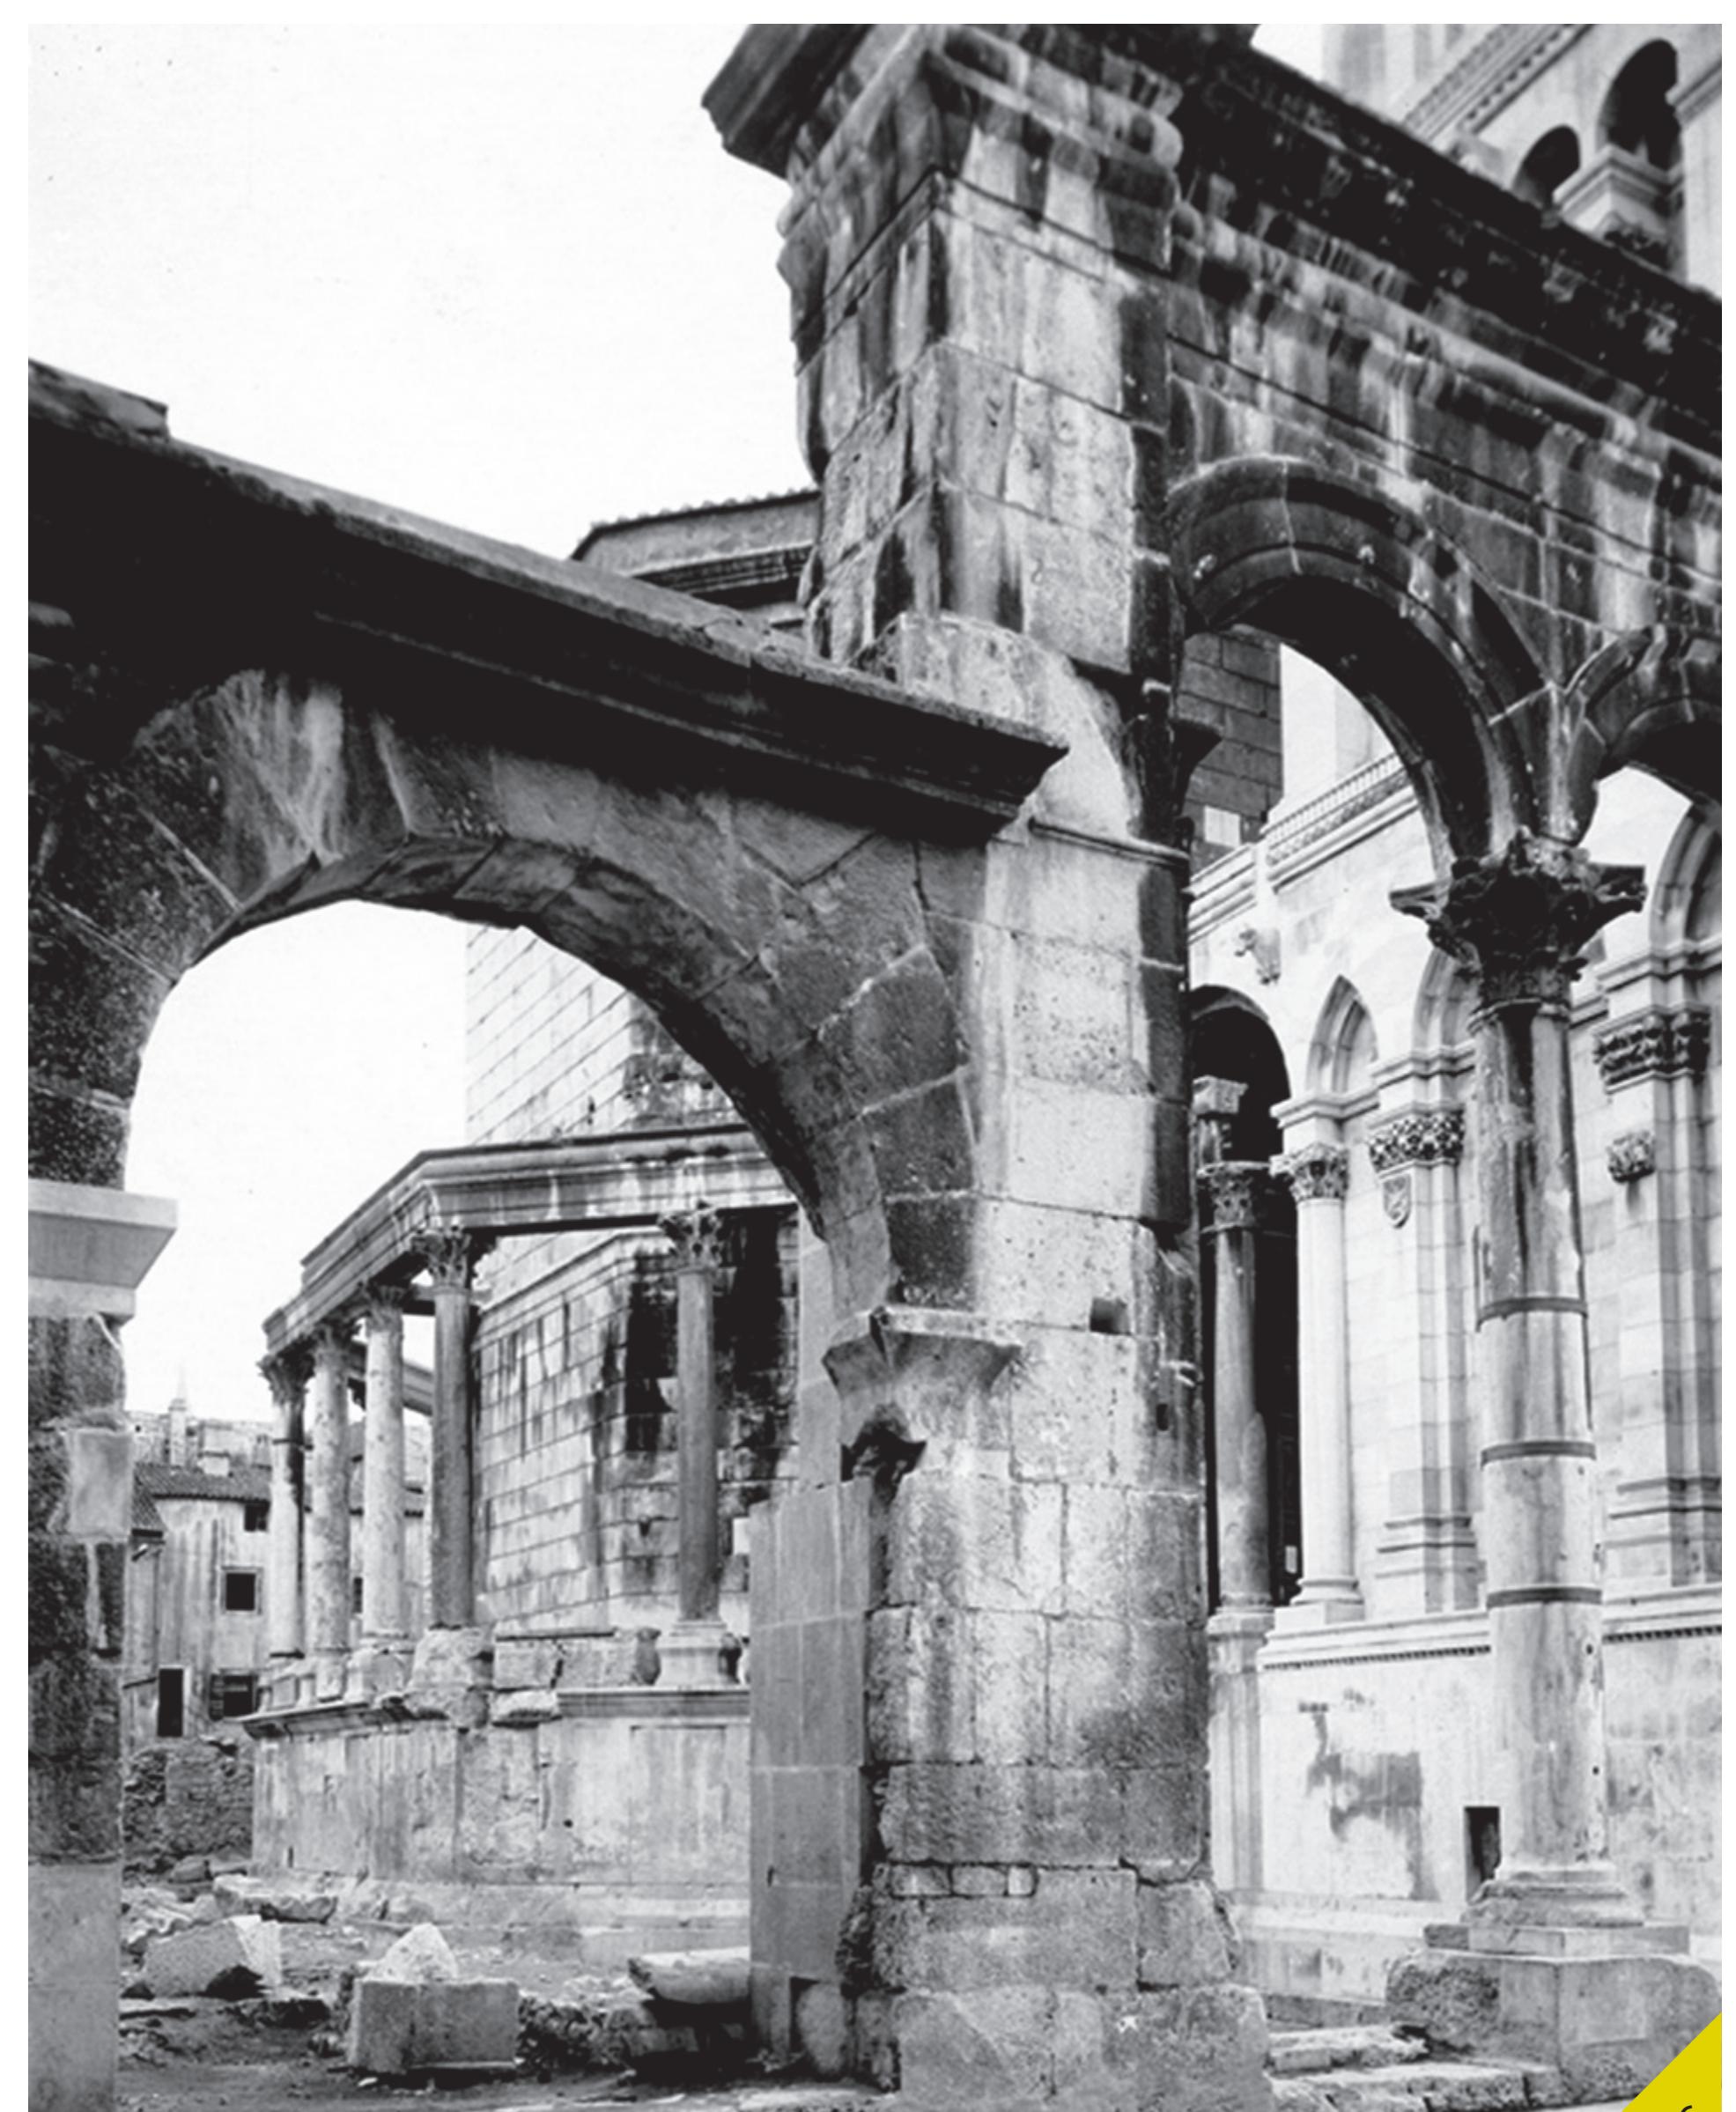
Dio oštećenja istočne kolonade Peristila preostao nakon rušenja kavane 'Al Tempio' popravljen je u vrijeme samog zahvata, no temeljita restauracija uslijedila je tek 1907. godine, kada su dva teško oštećena sjeverna stupa restaurirana tašeljiranjem i ojačana bakrenim obrucima. Demontirani su i ponovo montirani vjenac i trabeacija dijela istočne kolonade. Radovi su izvedeni pod nadzorom Pojverenstva za Dioklecijanovu palaču, koje je osnovano zaузimanjem glavnog konzervatora Frane Bulića.

Part of the damage of the east colonnade that had remained after the 'Al Tempio' demolition was repaired at the time, but thorough restoration took place only in 1907 when two heavily damaged northern columns were restored by patching and were reinforced with copper rings. Cornice and trabeation of one part of the east colonnade were dismantled and again reassembled. Works were monitored by the Committee for Diocletian's Palace established under the patronage of Frane Bulić, the chief conservator.

1. KAVANA 'AL TEMPIO' UNUTAR SJEVERNOG DIJELA ISTOČNE KOLONADE PERISTILA, PRIJE 1876.; 2, 3. SJEVERNI DIO ISTOČNE KOLONADE PERISTILA 1907., (2) DEMONTAŽA GORNJEG DIJELA KOLONADE.; (3) RESTAURACIJA DRUGOG STUPA; 4. POGLED PREMA KATEDRALI SV. DUJMA, PRIJE 1876.; 5, 6. DETALJI ISTOČNE KOLONADE, SREDINA 20. ST.

1. THE AL TEMPPIO CAFÉ INSIDE THE NORTHERN PART OF THE EASTERN COLONNADE OF THE PERISTYLE, BEFORE 1876.; 2. THE NORTHERN PART OF THE EASTERN COLONNADE OF THE PERISTYLE IN 1907, DISASSEMBLY OF THE UPPER PART OF THE COLONNADE.; 3. THE NORTHERN PART OF THE EASTERN COLONNADE OF THE PERISTYLE IN 1907, THE RESTORATION OF THE SECOND COLUMN.; 4. VIEW TOWARDS CATHEDRAL OF ST. DOMINIC, BEFORE 1876.; 5, 6. DETAILS OF THE EAST COLONNADE, MID 20TH CENTURY
