## Na završetku desetljeća obnove Peristila

## At the end of a Decade of the Peristyle Restoration

The conservation and restoration work on the Peristyle of Diocletian's Palace has been in many ways the most important project in recent period within the scope of renovation of the historical core of the town of Split. The Peristyle is the centre and the most impressive part of the imperial palace, and also the heart of the town which has grown around it. The square, which reflects historical layers of the creation and development of the town, has become its symbol and its main tourist attraction. It serves as the most attractive backdrop for cultural events, and a stage at which public life evolves.

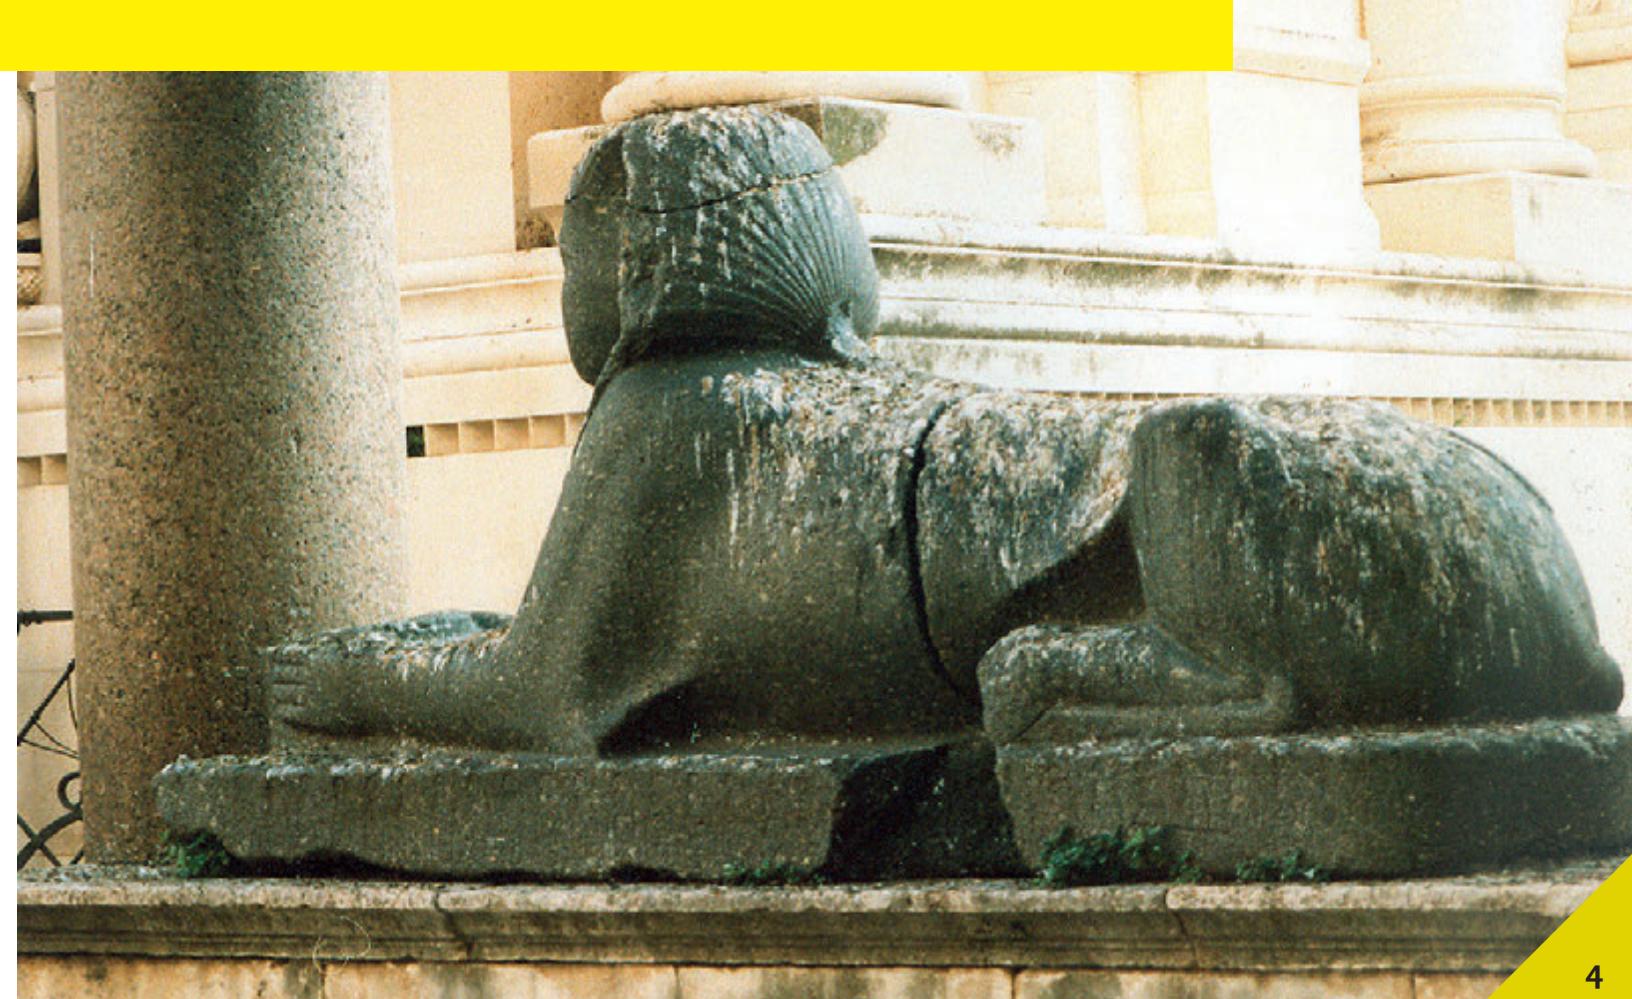
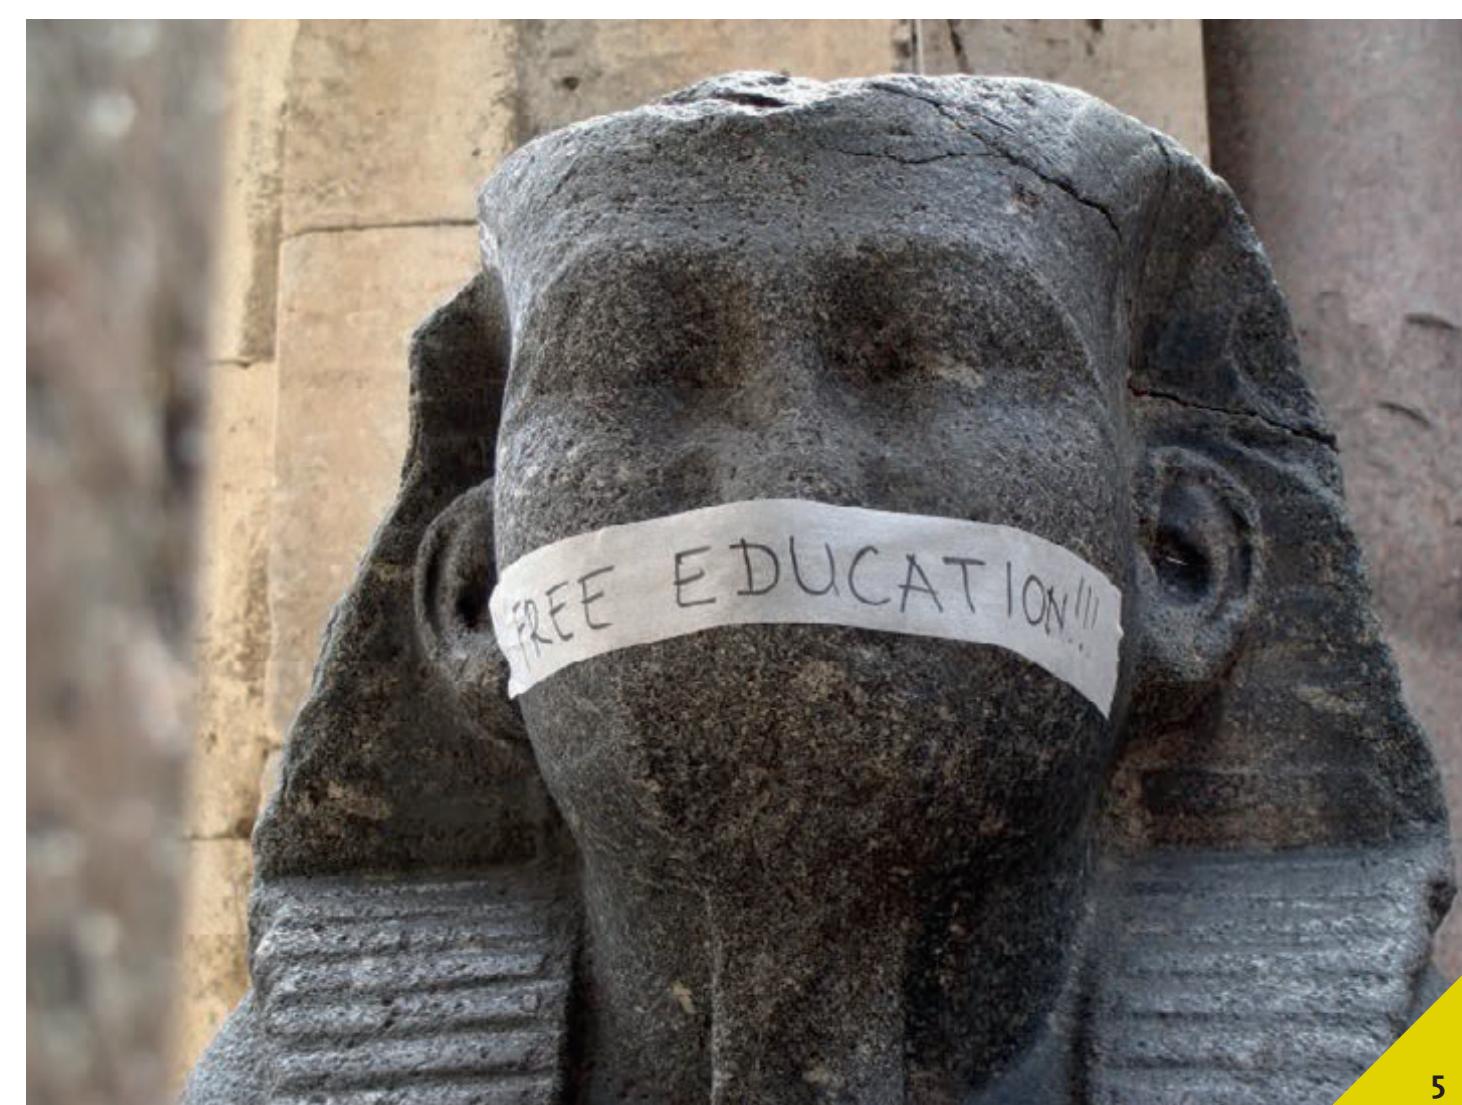
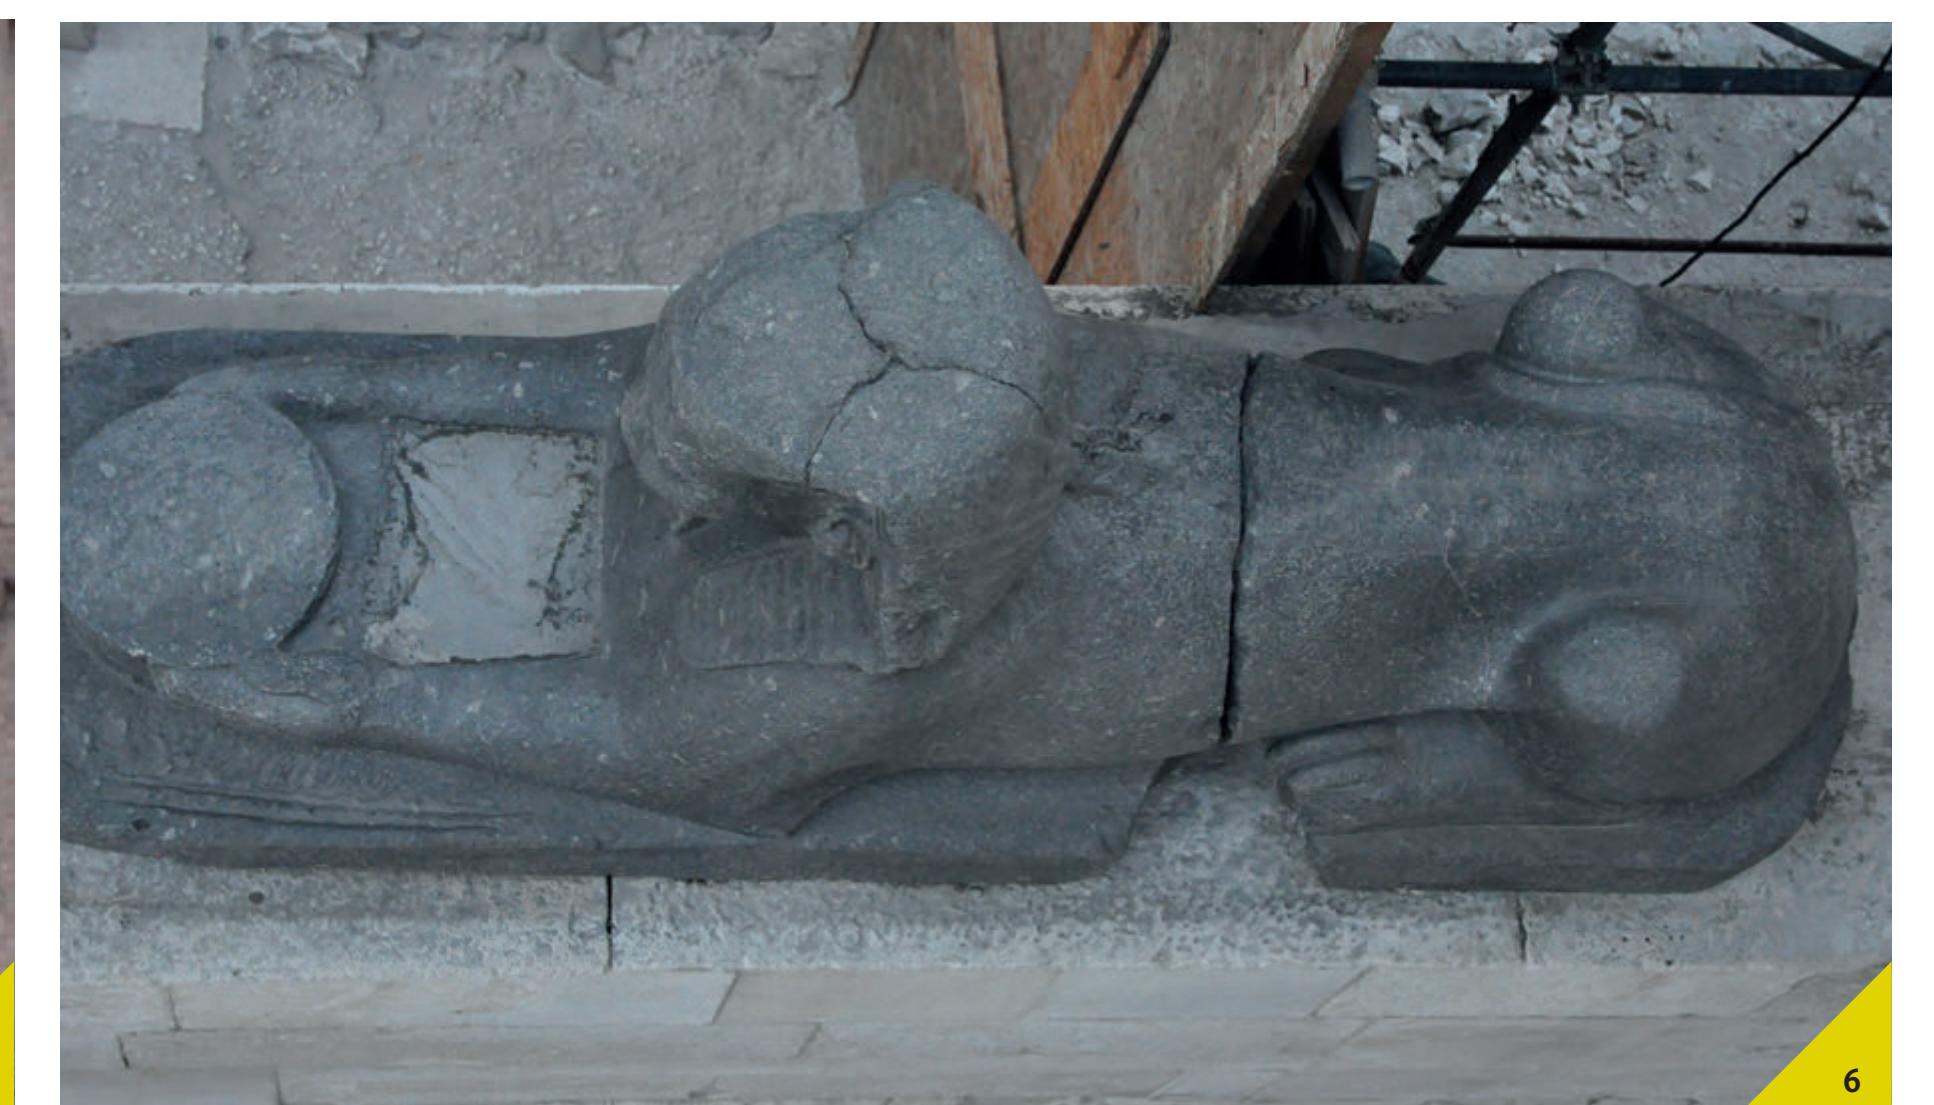
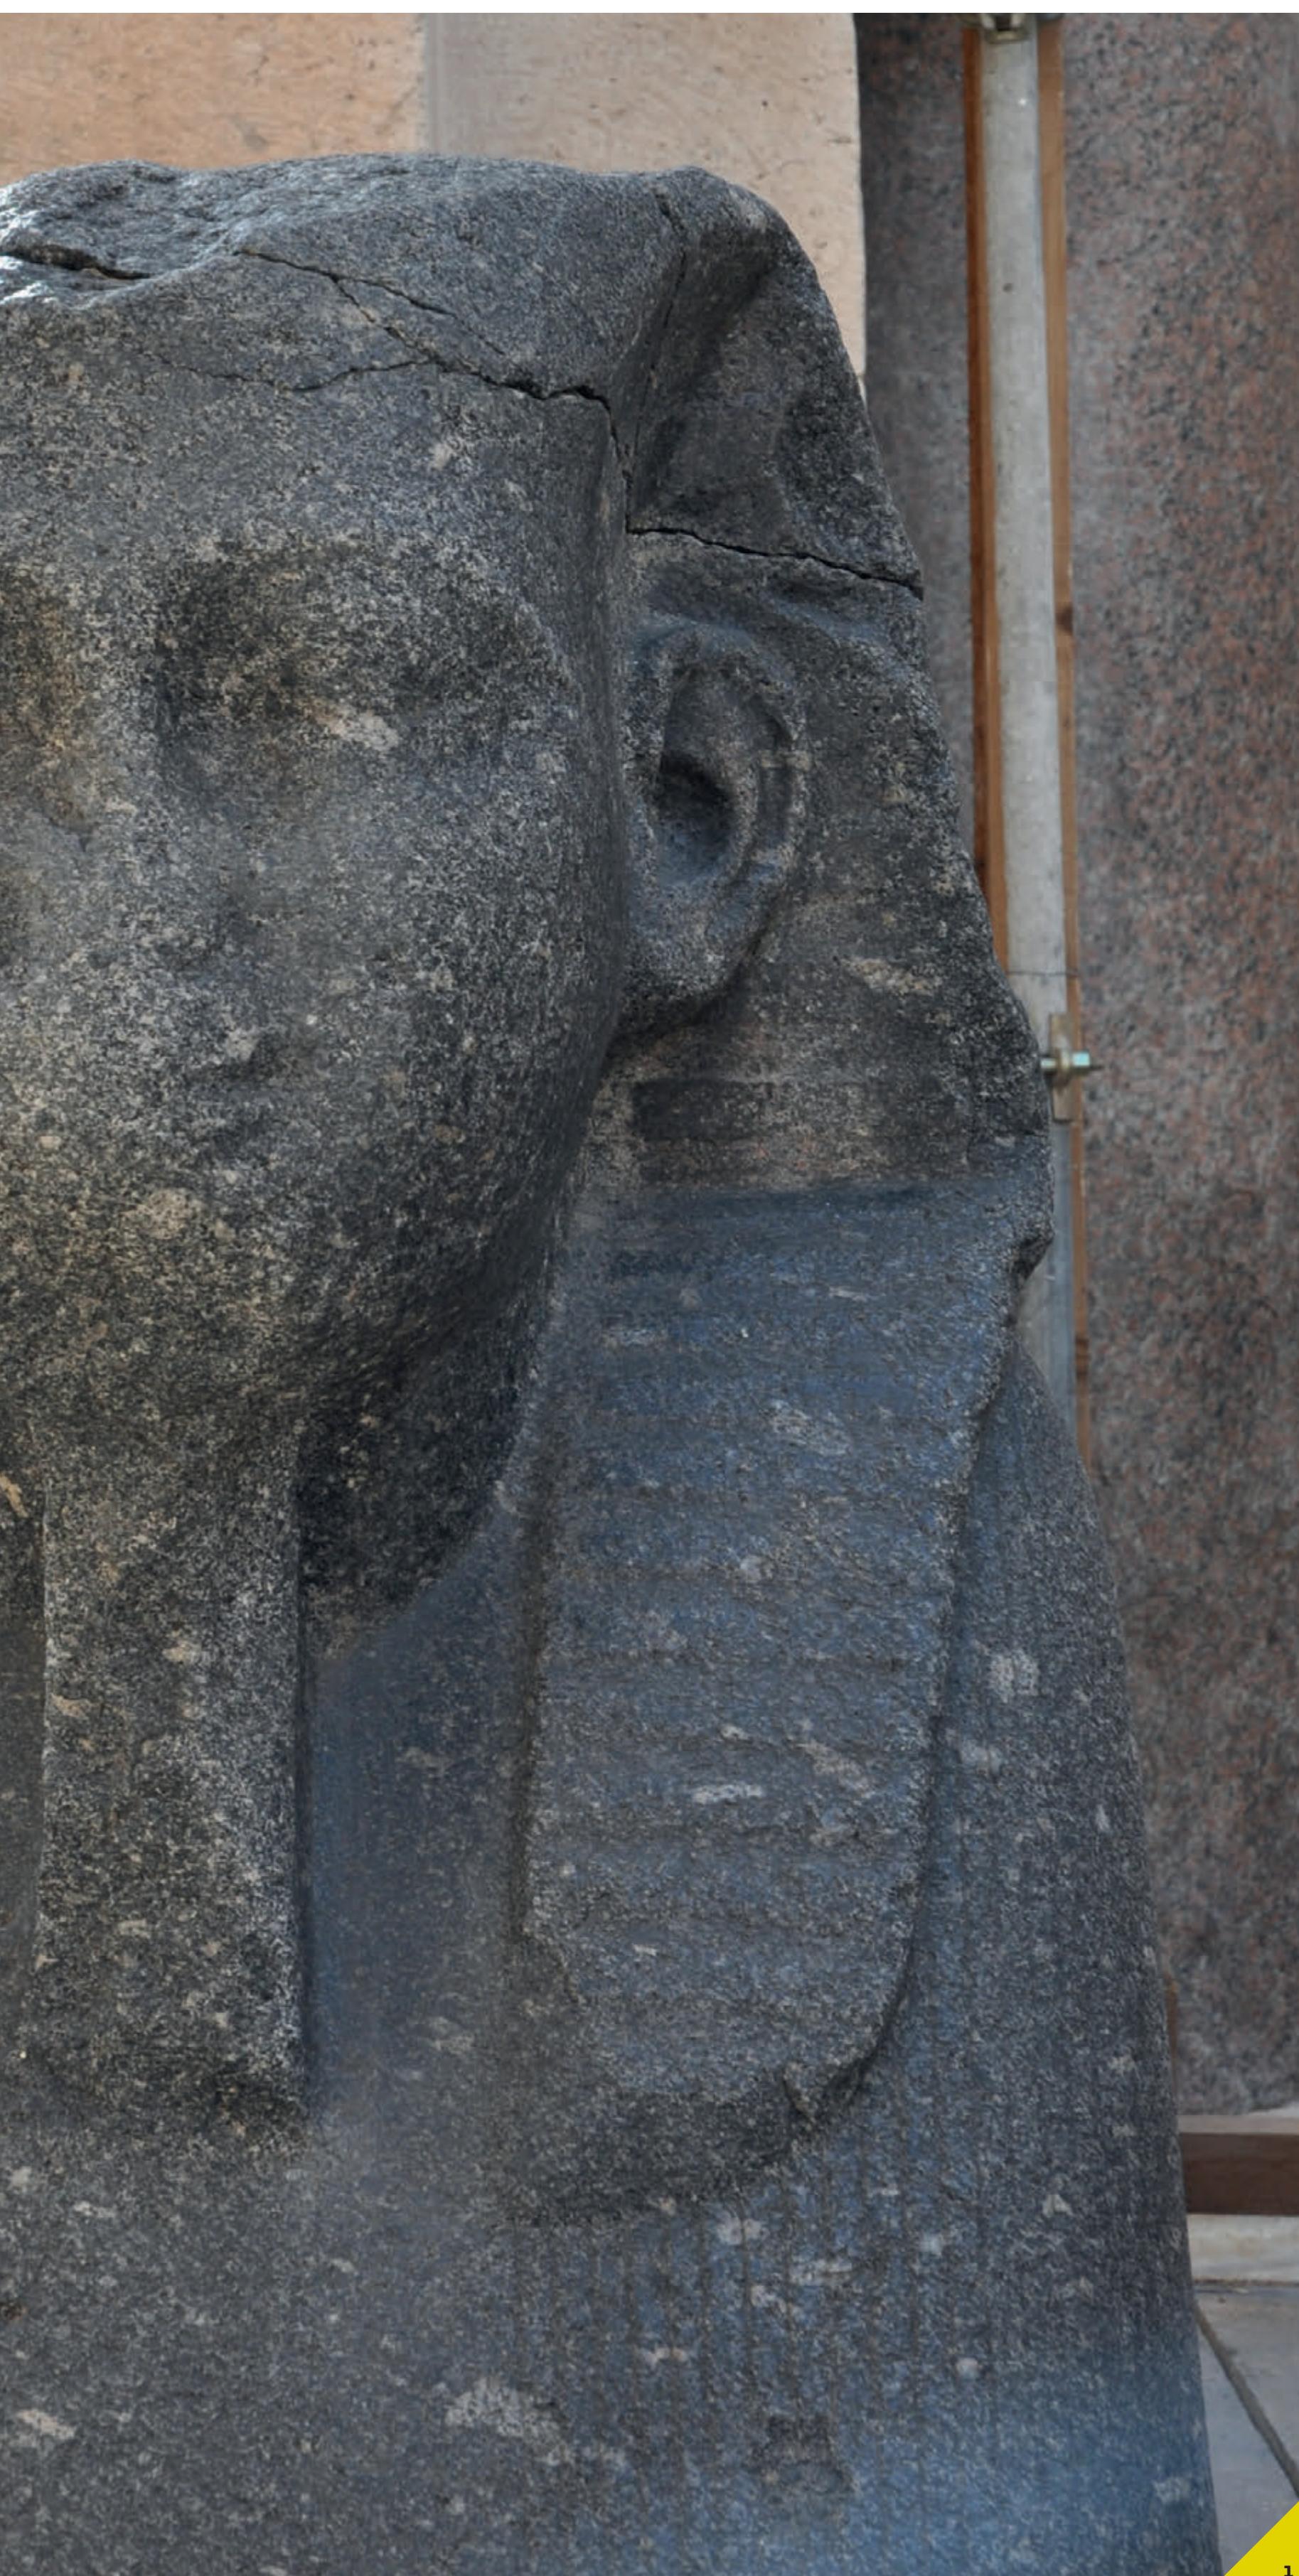
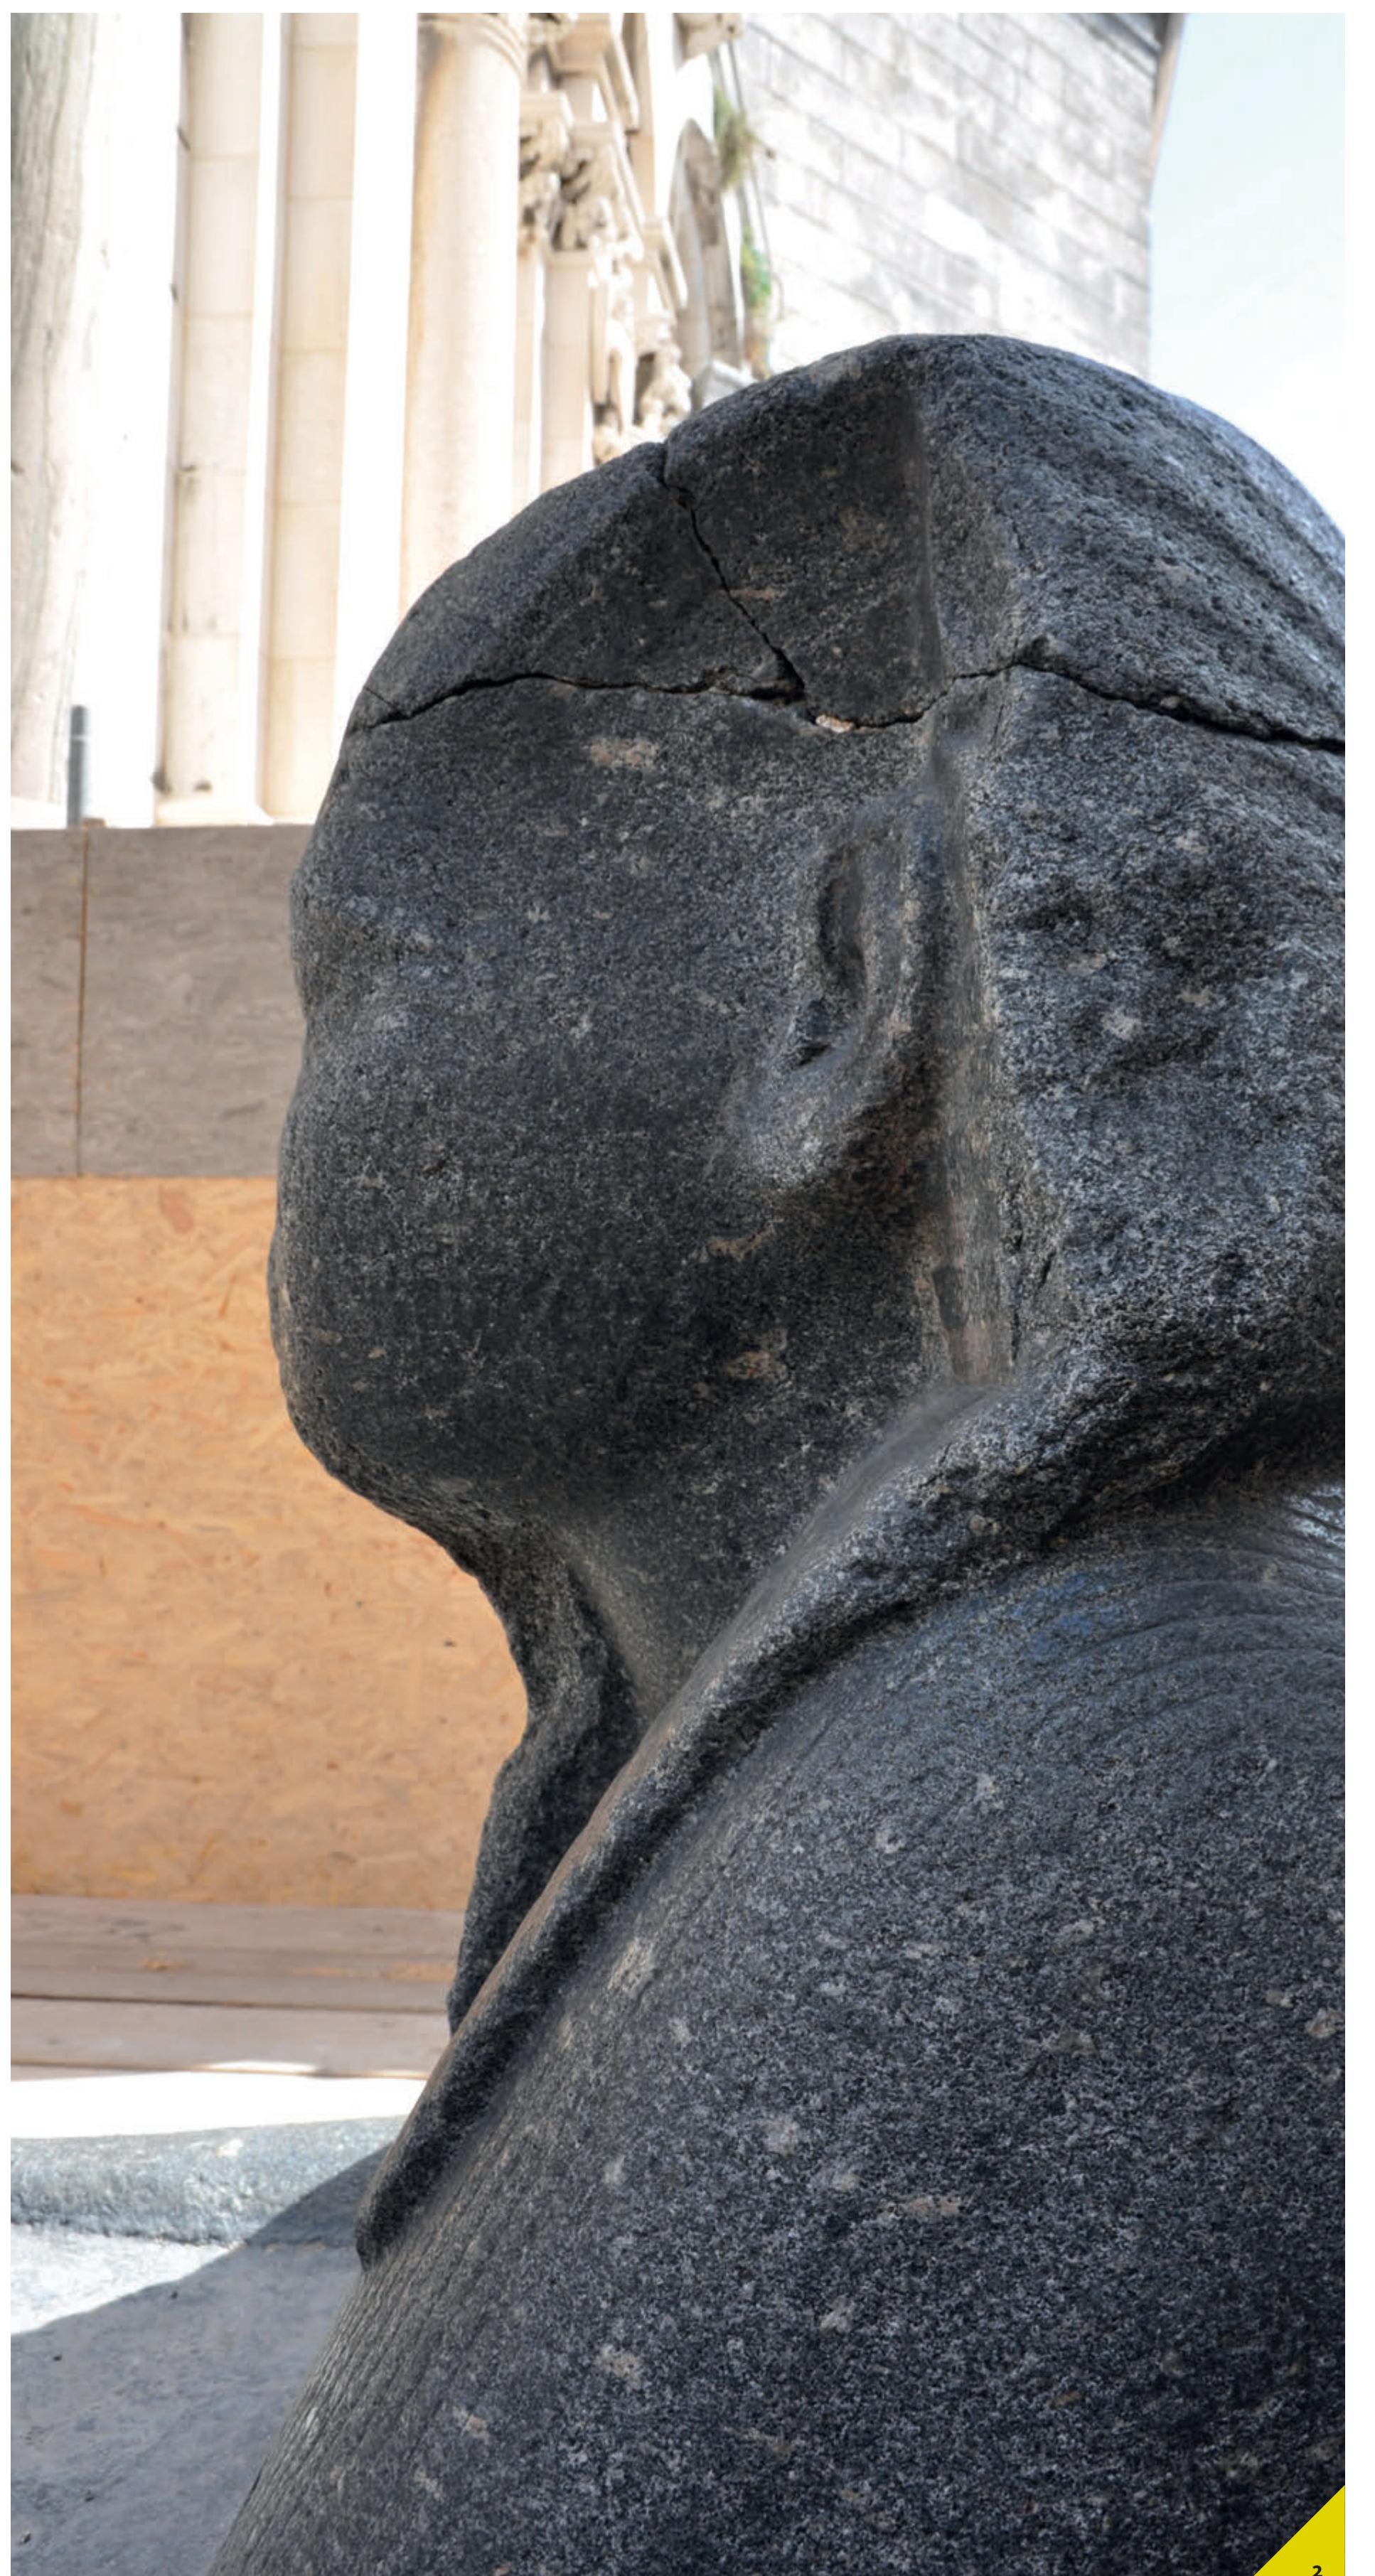
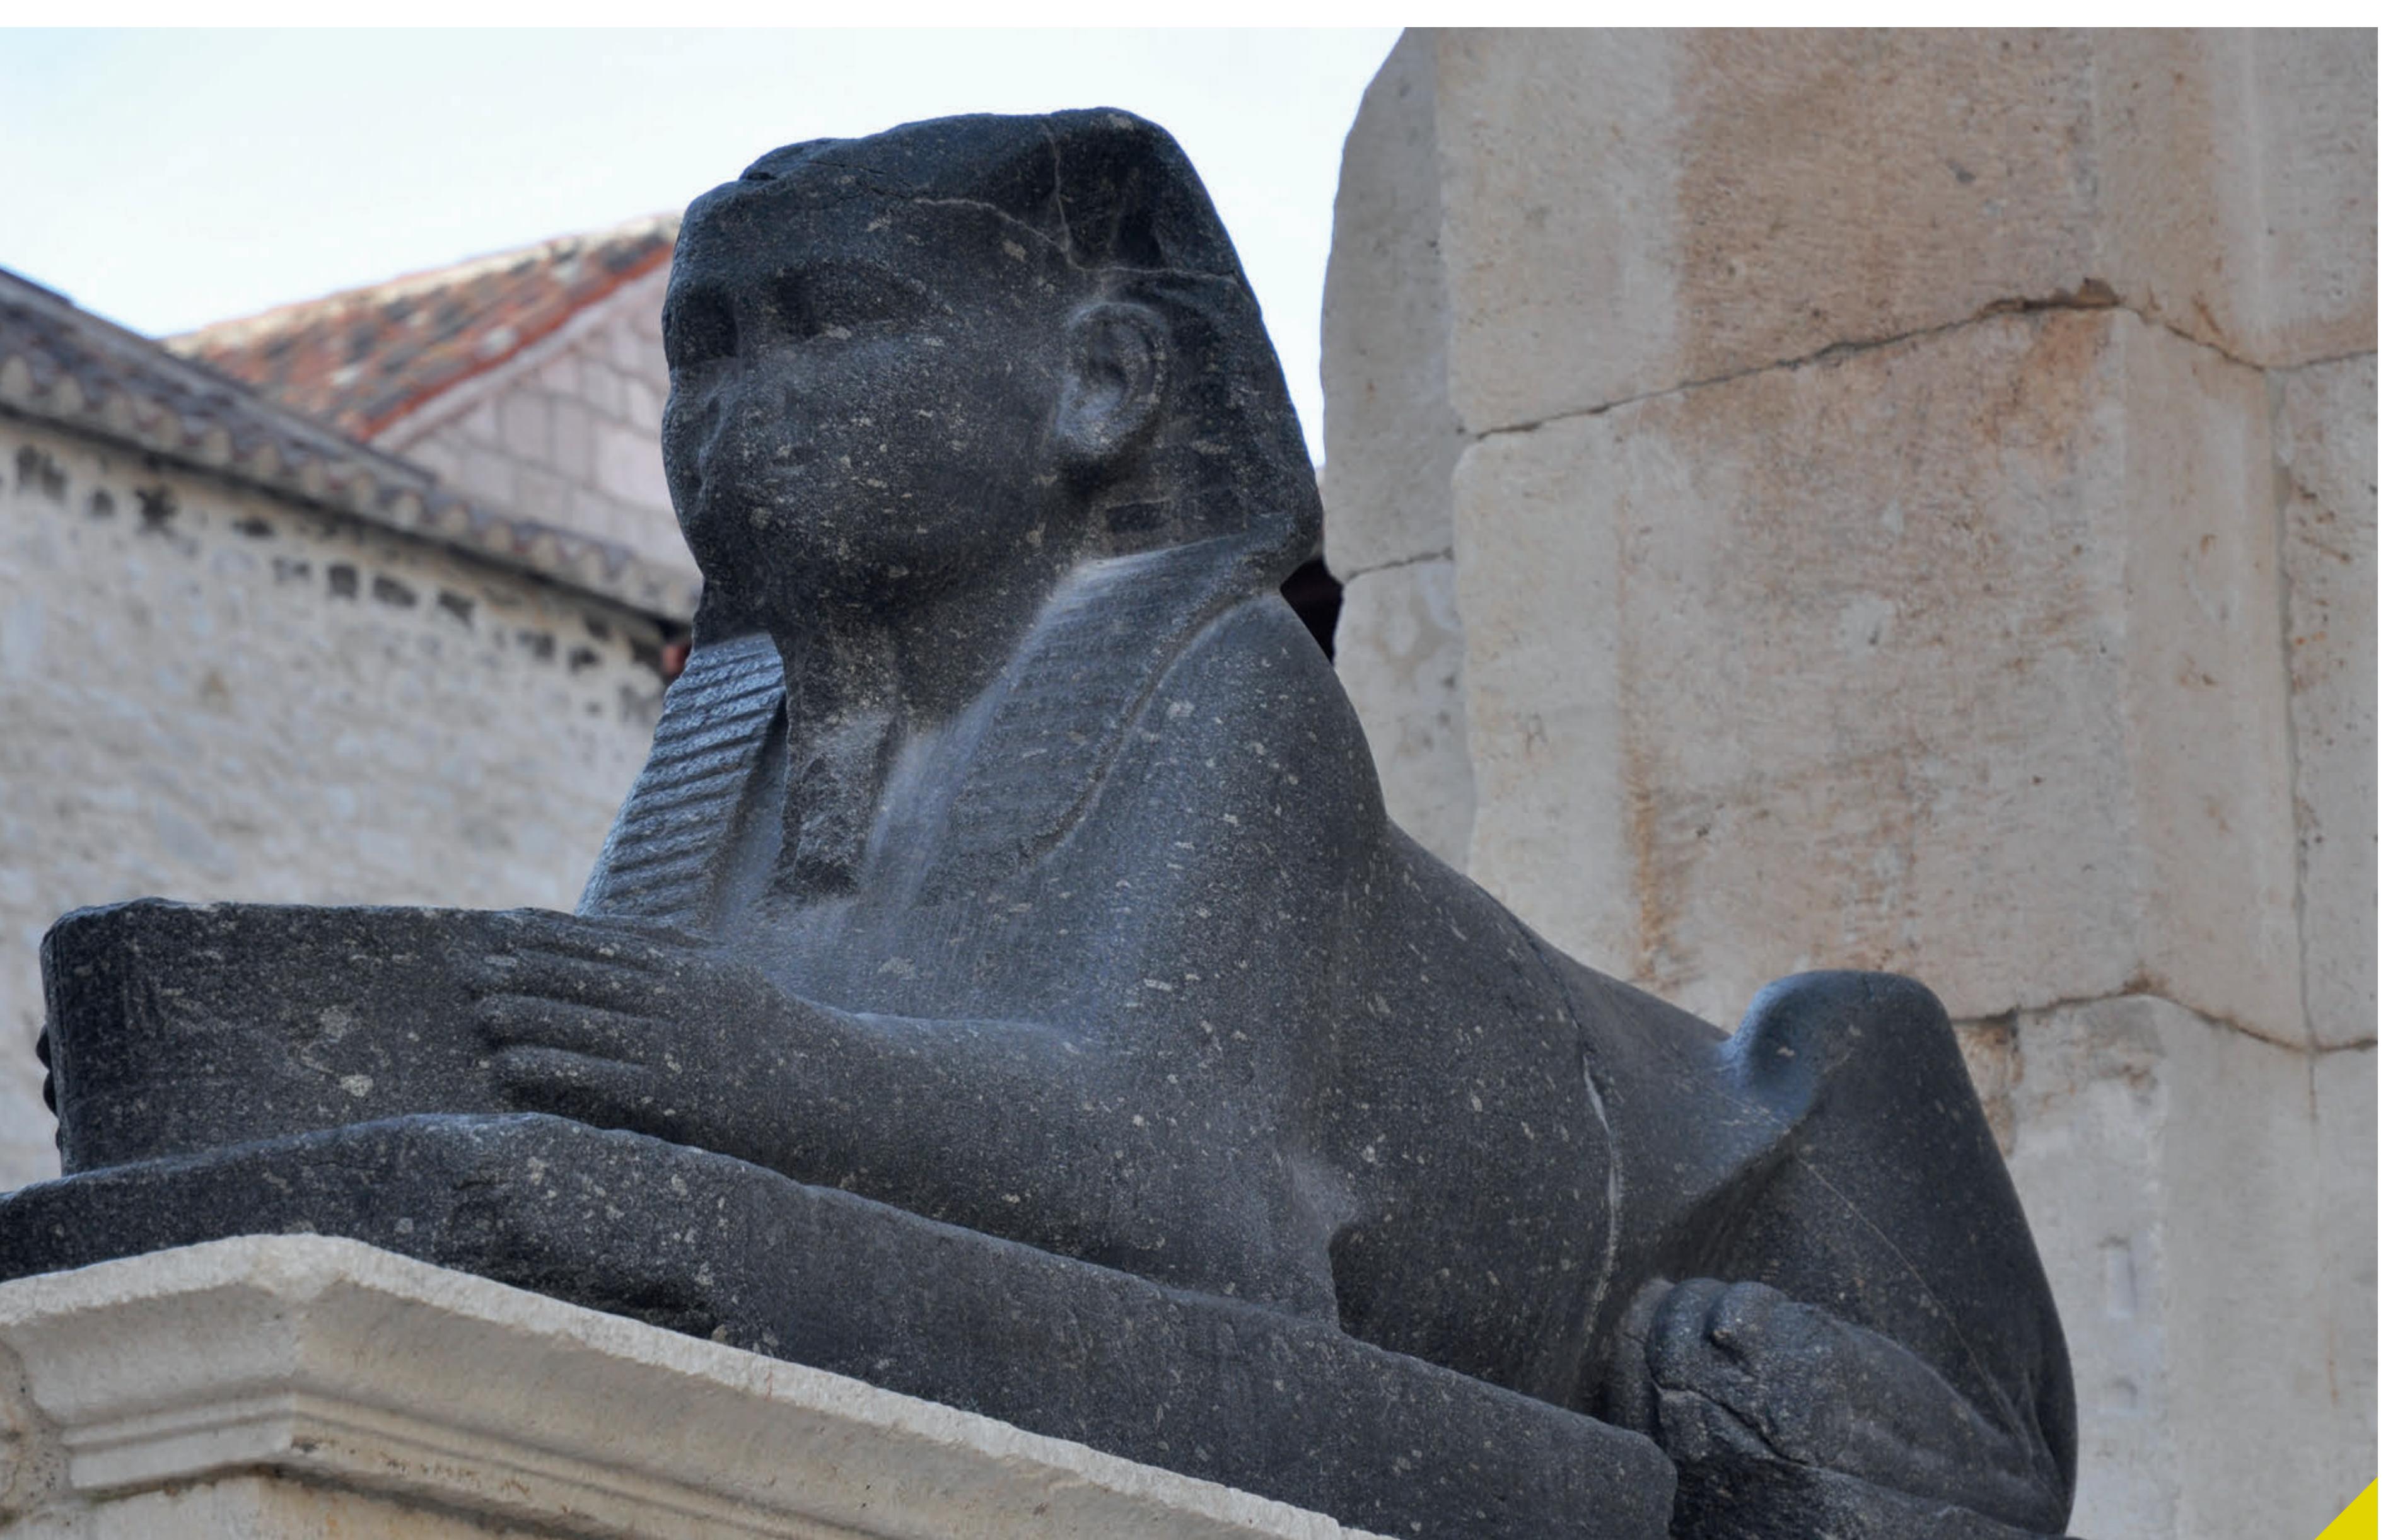
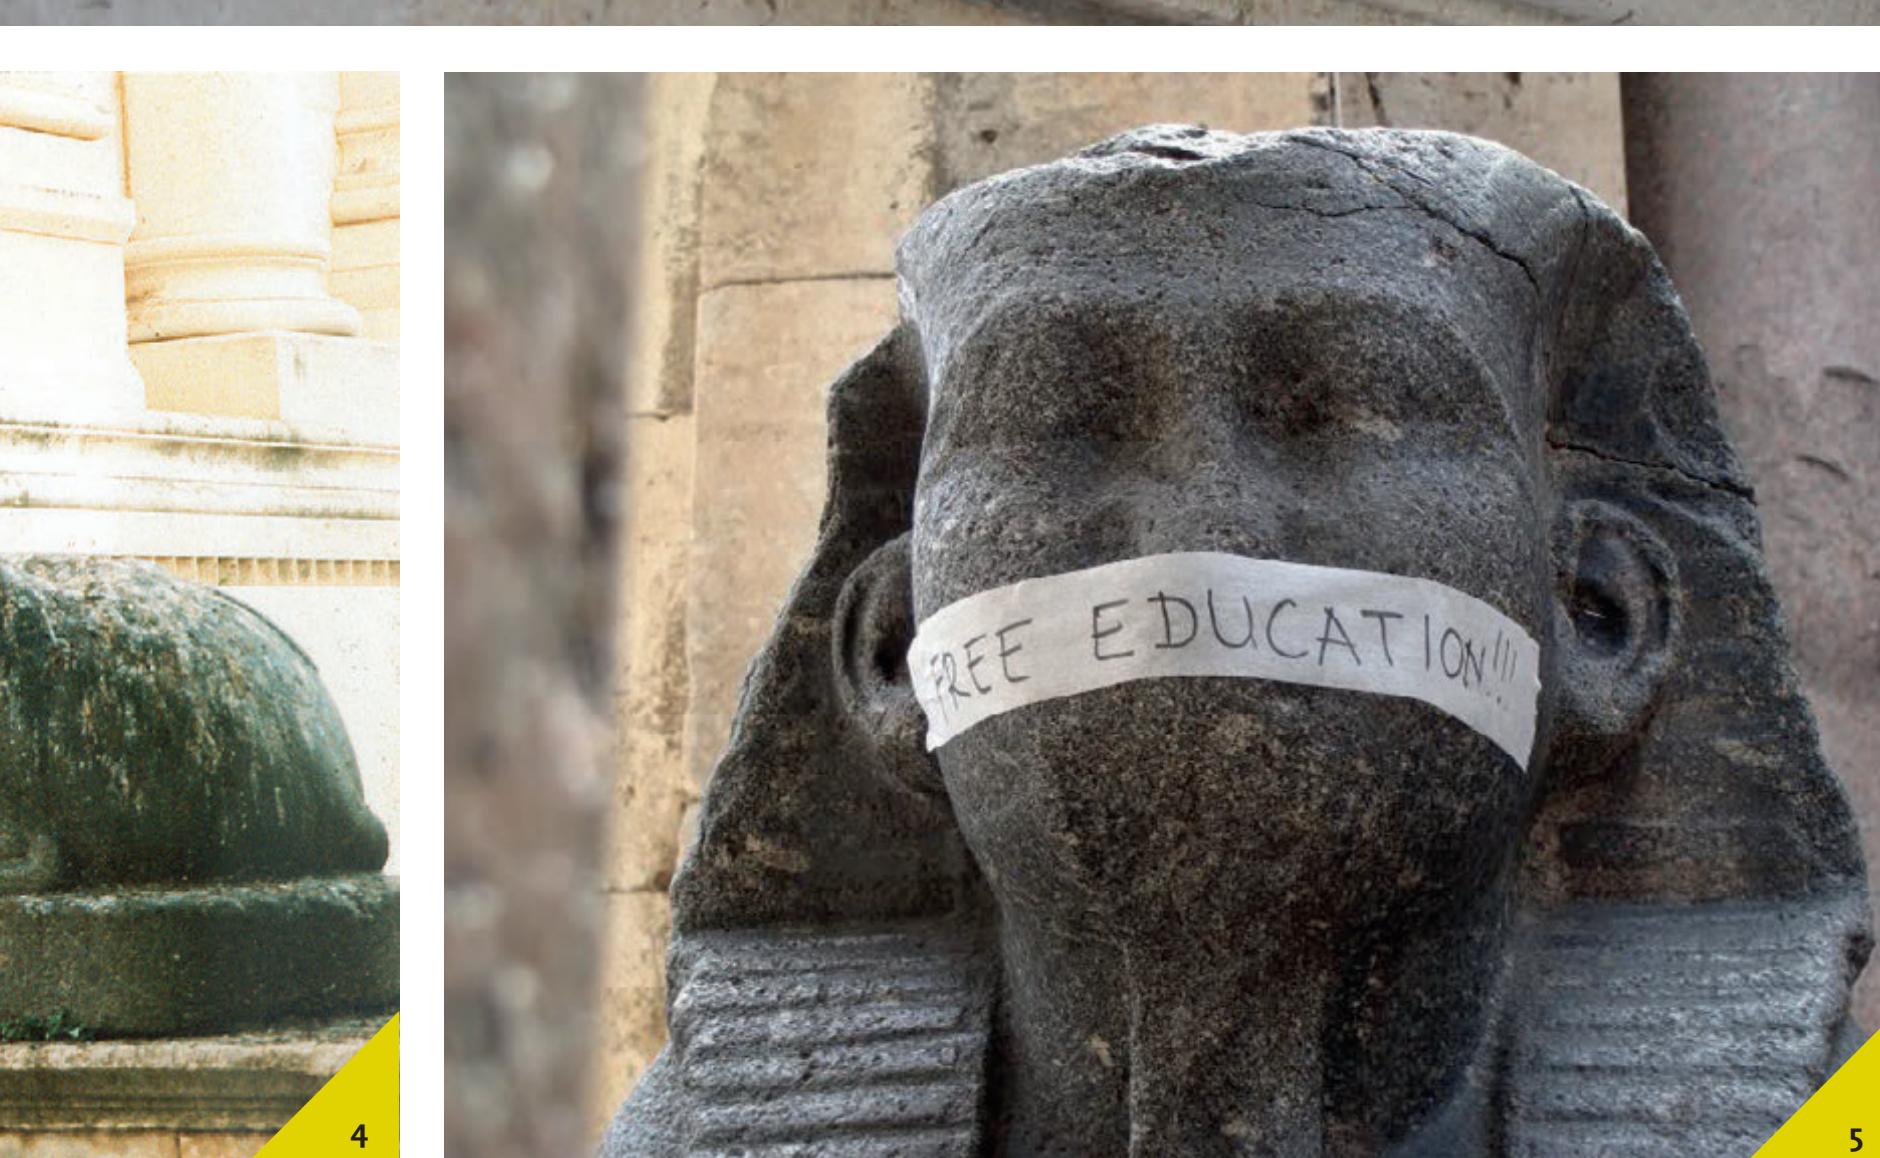
Egipatske skulpture su dio izvornog uređenja Dioklecijanove palače, a većina ih je samo djelomično očuvana. U staroj gradskoj jezgri i splitskim muzejima pronadeno je i sačuvano svega 12 egipatskih sfingi, odnosno njihovih ulomaka. Najlepša i najveća, jedina sačuvana u cijelosti, jest upravo sfinga u jugoistočnom kutu Peristila koja datira iz vremena Tuthmosisa III. Nekoliko znatnih oštećenja na glavi i velika pukotina koja je prepolovila tijelo sfinge nastali su davno, prema predaji, padom kamenja gornjih katova zvonika prilikom udara groma. Moguće je da su oštećenja nastala u obraćunu kršćanstva s poganskim ostacima, kao što su temeljito oštećene sve ostale do sada pronađene sfinge.

Egyptian sculptures belong to the original decoration of Diocletian's Palace, with most of them being only partially preserved. Merely 12 Egyptian sphinxes, or to be more precise their fragments, have been found within the old city core and in museums in Split. The largest and most beautiful, the only one completely preserved, is this sphinx placed in the south-east corner of Peristyle dating from the reign of Thutmose III. According to oral tradition, several significant damages on its head and a large fissure that has split its body in half have been created a long time ago by rocks that fell from the top floors of the bell tower as it was struck by lightning. It is also possible that damages were made as a part of Christian retaliation against pagan remains, the same way as other discovered sphinxes had been thoroughly damaged.

1, 2. SFINGA NA PERISTILU TIJEKOM KONZERVATORSKO-RESTAURATORSKOG ZAHVATA; 3. SFINGA NAKON KONZERVATORSKO-RESTAURATORSKOG ZAHVATA; 4. SFINGA POKRIVENA GOLOBLJIM IZMETOM, POKAZATELJ NEBRIGE, POČ. 20. ST.; 5. INTERVENCIJA NA SFINGI PRILIKOM PERFORMANSA „SV. DUJE ZA BESPLATNO OBRAZOVANJE“, 16.05.2009.; 6. SFINGA PRIJE KONZERVATORSKO-RESTAURATORSKOG ZAHVATA

1. THE PERISTYLE SPHINX DURING CONSERVATION-RESTORATION TREATMENT; 2. THE SPHINX AFTER CONSERVATION-RESTORATION TREATMENT; 3. THE SPHINX COVERED WITH PIGEON DROPPINGS, INDICATOR OF NEGLECT AT THE BEGINNING OF THE 20TH CENTURY; 5. THE SPHINX DURING PERFORMANCE "ST. DOMNIO FOR FREE EDUCATION", 16.05.2009.; 6. THE SPHINX BEFORE CONSERVATION-RESTORATION TREATMENT

U međuvremenu, za potrebe prezentacije i praćenja stanja skulpture izrađen je odjev s sfinge. Mnogo bolje nego na izvornoj skulpturi, gdje sjene zbog tamne boje kamena nisu tako izrazite, na odjelu od svjetlog materijala uočavaju se najsjajniji detalji površine kao što su oštećenja i spomenuti reljefi, ali su po prvi puta započeni i hijeroglifi na prednjoj strani koji su na izvornom mjestu zaklonjeni susjednim stupom kolonade. Ankh-det ili „vjekan života“, kako je hijeroglif na novootkrivenome reljefu protumačio egipatolog Igor Uranić, simbolična je poveznica s dugovječnošću skulpture koja je znatno starija od Peristila.

Meanwhile, a cast of the sphinx has been created for the needs of presentation and monitoring. The cast, created in light material shows much better surface details than the original dark stone. In addition to the aforementioned damages and reliefs, for the first time hieroglyphs on the front side have been detected, originally hidden by the adjacent column. Ankh-det or „the eternal life“ is how the newly discovered relief was interpreted by Igor Uranić, an Egyptologist. It can also be symbolically related to sculpture's own longevity, being considerably older than Peristyle itself.
