## Na završetku desetljeća obnove Peristila

## At the end of a Decade of the Peristyle Restoration

The conservation and restoration work on the Peristyle of Diocletian's Palace has been in many ways the most important project in recent period within the scope of renovation of the historical core of the town of Split. The Peristyle is the centre and the most impressive part of the imperial palace, and also the heart of the town which has grown around it. The square, which reflects historical layers of the creation and development of the town, has become its symbol and its main tourist attraction. It serves as the most attractive backdrop for cultural events, and a stage at which public life evolves.

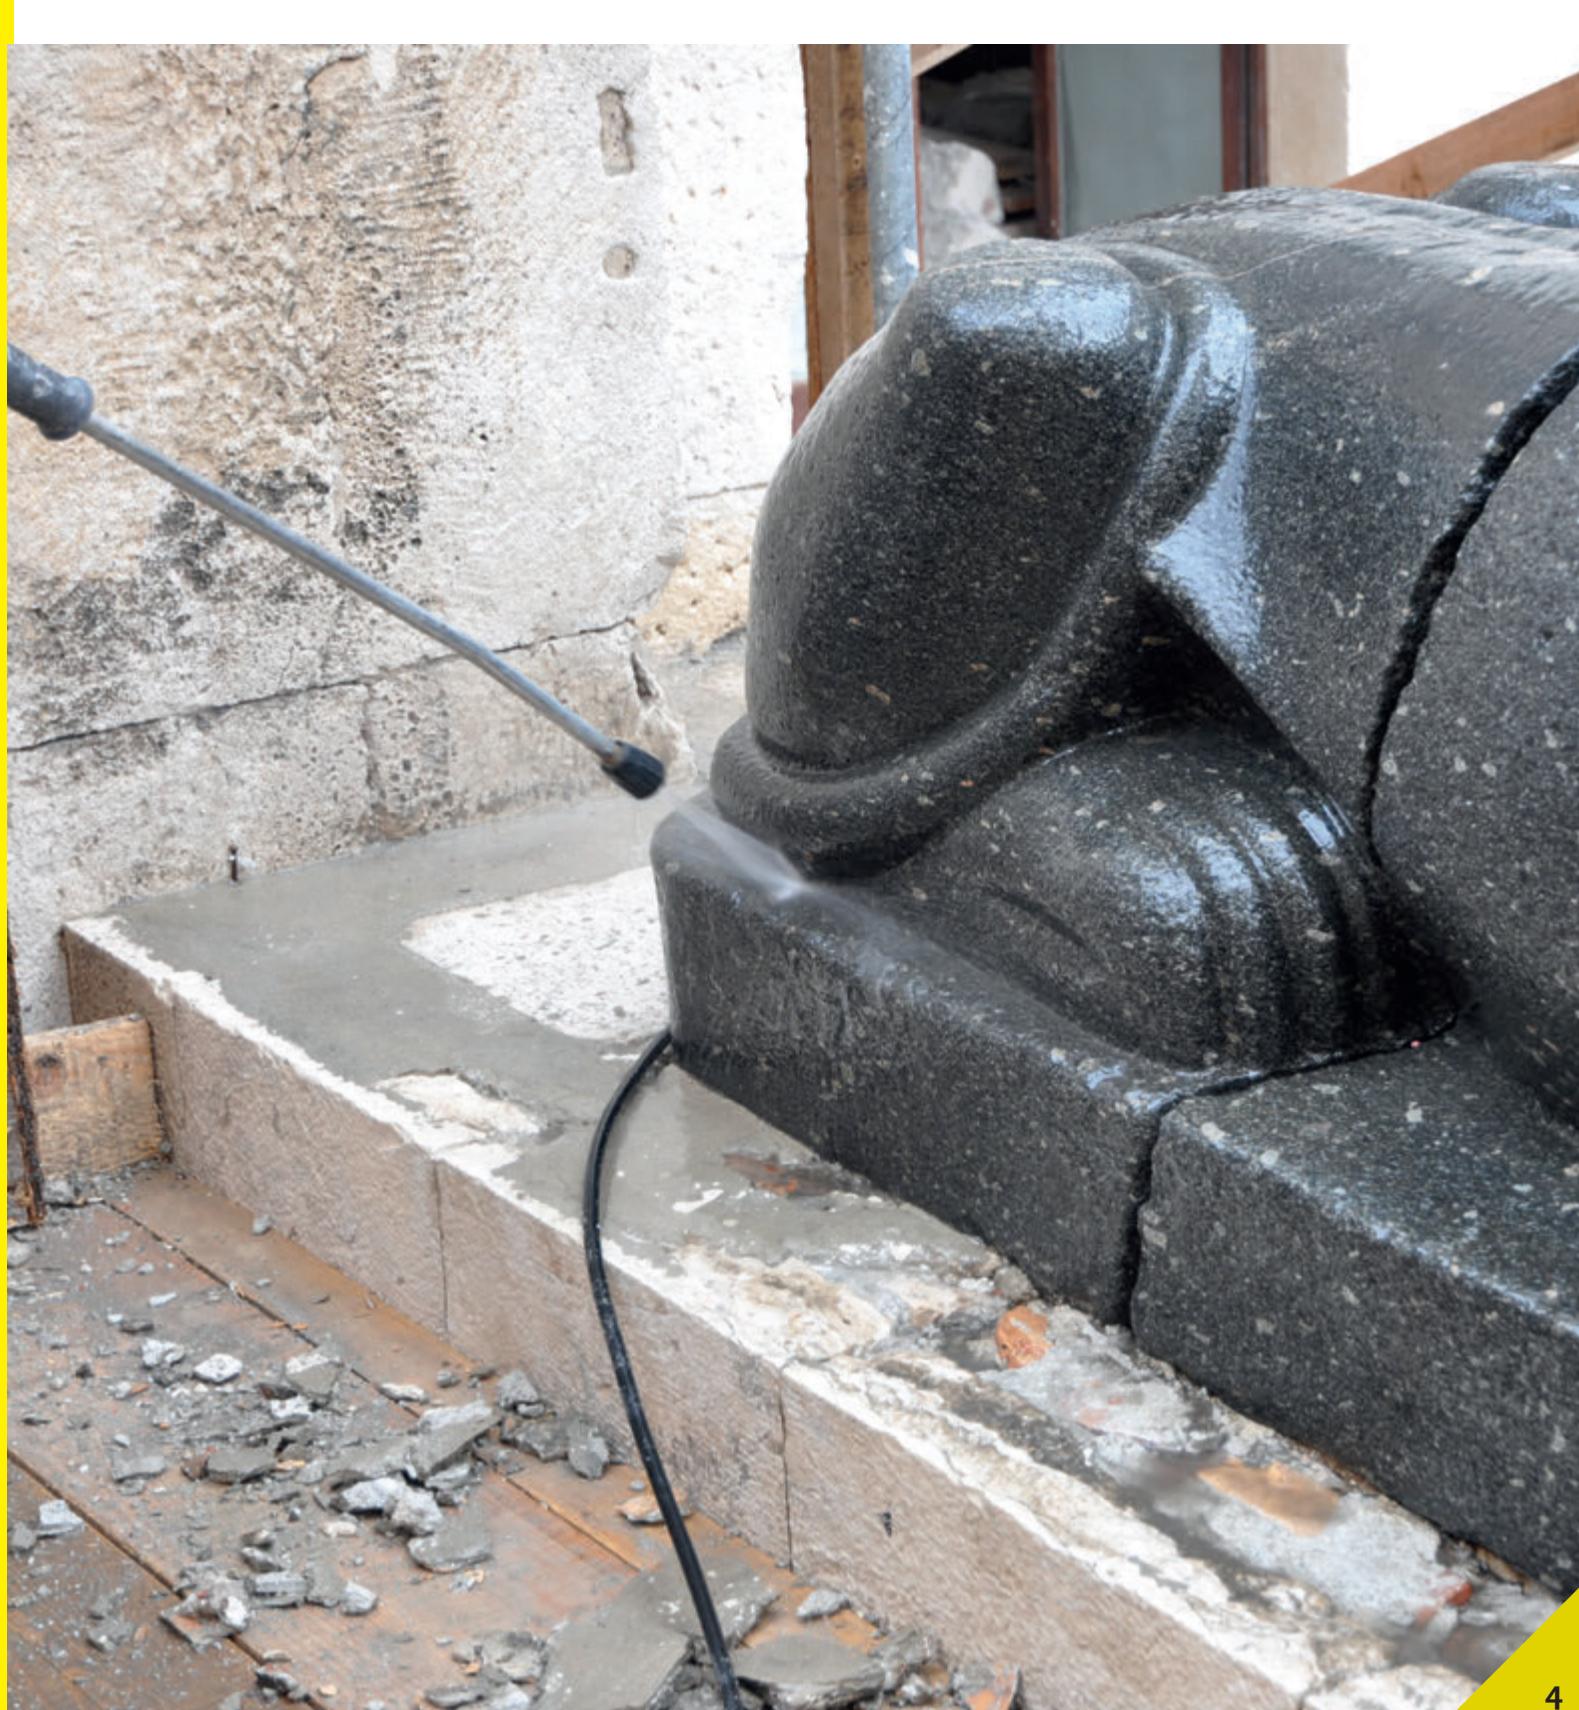
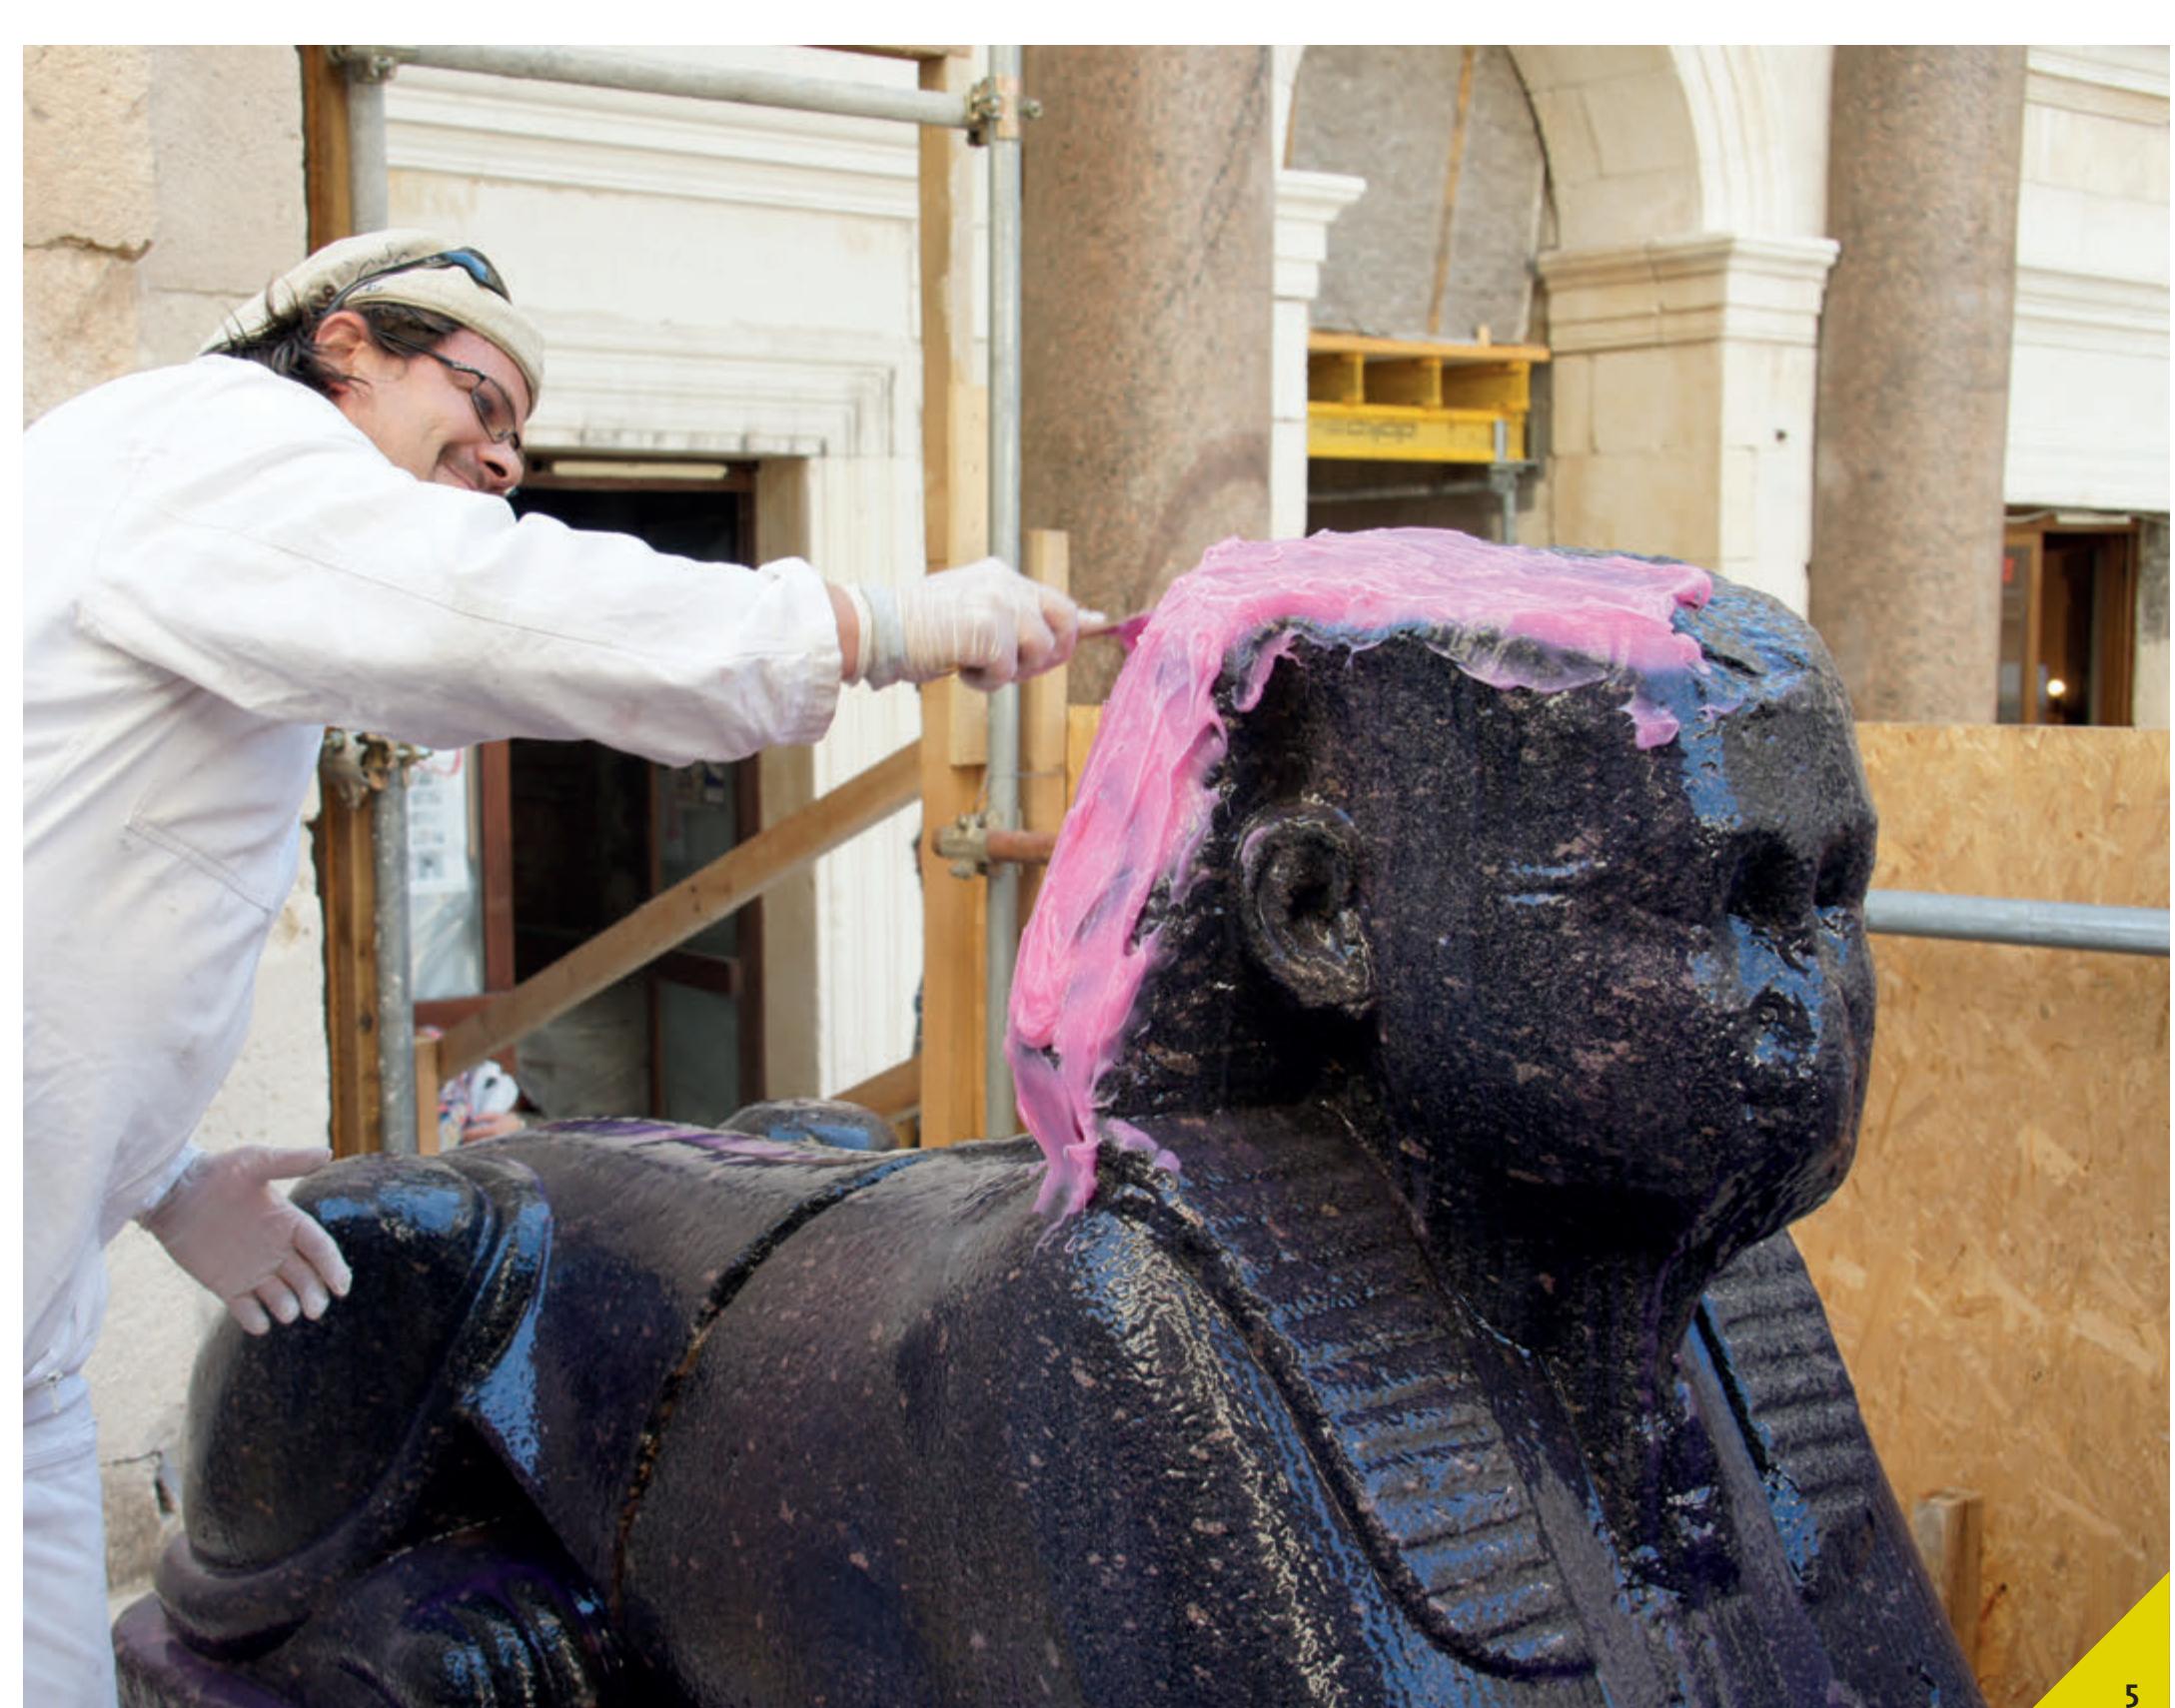
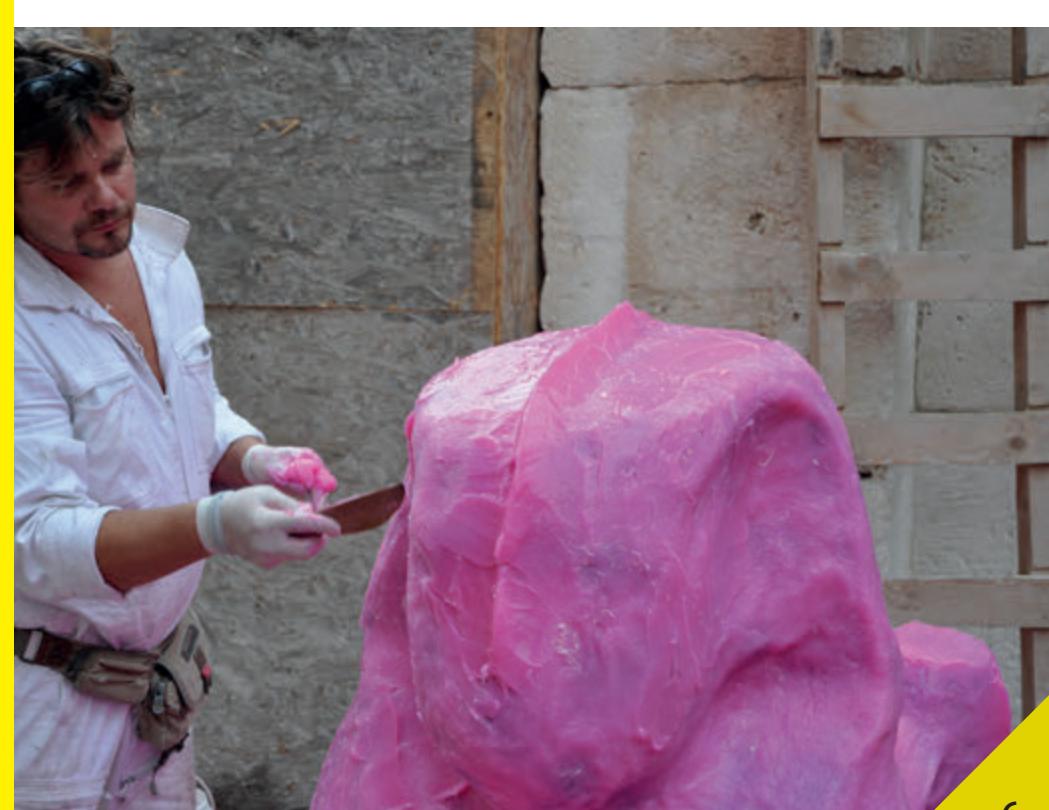
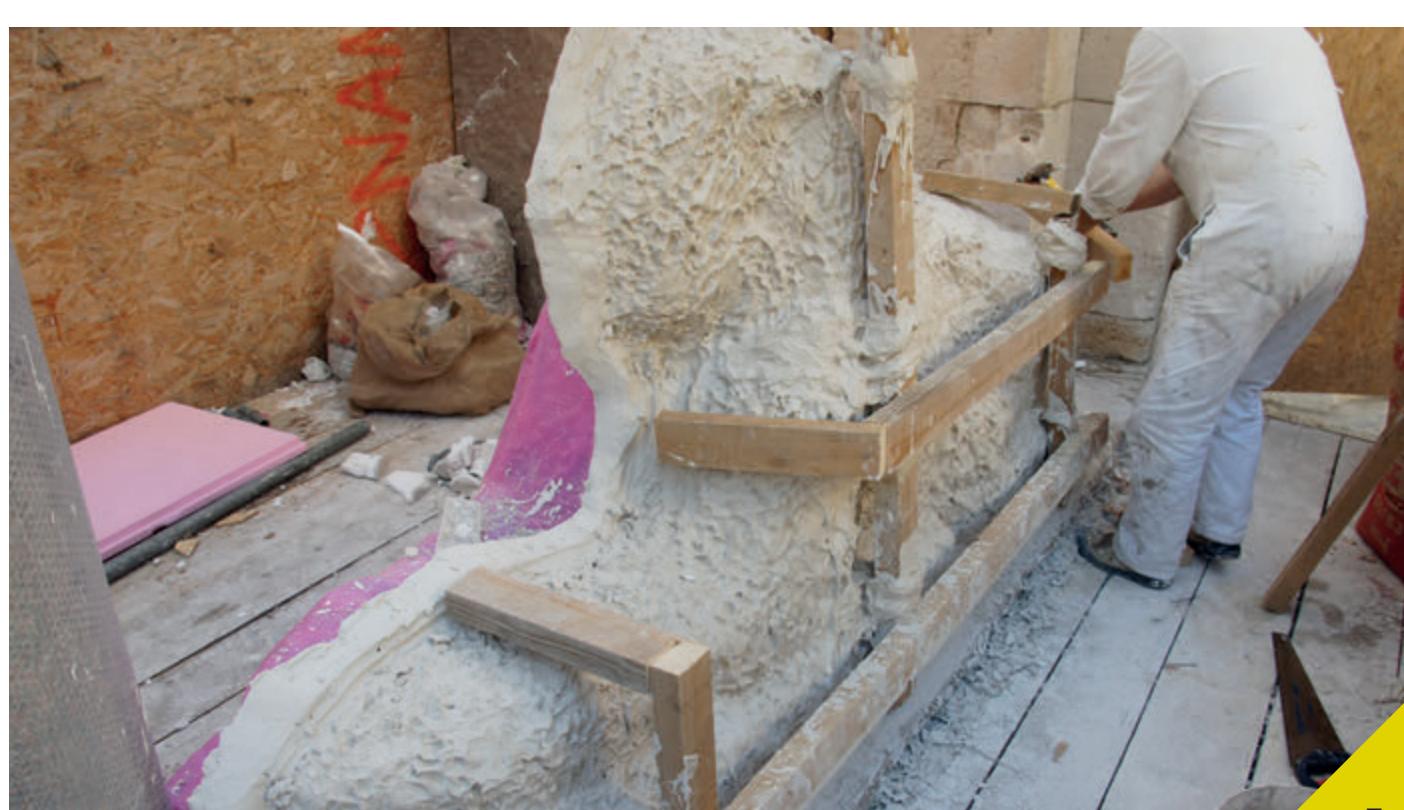
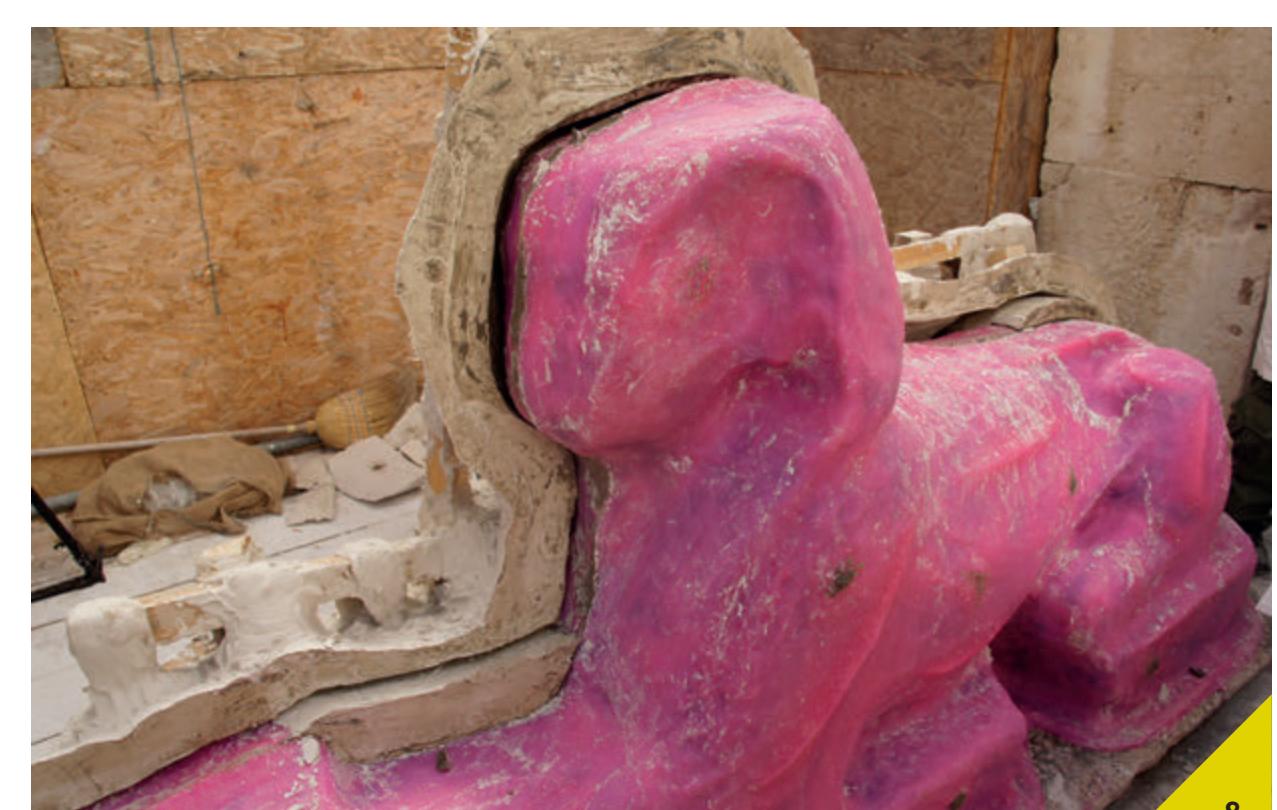
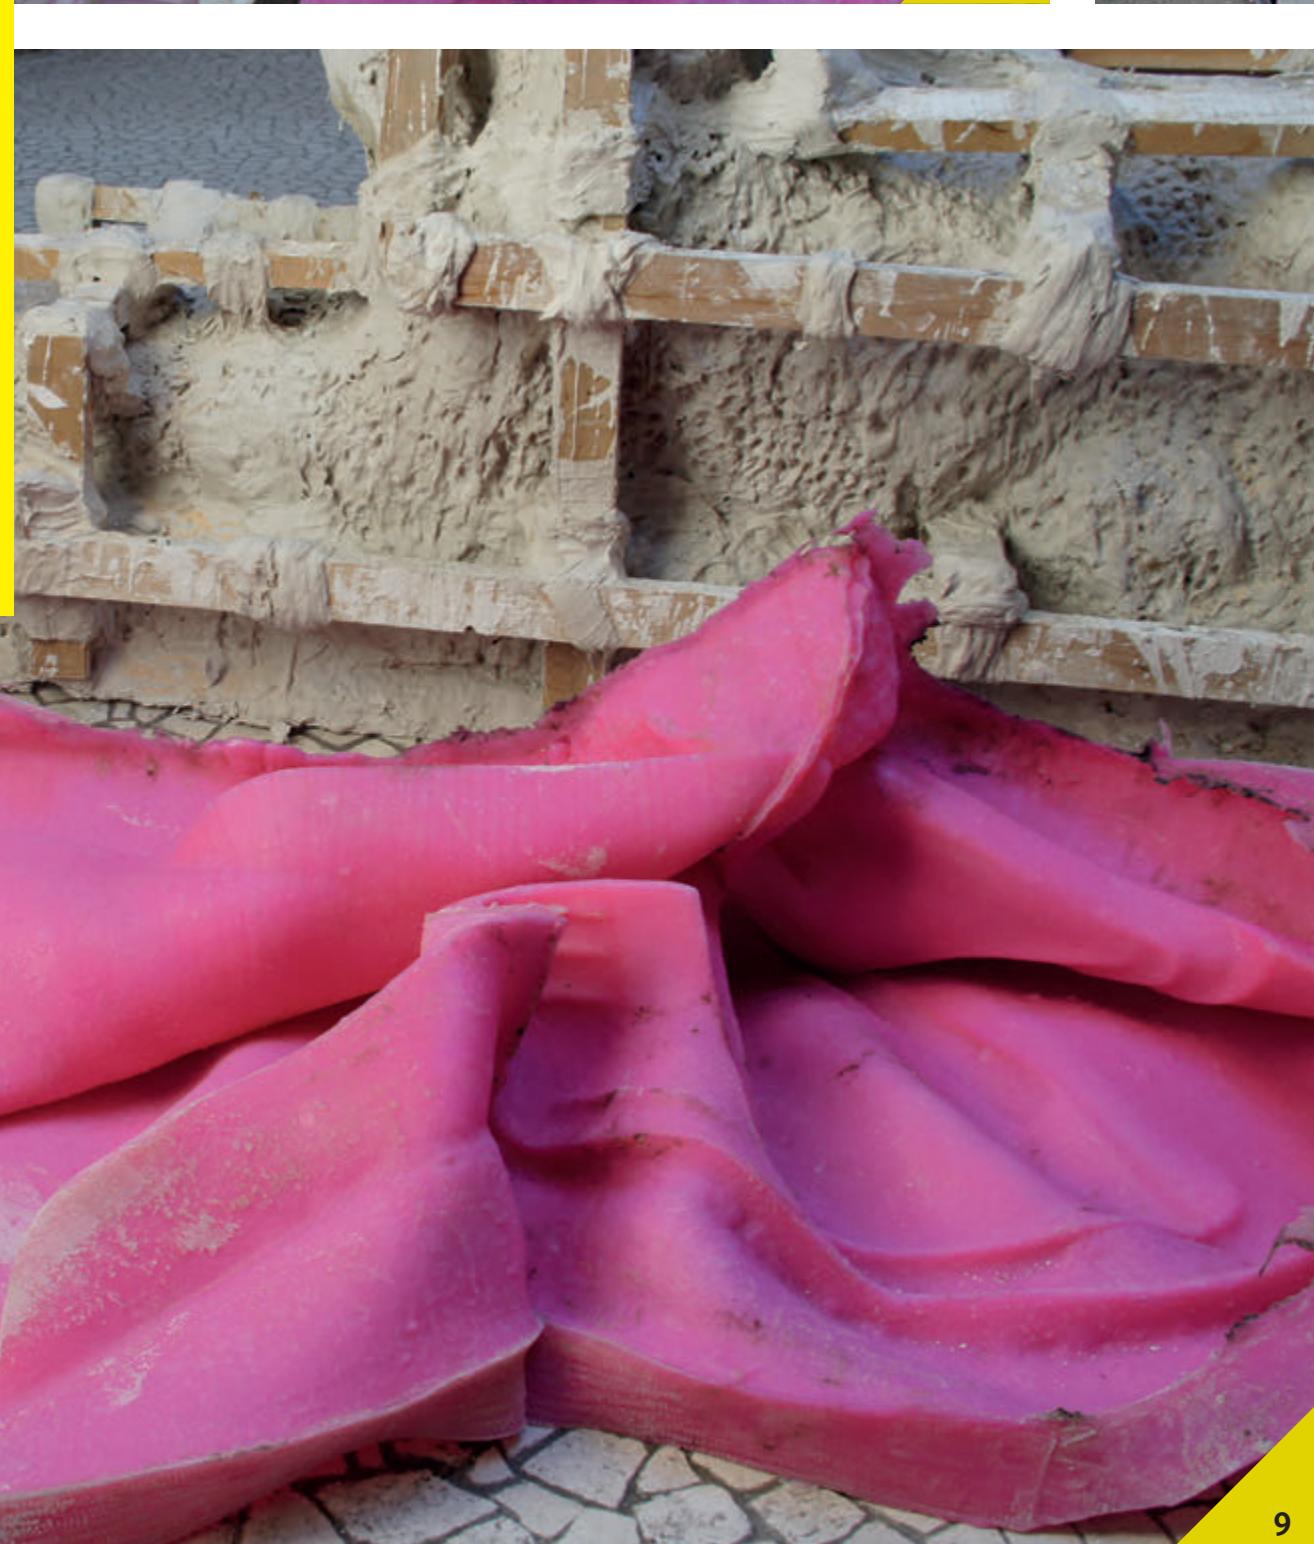
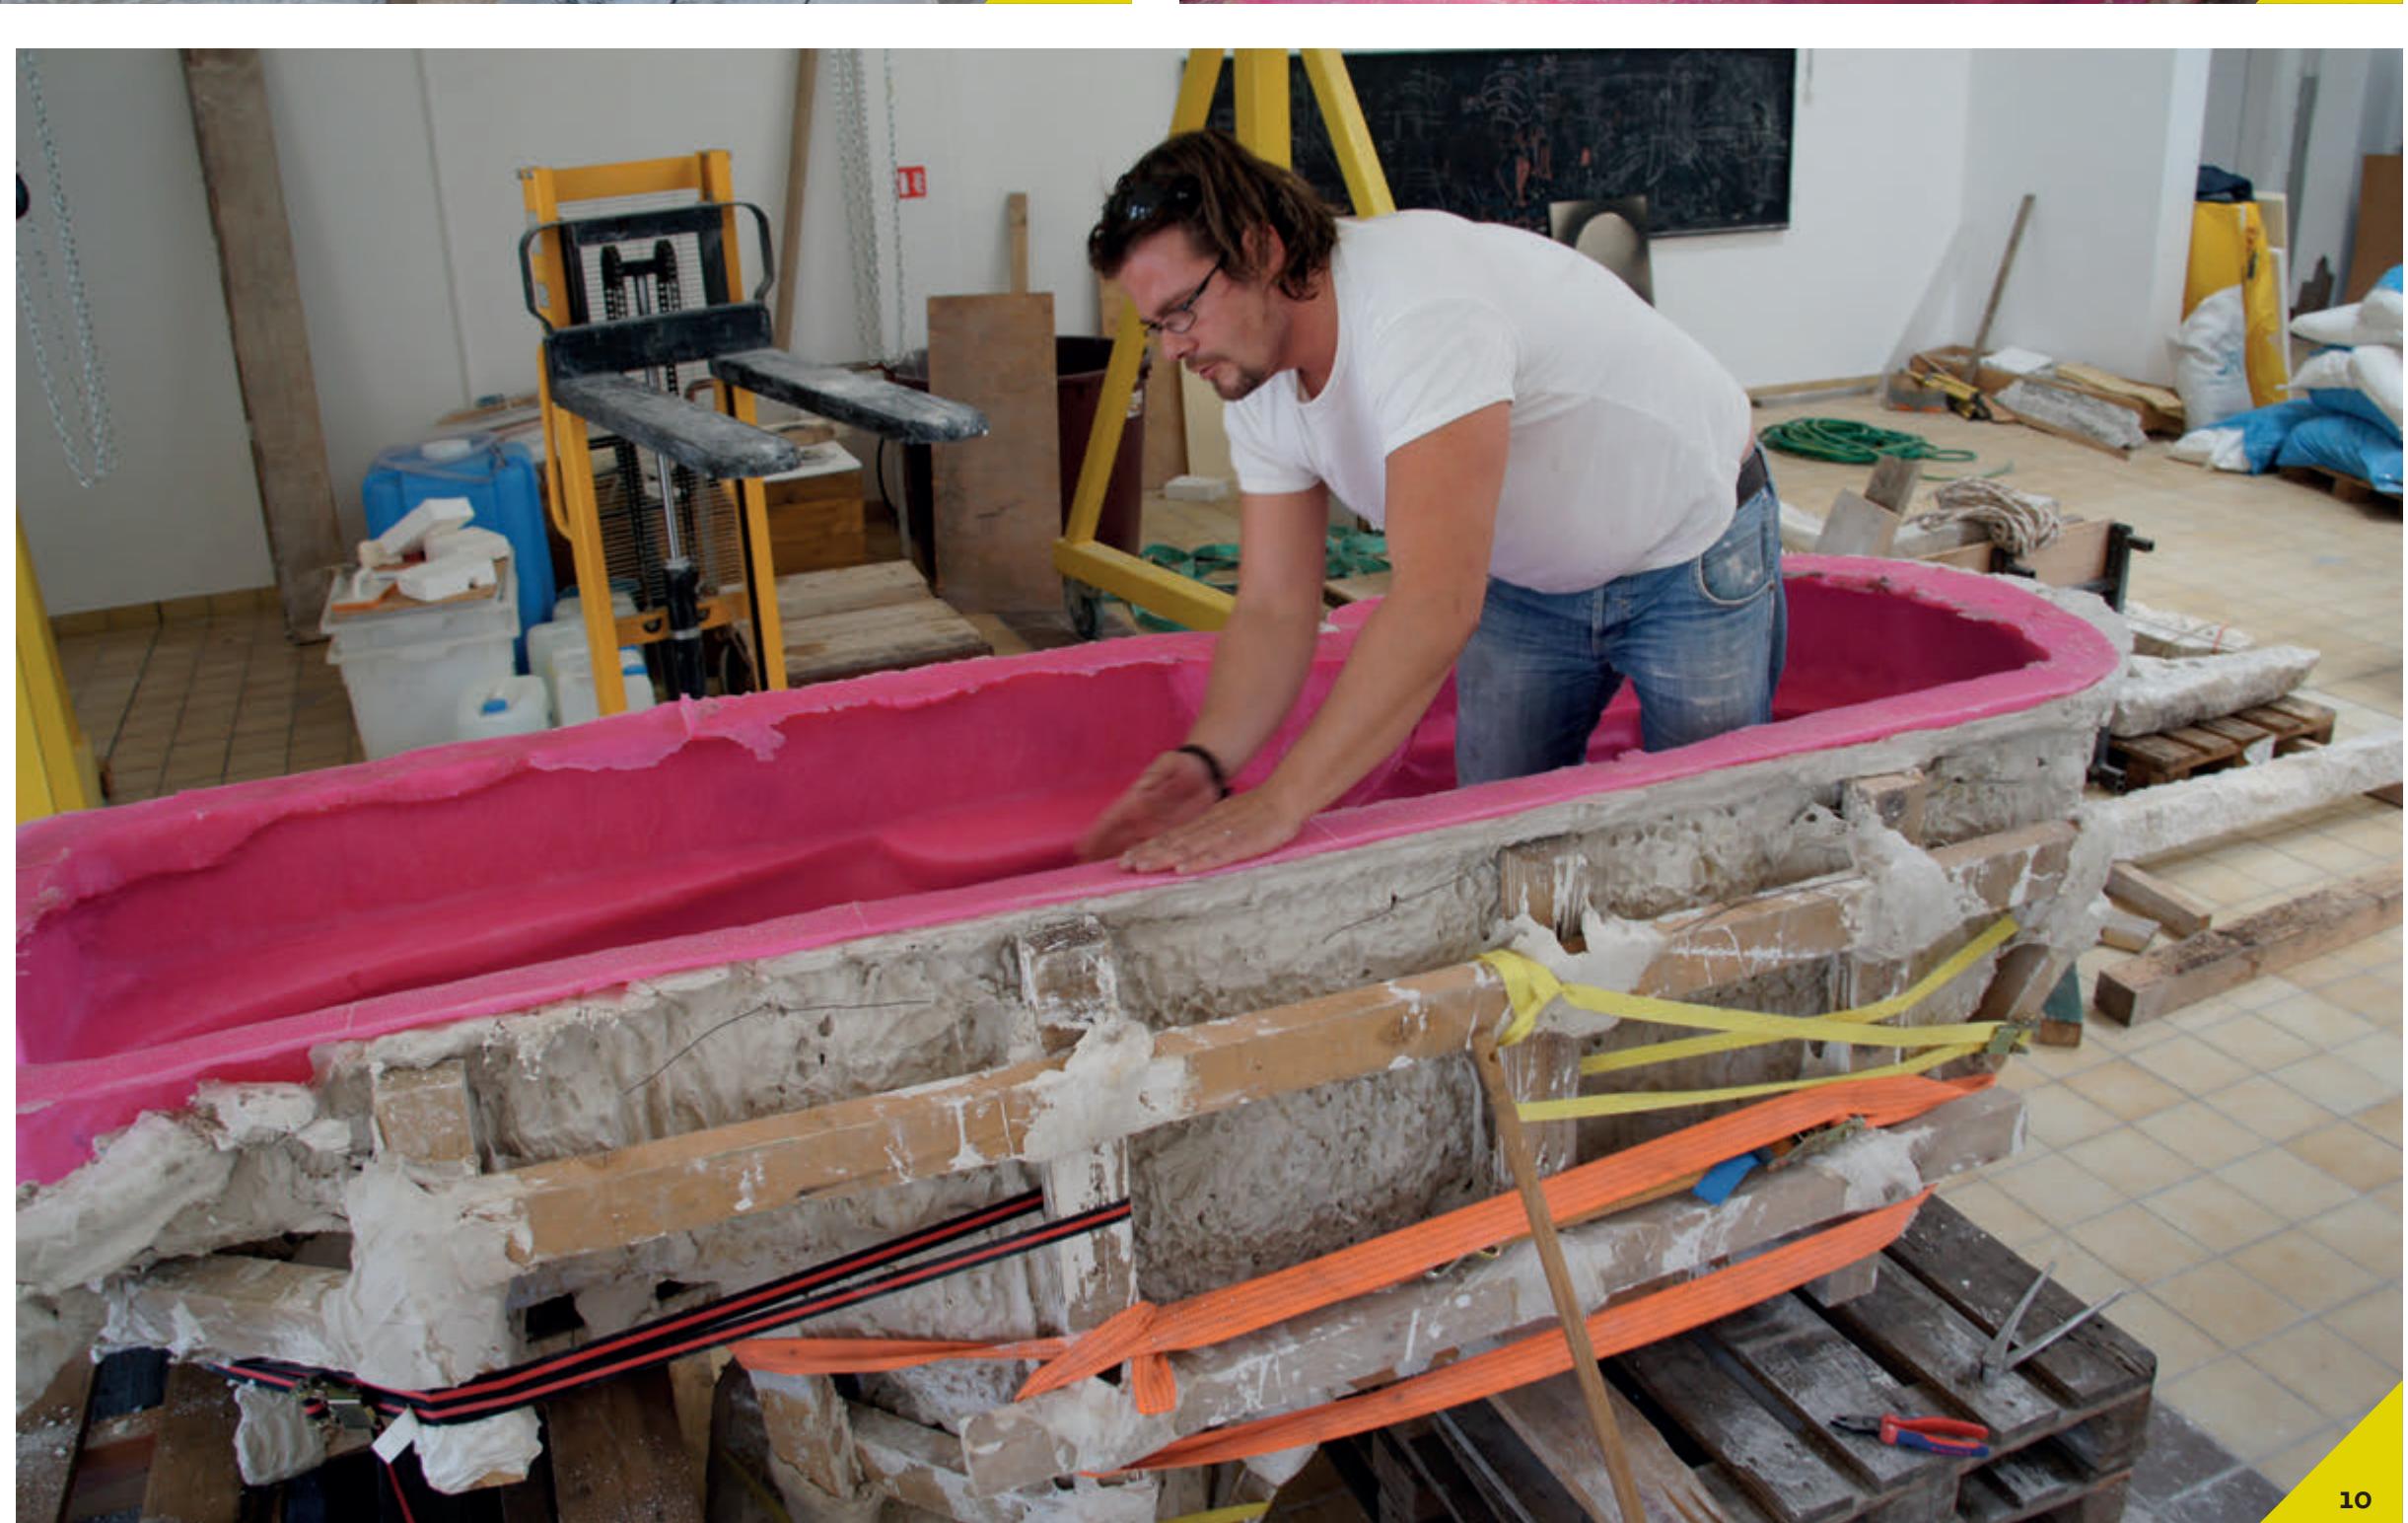
1, 2, 3. ODLJEV SFINGE SA PERISTILA; 4. PRANJE SPHINXE PRIJE NANOŠENJA SILIKONSKE GUME ZA UZIMANJE OTISKA; 5, 6. NANOŠENJE SILIKONSKIE GUME NA SPHINX; 7, 8. IZRADA GIPSANE KAPE; 9. SILIKONSKA GUMA NAKON UKLANJANJA SA SPHINXE; 10. UMETANJE SILIKONSKOG KALUPA U GIPSANU KAPU PRIJE LIJEVANJA ODLJEVA SFINGE

1, 2, 3. REPLICA OF THE PERISTYLE SPHINX; 4. WASHING THE SPHINX BEFORE APPLYING SILICONE RUBBER; 5, 6. APPLYING SILICONE RUBBER ON TO THE SPHINX; 7, 8. MAKING PLASTER JACKET; 9. SILICONE RUBBER AFTER REMOVAL FROM THE SPHINX; 10. INSERTING SILICON MOULD INTO THE PLASTER JACKET BEFORE CASTING THE SPHINX

Sfinga sa Peristila je izuzetno složena za uzimanje otiska zbog njezinog razvedenog volumena cije duboko zavučene šupljine otežavaju izvlačenje kalupa. Kalup se sastoji od silikonske gume "Alpa-Sil MF-3" koja ima izvanredna mehanička svojstva, te dvostrukne gipsane kape. Tekuća guma je četkom nanesena na sfingu nakon izoliranja njezinene površine pH neutralnom sapunicom kako bi se olakšalo odvajanje silikonskog kalupa. Nakon ovog prvog sloja, u silikonsku gumu je dodan uglašivač pomoću kojeg je ona postala pastozna pa se mogla nanositi drvenom špatulom.

Metal clasps previously inserted in silicone mould and plaster fillers, have been isolated with clay so that plaster could be applied without the possibility of fusion. After applying the first layer of plaster, hemp fibres were added that made the plaster jacket stronger. Both parts of the plaster jacket have been reinforced with wooden bars to secure its transport and handling.

When the plaster jackets were dry, they were separated from the silicone mould which was then removed from the sphinx like a rubber glove. After the transport to the workshop of the Croatian Conservation Institute, plaster jackets were reassembled again and plaster fillers were connected to them through their clasps with a wire. Silicon mould was inserted and attached with a wire to the jackets. The outer layer of the sphinx's replica was made of "Acrylstar" material that consists of water-based acrylic resin and mineral crystals. The inner layer was made of plaster, further reinforced with wooden construction. After drying the jackets were separated, silicone mould removed and the replica of the sphinx first saw the light of the day. Working with high-quality silicon rubber has enabled faithful reproduction of the tiniest details from the surface of the sphinx.
