## Na završetku desetljeća obnove Peristila

## At the end of a Decade of the Peristyle Restoration

The conservation and restoration work on the Peristyle of Diocletian's Palace has been in many ways the most important project in recent period within the scope of renovation of the historical core of the town of Split. The Peristyle is the centre and the most impressive part of the imperial palace, and also the heart of the town which has grown around it. The square, which reflects historical layers of the creation and development of the town, has become its symbol and its main tourist attraction. It serves as the most attractive backdrop for cultural events, and a stage at which public life evolves.

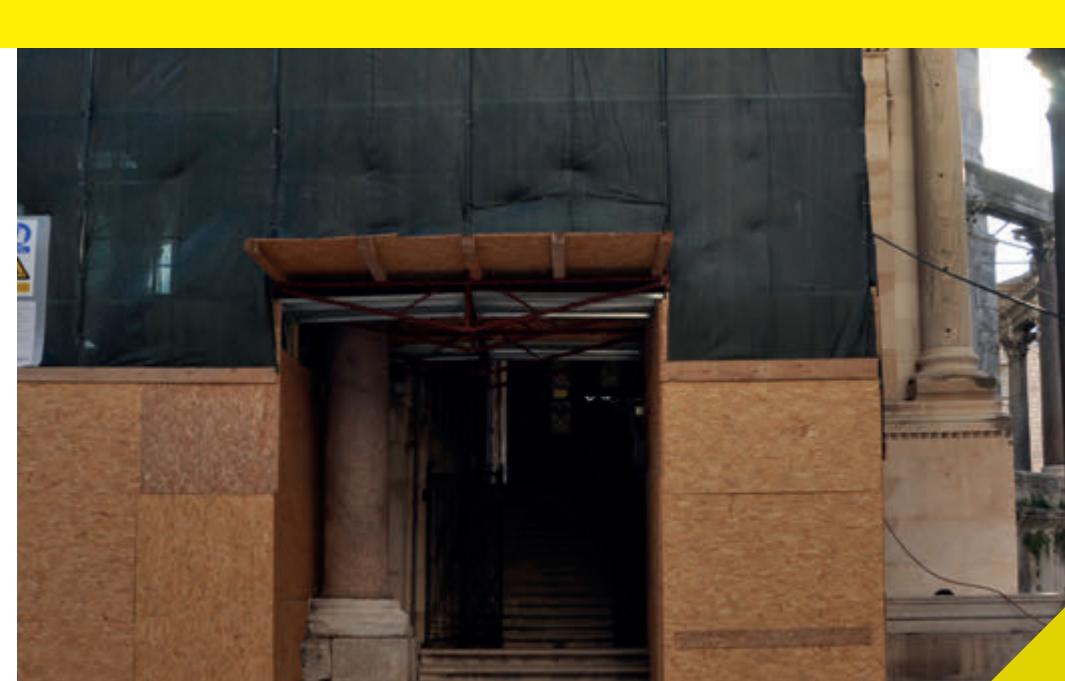
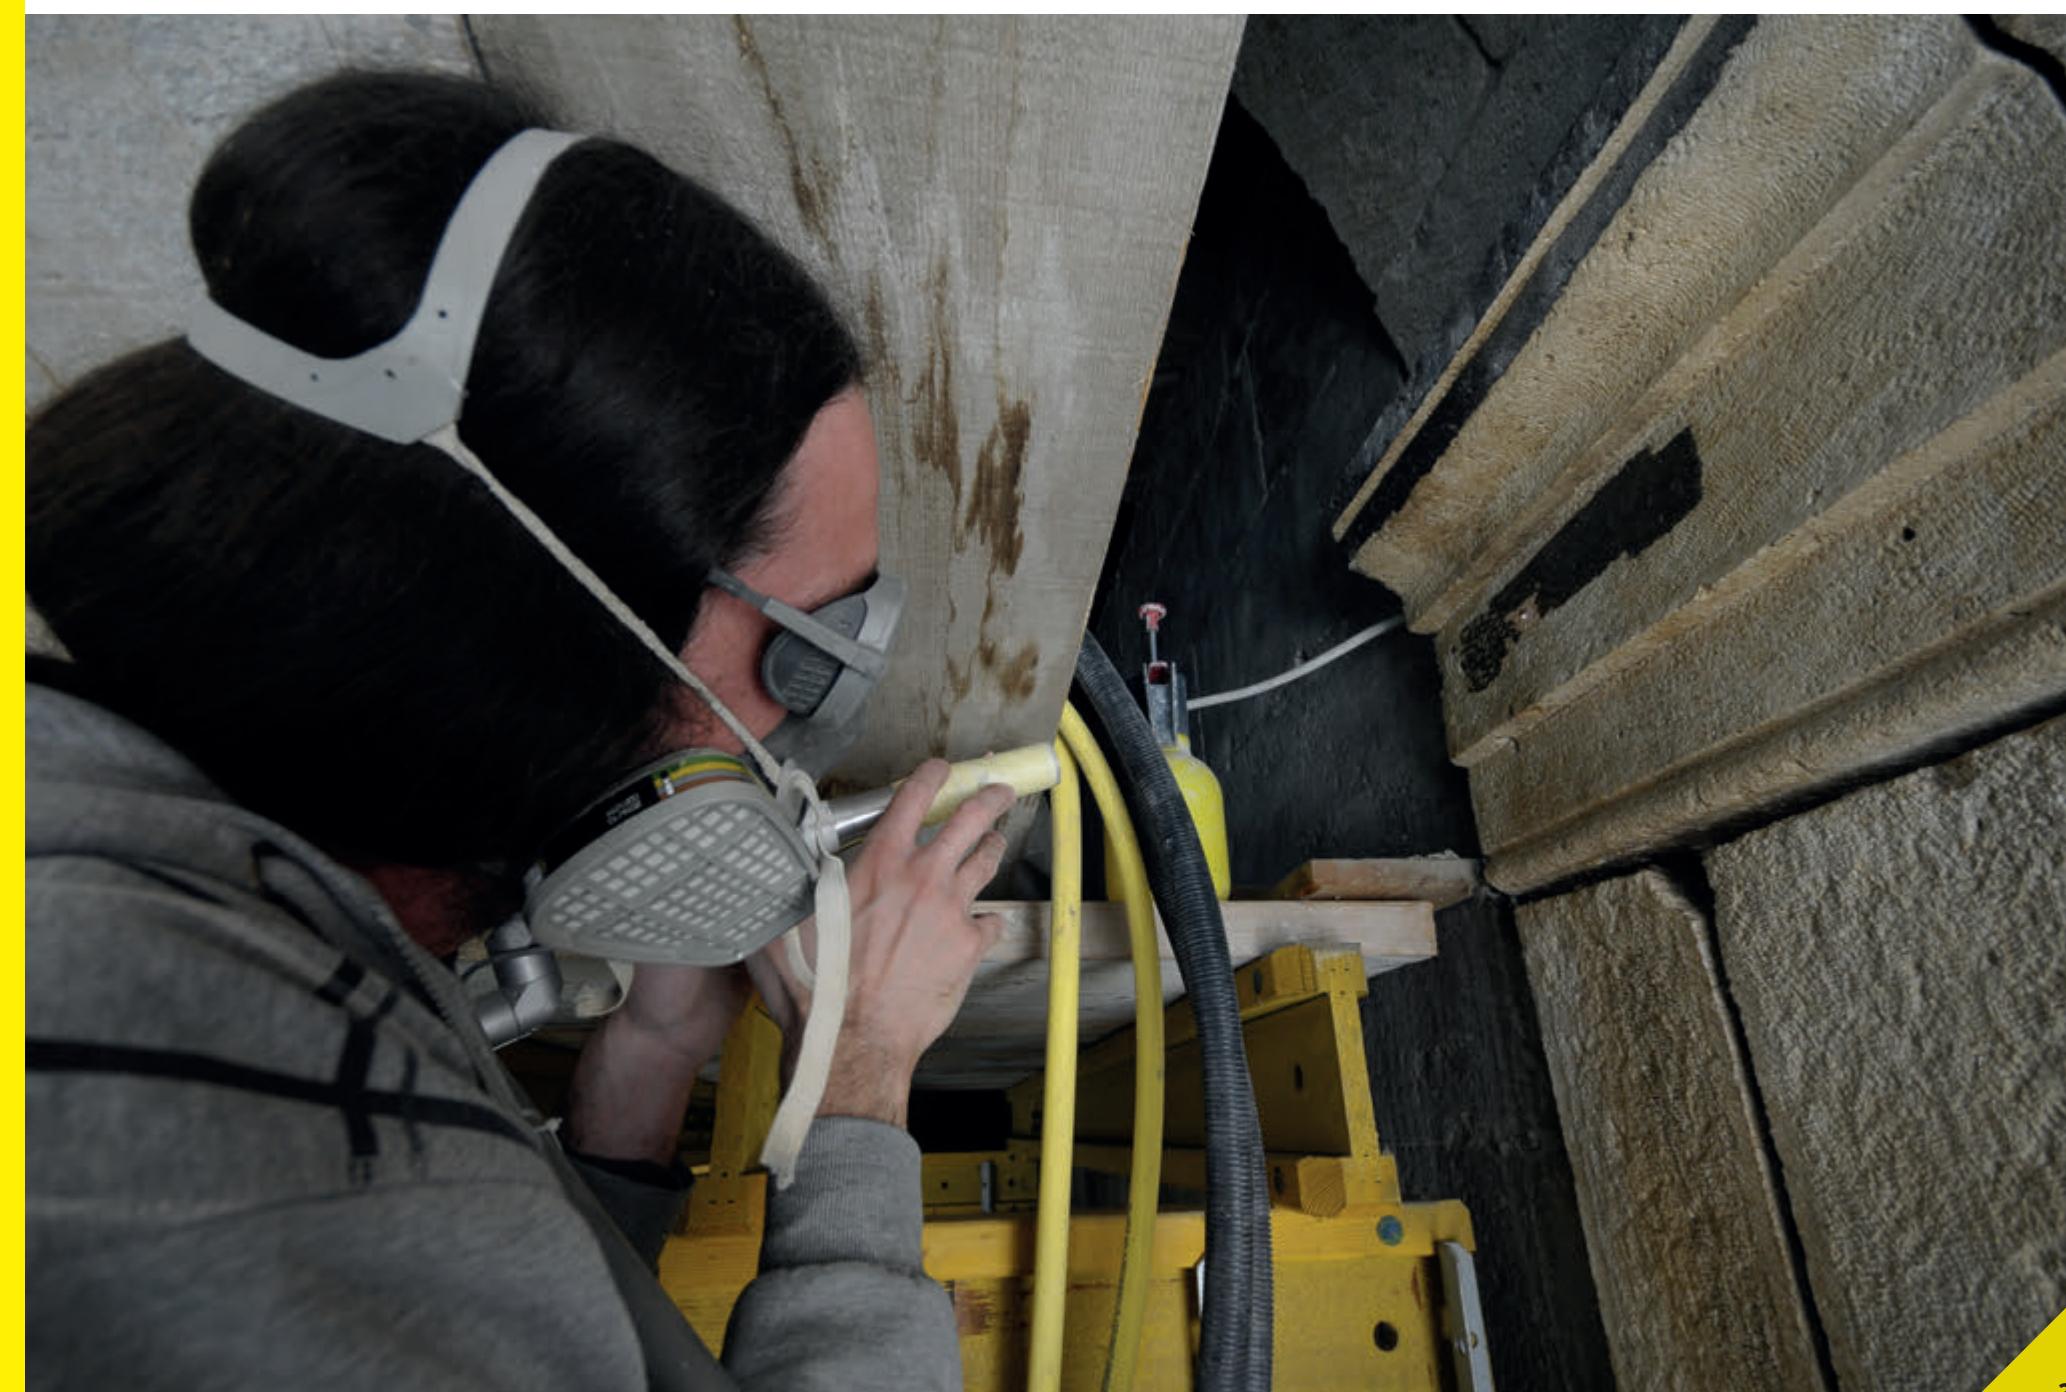
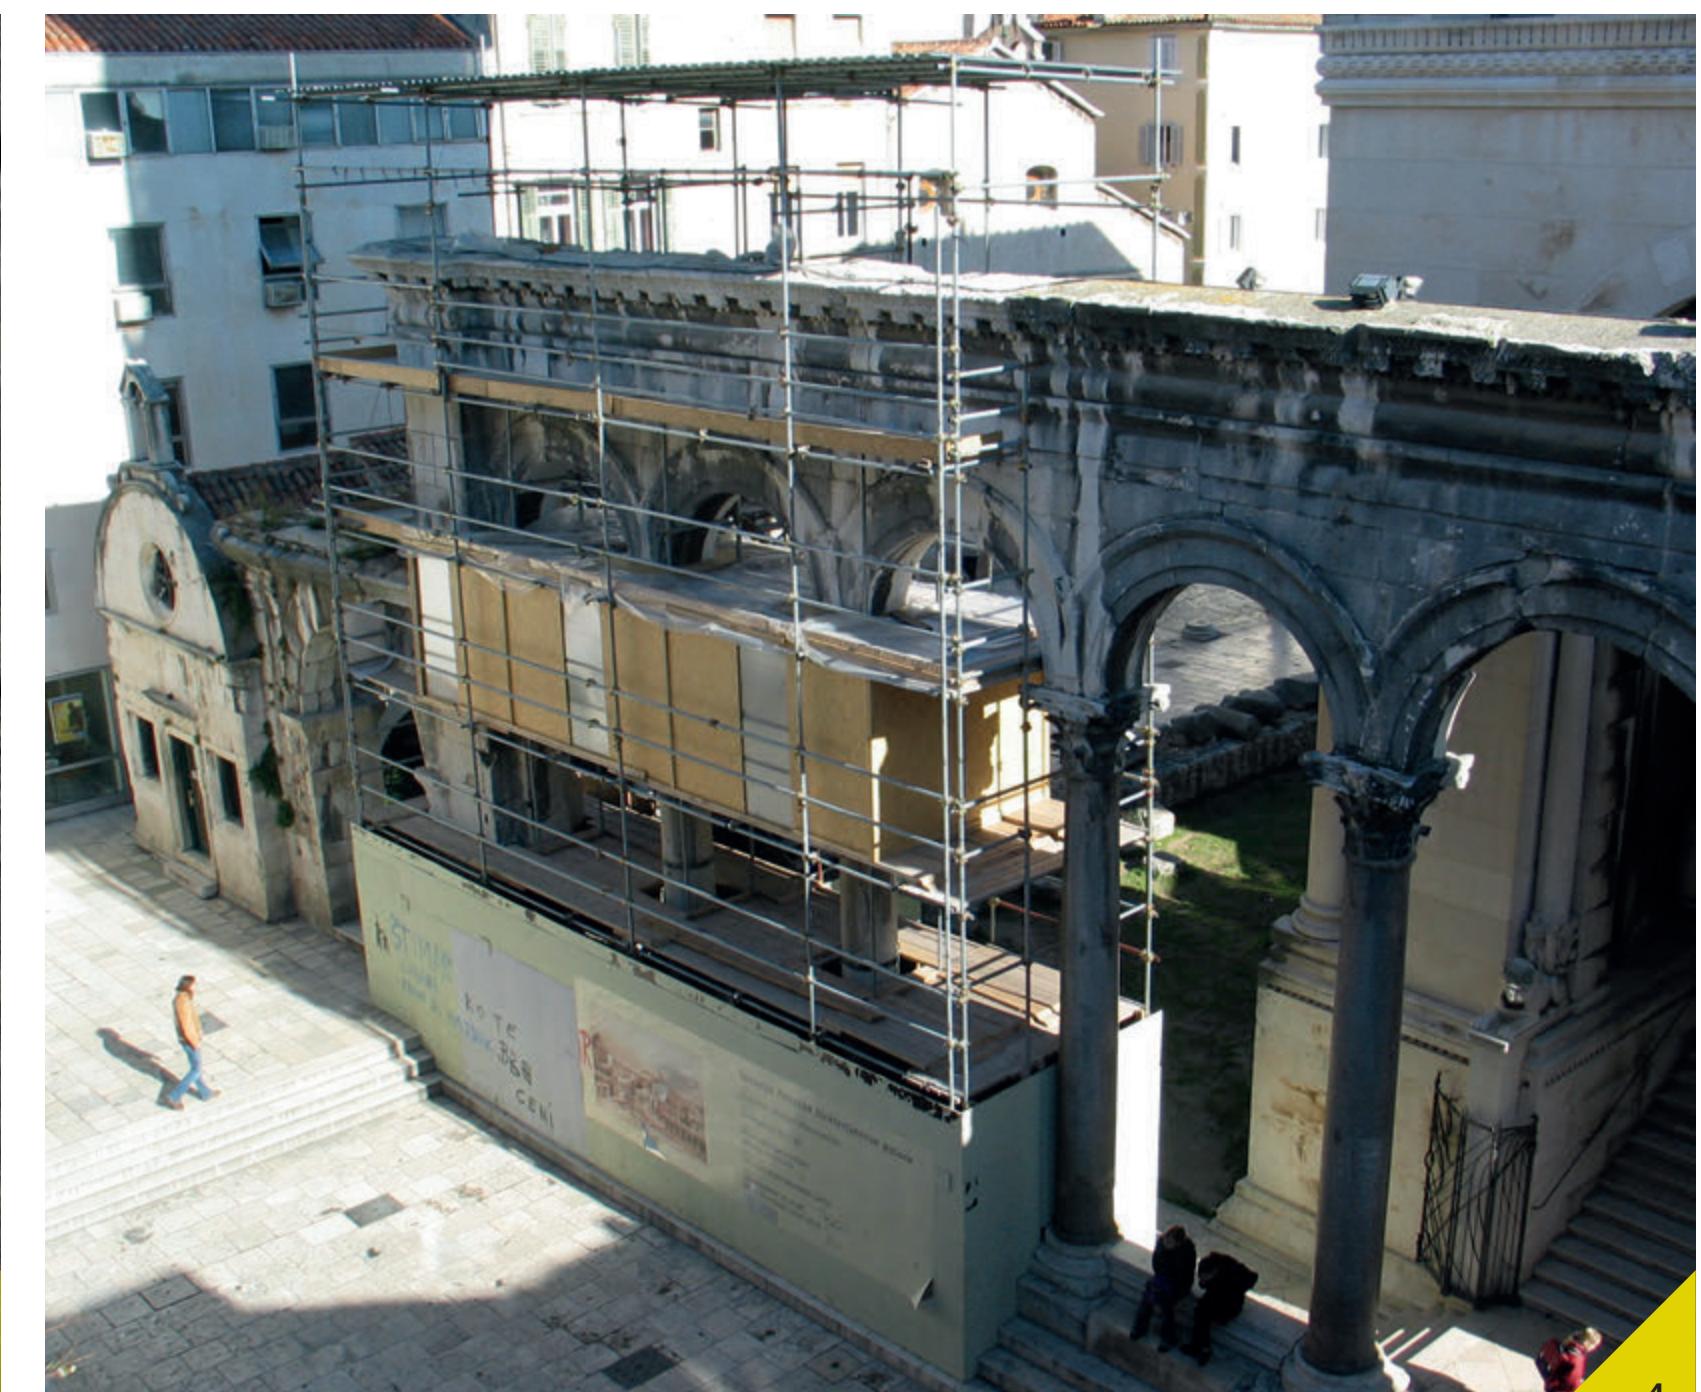
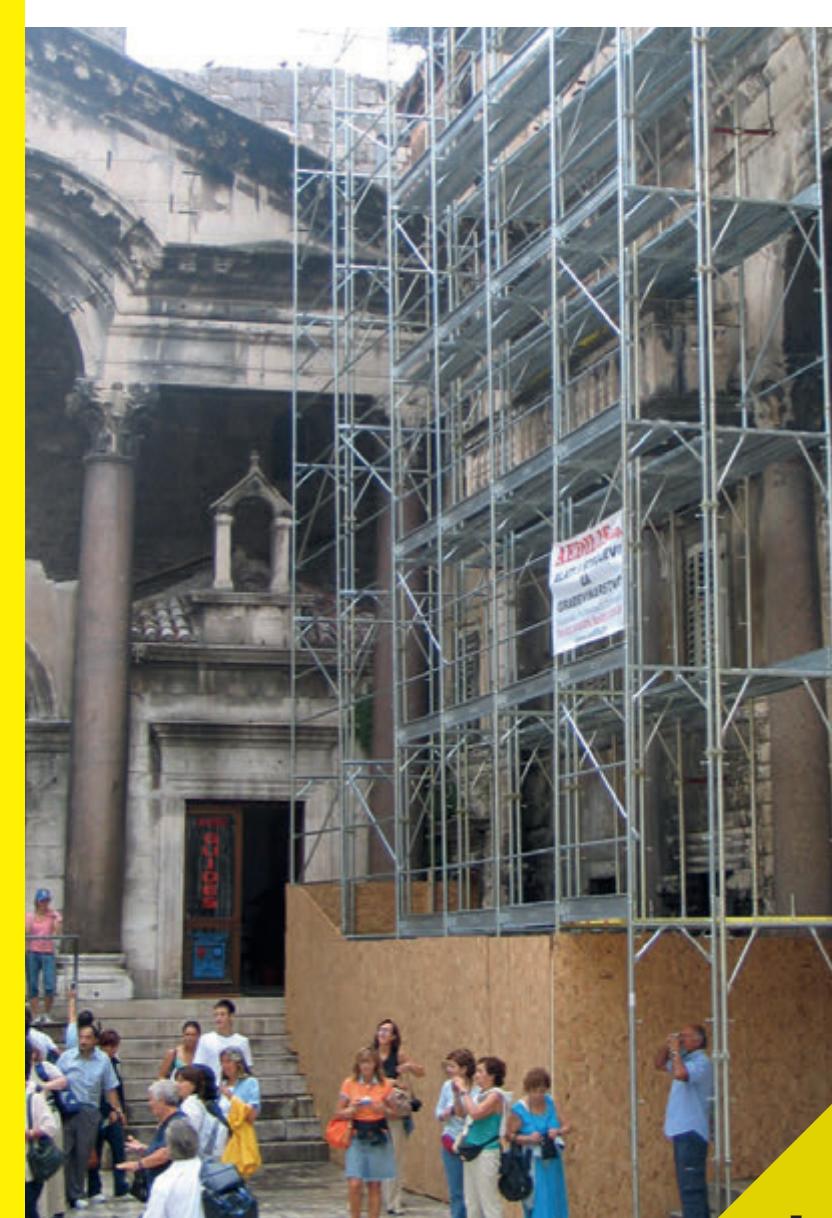
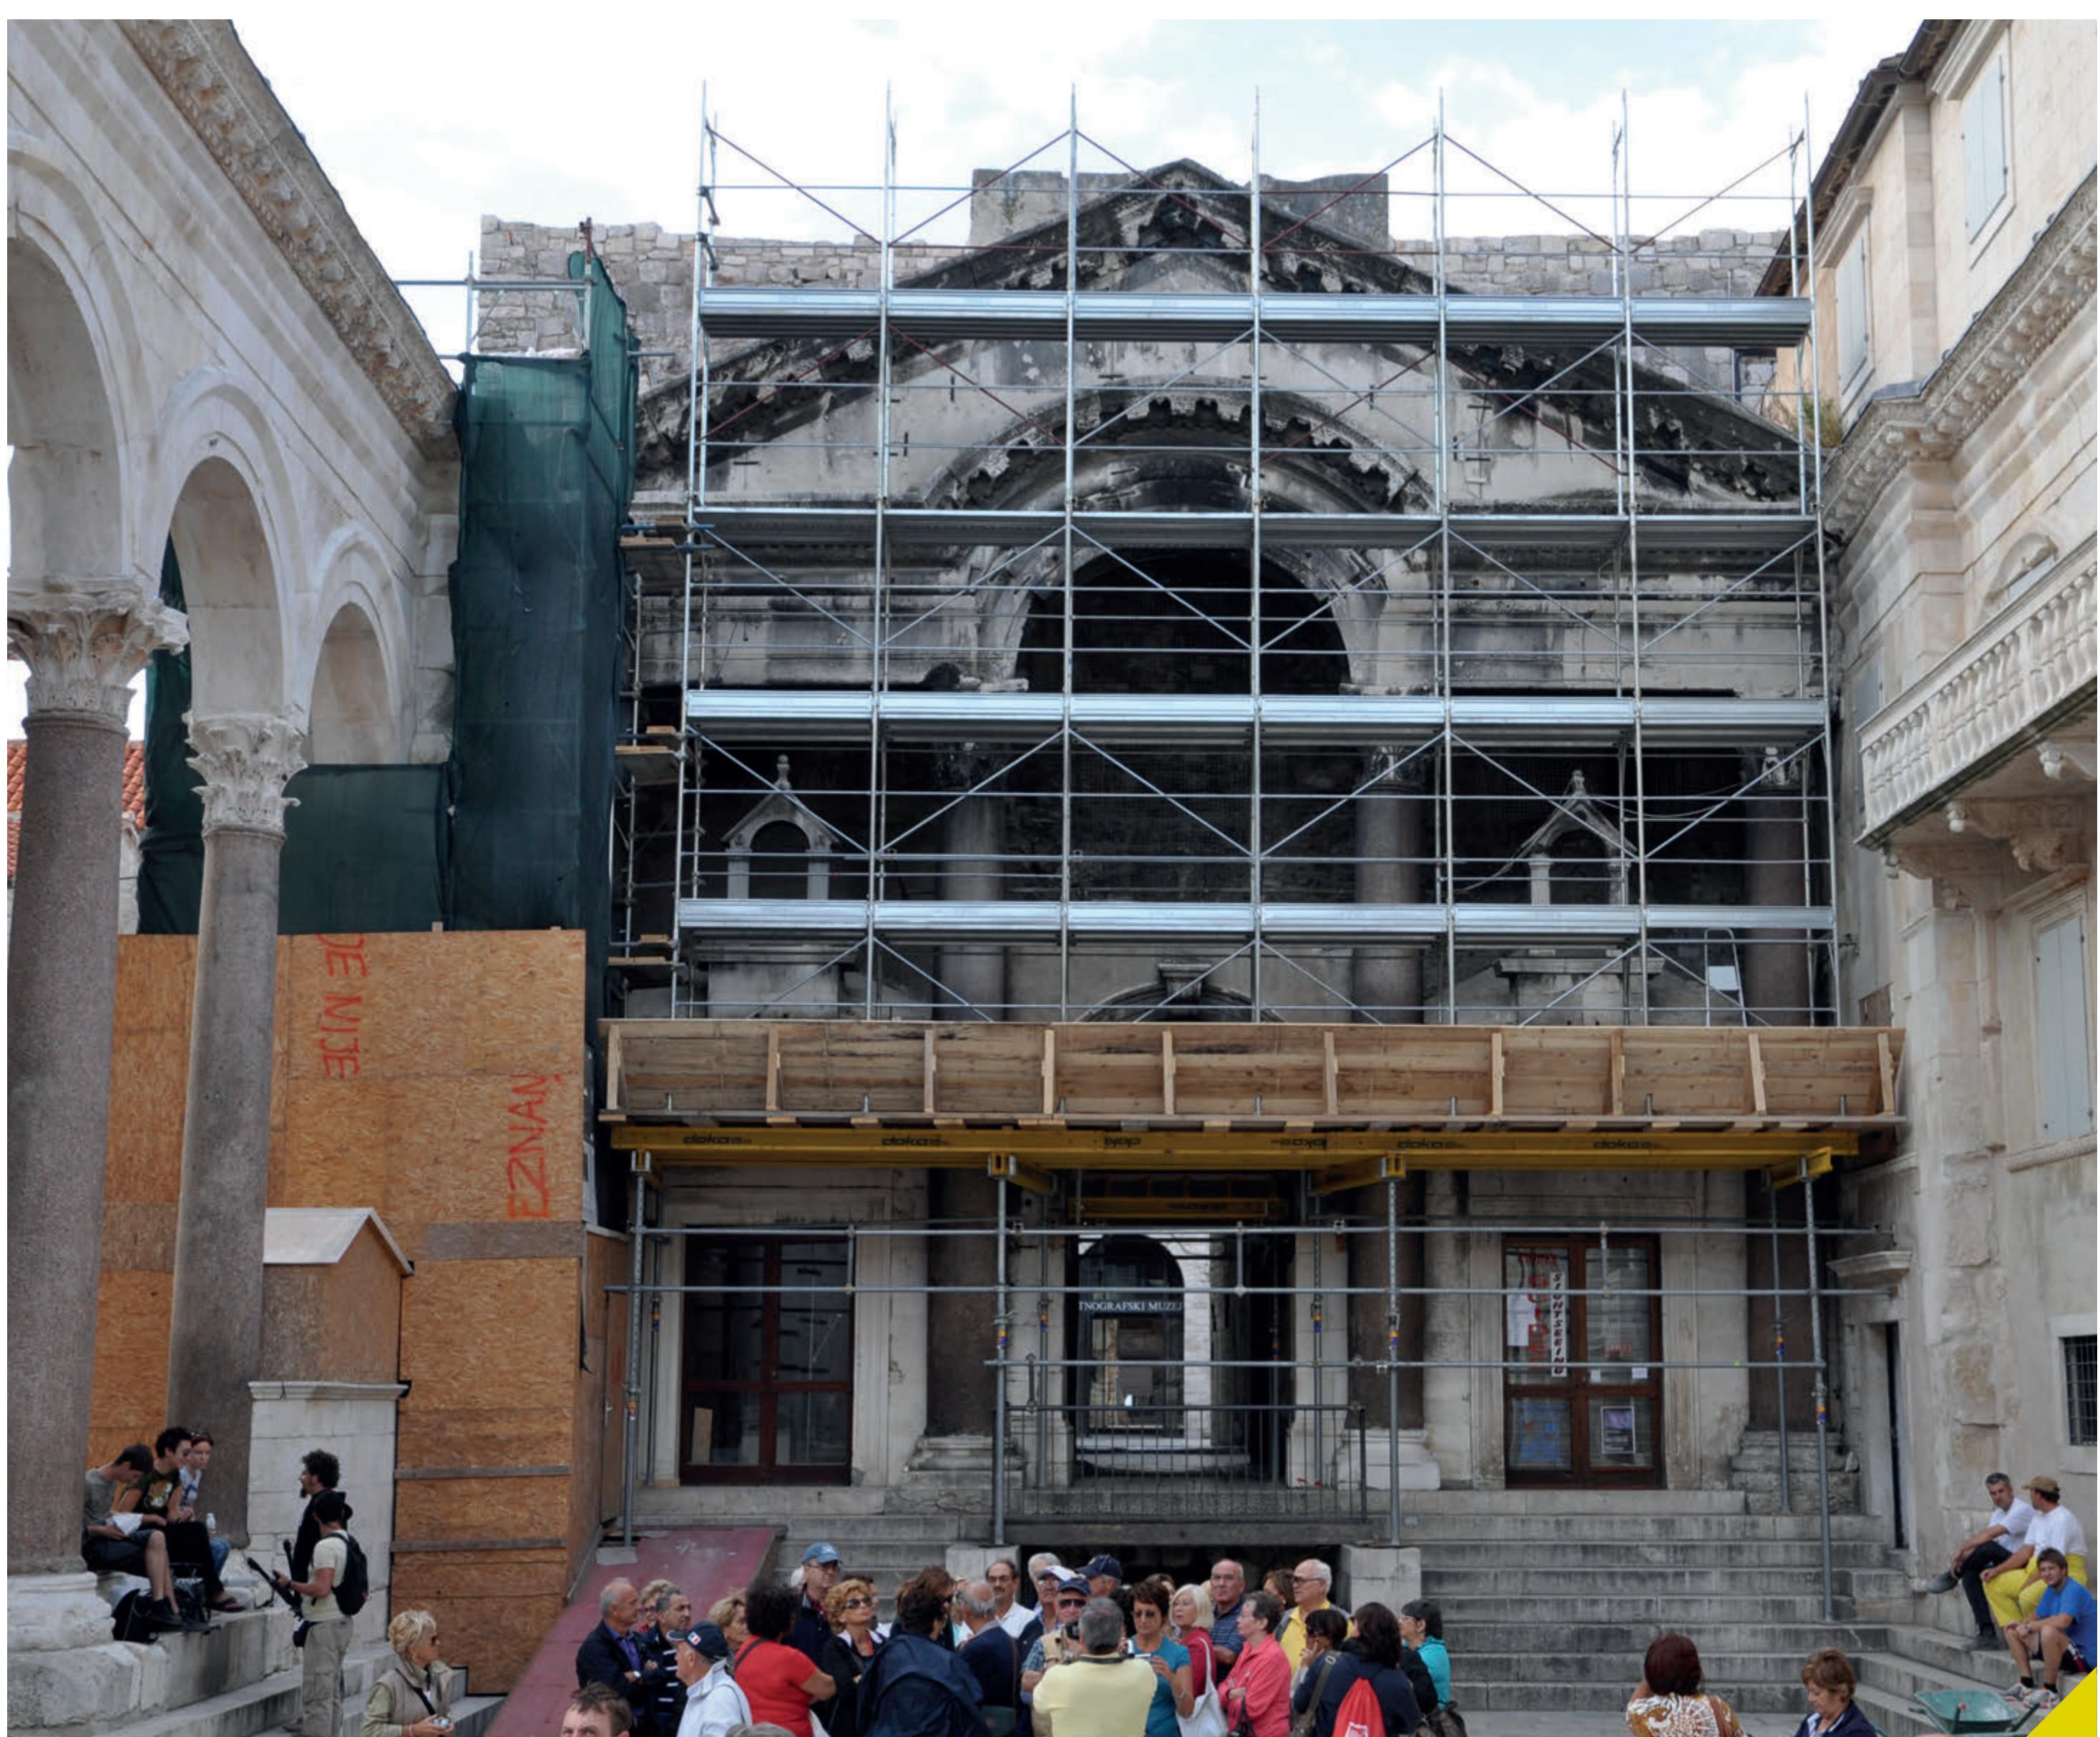
1. DETALJ UNUTRAŠNJEGL PORTALA VESTIBULA TIJEKOM KONZERVATORSKO-RESTURATORSKOG ZAHVATA; 2. UNUTRAŠNJI PORTAL VESTIBULA TIJEKOM KONZERVATORSKO-RESTURATORSKOG ZAHVATA; 3. LASERSKO ČIŠĆENJE KAMENA; 4. PRVA FAZA KONZERVATORSKO-RESTURATORSKOG ZAHVATA; 5. DRUGA FAZA KONZERVATORSKO-RESTURATORSKOG ZAHVATA; 6. ČETVRTA FAZA KONZERVATORSKO-RESTURATORSKOG ZAHVATA; 7. PETA FAZA KONZERVATORSKO-RESTURATORSKOG ZAHVATA

1. DETAIL OF THE INTERIOR VESTIBULE PORTAL DURING CONSERVATION-RESTORATION TREATMENT; 2. INTERIOR VESTIBULE PORTAL DURING CONSERVATION-RESTORATION TREATMENT; 3. LASER STONE CLEANING; 4. THE FIRST PHASE OF THE CONSERVATION-RESTORATION TREATMENT; 5. SECOND PHASE OF THE CONSERVATION-RESTORATION TREATMENT; 6. FOURTH PHASE OF THE CONSERVATION-RESTORATION TREATMENT; 7. FIFTH PHASE OF THE CONSERVATION-RESTORATION TREATMENT

The first phase (2004-2005) included a pilaster and first two columns of the north part of the east colonnade. The second phase (2006-2007) included the south part of the west colonnade and the façade of the Skočibučić – Lukaris Palace. This was followed by the third phase (2007-2008) located at the north part of the west colonnade and the façade of the Cipci Palace. It also included the remains of the arch of the ancient decumanus porch on the ground floor of the Grisogono Palace. The fourth phase (2008-2010) included the south part of the east colonnade, but was subdivided into two phases due to its complexity and conservation issues. The fifth phase included the Prothyrion and its interpolated parts, as well as the outer north wall and the Vestibule portal (2010-2012). The sixth phase included the Church of St. Roch and the arch belonging to the porch of the ancient decumanus. Because of the relation of the church restoration with the whole ancient structure, this phase was executed parallel to the works of the 4th and 5th phase (2009-2012). In early 2013, the works on the entrance to the substructures and on the preserved columns of the decumanus porch are carried out. This, together with the works performed on the sphinx and its casting, announces the following phase of the conservation-restoration work.
