## Na završetku desetljeća obnove Peristila

## At the end of a Decade of the Peristyle Restoration

The conservation and restoration work on the Peristyle of Diocletian's Palace has been in many ways the most important project in recent period within the scope of renovation of the historical core of the town of Split. The Peristyle is the centre and the most impressive part of the imperial palace, and also the heart of the town which has grown around it. The square, which reflects historical layers of the creation and development of the town, has become its symbol and its main tourist attraction. It serves as the most attractive backdrop for cultural events, and a stage at which public life evolves.

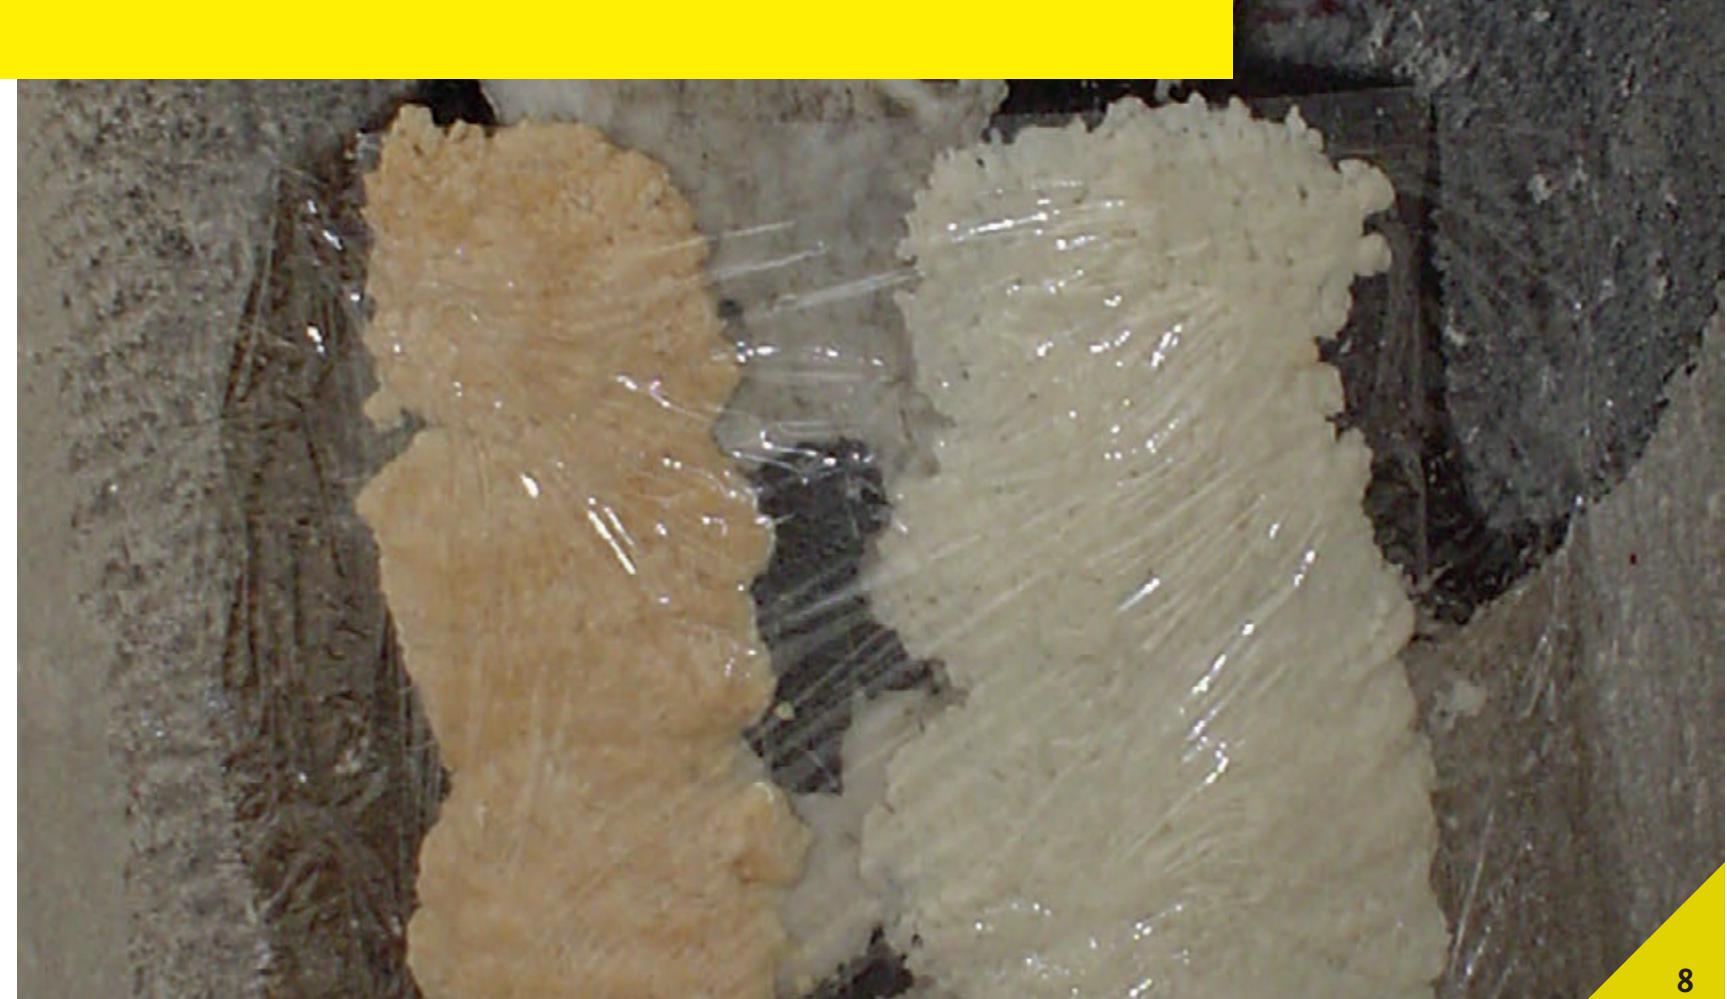
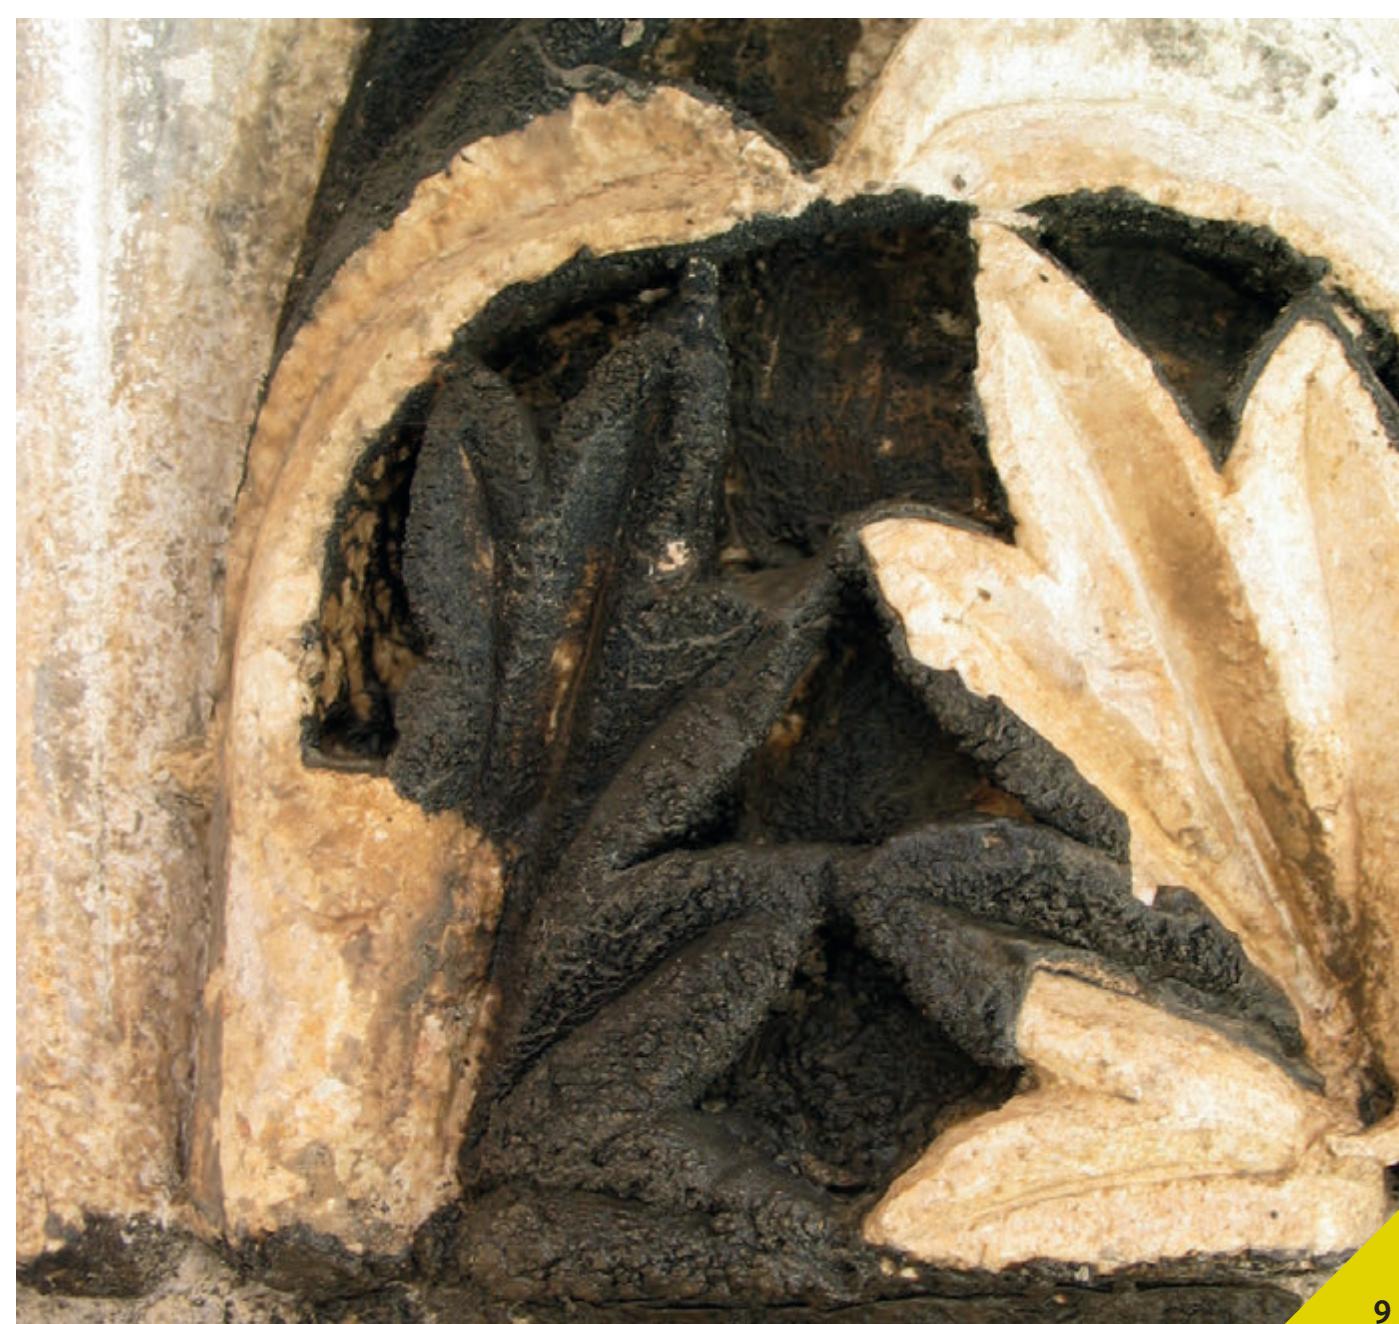
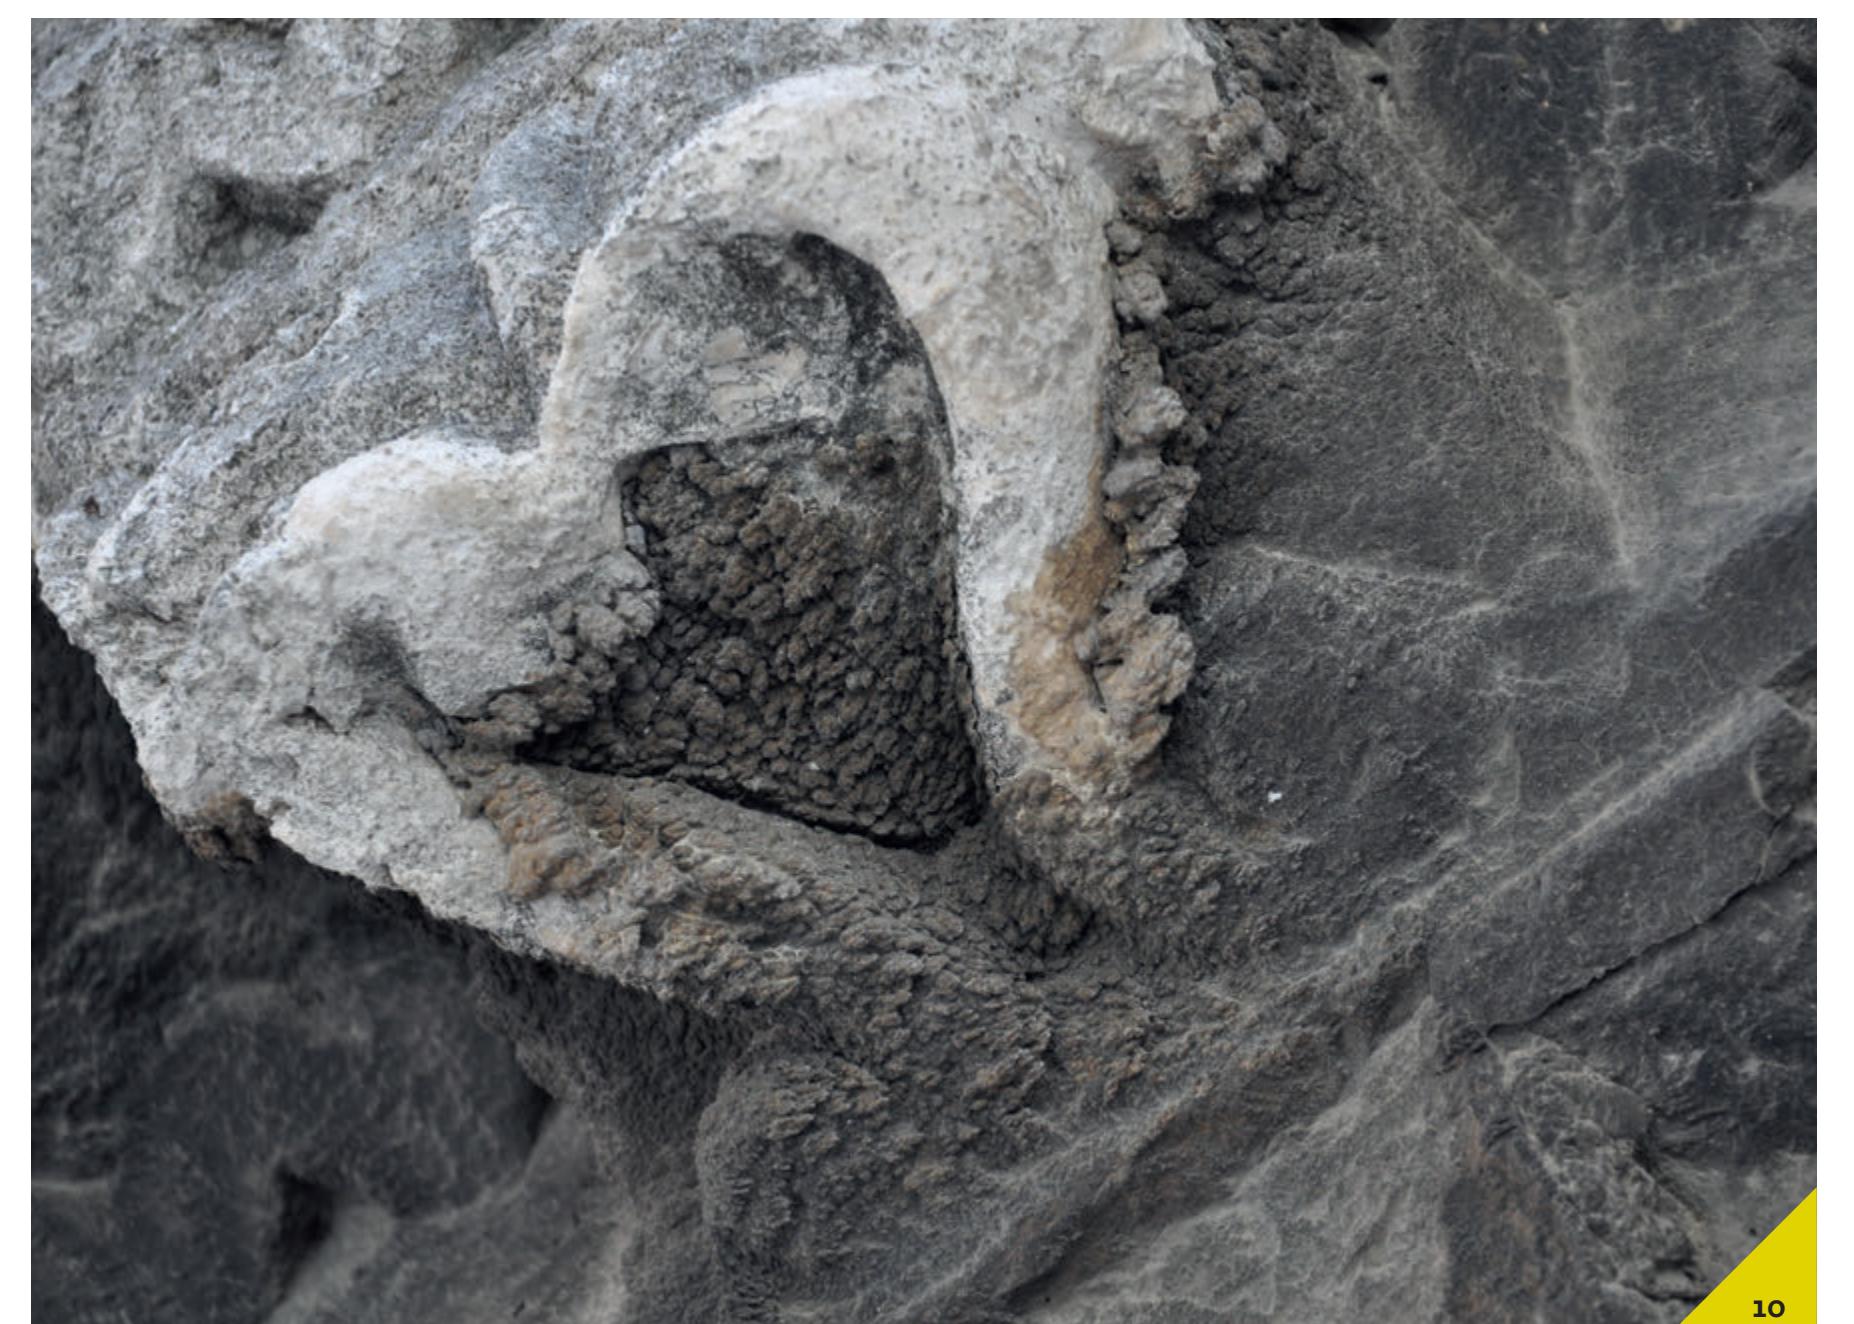
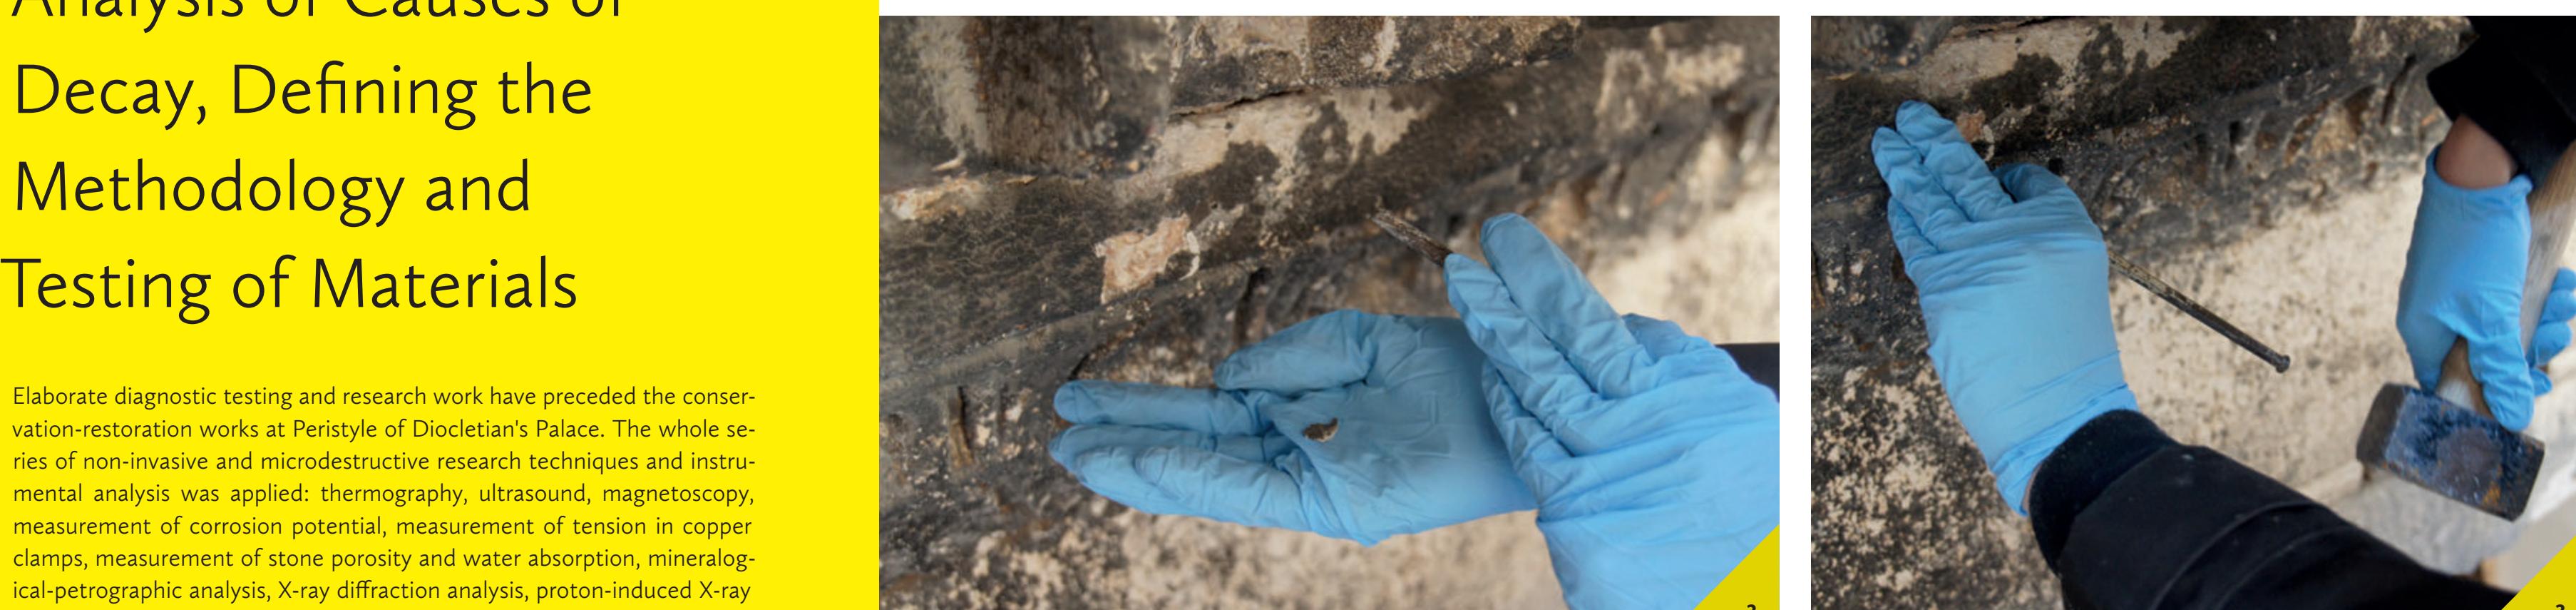
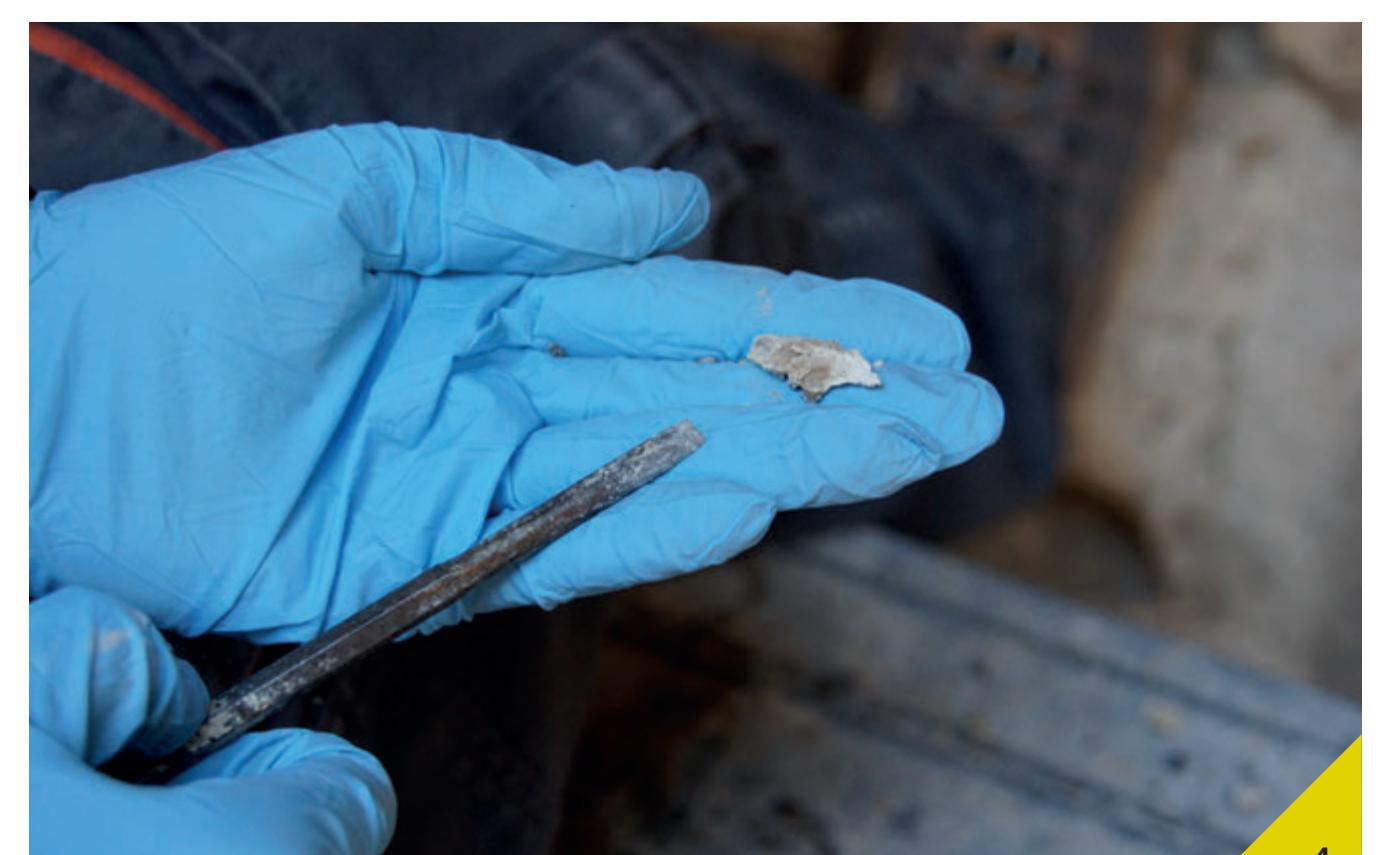
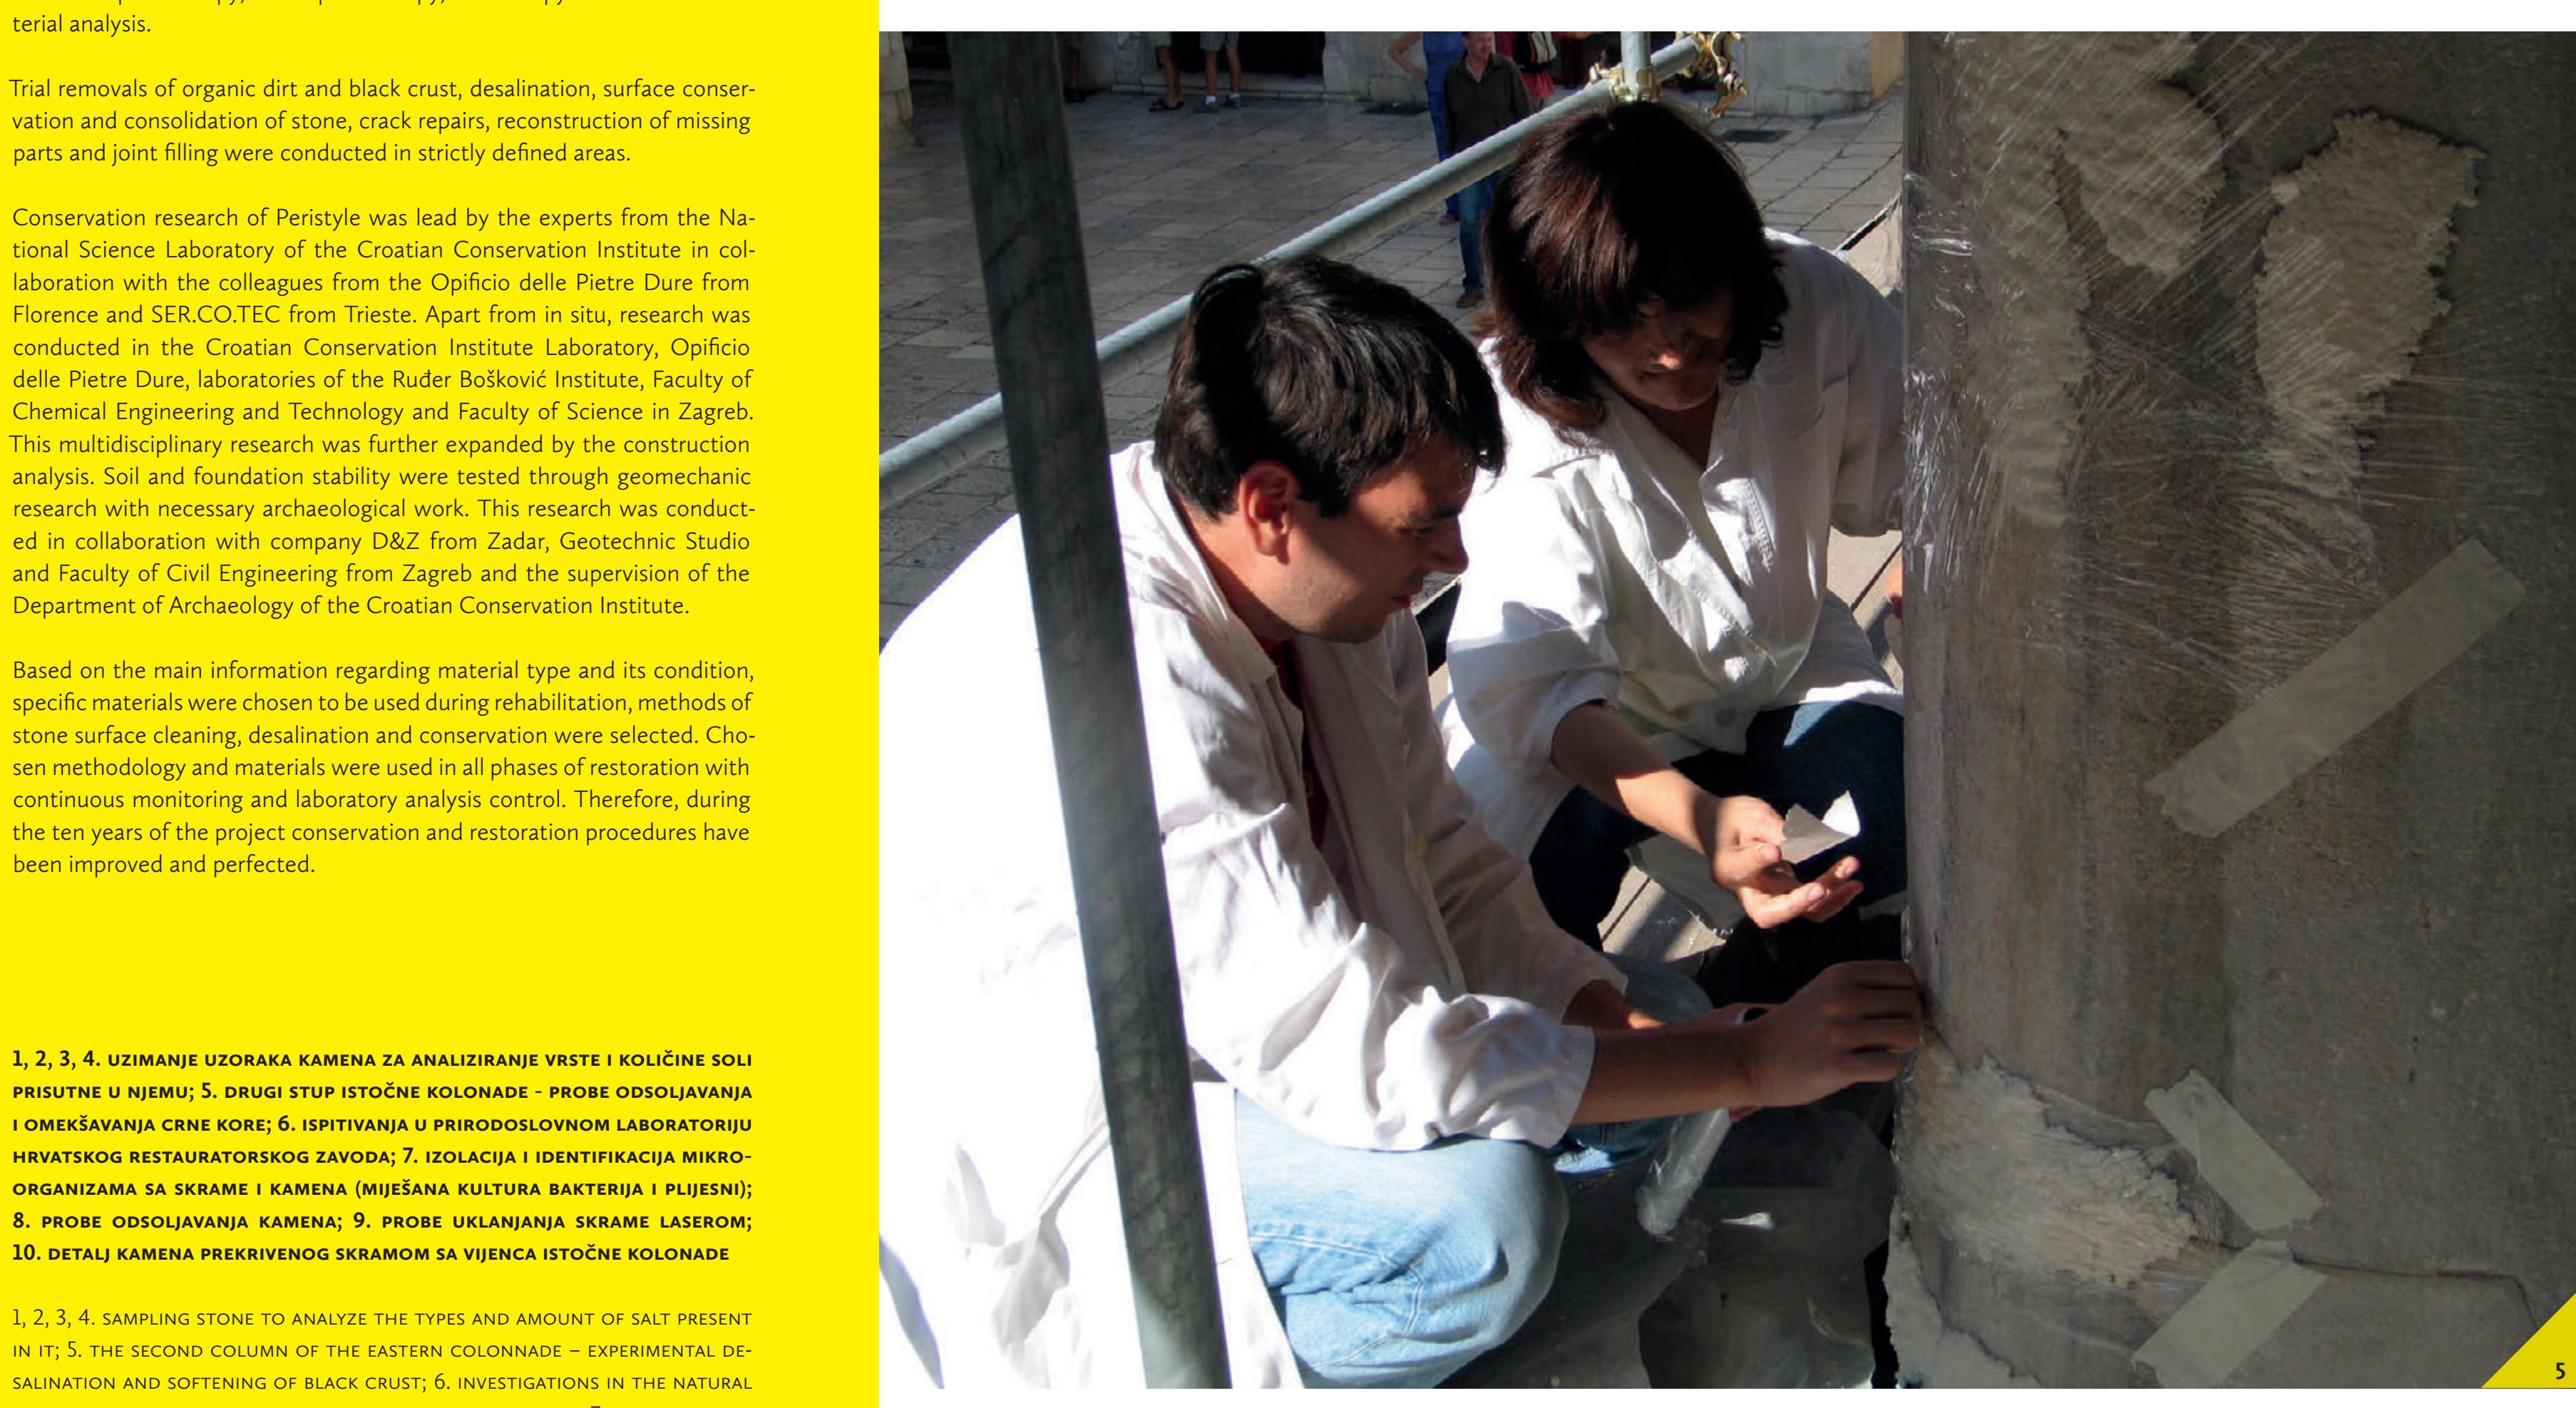
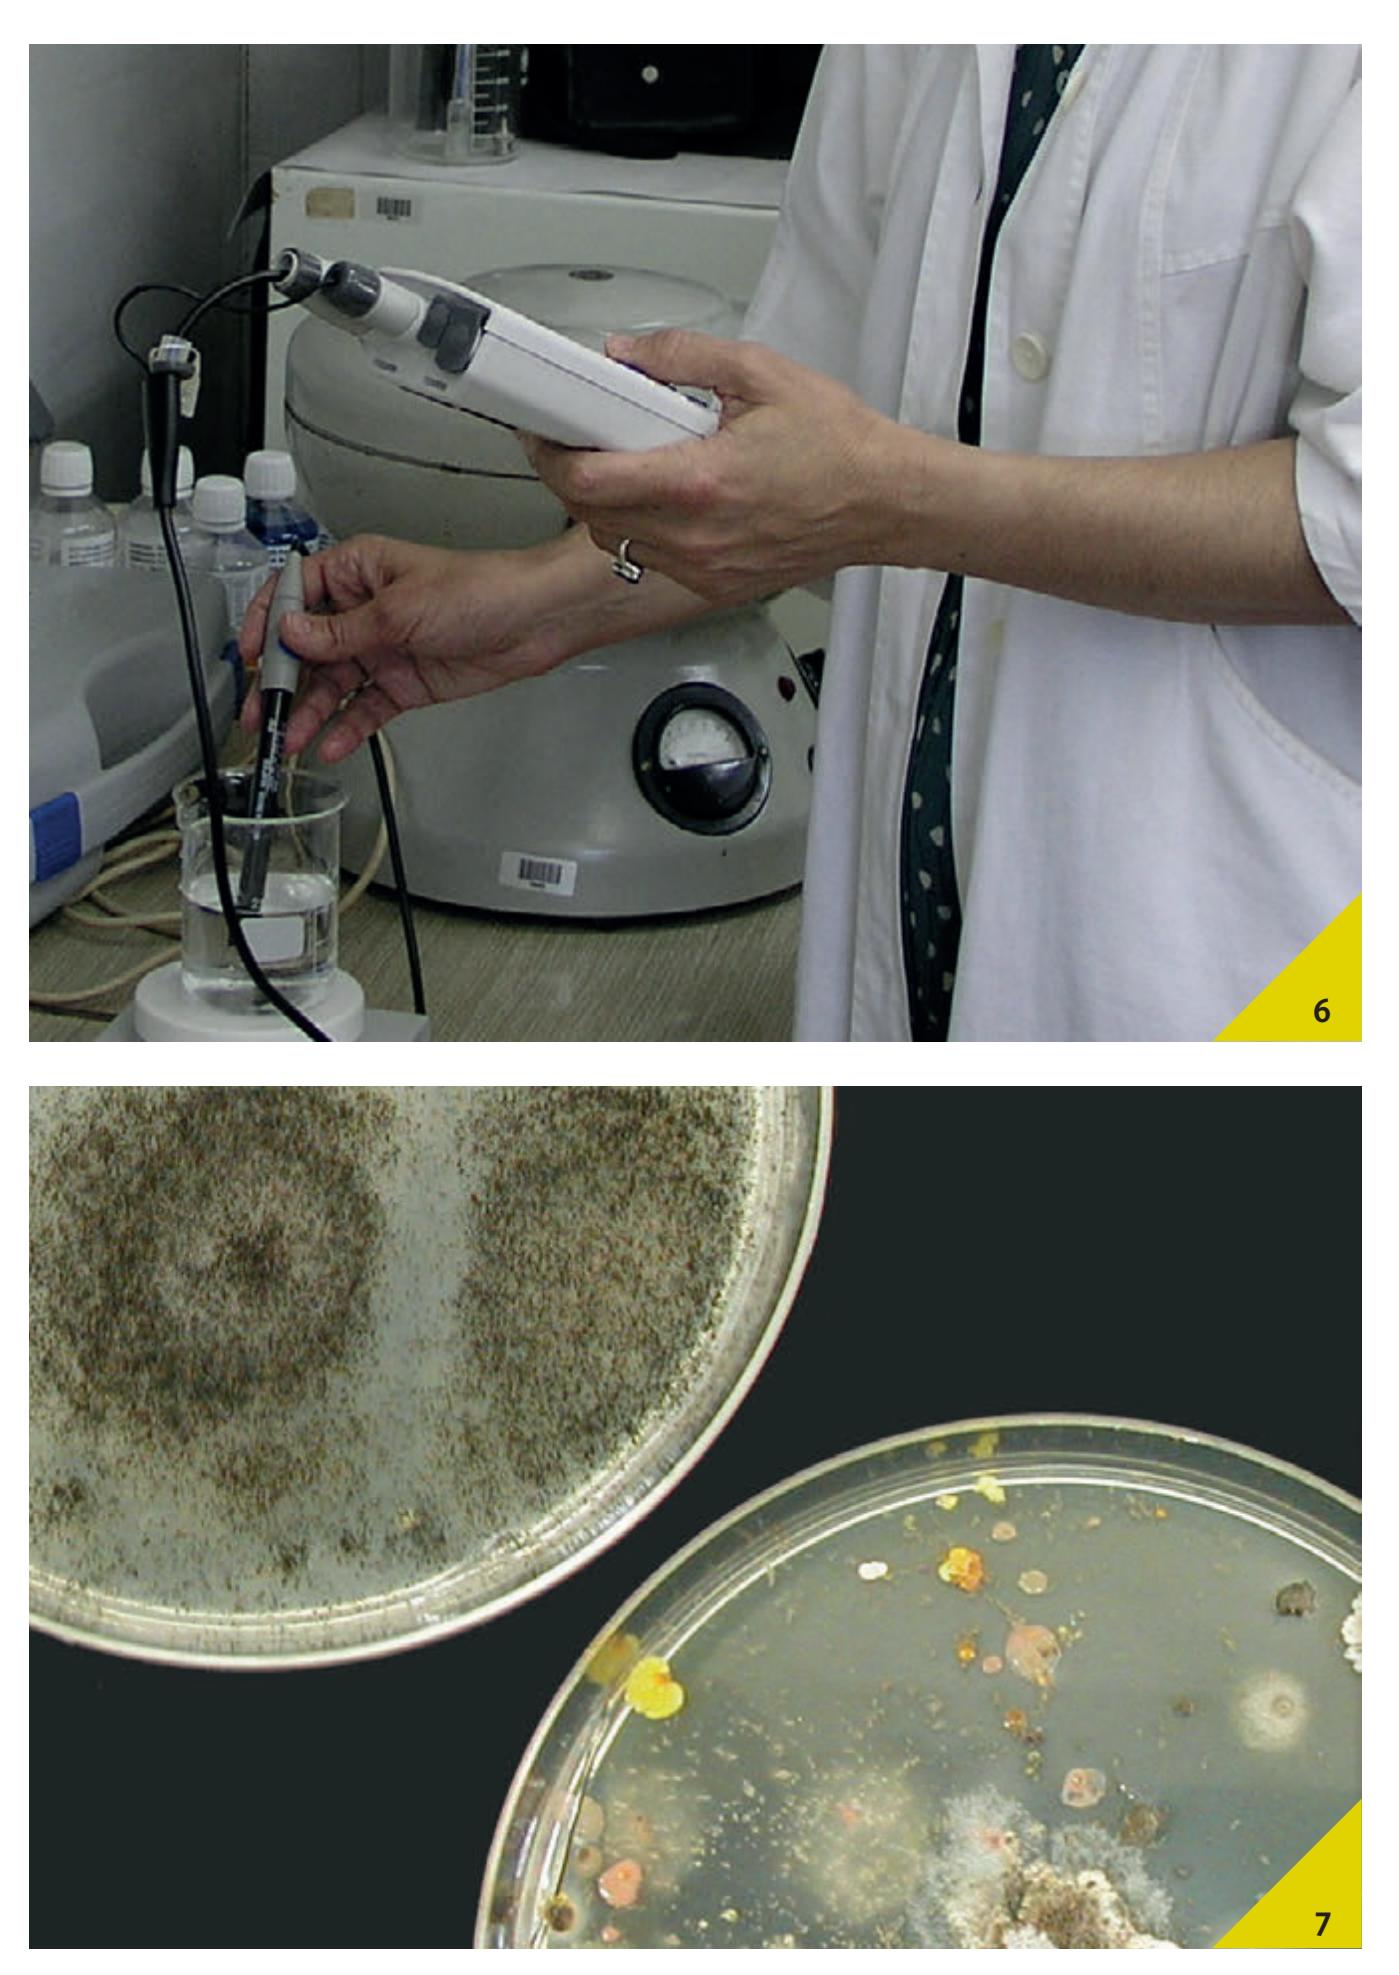
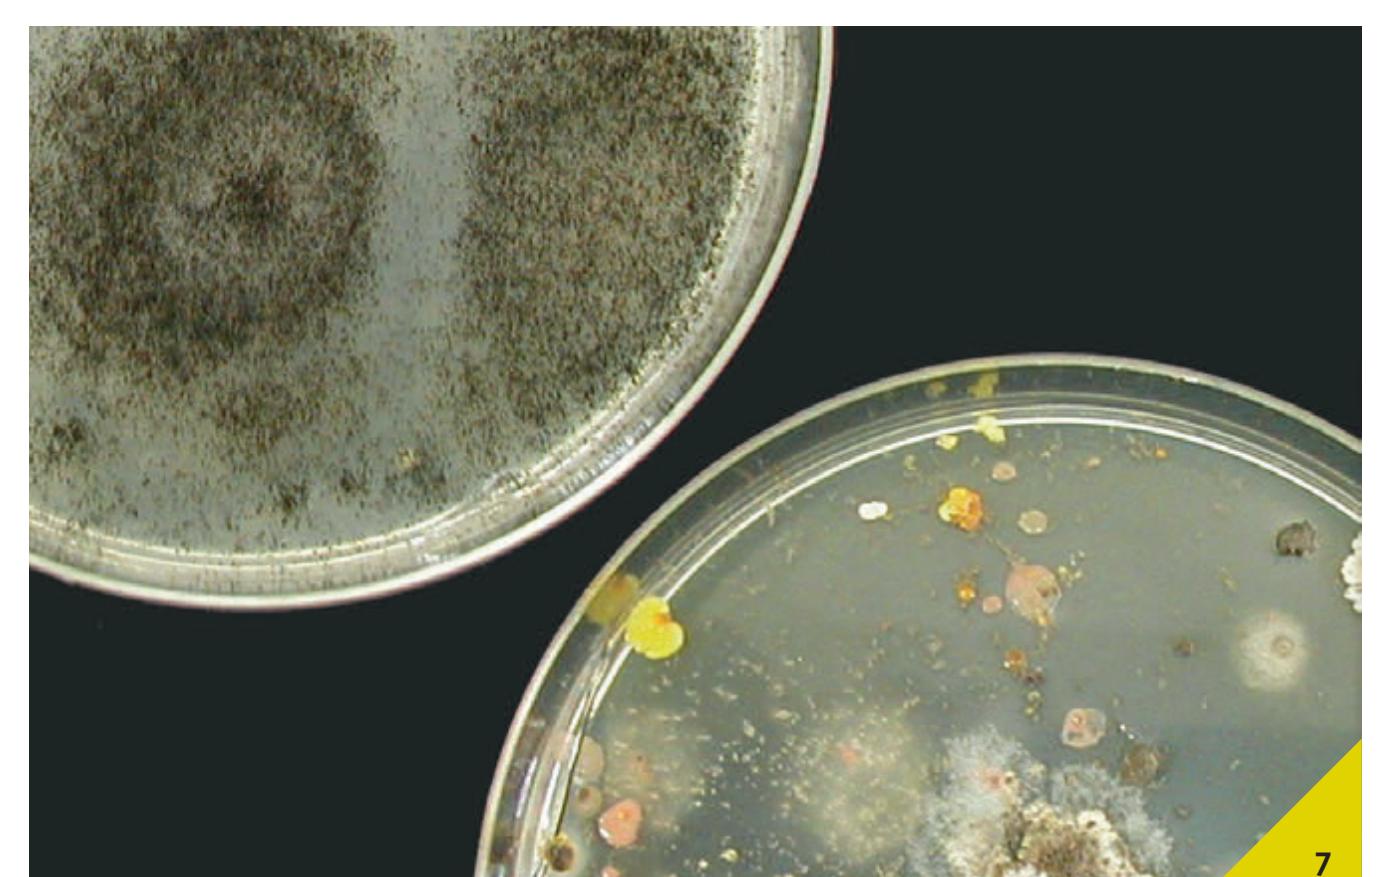
**1, 2, 3, 4. UZIMANJE UZORAKA KAME NA ANALIZIRANJE VRSTE I KOLIĆINE SOLI PRISUTNE U NJEMU;** **5. DRUGI STUP ISTOČNE KOLONADE - PROBE ODSOLJAVANJA I OMEŠAVANJA CRNE KORE;** **6. ISPITIVANJA U PRIRODOSLOVNOM LABORATORIJU HRVATSKOG RESTAURATORSKOG ZAVODA;** **7. ISOLACIJA I IDENTIFIKACIJA MIKROORGANIZAMA SA SKRAME I KAMENA (MIJEŠANA KULTURA BAKTERIJA I PUJESNI);** **8. PROBE ODSOLJAVANJA KAMENA;** **9. PROBE UKLANJANJA SKRAME LASEROM;** **10. DETALJ KAMENA PREKRIVENOG SKRAMOM SA VJENČA ISTOČNE KOLONADE**

**1, 2, 3, 4. SAMPLING STONE TO ANALYZE THE TYPES AND AMOUNT OF SALT PRESENT IN IT;** **5. THE SECOND COLUMN OF THE EASTERN COLONNADE - EXPERIMENTAL DE-SALINATION AND SOFTENING OF BLACK CRUST;** **6. INVESTIGATIONS IN THE NATURAL SCIENCE LABORATORY OF CROATIAN CONSERVATION INSTITUTE;** **7. ISOLATION AND IDENTIFICATION OF MICROORGANISMS FROM THE BLACK CRUST AND STONE SURFACE (MIXED FORMATION OF BACTERIA AND MOLD);** **8. EXPERIMENTAL DESALINATION OF STONE;** **9. LASER CLEANING TESTS - REMOVING BLACK CRUST;** **10. DETAIL OF THE STONE CORNICE OF THE EAST COLONNADE COVERED WITH BLACK CRUST**

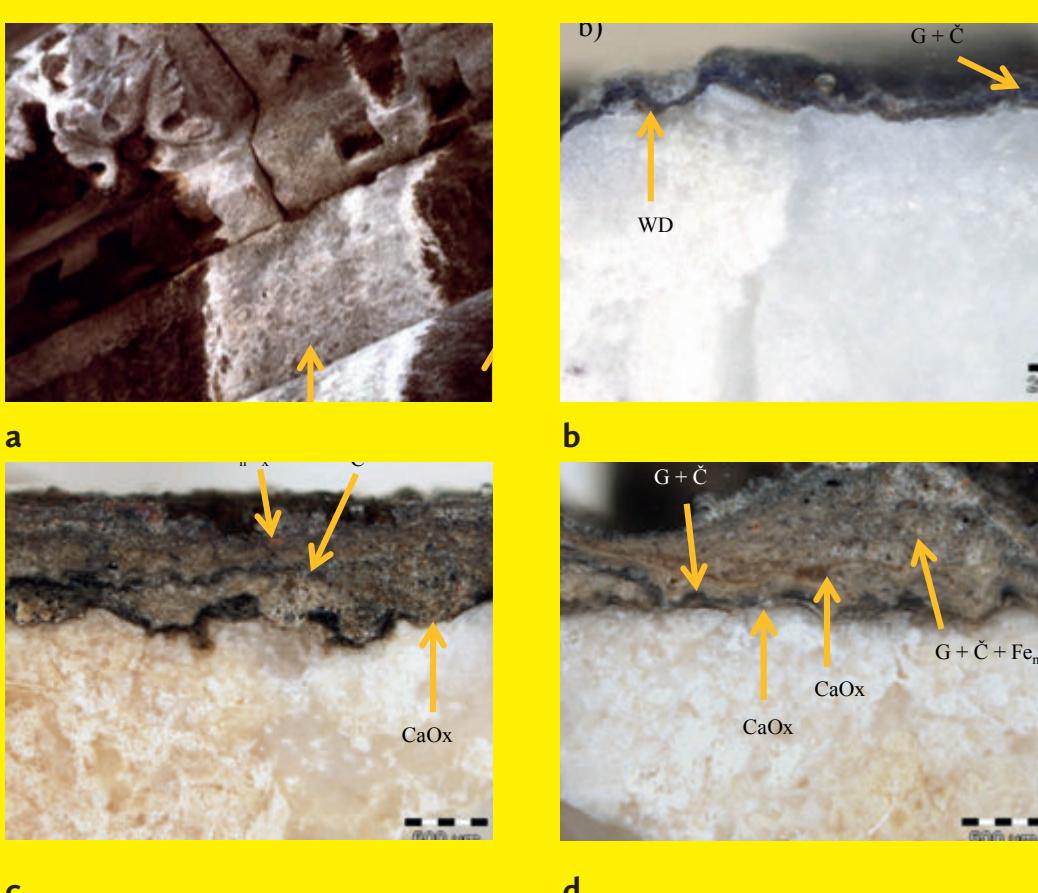
Black crusts on stone are composed of gypsum, soot and iron oxides and sporadic calcium oxalate. Gray patinas are composed of calcium oxalates and sporadic gypsum. Yellowish patinas that sometimes occur under the black crusts consist of calcium oxalates. Besides mineral patinas, algae and moss were found on stone surfaces.

- a) Makroskopski snimak površine kamena  
b) poprečni presjek kore na kamenu – na površini kamena nalazi se tanki sloj kalcijskih oksalata - wedellita (WD) iznad kojeg je crni sloj sastavljen od gipsa (G) te čestica čade (C)

c) poprečni presjek kore na kamenu – na površini kamena nalazi se tanki sloj kalcijskih oksalata (CaOx) iznad kojeg se izmjenjuju slojevi sastavljeni od gipsa, čestica čade, željeznih oksida (FeOx) te kalcijskih oksalata (CaOx)

c) cross-section of crust on stone – there is a thin layer of calcium oxalates (CaOx) on the stone surface, with alternating layers of gypsum, soot particles, iron oxides (FeOx) and calcium oxalates (CaOx)

d) cross-section of crust on stone – there is a thin layer of calcium oxalate on the stone surface with black layer of gypsum and soot particles on top. Above this, in the right corner of the sample again follows a layer of calcium oxalate and black layer of gypsum and soot, while in the left corner of the sample layers of gypsum, soot particles, iron oxides and calcium oxalates can be seen.

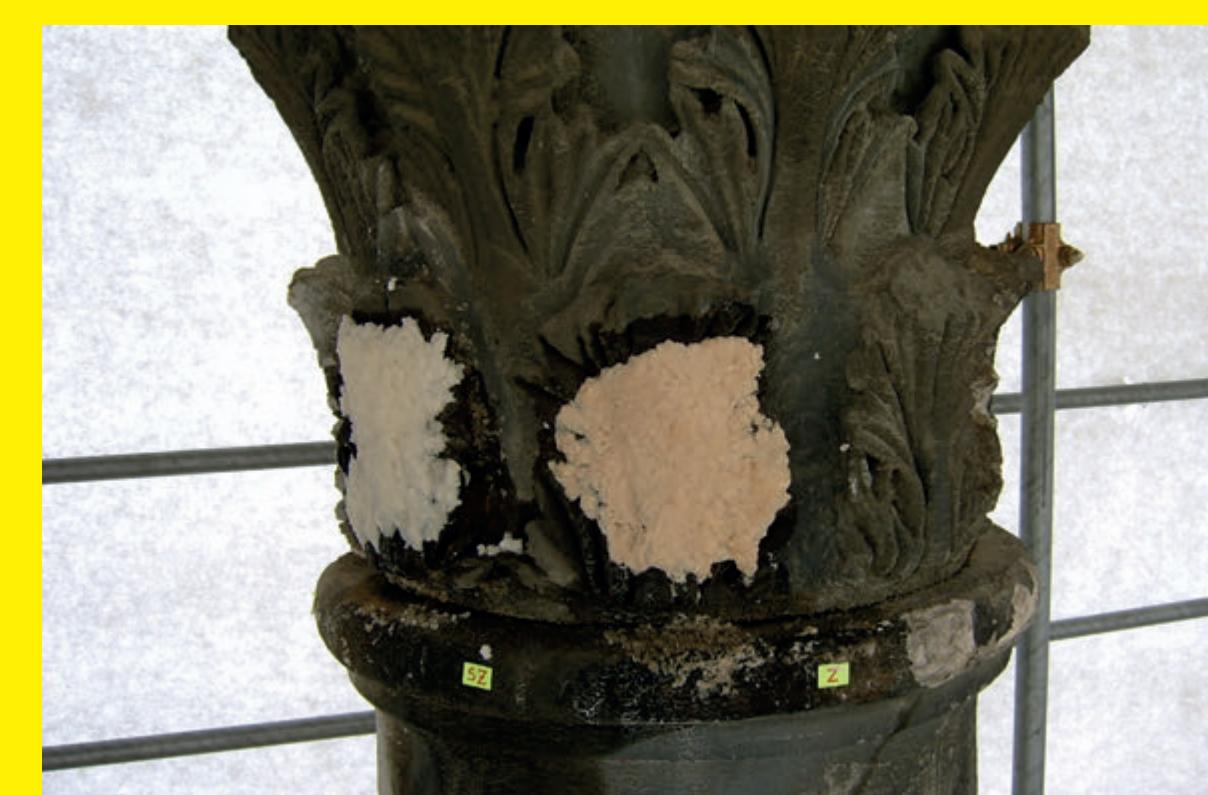
Probe odsoljavanja  
(amonij/barij – lijevo; ionski izmjjenjivač – desno)  
Experimental desalination  
(ammonium/barium – left; ion exchanger – right)

Od stetnih soli dokazano je najviše gipsa u područjima ispod crnih kora. Za neutralizaciju gipsa na temelju izvedenih probi odabранa je metoda amonij/barij (1), te u zadnjoj fazi (protiron) metoda amonijeva oksalata (2).

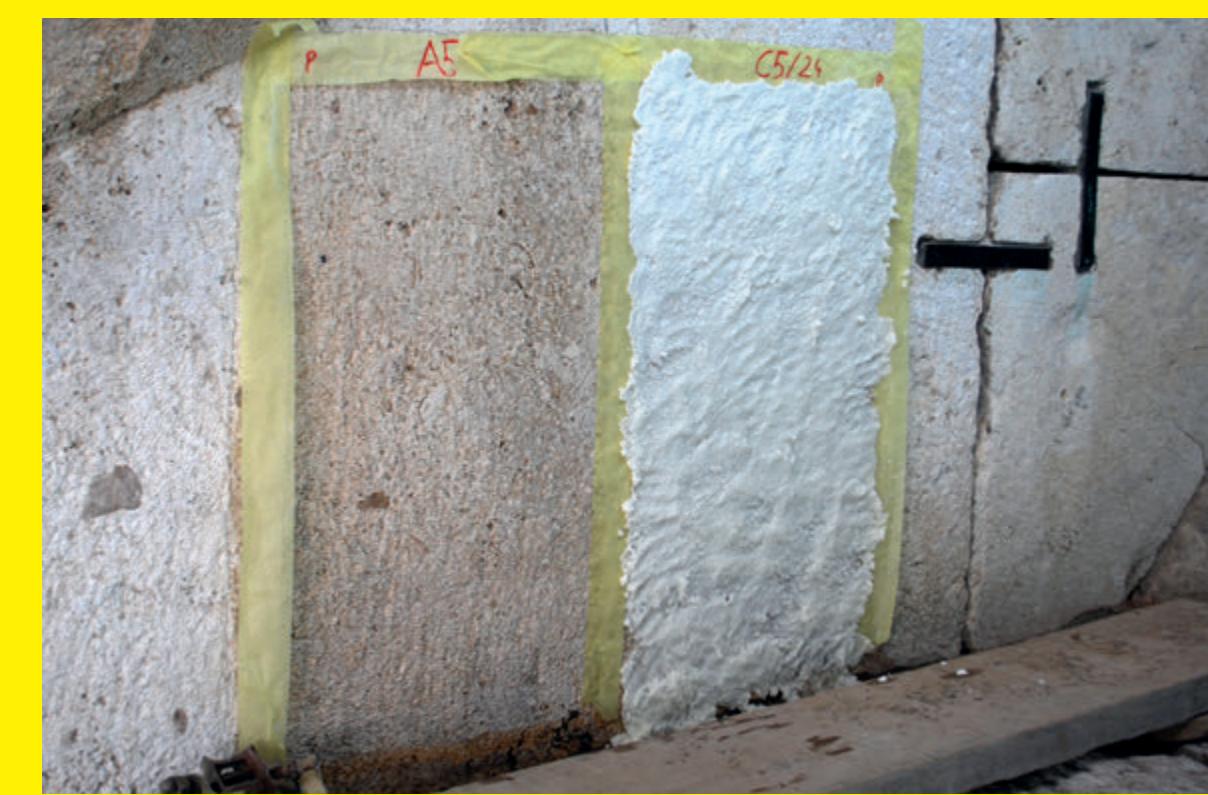
Probe odsoljavanja i zaštite amonijevim oksalatom  
(premazivanje – lijevo; pulpa – desno)  
Experimental desalination and protection of stone with ammonium oxalate
