## Na završetku desetljeća obnove Peristila

## At the end of a Decade of the Peristyle Restoration

The conservation and restoration work on the Peristyle of Diocletian's Palace has been in many ways the most important project in recent period within the scope of renovation of the historical core of the town of Split. The Peristyle is the centre and the most impressive part of the imperial palace, and also the heart of the town which has grown around it. The square, which reflects historical layers of the creation and development of the town, has become its symbol and its main tourist attraction. It serves as the most attractive backdrop for cultural events, and a stage at which public life evolves.

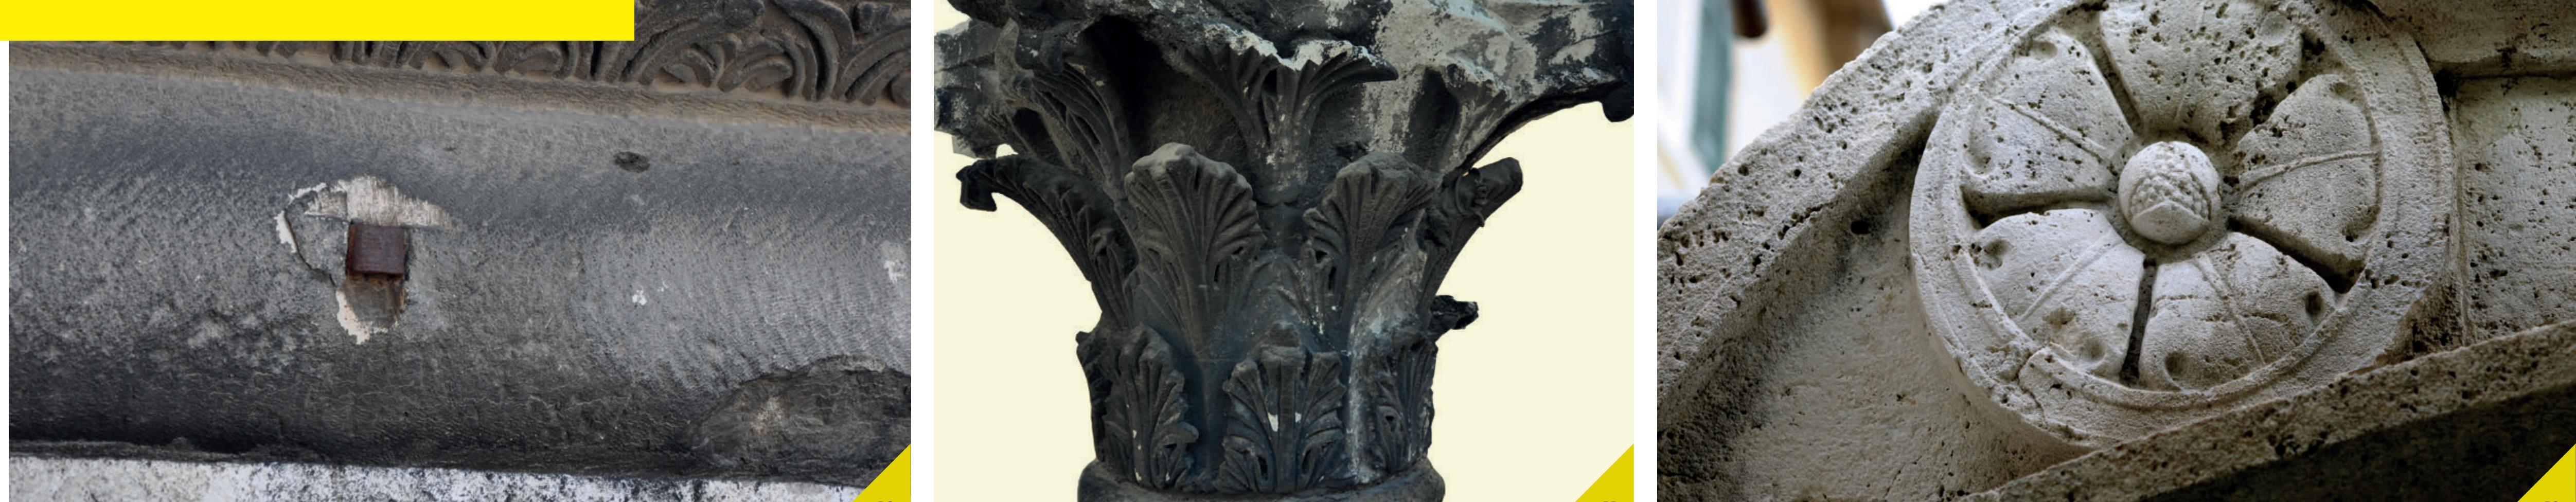
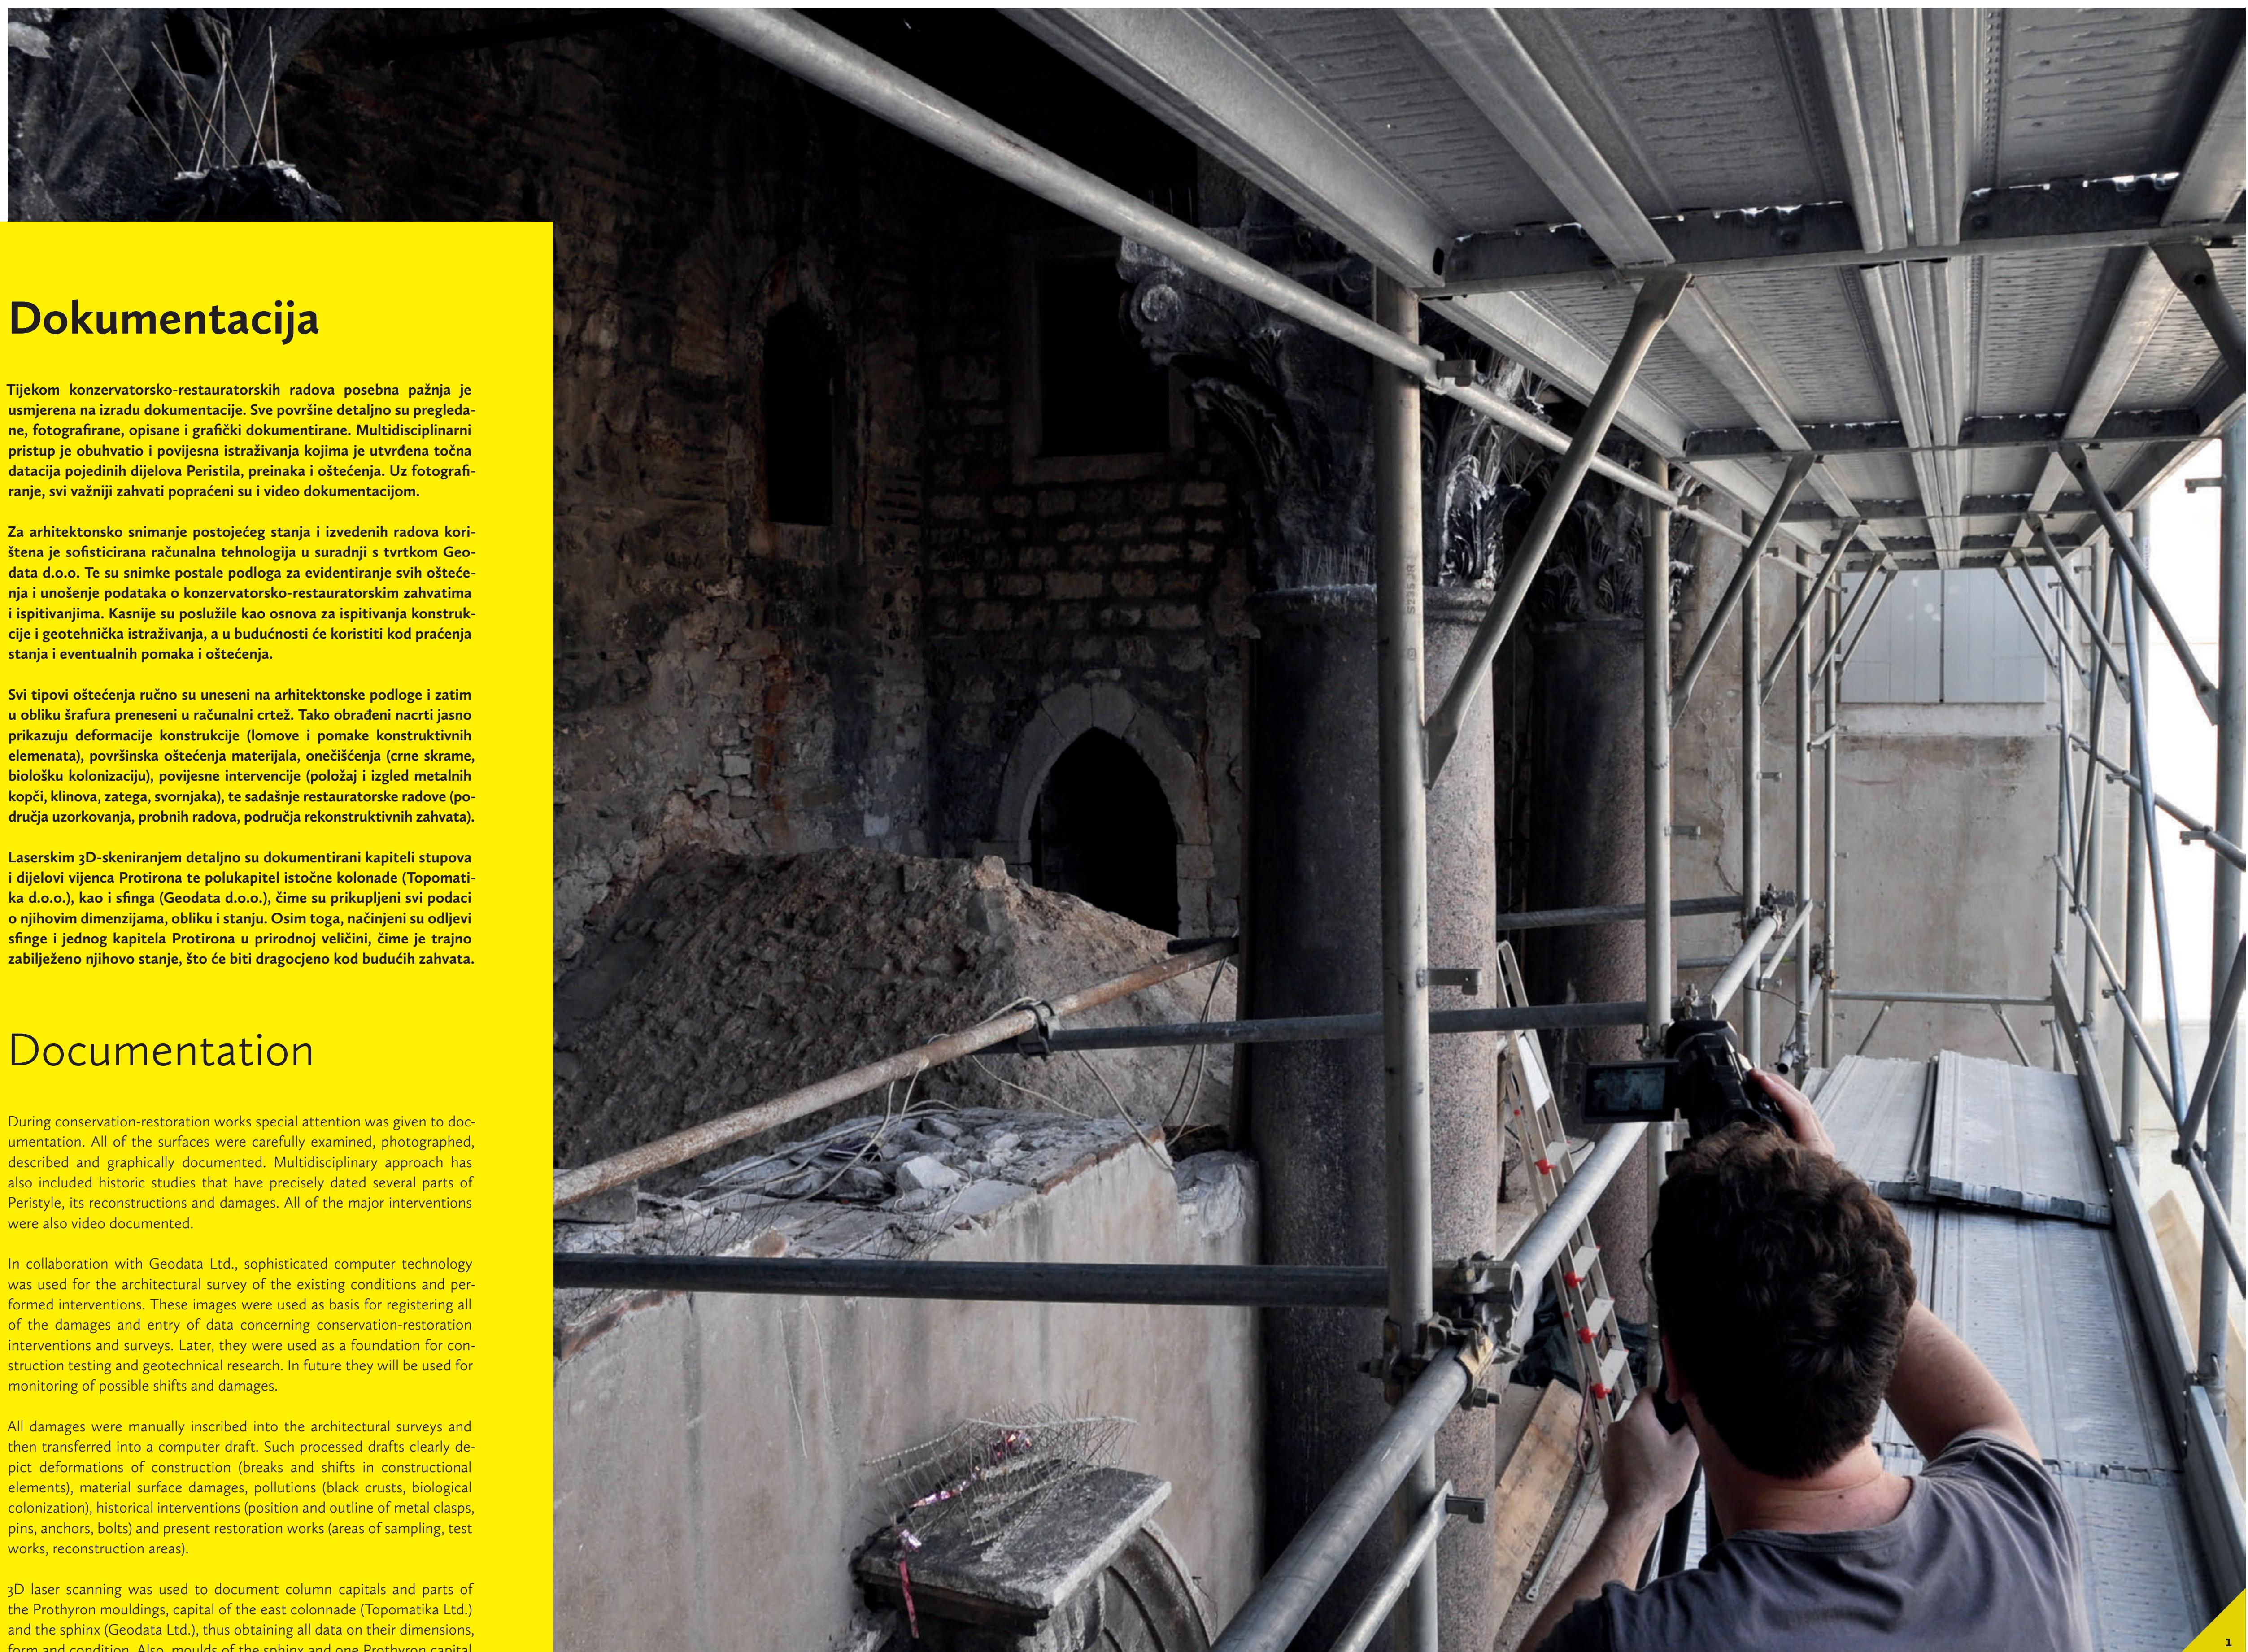
Dark sediments (crusts) appear on surfaces that were not exposed to rain, and their colour derives from the soot particles. Carbon particles found in black crusts on stone in Peristyle derive from the soot created by burning of coal in households and industry. Cement industry located in the vicinity of Split has over the 125 years also contributed to the creation of black cement crusts on stone. The problem of harmful soluble salts present in crusts should also be considered. Splitting and flaking of stone covered in crust is the result of crystal growth in the salts just beneath the surface. When crystallization pressure becomes higher than stone density, salts start destroying the structure. Recently, damages of stone sculptures in Peristyle have been repaired with cement mortar that releases salts into stone.

Rain influences stone in two ways: raindrops mechanically damage loosened particles of stone surface and lower its relief and since rain is usually mildly acidic, it chemically destroys stone as well. Its surface becomes ribbed and characteristic cavities are created from the decay of fossils.

Mechanical damages of stone in Peristyle are caused by various factors: damages caused by reconstructions, shifts in construction, II World War bombardment. Numerous damages were created by the expansion of rust of iron elements inserted in stone.

1, 3, 4. BIOLOŠKI OBRAŠTAJ; 2. POGOTCI GELERA; 5. DETALJ S PORTALA VESTIBULA - SKRAMA NA Površini KAMENA; 6. MACROFOTOGRAFIJA SKRAMA; 7. BIOLoŠKI OBRAŠTAJ NA ISTOČNOJ KOLONADI; 8. ŠUPLJINE U STRUKTURI KAMENA UZROKOVANA PROPADANJEM FOSILNIH ORGANIZAMA; 9. DETALJ KAPITELA - SKRAMA I PAUKOVE MREŽE; 10. PROPADANJE KAMENA UZROKOVANO KOROZIJOM METALA; 11. SKRAMA NA Površini KAPITELA; 12. EROZIJA PovršINE KAMENA UZROKOVANA KİŞOM

1, 3, 4. BIOLOGICAL SOILING; 2. SHRAPNEL HITS; 5. DETAIL FROM VESTIBULUM PORTAL - BLACK CRUST ON THE SURFACE OF STONE; 6. MACROPHOTO OF BLACK CRUST; 7. BIOLOGICAL SOILING ON THE EAST COLONNADE; 8. CAVITIES CREATED FROM THE DECAY OF FOSSILS; 9. DETAIL OF CAPITAL - CRUST AND SPIDER WEB; 10. DAMAGE CREATED BY THE EXPANSION OF RUST OF IRON ELEMENTS; 11. BLACK CRUST ON THE SURFACE OF THE CAPITAL; 12. EROSION OF STONE SURFACE CAUSED BY RAIN

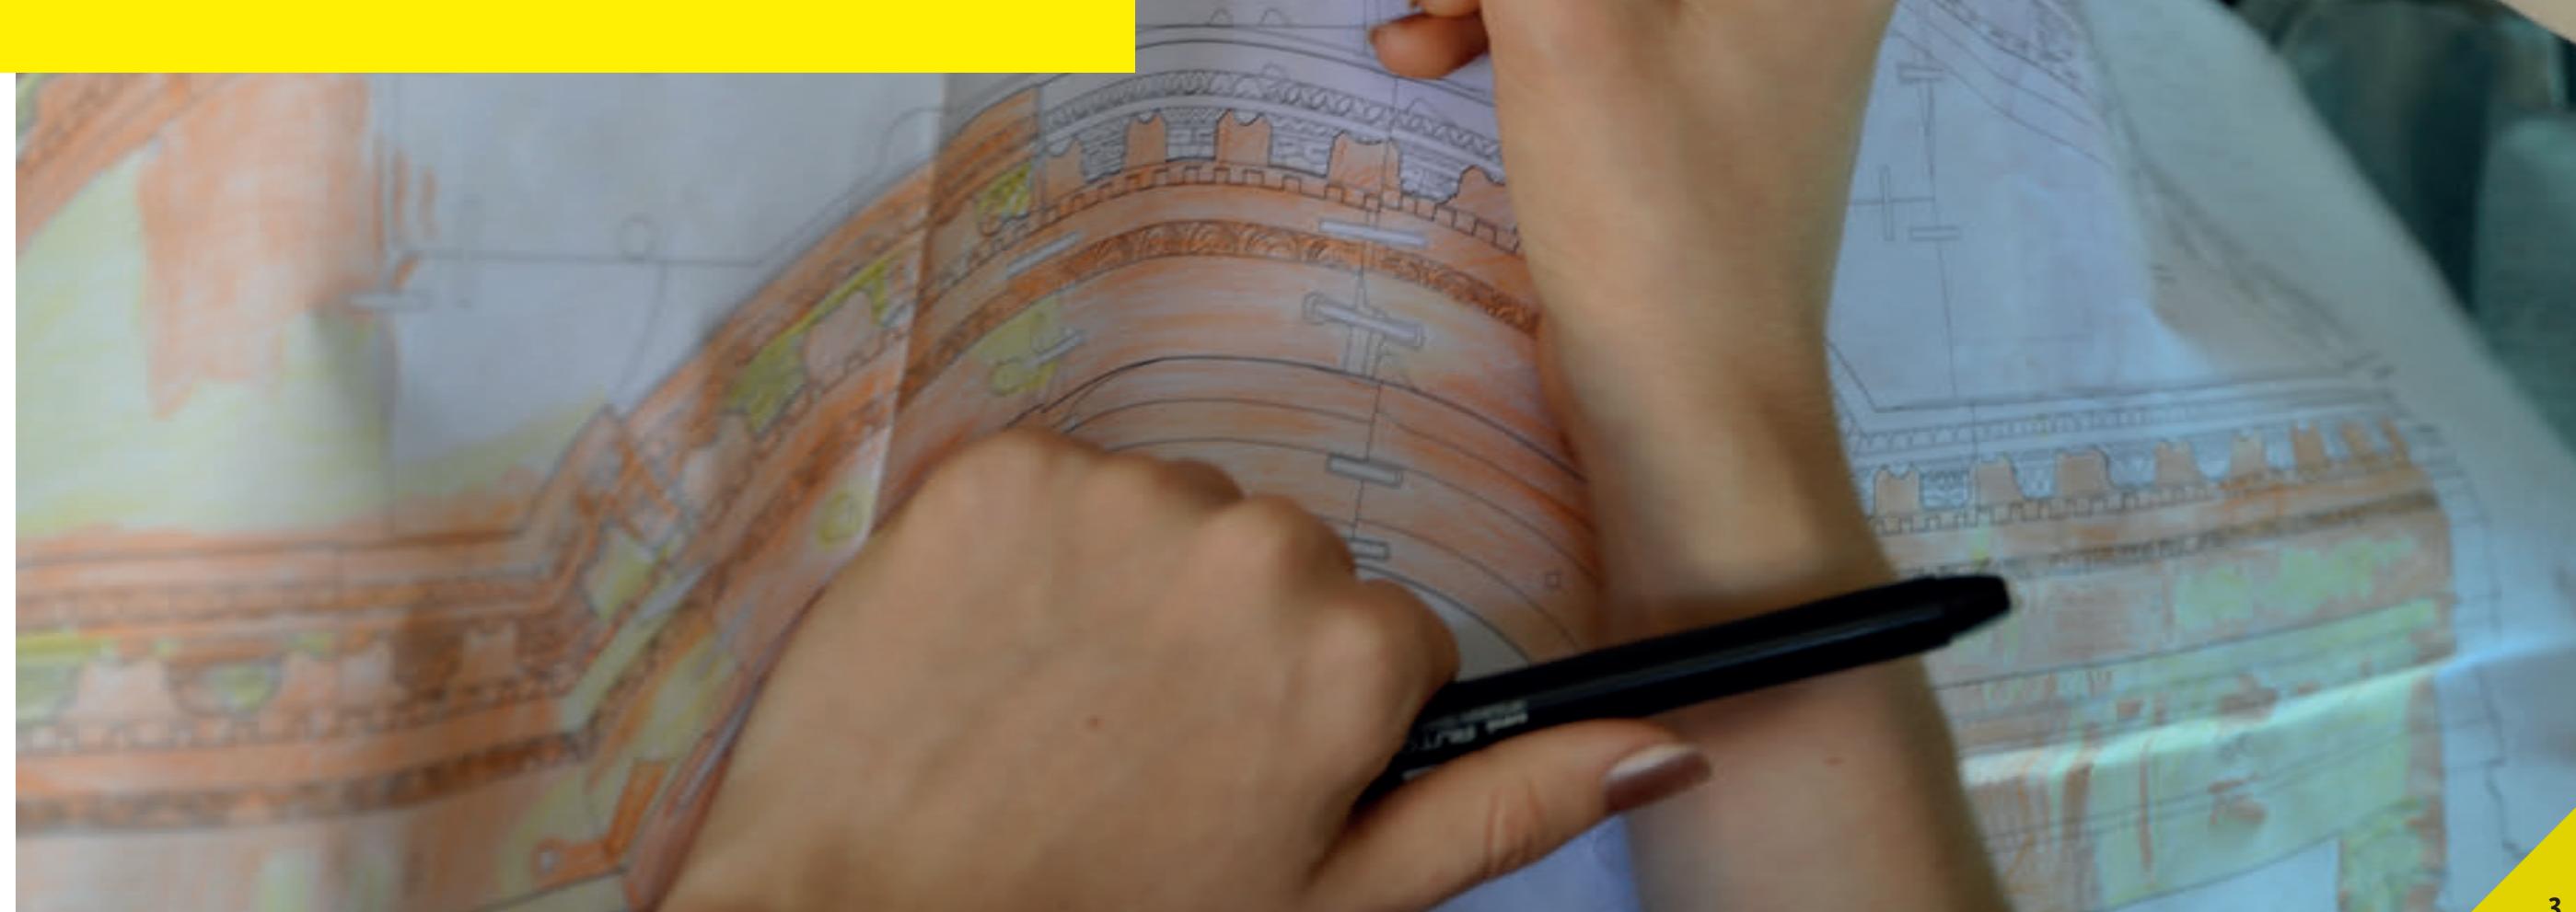
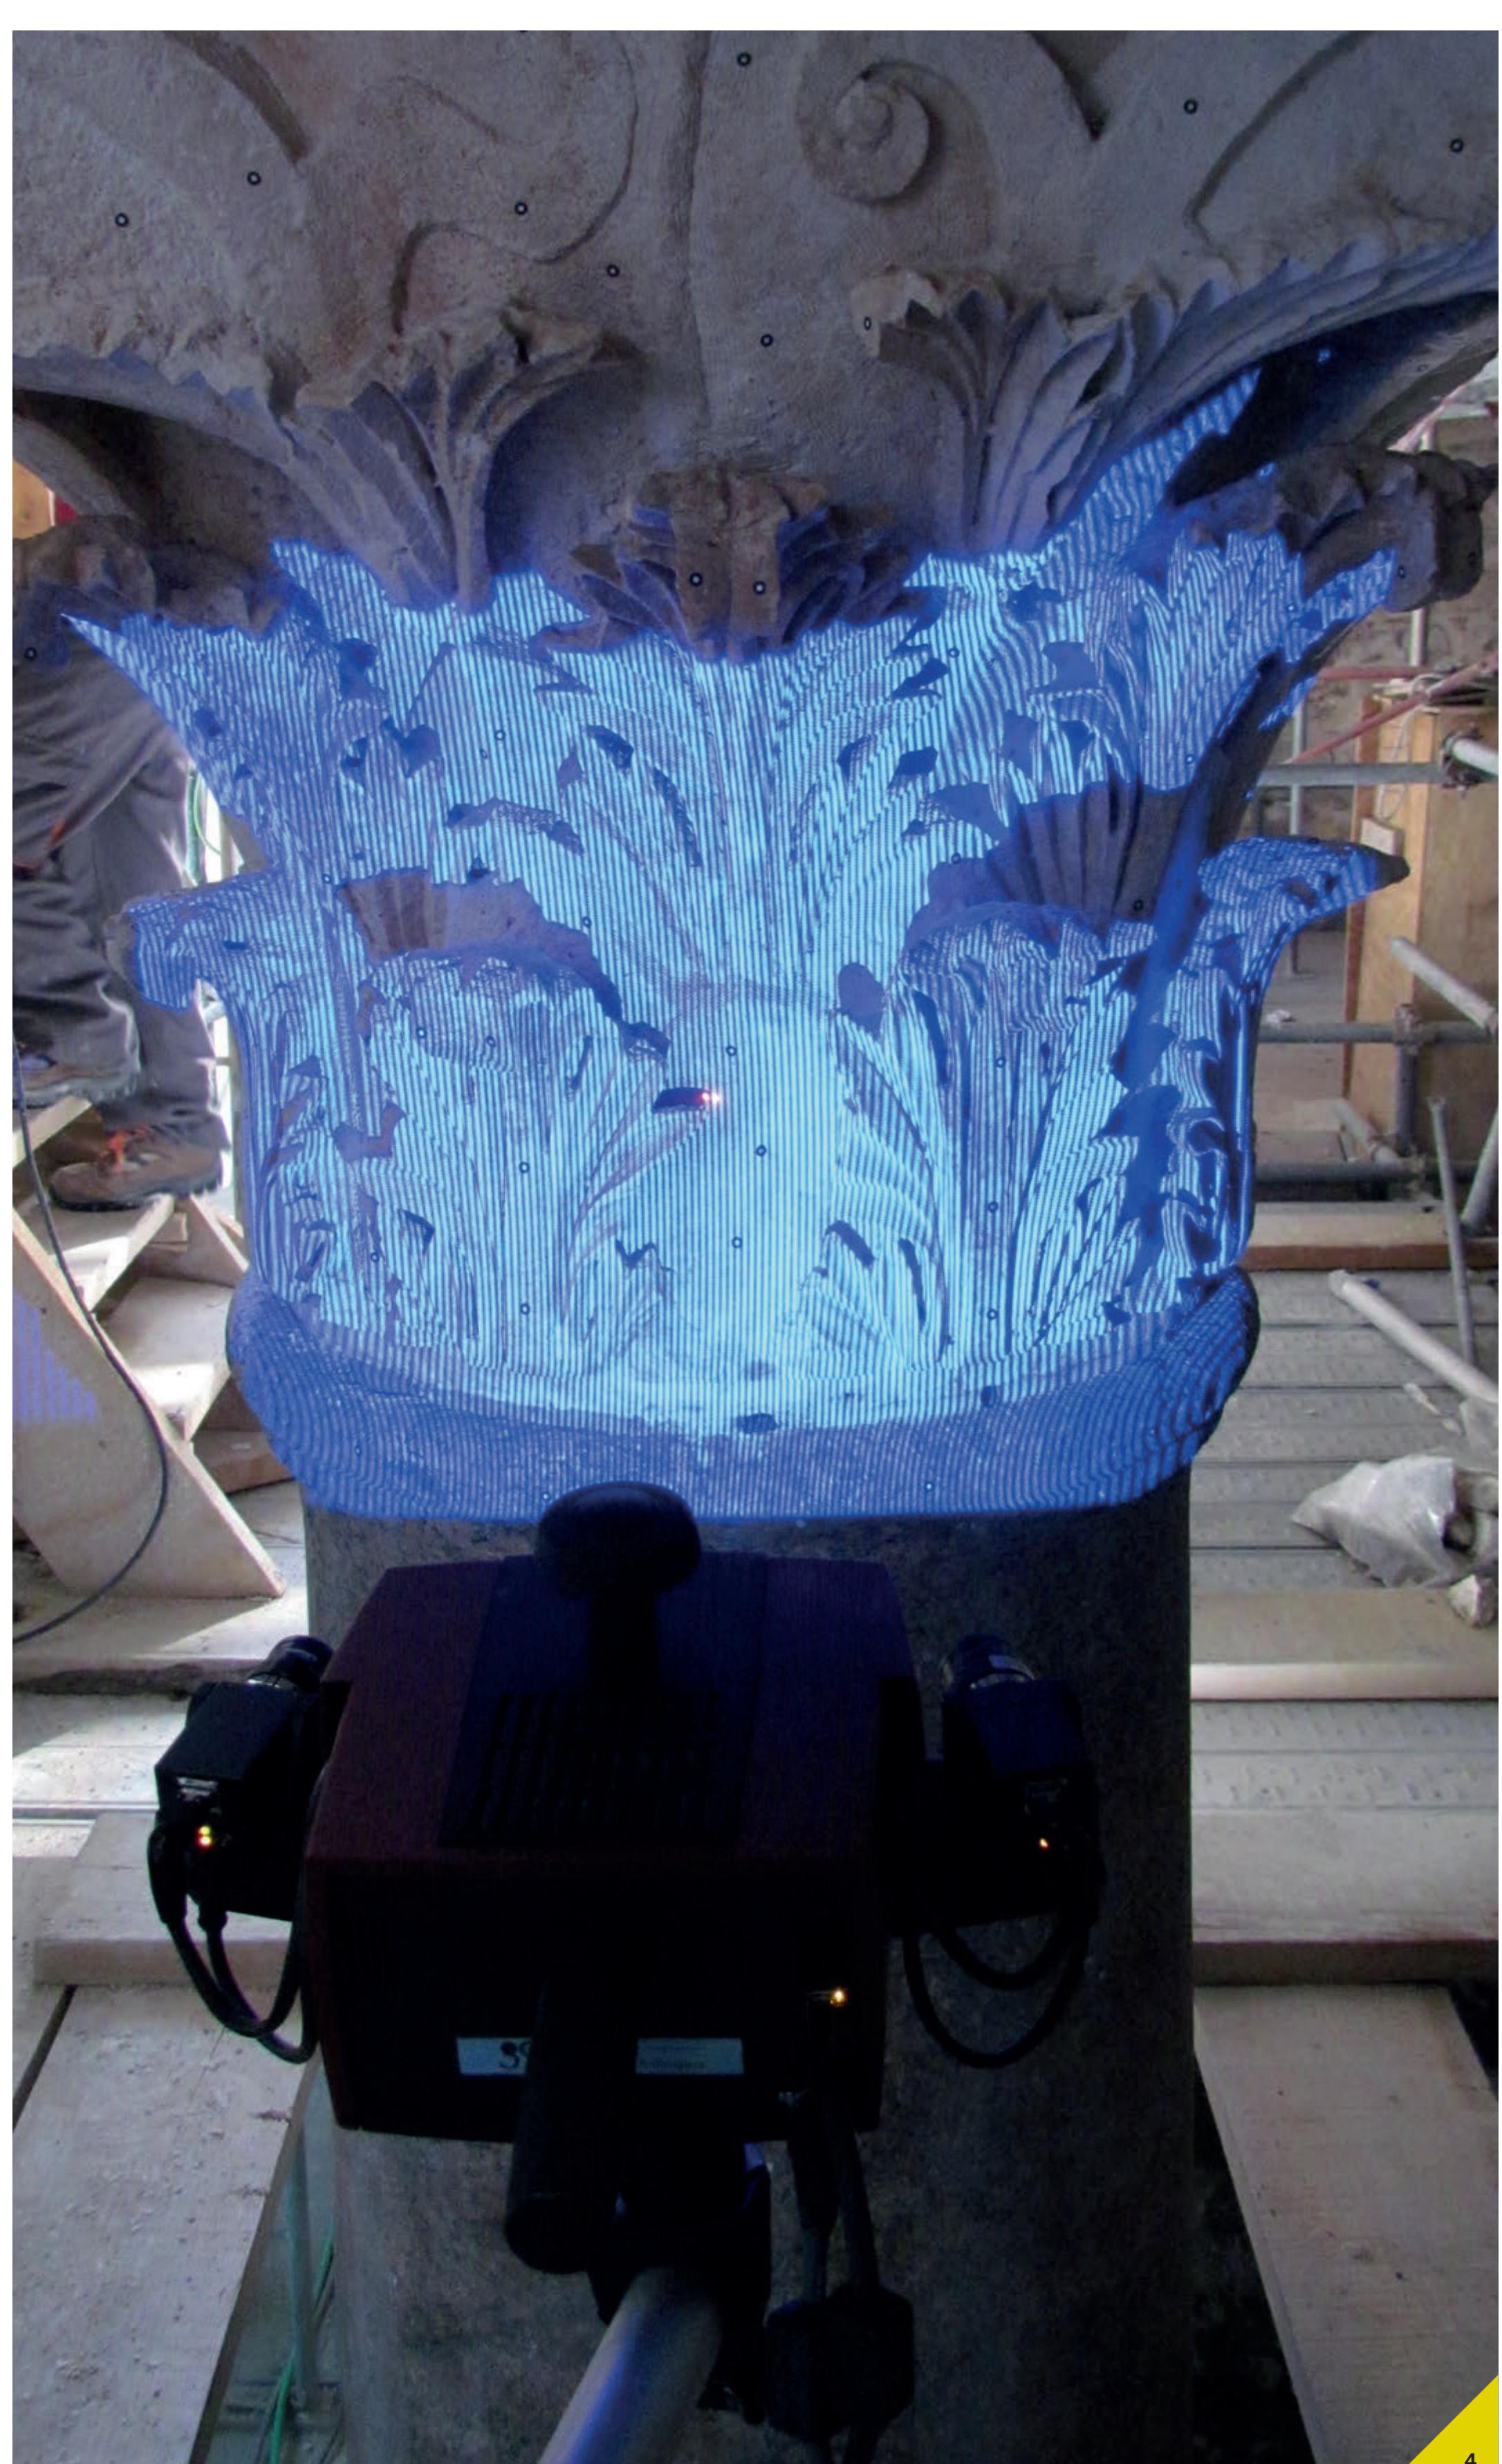
1. VIDEO SNIMANJE PROTIRONA PRIJE KONZERVATORSKO-RESTAURATORSKOG ZAHVATA; 2., 3. UCRTAVANJE OŠTEĆENJA ZATEĆENOG STANJA; 4. 3D SKENIRANJE KAPITELA PROTIRONA

1. VIDEO RECORDING OF THE PROTHYRON BEFORE CONSERVATION-RESTORATION TREATMENT; 2., 3. MAPPING OF THE DAMAGE; 4. 3D SCANNING OF THE CAPITAL FROM THE PROTHYRON
