## Na završetku desetljeća obnove Peristila

## At the end of a Decade of the Peristyle Restoration

The conservation and restoration work on the Peristyle of Diocletian's Palace has been in many ways the most important project in recent period within the scope of renovation of the historical core of the town of Split. The Peristyle is the centre and the most impressive part of the imperial palace, and also the heart of the town which has grown around it. The square, which reflects historical layers of the creation and development of the town, has become its symbol and its main tourist attraction. It serves as the most attractive backdrop for cultural events, and a stage at which public life evolves.

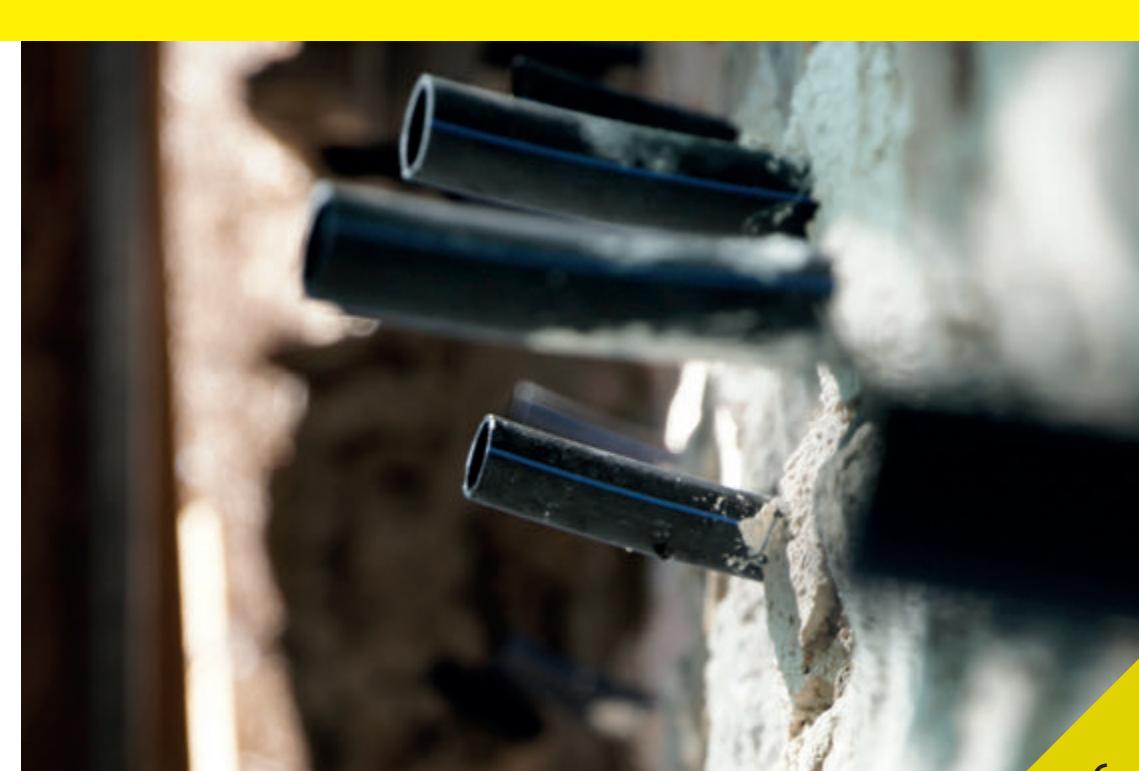
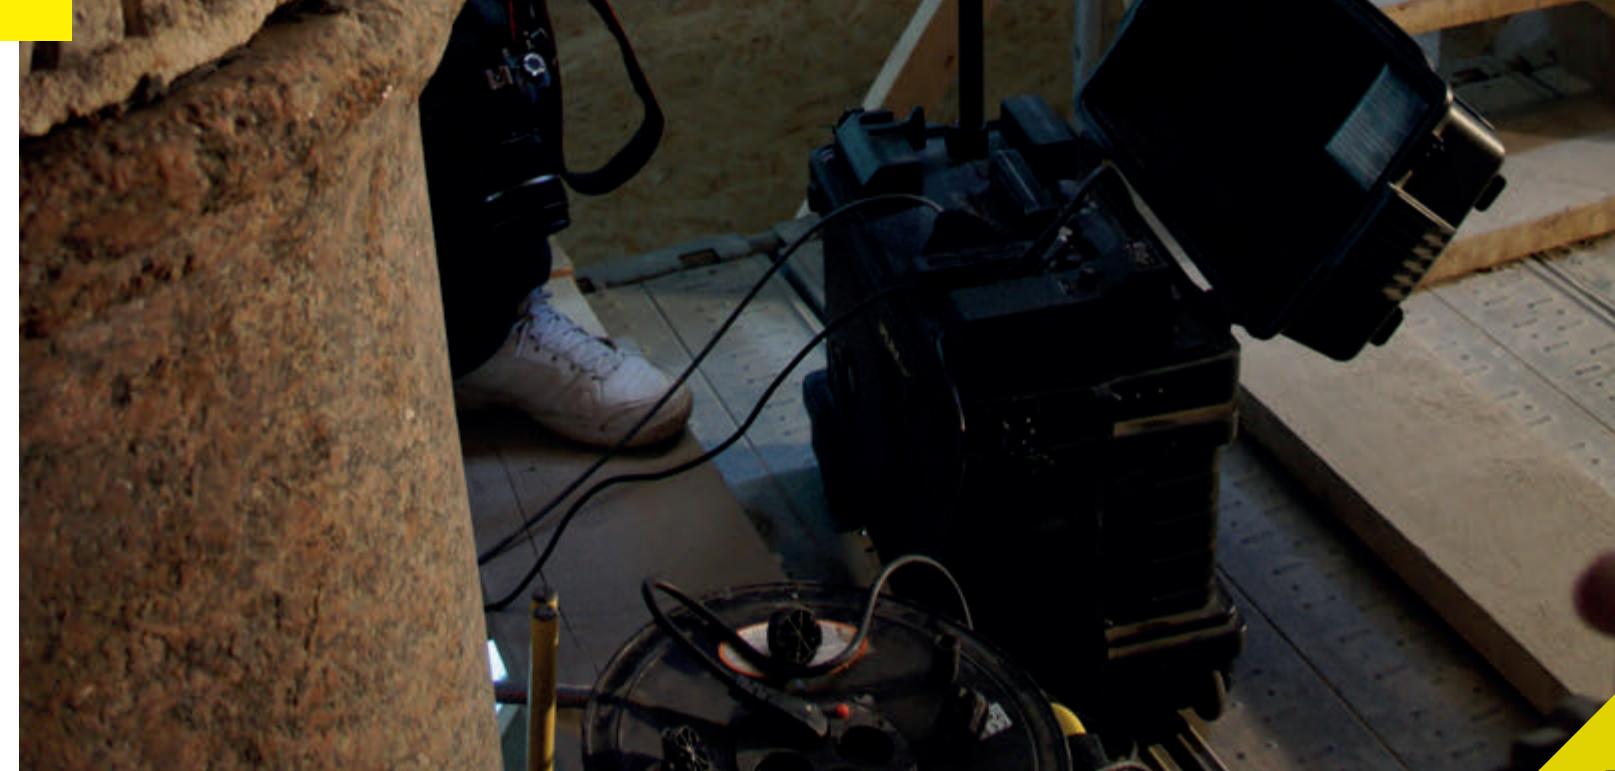
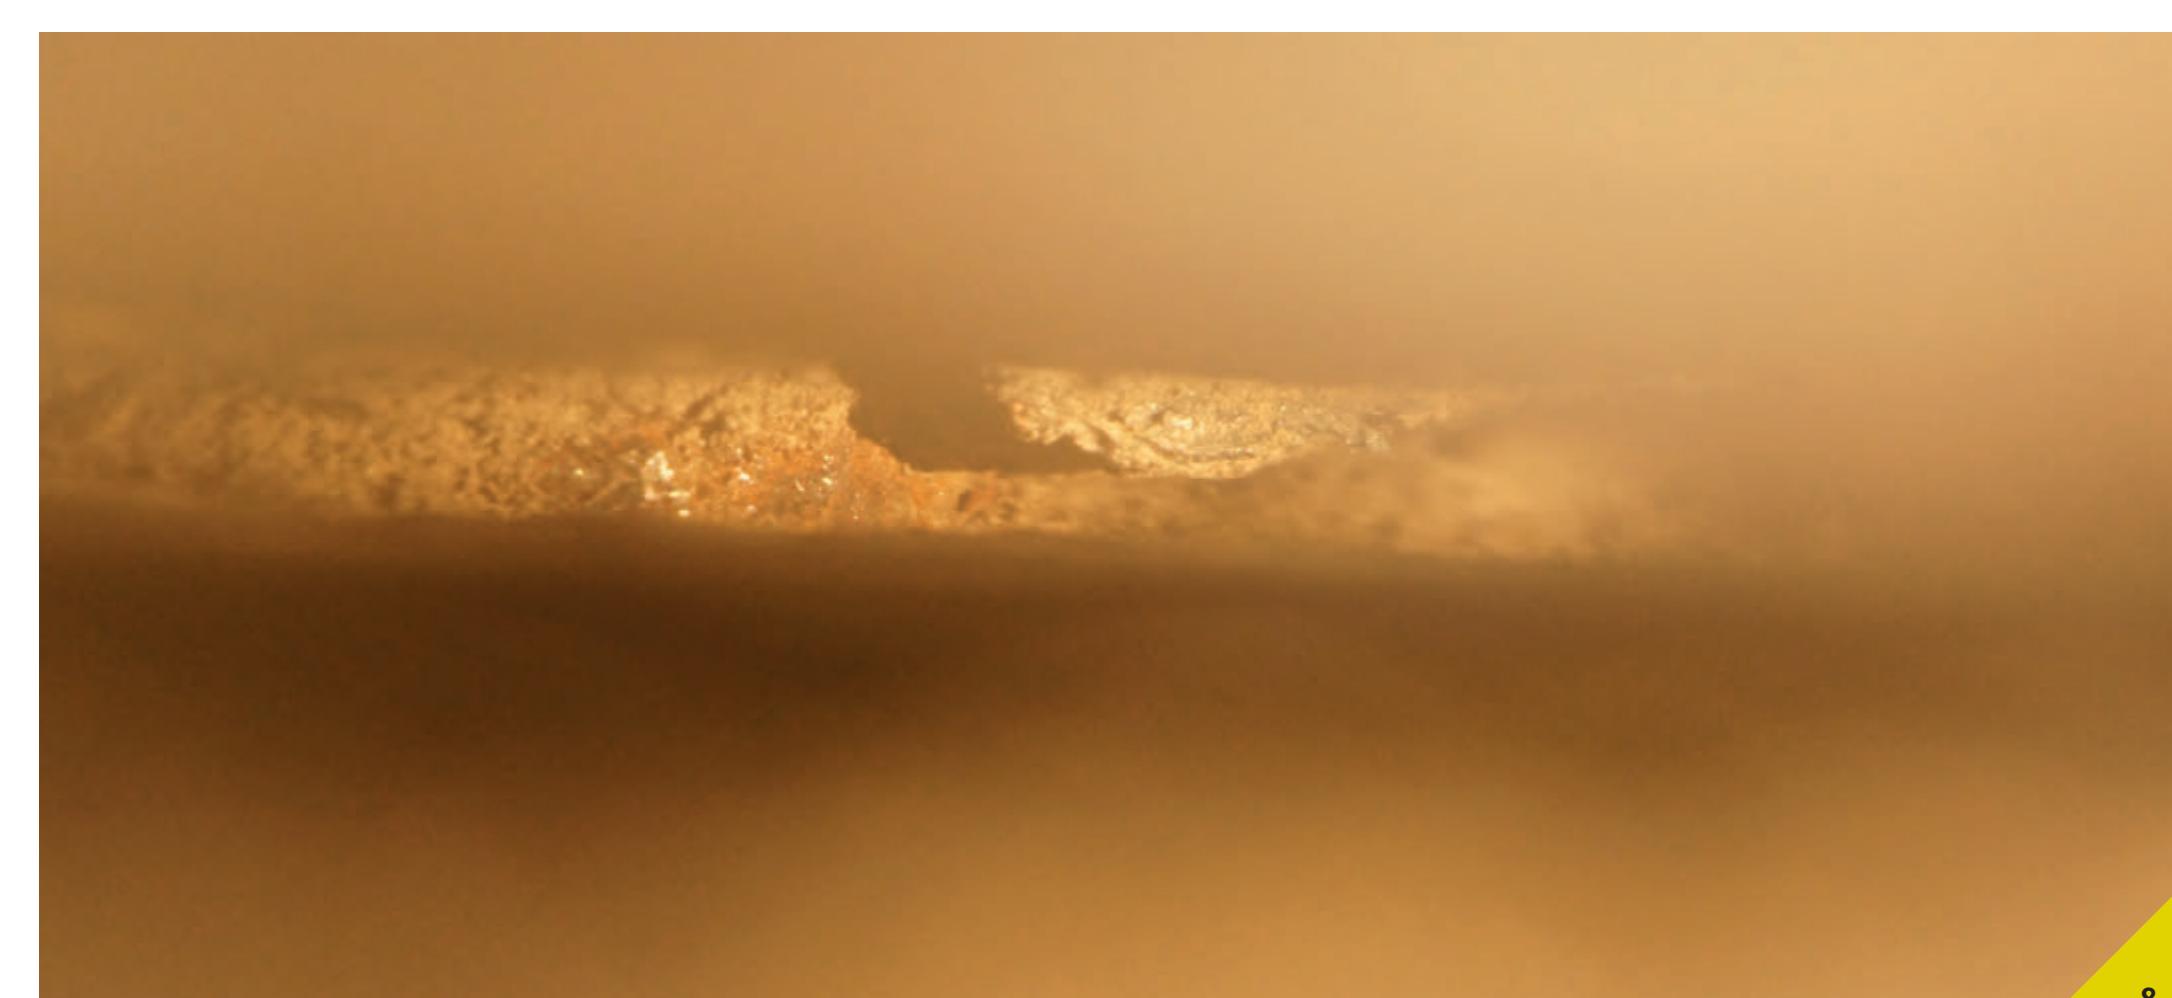
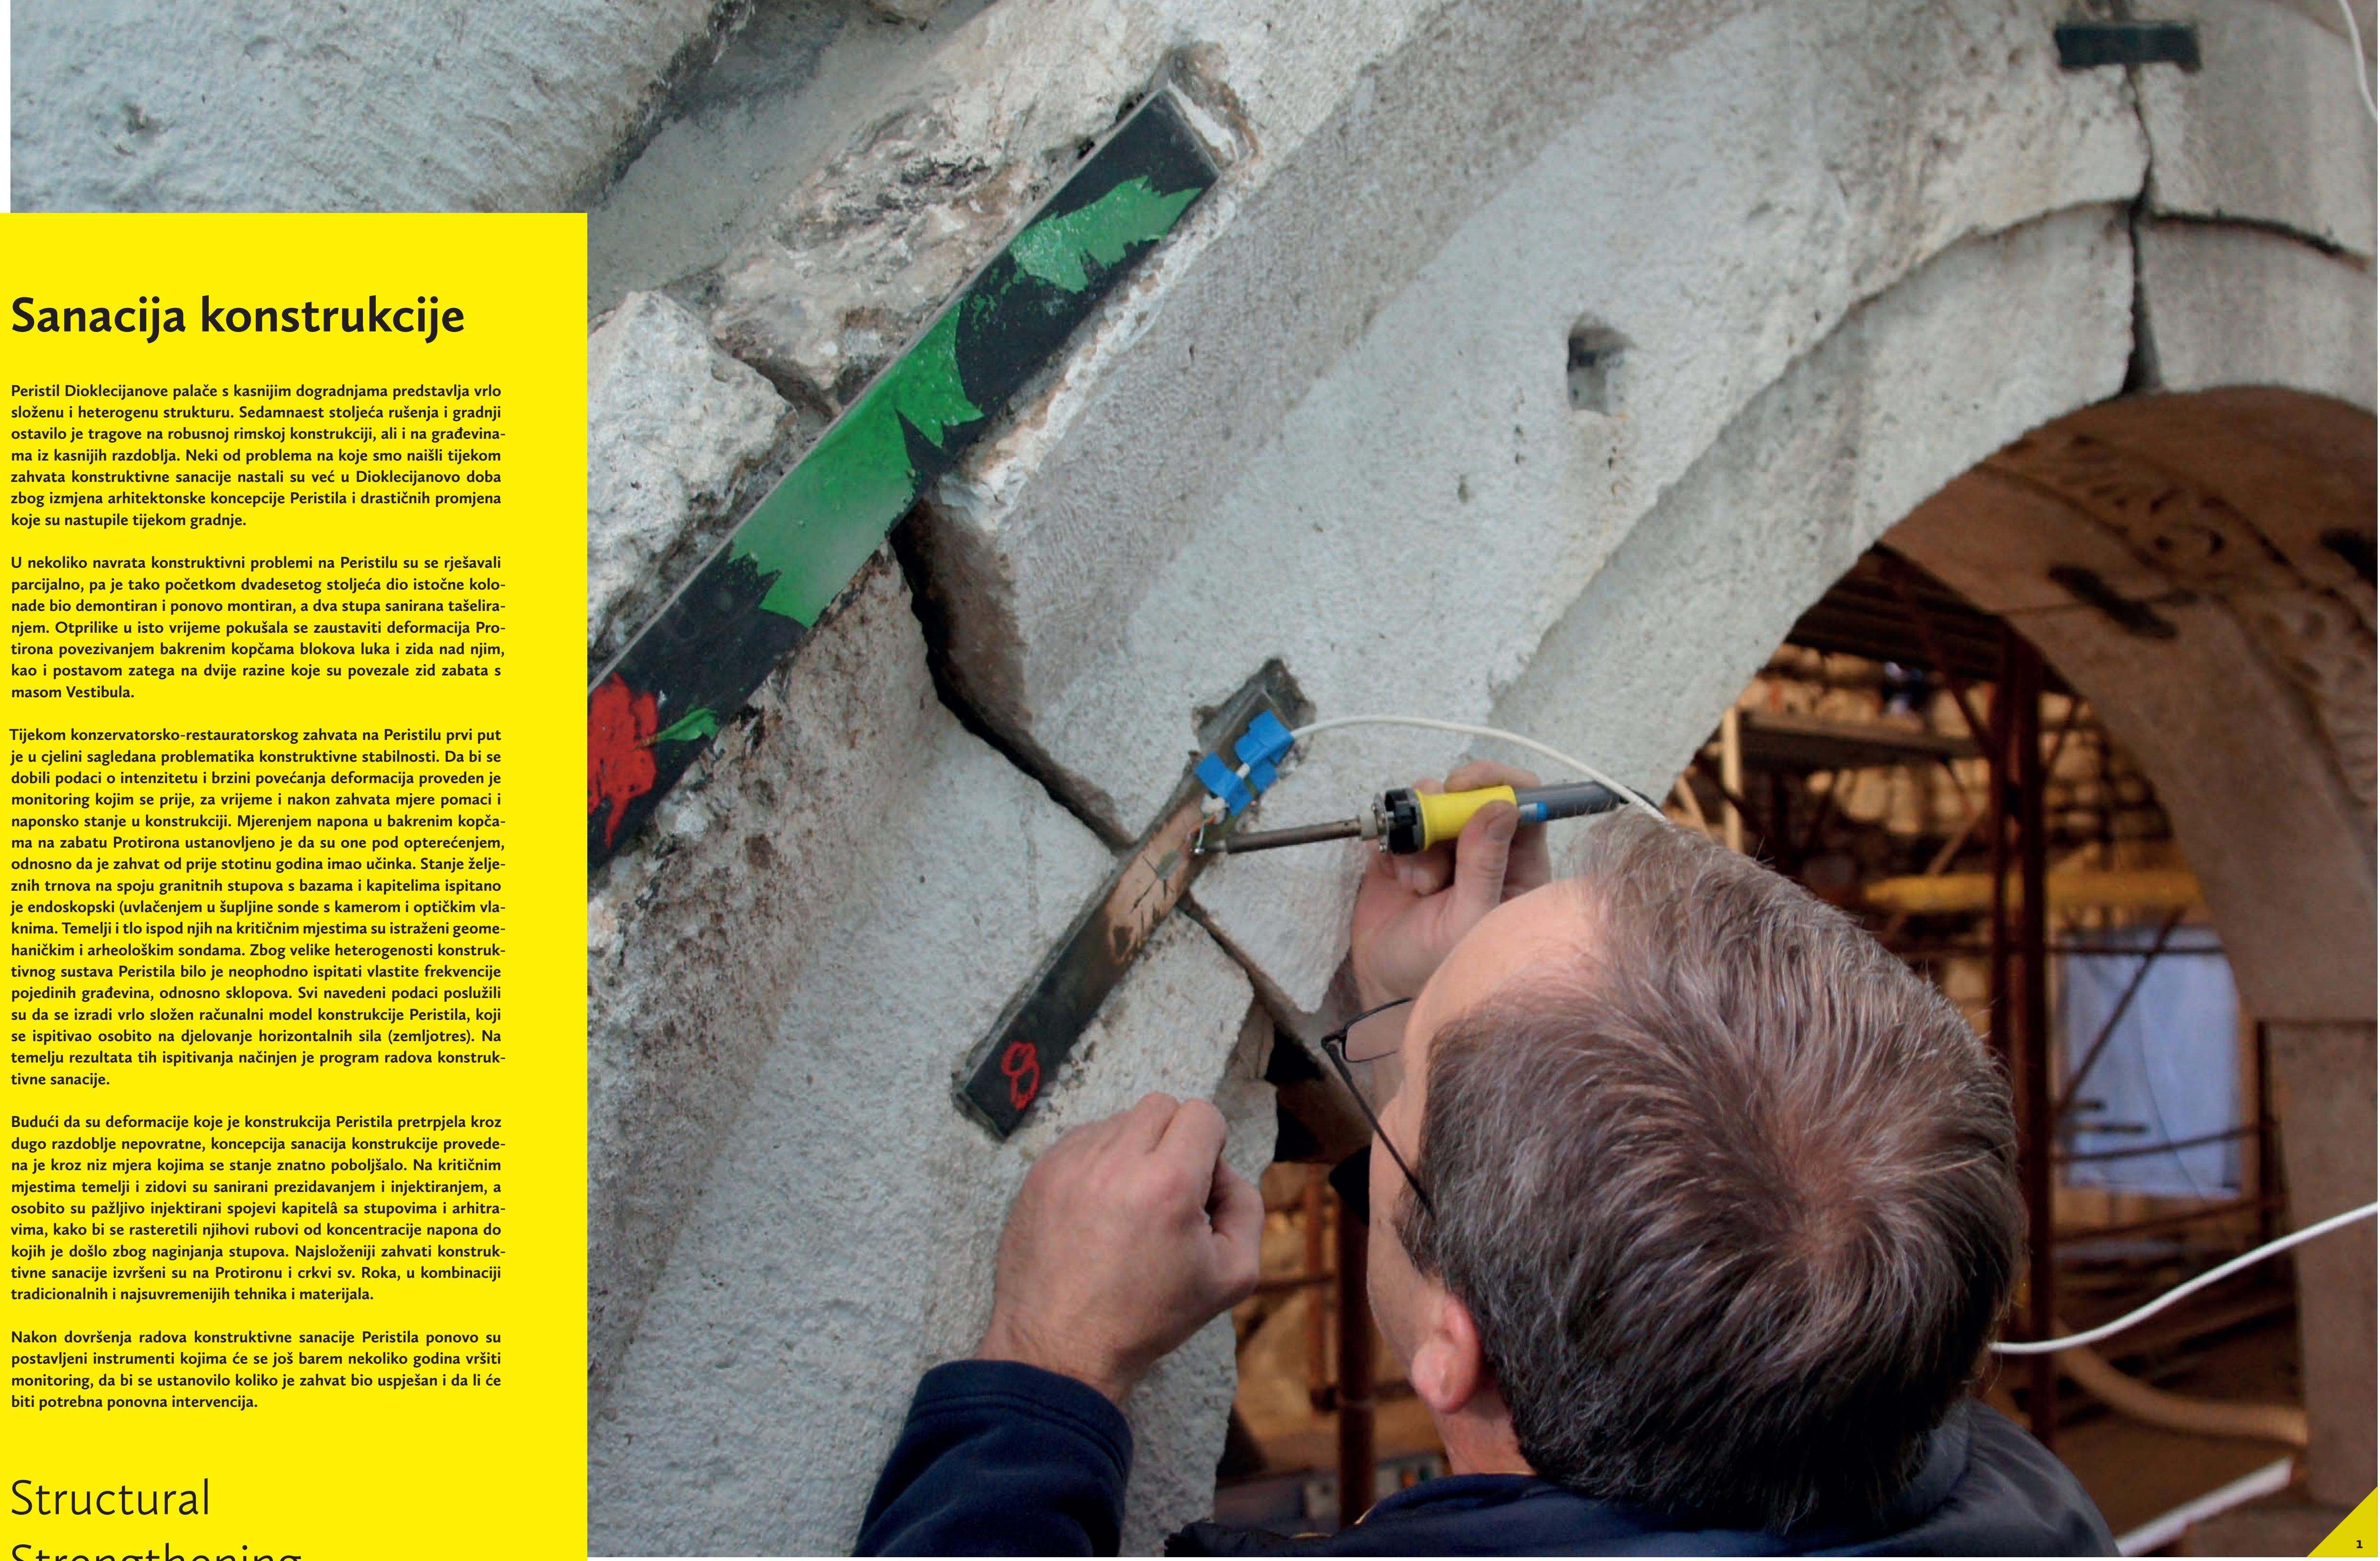
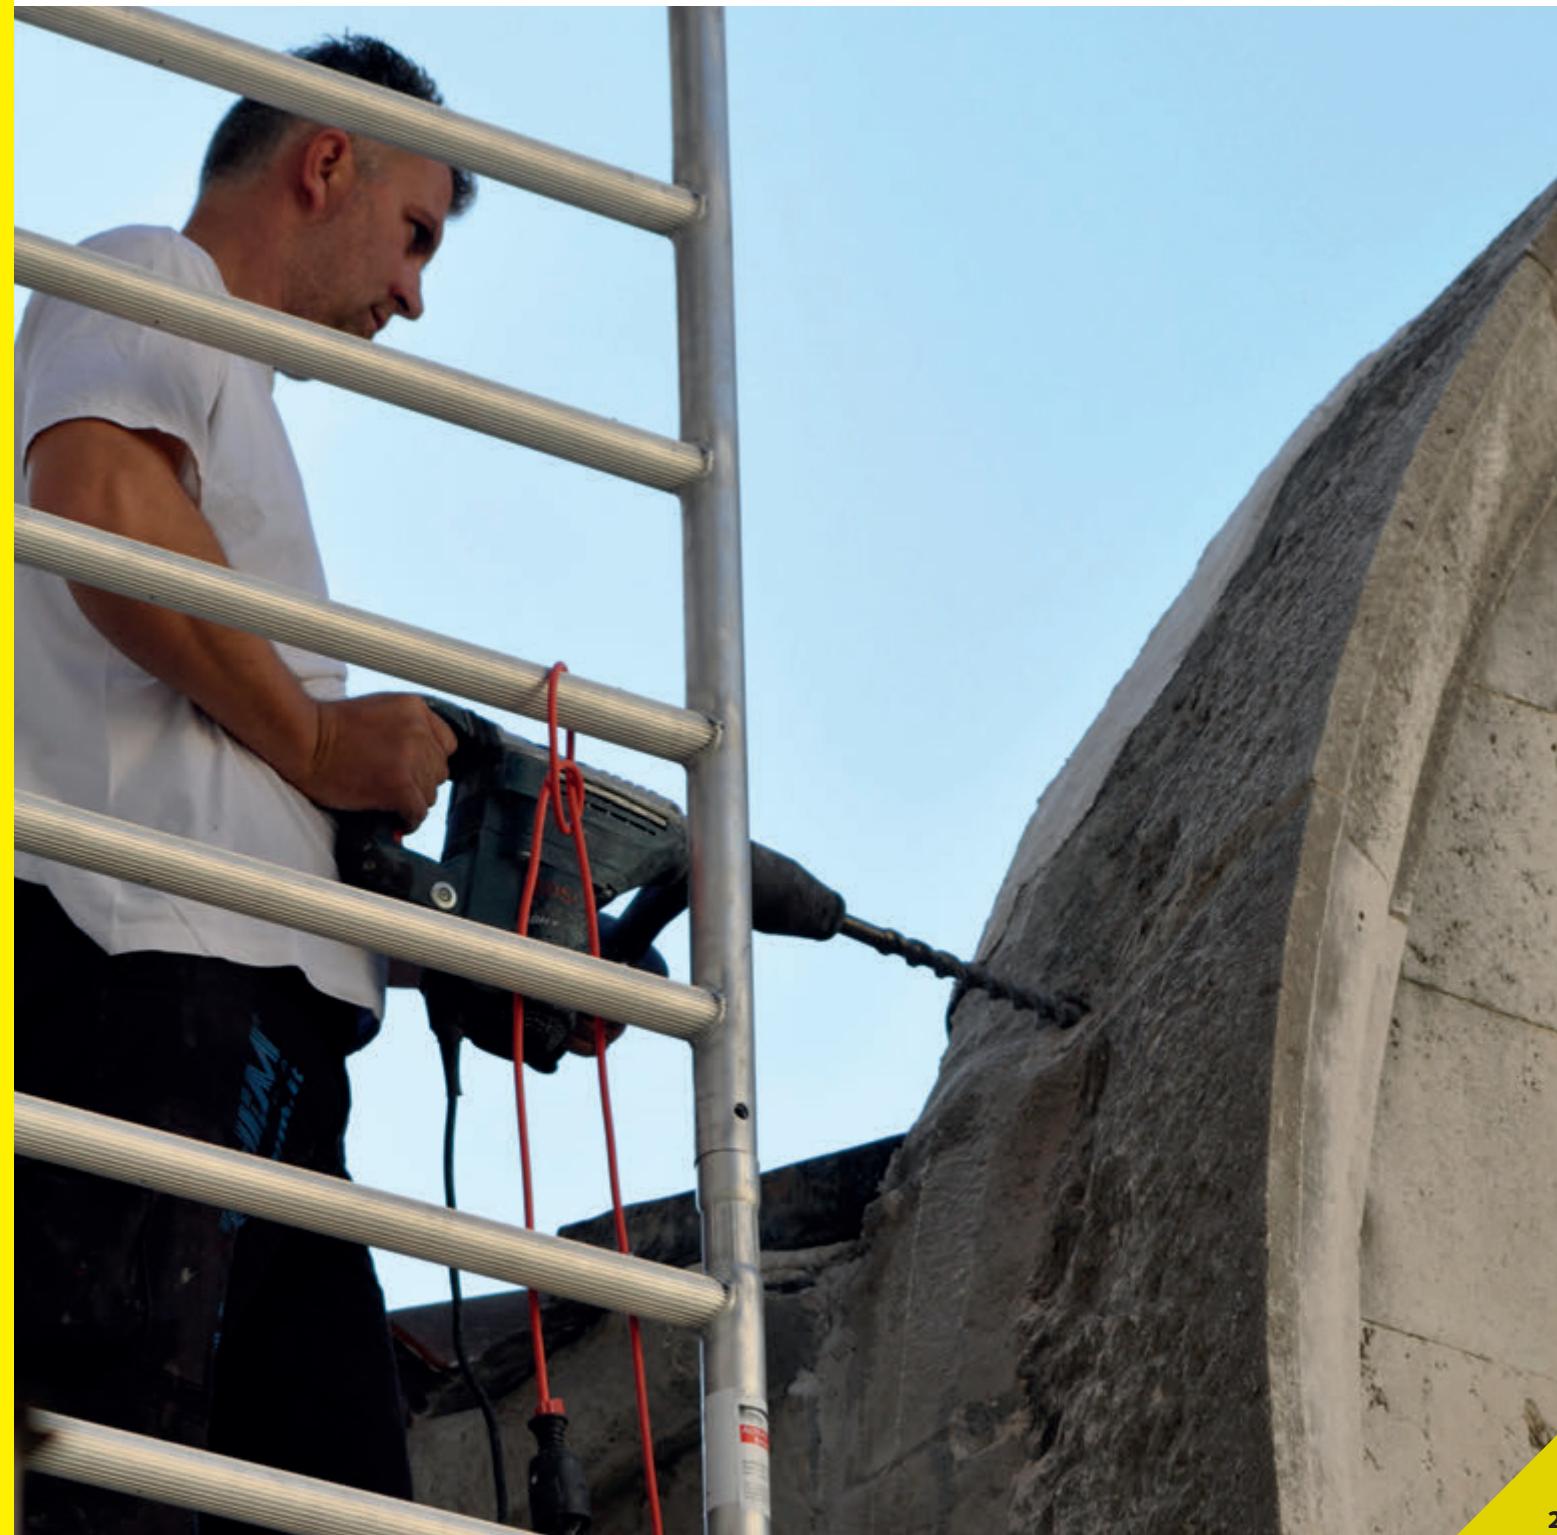
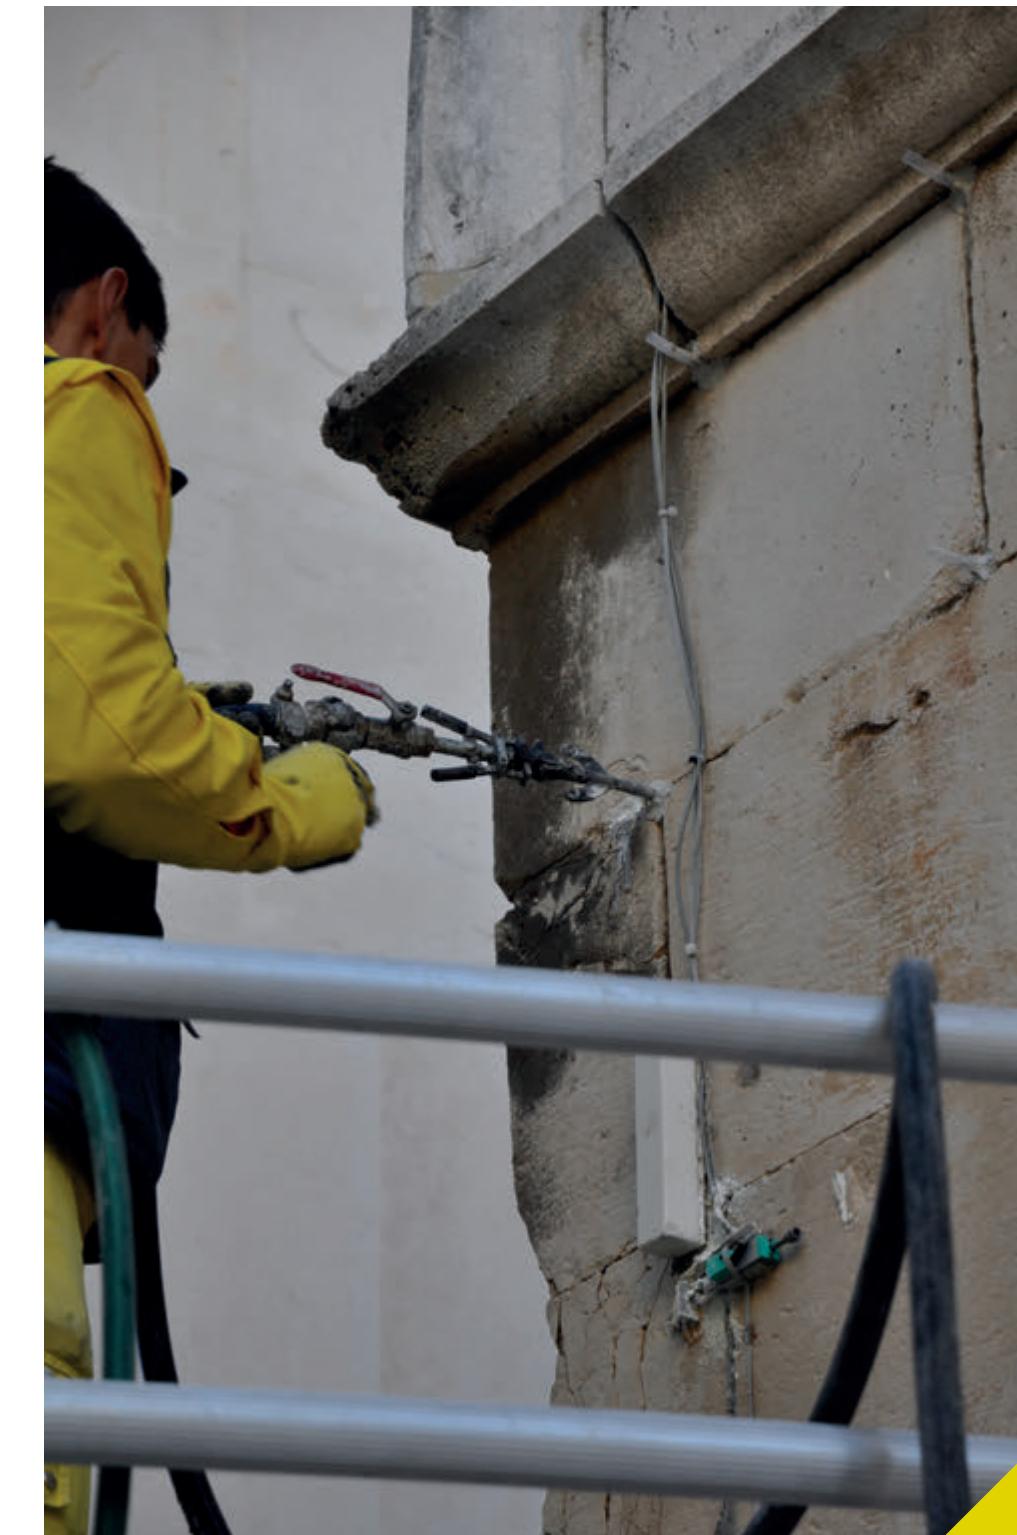
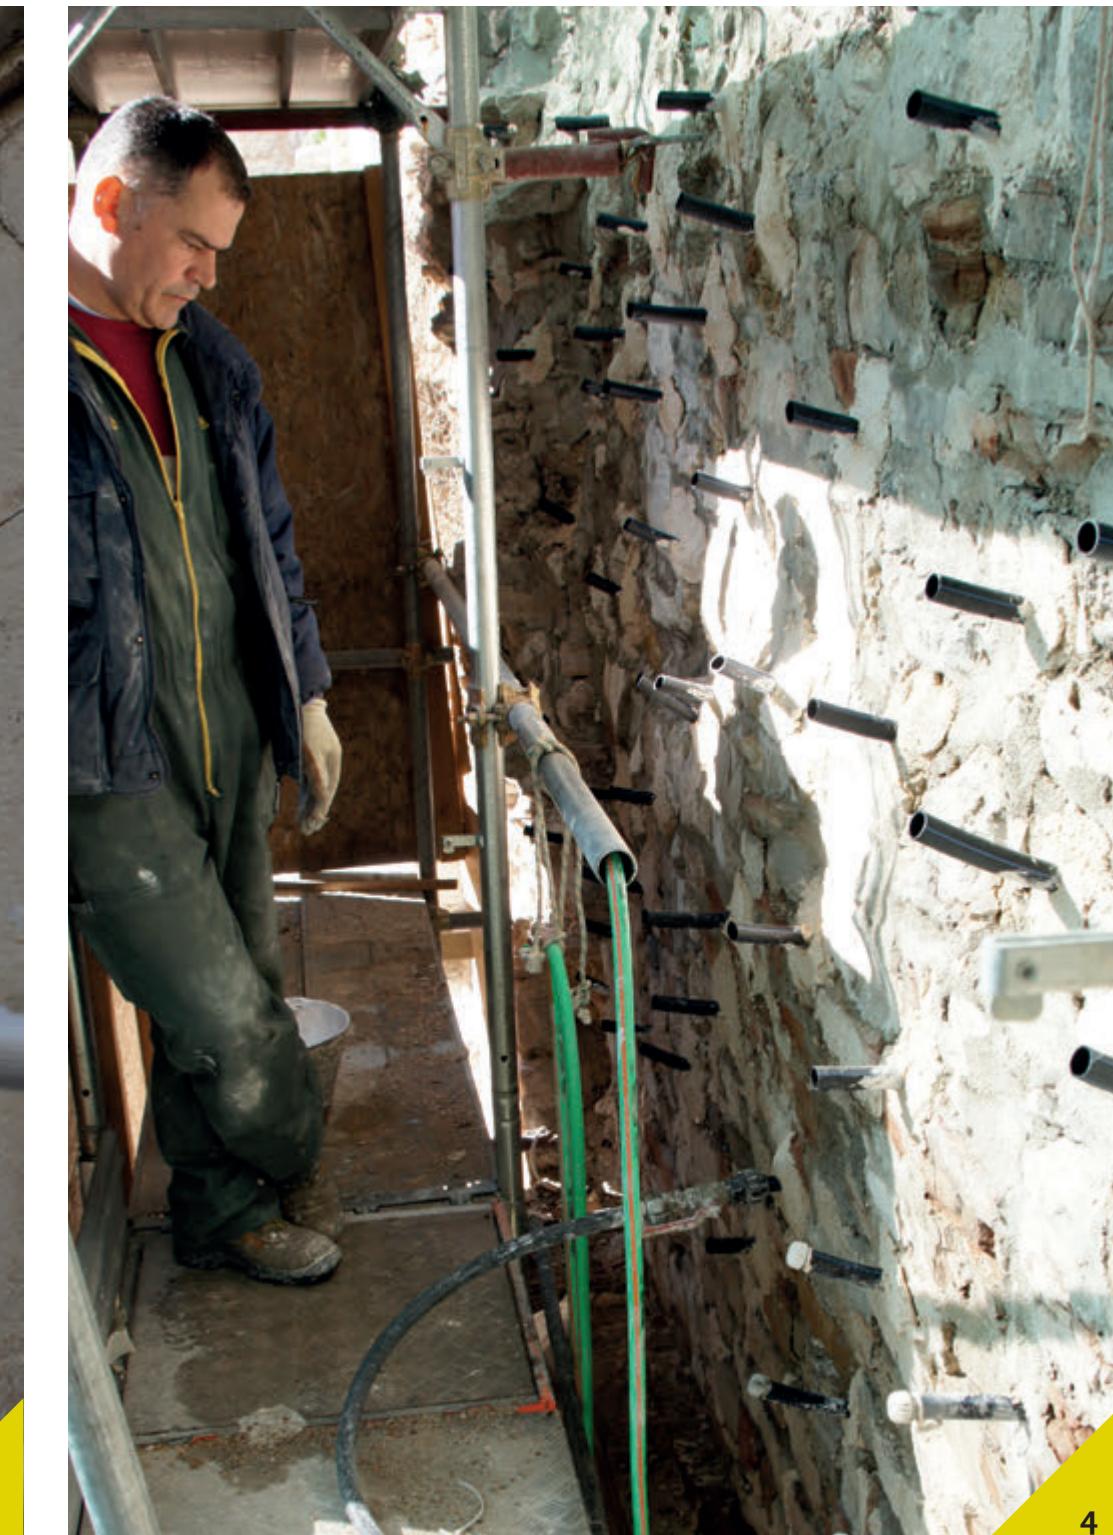
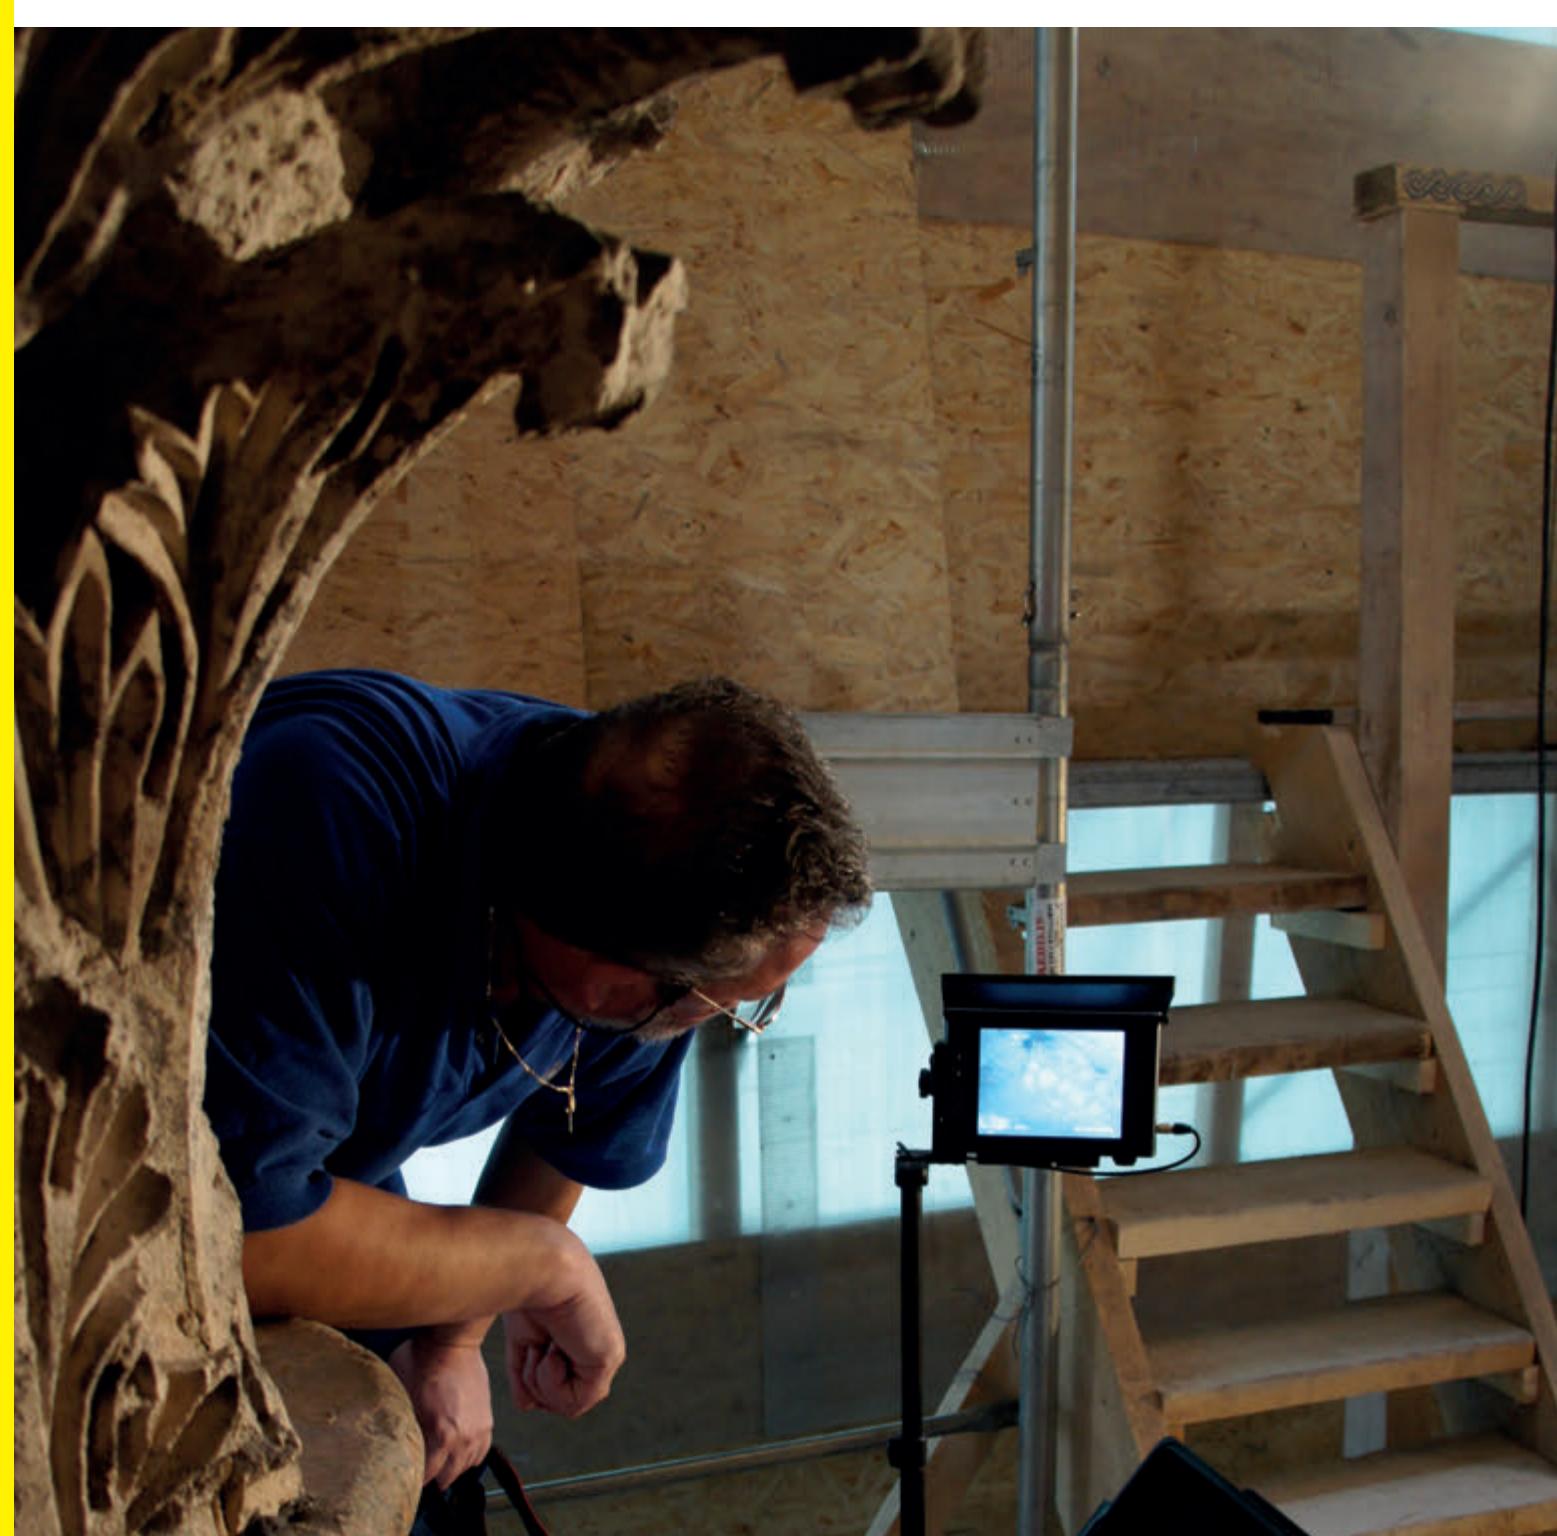
1. MJERENJE NAPONA U BAKRENNIM KLANFAMA NA ZABATU PROTIRONA; 2. BUŠENJE RUPA ZA INJEKTIRANJE ZIDOVA U SVRHU OJAČAVANJE KONSTRUKCIJE; 3, 4, 6. INJEKTIRANJE ZIDOVA U SVRHU OJAČAVANJA KONSTRUKCIJE; 5, 7. ENDOSKOPSKO ISPITIVANJE ŽELJEZNIH TRNOVA NA SPOJU GRANITNOG STUPA PROTIRONA SA KAPITELOM; 8. ŽELJEZNI TRN IZMEĐU GRANITNOG STUPA I KAPITELA NA PROTIRONU – FOTOGRAFIJAN POMOĆU ENDOSKOPA

1. MEASUREMENT OF STRESS IN THE COPPER CLAMPS ON THE PROTHYRON PEDIMENT; 2. DRILLING HOLES FOR GROUTING OF WALLS FOR STRUCTURAL STRENGTHENING; 3, 4, 6. GROUTING OF WALLS FOR STRUCTURAL CONSOLIDATION; 5, 7. ENDOSCOPIC EXAMINATION OF IRON DOWELS LOCATED BETWEEN THE GRANITE COLUMN AND ITS CAPITAL OF THE PROTHYRON; 8. IRON DOWEL BETWEEN THE COLUMN AND ITS CAPITAL, PHOTOGRAPHED USING ENDOSCOPIC TECHNIQUE

Since deformations of the construction of Peristyle are irreversible, the concept of construction rehabilitation was based upon numerous treatments that have significantly improved the condition. Critical areas of foundations and walls were reconstructed and injected. Special attention was given to injecting the joints between capitals and columns and lintels, so that the corner areas would suffer less thrust created by the tilting of the columns. The most elaborate treatments were conducted in Prothyon and the Church of St. Roch where traditional and most recent techniques and materials were combined.
