## Na završetku desetljeća obnove Peristila

## At the end of a Decade of the Peristyle Restoration

The conservation and restoration work on the Peristyle of Diocletian's Palace has been in many ways the most important project in recent period within the scope of renovation of the historical core of the town of Split. The Peristyle is the centre and the most impressive part of the imperial palace, and also the heart of the town which has grown around it. The square, which reflects historical layers of the creation and development of the town, has become its symbol and its main tourist attraction. It serves as the most attractive backdrop for cultural events, and a stage at which public life evolves.

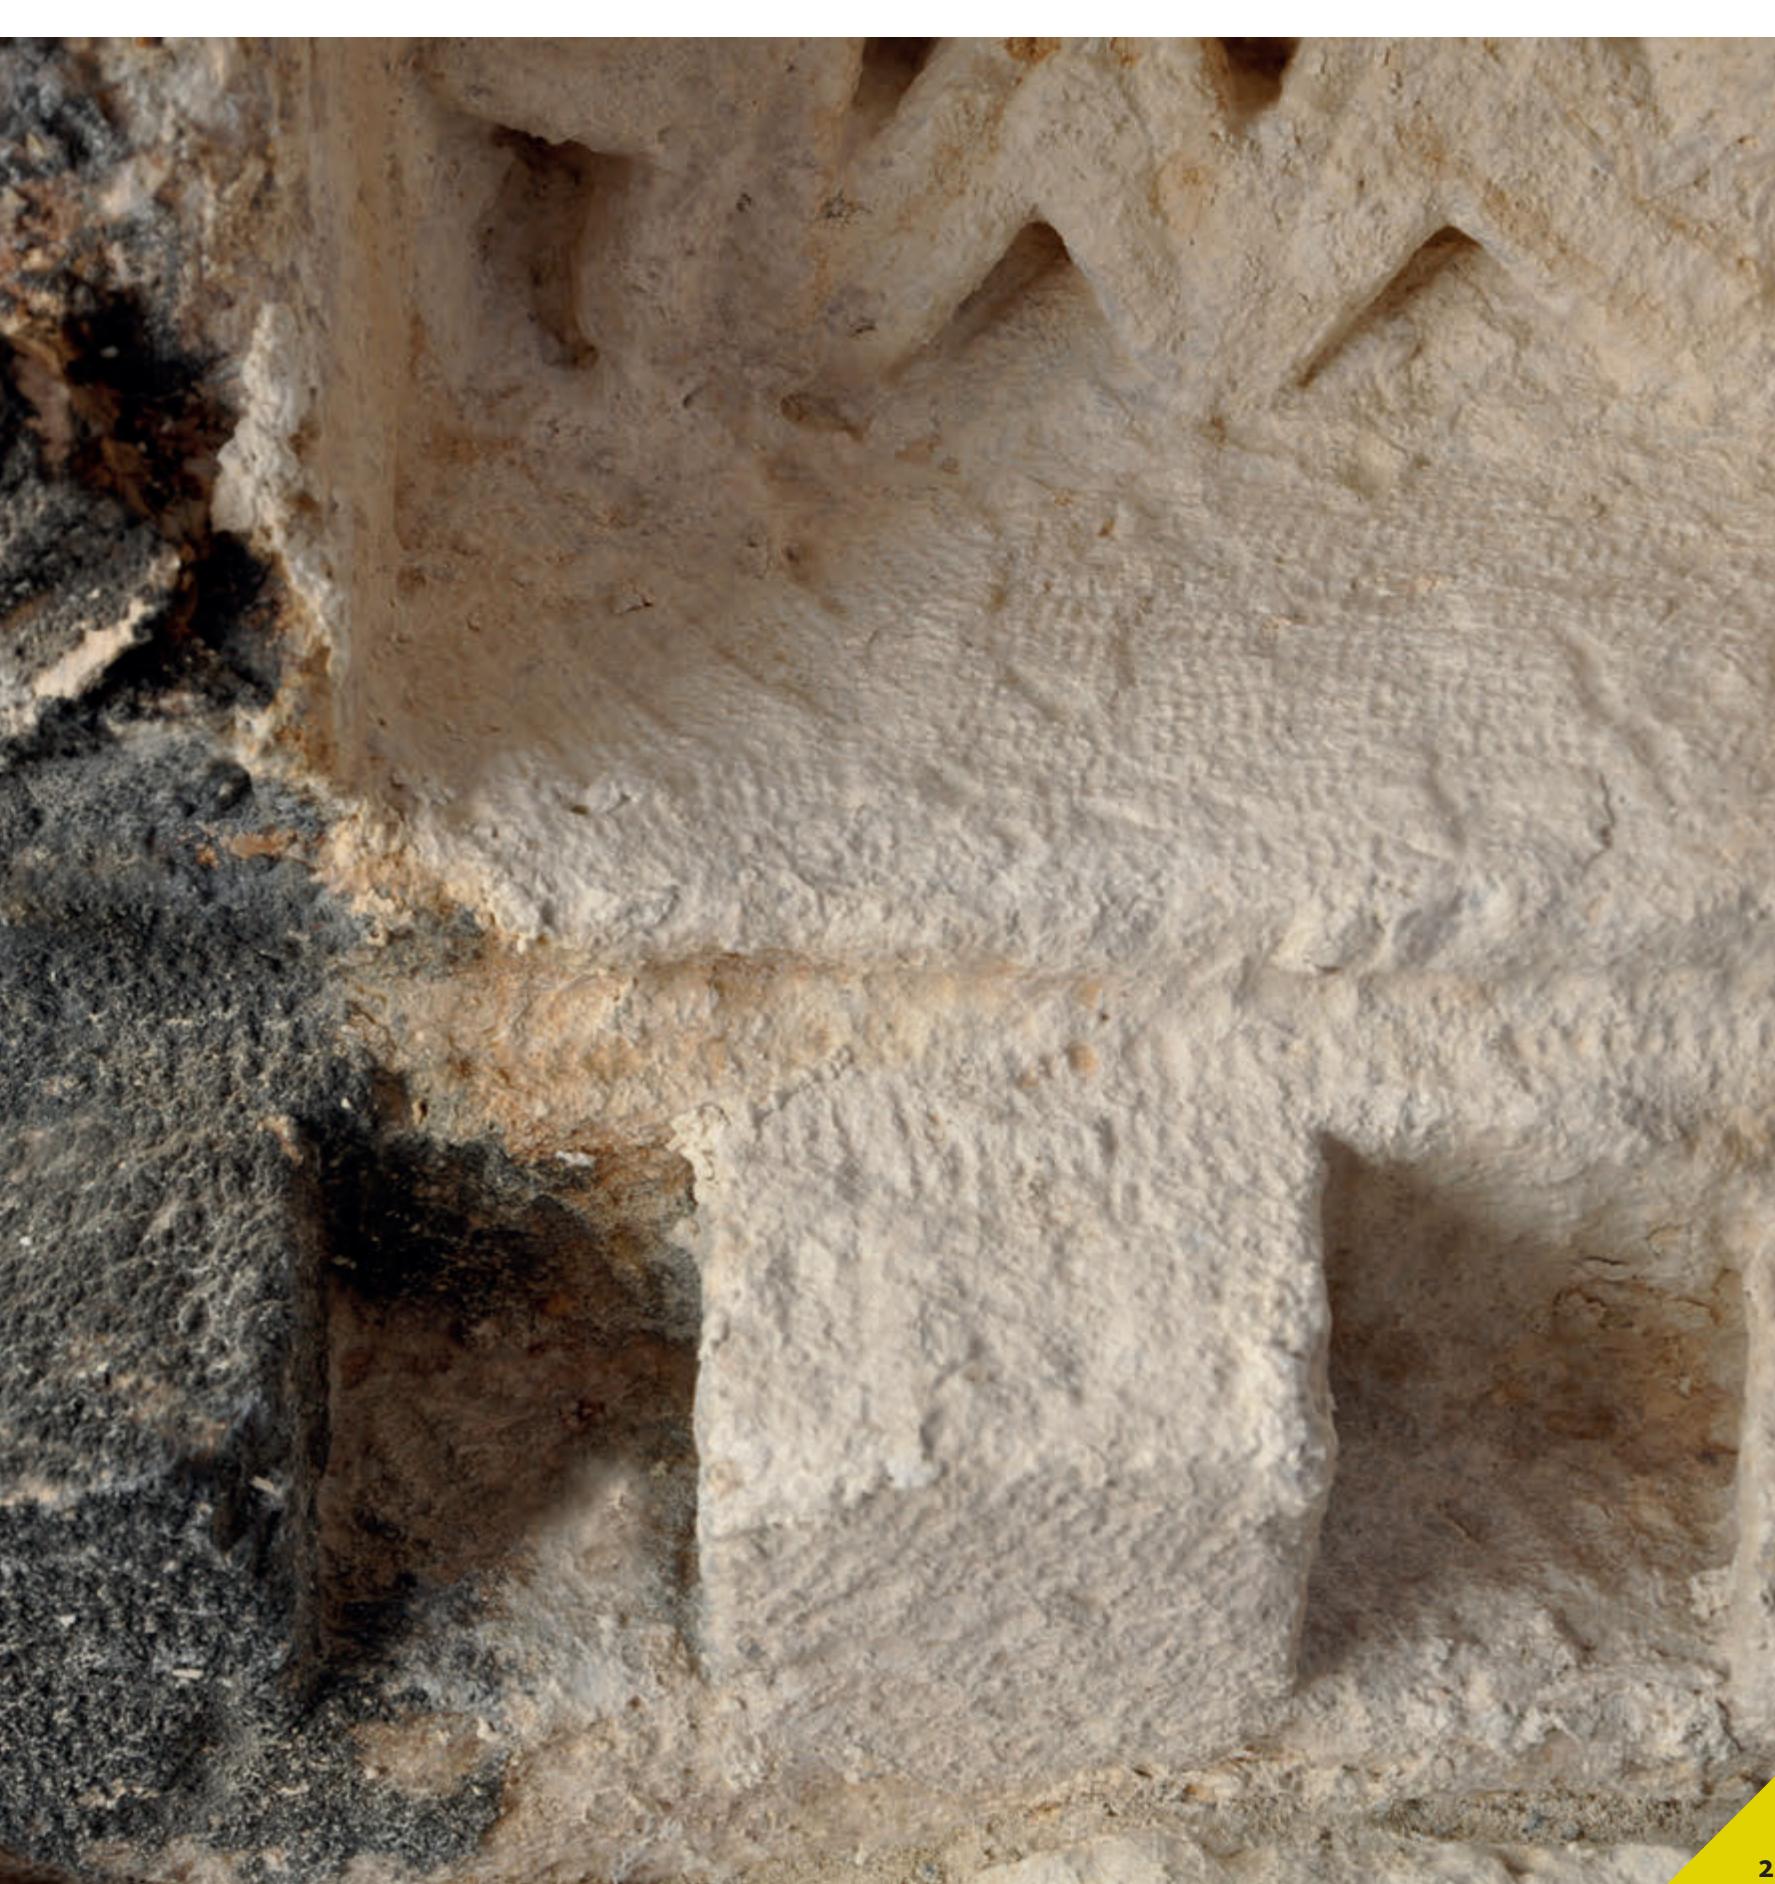
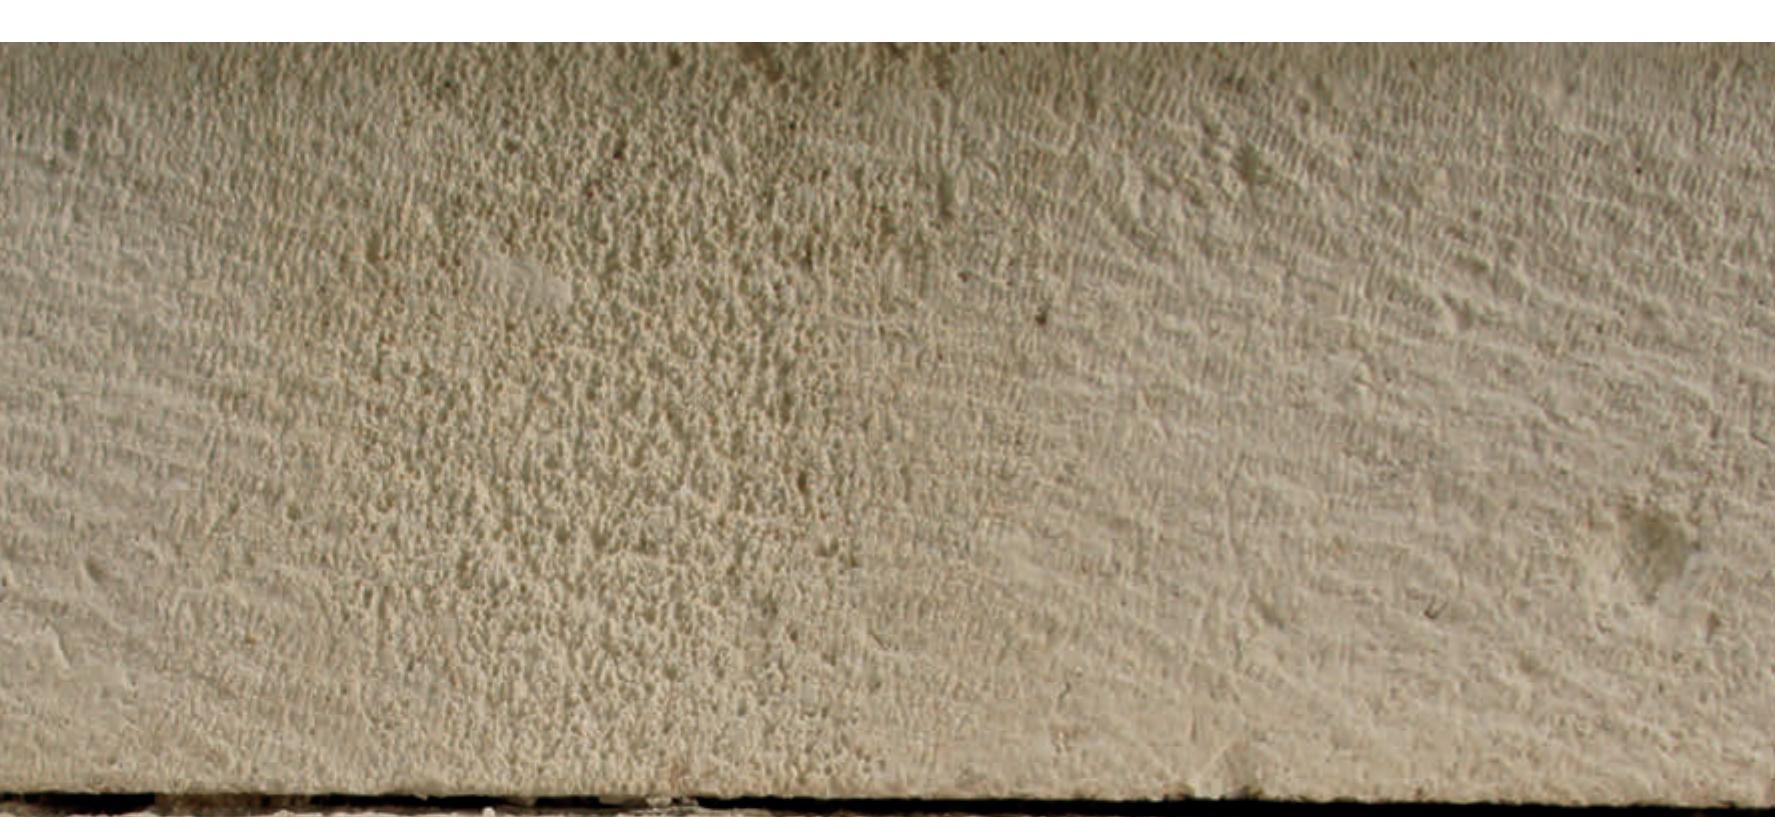
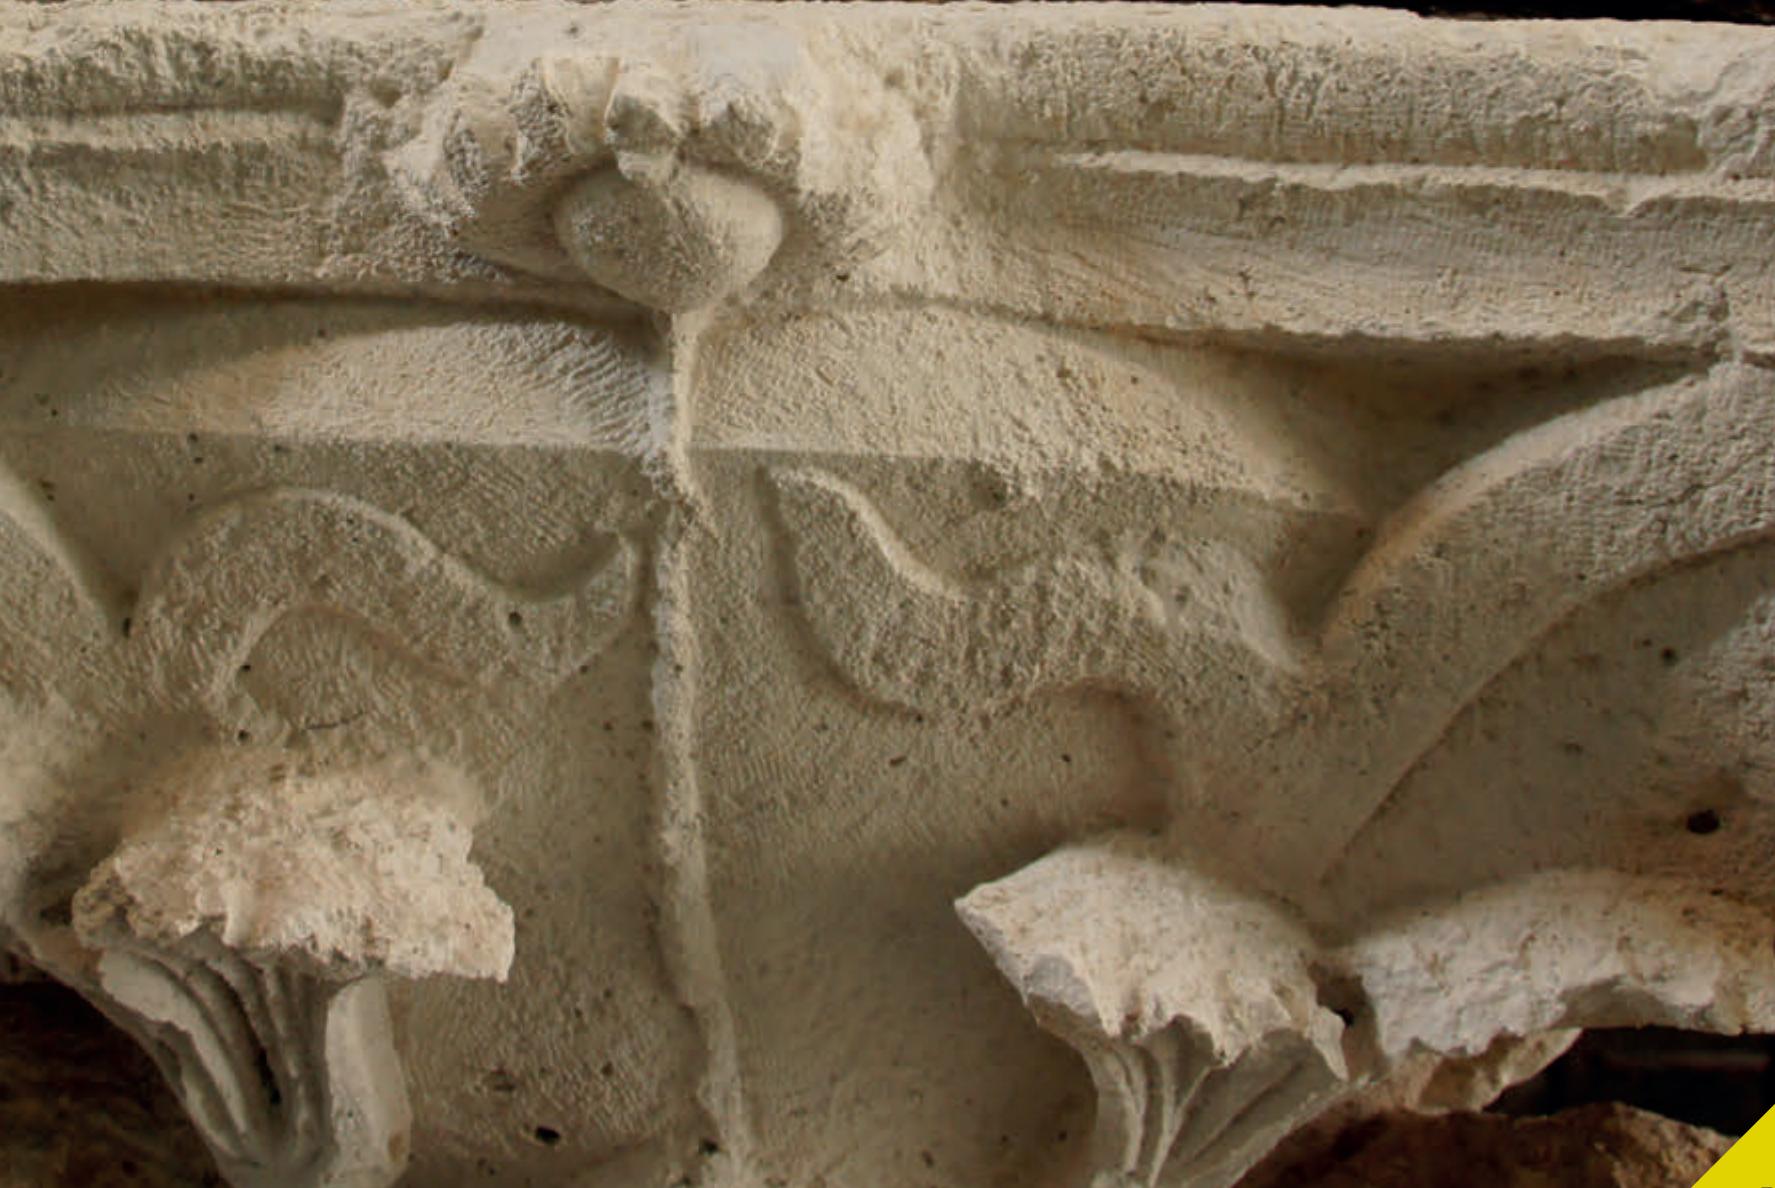
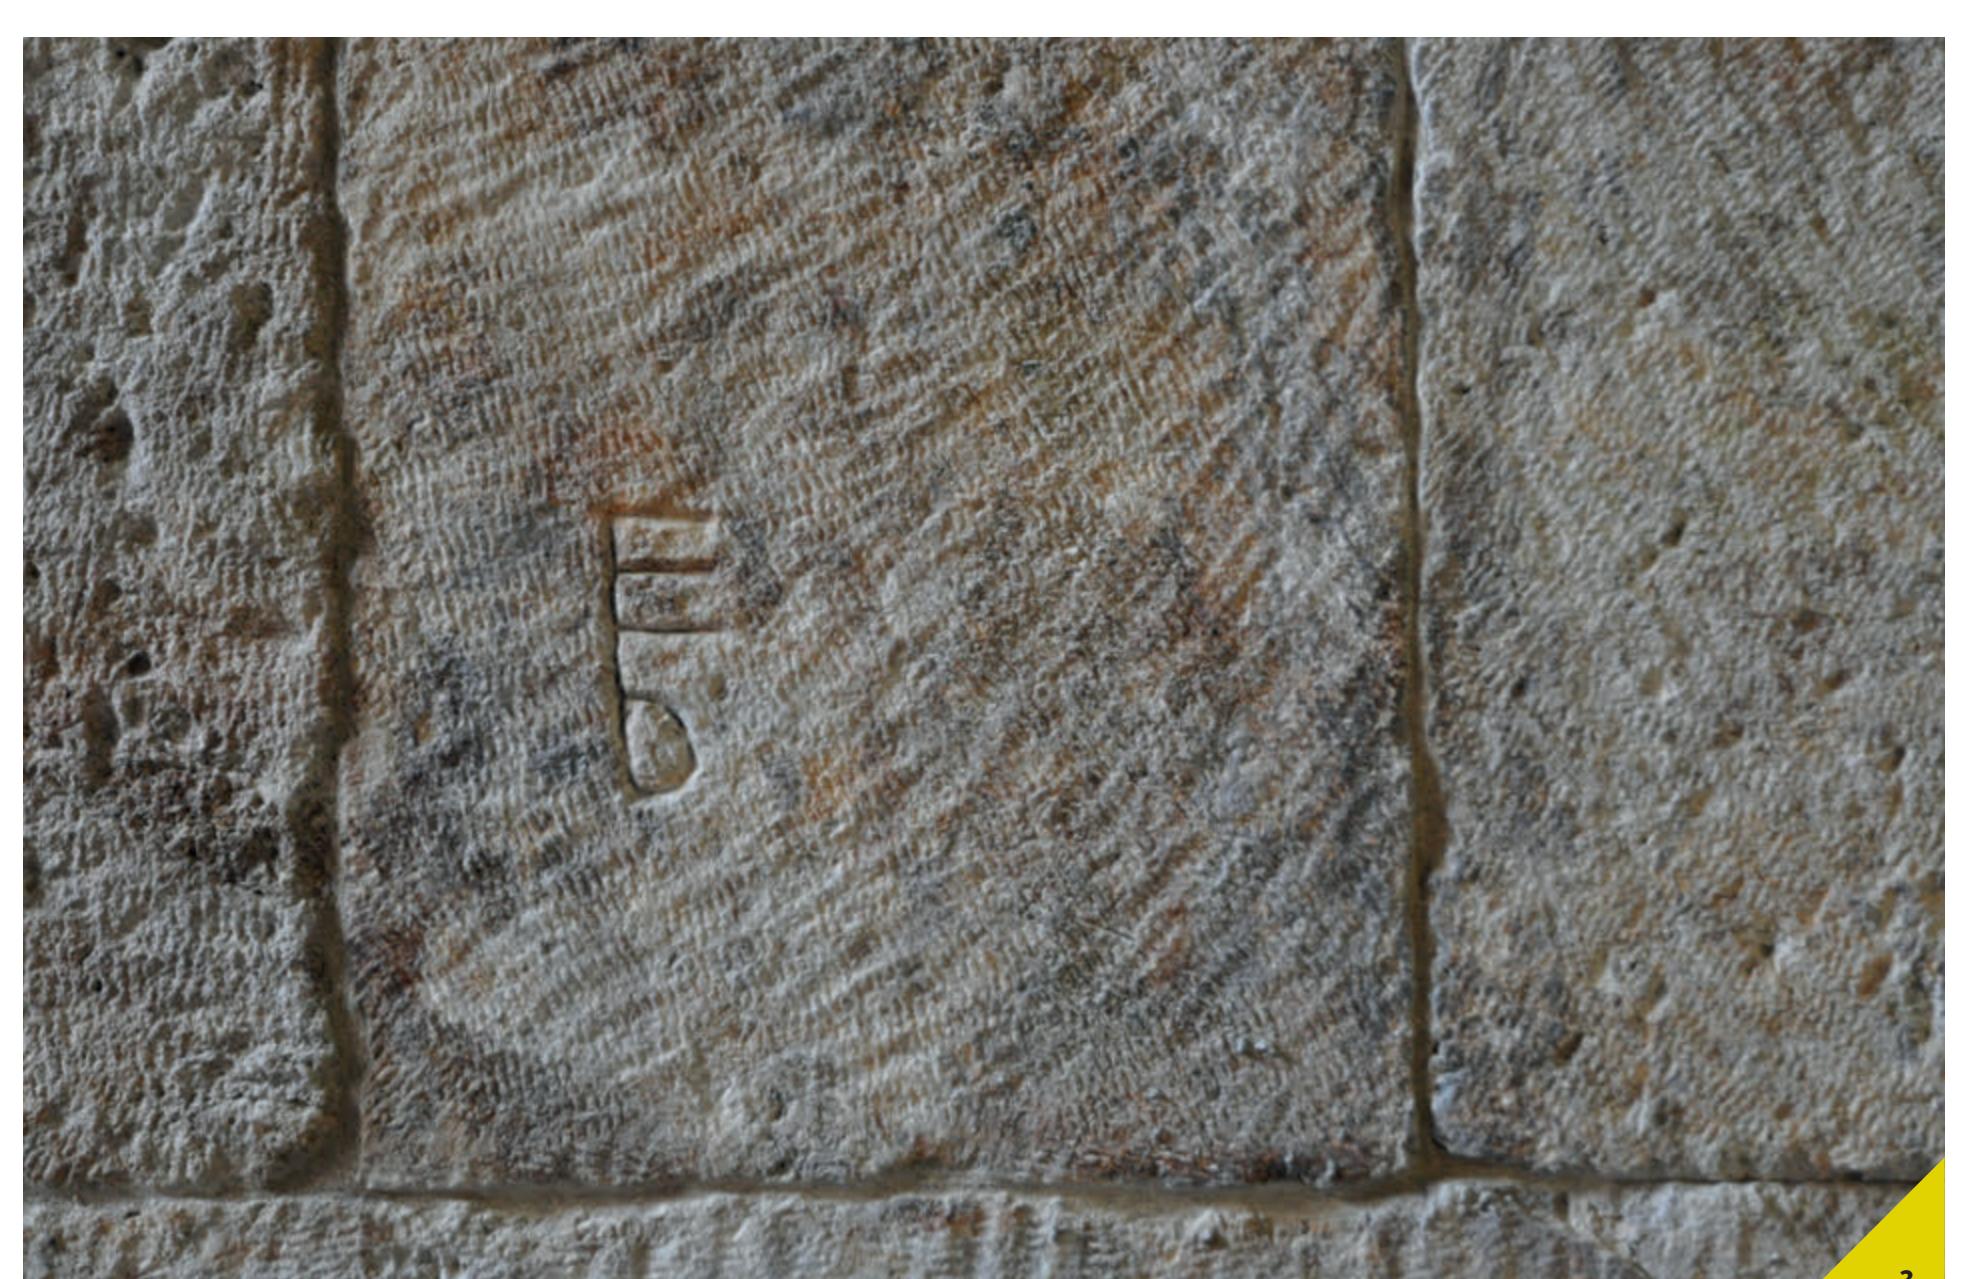
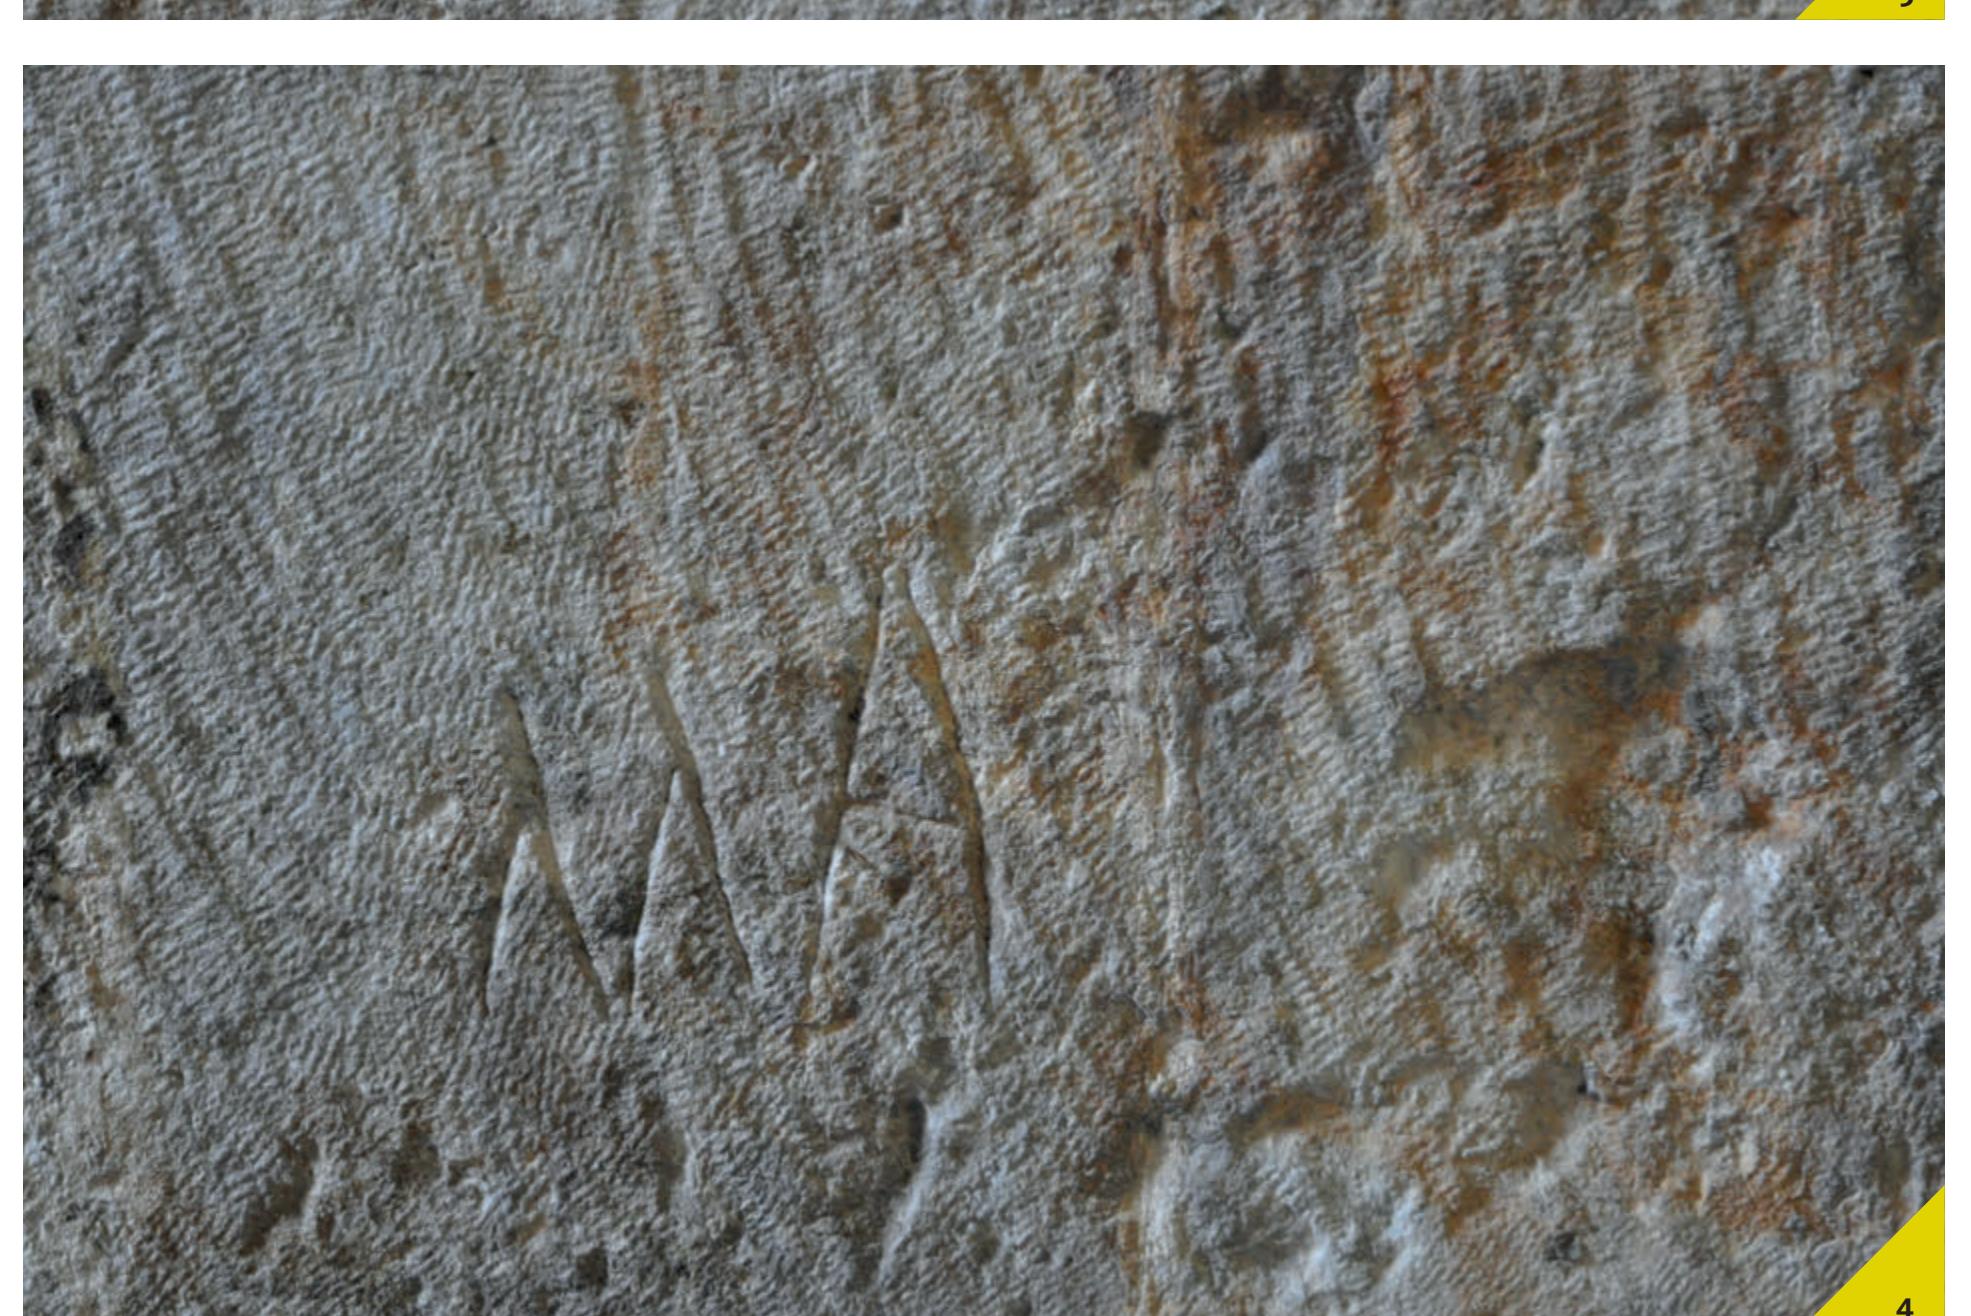
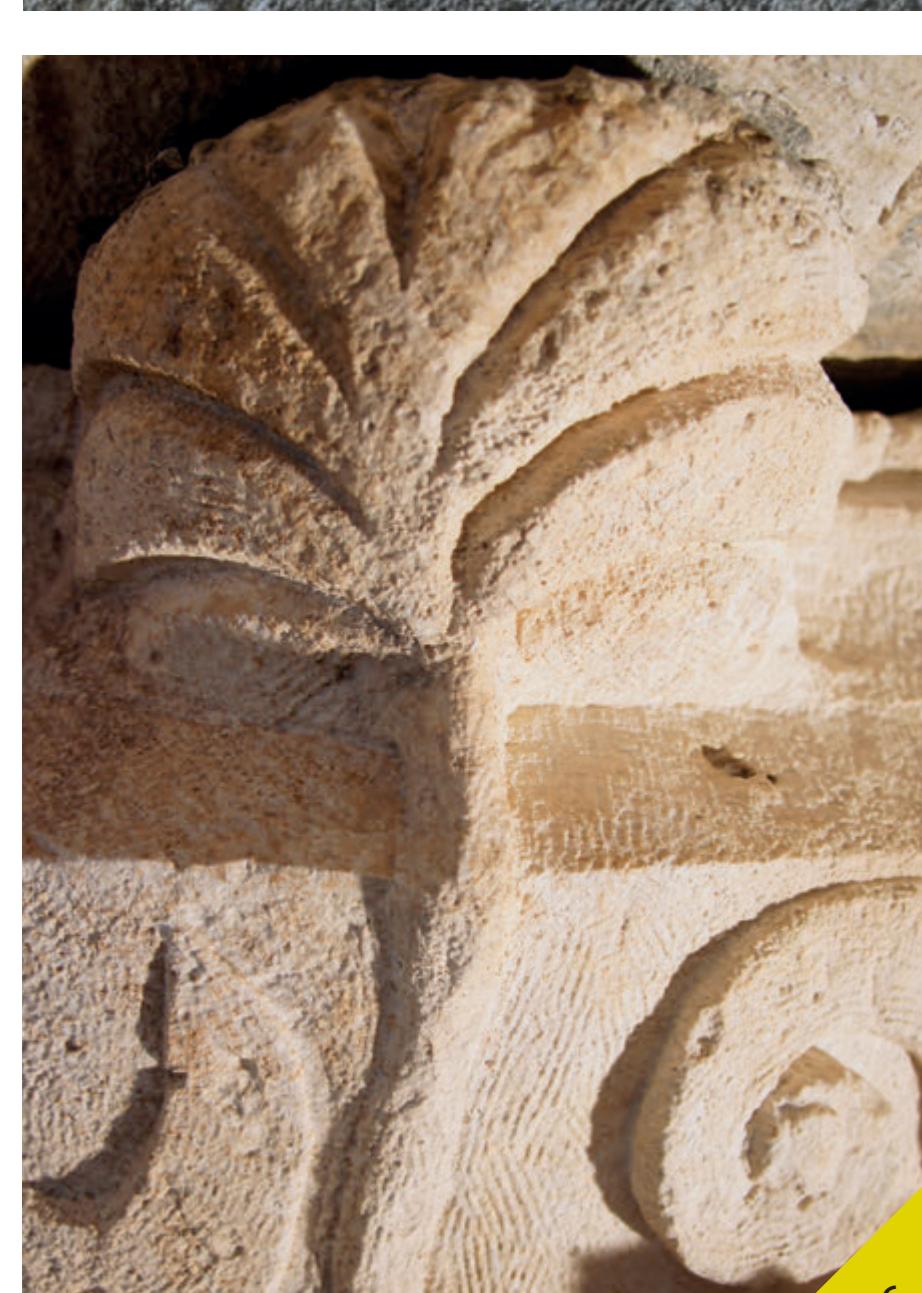
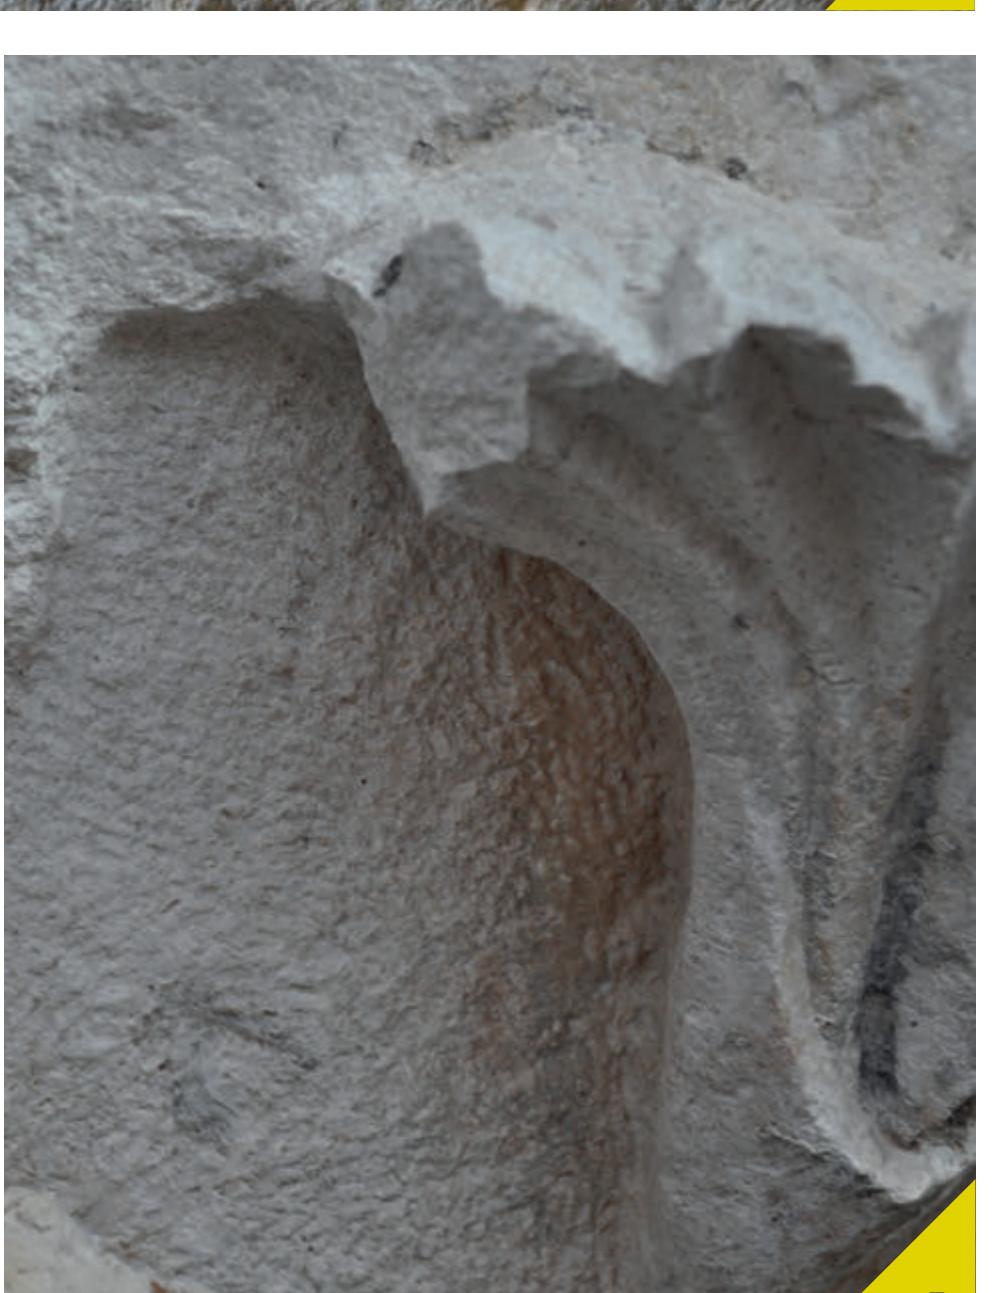
1, 3, 4. STONE CUTTERS' MARKS FOUND DURING THE RESTORATION WORKS; 2, 5, 6, 7. EXAMPLES OF THE STONE SURFACE FINISHINGS

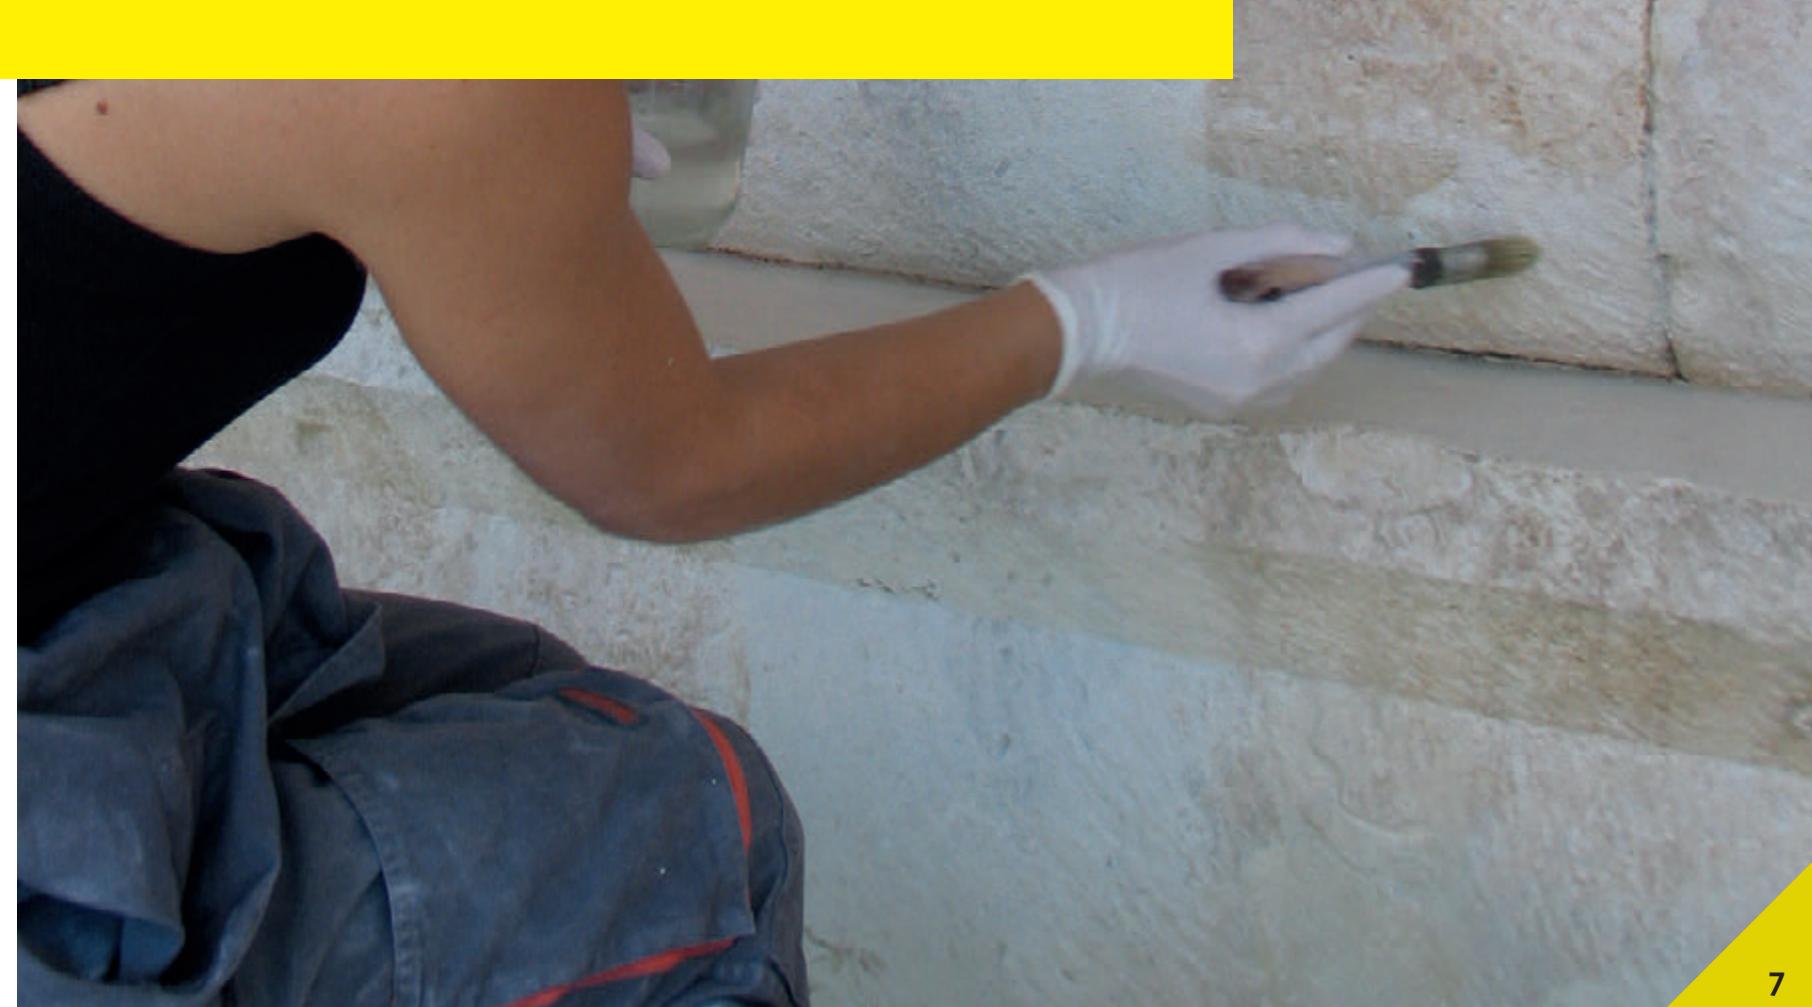
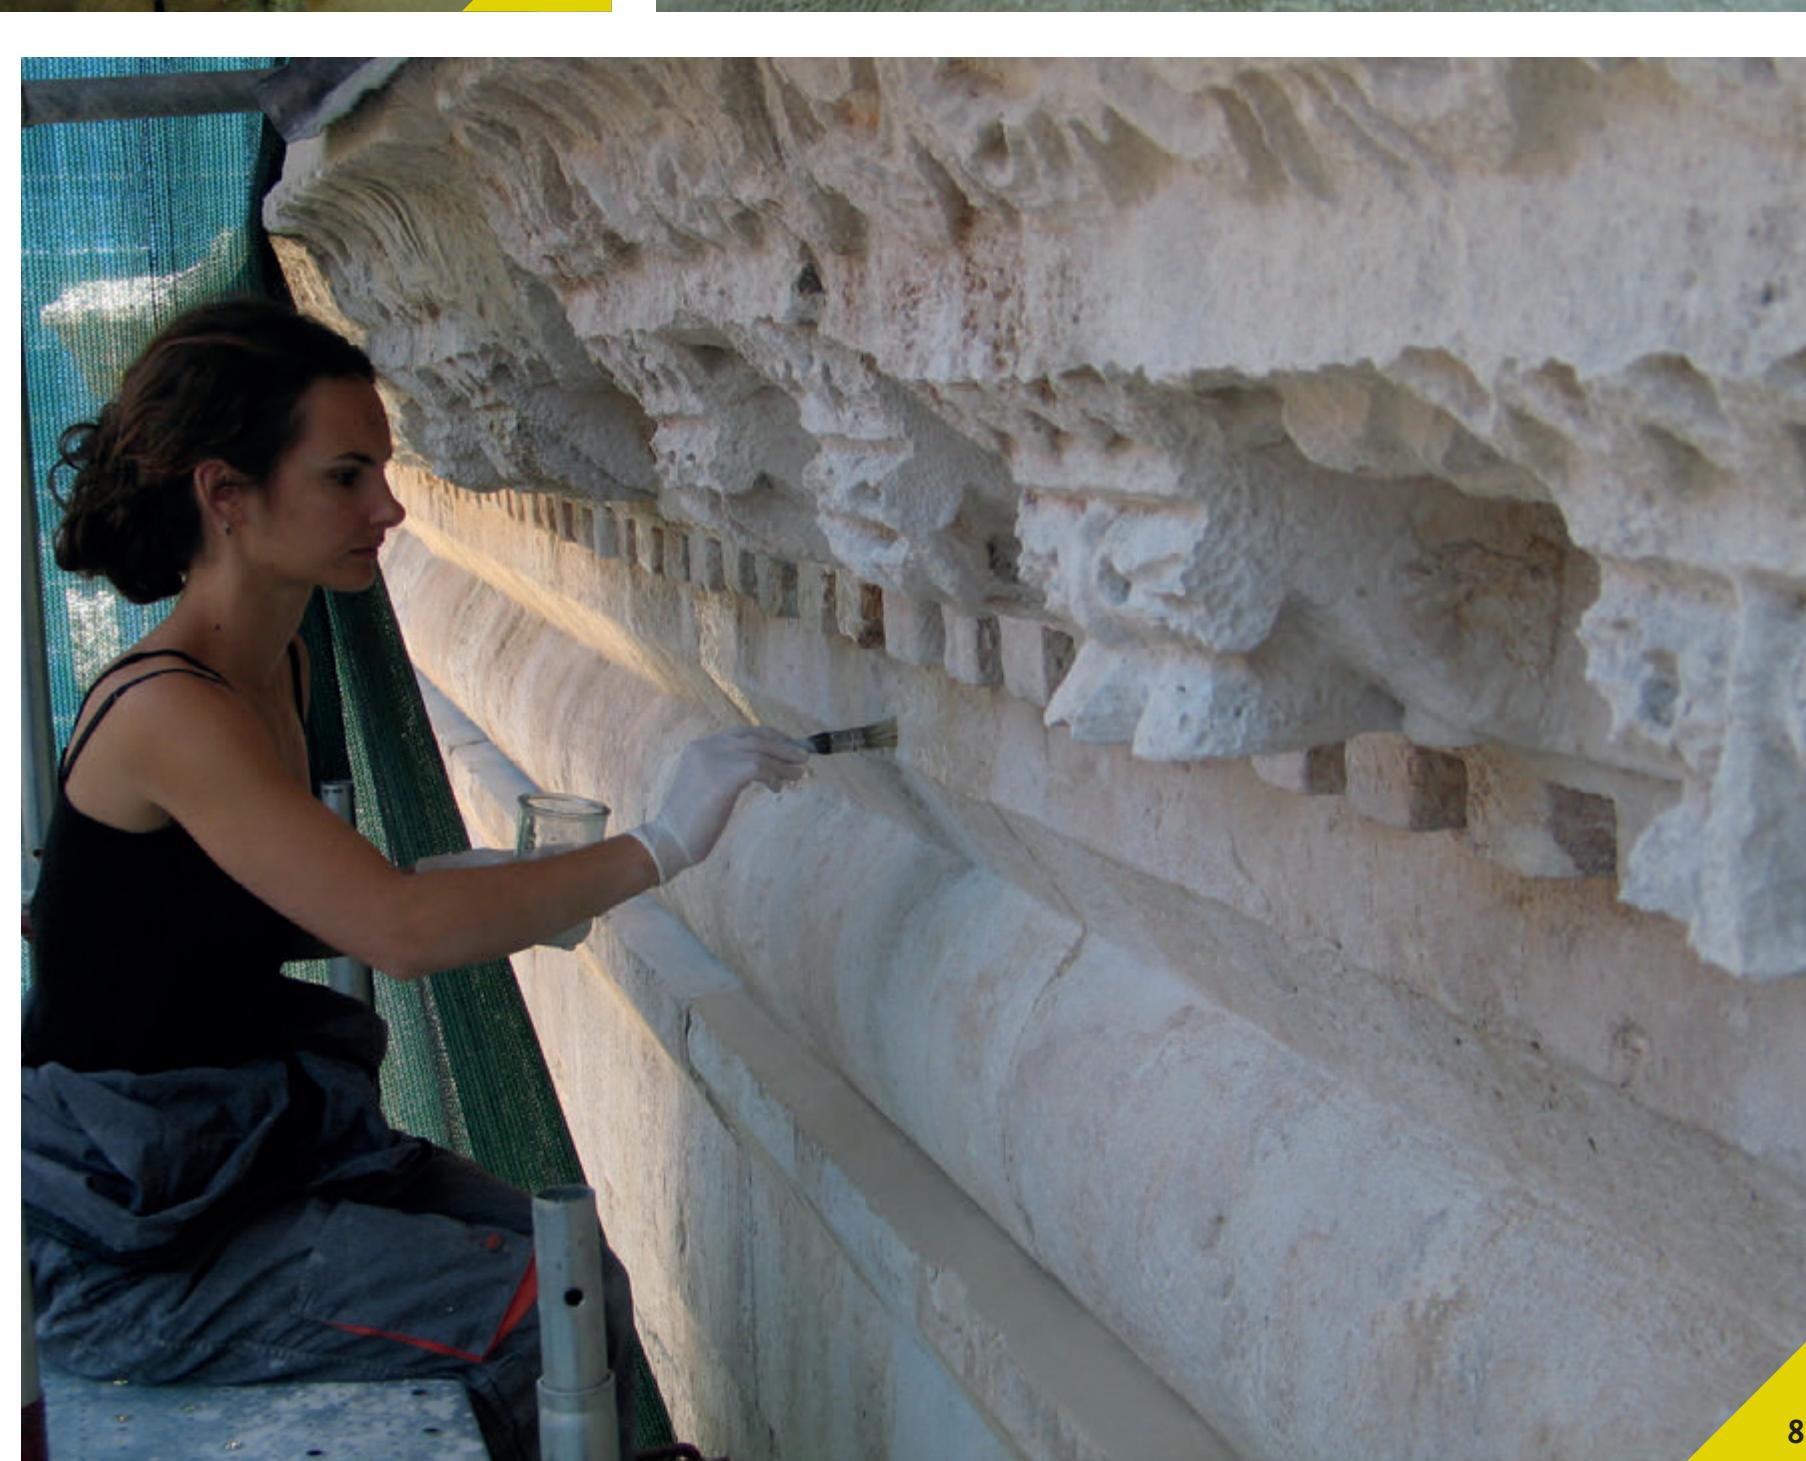
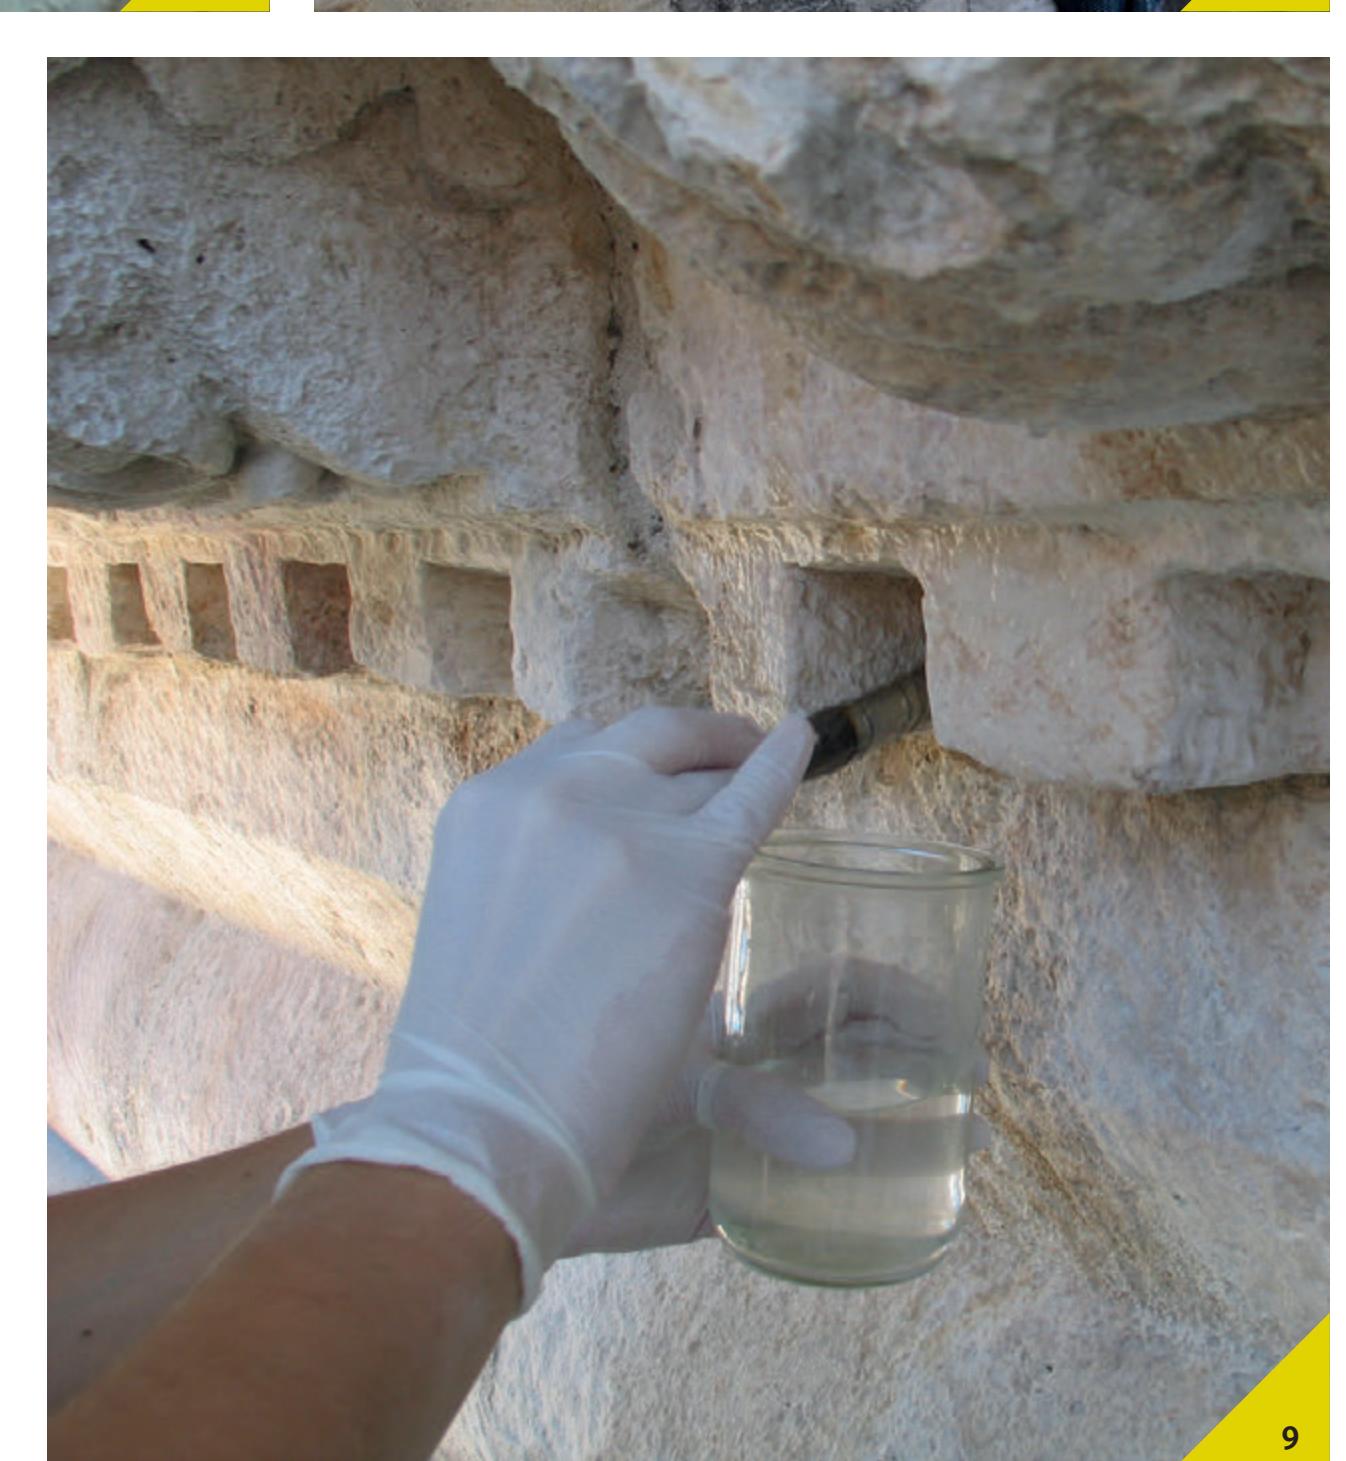
1. STONE BLOCK FROM THE EASTERN CHAPEL BEFORE THE MOUNTING; 2, 3. THE RESTORATION WORKS AT THE VESTIBUL PORTAL; 4. THE PORTAL LINTEL AFTER THE COMPLETION OF THE RESTORATION WORK; 5, 6. FINAL RETOUCHING OF THE RECONSTRUCTED PART OF A GRANITE COLUMN; 7. TAKING IMPRINT OF THE PROFILE FROM THE CORNICE; 8, 9, 10. FINISHING OF A STONE BLOCK; 11, 12. CONDITION AFTER THE RESTORATION WORK.

In the areas where stones were threatening to separate and fall off, they were reinforced with anchors made of carbon and epoxy glue, depending on the level of damage. Cracks and structural damages were reconstructed with an artificial stone mixture in order to prevent water from penetrating and further damaging the stone.

Areas of significant damage were reconstructed with previously installed carbon support framework and added carbon fibres. Artificial stone mixture was applied on the framework and modelled with spatulas. When dry, reconstructed parts were additionally treated with traditional stone carving tools to merge with the surrounding areas.

Reconstructions with natural stones were implemented in places of significant damages where load-bearing capacity of construction needed to be restored. Stone with physical characteristics and the appearance similar to the original limestone was used. Reconstructions in natural stone were especially challenging because the heavy stone blocks, previously prepared in a workshop, needed to be lifted on the scaffolding and set in a particular position. Skill, experience and demanding coordination were essential. After the stone block was set, the traditional carving hand tools were used for finishing the stone surface.
