## Na završetku desetljeća obnove Peristila

## At the end of a Decade of the Peristyle Restoration

The conservation and restoration work on the Peristyle of Diocletian's Palace has been in many ways the most important project in recent period within the scope of renovation of the historical core of the town of Split. The Peristyle is the centre and the most impressive part of the imperial palace, and also the heart of the town which has grown around it. The square, which reflects historical layers of the creation and development of the town, has become its symbol and its main tourist attraction. It serves as the most attractive backdrop for cultural events, and a stage at which public life evolves.

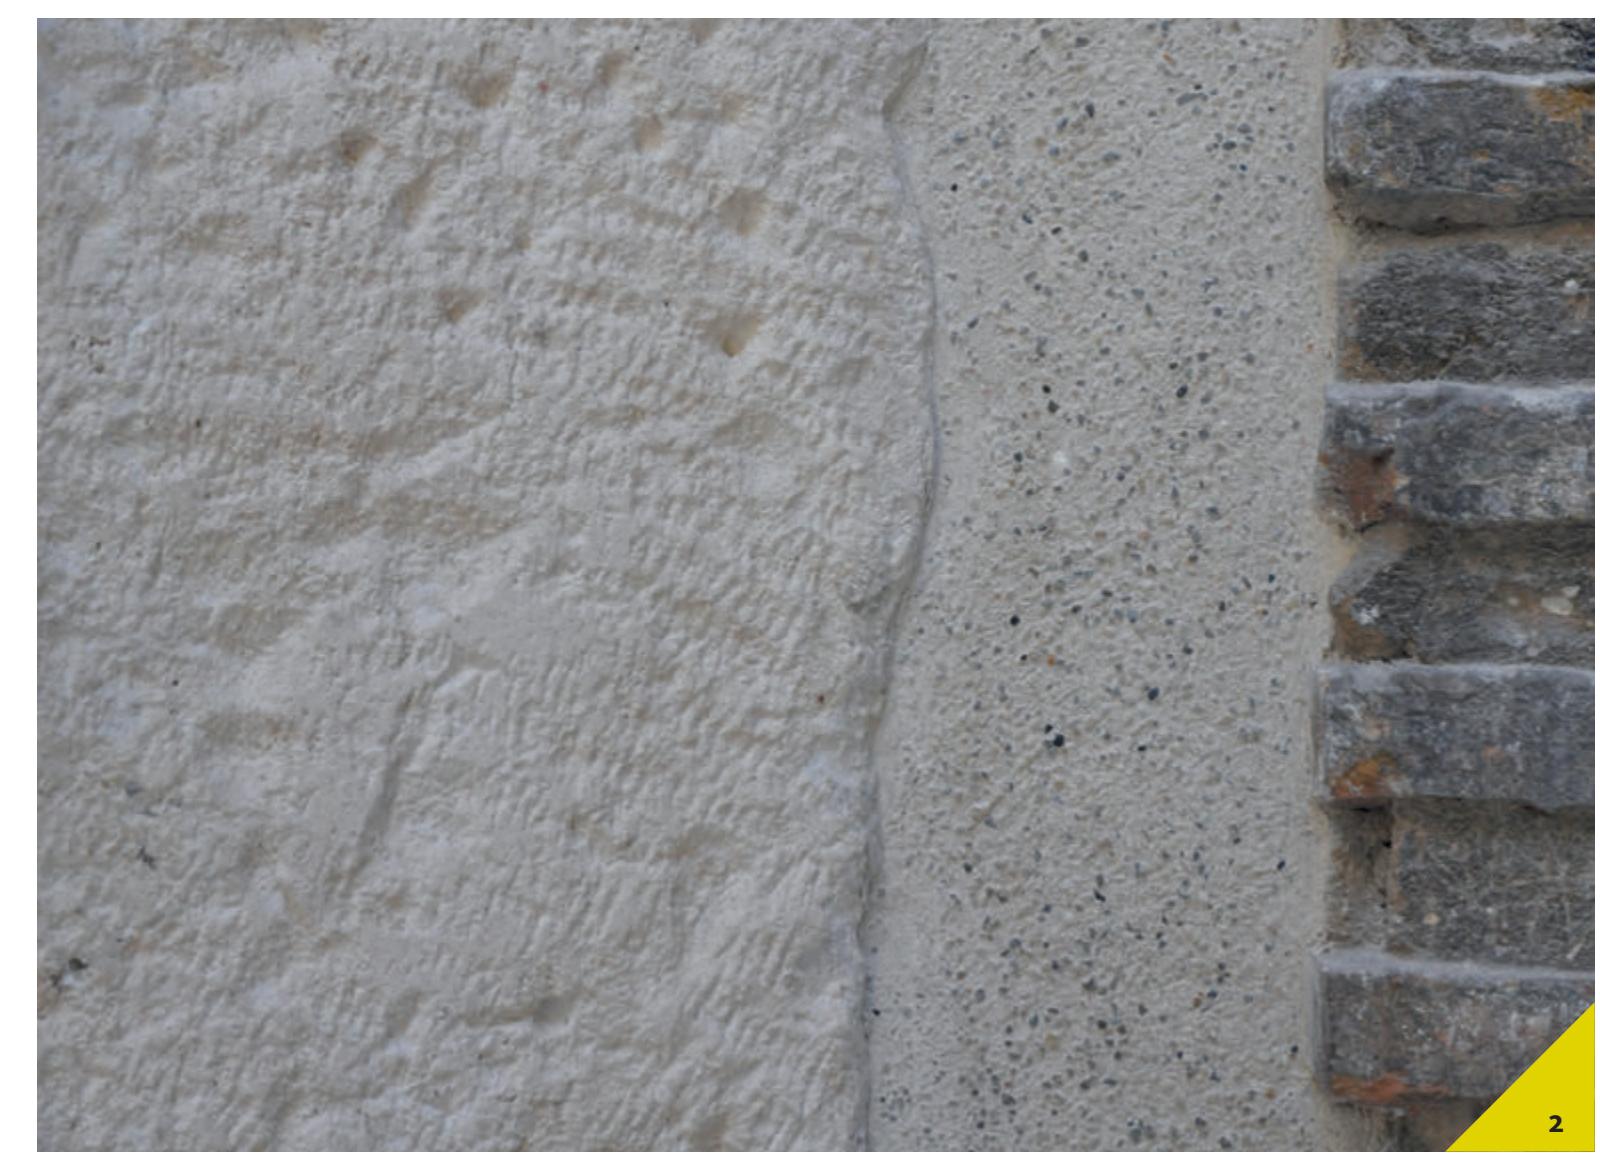
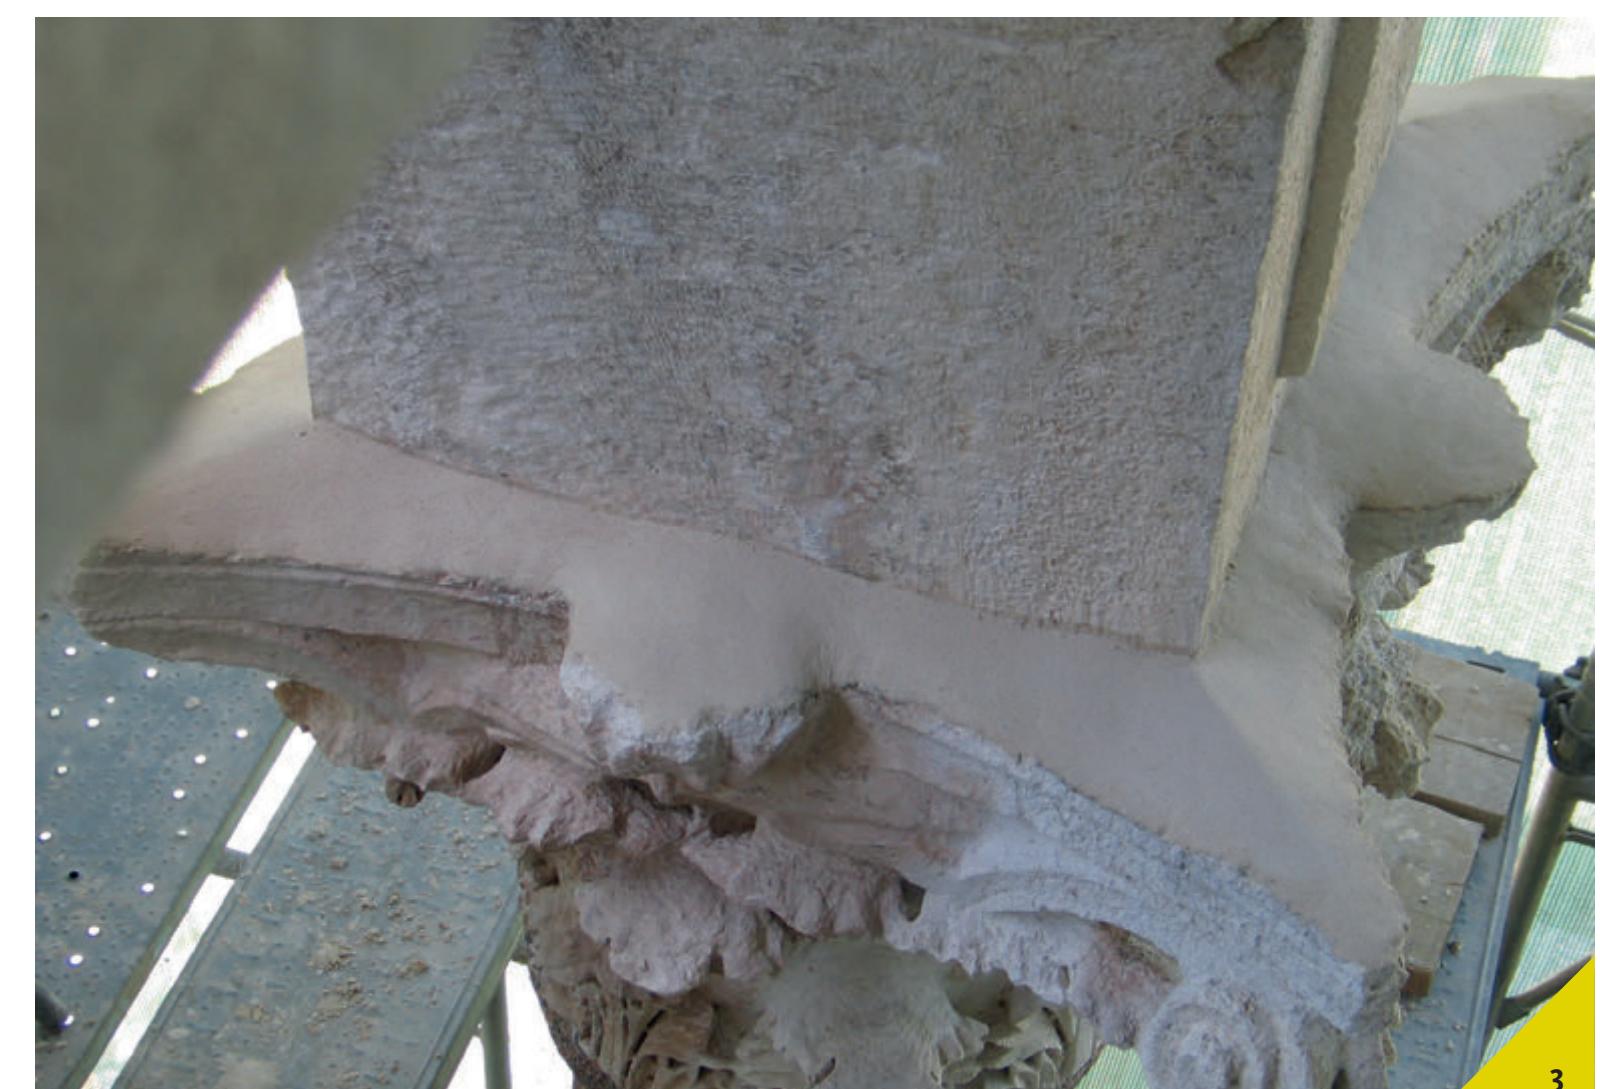
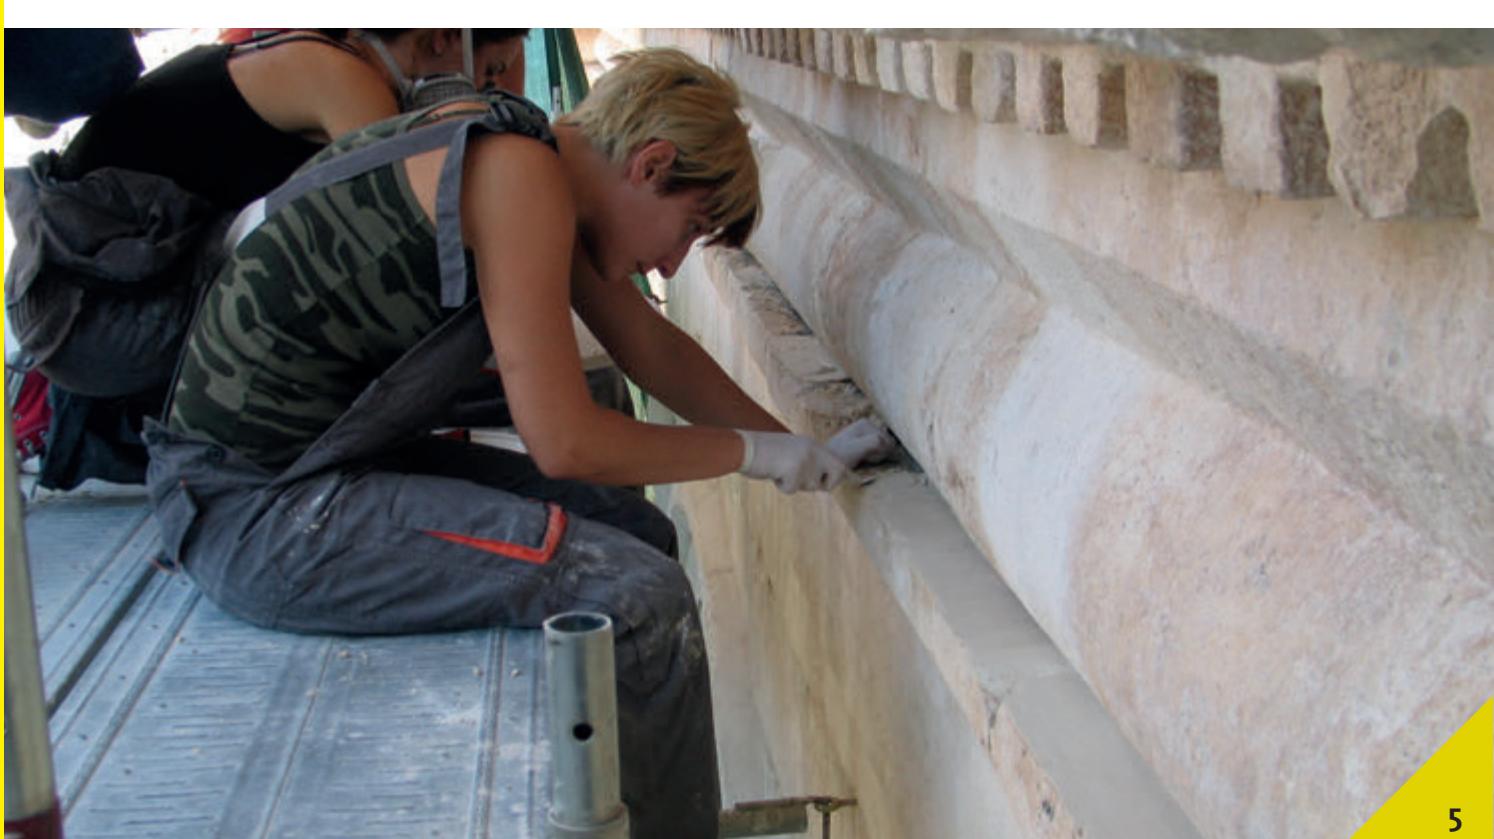
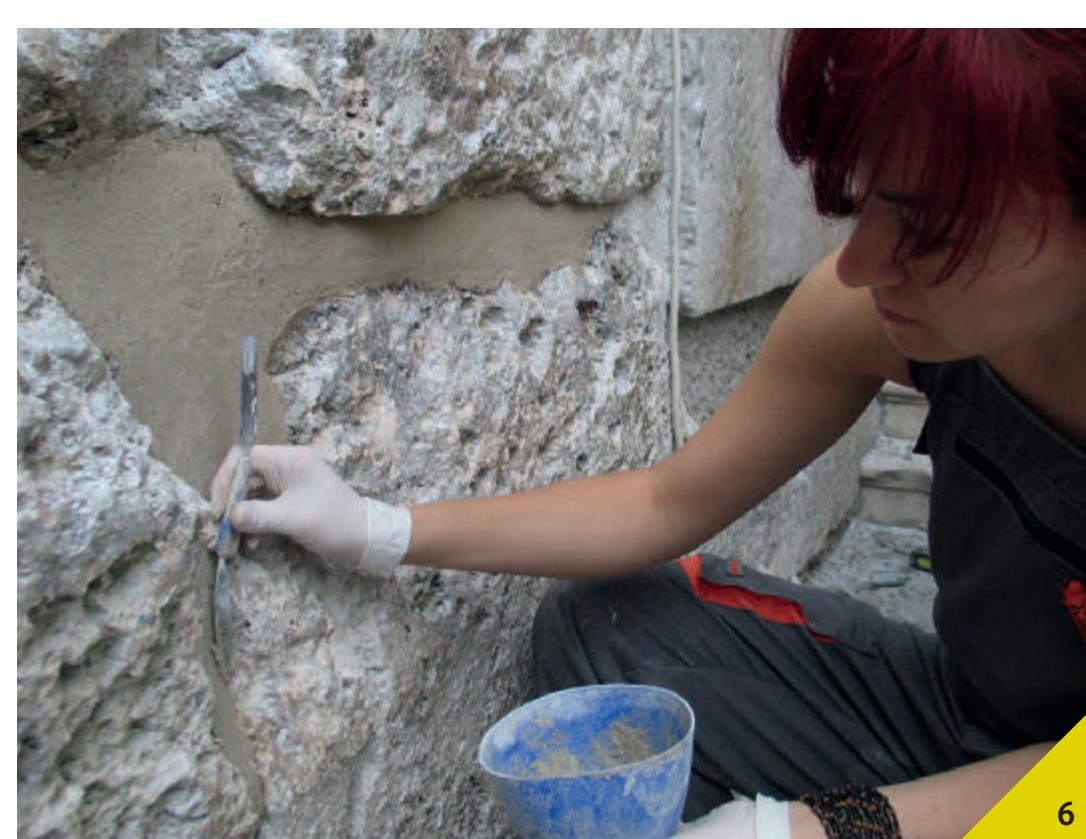
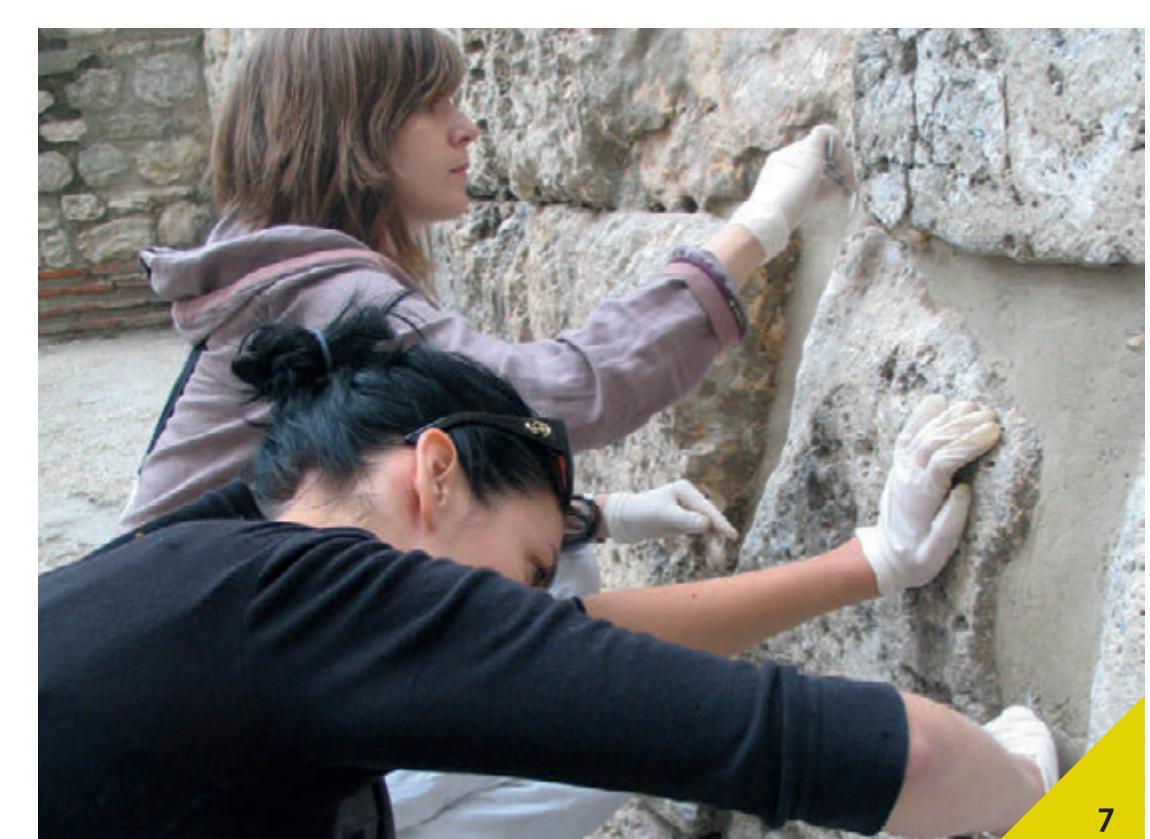
1. PLASTERING OF THE UPPER PARTS OF THE COLONNADE ARCHES; 2. NEW JOINT BETWEEN THE PORTAL AND THE VESTIBULE WALL; 3. PLASTERING OF THE UPPER PARTS OF THE CAPITAL; 4. ANTI-PIGEON SYSTEM OF SPIKES; 5. MORTAR PROTECTIVE LAYER ON THE UPPER SURFACES OF THE COLONNADES; 6, 7. FILLING-IN OF LACUNAS AND REPOINTING WITH ACRYLIC-LIME MORTAR; 8, 10. MORTAR CAPPING AND LEAD FLASHING; 9, 11. PEDIMENT OF PROTHYRON AND EASTERN COLONNADE WITH LEAD COVER

Joints between the stone blocks were repointed with acrylic-lime mortar. All of the large horizontal slabs were covered with slanted mortar with lead sheeting to protect stone from rain.

Smaller stone sculptures such as projections on capitals and stone cornices were plastered to prevent the corrosion and erosion caused by weathering. Finally, a system of spikes was installed on projecting surfaces to prevent birds from landing.

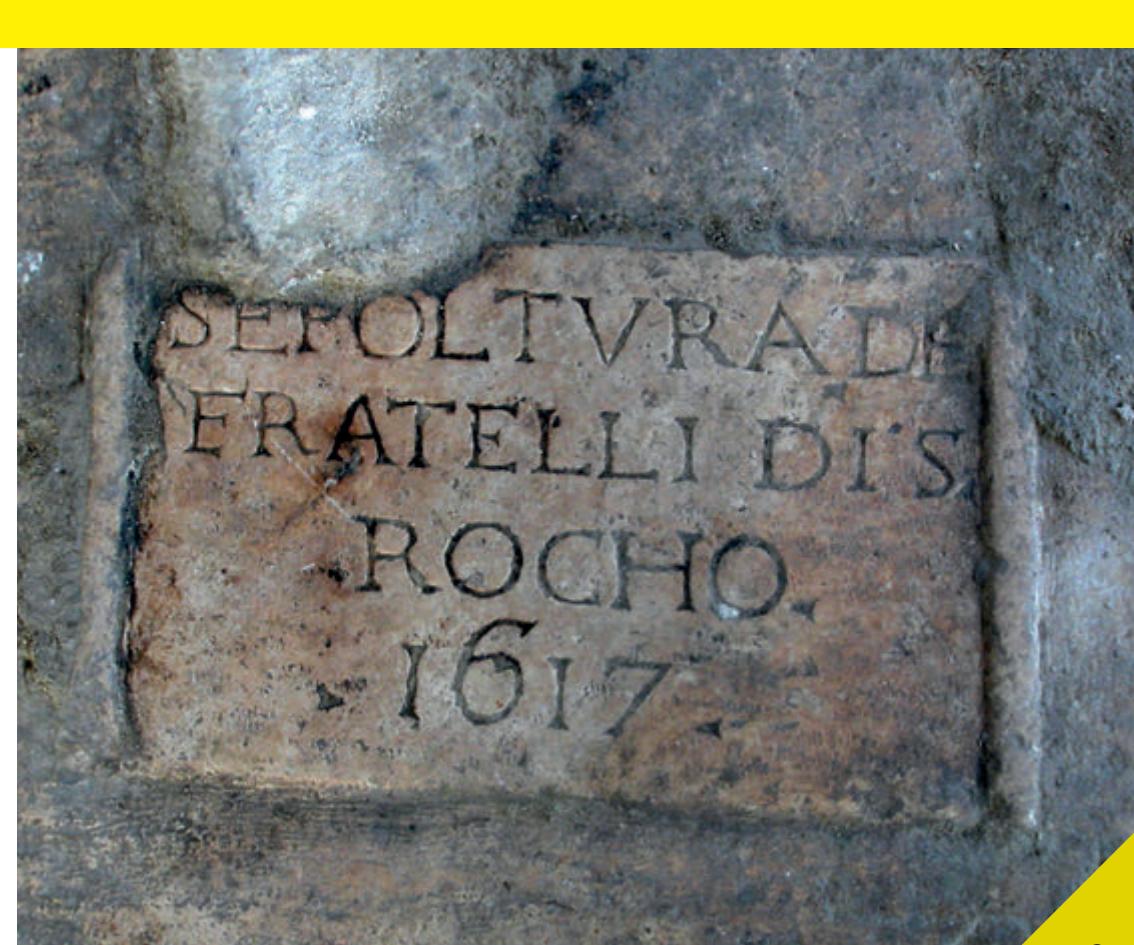
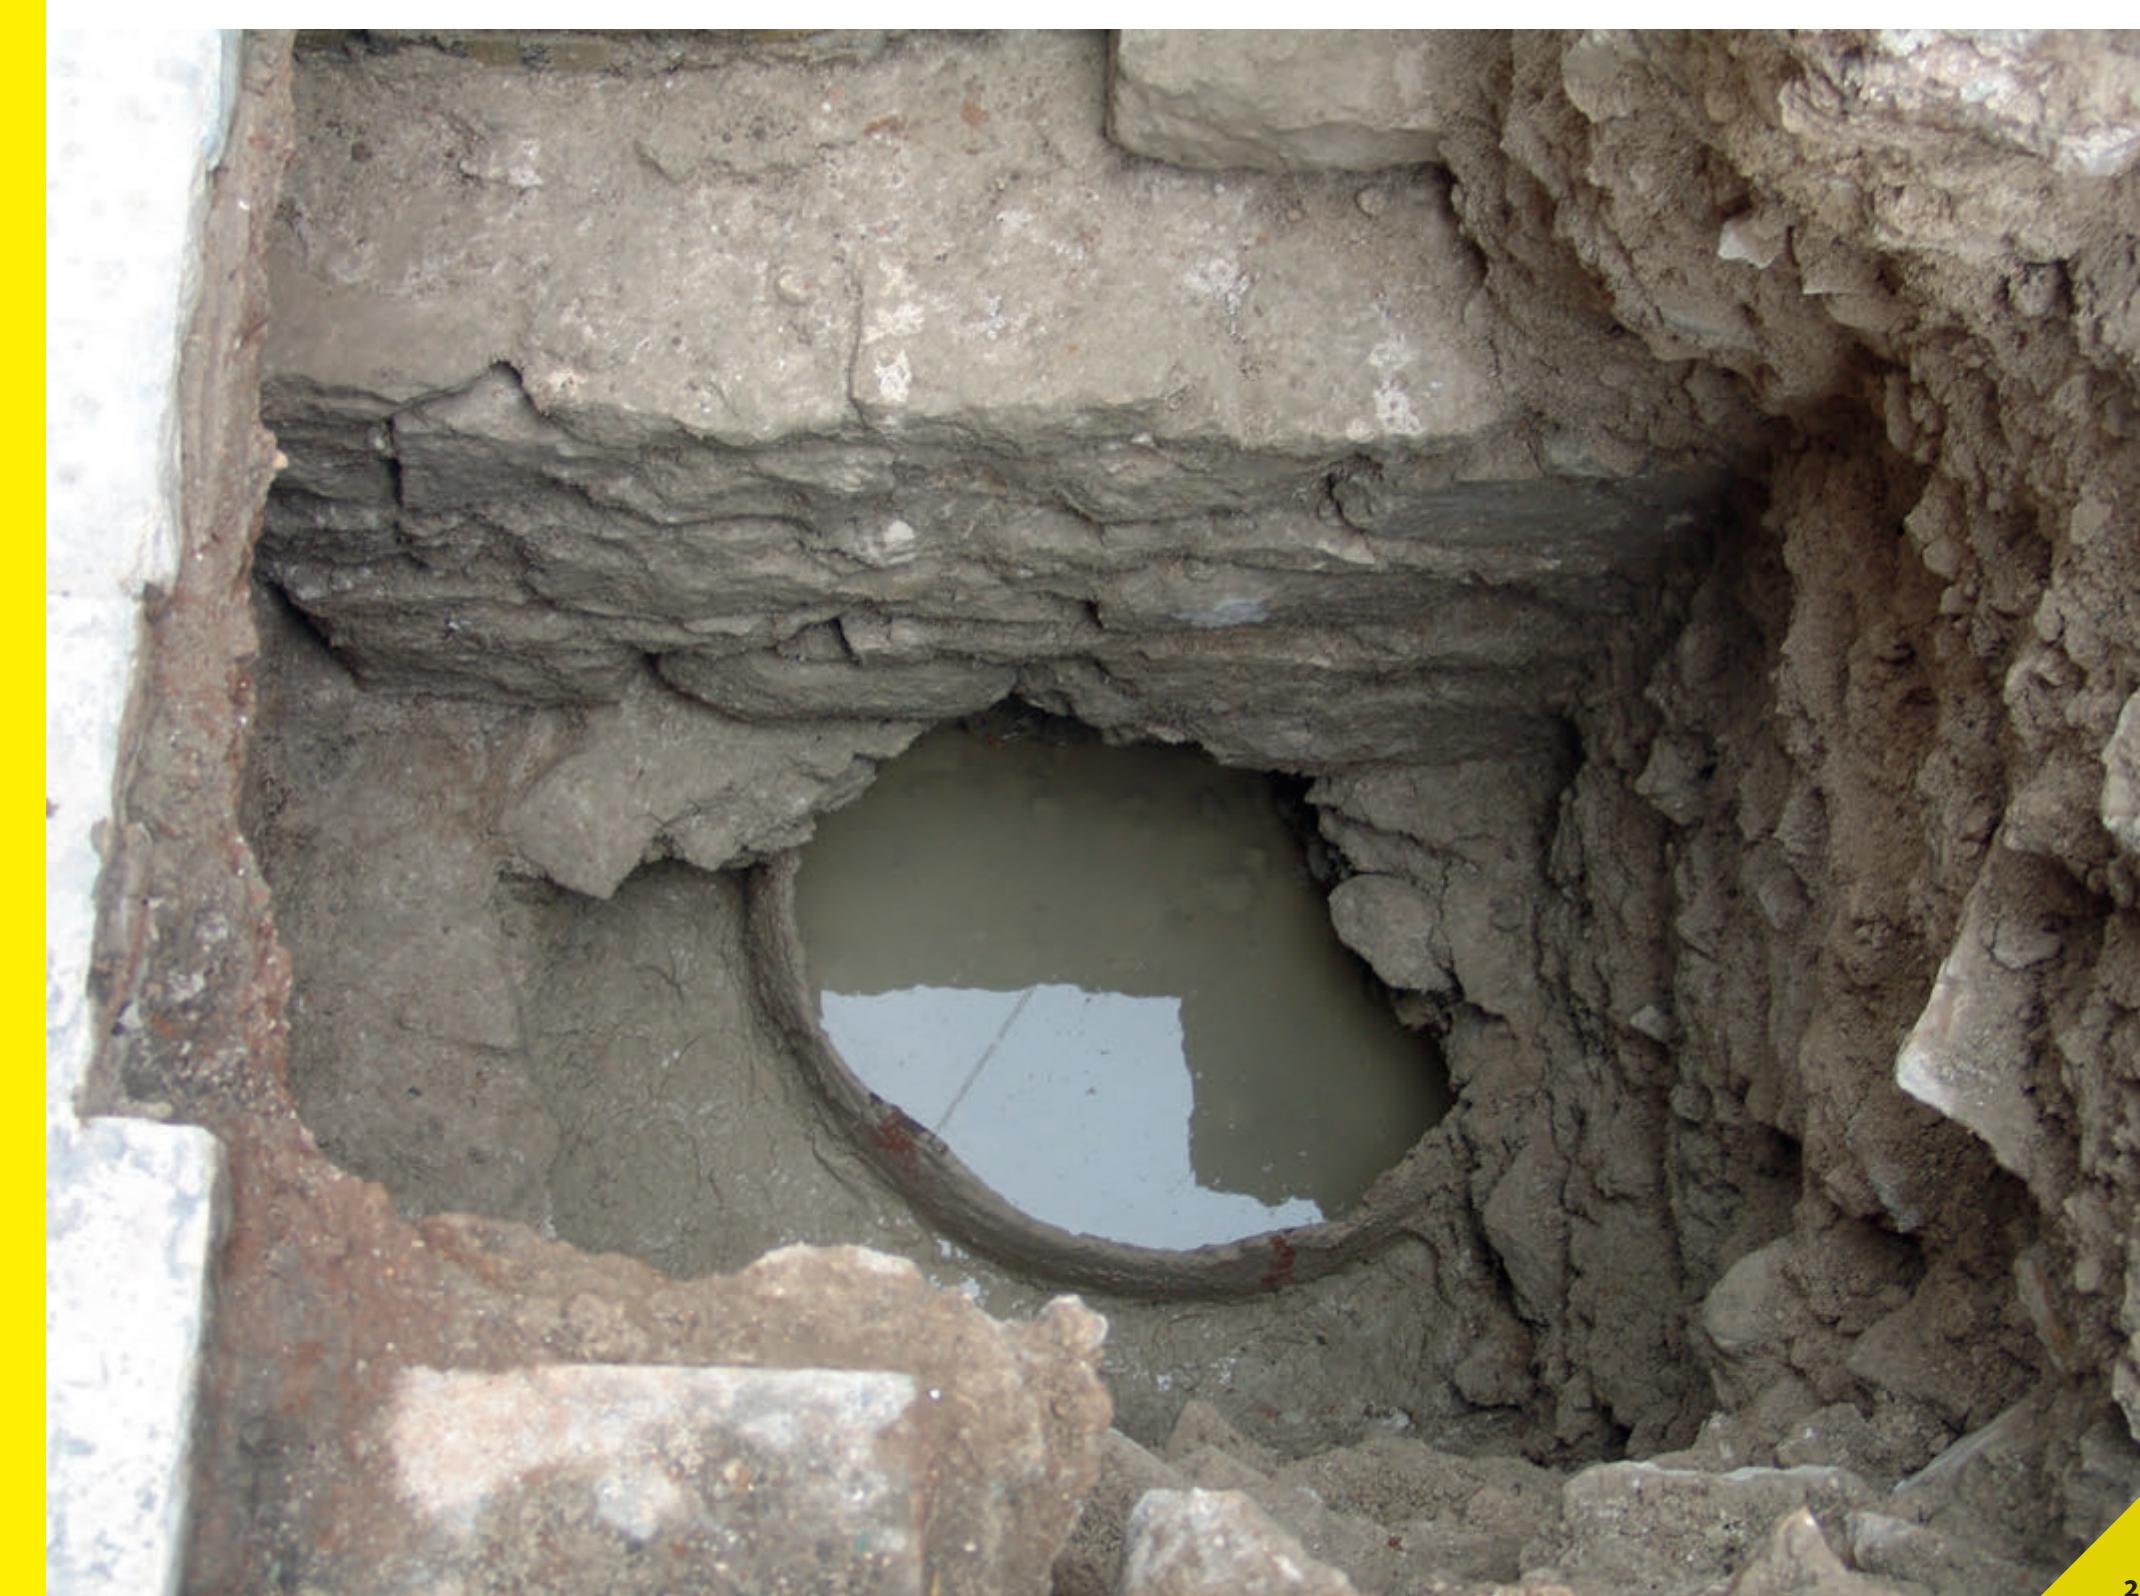
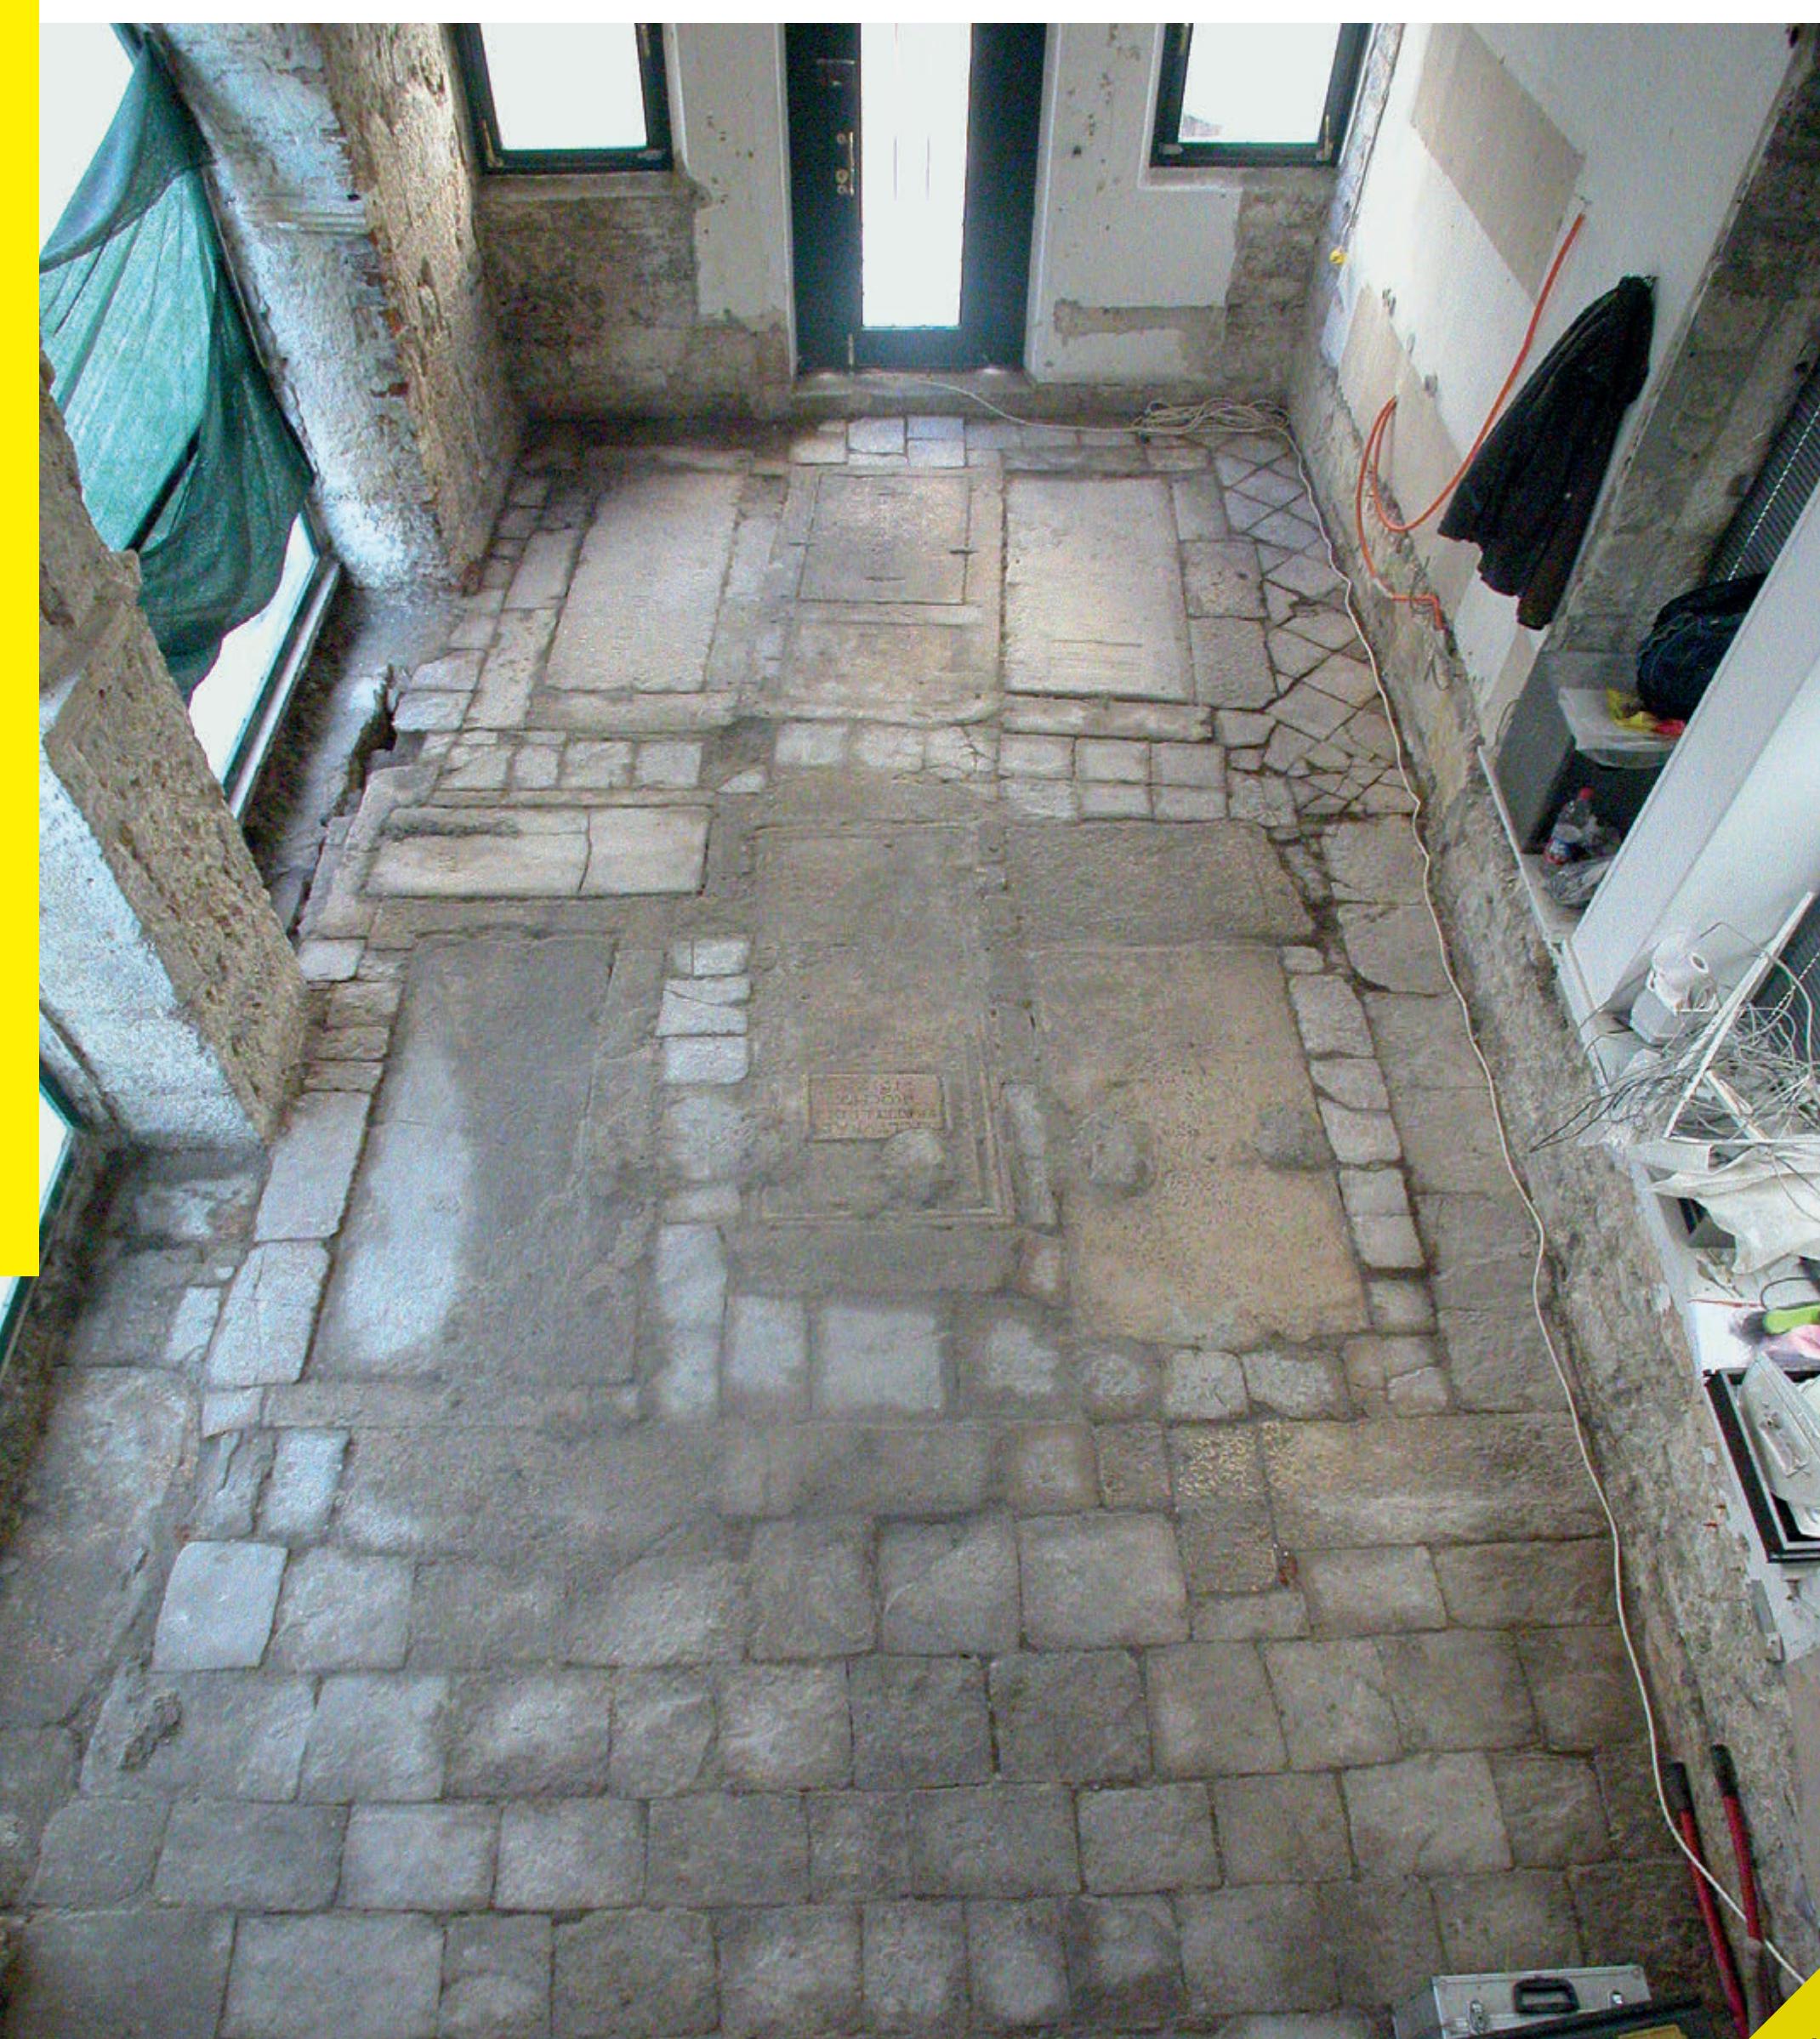
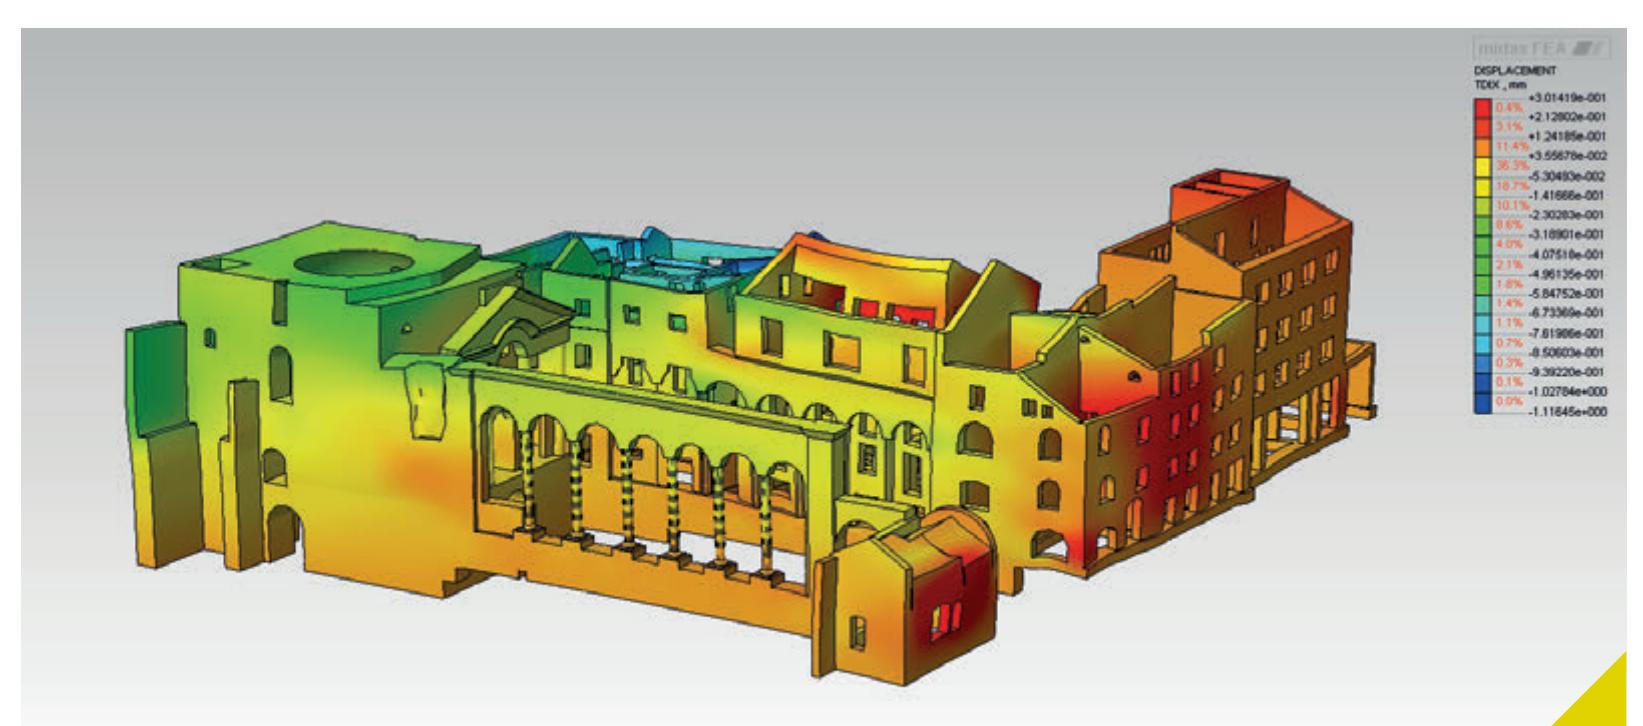
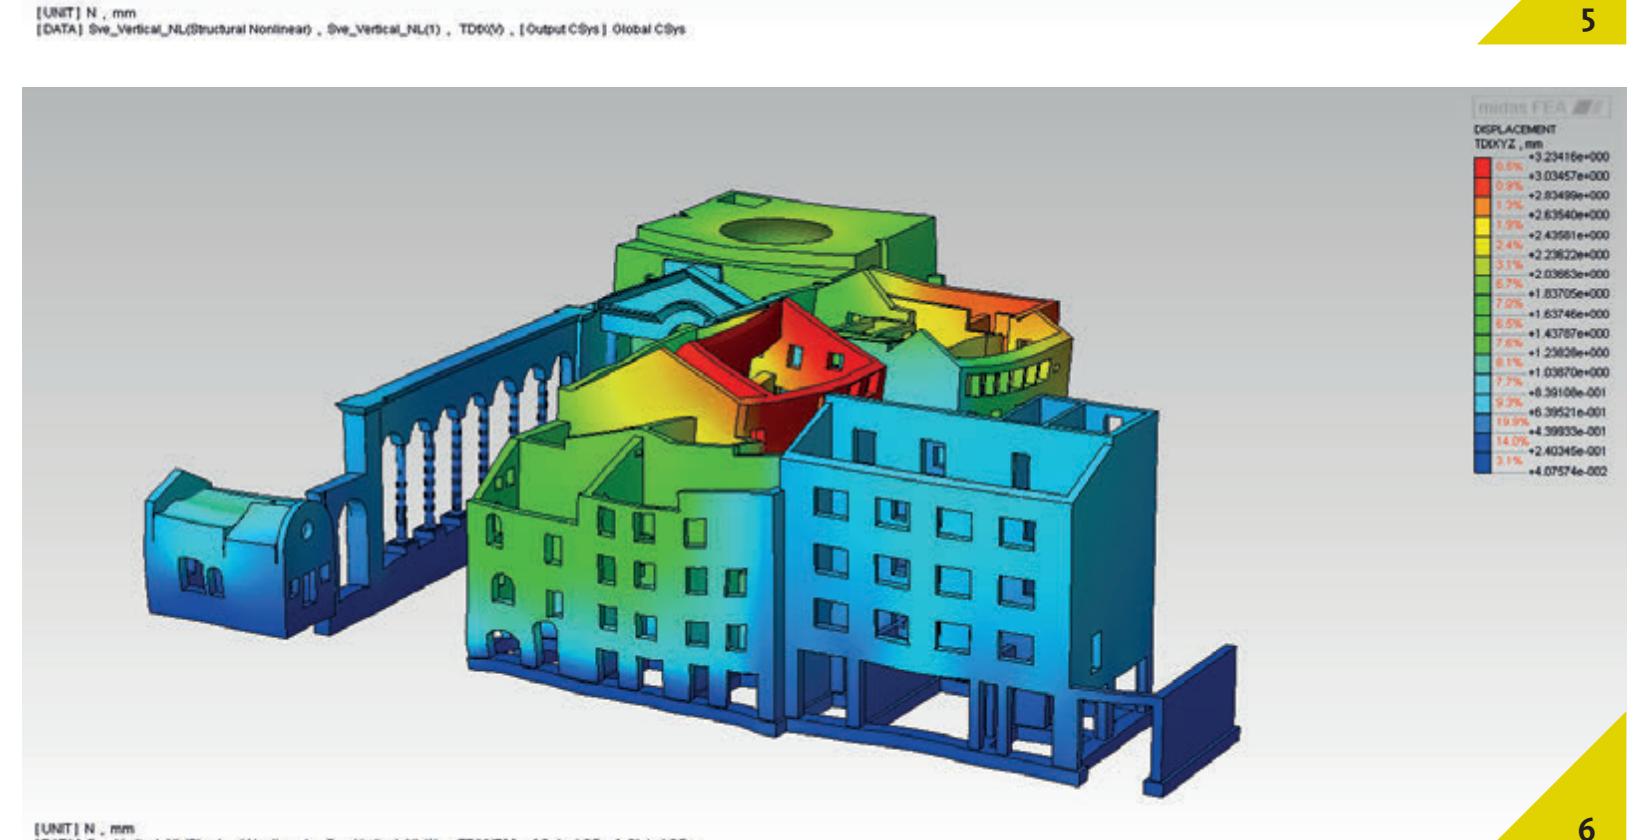
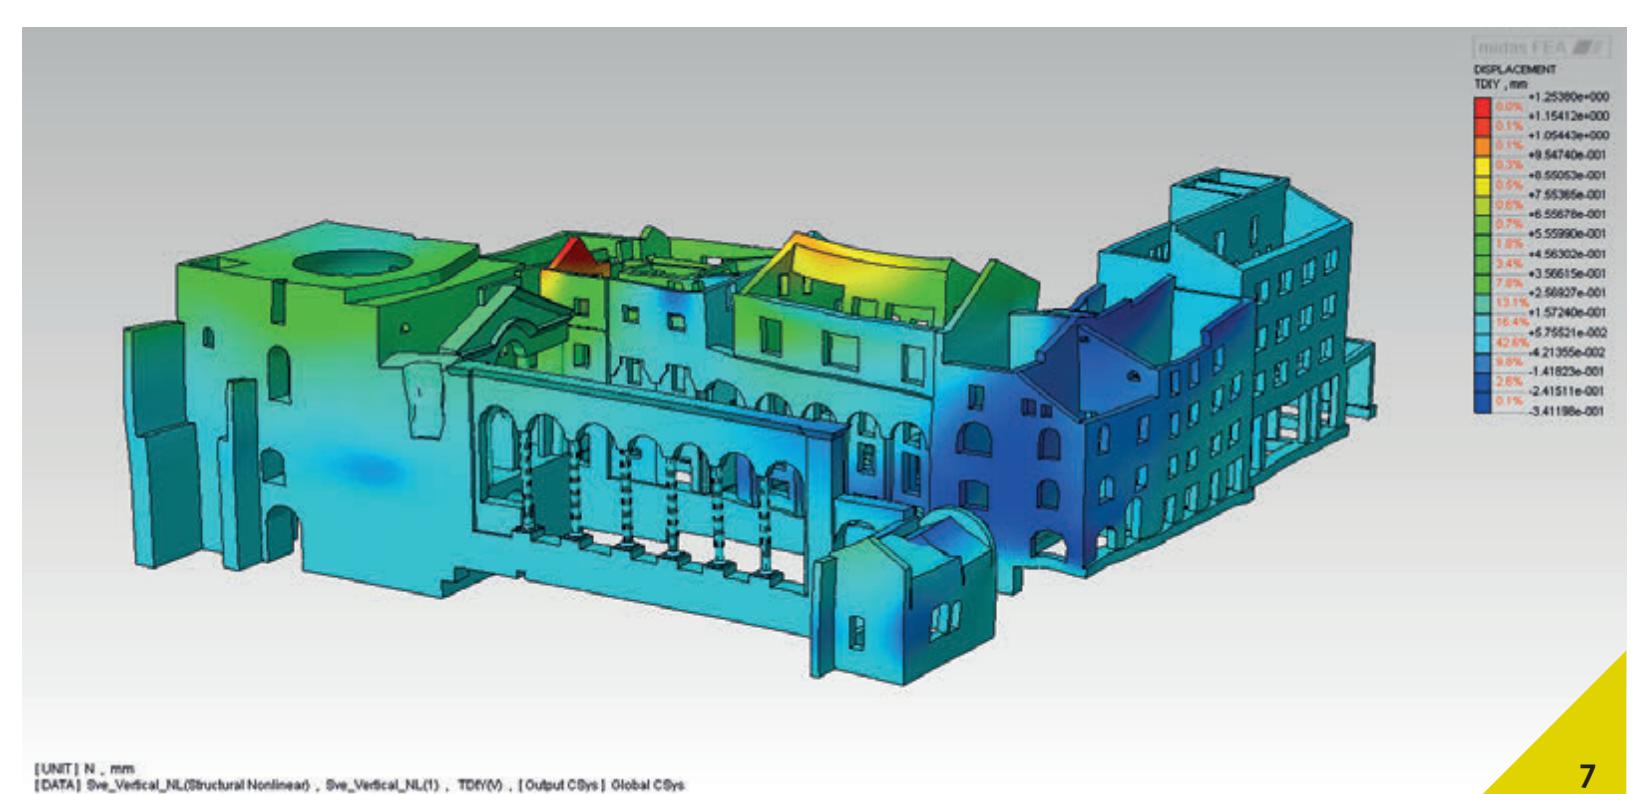
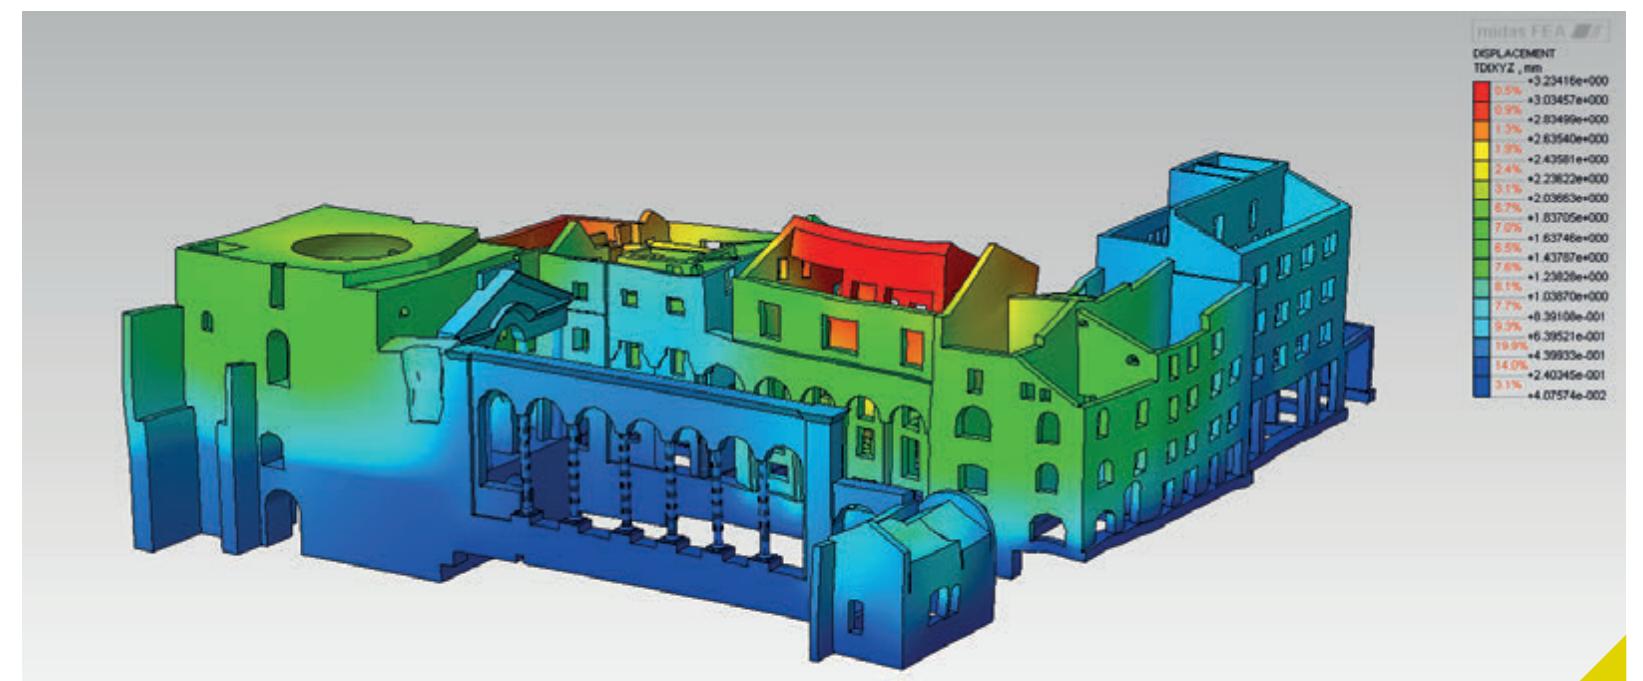
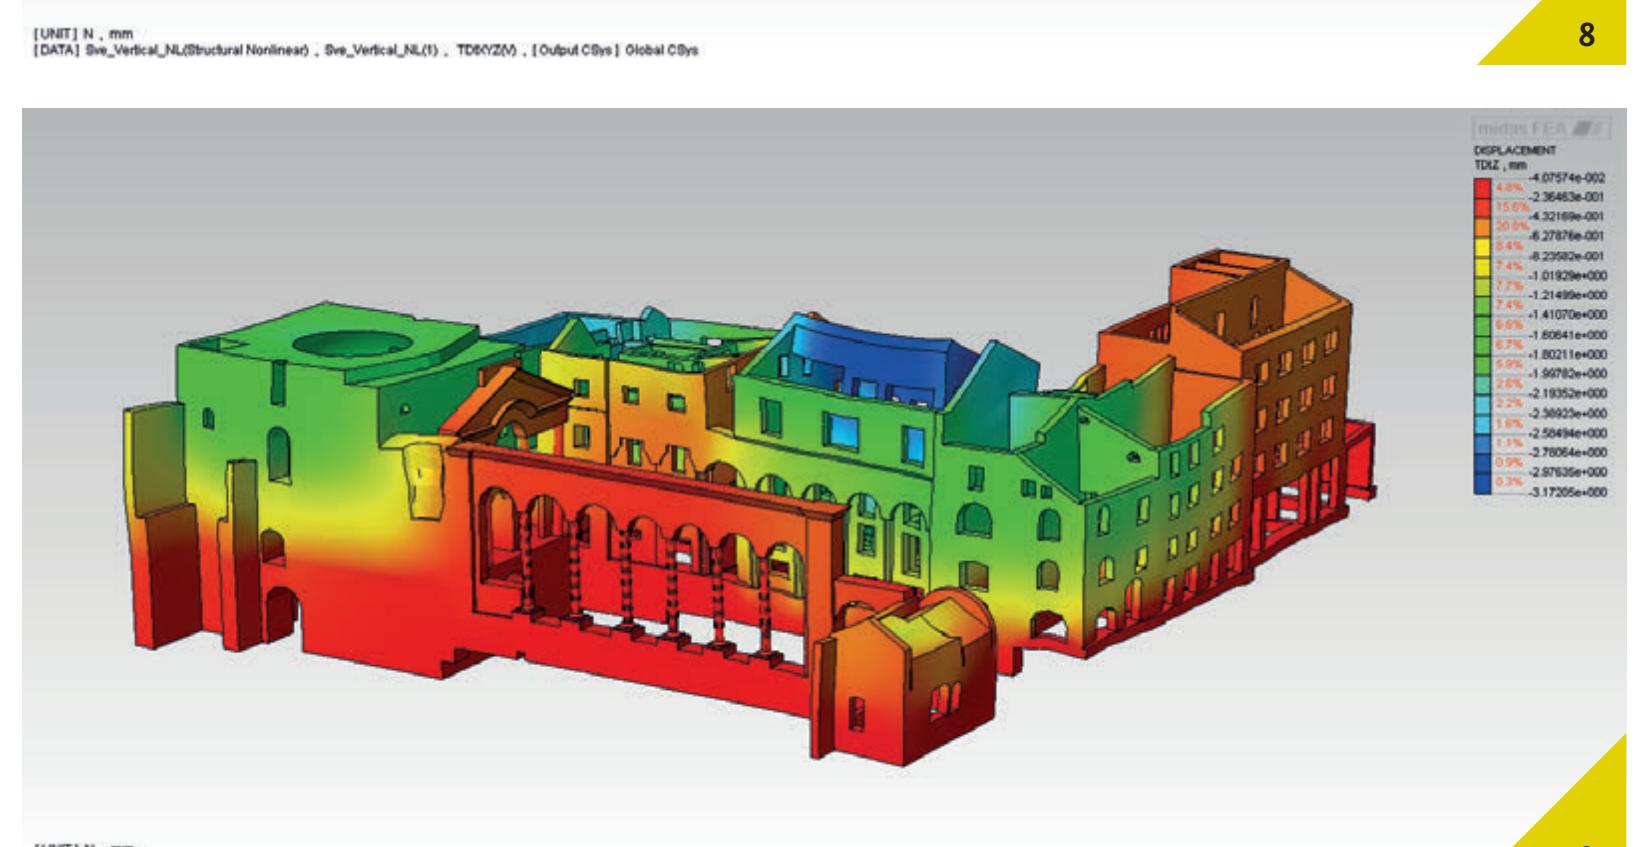
Research into the structure of the Peristyle started in 2007. During 2008 and 2009 the condition of the structure was monitored, the building's frequencies were tested and geophysical and geomechanical operations conducted. Tests into the state of the foundations are necessarily accompanied by rescue archaeological operations. The most recent archaeological research partially carried on from investigative operations that were conducted between 1956 and 1961 by the Architectural History Department of the Urban planning Bureau in Split.

1. ARCHAEOLOGICAL INVESTIGATIONS ON THE SOUTHERN SIDE OF ST. ROCH CHAPEL; 2. ARCHAEOLOGICAL TEST PIT AT THE SOUTHEAST CORNER WITH REMAINS OF A PITHOS; 3. AN INSCRIPTION ON A TOMBSTONE IN THE CHURCH OF ST. ROCH; 4. THE INTERIOR OF THE CHURCH OF ST. ROCH; 5, 6, 7, 8, 9. COMPUTER ANALYSIS OF THE STRUCTURAL STABILITY OF THE PERISTYLE IN THE EVENT OF AN EARTHQUAKE
