## Na završetku desetljeća obnove Peristila

## At the end of a Decade of the Peristyle Restoration

The conservation and restoration work on the Peristyle of Diocletian's Palace has been in many ways the most important project in recent period within the scope of renovation of the historical core of the town of Split. The Peristyle is the centre and the most impressive part of the imperial palace, and also the heart of the town which has grown around it. The square, which reflects historical layers of the creation and development of the town, has become its symbol and its main tourist attraction. It serves as the most attractive backdrop for cultural events, and a stage at which public life evolves.

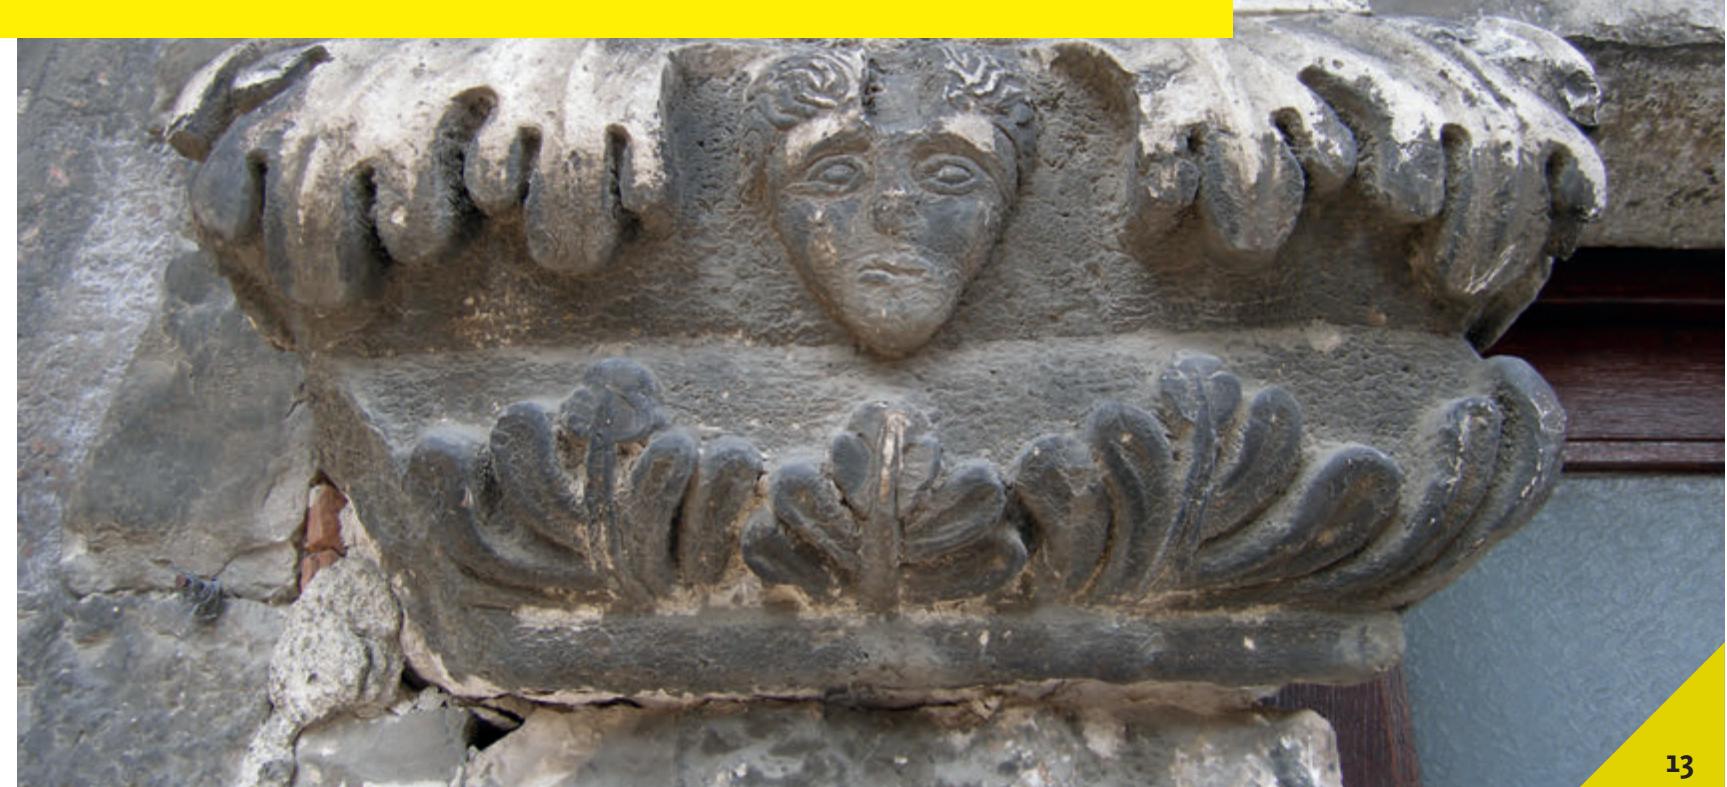
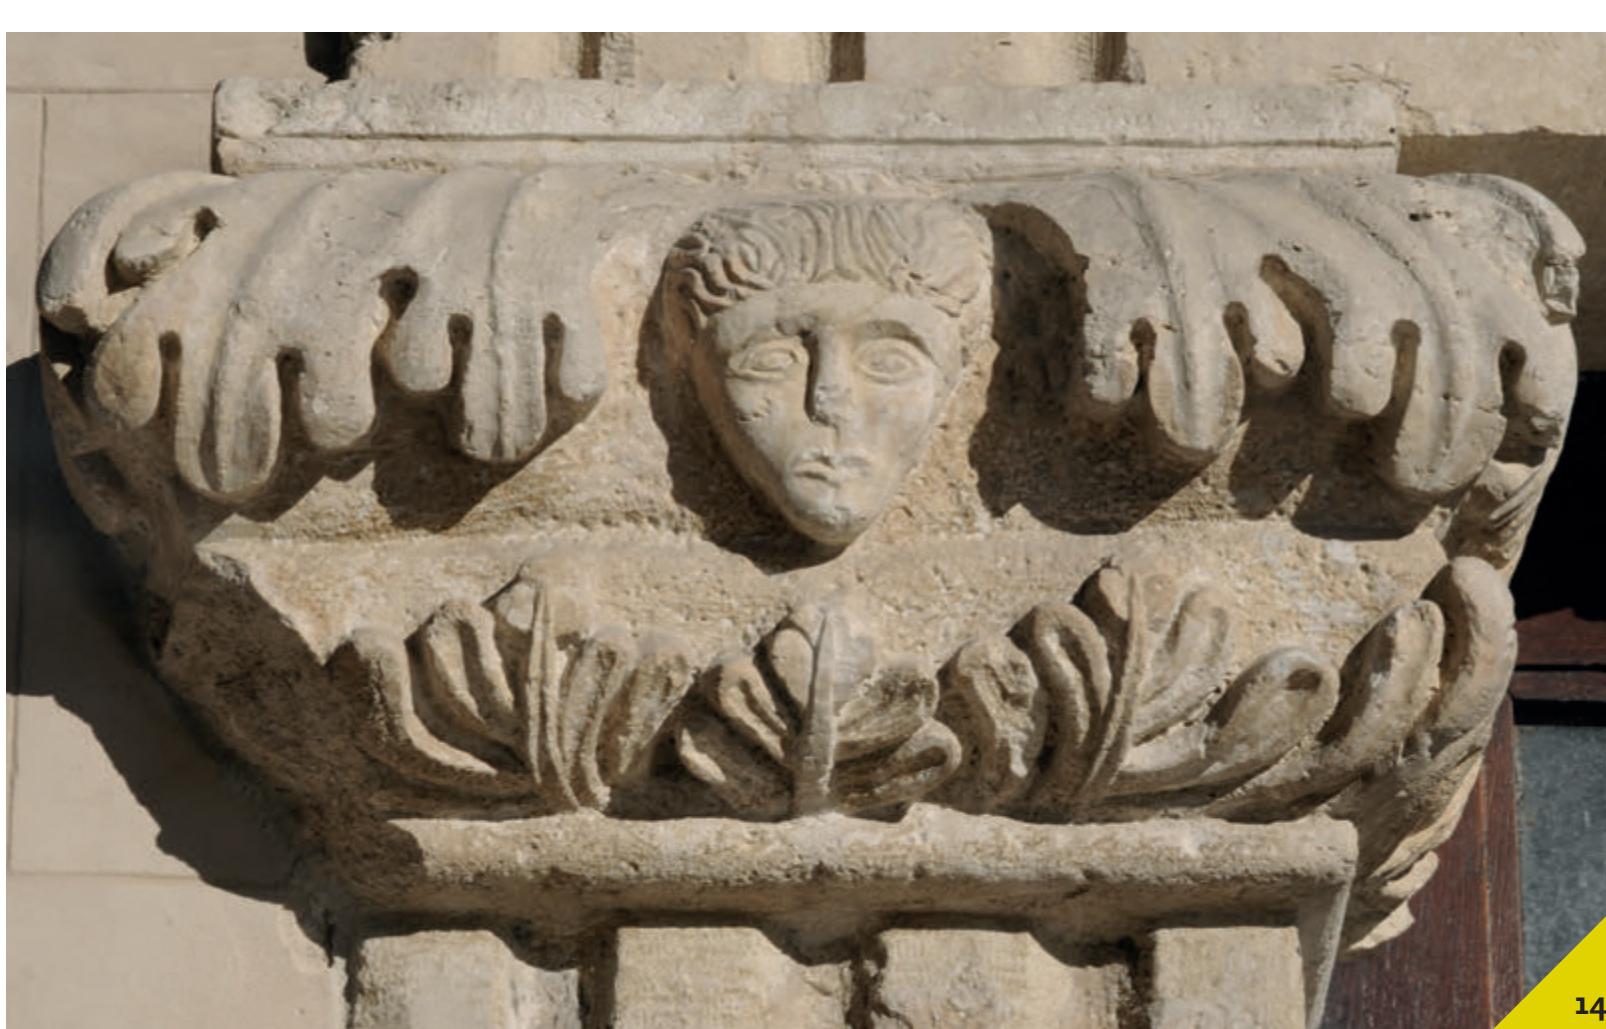
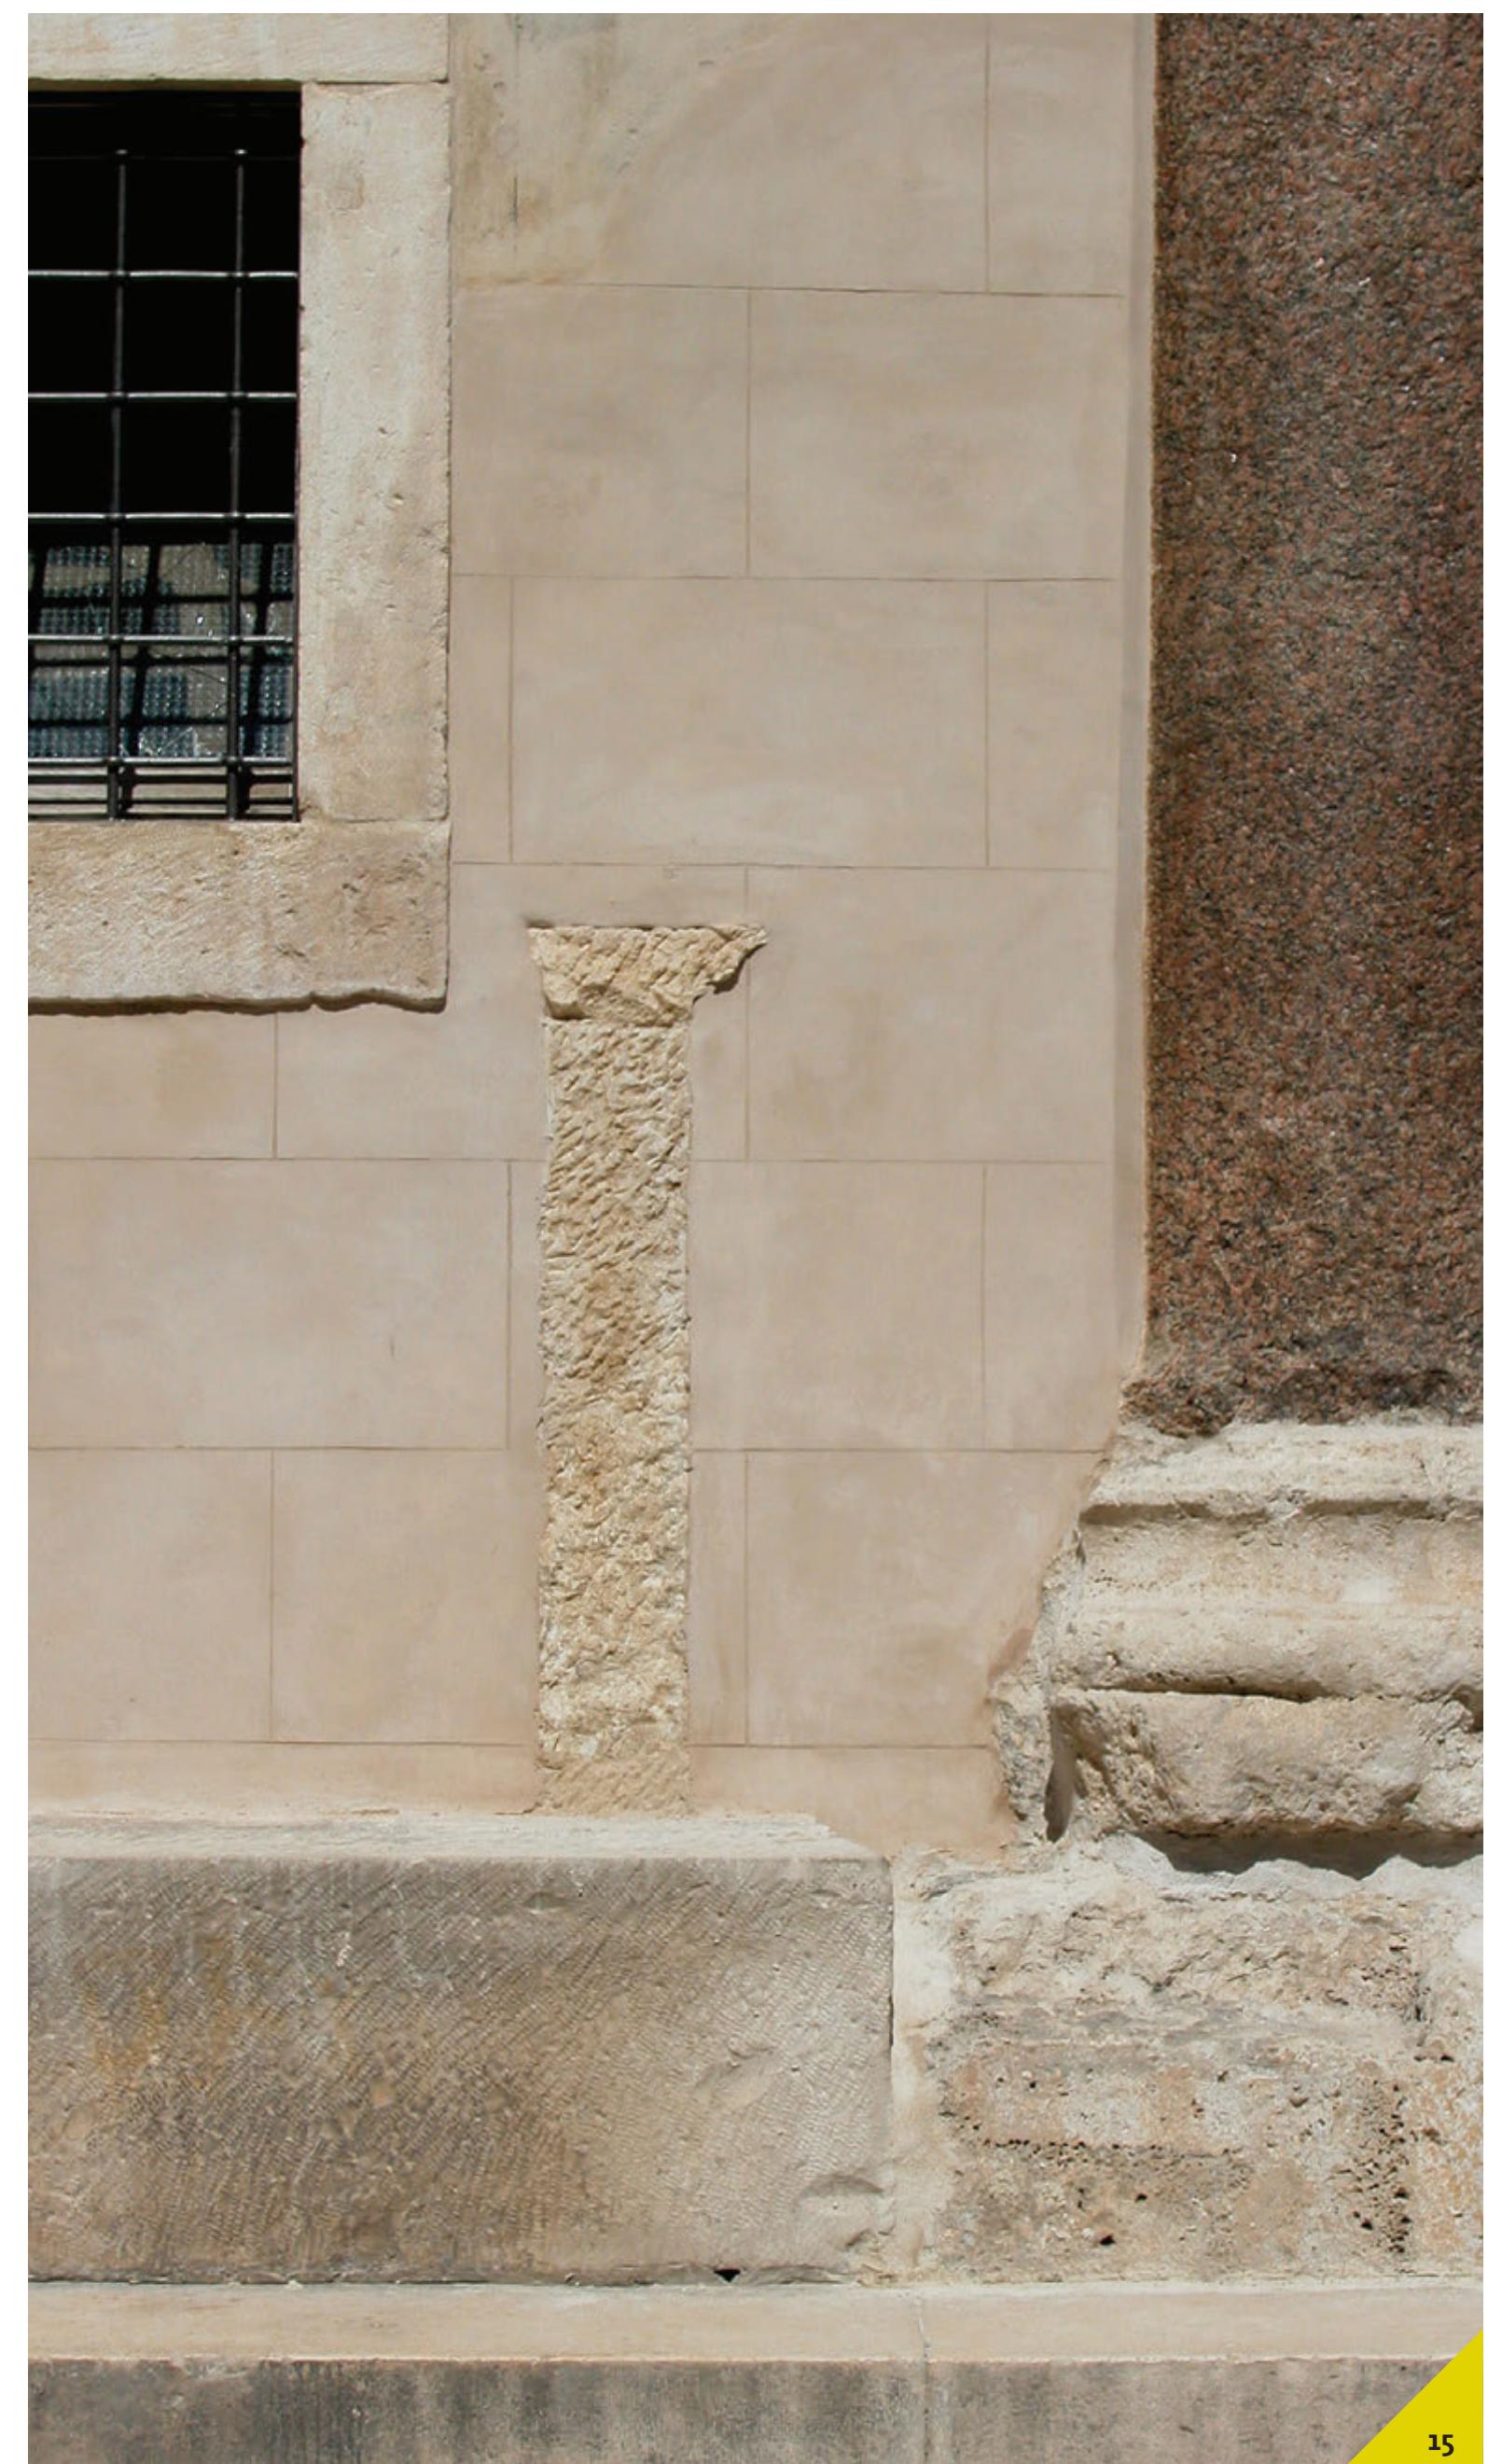
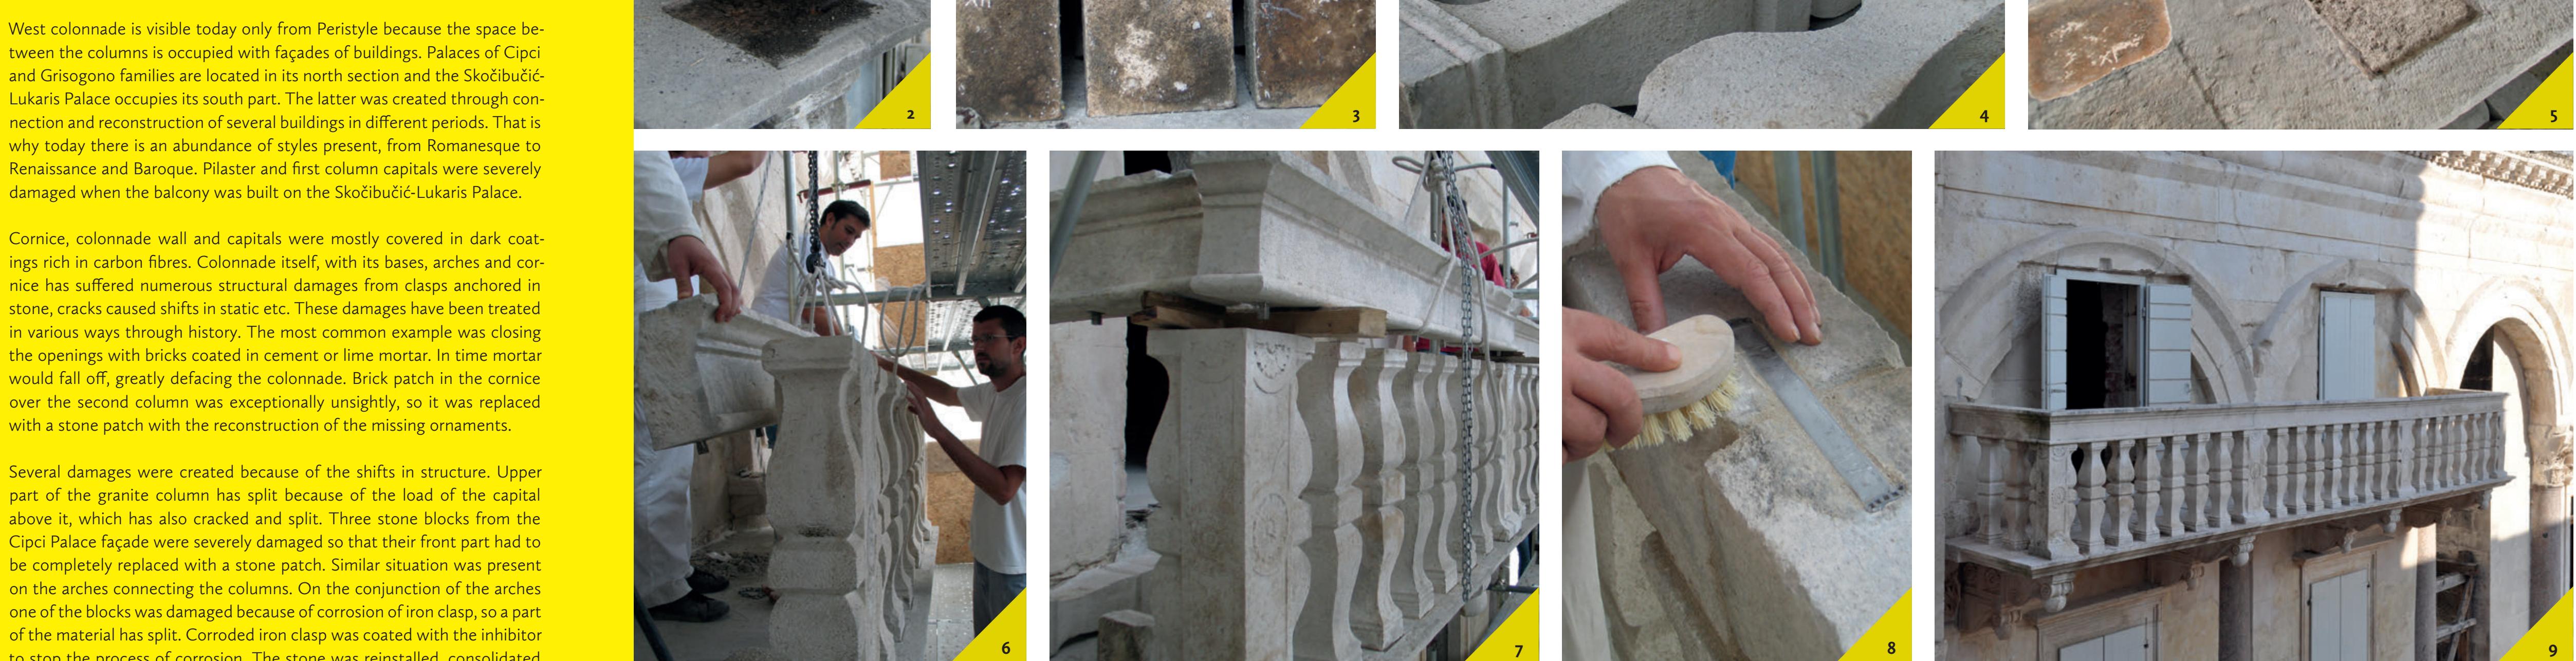
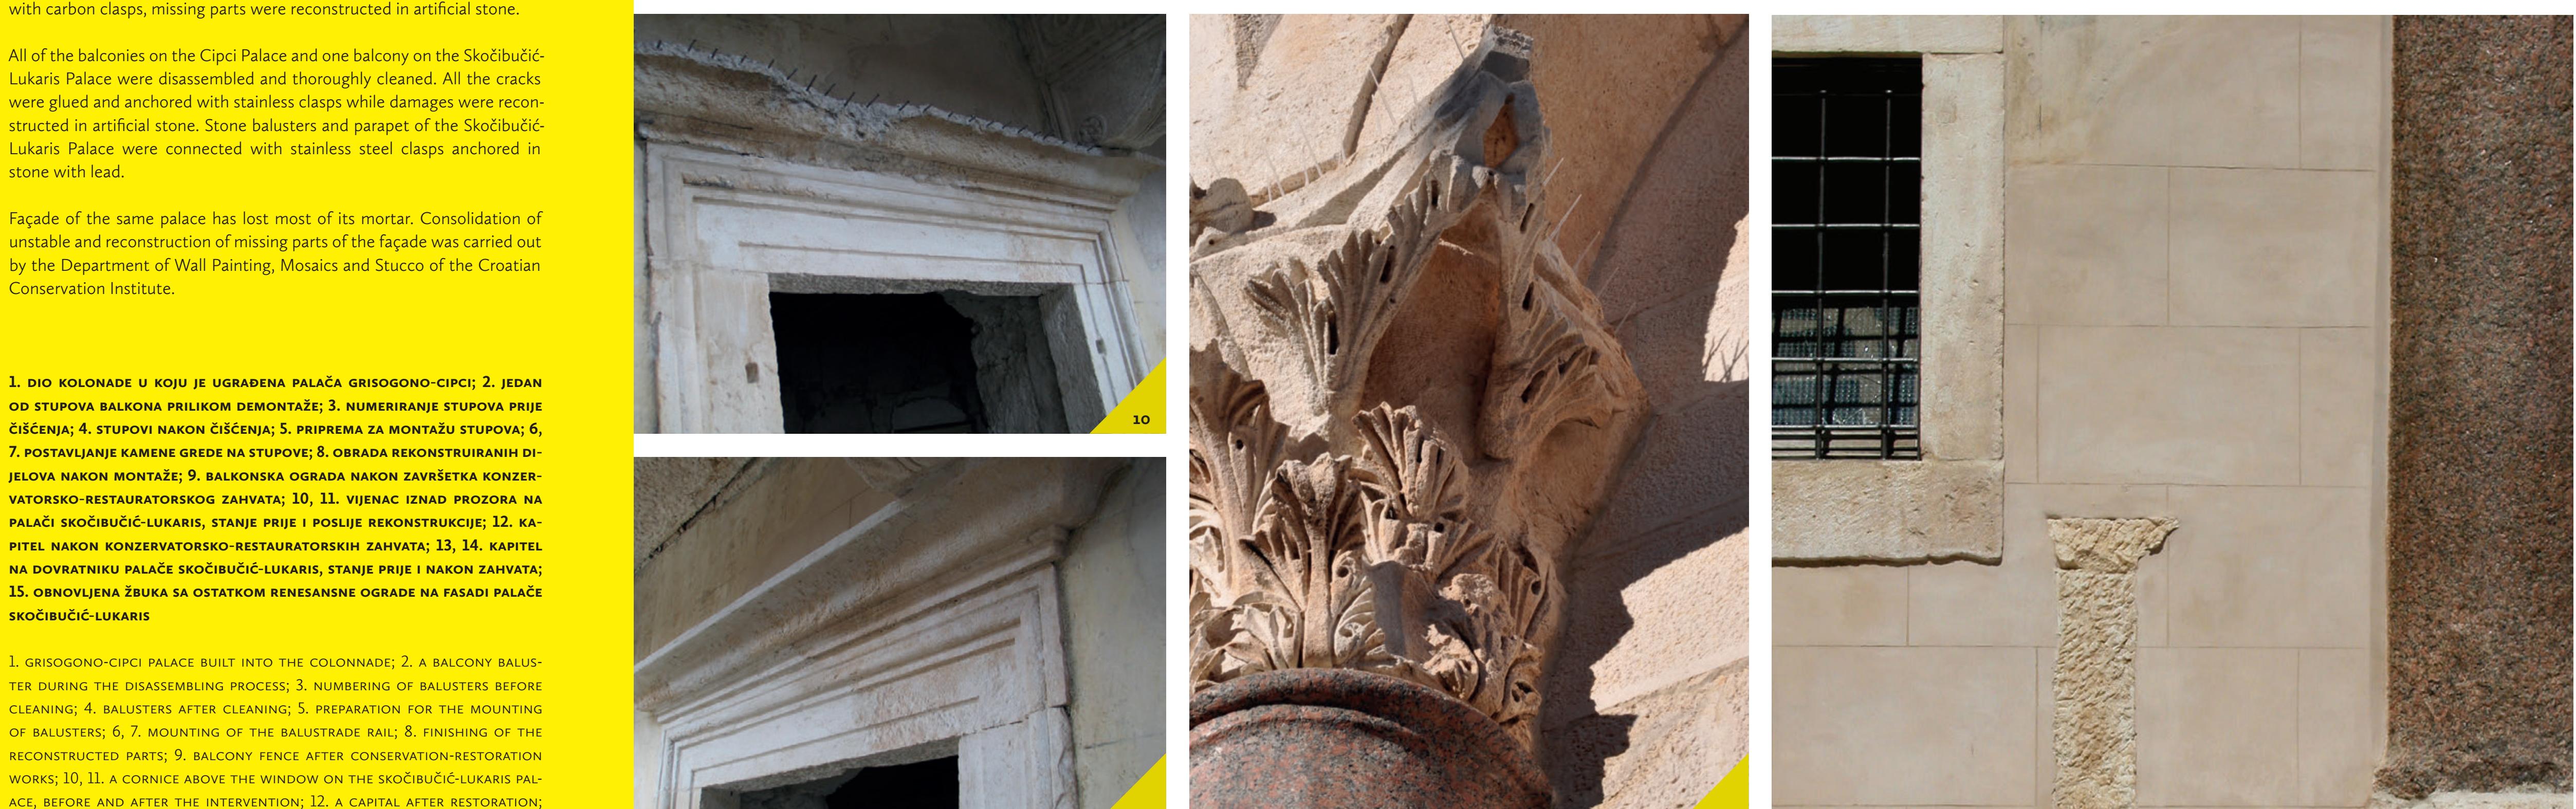
Cornice, colonnade wall and capitals were mostly covered in dark coatings rich in carbon fibres. Colonnade itself, with its bases, arches and cornice has suffered numerous structural damages from clasps anchored in stone, cracks caused shifts in static etc. These damages have been treated in various ways through history. The most common example was closing the openings with bricks coated in cement or lime mortar. In time mortar would fall off, greatly defacing the colonnade. Brick patch in the cornice over the second column was exceptionally unsightly, so it was replaced with a stone patch with the reconstruction of the missing ornaments.

Several damages were created because of the shifts in structure. Upper part of the granite column has split because of the load of the capital above it, which has also cracked and split. Three stone blocks from the Cipci Palace facade were severely damaged so that their front part had to be completely replaced with a stone patch. Similar situation was present on the arches connecting the columns. On the conjunction of the arches one of the blocks was damaged because of corrosion of iron clasp, so a part of the material has split. Corroded iron clasp was coated with the inhibitor to stop the process of corrosion. The stone was reinstated, consolidated with carbon clasps, missing parts were reconstructed in artificial stone.

1. GRISOGONO-CIPCI PALACE BUILT INTO THE COLONNADE; 2. A BALCONY BALUSTER DURING THE DISASSEMBLING PROCESS; 3. NUMBERING OF BALUSTERS BEFORE CLEANING; 4. BALUSTERS AFTER CLEANING; 5. PREPARATION FOR THE MOUNTING OF BALUSTERS; 6, 7. MOUNTING OF THE BALUSTRADE RAIL; 8. FINISHING OF THE RECONSTRUCTED PARTS; 9. BALCONY FENCE AFTER CONSERVATION-RESTORATION WORKS; 10, 11. A CORNICE ABOVE THE WINDOW ON THE SKOČIBUČIĆ-LUKARIS PALACE, BEFORE AND AFTER THE INTERVENTION; 12. A CAPITAL AFTER RESTORATION; 13, 14. A CAPITAL OF THE DOOR POST OF THE SKOČIBUČIĆ-LUKARIS PALACE, BEFORE AND AFTER THE INTERVENTION; 15. RENEWED PLASTER WITH THE TRACES OF THE RENAISSANCE BALUSTRADE ON THE FAÇADE OF THE SKOČIBUČIĆ-LUKARIS PALACE

All of the balconies on the Cipci Palace and one balcony on the Skočibučić-Lukaris Palace were disassembled and thoroughly cleaned. All the cracks were glued and anchored with stainless clasps while damages were reconstructed in artificial stone. Stone balusters and parapet of the Skočibučić-Lukaris Palace were connected with stainless steel clasps anchored in stone with lead.
