## Na završetku desetljeća obnove Peristila

## At the end of a Decade of the Peristyle Restoration

The conservation and restoration work on the Peristyle of Diocletian's Palace has been in many ways the most important project in recent period within the scope of renovation of the historical core of the town of Split. The Peristyle is the centre and the most impressive part of the imperial palace, and also the heart of the town which has grown around it. The square, which reflects historical layers of the creation and development of the town, has become its symbol and its main tourist attraction. It serves as the most attractive backdrop for cultural events, and a stage at which public life evolves.

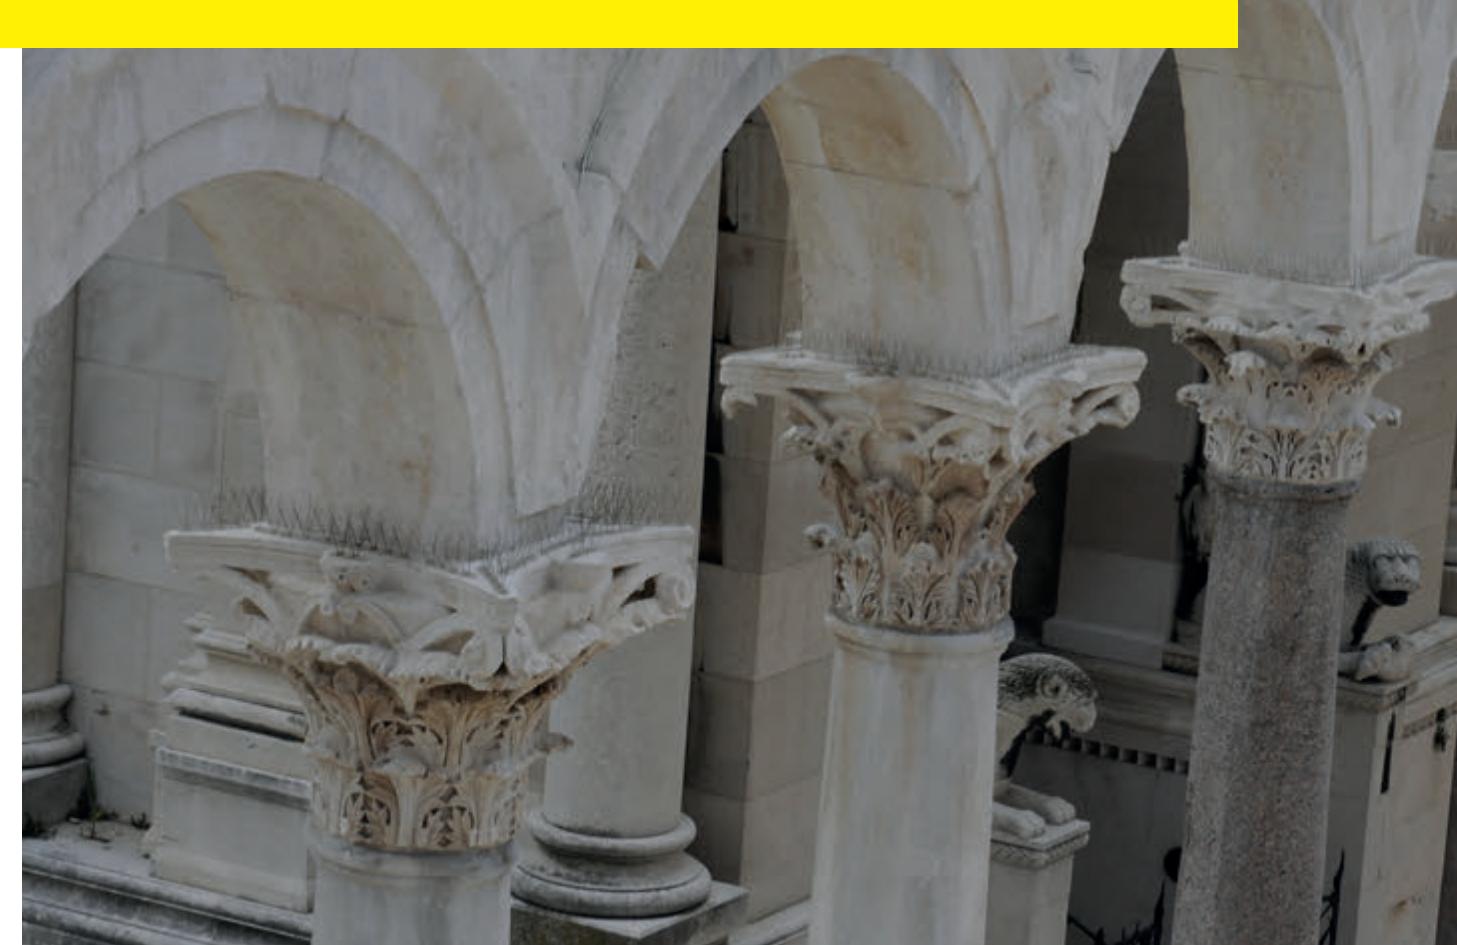
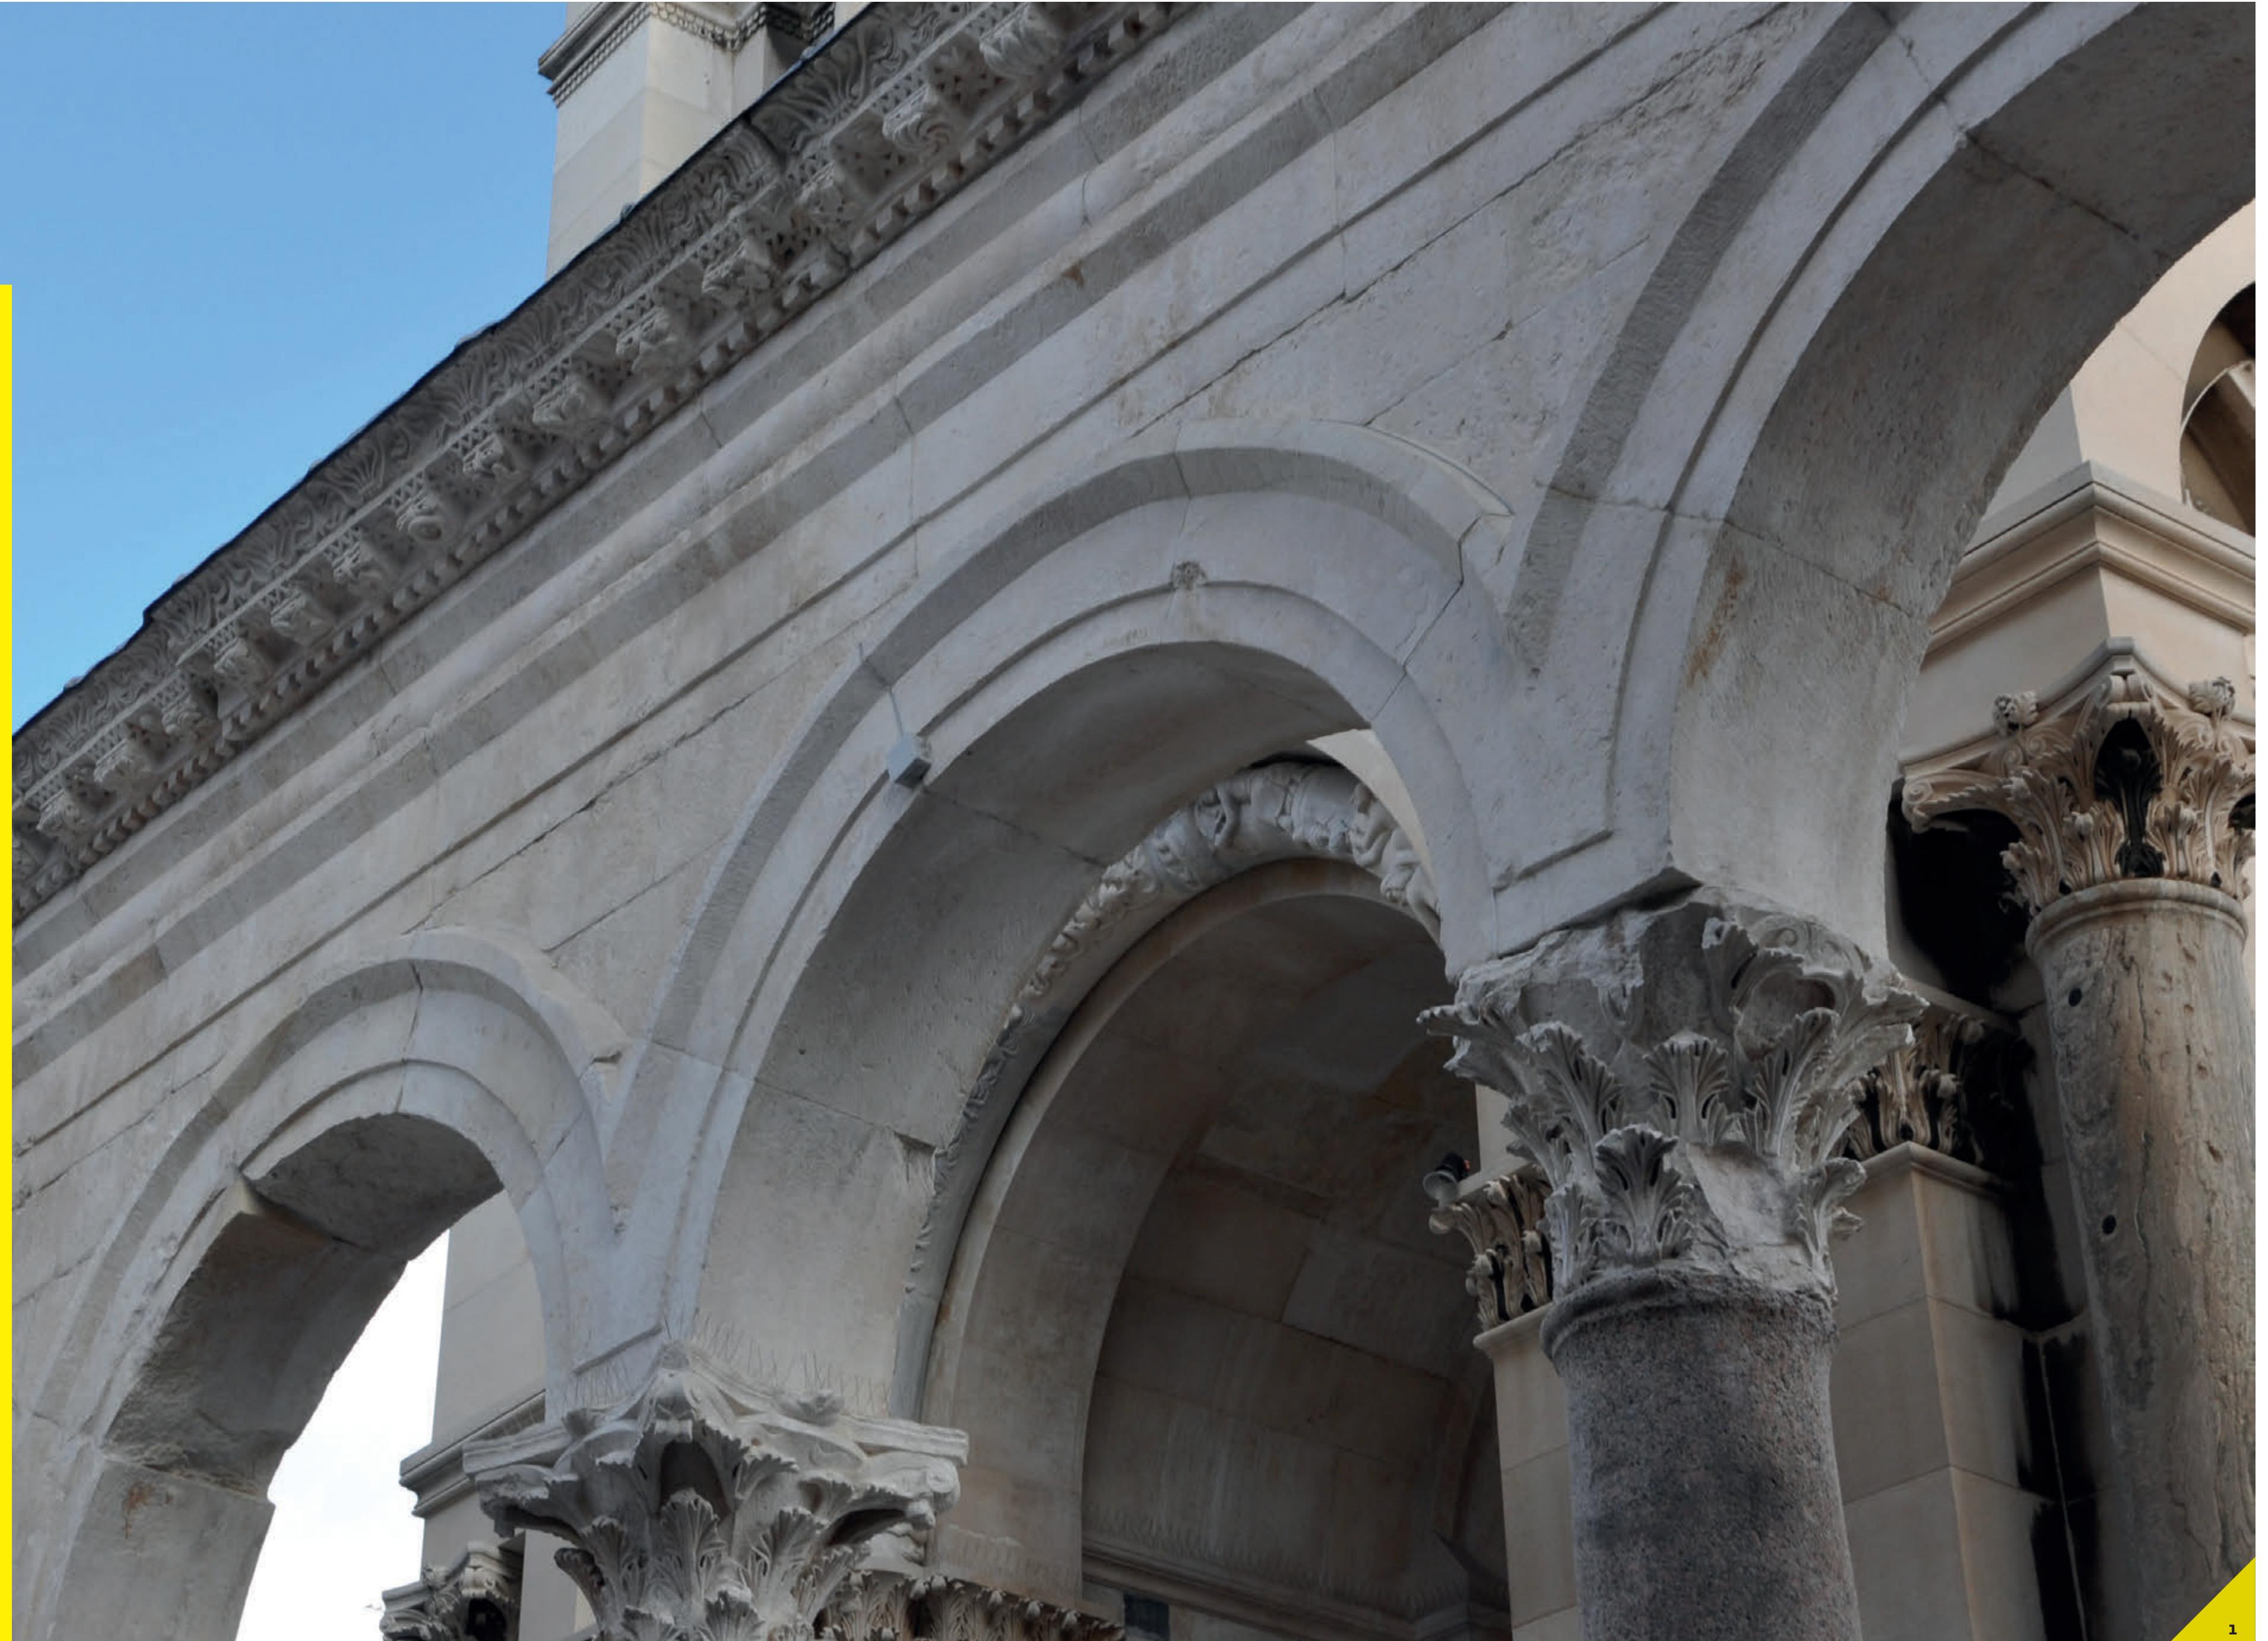
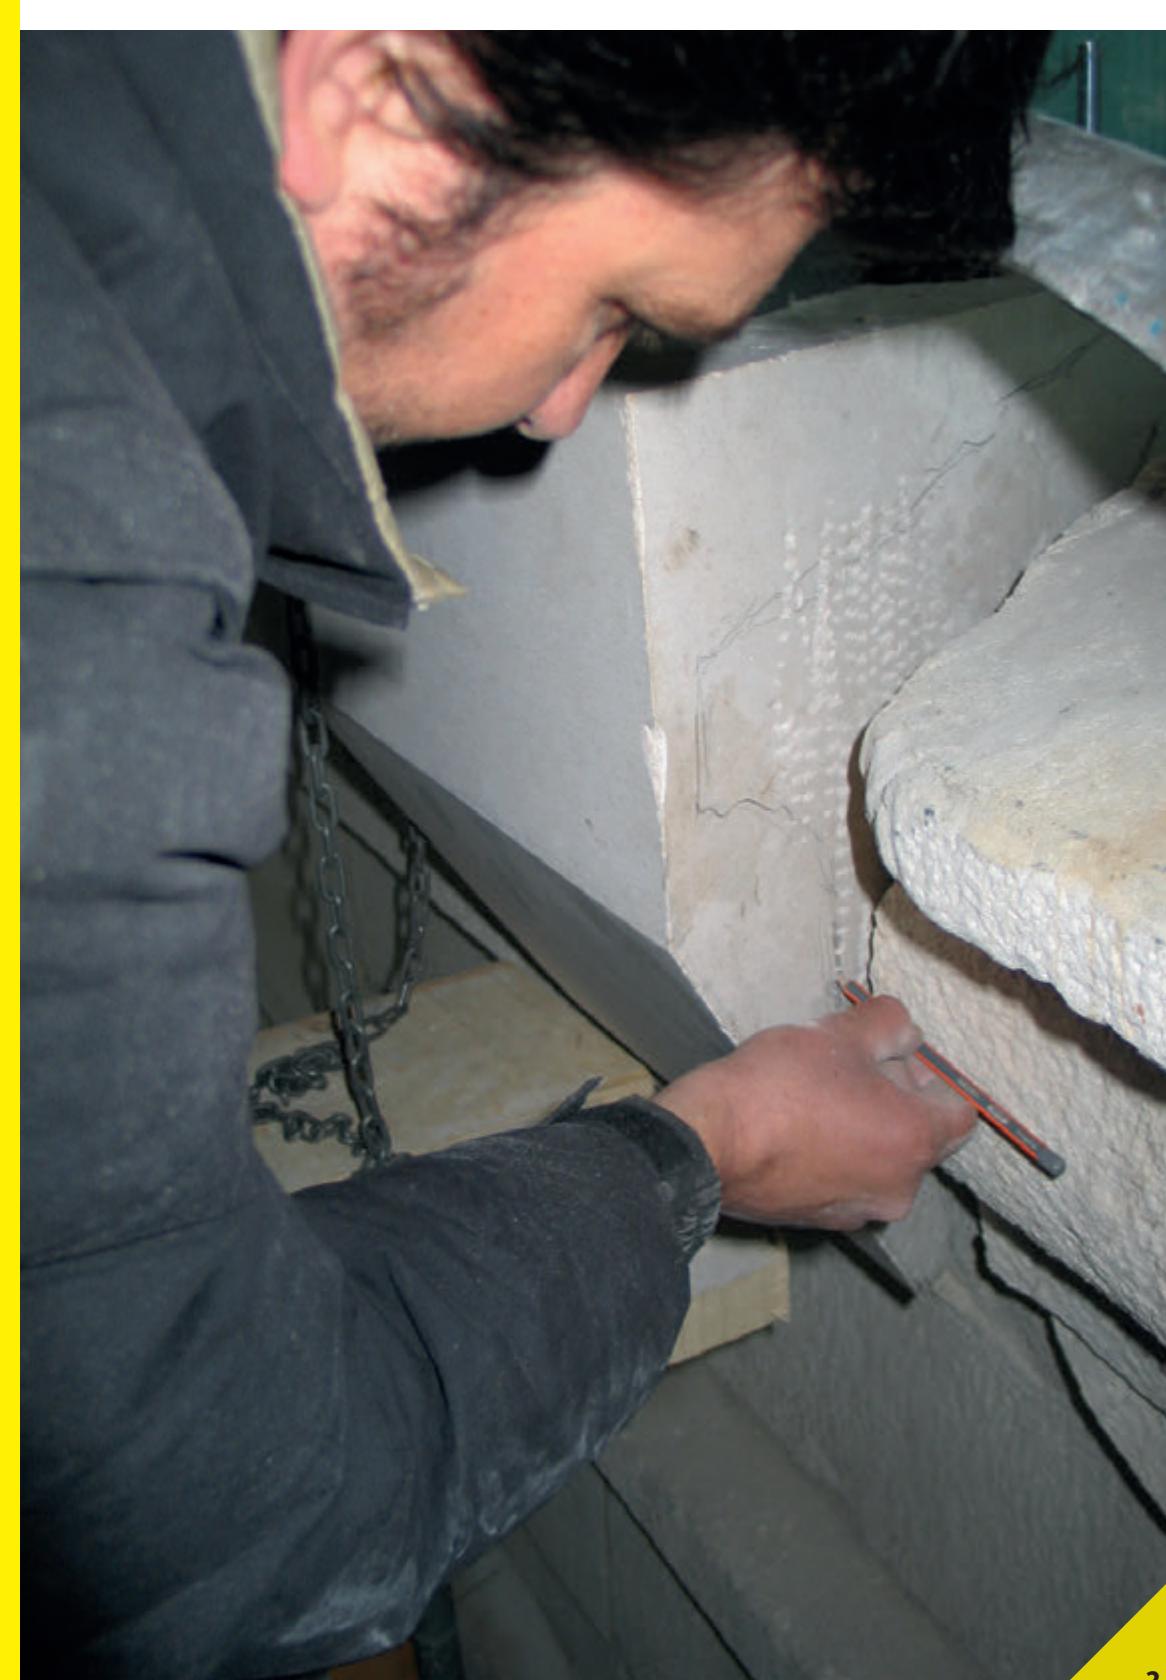
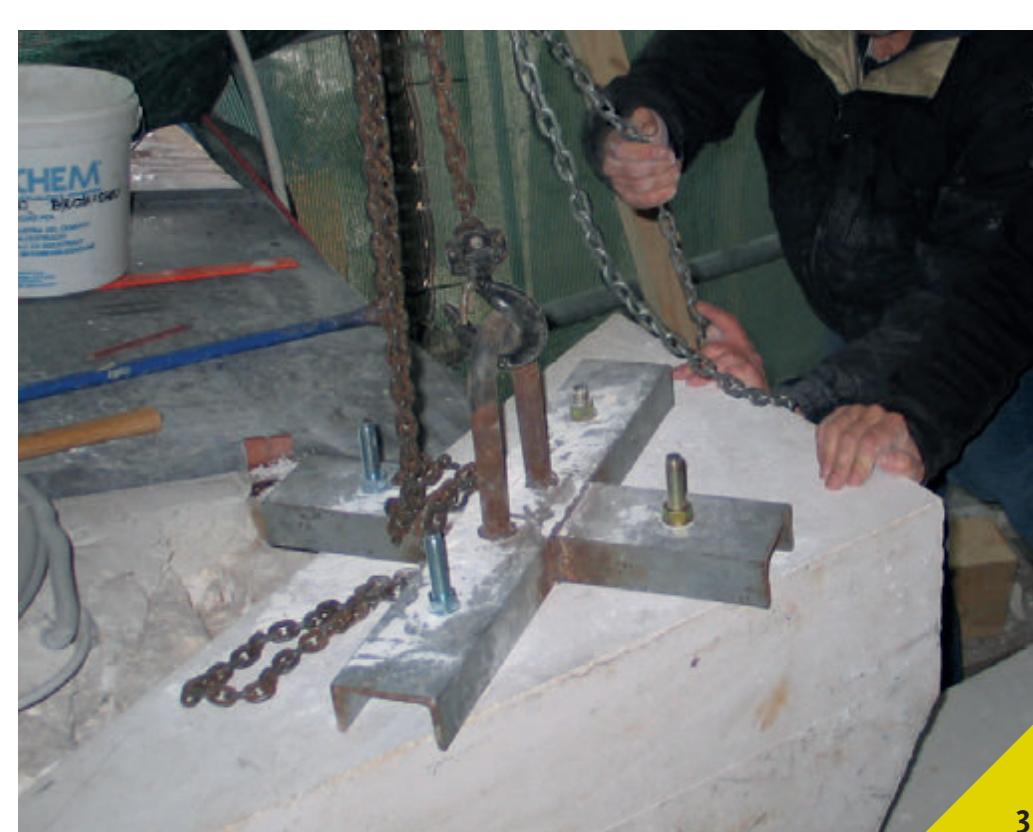
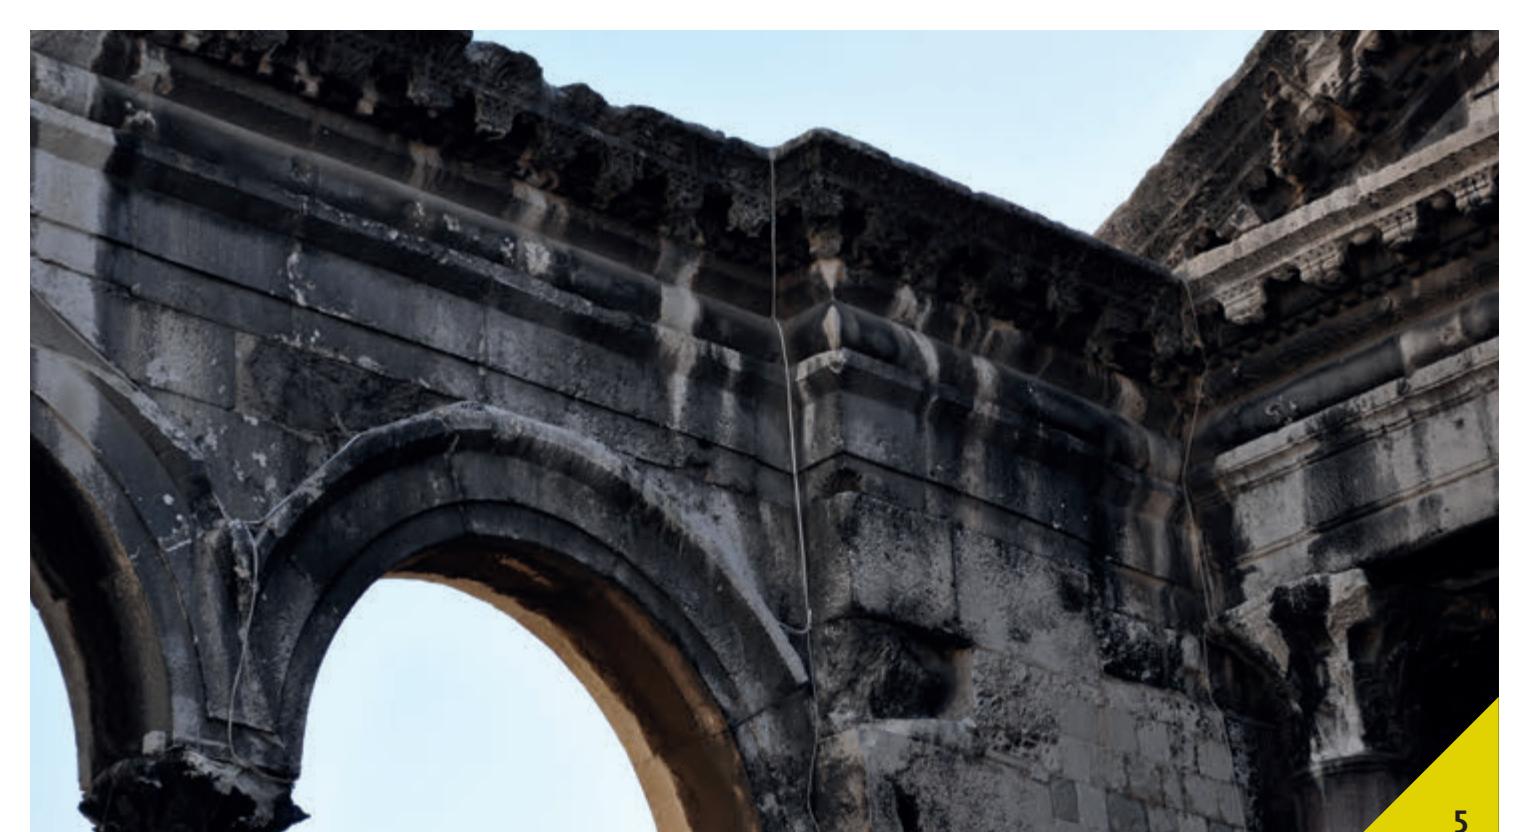
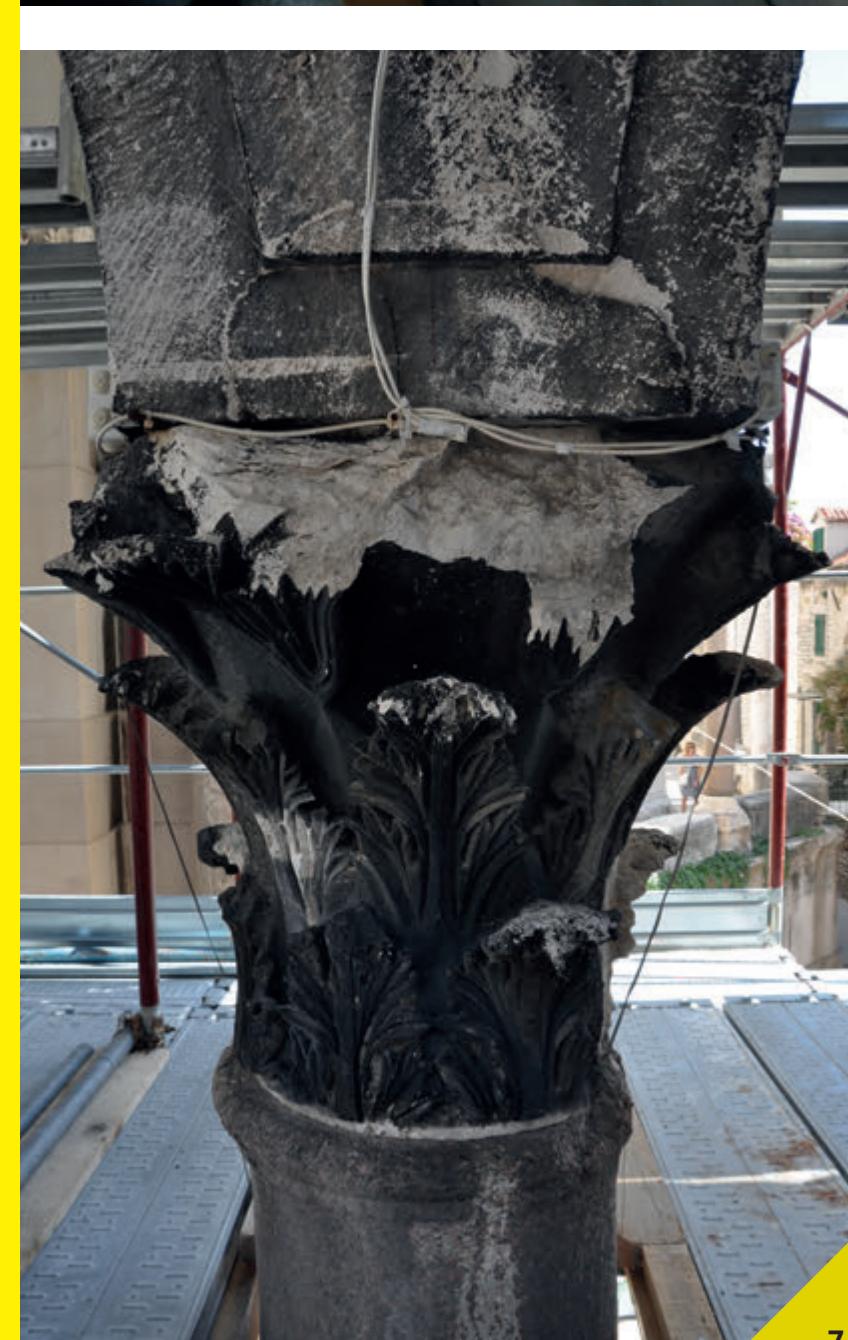
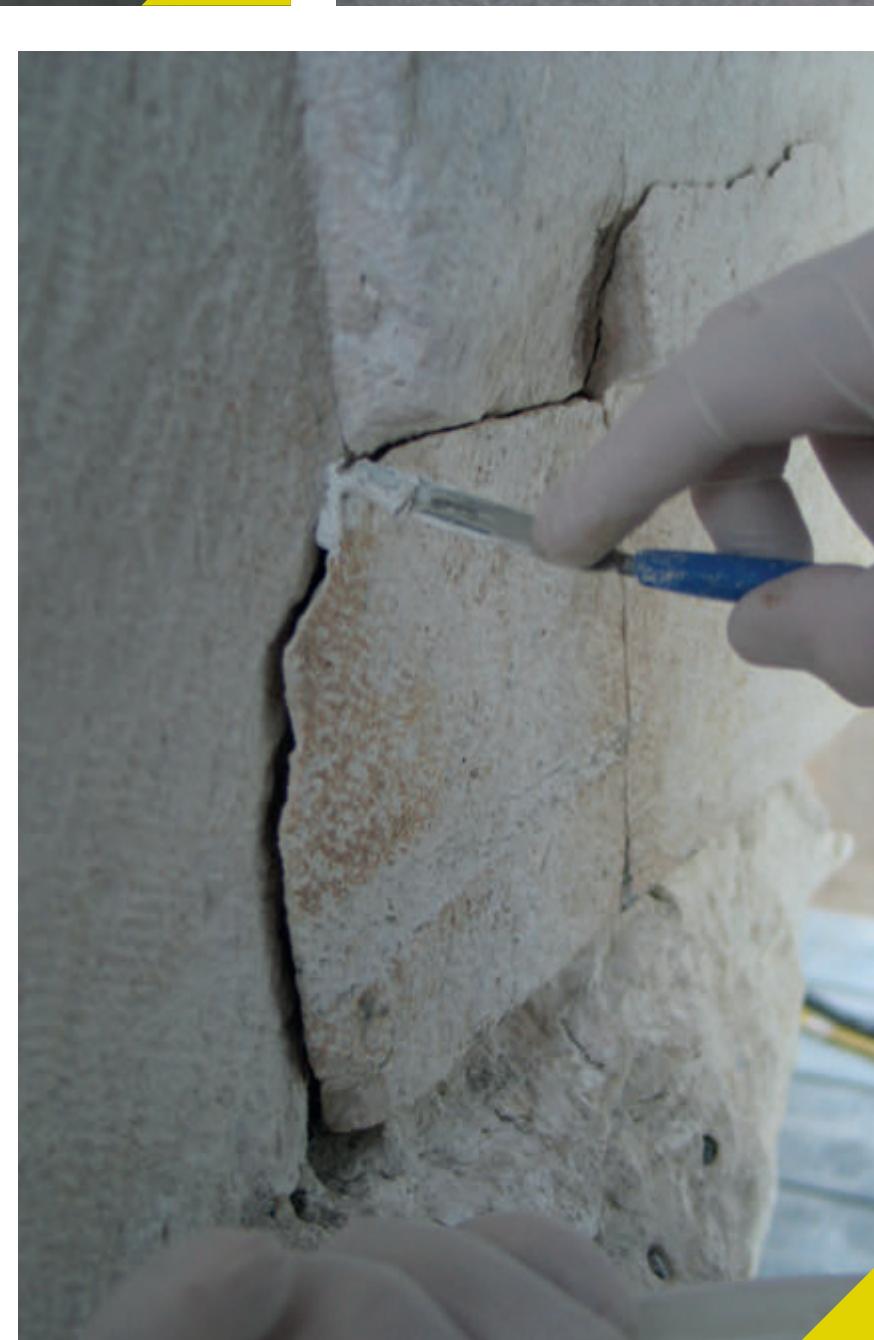
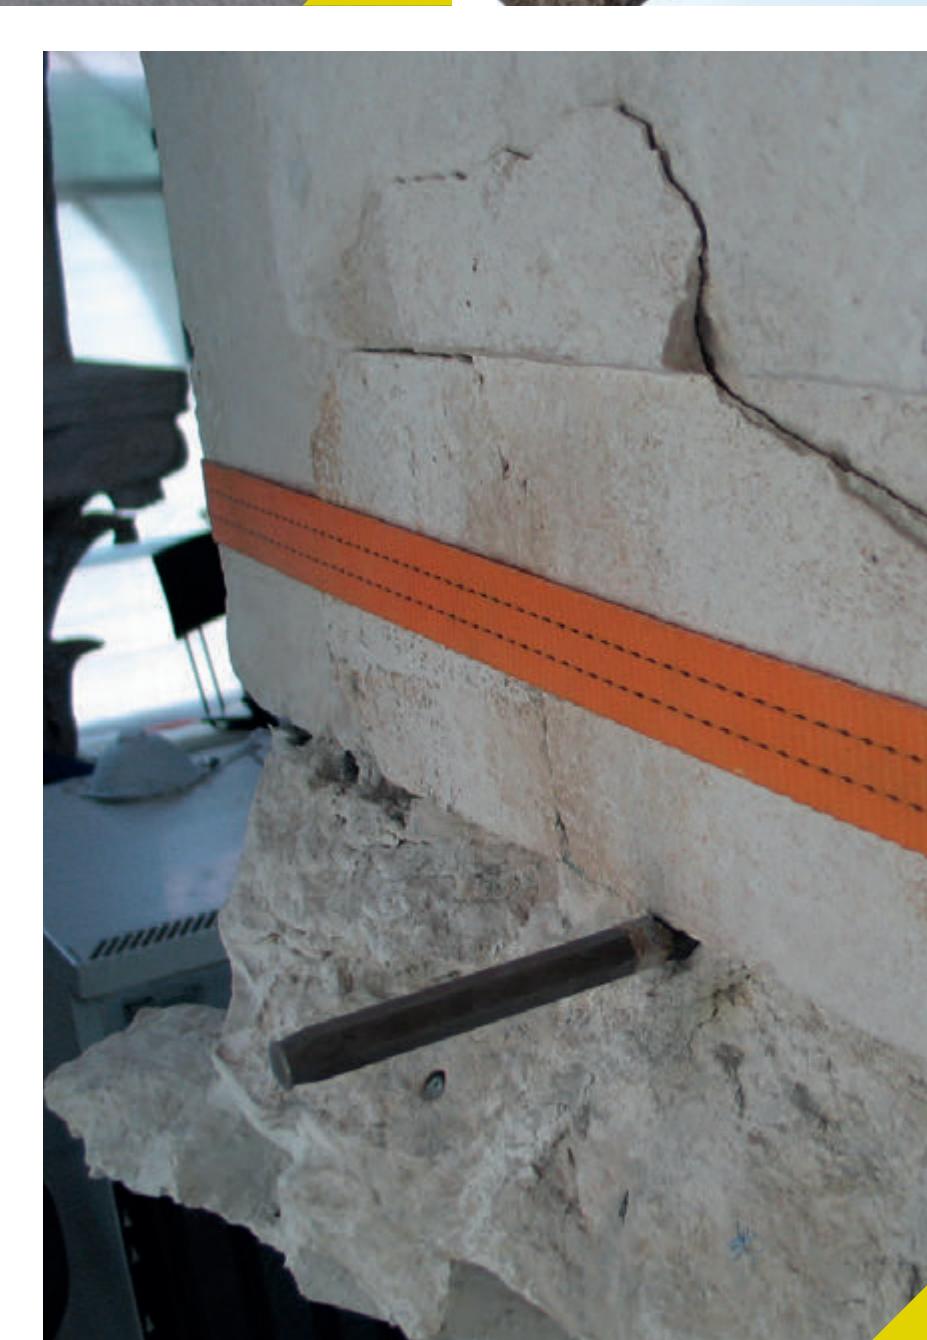
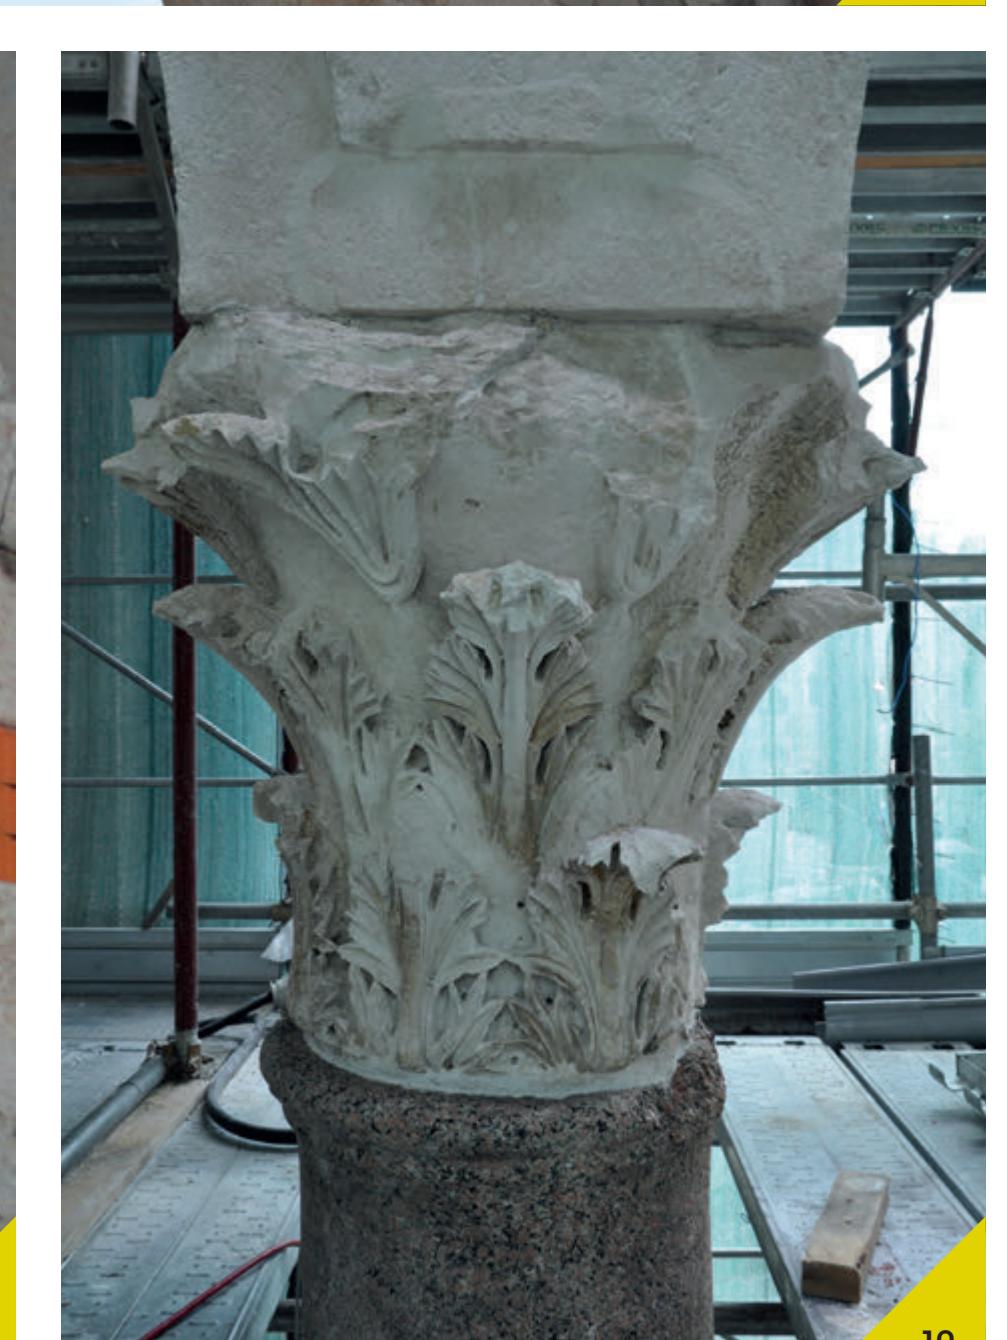
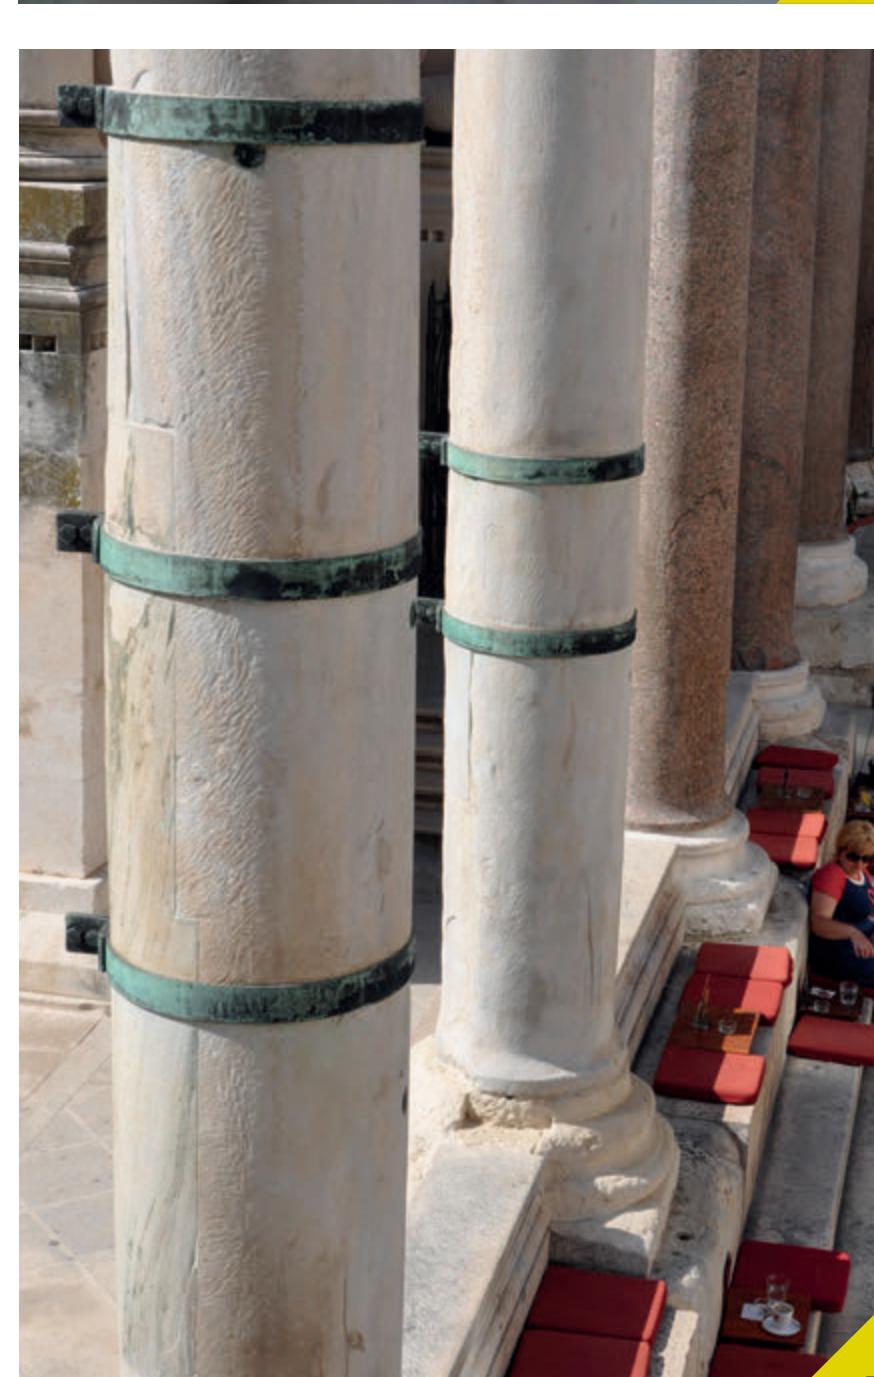
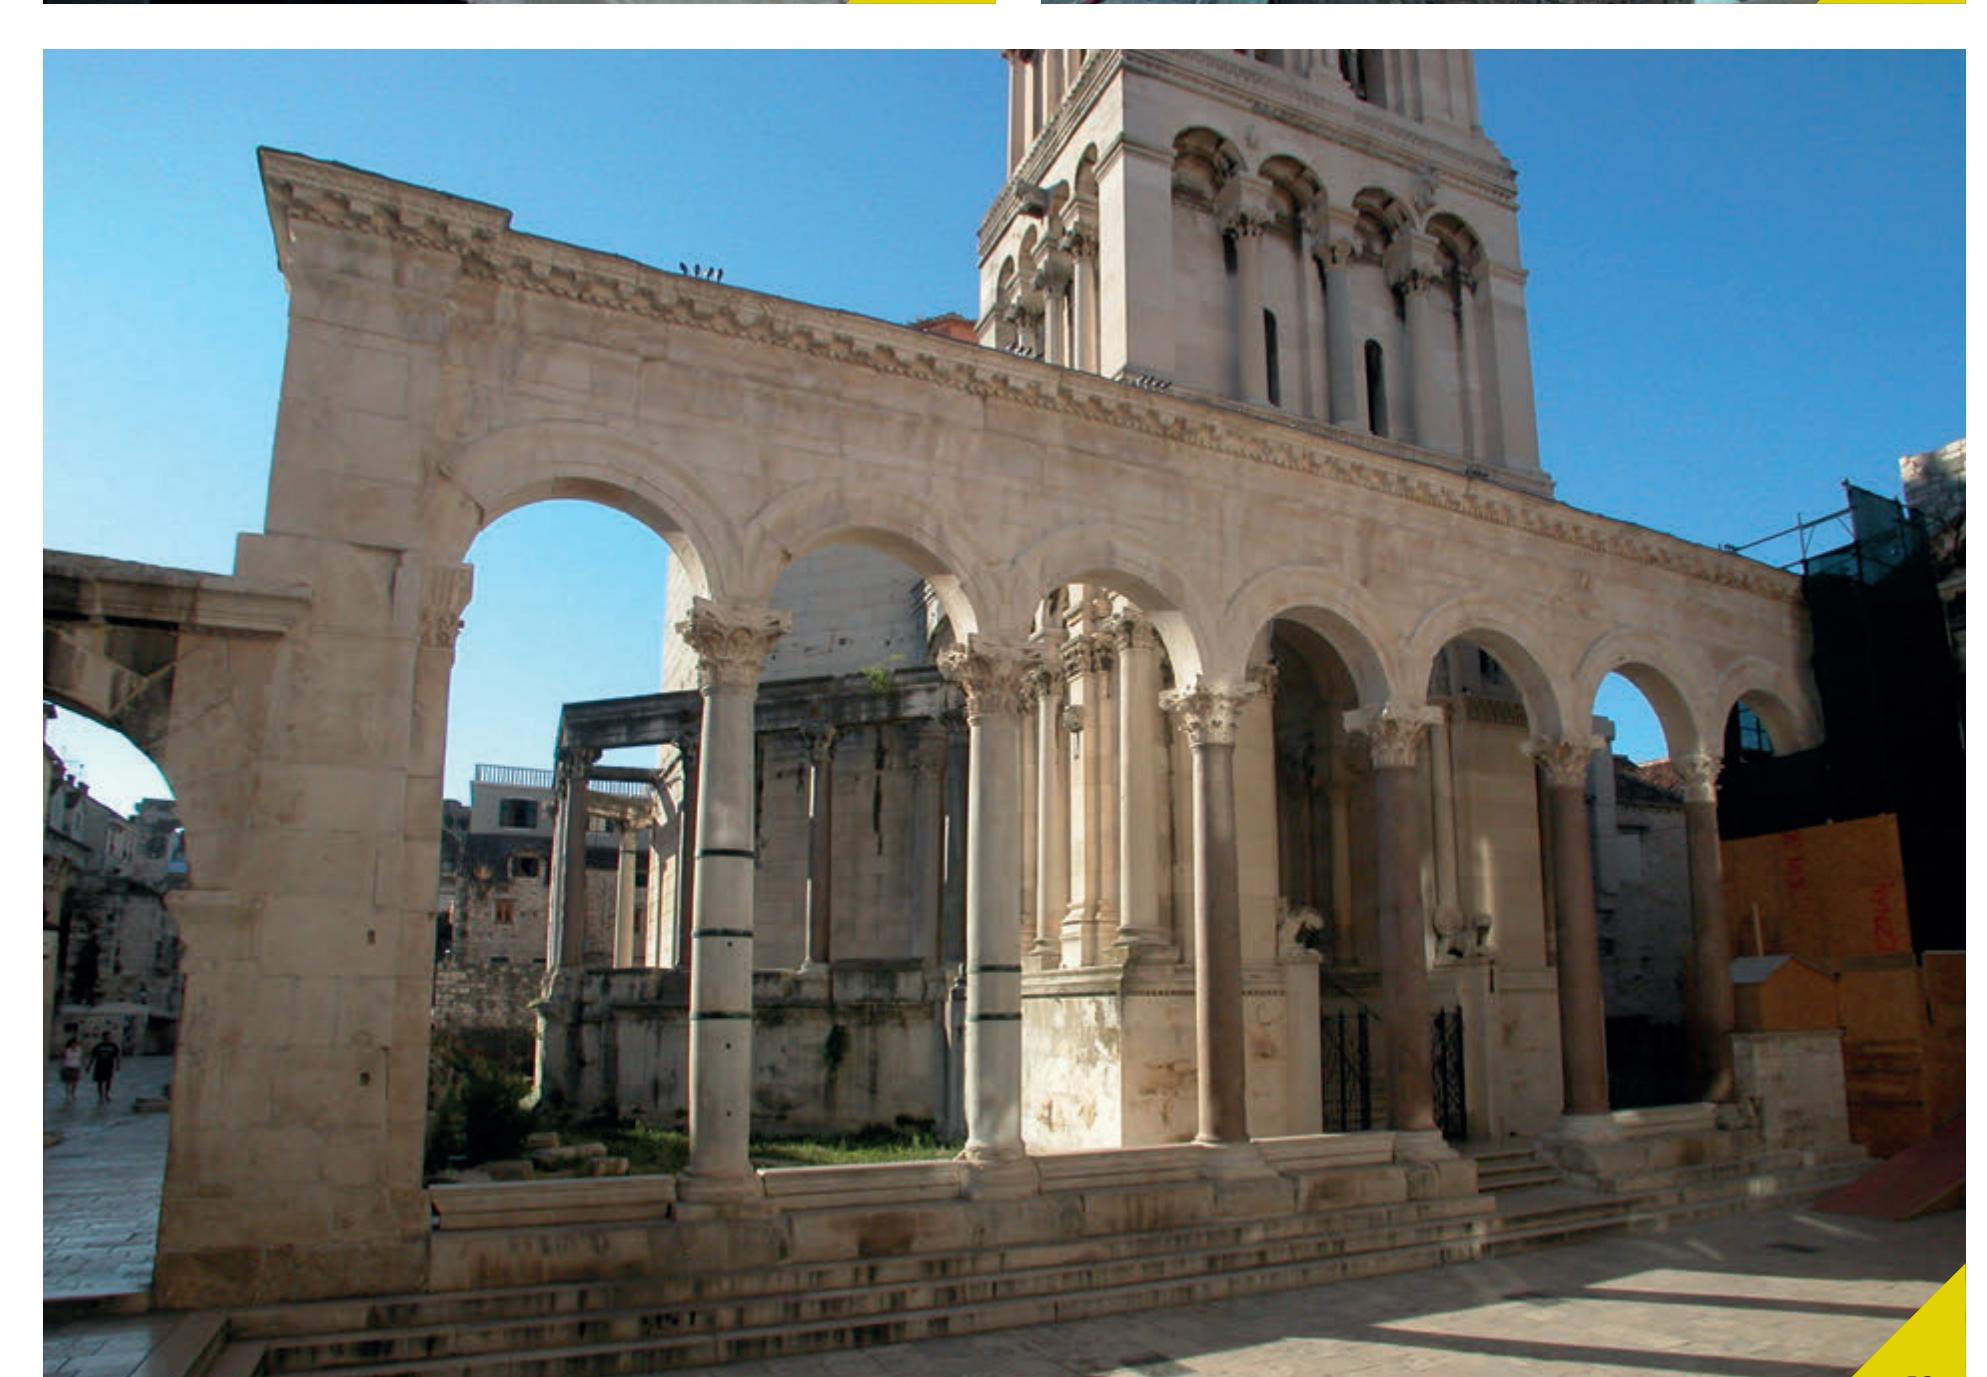
It is interesting that the outer sheet of this colonnade is bright, unlike the inner one that was almost completely covered in dark sediment. Reason for this lies in the position of the colonnade. The outer sheet is, unlike the inner one, exposed to strong wind that combined with rain and small sand particles continuously causes abrasion so that dark sediment cannot hold to the stone surface. Cornice was damaged in several places. That has produced breaks in the ornamental strip and disturbed the beauty and harmony of the whole cornice. In such places rain has intensively damaged the stone, creating big contrasts between washed, bright and soiled, dark surfaces thus making it hard to „decipher“ the architectural forms. These places were reconstructed in artificial stone. A lot of attention was paid to the logic of the ornamental strip and the method of the ancient stone carving. Besides the reconstructions made in artificial stone, a large stone patch was inbuilt into the outer cornice sheet that had no ornaments. This patch was roughly cut in a workshop and finely finished in situ. Finishing treatment was carried out with marteline, with special attention given to the texture. Damage made on the last capital towards south is exceptionally interesting. Iron clasp connecting the capital to the base of the arch has expanded because of humidity and created enough thrust to break out the stone of the capital and arch base. Stone separated from the rest was taken out, iron clasp was replaced with the new one made of stainless steel and was coated in lead so that it would hold firmly to its stone bed. Separated stone was returned to its place and anchored with carbon bars and epoxy glue and the conjunction was treated with artificial stone. Uppermost cornice of the colonnade was covered with Portland cement slanted coating. This has been removed and iron clasps connecting the stone blocks were replaced with the stainless steel ones. New lime mortar coating was installed as a base for the lead sheeting with a sash as a protection from rain.

1. A PART OF THE EASTERN COLONNADE IN FRONT OF THE ST. DOMINIC CATHEDRAL; 2, 3. MOUNTING AND FINISHING OF THE STONE BLOCK ON THE OUTER SIDE OF THE EASTERN COLONNADE; 4. STONE BLOCK AFTER THE RECONSTRUCTION; 5, 6. SOUTHERN SIDE OF THE EASTERN COLONNADE, CONDITION BEFORE AND AFTER THE INTERVENTIONS; 7, 8, 9, 10. REPAIR OF A CRACKED STONE CAUSED BY CORROSION OF AN IRON CLAMP, BEFORE, DURING AND AFTER TREATMENT; 11, 12, 13. VIEW OF THE EASTERN COLONNADE
