## Na završetku desetljeća obnove Peristila

## At the end of a Decade of the Peristyle Restoration

The conservation and restoration work on the Peristyle of Diocletian's Palace has been in many ways the most important project in recent period within the scope of renovation of the historical core of the town of Split. The Peristyle is the centre and the most impressive part of the imperial palace, and also the heart of the town which has grown around it. The square, which reflects historical layers of the creation and development of the town, has become its symbol and its main tourist attraction. It serves as the most attractive backdrop for cultural events, and a stage at which public life evolves.

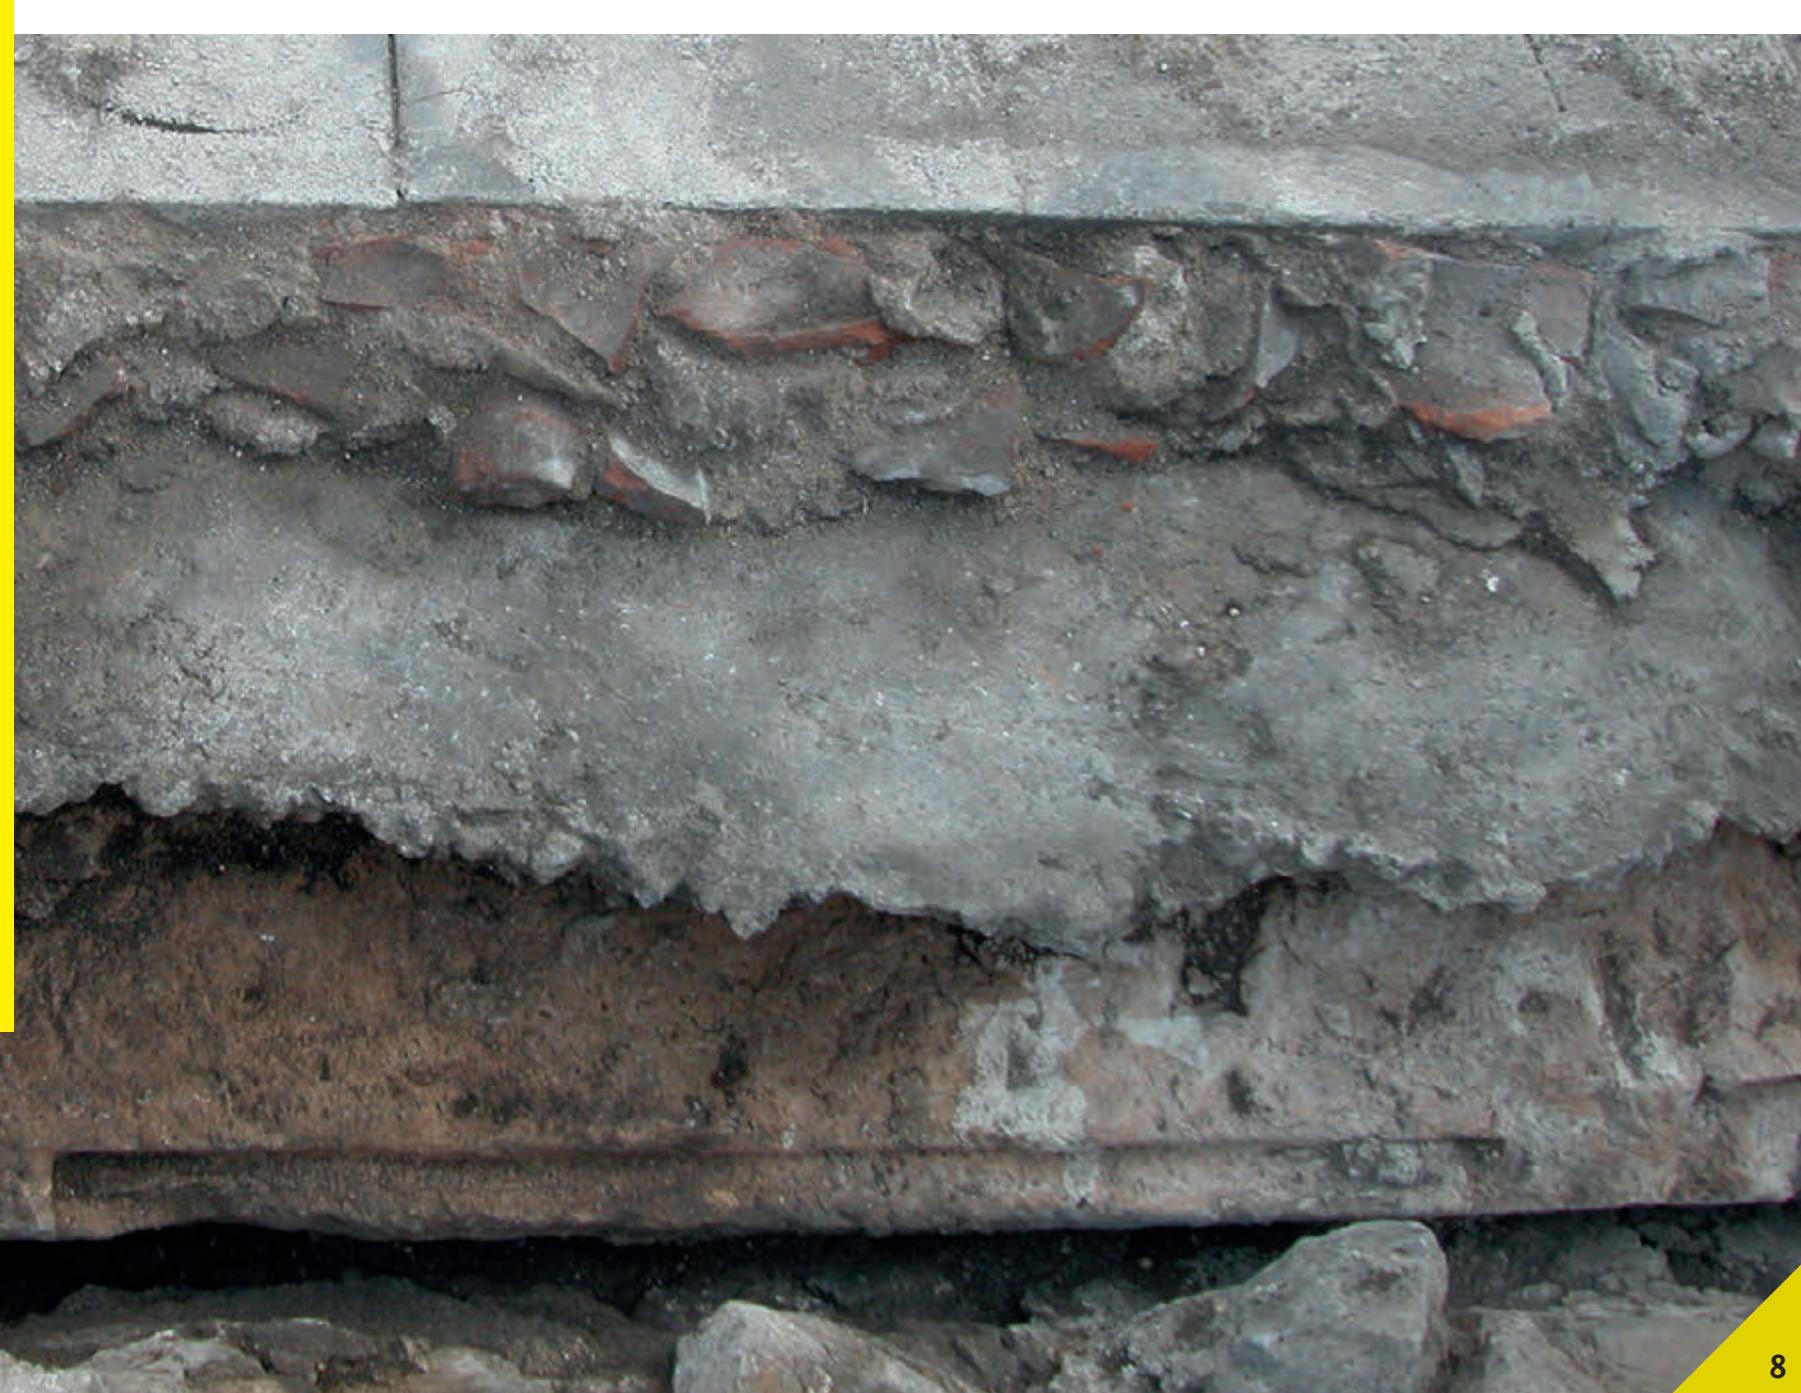
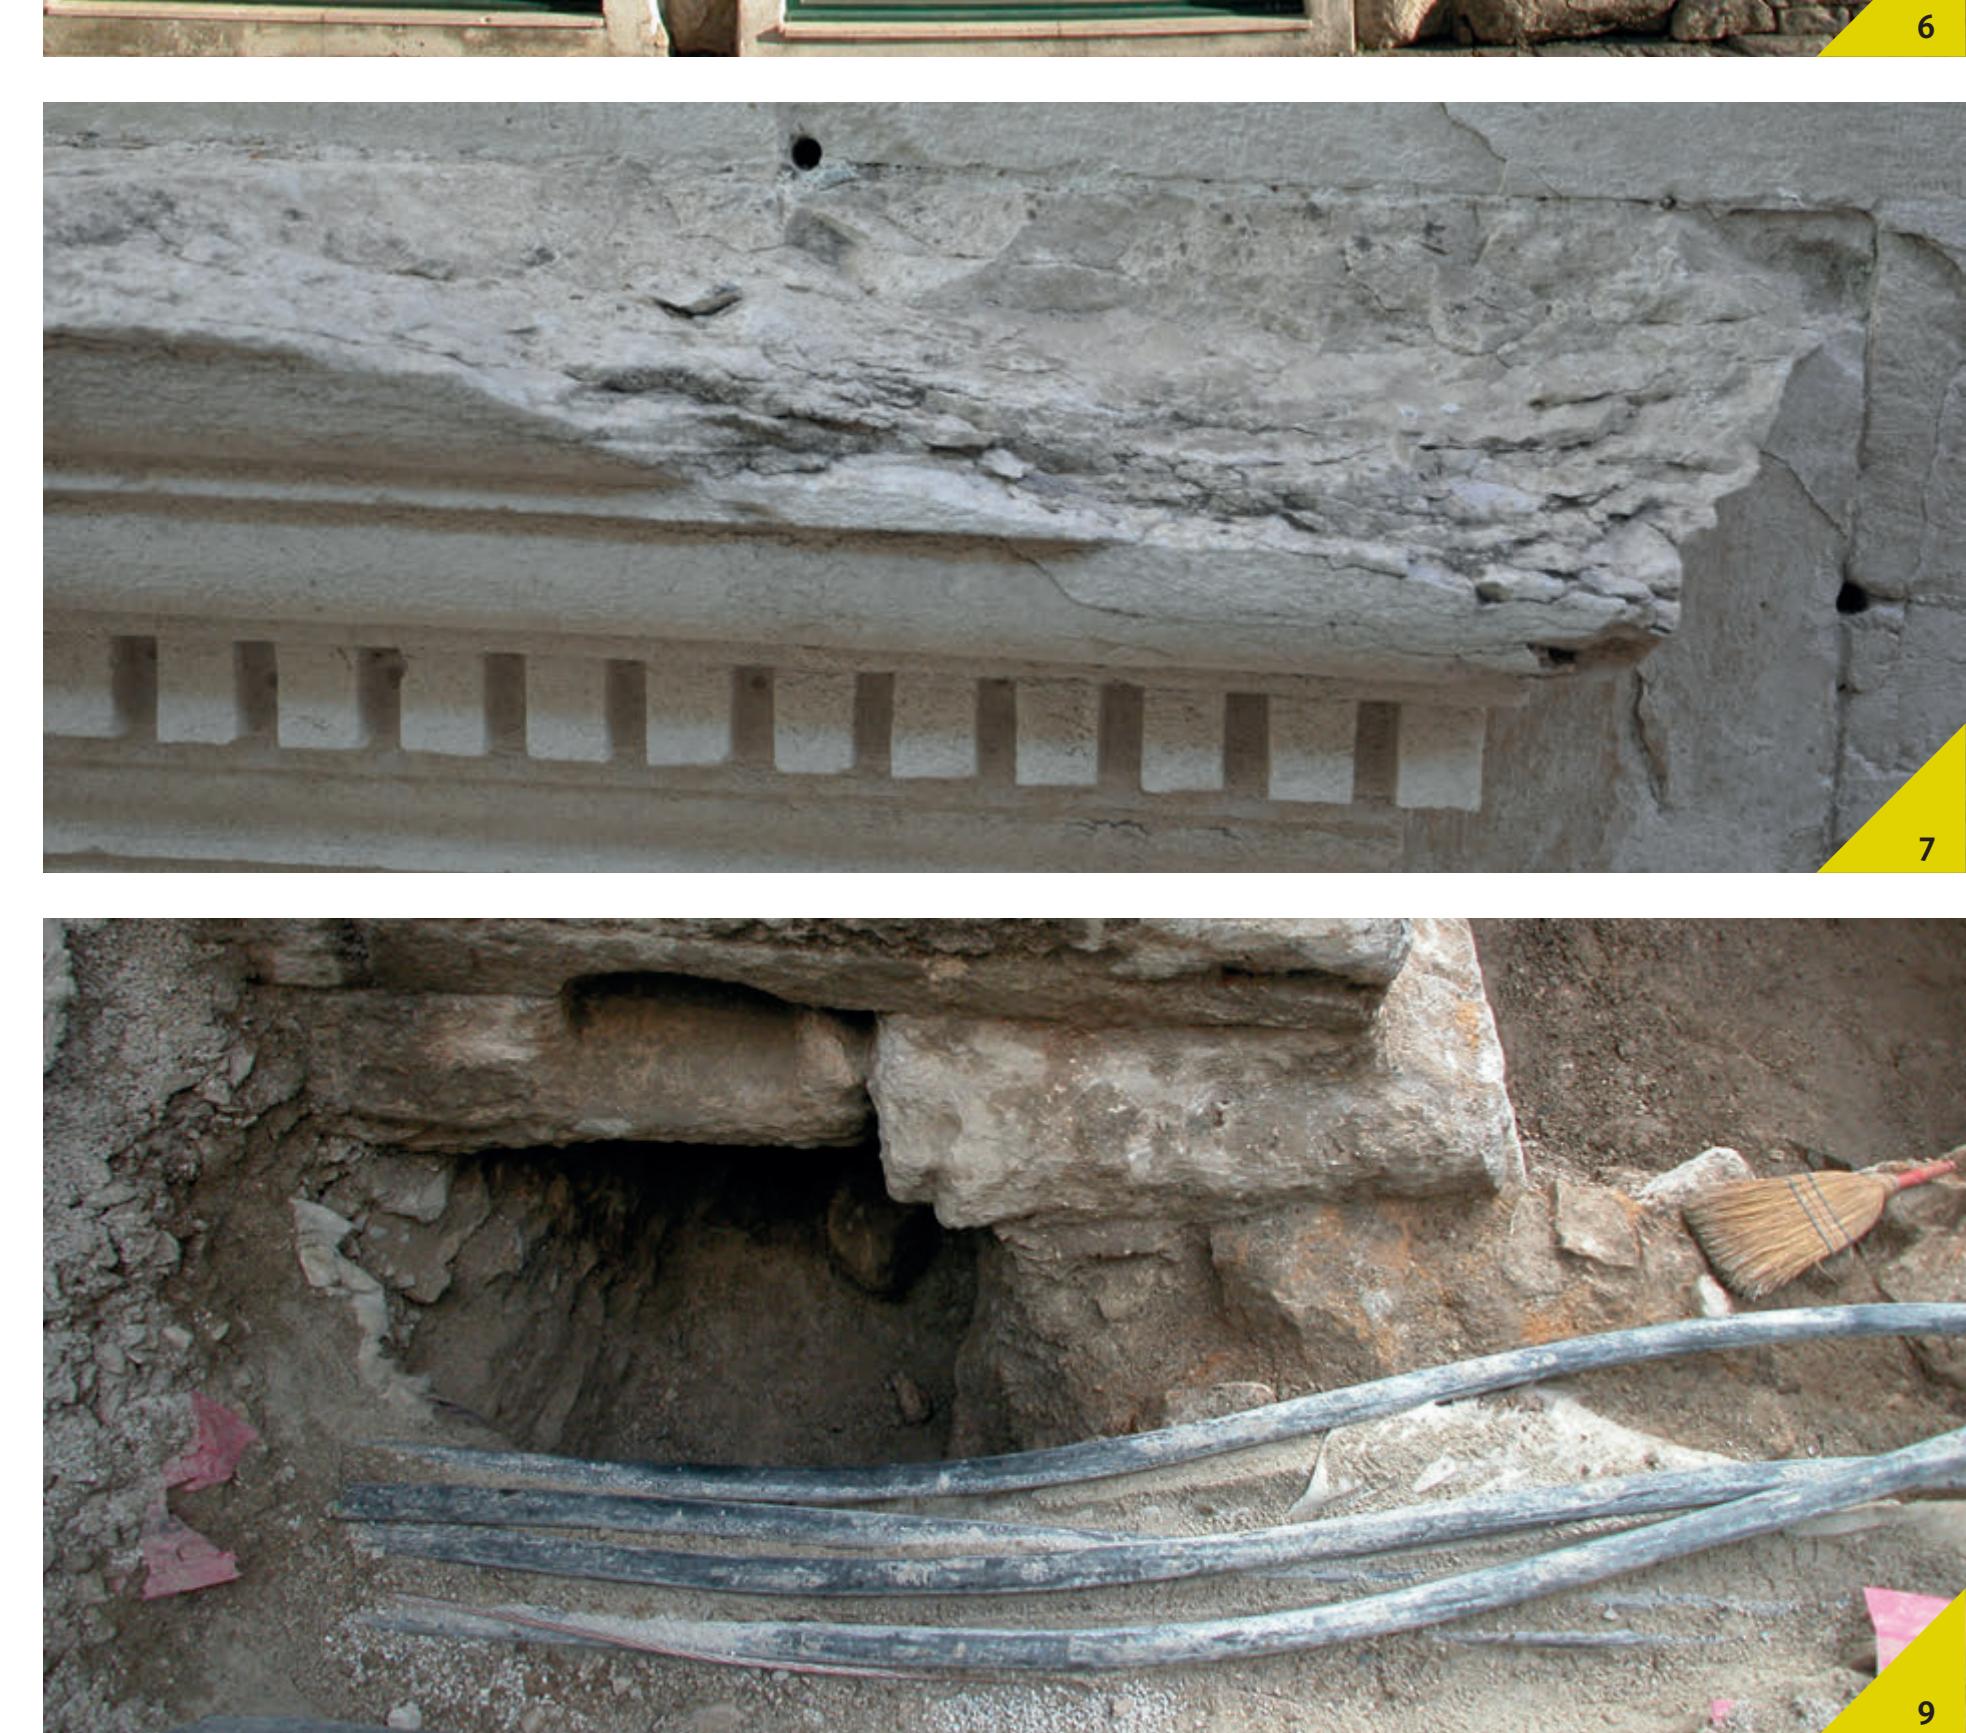
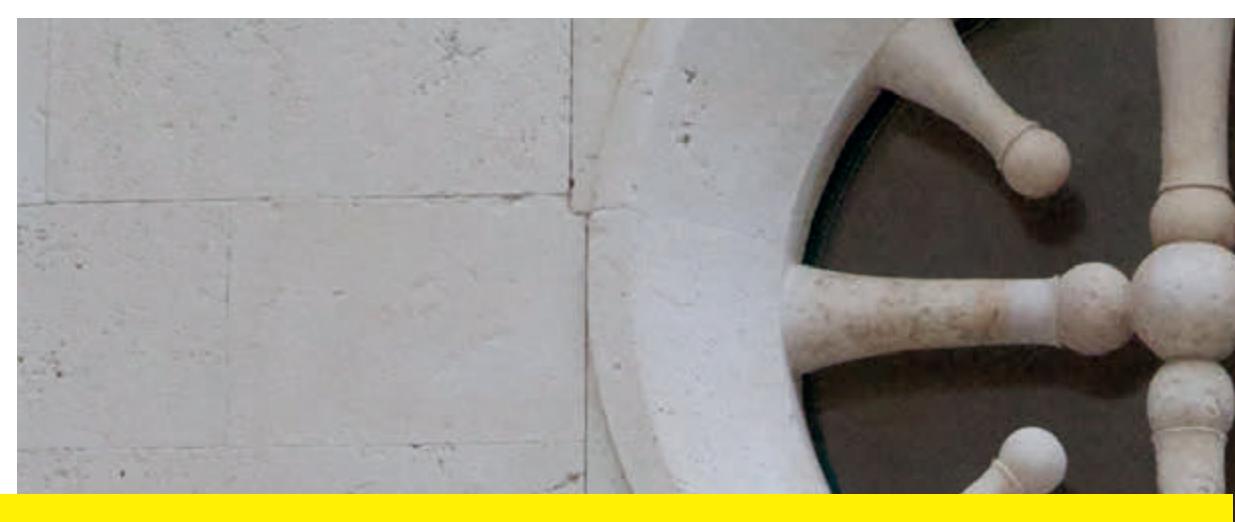
Series of damages of the main facade of the Church of St. Roch are concentrated in the area below the horizontal cornice. Causes of damage are manifold. Horizontal thrust of Roman arcades is transferred to the stone blocks of the facades that had originally been carved with slanted sides and installed without joints, so the exterior walls were overstrained and the stone was damaged mainly with vertical cracks. Bad foundations have added to the damages which was proven through geomechanical and archaeological research, as well as corrosion of iron bars (window), mechanical blows (transom above entrance) and weathering (protruding parts). Stone was soiled with black crusts that were found on the inner side of the bell-gable, indented parts of architectural elements and the whole rosette surface. Protruding parts exposed to rain were covered in biological growth. Side facades were also soiled with black incrustations while the rear facade was recently covered with mortar.

1. THE FIRST ARCH OF THE PORTICO OF THE ANCIENT DECMUMANUS; 2. THE FAÇADE OF THE CHURCH OF ST. ROCH; 3. VERTICAL CRACKING OF STONE ON THE FAÇADE OF THE CHURCH OF ST. ROCH; 4. ROSE WINDOW OF THE CHURCH OF ST. ROCH COVERED WITH BLACK CRUST; 5. DETAIL OF THE CHURCH OF ST. ROCH WITH A BLACK CRUST ON THE PARTS THAT ARE NOT WASHED BY RAIN; 6. THE SOUTH SIDE OF THE CHURCH OF ST. ROCH BEFORE CONSERVATION-RESTORATION WORK; 7. MECHANICAL DAMAGE TO THE PORTAL OF ST. ROCH; 8. TRACES OF ROMANESQUE WINDOWS WERE FOUND ON THE ARHITRAVES OF THE DECMUMANUS PORTICO; 9. FOUNDATIONS AT THE NORTHWEST CORNER OF THE CHURCH OF ST. ROCH

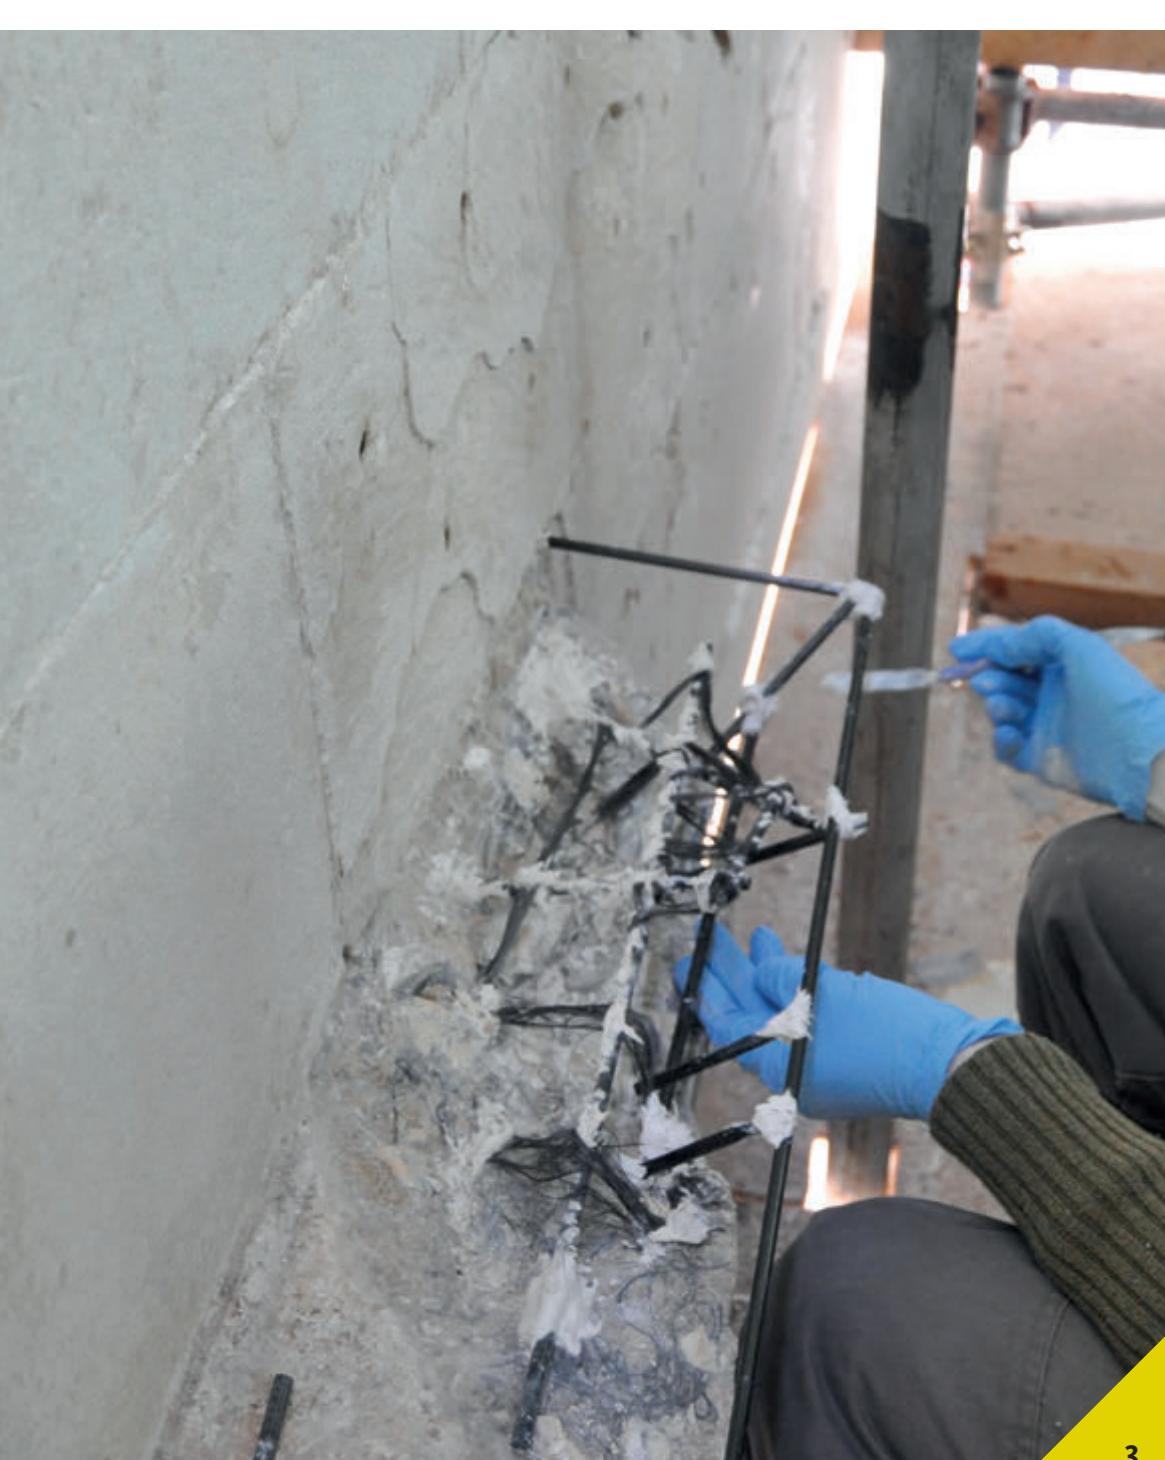
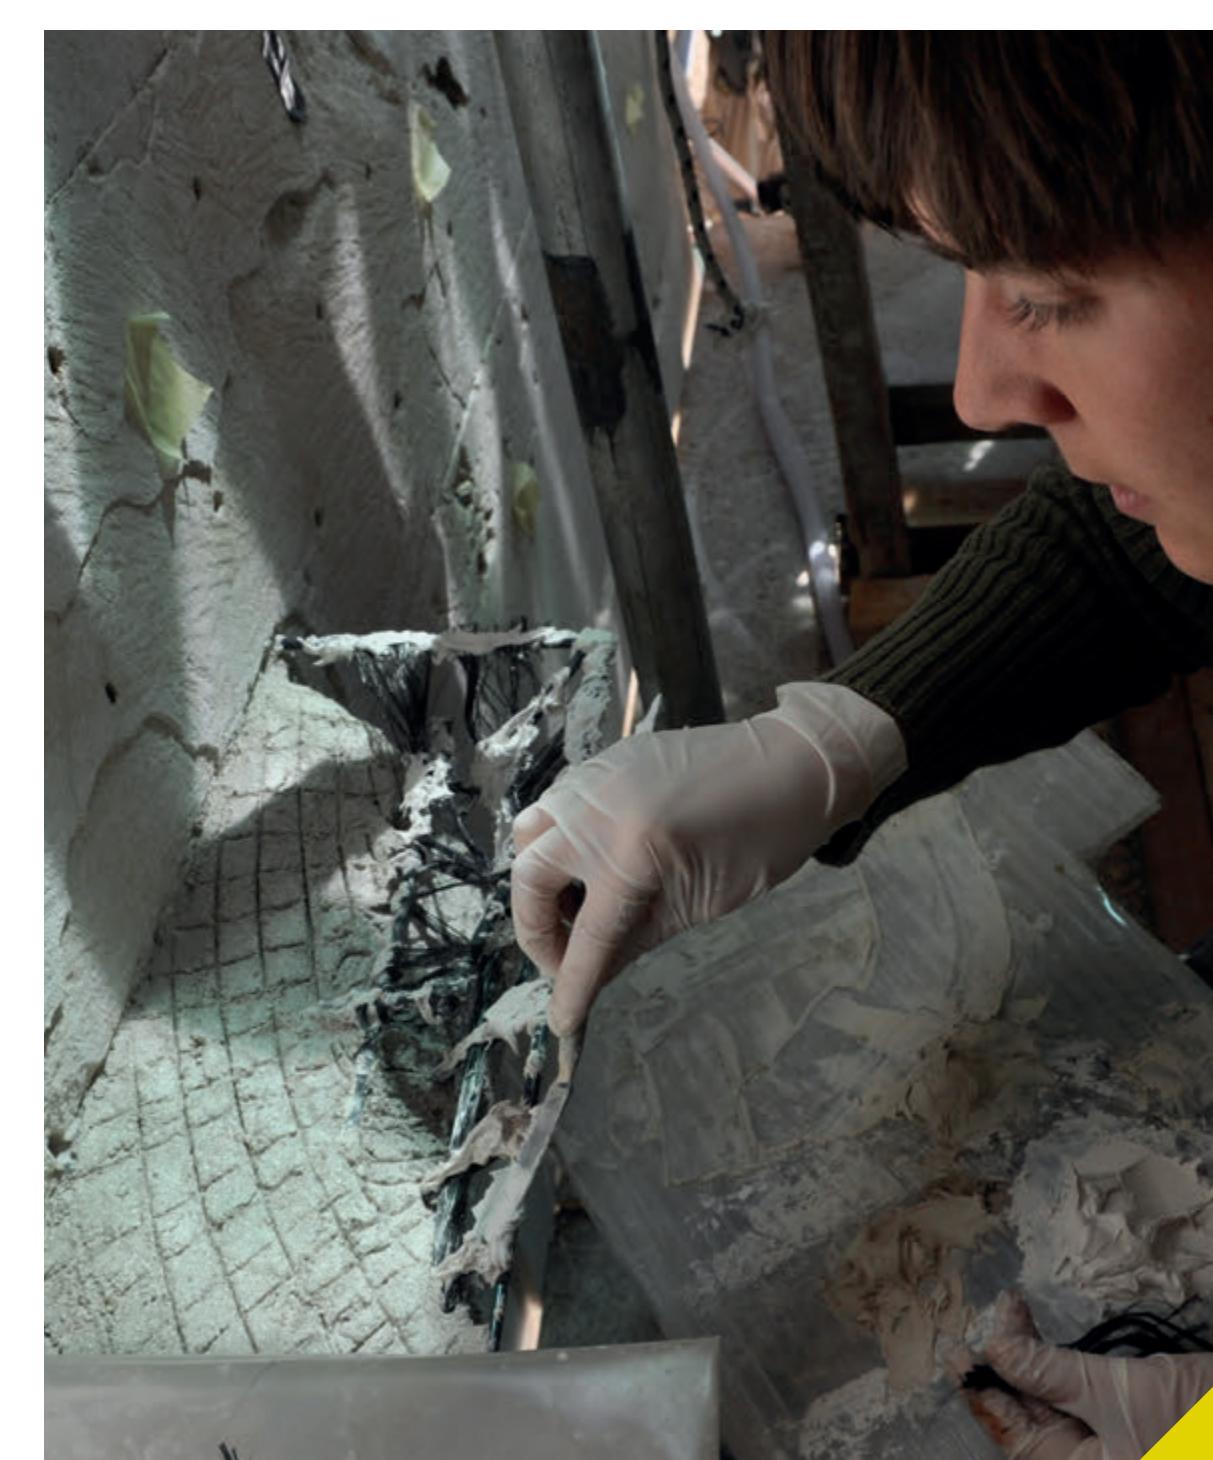
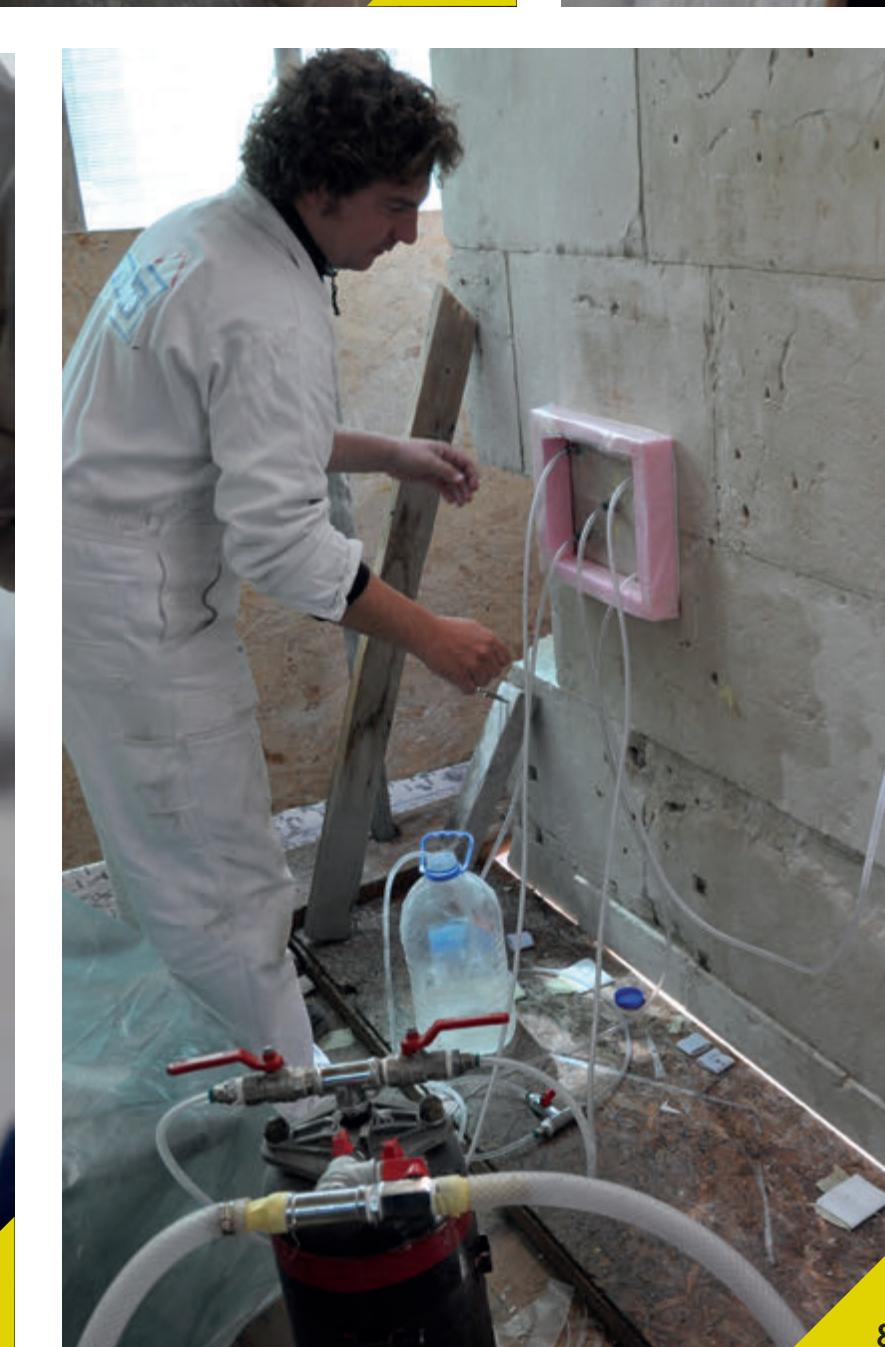
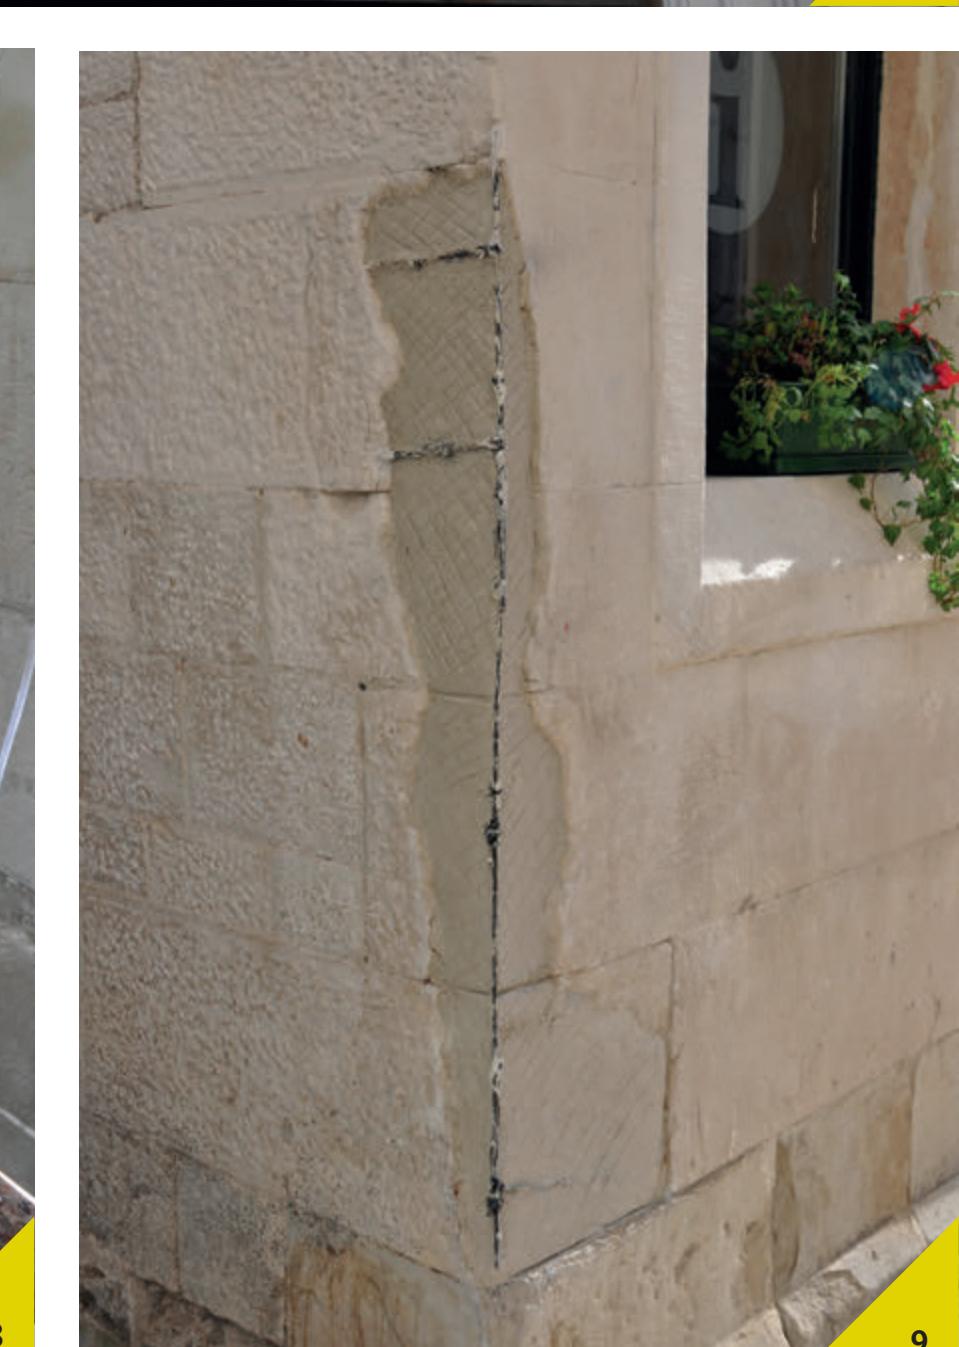
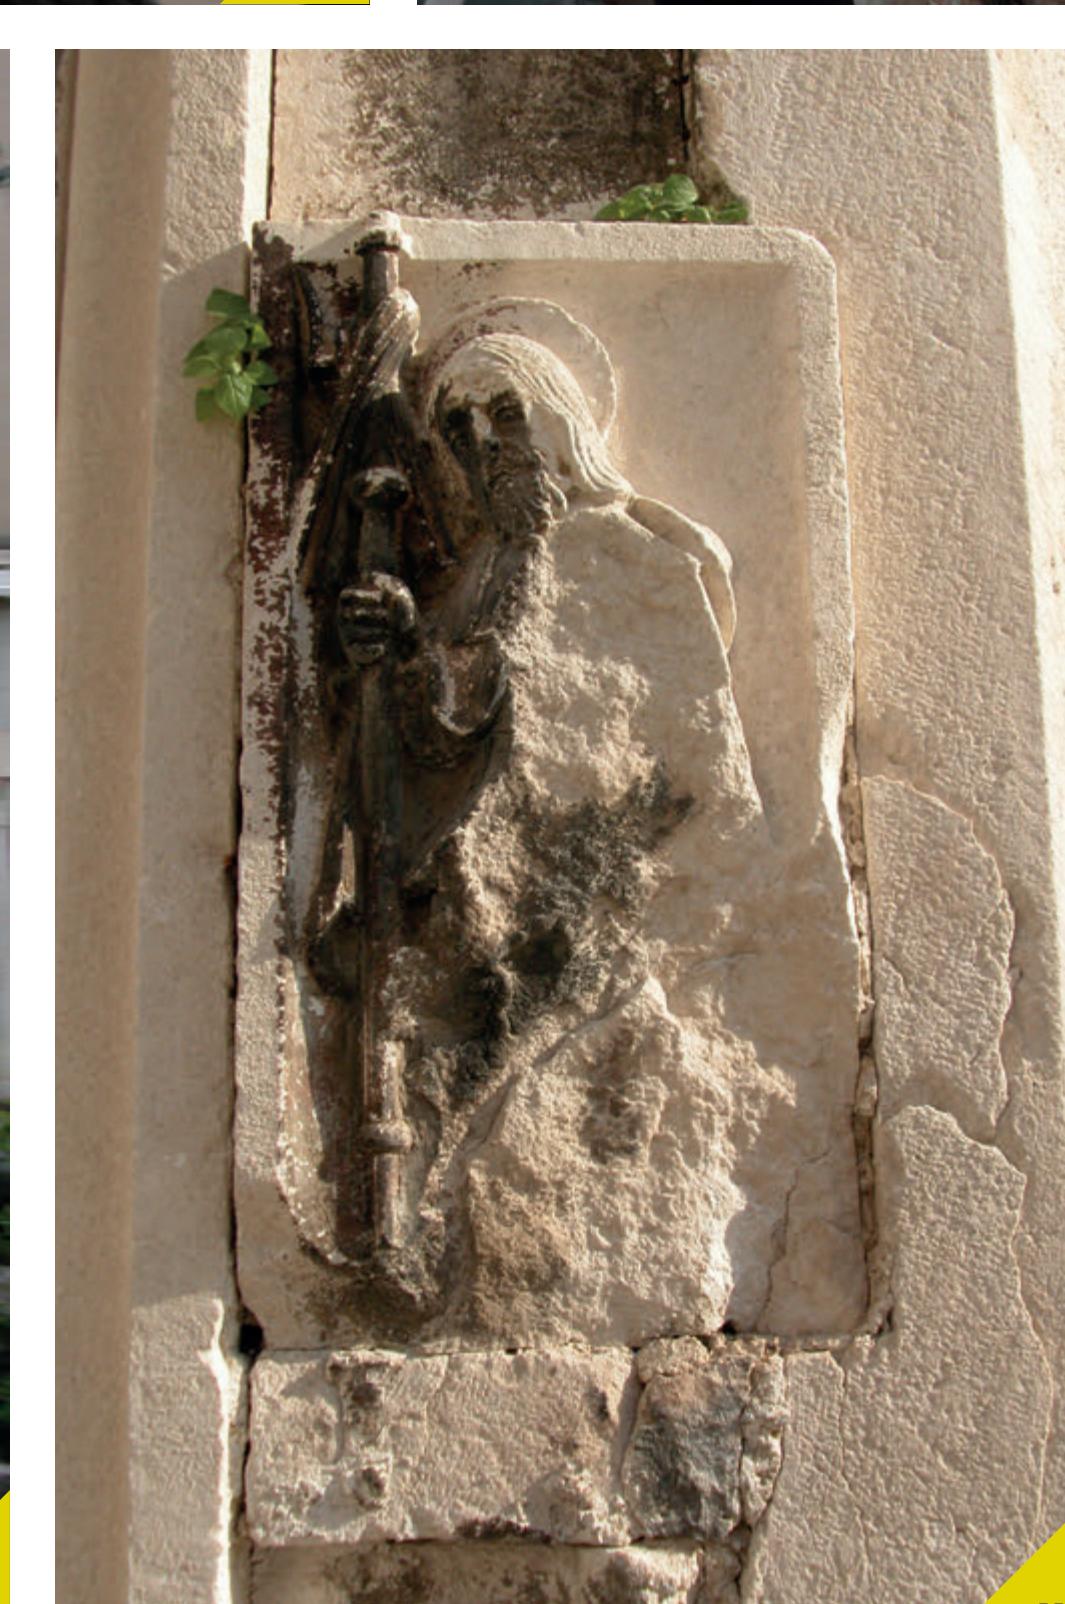
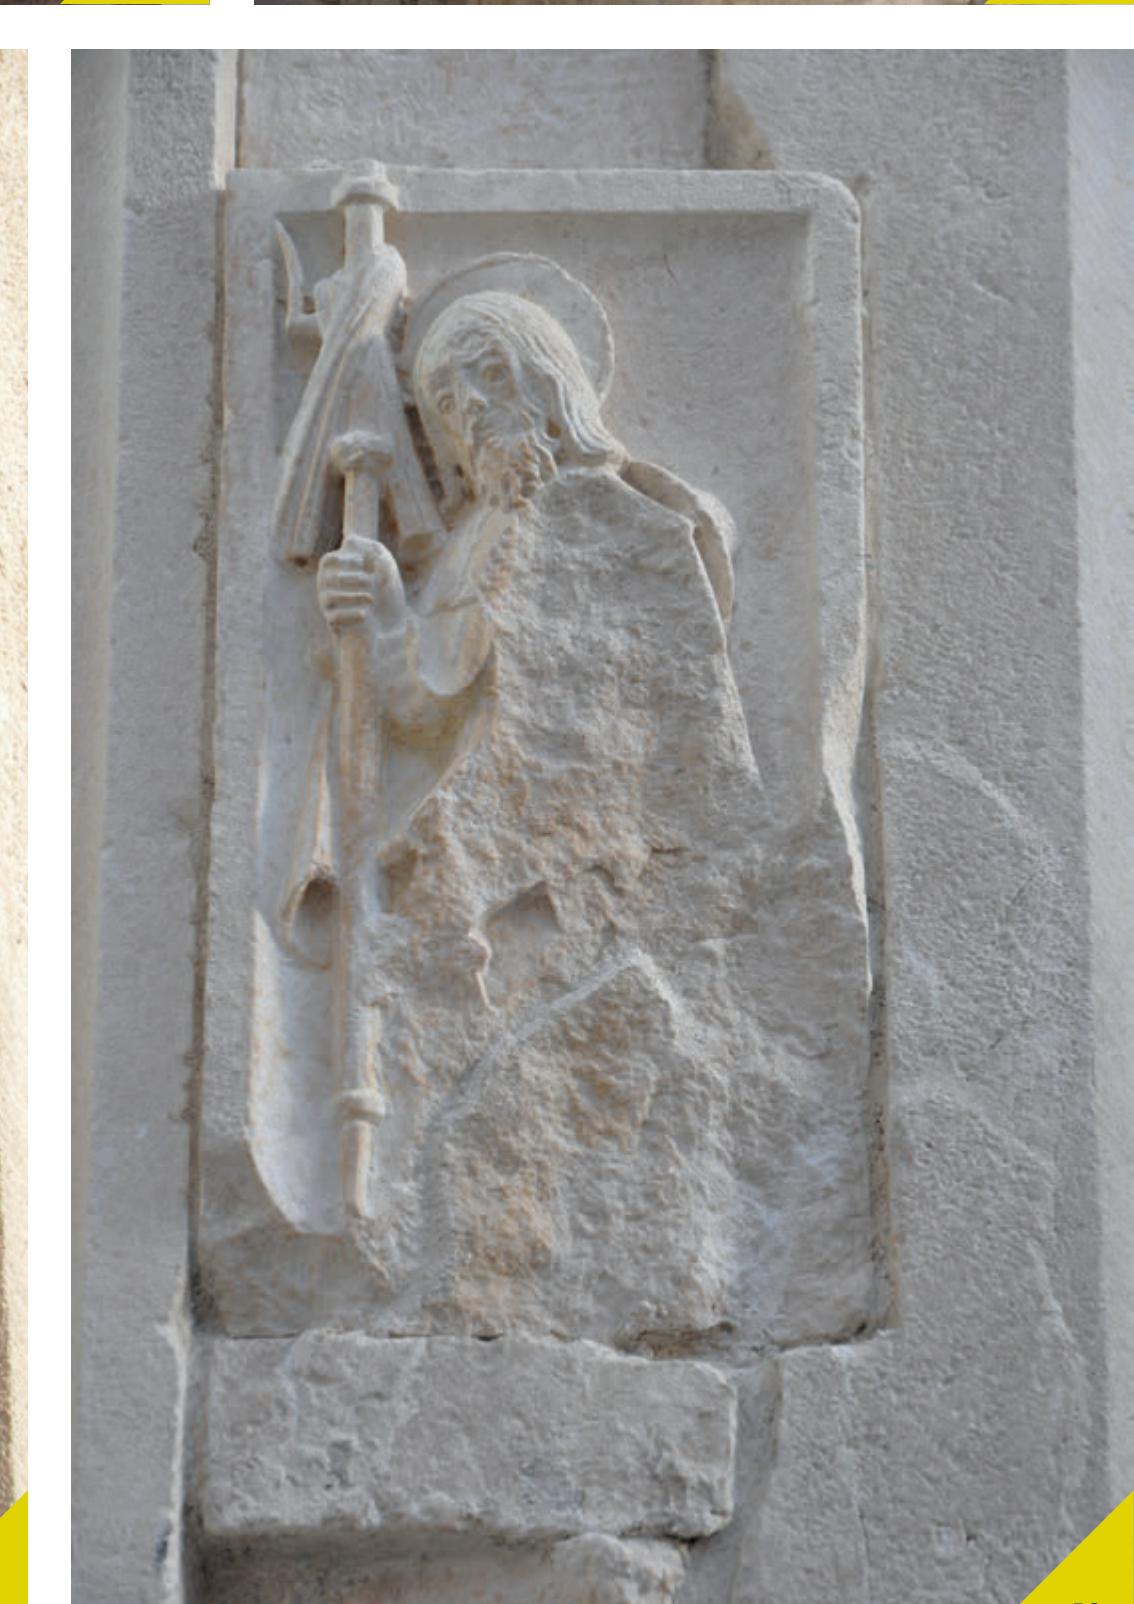
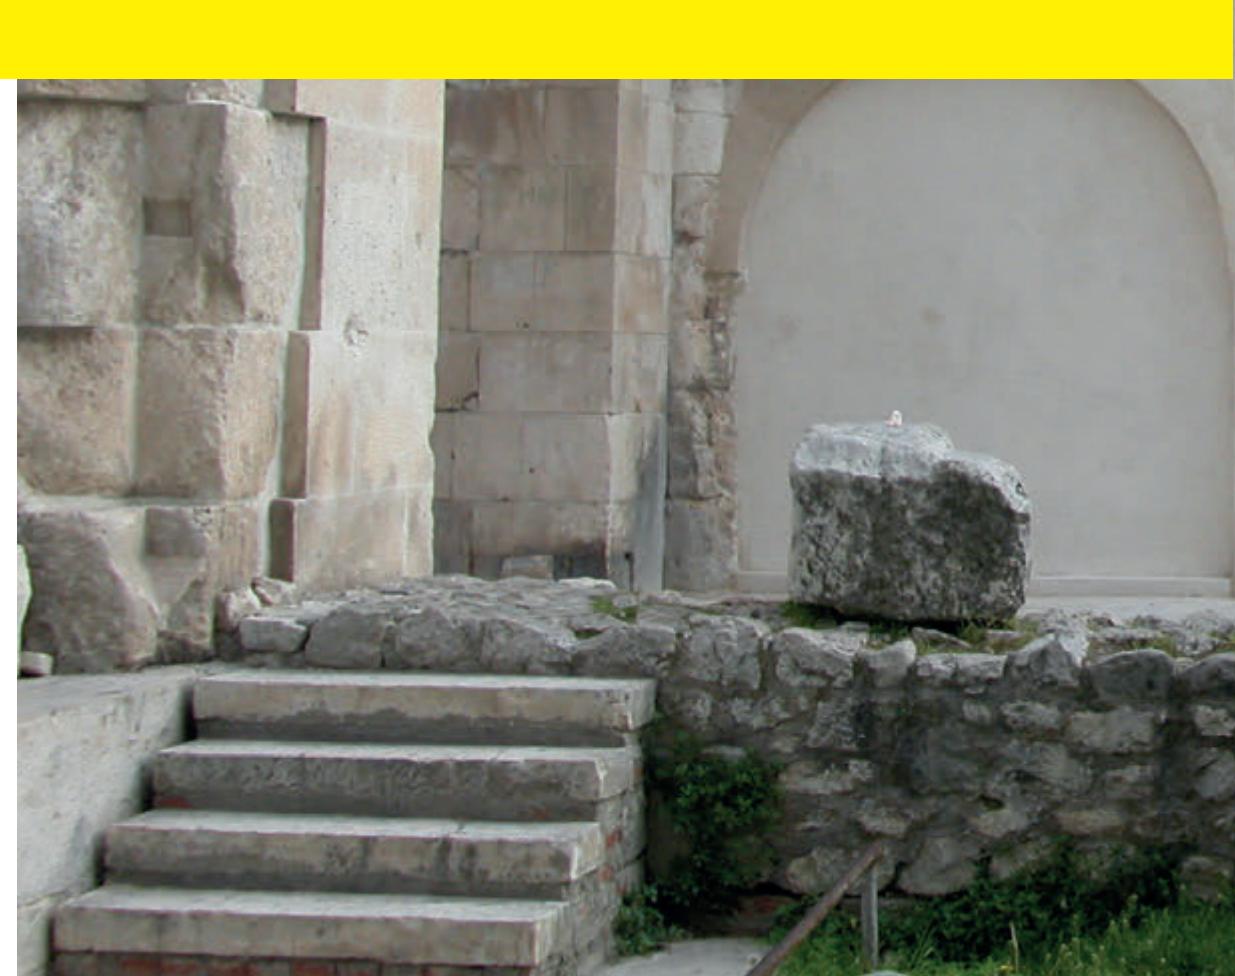
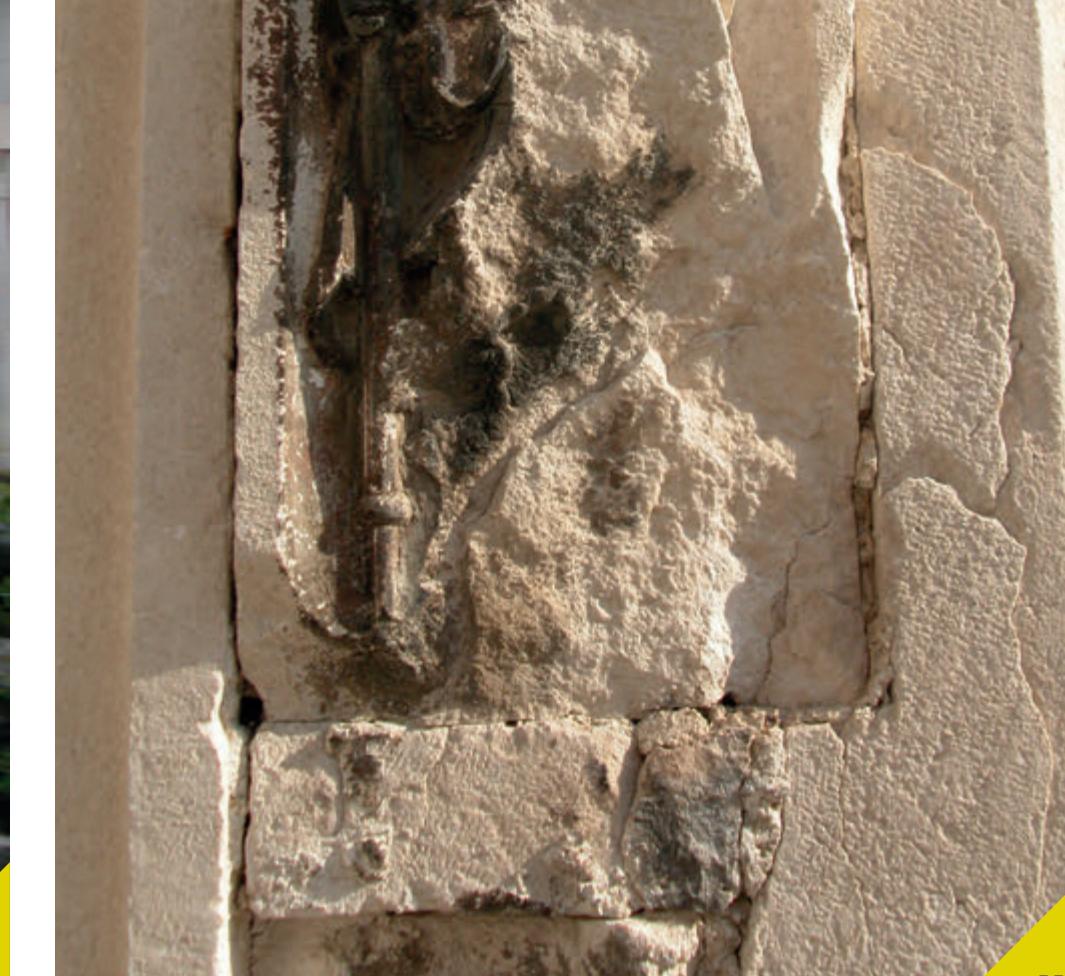
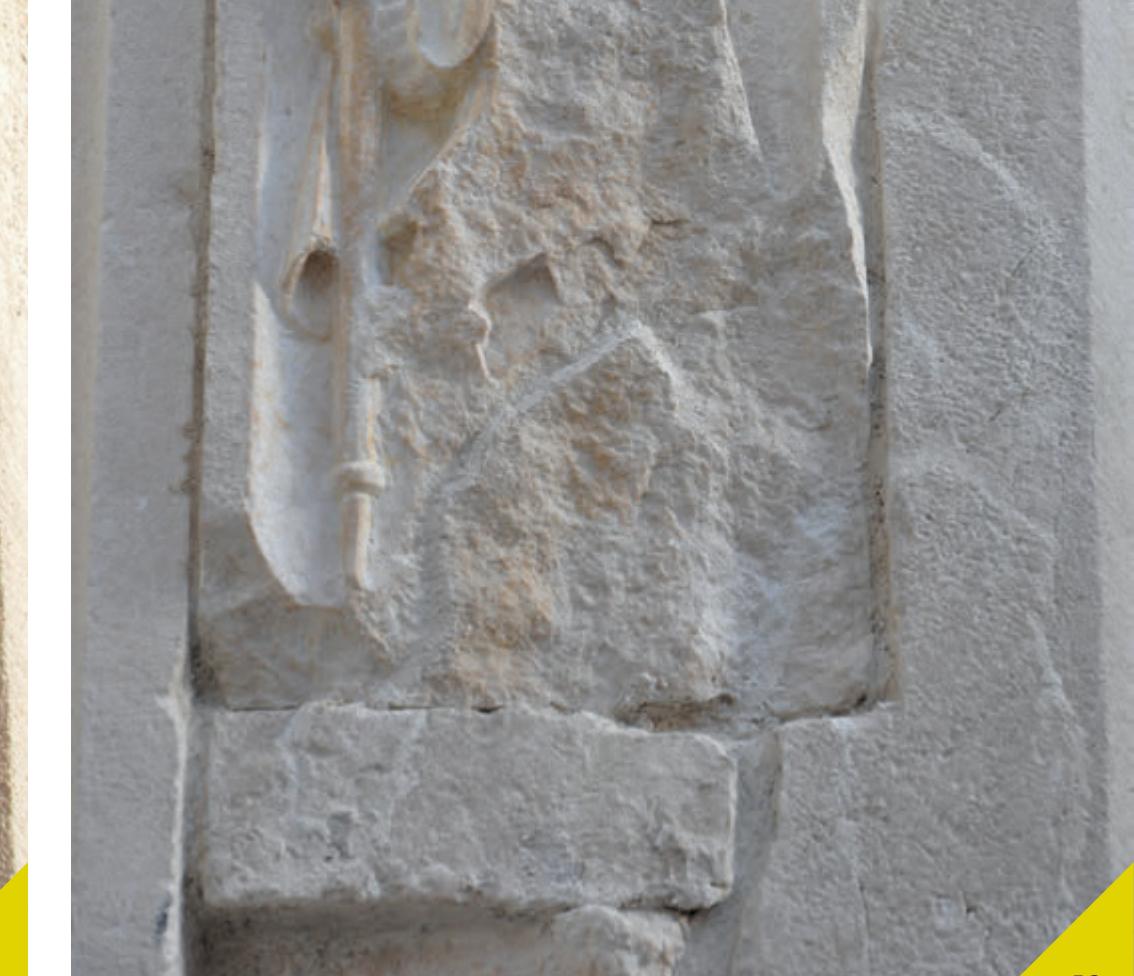
1. PROCESSING STONE BLOCK SO THAT IT FITS INTO THE FACADE OF THE CHURCH OF ST. ROCH; 2. THE FACADE OF THE CHURCH OF ST. ROCH AFTER CONSERVATION AND RESTORATION WORK; 3, 4. DURING THE RECONSTRUCTION OF THE CORNICE OF THE PORTAL OF ST. ROCH; 5, 6. WREATH OF THE PORTAL OF ST. ROCH BEFORE AND AFTER CONSERVATION-RESTORATION WORK; 7. INJECTING EPOXY RESIN AND CARBON CLAMPS IN VERTICALLY FRACTURED STONE IN ORDER TO STRENGTHEN IT; 8. THE FACADE OF THE CHURCH OF ST. ROCH DURING CONSOLIDATION OF STONE WITH VACUUM METHOD; 9. RECONSTRUCTION ON THE FACADE OF THE CHURCH OF ST. ROCH; 10. THE SOUTH SIDE OF THE CHURCH OF ST. ROCH AFTER CONSERVATION-RESTORATION WORK; 11, 12. RELIEF OF ST. ROCH ON THE FACADE OF THE CHURCH BEFORE AND AFTER THE CONSERVATION-RESTORATION WORK

Rehabilitation of construction of the Church of St. Roch started with the removal of cover and repair of the upper part of the vault. Edges were, together with longitudinal cornices, reinforced with carbon straps. The same method was used on the interior side of the west façade. Cavities in the wall of the west façade were injected with lime-based mixture, so that the thread concentrated on the outer layer would be evenly transferred throughout the wall. Severely damaged stone blocks were replaced with new ones and smaller damages were reconstructed with the mixture of artificial stone. The same method was used for the missing part of the cornice over the entrance. Damages and cracks of the main façade were repaired with carbon clasps and epoxy glue. Major part of stone blocks was reinforced with consolidants, further enhanced by surface vacuum molding. Old cement joints were replaced by new ones made of acrylic-lime mortar. Biological colonization was removed using chemical and mechanical methods and black incrustations were cleaned by laser. Future water absorption in the construction was prevented with installation of new roof cover of channel tiles, and with covering the critical areas of connection of walls and a roof and the upper part of the pediment with lead sheeting. Damaged and hardly recognizable Roman capital belonging to the corner pillar of the decumanus porch, for the most part hidden by the south wall of the church, was reconstructed after the well-preserved capital of the pillar situated in the neighbouring bank.

Interior was redecorated in accordance with conservation demands. Tombs found under the recent floor have been conserved and protected with a new stone pavement. Stone imposts and cornices on the walls have been reconstructed, wide arch openings in the south wall have been walled-up and old mortar was replaced with a new acrylic-lime mortar.

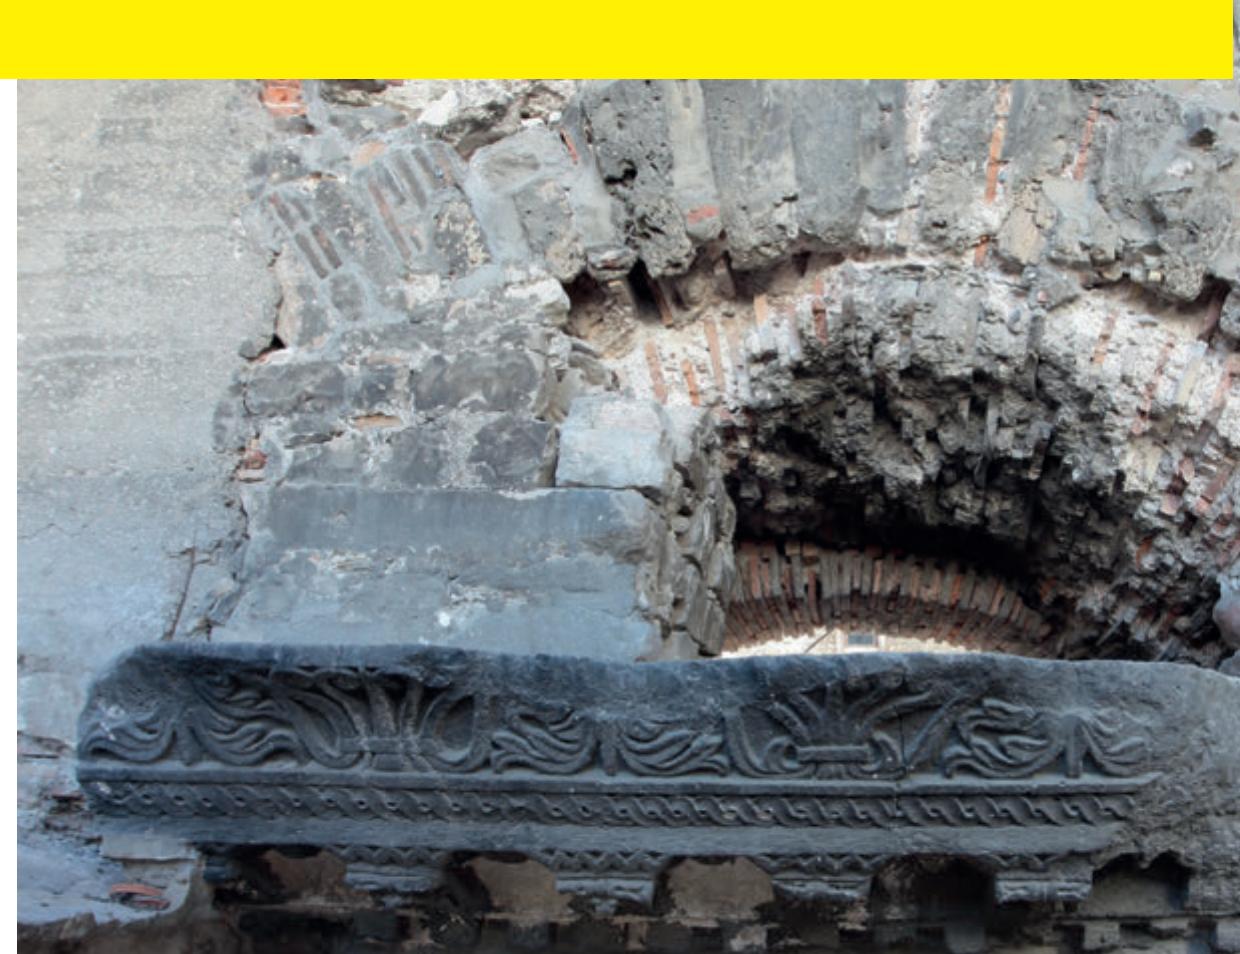
1. PROTHYRON GABLE, CONDITION BEFORE RESTORATION; 2. PART OF THE STONE ARCH DAMAGED BY STRUCTURAL MOVEMENT; 3. THE MOST DAMAGED CAPITAL; 4. DETAIL OF CORNICE BEFORE RESTORATION; 5. CONTAMINATION CAUSED BY BIRDS' DROPPINGS; 6, 7, 8. RELIEVING ARCH ABOVE THE VESTIBULE PORTAL, CONDITION BEFORE, DURING AND AFTER RESTORATION
