## Na završetku desetljeća obnove Peristila

## At the end of a Decade of the Peristyle Restoration

The conservation and restoration work on the Peristyle of Diocletian's Palace has been in many ways the most important project in recent period within the scope of renovation of the historical core of the town of Split. The Peristyle is the centre and the most impressive part of the imperial palace, and also the heart of the town which has grown around it. The square, which reflects historical layers of the creation and development of the town, has become its symbol and its main tourist attraction. It serves as the most attractive backdrop for cultural events, and a stage at which public life evolves.

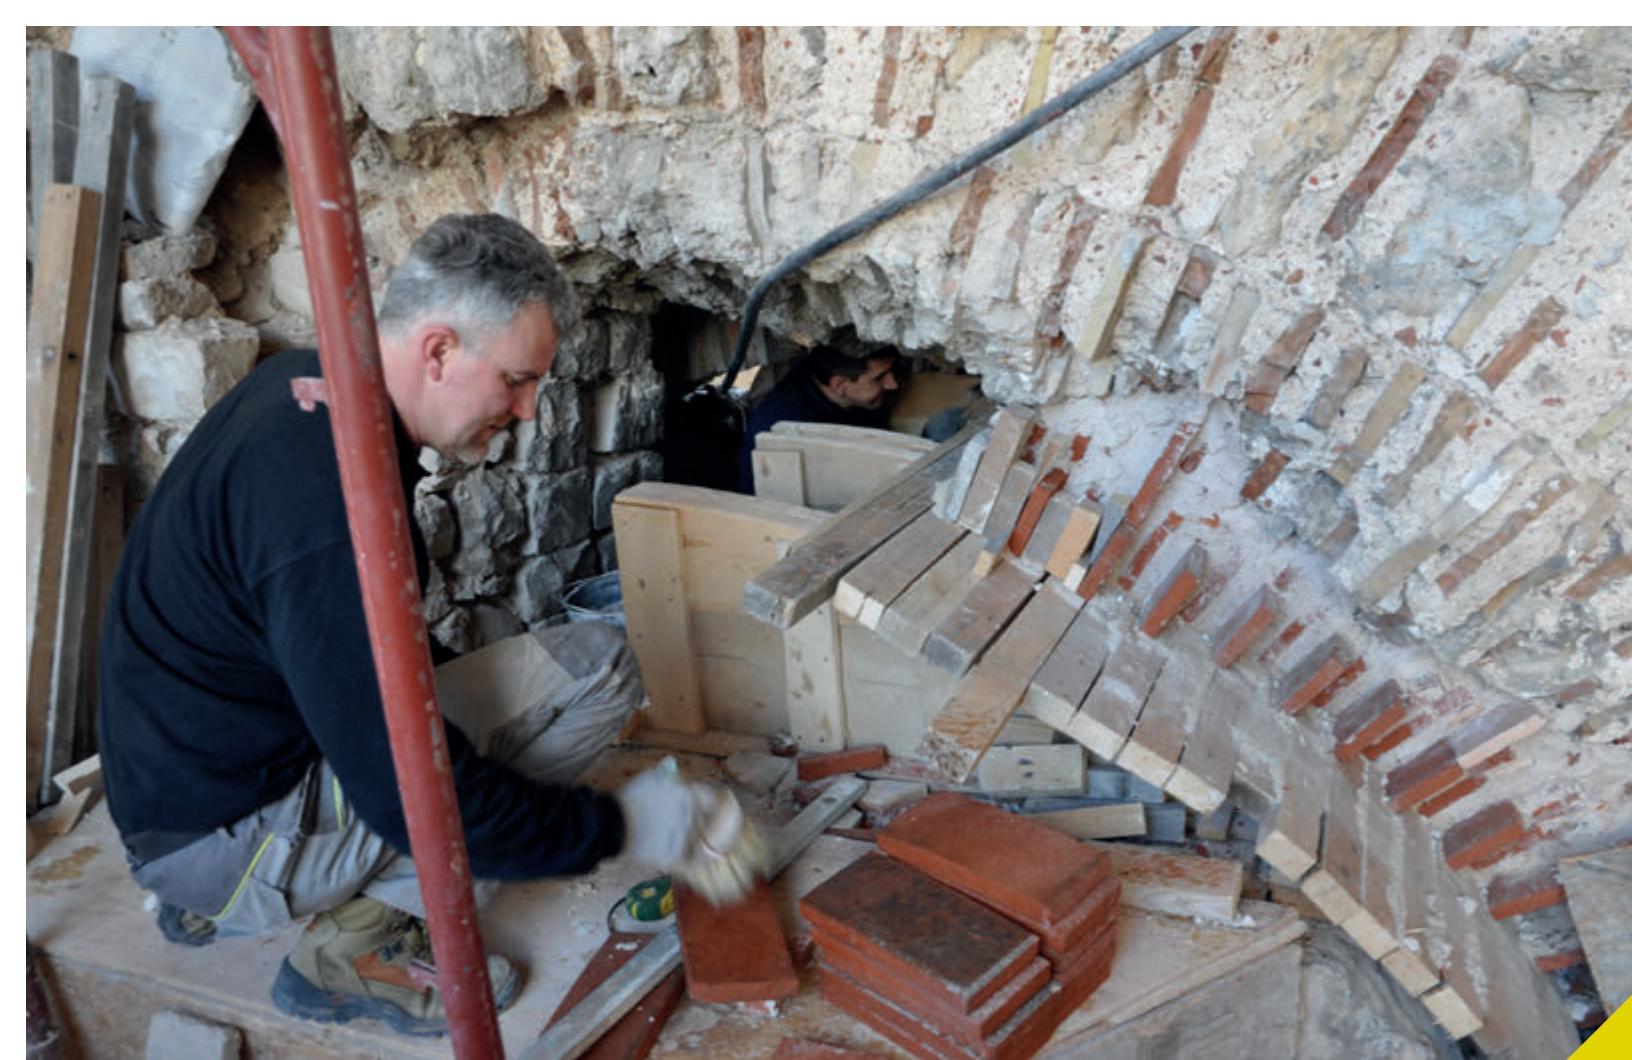
1. PROTHYRON GABLE, CONDITION BEFORE RESTORATION; 2. PART OF THE STONE ARCH DAMAGED BY STRUCTURAL MOVEMENT; 3. THE MOST DAMAGED CAPITAL; 4. DETAIL OF CORNICE BEFORE RESTORATION; 5. CONTAMINATION CAUSED BY BIRDS' DROPPINGS; 6, 7, 8. RELIEVING ARCH ABOVE THE VESTIBULE PORTAL, CONDITION BEFORE, DURING AND AFTER RESTORATION

Deformations of construction have caused Prothyron columns to tilt sideways and towards front, and created severe structural damages (cracks) on three out of four Corinthian capitals, on the lintel of the Vestibule entrance and on the supporting arch above it. Damages on the outer side of the Prothyron have been increased by crystallization of harmful soluble salts, by weathering and biological colonization. Black crusts were formed in all indented areas and were exceptionally thick on the inside of a central arch, lintels and capitals. They were found on the north front of the Vestibule and on stone decoration of the portal. The inner side of the Prothyron pediment was not covered in black crust, but stones were extremely soiled with bird droppings. Layers of cement were found on large surfaces; upper surface of the cornice and column bases. Joints of the north Vestibule wall and damages on its arch were treated with cement.

To stop or at least slow down further deformation of Prothyron construction, non-invasive interventions were conducted that have greatly reclaimed stability. After the computer model analysis had shown that it was inevitable to connect the pediment to the firm body of the Vestibule, it was decided to replace the roof of the Prothyron that has unjustifiably (exclusively with the attention of partial and questionable reconstruction of the original state) been installed in mid-20th century with a new one, but this time to use it to consolidate the whole system of construction. Threefold wooden revetment was strongly bound to wooden roof beams that were anchored to the stone pediment structure on one side, and to the massive north wall of the Vestibule on the other. Old metal anchors were no longer actively connecting the pediment wall on two levels, and were replaced with new ones. Copper clasps that were used in the early 20th century to connect stone blocks of the pediment on its inner and outer side to prevent joints from opening up were not removed, because the surveys have shown that they were still active. All the joints on the pediment were injected, especially the ones connecting the capitals to the columns and lintels, so that the edges of stone blocks could be relieved of thrust that is concentrated in those areas due to the shifts in construction. All remaining walls of Prothyron and Vestibule were also injected. A large supporting arch built of brick and tuff placed over the portal leading from Prothyron to Vestibule was heavily damaged and was, maybe as early as during the Middle Ages, supported with stone blocks in mortar. That is how the weight of the wall above the arch was transferred to the stone lintel over the portal that has broken. For this reason it was necessary to reconstruct the supporting arch. Bricks of original Roman shape and blocks of tuff were used.

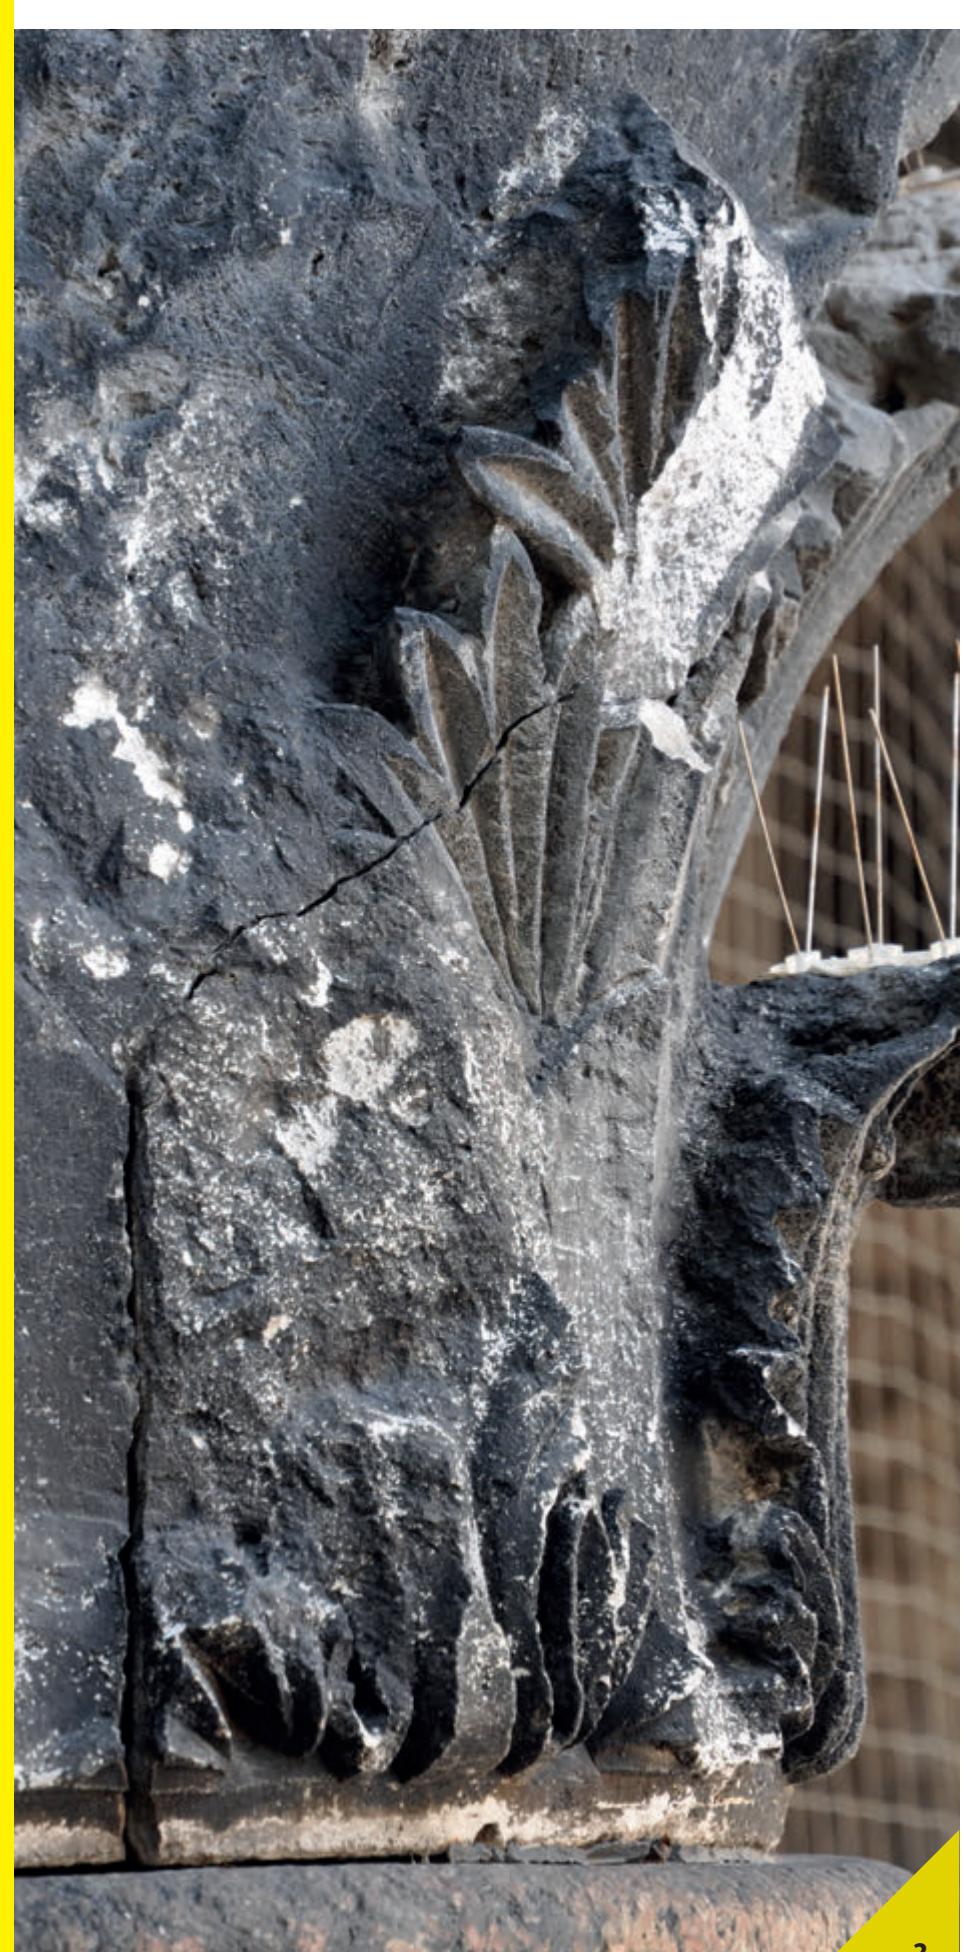
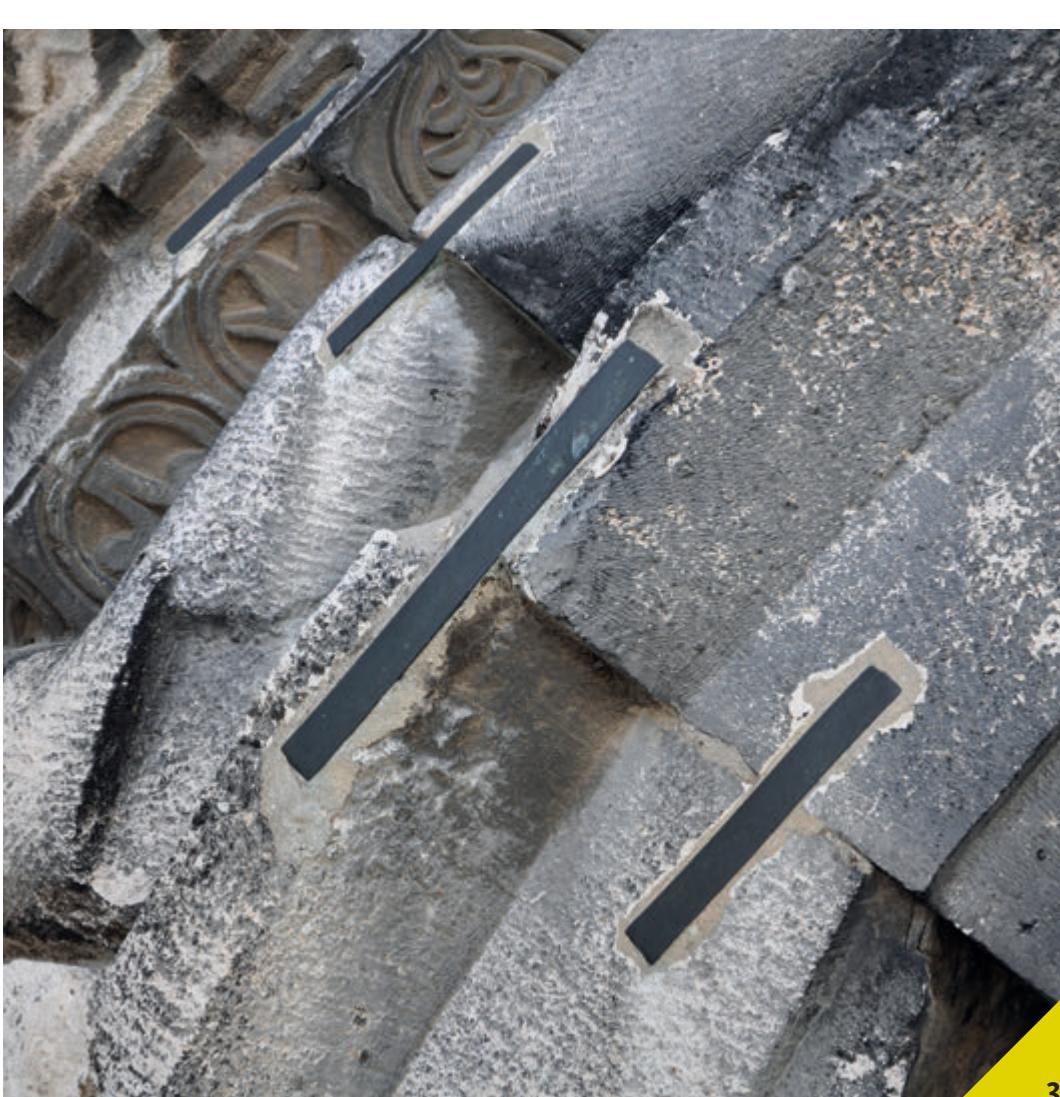
1. PROTHYRON ARCH BEFORE RESTORATION; 2. STONE CRACKS CAUSED BY STRUCTURAL MOVEMENT; 3. COPPER CLAMPS HOLDING STONE ELEMENTS OF THE PROTHYRON TOGETHER; 4. A CAPITAL COVERED WITH BLACK CRUSTS AND BIRD'S DROPPINGS; 5. BACK SIDE OF THE GABLE WITH OLD COPPER TIES; 6. STRUCTURAL STABILIZATION USING ROOF BEAMS; 7, 8. ROOF CONSTRUCTION WORKS; 9. THE NEW STAINLESS STEEL TIE IN THE INTERIOR OF THE PROTHYRON, DETAIL; 10. THE VESTIBULE WALL, TO WHICH THE PROTHYRON GABLE WAS TIED; 11. NEW TIES AND THE NEW ROOF

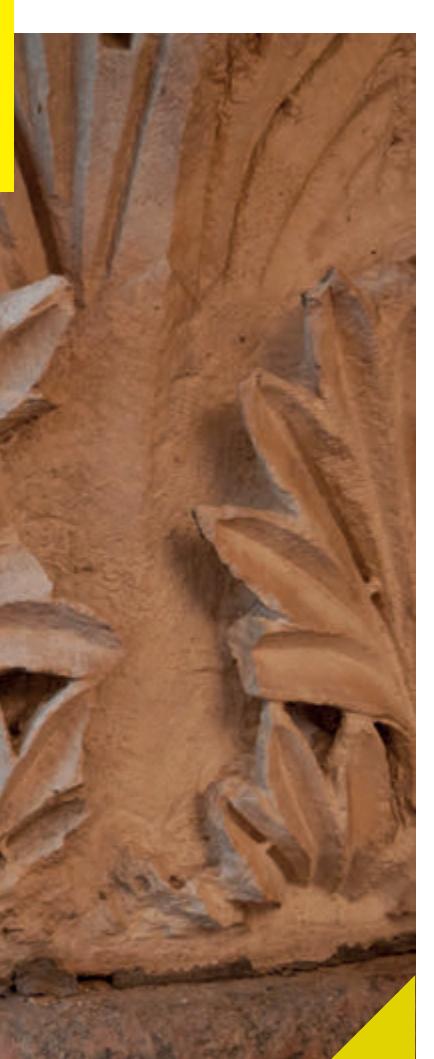
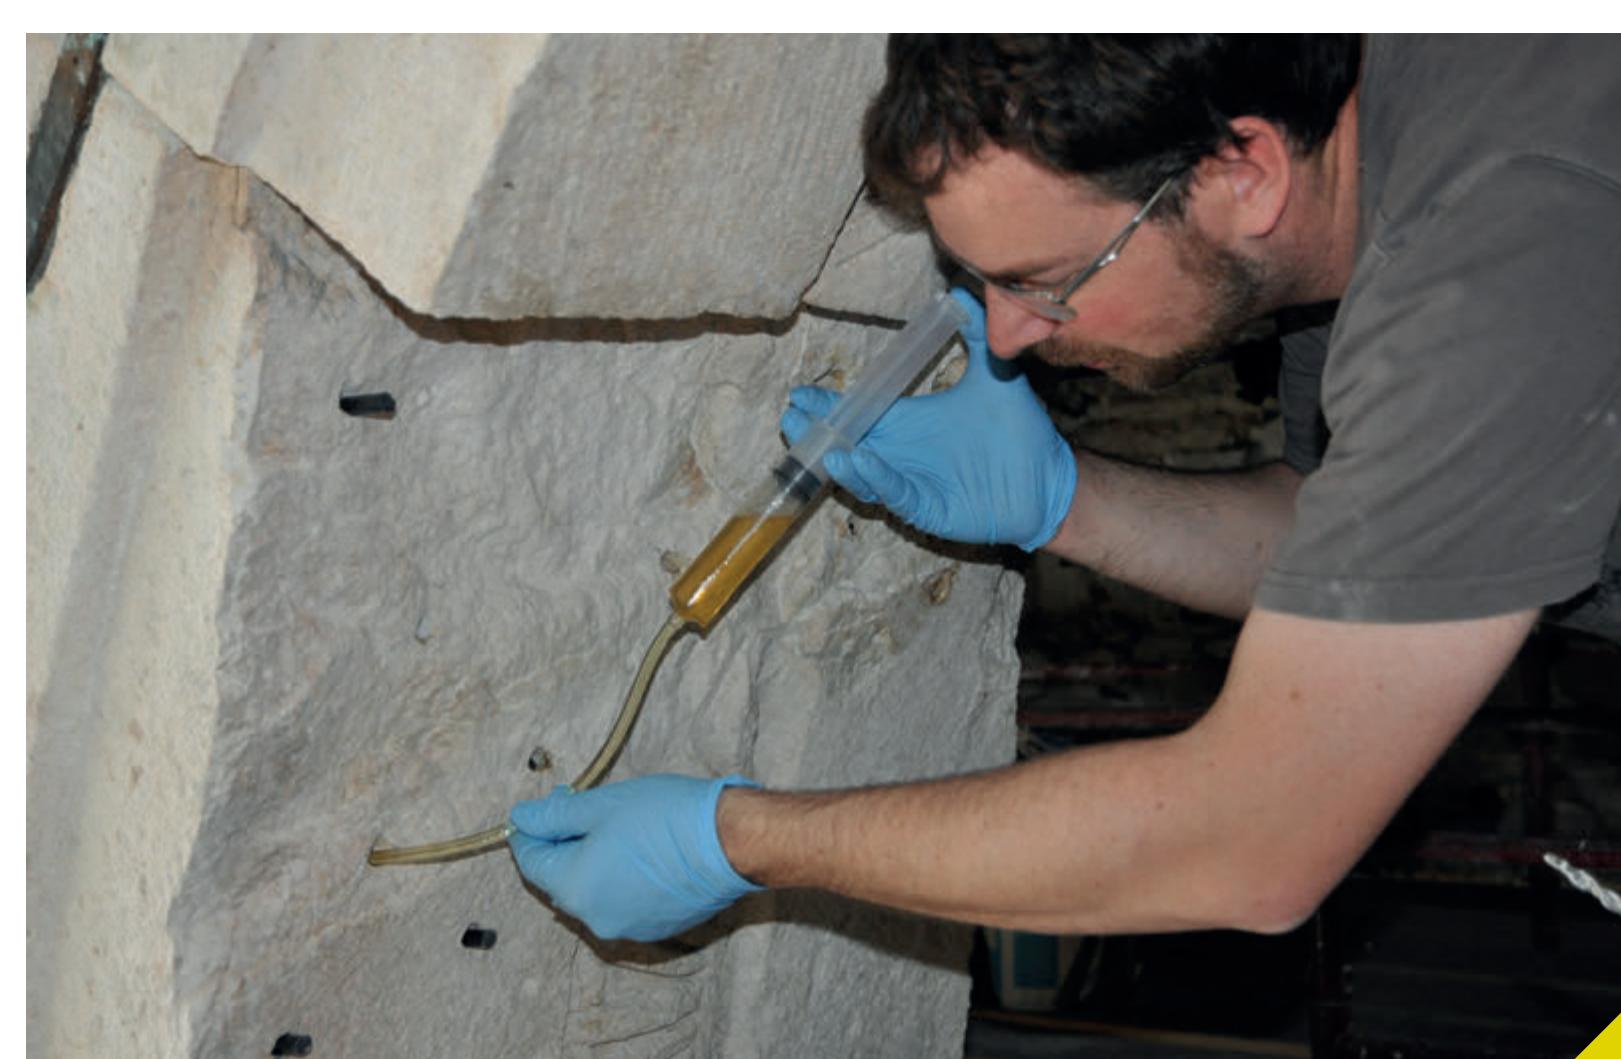
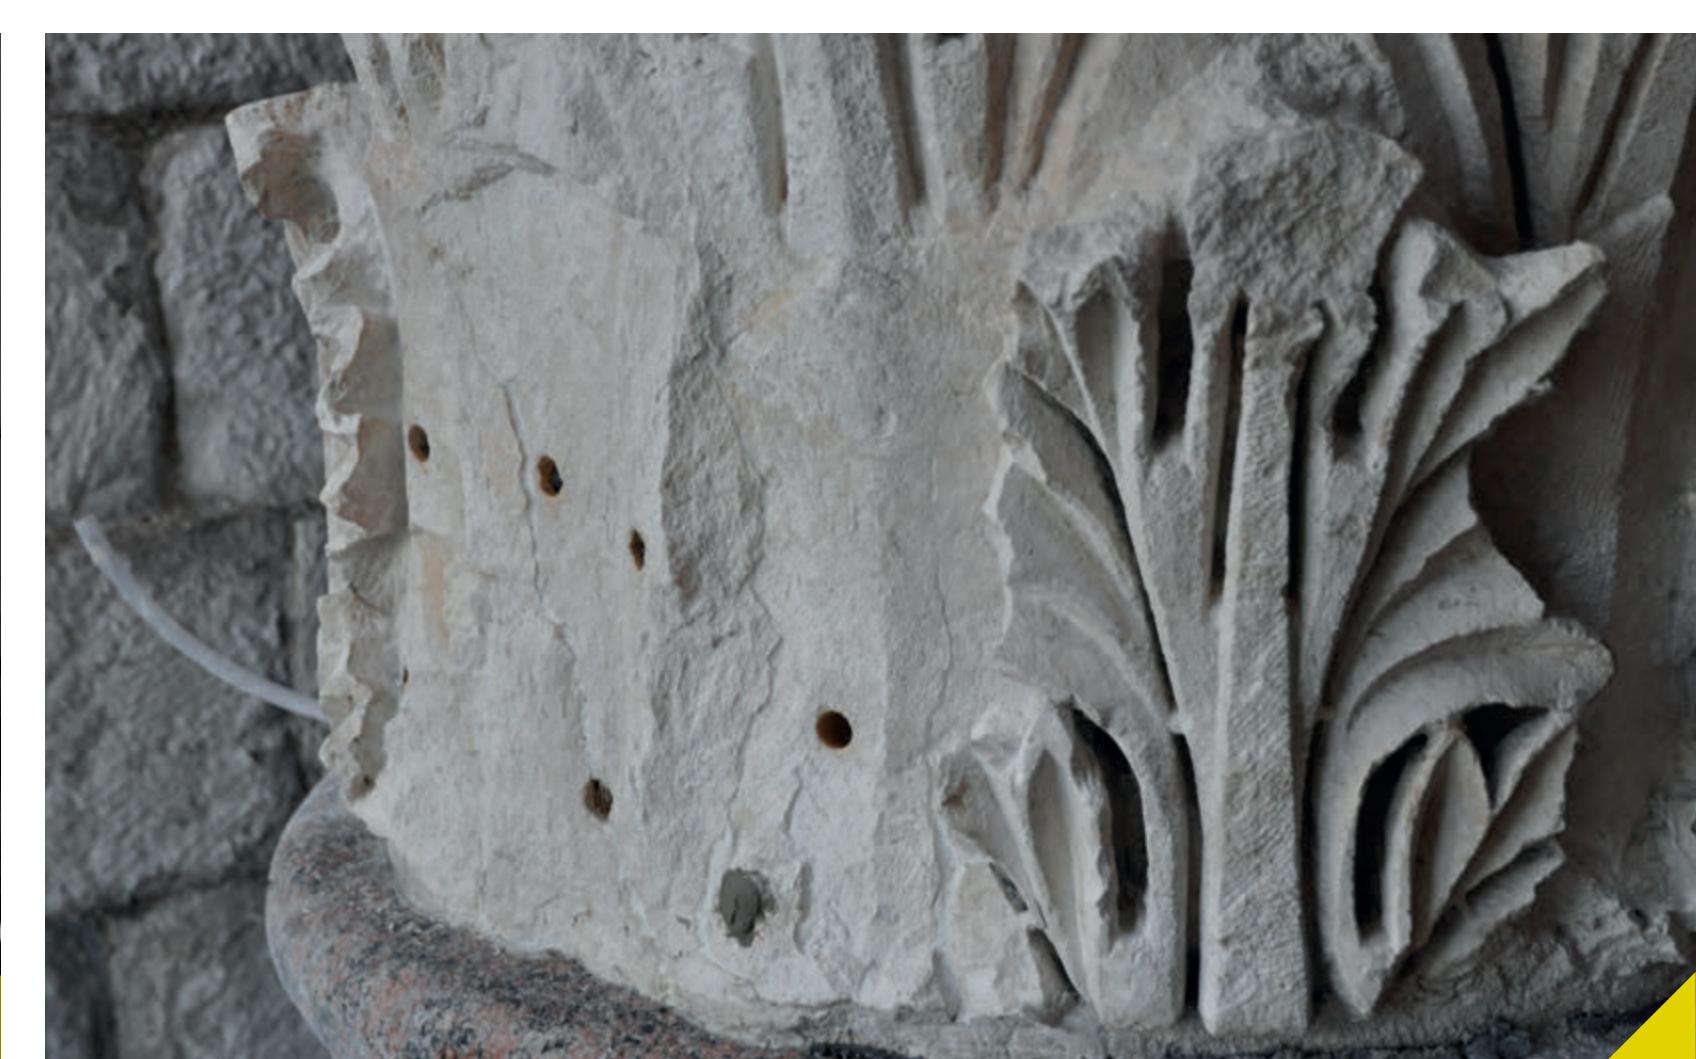
1. PROTHYRON GABLE, CONDITION AFTER RESTORATION; 2, 3, 4, 5, 6. RESTORATION OF THE STONE ARCH IN THE EASTERN CHAPEL; 7, 8, 9. CONSOLIDATION OF THE CRACKED CAPITAL AND ARCH

This phase of work includes the construction rehabilitation of roof structures. Simultaneous to the construction works, iron elements anchored in stone were being replaced with the stainless steel ones. Cracked parts of stone are reinforced with carbon clasps.
