# konzervatorsko-restauratorski radovi na pilu sv. trojstva u osijeku

CONSERVATION AND RESTORATION WORK ON THE HOLY TRINITY VOTIVE  
MONUMENT (PIL) IN OSIJEK

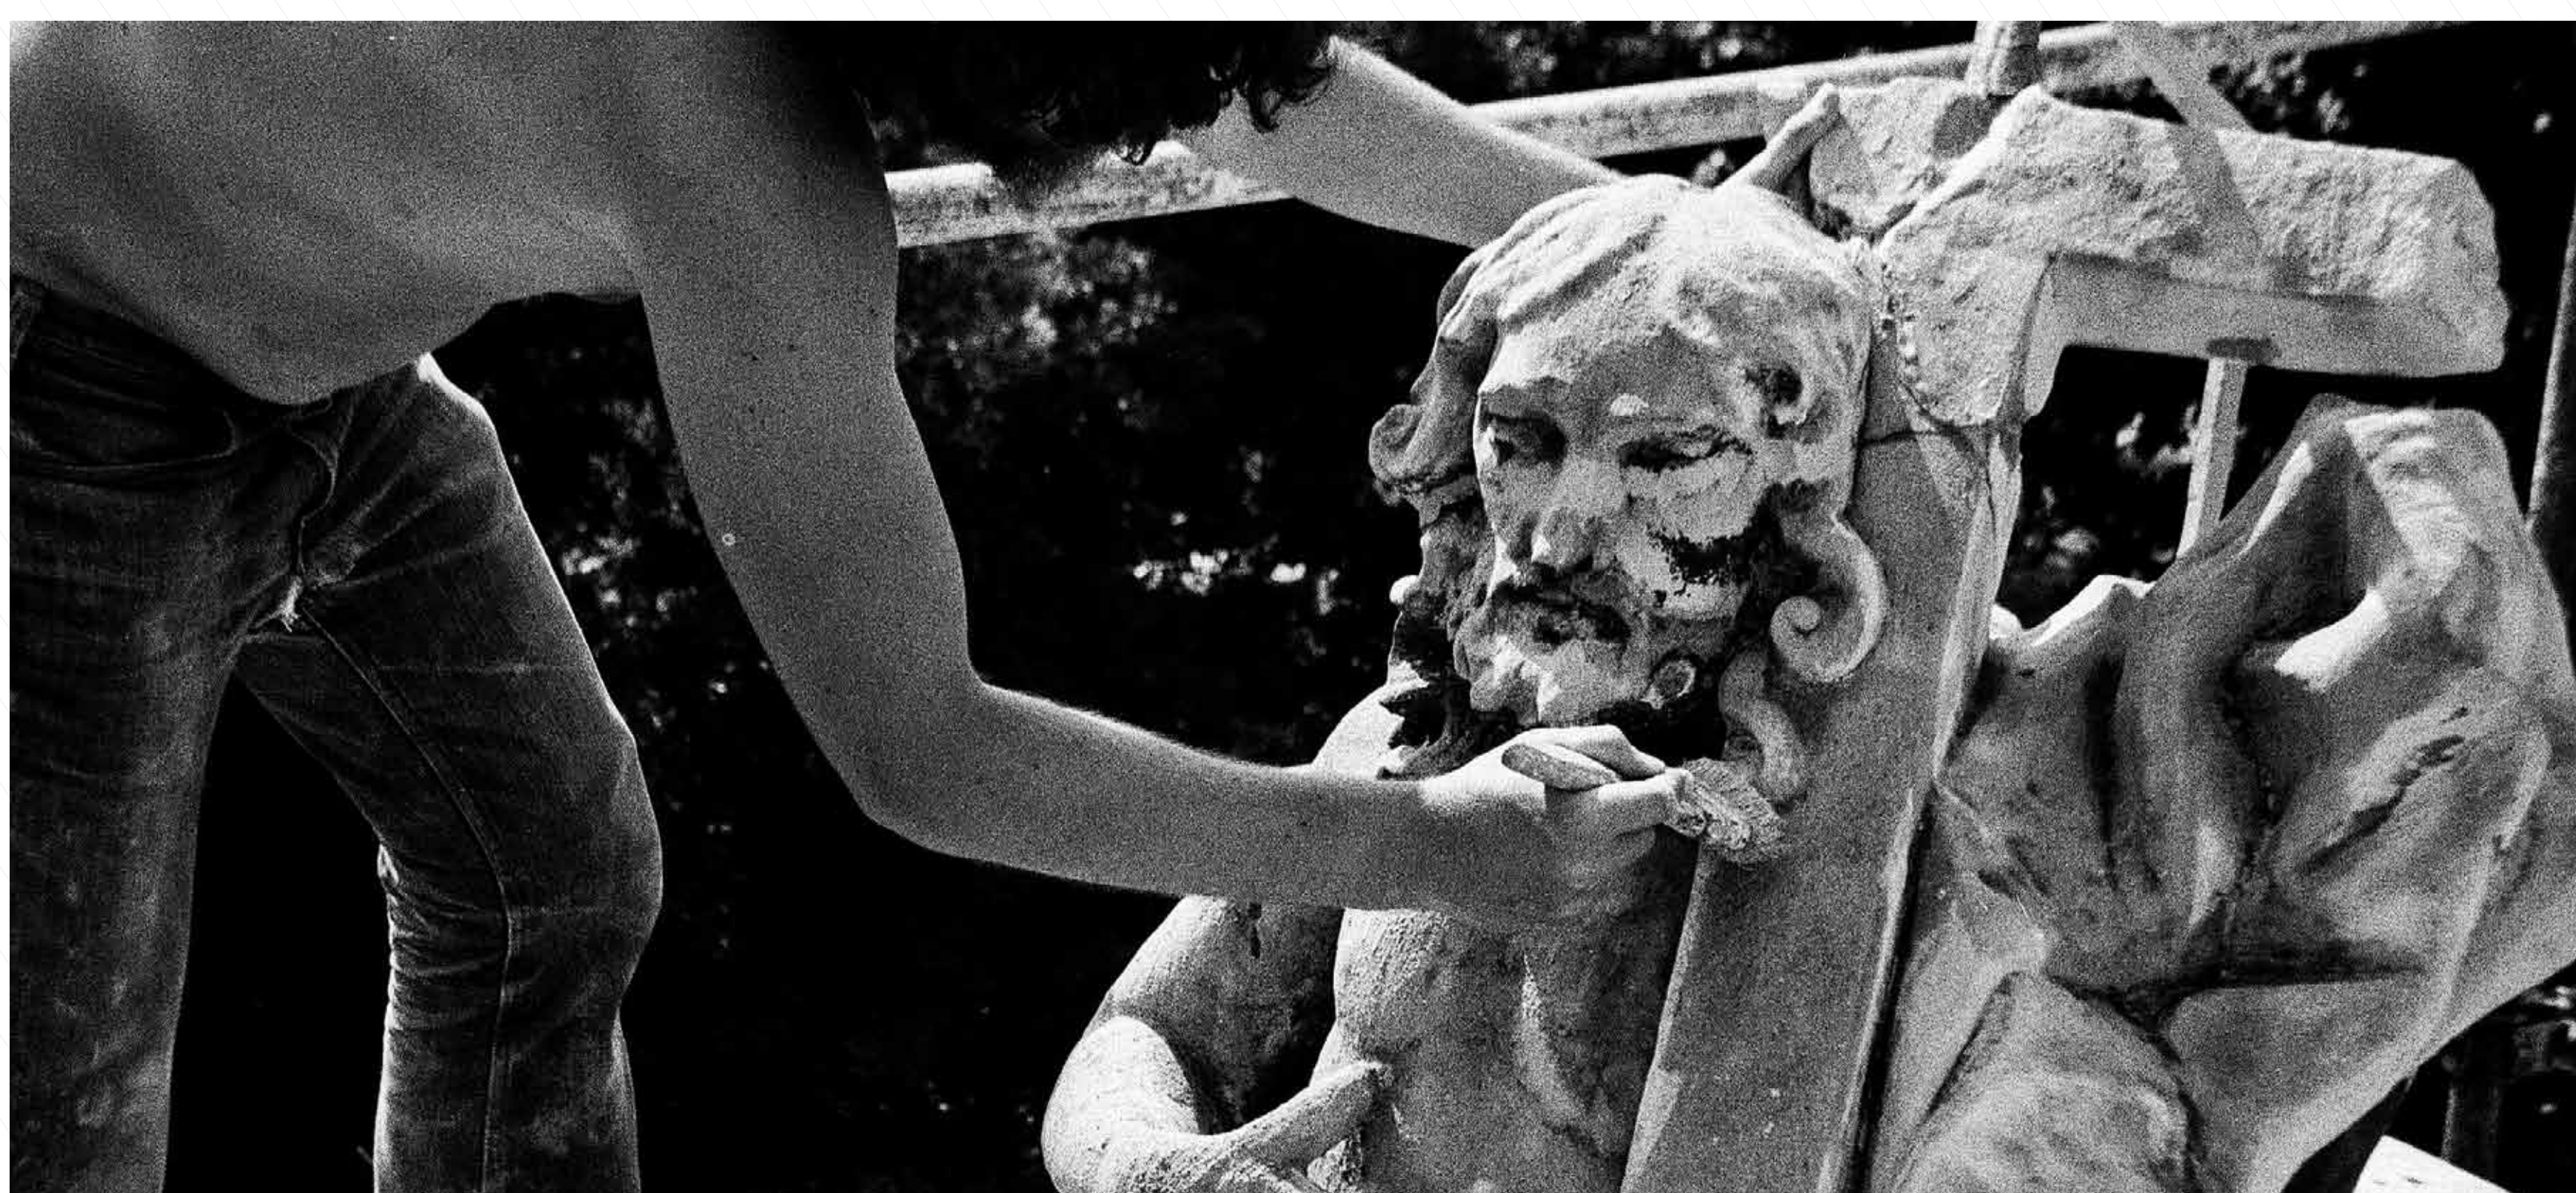
Impregnacija skulpture Krista, 1975. godina  
Water-proofing of the statue of Christ in 1975

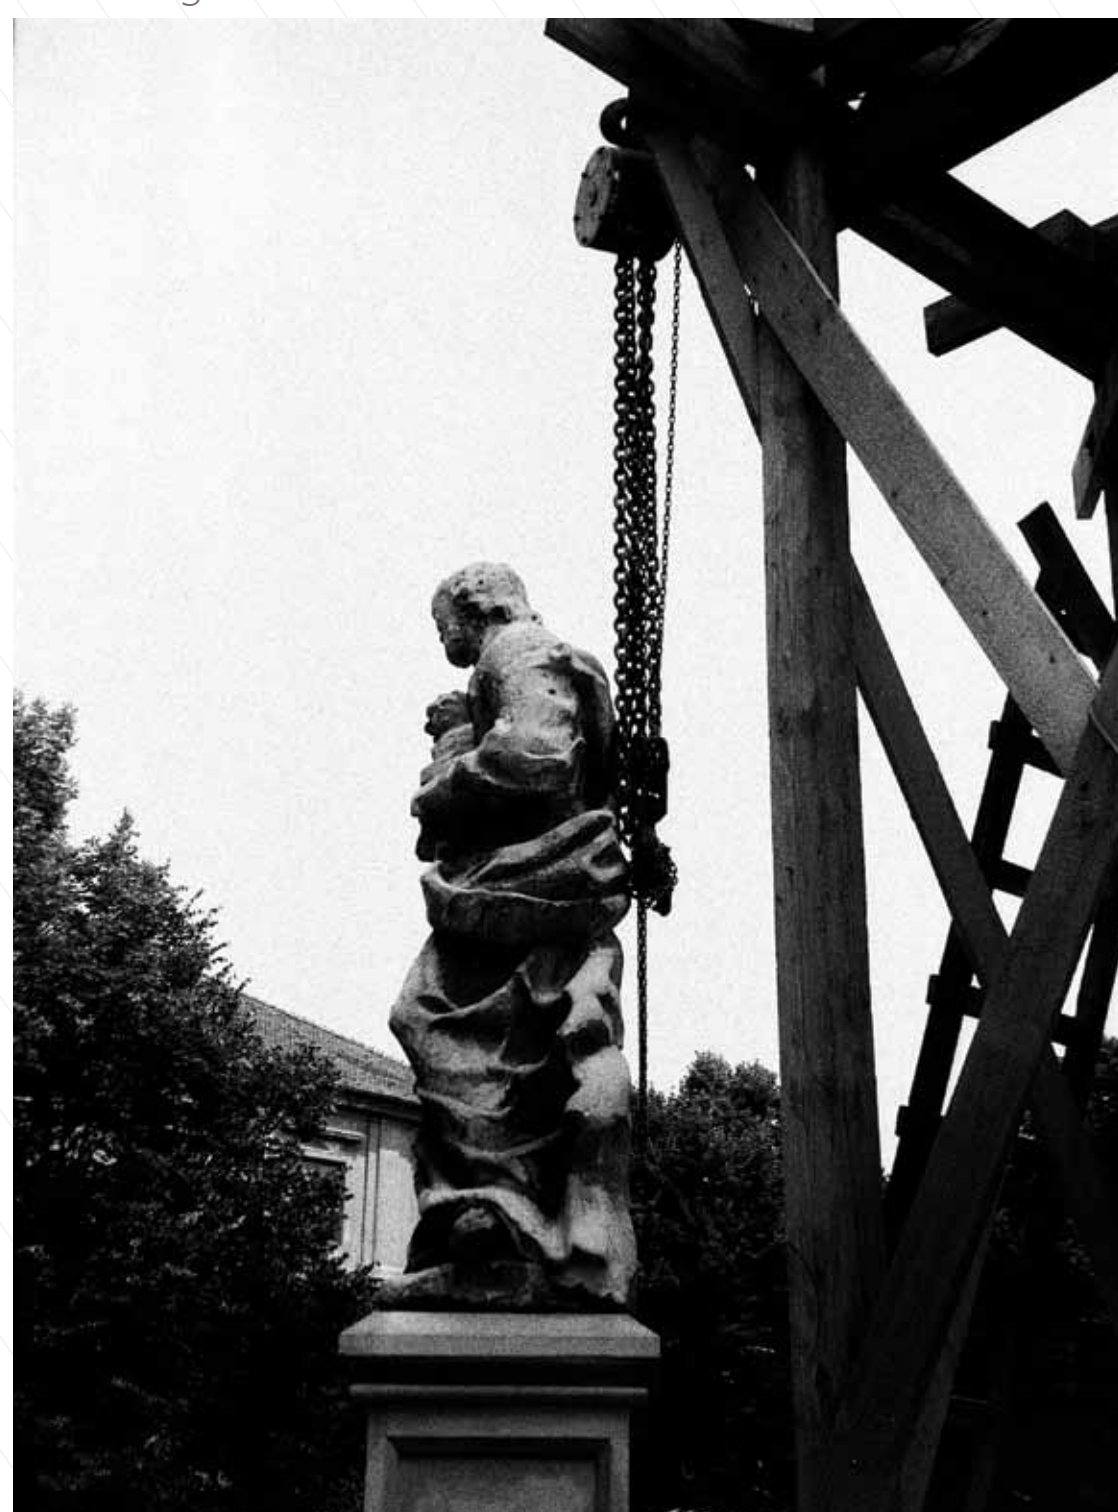
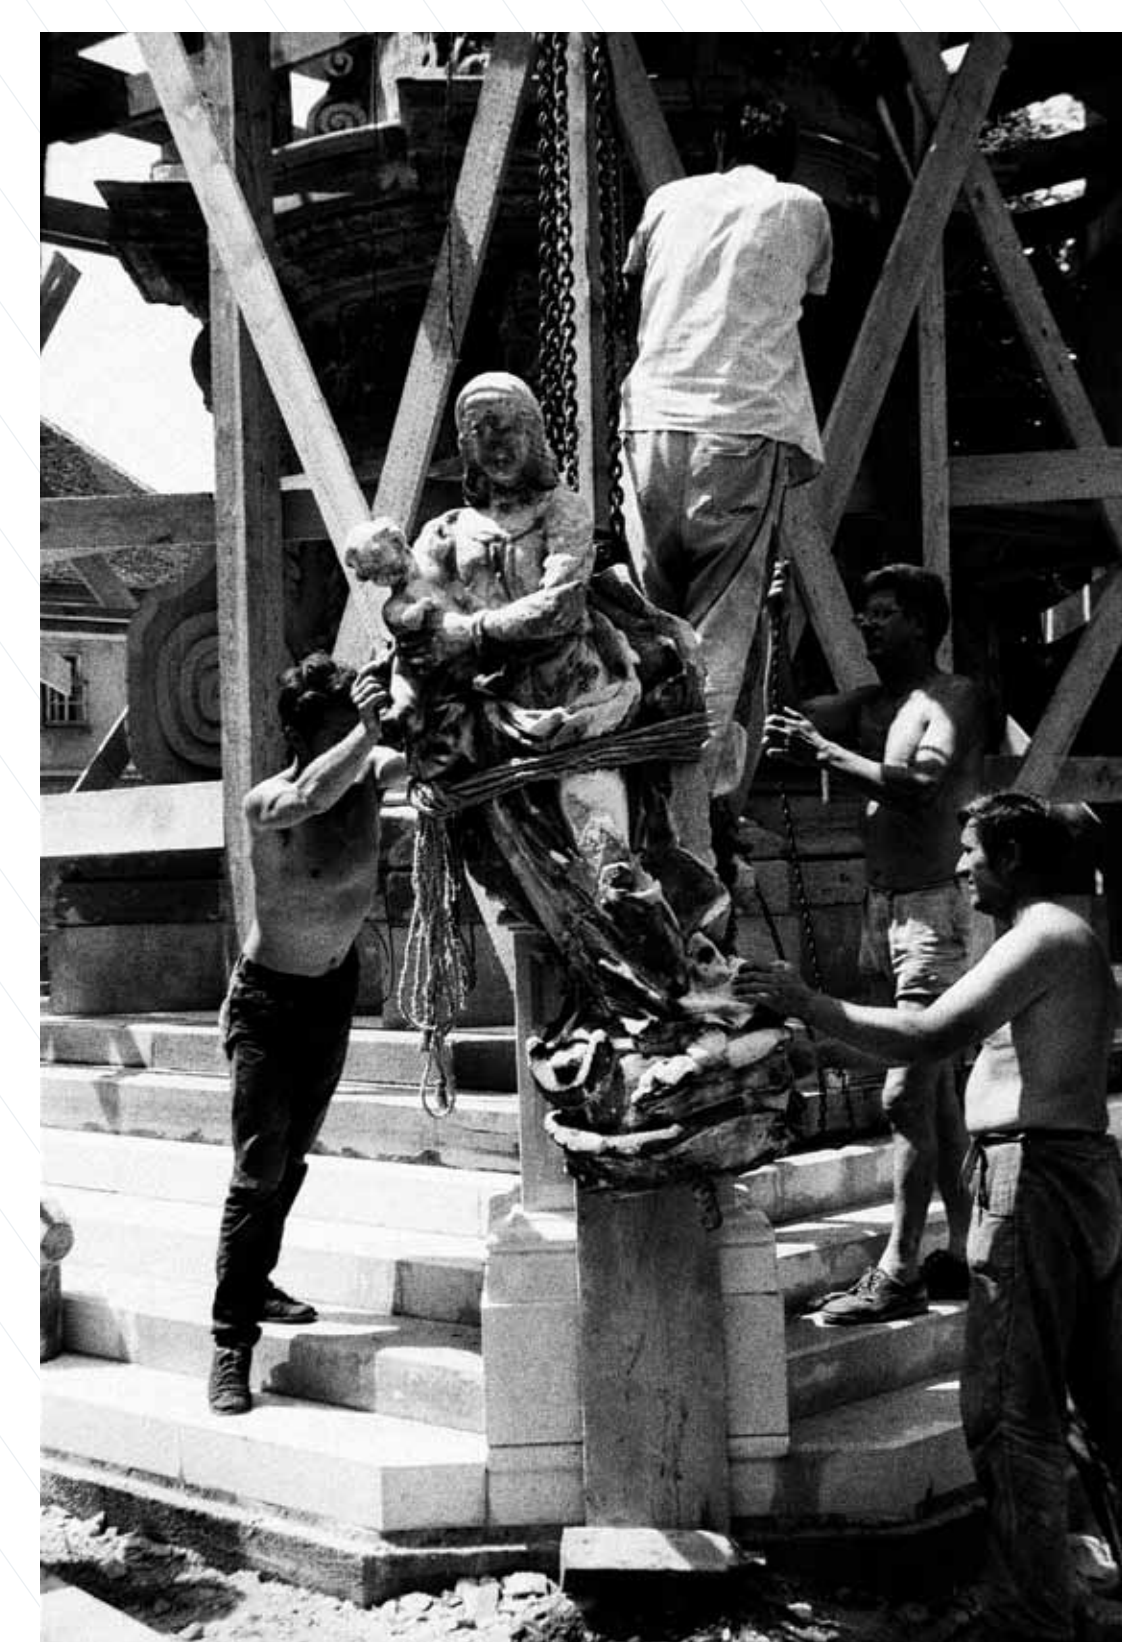
Podizanje skulpture Bogorodice, 1975. godina  
Mounting of the statue of Mother of God in 1975

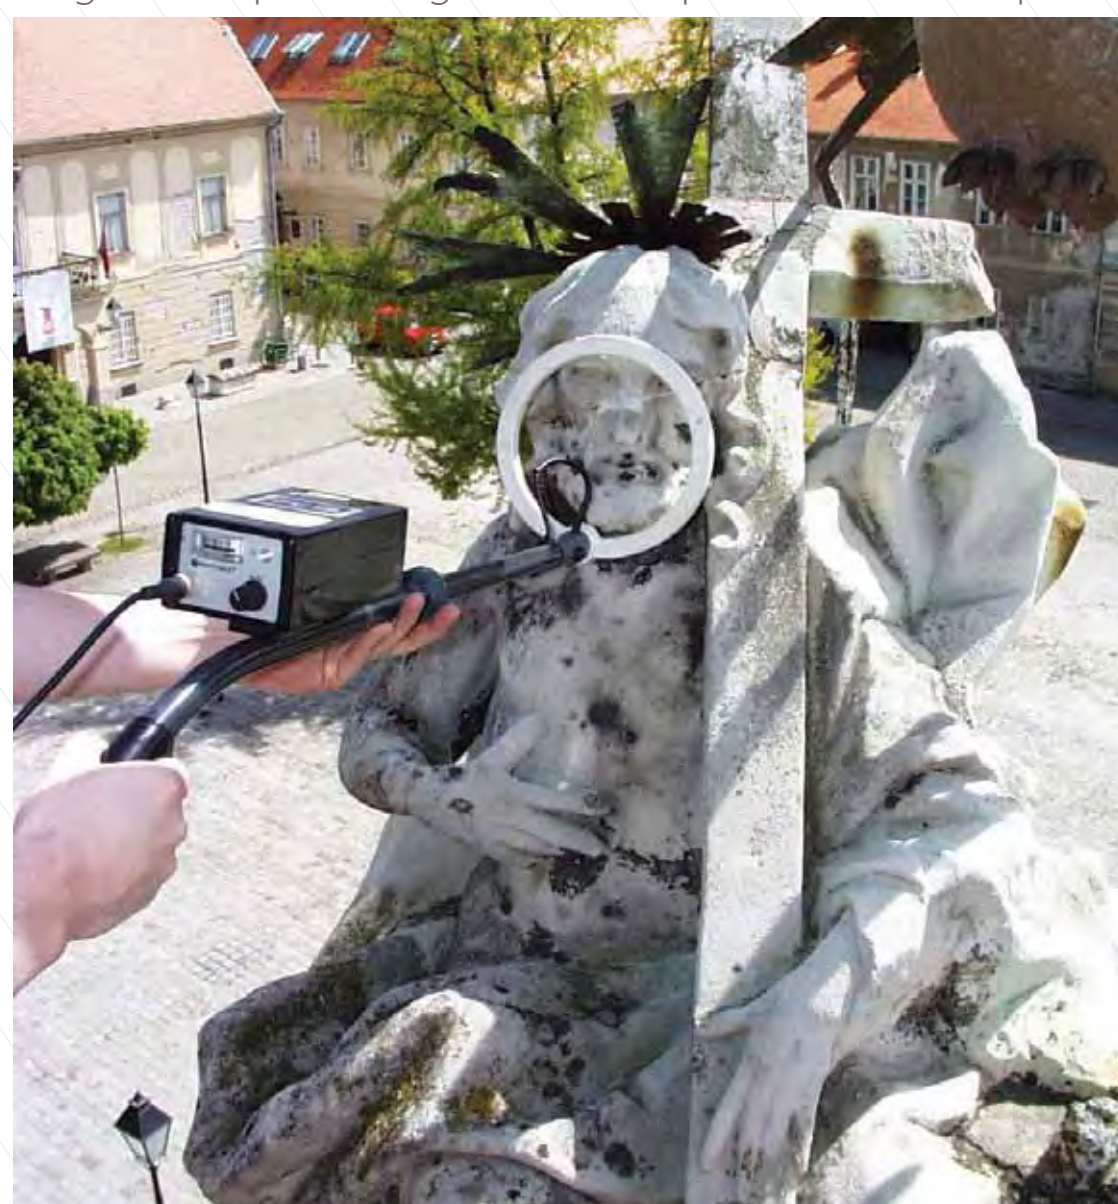
IN ORDER TO OBTAIN an accurate view of the general condition of the structural elements which make up the monument, modern technologies were used to test the material and the condition of the structure. SER.CO.TEC. company from Italy was commissioned for this task, which had undertaken sonographic and thermal imaging tests, as well as metal detector tests. The sonographic testing revealed fissures on sections of the monument, establishing all the fissures to be of the surface type, except the fissure on the capitel of the central composite column, extending the full depth of the capitel. Thermal imaging tests revealed the stone structure to be extremely porous, and subsequently prone to decay, so it was established that after completion of the conservation-restoration works, additional surface protection against precipitation was required. The metal detector tests established the position of the iron rods, and other

iron elements. The corrosion of the iron objects anchored in the stone with its increase in volume caused the rupture of the stone, therefore, their replacement during the conservation and restoration works was necessary with non-corrosive metal parts.

Magnetoskopskim se ispitivanjem utvrđuje položaj željeznih klinova  
Magnetoscopic testing reveals the position of metal pins

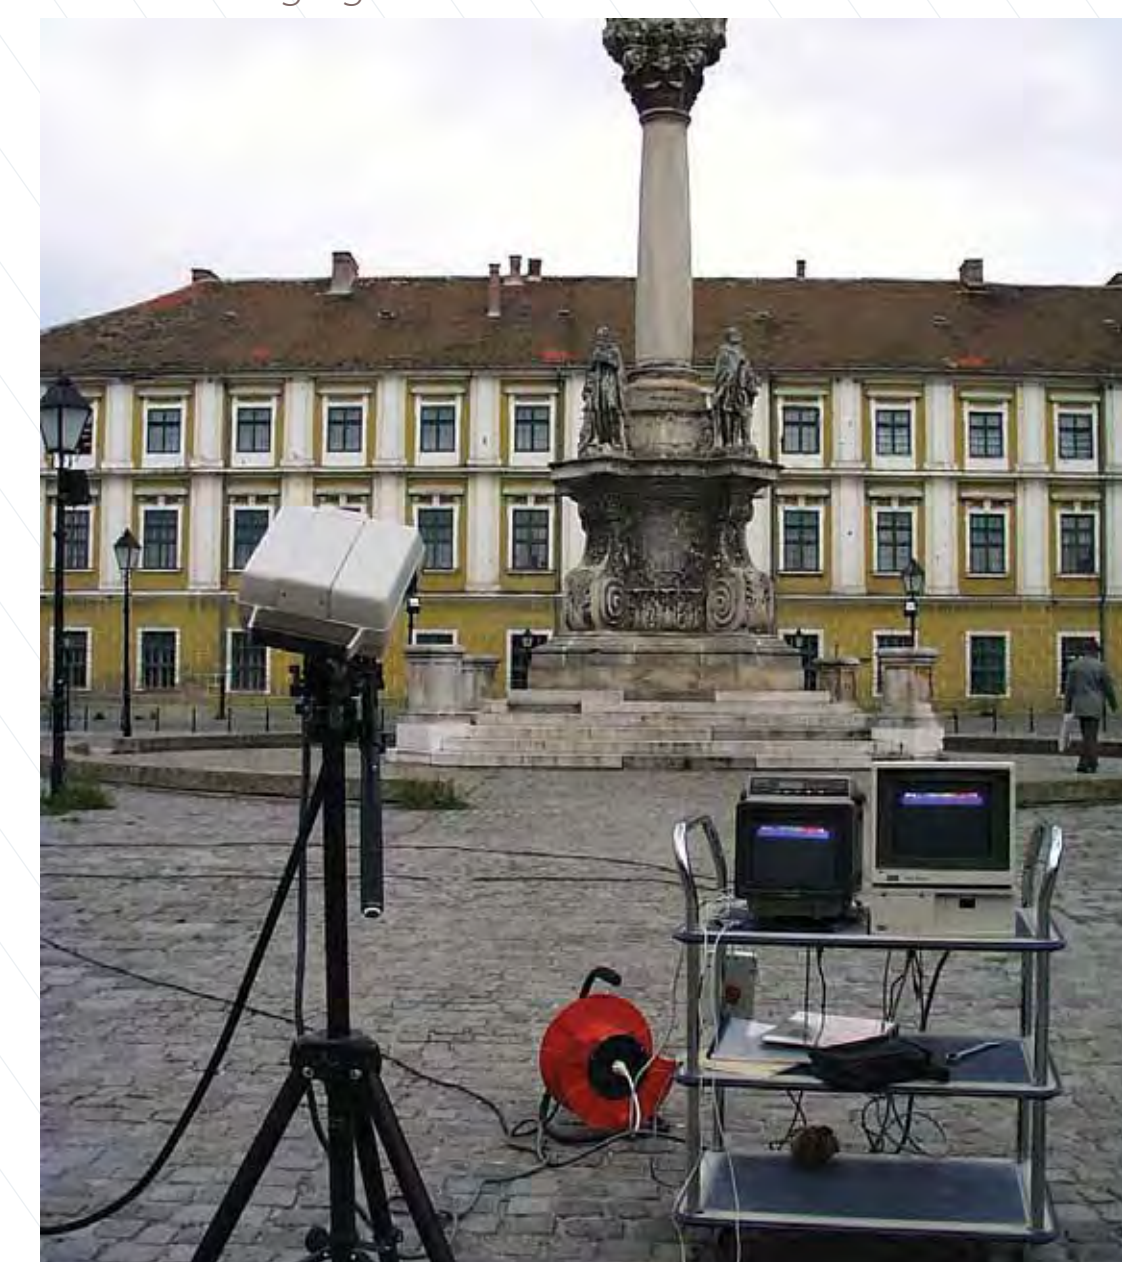
Snimanje spomenika termografskom kamerom  
Thermal imaging of the monument

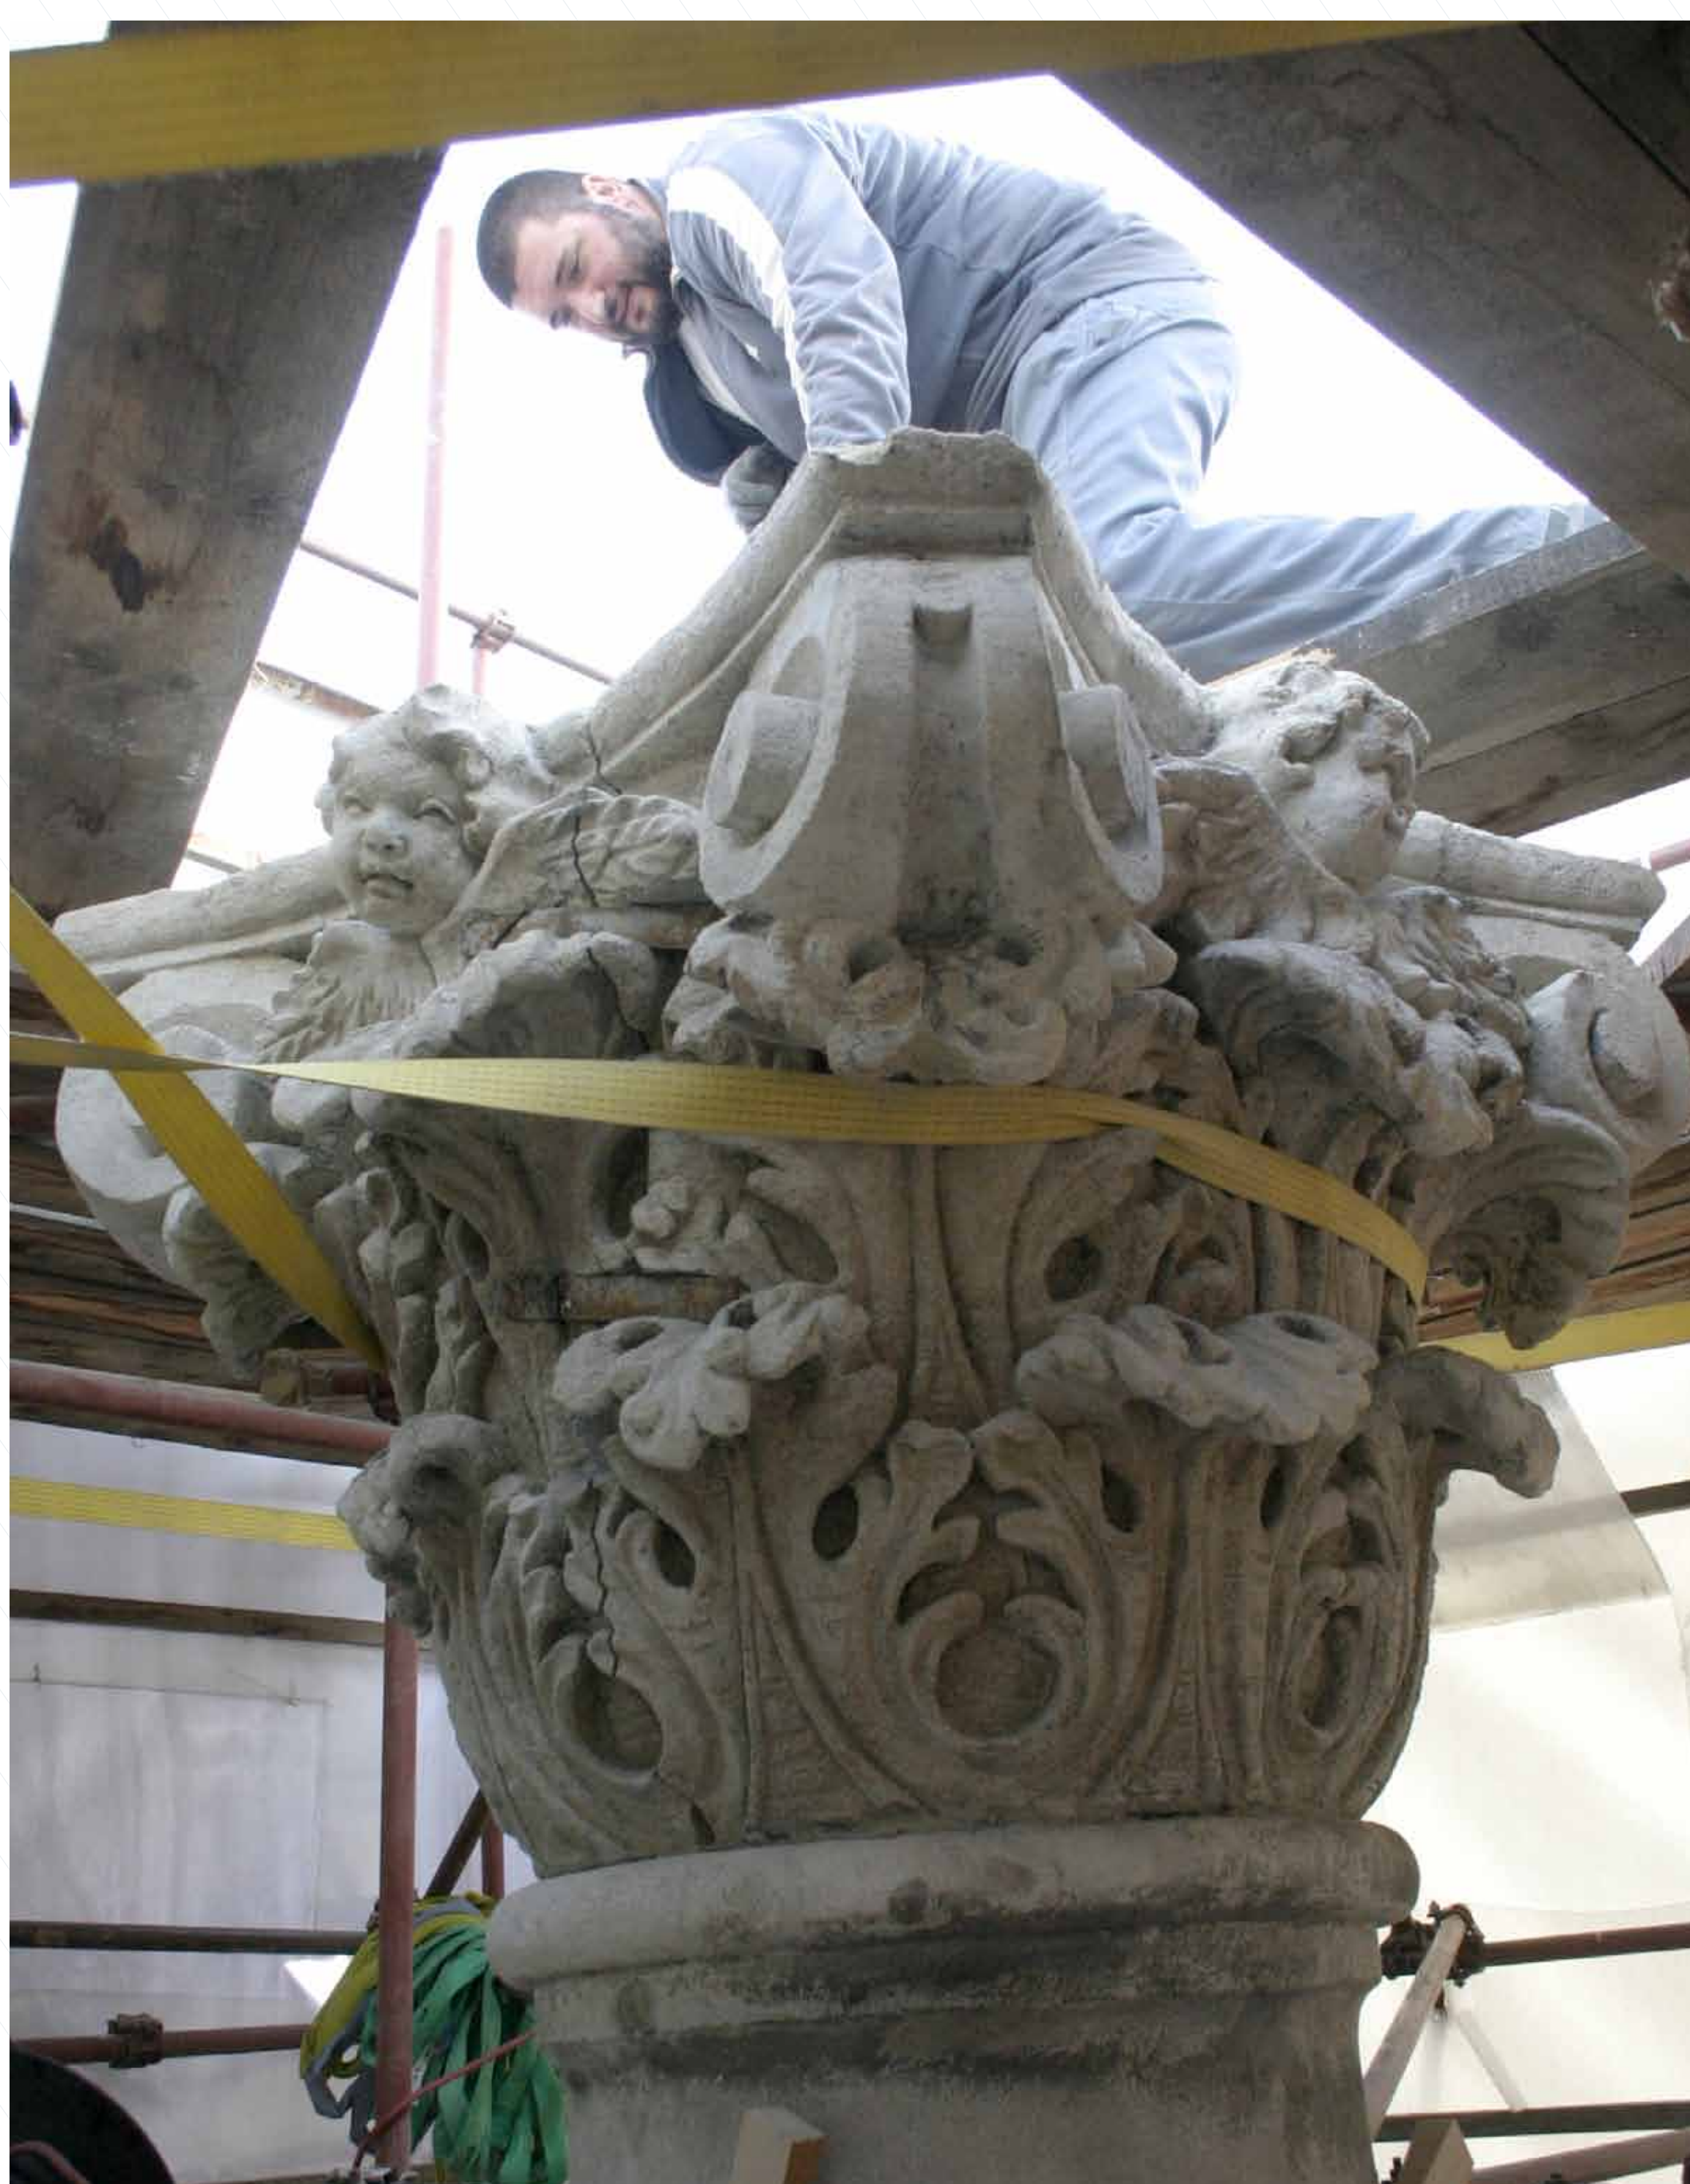
Demontaža kapitela  
Dismantling of capital

ZBOG VERTIKALNOG PUKNUĆA kompozitnog kapitela u gornjem dijelu spomenika, u svrhu restauratorske obnove je bilo potrebno demontirati gornje dijelove pila. Skela je postavljena 2005. godine, a 2008. su demontirana četiri kamena bloka: skulpture Krista i Boga Oca, oblak na kojemu su skulpture postavljene te kapitel. Tijekom i nakon demontaže je otkriveno da su kameni blokovi bili povezani vertikalnim trnom kvadratnoga presjeka od kovanoga željeza u duljini od 3 metra koji je povezivao stup, kapitel, oblak i dvije kamene skulpture na vrhu. Dvije su skulpture bile dodatno povezane i

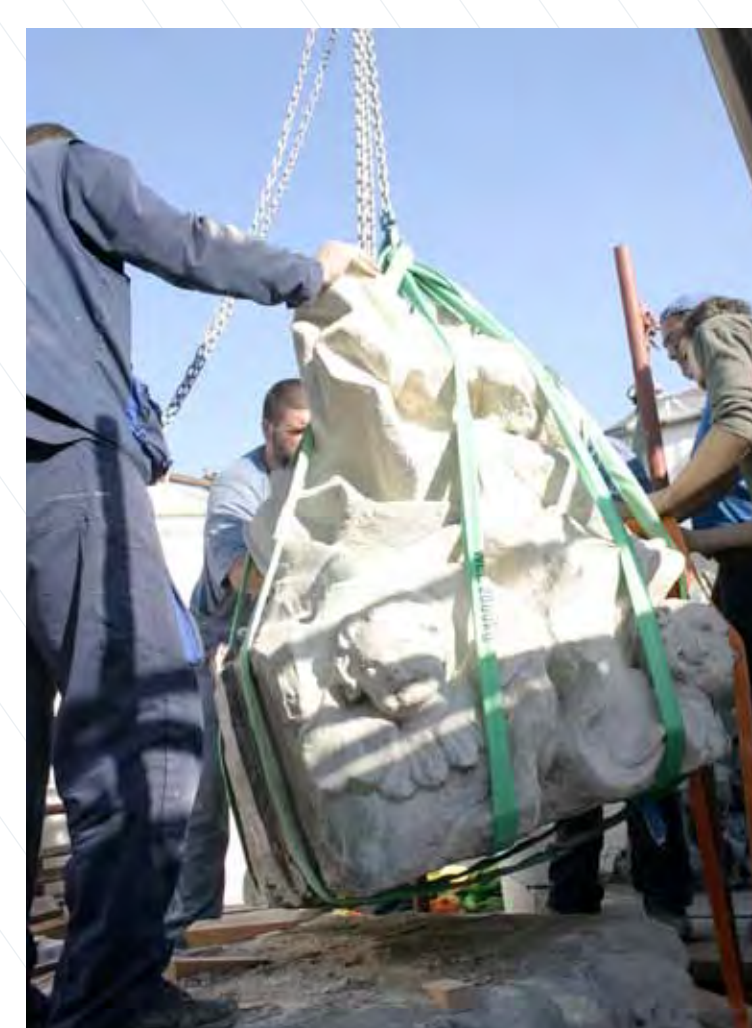
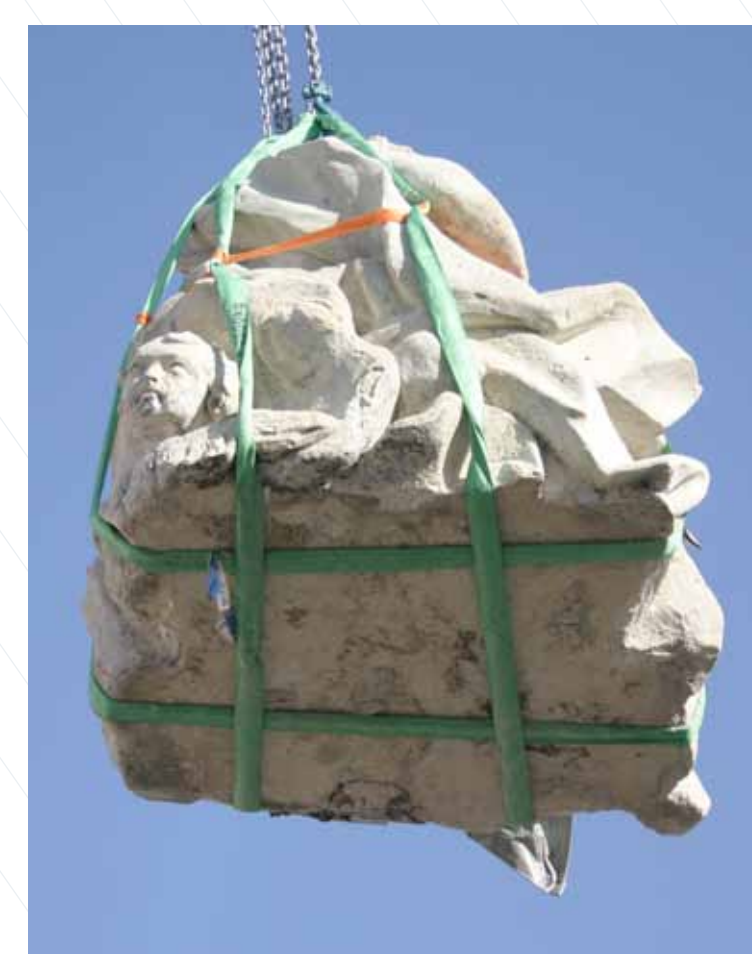
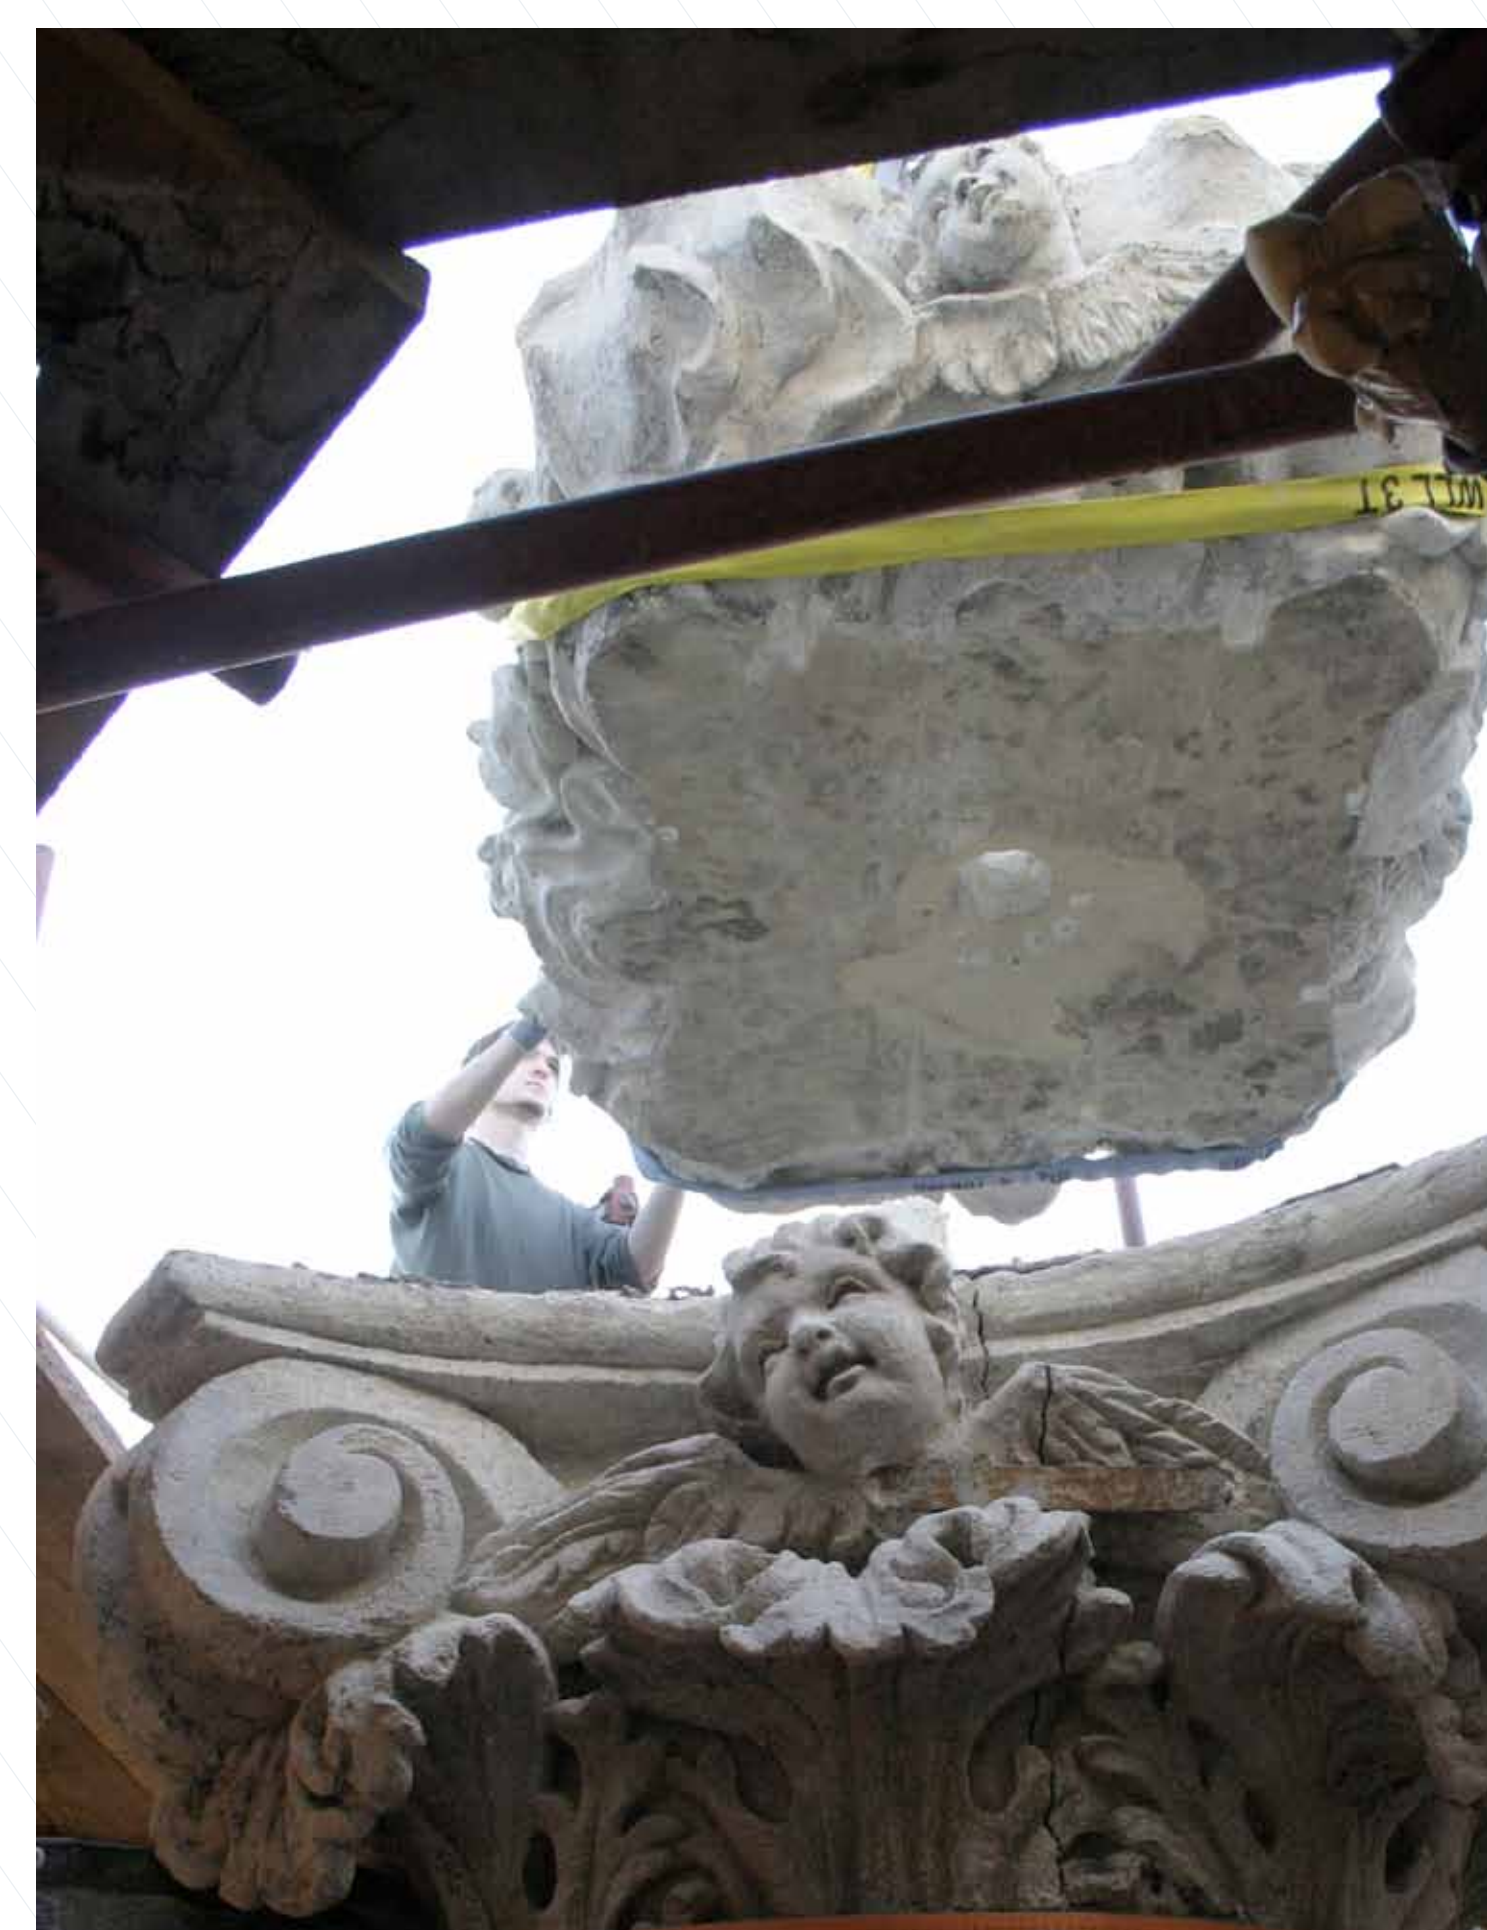
Demontaža oblaka kompozicije sv. Trojstva  
Dismantling of the cloud from the upper part of the monument

the cloud on which the statues were mounted, and the capital. During and after the dismantling it was revealed that the blocks of stone were linked with a square vertical hand hammered iron pin, 3 meters in length, connecting the column, the capital, the cloud and two of the stone statues on top. The two statues

were additionally bound, fastened and interlinked by a horizontal iron pin, also connected to the central vertical pin. Using the crane, the statues and parts of the architectural elements were dismantled from the top of the monument and transported to a workshop for conservation and restoration work.

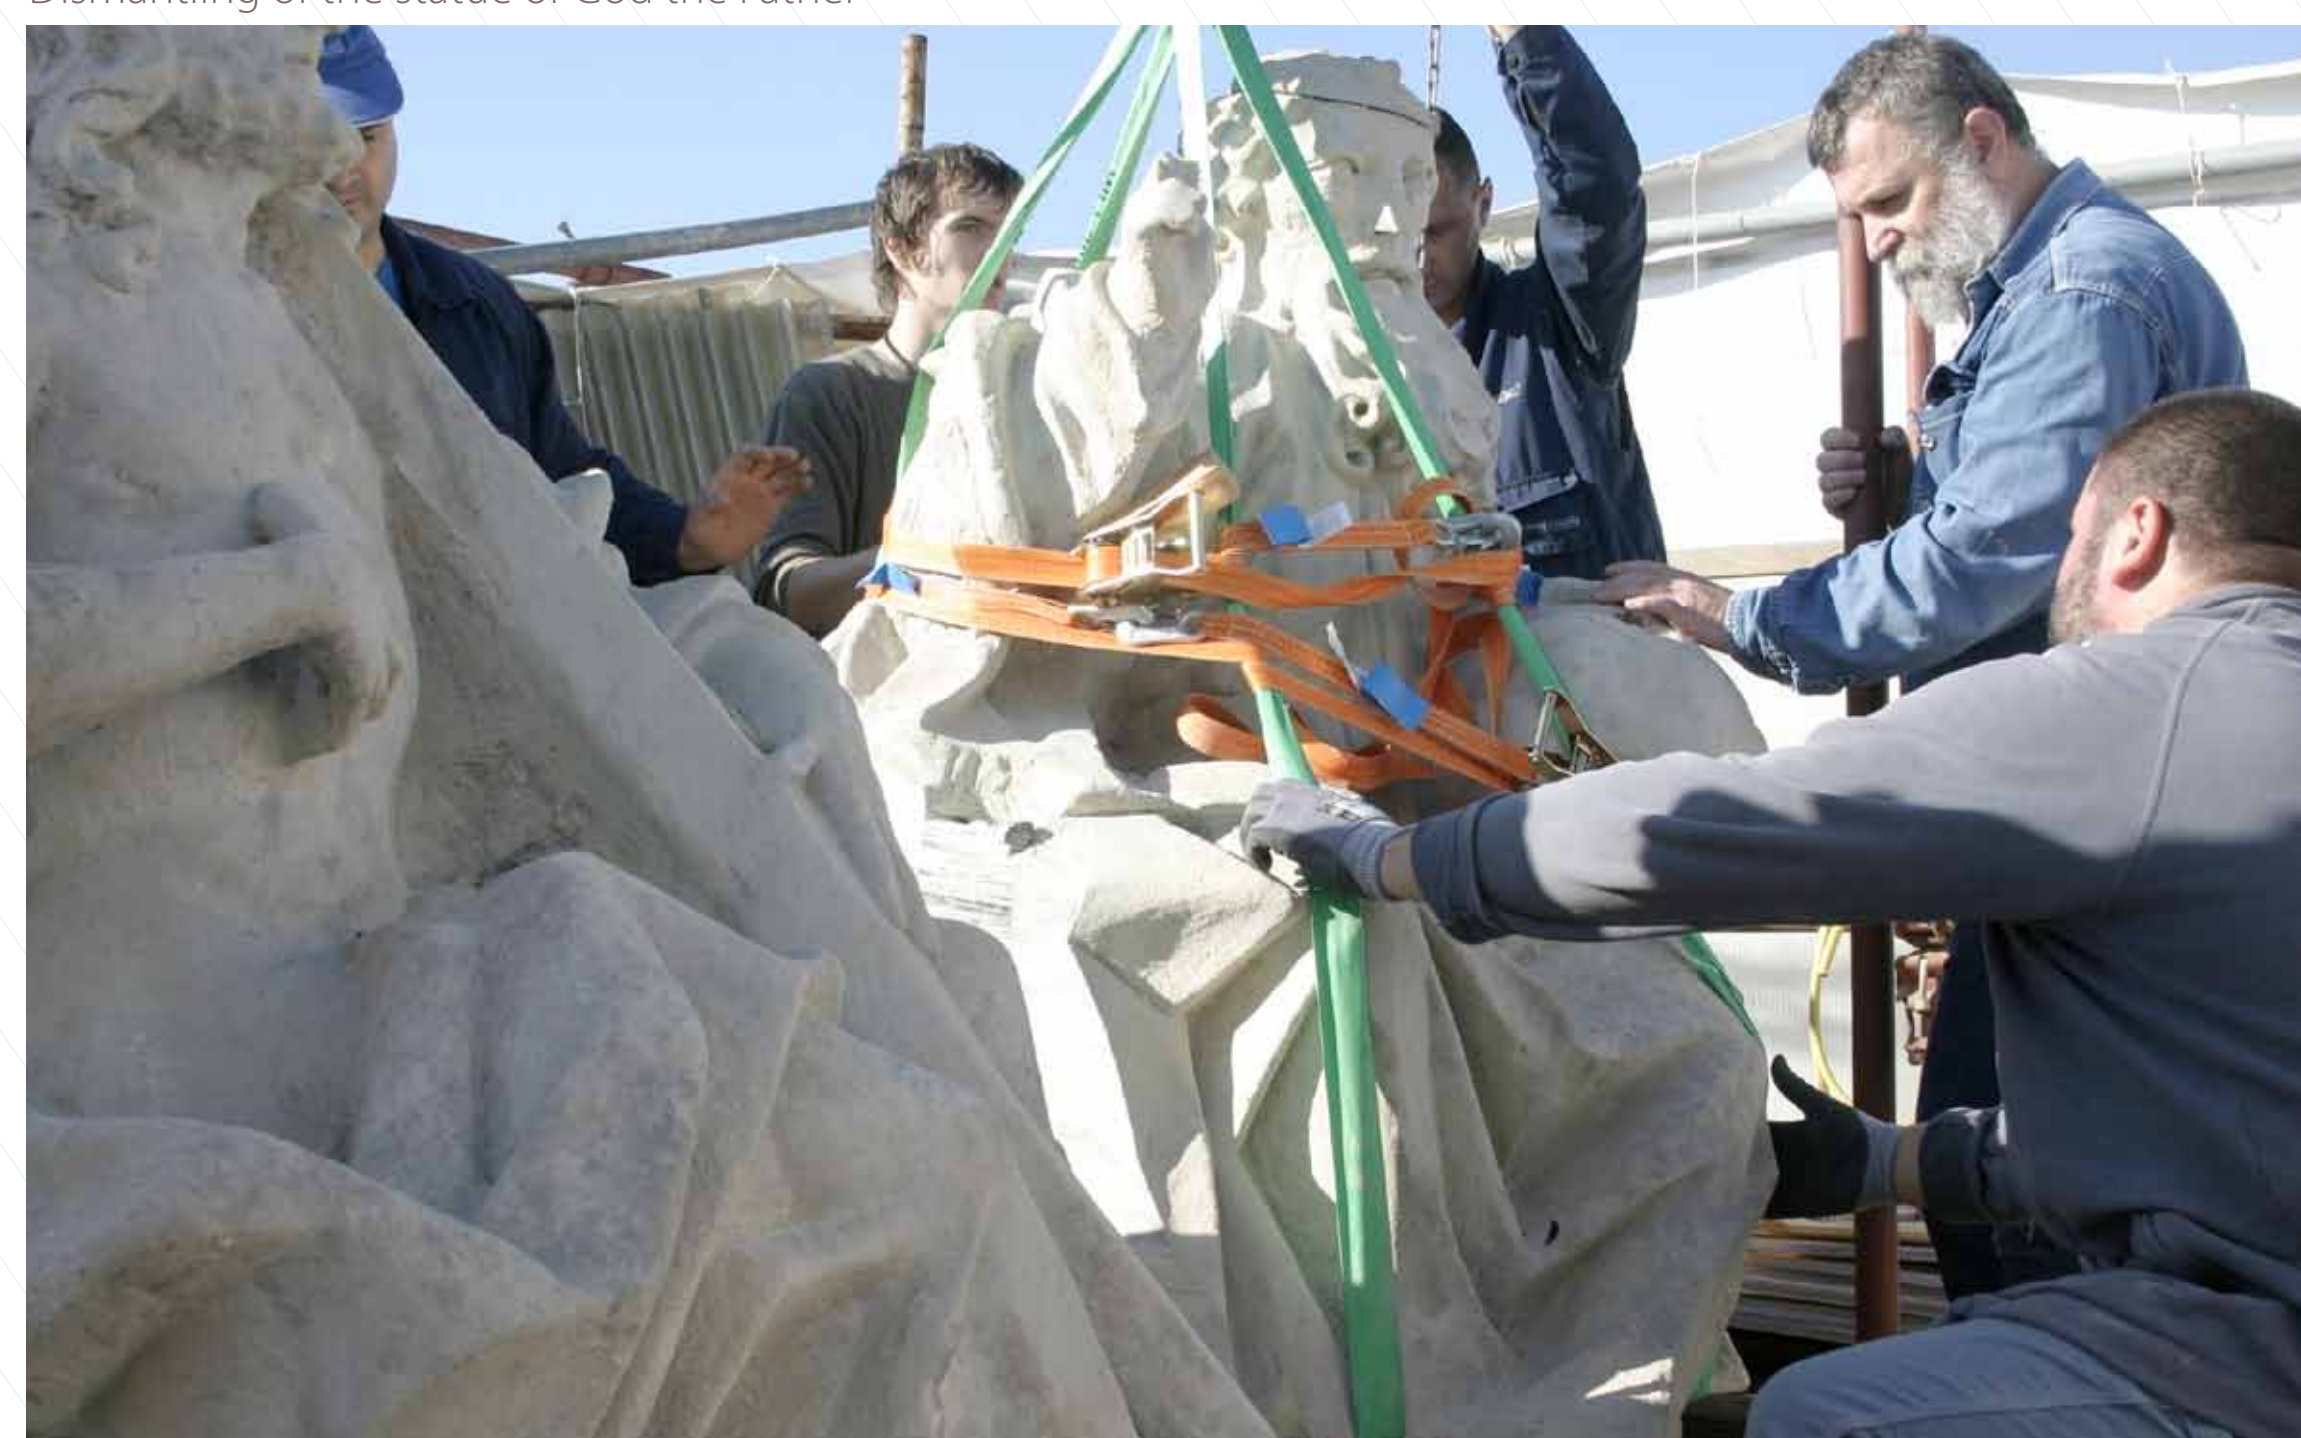
Demontaža skulpture Boga Oca  
Dismantling of the statue of God the Father
