# konzervatorsko-restauratorski radovi na pilu sv. trojstva u osijeku

CONSERVATION AND RESTORATION WORK ON THE HOLY TRINITY VOTIVE  
MONUMENT (PIL) IN OSIJEK

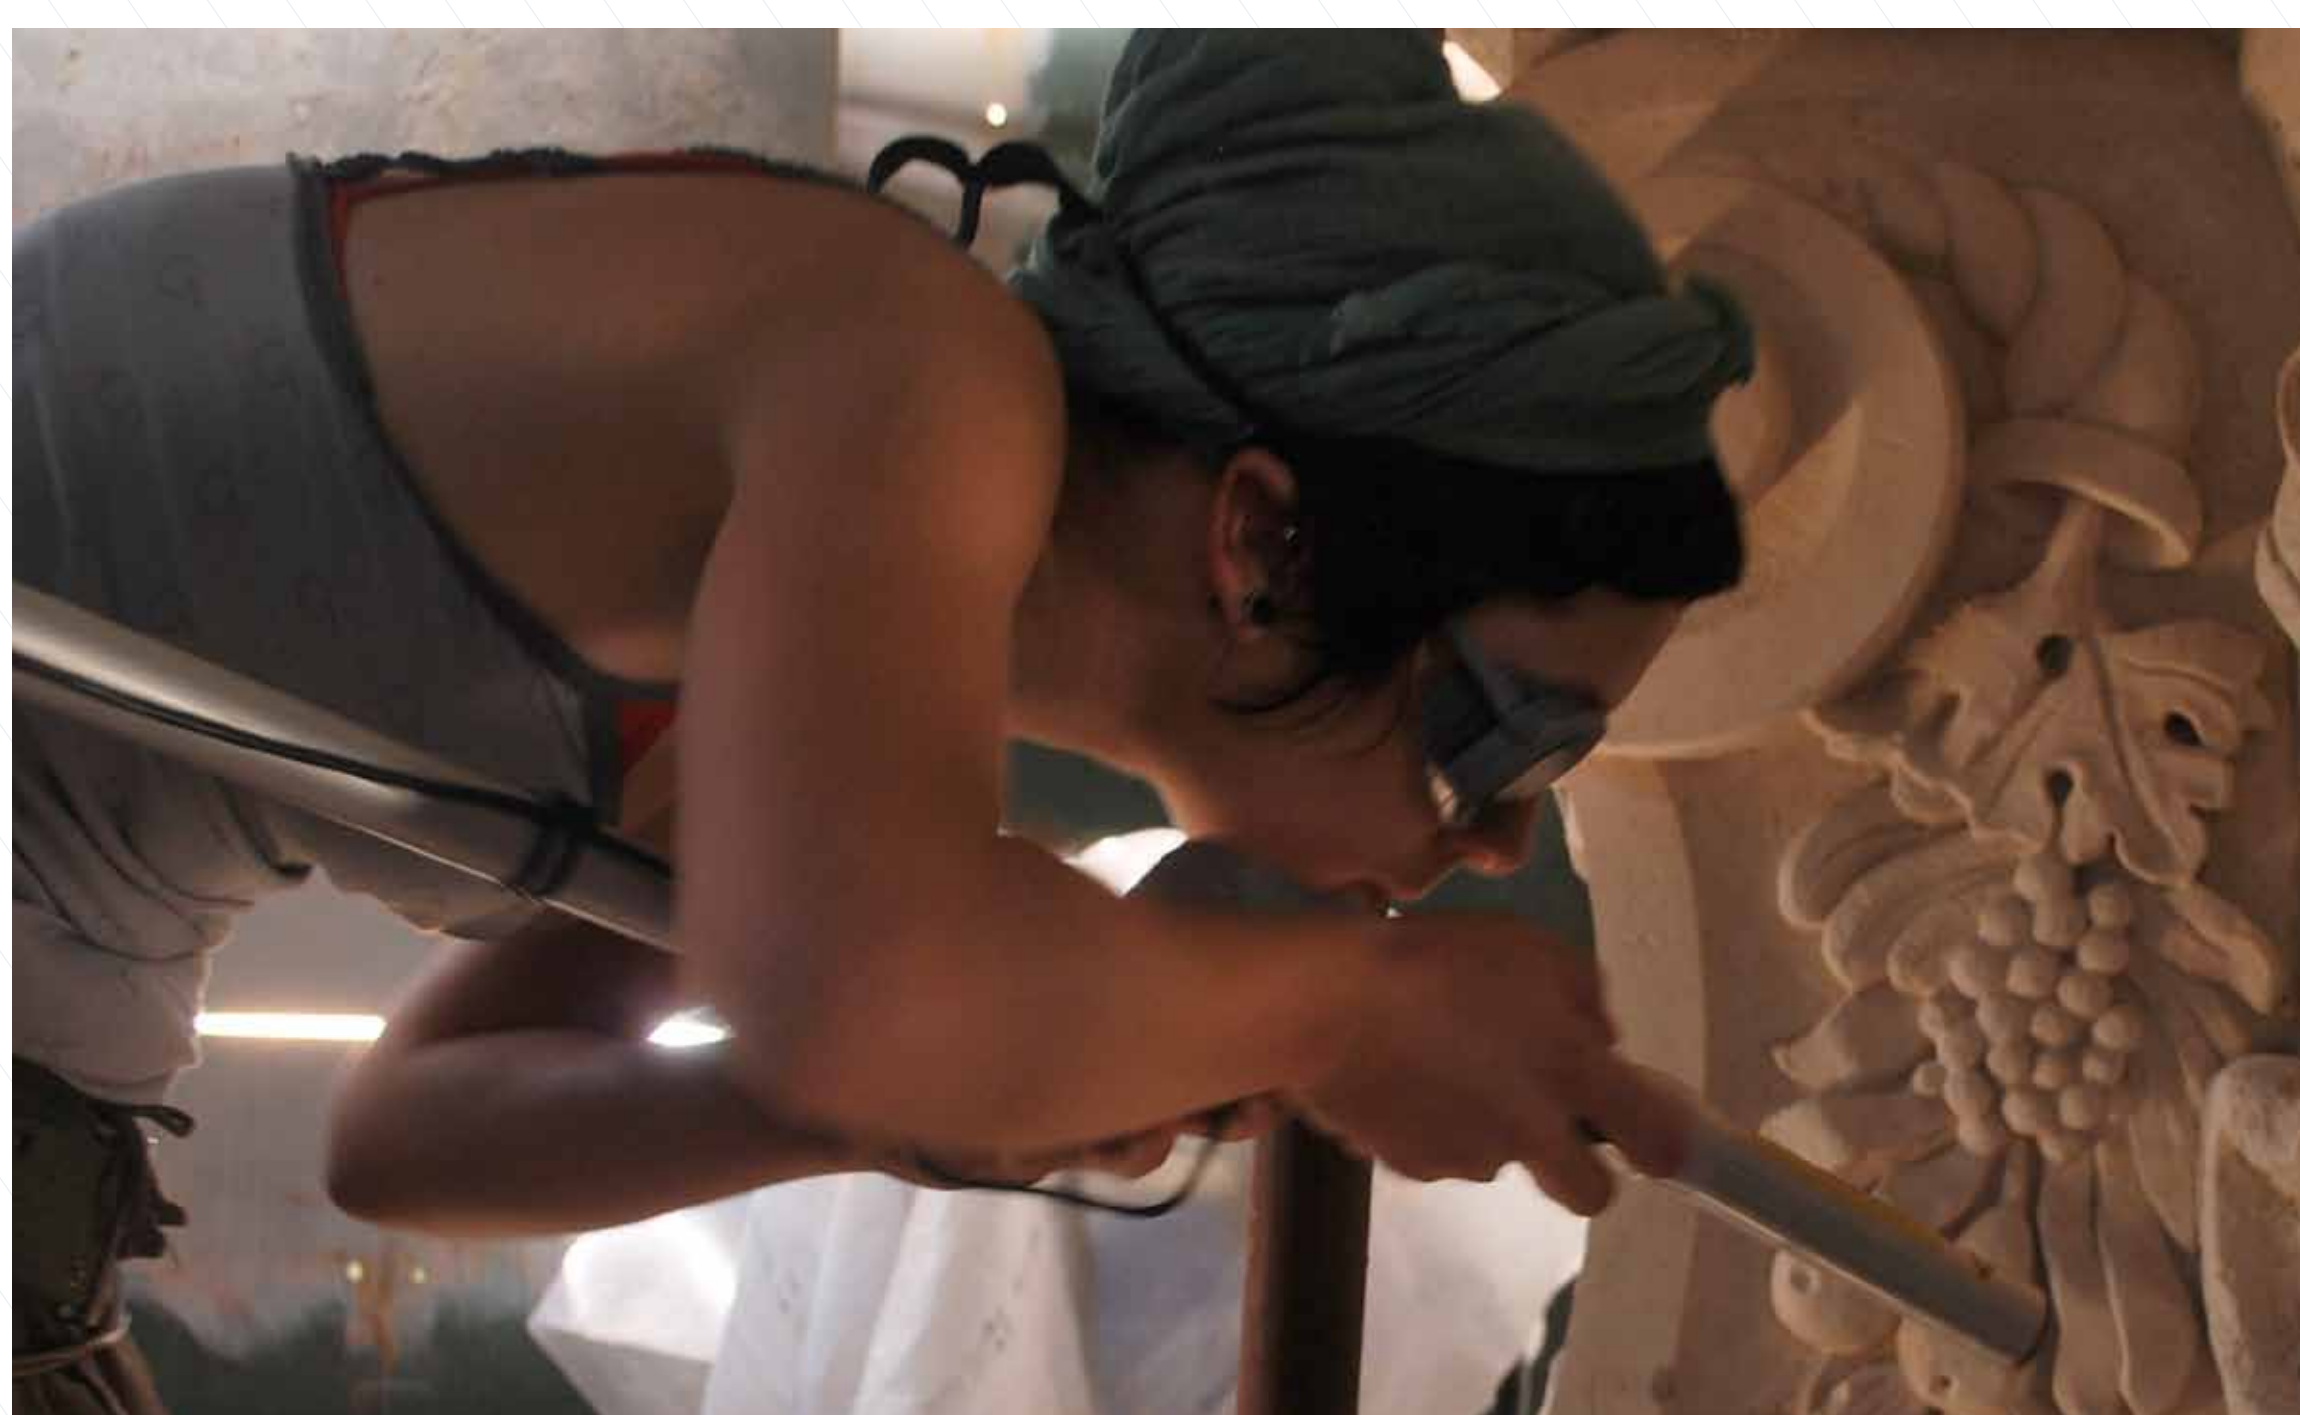
Čišćenje dijela podnožja laserom  
Laser cleaning of part of the high stand

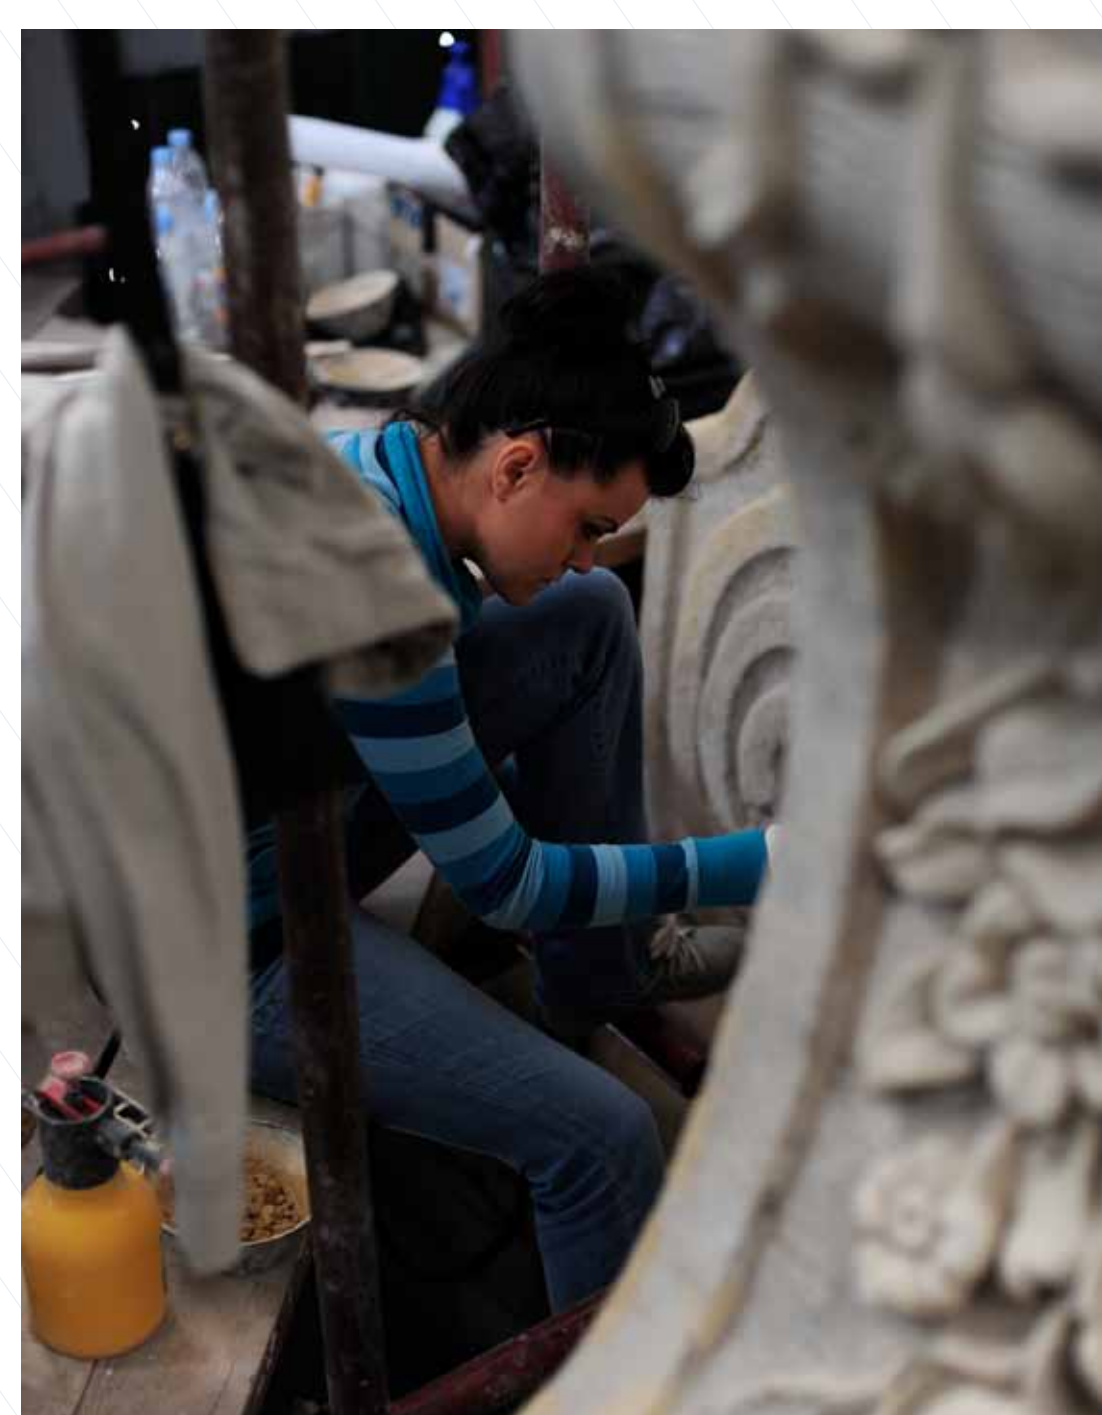
Lasersko čišćenje polja s natpisom  
Laser cleaning of the inscription

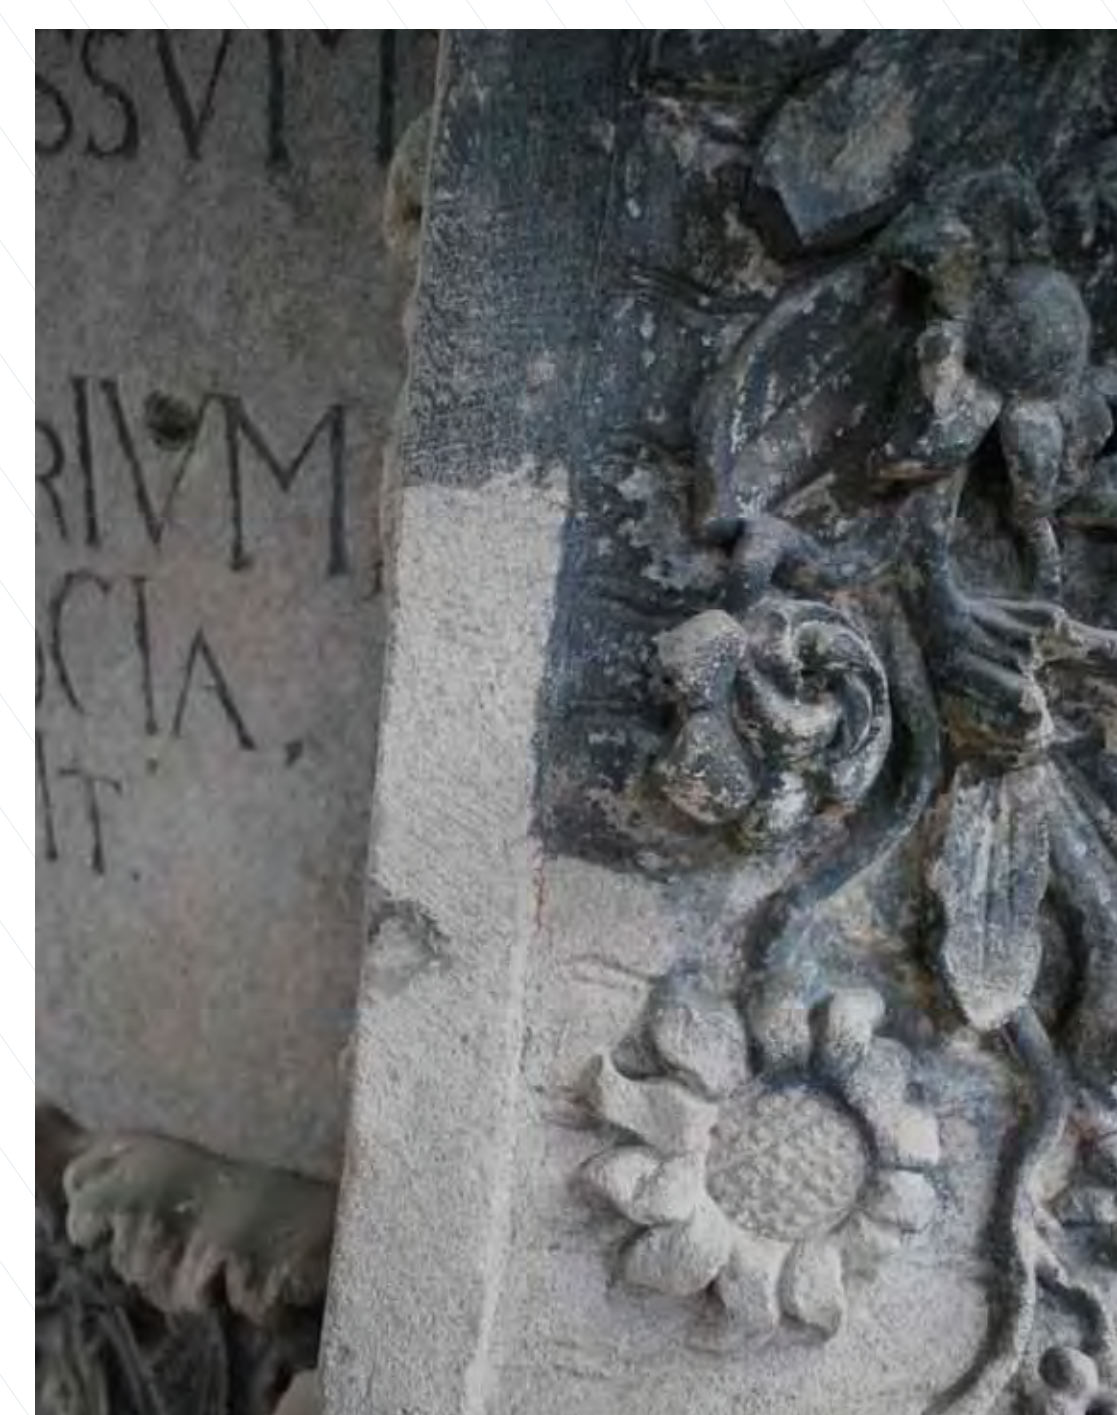
Djelomično očišćen segment postolja  
Partially cleaned part of the high stand

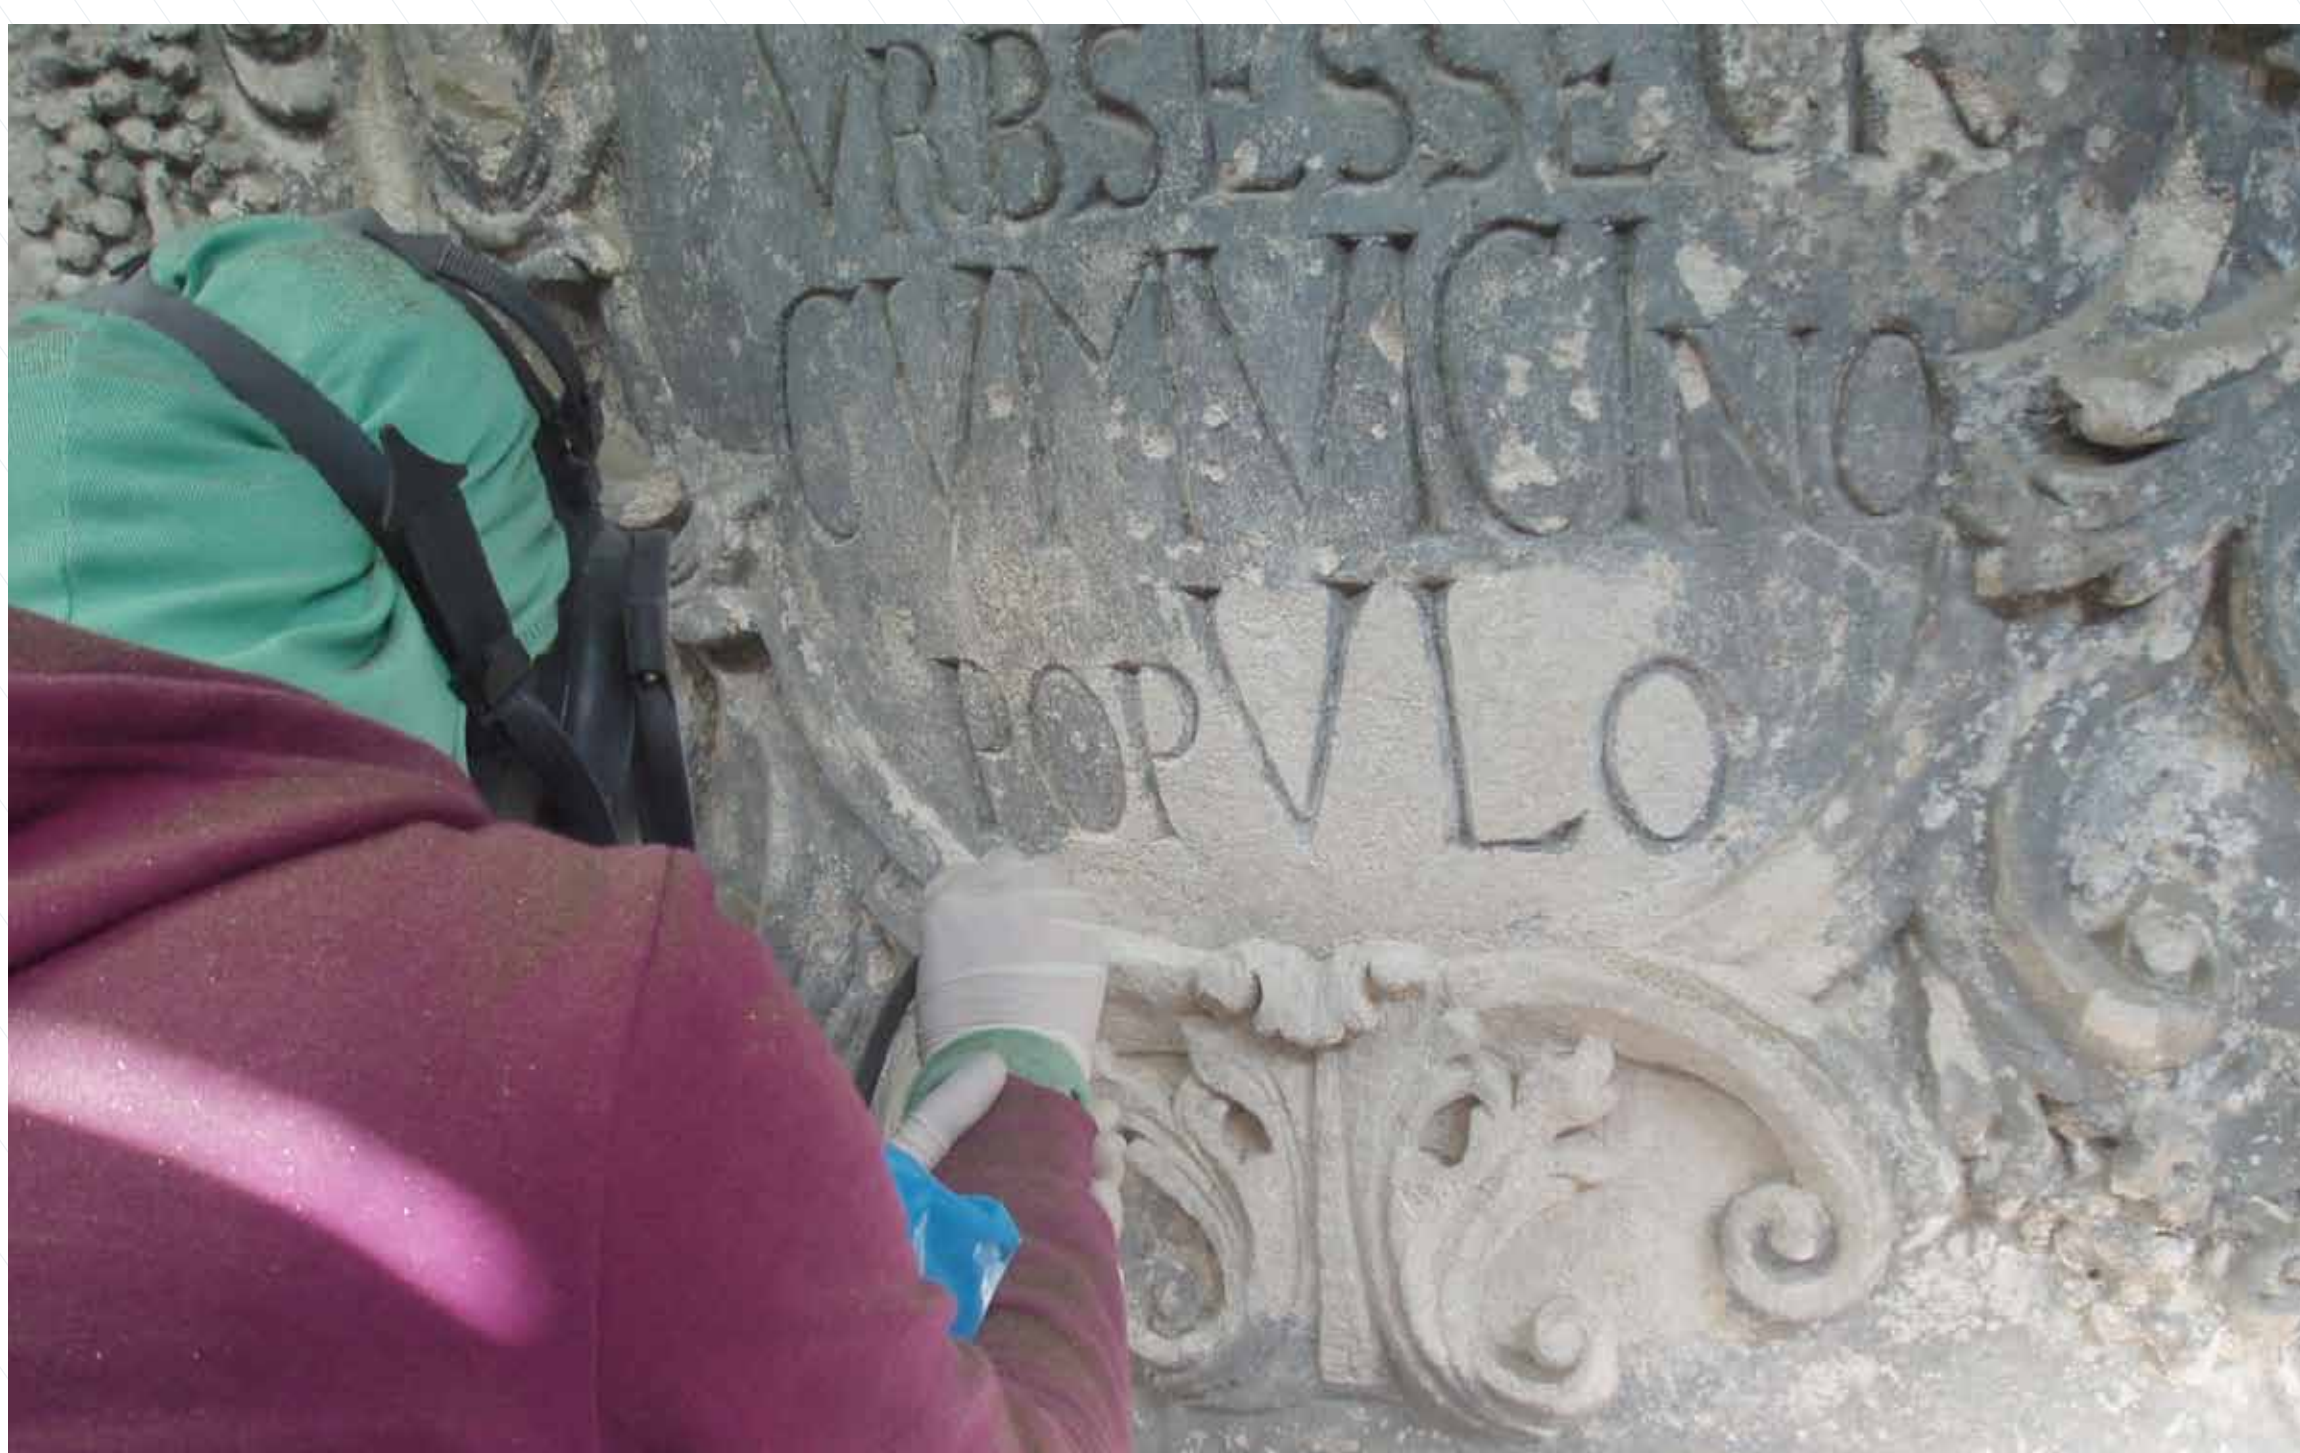
Čišćenje arhitektonskih dijelova mikropjeskarnikom  
Microsandblasting of architectural parts

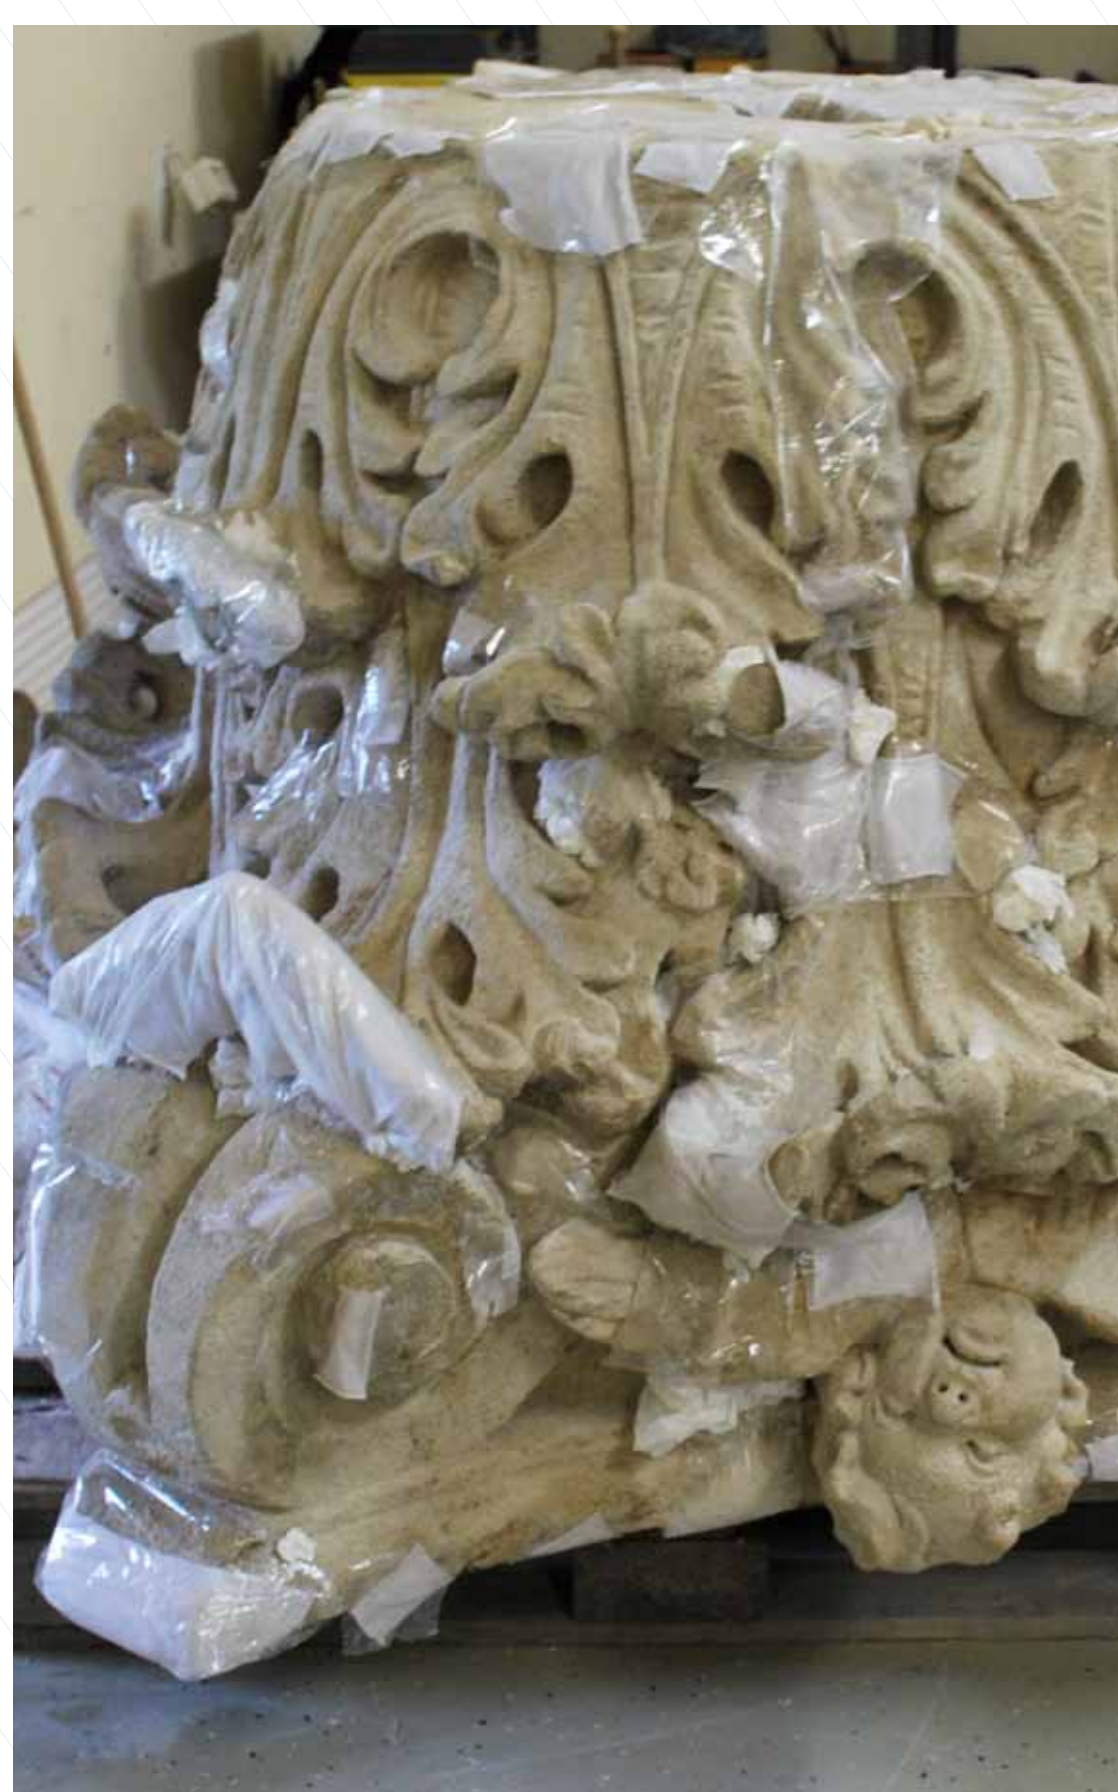
Kemijsko tretiranje kapitela u radionici  
Chemical treatment of the capitel in the workshop

OSIM MEHANIČKI, na pilu je bilo potrebno intervenirati i kemijskim sredstvima. Laboratorijskim je analizama utvrđeno da se u strukturi kamena s vremenom nakupila velika količina topivih soli koja je u materijal dospjela prodorom kapilarne vlage. Topive su soli štetne budući da putuju po strukturi kamena, a sušenjem se kristaliziraju čime im se višestruko povećava volumen te na

APART FROM THE mechanical methods, chemical treatment of the monument was also required. A laboratory analysis found that over time, a large amount of soluble salts had accumulated in the stone structure, permeating the material by way of capillary moist. Soluble salts are damaging, since they move through the stone structure and chrystalize by drying, multiplying manifold in volume, and thus slowly destroying the stone. In order to transform them into insoluble salts, harmless to the stone, the so called Lewin method was used to treat the monument. The procedure involves placement of cellulose pulp saturated with barium hydroxide on the stone, which converts soluble salts into insoluble. It is necessary to repeat the procedure enough times, until the amount of soluble salts is reduced to an acceptable level.

taj način polako razaraju kamen. Kako bi ih se pretvorilo u, za kamen neškodljive, netopive soli spomenik je tretiran tzv. Lewinovom metodom. Postupkom se na kamene površine stavljaju oblozi, celulozne pulpe, natopljeni barijevim hidroksidom koji topive soli pretvara u netopive. Postupak je potrebno ponoviti dovoljan broj puta dok se količina topivih soli ne svede na prihvatljivu razinu. Osim tretiranja soli u strukturi materijala, kemijski su tretirane i tzv. malahitne mrlje koje su se pojavile na površinama gornjih dijelova spomenika kao posljedica pada bakrenih čestica sa golubice i ostalih bakrenih dijelova kompozicije sv. Trojstva. Čestice bakra prodrle su u strukturu kamena zbog čega su na površinama nastale zelene mrlje. Mrlje su tretirane natapanjem celuloznom pulpom natopljenom amonijevim karbonatom koji otapa

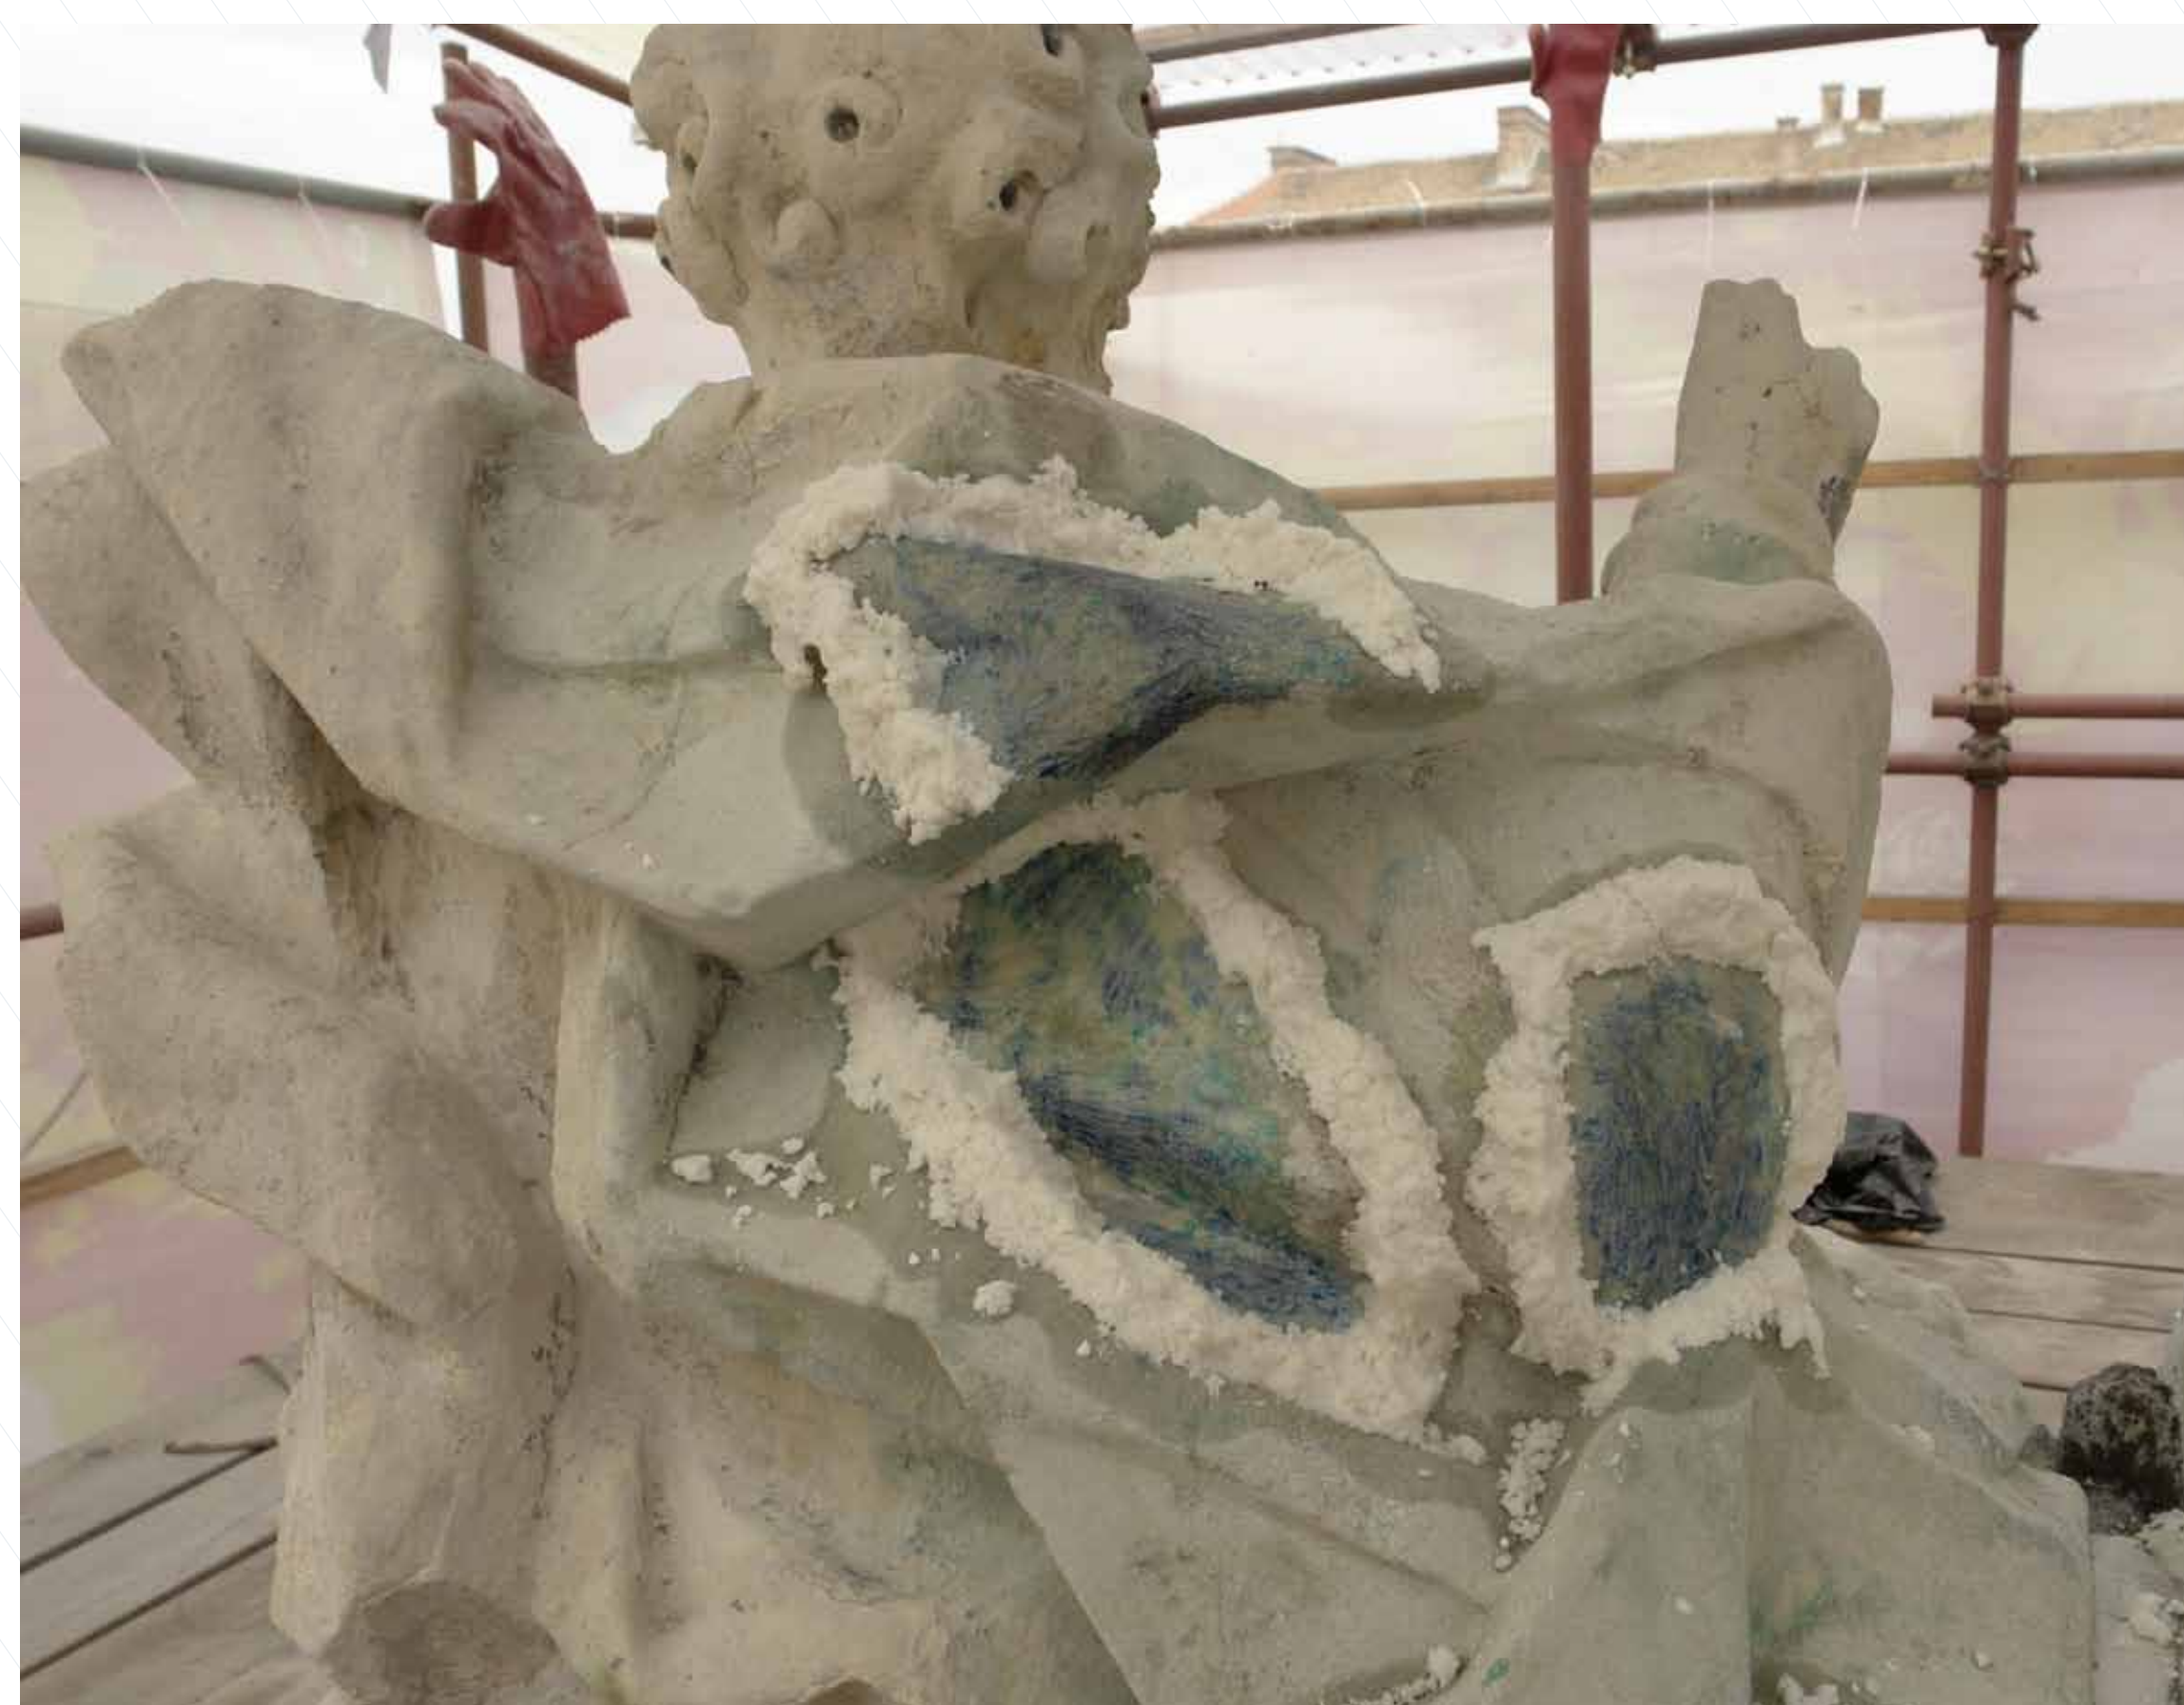
Uklanjanje malahitnih mrlja sa skulpture Boga Oca pulpom natopljenom amonijevim karbonatom  
Removal of malachite stains from the statue of God the Father by pulp saturated with ammonia carbonate

Apart from the treatment of the salt in the material structure, also chemically treated were the so called malachite stains, found on the surfaces of the upper sections of the monument, caused by the copper particles from the dove

and other copper parts of the Holy Trinity composition. Copper particles had penetrated the stone structure, creating green staining on the surfaces. The staining was treated with cellulose pulp saturated with ammonia carbonate which dissolves copper. Drying of the pulp draws the dissolved copper to the stone surface and into the actual pulp, where it manifests as blue staining.

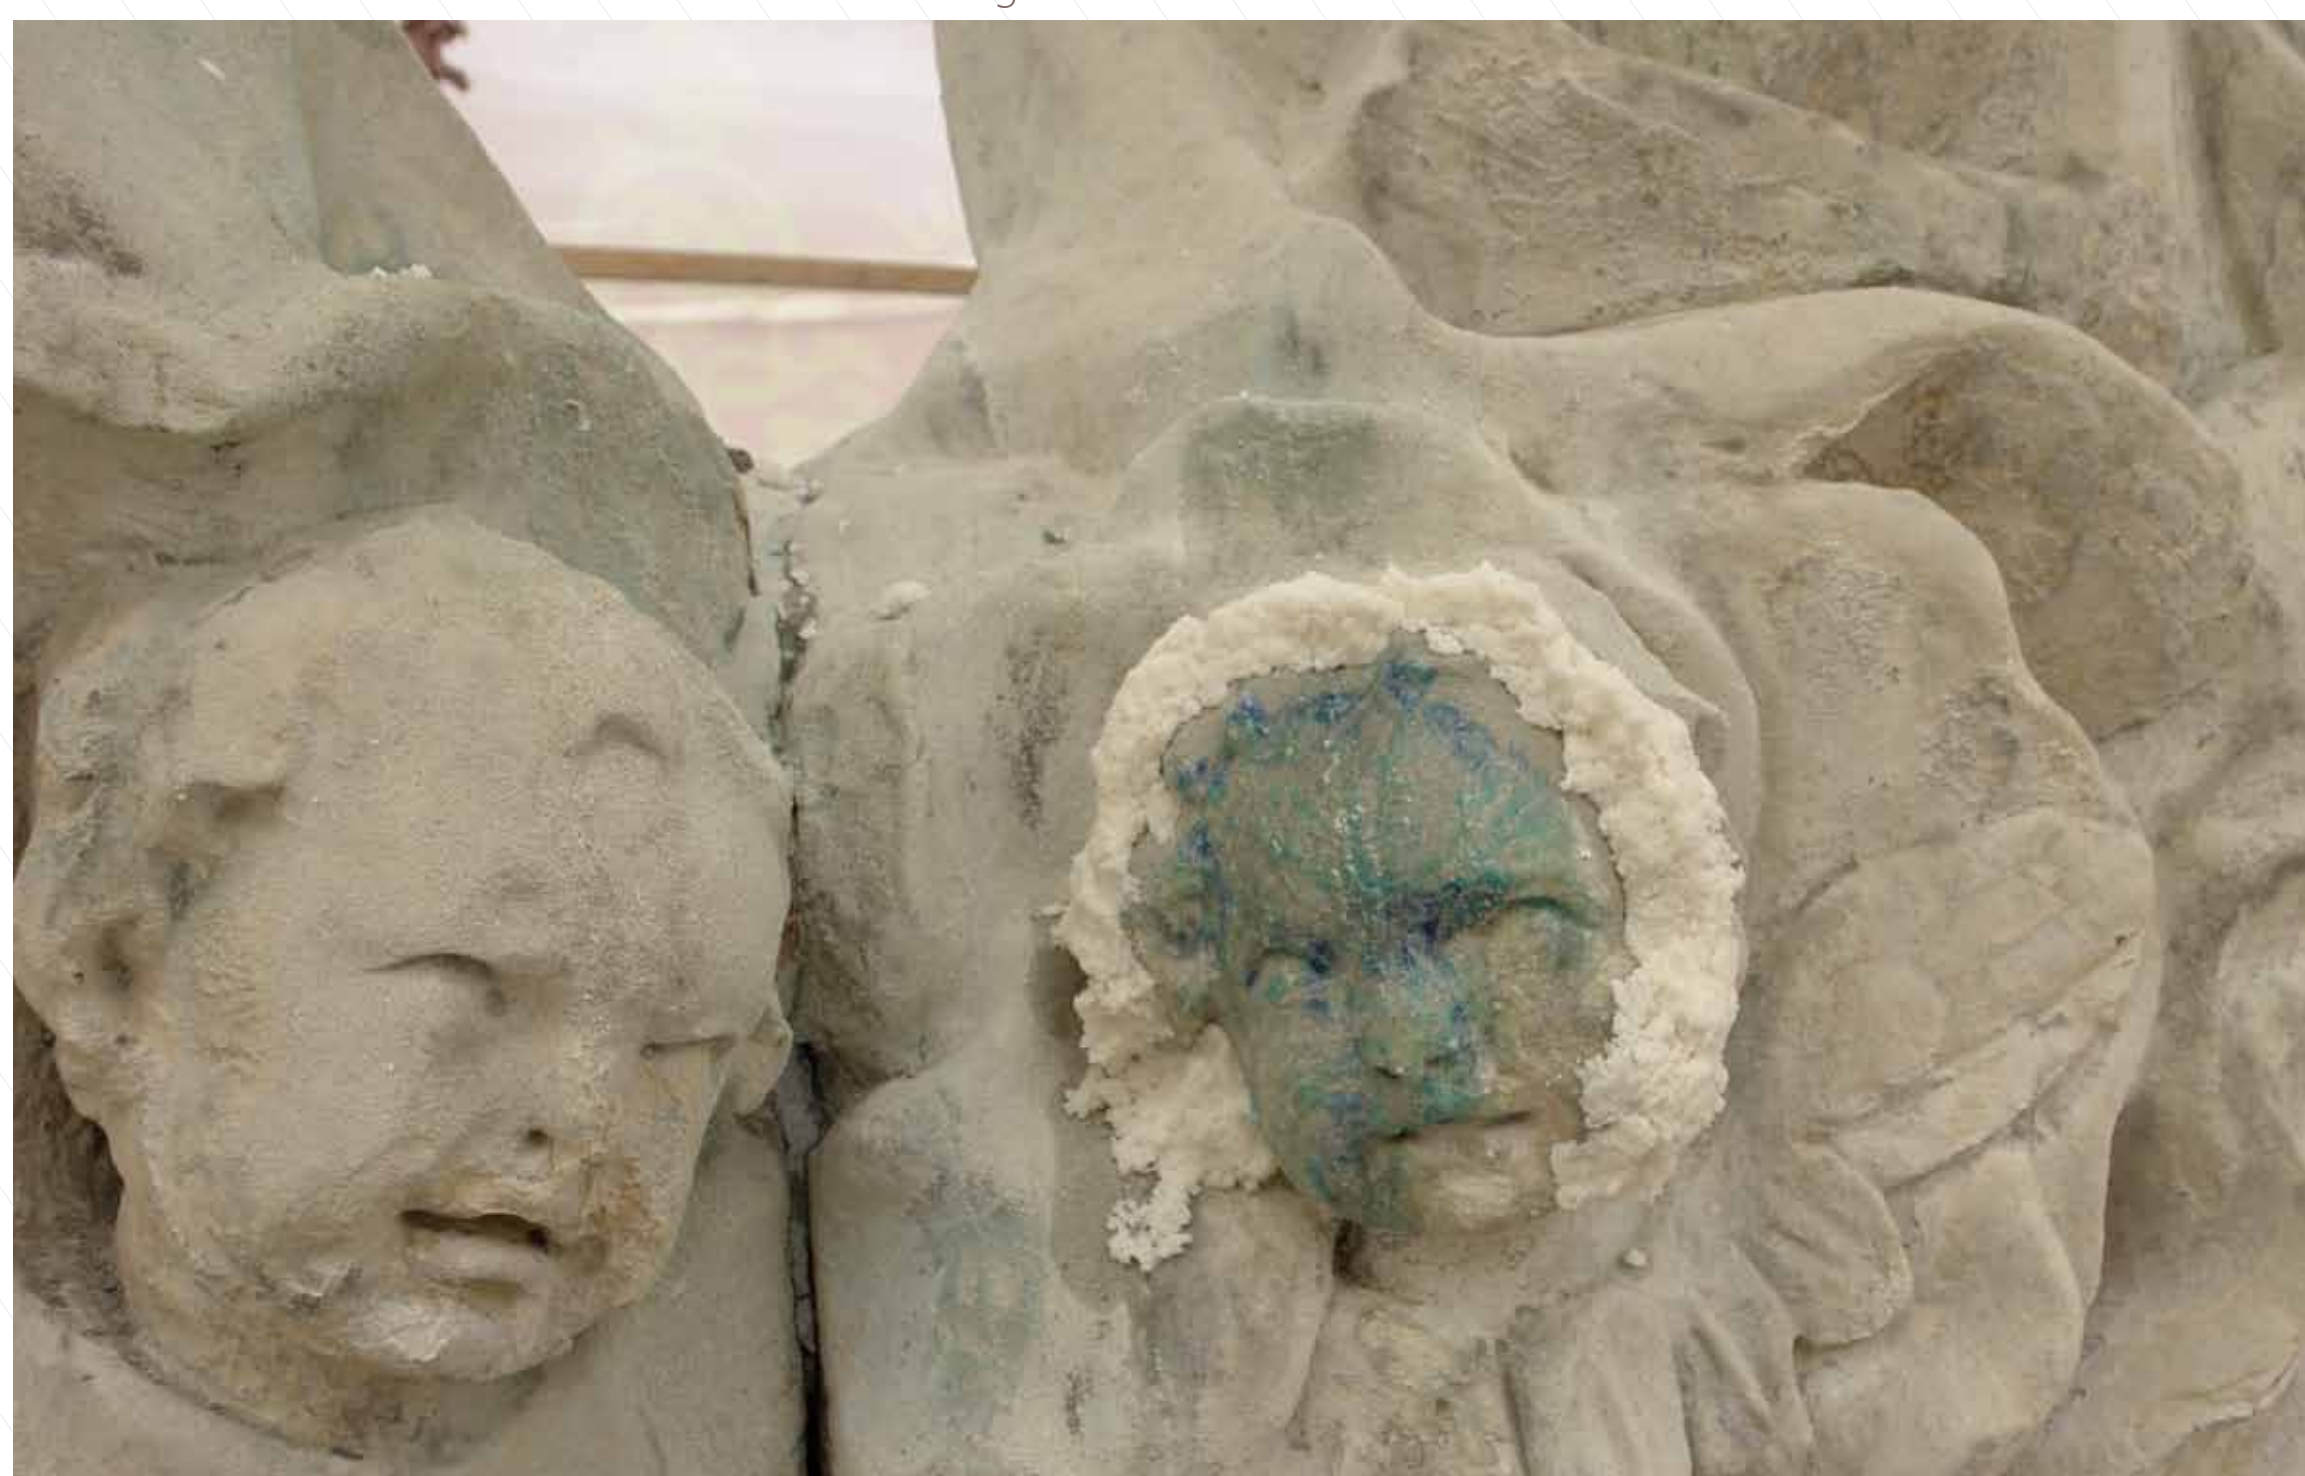
Malahitne mrlje na glavi anđela  
Malachite stains on the head of an angel

Uklanjanje malahitnih mrlja s glave anđela  
Removal of malachite stains from the head of an angel

bakar. Sušenjem pulpa povlači otopljeni bakar na površinu kamena i u samu pulpu na kojoj se on manifestira kao plava mrlja.

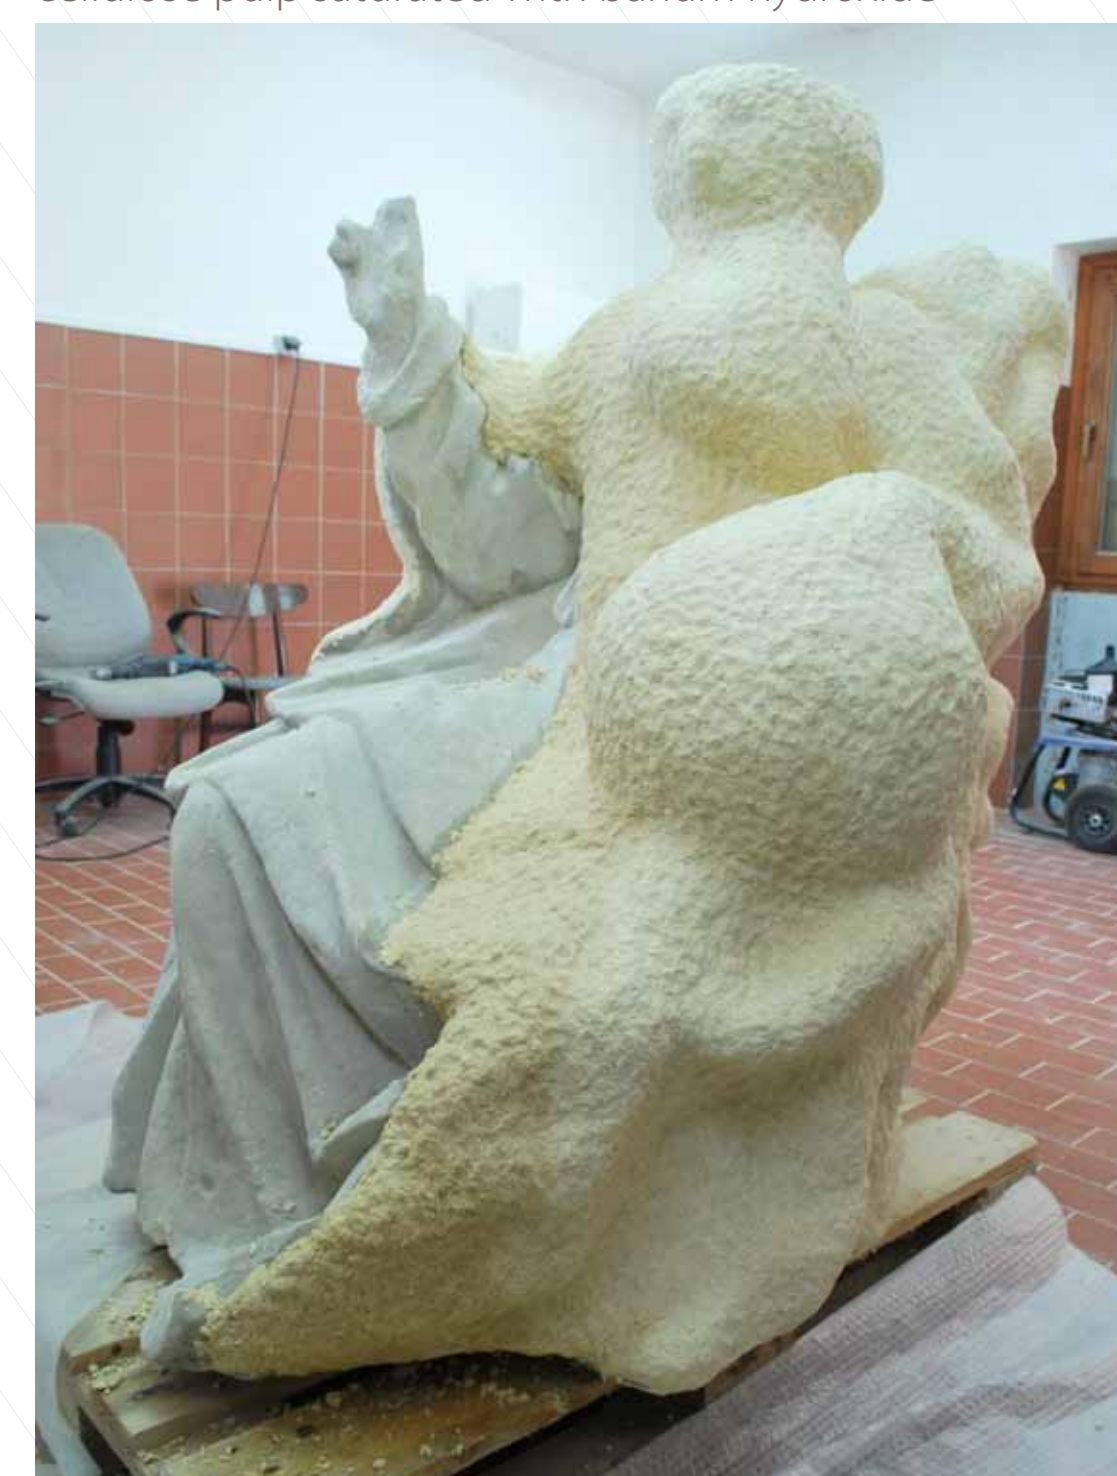
Skulptura Boga Oca u radionici obložena celuloznom pulpom natopljenom barijevim hidroksidom  
Statue of God the Father in the workshop covered with cellulose pulp saturated with barium hydroxide
