# konzervatorsko-restauratorski radovi na pilu sv. trojstva u osijeku

CONSERVATION AND RESTORATION WORK ON THE HOLY TRINITY VOTIVE  
MONUMENT (PIL) IN OSIJEK

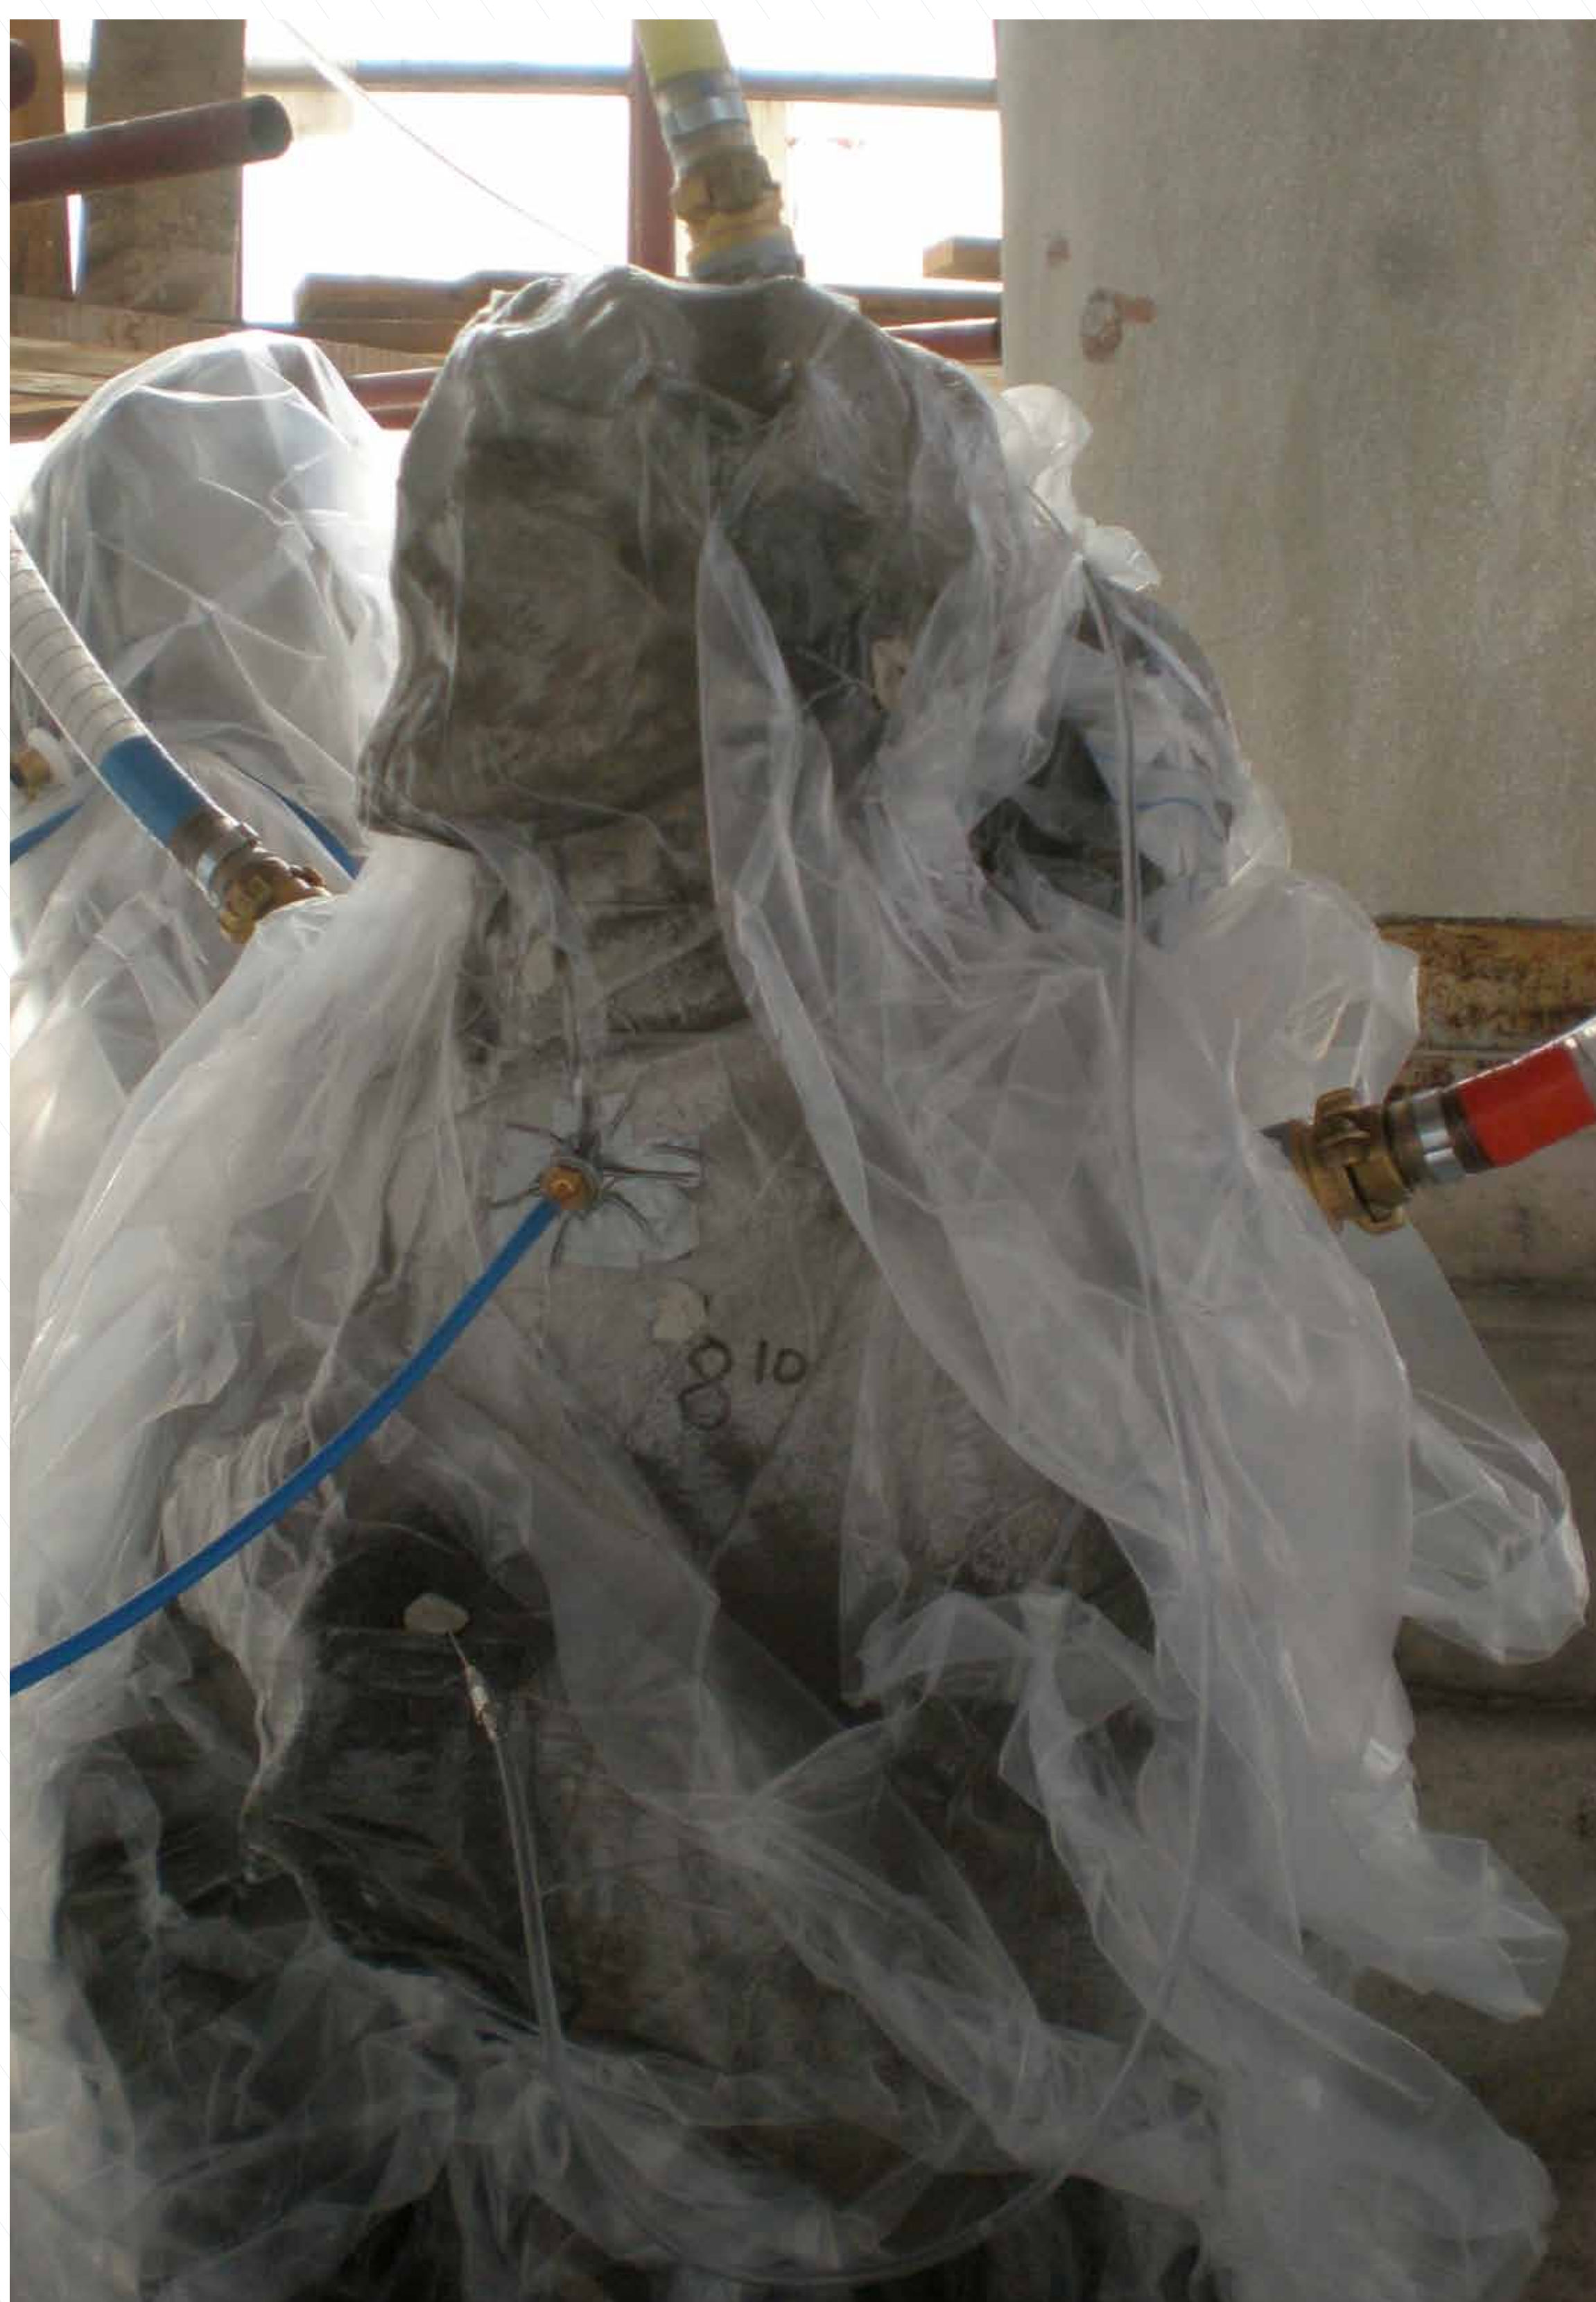
Vakuumsko učvršćivanje skulpture sv. Roka in situ  
Vacuum reinforcement of the statue of St. Roch *in situ*

POROZNA SE STRUKTURA kamena od kojega je spomenik napravljen tijekom vremena dodatno povećala. Restauratorskim zahvatom 70-ih su kamene površine tretirane sredstvom za učvršćivanje u skladu s tadašnjom konzervatorsko-restauratorskom praksom što se kasnije pokazao neadekvatnim te je dodatno oštetilo kamen. Sredstvo za učvršćivanje koje se tada koristilo stvrdnulo je samo površinski sloj te je on s vremenom počeo otpadati zbog razlike u čvrstoći

površinskoga i dubinskoga sloja koju je pojačalo djelovanje atmosferskih utjecaja. Zbog navedenih je razloga bilo potrebno kamen učvrstiti suvremenim tehnikama i materijalima. Čitav je gornji dio pila, kapitel, oblak i kipovi Boga Oca i Krista te pet donjih skulptura središnje kompozicije učvršćeno vakuumski. Skulpture i dijelovi arhitektonske plastike su umotani u najlonske vreće te je iz njih vakuum pumpom izvučen zrak na

mjesto kojega je podtlakom ubačen učvršćivač za kamen (esteri silicijske kiseline). Gornji su demontirani dijelovi vakuumski obrađeni u radioni, a pet skulptura in situ. Opisane je radove izveo Atelier Erich Pummer iz Austrije u suradnji sa tvrtkom Remmers iz Njemačke čiji je zastupnik Arp d.o.o. iz Zeline.

THE POROUS STRUCTURE of the stone used for the construction of the monument had increased over time. During the 1970s restoration work, the stone surfaces were treated with a reinforcement agent, following the conservation and preservation practice standard at the time, which would later prove inadequate, and additionally damage the stone. The reinforcement agent used only hardened the surface layer, causing its flaking over time due to the difference in solidity between the surface and the deep layer, further enhanced by weathering.

architectural elements were wrapped in plastic bags, air was extracted using a vacuum pump and replaced with a reinforcing agent for stone (silicic acid esters). The upper dismantled parts were vacuum processed in the workshop, and the five statues in situ. The described works were carried out by Atelier Erich Pummer from Austria, in cooperation with Remmers company from Germany, represented by agent Arp d.o.o. from Zelina.

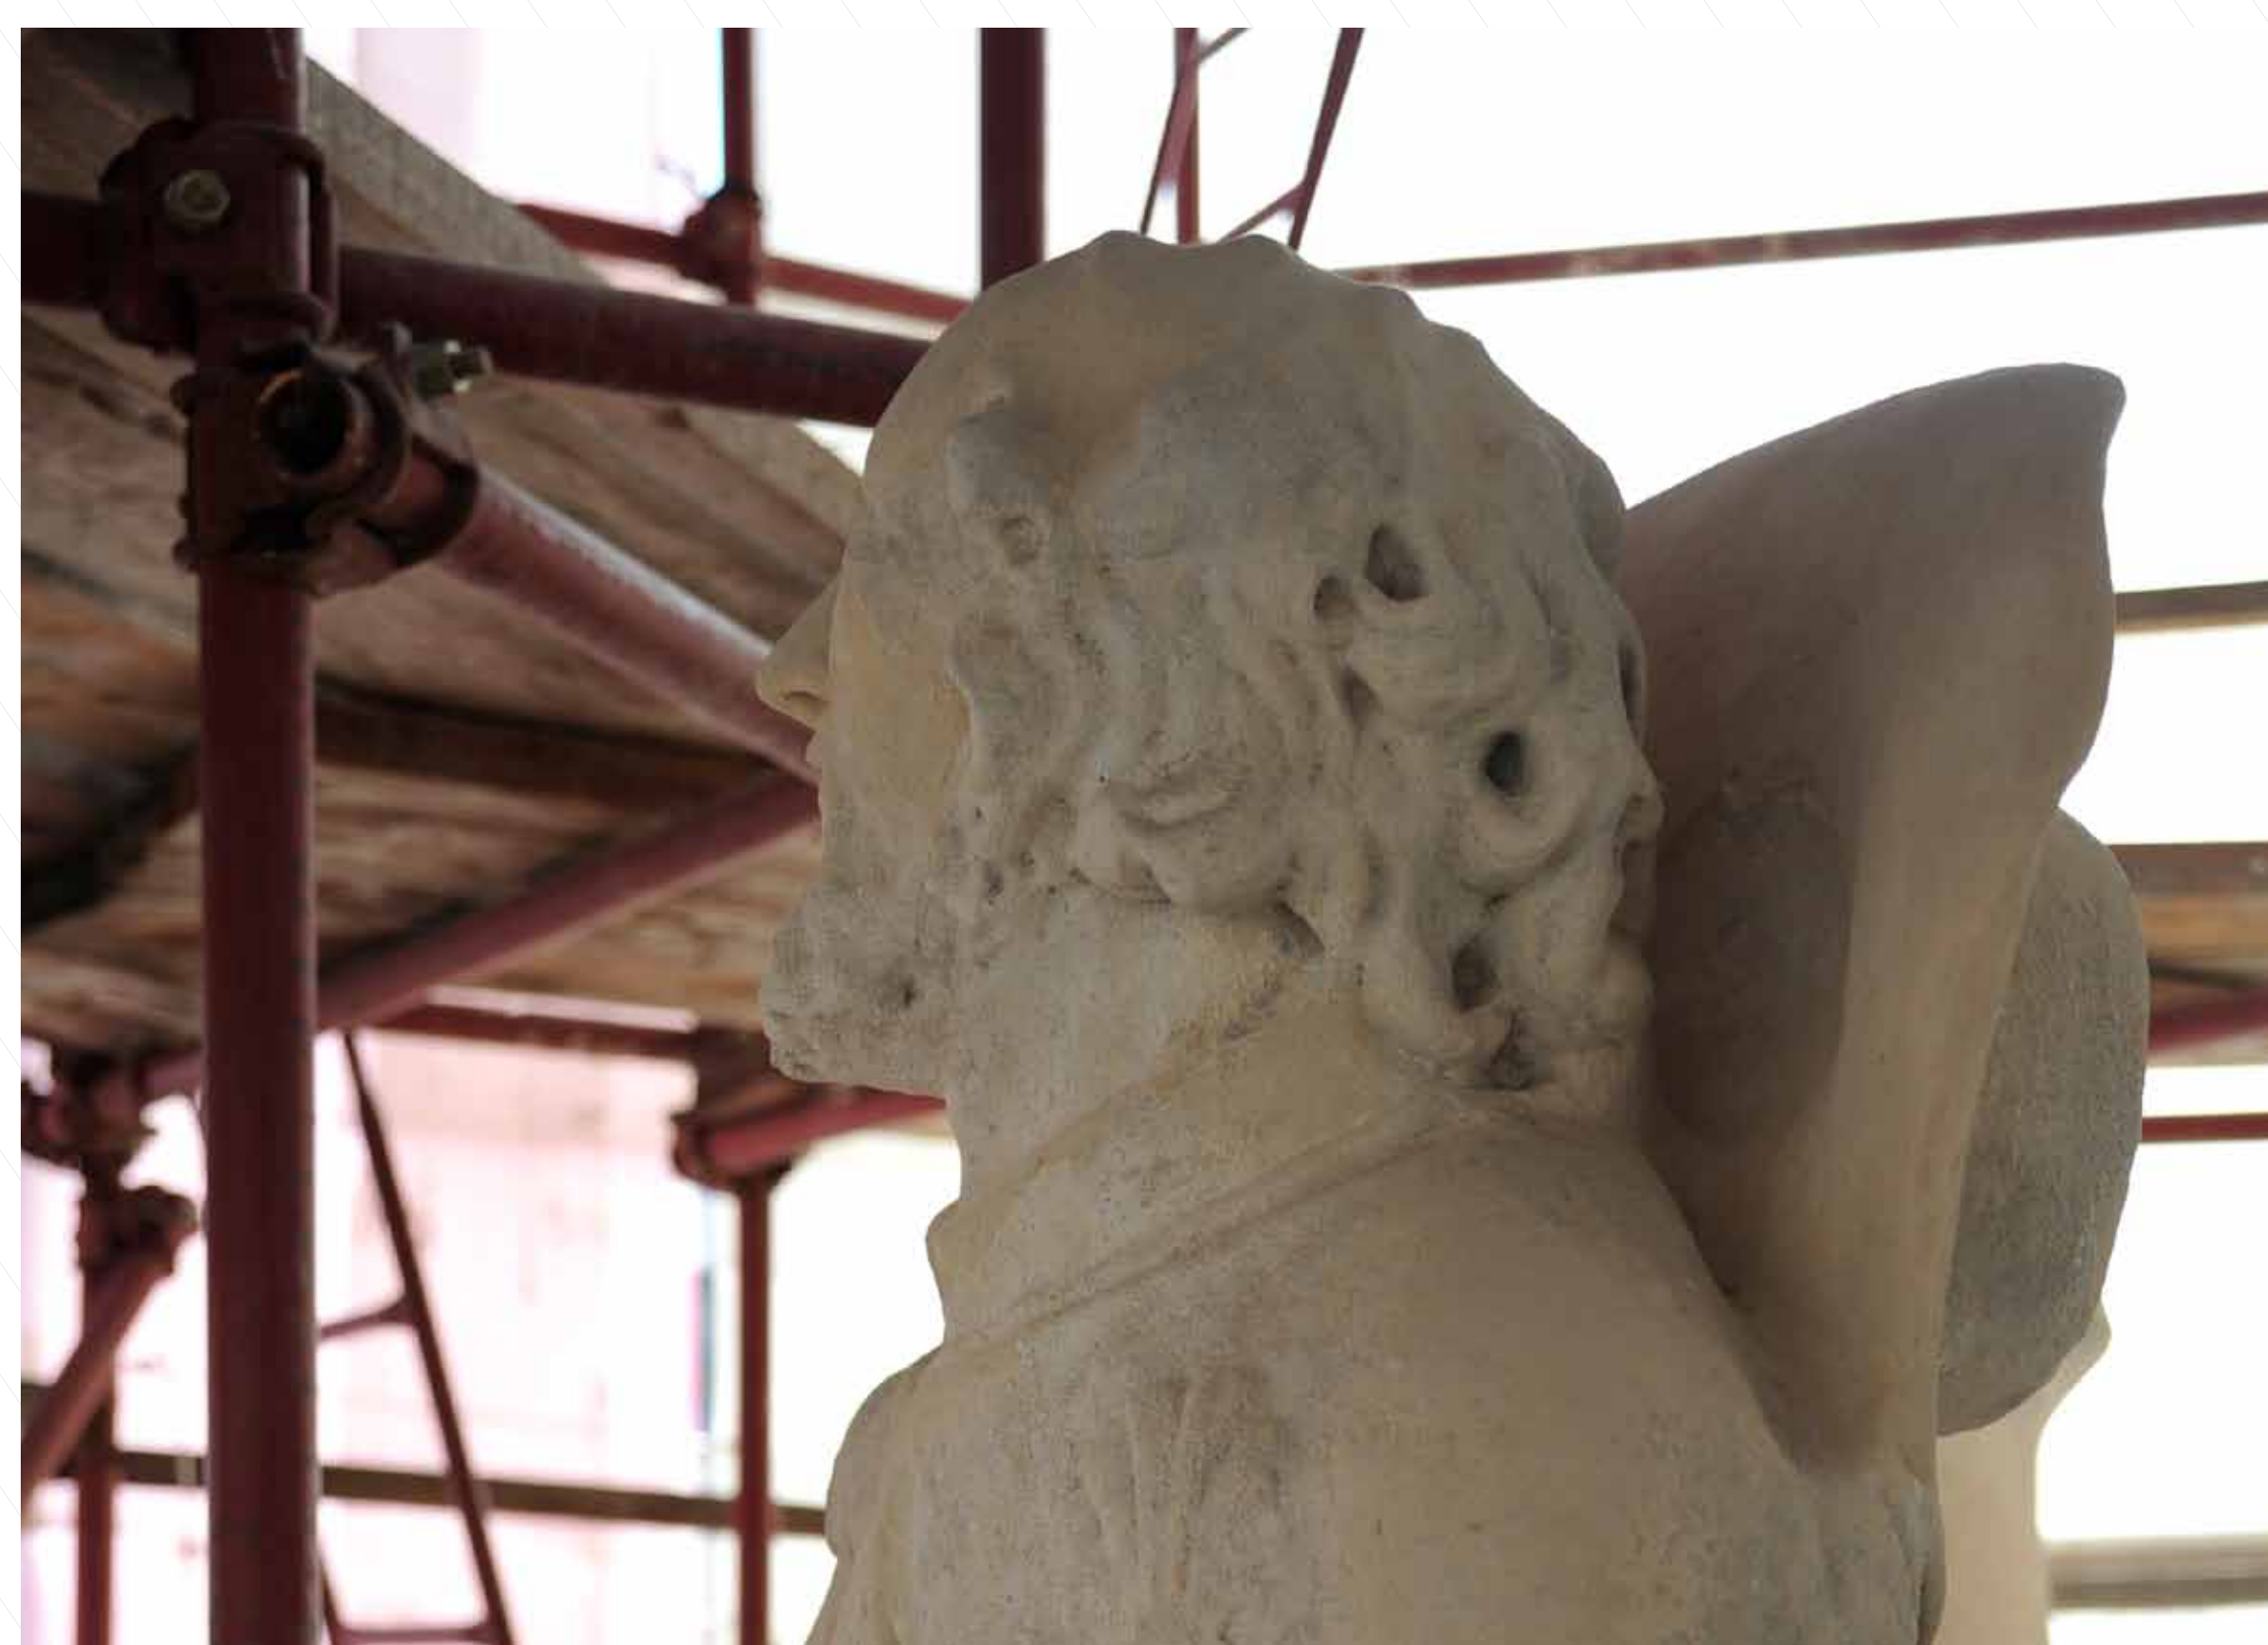
Skulptura sv. Roka nakon vakuumskoga učvršćivanja  
The statue of St. Roch after vacuum reinforcement

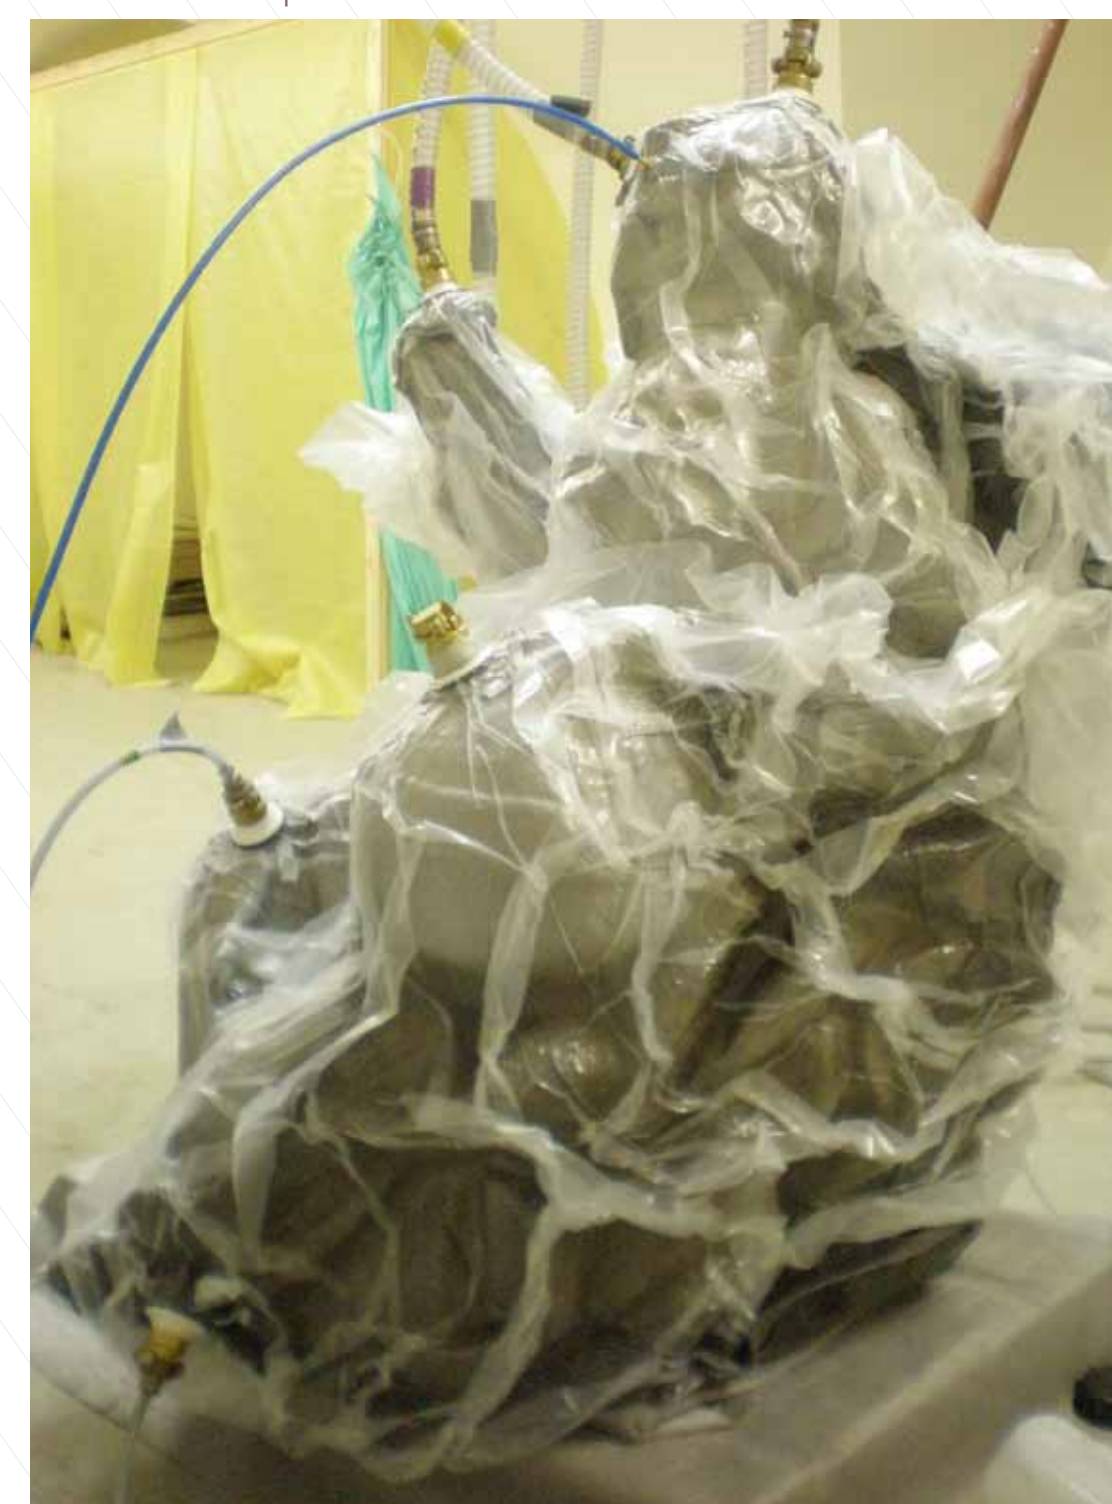
Vakuumsko učvršćivanje skulpture Boga Oca u radionici  
Vacuum reinforcement of the statue of God the Father in the workshop

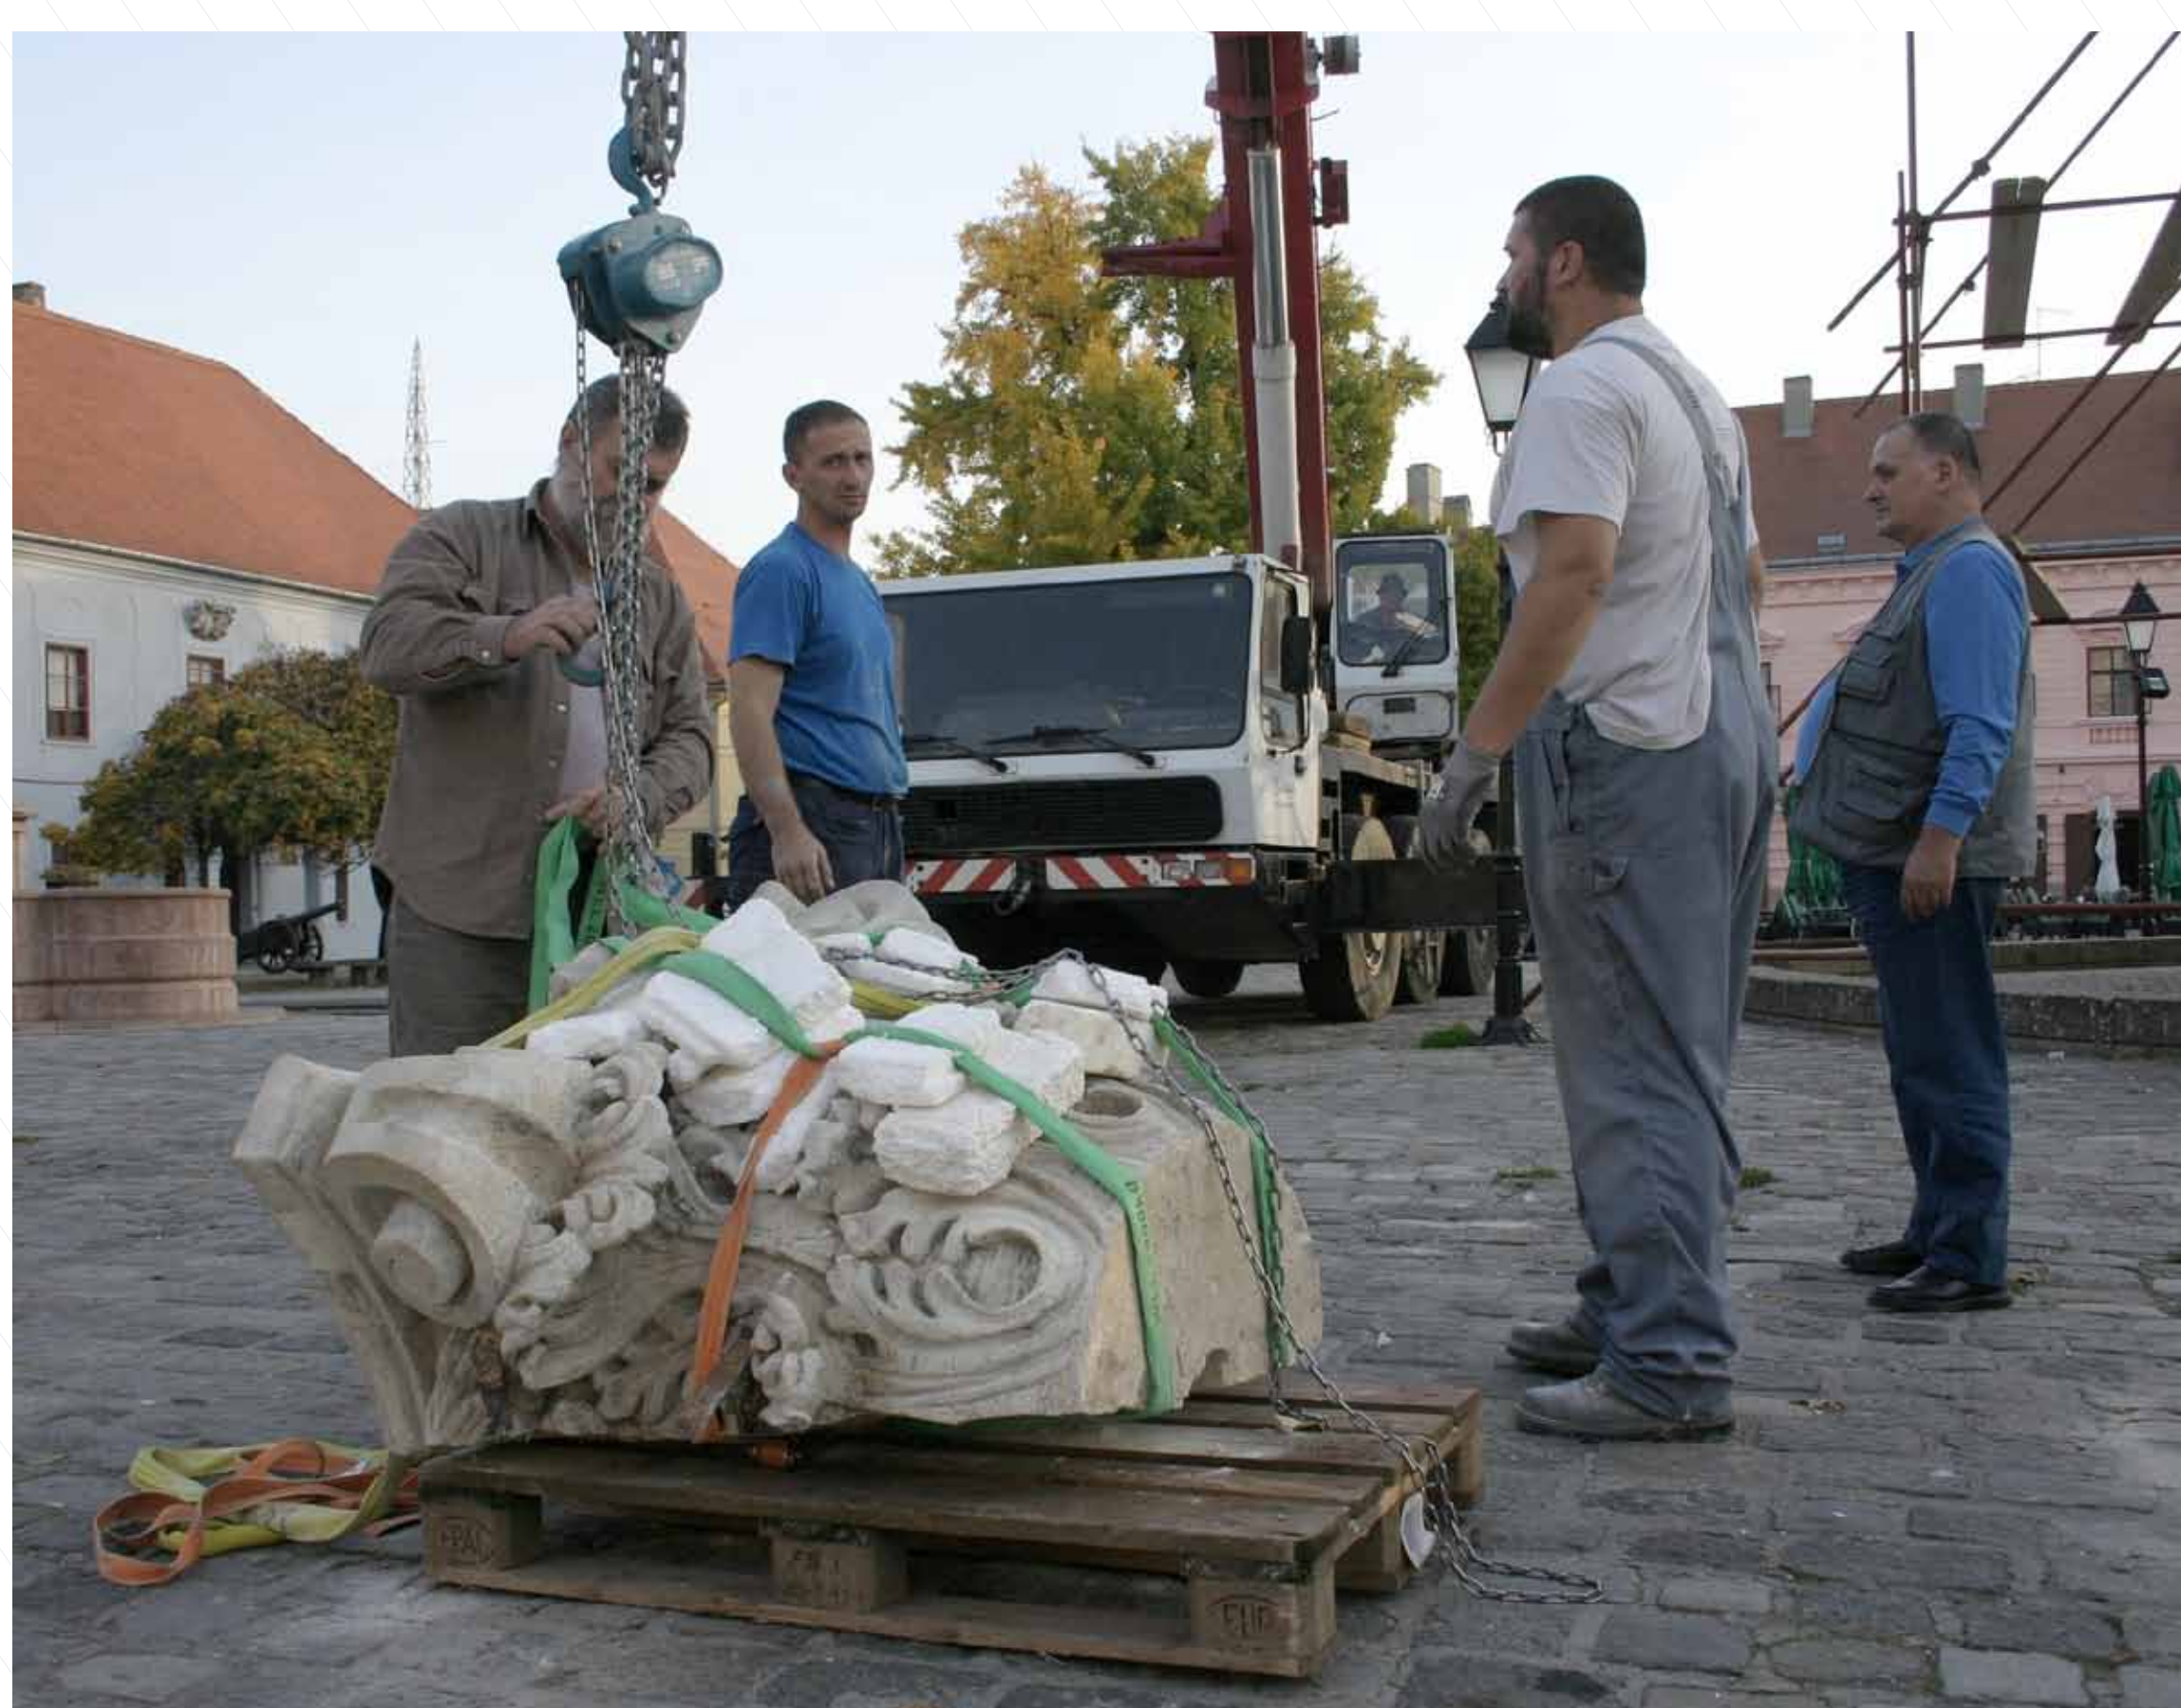
Montaža dijelova kompozicije sv. Trojstva  
Assembly of parts of the composition of St. Trinity

the Father and Christ) were placed back to their original positions with the aid of a crane. During the assembly all the traditional procedures for the joining of individual blocks of stone were applied. The main vertical truss, originally an iron rod, was replaced with a seamless inox pipe, 6cm in diameter, in order to prevent corrosion damaging to the stone. The process of corrosion increases the volume of metal objects, causing gradual cracking of the stone elements to which they are affixed through expansion. The statues of God the Father and Christ are interlinked by a horizontally laid piece of inox, fitted to the central vertical rod, increasing the stability. Originally they were joined by a piece of iron which had corroded due to atmospheric damp. Other iron rods, as well as cramps were also replaced with inox versions, and reinforced by melted lead. During the assembly, the

NAKON ZAVRŠETKA konzervatorsko-restauratorskih radova izvedenih u radionici, gornji su demontirani dijelovi spomenika (kapitel, oblak, skulpture Boga Oca i Krista) dizalicom vraćeni na svoj položaj. Prilikom montaže su poštovani svi tradicionalni postupci povezivanja odvojenih kamenih blokova. Glavni je vertikalni nosač, trn, izvorno željezni, zamijenjen bešavnom cijevi promjera 6 cm od inoksa kako bi se izbjegla korozija štetna za kamen. Metalnim se predmetnima procesom korozije višestruko povećava volumen te svojim širenjem postupno uzrokuju pucanje kamenih elemenata na koje su pričvršćeni. Skulpture Boga Oca i Krista međusobno su povezane horizontalno postavljenim komadom inoksa učvršćenoga na središnji vertikalni trn čime im je pojačana stabilnost. Izvorno su bili povezani komadom željeza koje je pod utjecajem atmosferske vlage korodiralo. I ostali su trnovi, kao i klanfe, također zamijenjeni inoksnima te učvršćeni rastaljenim olovom. Prilikom montaže je primijenjen i tradicionalni postupak postavljanja olovnih ploča, tzv. posteljica između kamenih elemenata kako bi se smanjilo

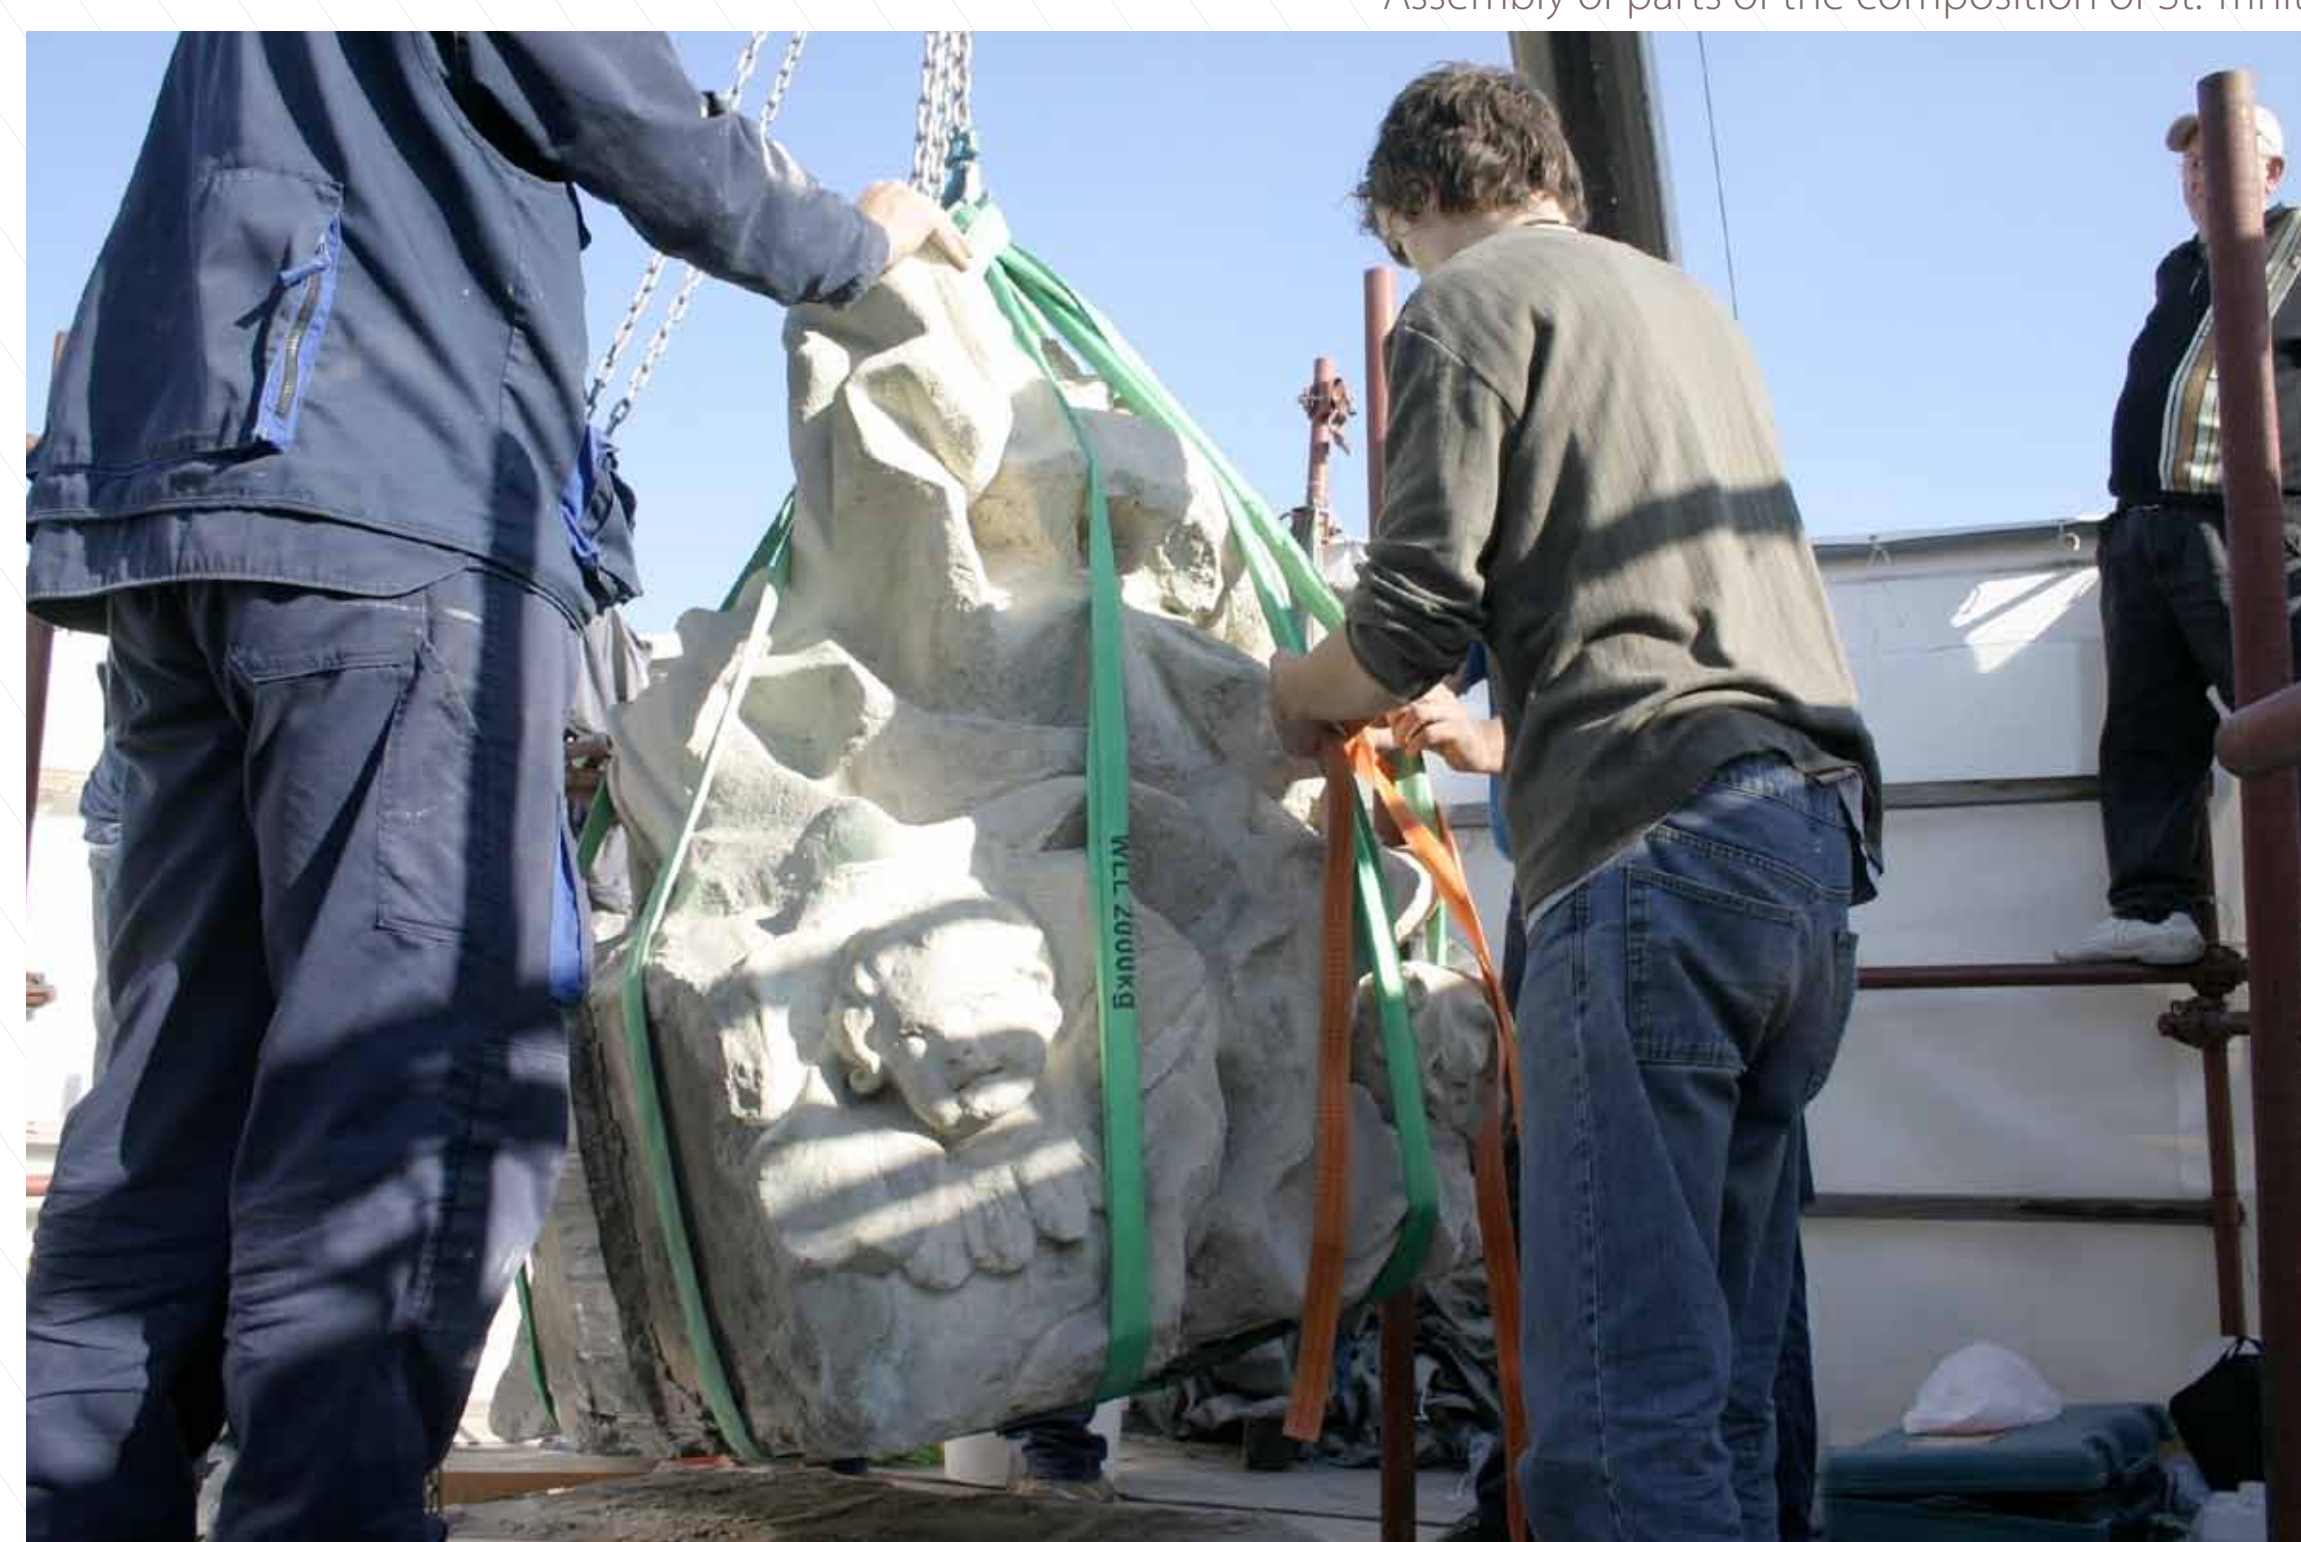
Montaža dijelova kompozicije sv. Trojstva  
Assembly of parts of the composition of St. Trinity

traditional procedure of the fitting of the lead panels was applied, a fitting level, between the stone elements, in order to reduce friction and damage to the blocks at the joints. A total of half a tonne of lead was used during the assembly of the dismantled parts of the monument and the fitting of the new cramps in the lower parts of the monument.

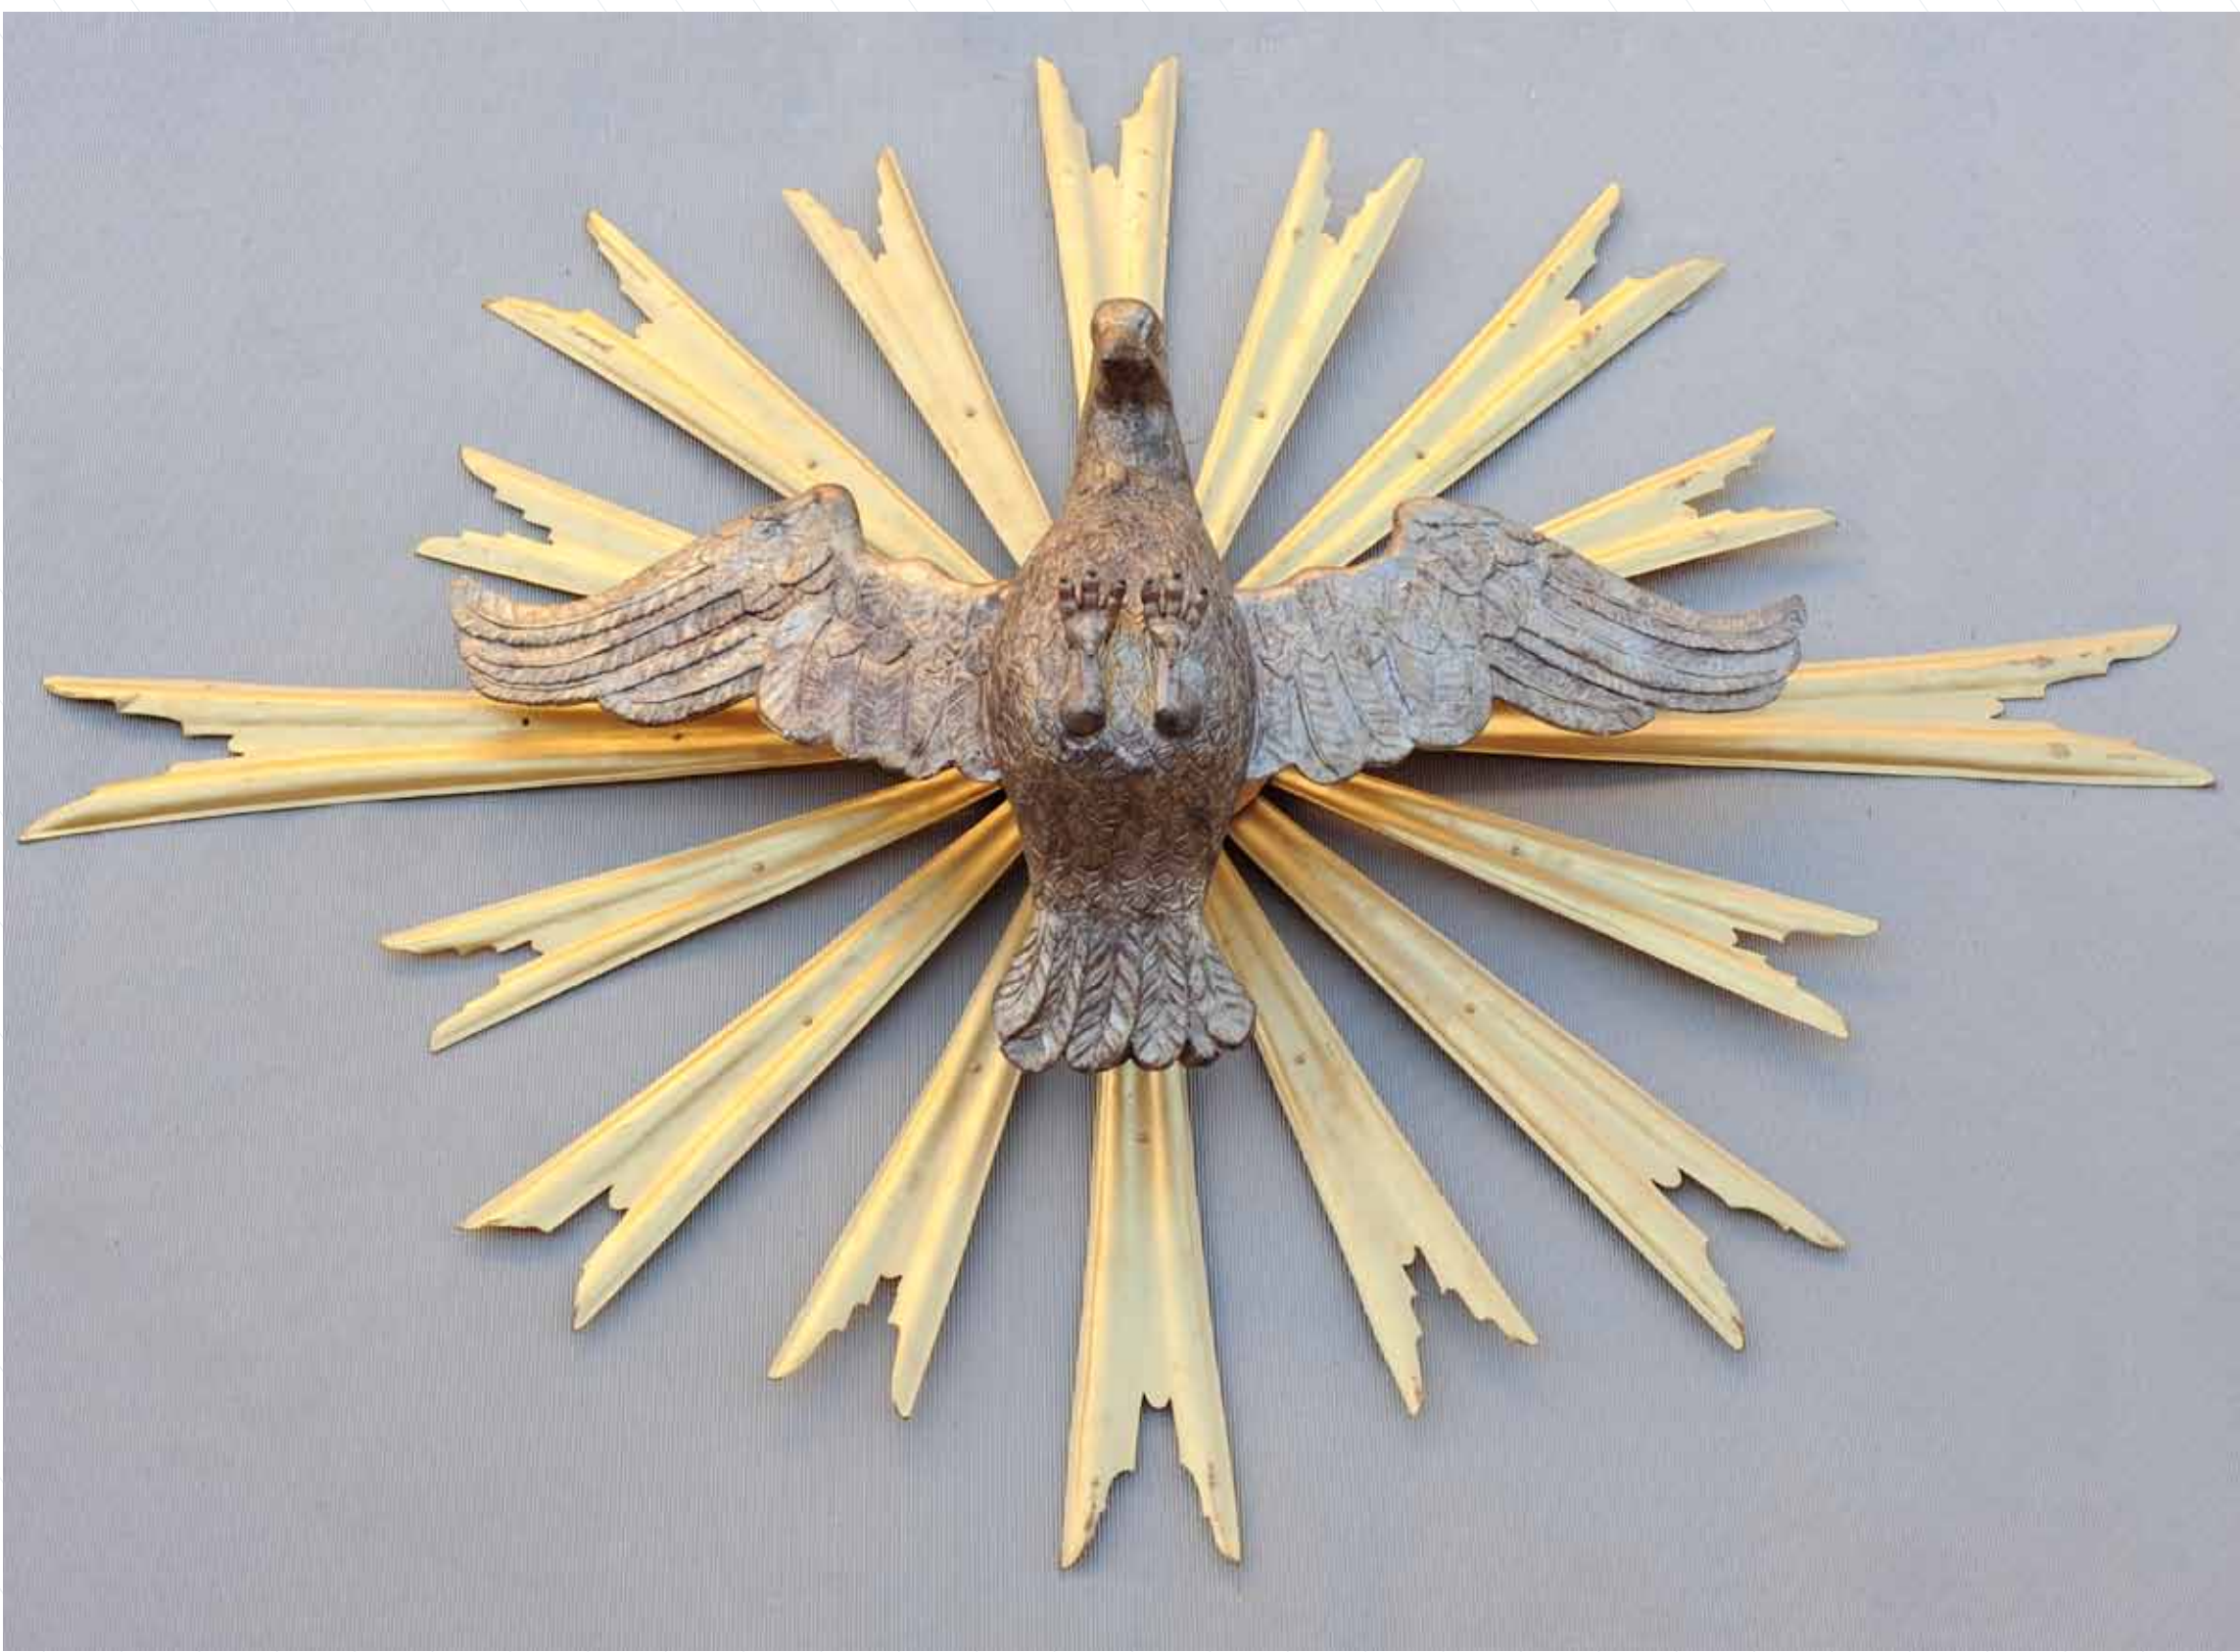
Rekonstruirana golubica Duha svetoga sa restauriranom zrakastom aureolom  
Replica of the dove depicting the Holy Spirit with restored halo with rays

In the course of the last performed restoration work, a decision was made that a new metal replica of the dove should be fitted on the monument top to better fit into the composition, and also due to the durability of the material, whereas other copper parts of the composition would be restored. The restoration was preceded by a scientific analysis of all the metal, and the products of corrosion, as well as the restoration analysis of all the metal parts and the method of their joining and assembly. After it was manufactured, the galvanic replica was silver-plated, and treated with transparent acrylic coating to provide more permanent protection.
