# konzervatorsko-restauratorski radovi na pilu sv. trojstva u osijeku

CONSERVATION AND RESTORATION WORK ON THE HOLY TRINITY VOTIVE  
MONUMENT (PIL) IN OSIJEK

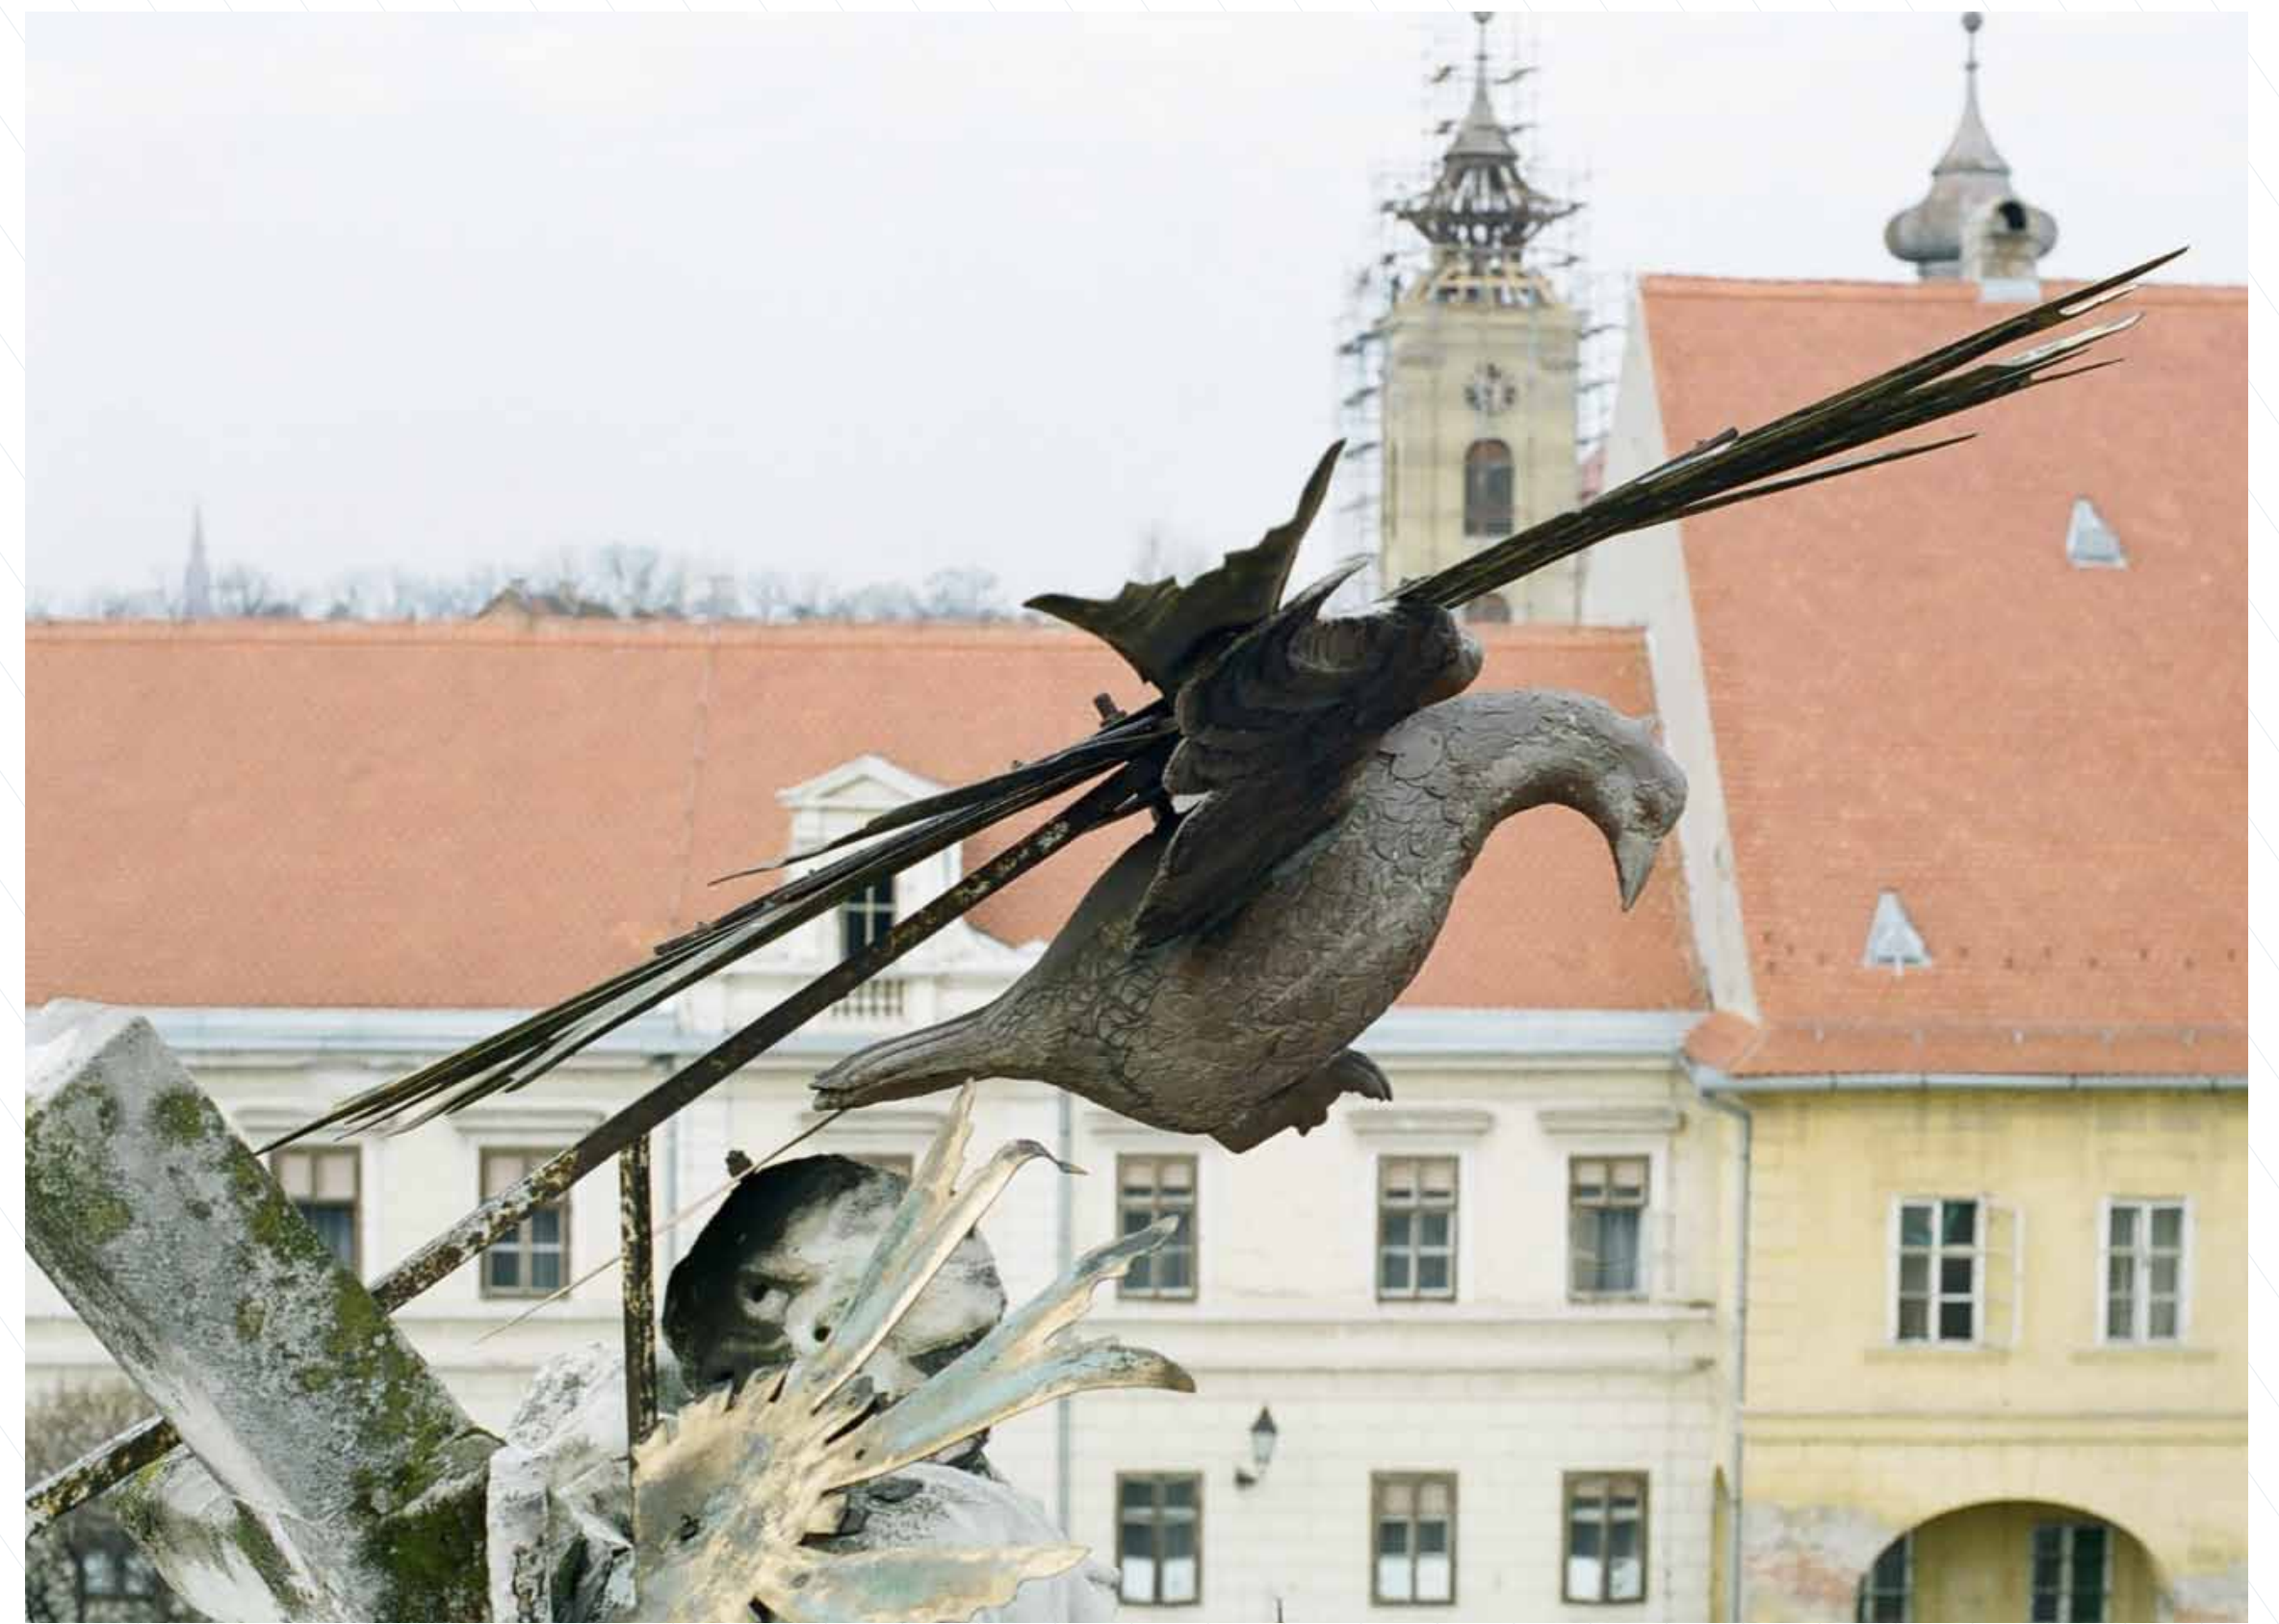
Poliesterska kopija golubice postavljena tijekom restauratorskih radova 70-ih godina  
Replica of the dove made of polyester during the restoration work in the 1970s

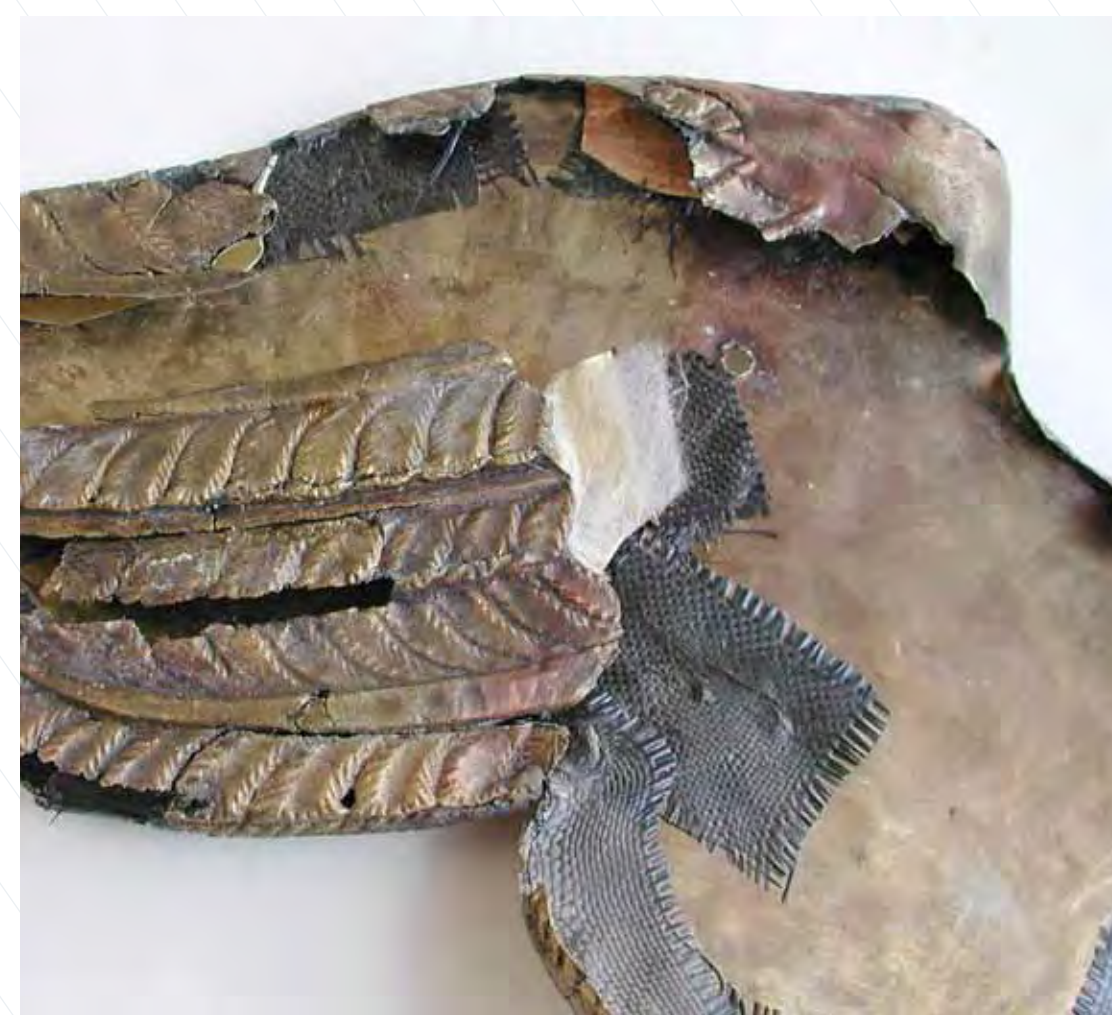
Restauratorski radovi na krilu izvorne golubice  
Restoration work on the wing of the original dove

The copper elements from the top of the monument were cleaned, the material stabilized, partial reconstruction of the missing parts was carried out where necessary, and the elements were coated with a new layer of gold leaf. The preserved parts of the original dove were tightened, conserved and prepared for the museum presentation. The reconstruction of the dove and the restoration work on the copper elements were performed by the metal restoration expert Valentina Ljubić.

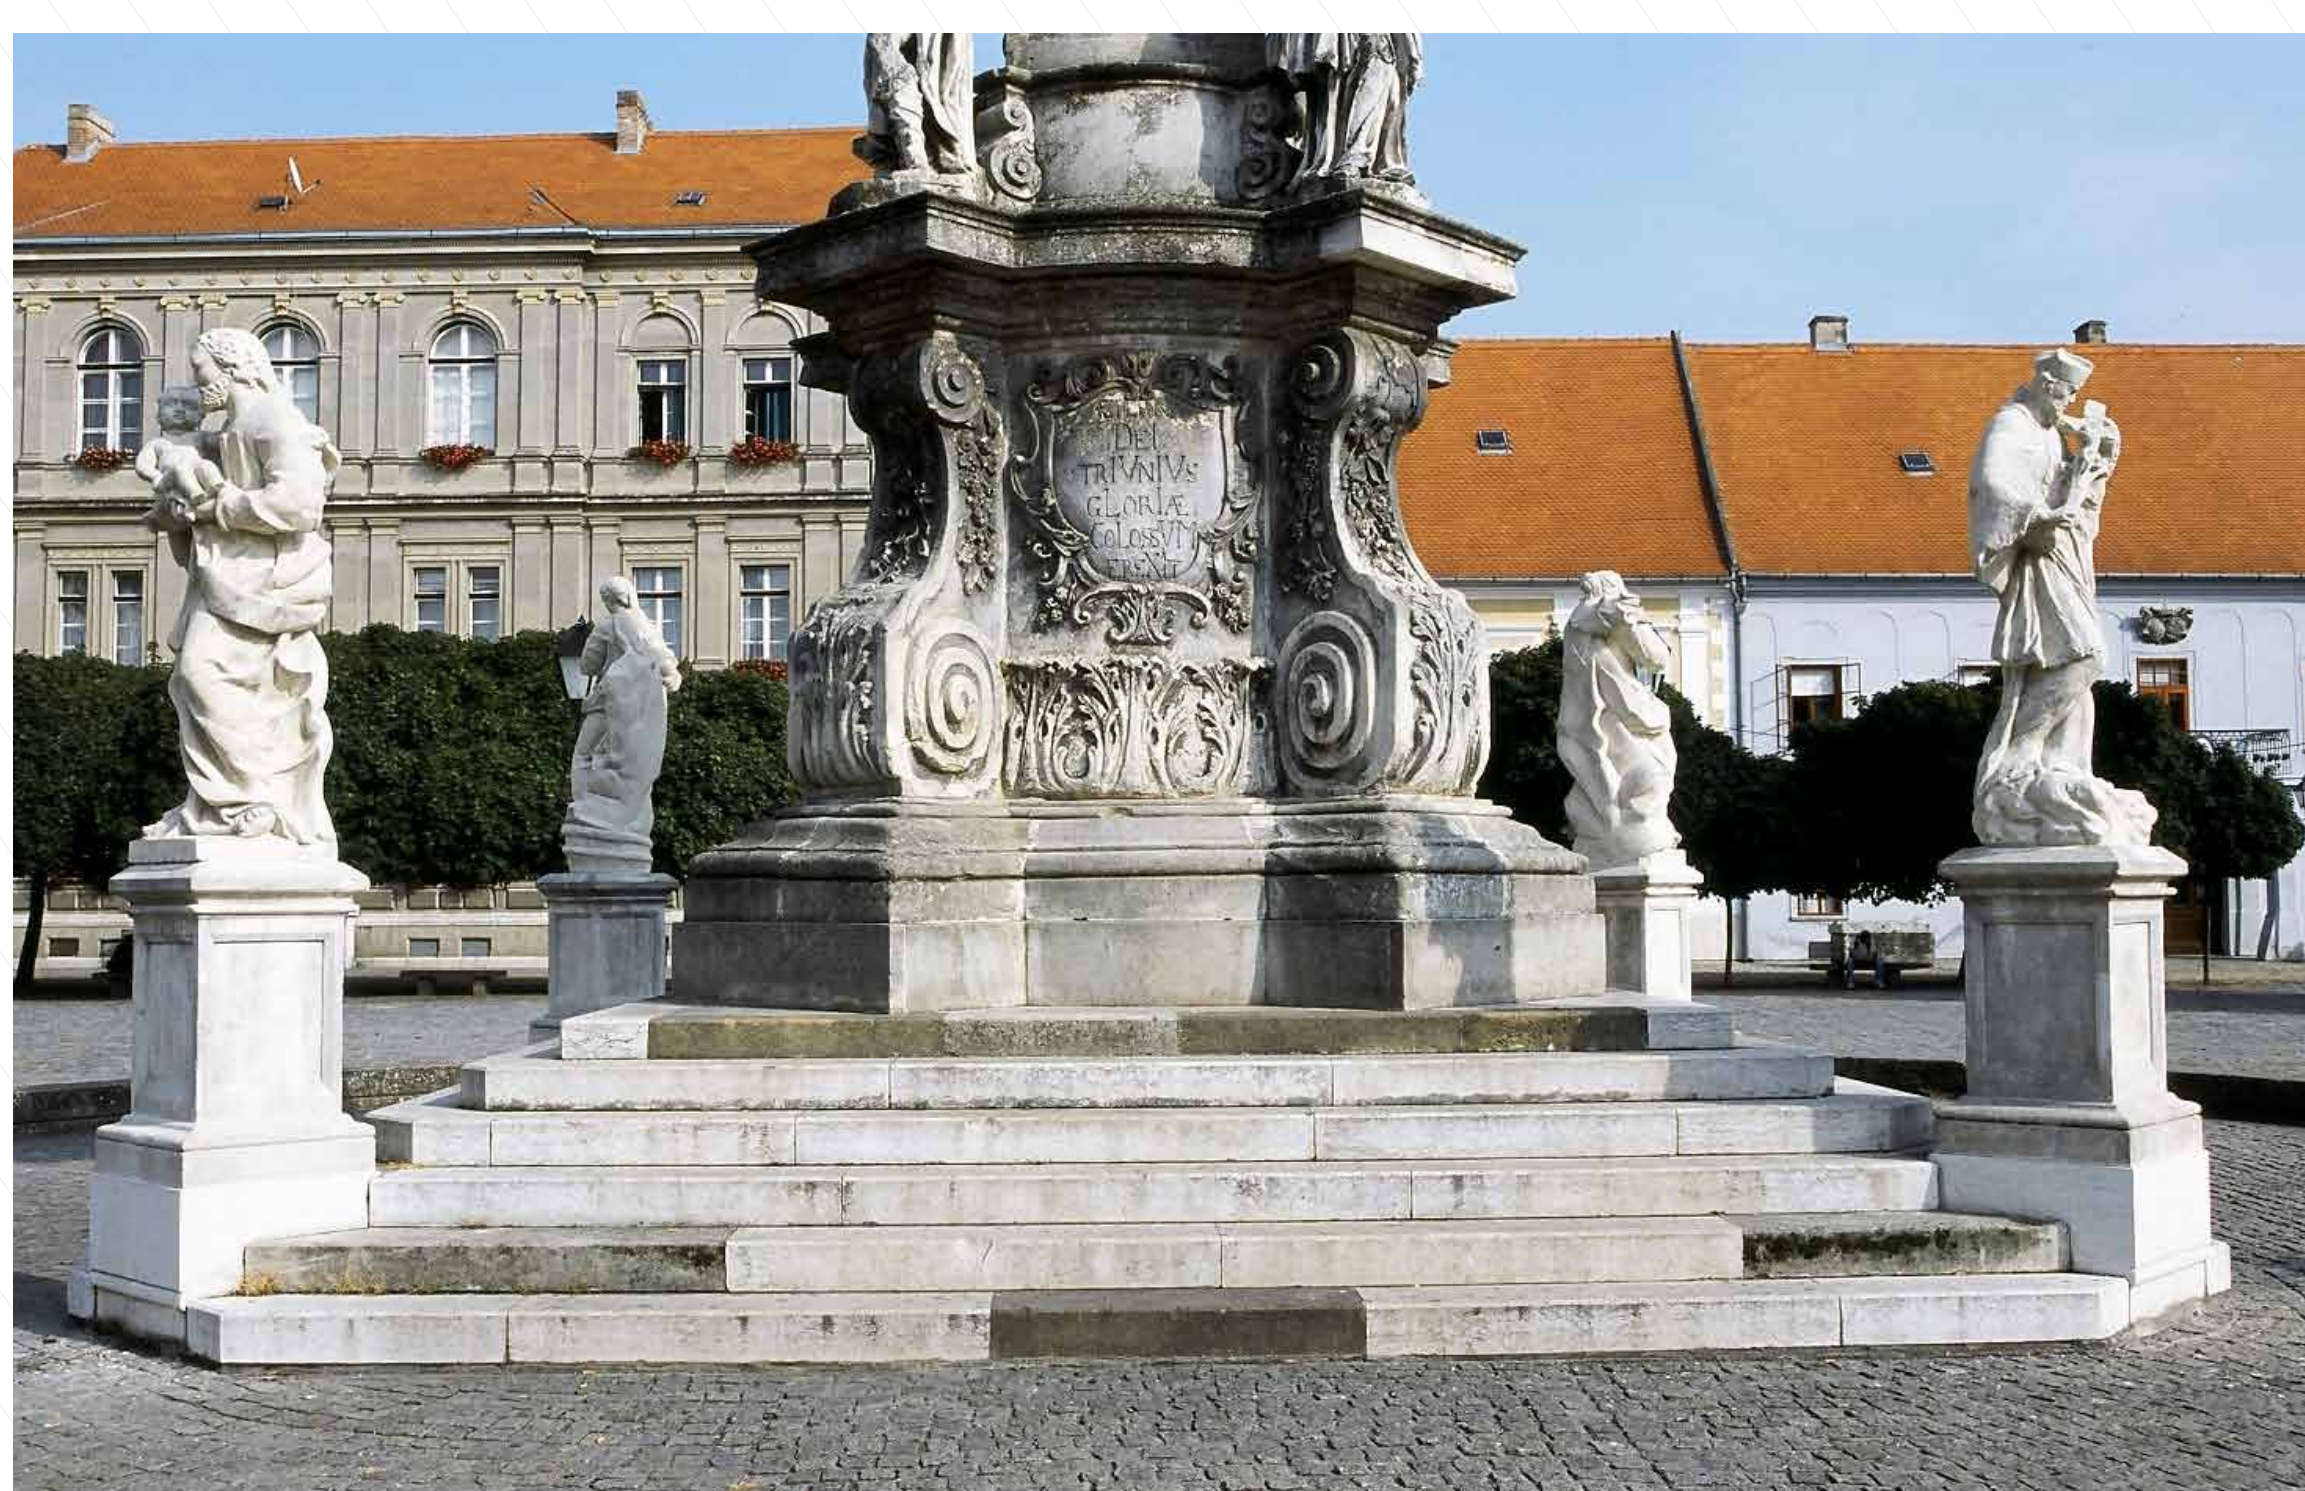
Replike četiri lateralne skulpture nakon postavljanja na pil  
Replicas of four lateral statues after assembly

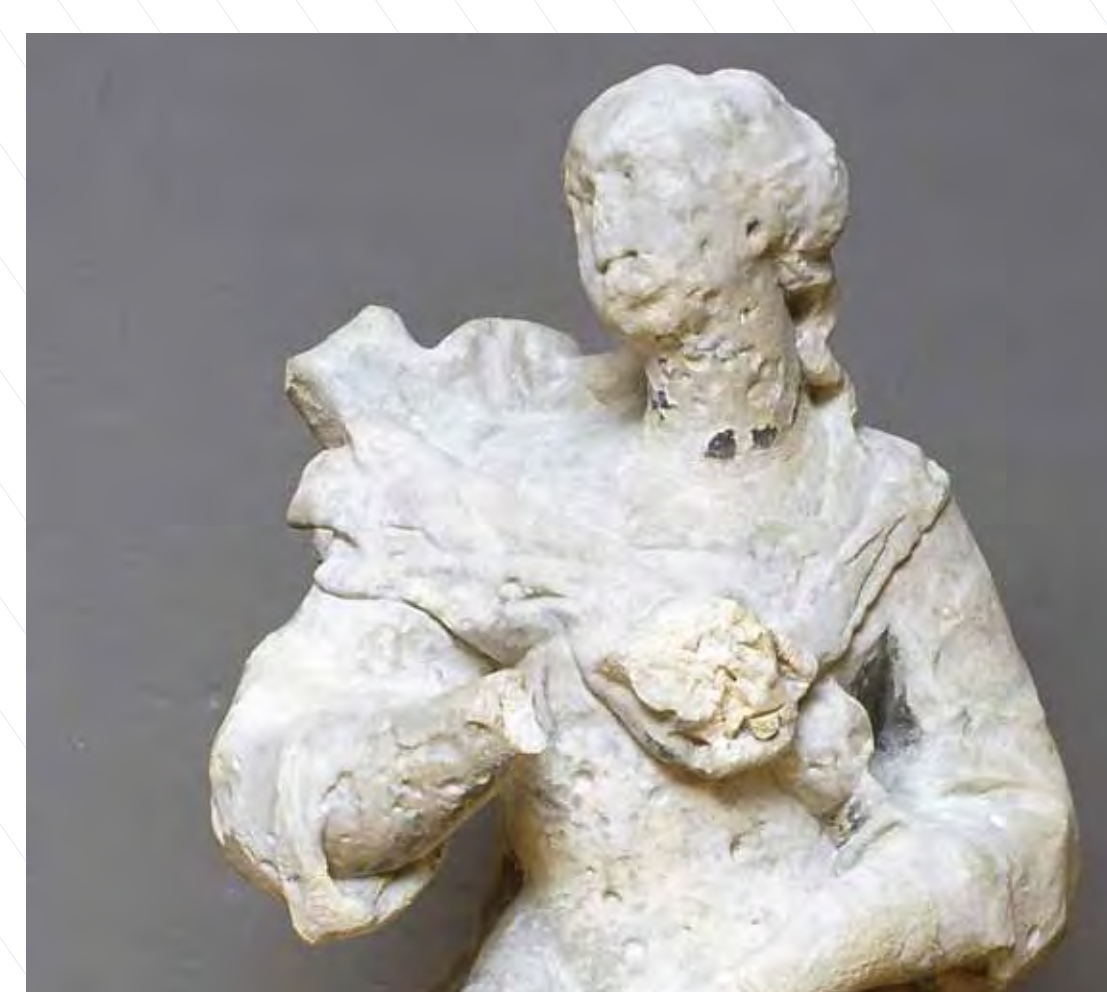
Original skulpture sv. Katarine  
Original of the statue of St. Catherine

AFTER IT HAD been toppled from its base by vandals, the statue of St. Catherine, broken into pieces and badly damaged, was transported to the workshop of the Croatian Conservation Institute in 2001. After the joining of individual parts, a partial reconstruction of the missing parts was carried out in order to return the form to the statue. During the restoration work it was established that the statue, as well as other three lateral statues, were in such a bad condition that it was deemed necessary to store them in a controlled environment, in order to prevent further decay, and use replicas on the monument.

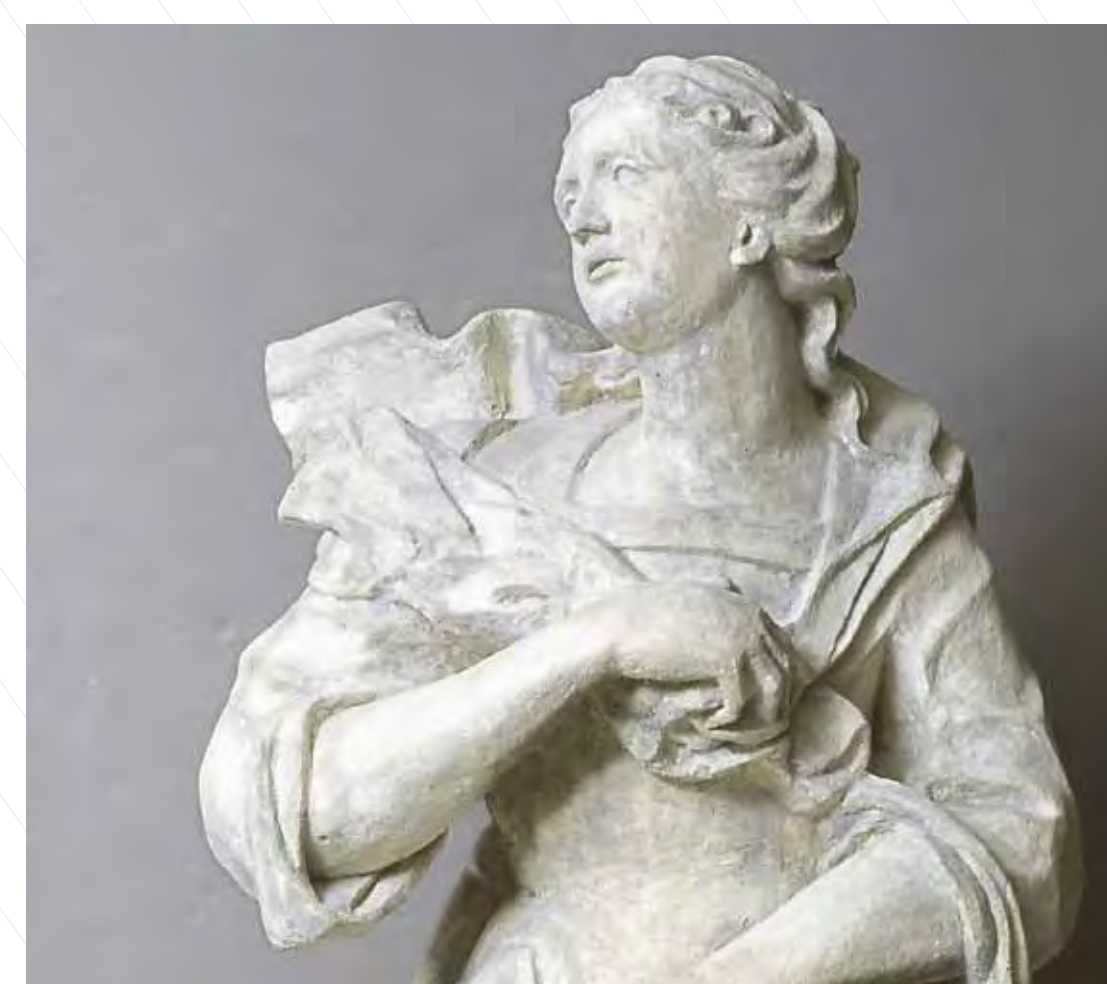
Replika skulpture sv. Katarine  
Replica of the statue of St. Catherine

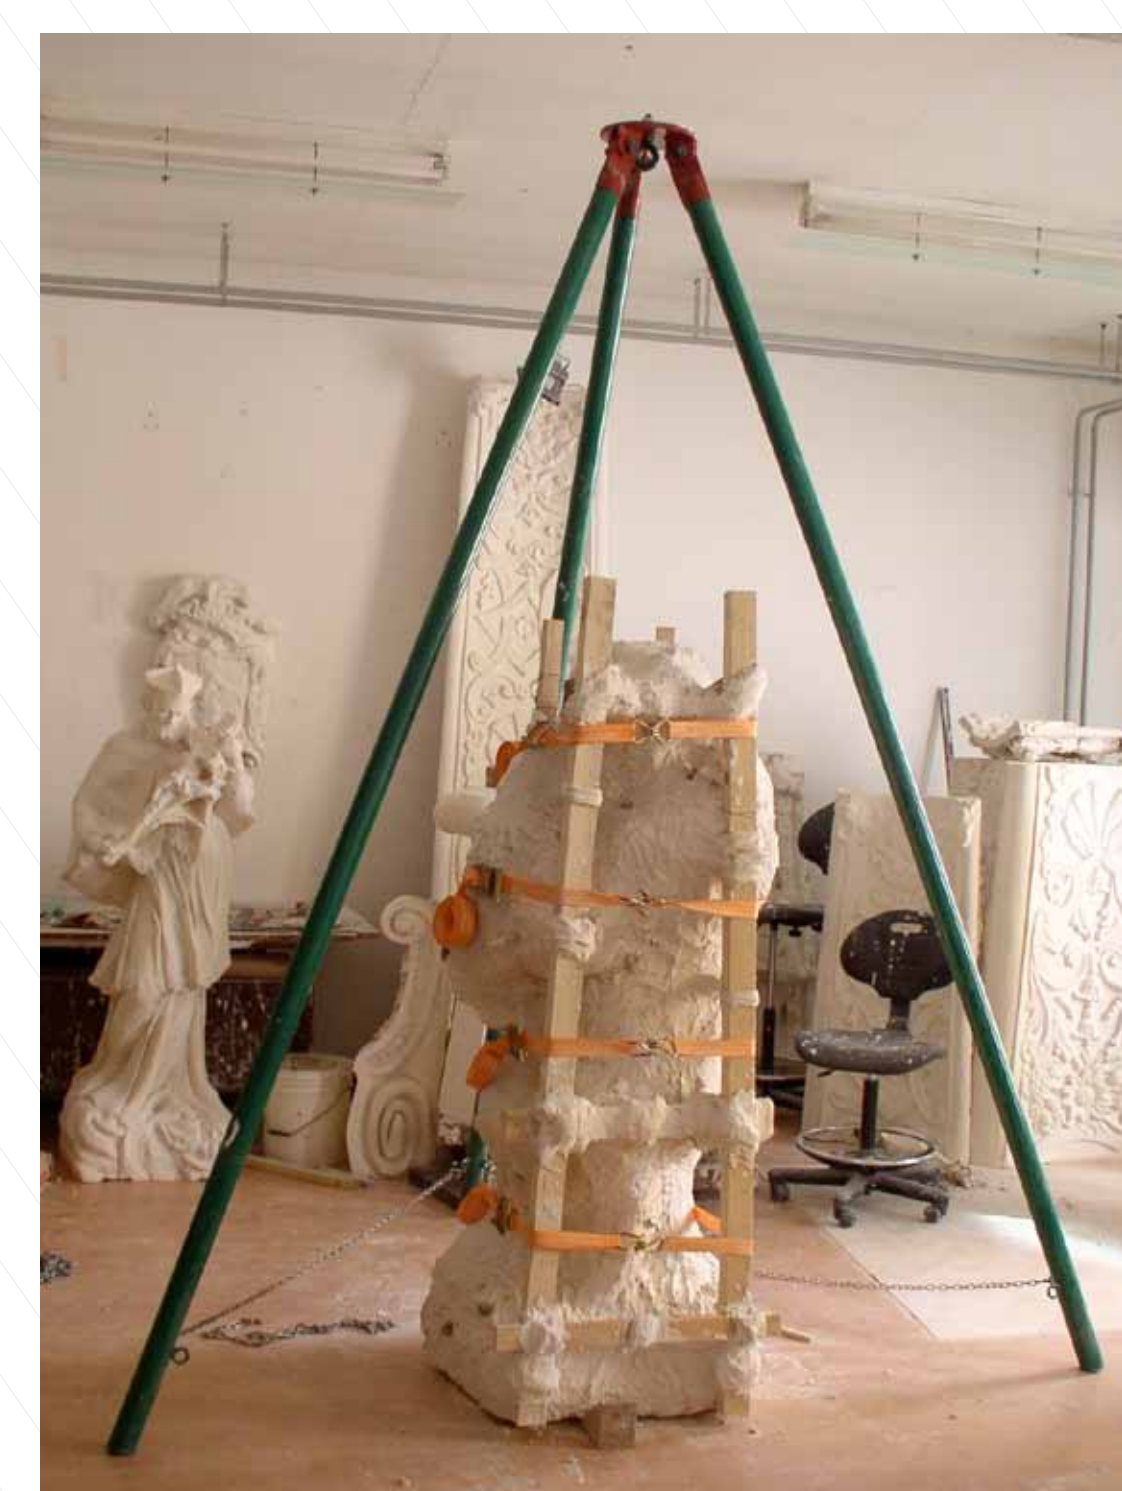
Izrada replike u radionici  
Making of replica in the workshop

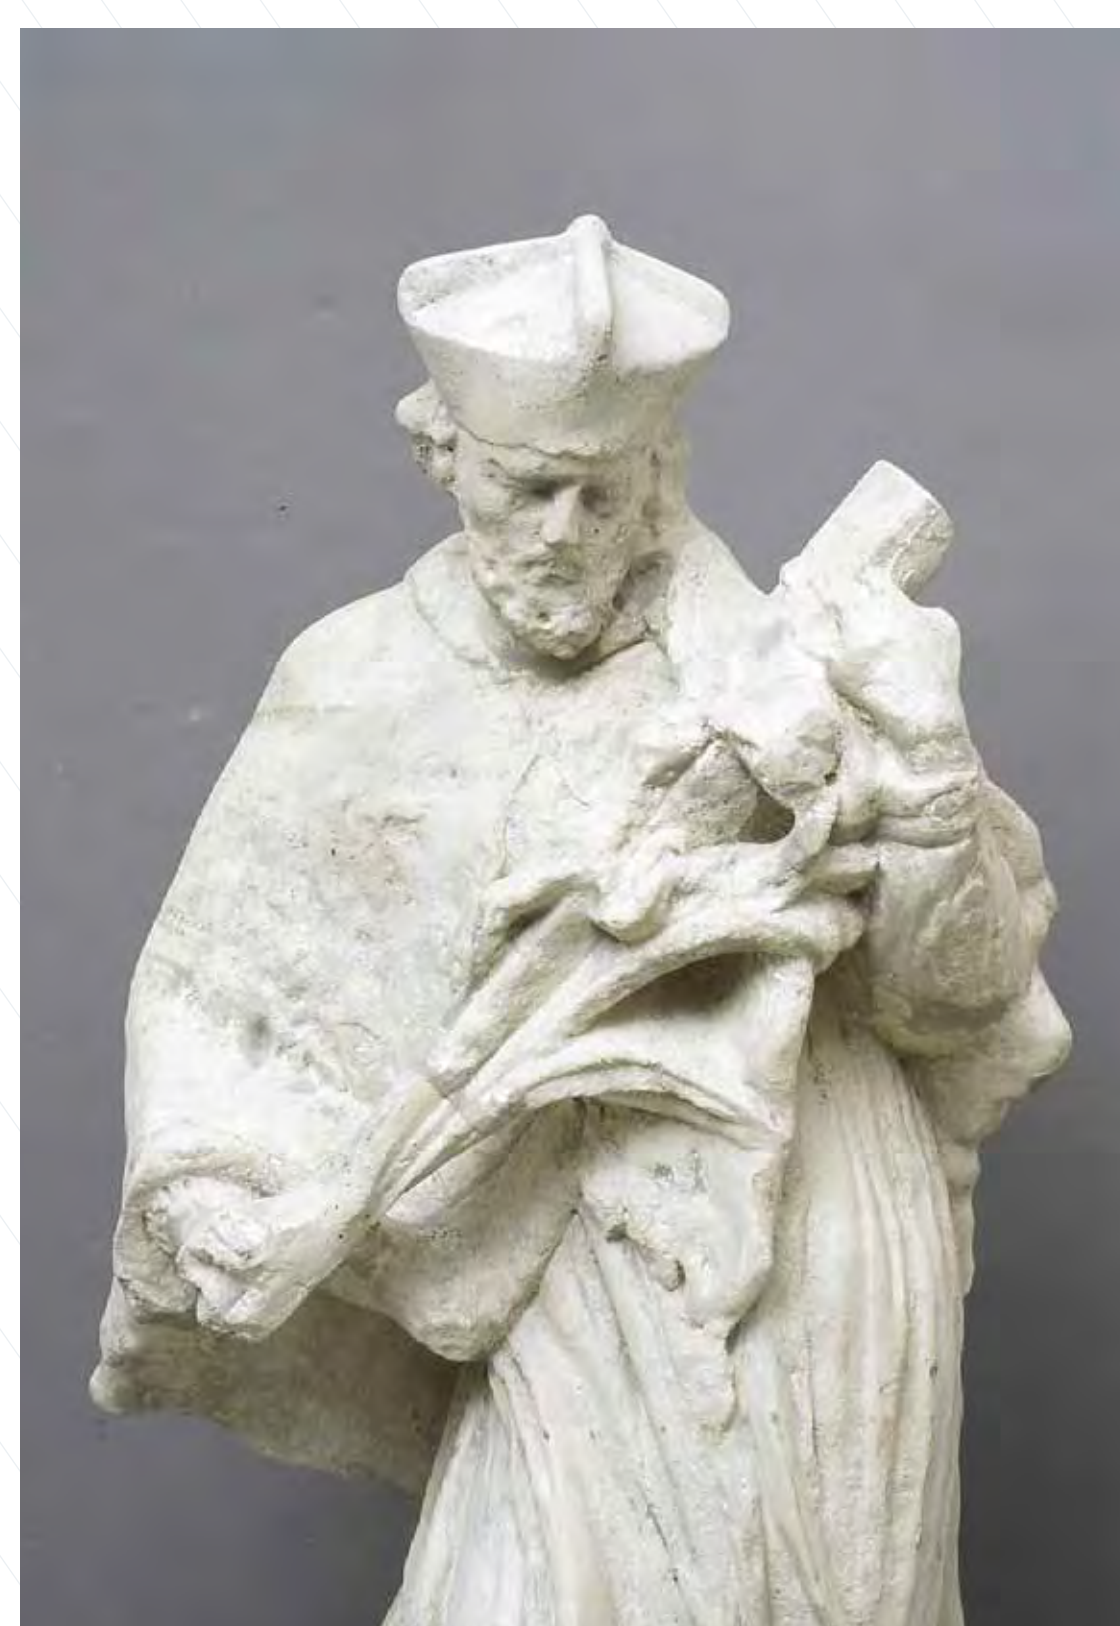
Replika skulpture sv. Ivana Nepomuka  
Replica of the statue of St. John of Nepomuk

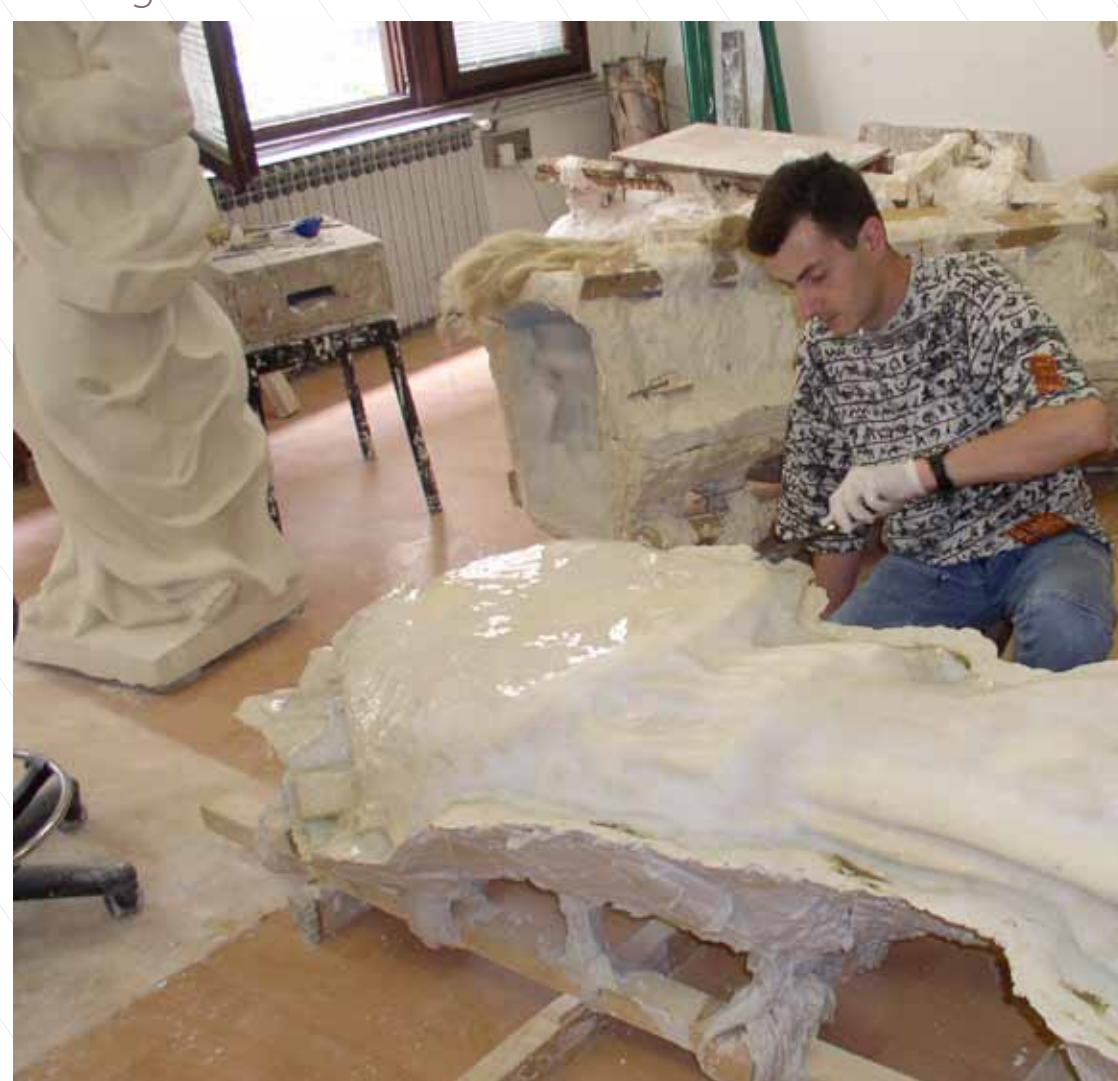
Izrada kalupa  
Making of the mould

After the dismantling of the remaining three statues, they all underwent reconstruction of the missing forms and parts in plasticine, and casts and moulds were made. During the production of the moulds the surface of the stone was insulated with a special agent, the separator, to prevent the bottom layer of the rubber applied to the surface of the sculpture from attaching to the original

during the making of the mould. A plaster cap was placed on the rubber, and where necessary, a wooden construction, in order to reinforce the mould. Artificial stone mix was next poured into the moulds. The replicas of the statues produced in this manner were fitted onto the monument, and the originals were exhibited in the building of the University of Osijek Rector's Office. Reconstruction of the missing parts was carried out according to archival documentation and old photographs from the Museum of Slavonia in Osijek.

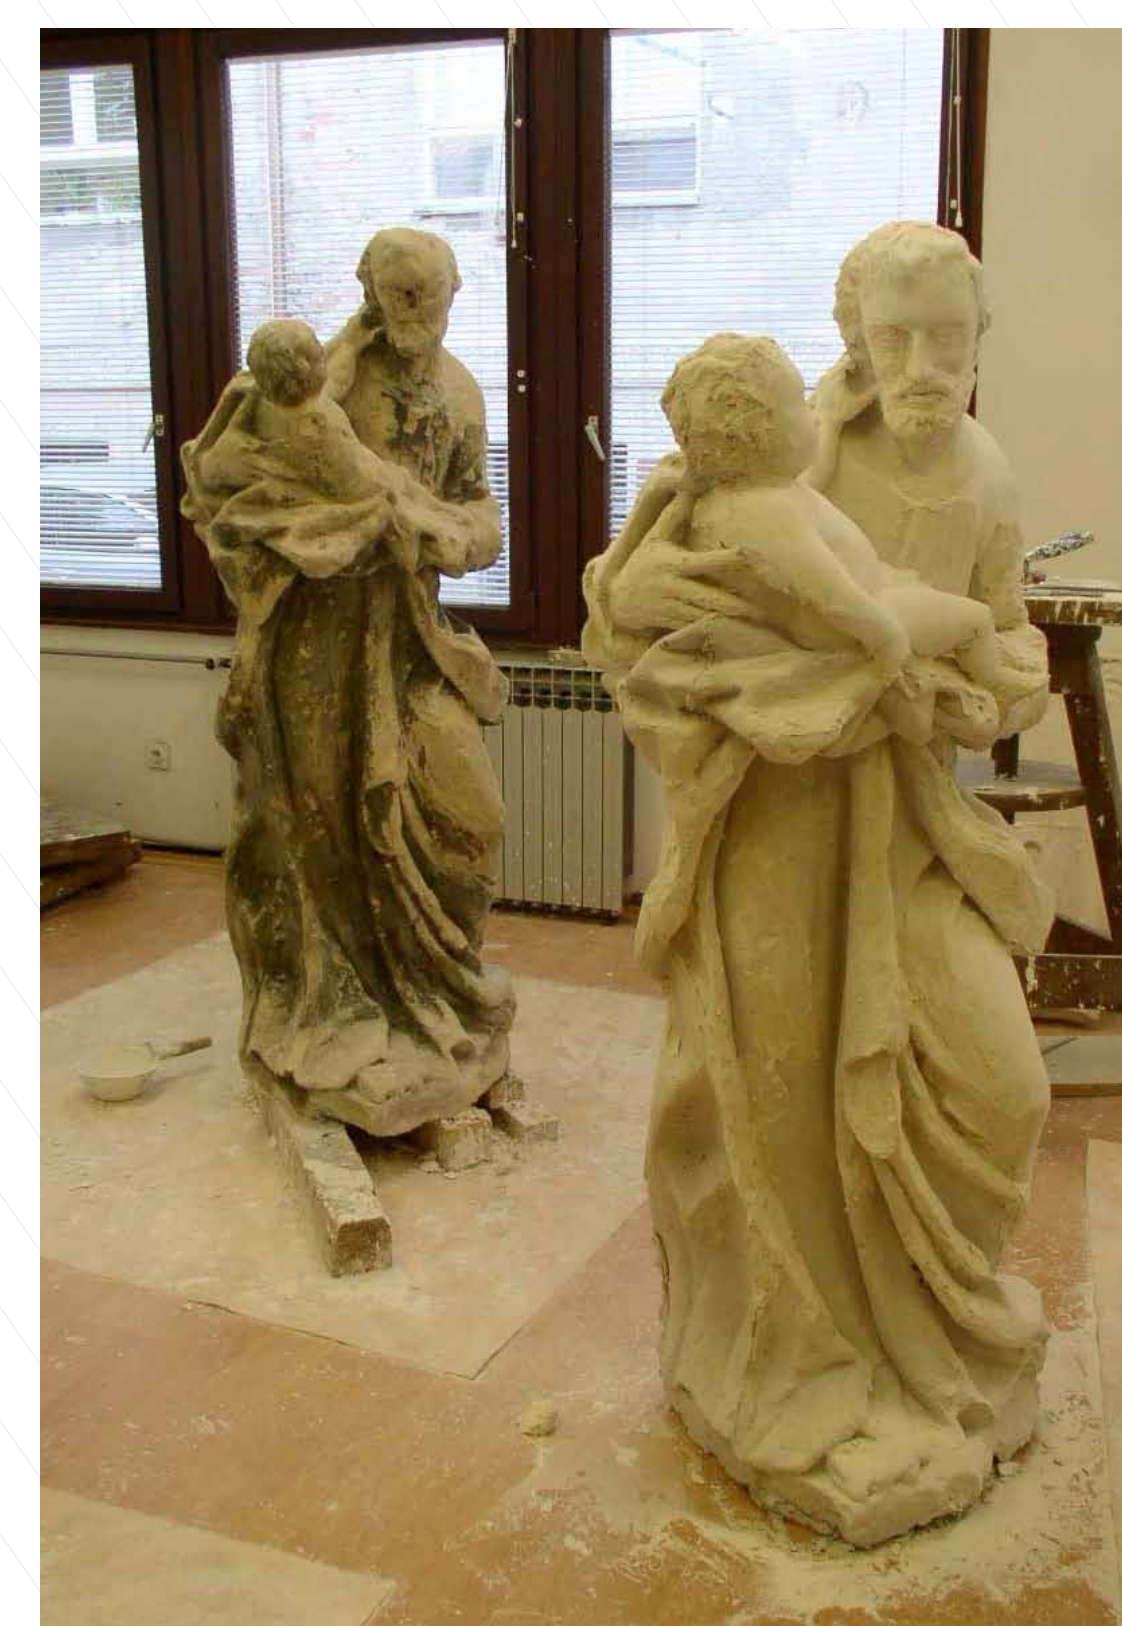
Original i replika skulpture sv. Josipa u radionici  
Original and replica of the statue of St. Joseph in the workshop
