# **ZIDNE SLIKE I ŠTUKATURA NA ŽBUKANIM DRVENIM KONSTRUKCIJAMA**

## **KNJIGA SAŽETAKA**

# **WALL PAINTINGS AND STUCCO ON PLASTERED WOODEN STRUCTURES – *Challenges and Solutions***

## **BOOK OF ABSTRACTS**

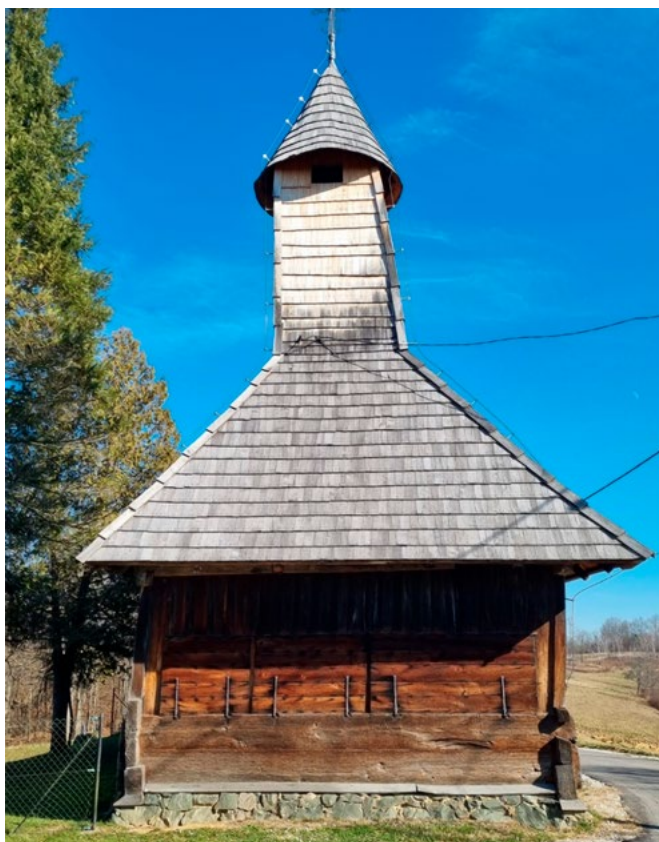
Zbog izvornih nedostataka izvedenog statičkog sustava (sustav nepridrženih okvira), kapela sv. Jurja u L. Štefankima doživjela je znatan horizontalni translacijski pomak, što je posebno izraženo na prednjem pročelju. Horizontalni otklon konstrukcije uočava se i na zvoniku, ali je on suprotnog smjera od otklona prednjeg pročelja (izvor: Studio Arhing d.o.o., crtež: J. Pojatina)

Due to inherent deficiencies in the original structural system (unsupported frames), the St. George chapel in L. Štefanki experienced significant horizontal displacement, most pronounced at the front façade. A horizontal shift is also visible in the bell tower, but in the opposite direction to that of the façade (source: Studio Arhing d.o.o., J. Pojatina)

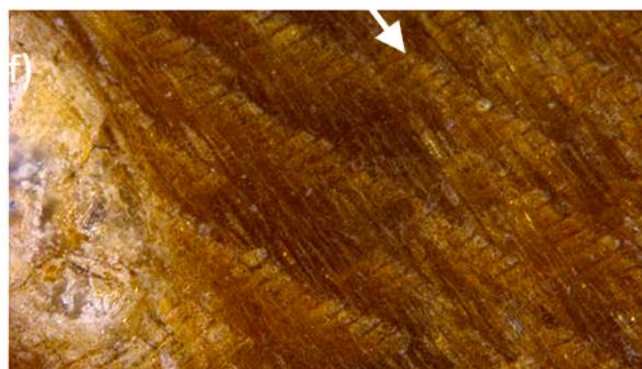
Primjeri analitičkih uzoraka: slike od a) do c): rezistogram zdrave nazidnice (a), izvrtak 12,5 mm (b) kao i mikrografija (40 x) (c) pokazuju potpuno zdravo drvo, njemu se mjeri sadržaj vode 11–12 % i velika gustoća (oko 700 kg/m<sup>3</sup>), što odgovara maloj širini goda i udjelu kasnog drva od oko 80 % (rezistografski prikaz). (izvor: Laboratorij za drvo u graditeljstvu (LDG) Fakulteta šumarstva i drvne tehnologije Sveučilišta u Zagrebu)

Examples of analytical samples: images a) to c): resistograph of a sound wall plate (a), 12.5 mm core sample (b), and micrograph at 40x (c) showing completely sound wood. Moisture content measures 11–12%, with high density (approx. 700 kg/m<sup>3</sup>), corresponding to narrow annual rings and a latewood proportion of about 80% (resistograph display). (source: Laboratory of Wood in Construction (LDG), Faculty of Forestry and Wood Technology, University of Zagreb)

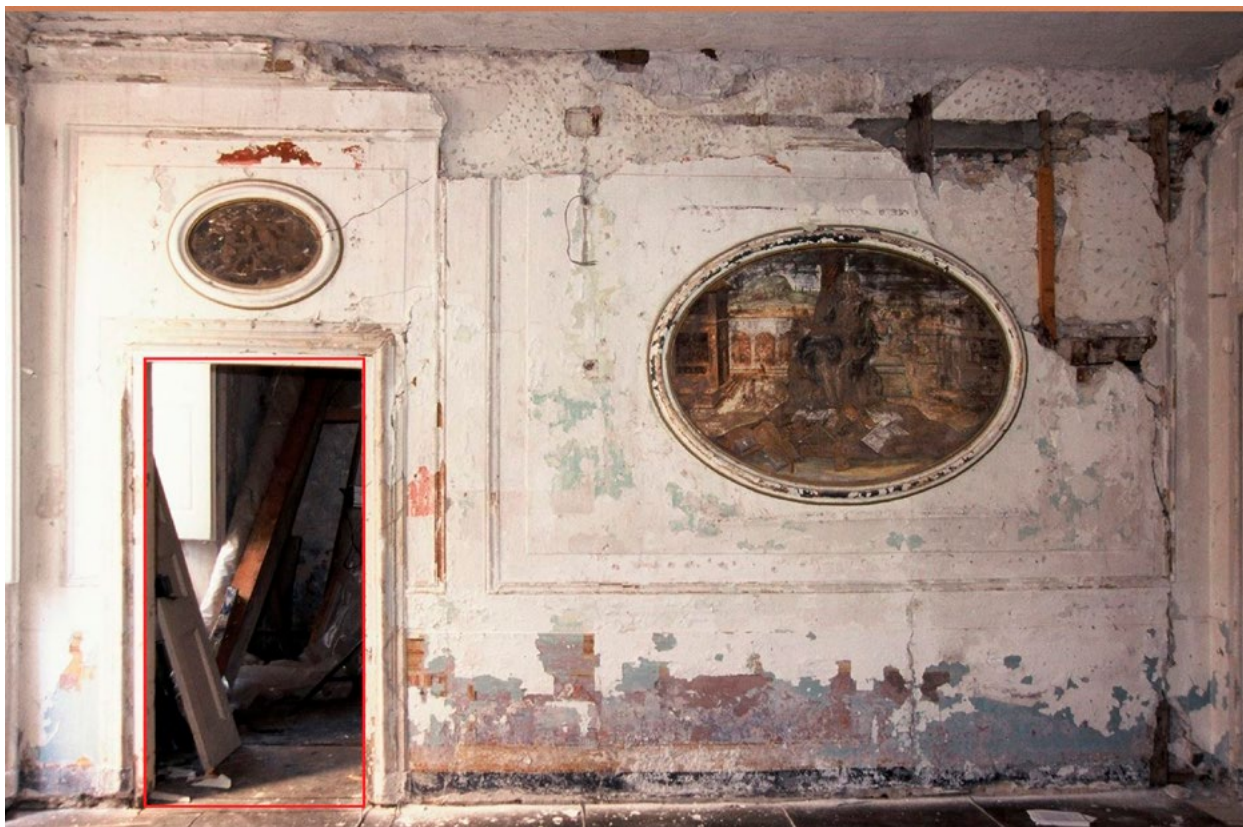
Palača Kerša (Festivalska palača) Dubrovnik, Salon S-I-5, pogled na sjeverni pregradni zid prije radova (arhiva HRZ-a, snimka: I.Srša, 2002.)

Kerša Palace (Festival Palace), Dubrovnik, Salon S-I-5, view of the north partition wall before restoration (HRZ Archive, photo: I. Srša, 2002)

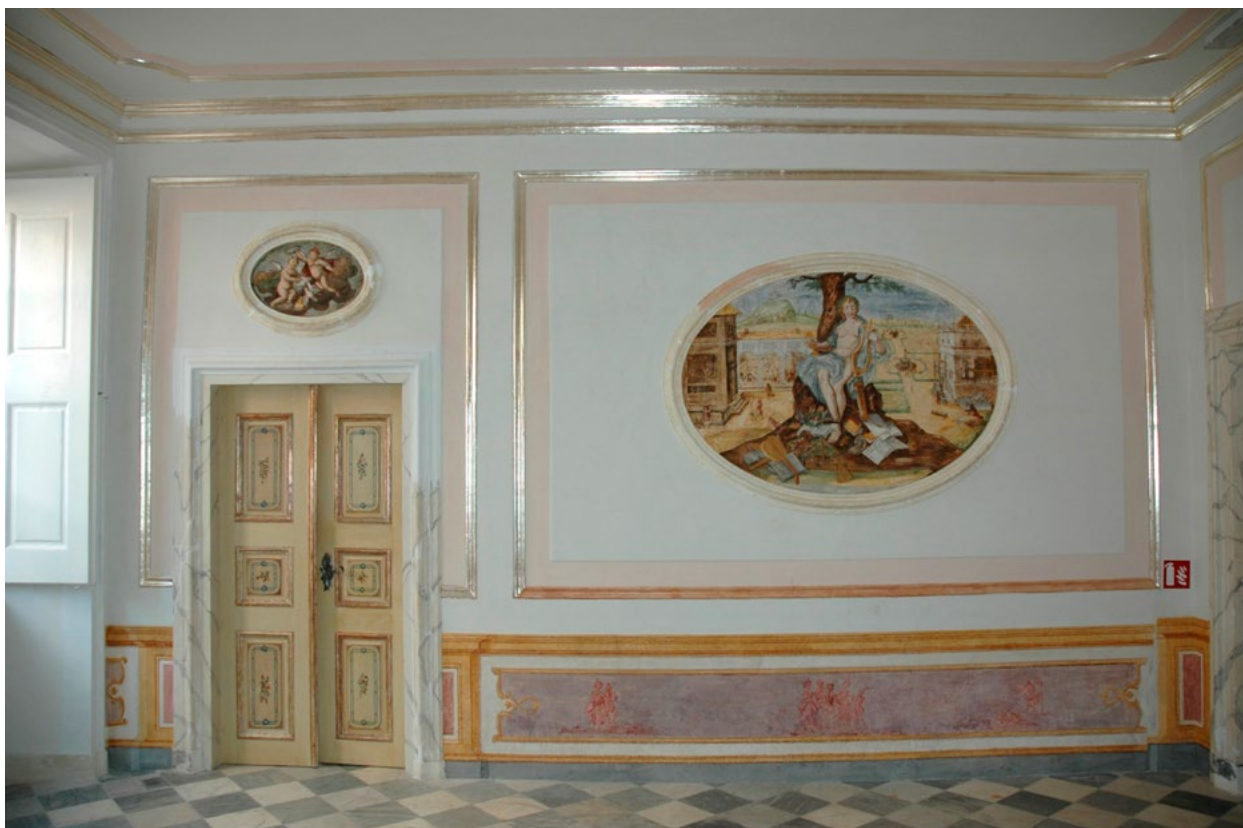
Palača Kerša (Festivalska palača) Dubrovnik, Salon S-I-5, pogled na sjeverni pregradni zid nakon radova (arhiva HRZ-a, snimka: I.Srša, 2002.)

Kerša Palace (Festival Palace), Dubrovnik, Salon S-I-5, view of the north partition wall after restoration (HRZ Archive, photo: I. Srša, 2002)

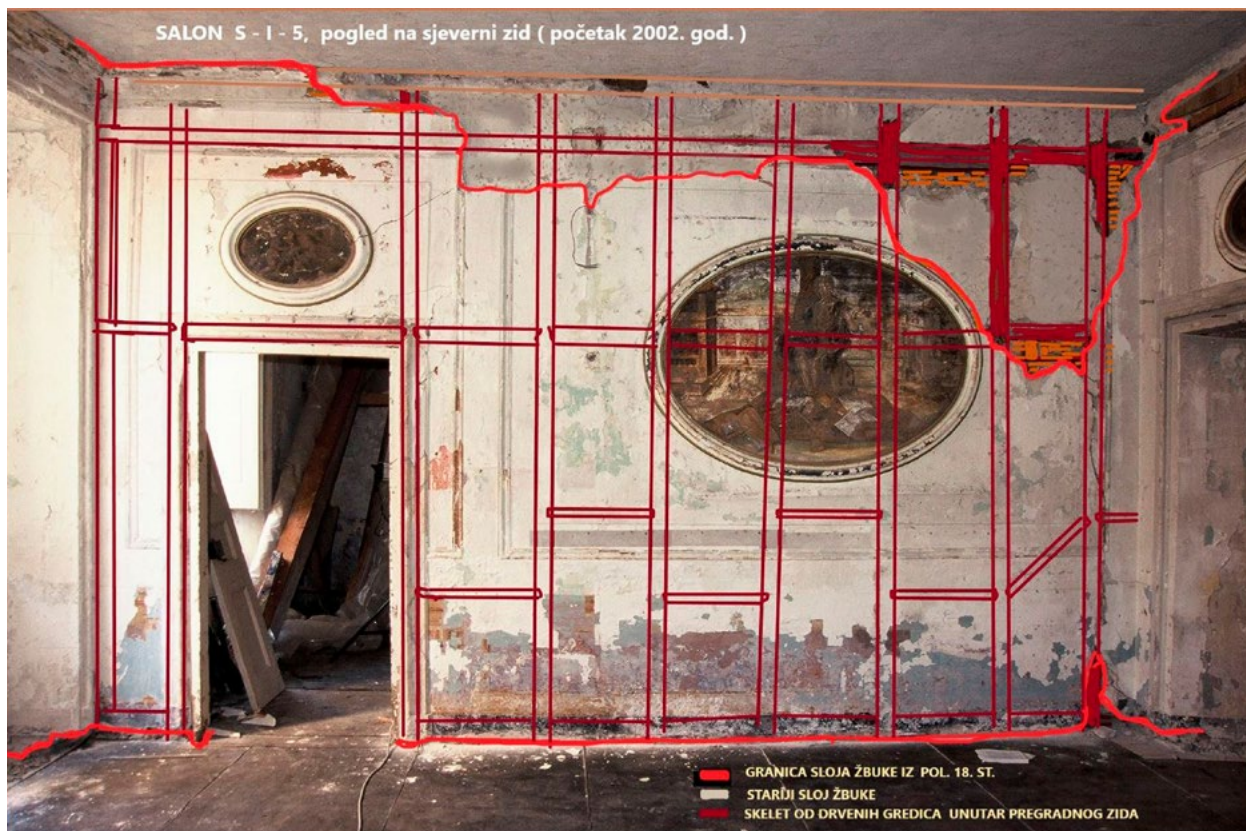
Palaca Kerša (Festivalaska palaca) Dubrovnik, Salon S-I-5, pogled na sjeverni pregradni zid s ucrtanom shemom nosive konstrukcije (snimka: I. Srša, 2002., crtala: B. Matica, 2025.)

Kerša Palace (Festival Palace), Dubrovnik, Salon S-I-5, view of the north partition wall with schematic drawing of the supporting structure (photo: I. Srša, 2002., drawn by: B. Matica, 2025)

Vanjski i nosivi zidovi palače građeni su kamenom, a stubište, međukatne konstrukcije i krovna konstrukcija su drveni. Pregradni, tanki, žbukani zidovi su skeletni s okvirom od drvenih gredica i ispunom od opeke i žbuke. Tanki žbukani zidovi uz stubišni prostor izvedeni su kao suhomontažni, bez ispune, s okvirima od drvenih gredica obostrano povezanih nizom dijagonalnih i razmaknutih drvenih letvica – štuketa.

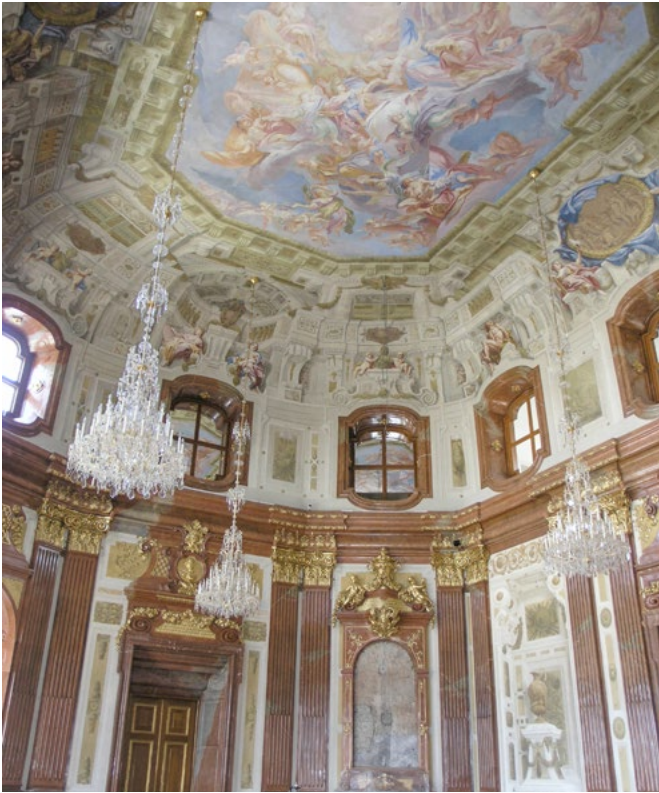
Marble Hall in the Upper Belvedere, Vienna, after restoration. The structure was heavily damaged in 1944. (BDA Archive, photo: Tinzl, 2005)

Mramorna dvorana u Gornjem Belvedereu u Beču nakon restauracije. Konstrukcija je teško oštećena 1944. (arhiva BDA, snimka: Tinzl, 2005.)

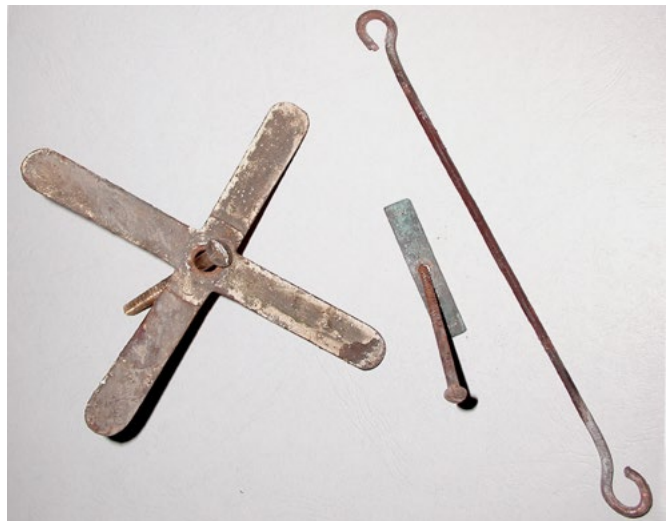
Typical metal attachments to reattach structurally unstable supports, dating from the late 1940s. (BDA Archive, photo: Tinzl, 2005)

Tipični metalni učvršćivači za ponovno pričvršćivanje strukturno nestabilnih nosača koji datiraju iz kasnih 1940-ih (arhiva BDA, snimka: Tinzl, 2005.)

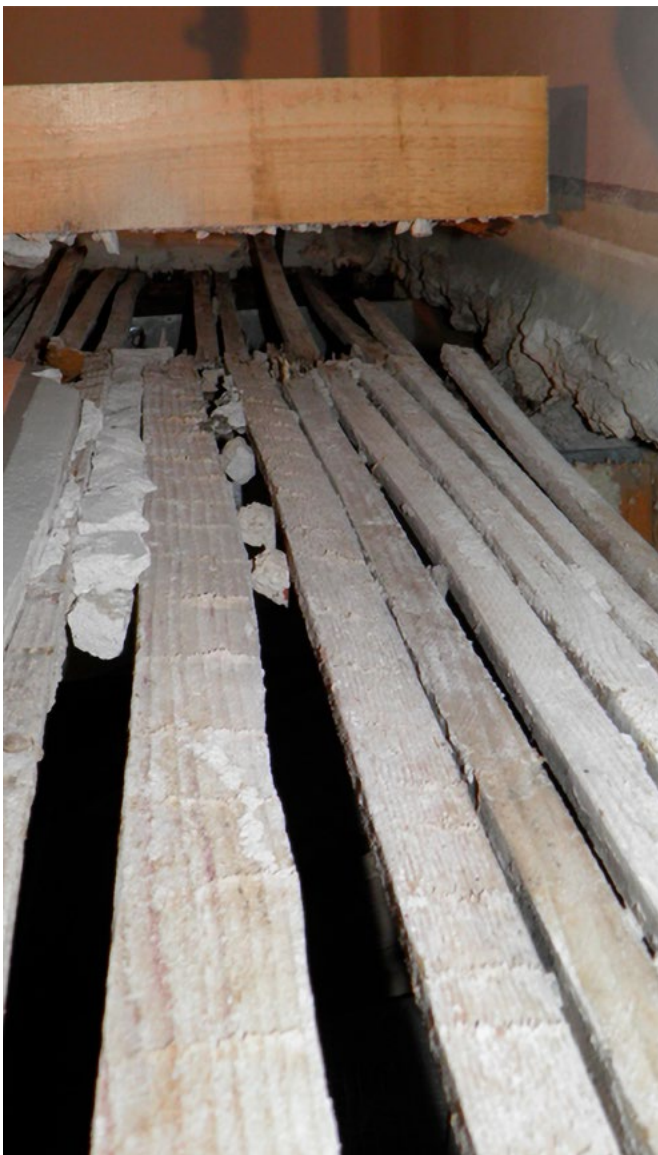
Labin, Teatrino, preširoko postavljene stropne letvice (snimka: S. Tomišić, 2019.)

Labin, Teatrino, ceiling battens set too wide (photo: S. Tomišić, 2019)

Another important element of the ceiling system is the wooden substructure – ceiling laths or reeds. Problems arise if the laths are too large (too thick or too wide), if the spacing between them is too narrow or too wide, if the wood swells or shrinks, or if they are nailed with conical forged nails. The most evident examples of inadequate ceiling laths can be seen on the painted ceiling of the Rovinj City Museum or the ceiling of the Teatrino in Labin.

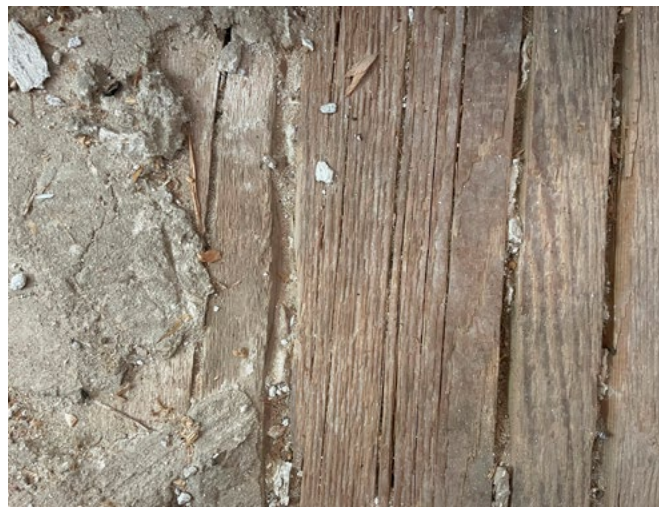
Rovinj, Muzej grada Rovinja, preširoke stropne letvice s premalim razmakom (snimka: B. Orbanić, 2025.)

Rovinj, Rovinj City Museum, ceiling battens too wide with a too small gap (photo: B. Orbanić, 2025)

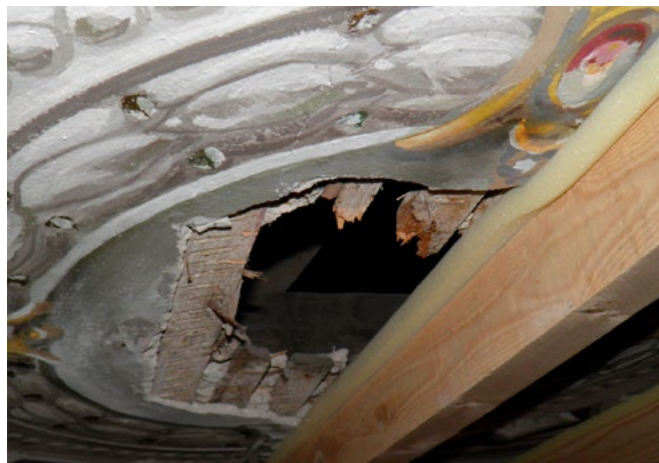
Labin, Teatrino, rupa u stropnom sustavu (snimka: S. Tomišić, 2019.)

Labin, Teatrino, hole in the ceiling system (photo: S. Tomišić, 2019)

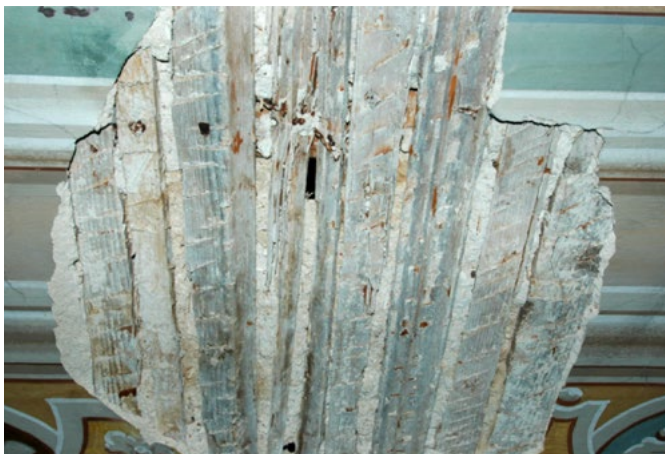
Motovun, crkva sv. Stjepana, otpala oslikana žbuka sa stropa (snimka: B. Orbanić, 2007.)  
 Motovun, Church of St. Stephen, painted plaster falling off the ceiling  
 (photo: B. Orbanić, 2007)

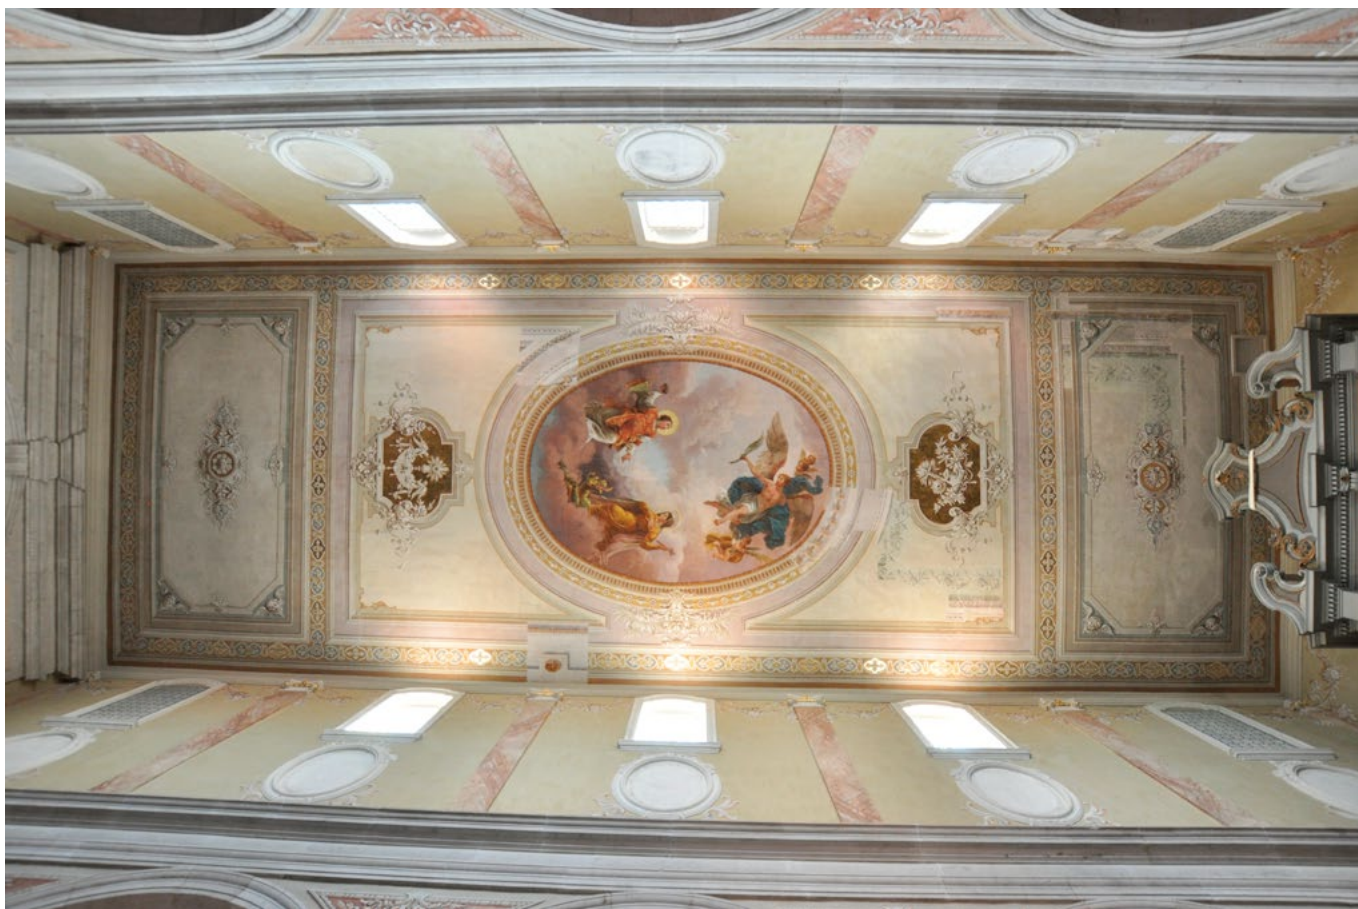
Motovun, crkva sv. Stjepana, strop glavnog broda nakon radova (arhiva HRZ-a, 2010.)  
 Motovun, church of St Stephen, ceiling of the main nave after conservation (HRZ Archive, 2010)

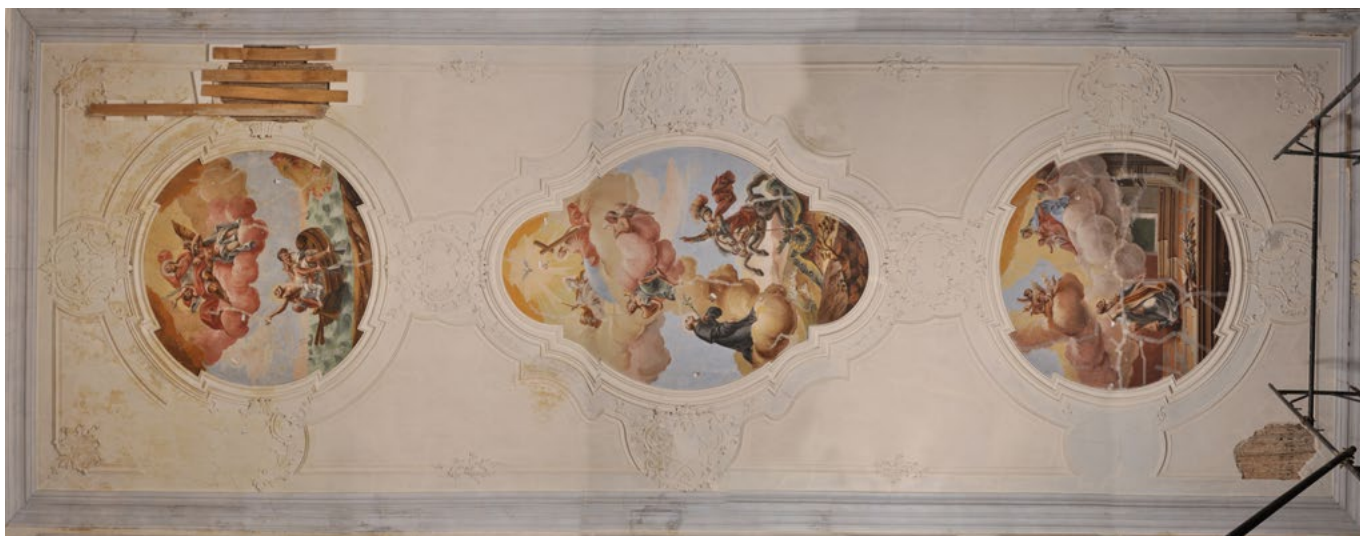
Buzet, crkva sv. Jurja, strop crkve prije radova (arhiva HRZ-a, snimka: M. Čubrić, 2010.)

Buzet, church of St George, ceiling before conservation (HRZ Archive, photo: M. Čubrić, 2010)

The ceiling in the church of St George in Buzet acquired its present form during a renovation at the end of the 18<sup>th</sup> century. It stands out as a representative example of wall paintings and stucco on plastered wooden structures in Istria (wooden laths serve as base for the plaster). It is decorated with paintings by the Venetian master Matteo Furlanetto and stuccoes by Francesco Schiavi from Tolmezzo. Over time, there were signs of serious structural damage, and water damage from 2009 when the roof was replaced caused a sudden deterioration of the ceiling. Plaster and stucco began detaching and falling off, and the painted layers of the medallions were damaged in several places. This resulted in emergency protective measures being carried out, and detailed documentation of the existing condition being prepared. Afterwards, the ceiling was "softly" propped with a custom scaffold and a wooden structure padded with sponge.

The rehabilitation project proposed reinforcing the wooden structure with galvanized steel reinforcements and laminated wood. Unstable plaster on the attic side was removed, and the plaster was secured by "stitching" with PVC threads to the wooden laths. The drilling positions for the small holes required for stitching were carefully selected so that the medallion paintings and stuccoes would not be damaged. Detached parts of the plaster on the underside of the ceiling were also injected, and minor plaster damage was repaired. The resulting grid of "stitching" points was retouched using the *trateggio* technique, following all necessary phases of conservation and restoration process.

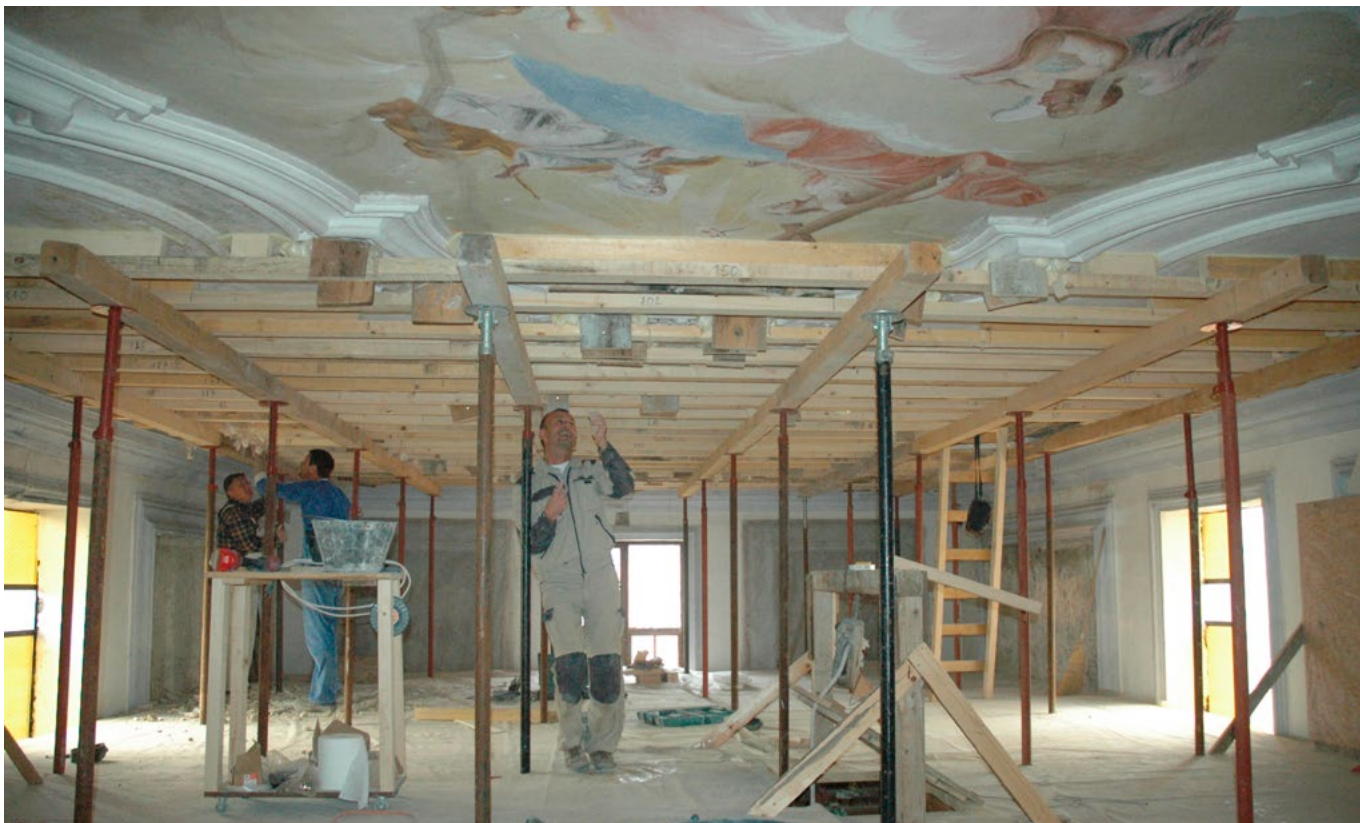
Buzet, crkva sv. Jurja, podupiranje stropa i konstruktivna sanacija žbuke i štukatura stropa (arhiva HRZ-a, snimka: T. Šaina, 2010.)

Buzet, church of St George, propping the ceiling and structural rehabilitation of ceiling plaster and stuccoes (HRZ Archive, photo: T. Šaina, 2010)

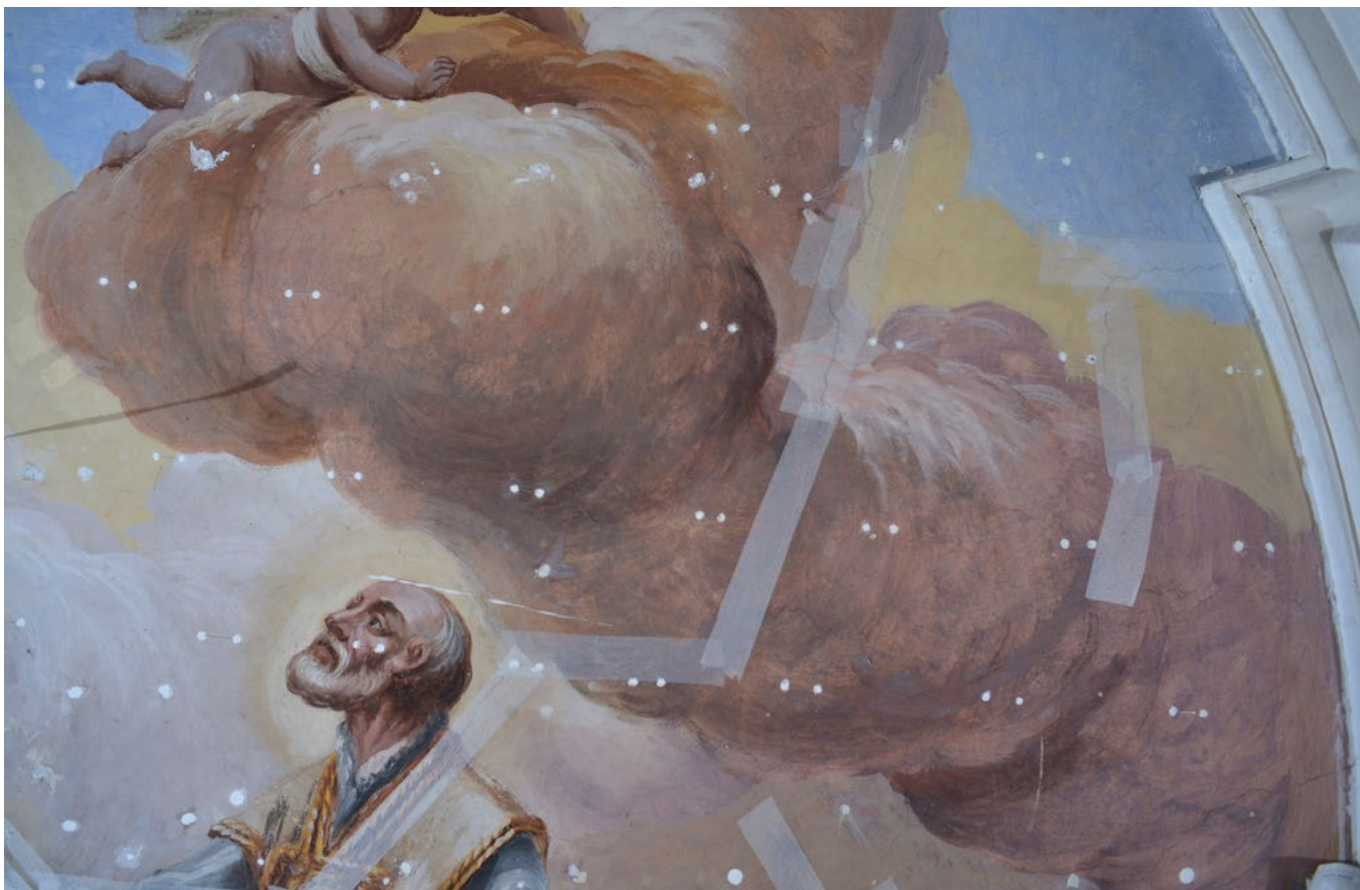
Buzet, crkva sv. Jurja, detalj oslika stropa nakon učvršćivanja PVC nitima (arhiva HRZ-a, snimka: J. Kliska, 2013.)

Buzet, church of St George, detail of the ceiling painting after consolidation with PVC threads (HRZ Archive, photo: J. Kliska, 2013)

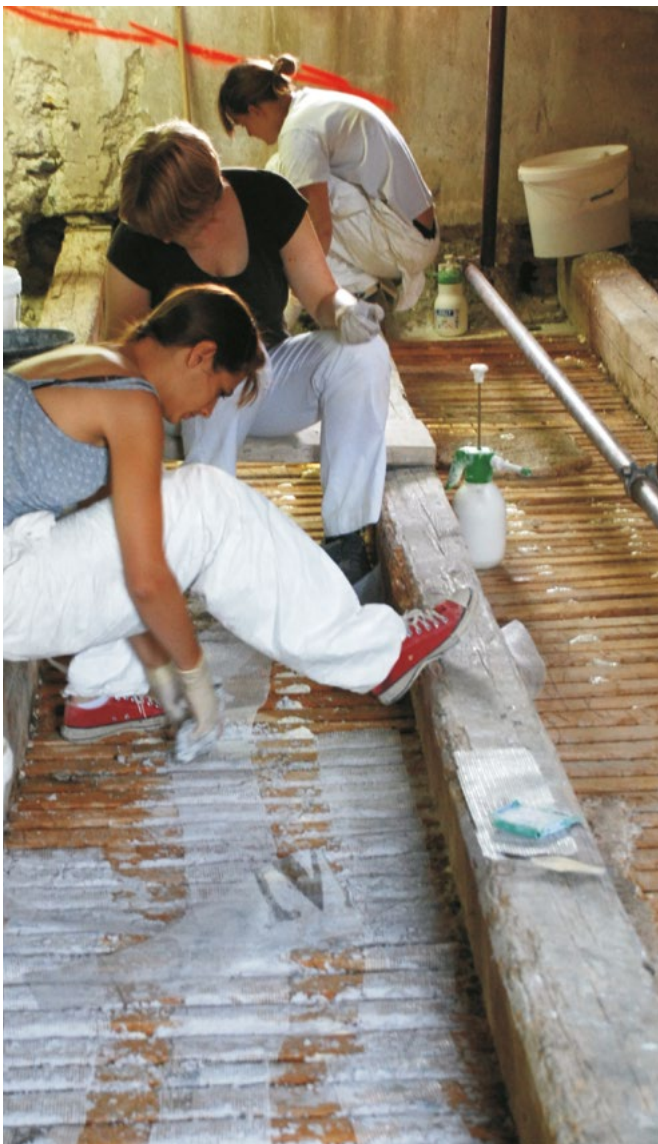
Consolidation of the upper side of the painted ceiling (photo: A. Jazbec, 2012)  
Učvrščivanje gornje strane oslikanog stropa (snimka: A. Jazbec, 2012.)

Before consolidating the plaster and wooden structure, the entire ceiling of the hall was braced with foam-padded laths screwed through the plaster into the wooden structure. The work then continued from the upper side of the ceiling: removing dirt, removing deteriorated old plaster above and between the laths, and consolidating the original plaster with a lime-in-alcohol emulsion (CaLoSil E25) applied in the spaces between the laths.

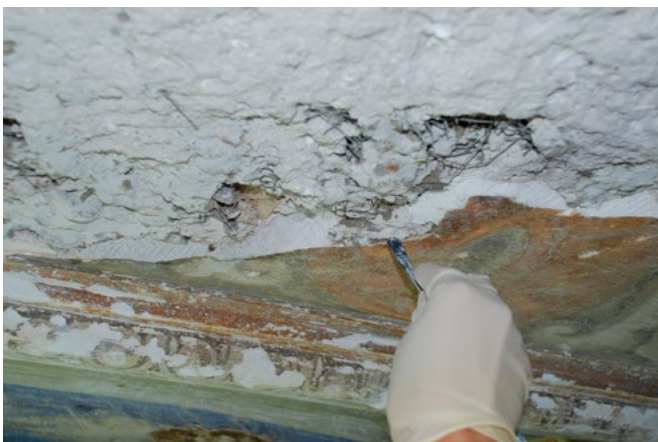
Consolidation of damaged edges of the painting (photo: A. Jazbec, 2012)  
Konsolidacija oštećenih rubova oslika (snimka: A. Jazbec, 2012.)

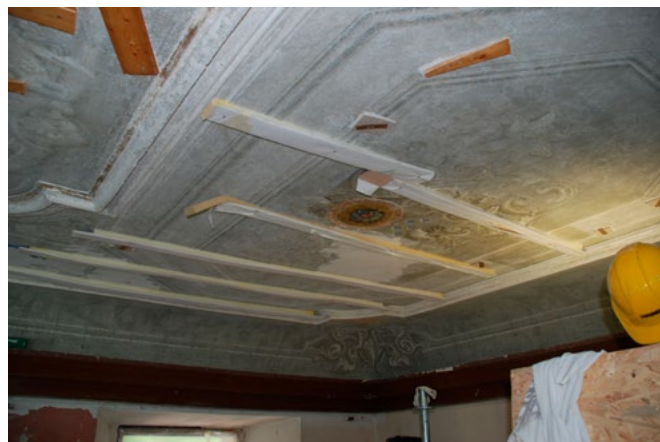
Protection of the ceiling from detachment using foam-covered slats fastened with screws through the plaster into the wooden structure (photo: A. Jazbec, 2012)  
Zaštita stropa od odvajanja pomoću letvica obloženih pjenom, pričvršćenih vijcima kroz žbuku u drvenu konstrukciju (snimka: A. Jazbec, 2012.)

Glavni problem bio je odvajanje grube žbuke od drvenog nosioca na donjoj strani na kojoj je slika. Prije konsolidacije žbuke i drvene konstrukcije, cijeli strop dvorane učvršćen je letvama obloženim s umjetnom pjenom koje su vijcima pričvršćene kroz žbuku za drvenu konstrukciju. Radovi su zatim nastavljeni s gornje strane stropa: uklonjena je prljavština, kao i dotrajala stara žbuka iznad i između letvi, a izvorna žbuka je konsolidirana emulzijom vapna u alkoholu (*CaLoSil E25*) nanesenom u prostore između letvi.

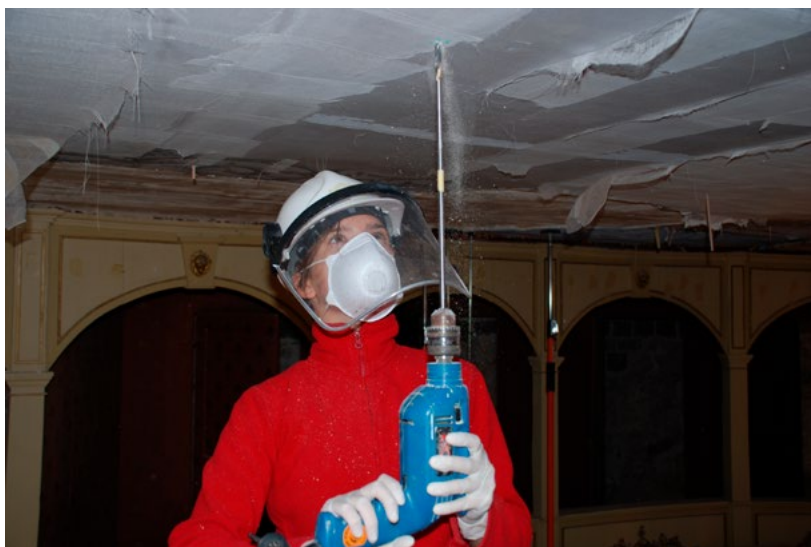
Hvar, Kazalište, priprema za umetanje drvenih štapića (snimka: A. Gluhan, 2010.)

Hvar, Theatre, preparation for inserting wooden sticks (photo: A. Gluhan, 2010)

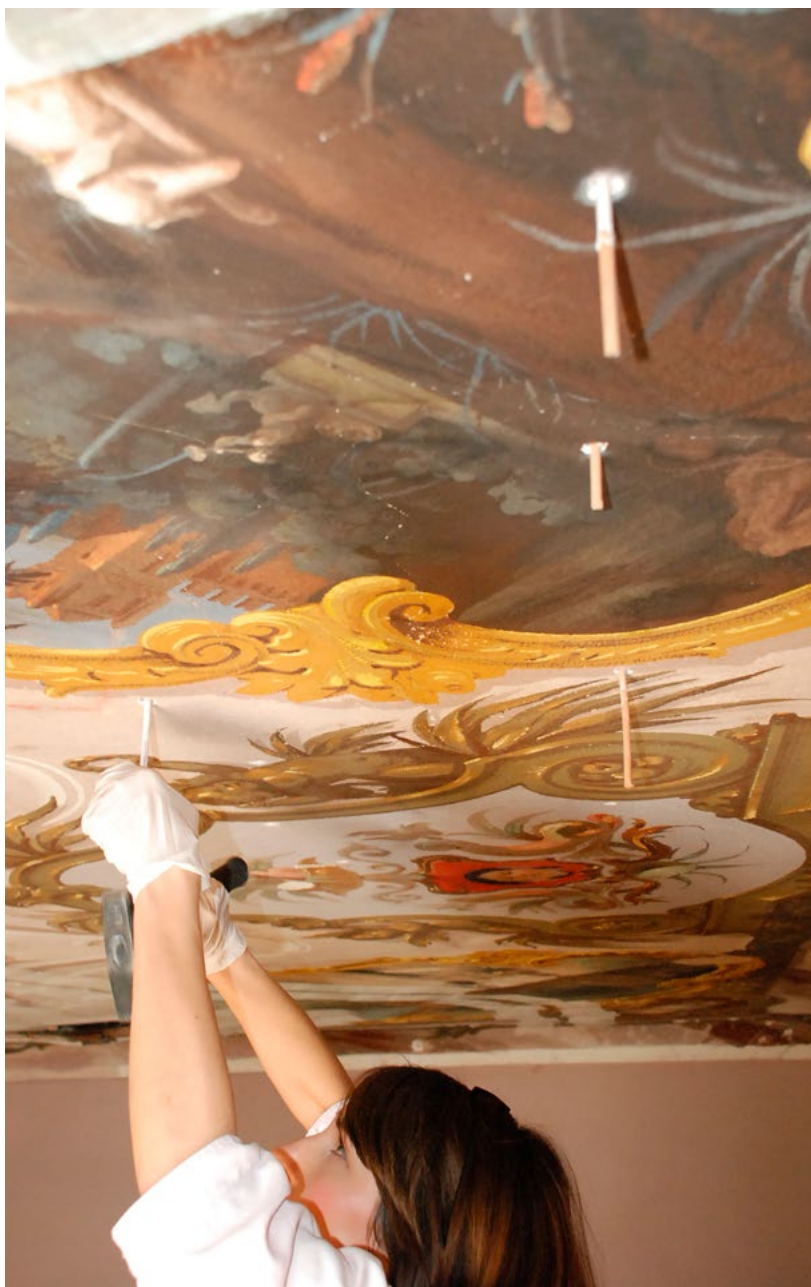
Split, Palača Bajamonti-Dešković, umetanje drvenih štapića (snimka: I. Jerković, 2010.)

Split, Bajamonti-Dešković Palace, inserting wooden sticks (photo: I. Jerković, 2010)

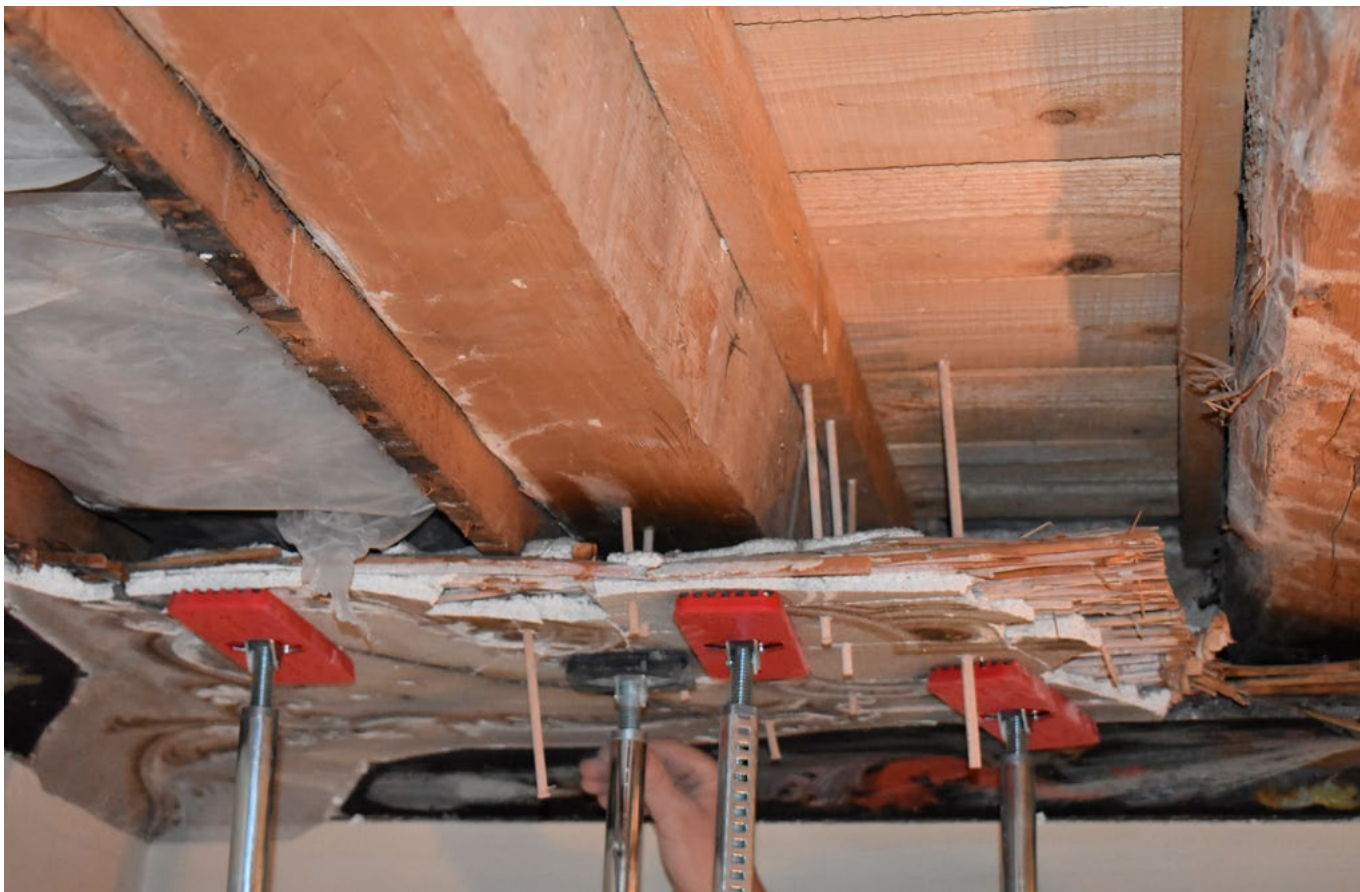
Split, Palača Bajamonti-Dešković, učvršćenje odvojenih dijelova stropa (snimka: A. Gluhan, 2018.)

Split, Bajamonti-Dešković Palace, fixing of separate parts of the ceiling (photo: A. Gluhan, 2018)

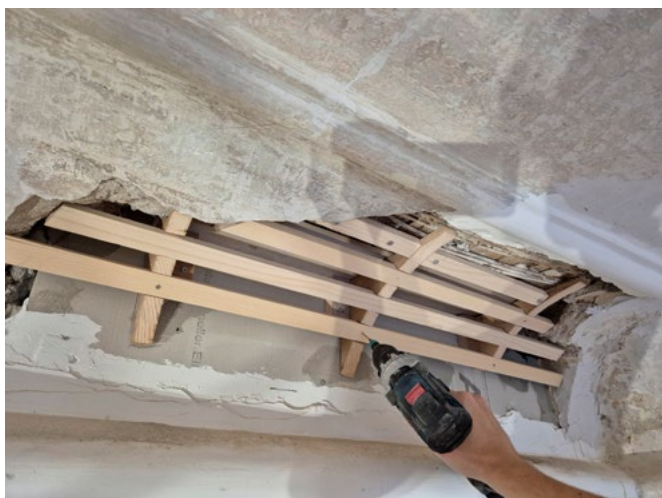
Zagreb, Hrvatski povijesni muzej, rekonstrukcija drvenog nosioca holkela (snimka: D. Matešan, 2025.)

Zagreb, Croatian History Museum, reconstruction of the wooden support of the wall-to-floor junction (photo: D. Matešan, 2025)

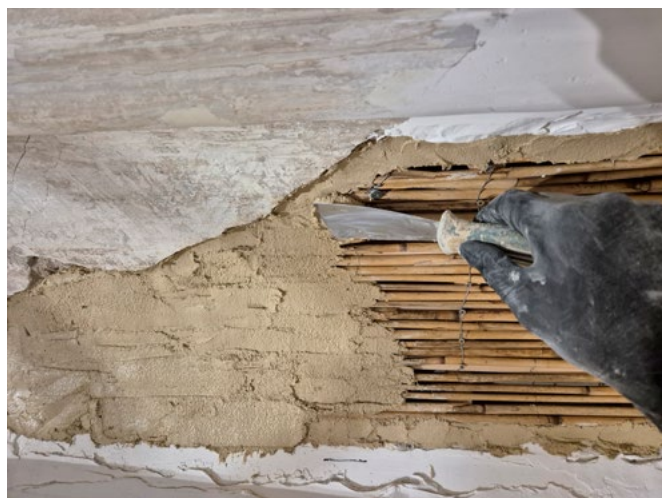
Zagreb, Hrvatski povijesni muzej, nanošenje nove vapnene žbuke na trščanu građu holkela (snimka: D. Matešan, 2025.)

Zagreb, Croatian History Museum, applying new lime plaster to the reed structure of the wall-to-floor junction (photo: D. Matešan, 2025)

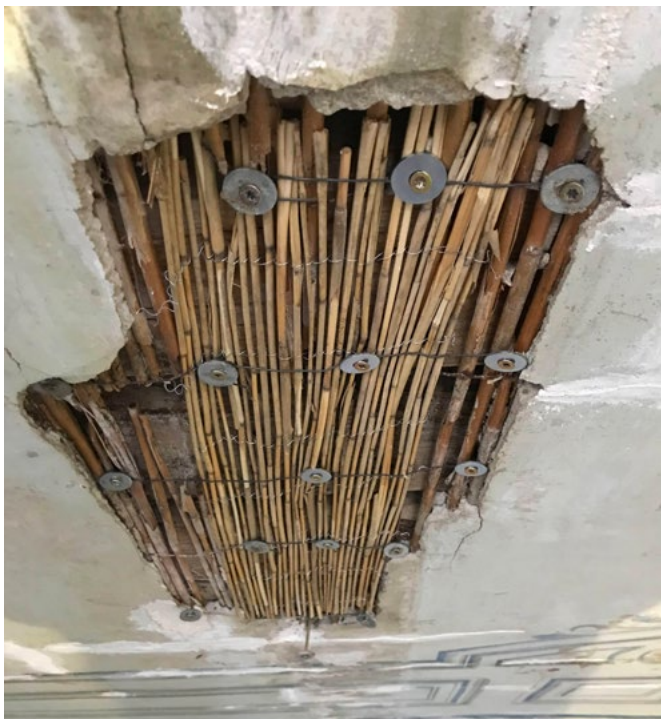
Bizovac, dvorac Norman, učvršćivanje tršćane građe stropa  
(snimka: D. Jurčić, 2022.)

Bizovac, Norman castle, consolidation of the ceiling reed structure  
(photo: D. Jurčić, 2022)

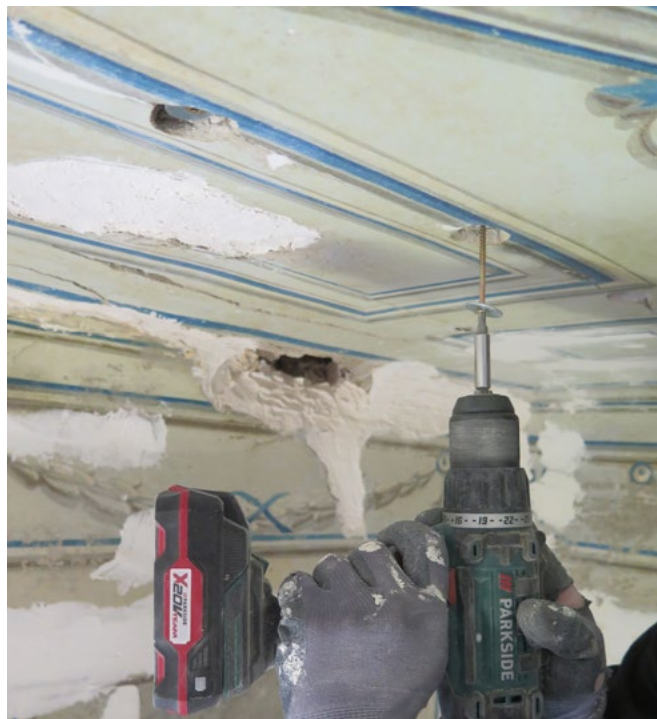
Bizovac, dvorac Norman, priprema za učvršćivanje tršćane građe stropa  
(snimka: D. Jurčić, 2022.)

Bizovac, Norman castle, preparation for consolidation of the reed ceiling structure  
(photo: D. Jurčić, 2022)

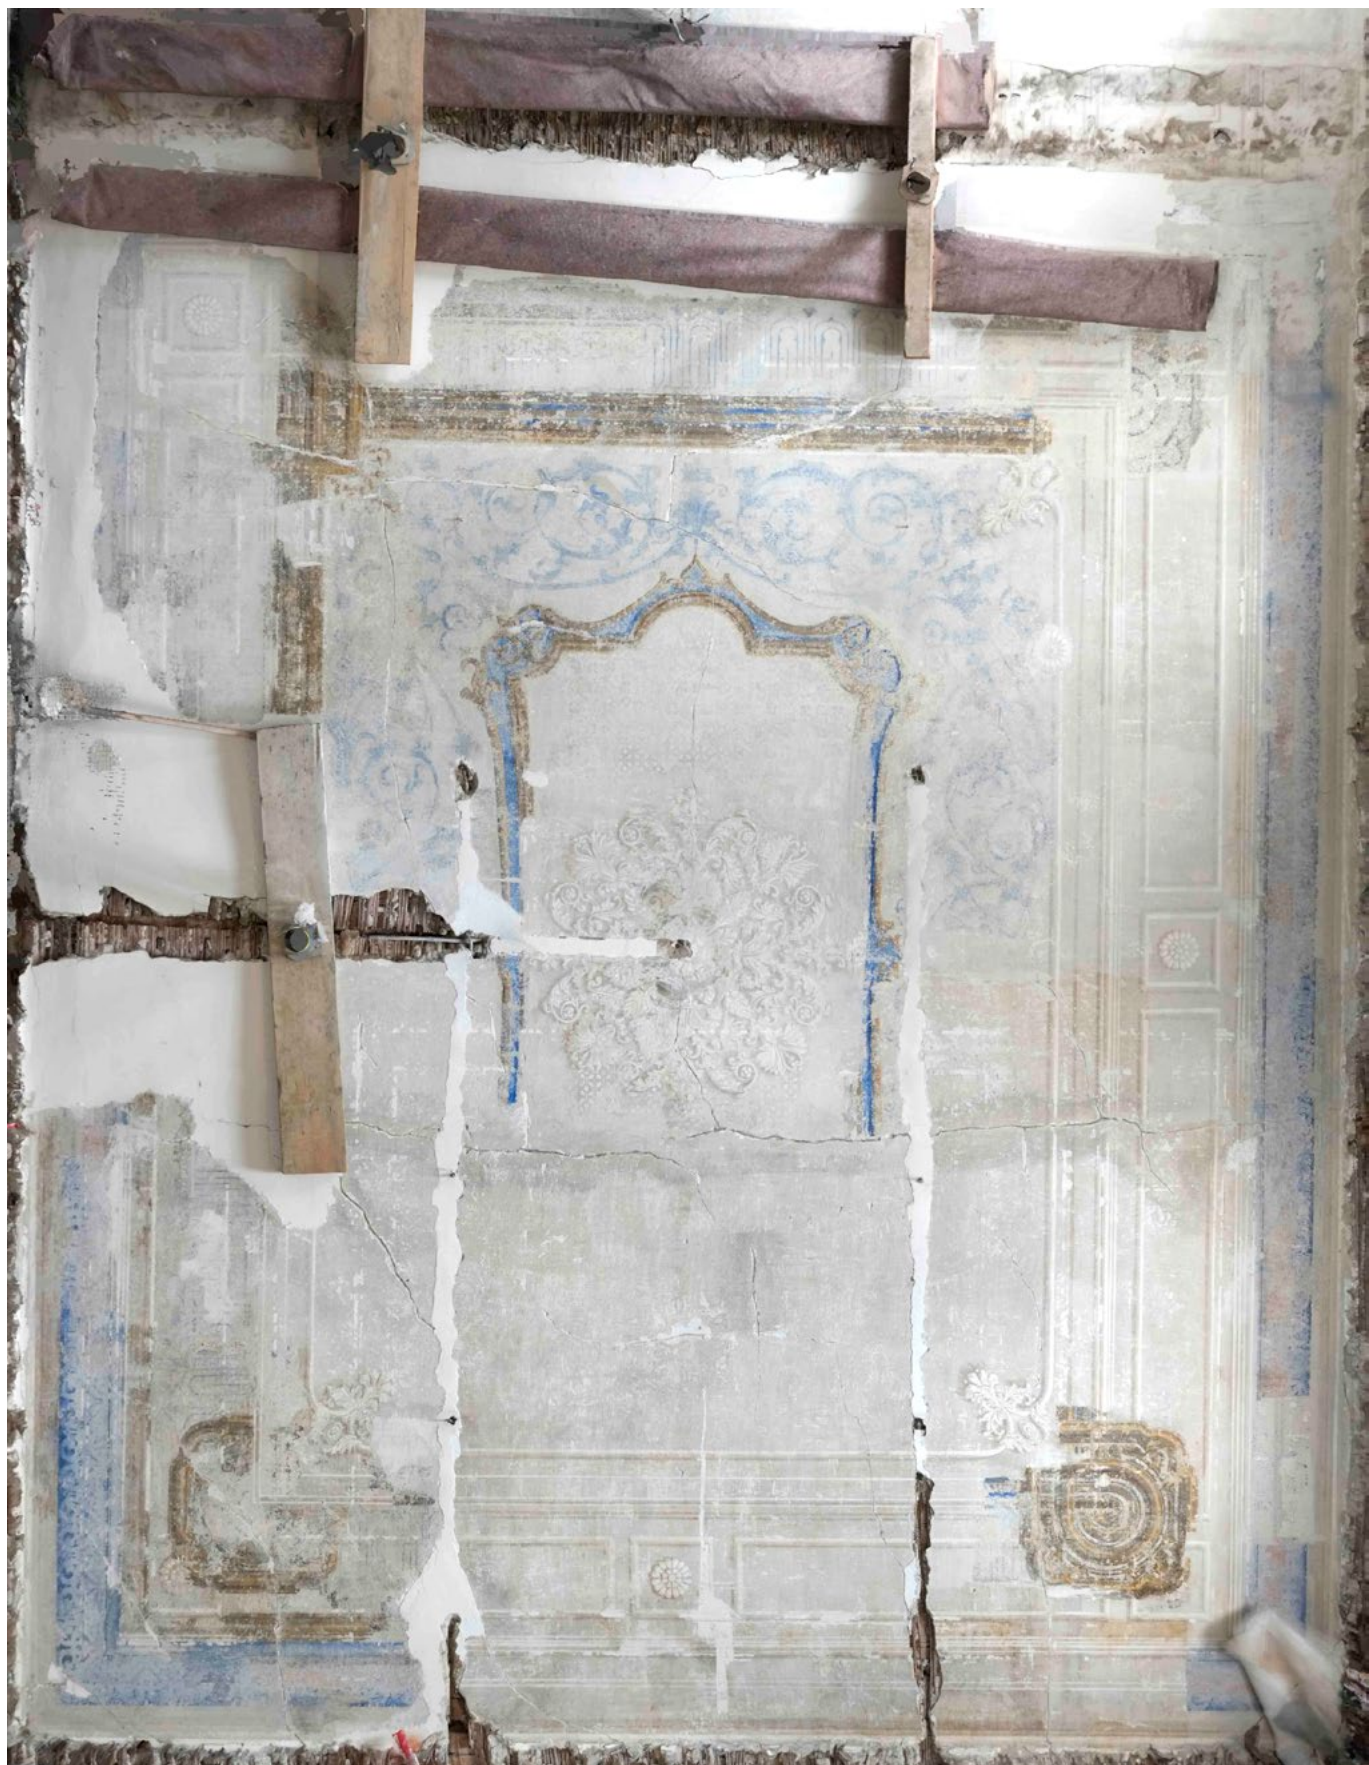
Zagreb, Palača Drašković, Opatička 18. Salon 8 – stanje stropa tijekom uklanjanja recentnih naliča i cementnih zakrpa (ortofoto snimka: Pro Elemento d.o.o., 2025.)

Zagreb, Drašković Palace, Opatička 18. Salon 8 – condition of the ceiling during the removal of recent paint and cement patches (orthophoto: Pro Elemento d.o.o., 2025)

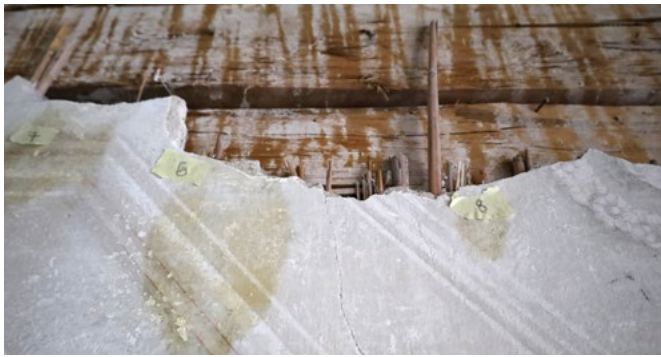
Zagreb, Palača Drašković, Opatička 18. Salon 9 – probe injektiranja žbuke (snimka: A. Dumbović, 2025.)

Zagreb, Drašković Palace, Opatička 18. Salon 9 – plaster injection tests (photo: A. Dumbović, 2025)

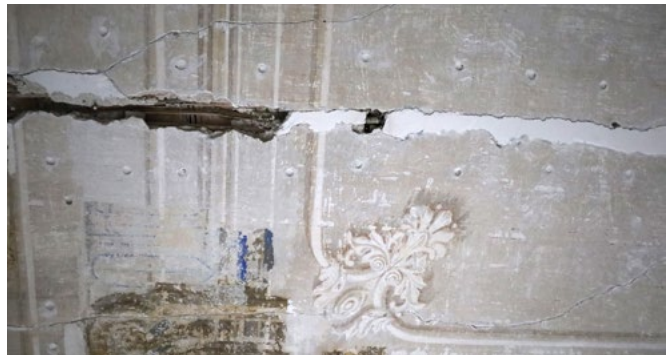
Zagreb, Palača Drašković, Opatička 18. Salon 8 – učvršćivanje odvojene tršćane građe za gredu ankeriranjem nehrđajućim vijcima s maticama i vlaknastom žbukom (snimka: A. Dumbović, 2025.)

Zagreb, Drašković Palace, Opatička 18. Salon 8 – attaching the separated reed material to the beam by anchoring with stainless steel screws with nuts and fibrous plaster (photo: A. Dumbović, 2025)
