# **ZIDNE SLIKE I ŠTUKATURA NA ŽBUKANIM DRVENIM KONSTRUKCIJAMA**

## **KNJIGA SAŽETAKA**

# **WALL PAINTINGS AND STUCCO ON PLASTERED WOODEN STRUCTURES – *Challenges and Solutions***

## **BOOK OF ABSTRACTS**

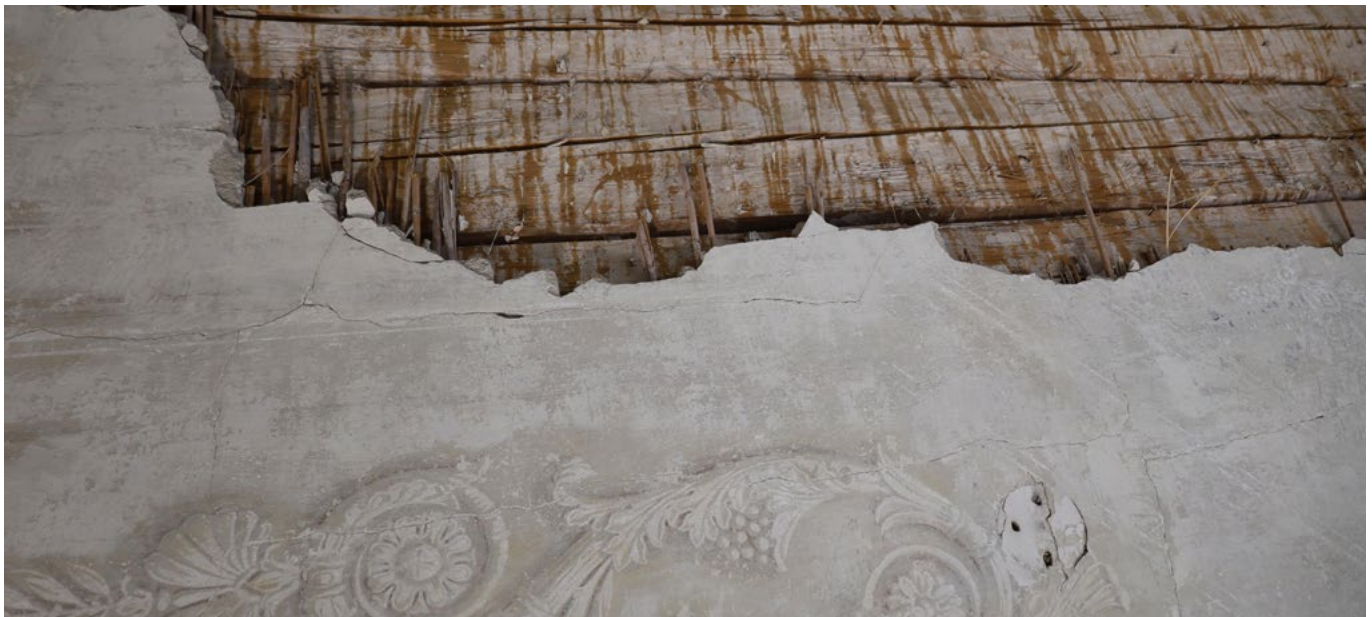
Zagreb, Palača Drašković, Opatička 18. Salon 9 – nedostatak tršćano-žbukane građe s oslikom na južnoj strani stropa (snimka: A. Dumbović, 2025.)

Zagreb, Drašković Palace, Opatička 18. Salon 9 – missing reed-plaster with wall painting on the south side of the ceiling (photo: A. Dumbović, 2025)

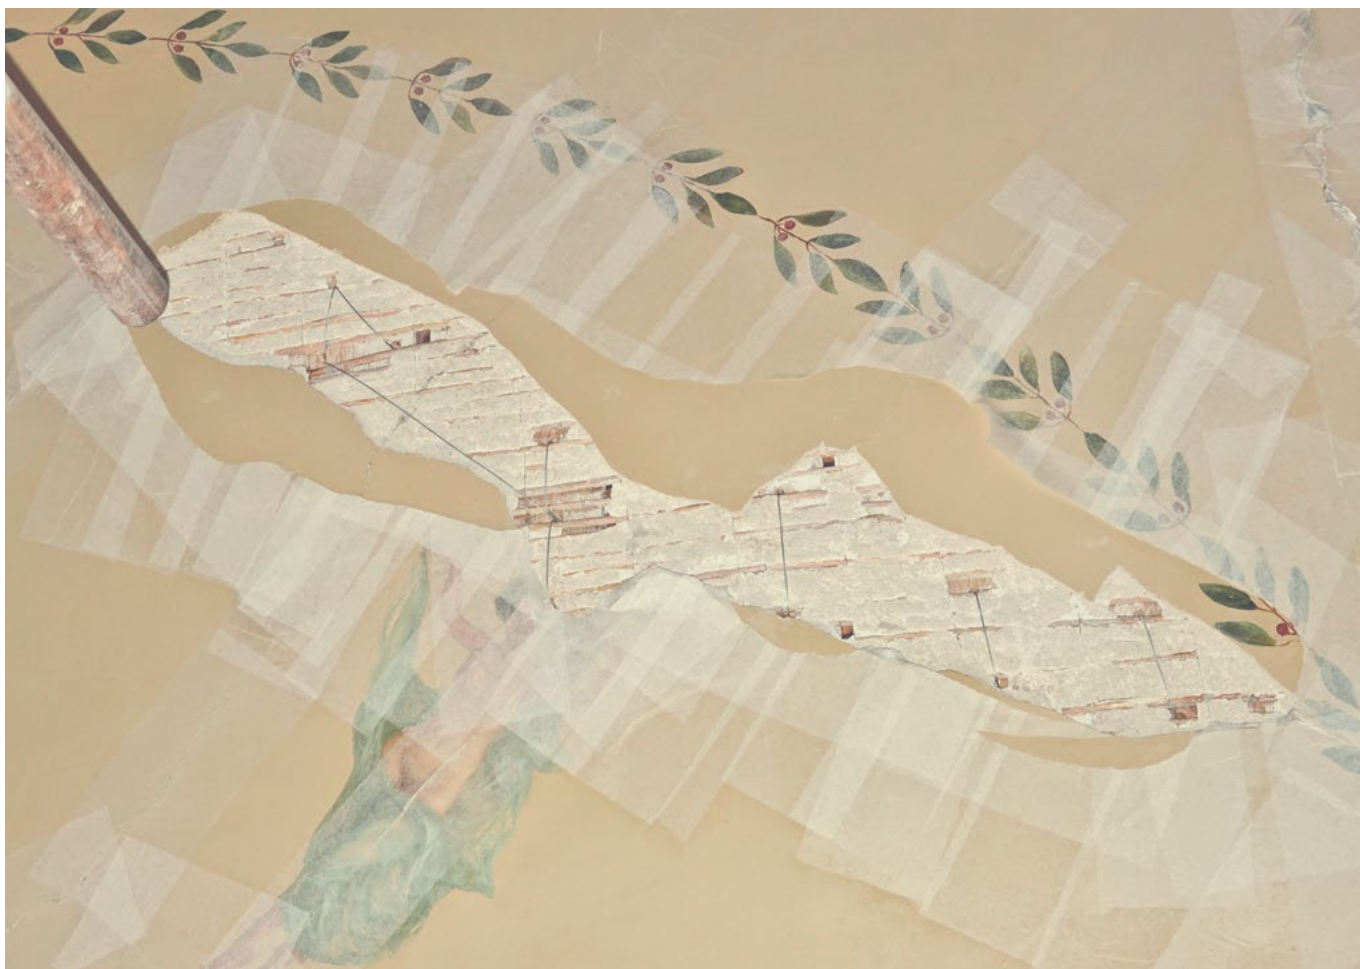
Zagreb, Palača bogoštovlja i nastave (Hrvatski institut za povijest), Pompejanska soba – tijekom konzervatorsko-restauratorskih radova; preventivna zaštita oštećenog dijela stropa (arhiva HRZ-a, snimka: A. Filip, 2022.)

Zagreb, Palace of Religious Affairs and Education (Croatian Institute of History), Pompeian Room – during conservation and restoration; preventive protection of the damaged part of the ceiling (HRZ Archive, photo: A. Filip, 2022)

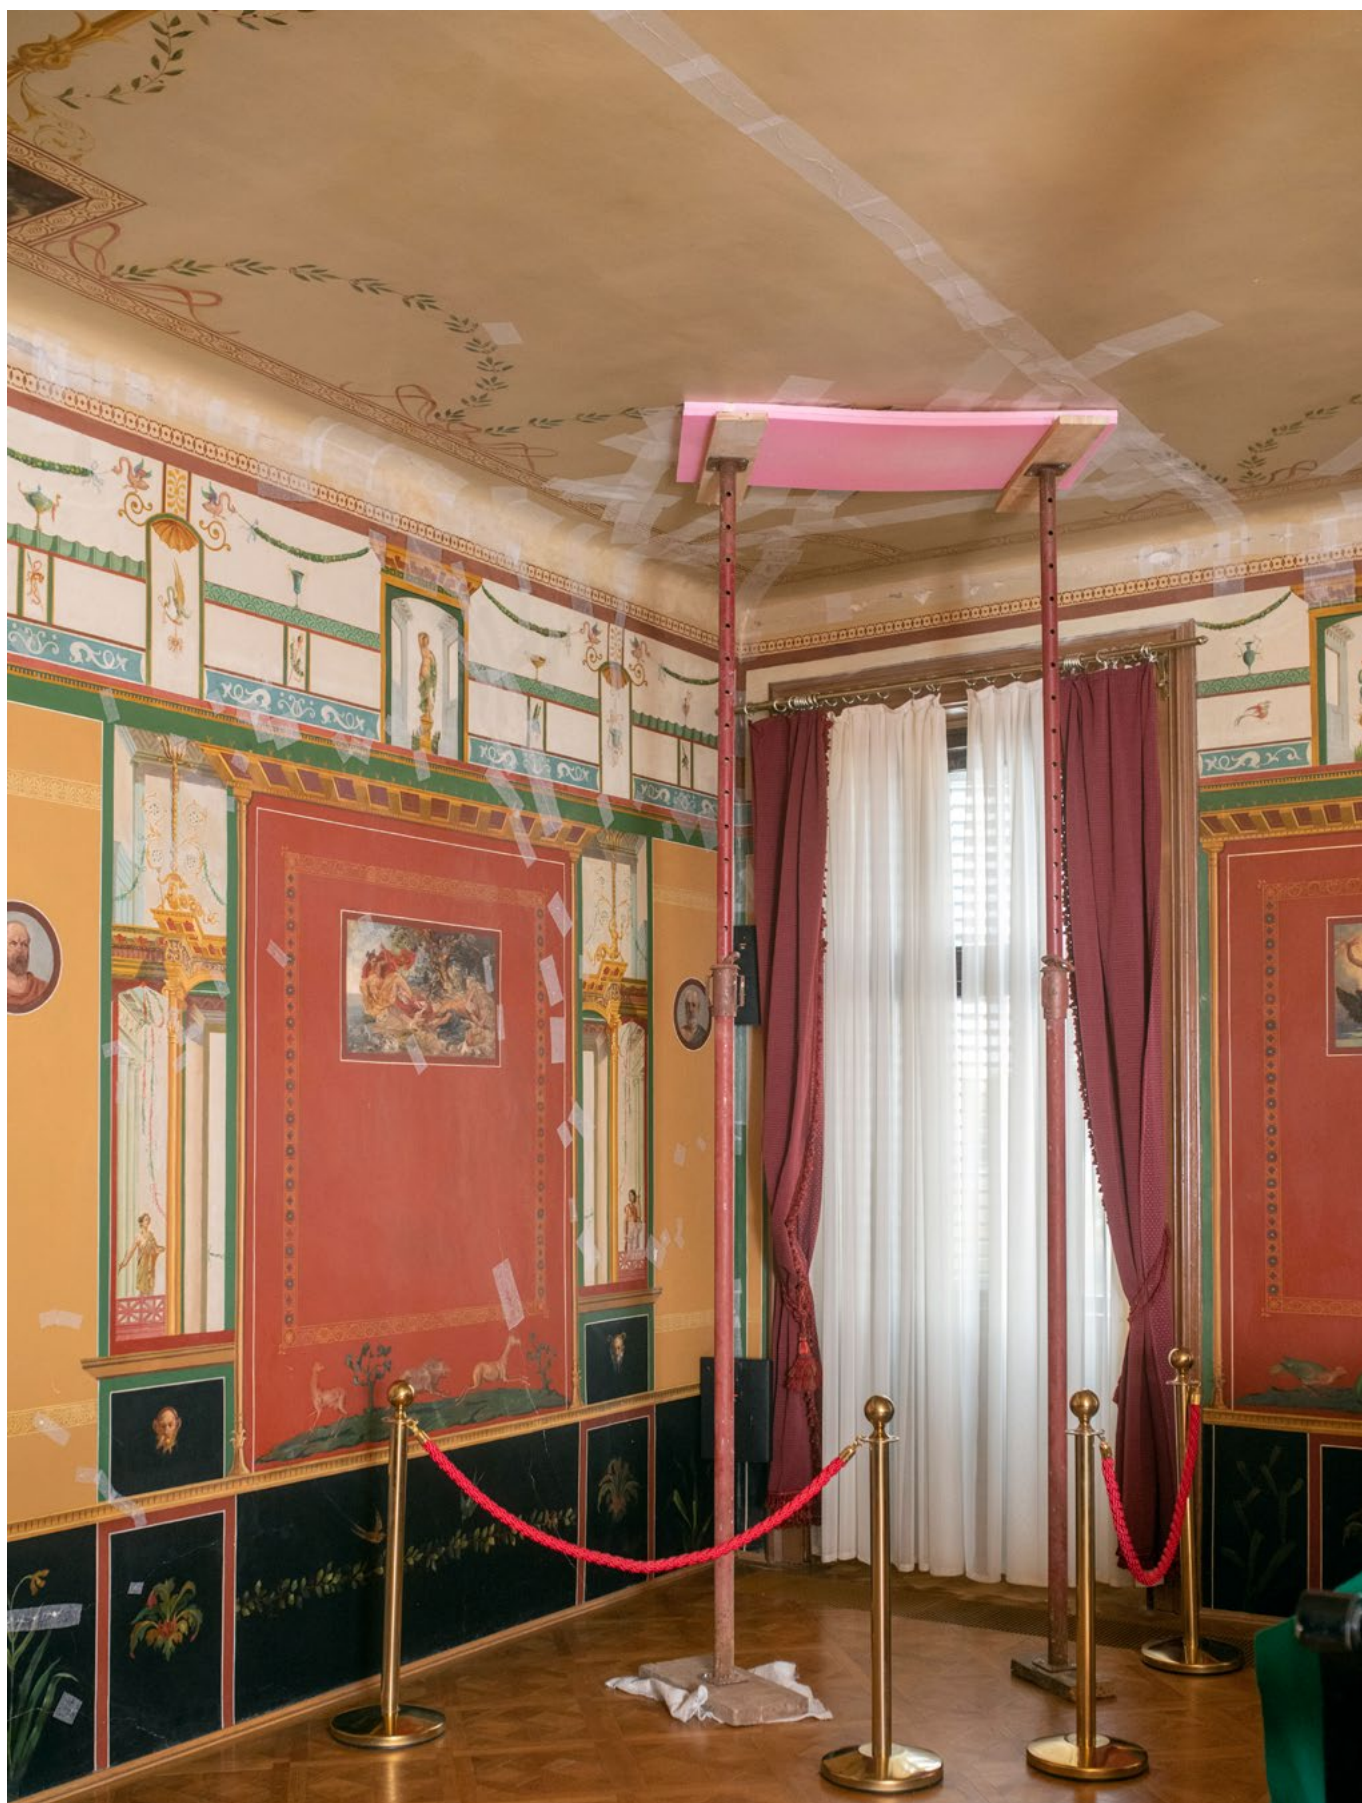
Zagreb, Palača bogoštovlja i nastave (Hrvatski institut za povijest), Pompejanska soba – zatečeno stanje stropa nakon potresa (arhiva HRZ-a, snimka: G. Tomljenović, 2020.)

Zagreb, Palace of Religious Affairs and Education (Croatian Institute of History), Pompeian Room – condition of the ceiling after the earthquake (HRZ Archive, photo: G. Tomljenović, 2020)

The methodology applied during the conservation and restoration project is presented using the painted ceiling of the Pompeian Room as an example. During the earthquake, the movement of the inter-floor wooden structure caused the binding wires securing the reed lathing to break. Consequently, the plastered reed detached from the structural framework, resulting in deformations, cracks in the plaster and painted layer, and irretrievable losses of parts of the wall paintings. In order to reintegrate the damaged parts, it was necessary to access the plaster and the reed lathing from both the underside and the upper side of the ceiling structure. By re-establishing the cohesion between all stratigraphic layers, comprehensive conservation and restoration was made possible, ensuring the preservation of wall paintings in the Pompeian Room.
