Naslovna strana: skulptura sv. Karla Boromejskoga prije konzervatorsko-restauratorskih radova
Preklop: pil Svetoga Trojstva krajem 19. stoljeća
Cover: the statue of St. Charles Borromeo before conservation- restoration works
Fold: The Holy Trinity votive monument at the end of the 19th century

KONZERVATORSKO –
RESTAURATORSKI RADOVI NA
PILU SV.TROJSTVA U OSIJEKU
**CONSERVATION AND RESTORATION
WORK ON THE HOLY TRINITY VOTIVE
MONUMENT IN OSIJEK**

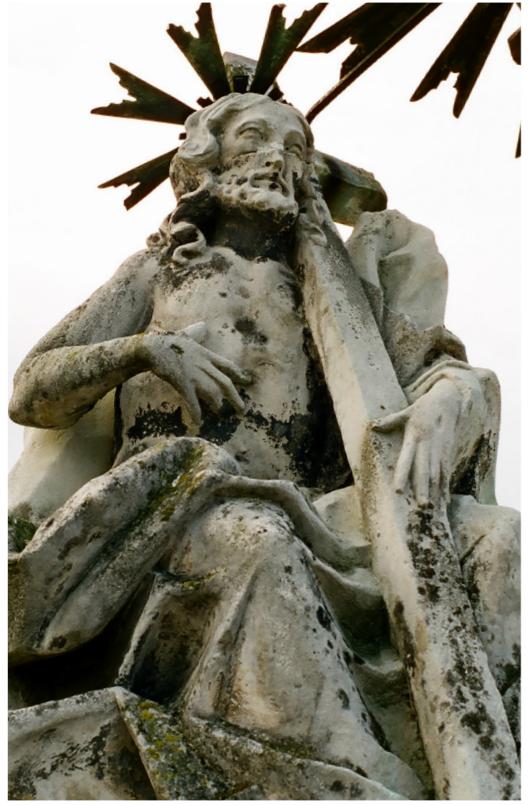
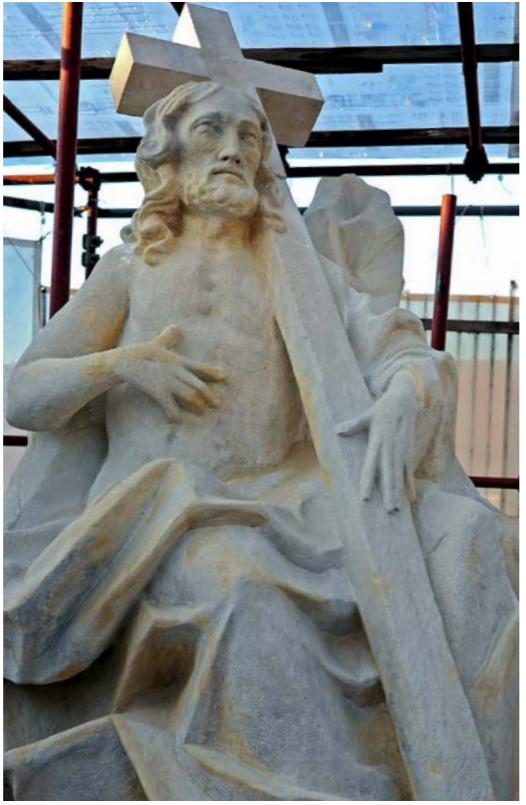
Skulptura Krista prije i nakon konzervatorsko-restauratorskih radova
The statue of Christ before and after conservation-restoration works

lovima radovi izvedeni *in situ*. Radovi su obuhvatili mehanička čišćenja vodom, mikropjeskarnicom i laserom, a kamen je tretiran i kemijskim sredstvima da bi se umanjila količina štetnih soli u strukturi materijala te uklonile zelene mrlje od bakrenih čestica. Na dijelovima spomenika je kamen učvršćen vakuumskom metodom. Pozlaćeni i posrebreni dijelovi na vrhu pila također su restaurirani. Izvorna je golubica, prikaz Duha Svetoga, pohranjena u muzej, a na njezino je mjesto postavljena kopija. Četiri

and the metal parts of the monument. The upper parts of the monument, with the statues of God the Father and Christ were dismantled, in order to carry out necessary conservation and restoration procedures in the workshop, whereas on other parts the work was done *in situ*. The work comprised mechanical cleaning using water, micro sandblaster and laser, and the stone was further treated chemically, to reduce the amount of harmful salts in the structure of the material, and remove green staining caused by copper particles. On parts of the monument the stone was reinforced using vacuum. The silver and gold plated elements on the top of the monument were also restored. The original dove, the depiction of the Holy Spirit, was deposited in a museum, and a replica was fitted in its place. The bottom four stone statues were replaced with replicas previously due to a very bad condition of the originals, exhibited in the building of the University of Osijek Rector's Office.

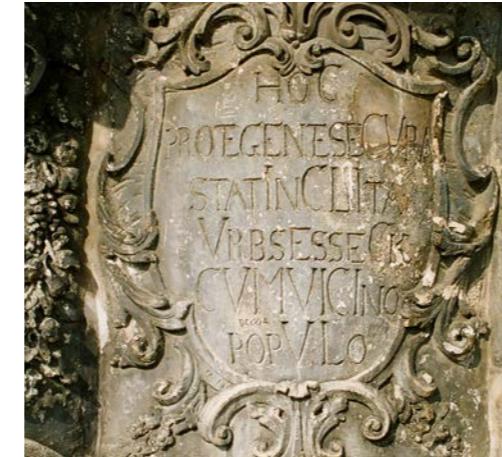
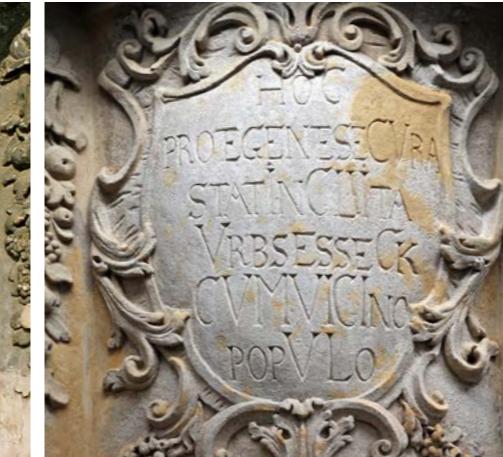
Gore: polje s natpisom na podnožju pila prije i nakon konzervatorsko-restauratorskih radova Dolje: glave anđela, Boga Oca i sv. Josipa s vidljivim oštećenjima Above: inscription on the high stand before and after conservation- restoration works
Below: heads of an angel, God the Father and St. Joseph with visible damages
