**DIOCLETIAN'S PALACE AND THE
MEDIEVAL CORE OF THE CITY OF SPLIT**

**Manual for Built Heritage
Maintenance and Disaster Risk Management**

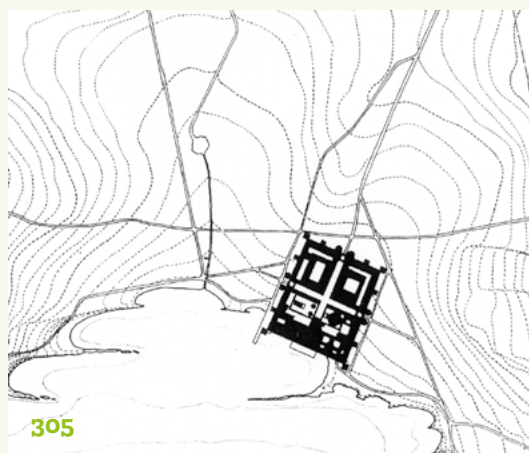
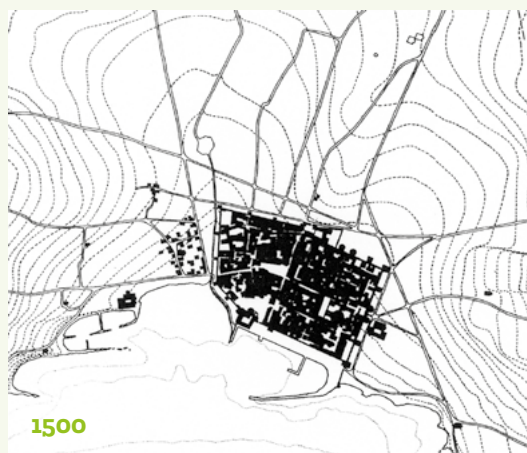
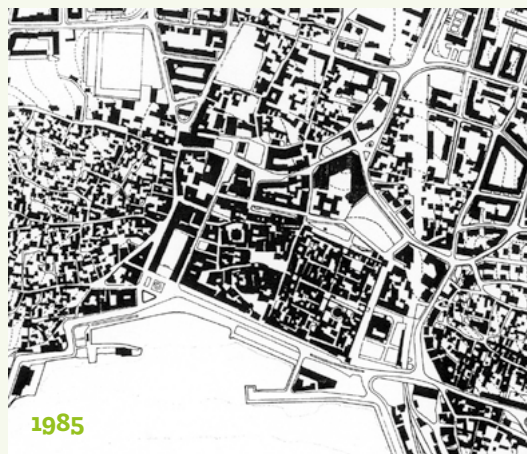
The spatial development of the historic core of Split (J. Marasović)

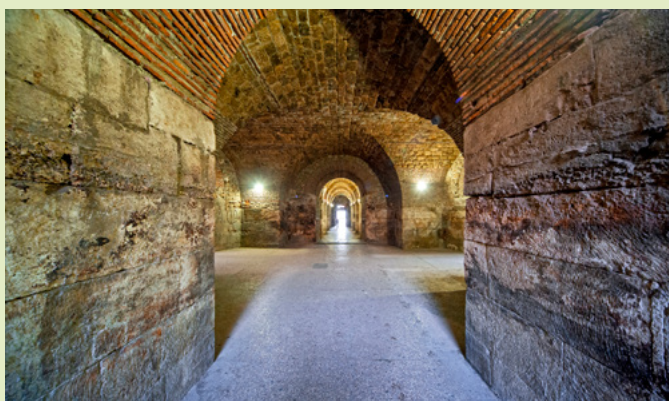
The substructures of the Diocletian's Palace
(I. Pervan)

Single buildings or groups of buildings of outstanding historical, artistic, scientific, social or technical significance can be protected as individual cultural goods even where they are part of an already protected site. For example, although the historical complex of Split had already been a designated site, the Ministry of Culture and Media of the Republic of Croatia protected the Substructures of the Diocletian's Palace as built heritage. The heritage order was issued in 2019, declaring the Substructures an object of great archaeological importance and object of interest to the Republic of Croatia, a public good in common use, and an inalienable possession of the Republic of Croatia. The designation was preceded by an arduous and time-consuming legal procedure concerning legal doubts over property lines and a nerve-wrecking amount of paperwork. Namely, although the Substructures in some places blend with the foundations of the medieval houses built above them, from the standpoints of function and archaeology they are a separate whole. The problem was that the cadastre did not recognise the situation in which the ownership of a property above the ground was different from that of its basement. However, due to the efforts of the Conservation Department in Split, and the cooperation between the Ministries of Culture, Justice and State Property, the long-standing ownership dispute was finally ended. The necessary changes and amendments to the *Act on the Protection and Preservation of Cultural*

Property were adopted, the problematic plots were resurveyed and registered again in the cadastre, and the Republic of Croatia and the City of Split signed the *Facility Use Agreement*. This opened the way for their integral research and improvement as the point of departure for the restoration of the whole south-east quadrant of the Palace and the final solving of the accumulated communal problems.

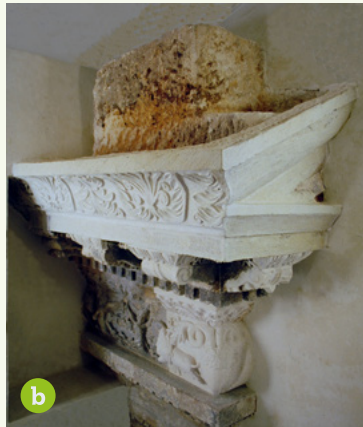
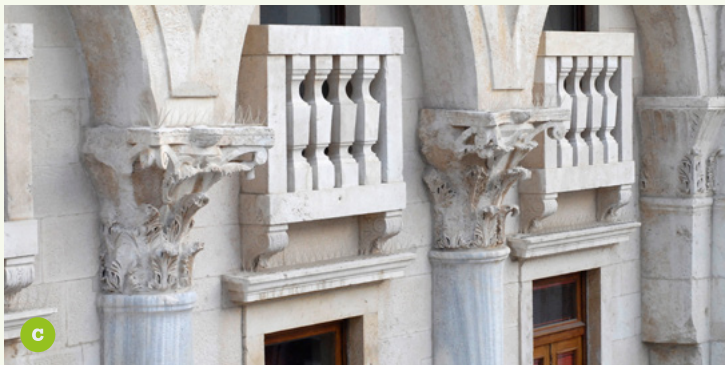
(fig. a) The place in which a house joins the cornice of the so called Jupiter's Temple (V. Marinković)

In present-day Split, due to its rich history and the continuity of life there, different historic layers are often physically and functionally interlaced. The result are almost unbelievable examples of new constructions. So for example, in some medieval houses one can still see a storey-high portion of the Palace wall. Its markedly well preserved construction details stand out from the building fronts on the Riva which were interpolated into its southern façade. Elements of the Vestibule, late Roman houses and the Western Thermae are put on display in tourist facilities (hotels), while an ancient conch (semi-dome), containing the remains of a Roman wall mosaic, still stands in a private courtyard at Dosud. Inside the Ethnographic Museum, a visitor will find a small church dedicated to St. Andrew and Fenstris, as well as the west niche of the Triclinium and yet another Roman (floor) mosaic. The columns of the Peristyle's colonnade are

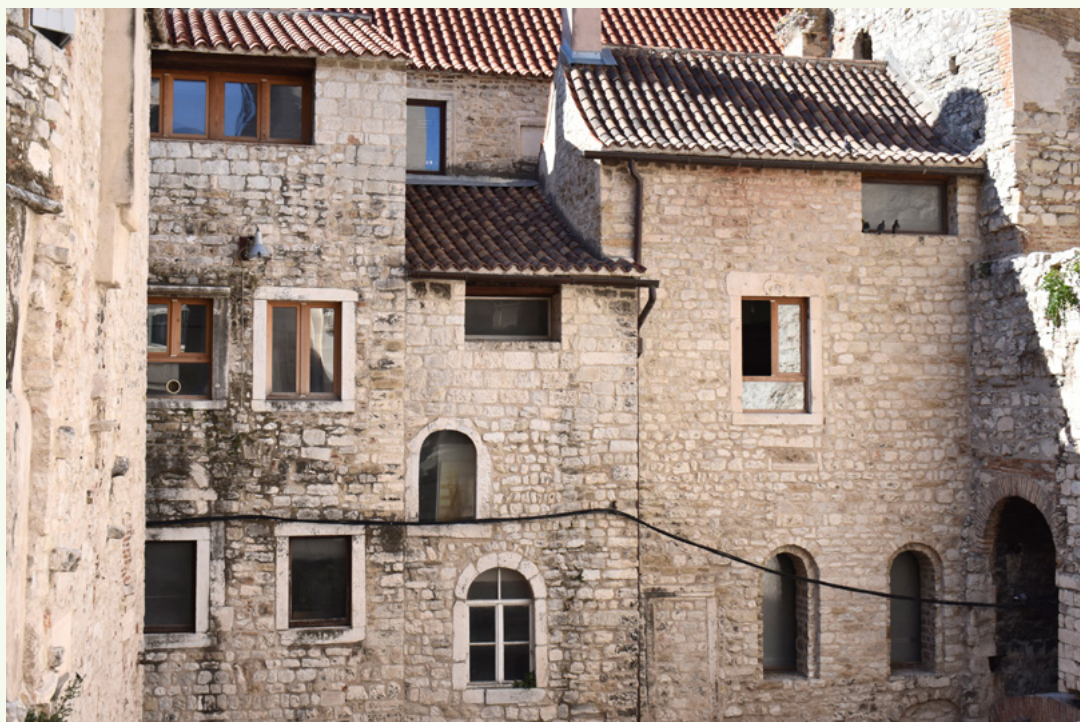
A group of Romanesque houses situated to the west of the Vestibule (V. Marinković)

The earliest examples of residential architecture in the historic core of Split go back to the 9th century. However, the overwhelming majority of the houses are from between the 12th and 14th centuries, when the building activity in the city core was most lively. Somewhat smaller in number, but no less important or less rare, are the residential buildings erected from the 14th to the 19th century. Most of them have not survived in the original form, as over the centuries many houses got partly or completely removed, remodelled, merged into larger units, or transformed to meet the new needs of everyday life. The buildings that had not been pulled down received new constructive details, now storeys, new access areas, new roofs, and sometimes even entirely new shapes. Yet in spite of that, many of them have preserved the characteristic form conditioned by the style of the period in which they were built and economic and social circumstances of the day. Based on the surviving examples it is possible to reconstruct their general layout and characteristic shapes. Although they may differ one from another in style and time of building, they share the same recognisable elements that come from using traditional materials and living in Mediterranean climate. These elements and materials are not always genuine, as they changed over the centuries to eventually become a group of architectural details that add to the local colour and the authenticity of the local building fabric. By conserving these traditional details, materials and colours, we both protect the historic city core of Split and preserve the vernacular and economic values of its residential architecture. One of the prominent elements of residential architecture is the

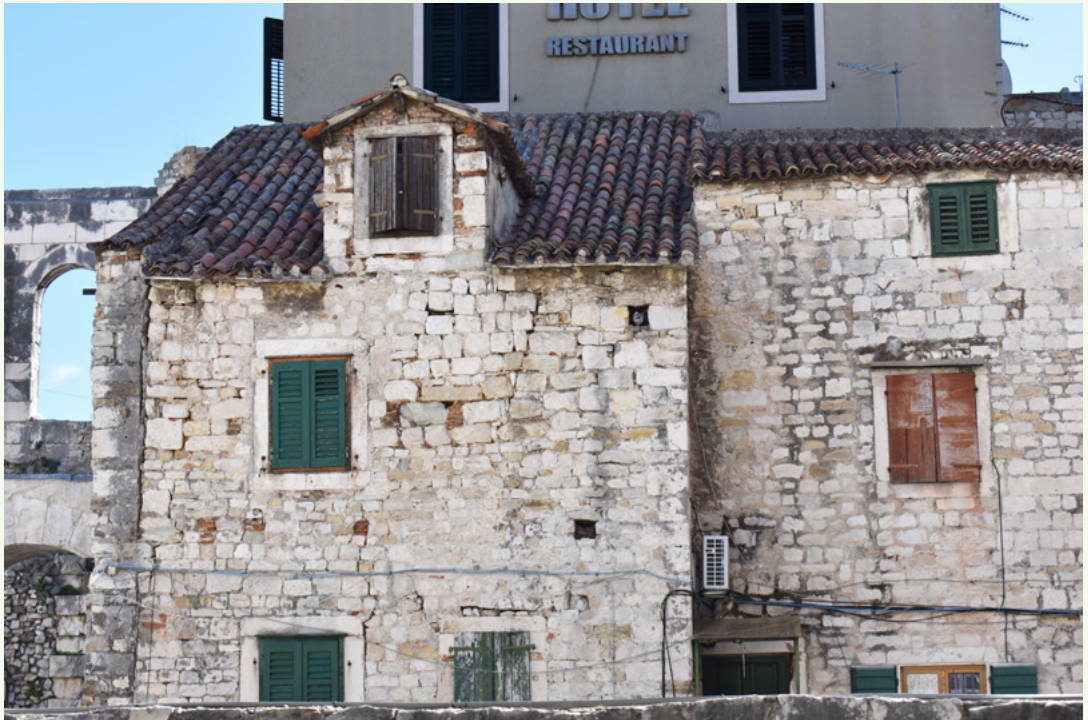
Details of an old house in Bulić Street (V. Marinković)

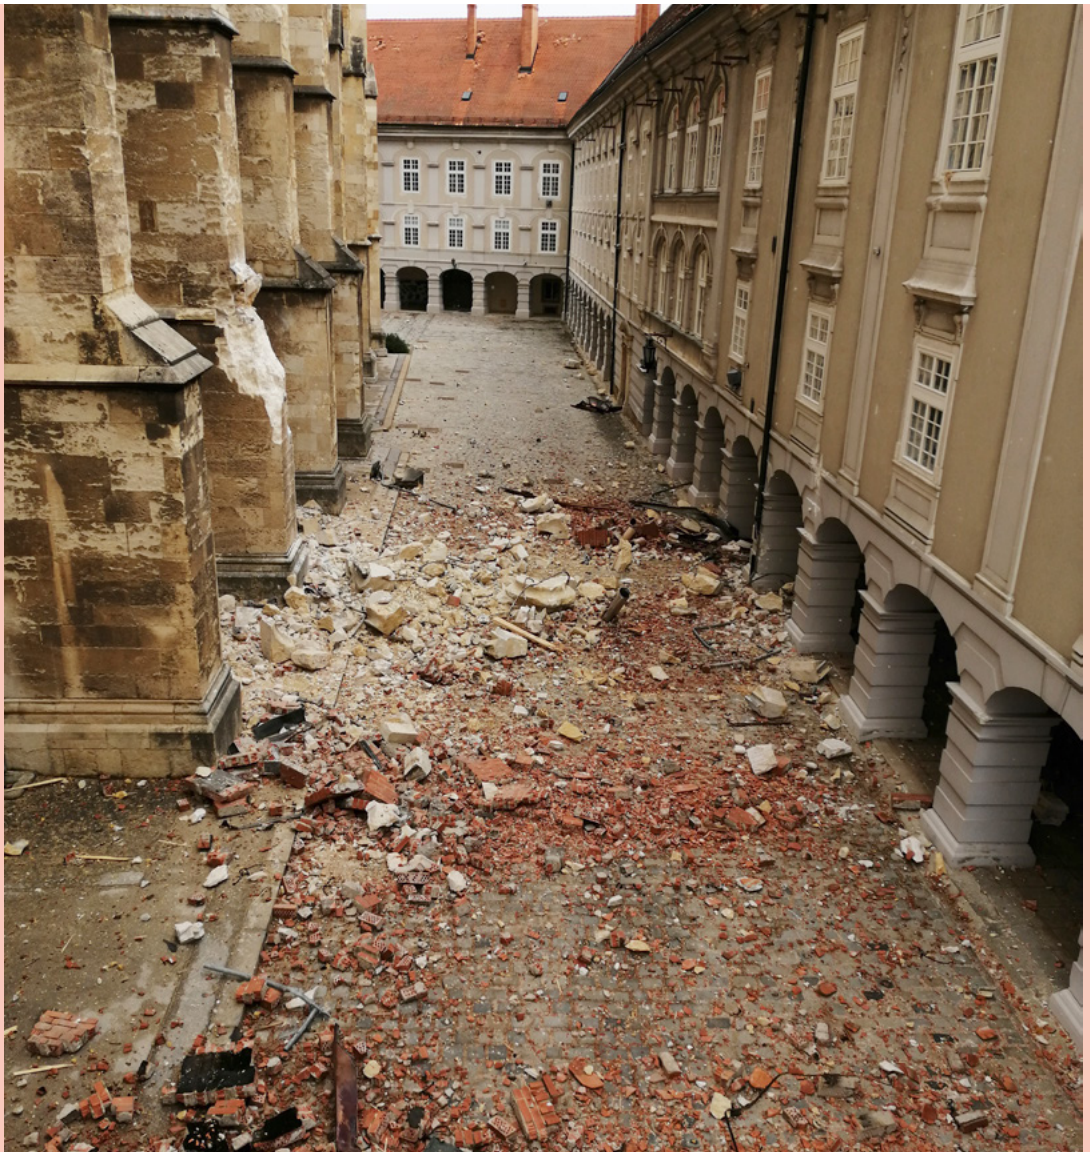
The consequences of the 2000 Zagreb earthquake (J. Kadija)

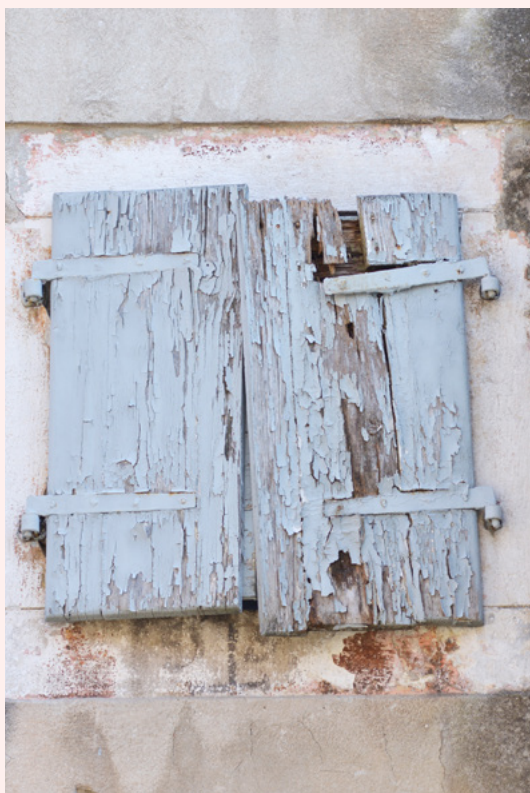
Unmaintained carpentry (J. Kliska)

Underutilized historic buildings, most often due to unresolved ownership issues, can have different problems. The long-term consequences of neglect are deteriorated roofs (clay tiles crack and/or become loose) and crumbling and detachment of façade plaster. Plants grow into joints, additionally destabilizing the masonry, and water (rainfall) migrates into roof constructions, walls and woodwork, giving rise to deterioration processes in the interior of the building (e.g., wooden floor construction rots). To thus weakened structures, even a minor earthquake can cause serious damage. Loose roof tiles and plaster can come off and, ultimately, the whole building can collapse. The ensuing physical loss results in tangle damage and, in case of a protected cultural good, in the loss of heritage attributes of a building and a historic environment. The building material that falls off unmaintained buildings poses a serious threat to lives of the remaining occupants and casual passers-by. This is exactly what happened to Zagreb, Sisak and Petrinja in March 2020, when they were hit by a series of earthquakes which caused great material damage and regrettable loss of lives.

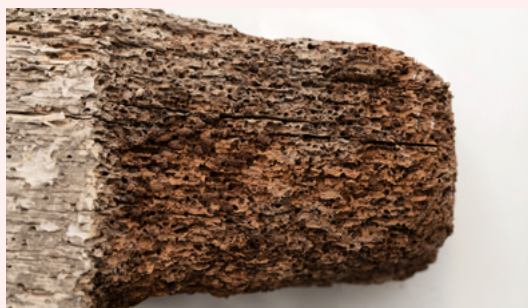
A damaged timber joist (P. Gamulin)

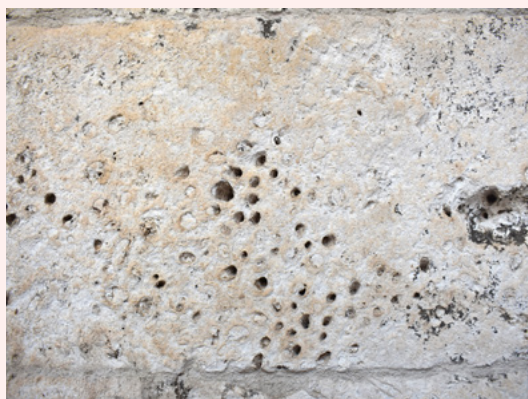
Deterioration of stone (V. Marinković)

Two main causes of the degradation of the historic core are the very old age of the material of which it is built and the poor maintenance of the buildings. The aging process affects physical properties of materials, which become non resistant to weathering. It manifests as scaling and cracking of stone, rotting of wood, corrosion of metal, and loss of binding properties of mortars. Due to these processes, roofs, floor constructions, carpentry and wall joints, along with entire facades, deteriorate, reducing stability and functionality of the structures. In the oldest part of the city core (area encompassed by the Diocletian's Palace), degradation processes are particularly pronounced, and the stability of the buildings is additionally threatened by the fragility of the Roman foundations on which they are built.

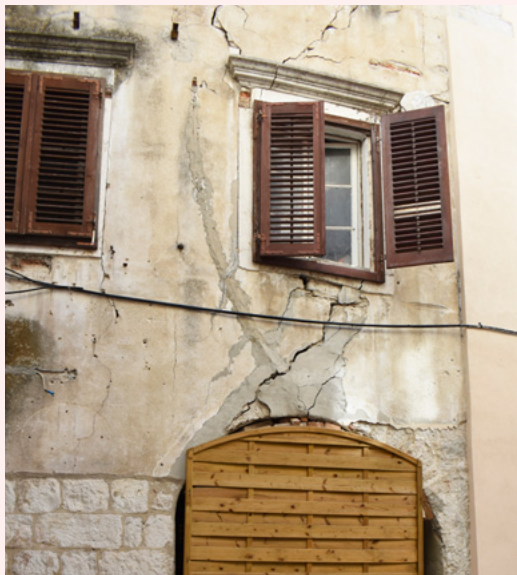
Structural damage on a house in Bulić Street, such constructions are extremely vulnerable to earthquake (V. Marinković)

The area of the city of Split and its wider surroundings is a zone of high seismic intensity. The historical complex of Split is very vulnerable to earthquakes. This is particularly true for the poorly maintained medieval houses in the south-east quadrant of the Palace which are built on the shaky ground and have the Roman Substructures in their foundations.

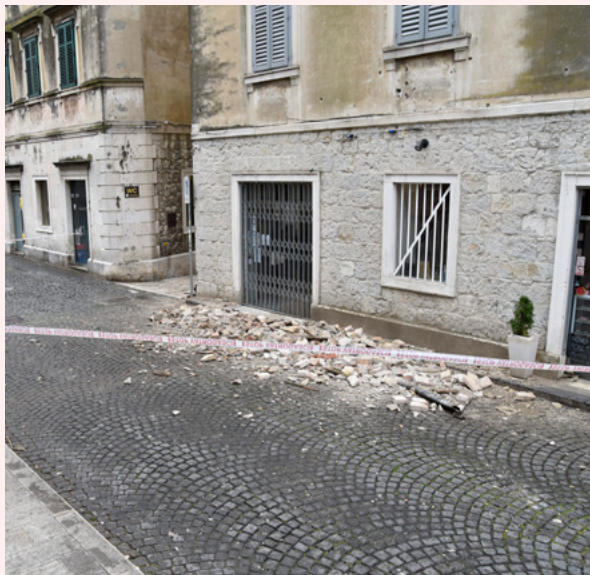
The roof cornice collapsed due to the 2021 heavy rain (J. Šupić / Cropix)

In 2021, due to heavy rain, the broken cornice of a modern house in Vicka Andrića Street, in the historic core of Split, detached, causing serious material damage. Fortunately, there were no casualties.

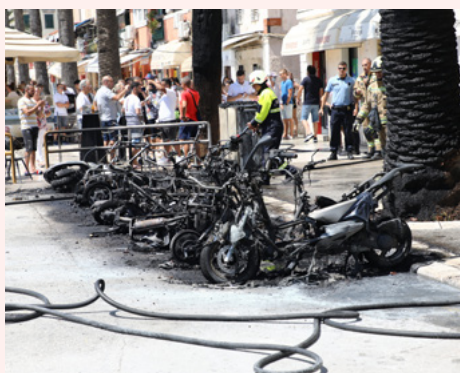
Consequences of a fire on the Riva, 2020 (V. Bašić / Cropix)

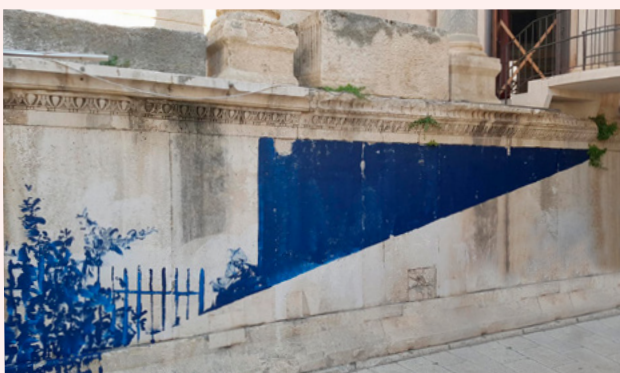
In 2018, the Diocletian's Mausoleum was a target of vandalism (V. Marinković)

Vandalism designates a voluntary act resulting in damage and/or destruction of public and private property. In the historic core of Split, a large number of graffiti have been recorded on stone surfaces, including those of protected buildings. The municipal services remove every new graffiti within 24 hours of its appearance. However, the application of paint and its removal cause irreversible damage to stone. Paint penetrates deep into substrate, which sometimes calls for more aggressive cleaning methods that can damage the surface of historic stones, opening the way for other harmful agents such as water or frost, which gradually degrade the stone material.

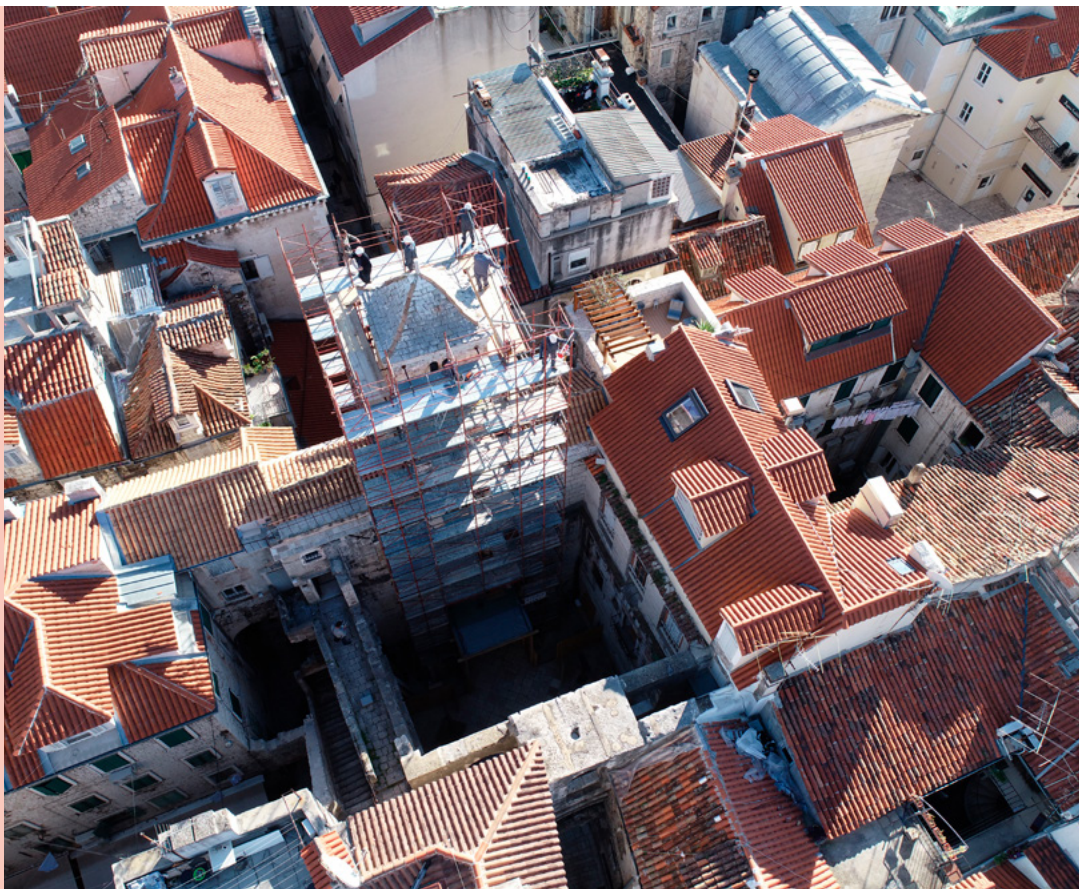
Restoration works on the bell tower of the church of Gospe od Zvonika (archives of the Croatian Conservation Institute and Geoprojekt d.d.)

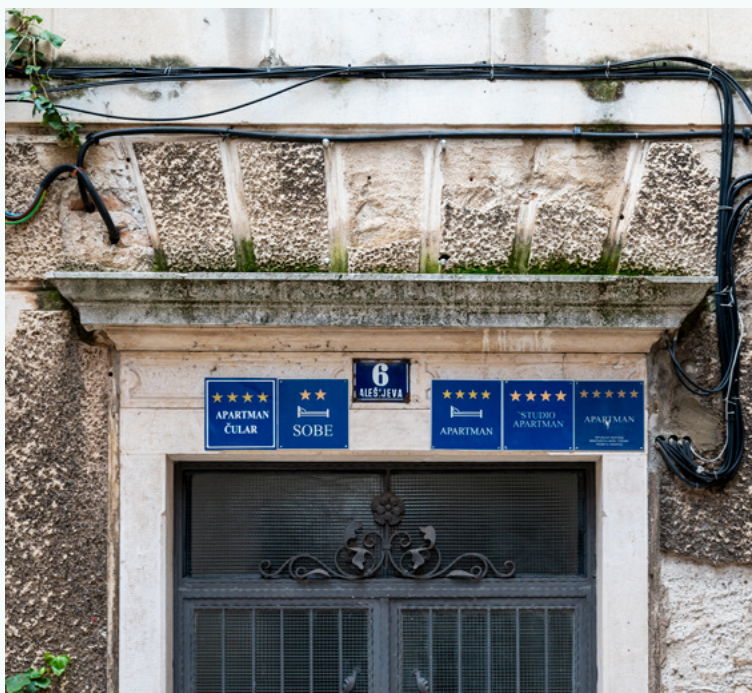
Pursuant to the *Order on the Communal Order*, it is prohibited to put signs on stone frames of the openings in the protected Zone A (V. Marinković)

Local regulations such as the *Order on the Communal Order of the City of Split* define, among other things, special responsibilities of the owners of properties in the protected Zone A. For example, if you want to put a sign on the front-facing façade of your building which happens to be in the zone of complete protection, pursuant to the *Order*, you must place it within the boundaries of your window or door panes, and not higher than 25 cm. Furthermore, it is prohibited to fix signage to stone frames of the openings on the front-facing facades or install metal security roller shutters on doors and shop windows of business premises. See-through shutters are, however, allowed, but must have the permission of the Conservation Department. The *Order* also prohibits flue pipes and ventilation systems on the facades over public spaces, and money dispensers (ATMs) on front-facing facades and in public areas. Clothes drying lines ("tiramole") are allowed. Yet, for practical, functional, and safety reasons, there is a ban on stringing drying ropes across certain streets and squares. They are as follows: Ban Mladenova, Bana Jelačića, Matošićeva, Ujevićeva poljana, Porinova, Trg Gaje Bulata, Sinjska, Manuška poljana, Zagrebačka, Tončićeva, Marmontova, Obrov, Domaldova, Šubićeva, Bosanska, Marulićeva, Dioklecijanova, Kraj sv. Marije, Krešimirova, Ilićev prolaz and Zadarska.

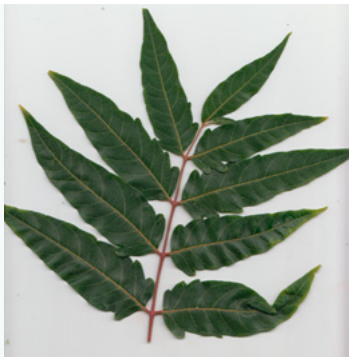
Tree of heaven, leaf
(V. Marinković)

The vegetation noticed on walls and roofs during routine inspections should be removed. Plants with their root system may damage both joint infills and stone. Some plant species may even threaten the stability of roofs, walls, pavements and piping infrastructure. Of the plant species identified in the old city core, particularly damaging to the structural components of the buildings are capers (*Capparis spinose* L.), the fig tree (lat. *Ficus*) and the tree of heaven (*Ailanthus altissima*). The most invasive of the three species is the tree of heaven, which is not native to the Mediterranean region. This fast growing plant, with a long, resistant and adaptable root system, damages built heritage and infrastructure. Therefore, it should be kept under control and removed in a systematic way.

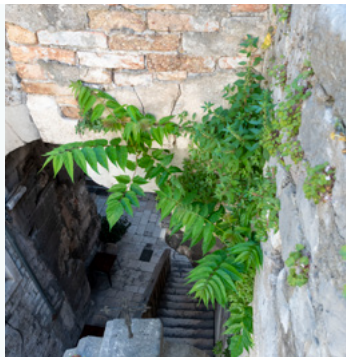
Trees of heaven in the streets of the old city
core of Split (V. Marinković)

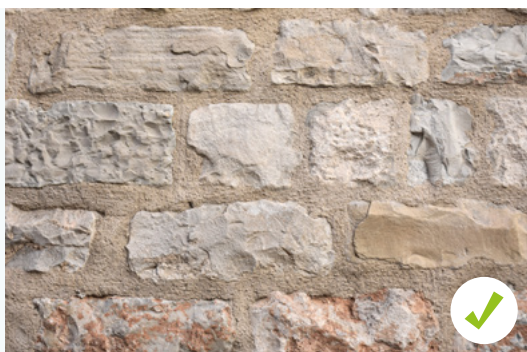
Correctly grouted lime mortar joint
(V. Marinković)

Repointing of joints is preceded by a series of preparatory operations, which include removal of vegetation (if there is any), mechanical removal of the old and eroded mortars, sometimes even washing of the whole wall in order to remove dirt. The process of repointing implies gradual grouting of cleaned joints with new lime mortar. The cleaning of joints is carried out with a blower. The cleaned joints are moistened, and the mortar infill is kept wet in order to dry gradually. This will prevent mortar from cracking. When mortar is dry, the repointed joint is brushed with a stiff brush. Preparation of lime mortar according to the traditional recipe is a demanding job and requires a lot of practical skill and knowledge, as does the preparation of a quality lime. This should not worry you, as all stores sell pre-mixed lime mortars manufactured according to traditional recipes. They are easy to prepare and you can choose among different hues and aggregate sizes. The use of manufactured lime mortars considerably facilitates

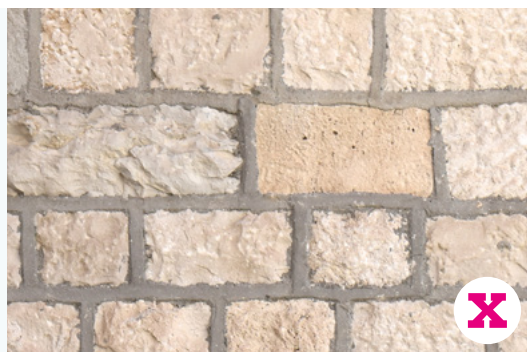
Incorrectly grouted joint: inadequate material and treatment (V. Marinković)

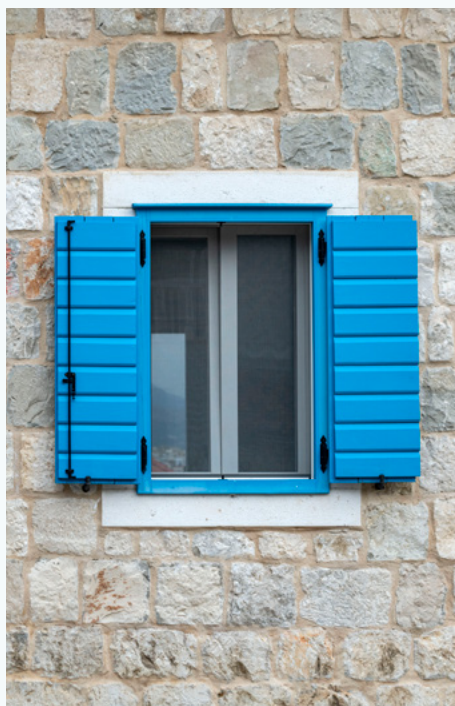
Blue carpentry is not typical of the area of the historic core of Split (P. Gamulin)

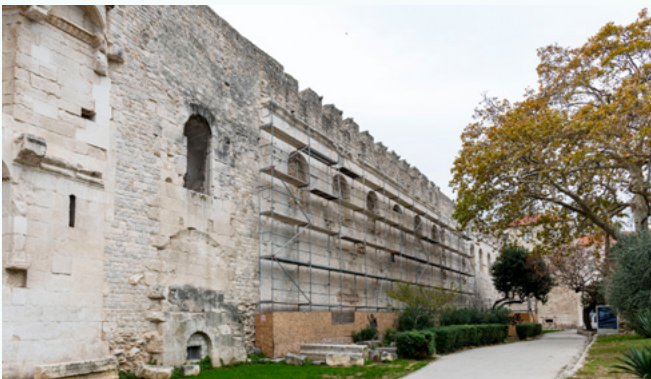
Scaffolding must satisfy the rules, regulations and standards of protection (P. Gamulin)

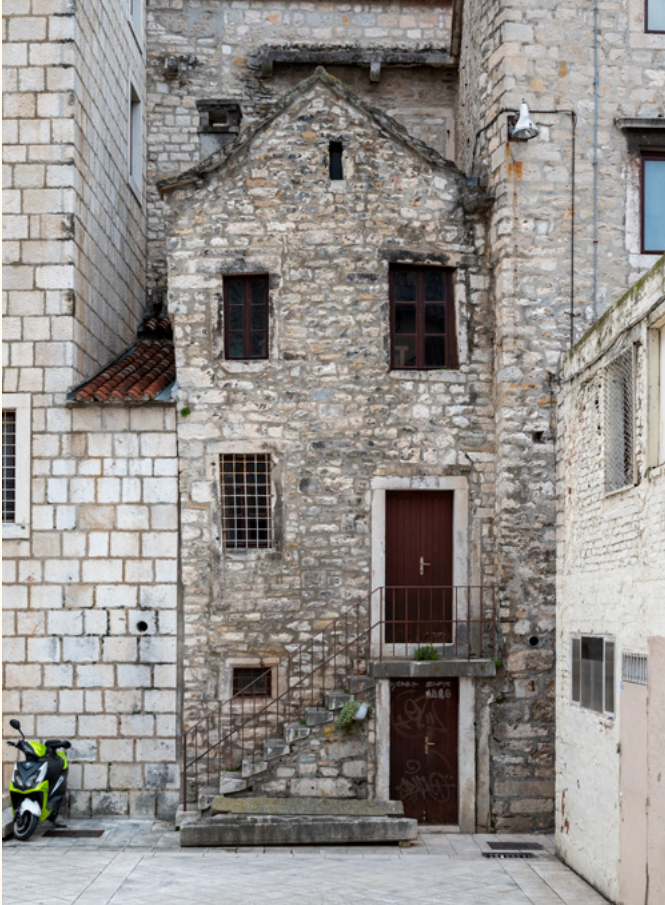
A house in Carrarina poljana: an example of medieval residential architecture (Lj. Gamulin)

The earliest examples of residential houses in the old city core came into being in two ways. One of them was the change of use. Here, the Roman structure was converted into a habitation, using minimal spatial interventions (new horizontal and vertical division of space). The second design was more complex, as here the new house relied on the existing Roman walls and porches, which it partly used as its own walls or facades. This type of house is a narrow, high, single-cell, two-storey structure, with external staircase. In such houses each floor is a single unit, with the cellar or shop (*canava*) on the ground floor, the room on the first floor, and the kitchen on the second floor. It is built of rather small, uneven and roughly dressed blocks, and has no conspicuous elements of style. This house form persisted throughout the Middle Ages, with gradual improvements in constructive details and building methods. Later on, its dependency on Classical material diminished. The houses better conformed to the street grid, often bridged the streets and acquired more pronounced elements of style. Their stone façades became more evenly dressed, and the window openings were accentuated with arches.

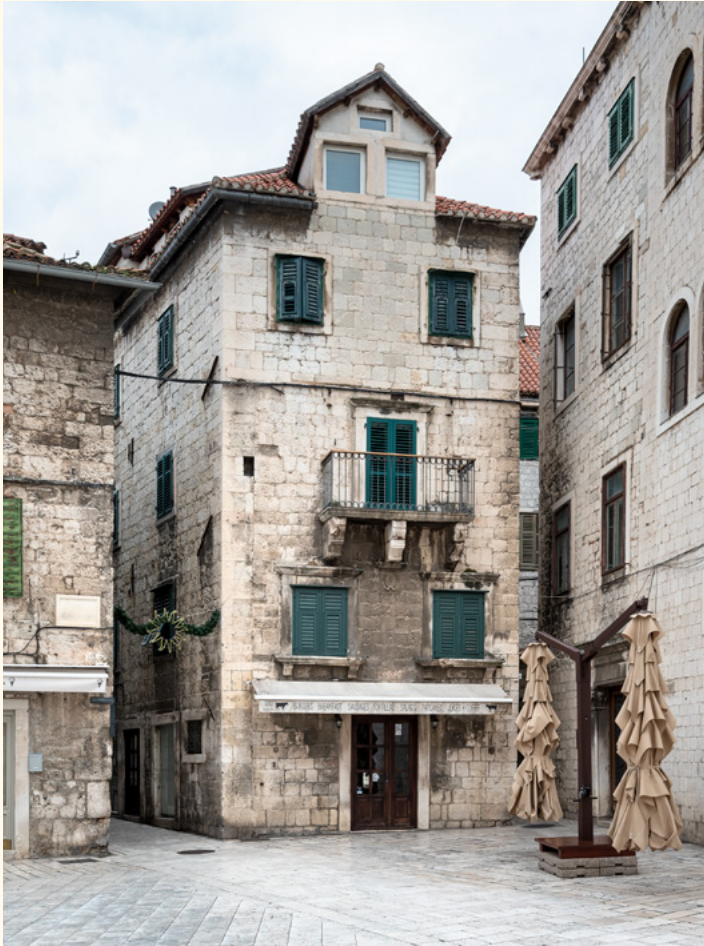
The Štambuk House: an example of the 18th century patrician house (Lj. Gamulin)

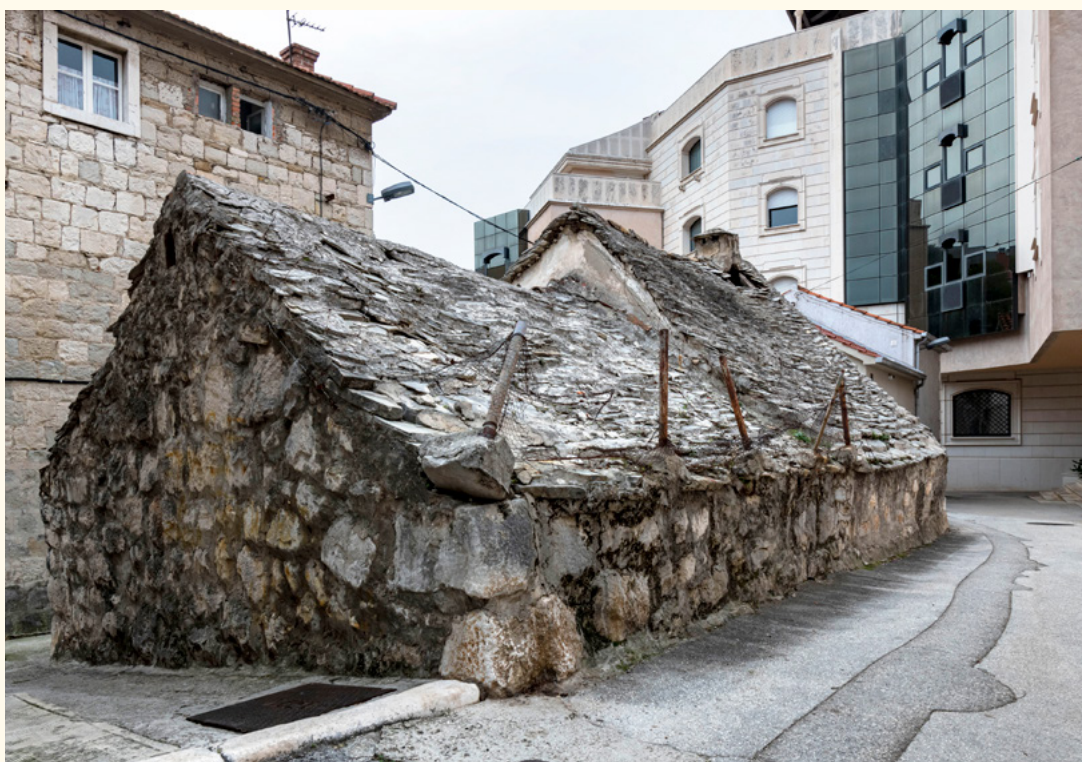
Traditional Stone House

The traditional stone houses first appeared in the Middle Ages, outside of the present-day protected Zone A. In the majority of cases, they are detached, single-storey buildings, without elements of style. Their walls are built of broken stone or rubble and they are roofed with stone slabs or barrel tiles. The floor below is the cellar, and the upper floor is the living floor. The two floors are connected by an exterior staircase with the *balatura*, which shelters the cellar entrance. Today, they can be seen in the protected Zone B, in the areas of Varoš, Dobri and Lučac.

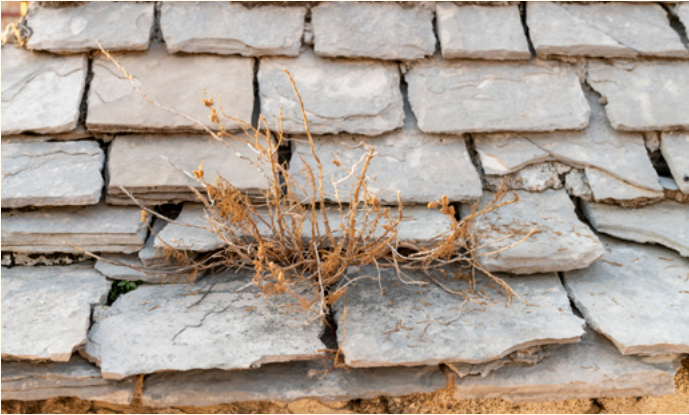
Detail of the stone roof (P. Gamulin)

The traditional roofs have luminaries (openings), chimneys, gently curved eaves, and a characteristic angle of inclination (from 30 to 45 degrees). Their specific shape gives authenticity to the overall picture of the old city core. The roof frames are commonly made of softwood. The prevailing shapes are ridge roof and ridge roof with end hips. The traditional roofing materials are stone slabs and barrel clay tiles (pan and cover tiles). Stone slabs are made by splitting surface parts of limestone rock along bedding planes into thin sheets. These slabs are generally laid on steep roof frames. The eaves slabs, which are placed first, are set in lime mortar. Then the rest of the slabs are laid, without use of mortar. Stone roofs are whitewashed to protect the stone material from rainwater and the heat of the sun. Today, the majority of stone roofs are replaced with clay tile roofs (barrel tiles), which were introduced in the 15th century.

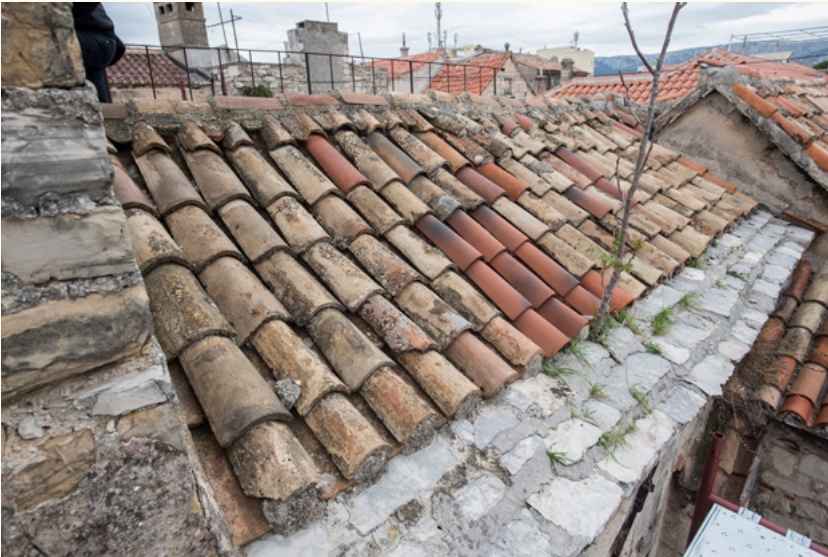
Detail of the roof containing remains of the old stone roofing and the new barrel tiles (N. Vasić)

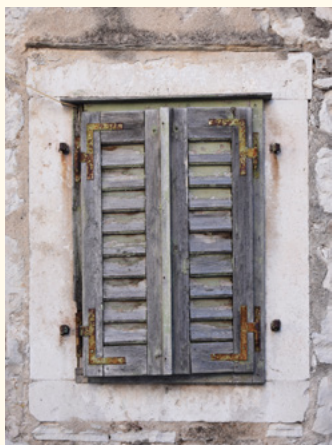
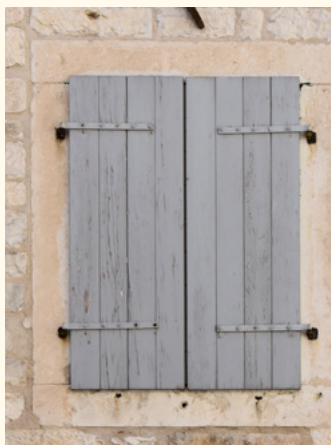
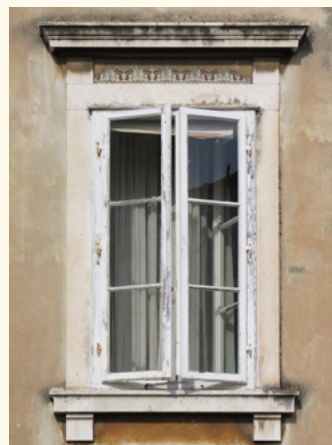
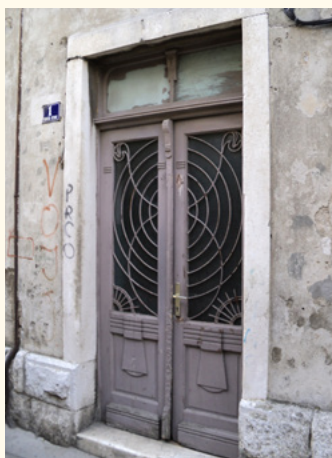
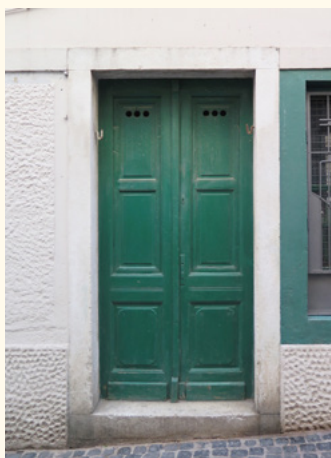
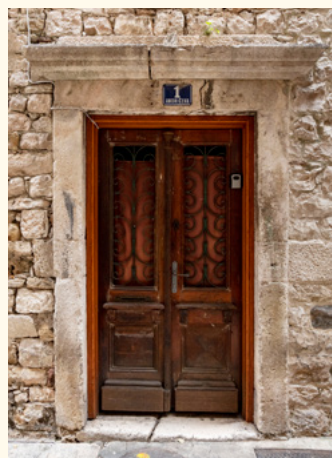
Doors and Windows

Stone door and window frames are the elements that contribute most to the overall impression of a façade. In the historic core of Split their appearance, shape and decoration depend on the period in which they were made and the capacity of the owner. Today, in the streets of Split, one can see a wide variety of such frames. They frame windows, whose shapes ranges from simple, to mullioned, to coupled, to round and horseshoe arch windows. The same applies to doors, which can be simple openings, doors with lunettes and arched doors. There is also the P-shaped (*“na koljeno”*) door with a window, which, although appertaining to the same group, makes a case apart. This type of door with round top developed in the residential architecture of main streets and squares. Introduced in the 13th century, it served as the shop front door. Its specific design allowed the sunlight to penetrate to the depth of the shop, making possible the display of goods inside it. Due to its practicality and functionality, the P-shaped frame was used as late as the 19th century.

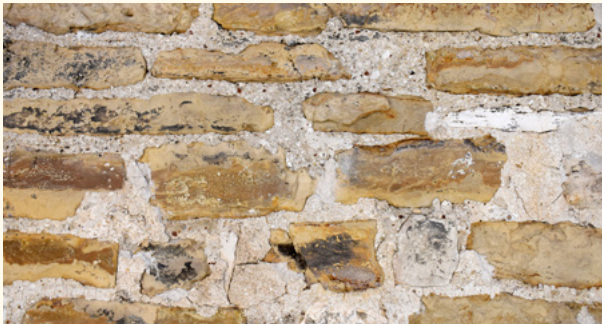
Detail of the wall made of sedimentary rocks – flysch (V. Marinković)

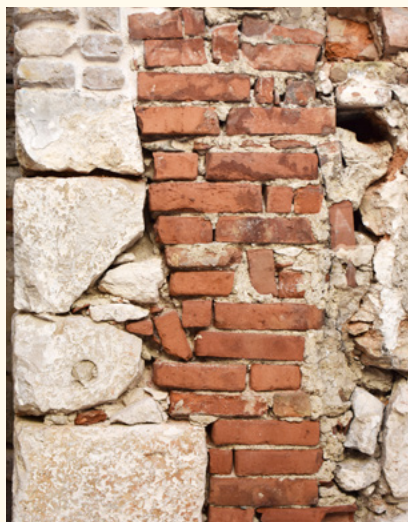
Detail of brick and stone masonry (V. Marinković)

Brick is the common material of masonry construction. Bricks are made of clay. They are formed, dried and fired. They are usually cuboidal in shape. Their dimensions and thickness depend on the mould, while their colour depends on the composition of clay and the method of firing. Bricks are used to build pavements, chimneys and vaults. It is important to stress that clay roof tiles are also a type of brick. In the city core of Split, the traditional roof tiles are hemicylindrical in shape (barrel tiles). In later times, they were replaced with different shapes of industrially manufactured tiles.
